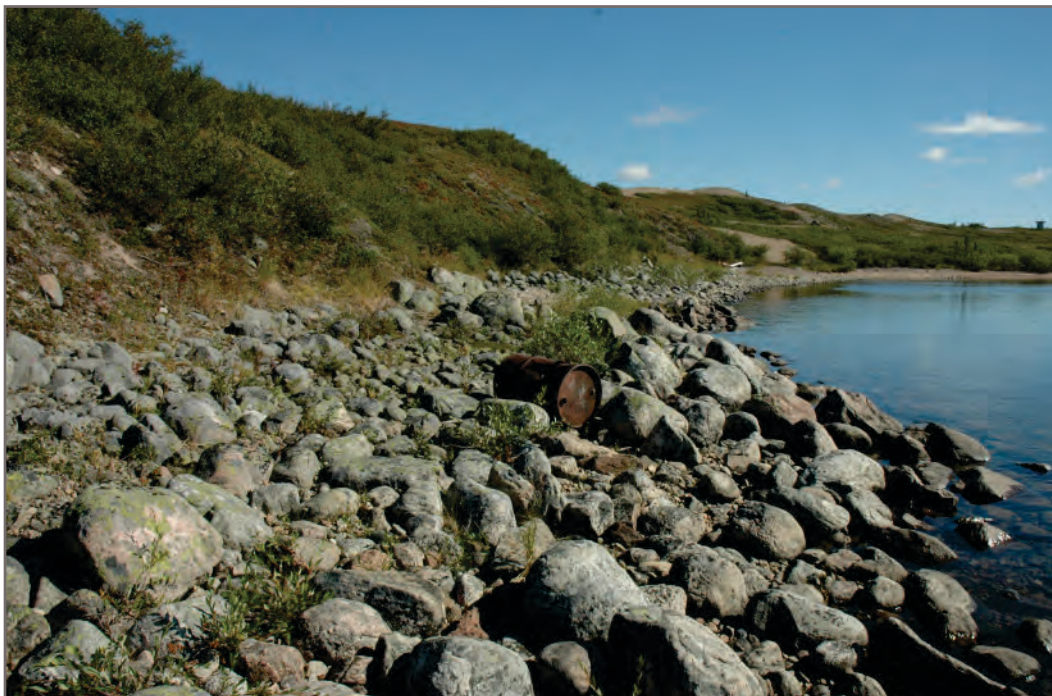
**Photo E-27:** APEC 29 - Shoreline - Various empty barrels were found around the Site; there was no staining or odour noted

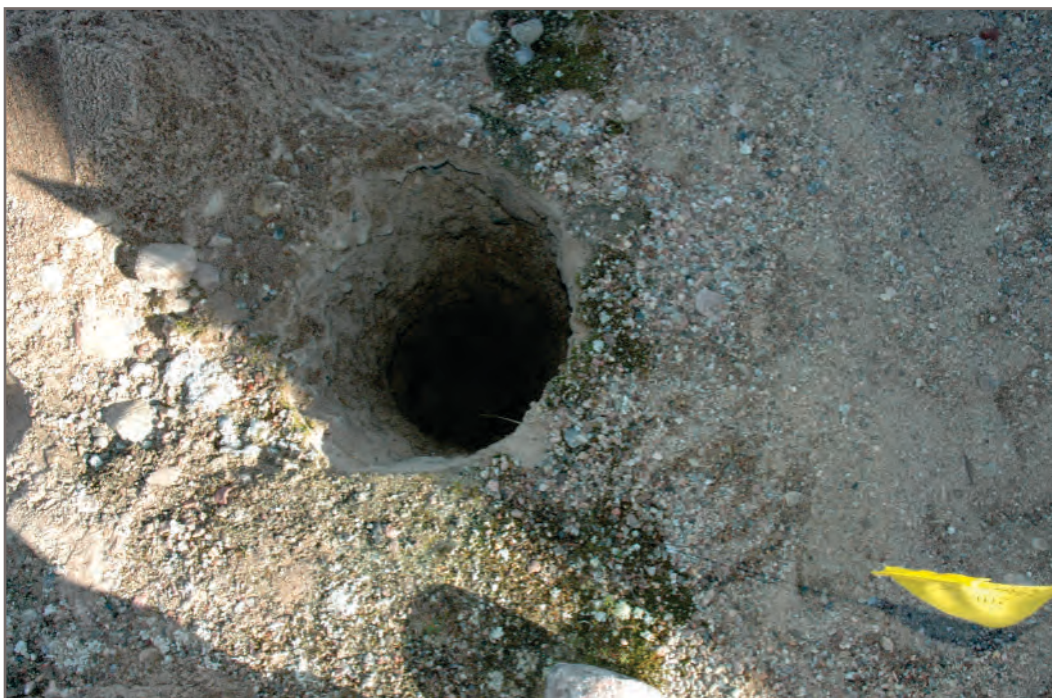
**Photo E-28:** General Soil Condition taken at APEC 12 - Sand with an estimated 5 - 10% cobbles, located at the toe of APEC 12

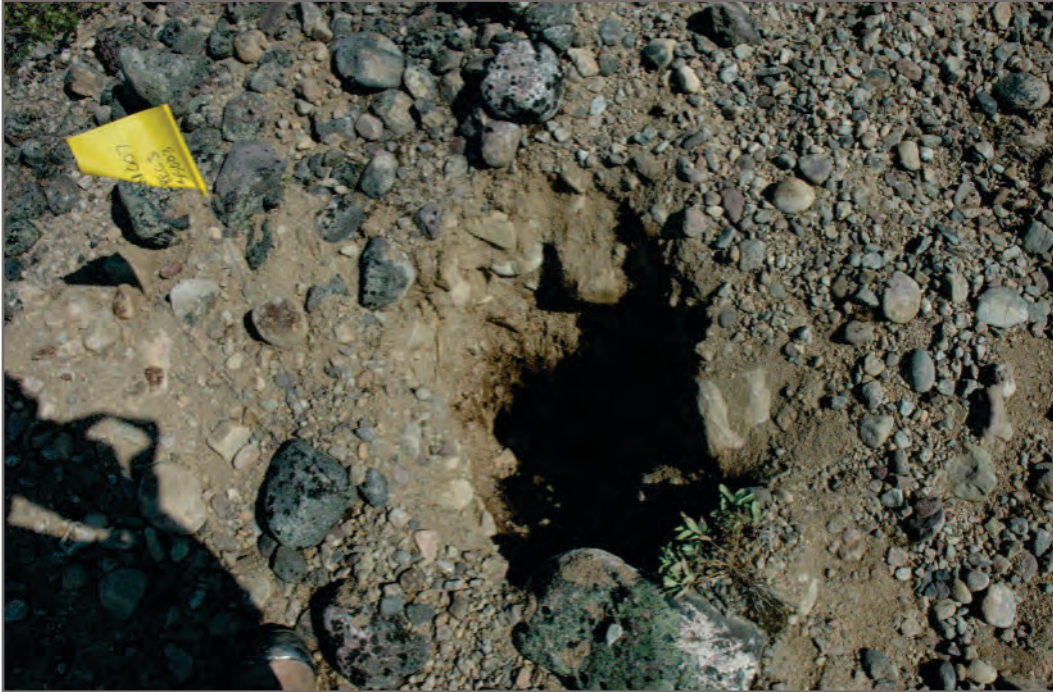
**Photo E-29:** General Soil Condition at APEC 3 - Sand with an estimated 10 - 20 % cobbles and gravel at terminal extent of pipeline near Stain 3

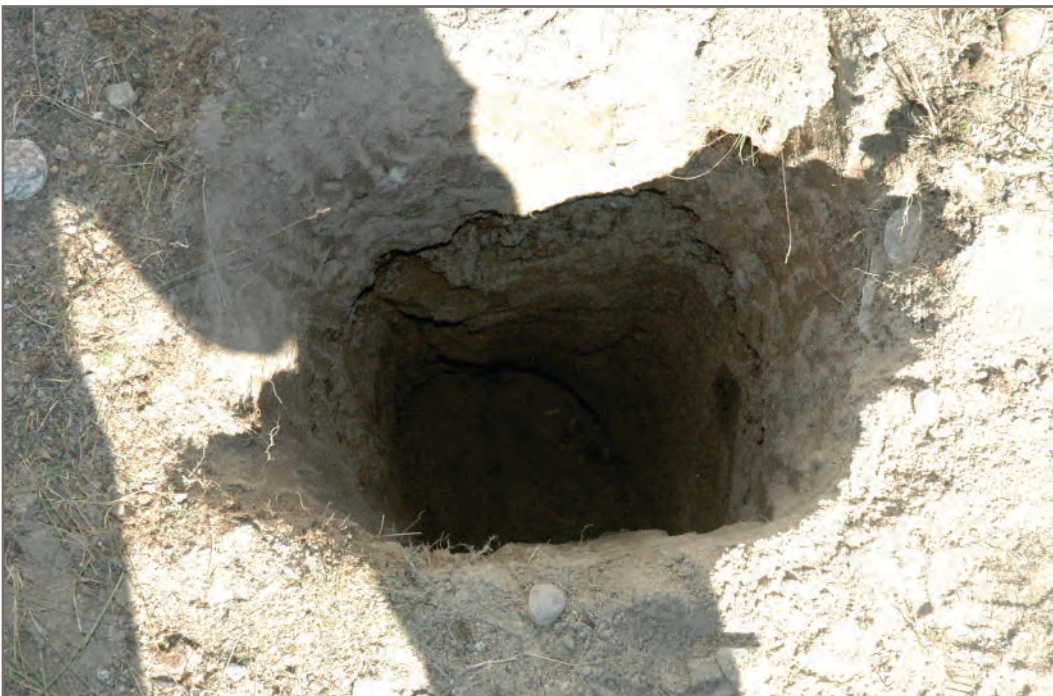
**Photo E-30:** General Soil Condition at APEC 13 (Central Buildings) - Well sorted sand with some gravel

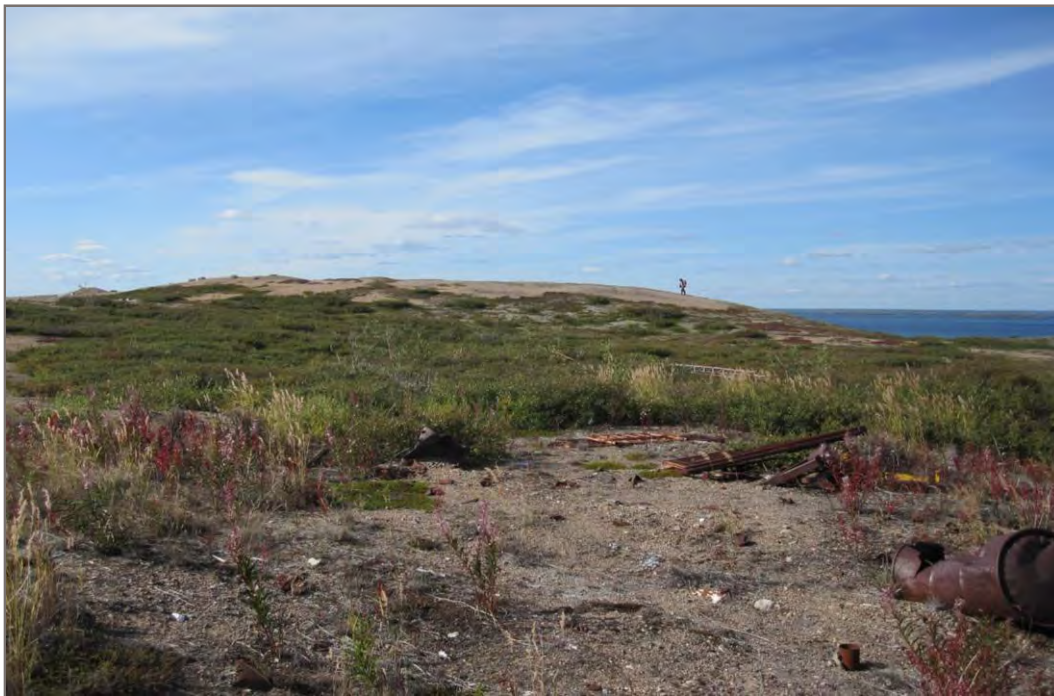
**Photo G12:** Borrow 1 in the background, with debris in Landfill 2 in the foreground, looking north northwest.

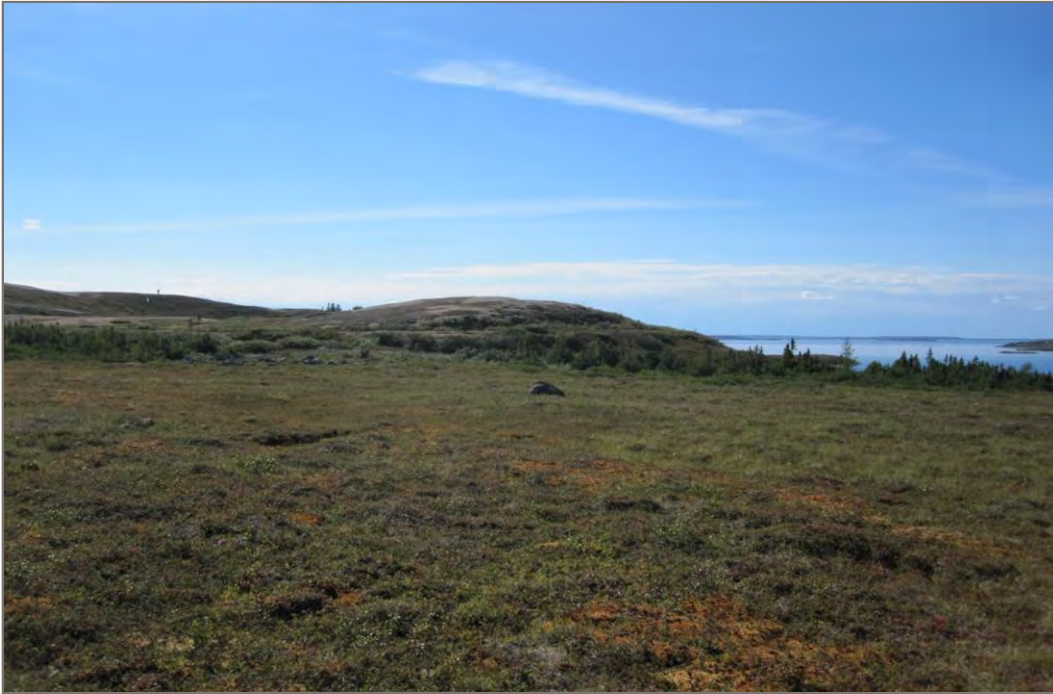
**Photo G13:** Borrow 1, with organic deposit in the foreground, looking southwest.

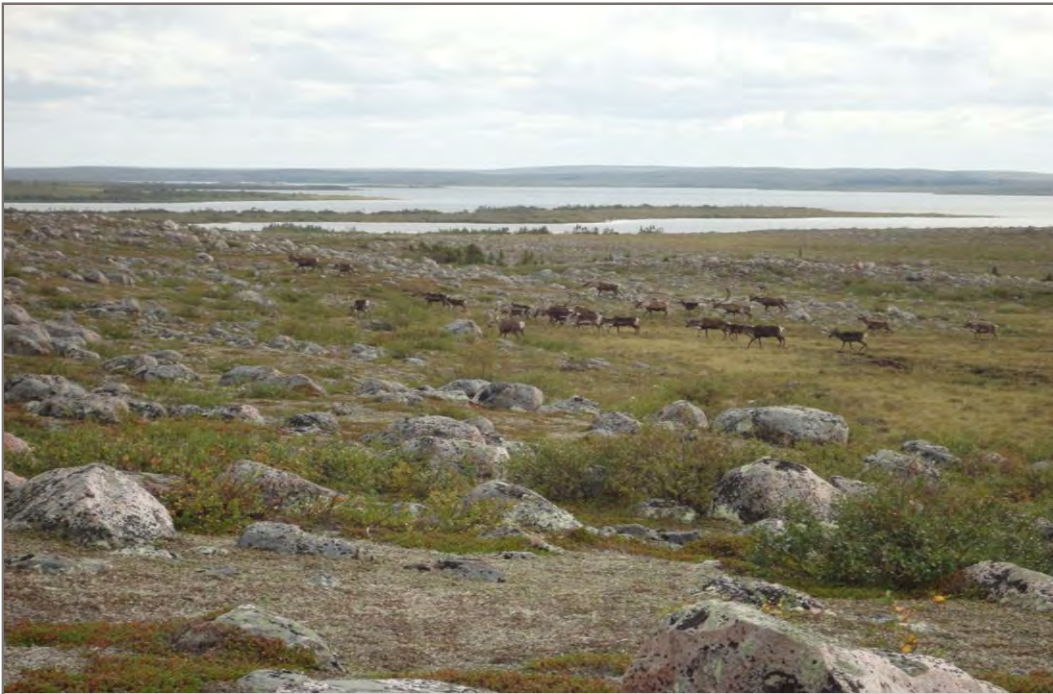
**Photo G28:** Borrow 7, southern extent, showing gentle side slopes and adjacent organic deposits, looking southeast.

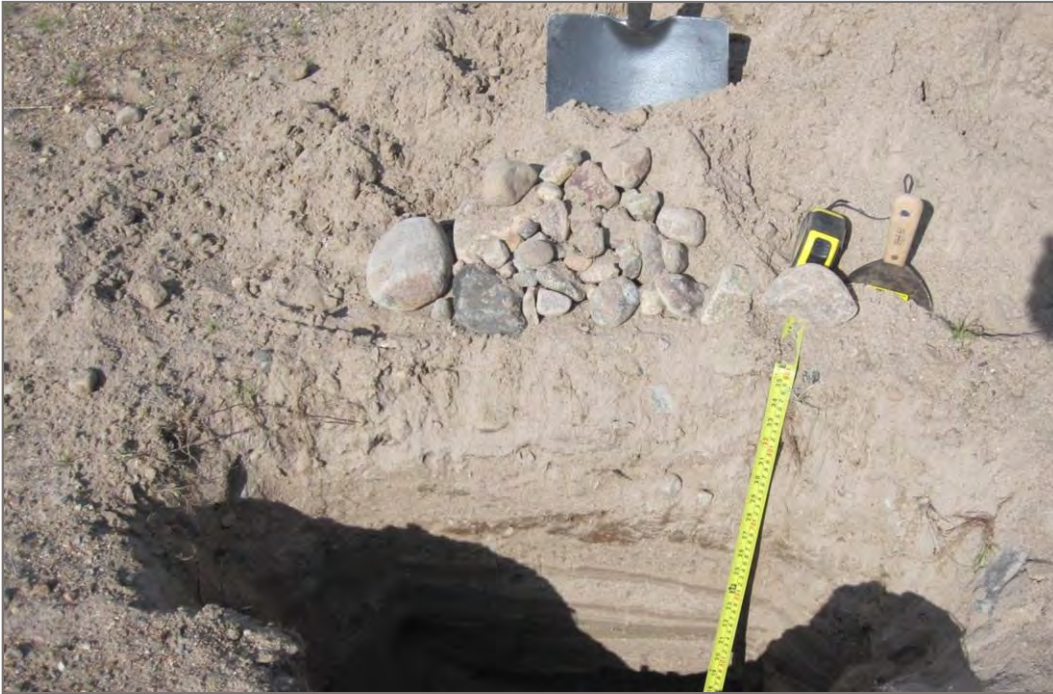
**Photo G35:** Potential Landfill 2 - Testpit (TP04), showing subrounded gravel removed from testpit.
