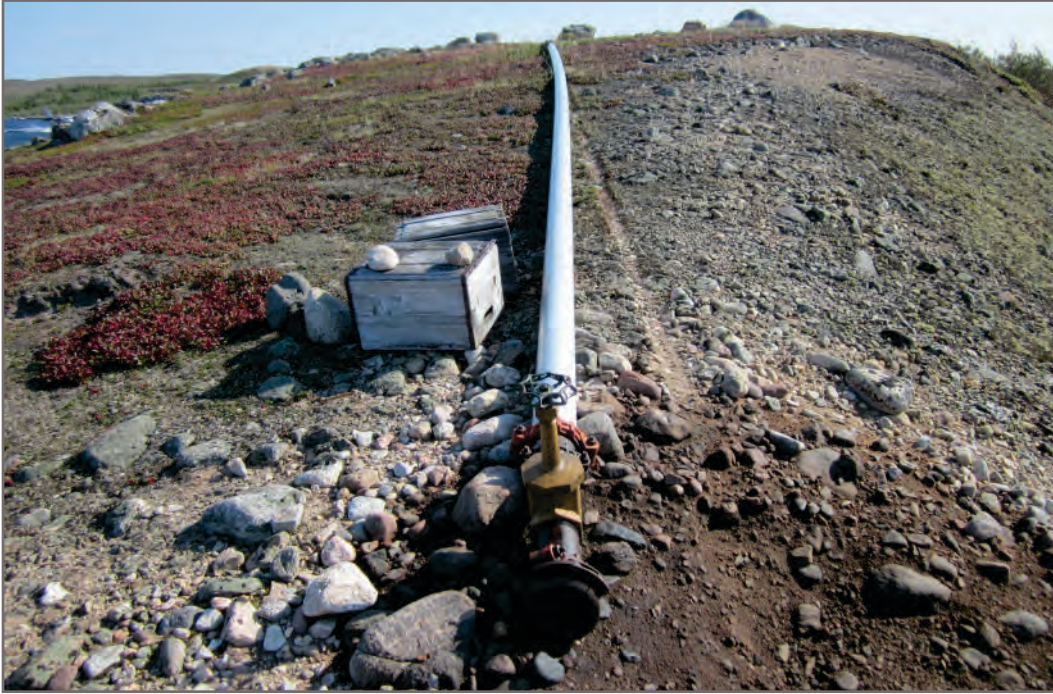
Photo H-1: APEC 3 – Stain 3 – Organic content remaining in the pipeline

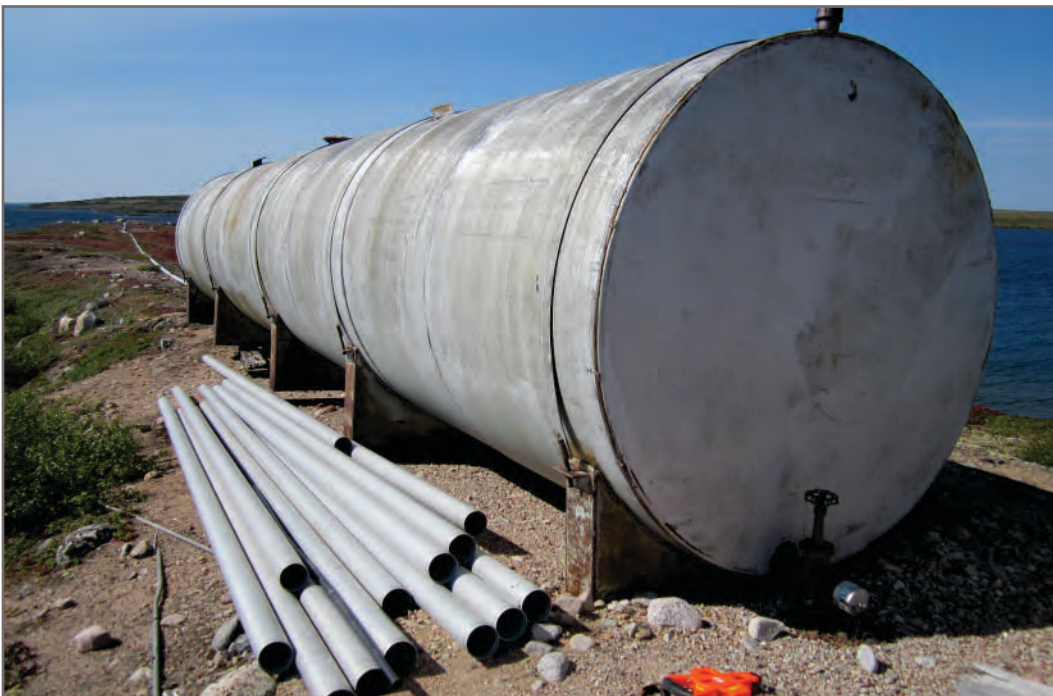
Photo H-2: APEC 4 - Tank 5 (42000L) - Organic content remaining in Tank 5

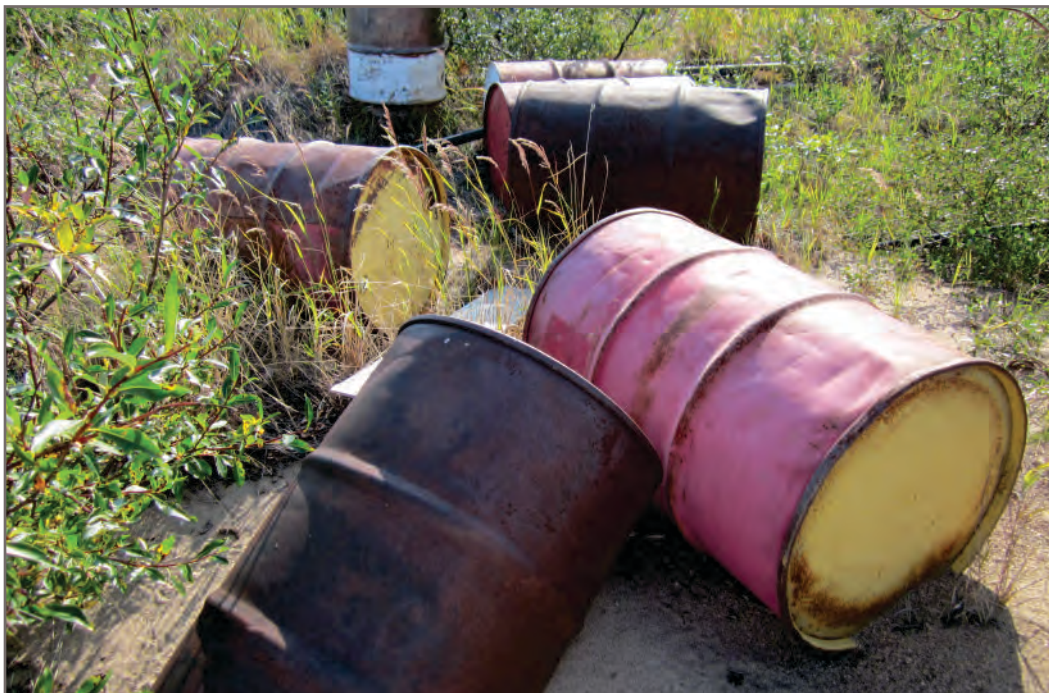
Photo H-3: APEC 5 - Drums (Located on the shore of Ennadai Lake) - Total and leachable lead painted drums

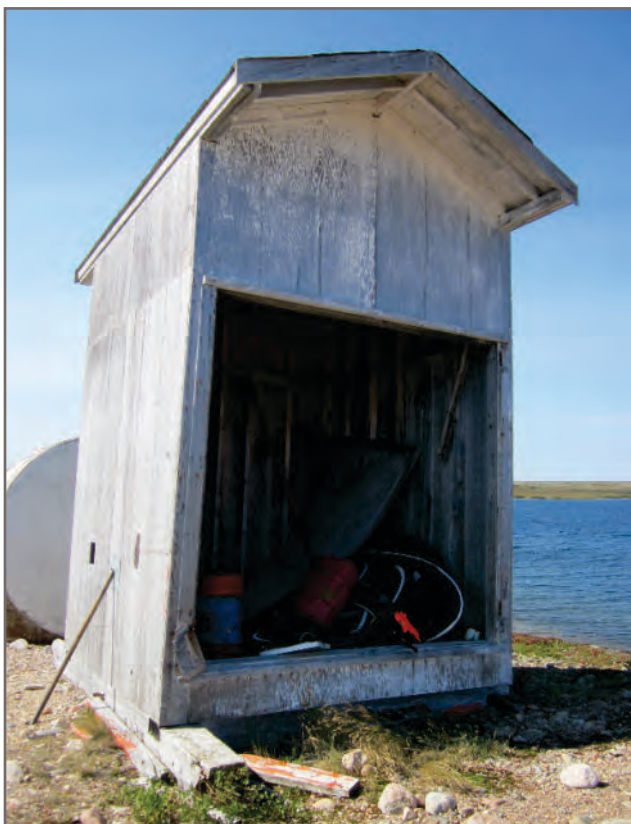
Photo H-4: APEC 6 - Medium Cabin - Asbestos black felt, total lead and leachable lead painted wood exterior and drums and lubricants

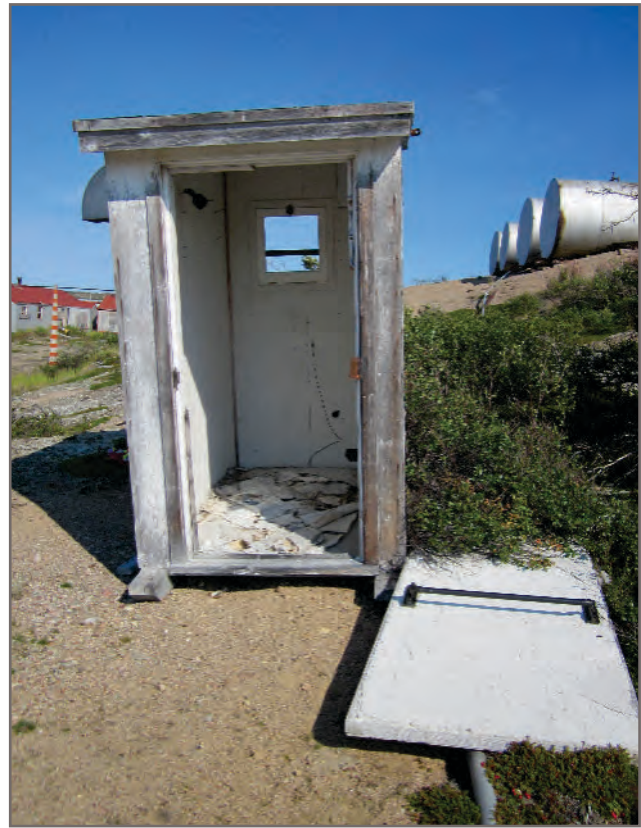
Photo H-5: APEC 7 - Small Cabin - Asbestos black felt and panels, and total and leachable painted wood

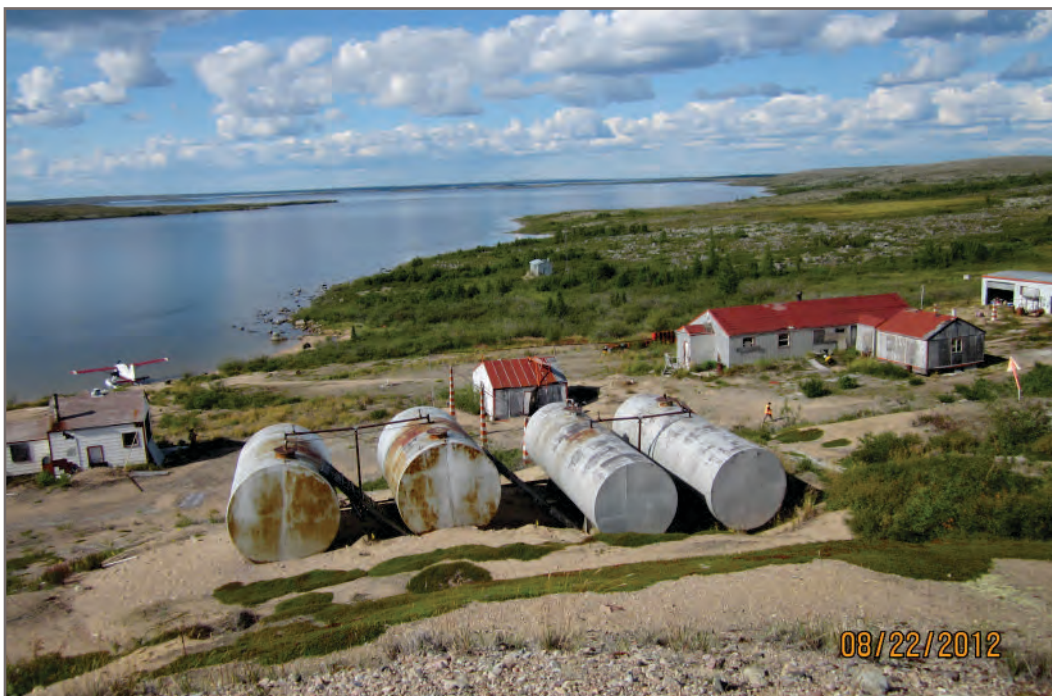
Photo H-8: APEC 9 - 12 - Tanks 1-4 - View looking west, Tank 1 on the far right and Tank 4 is on the far left; asbestos gaskets on all tanks and organic content in all tanks, except for Tank 3

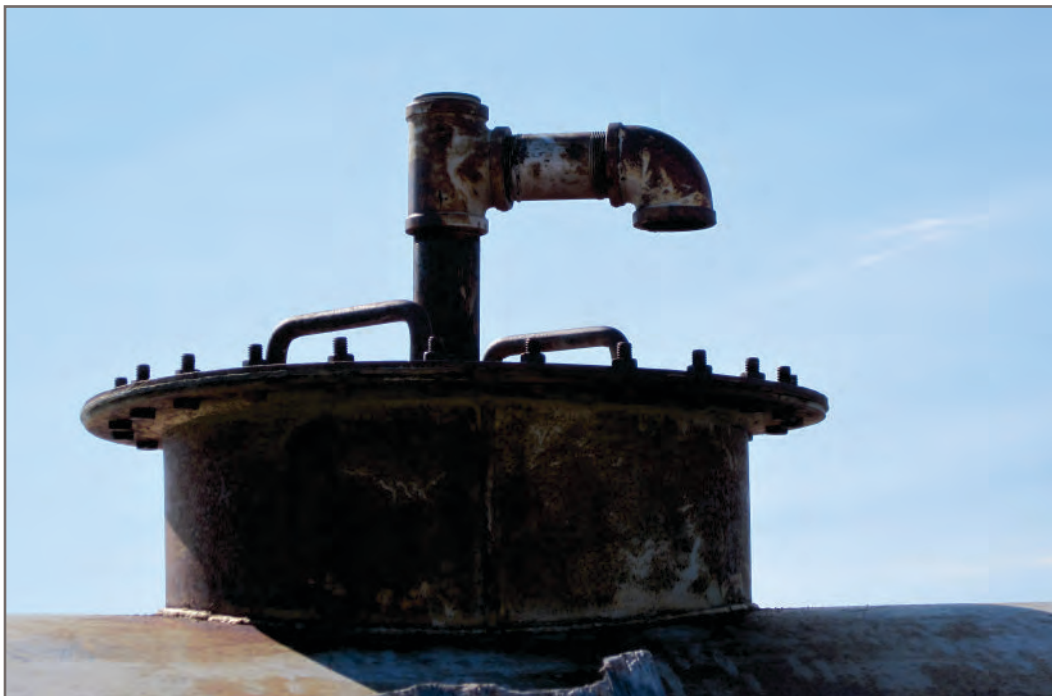
Photo H-9: APEC 9 - Tank 1 - Close-up of asbestos gasket

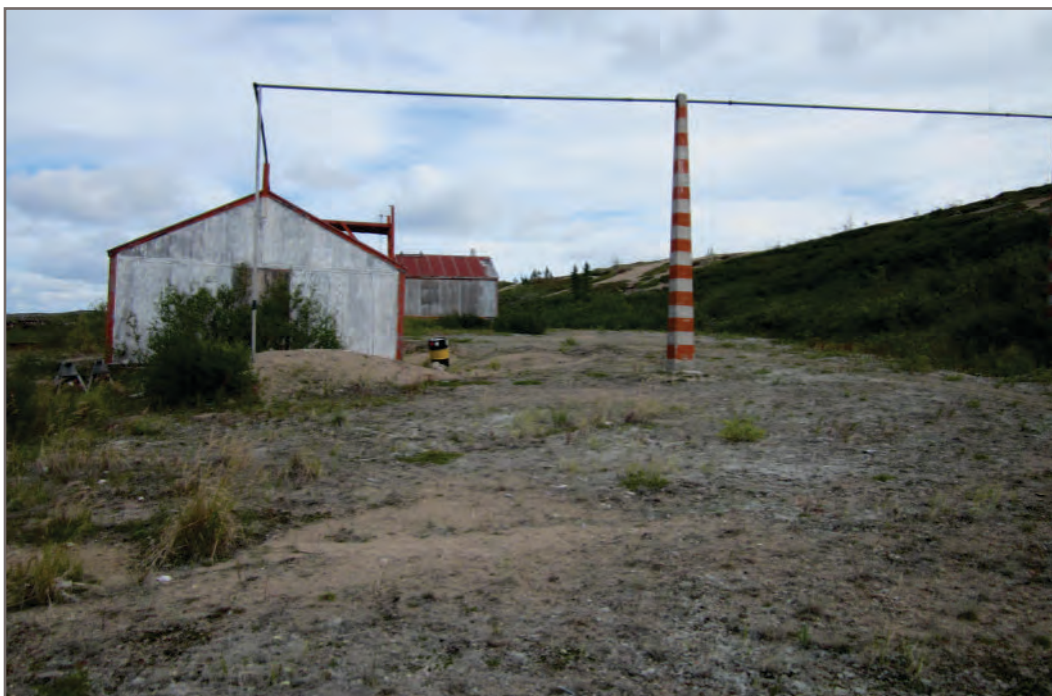
Photo H-10: APEC 13 - Overhead piping from tanks to Buildings - View of overhead piping towards Building 3; total and leachable lead painted concrete and organic content in pipeline

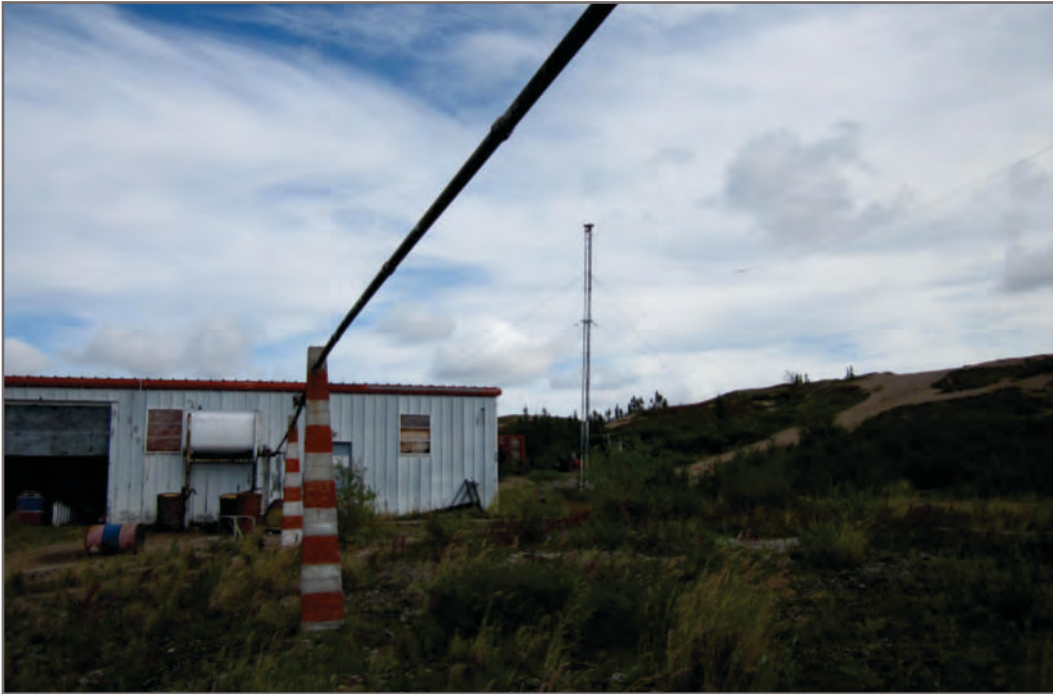
Photo H-11: APEC 13 - Overhead piping from tanks to Building - View of overhead piping towards Building 2; total and leachable lead painted concrete and organic content in pipeline

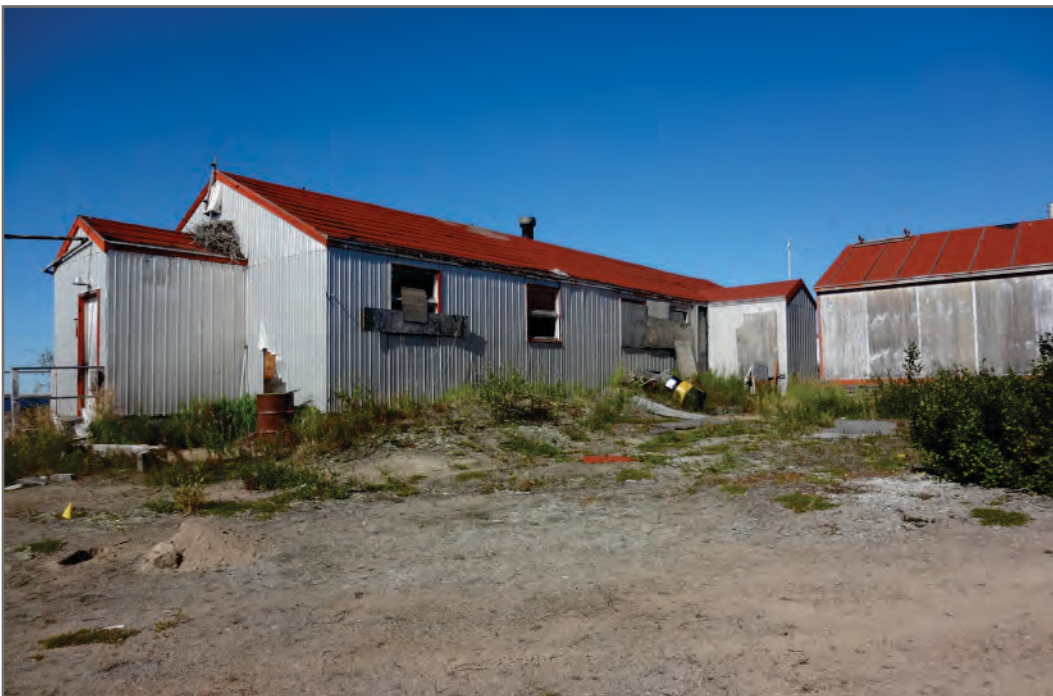
Photo H-12: APEC 14 - Building 1 - Asbestos black felt, asbestos window caulking, total and leachable lead painted wood

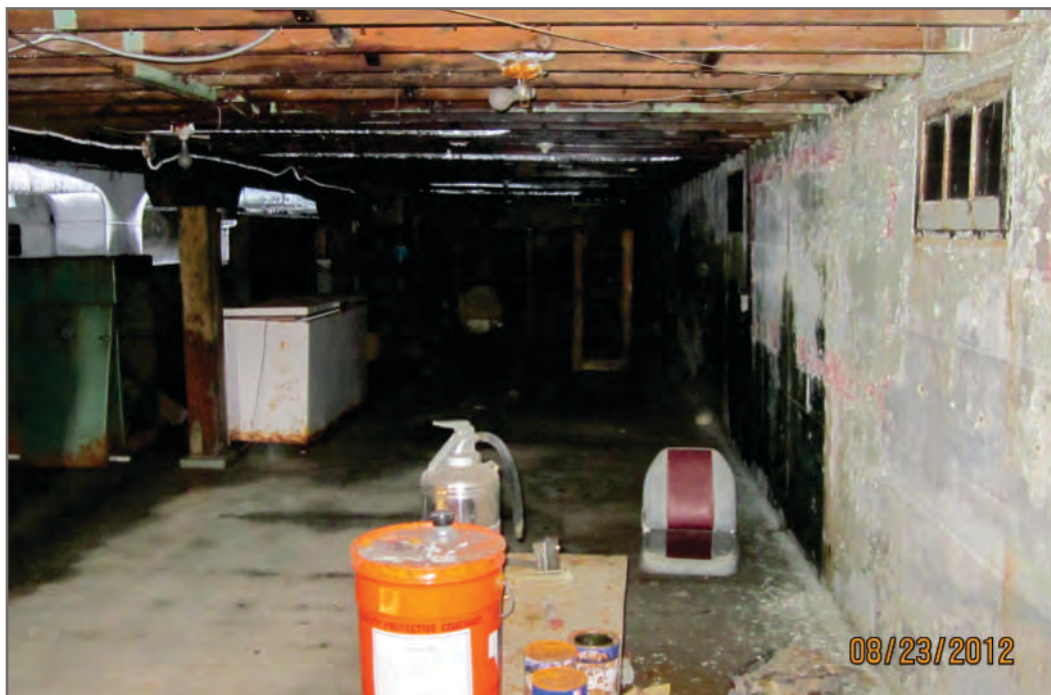
Photo H-13: APEC 14 - Building 1 - Basement total lead and leachable lead painted concrete walls, miscellaneous chemicals, ODS in freezer, mould on wood beams and concrete

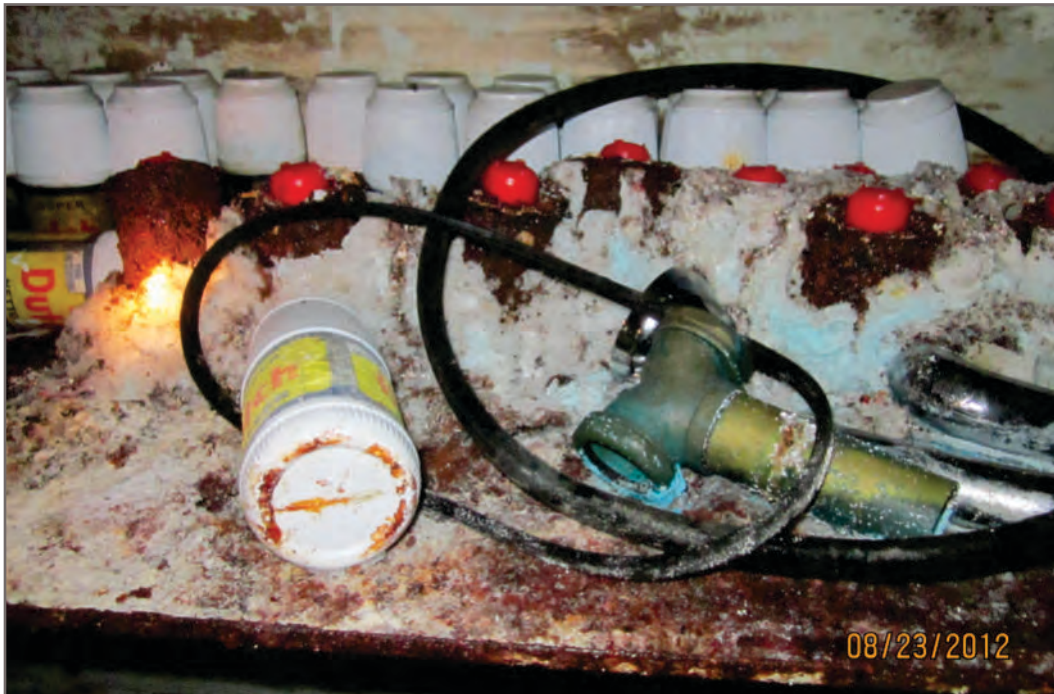
Photo H-15: APEC 14 - Building 1 - Basement unknown crystallized white material (possibly a cleaning product)

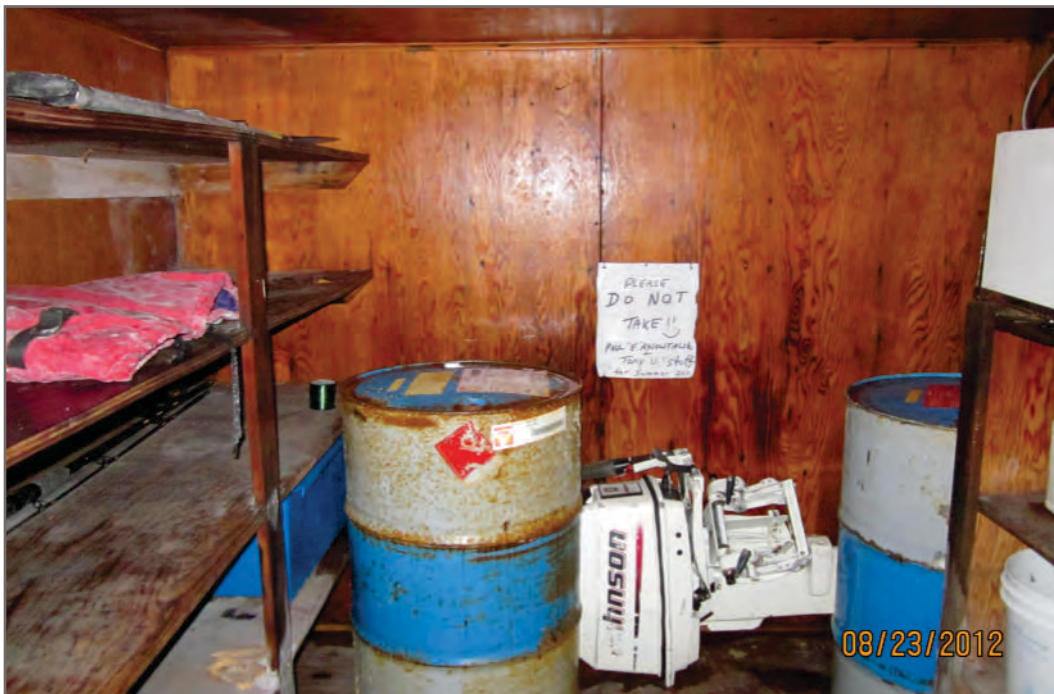
Photo H-16: APEC 14 - Building 1 - Basement two drums and jerry cans, assumed to be full of diesel, new, labelled: Paul Anowtalik and Tony V's property

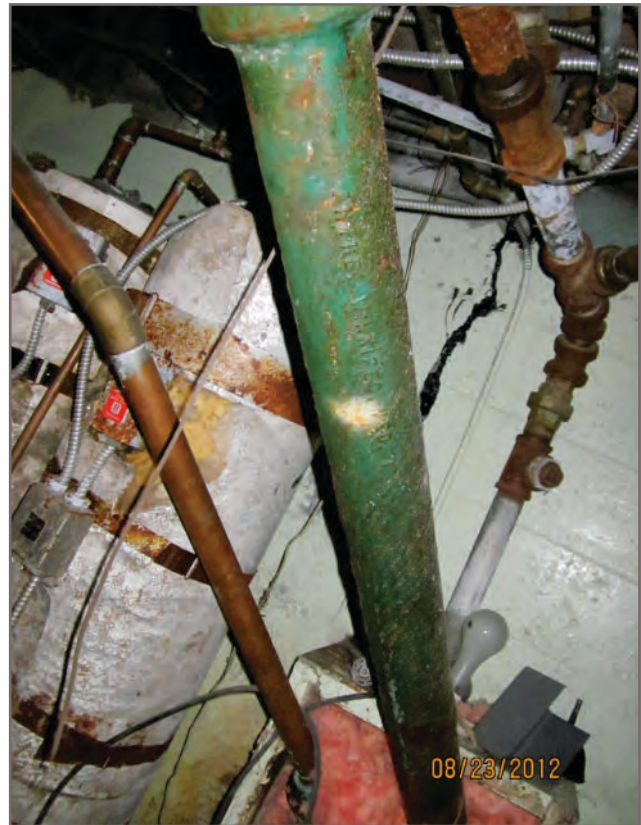
Photo H-17: APEC 14 - Building 1 - Leachable lead seals on cast iron piping and tanks behind

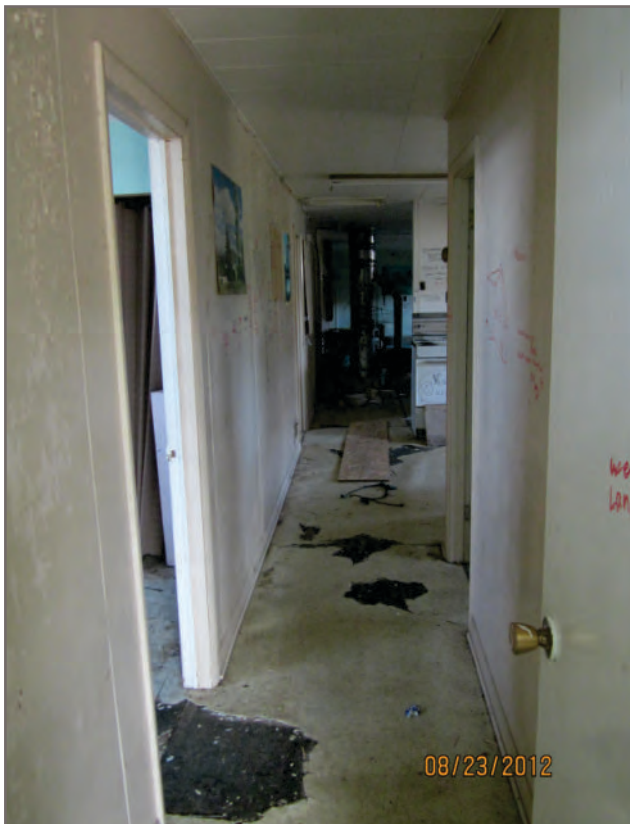
Photo H-18: APEC 14 - Building 1 - Main floor hallway, viewing northeast; asbestos flooring wall panels and ceiling, total lead and leachable lead painted asbestos panels on walls and second layer of ceiling particulate board

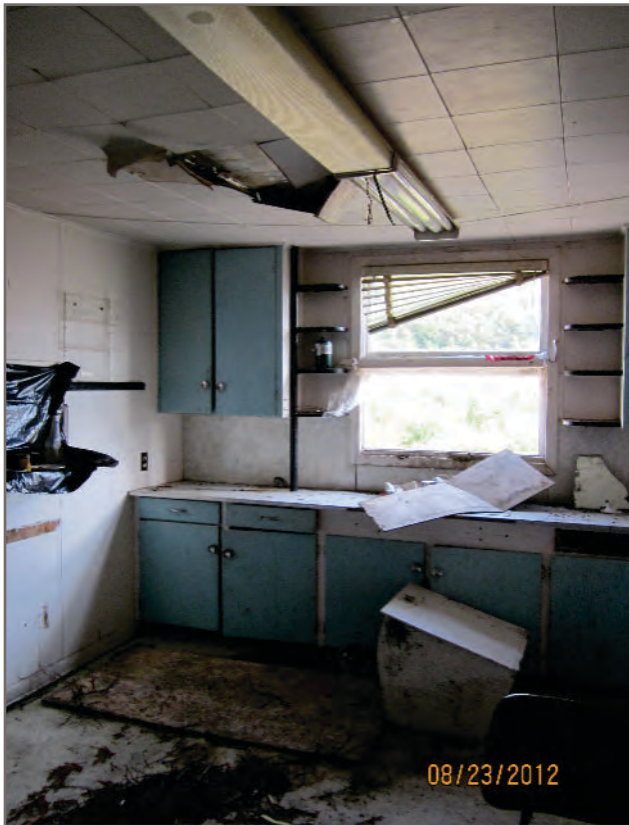
Photo H-19: APEC 14 - Building 1 - Main floor kitchen; asbestos flooring, wall panels and ceiling, total lead and leachable lead painted wood shelves, mercury vapor in lights and PCBs in light ballasts

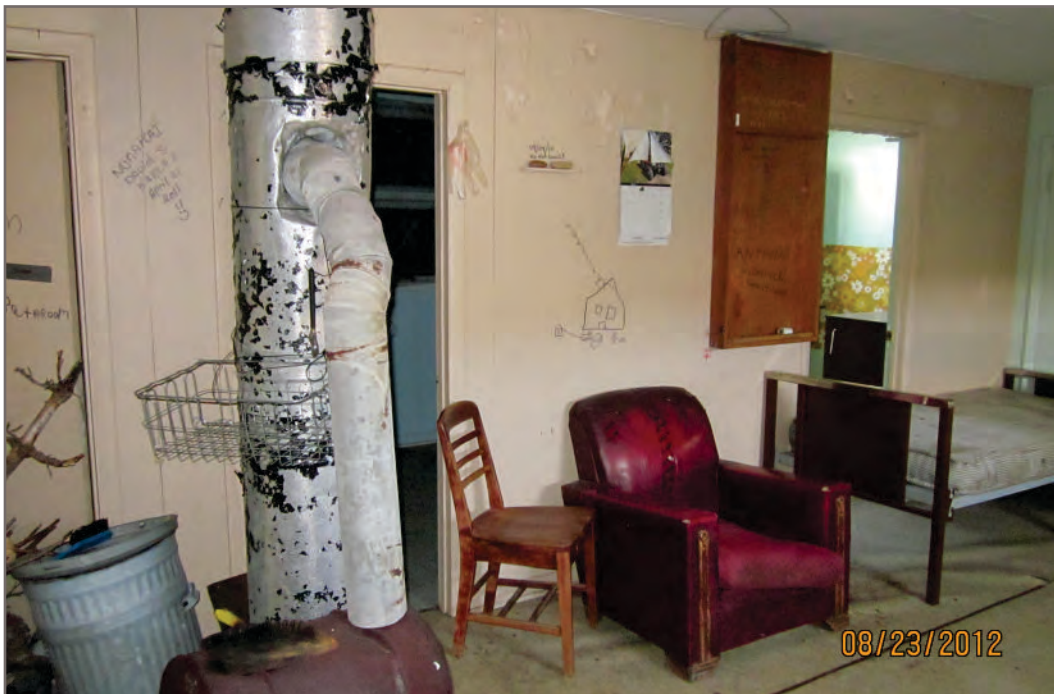
Photo H-20: APEC 14 - Building 1 - Main floor living room and bedrooms; asbestos flooring, wall panels and ceiling

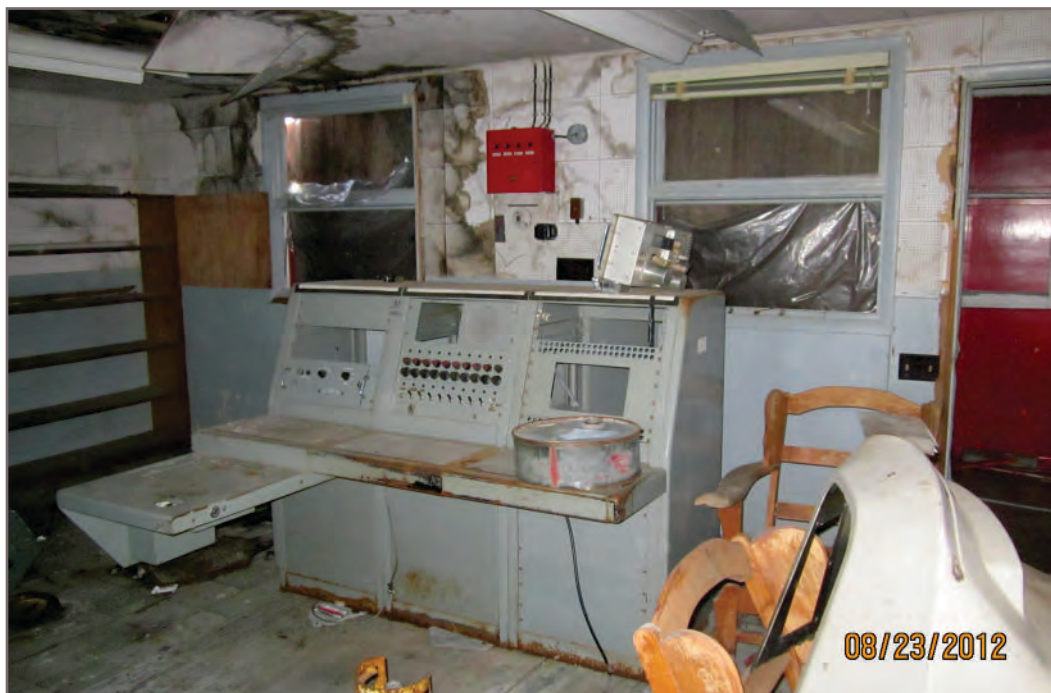
Photo H-21: APEC 14 - Building 1 - Main floor control desk; asbestos walls and ceiling, PCBs, mercury and lead solder in electrical parts

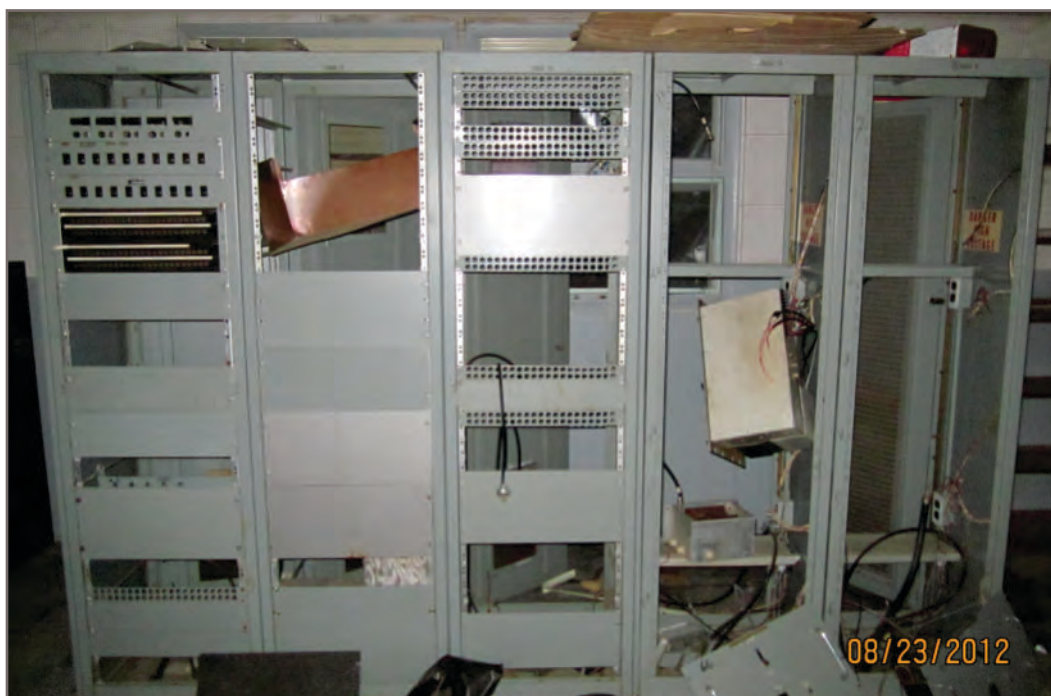
Photo H-22: APEC 14 - Building 1 - Main floor electrical box. Asbestos walls and ceiling, PCBs, mercury and lead solder in electrical parts.

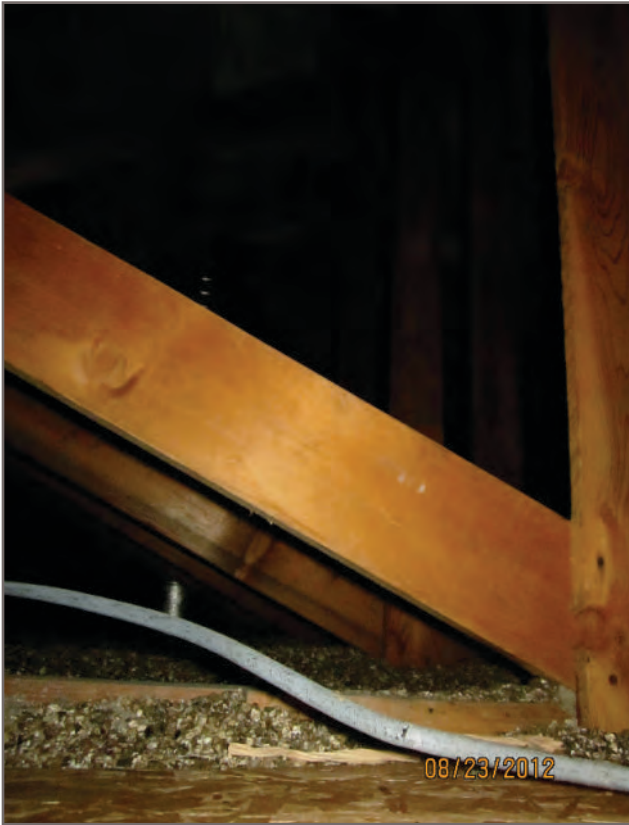
Photo H-23: APEC 14 - Building 1 -
Asbestos attic insulation

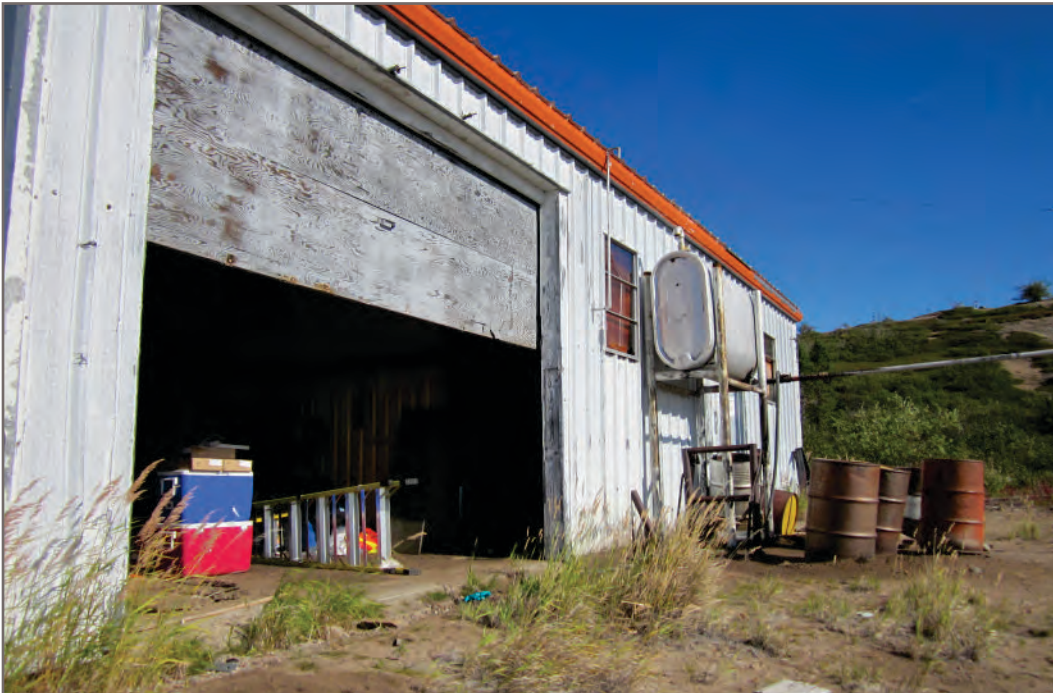
Photo H-24: APEC 15 - Building 2 - Asbestos black felt, asbestos window caulking, total and leachable lead painted wood, organic content in the AST and drum

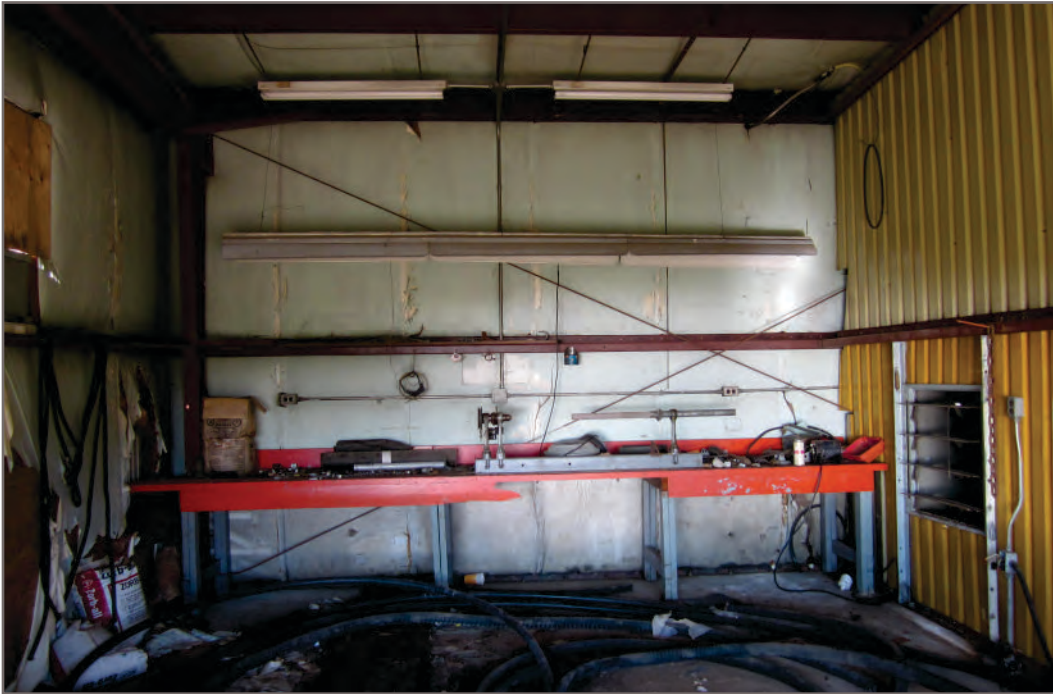
Photo H-25: APEC 15 - Building 2 - Northwest half of building; total lead and leachable lead painted metal walls, ceiling and concrete floor, mercury in lights and PCBs in light ballasts

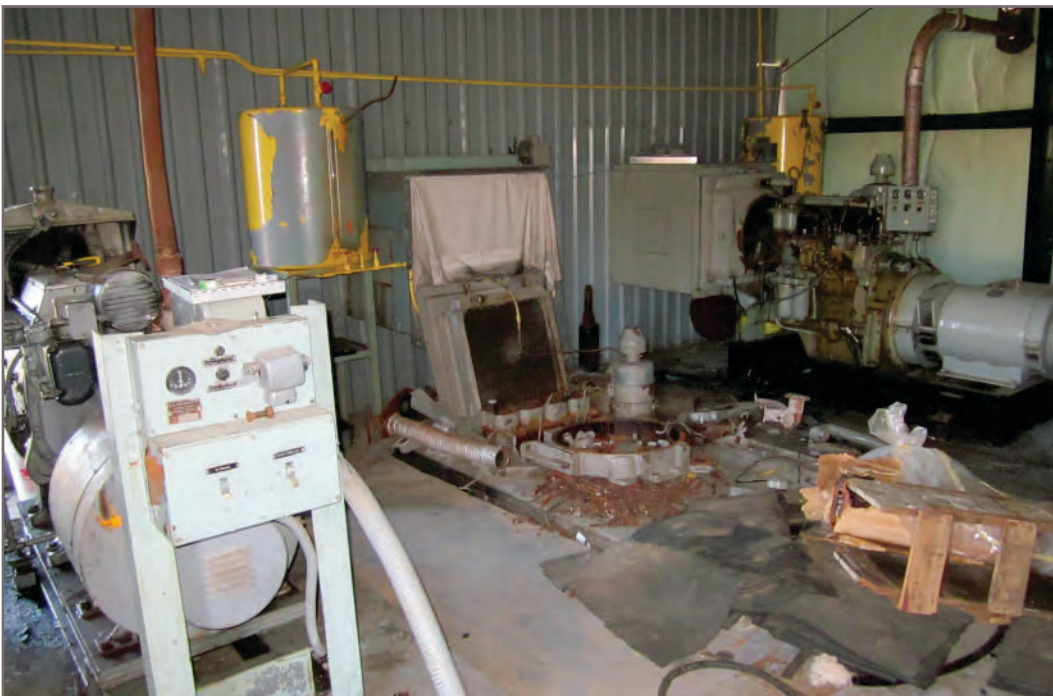
Photo H-26: APEC 15 - Building 2 - Total lead, leachable lead and PCBs painted generators, total lead, leachable lead and PCBs painted plastic over fiberglass insulation, ceiling and concrete floor miscellaneous fluids in generators and lead acid batteries

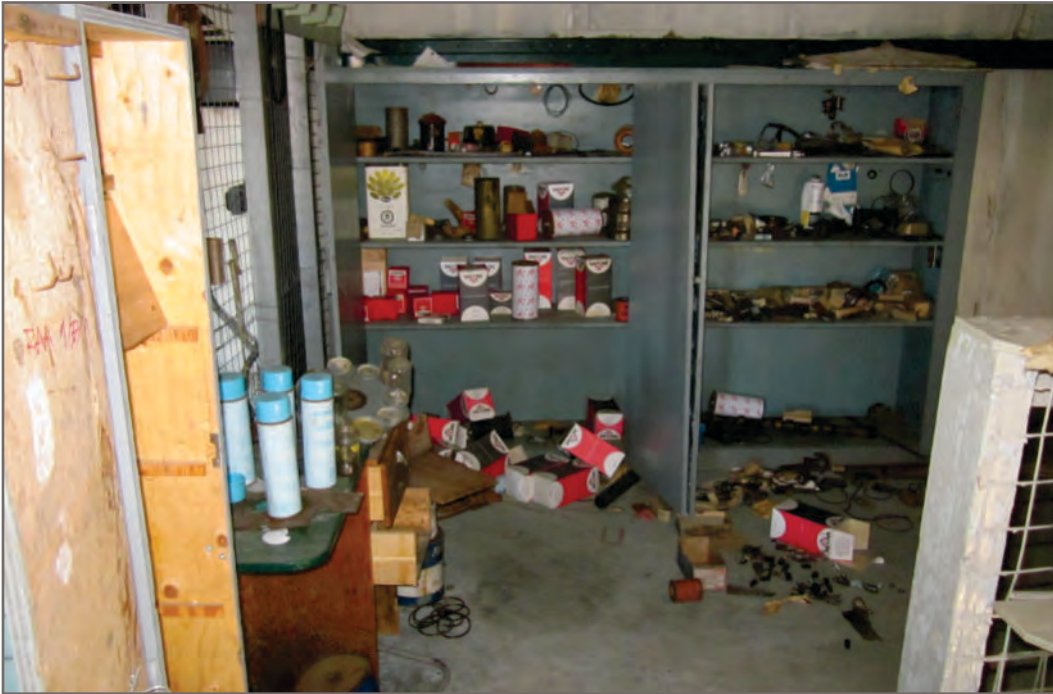
Photo H-27: APEC 15 - Building 2 - Miscellaneous chemicals, total lead and leachable lead painted metal walls, ceiling and concrete floor

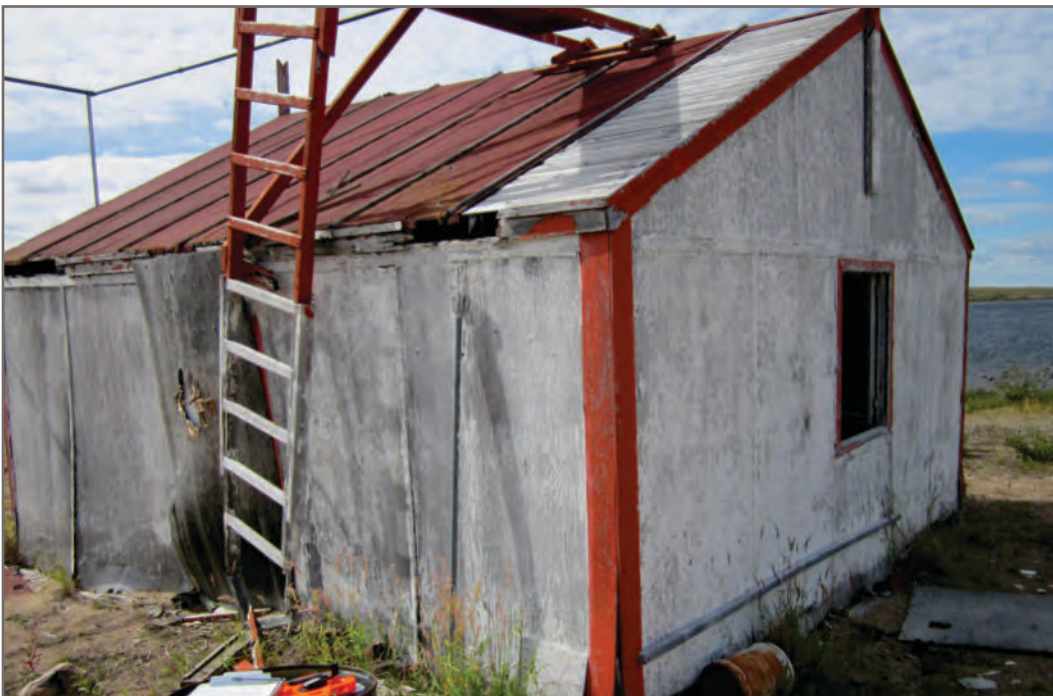
Photo H-28: APEC 16 - Building 3 - Asbestos black felt, attic insulation, window caulking and total lead and leachable lead painted wood

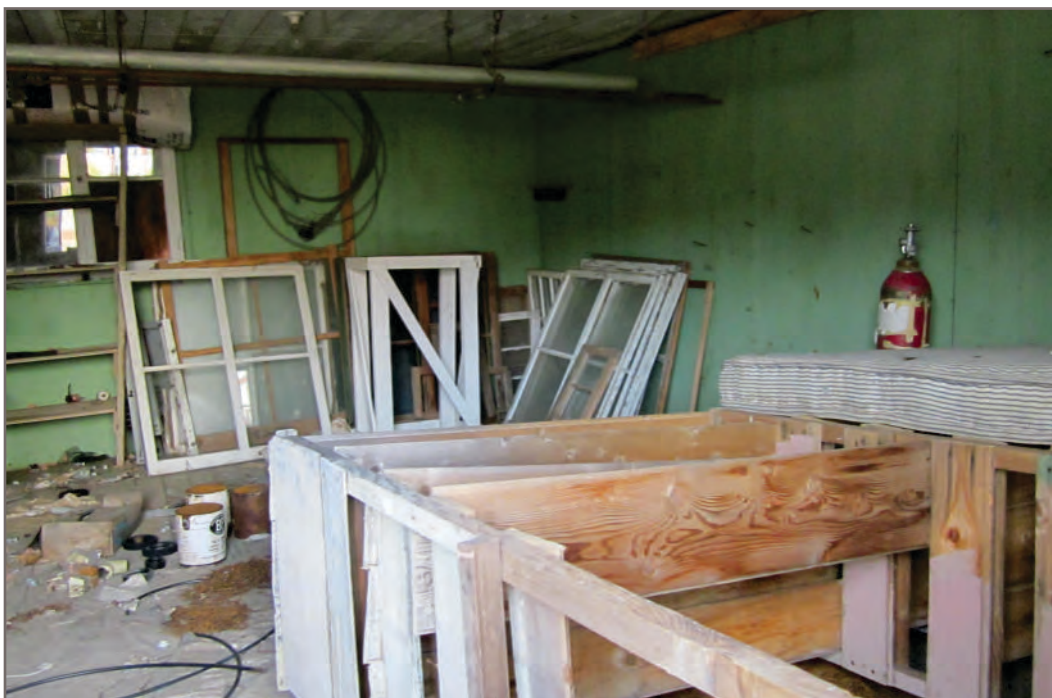
Photo H-29: APEC 16 - Building 3 - Total lead and leachable lead painted wood and compressed gas cylinder

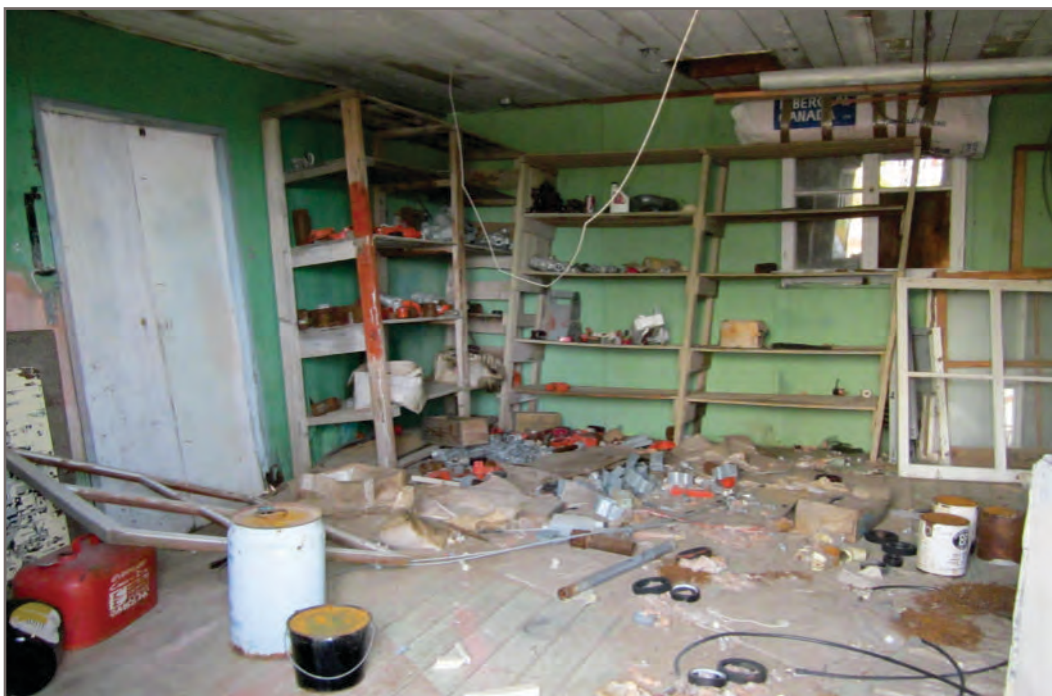
Photo H-30: APEC 16 - Building 3 - Total lead and leachable lead painted wood and miscellaneous containers of oil/lubricants/fuel

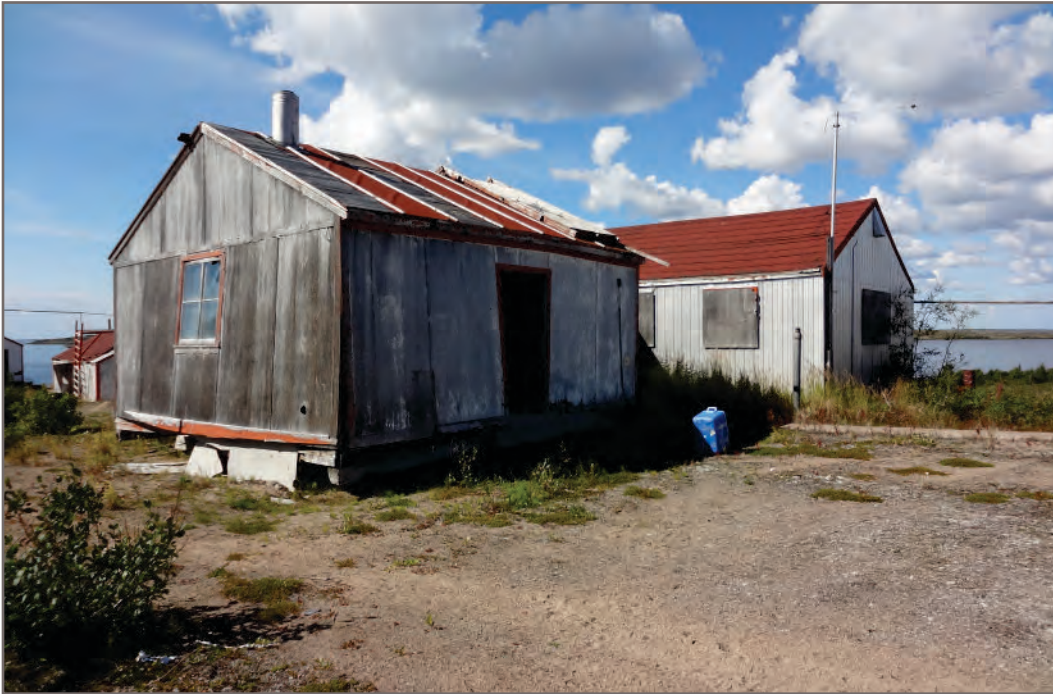
Photo H-31: APEC 17 - Building 4 - Asbestos black felt, attic insulation, window caulking, walls panels and total lead and leachable lead painted wood

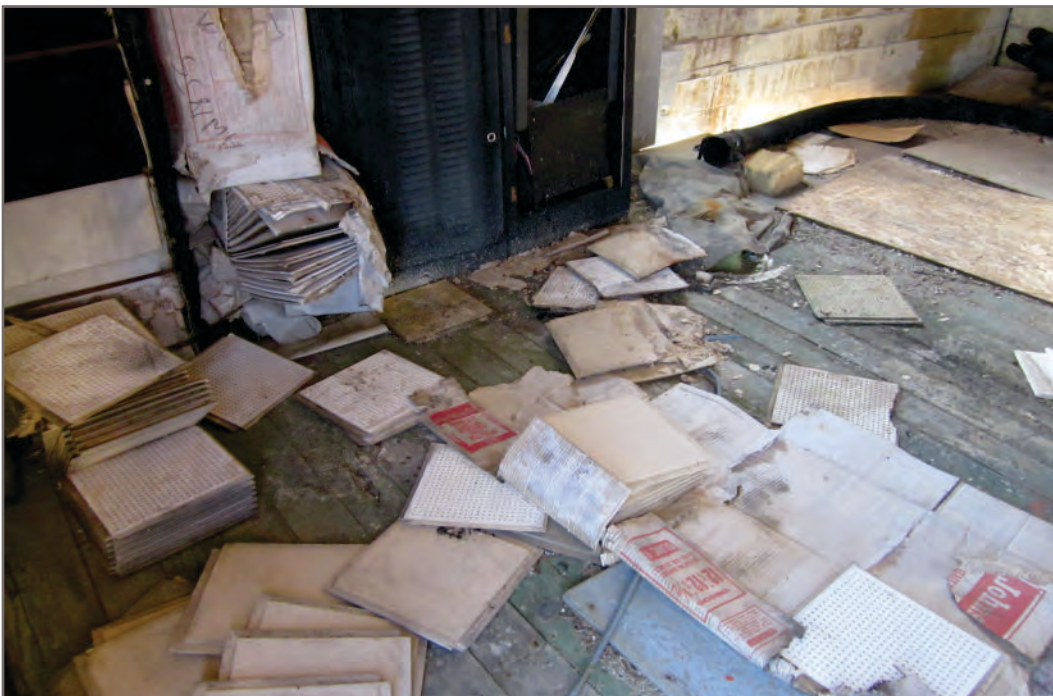
Photo H-32: APEC 17 - Building 4 - Asbestos chimney tile and ceiling tile, and total lead and leachable lead painted wood

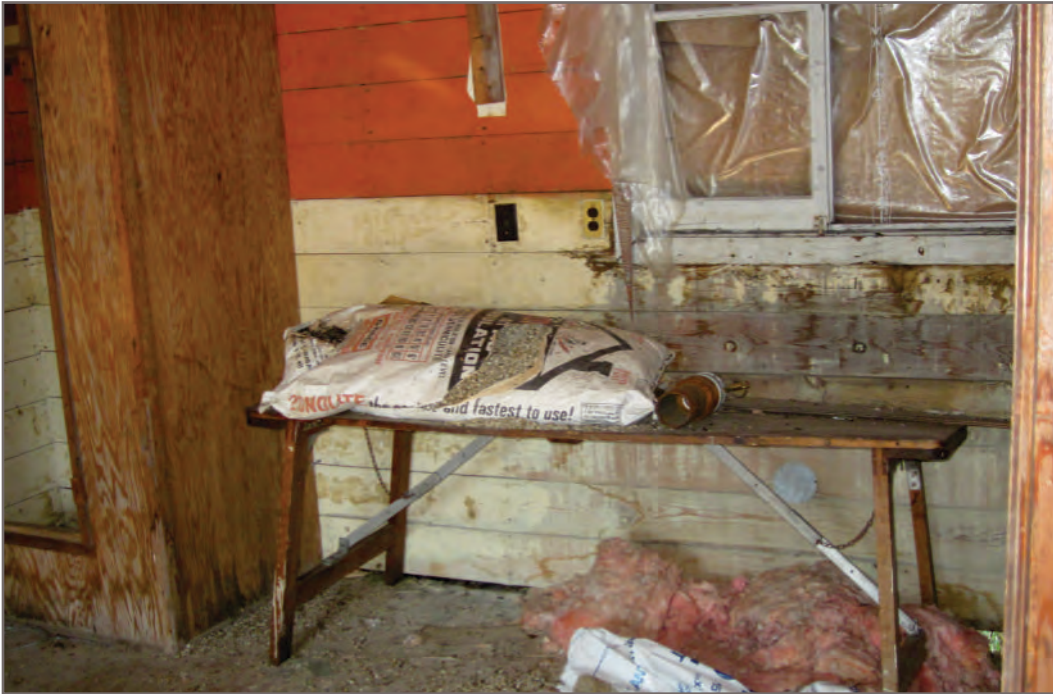
Photo H-33: APEC 17 - Building 4 - Asbestos insulation, and total lead and leachable lead painted wood

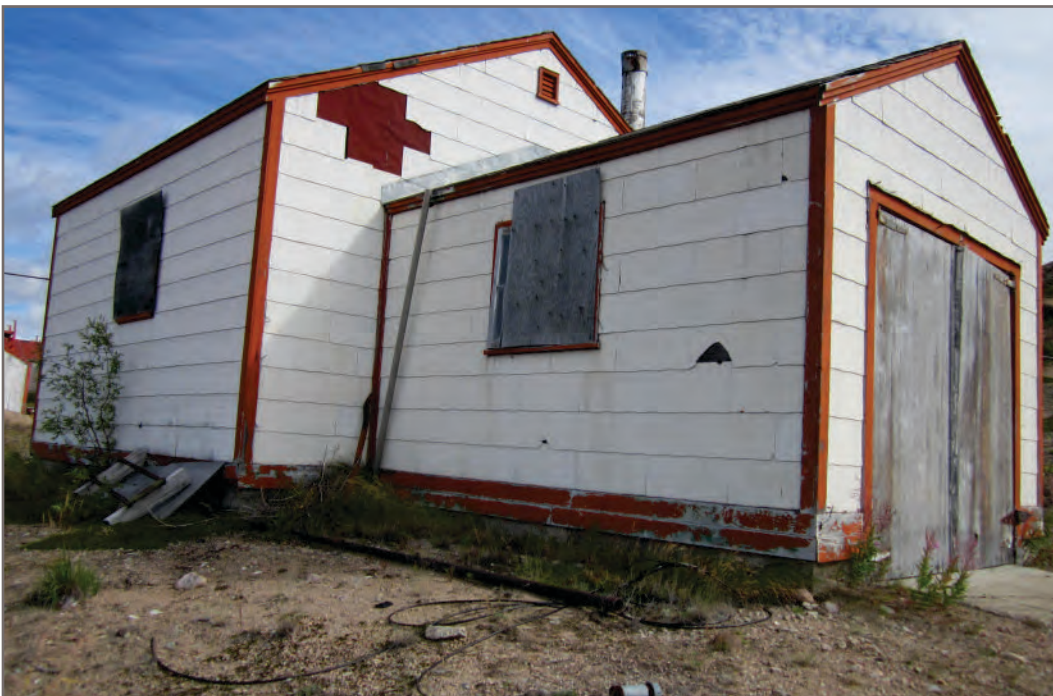
Photo H-34: APEC 18 - Building 5 - Asbestos exterior panels, black felt, attic insulation, window caulking, and total lead and leachable lead painted wood
