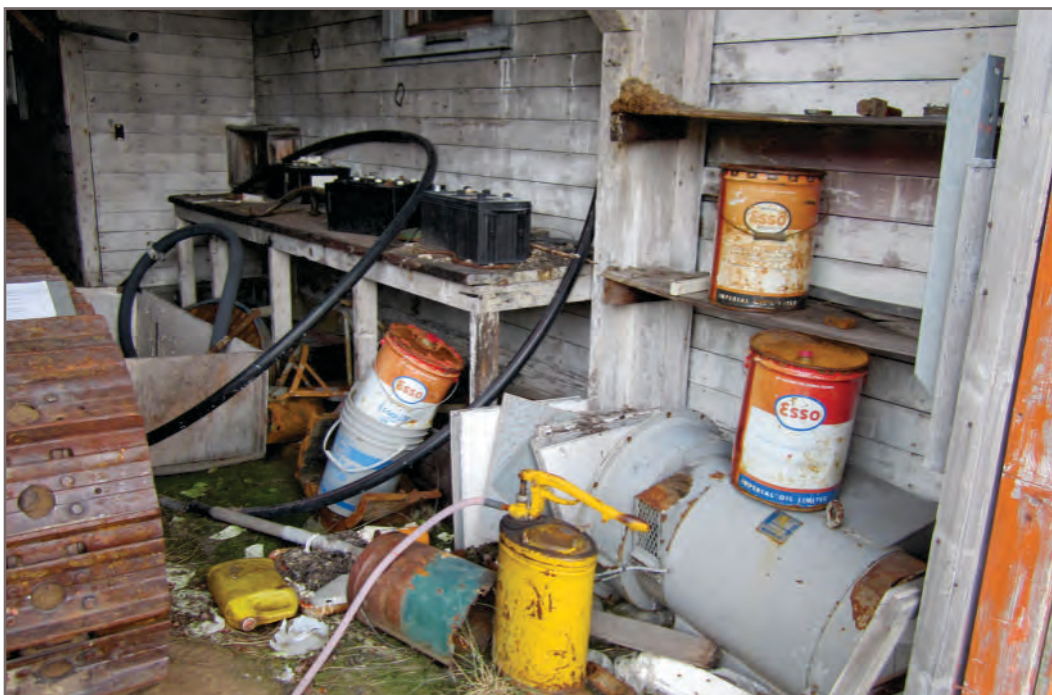
Photo H-35: APEC 18 - Building 5 - Total lead and leachable lead painted wood and equipment, lead acid batteries and miscellaneous containers of oil/lubricants

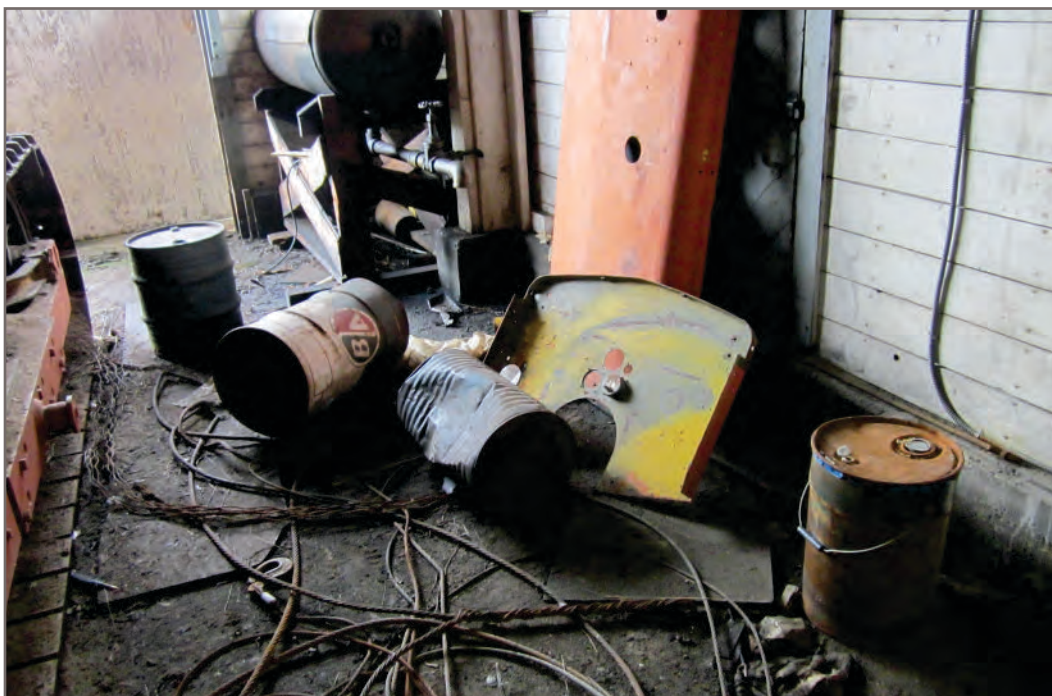
Photo H-36: APEC 18 - Building 5 - Total lead and leachable lead painted wood, AST organic contents and miscellaneous containers of oil/lubricants
