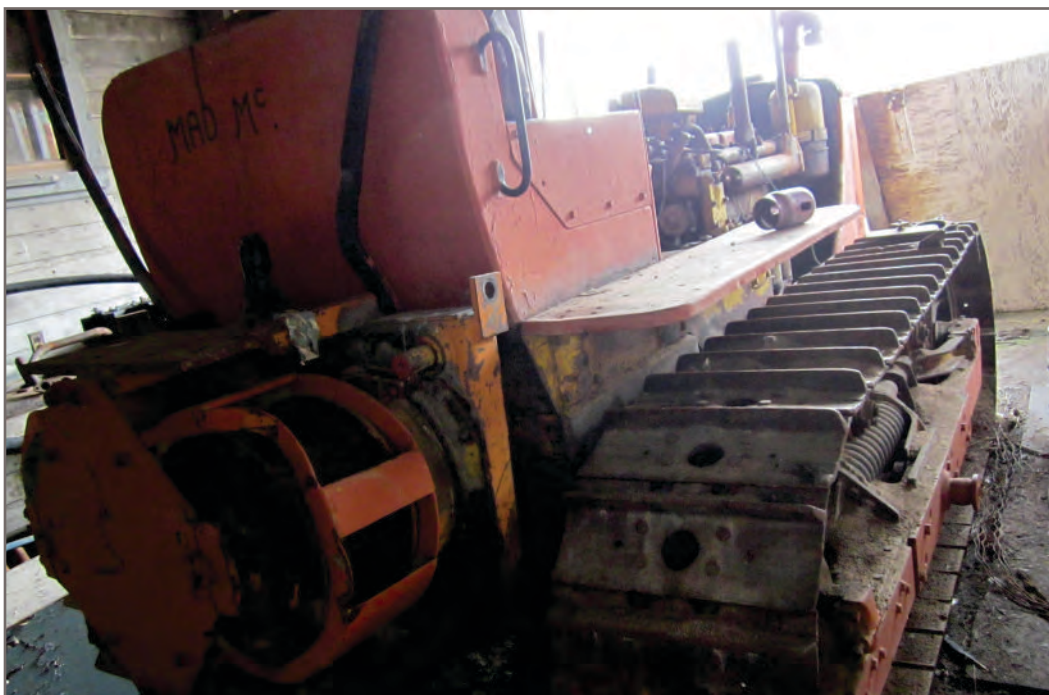
Photo H-37: APEC 18 - Building 5 - Total lead and leachable lead painted caterpillar

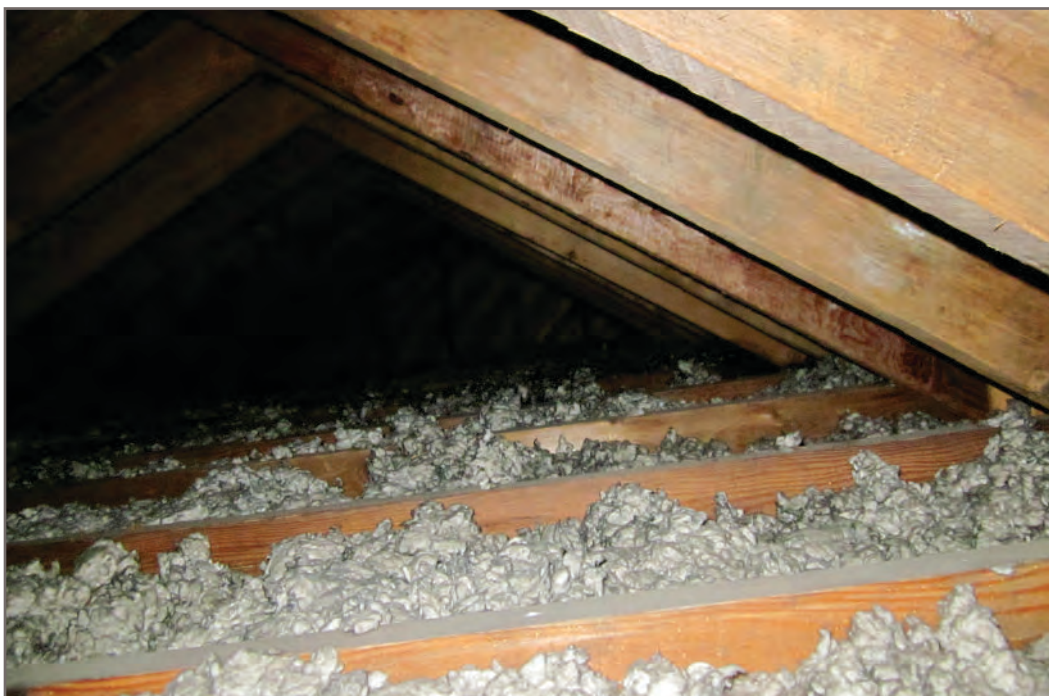
Photo H-38: APEC 18 - Building 5 - Fibre glass insulation (not containing asbestos)

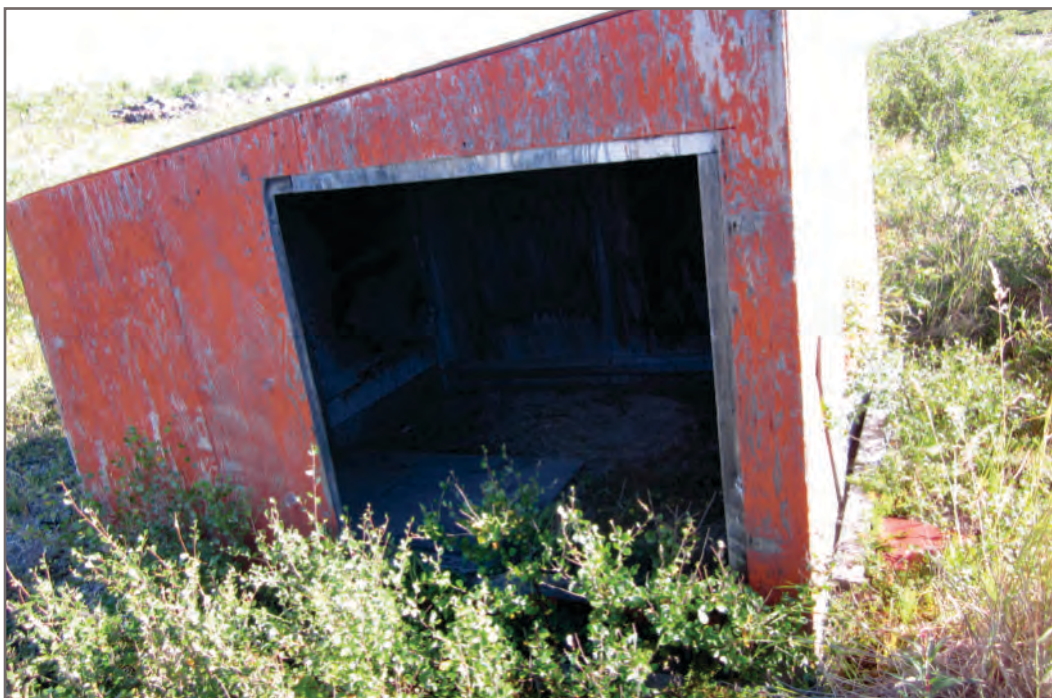
Photo H-39: APEC 19 - Building 6 - Total lead and leachable lead painted wood

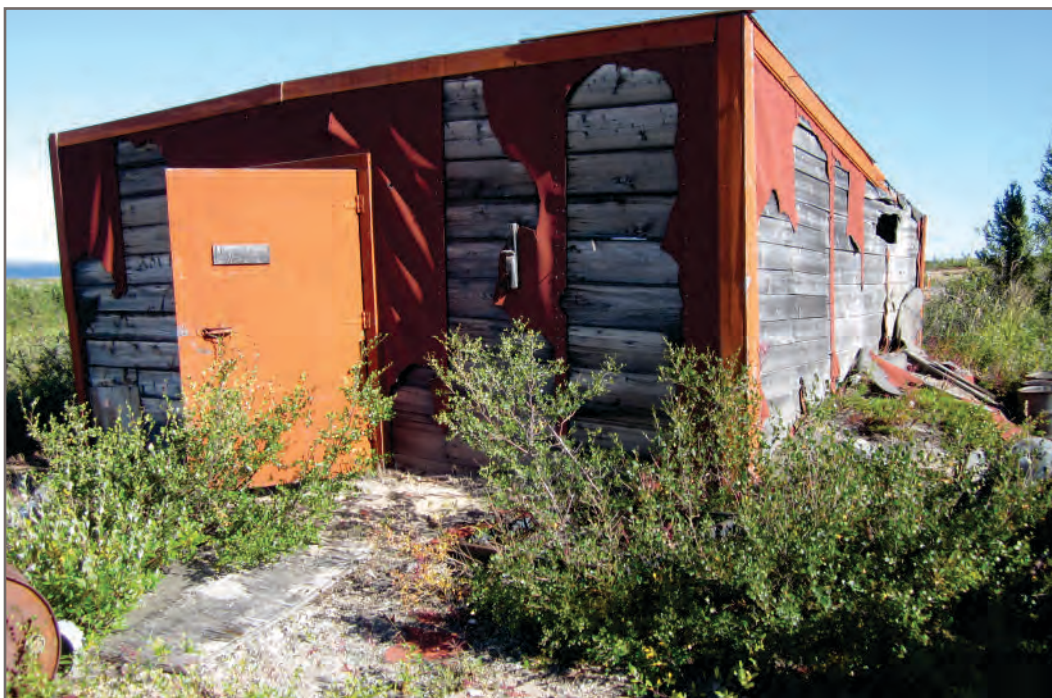
Photo H-40: APEC 20 - Building 7 - Asbestos exterior asphalt shingles and total lead and leachable lead painted wood

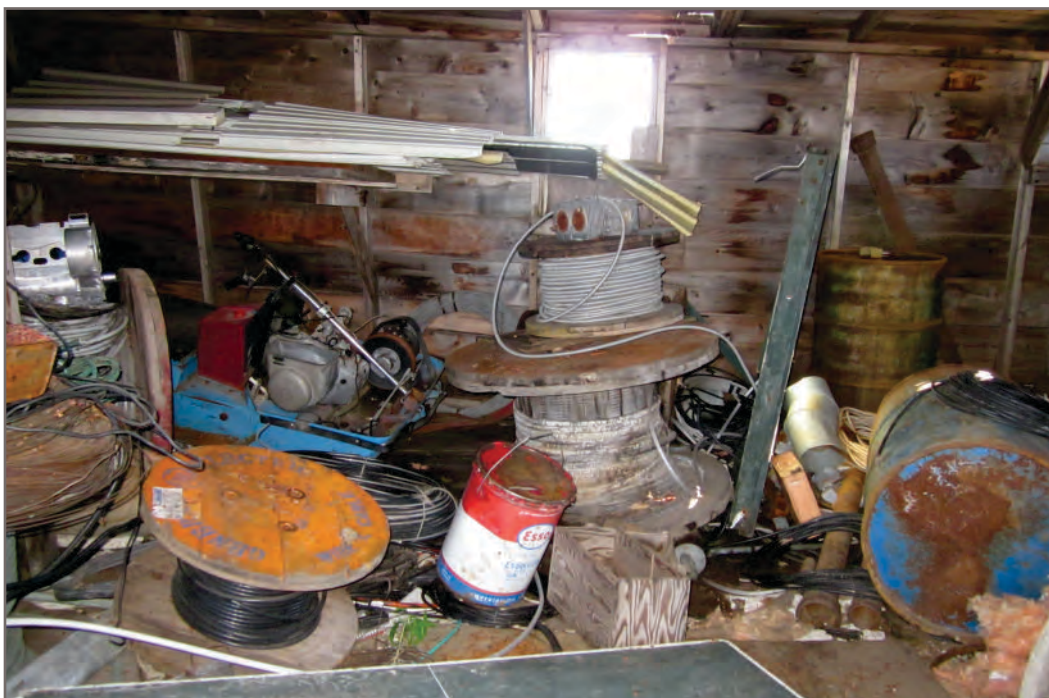
Photo H-41: APEC 20 - Building 7 - Asbestos flooring, asbestos white piping, asbestos black felt, total and leachable lead painted wood and metal, miscellaneous containers of oil/lubricants, drum content (clear, flammable) and PCBs in light ballasts and electrical equipment

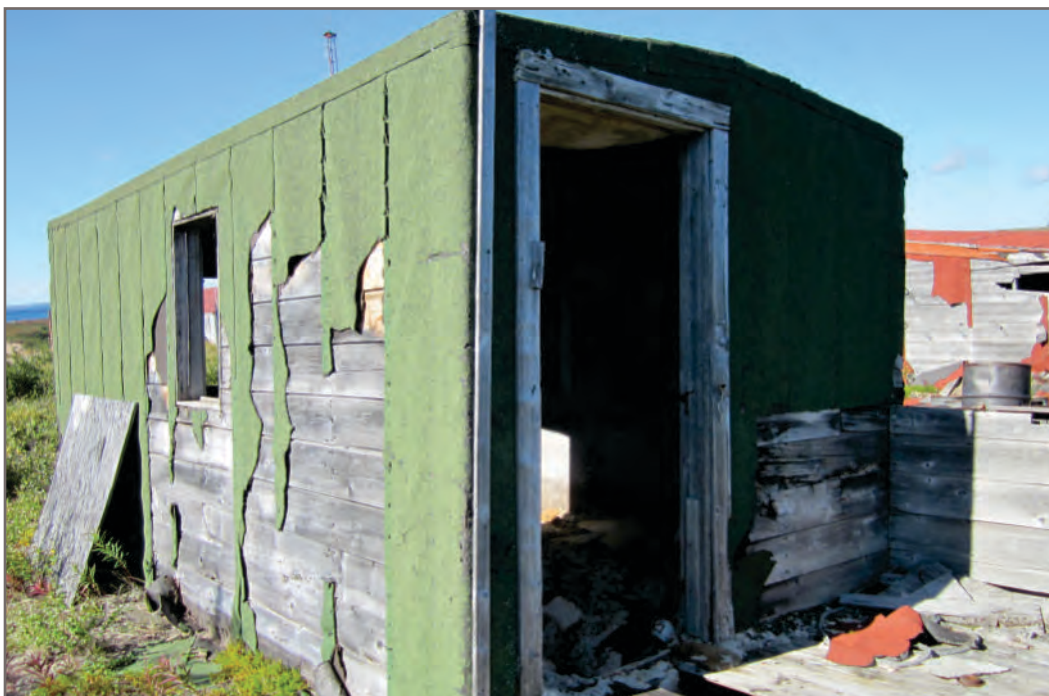
Photo H-42: APEC 21 - Building 8 - Asbestos exterior asphalt shingles and black felt

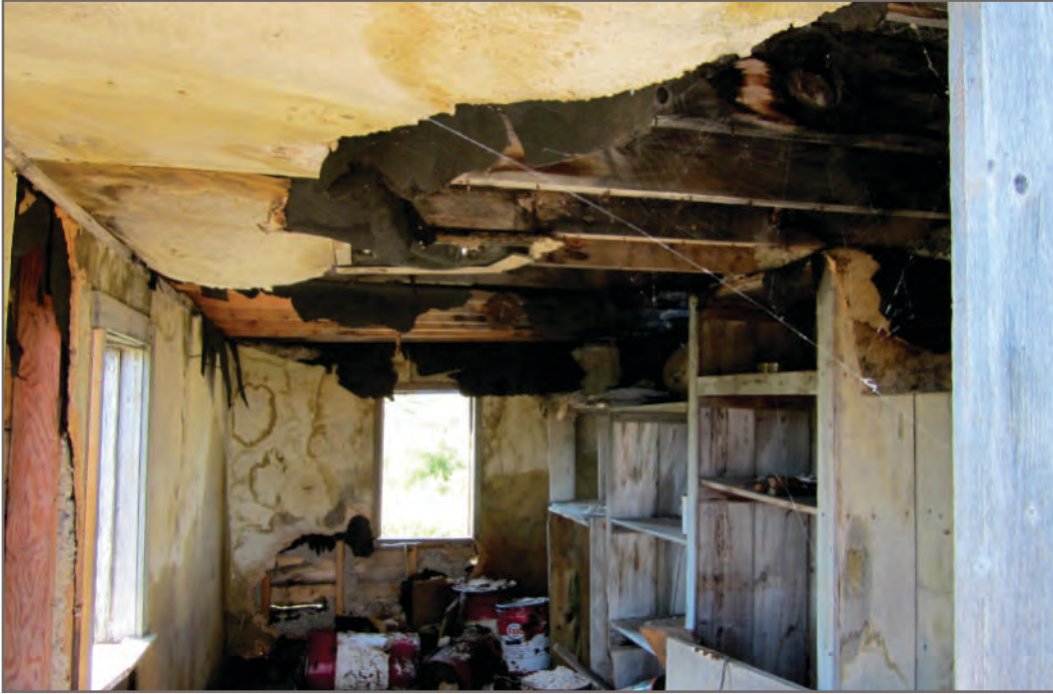
Photo H-43: APEC 21 - Building 8 - Miscellaneous containers of oil/lubricants

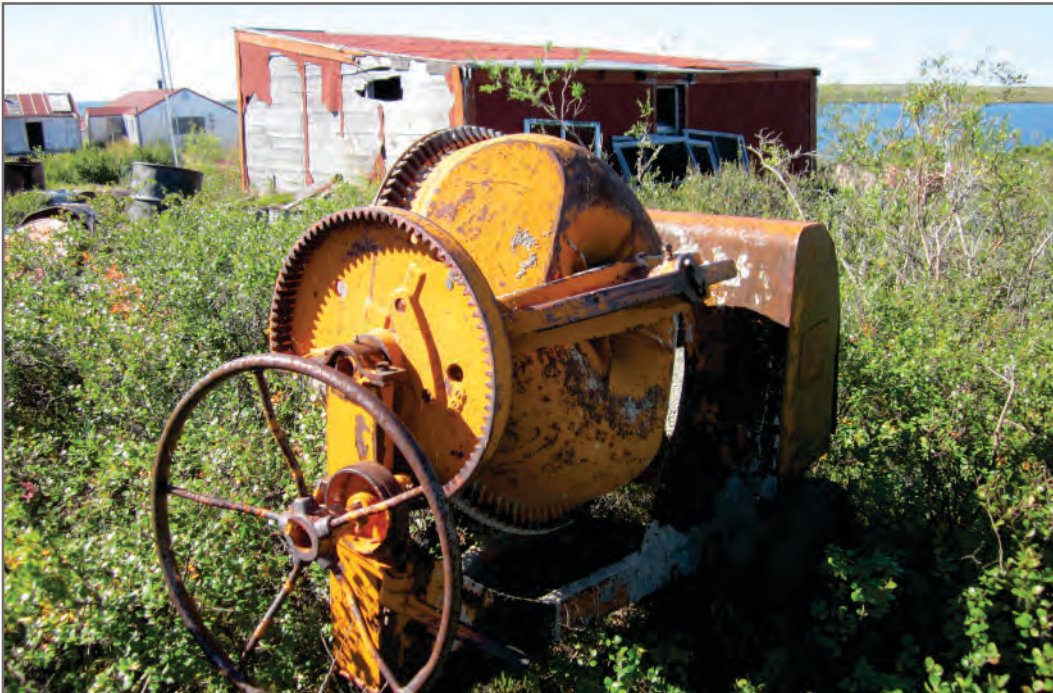
Photo H-44: APEC 21 - Cement mixer, painted with total lead and leachable lead paint

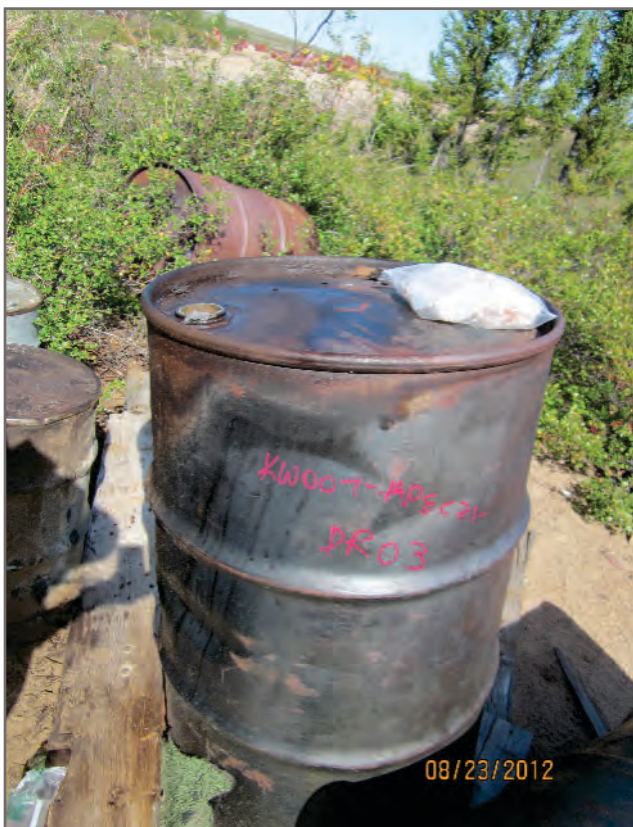
Photo H-45: APEC 21 - Organic content in 205L and 20L drums between Building 7 and Building 8

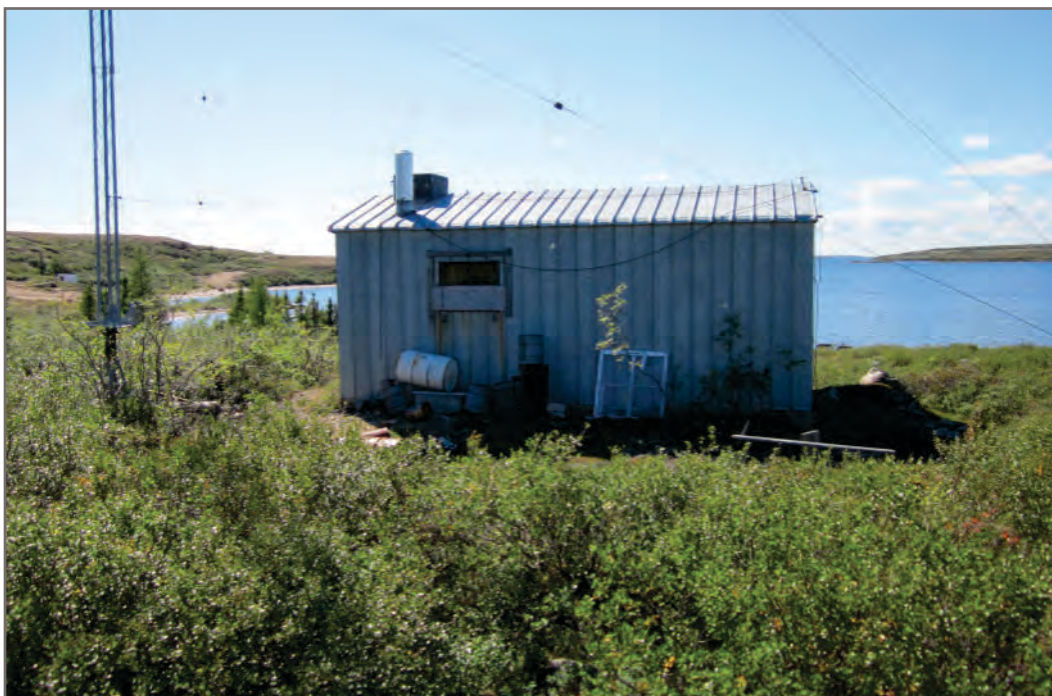
Photo H-46: APEC 22 - Building 9 - Metal exterior and total lead and leachable lead painted metal tower and drums, and drum content (organic)

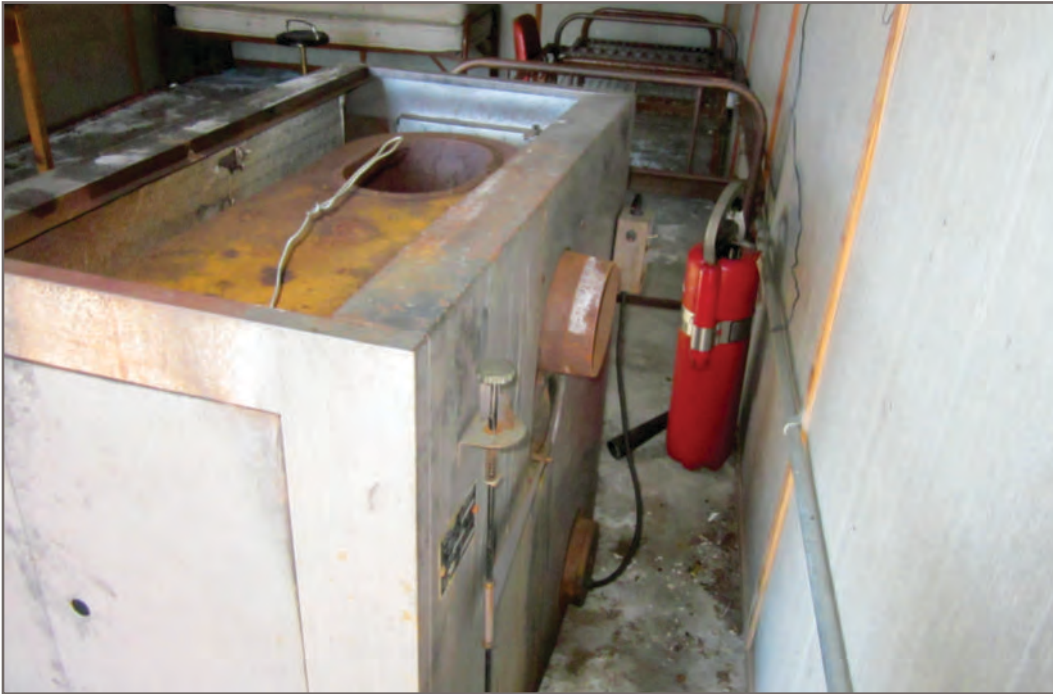
Photo H-47: APEC 22 - Building 9 - Interior asbestos panels and fire extinguisher

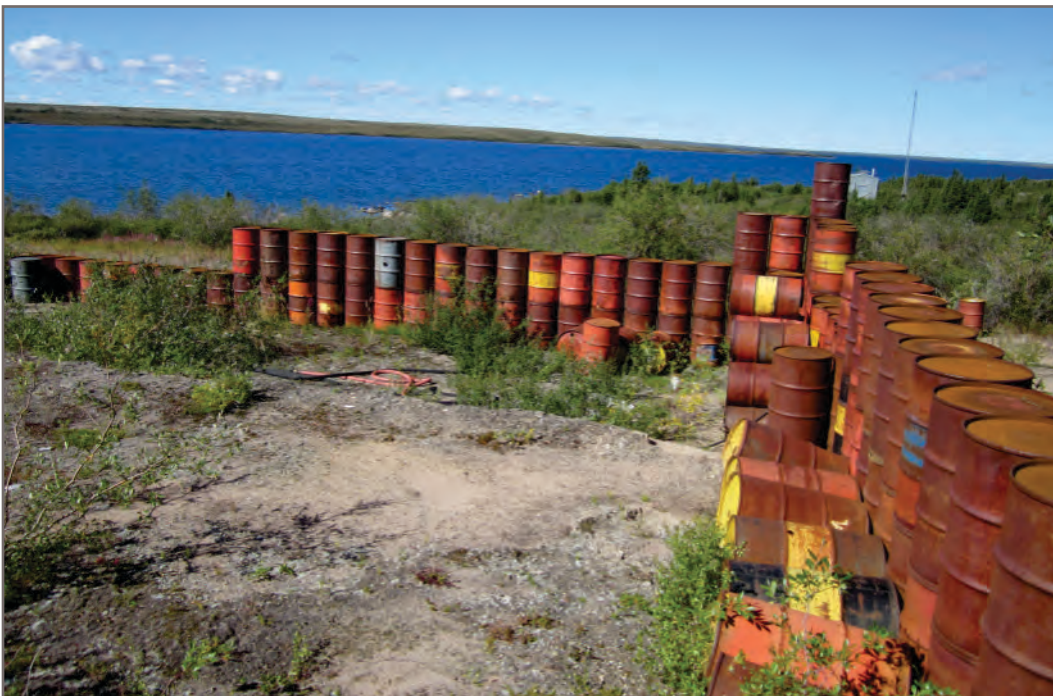
Photo H-48: APEC 23 - Drum Cache 1 - Total lead and leachable lead painted drums welded together and drum content (organic)

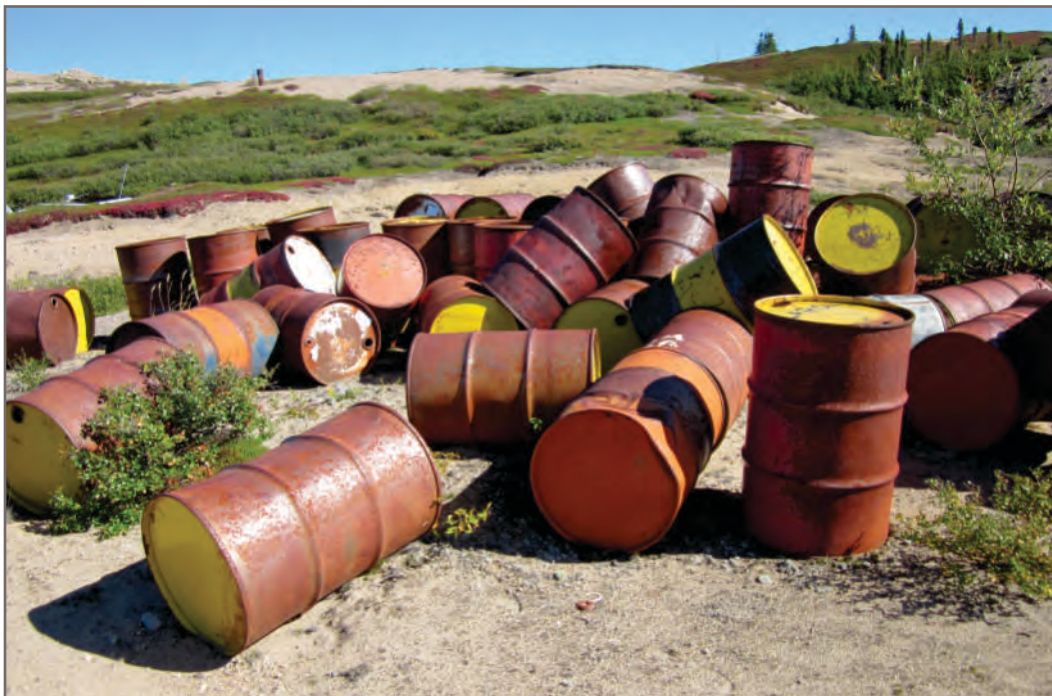
Photo H-49: APEC 24 – Drum Cache 2 - Total lead and leachable lead painted drums and drum content (organic)

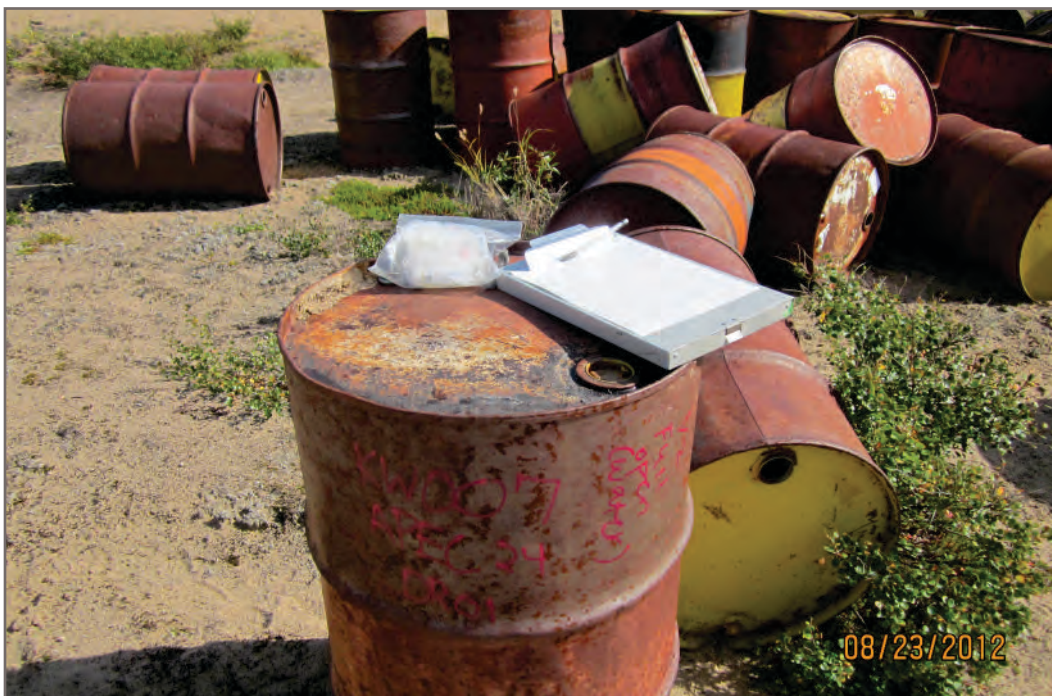
Photo H-50: APEC 24 – Drum Cache 2 - Total lead and leachable lead painted drum and some organic drum content

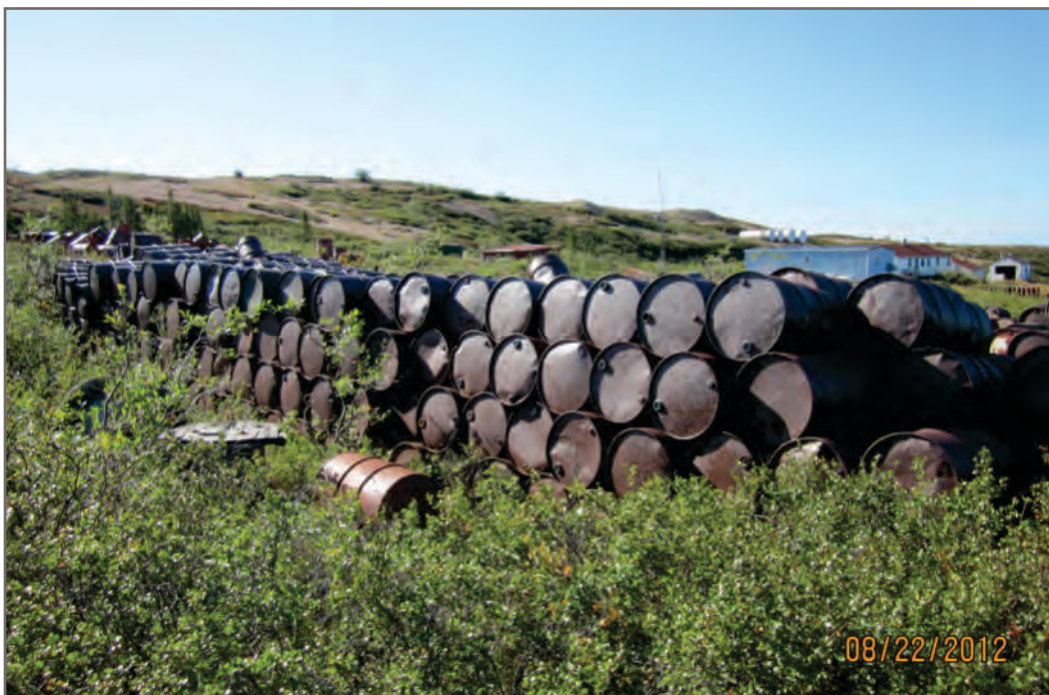
Photo H-51: APEC 25 - Drum Cache 3 - Total lead and leachable lead painted drums and drum content (organic)

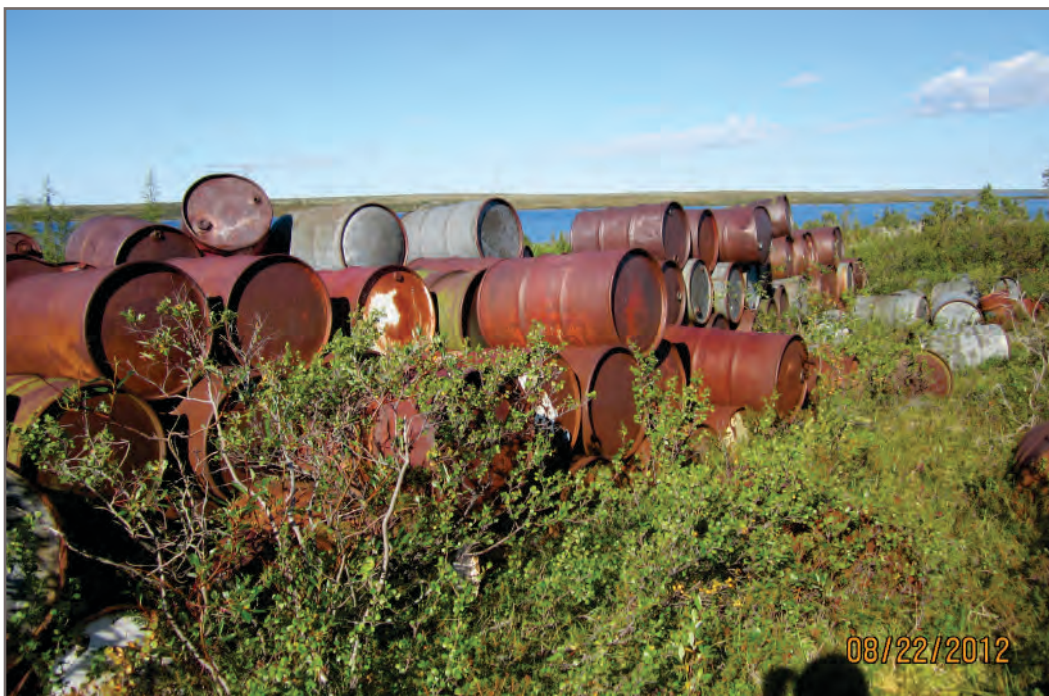
Photo H-52: APEC 26 - Drum Cache 4 - Total lead and leachable lead painted drums

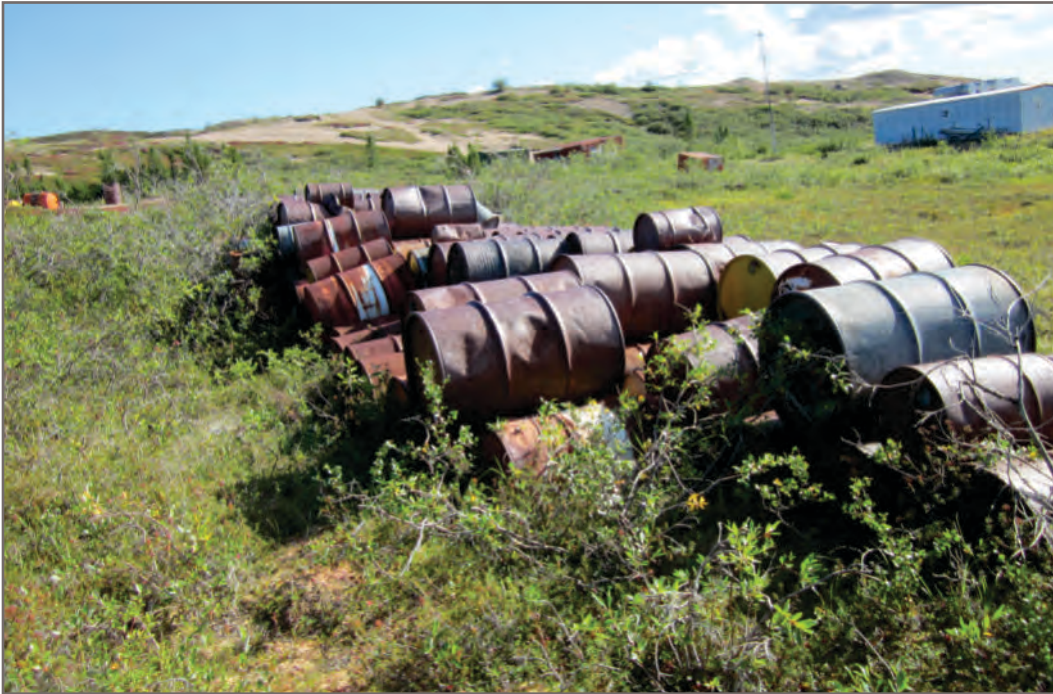
Photo H-53: APEC 27 - Drum Cache 5 - Total lead and leachable lead painted drums

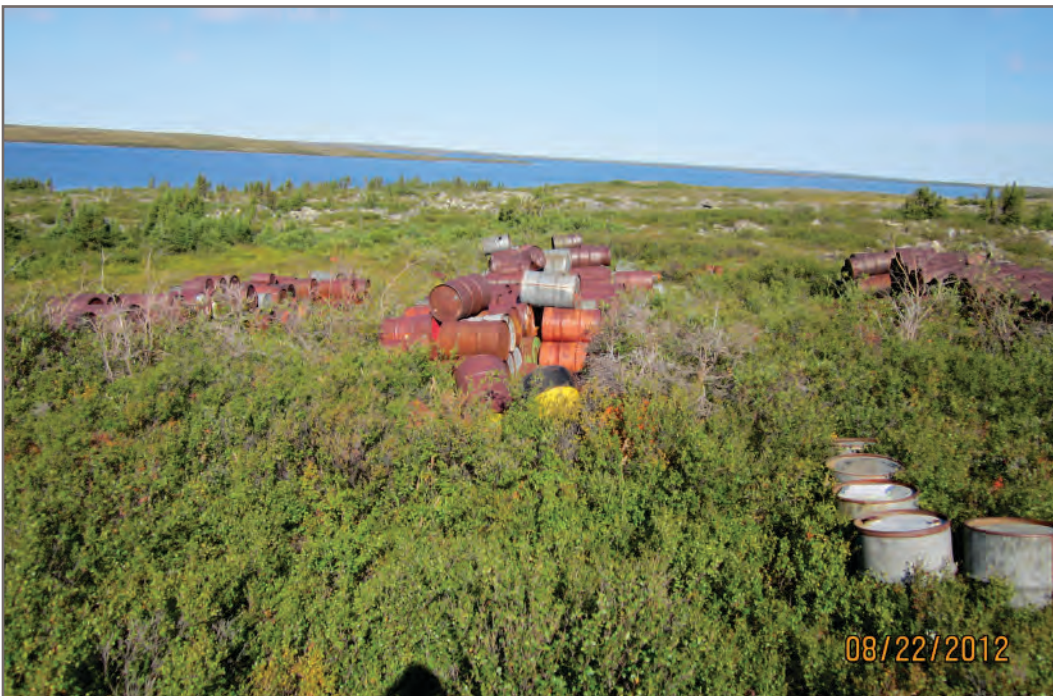
Photo H-54: APEC 25-27 - Drum Cache 3 on the right, Drum Cache 4 in the center and Drum Cache 5 on the left - Total lead and leachable lead painted drum and drum content (organic)

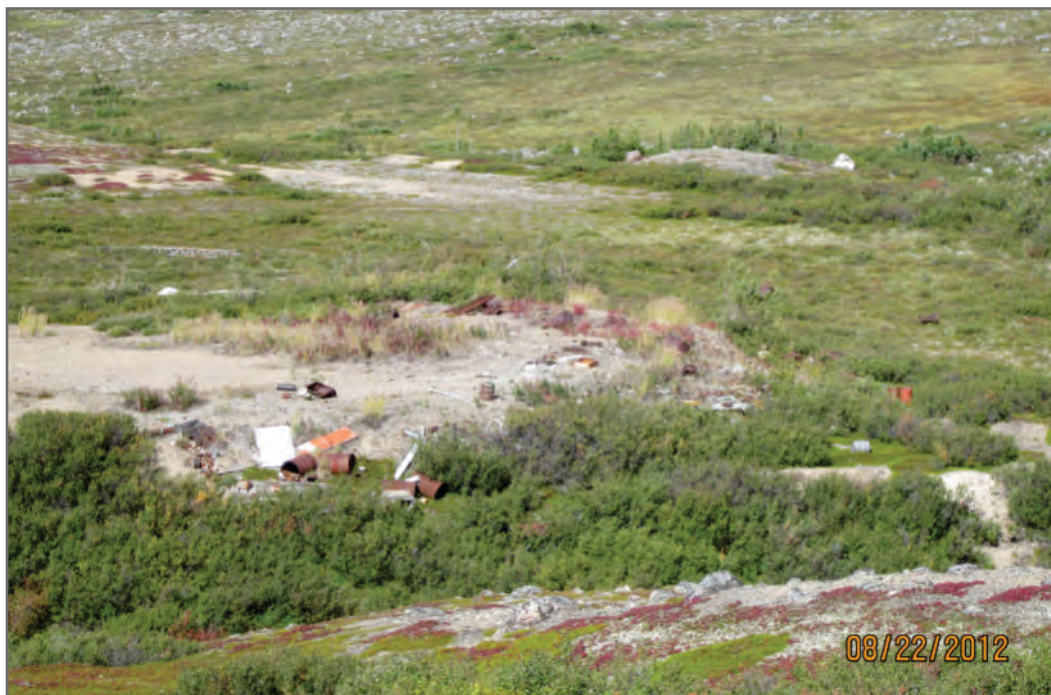
Photo H-55: APEC 28 - Main Debris Area - Metal debris

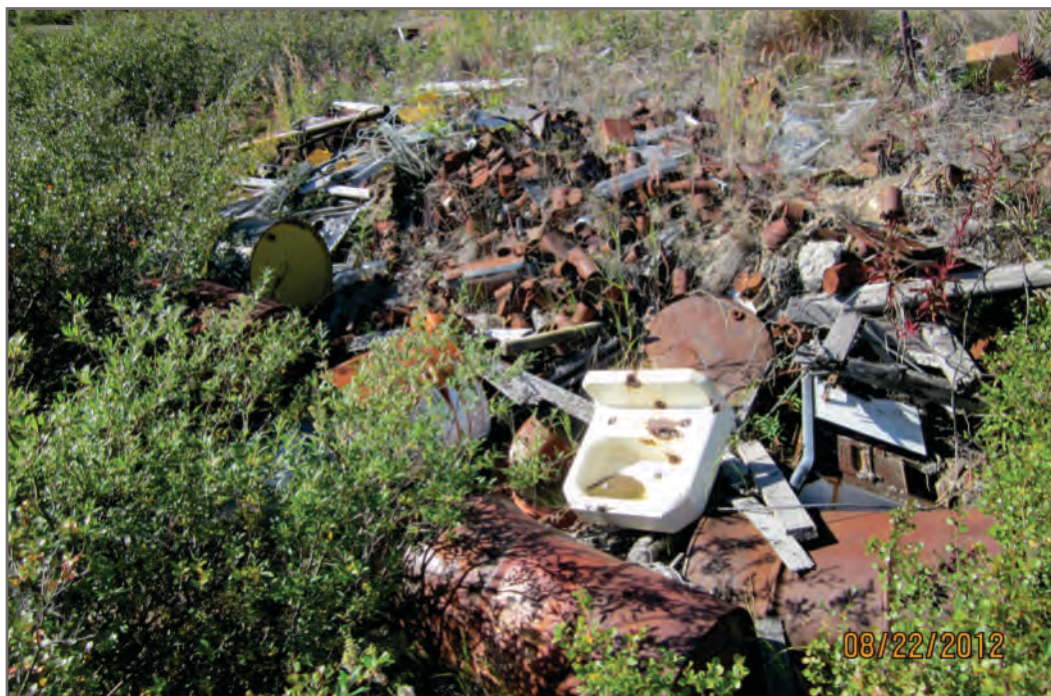
Photo H-56: APEC 28 - Main Debris Area - Partially buried total and leachable lead paint wood, metal and drums, electrical parts and lead acid batteries

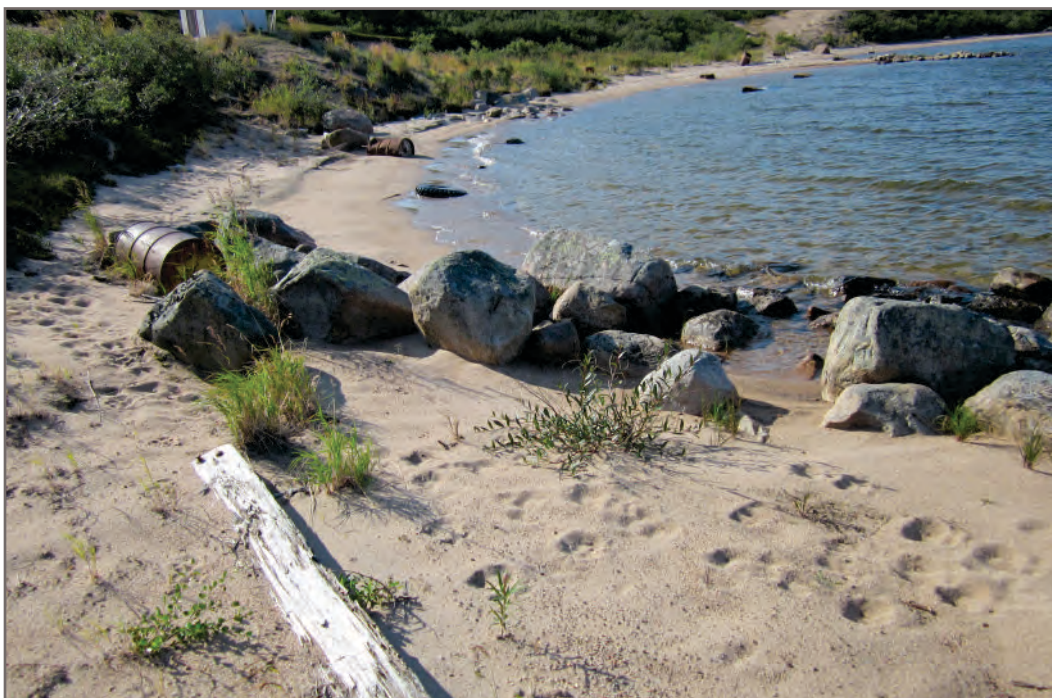
Photo H-57: APEC 29 - Shoreline Debris Area and Pumphouse (in background) - Various metal and wood debris

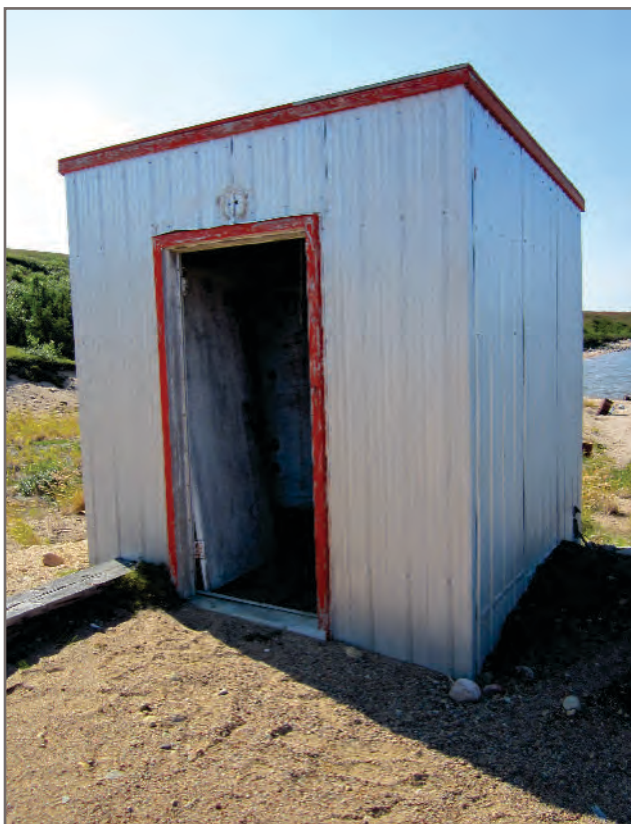
Photo H-58: APEC 29 - Pumphouse - Asbestos black felt, total lead and leachable lead painted equipment and wood

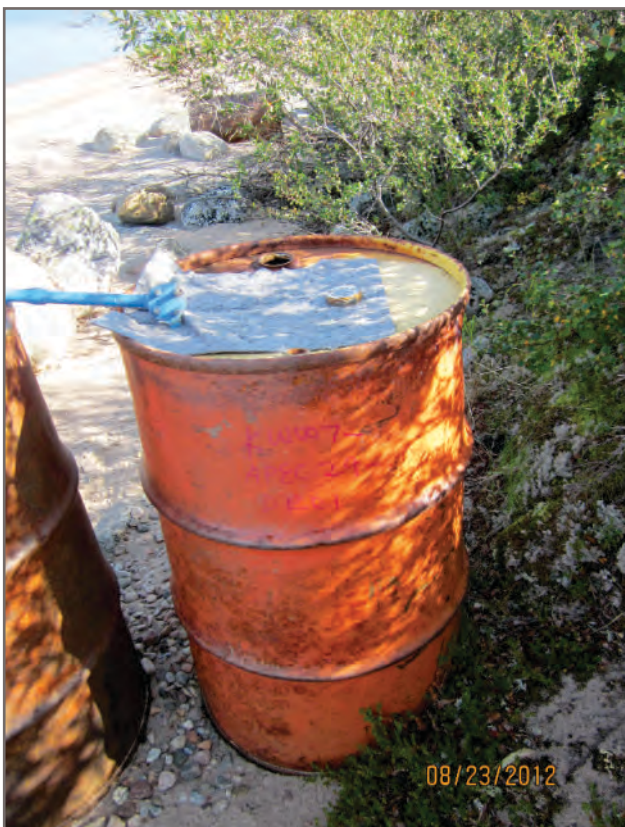
Photo H-59: APEC 29 - Total lead and leachable lead painted drum with blue, flammable content

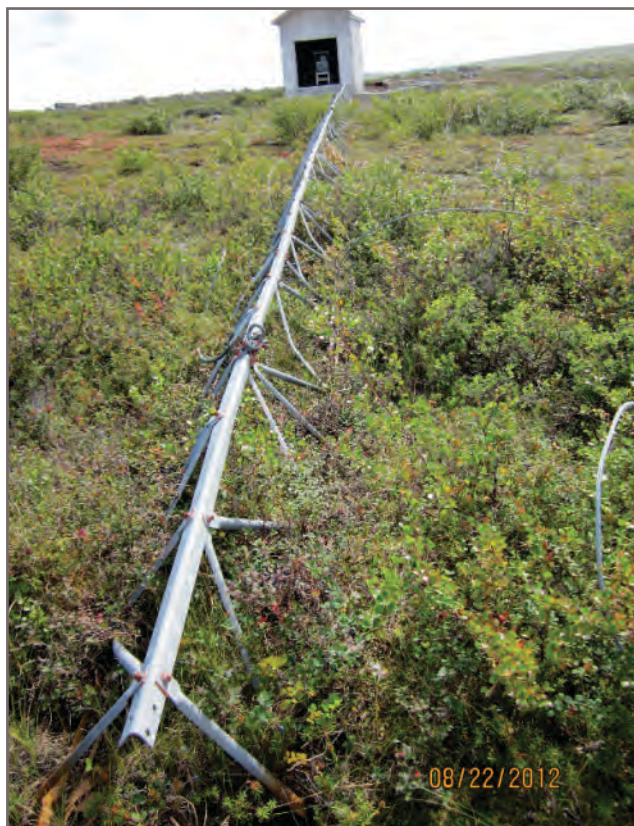
Photo H-60: APEC N/A - Building 10 - Total and leachable lead painted metal tower and Building 10 in background

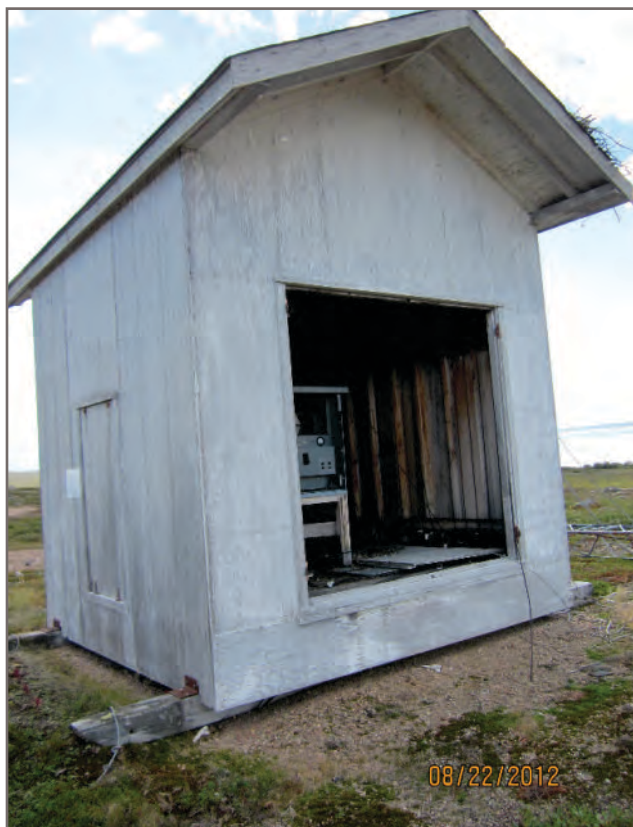
Photo H-61: APEC N/A - Building 10 -
Antenna Tuning Unit Shelter,
Total lead and leachable lead
painted wood and asbestos
panel

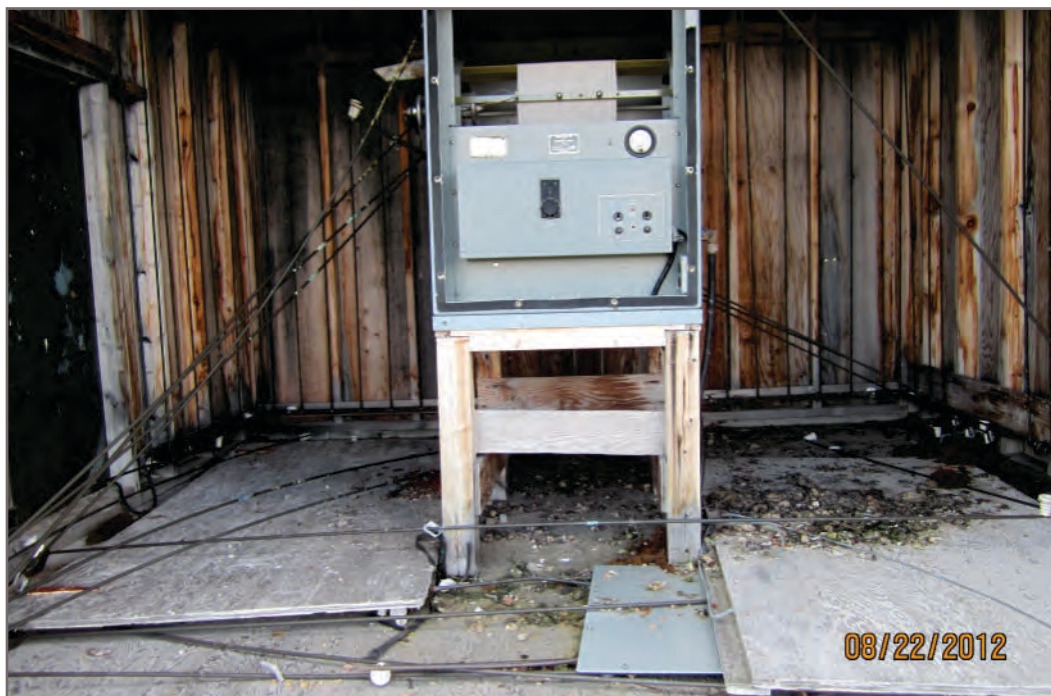
Photo H-62: APEC N/A - Building 10 - Antenna Tuning Unit Shelter interior

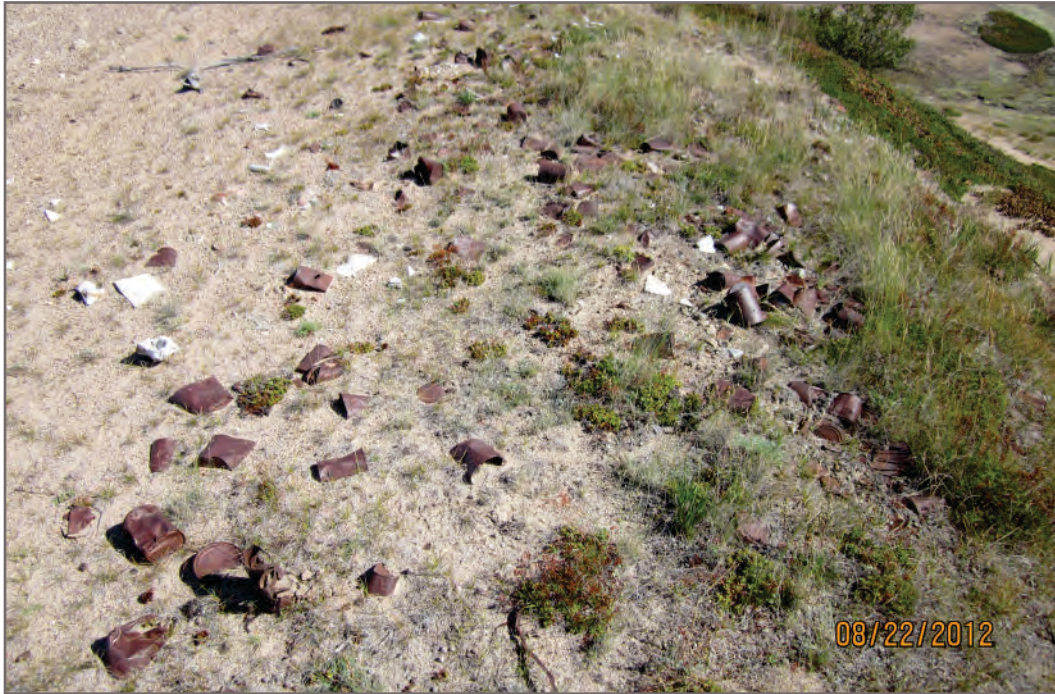
Photo H-63: APEC N/A - Scattered debris throughout and adjacent to the site - metal cans and debris west of the main building cluster on the hill

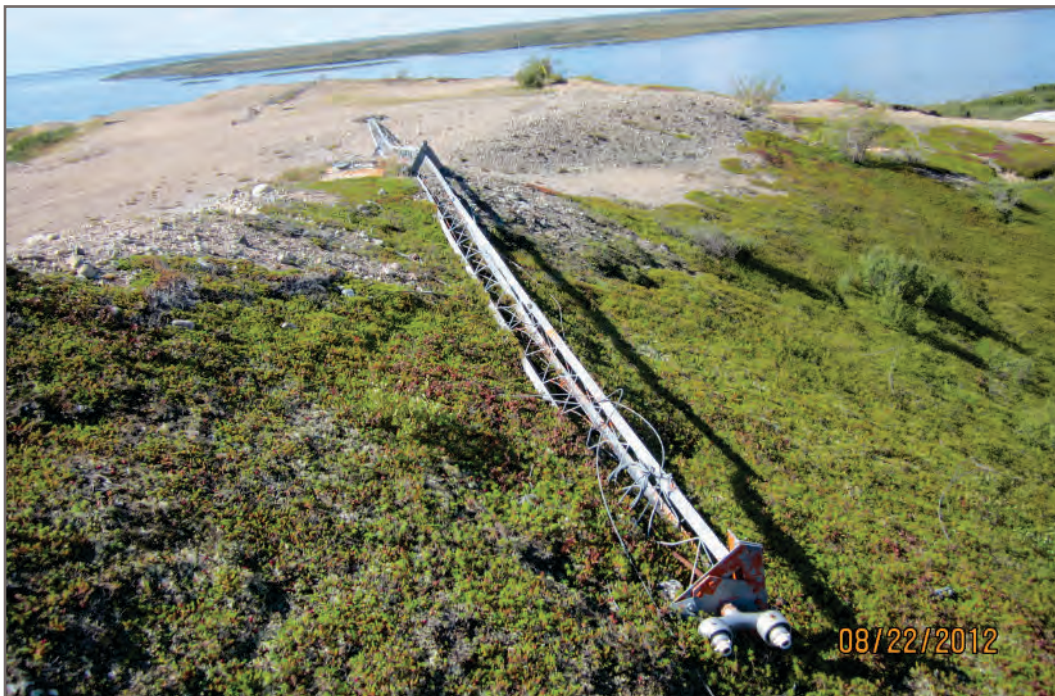
Photo H-64: APEC N/A - Scattered debris throughout and adjacent to the site - Two total lead and leachable lead painted metal towers west of the main building cluster, on the top of the hill

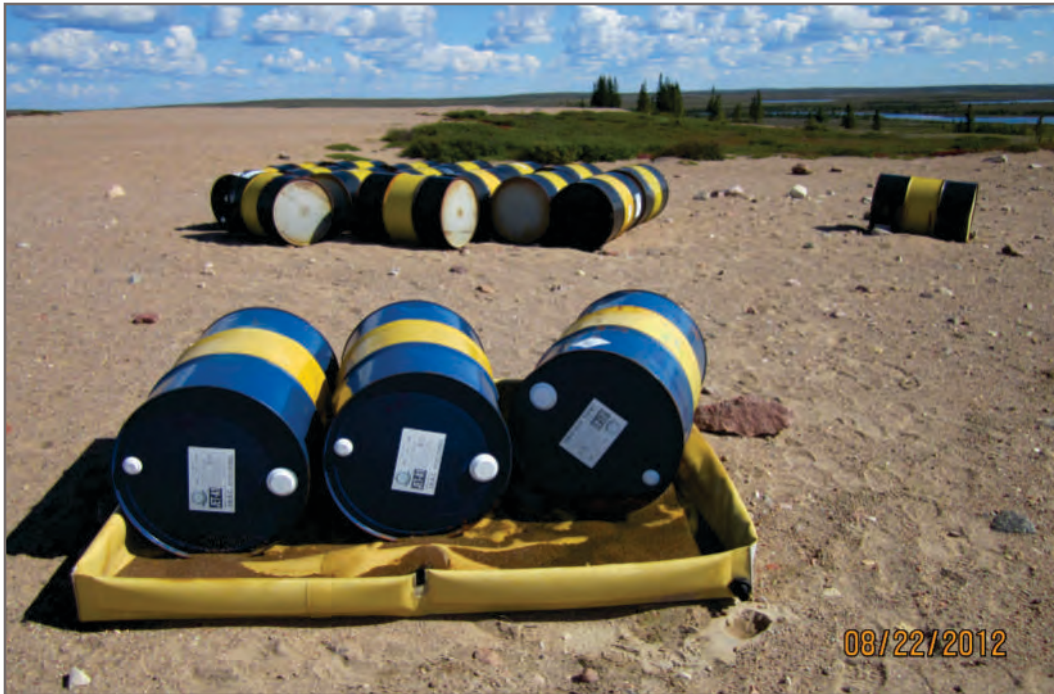
Photo H-65: APEC N/A - Scattered debris throughout and adjacent to the site; new drums and organic drum content by the airstrip
