**THE COLLECTION OF LANDFILL  
MONITORING DATA AT THE FORMER  
FOX-3 DISTANT EARLY WARNING LINE SITE**

Dewar Lakes, Nunavut

**FINAL REPORT – 2013**

**DEFENCE CONSTRUCTION CANADA**

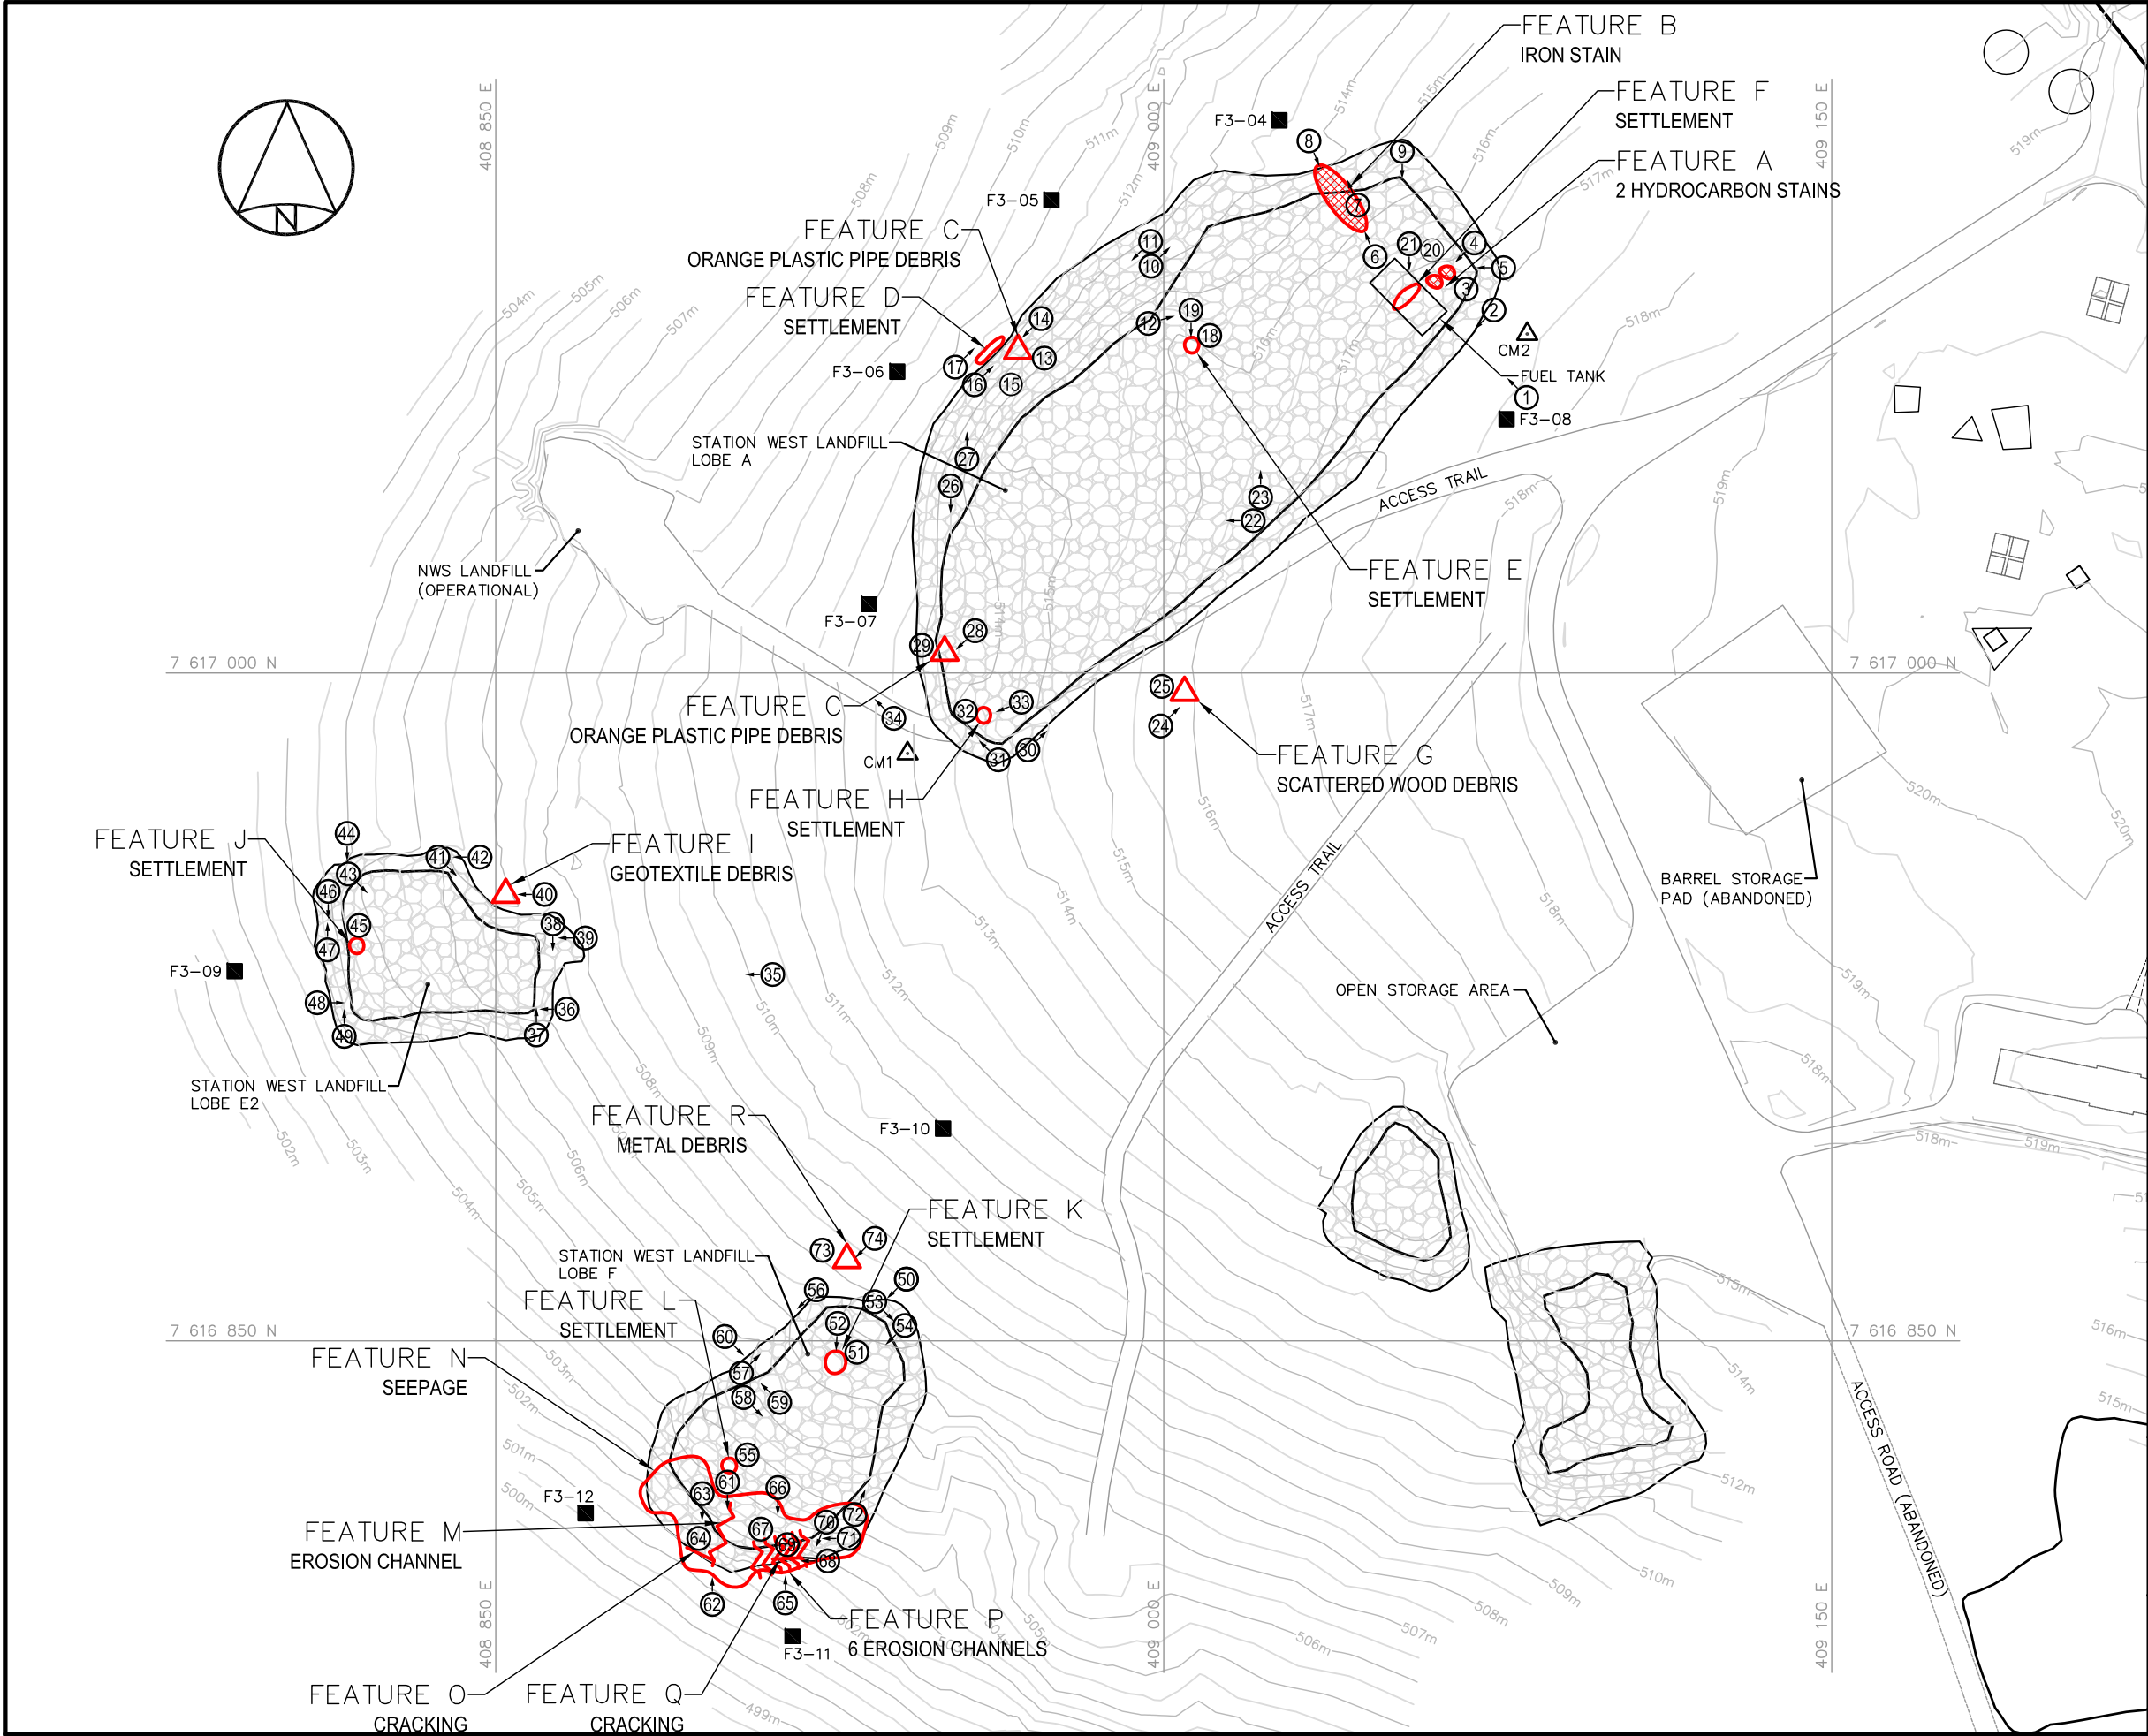
| Checklist Item | Present Yes/No | Location | Length | Width | Depth | Extent relative to Area of Landfill (%) | Description | Photographic Records (Refer to the photographic log for more details) | Additional Comments |
|---|---|---|---|---|---|---|---|---|---|
| | | Feature K - Lobe F - refer to figure FOX-3-2 | 0.50 m | 0.60 m | 0.05 m | <1% | Circular area of settlement. | 51 and 52 | Previously observed: Little change in size since baseline investigation. |
| | | Feature P - Lobe F - refer to figure FOX-3-2 | 10.00 m | 0.20 m | 0.05 – 0.10 m | 1% | Six erosion channels. | 65, 66 and 67 | Previously observed: Minor - Self-armouring. |
| Sloughing and Cracking | Yes | Feature O - Lobe F - refer to figure FOX-3-2 | 3.00 m | 0.002 – 0.005 m | Unknown | <1% | Small tension crack. | 63 and 64 | <b>New Observation:</b> minor tension crack on the southwest landfill toe. |
| | | Feature Q - Lobe F - refer to figure FOX-3-2 | 4.00 m | 0.002 – 0.005 m | Unknown | <1% | Small desiccation crack. | 68 and 69 | <b>New Observation:</b> minor desiccation cracking in silt deposited at the base of the landfill by Feature P. |

| Checklist Item | Present Yes/No | Location | Length | Width | Depth | Extent relative to Area of Landfill (%) | Description | Photographic Records (Refer to the photographic log for more details) | Additional Comments |
|---|---|---|---|---|---|---|---|---|---|
| Staining | Yes | Feature A - Lobe A - refer to figure FOX-3-2 | 0.50 – 0.60 m | 0.40 – 0.50 m | N/A | <1% | 2 small hydrocarbon stains. | 3 and 4 | Previously observed: minor staining on the northeast landfill cap. |
| | | Feature B - Lobe A - refer to figure FOX-3-2 | 18.00 m | 6.00 m | N/A | <1% | Iron staining. | 6, 7, 8 and 9 | Previously observed: large area of iron staining extending from the landfill cap to the toe. |
| Seepage Points | Yes | Feature N - Lobe F - refer to figure FOX-3-2 | 20.00 m | 10.00 m | N/A | 25% of Lobe F | | 59 and 60 | Previously Observed: Feature has increased in size. |
| Debris Exposed | Yes | Feature C - Lobe A - refer to figure FOX-3-2 | 0.04 m | 0.04 m | 0.20 – 0.25 m | <1% | Two plastic pipes. | 13, 14, 28 and 29 | Previously Observed: Plastic piping used to indicate lift heights by surveyor during construction. |
| | | Feature G - south of Lobe A - refer to figure FOX-3-2 | 10.00 m | 10.00 m | N/A | <1% | Scattered wood debris. | 24 and 25 | Previously Observed: Large wood debris during baseline has been removed, small wood fragments remain. |
| | | Feature I - northeast of Lobe E2 - refer to figure FOX-3-2 | 2.50 m | .50 m | 0.02 m | <1% | Geotextile debris. | 40 | Previously Observed: Northeast of the landfill, debris is lying on the ground surface. Result of construction work, not DEW line operations. |

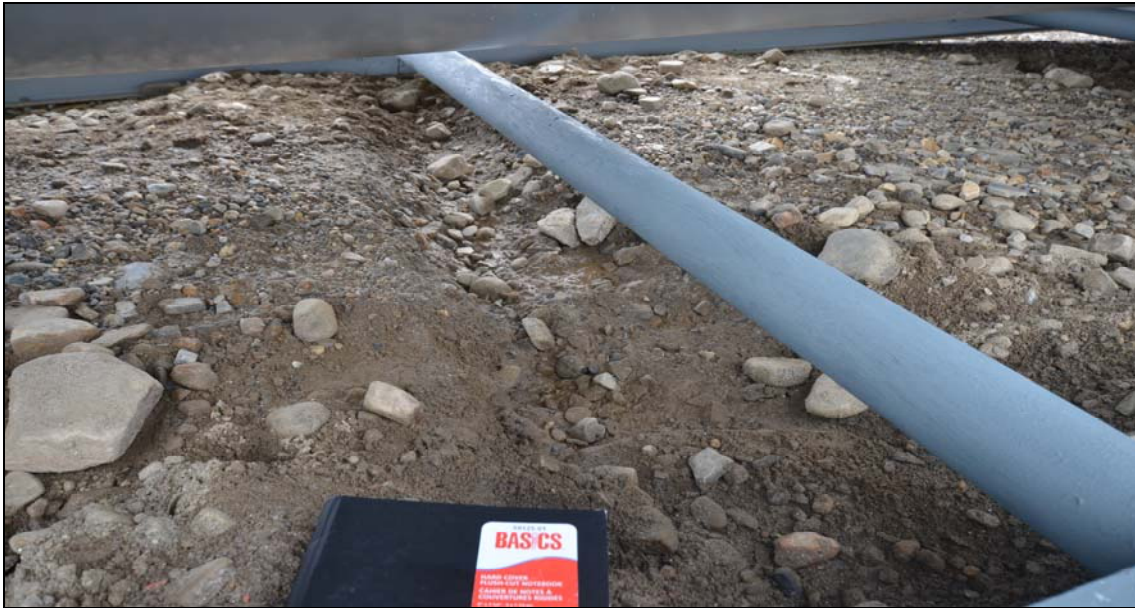
Figure 1: Photo - 2013-F3-SW-20 - Feature F - Close-up of linear depression under cross beam of fuel tankbase located on Lobe A - (new observation).

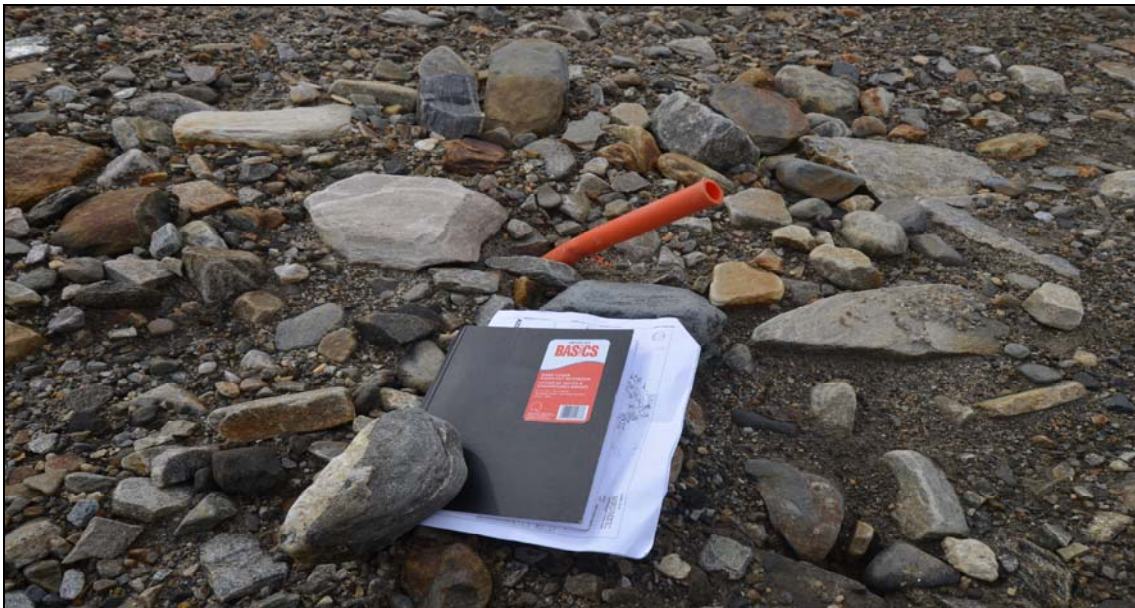
Figure 2: Photo - 2013-F3-SW-13 - Feature C - Close-up - orange plastic pipe in north landfill toe, used to mark material lift heights by surveyors; 1 of 2 plastic pipes present on the Lobe A - (previously observed).

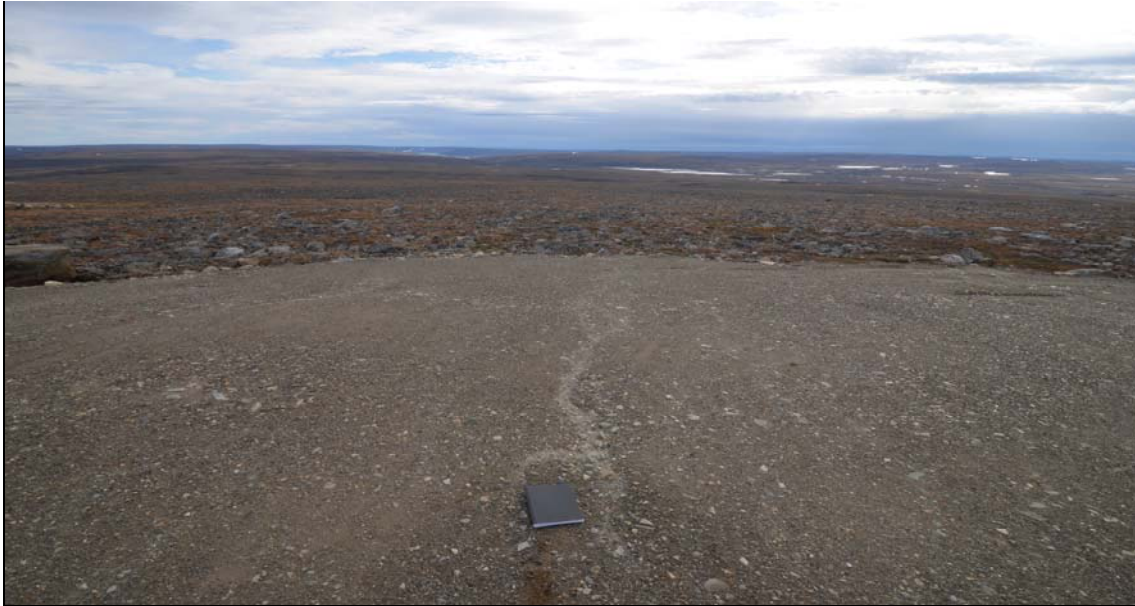
Figure 3: Photo - Feature M - view S of erosion channel extending from the landfill surface to the southwestern toe of the lobe, taken from the top of the channel on Lobe F - (new observation).

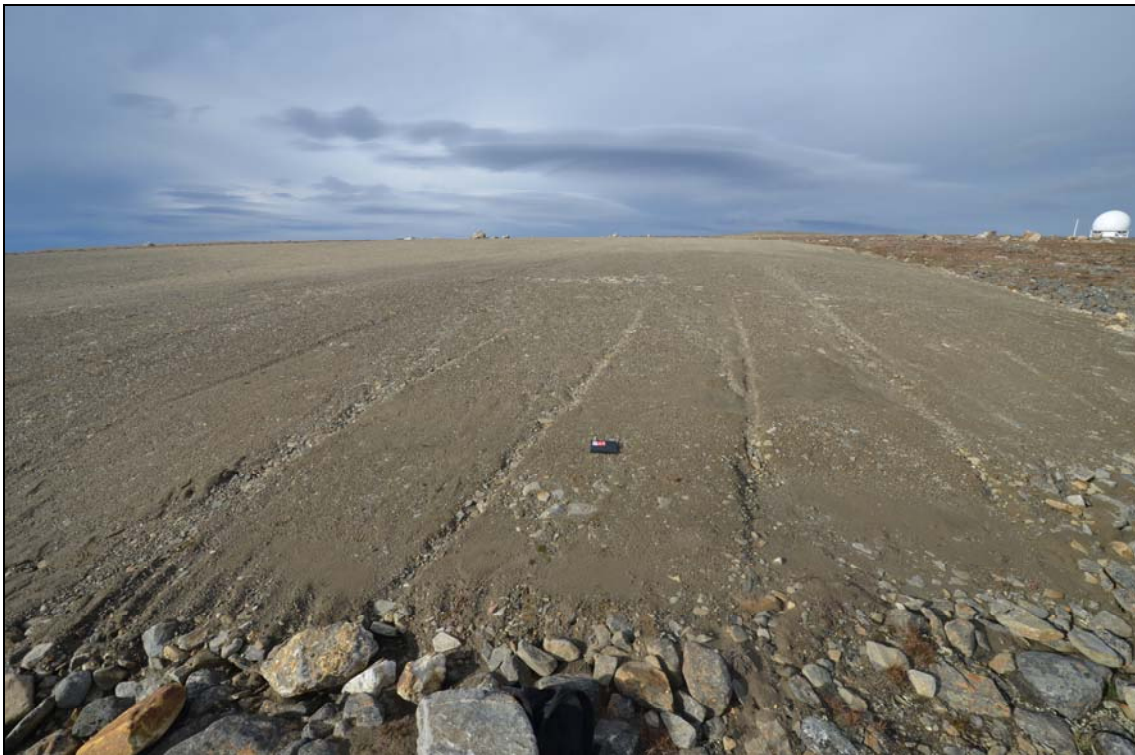
Figure 4: Photo - 2013-F3-SW-65 - Feature P - view N - of six erosion channels extending from the southwestern landfill surface to the toe taken from the bottom of channels, located on Lobe F - (previously observed).

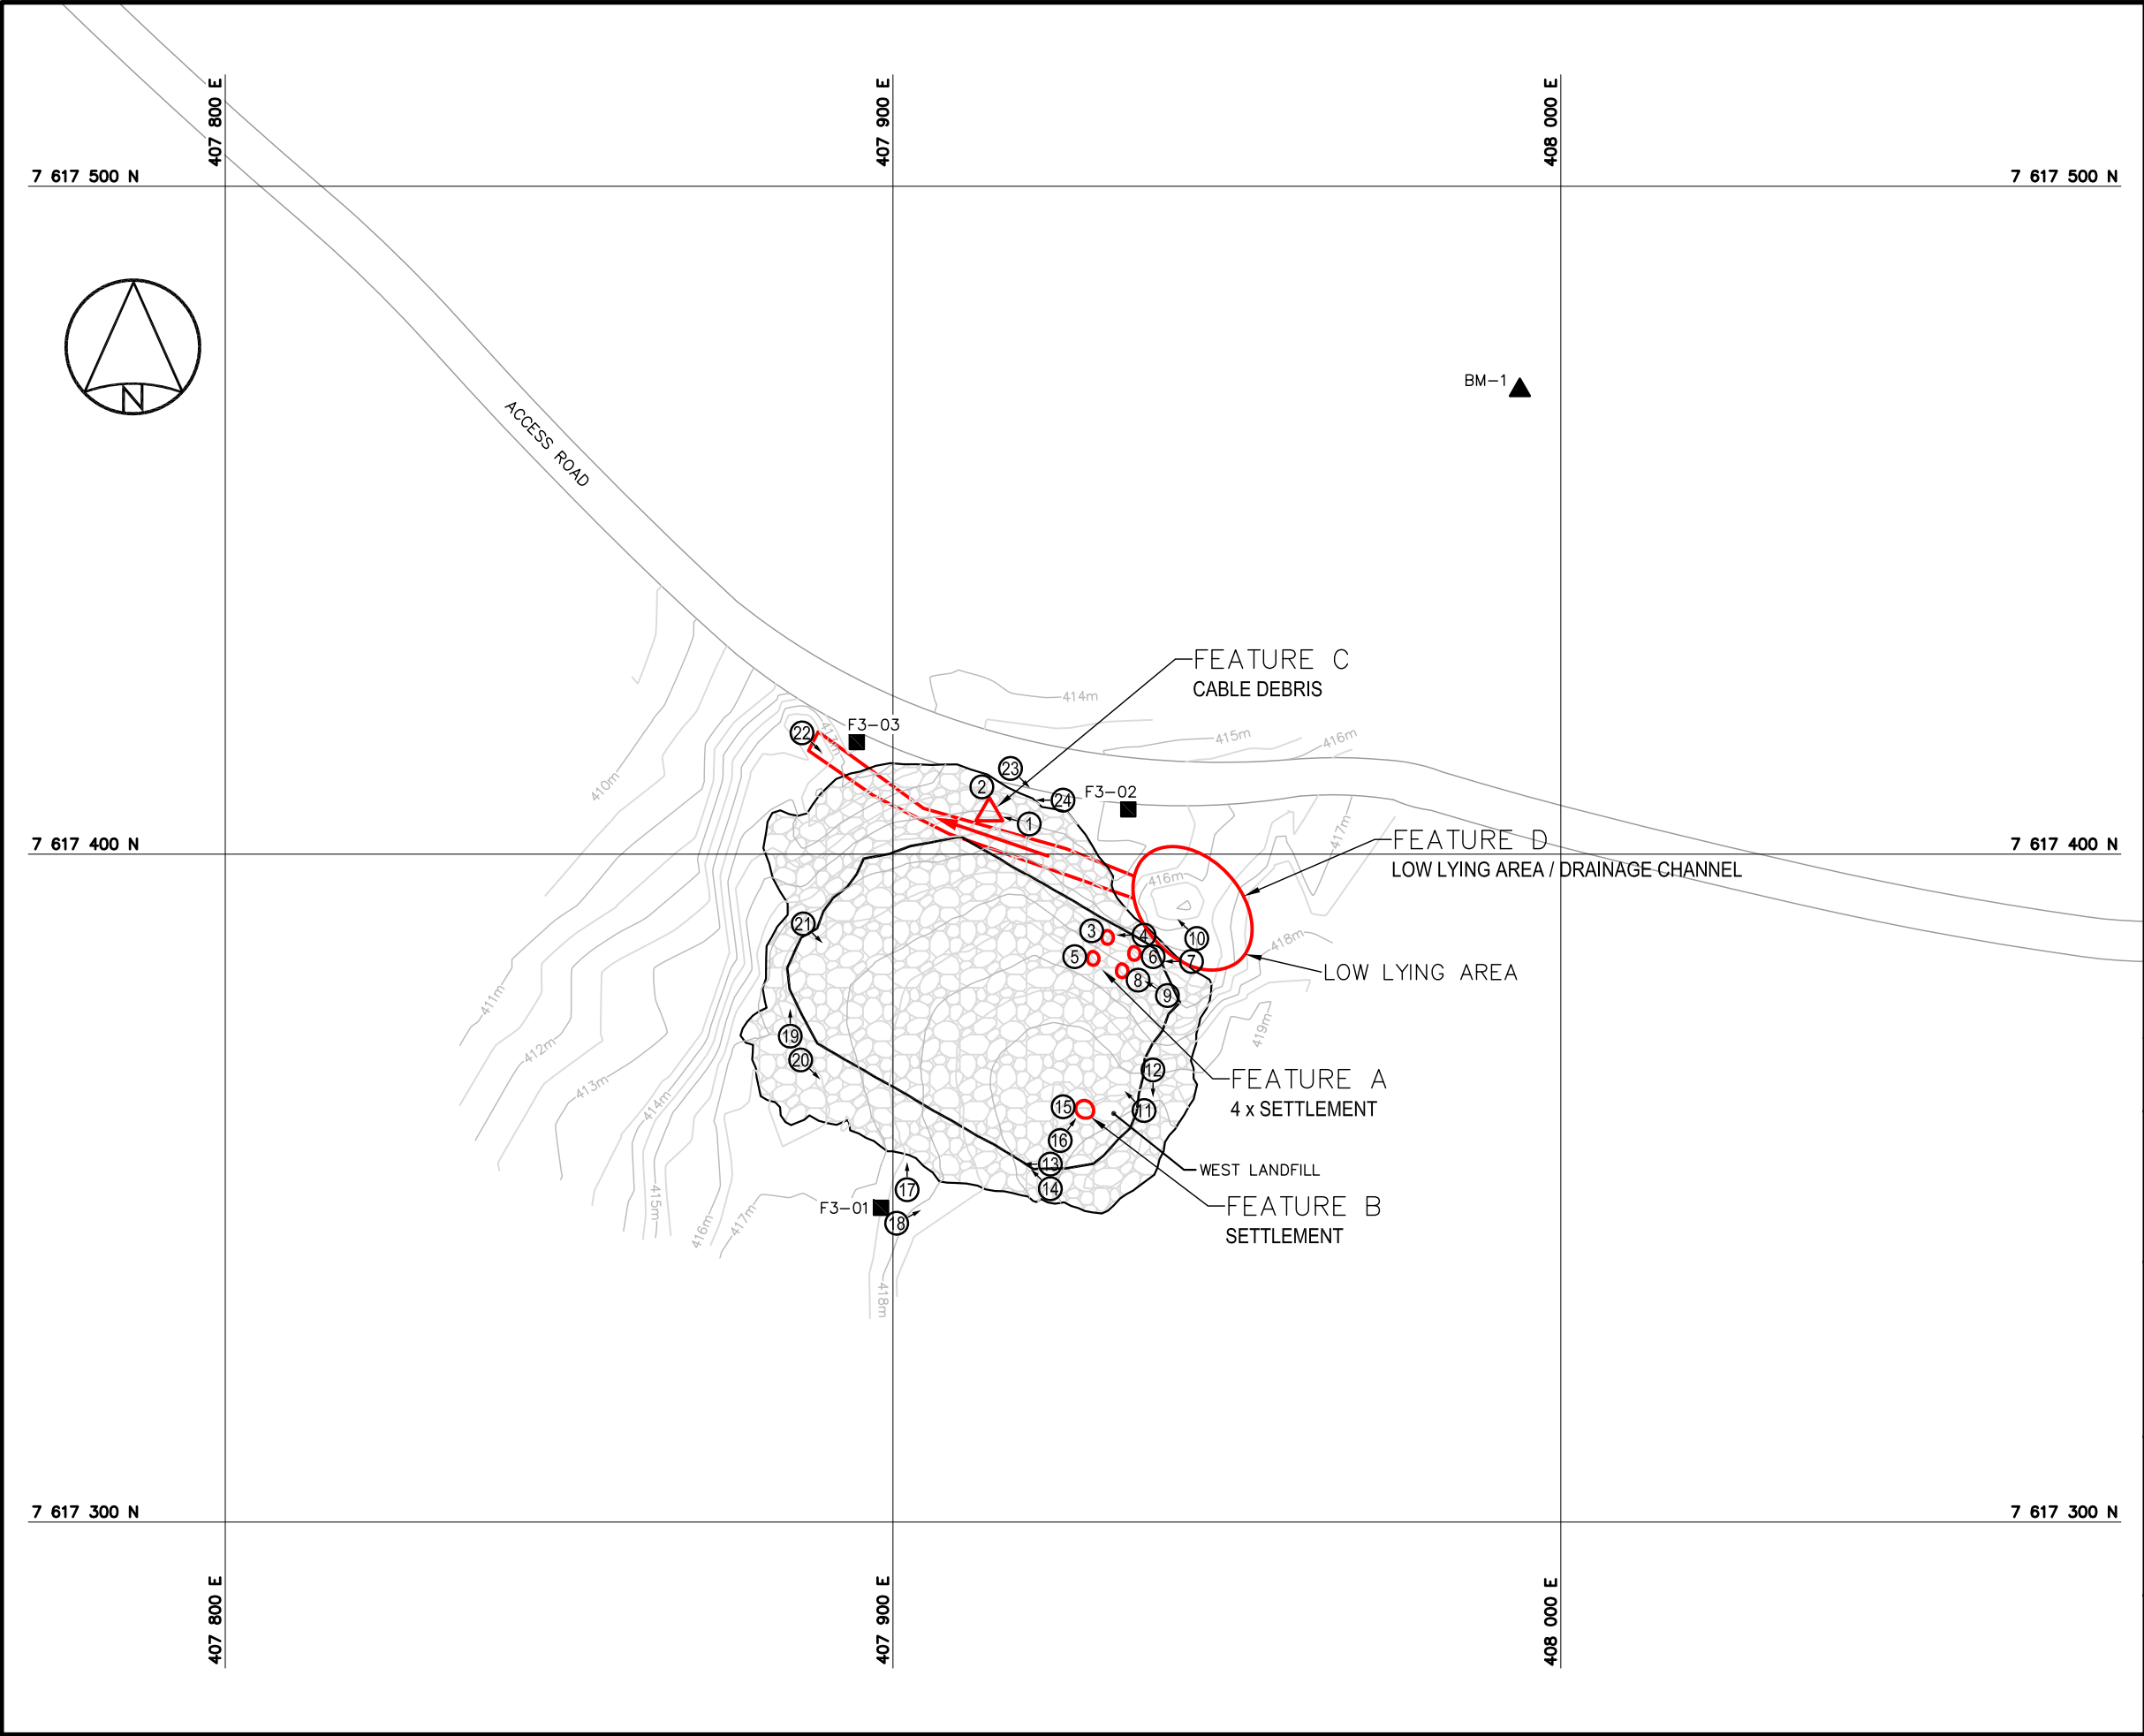
| Checklist Item | Present Yes/No | Location | Length | Width | Depth | Extent relative to Area of Landfill (%) | Description | Photographic Records (Refer to the photographic log for more details) | Additional Comments |
|---|---|---|---|---|---|---|---|---|---|
| <b>Features of Note.</b> | Yes | Feature D - refer to figure FOX-3-3 | 50.00 m | 0.50 – 10.00 m | N/A | >1% | Low lying area and drainage channel. | 1, 10, 22, 23 and 24 | Previously observed: Low lying area to the north of the landfill, in contact with toe, water draining on north landfill lobe. No significant erosion to note at this time. |

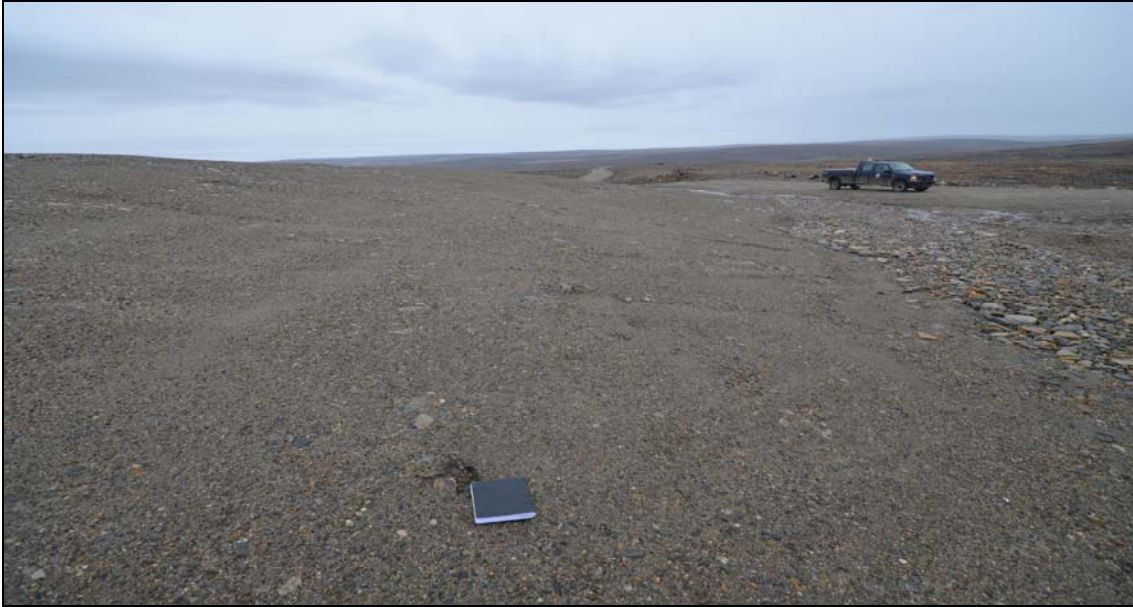
Figure 5: Photo - 2013-F3-W-9 - Feature A - View W - of 1 of 4 small depressions identified on the northern section of the landfill cap - (New observation).

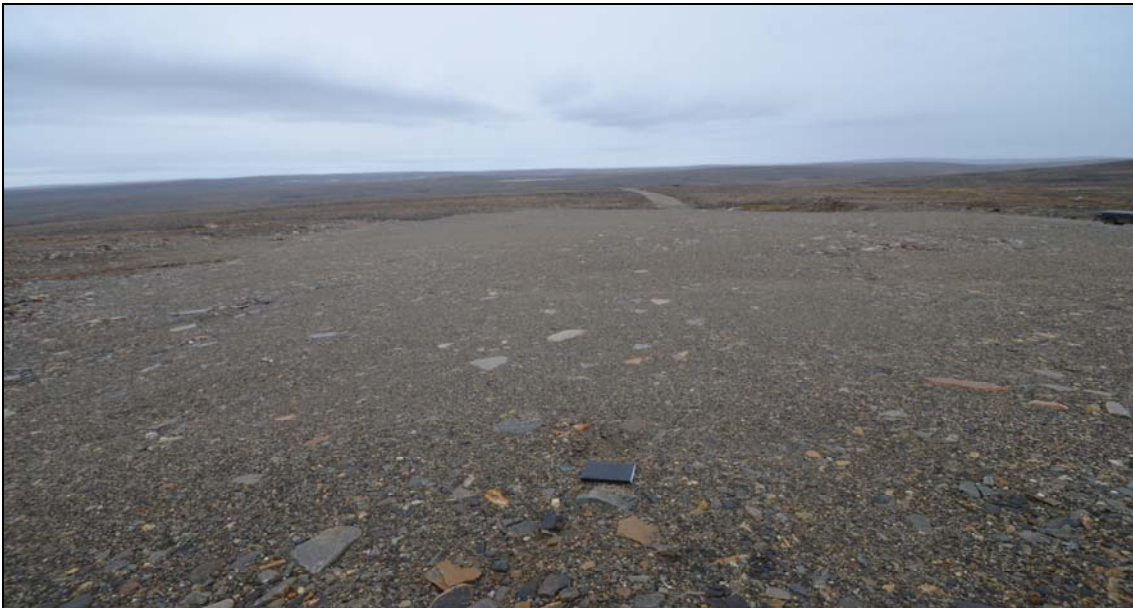
Figure 6: Photo - 2013-F3-W-16 - Feature B - View NW - of small depression identified on the northeast landfill cap.

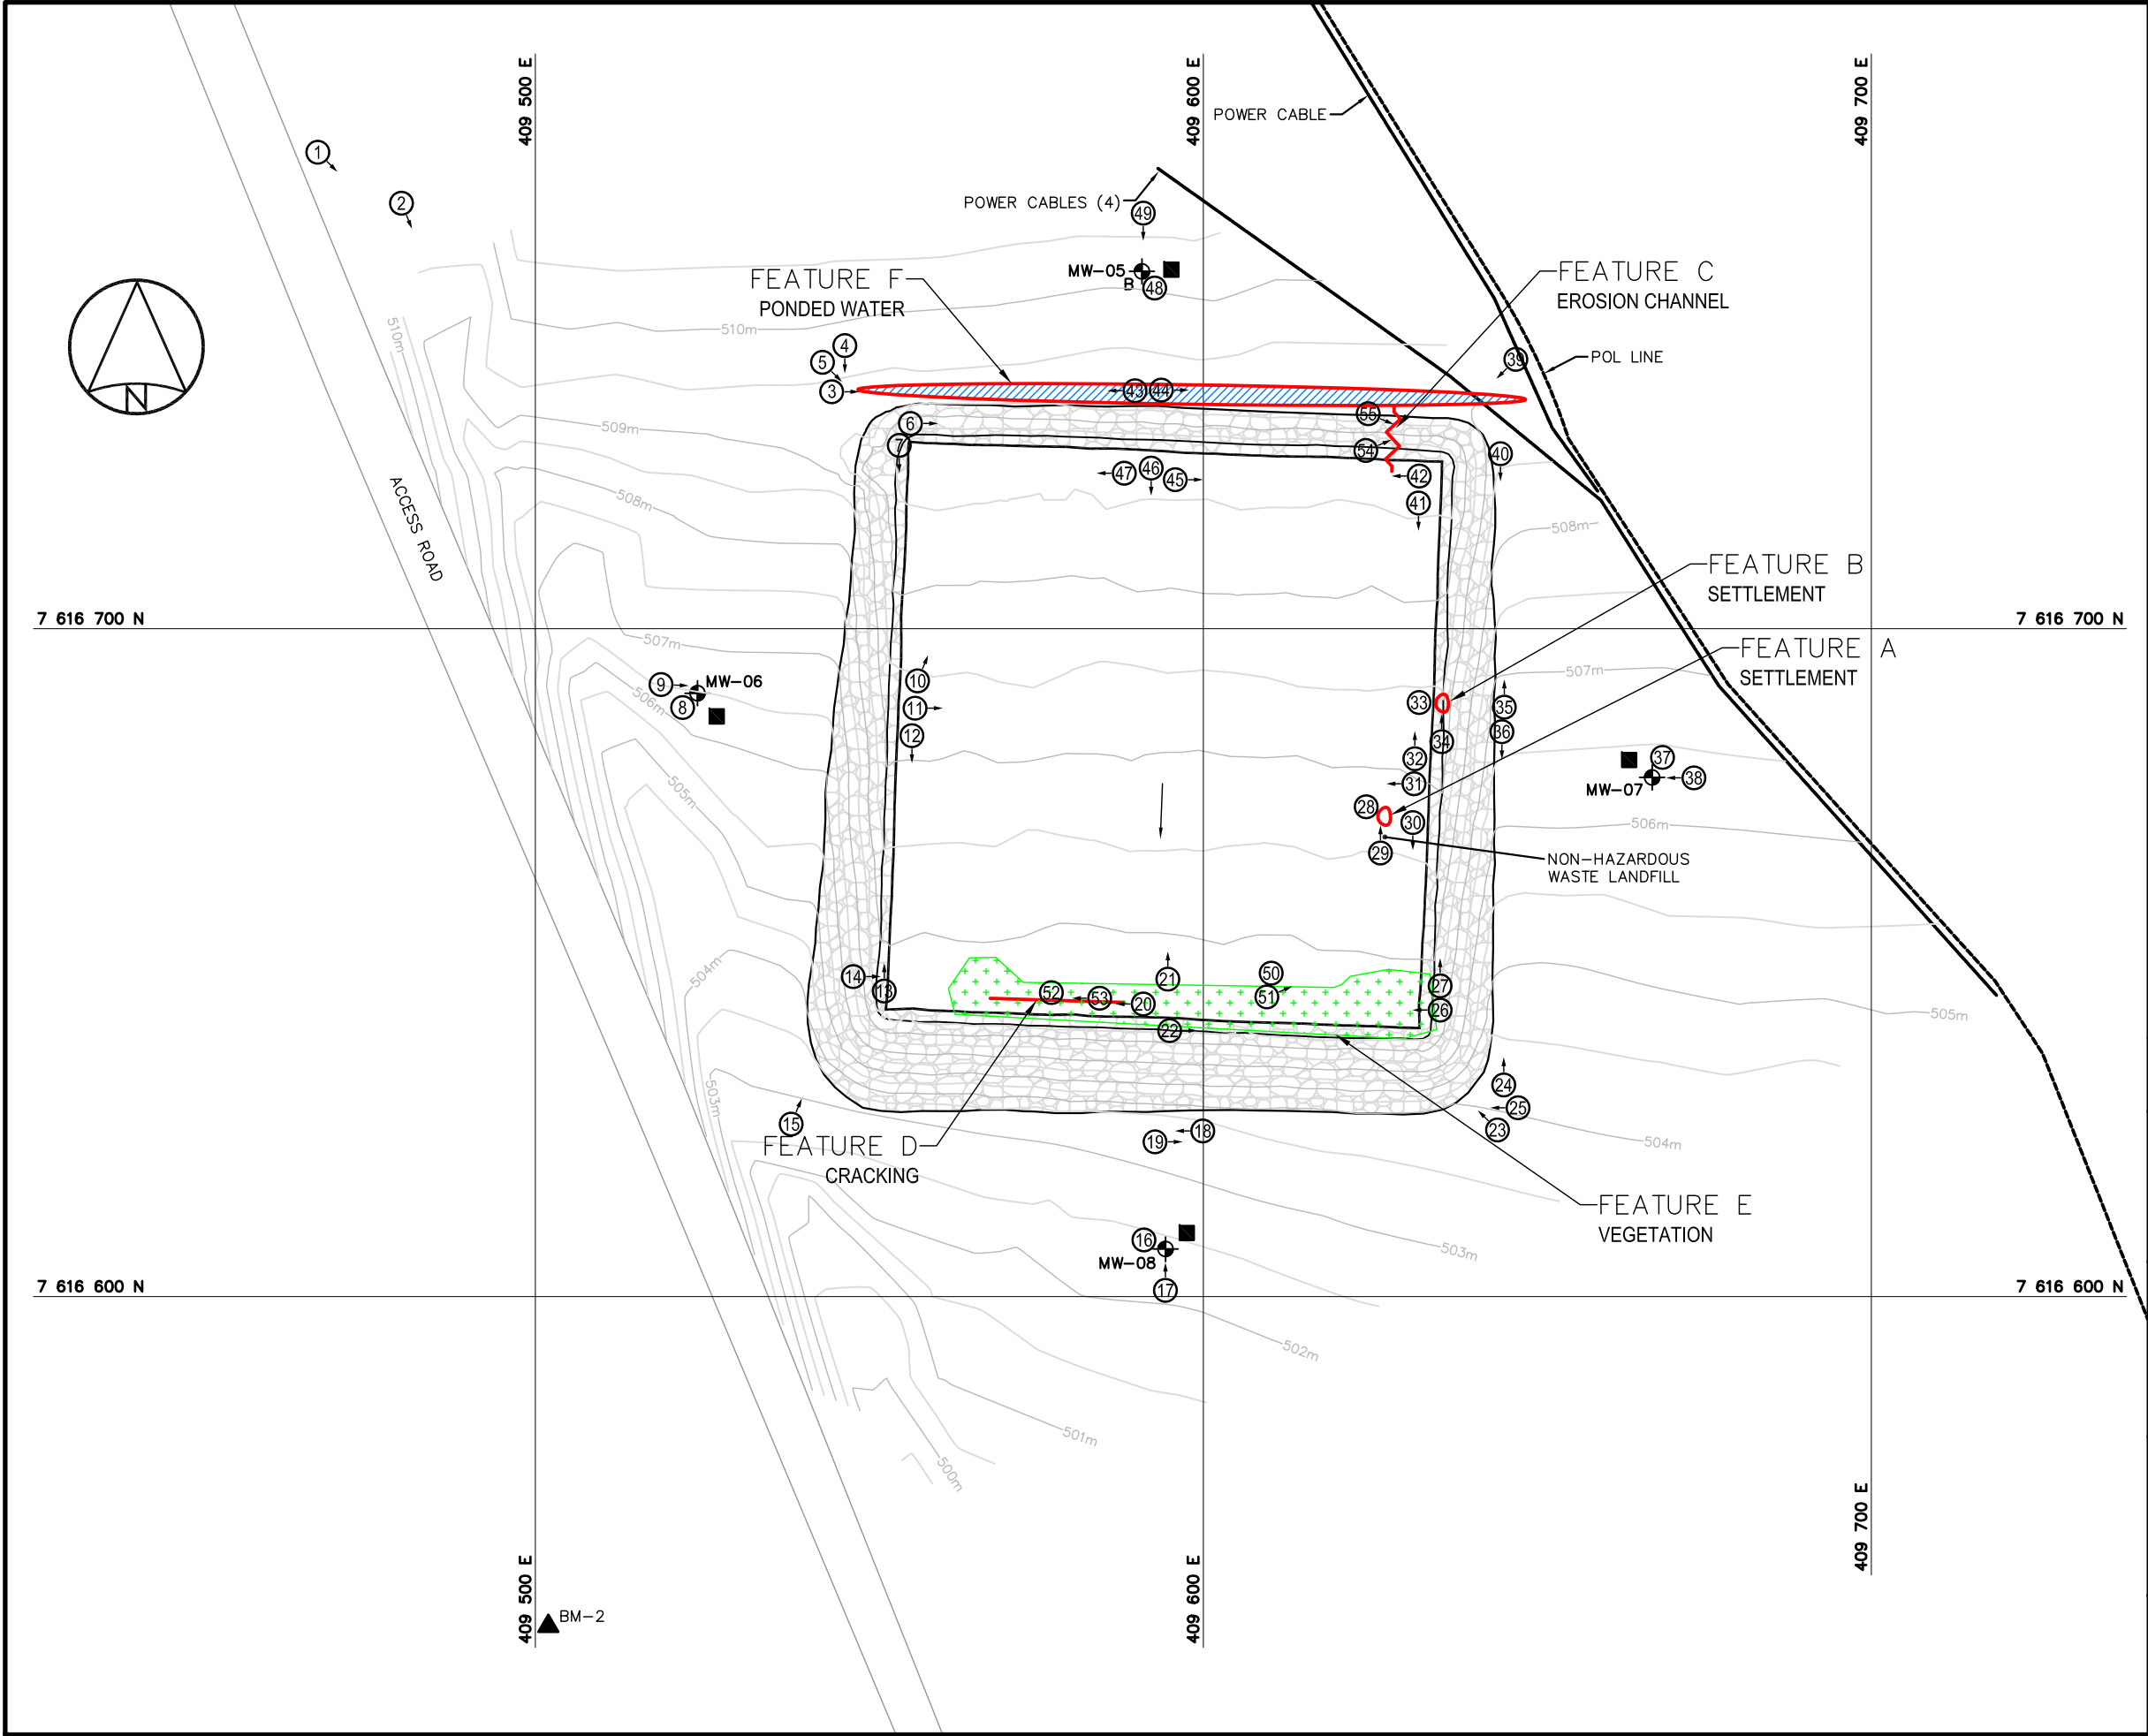
COLLECTION OF  
LANDFILL MONITORING DATA  
FOX-3, DEWAR LAKES, NUNAVUT  
NON-HAZARDOUS  
WASTE LANDFILL

| Checklist Item | Present Yes/No | Location | Length | Width | Depth | Extent relative to Area of Landfill (%) | Description | Photographic Records (Refer to the photographic log for more details) | Additional Comments |
|---|---|---|---|---|---|---|---|---|---|
| Erosion | Yes | Feature C- refer to figure FOX-3-4 | 4.00 m | 0.10 m | 0.03 | <1% | Singular erosion channel. | 54 and 55 | Previously observed: Minor erosion channel on the north slope of the landfill, barely discernible as of 2013 – self armouring. |
| Sloughing and Cracking | Yes | Feature D- refer to figure FOX-3-4 | 20.00 m | 0.02 m | Unknown | <1% | Tension crack. | 52 and 53 | <b>New observation:</b> Discontinuous tension crack running parallel to the south toe on the landfill cap. |
| Presence/Condition – Monitoring Instruments | Yes | MW-05, MW-06, MW-07 and MW-08 - refer to figure FOX-3-4 | N/A | N/A | N/A | N/A | Groundwater monitoring wells. | 8, 9, 16, 17, 37, 38, | All wells appear in good condition. |
| Features of Note. | Yes | Feature F - refer to figure FOX-3-4 | 100.00 m | 0.30 – 3.00 m | 0.03 – 0.05 m | >1% | Ponded water. | 3, 5, 6, 43 and 44 | Previously Identified: Ponded water north of the landfill. Water is pooled in shallow ruts caused by truck traffic and other low-lying areas. |

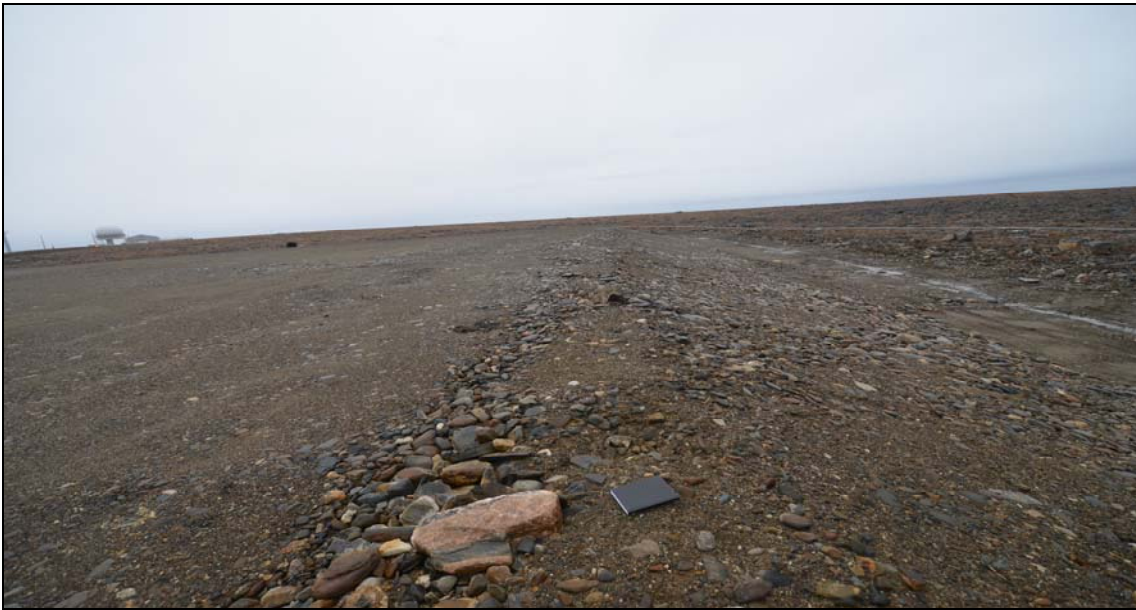
Figure 7: Photo - 2013-F3-NHWL-34 - Feature B - View N - of minor depression on the crest of the east side-slope - (new observation)

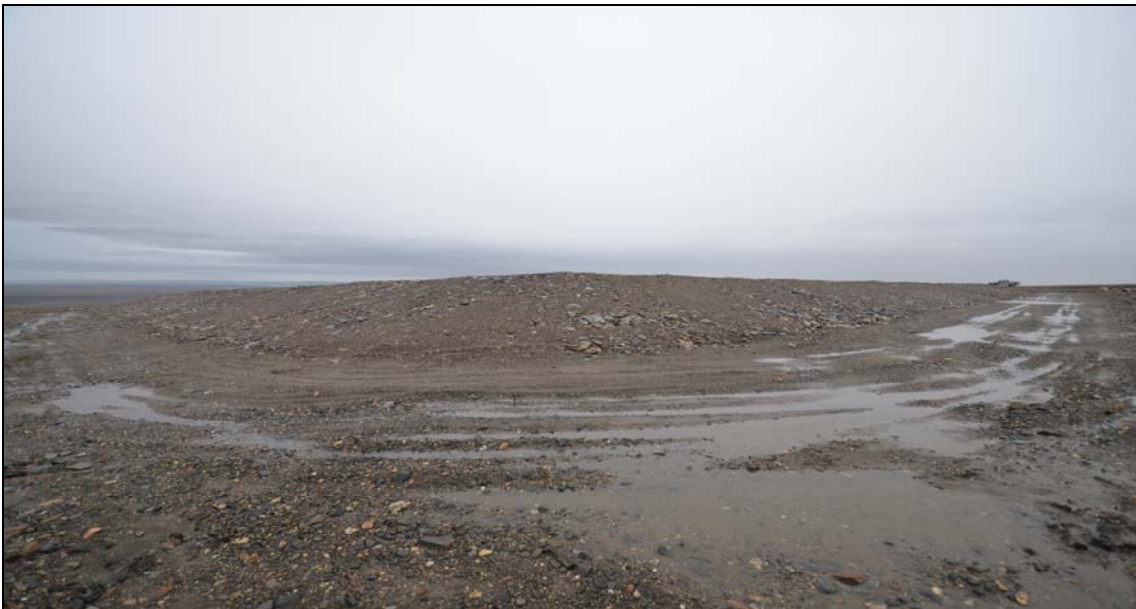
Figure 8: Photo - 2013-F3-NHWL-39 - View SW - of the northeast corner of the landfill.

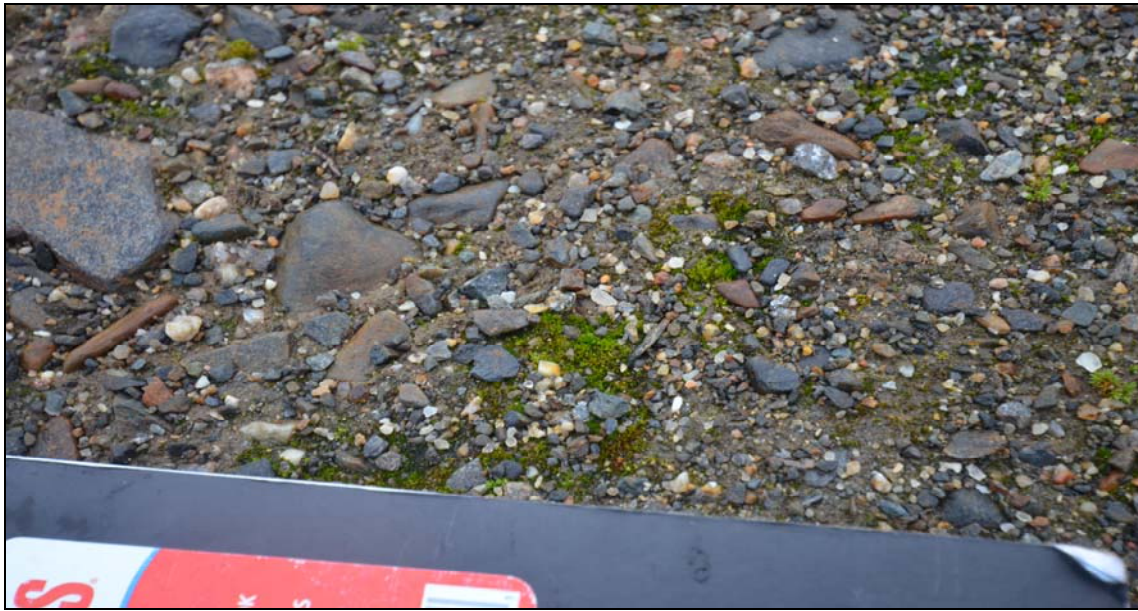
Figure 9: Photo - 2013-F3-NHWL-50 - Feature E - Close-up - of vegetation growing on the southern portion of the landfill surface - (new observation).

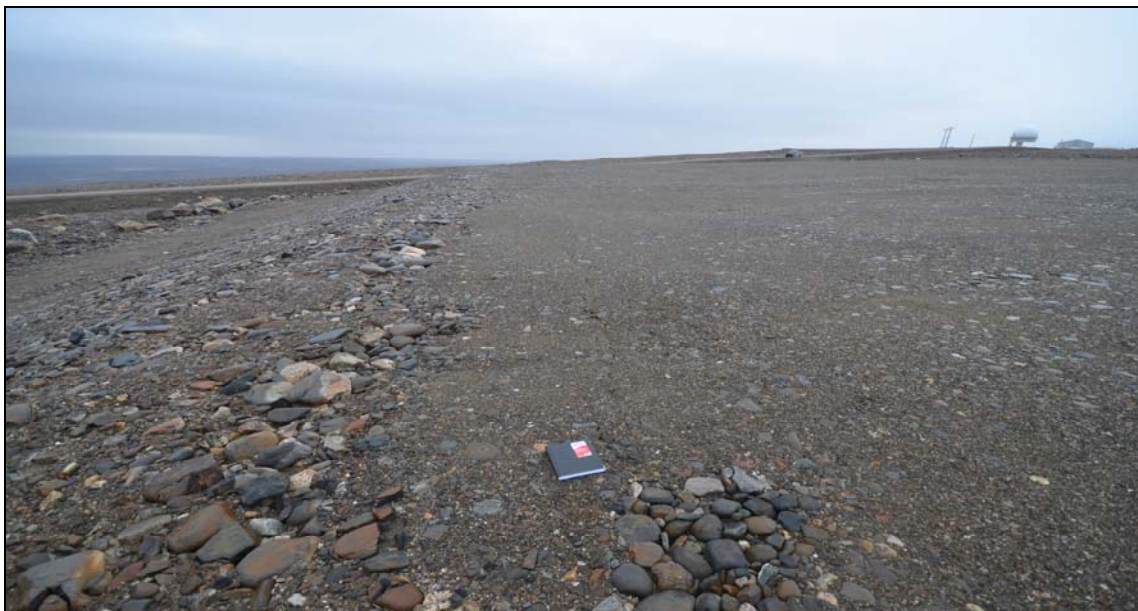
| Photo | Filename | Size (MB) | Date | Vantage Point | | Focal Length | Caption |
|---|---|---|---|---|---|---|---|
| 53 | 2013-F3-NHWL-53 | 7.97 | 23/08/2013 | 409582 | 7616647 | 10 | Feature D - view W - of discontinuous crack on the southern surface of the landfill. |

Figure 10: Photo - 2013-F3-NHWL-53 - Feature D - View W - of the discontinuous crack on the southern surface of the landfill - (new observation).
