**THE COLLECTION OF LANDFILL  
MONITORING DATA AT THE FORMER  
FOX-3 DISTANT EARLY WARNING LINE SITE**

Dewar Lakes, Nunavut

**FINAL REPORT – 2013**

**DEFENCE CONSTRUCTION CANADA**

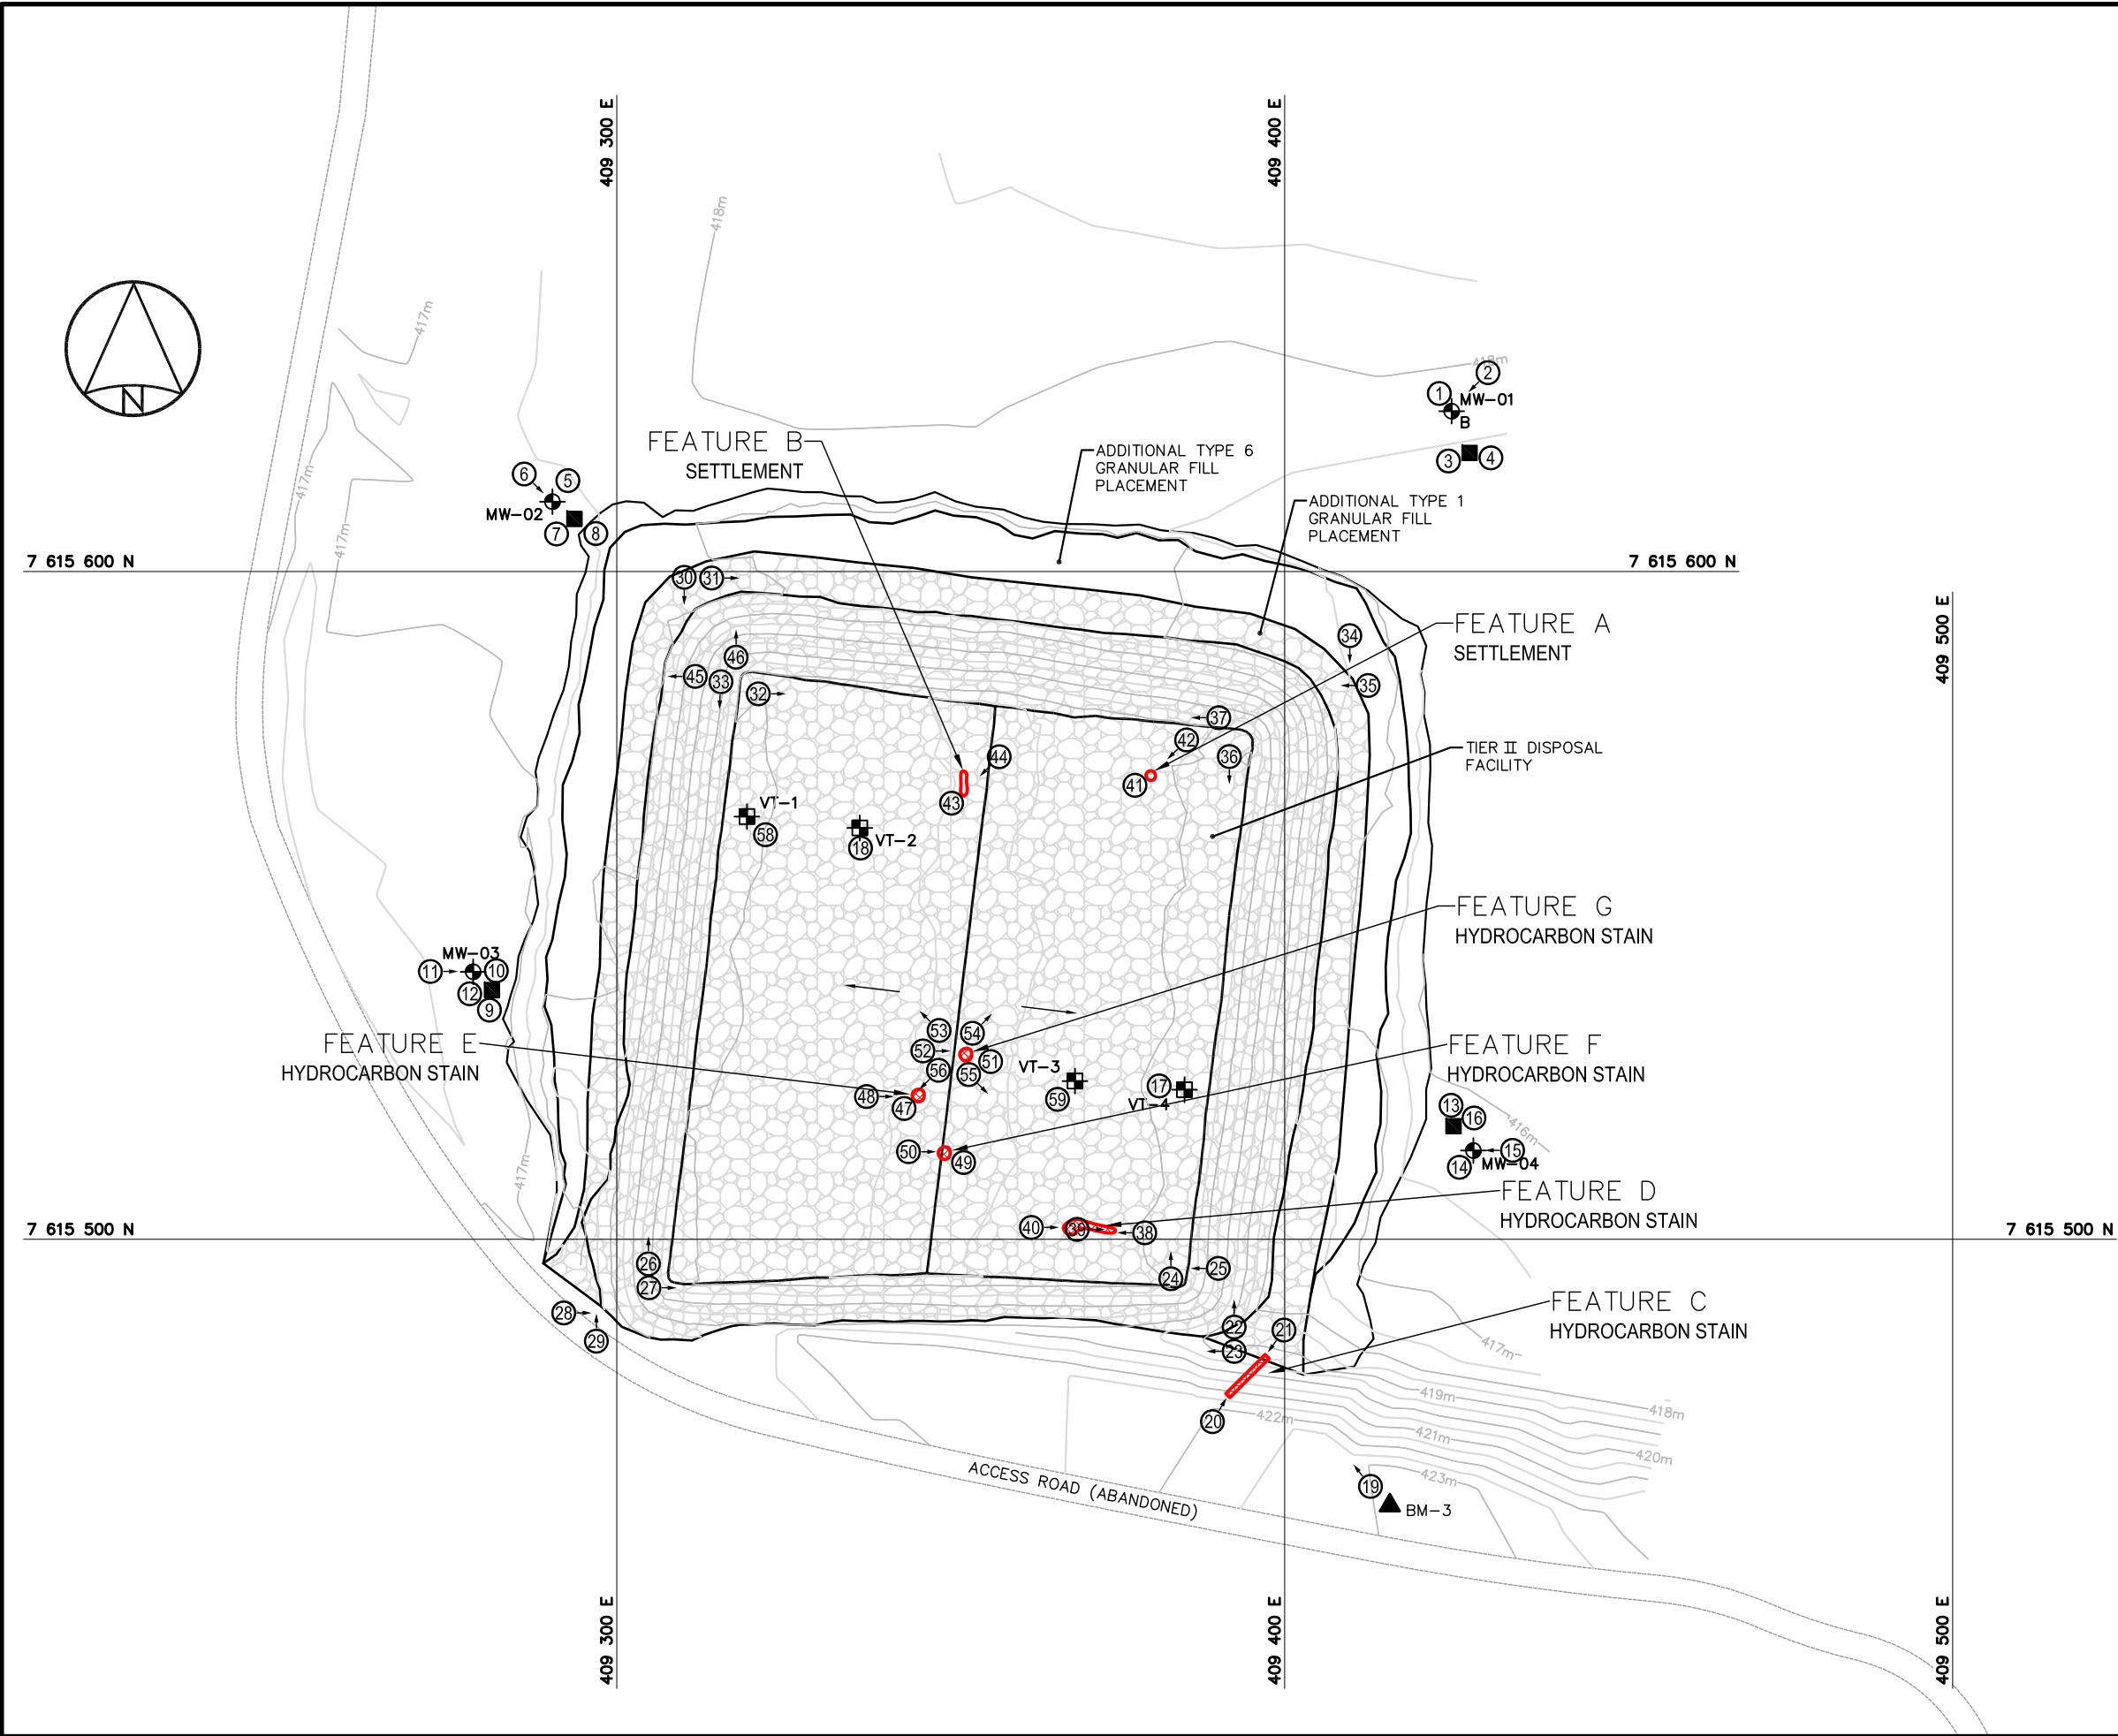
| Checklist Item | Present Yes/No | Location | Length | Width | Depth | Extent relative to Area of Landfill (%) | Description | Photographic Records (Refer to the photographic log for more details) | Additional Comments |
|---|---|---|---|---|---|---|---|---|---|
| <b>Staining</b> | Yes | Feature C - refer to figure FOX-3-5 | 17.00 m | 0.30 m | Unknown | 1% | Large hydrocarbon stain. | 20 and 21 | Previously observed: Large hydrocarbon stain extending from the top to the bottom of a slope to the southeast of the landfill. |
| | | Feature D - refer to figure FOX-3-5 | 6.00 m | 0.30 – 1.00 m | Unknown | <1% | Hydrocarbon stain. | 38, 39, and 40 | Previously observed: Hydrocarbon stain on the south landfill surface. |
| | | Feature E - refer to figure FOX-3-5 | 0.40 m | 0.30 m | Unknown | <1% | Small hydrocarbon stain. | 47 and 48 | Previously observed: Hydrocarbon stain located on the south landfill cap. |
| | | Feature F - refer to figure FOX-3-5 | 1.00 m | 1.00 m | Unknown | <1% | Small hydrocarbon stain. | 49 and 50 | Previously observed: Hydrocarbon stain located on the south landfill cap. |
| | | Feature G - refer to figure FOX-3-5 | 0.20 m | 0.20 m | Unknown | <1% | Small hydrocarbon stain. | 51 and 52 | Previously observed: Hydrocarbon stain located centrally on the landfill cap. |
| <b>Presence/Condition – Monitoring Instruments</b> | Yes | MW-01, MW-02, MW-03, MW-04, VT-1, VT-2, VT-3 and VT-4 - refer to figure FOX-3-5 | N/A | N/A | N/A | N/A | Groundwater monitoring wells and thermistor installations. | 1, 2, 5, 6, 10, 11, 14, 15, 17, 18, 58 and 59 | Groundwater wells and thermistors are in good condition. |

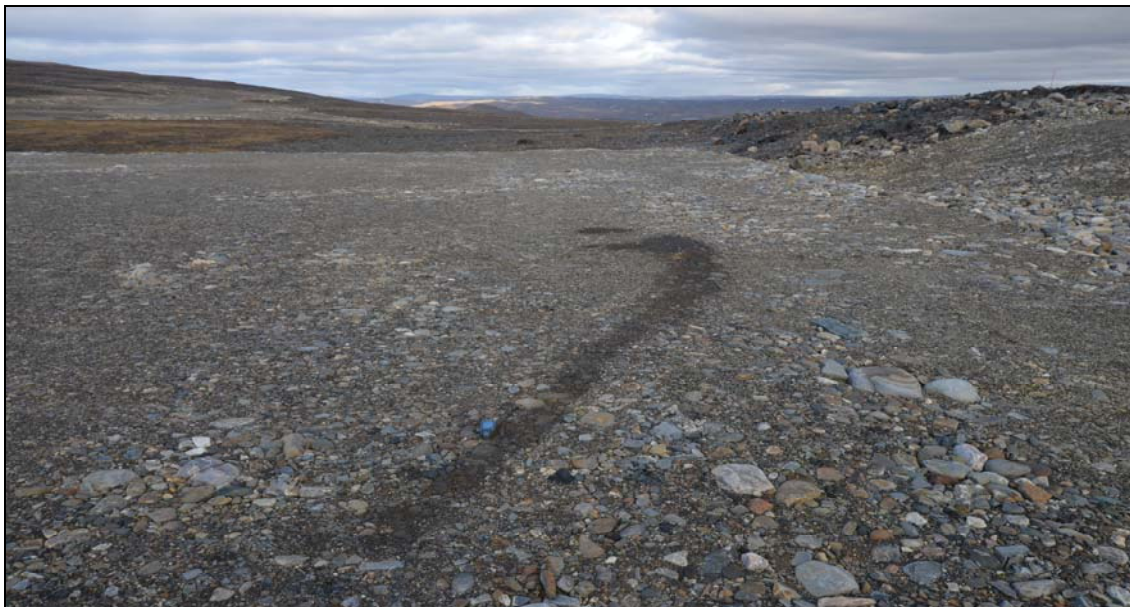
| Photo | Filename | Size (MB) | Date | Vantage Point | | Focal Length | Caption |
|---|---|---|---|---|---|---|---|
| 40 | 2013-F3-TII-40 | 8.70 | 24/08/2013 | 409363 | 7615501 | 16 | Feature D - view E - of a large hydrocarbon stain on the southeastern landfill surface, taken from the western extent of the stain. |

Figure 11: Photo – 2013-F3-TII-40 - Feature D - View E - of a large hydrocarbon stain on the southeastern landfill surface, taken from the western extent of the stain. Previously observed.

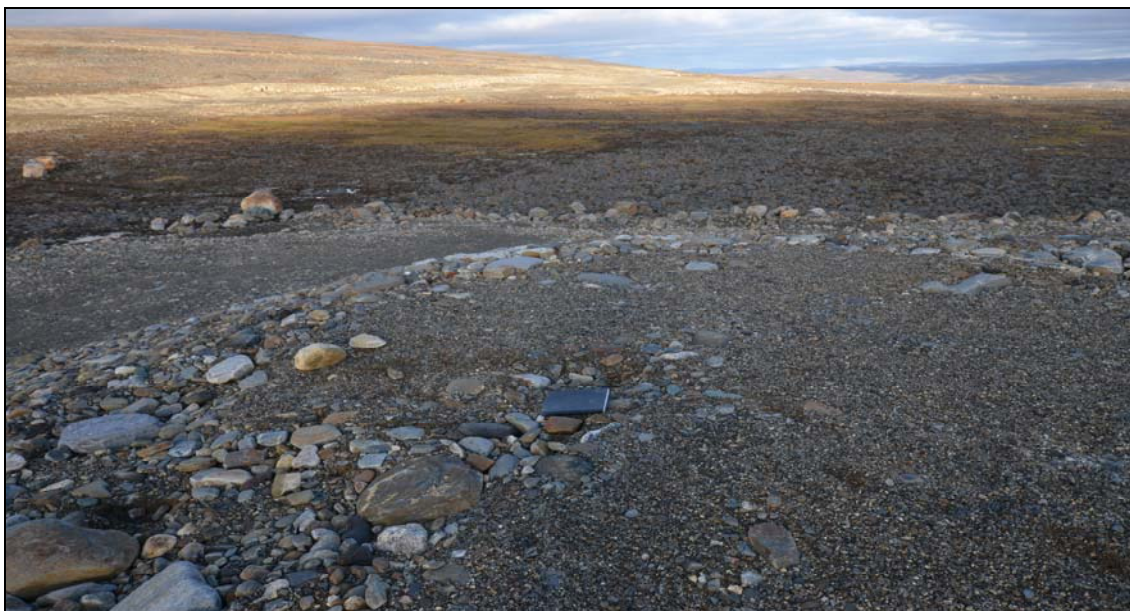
Figure 12: Photo – 2013-F3-TII-42 - Feature A - View SW - of minor depression on the landfill surface at the northeast corner. New observation.

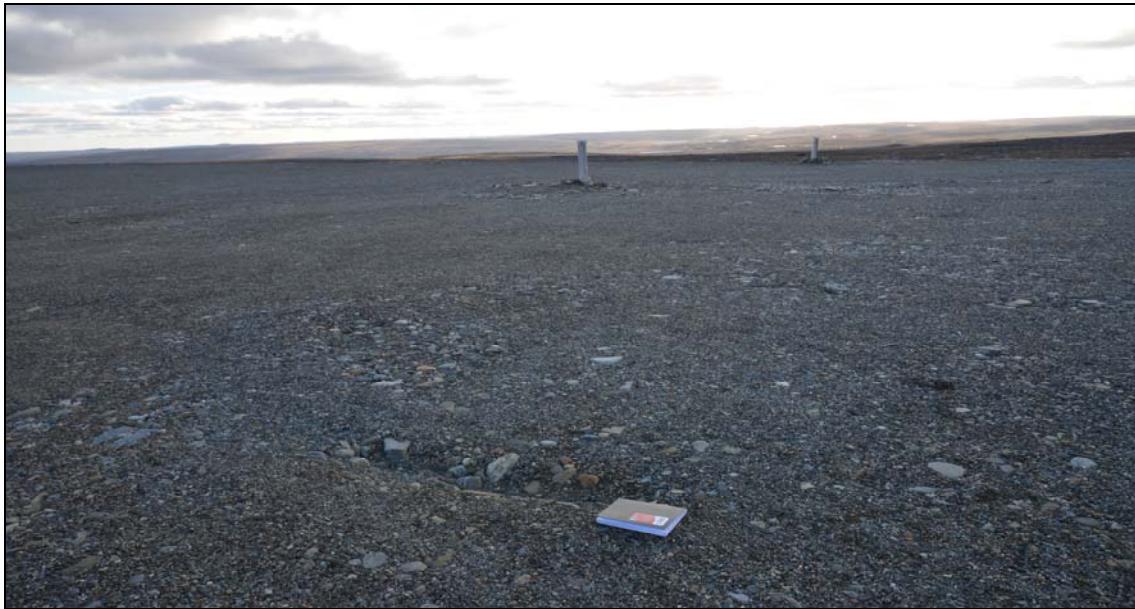
**Figure 13:** Photo – 2013-F3-TII-44 - Feature B - View SW - of minor linear depression on the northern landfill surface. New observation.

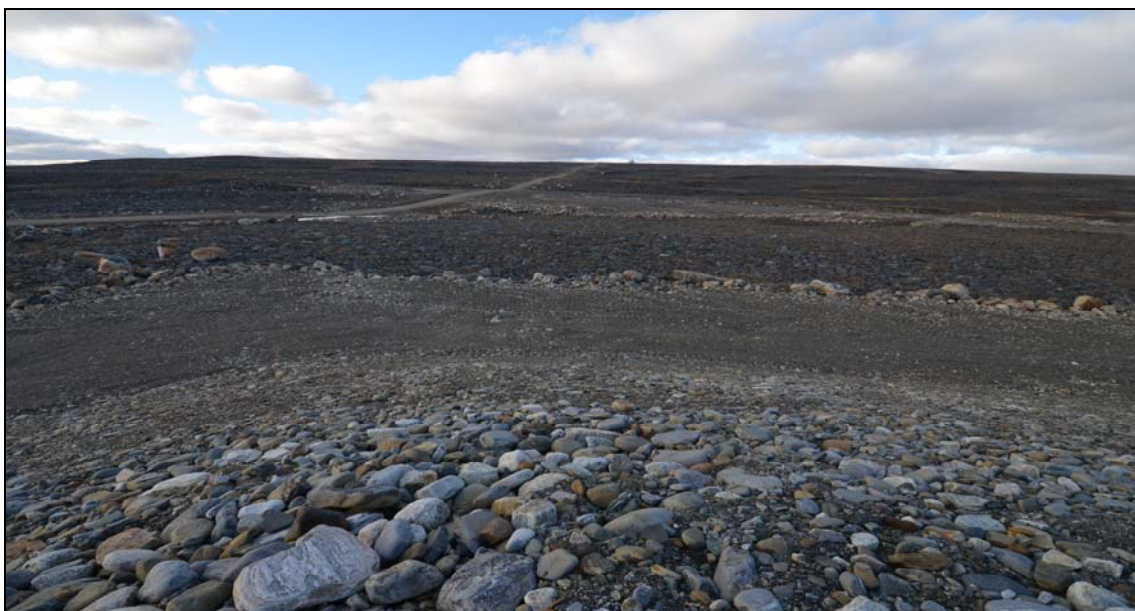
**Figure 14:** Photo – 2013-F3-TII-46 - View N - of area previously identified to have ponded water - no longer visible.
