QIKIQ15 BAFFIN REGION DEW LINE SITE MONITORING

2016 FOX-3 Monitoring Report

Report Number: 1530908-2000-R3-V2

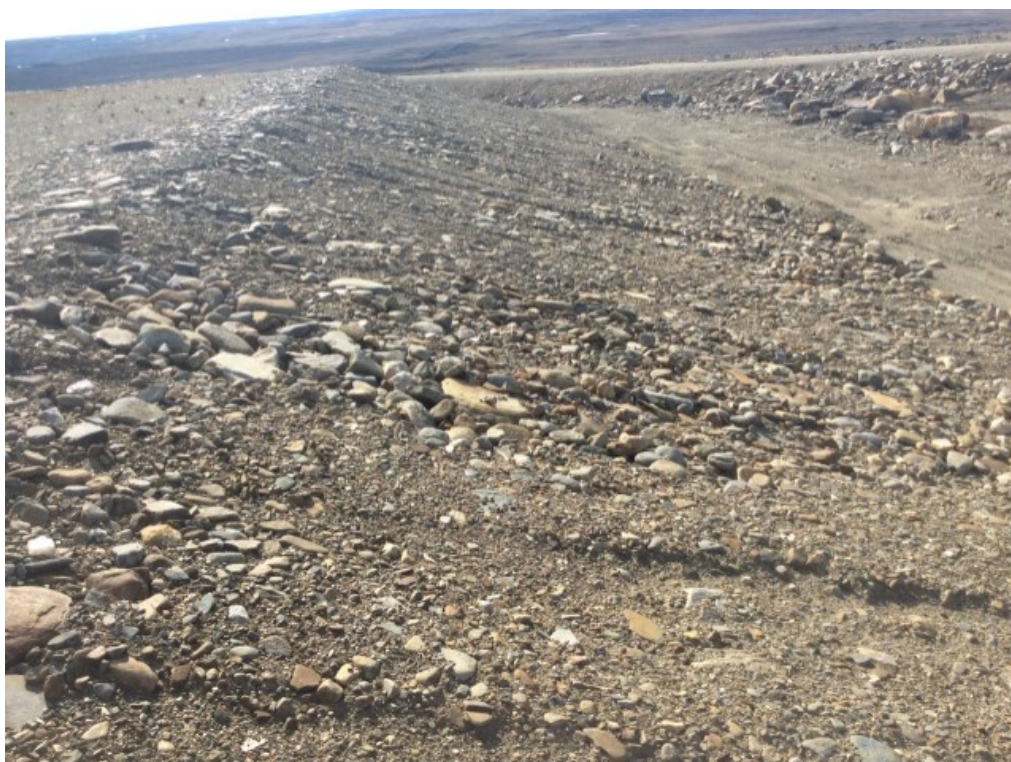
Photo 16: FOX-3 – Non Hazardous Waste Landfill – West slope – Feature I – Self-armoured erosion [Acceptable], facing south (ATT42_Photo42.jpg)

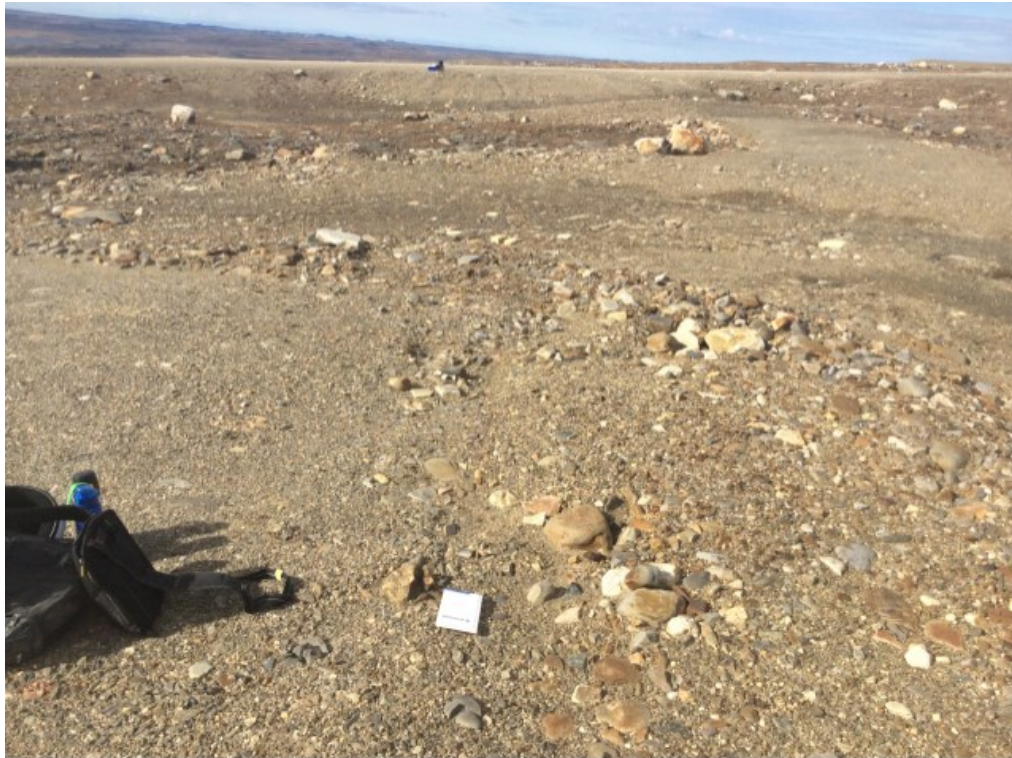
Photo 17: FOX-3 – Non Hazardous Waste Landfill – Northwest crest corner – Feature L – Small depressions [Acceptable], facing northwest (ATT33_Photo33.jpg)

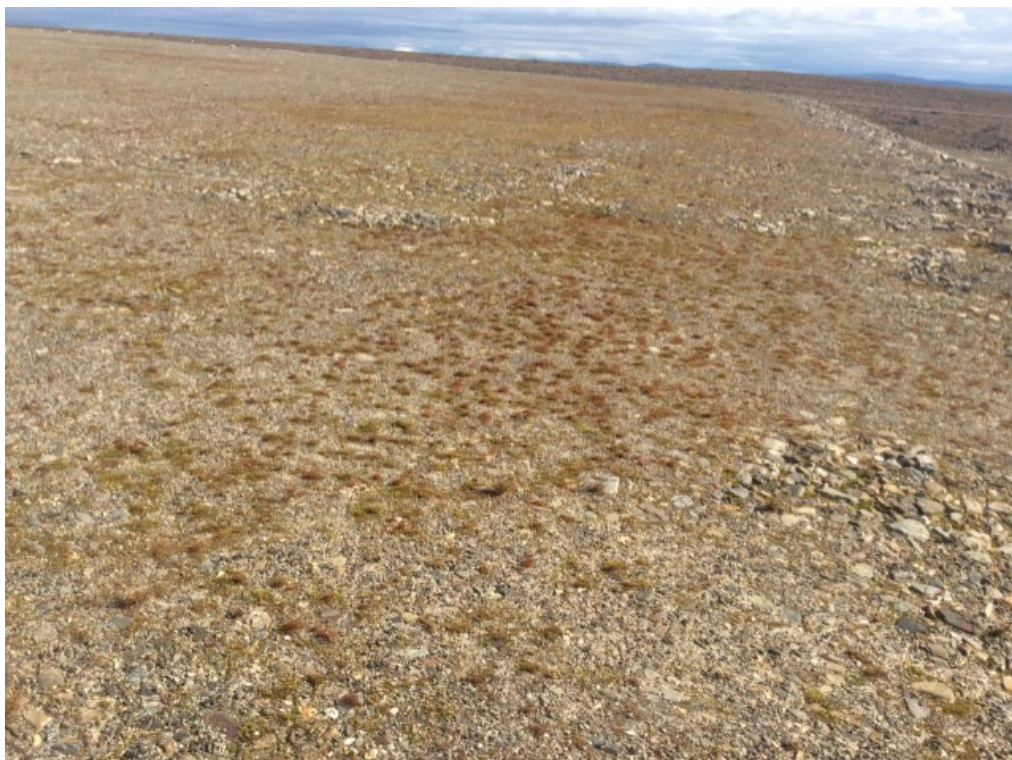
Photo 18: FOX-3 – Non Hazardous Waste Landfill – Cover surface – Feature J – sparse grass vegetation along south crest [Acceptable], facing east (ATT41_Photo41.jpg)

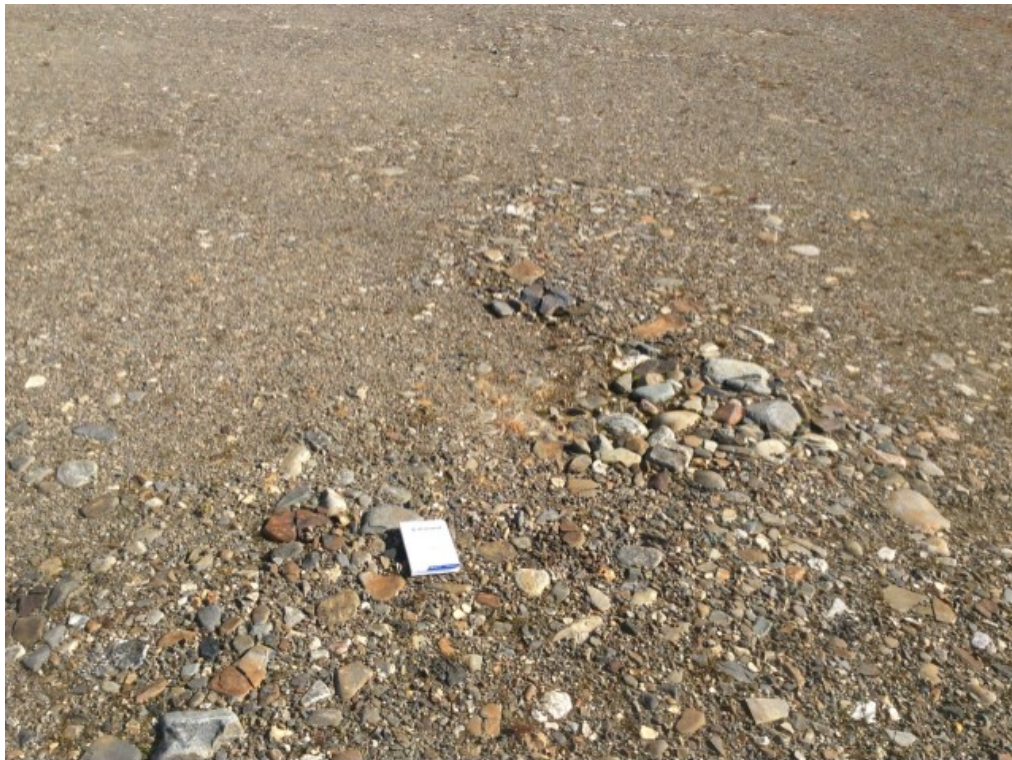
Photo 19: FOX-3 – Non Hazardous Waste Landfill – Central crest surface – Feature M – Small depression [Acceptable], facing south (ATT44_Photo44.jpg)

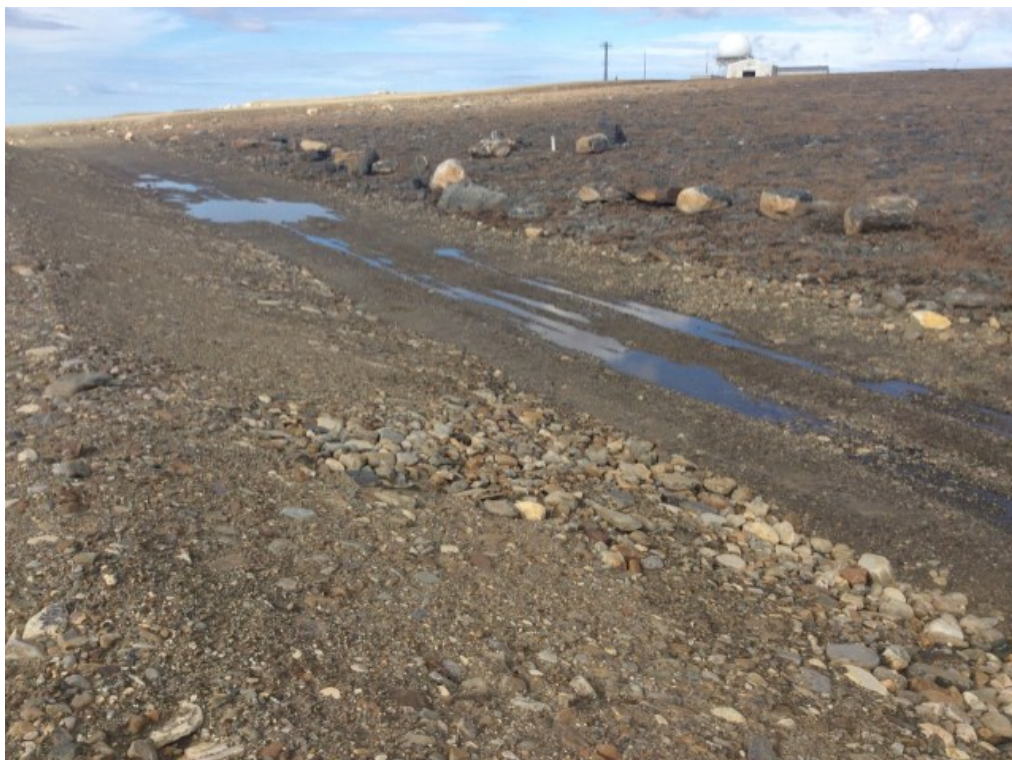
Photo 20: FOX-3 – Non Hazardous Waste Landfill – North toe – Feature F – Ponded water along toe [Acceptable], facing west (ATT34_Photo34.jpg)

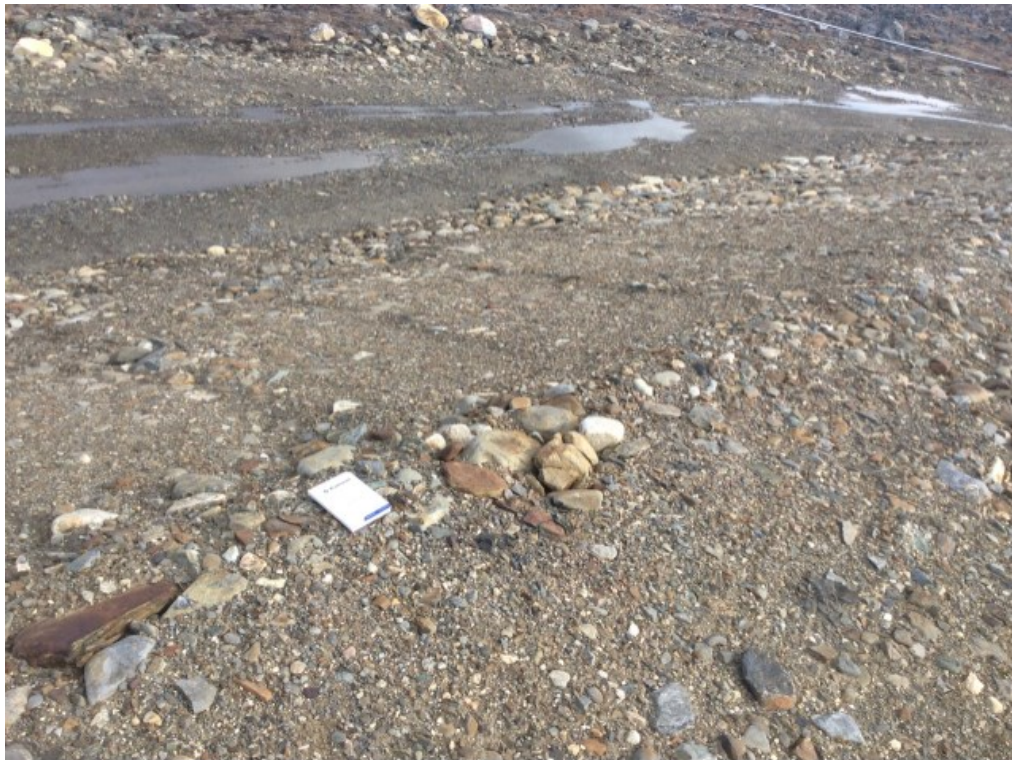
Photo 21: FOX-3 – Non Hazardous Waste Landfill – North slope – Feature C – self-armouring erosion [Acceptable], facing northeast (ATT35_Photo35.jpg)

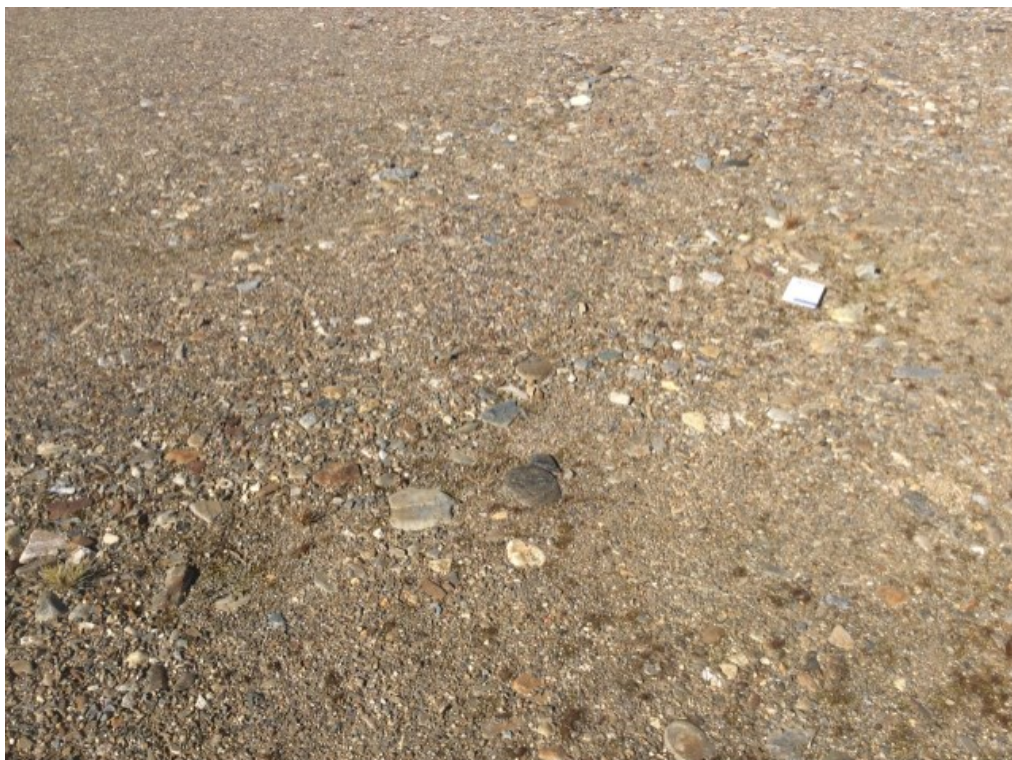
Photo 22: FOX-3 – Non Hazardous Waste Landfill – East crest – Feature A – Small depressions [Acceptable], facing north (ATT39_Photo39.jpg)

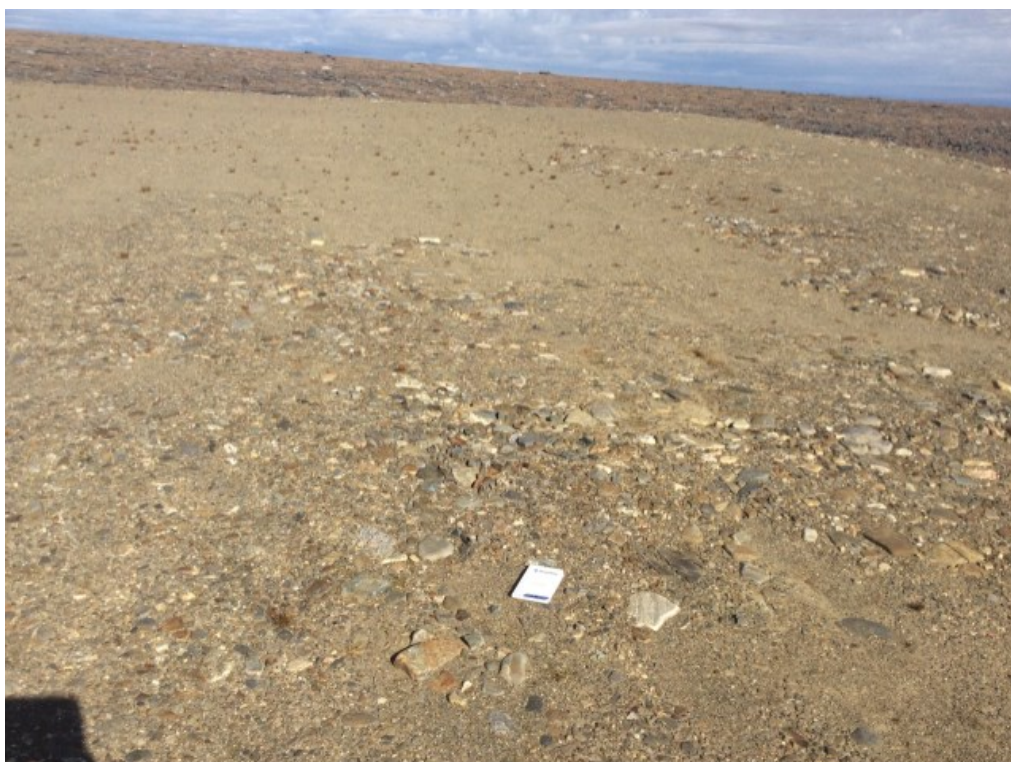
Photo 23: FOX-3 – Non Hazardous Waste Landfill – Cover surface – Feature G – Small depressions [Acceptable], northwest (ATT40_Photo40.jpg)

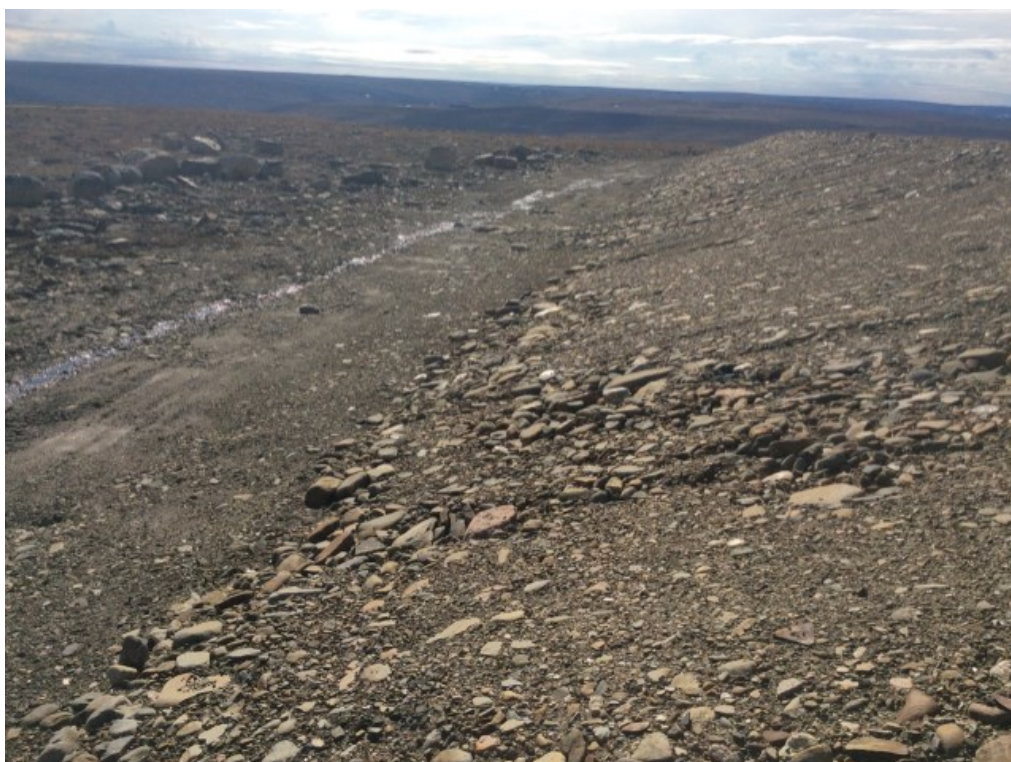
Photo 24: FOX-3 – Non Hazardous Waste Landfill – East toe – Feature K – Ponded water running along toe [Acceptable], facing south (ATT38_Photo38.jpg)

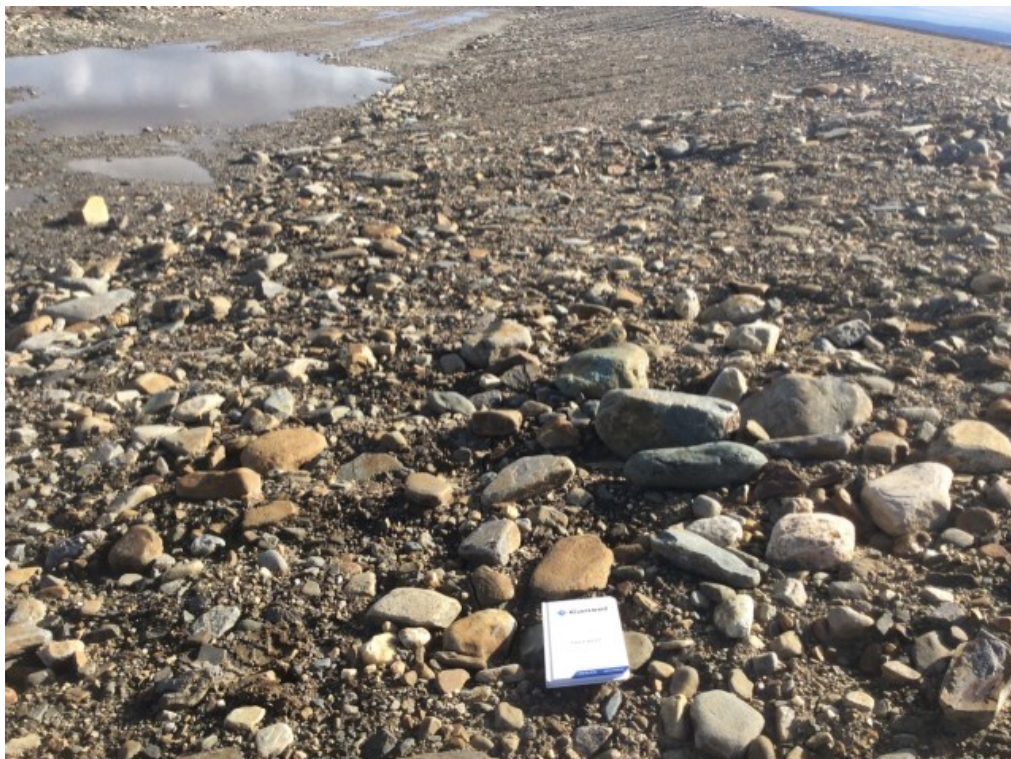
Photo 25: FOX-3 – Non Hazardous Waste Landfill – North slope – Feature N – Tension crack extended along the north slope below which the area is wet but no signs of seepage, facing east (ATT36_Photo36.jpg)

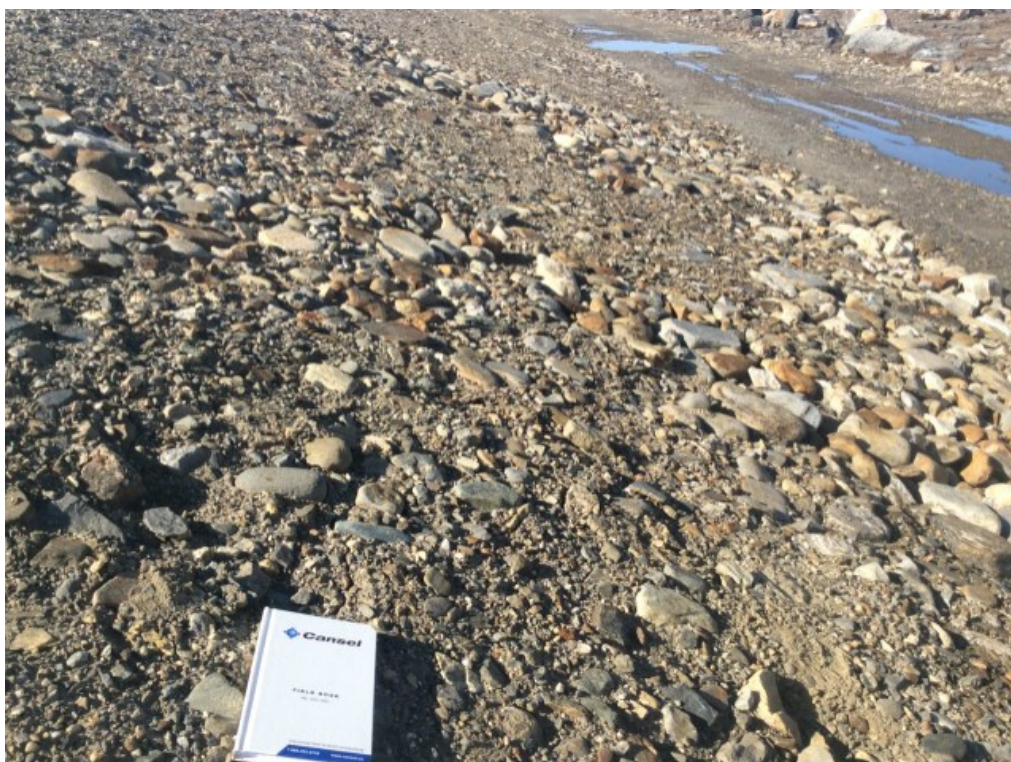
Photo 26: FOX-3 – Non Hazardous Waste Landfill – North slope – Feature N – Tension crack extended along the north slope below which the area is wet but no signs of seepage, facing west (ATT37_Photo37.jpg)

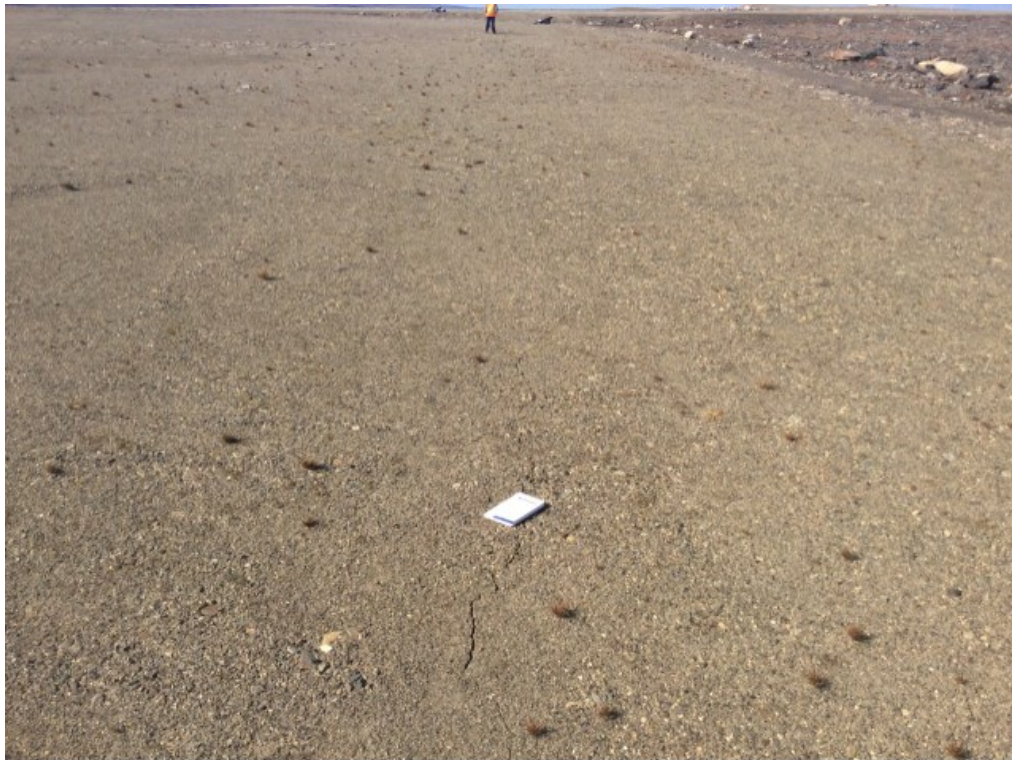
Photo 27: FOX-3 – Non Hazardous Waste Landfill – North crest – Feature O – Minor tension crack along the north crest, facing west (1 point) (ATT45_Photo45.jpg)

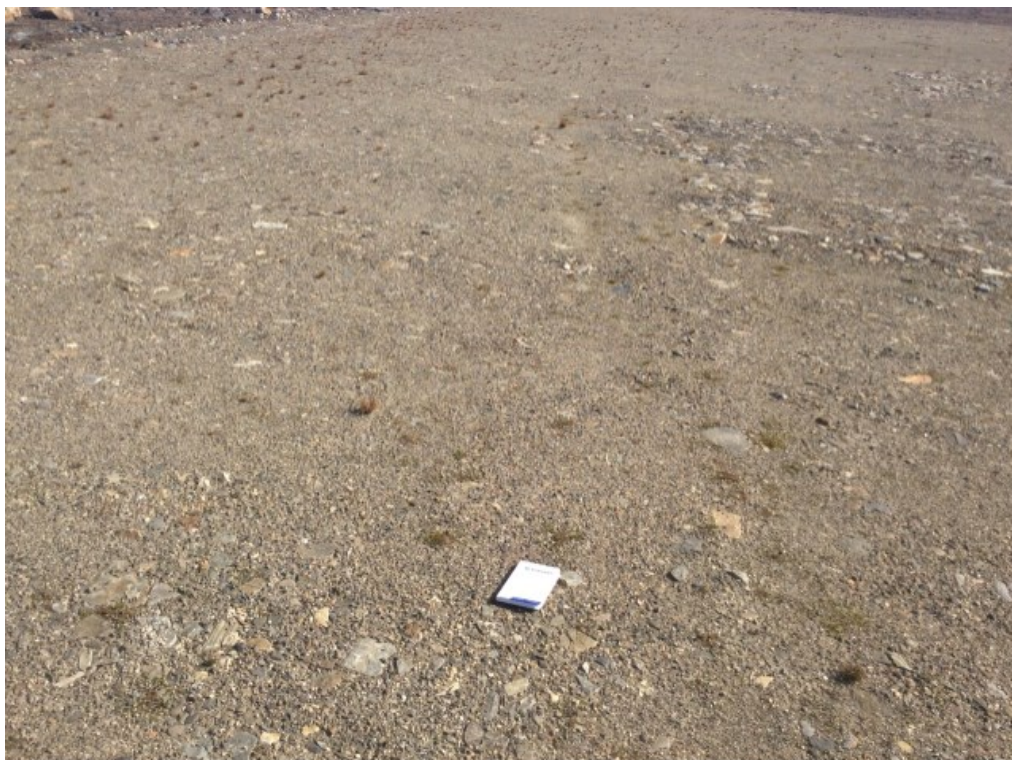
Photo 28: FOX-3 – Non Hazardous Waste Landfill – North crest – Feature O – Minor tension crack along the north crest, facing east (ATT46_Photo46.jpg)

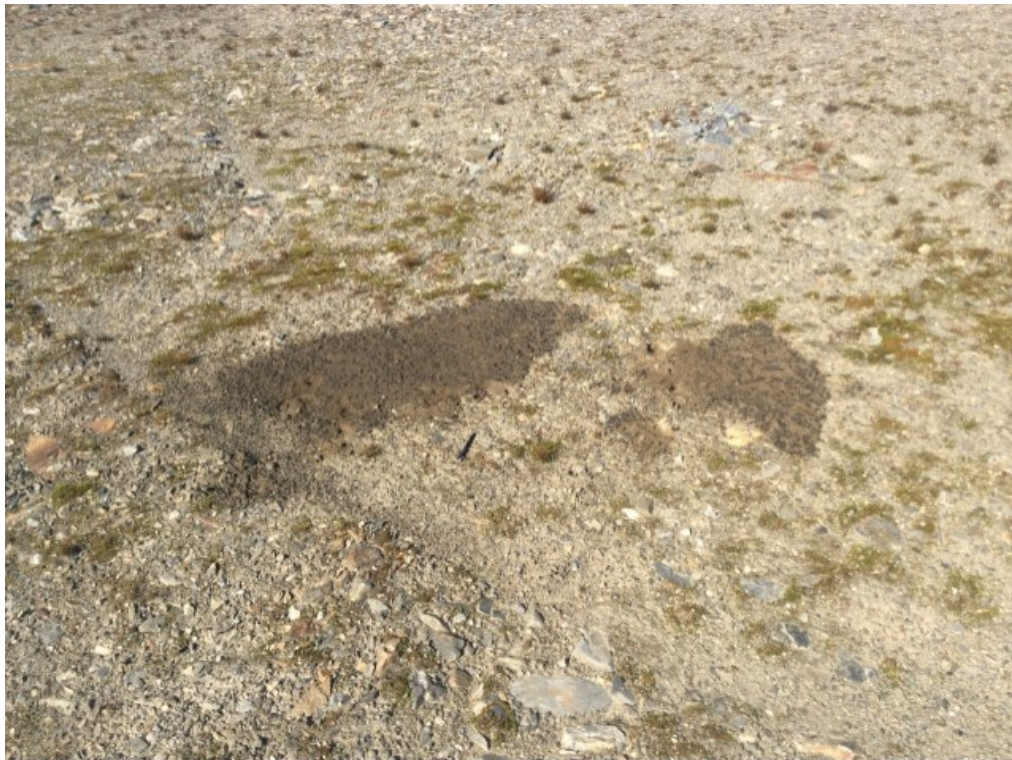
The concentrations of most metal parameters were highest at F3-9, located downgradient of Lobe E2 and at F3-11, located downgradient of Lobe F of the landfill where black staining was observed on the southern slope. In a few cases, the 2016 concentrations were slightly higher than in earlier years (e.g., copper, lead and arsenic at F3-11); however in most cases they were similar to previous monitoring results. The concentrations of copper and arsenic in both samples at F3-11 exceeded the baseline mean concentrations plus three standard deviations (3σ). The modified total petroleum hydrocarbons (TPH) concentration observed in the shallow sample at F3-4 in 2016 remained below the concentration reported in 2012. No petroleum hydrocarbons (PHC) were detected at the remaining sampling locations and no detectable concentrations of cadmium, mercury or polychlorinated biphenyls (PCB) were noted in any of the samples in 2016.

In general, the data from this site are not indicative of increasing influence from the landfill with the possible exception of location F3-11, where results from both the shallow and deep samples may be reflective of a potential influence; insufficient data are currently available to confirm this.

Photo 81: FOX-3 – Station West Landfill – Lobe F, south slope – Feature N – Minor black staining [Acceptable], facing north (ATT24_Photo24.jpg)

It is recommended that a sample of the black stained cover material be collected in the next sample round and analyzed for the standard parameter list to determine if the staining is of concern. Should the observed black staining of the landfill cover increase, or should the quality of the next sample collected from F3-11 indicate further increases in parameter concentrations, additional actions may need to be considered. No modifications to the ongoing monitoring program at this landfill are recommended at this time.

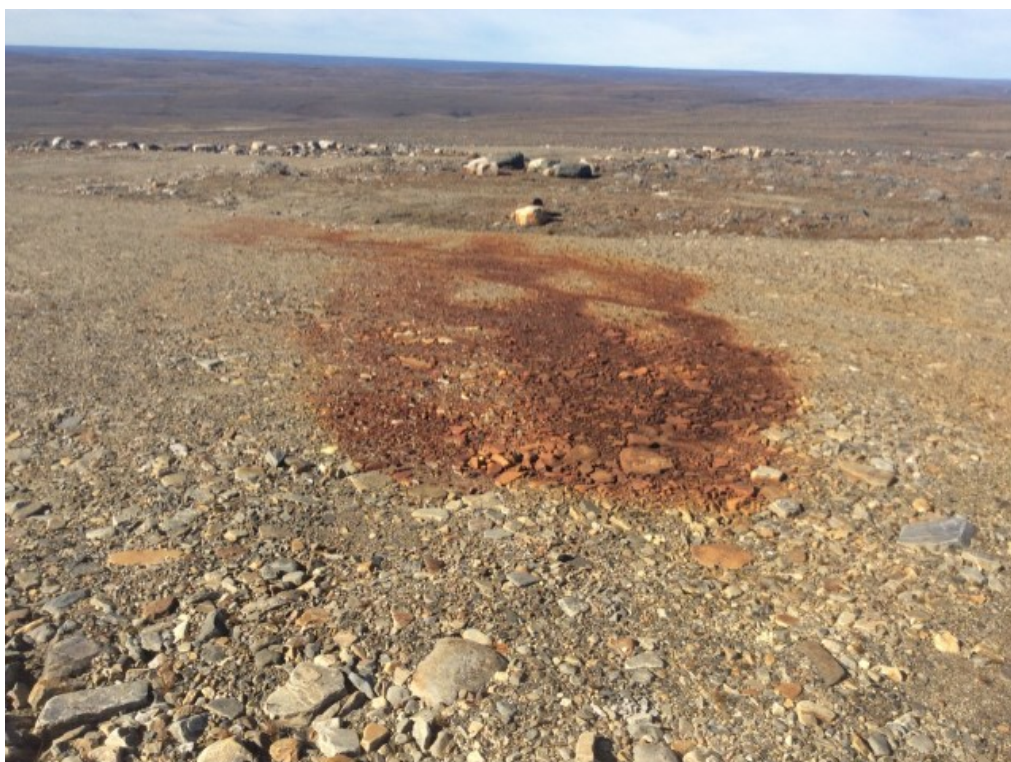
Photo 92: FOX-3 – Station West Landfill – Lobe A, north crest edge – Feature B – Red staining [Acceptable], facing northwest (ATT13_Photo13.jpg)

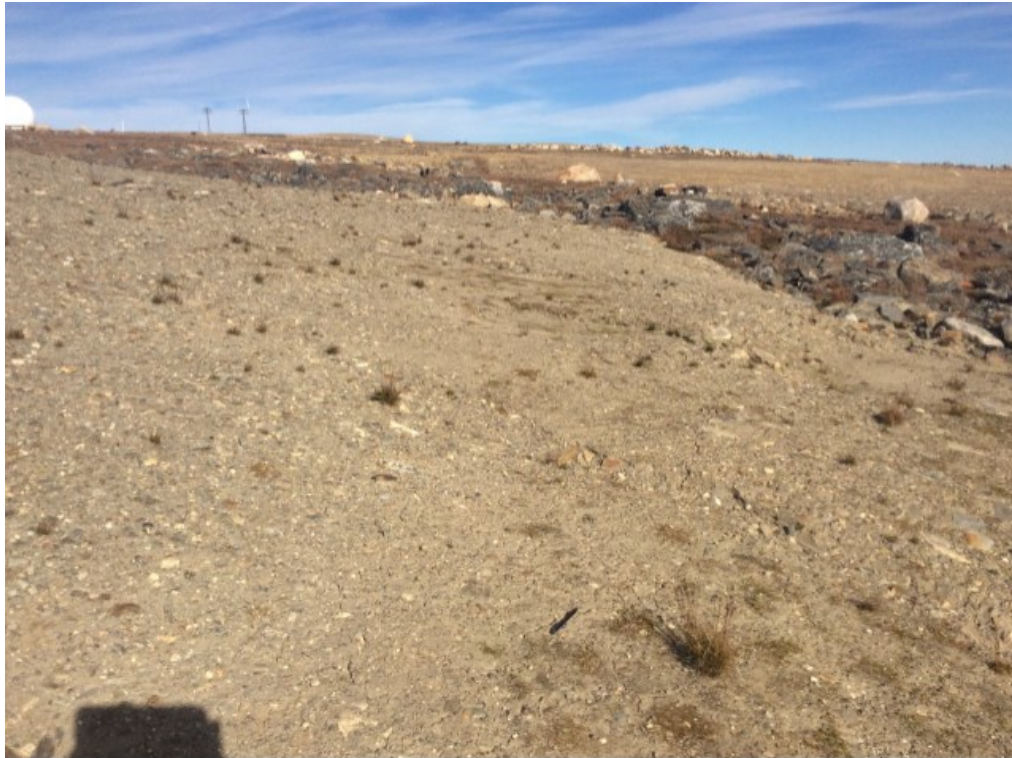
Photo 99: FOX-3 – Station West Landfill – Lobe F, southeast toe – Feature AE – Minor tension crack at toe, (ATT27_Photo27.jpg)

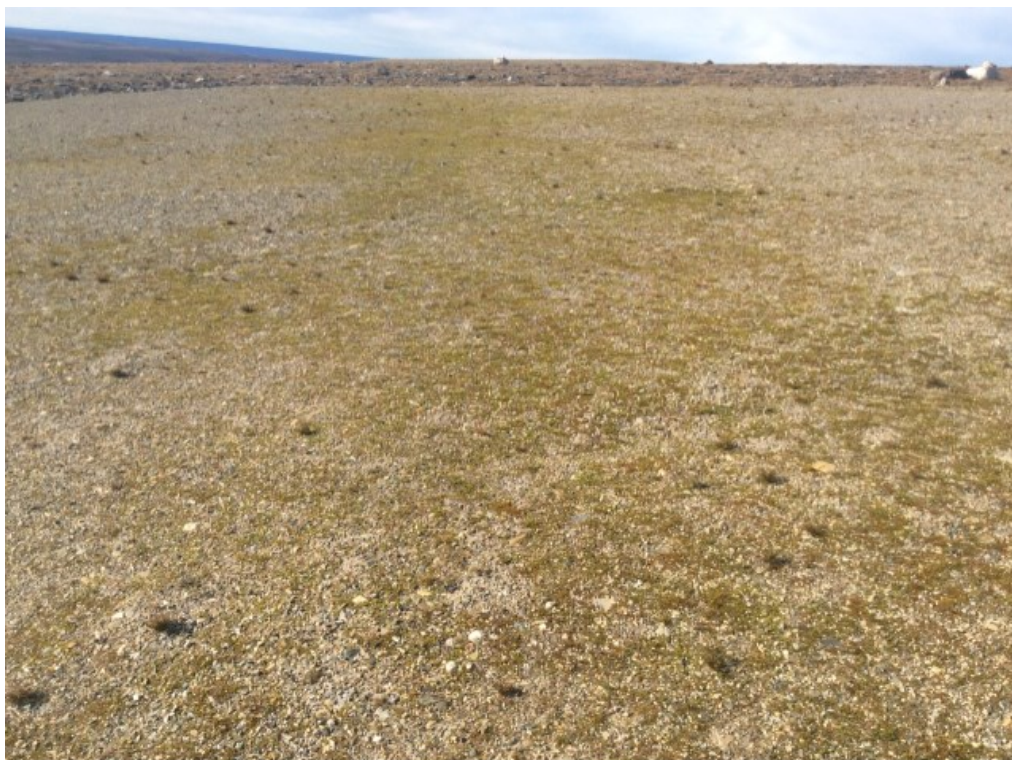
Photo 100: FOX-3 – Station West Landfill – Lobe F, Feature Z – Sparse vegetation covers the cover surface, facing northwest (ATT28_Photo28.jpg)

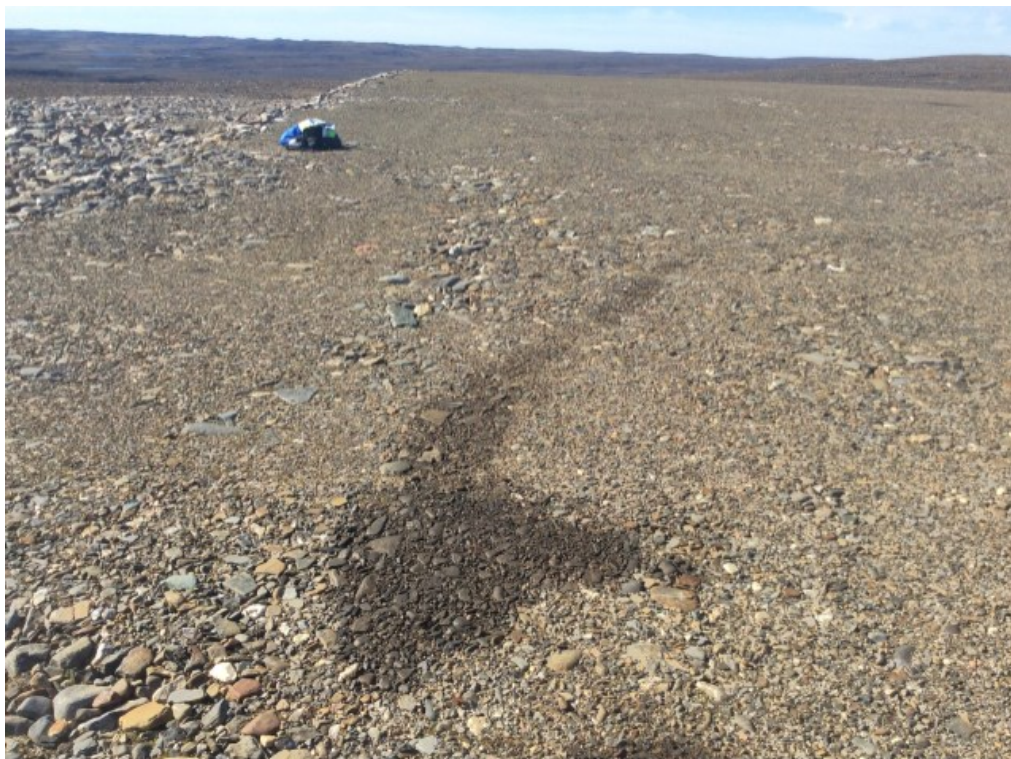
Photo 151: FOX-3 – Tier II Disposal Facility – Cover surface, Feature D – Staining, facing west (ATT6_Photo6.jpg)

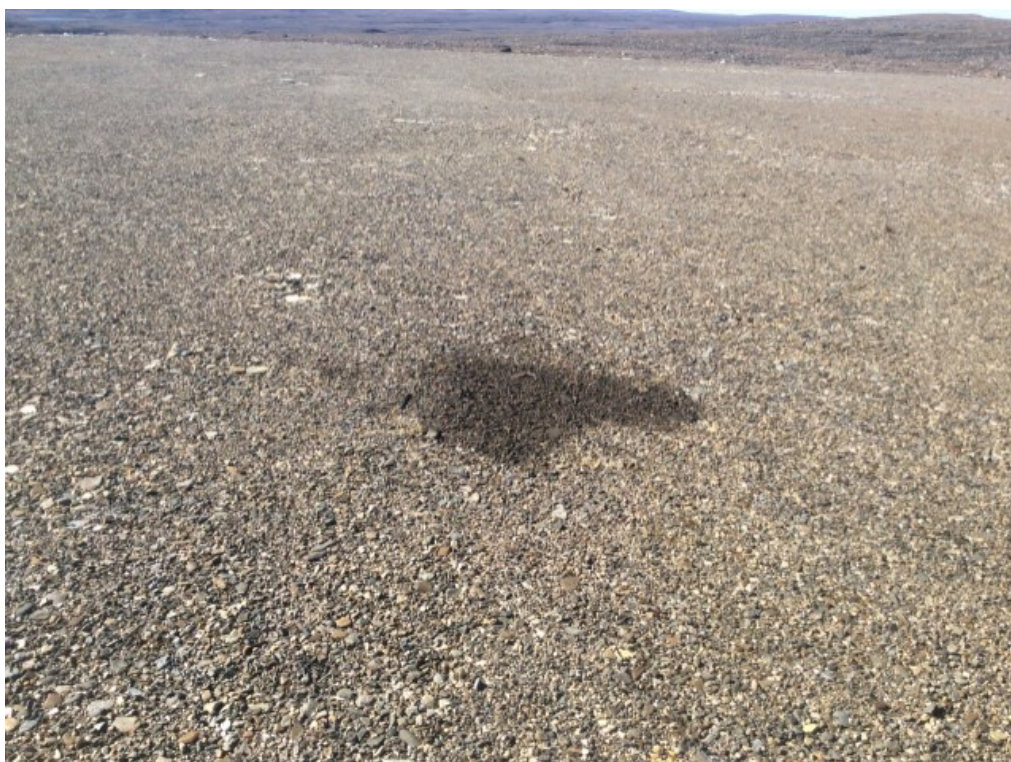
Photo 152: FOX-3 – Tier II Disposal Facility – Cover surface, Feature F– Staining, facing west (ATT7_Photo7.jpg)

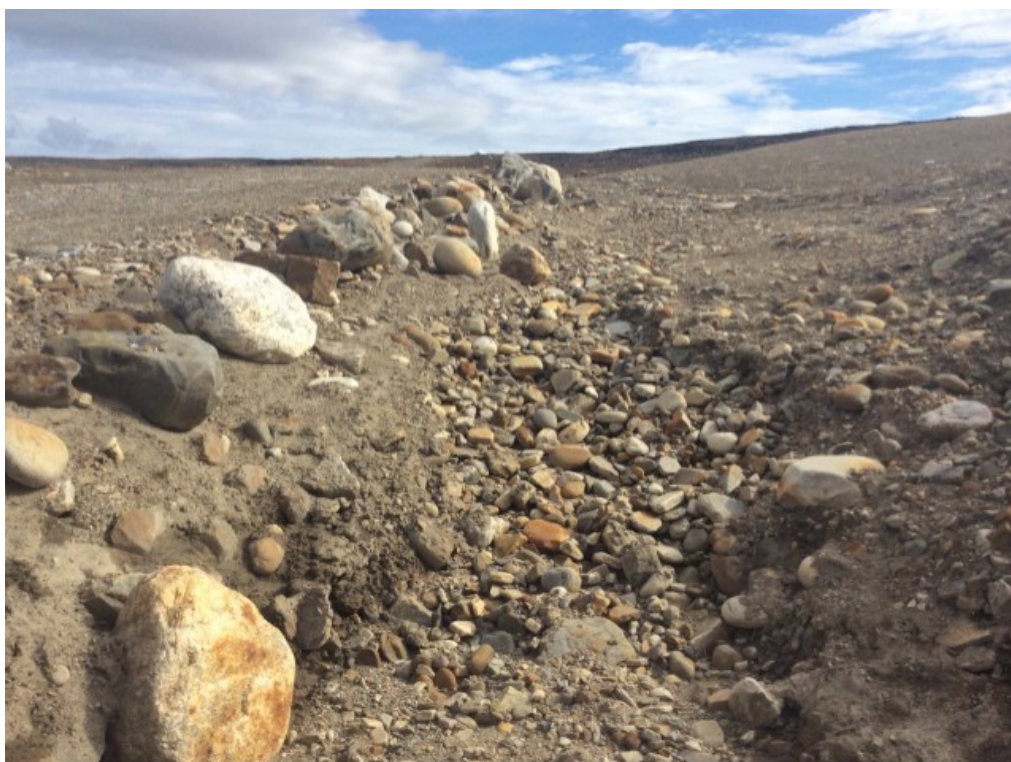
Photo 182: FOX-3 – West Landfill – Drainage channel along the north toe with no water, previously observed with running water (Feature D), facing southeast [Acceptable] (ATT58_Photo58.jpg)

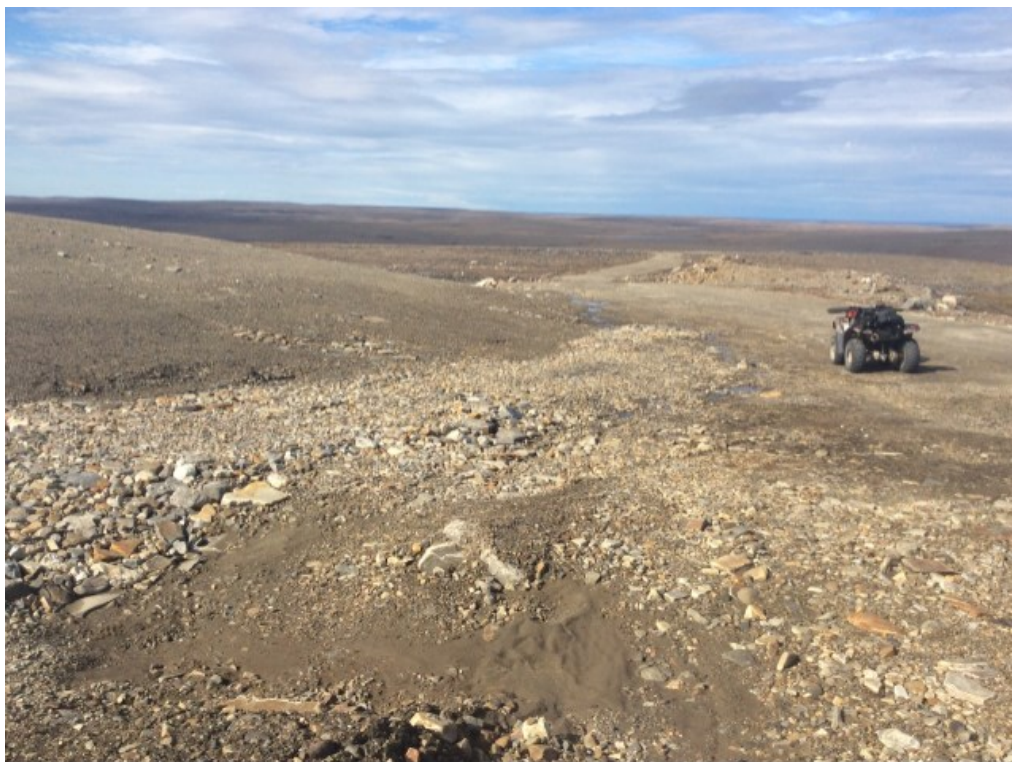
Photo 192: FOX-3 – West Landfill – North toe, east end – Rough area at the north toe previously observed running water (Feature D) [Acceptable], facing northwest (ATT47_Photo47.jpg)

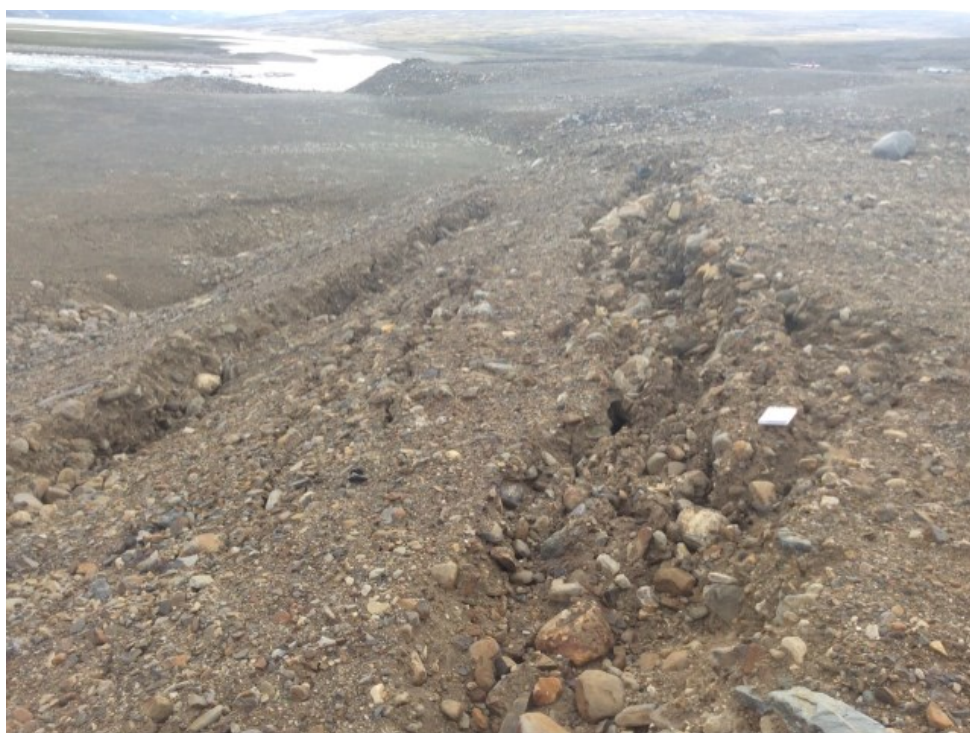
Photo E18: FOX-3 – Thermokarst Area – Top of upper tension crack (Feature B), facing southwest (ATT106_Photo106.jpg)
