RE: 2002 Annual Report - Water Use Licence NWB5FRA0209 for PIN-3, Lady Franklin Point

UMA Engineering Ltd. is submitting the following annual report, as per Part B, Section 1 of the Water Use Licence NWB5FRA0209 issued for the clean up of the PIN-3, Lady Franklin Point DEW Line site. The annual report is being submitted on behalf of Defence Construction Canada and the Department of National Defence. The information presented herein was compiled from the weekly site reports provided by the Site Engineer and the Scientific Advisors.

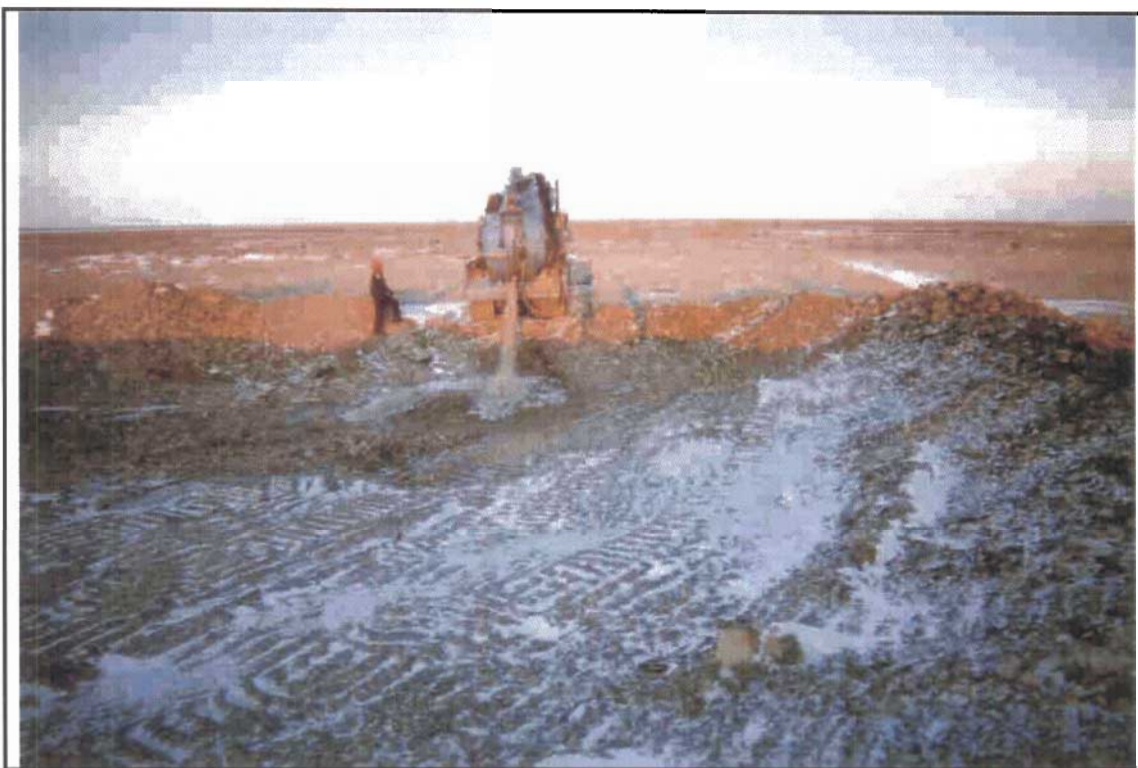
A sewage lagoon was constructed in 2002 to support the construction camp as per the specifications included in the water use licence application. However, due to the coarse-grained nature of the materials available at PIN-3, the sewage lagoon was not able to retain the effluent that was discharged into the lagoon. All effluent discharged into the lagoon infiltrated the ground, typically within 8-12 hours of discharge. Because of this, the on-site project team was not able to collect any effluent samples, as per the proposed SNP requirements. Photos of the sewage lagoon are shown in Figures 2-5 attached.

Figure 2: 26-Sep-02 6:35pm Truck discharging into lagoon, facing E.

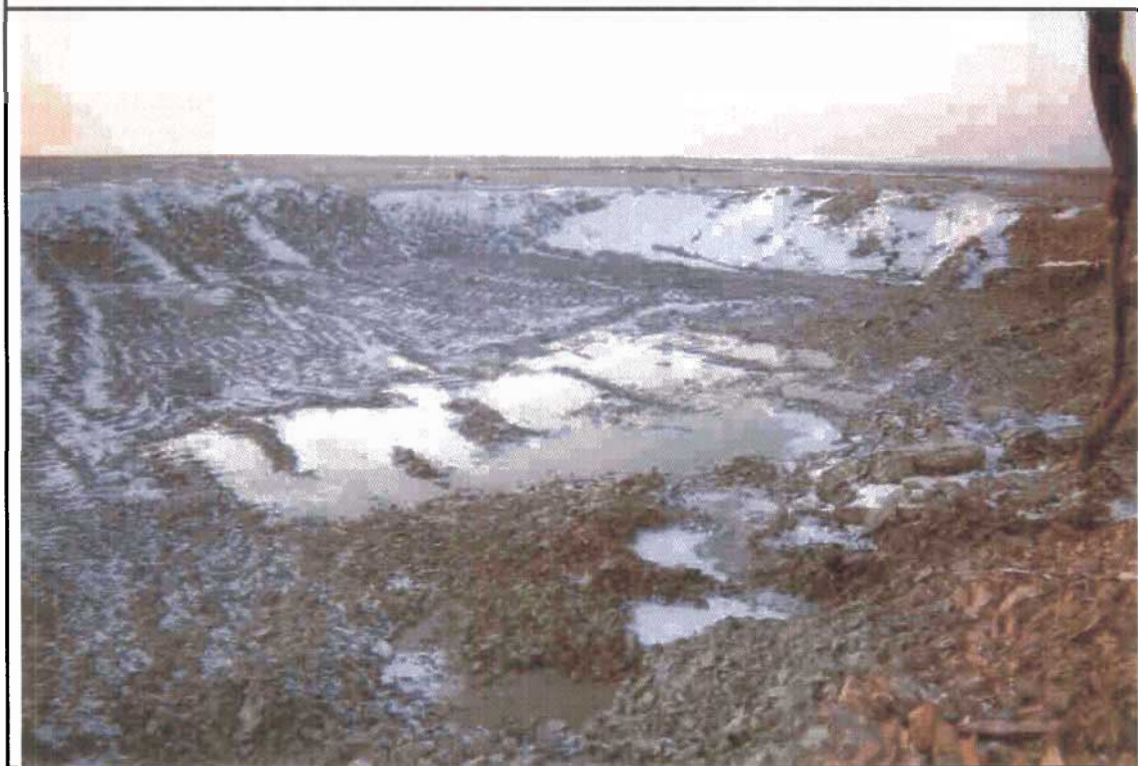
Figure 3: SE corner of lagoon. Effluent drains from point of discharge to east end.

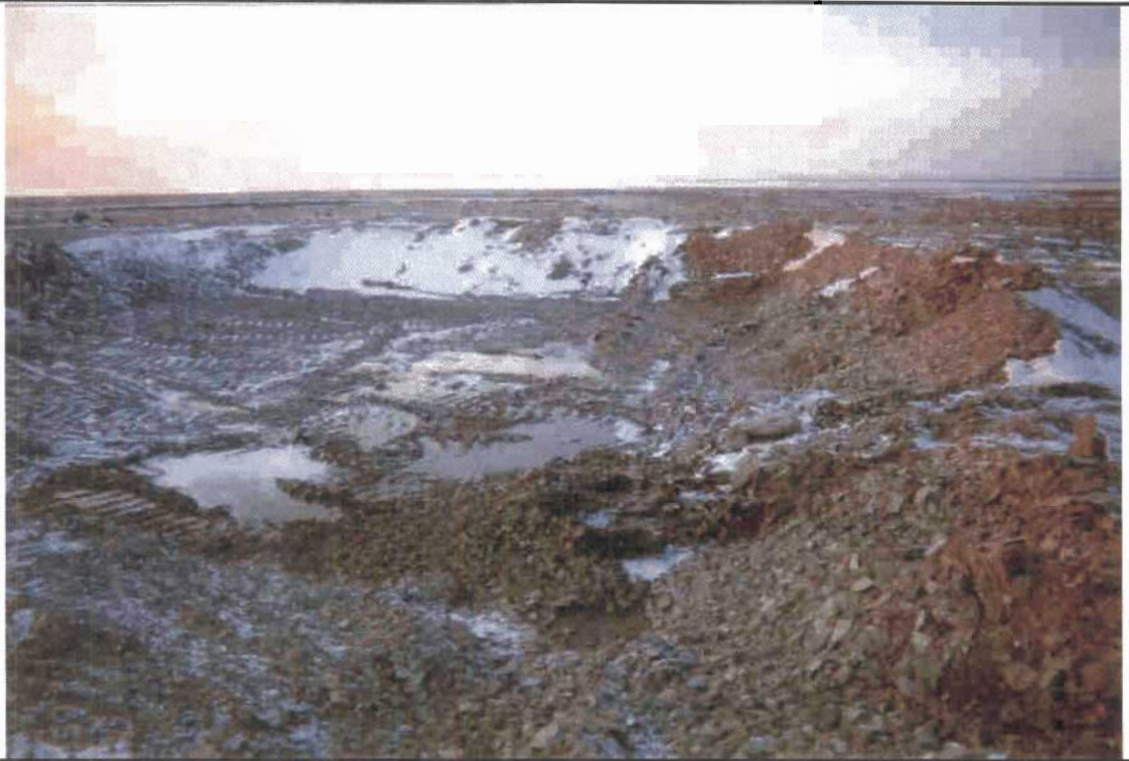
Figure 4: Ten minutes after discharge into lagoon. SE corner of lagoon, facing E.

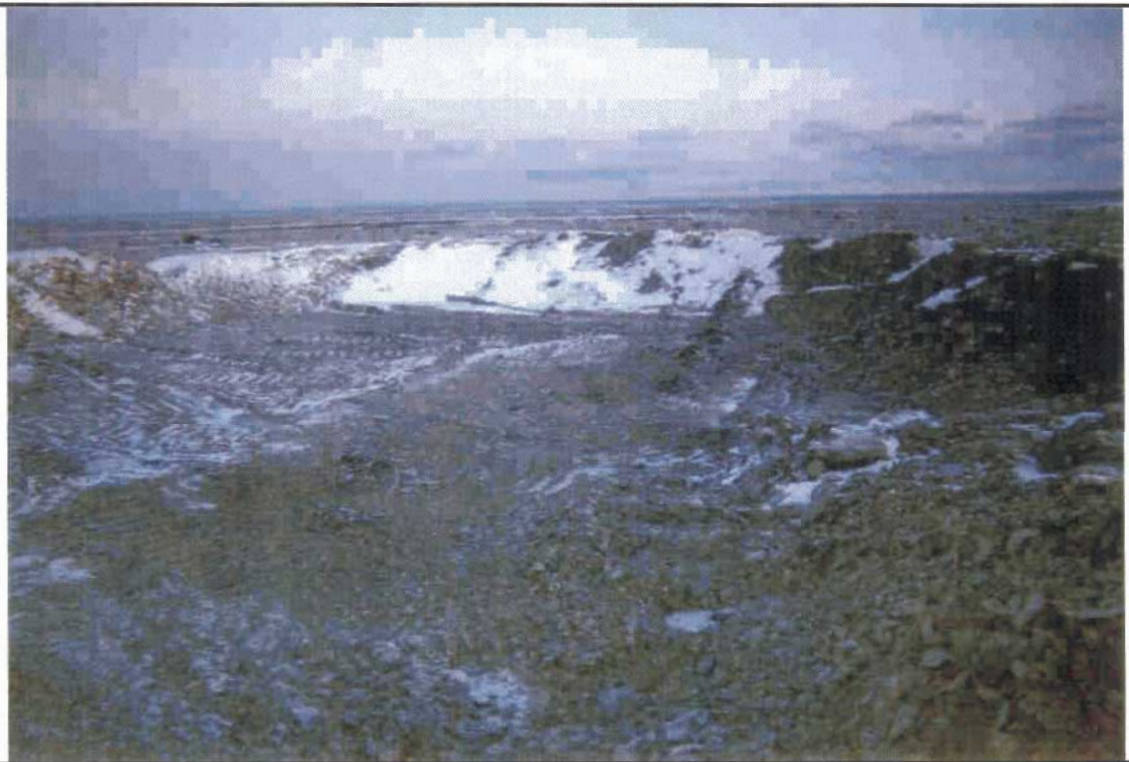
Figure 5: 27-Sep-02 7:52am Facing NE from SW corner.
