Project No.: PIN-3 (3.6)

**RE: 2004 Annual Report - Water Use License NWB5FRA0209**

PROJECT - PROJET  
**PIN-3 LADY FRANKLIN POINT**

**DEW LINE CLEAN UP**  
© COPYRIGHT  
HER MAJESTY THE QUEEN IN RIGHT OF  
CANADA 2002, AS REPRESENTED BY THE  
MINISTER OF NATIONAL DEFENCE.

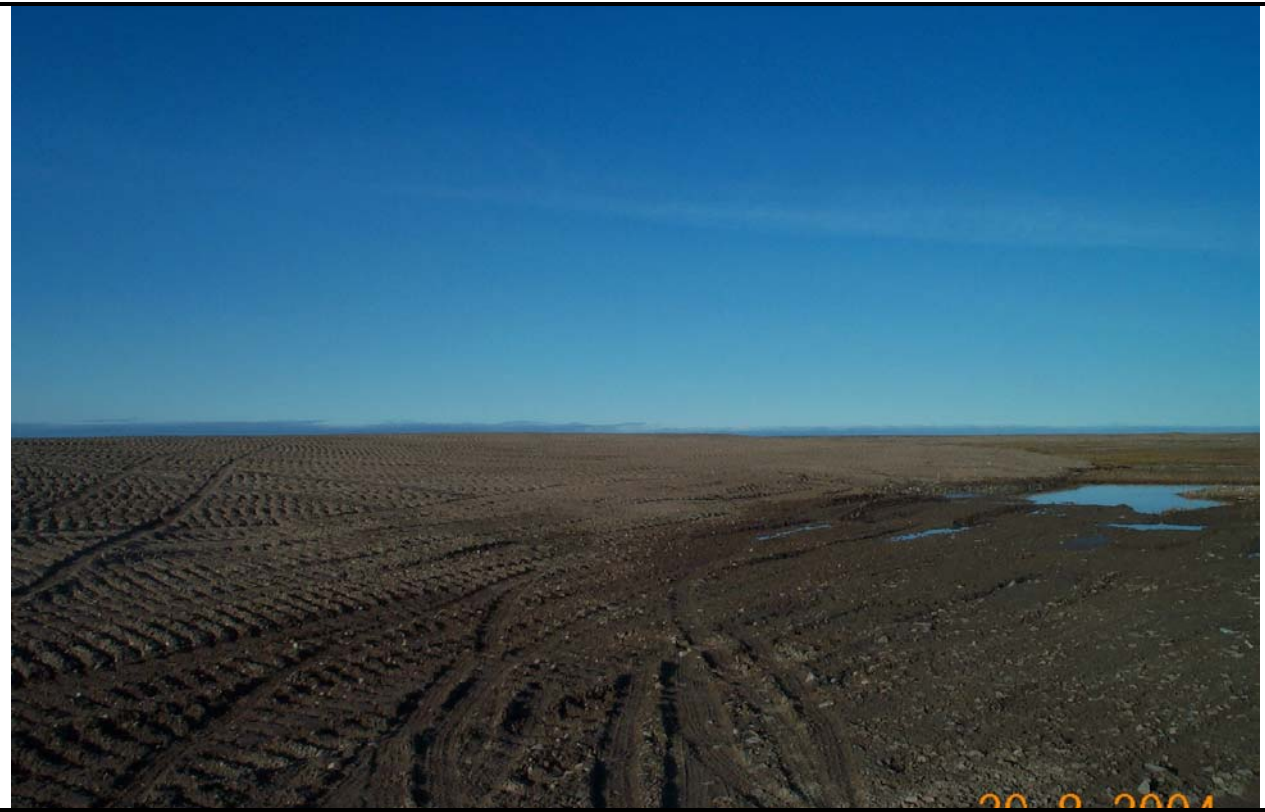
Photo 1: Graded South Landfill area.

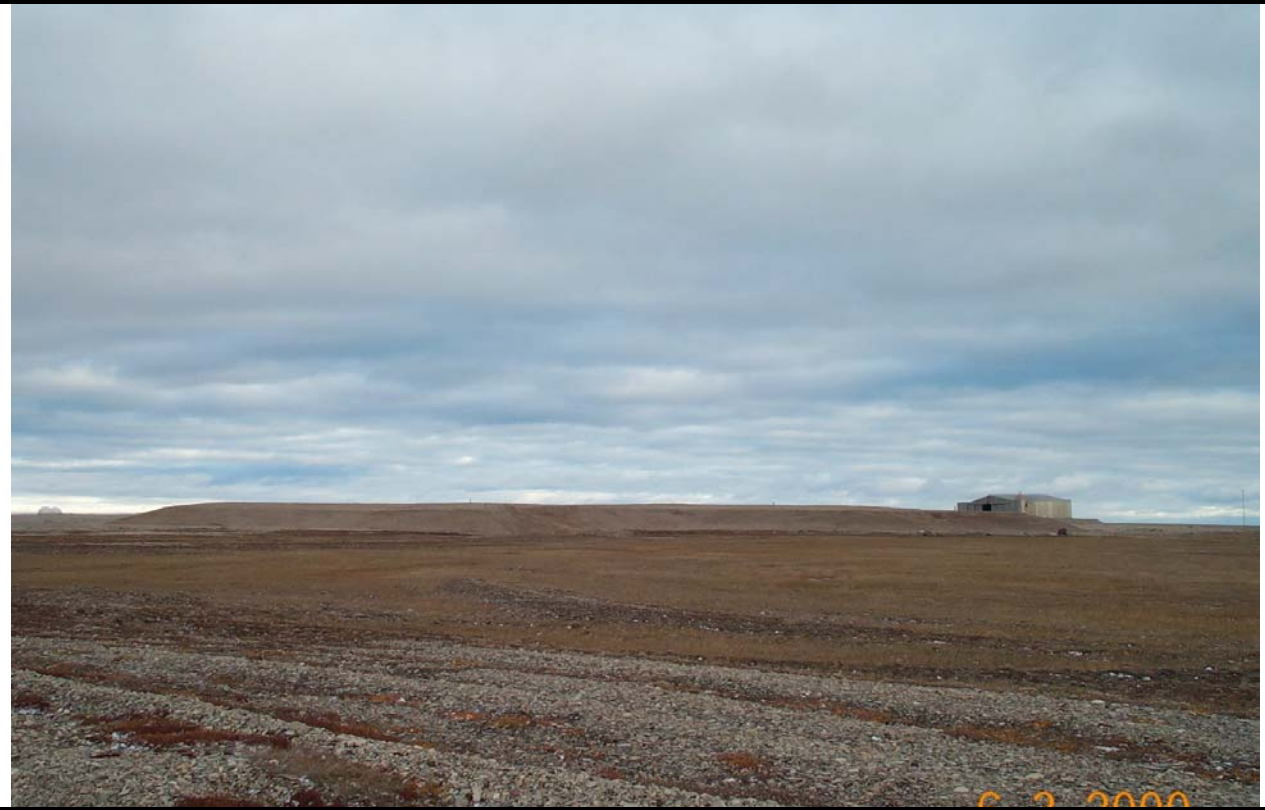
Photo 2: Main Landfill, looking south.

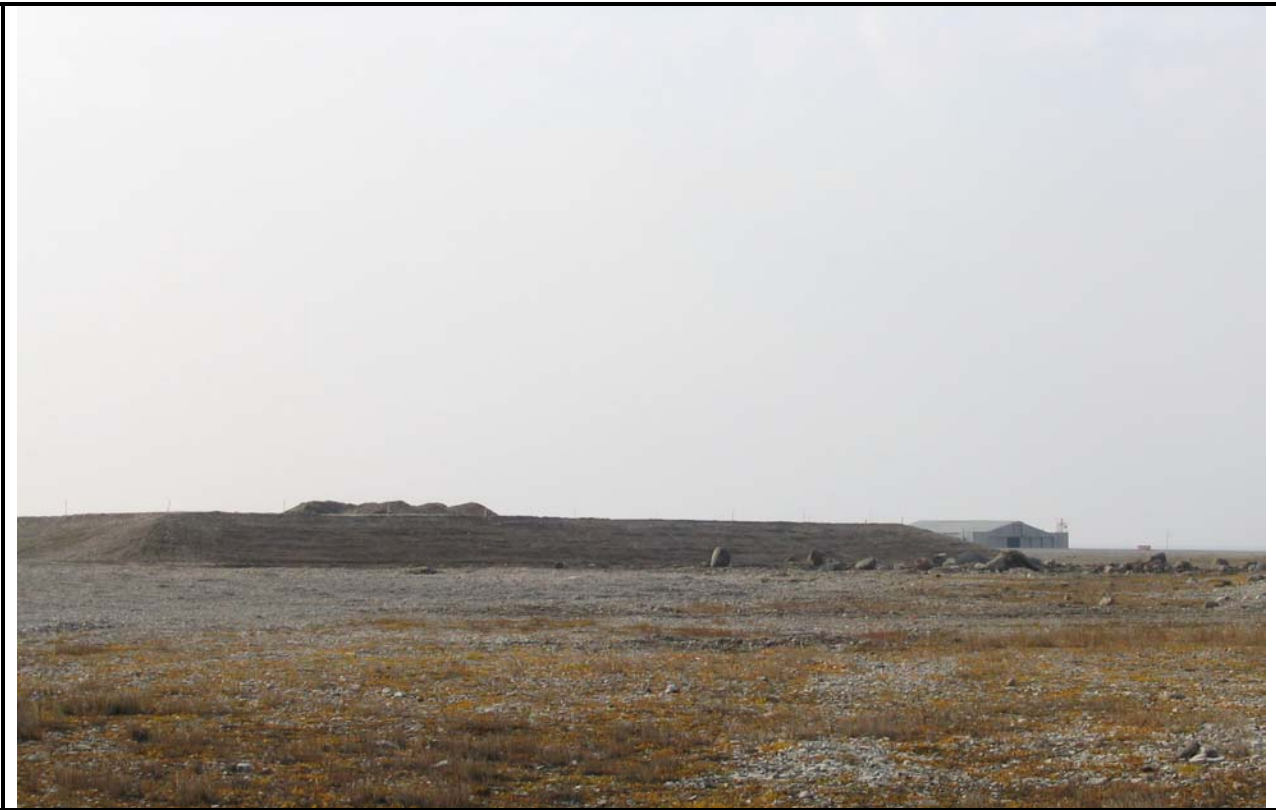
Photo 3: Non-Hazardous Waste Landfill

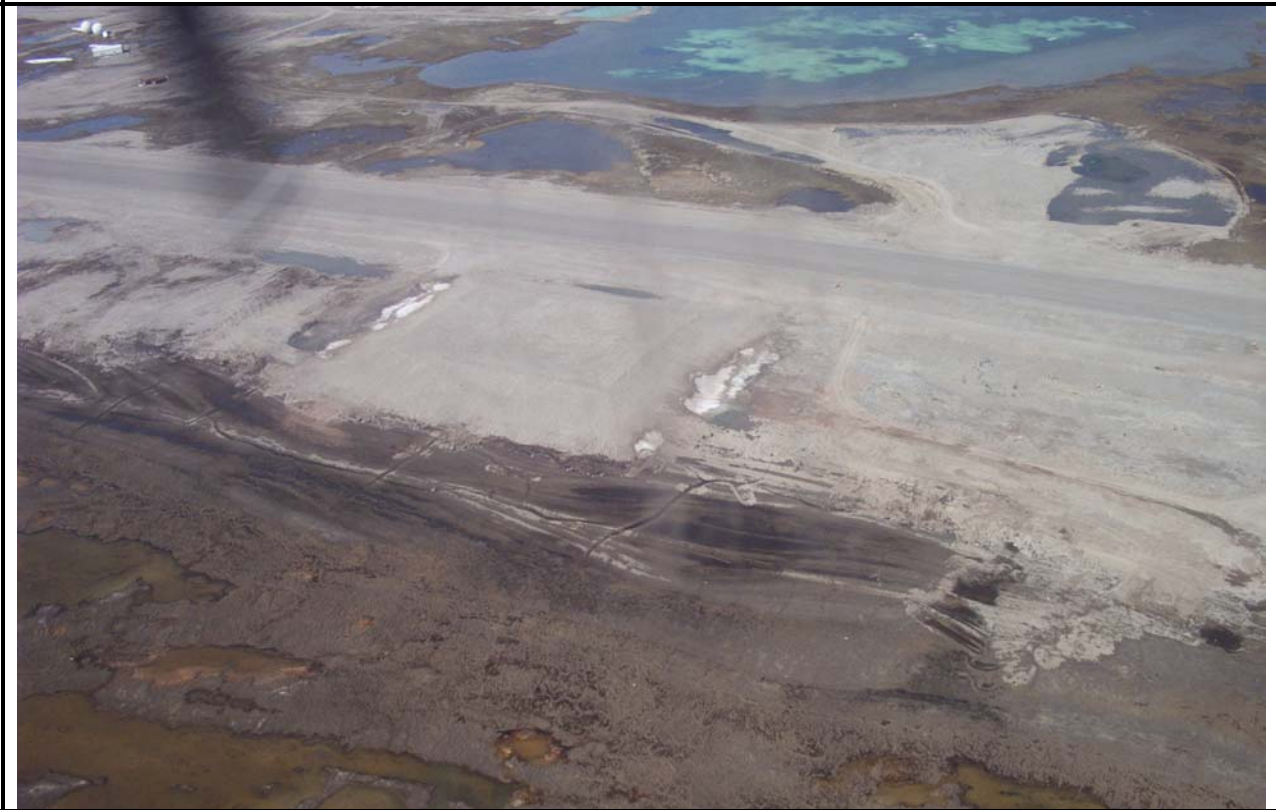
Photo 4: Tier II Soil Disposal Facility

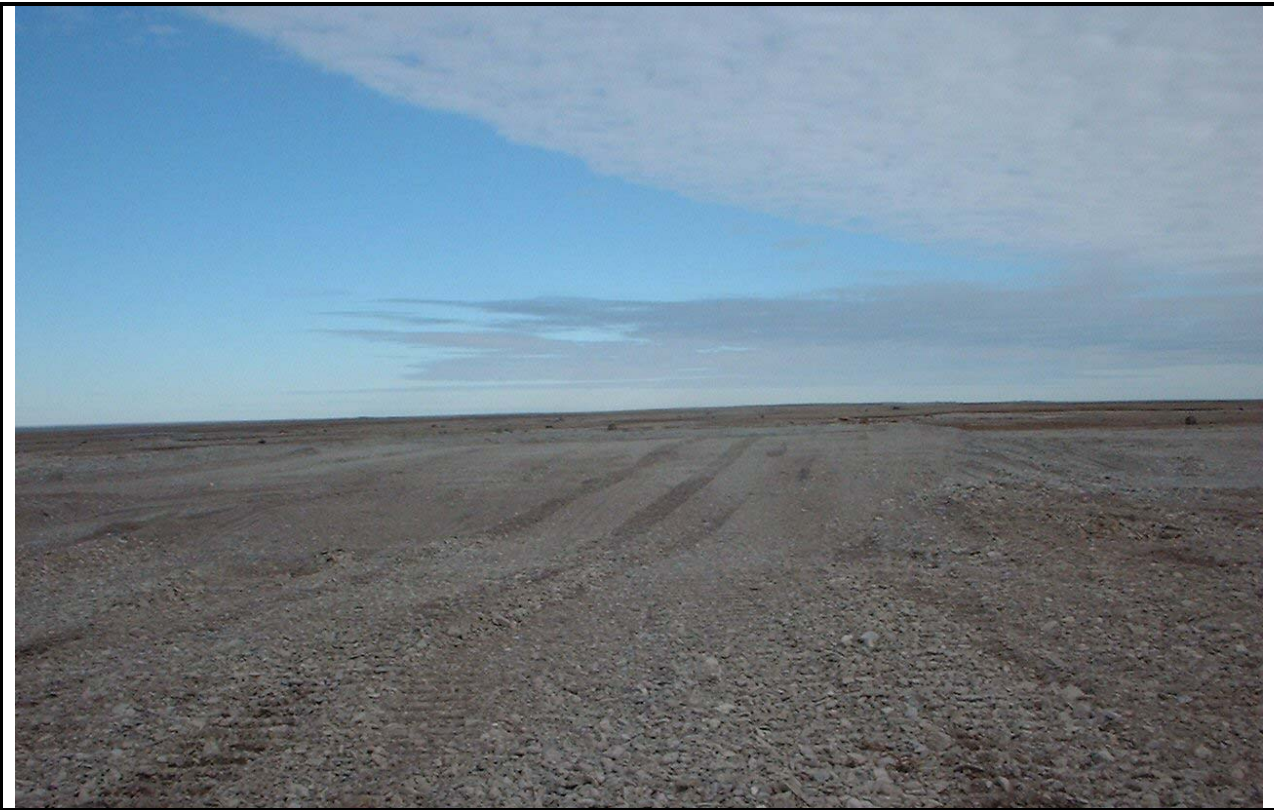
A sewage lagoon was constructed late in August 2002, to support the construction camp as per the specifications included in the water use licence application. Due to the coarse-grained nature of the material available at the PIN-3 site, the sewage lagoon did not retain the discharged effluent. All effluent discharged into the lagoon infiltrated the ground. No samples of the sewage effluent were collected because insufficient effluent quantities were available to obtain a sample for analysis.

Photo 5: Reclaimed sewage lagoon.

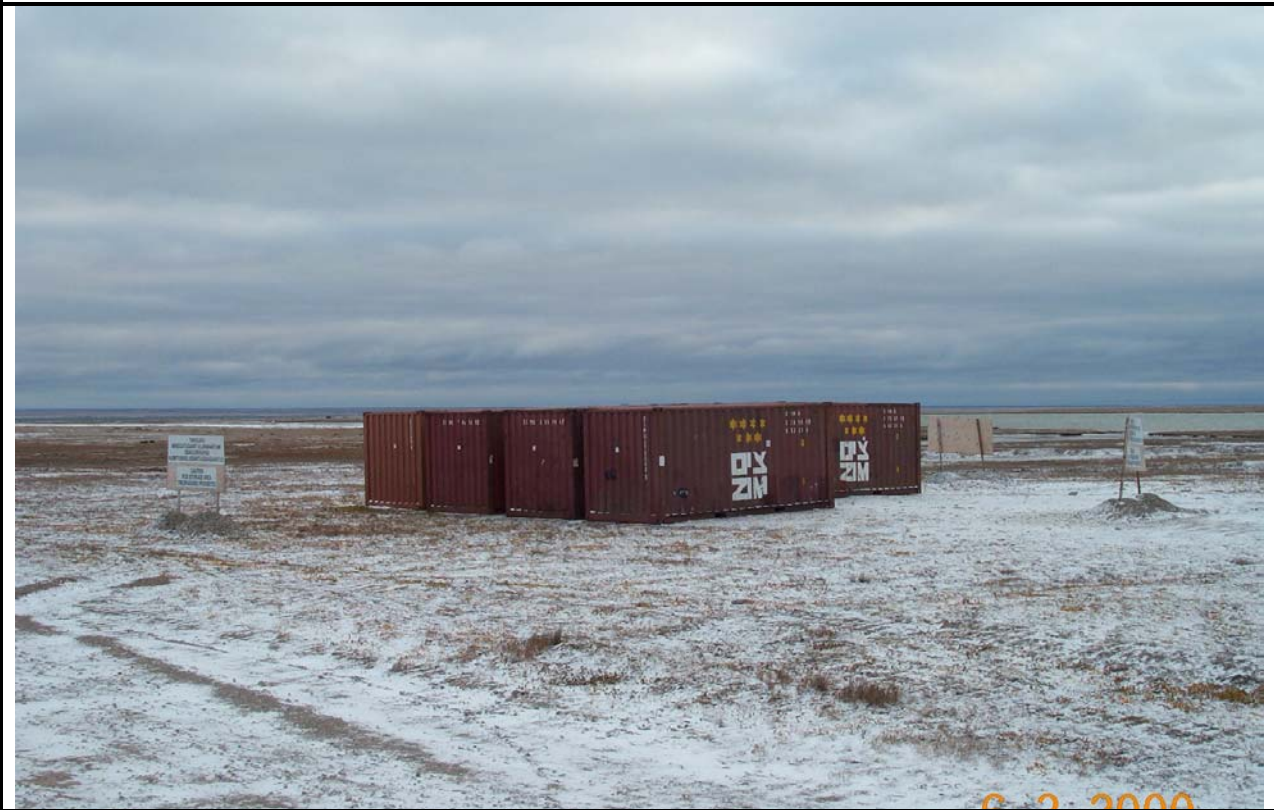
There were PCB Amended Painted (PAP) materials and other hazardous materials packaged and stored for later removal from the site to a licensed disposal facility. The contract to remove these materials will be a separate contract from the current clean up contract. The following materials are currently stored in the PCB Storage Area and Hazardous Materials Storage Area, respectively.

- 7 containers of PAP materials;
- 12 containers of soils contaminated with PCBs above CEPA regulations;
- 1 PCB capacitor in an overpack barrel;
- 51 containers of soils contaminated with hazardous levels of chemicals; and
- 3 plastic drums containing neutralized acid.

Photo 6: PCB Storage Area

The remaining work to be completed in 2005 includes the final tilling event and closure of the landfarm, as well as demobilization of the remaining camp equipment. The materials in the PCB Storage Area and Hazardous Materials Storage Area will also be removed by separate contract in 2005.
