Defence Construction Canada

The Collection of Landfill Monitoring Data at the PIN-3 Lady Franklin Point Site – 2008

October, 2008

Project Number: 80-297-3

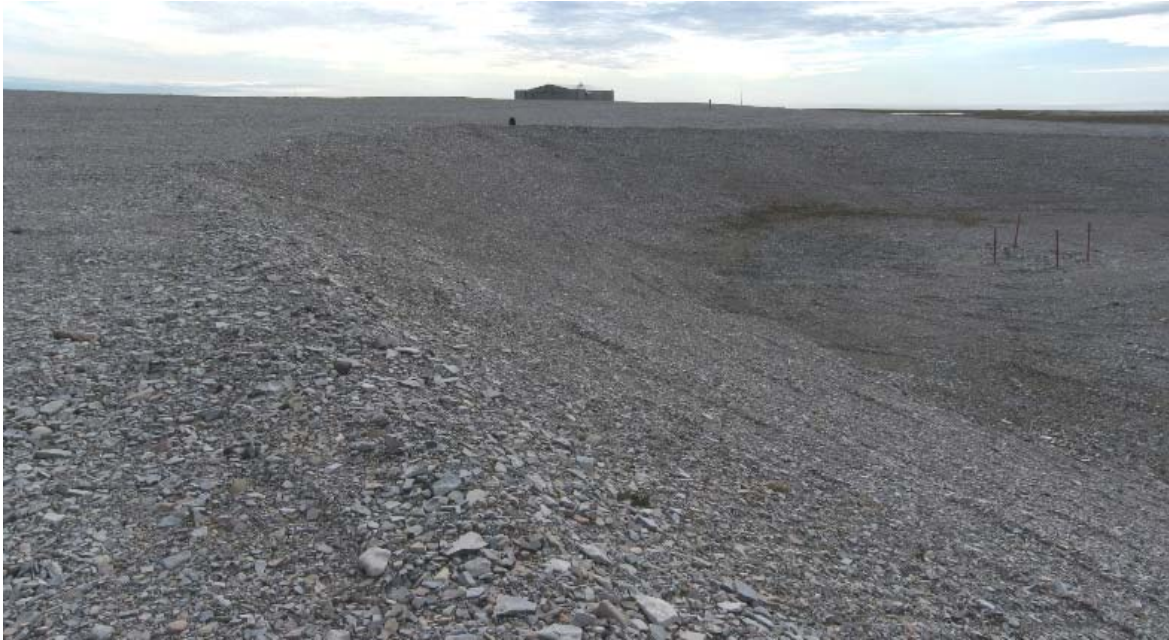
Photograph MLF-15. Panoramic looking ESE to SE from crest to curved slope. Hangar and VT-3 visible in the background. Slope and crest appear stable and well armoured. ↑

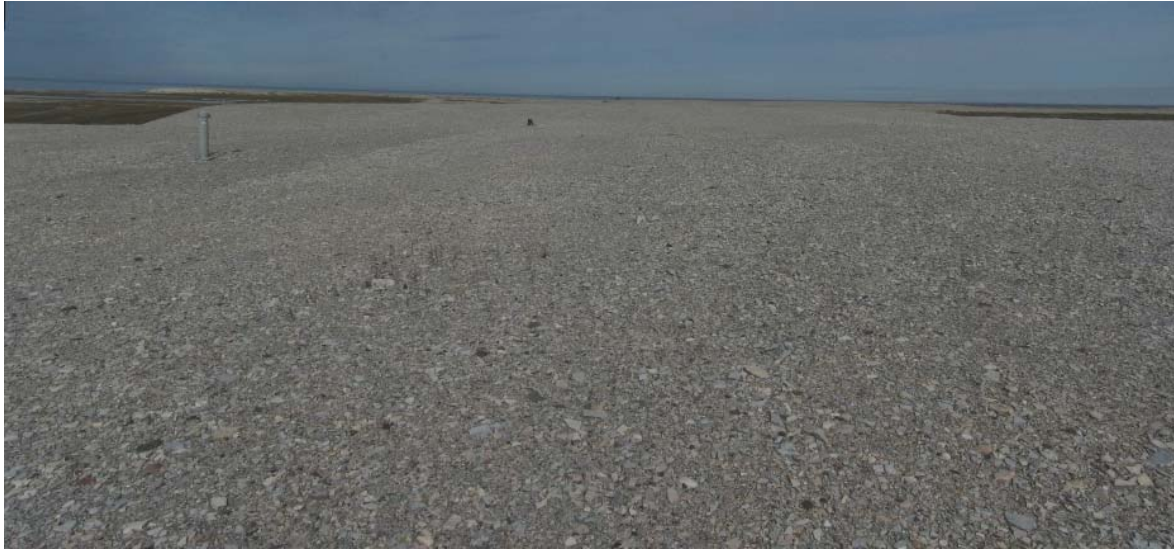
As noted in the 2006 and 2007 inspections, the top surface of the landfill appears to have several areas of broad depression; specifically in the areas around thermistors VT-1 and VT-3 (refer to Photographs 23, 25 and 26). There is no as-built survey information available for this landfill; therefore it is not possible to compare the current surface contours with the original shaping of the landfill. There is no indication of significant differential settlement or problematic foundation conditions associated with these broad depressions. These depressions should continue to be monitored to confirm that they are not associated with problematic foundation conditions.

Photograph MLF-23. Panoramic looking NNW to N. VT-3 visible near, and VT-1 to right in distance. Backpack is near centre of depression. ↑

The overall performance of the landfill is considered acceptable. The noted areas of broad depression should continue to be monitored.

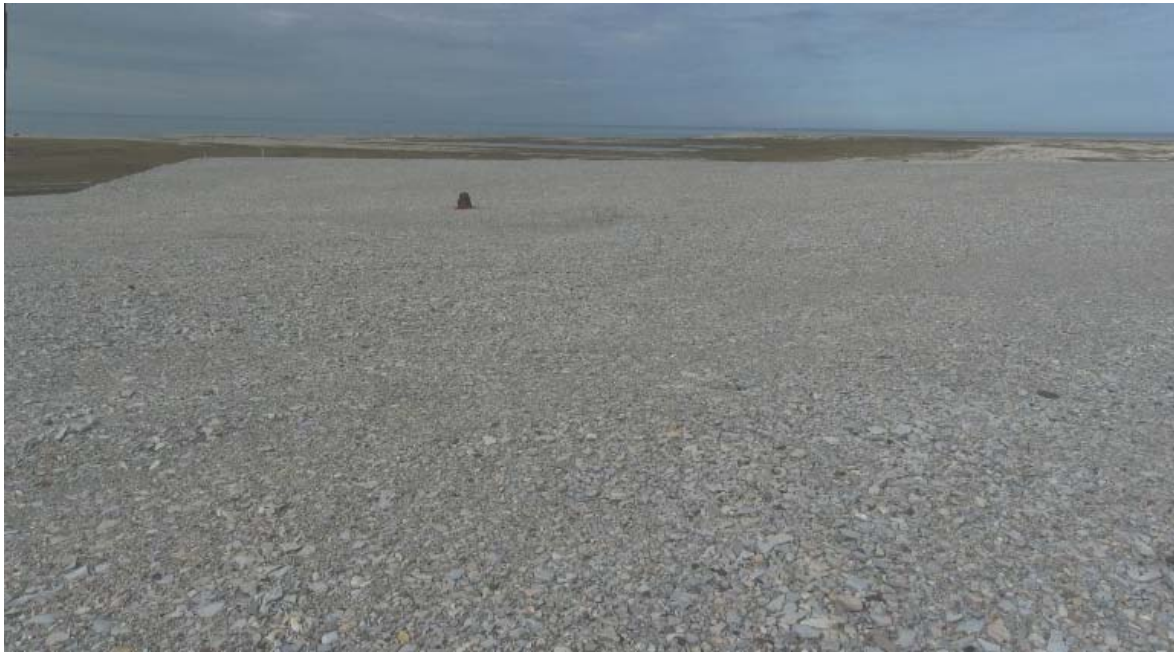
Photograph MLF-25. Panoramic looking NW from 2m S of VT-1. Backpack in centre of area of generalized depression. Appears unchanged from previous two inspections. ↑

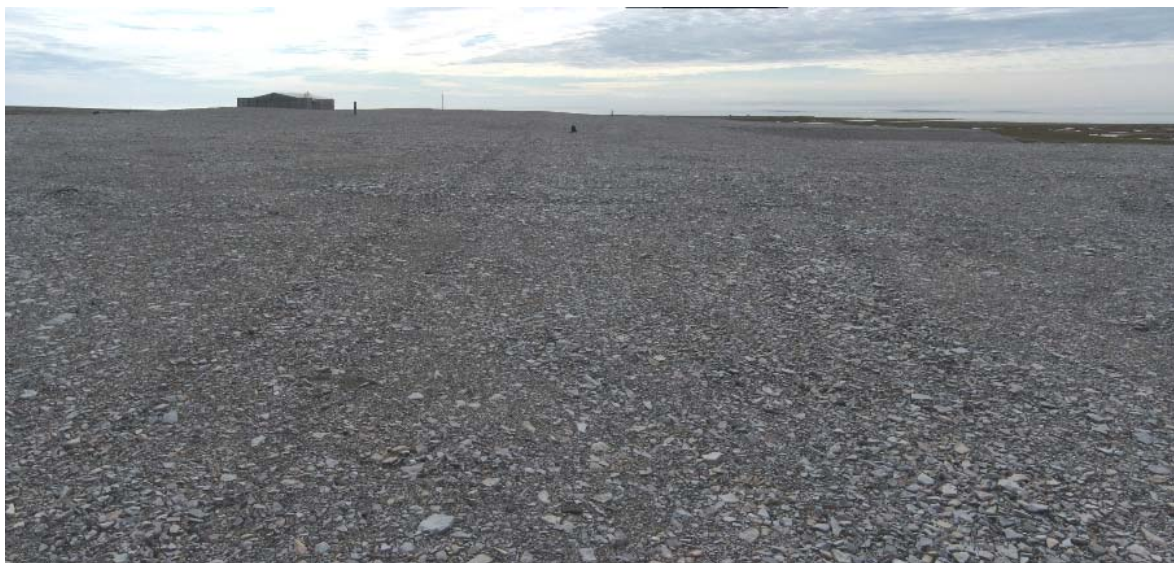
Photograph MLF-26. Looking S from N end near crest. VT-1 near and VT-3 far. Backpack near centre of area of generalized depression. ↑

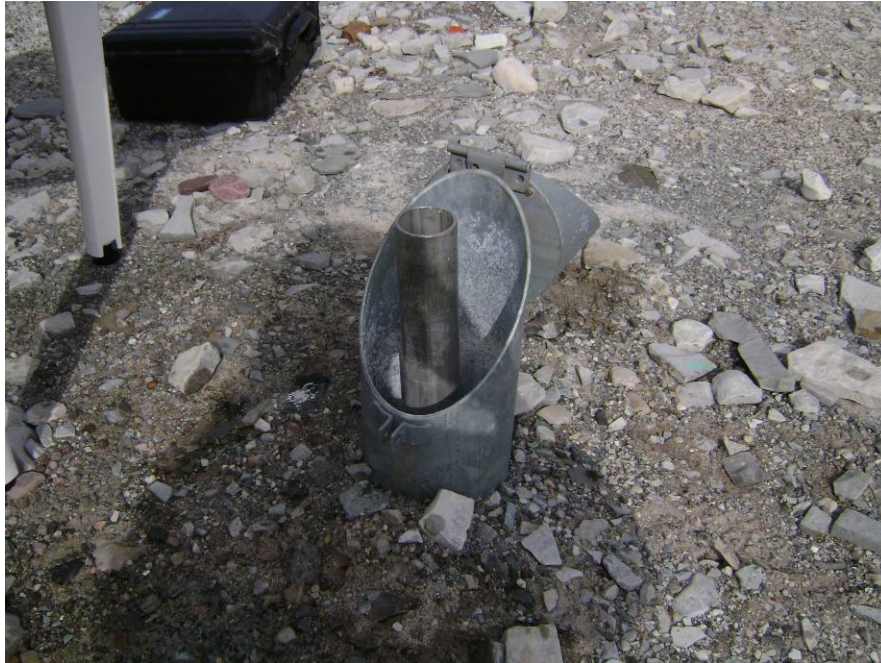
Photograph 5. Monitoring well MW-7. Sample P3-MW-7 collected from flow-through cell. Well ran dry during purge. No appreciable recharge.____ ↑

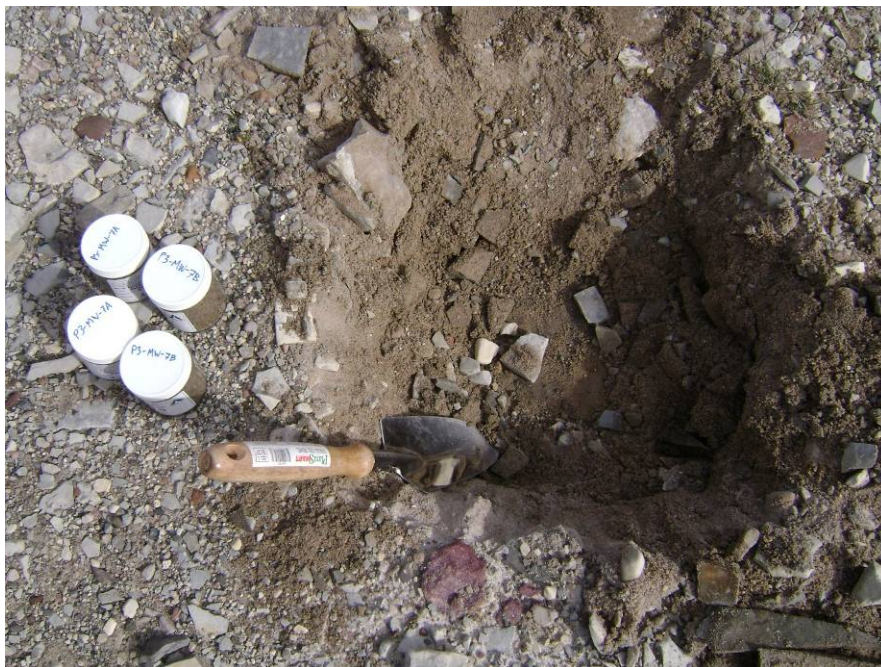
Photograph 6. Test pit at MW-7. Samples P3-MW-7A and P3-MW-7B collected. Bedrock at 0.15m____ ↑

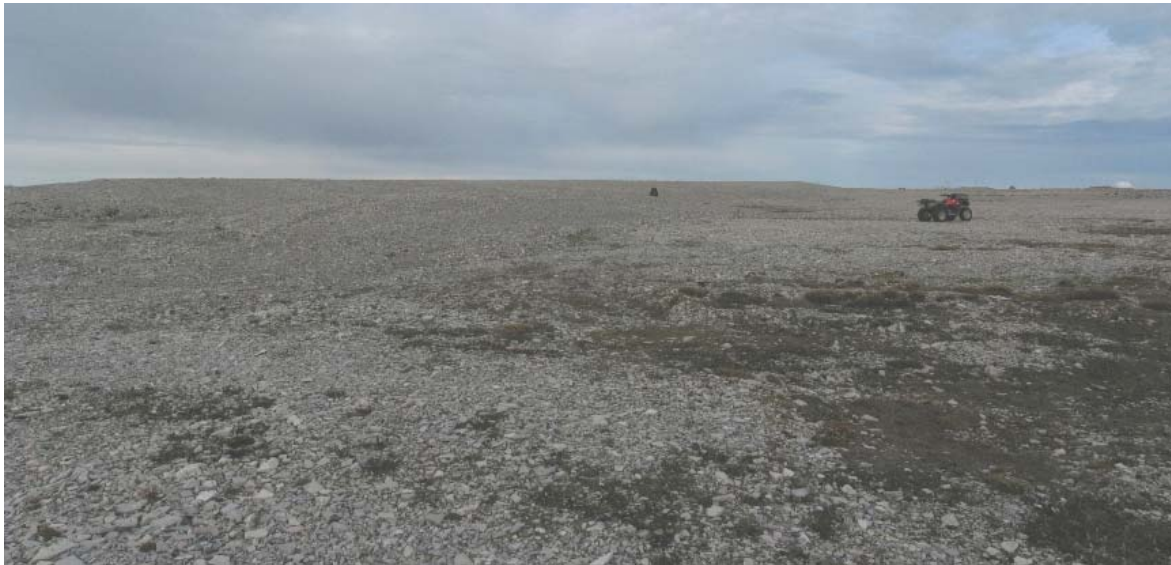
Photograph NWS-6. Looking ENE from about 25m SW of SW corner of East cell. The indentation in the south slope is directly behind the backpack. ↑

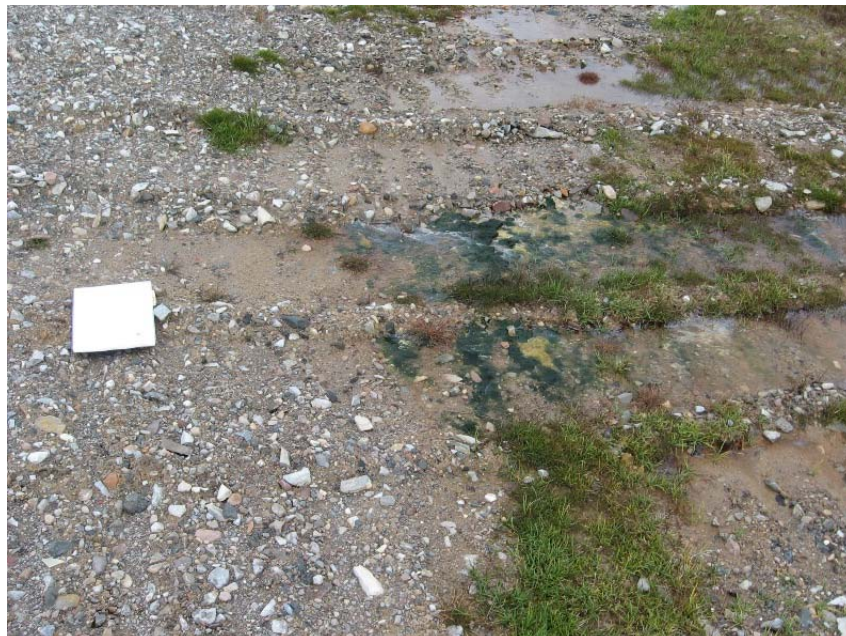
Photograph SLF-4. Close-up of green algae growing along toe in area of staining. ↑

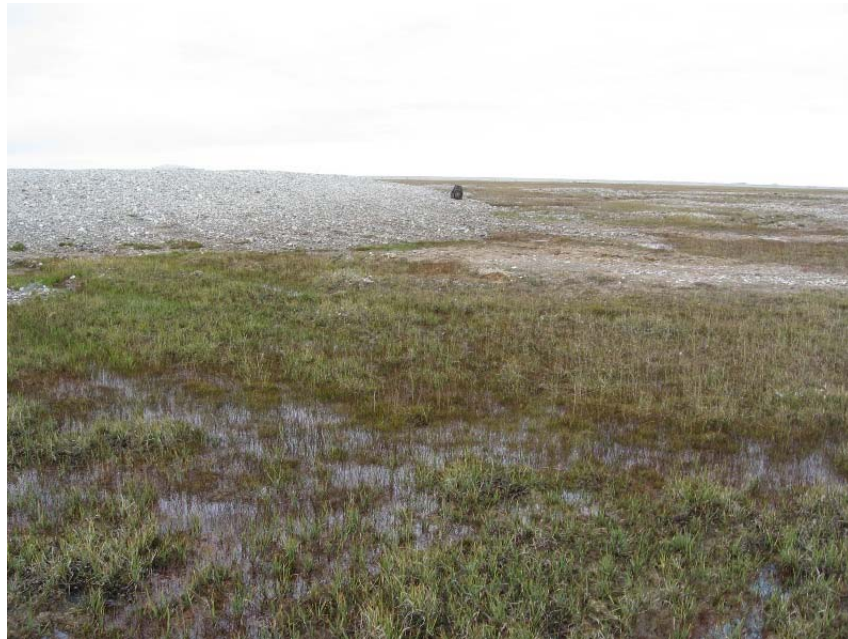
Photograph SLF-5. Looking NW to NE corner of South LF - East. Almost all ponded water to E of East cell has a "rainbow sheen". ↑

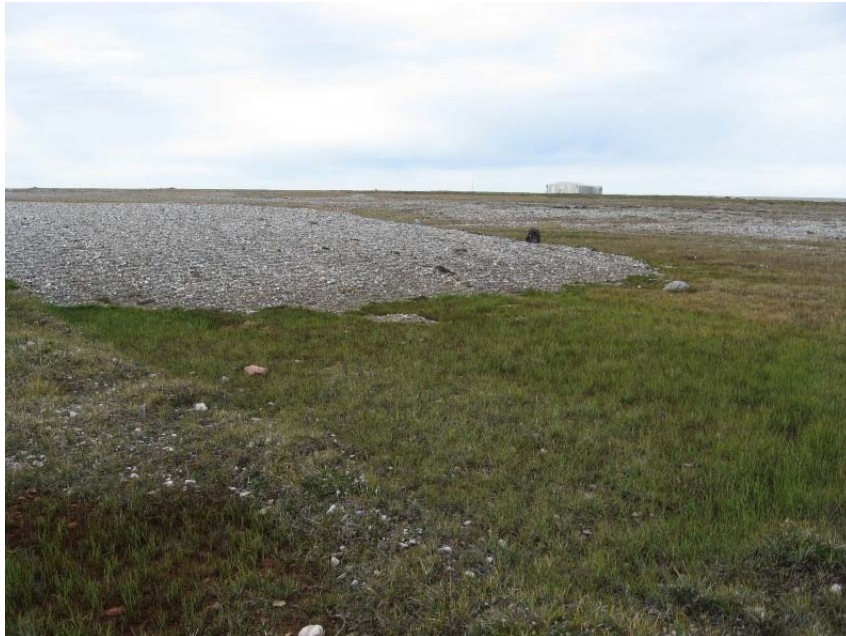
Photograph SLF-22. Looking NNW to the NE corner of the North cell. Hangar in background. Staining unchanged from last year. ↑

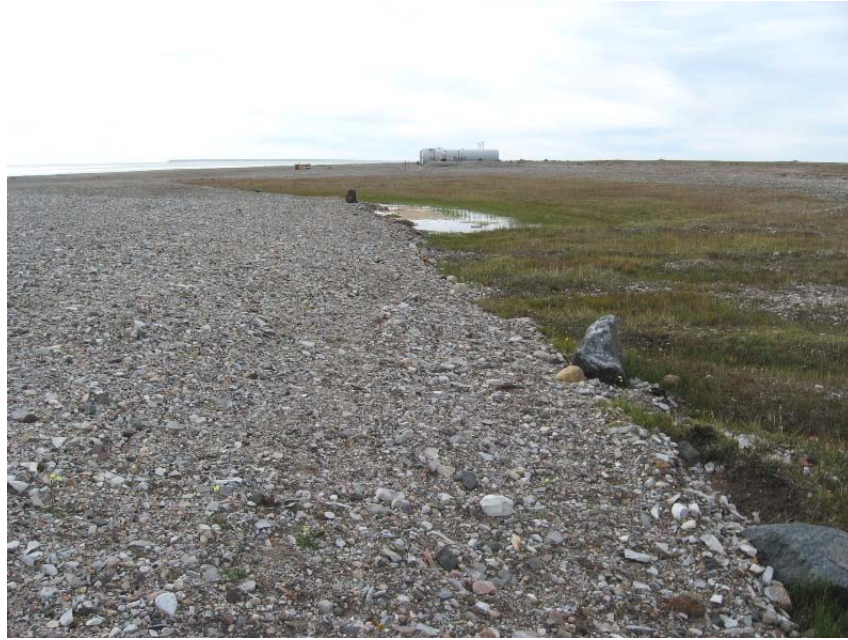
Photograph SLF-23. Looking W along N end of Western cell. Abundant green/yellow/orange/pink algae in puddle adjacent to backpack. ↑

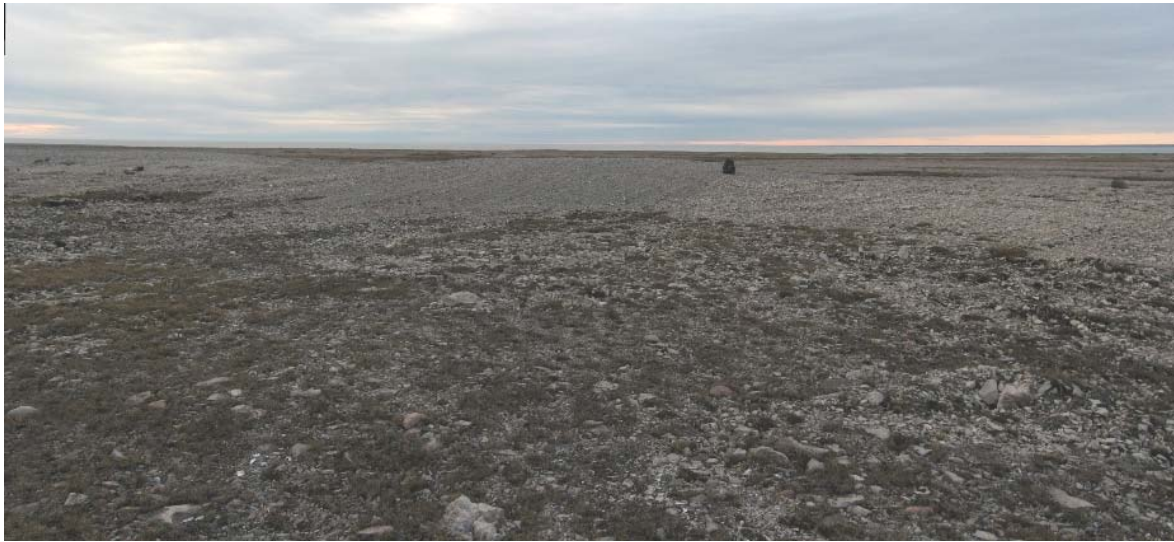
Photograph NLF-5. Looking WNW to NNW to SE corner of Central cell. Stable and unchanged from previous two inspections. ↑

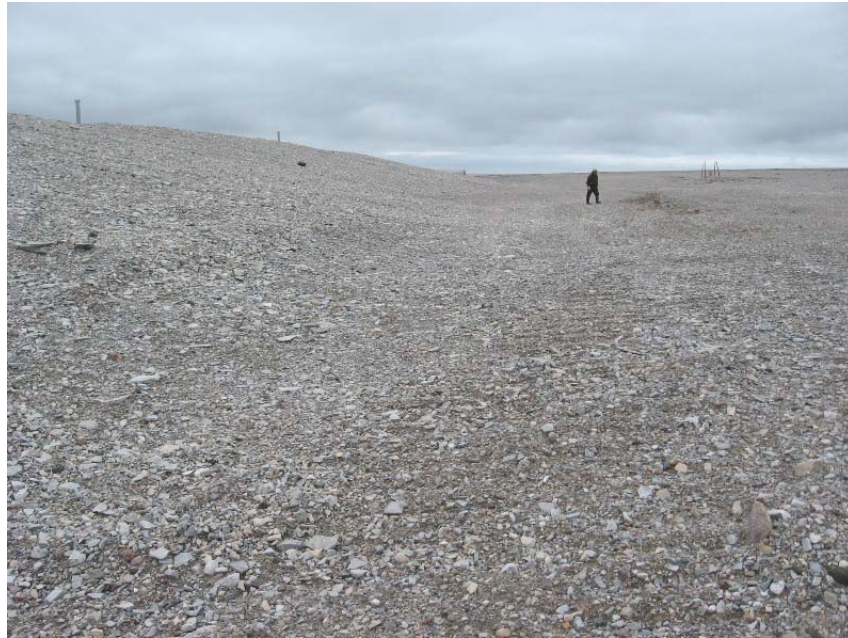
Photograph T2-2. Looking W from NE corner along toe of N slope. Condition of slope appears unchanged from previous two inspections (2006 and 2007); however, inconsistent finished grade (undulations and vehicle ruts) makes it difficult to discern differential settlement. ↑

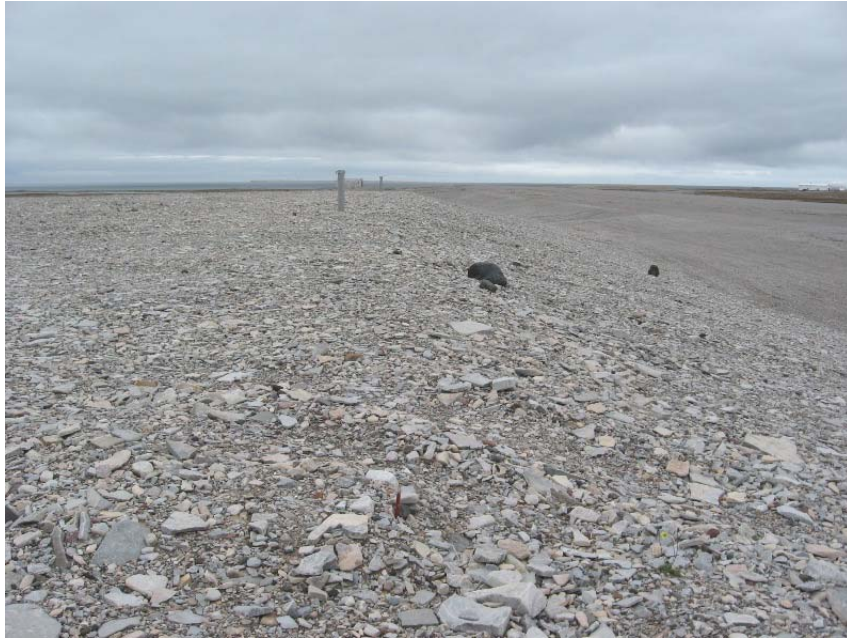
Photograph T2-3. Looking W along crest from NE corner of landfill. VT-6 visible in frame. A depression (0.5mx 4mx6m) centred about 4m NE of VT-6 appears unchanged from previous inspection. ↑

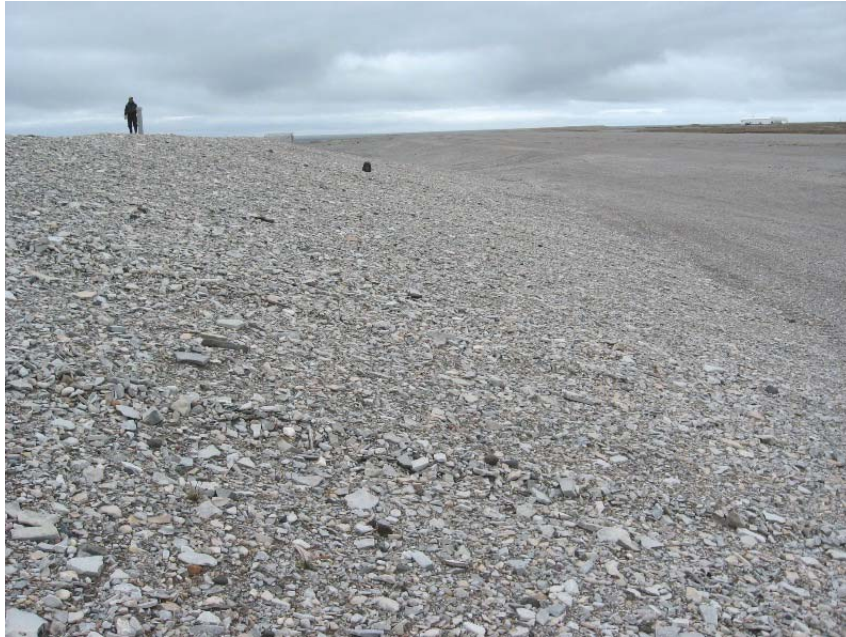
Photograph T2-5. Looking W from mid-slope along N face. Backpack is located near eastern limit of the above noted zone of depression. Zone of depression appears unchanged since previous inspection; however, no as-built survey is available for comparison. ↑

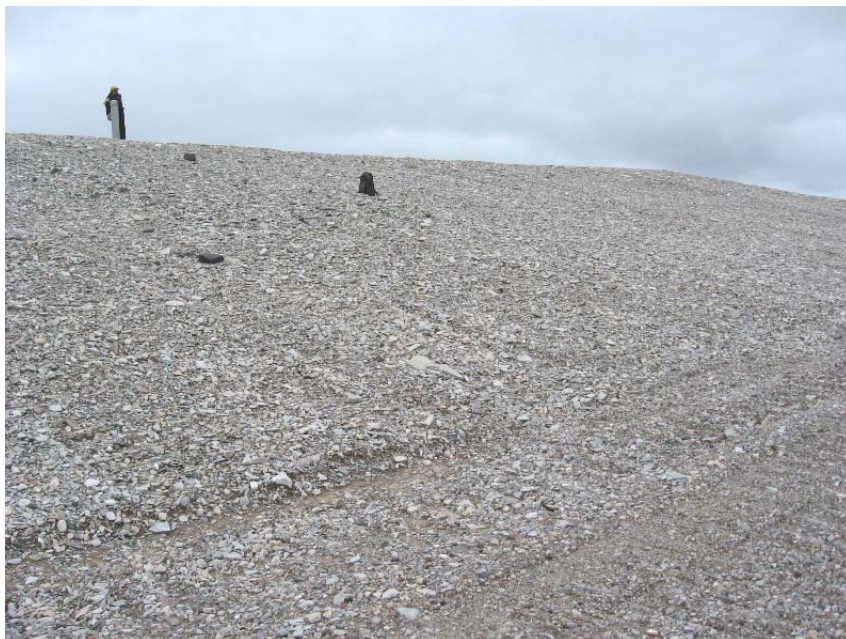
Photograph T2-6. Looking SW from toe of slope to area of depression adjacent to VT-5. ↑

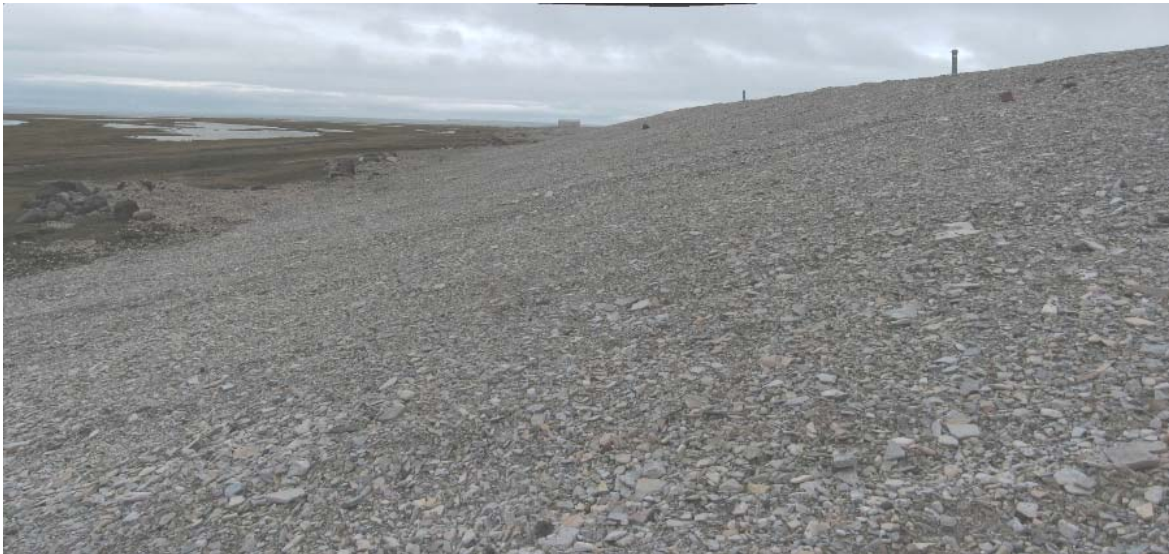
Photograph T2-18. Looking W along S slope from about mid-slope near SE corner. VT-8 (near) and VT-7 (distant) visible along crest. Minor surface irregularities and undulations are visible (consistent with irregular construction finish); however, the slope appears stable. ↑

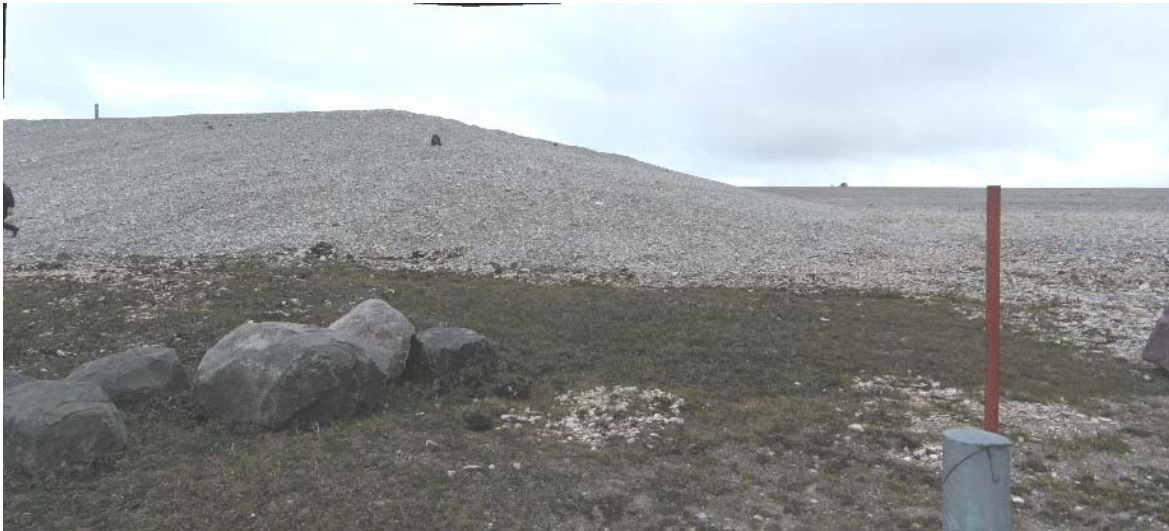
Photograph T2-19. Looking N along E slope from adjacent to MW-12. Slope appears stable.

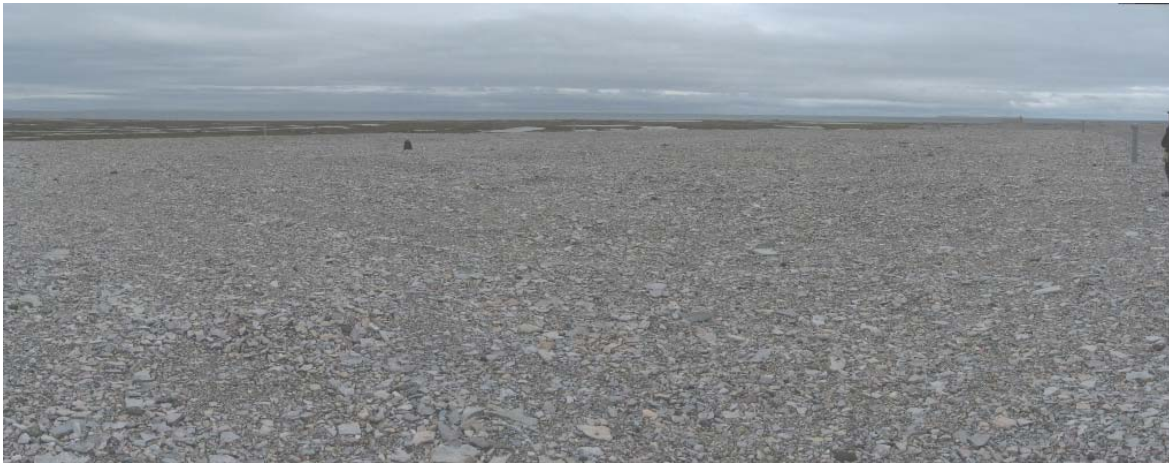
Photograph T2-22. Panoramic, L to R, looking SW from NE corner. VT-6 visible along right side of photo. No clear indications of problematic conditions (i.e., slope movement or significant differential settlement). The irregular surface (poor construction finish) masks minor changes. Condition of the landfill cover should continue to be monitored. ↑

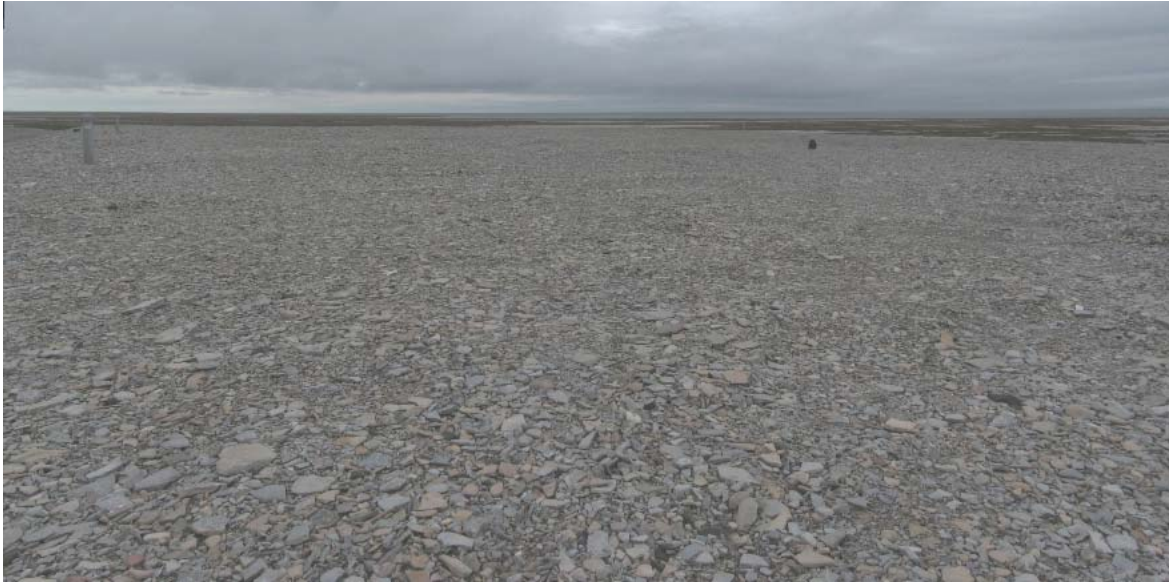
Photograph T2-23. Panoramic, L to R, looking SE from NW corner. Note gentle undulation and inconsistent construction finish. ↑

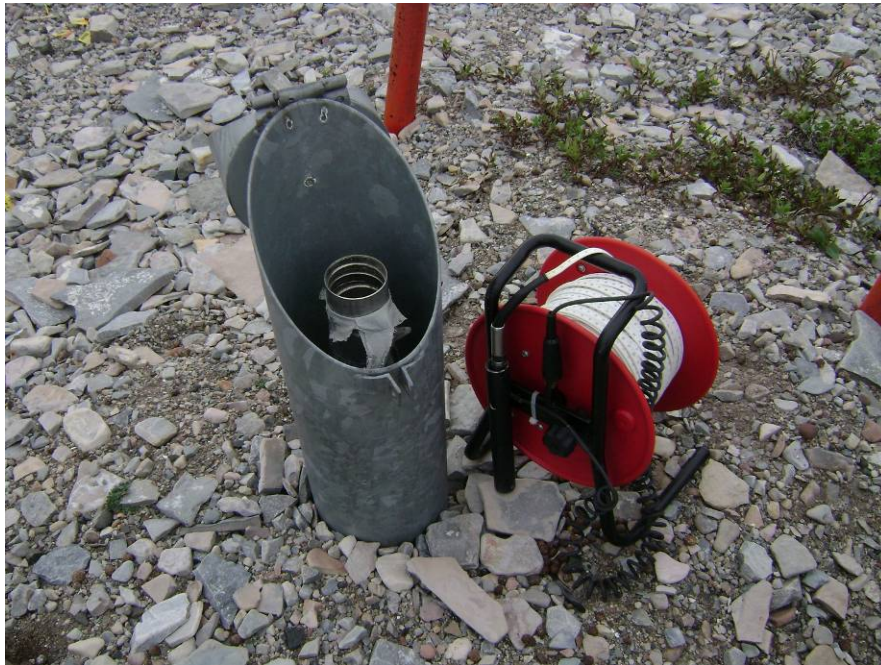
Photograph 1. Monitoring well MW-9. Well frozen at 1.97m. No water for sampling.____ ↑

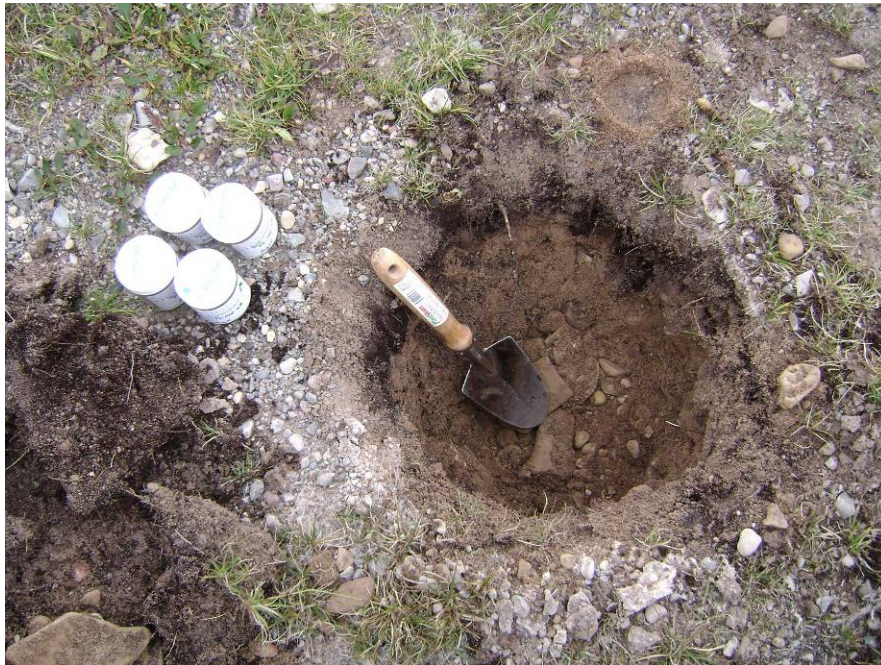
Photograph 3. Test pit at MW-10 – Samples P3-MW-10A and P3-MW-10B collected.
NOTE: photo of MW-10 was inadvertently deleted and is unrecoverable, however the well appeared unchanged from 2007 upon inspection.____ ↑
