## **The Collection of Landfill Monitoring Data at the PIN-3 Lady Franklin Point Site – 2008**

**AECOM Canada Ltd.**

January, 2009

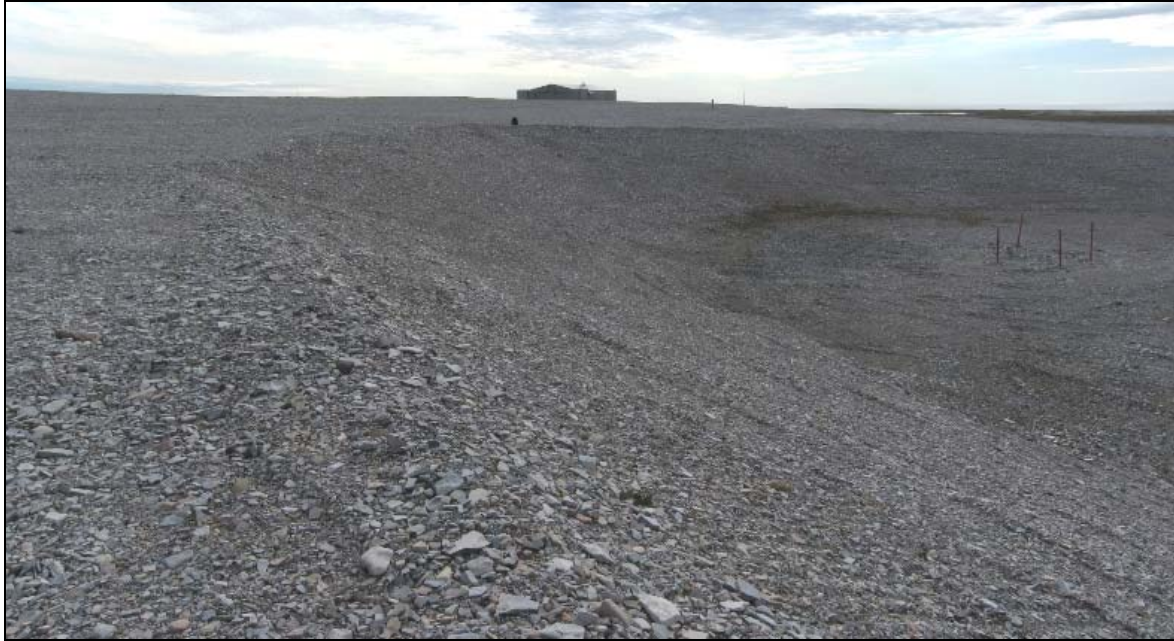
**Photograph MLF-15.** Panoramic looking ESE to SE from crest to curved slope. Hangar and VT-3 visible in the background. Slope and crest appear stable and well armoured. ↑

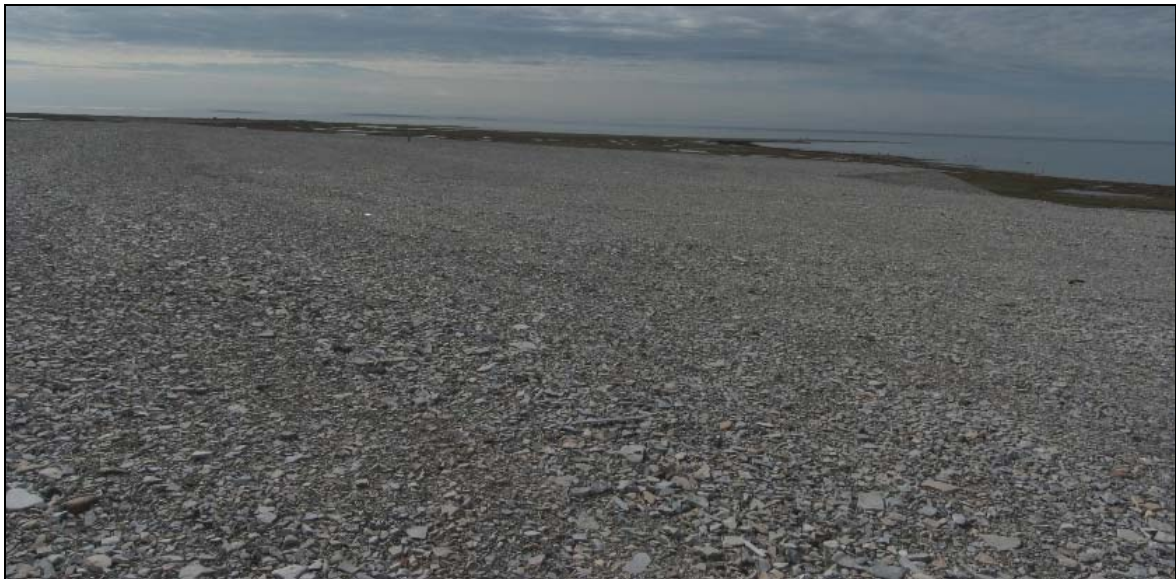
As noted in the 2006 and 2007 inspections, the top surface of the landfill appears to have several areas of broad depression; specifically in the areas around thermistors VT-1 and VT-3 (refer to Photographs 23, 25 and 26). There is no as-built survey information available for this landfill; therefore it is not possible to compare the current surface contours with the original shaping of the landfill. There is no indication of significant differential settlement or problematic foundation conditions associated with these broad depressions. These depressions should continue to be monitored to confirm that they are not associated with problematic foundation conditions.

**Photograph MLF-23.** Panoramic looking NNW to N. VT-3 visible near, and VT-1 to right in distance. Backpack is near centre of depression. ↑

The overall performance of the landfill is considered acceptable. The noted areas of broad depression should continue to be monitored.

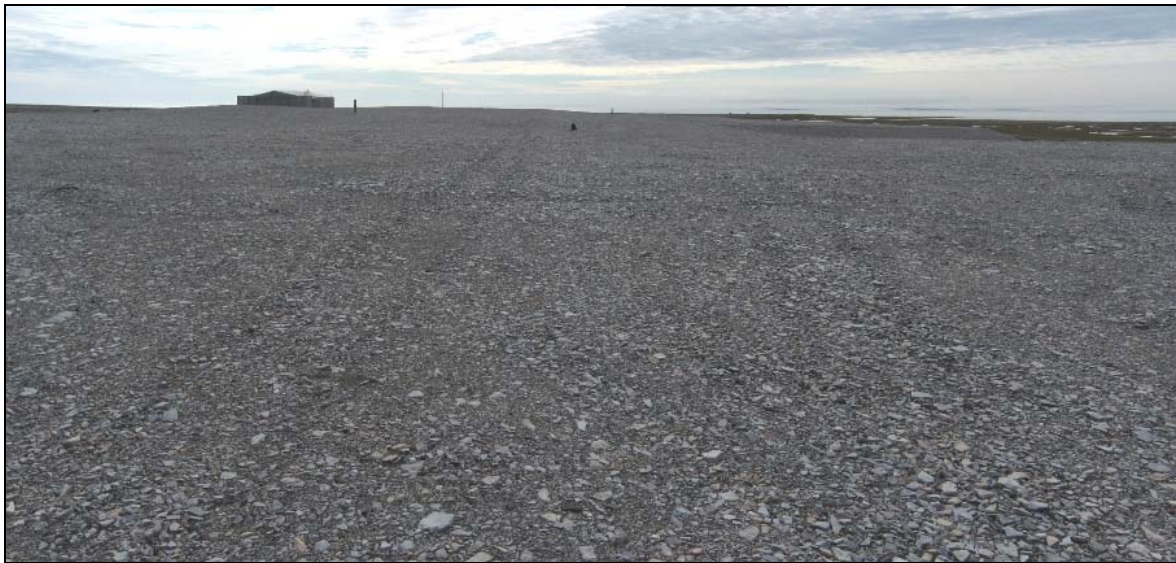
**Photograph MLF-25.** Panoramic looking NW from 2m S of VT-1. Backpack in centre of area of generalized depression. Appears unchanged from previous two inspections.   ↑

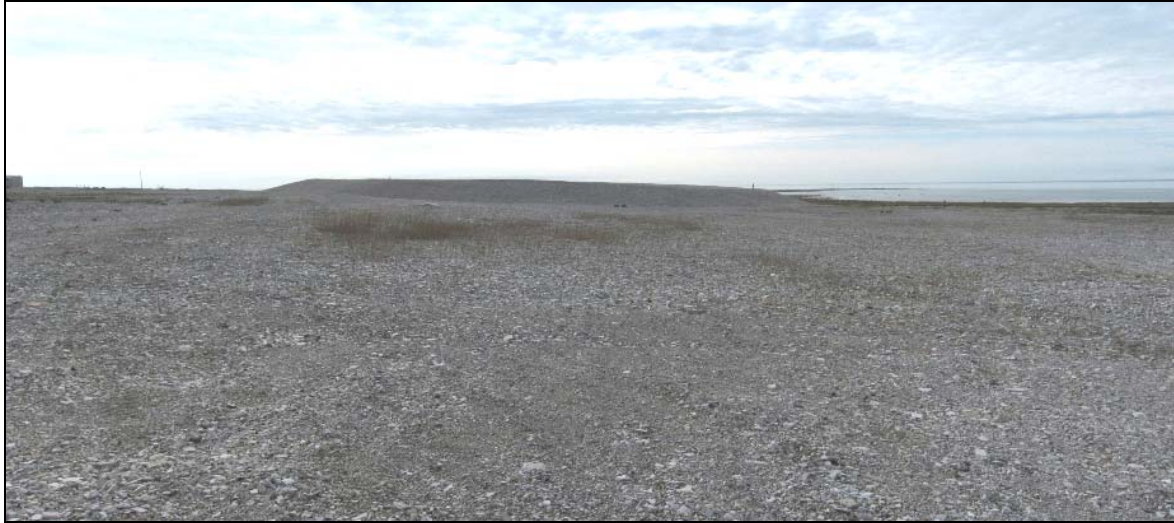
**Photograph MLF-26.** Looking S from N end near crest. VT-1 near and VT-3 far. Backpack near centre of area of generalized depression.   ↑

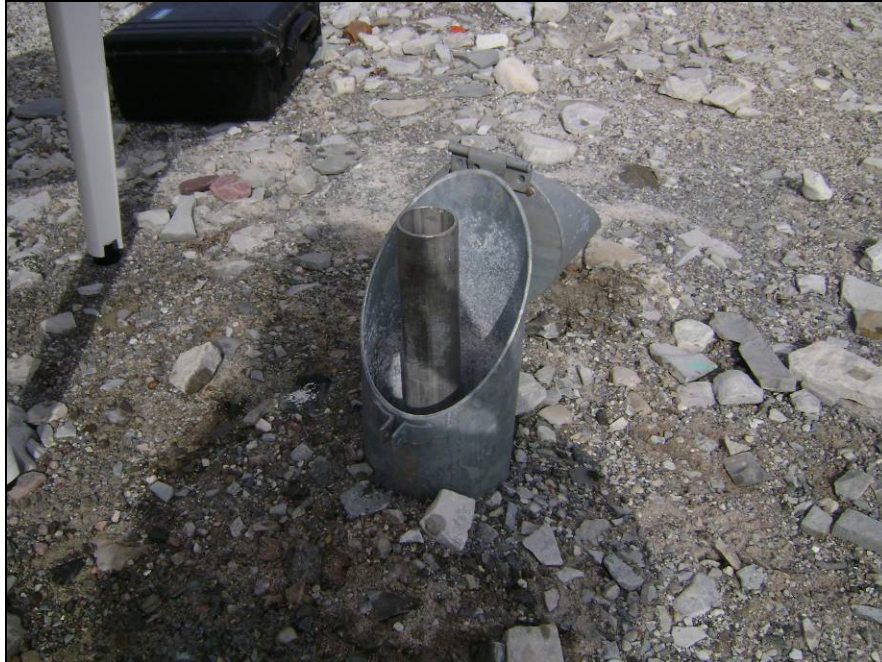
**Photograph 5.** Monitoring well MW-7. Sample P3-MW-7 collected from flow-through cell. Well ran dry during purge. No appreciable recharge. ↑

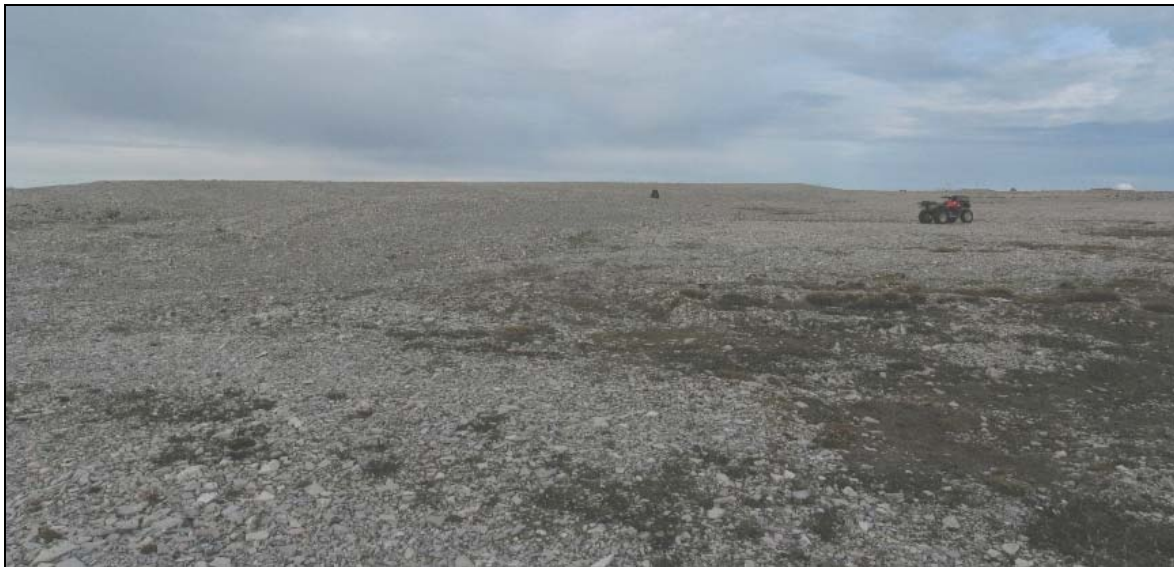
**Photograph NWS-6.** Looking ENE from about 25m SW of SW corner of East cell. The indentation in the south slope is directly behind the backpack. ↑

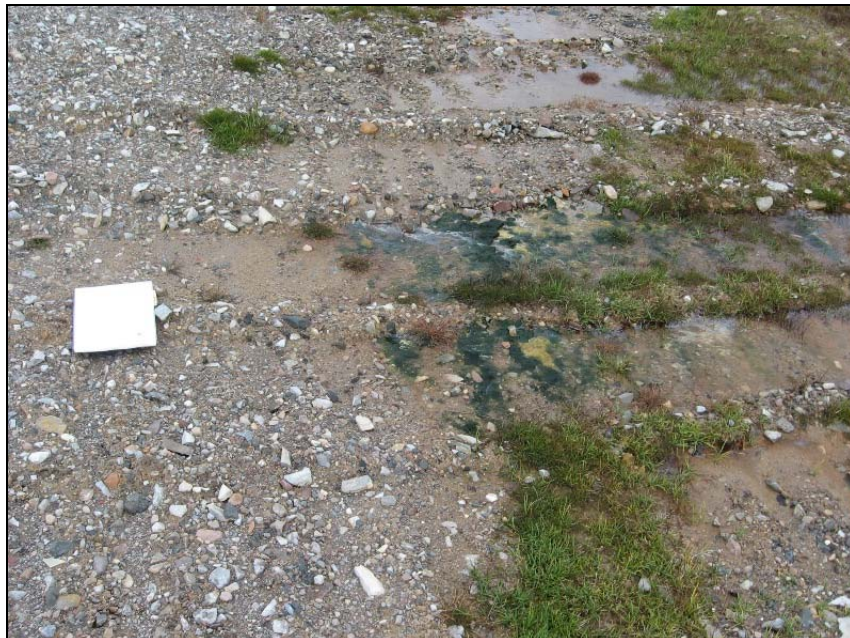
**Photograph SLF-4.** Close-up of green algae growing along toe in area of staining. ↑

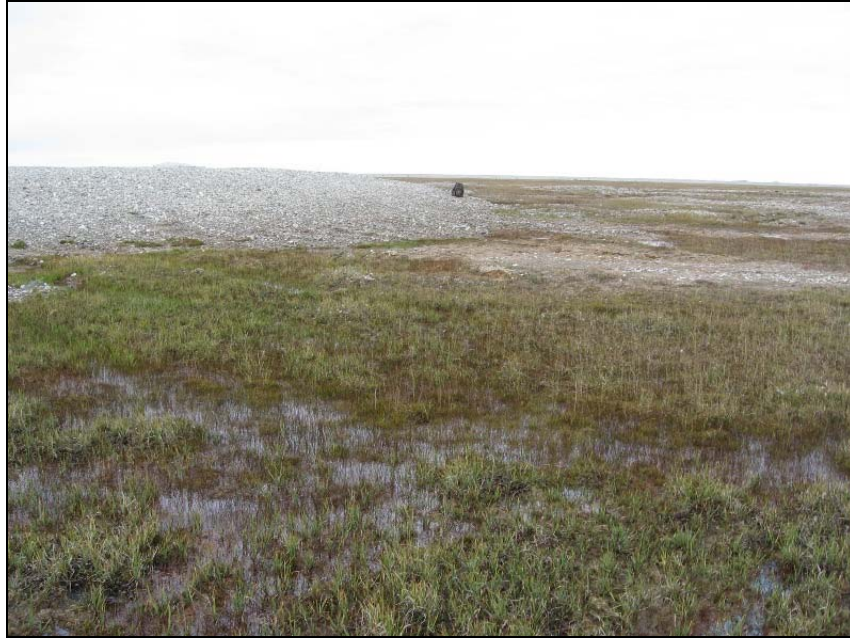
**Photograph SLF-5.** Looking NW to NE corner of South LF - East. Almost all ponded water to E of East cell has a "rainbow sheen". ↑

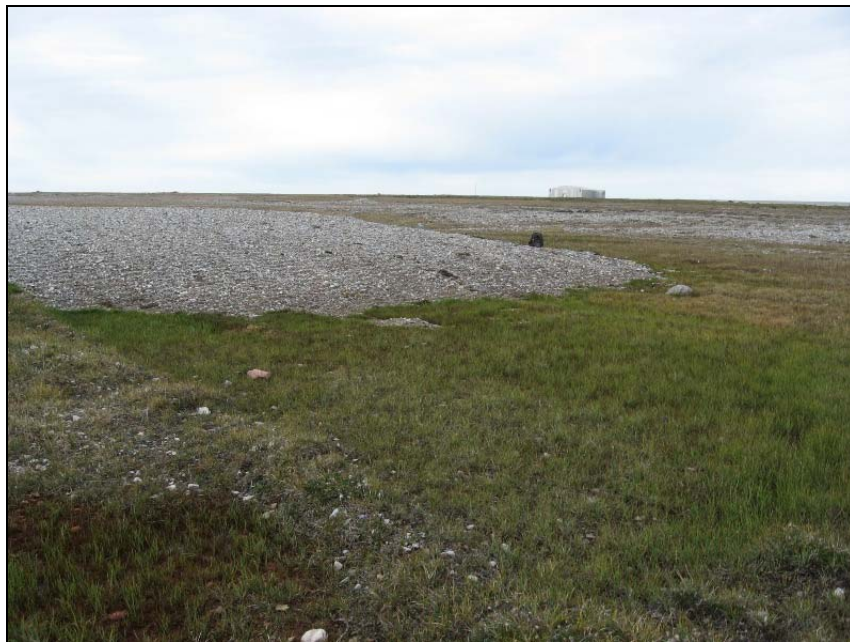
**Photograph SLF-22.** Looking NNW to the NE corner of the North cell. Hangar in background. Staining unchanged from last year. ↑

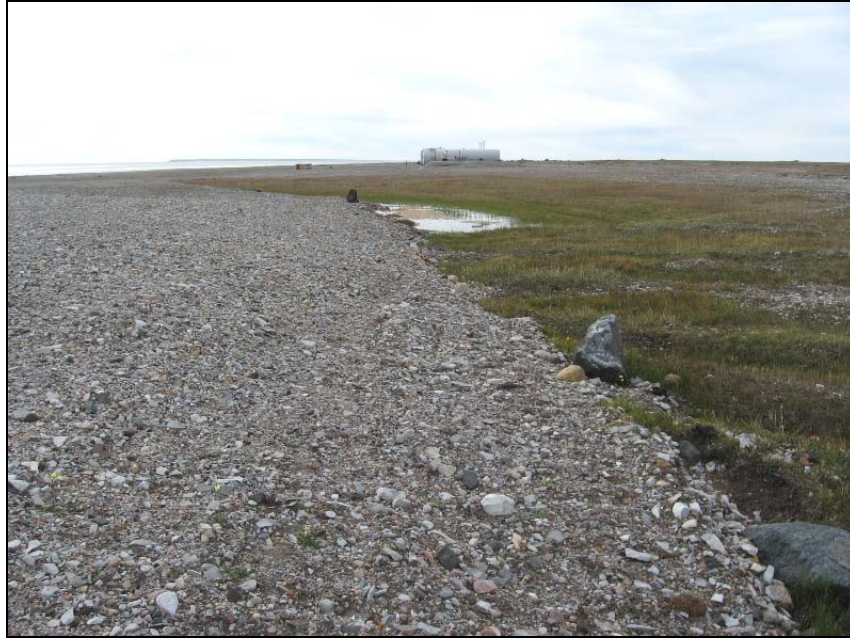
**Photograph SLF-23.** Looking W along N end of Western cell. Abundant green/yellow/orange/pink algae in puddle adjacent to backpack. ↑

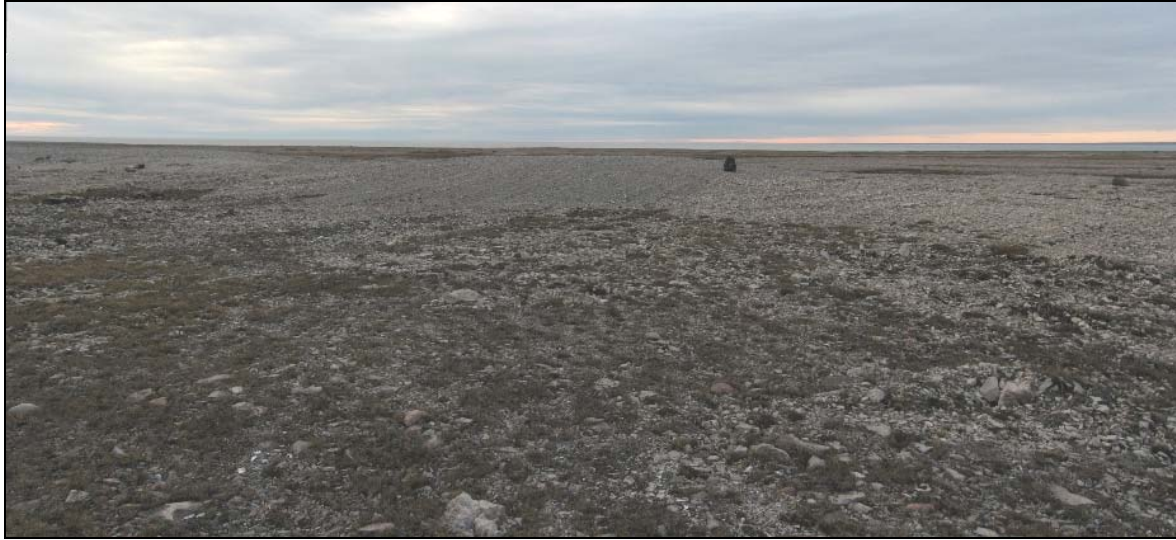
**Photograph NLF-5.** Looking WNW to NNW to SE corner of Central cell. Stable and unchanged from previous two inspections. ↑

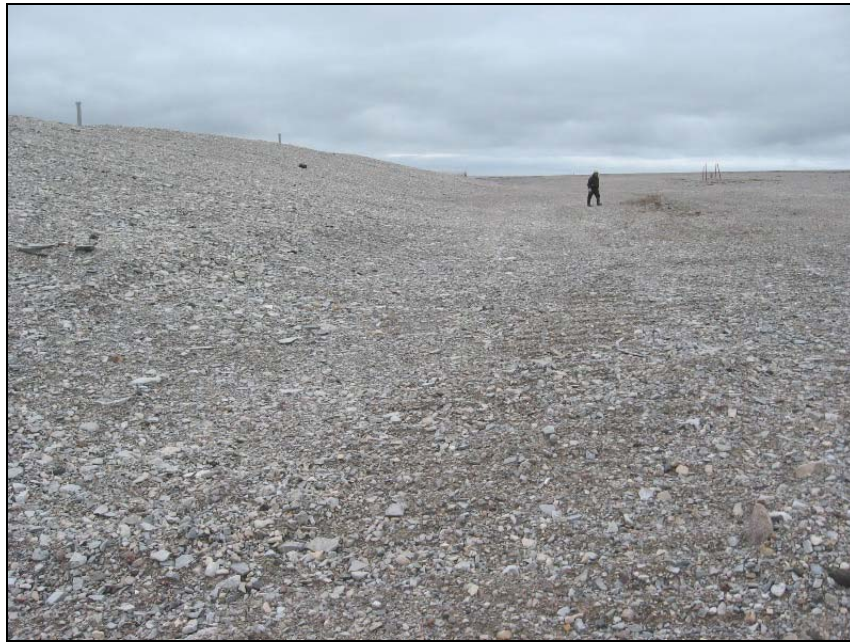
**Photograph T2-2.** Looking W from NE corner along toe of N slope. Condition of slope appears unchanged from previous two inspections (2006 and 2007); however, inconsistent finished grade (undulations and vehicle ruts) makes it difficult to discern differential settlement. ↑

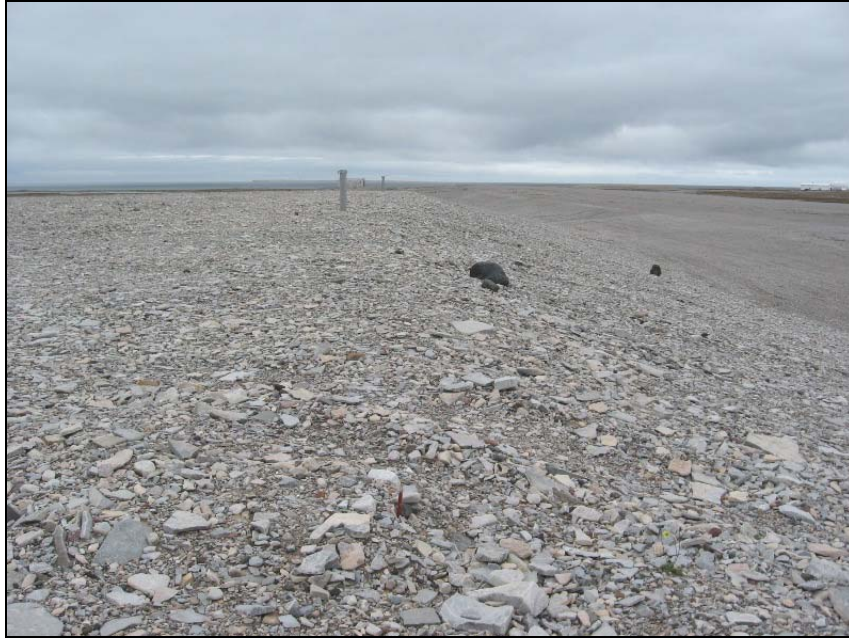
**Photograph T2-3.** Looking W along crest from NE corner of landfill. VT-6 visible in frame. A depression (0.5mx 4mx6m) centred about 4m NE of VT-6 appears unchanged from previous inspection. ↑

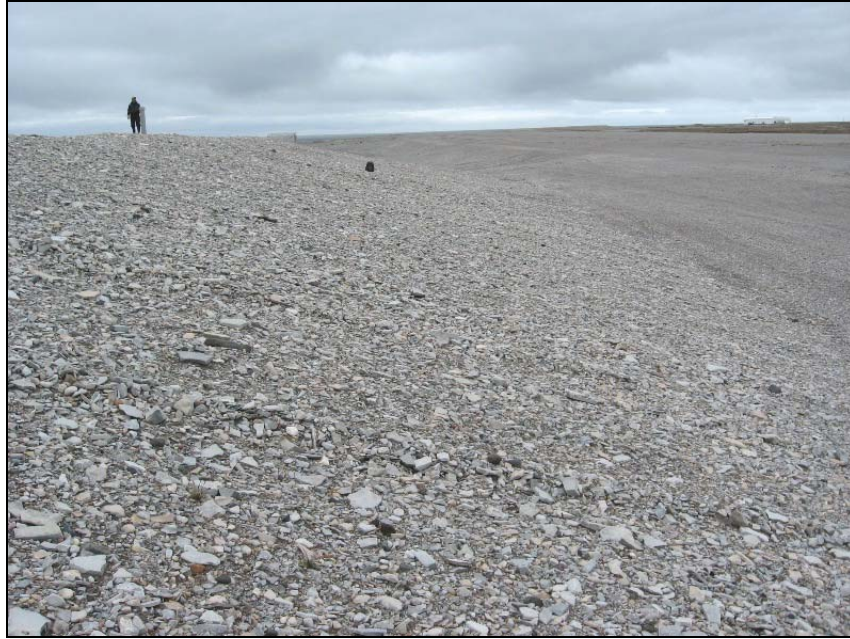
**Photograph T2-5.** Looking W from mid-slope along N face. Backpack is located near eastern limit of the above noted zone of depression. Zone of depression appears unchanged since previous inspection; however, no as-built survey is available for comparison. ↑

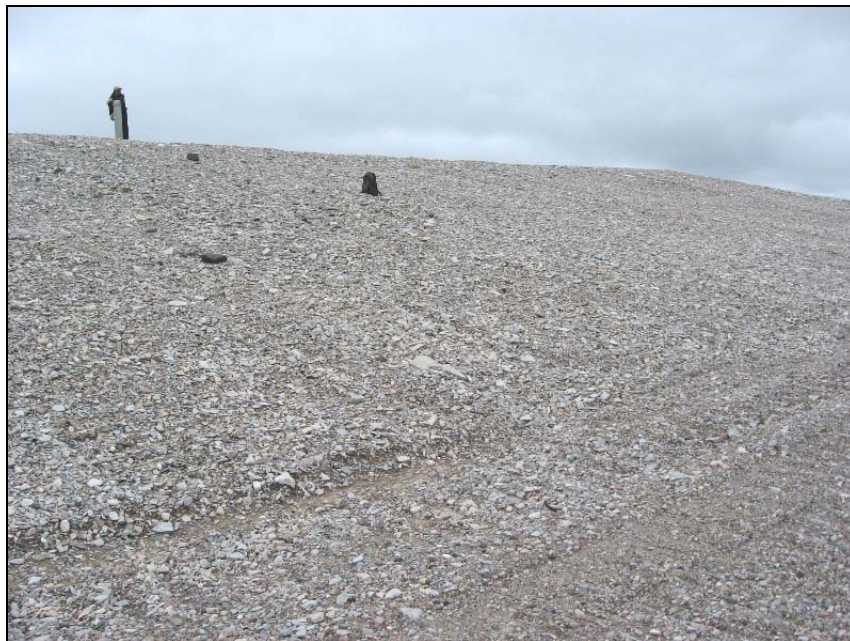
**Photograph T2-6.** Looking SW from toe of slope to area of depression adjacent to VT-5. ↑

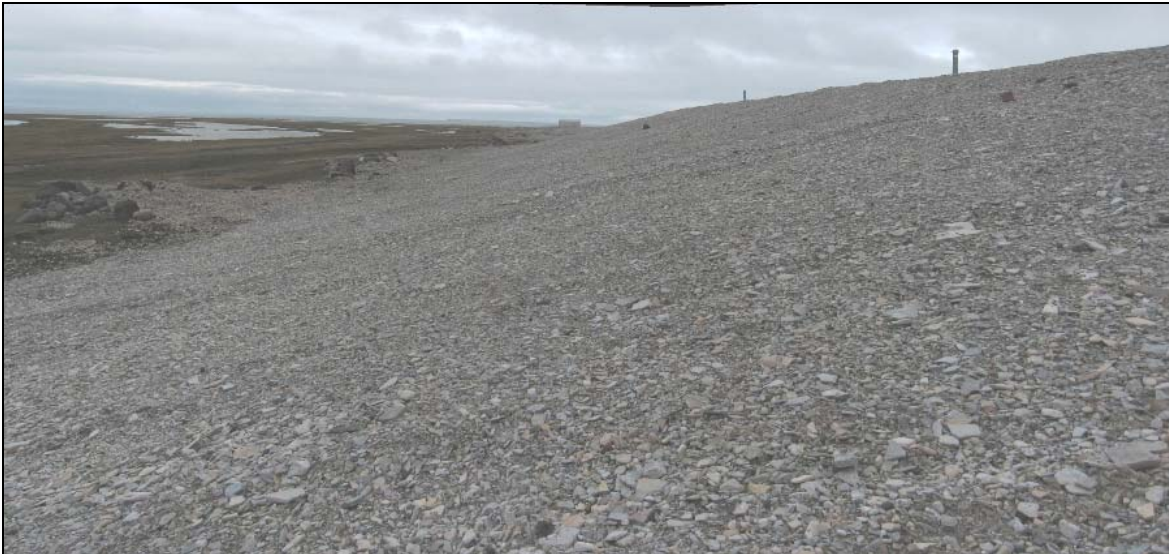
**Photograph T2-18.** Looking W along S slope from about mid-slope near SE corner. VT-8 (near) and VT-7 (distant) visible along crest. Minor surface irregularities and undulations are visible (consistent with irregular construction finish); however, the slope appears stable. ↑

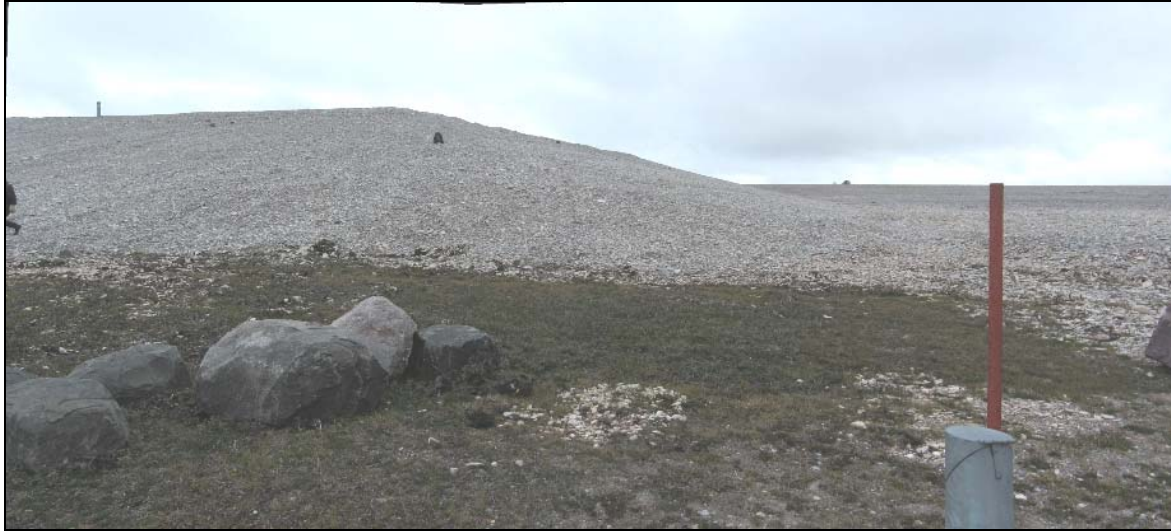
**Photograph T2-19.**

Looking N along E slope from adjacent to MW-12. Slope appears stable. ↑

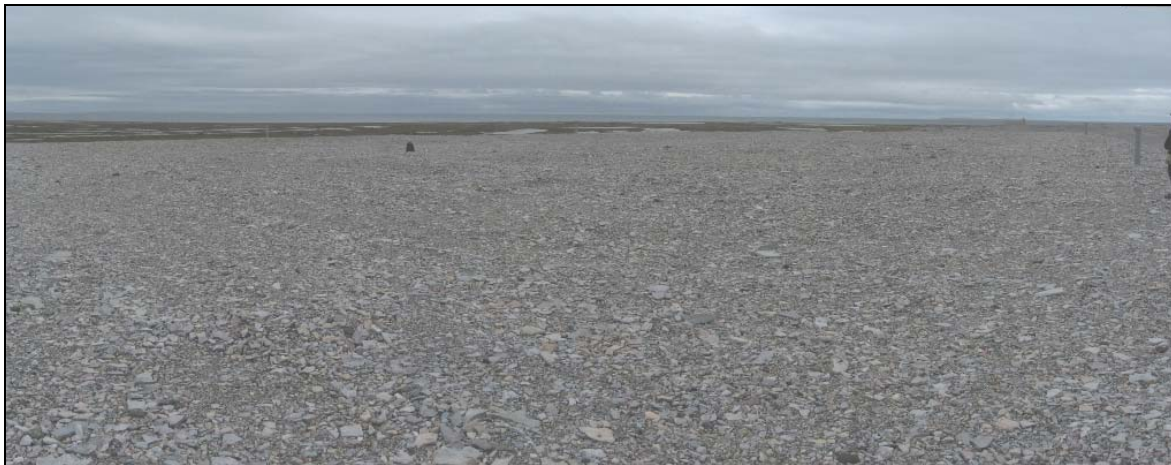
**Photograph T2-22.** Panoramic, L to R, looking SW from NE corner. VT-6 visible along right side of photo. No clear indications of problematic conditions (i.e., slope movement or significant differential settlement). The irregular surface (poor construction finish) masks minor changes. Condition of the landfill cover should continue to be monitored. ↑

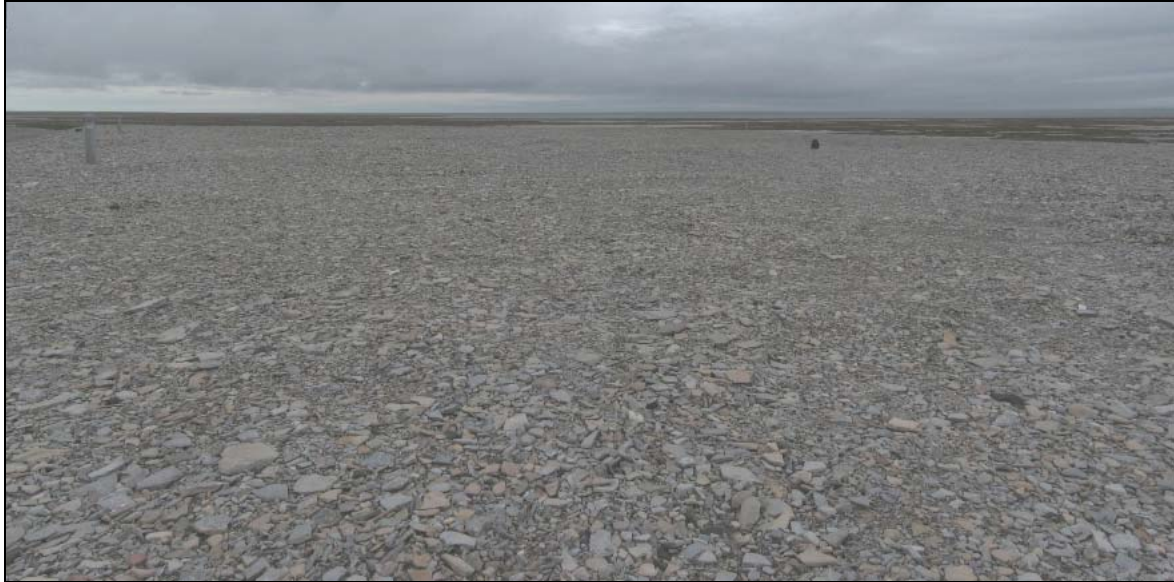
**Photograph T2-23.** Panoramic, L to R, looking SE from NW corner. Note gentle undulation and inconsistent construction finish. ↑

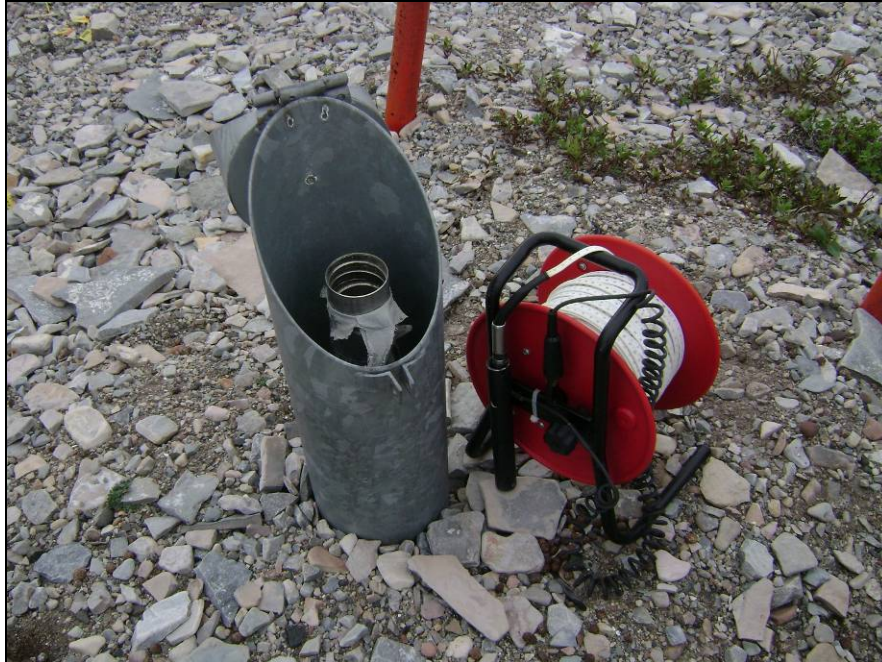
**Photograph 1.** Monitoring well MW-9. Well frozen at 1.97m. No water for sampling. ↑
