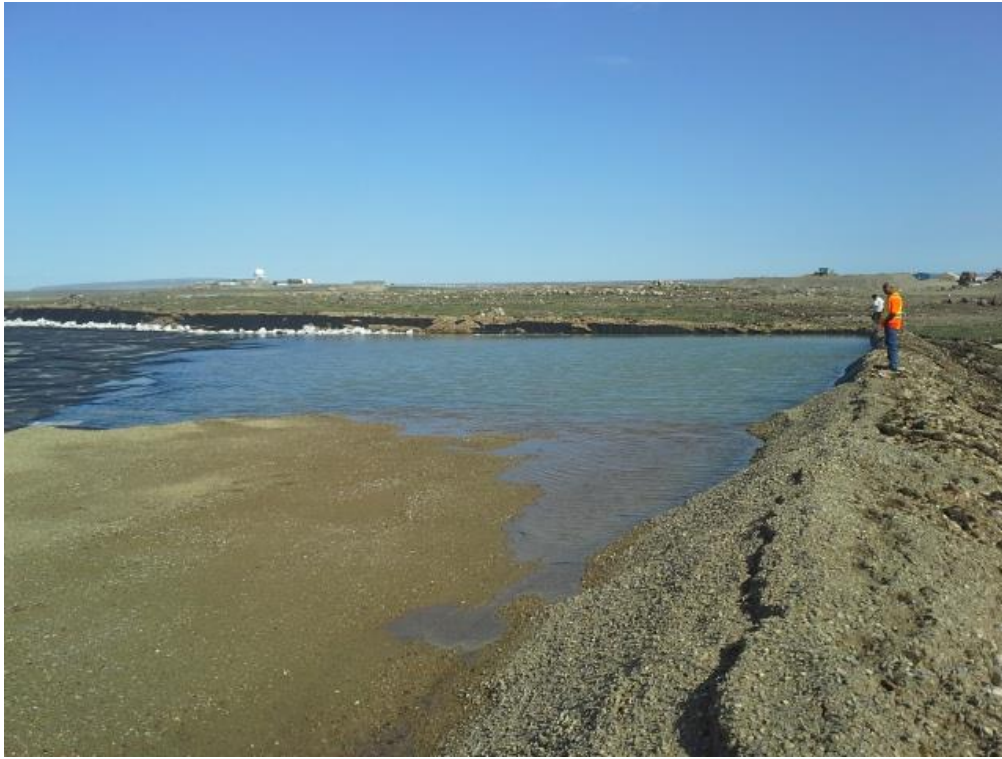
Photo #1: View looking east, accumulated snowmelt and rainfall in the FTA LTU.

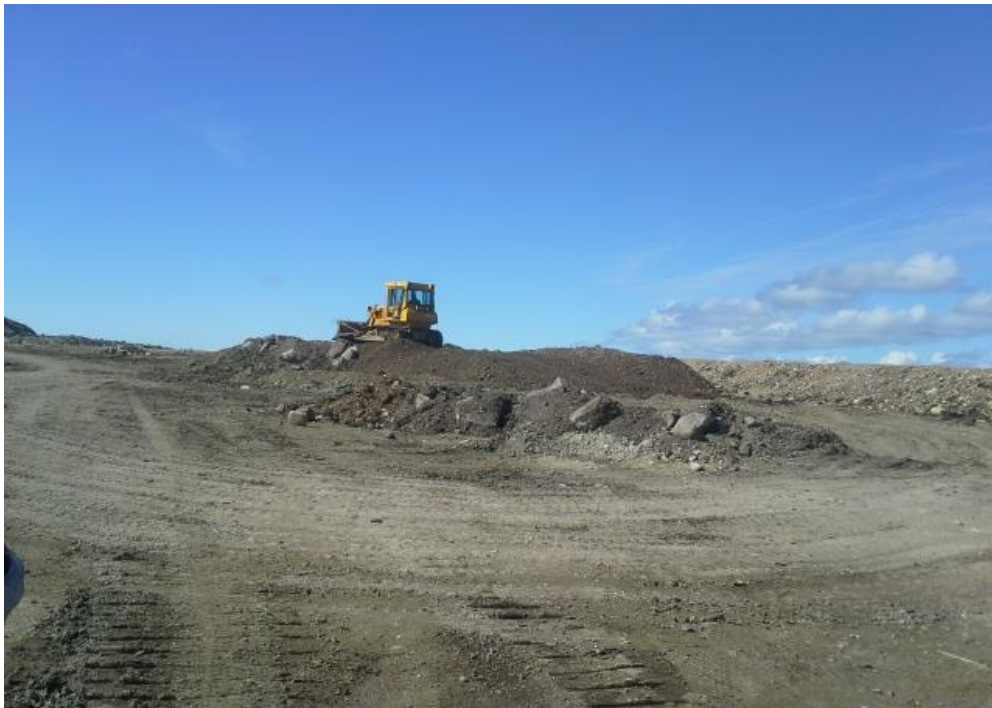
Photo #2: View looking north, importing backfill for FTA excavation.

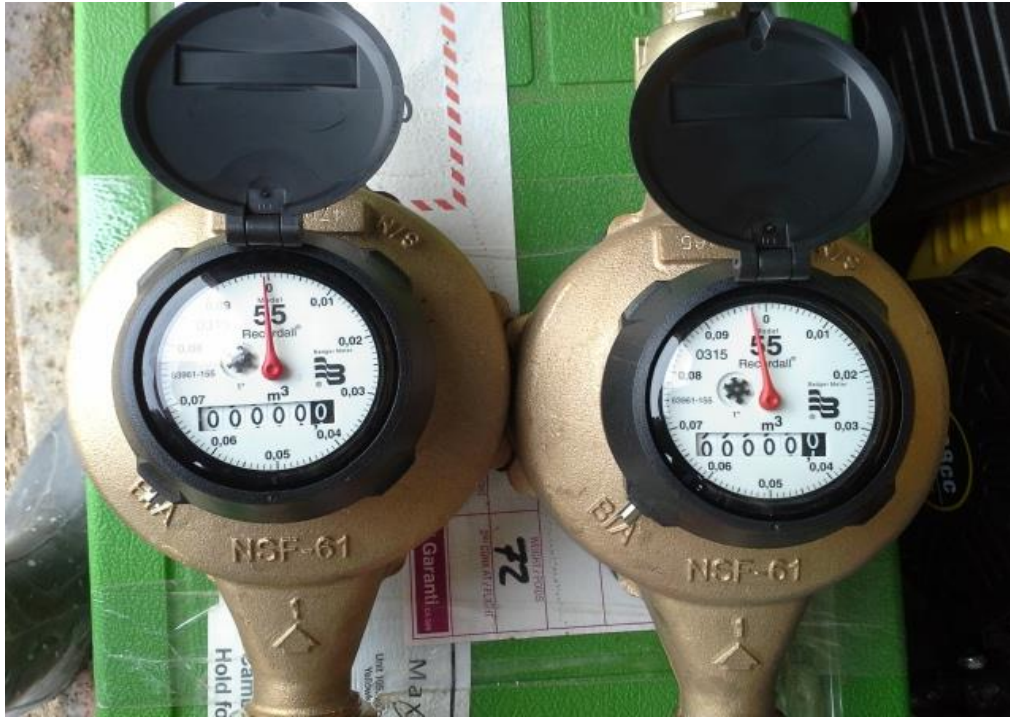
Photo #3: Flow meters to be used for FTA LTU de-watering.

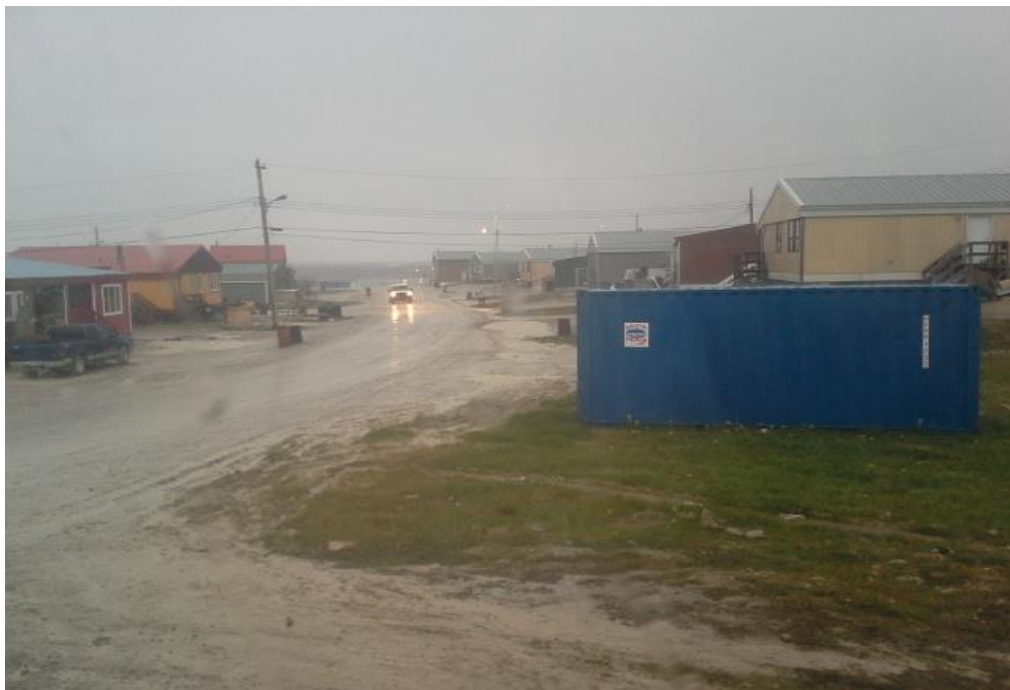
Photo #4: Heavy rain in Cambridge Bay.

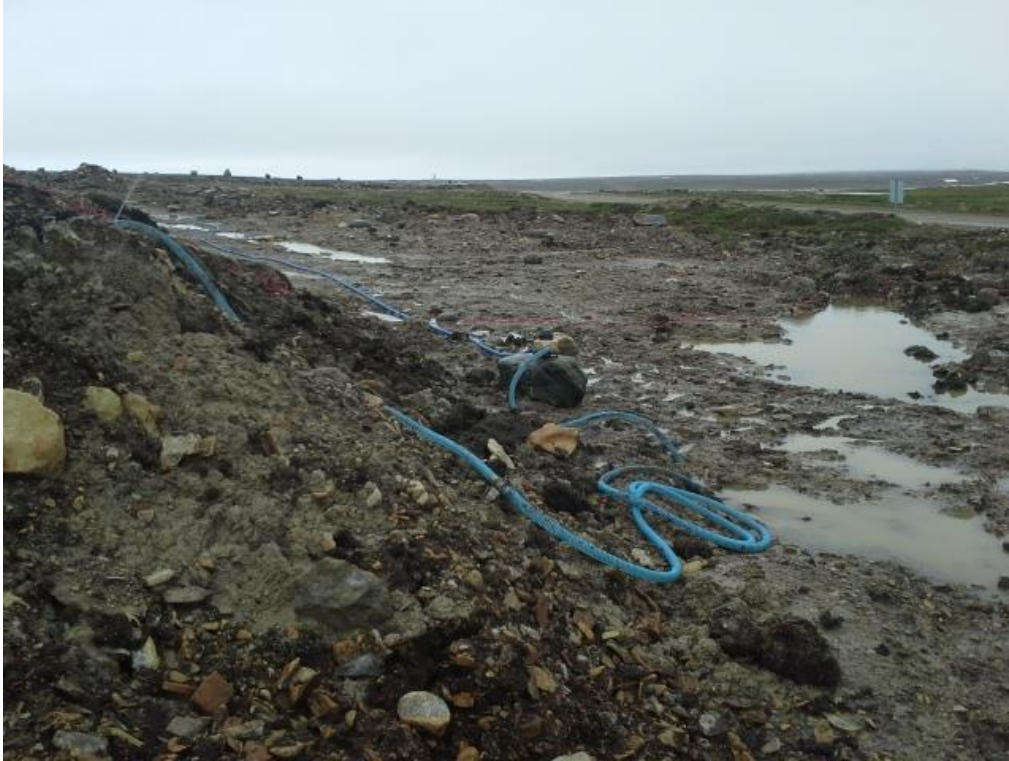
Photo #5: View looking south, de-watering FTA LTU.

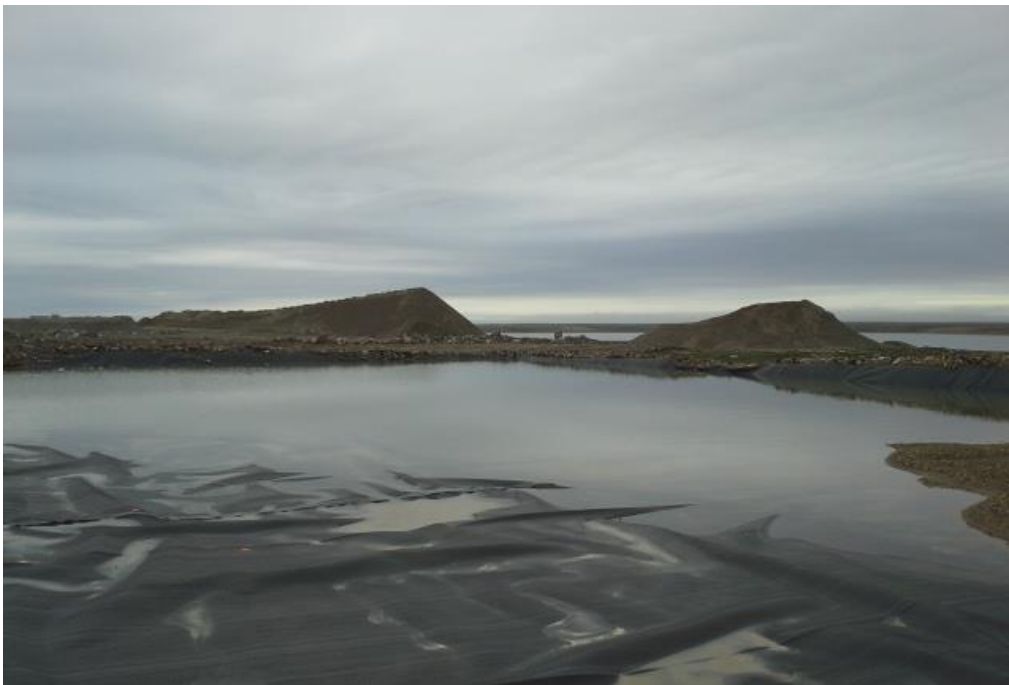
Photo #6: View looking south east, de-watering FTA LTU.

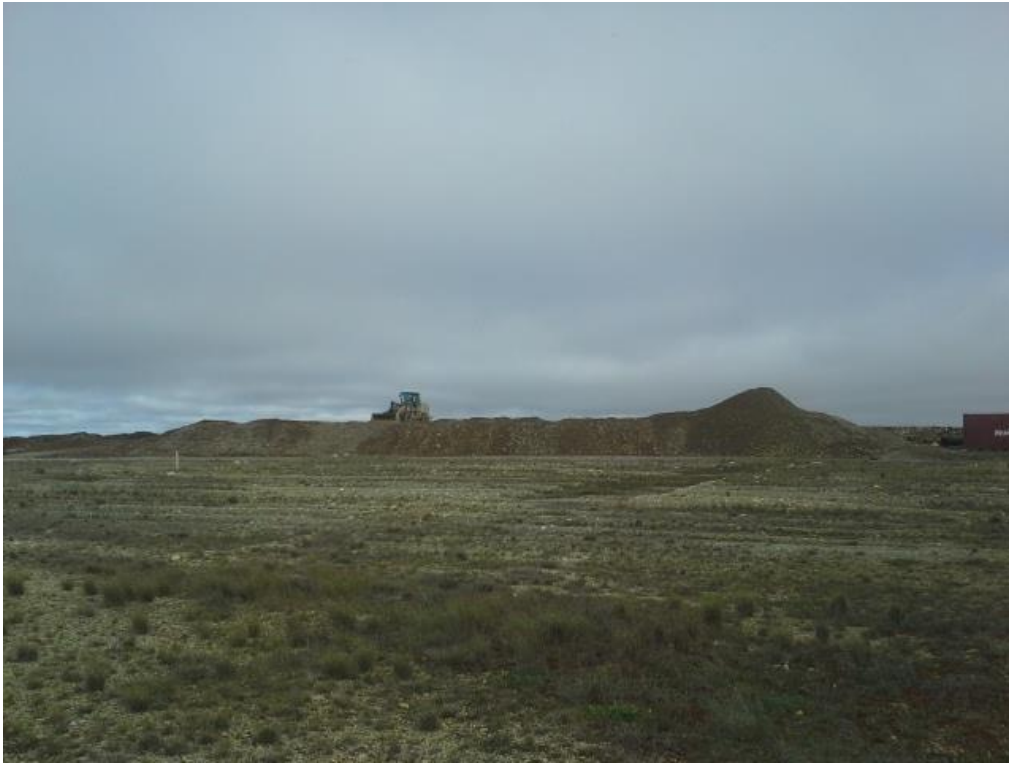
Photo #7: View looking north, importing backfill for FTA LTU excavation.

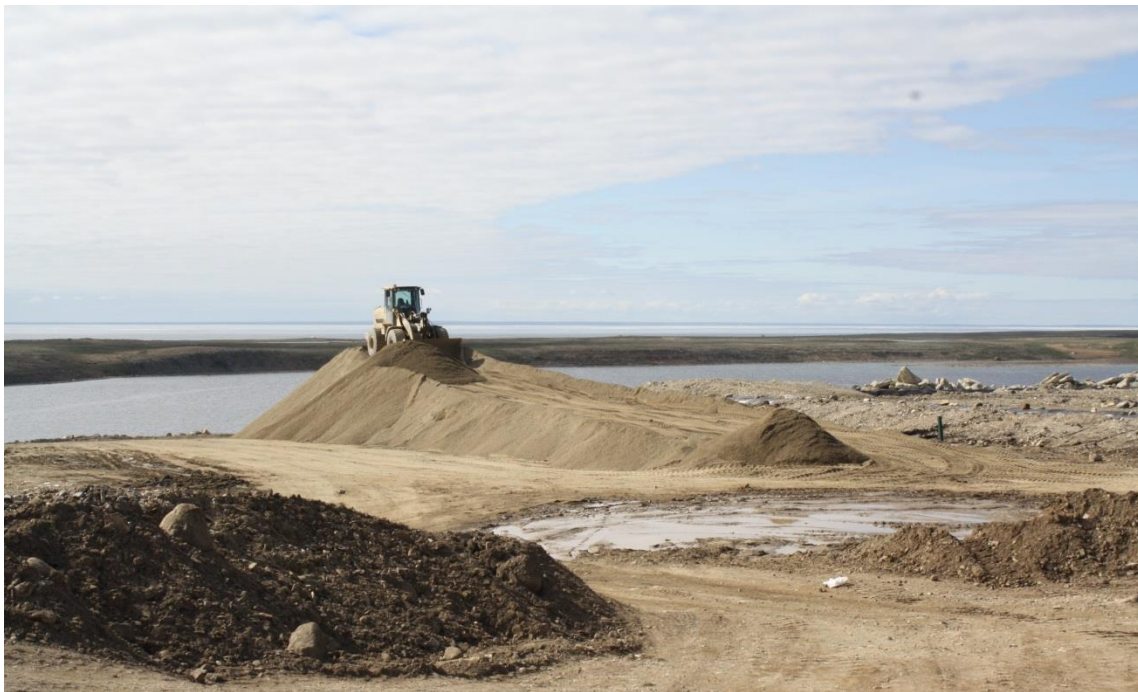
Photo #8: View looking south, importing demarcation material/crush.

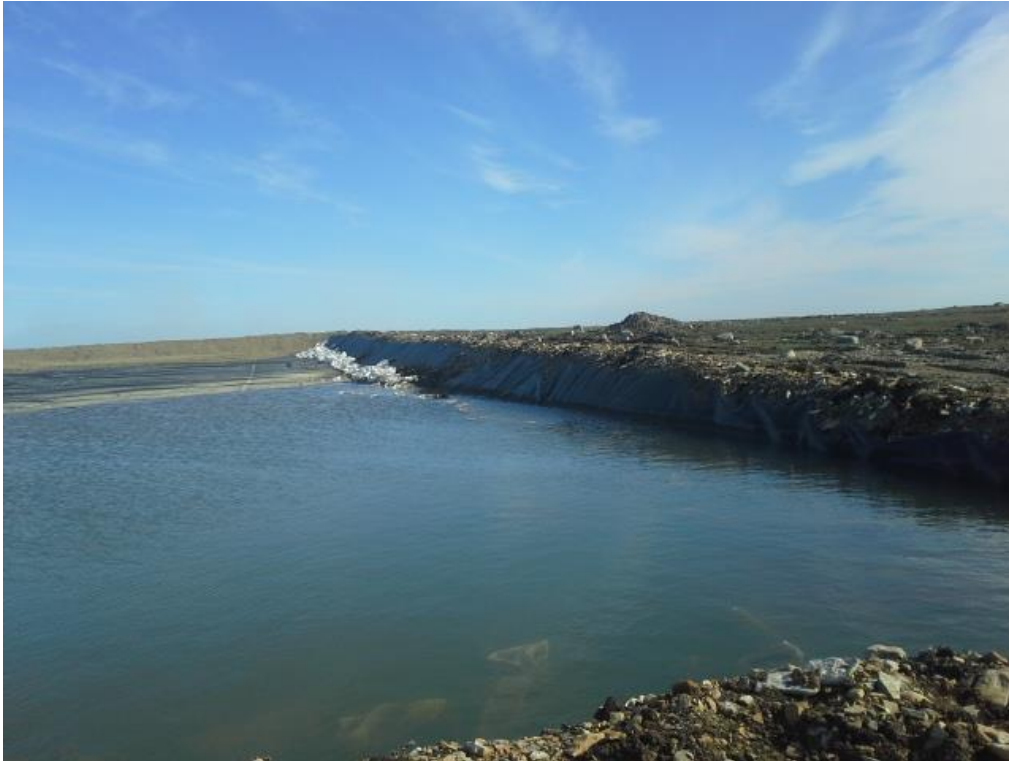
Photo #9: View looking north, dewatering FTA LTU.

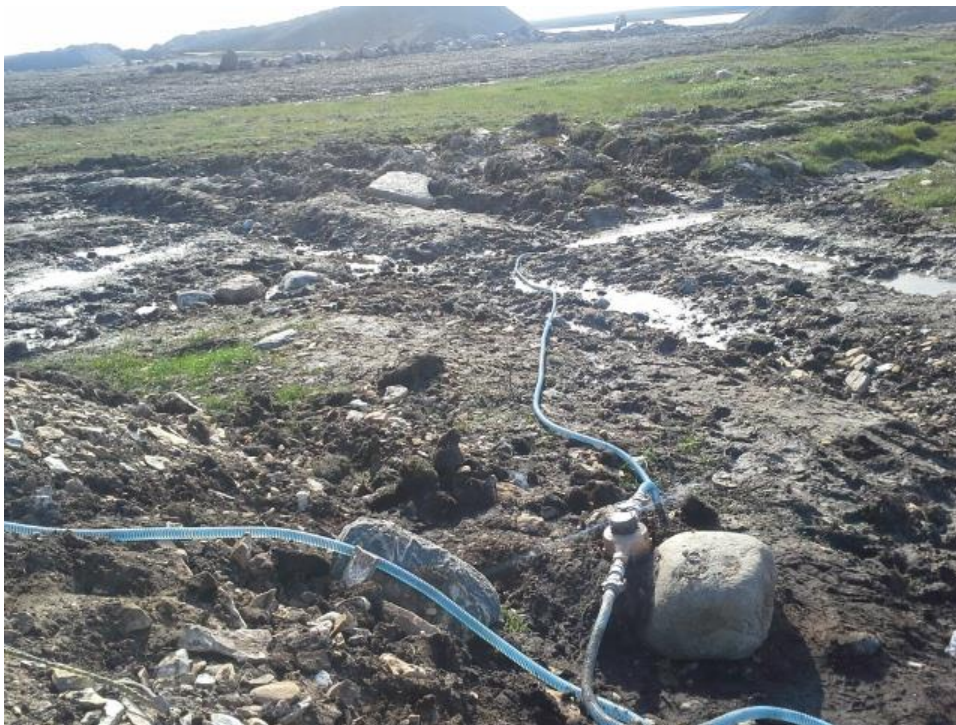
Photo #10: View looking east, dewatering FTA LTU.

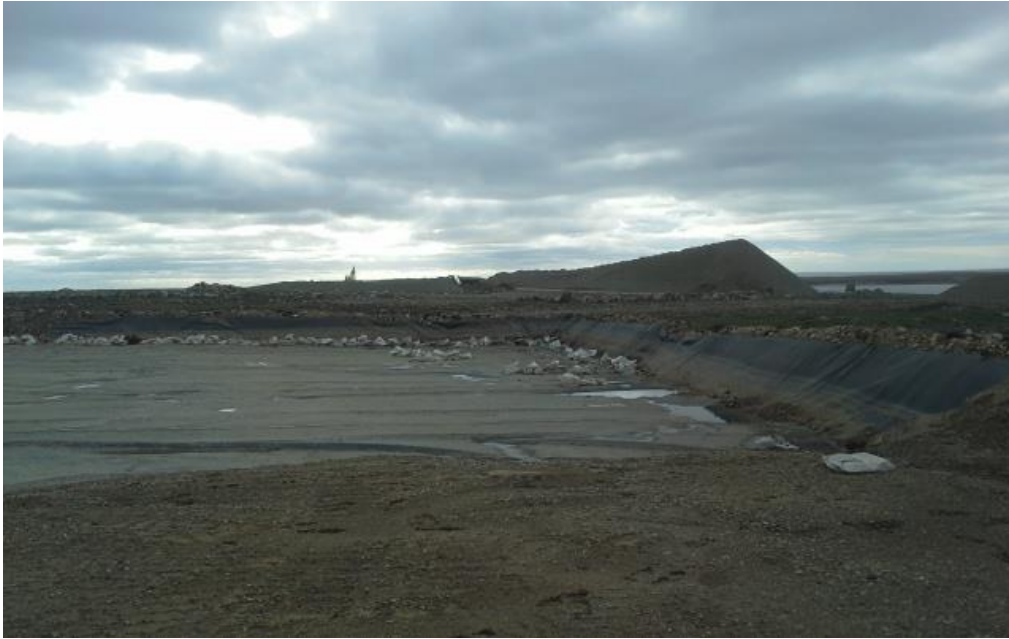
Photo #11: View looking east, de-watered FTA-LTU.

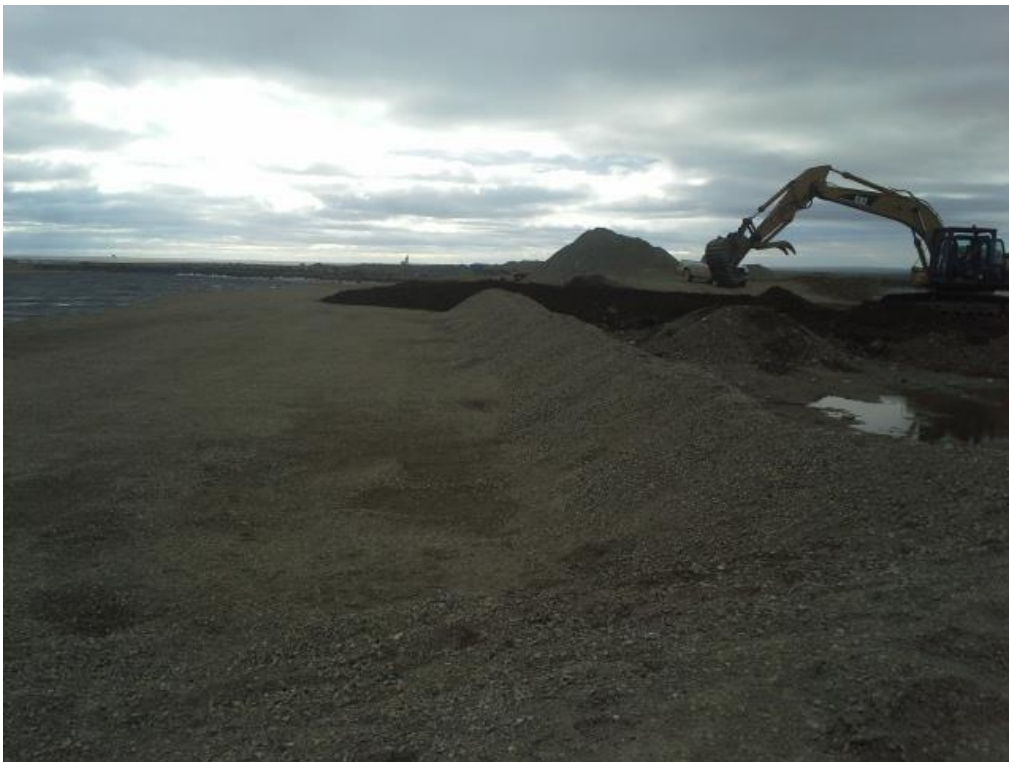
Photo #12: View looking east, constructing ramp to access the interior FTA LTU.

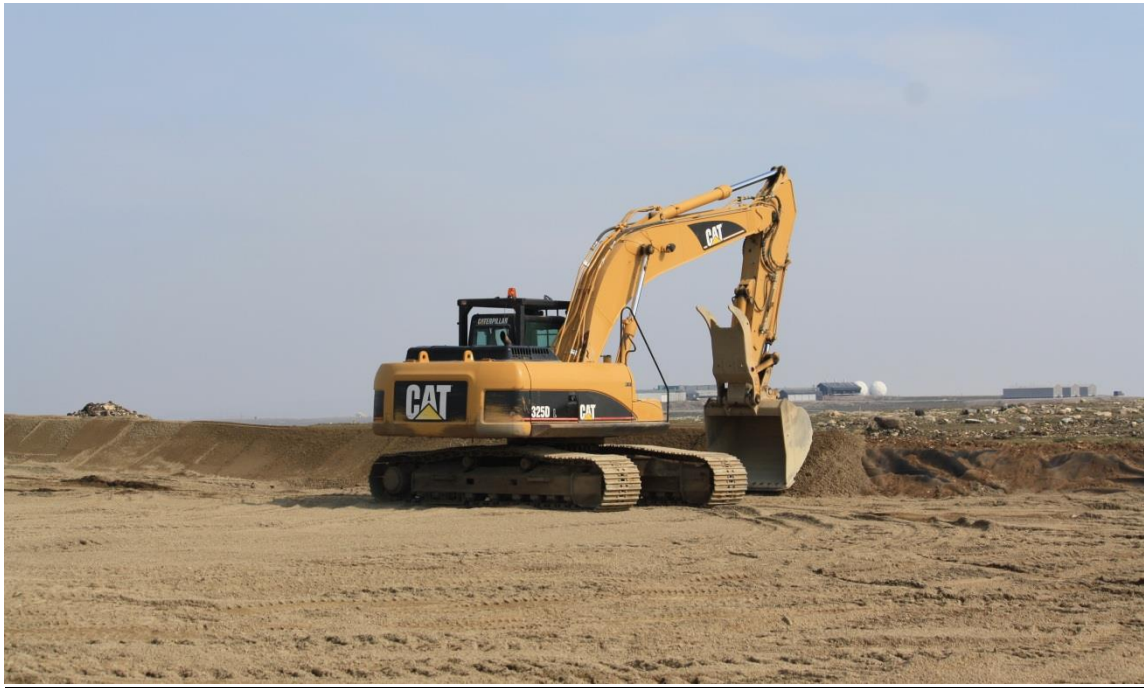
Photo #13: View looking northwest, placing demarcation material/crush along eastern berm.

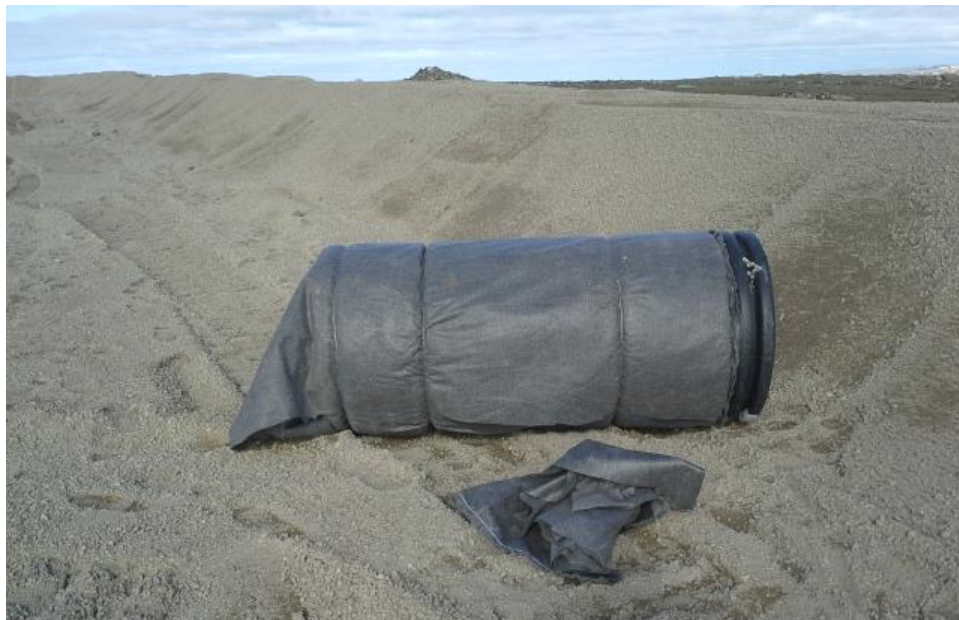
Photo #14: Looking at the south eastern sump prior to installation.

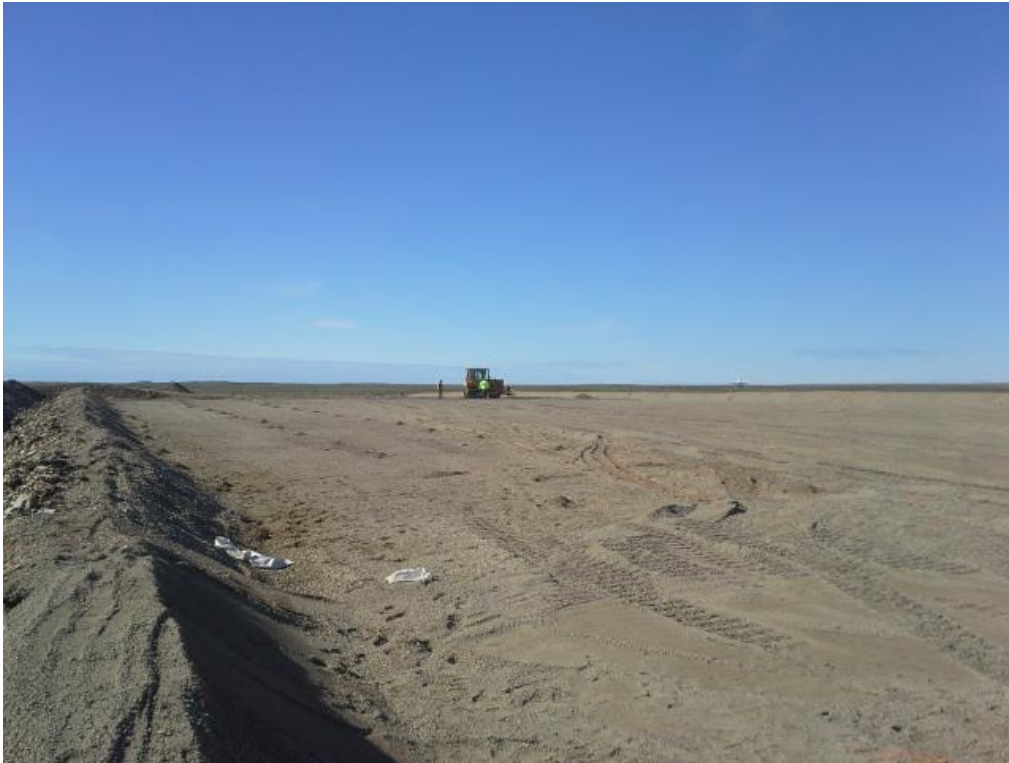
Photo #15: View looking west, spreading demarcation material.

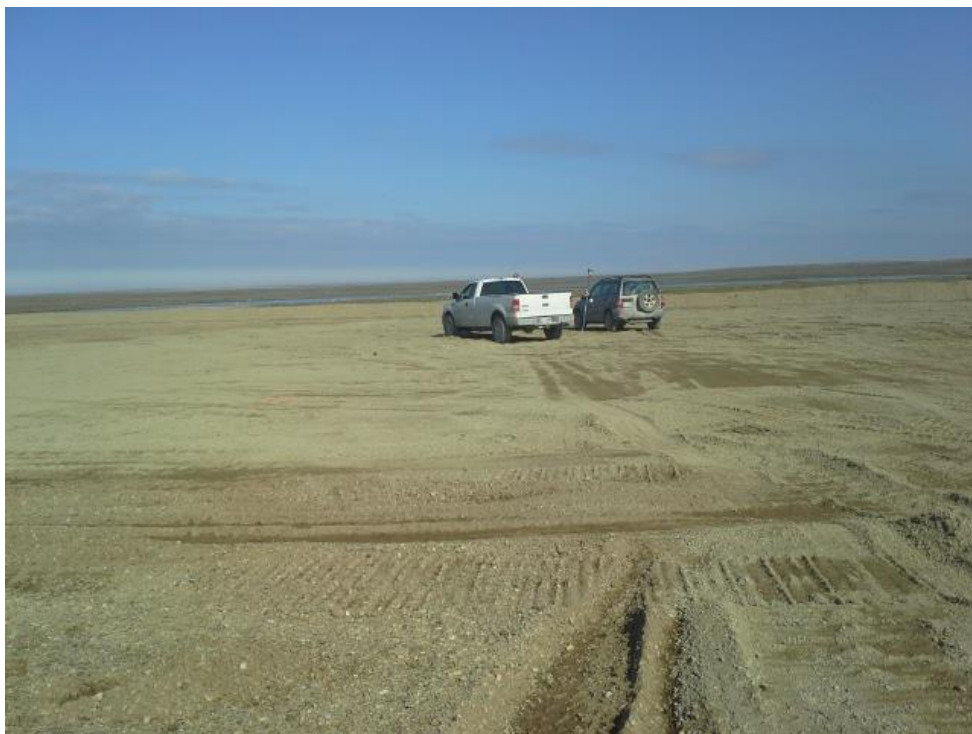
Photo #16: View looking north, spreading and surveying demarcation material.

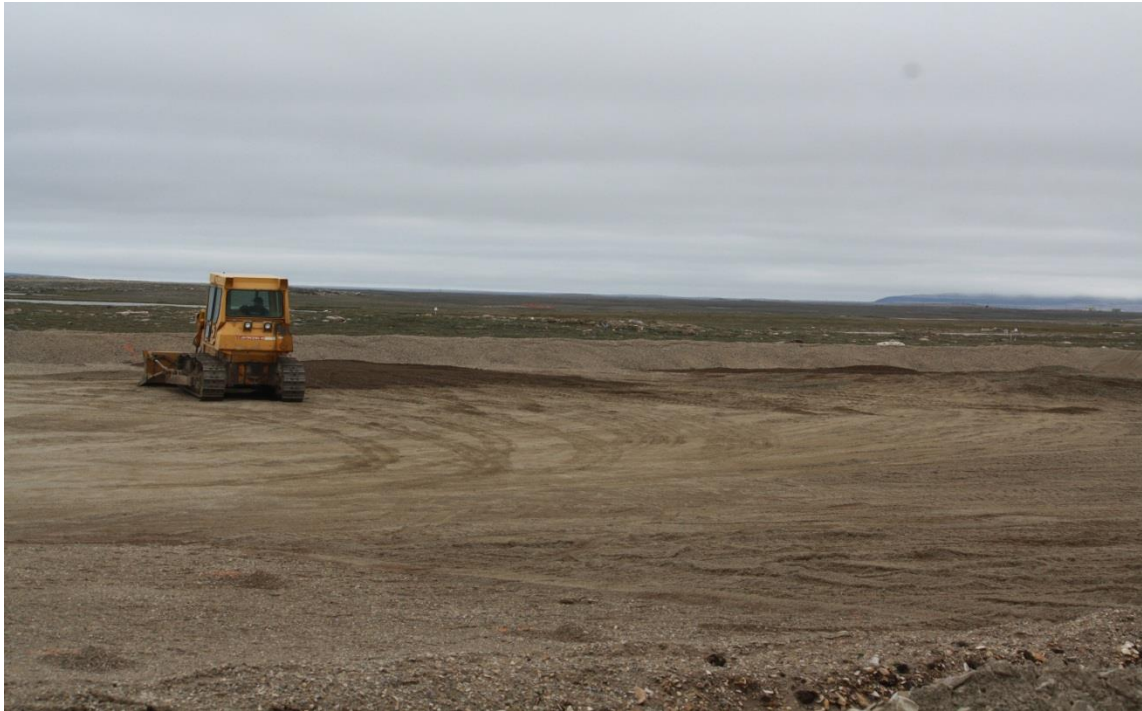
Photo #17: View looking north, spreading demarcation material.

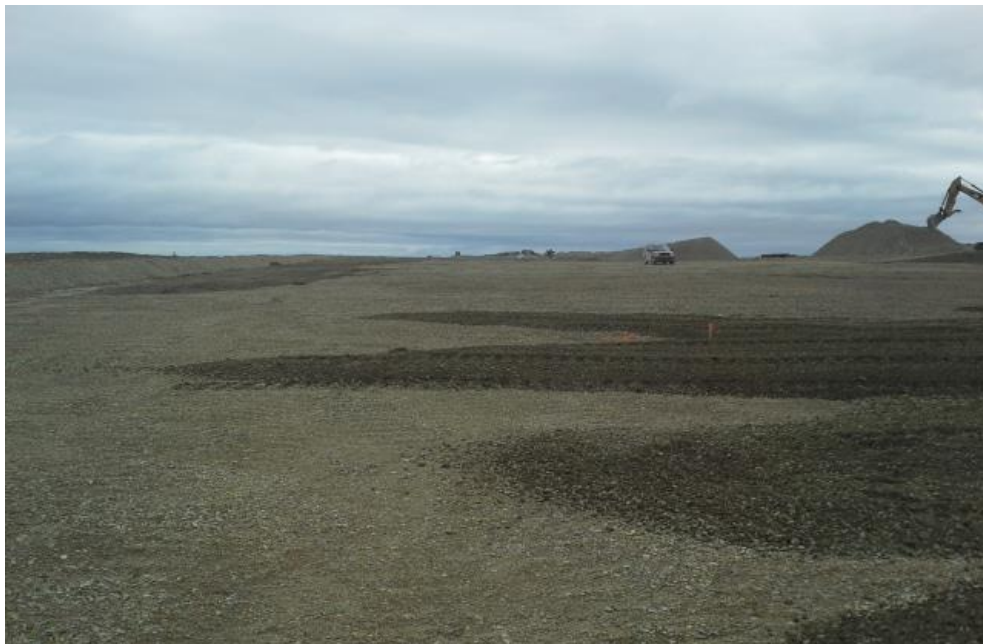
Photo #18: View looking east, spreading demarcation material.

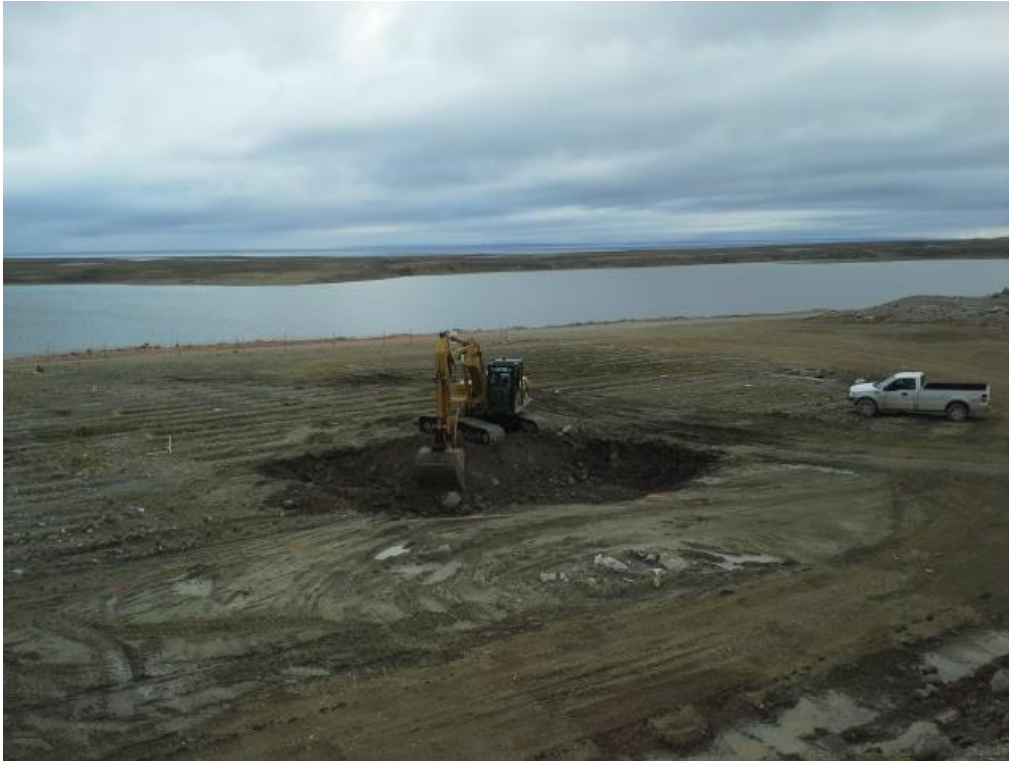
Photo #19: View looking south, FTA remedial excavation.

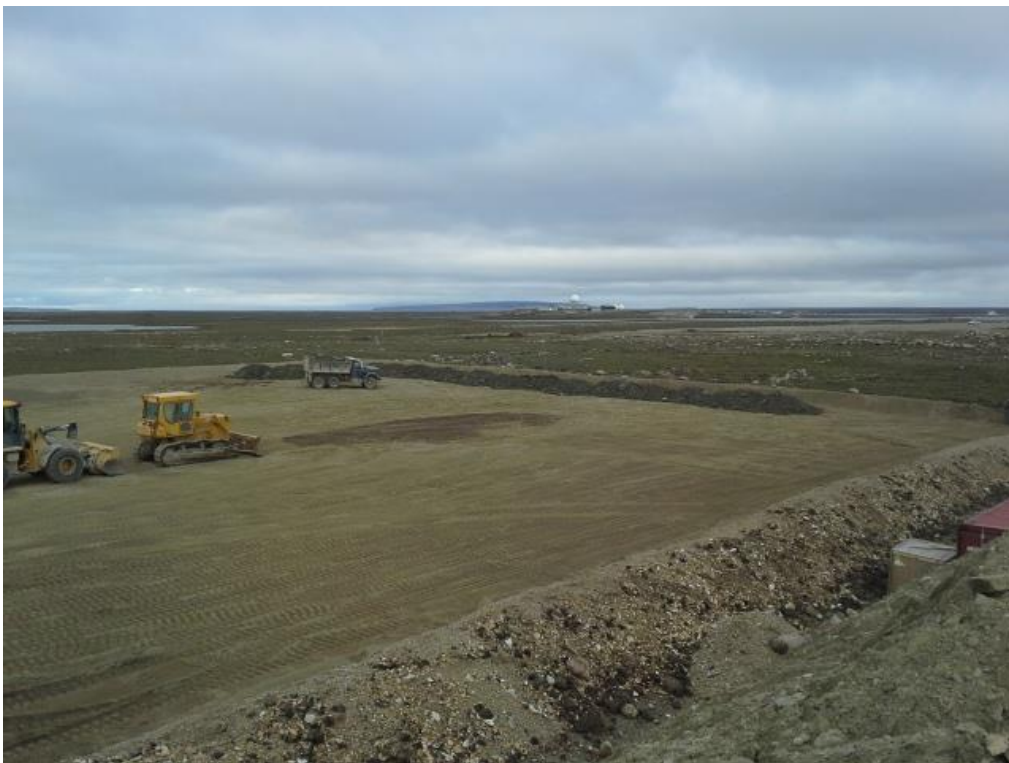
Photo #20: View looking north east, spreading impacted soil in the FTA LTU.

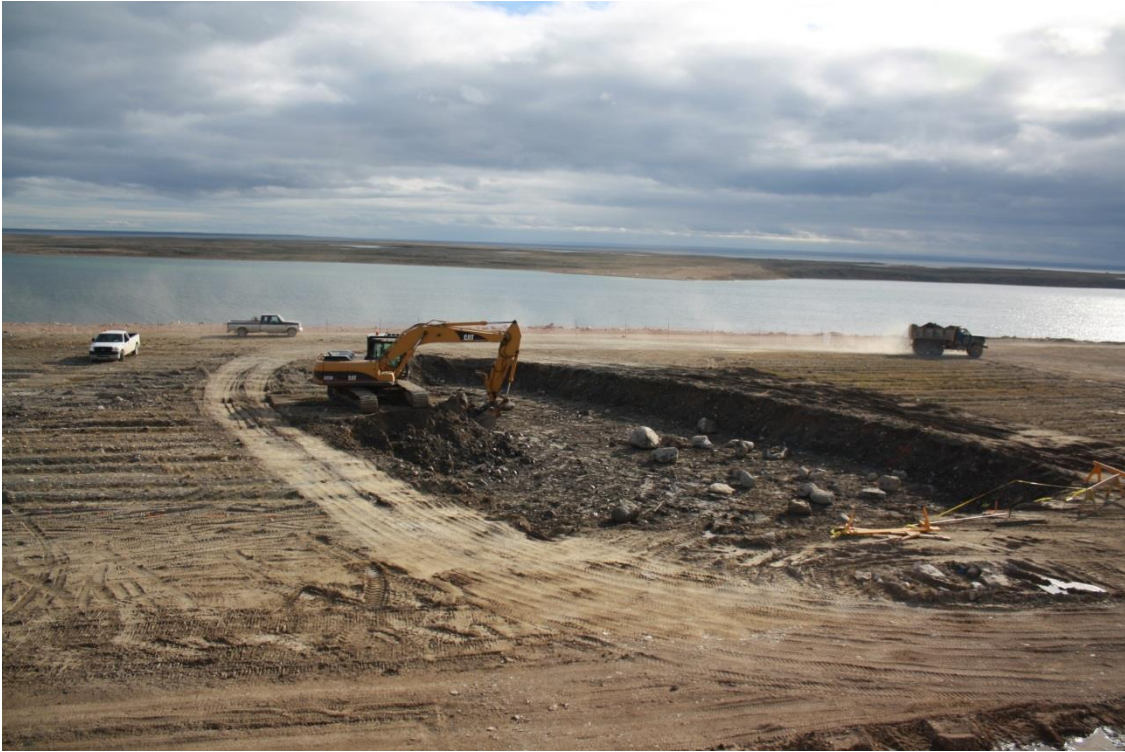
Photo #21: View looking south, FTA remedial excavation

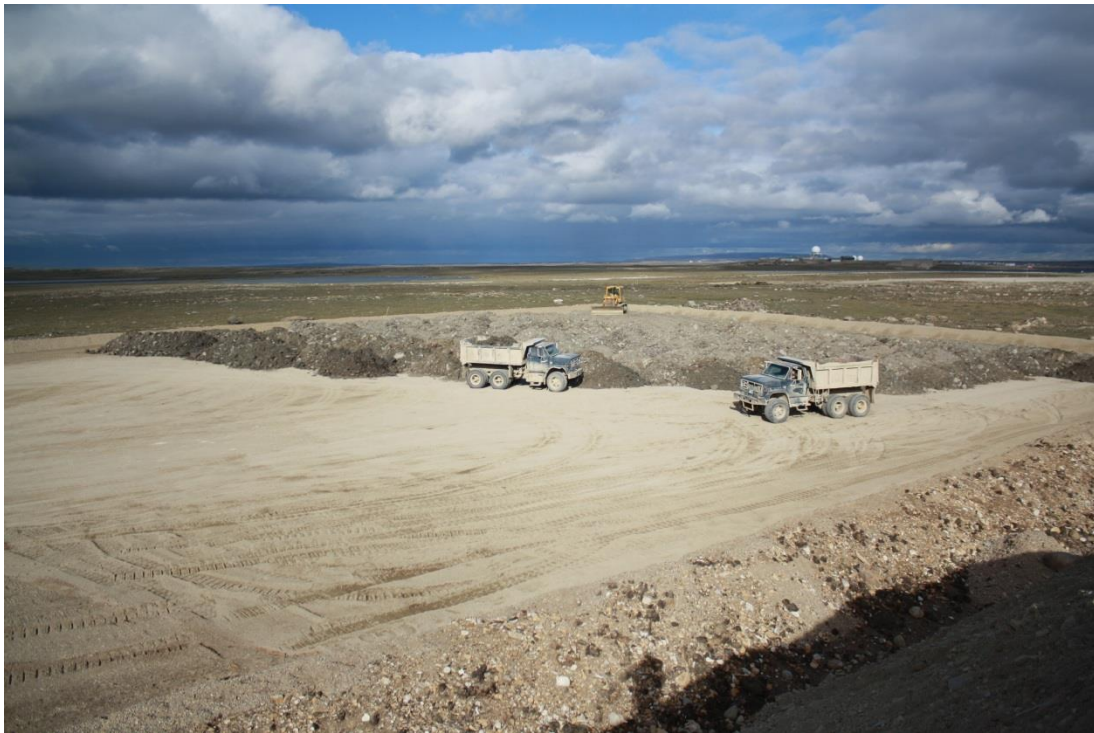
Photo #22: View looking north east, spreading impacted soil in the FTA LTU.

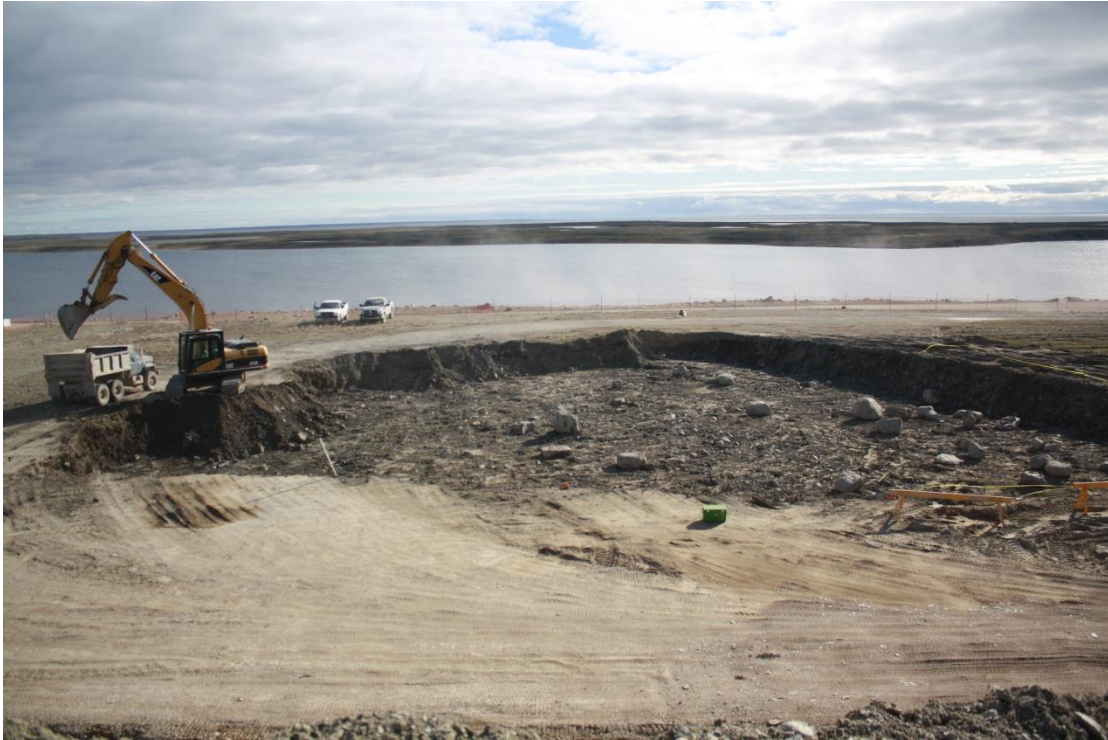
Photo #23: View looking south, FTA remedial excavation

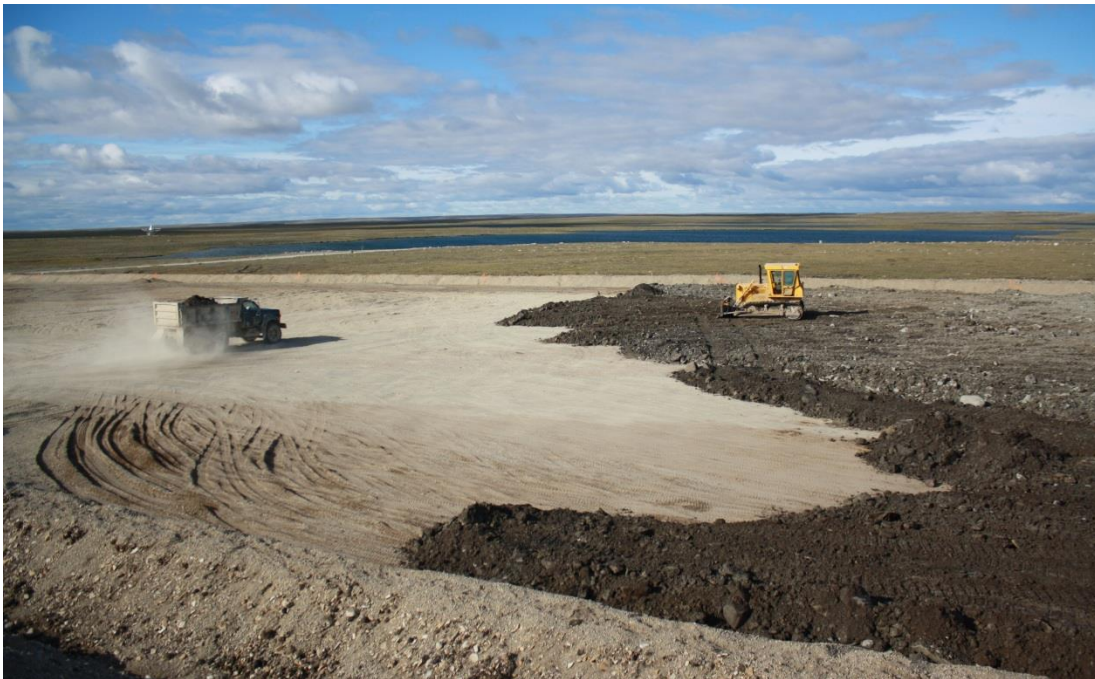
Photo #24: View looking north east, spreading impacted soil in the FTA LTU.

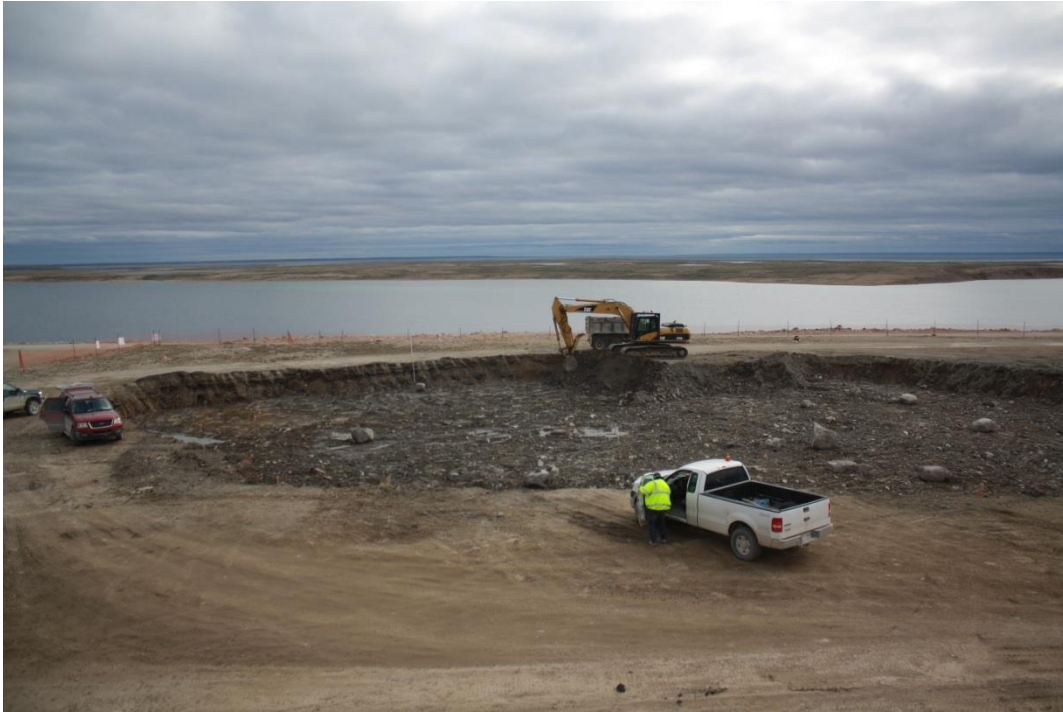
Photo #25: View looking south, FTA remedial excavation.

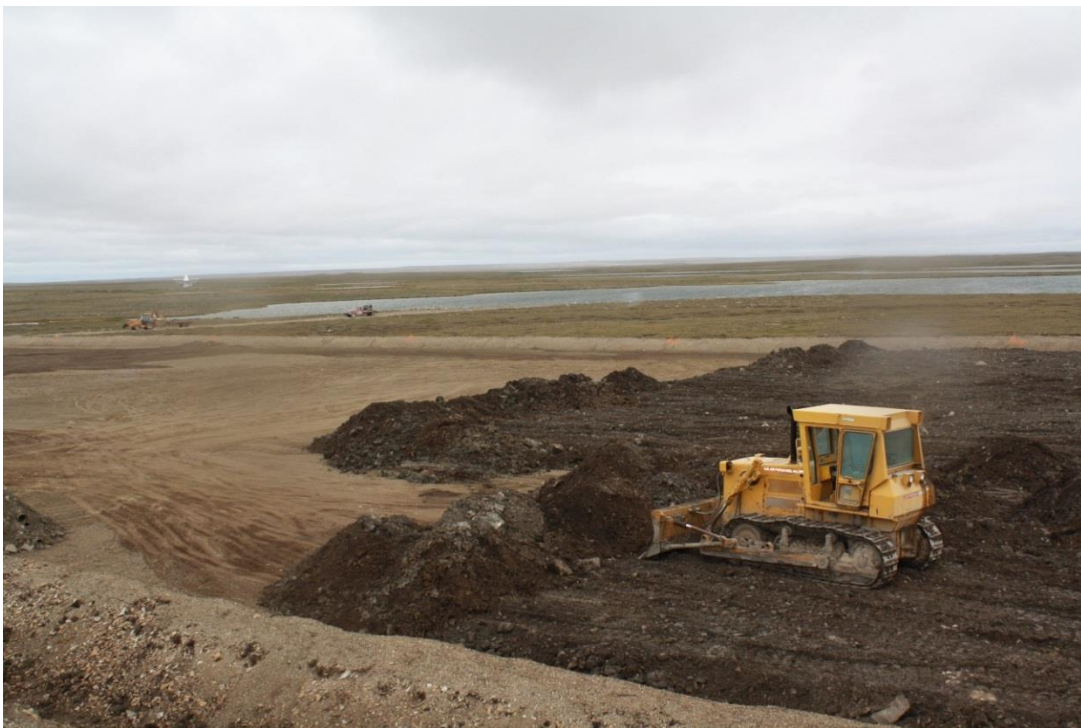
Photo #26: View looking north east, spreading impacted soil in the FTA LTU.

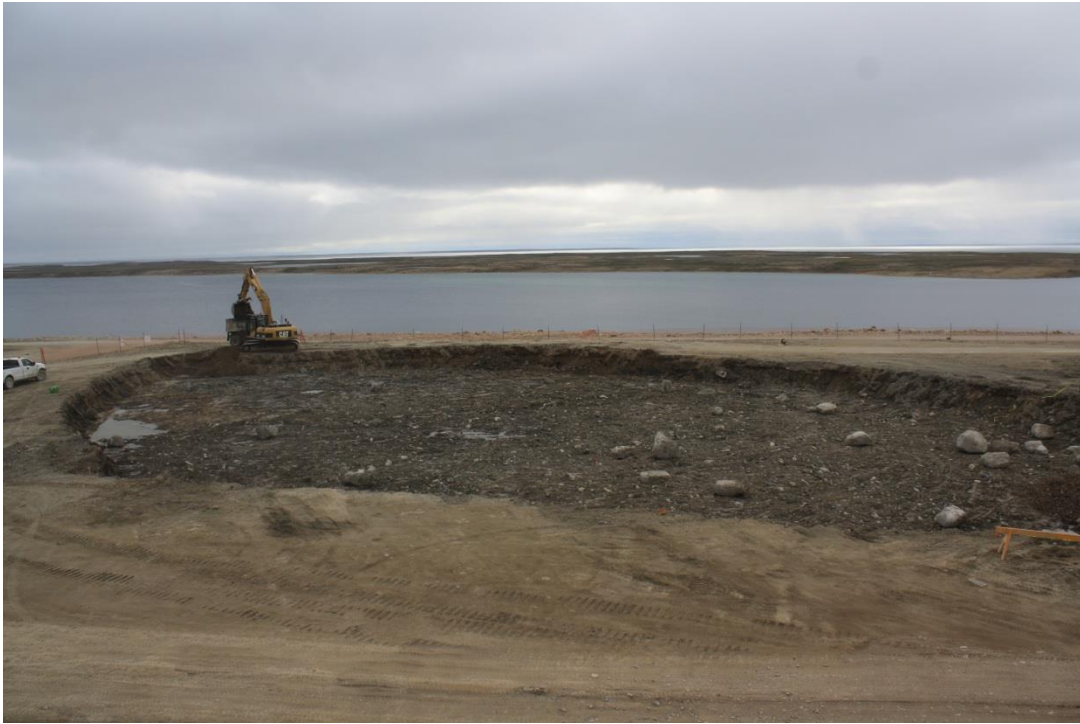
Photo #27: View looking south, FTA remedial excavation.

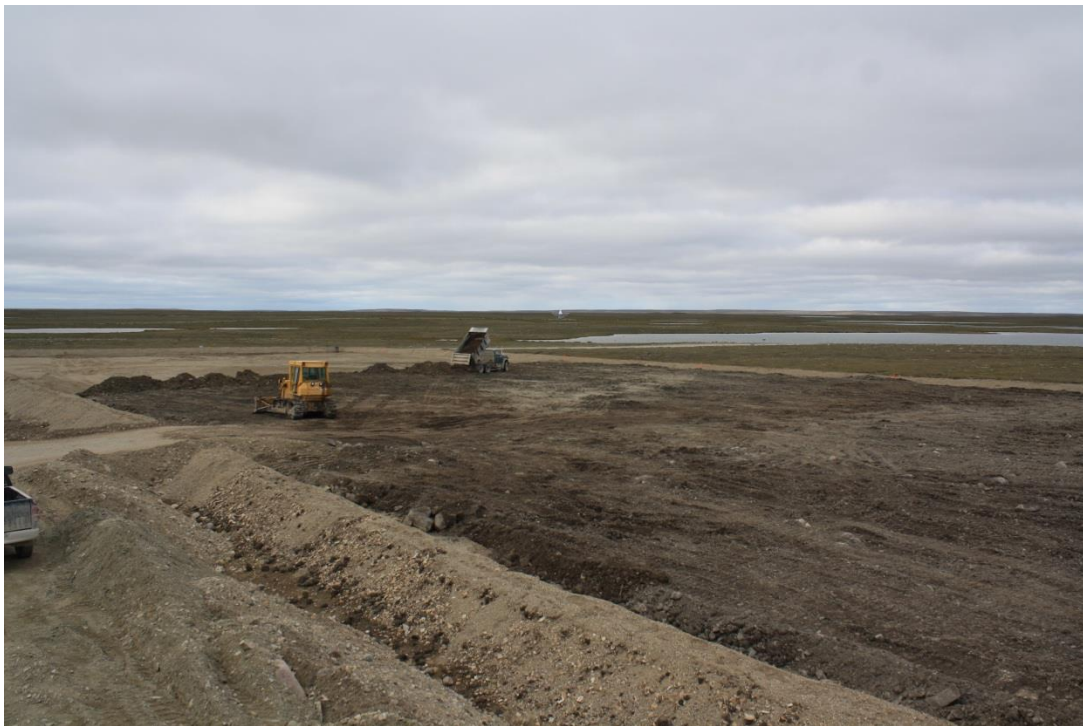
Photo #28: View looking north east, spreading impacted soil in the FTA LTU.

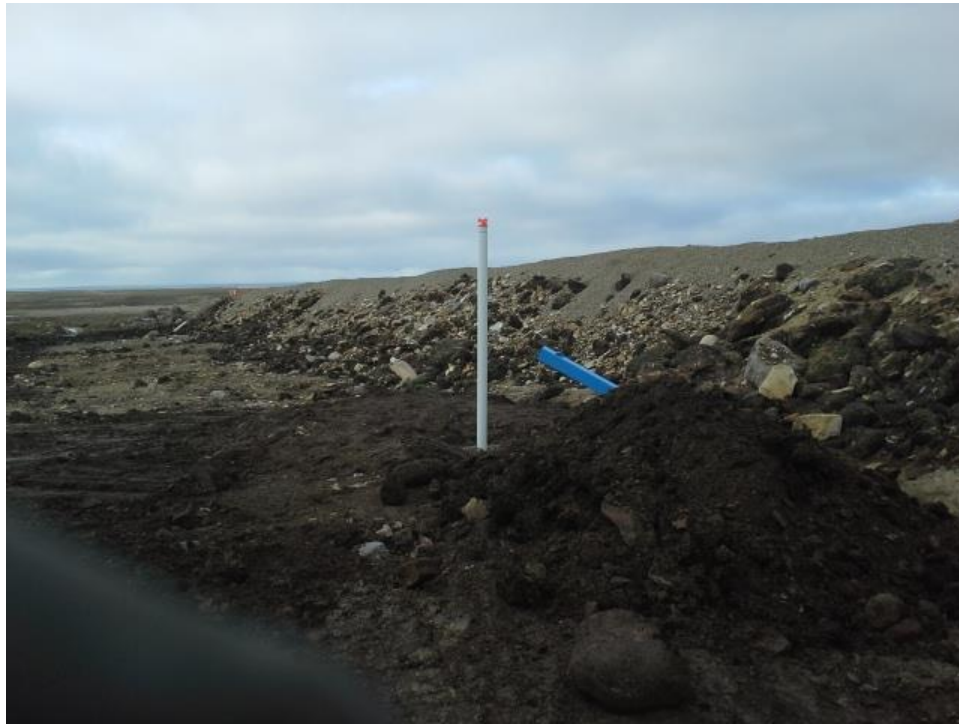
Photo #29: View looking north, monitor well installation.

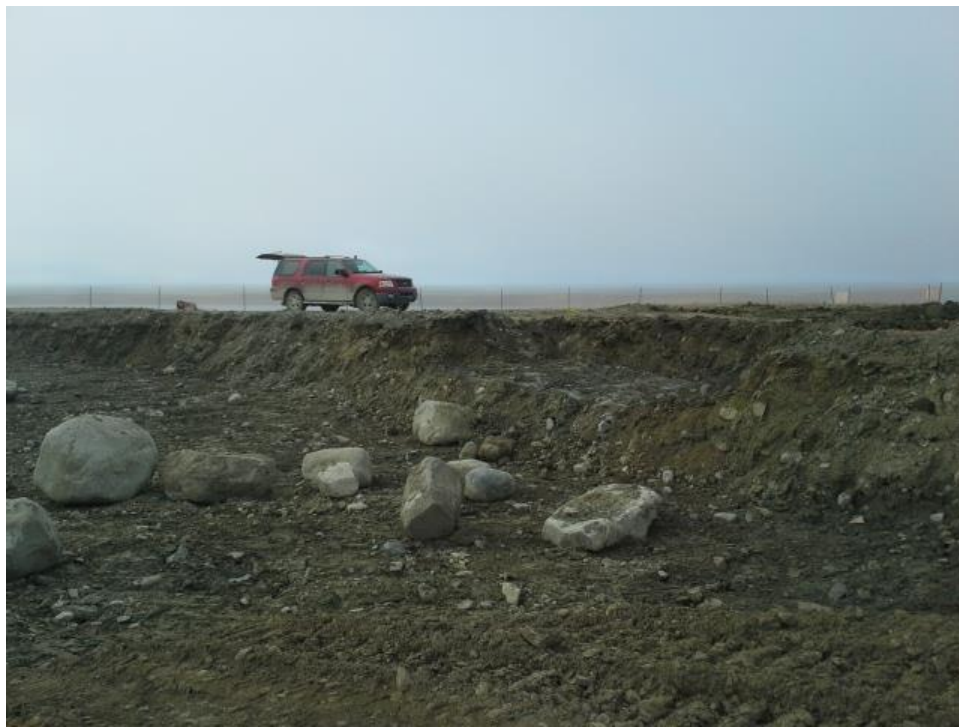
Photo #30: View looking south, additional impacted soil removed.
