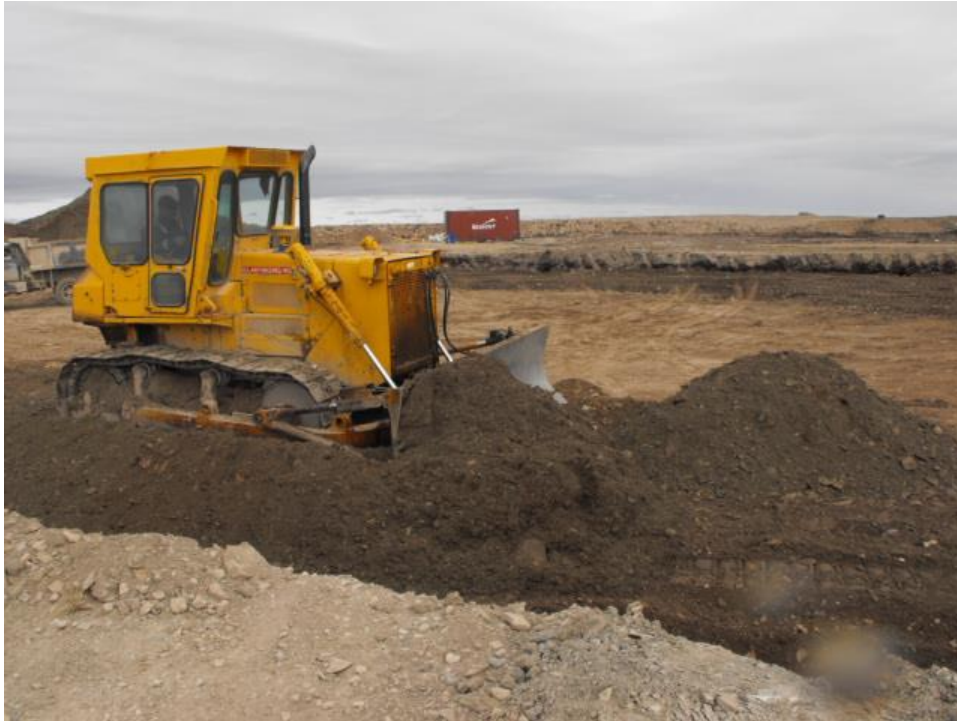
Photo #31: View looking north, backfilling excavation.

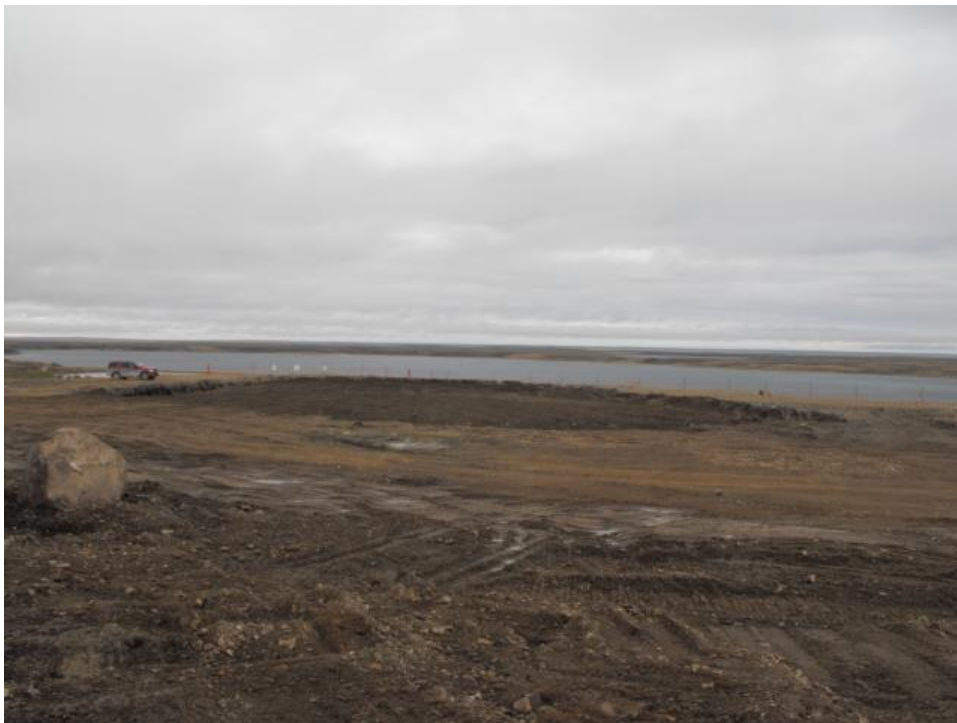
Photo 32: View of FTA Excavation backfill facing south.

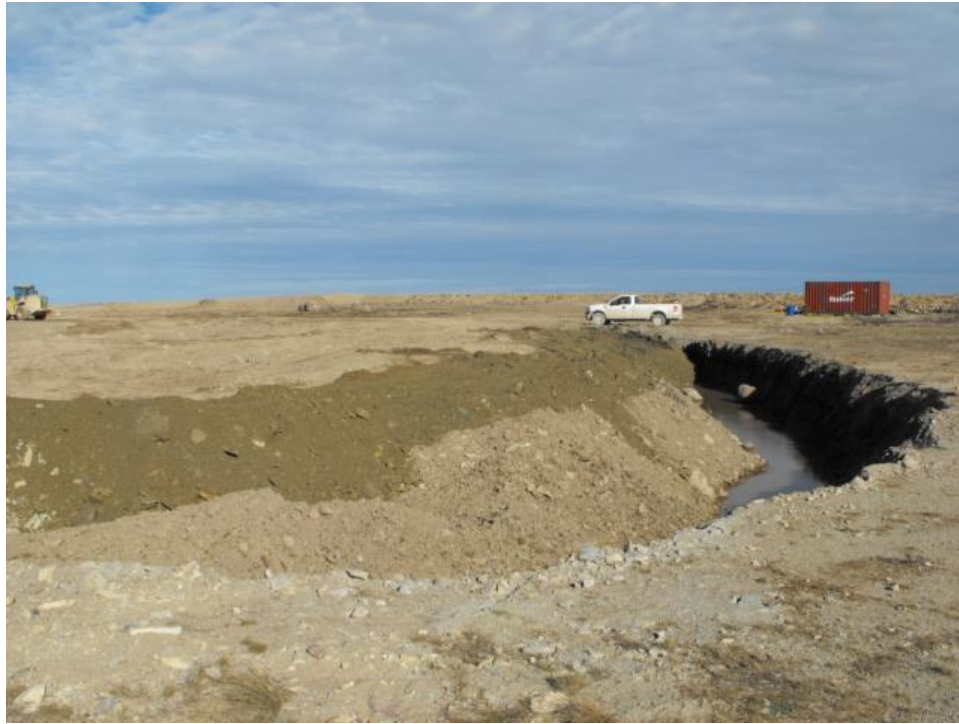
Photo 33: View of FTA excavation backfill facing northwest.

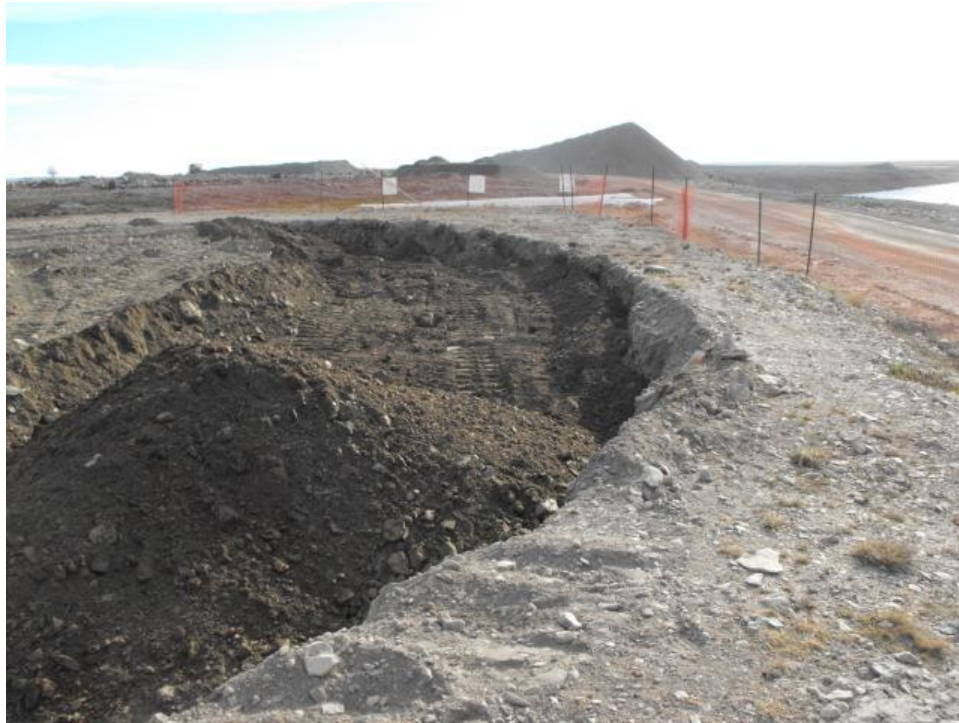
Photo 34: View of FTA backfill process facing east.

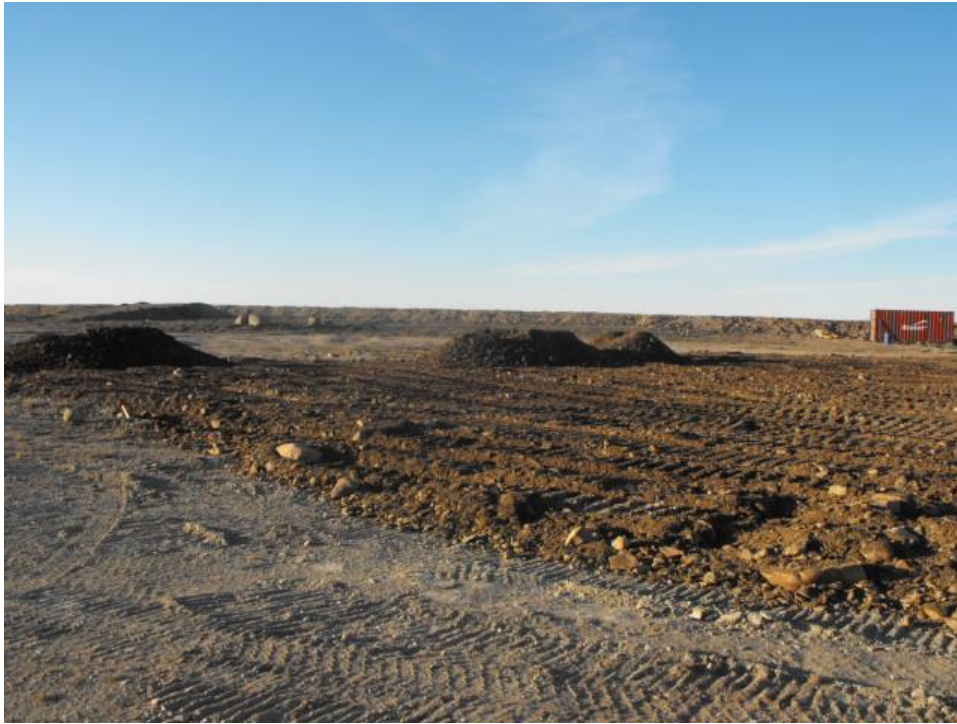
Photo 35: View of west side of FTA excavation backfill facing north.

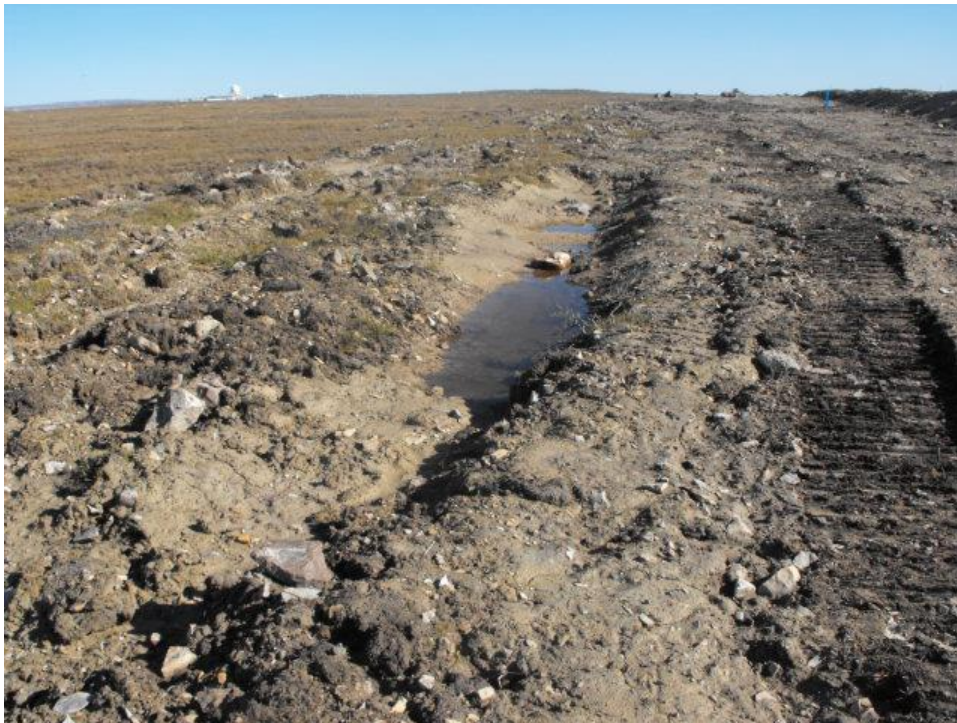
Photo 36: View of low area of water on the north side of the FTA LTU facing east.

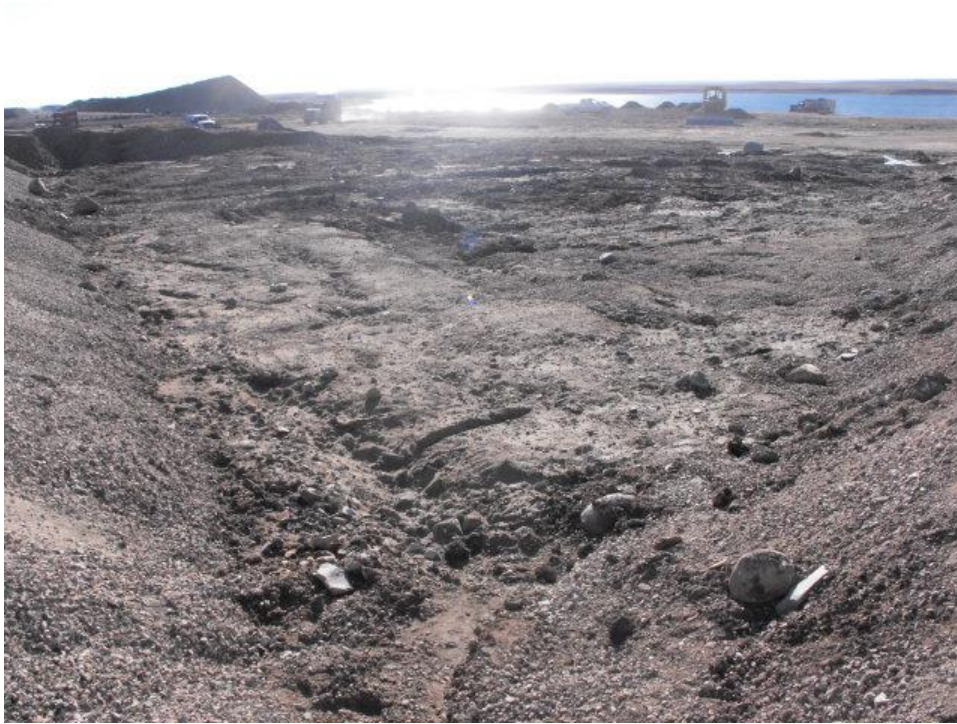
Photo 37: View of low area on the south side of FTA LTU facing southeast.

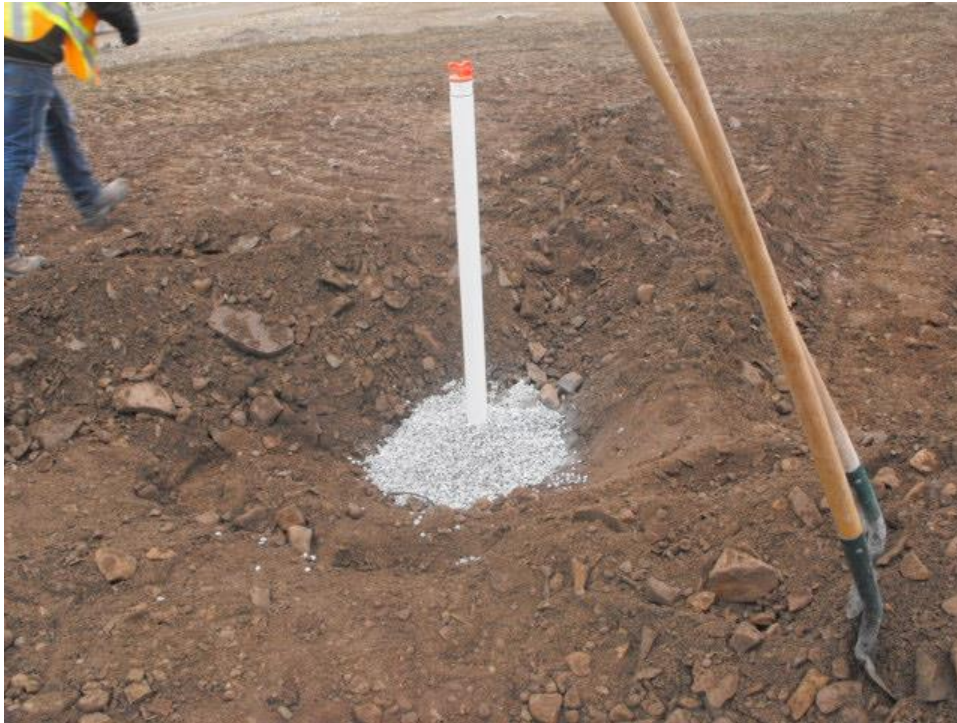
Photo 38: View of instillation of MW15-9.

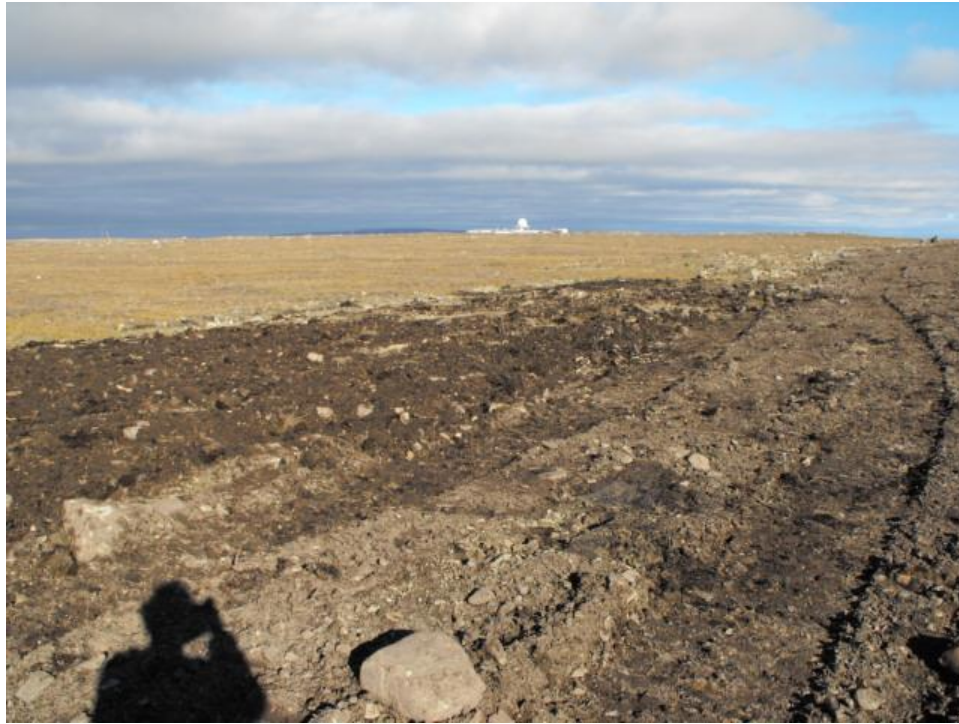
Photo 39: View corrected low area to the north of FTA LTU facing east.

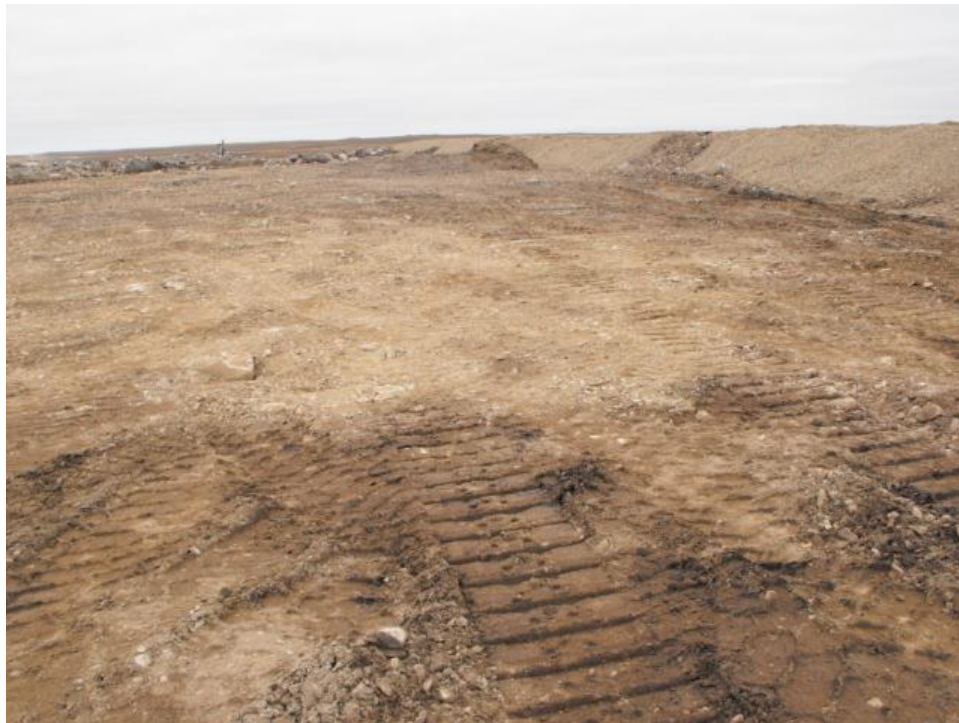
Photo 40: View of corrected low area to the south of FTA LTU facing west.

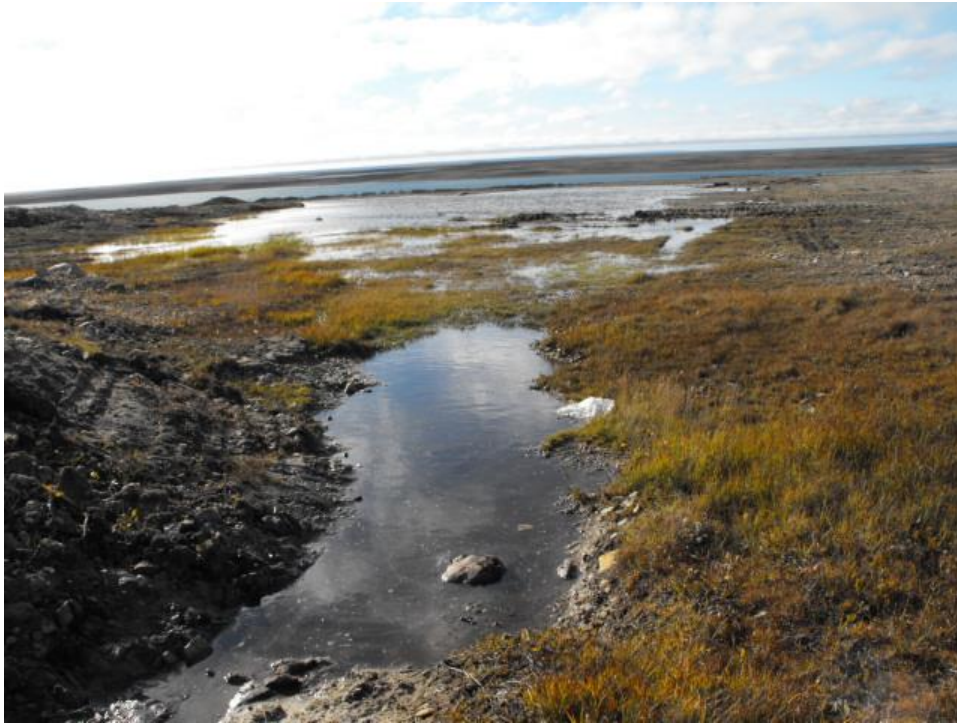
Photo 41: View of water accumulation to the southeast of the FTA facing south.

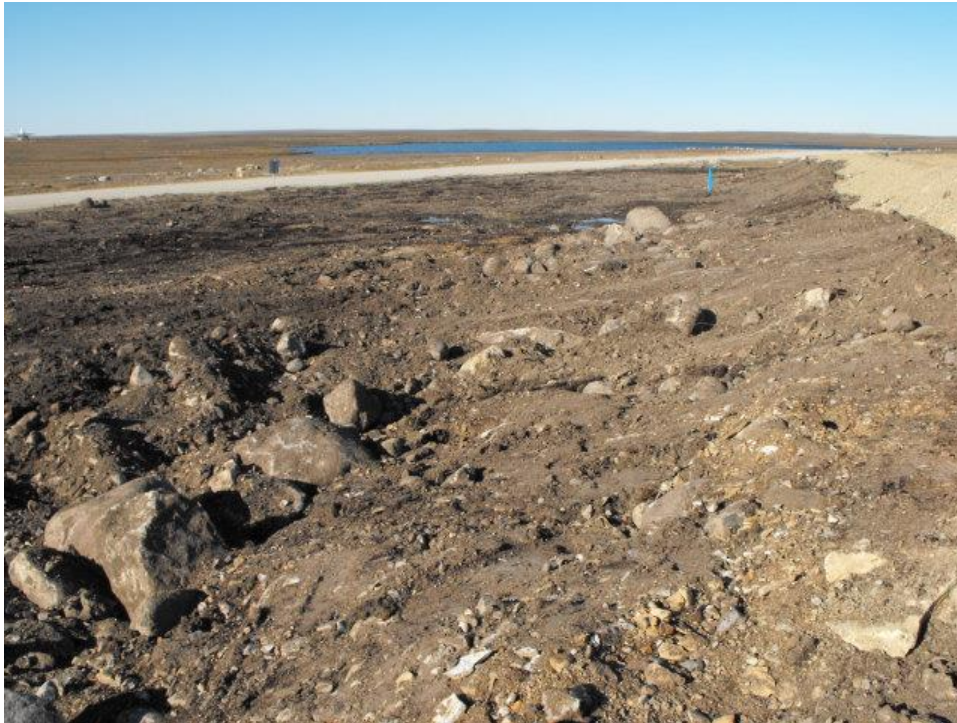
Photo 42: View of the west side of the FTA LTU facing northwest.
