Reference: 2020 De-Watering Activities, Apron Land Treatment Unit, Cambridge Bay Airport, Cambridge Bay, Nunavut (Water License No. 1BR-FTA-1828)

2020AUG06 Cambridge Bay Apron LTU Daily Field Report

2020AUG07 Cambridge Bay Apron LTU Daily Field Report

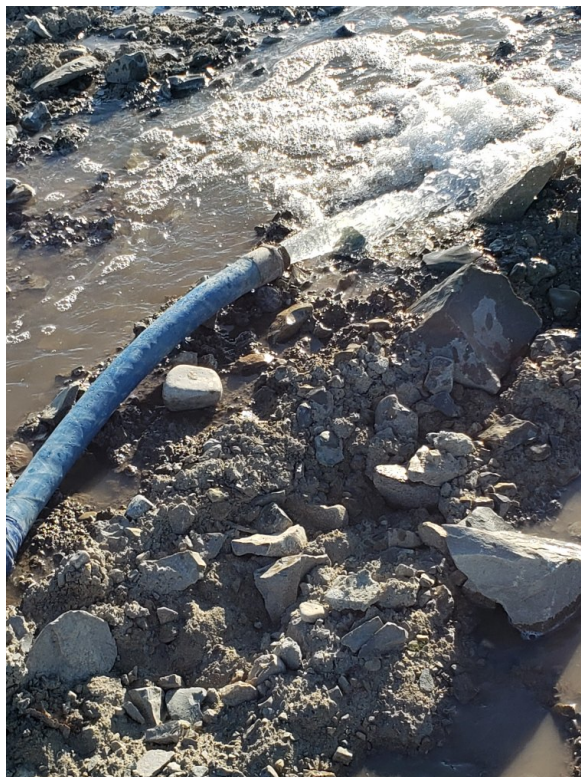
Photo 1 – Hose discharging water from Apron LTU sump onto LTU

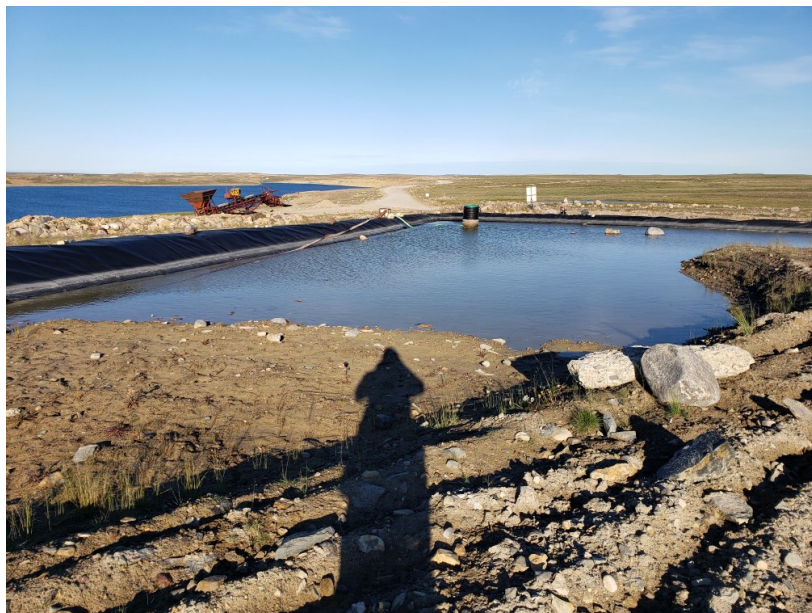
Daily Update Report		Date: 6 August 2020 Consultant Name: Stantec
Author	Luke Anderson	Project Site/ Name: Cambridge Bay Apron
Distribution		Natalie Robinson
Objective		Daily Field Report
Reporting Items		
TOPIC		WORK ACTIVITY AND PROGRESS
Start and End Time		7:00 to 15:30
Field Personnel on site		Keith Howsam (Qillaq Innovations)
Daily Progress		Set-up pump at Apron LTU sump, completed pumping of water (approximately 70 m ³ of water), reported activities, and sent photos to Stantec for documentation
Planned Activities (next day)		Monitor recharge at Apron LTU sump and document absorption level
Schedule field update		95 percent completed
Health/Safety Comments		Discussed with Stantec the importance of remaining safe while transporting pumps and hoses, especially within LTU berm and muddy areas
Deviations from workplan		None
Notes Include visitors, Any equipment issues etc		Pump operated continuously besides periods of refueling or adding hoses. Note that equipment visible in photo 2 was present at the Site in 2018 and 2019.

Photo 2 – Apron LTU sump facing southwest prior to dewatering

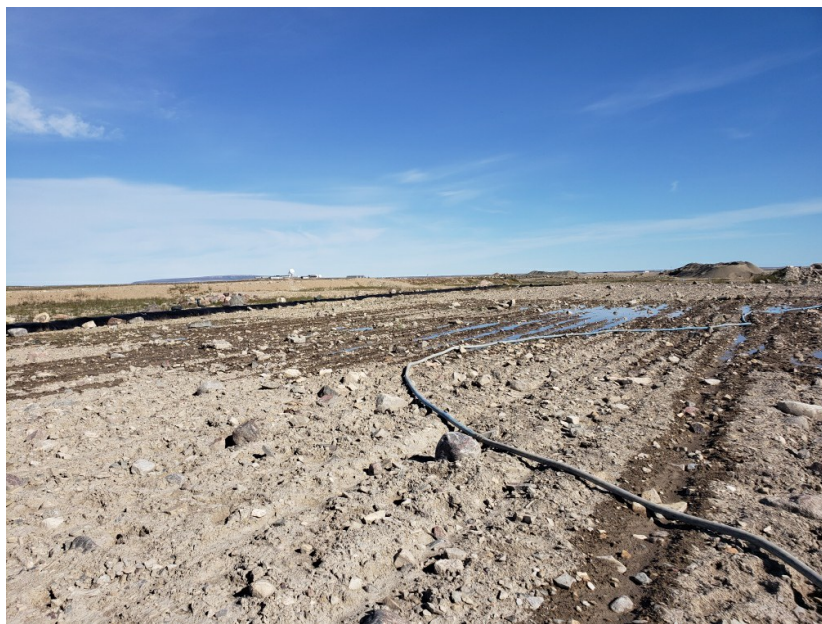
Photo 3 -Apron LTU sump facing NE during dewatering showing good absorption and dispersion of discharged sump water

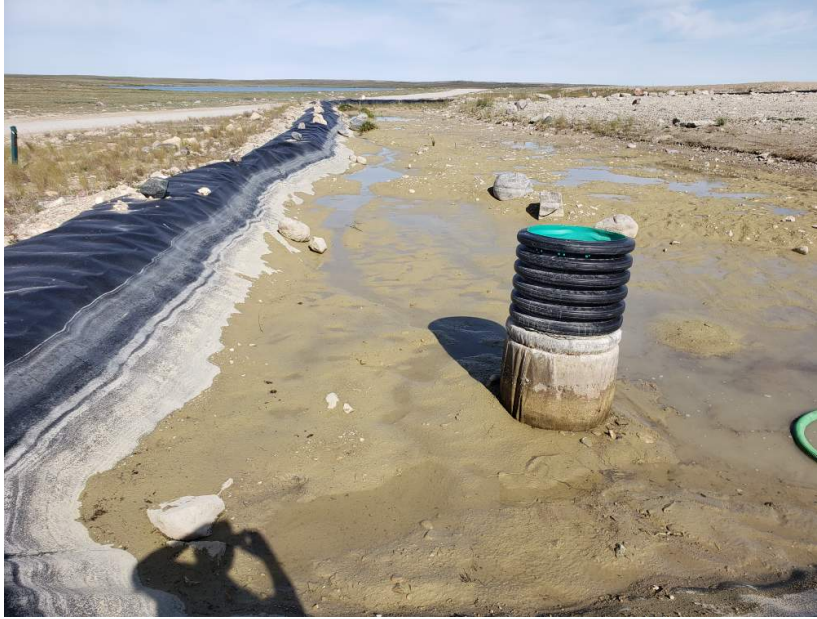
Qillaq visually assessed the Apron LTU and sump area under the direction of Stantec. At the time of the August 2020 work, no surface water was observed adjacent to the Apron LTU outside of the sump area. Qillaq did not observe any visual deficiencies in the Apron LTU berm or liner. It was noted by Qillaq that approximately 8 centimeters (cm) of sediment had accumulated in the sump area of the Apron LTU.

Photo 4 – Apron LTU sump facing north upon completion of dewatering

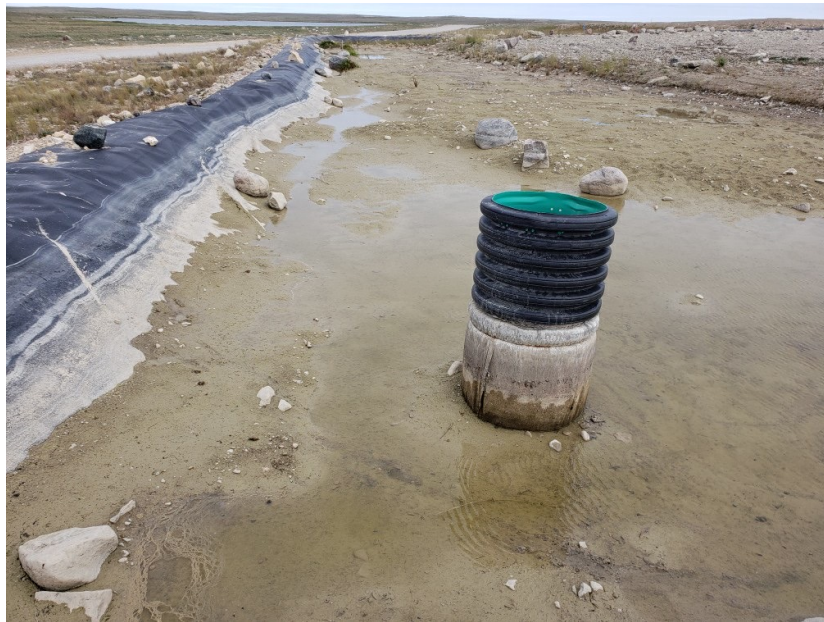
Based on field measurements provided by Qillaq, Stantec estimated that the Apron Sump contained approximately 70 cubic metres (m³) of water. The Apron sump was fully de-watered onto the Apron LTU on August 6, 2020. After de-watering, Qillaq personnel noted that the sump had begun to recharge; however, the re-charge rate was not measured. As such, the recharged water was removed from the sump again on August 7, 2020, prior to Qillaq leaving the Site. An additional approximately 4 m³ of water was removed from the Apron Sump during the second event.

Photo 1 – Apron LTU sump facing north one day after dewatering

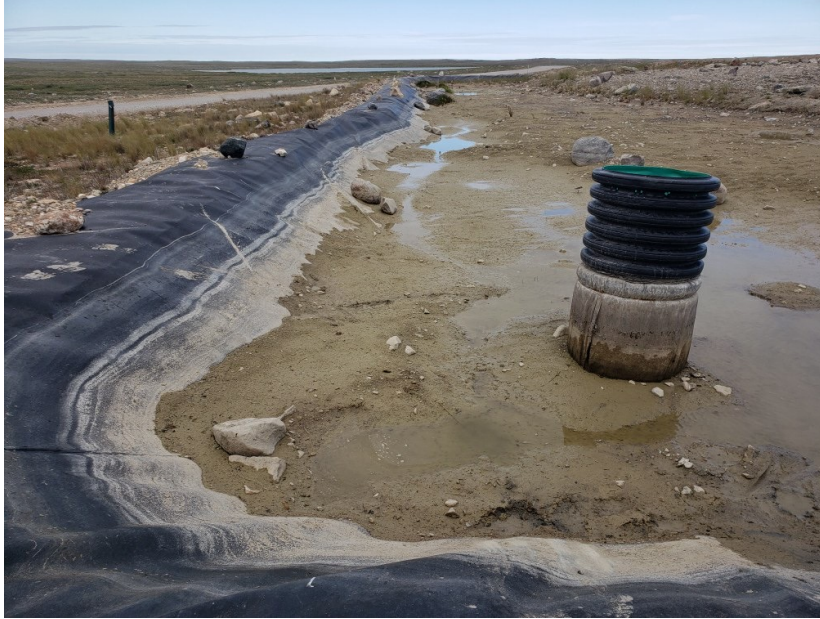
Photo 2 – Apron LTU sump facing north after second dewatering event completed

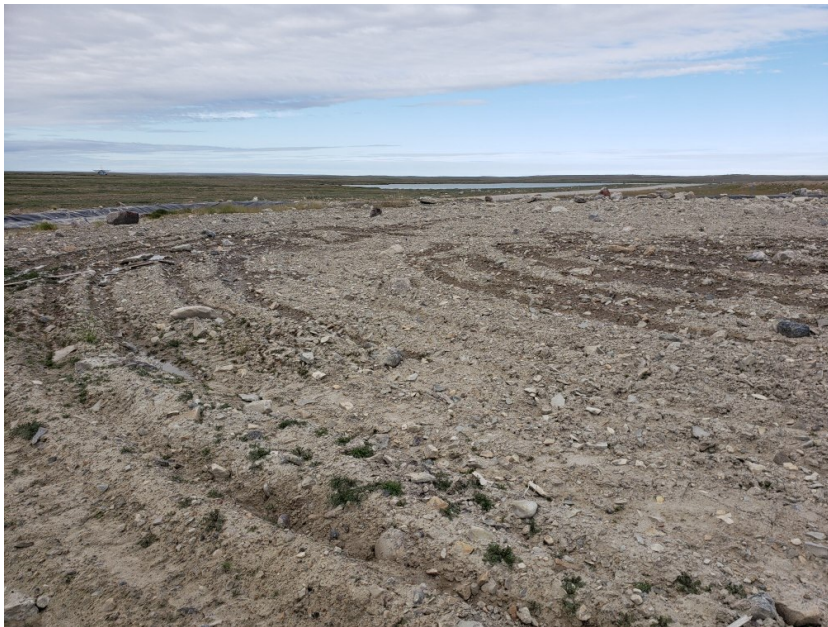
Photo 3 -Apron LTU sump facing northwest after dewatering showing good absorption and dispersion of discharged sump water upon completion of dewatering
