Stantec Consulting Ltd.

November 10, 2020

Reference: 2020 De-Watering Activities, Fire Training Area Land Treatment Unit, Cambridge Bay Airport, Cambridge Bay, Nunavut (Water License No. 1BR-FTA-1828)

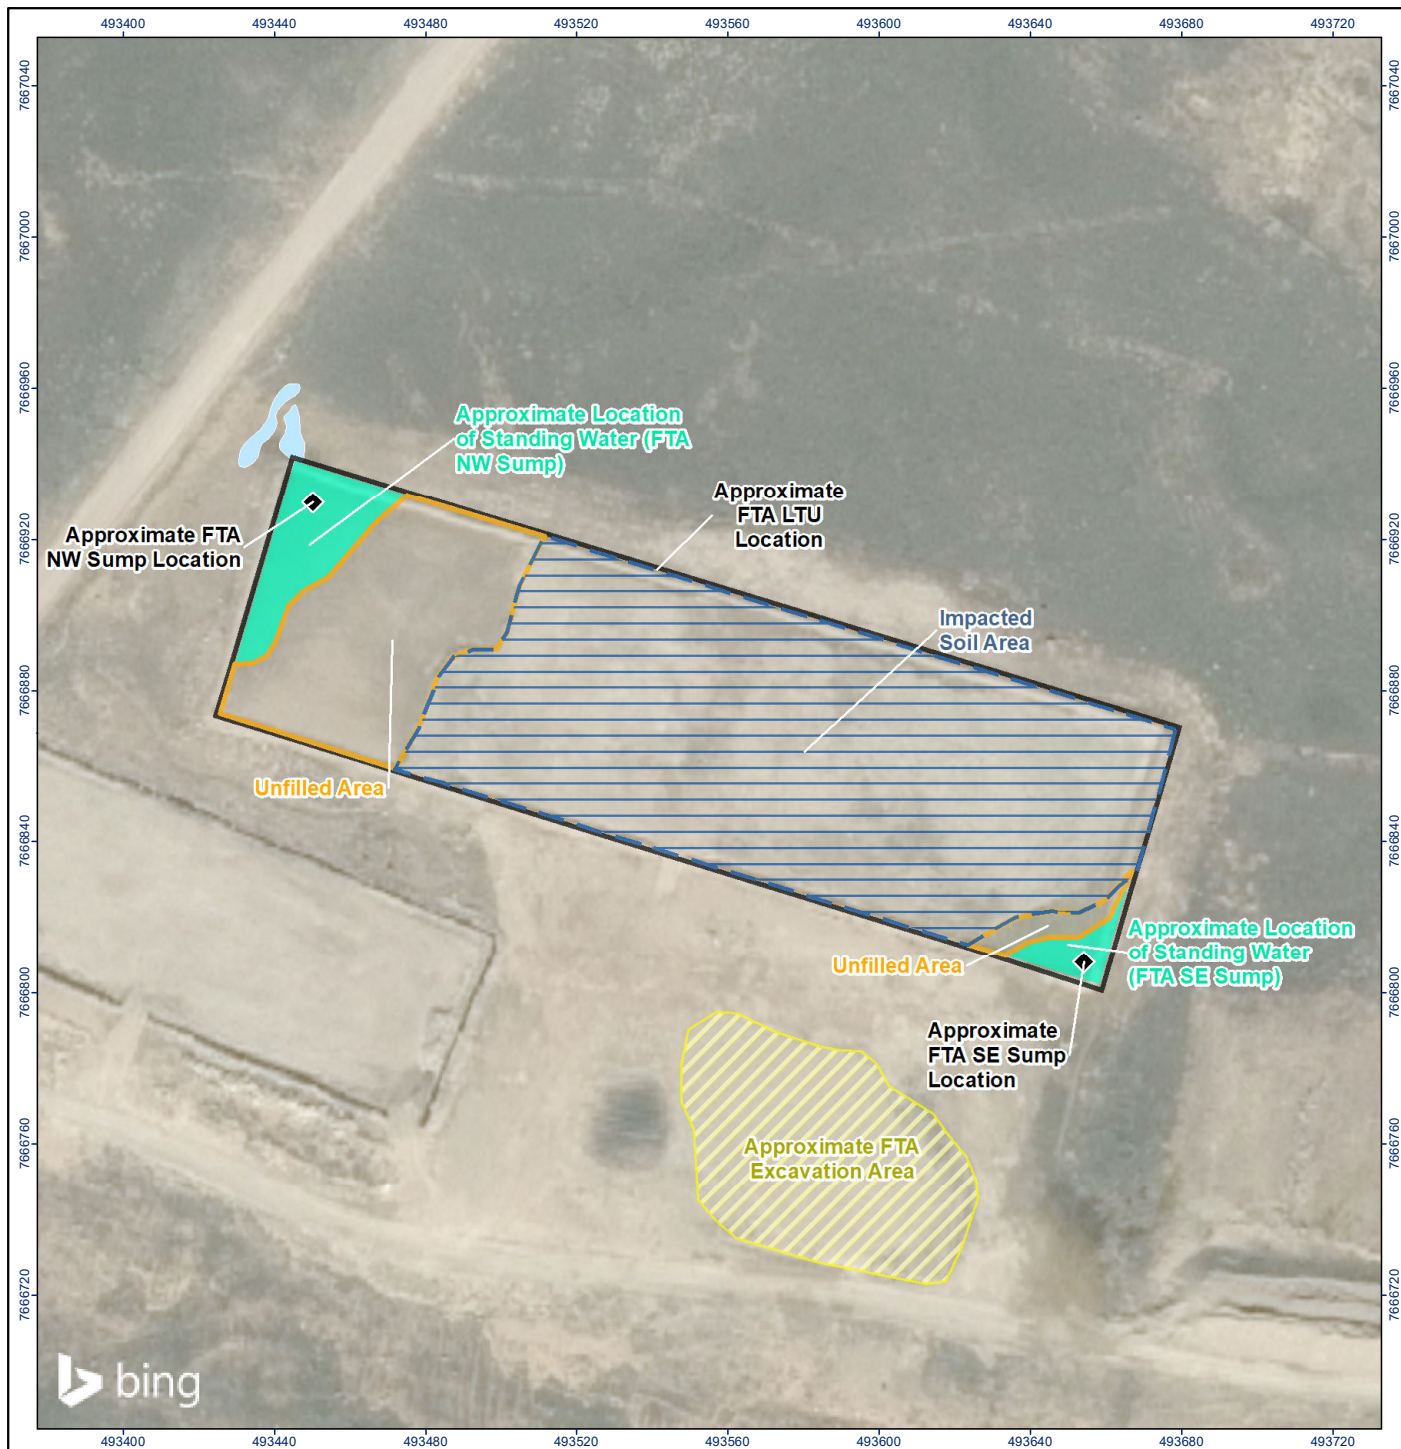
Figure No.

Qillaq visually assessed the FTA LTU, sump areas, and surrounding area under the direction of Stantec. At the time of the August 2020 work, surface water was observed adjacent to the LTU in the northwest corner. This observation is consistent with observations in previous years. The extent of the surface water is shown on Figure 2, **Attachment A**. Qillaq also noted that the berm in the southeast corner of the FTA LTU appeared to be lower in elevation than the surrounding berm and noted signs of erosion, potentially due to water flow over the berm when water levels were high, in the FTA-SE sump. Approximately 25 cm and 4 cm of sediment had accumulated in the FTA-SE and FTA-NW sump areas, respectively.

Title
Site Plan Showing Surface Water Extents

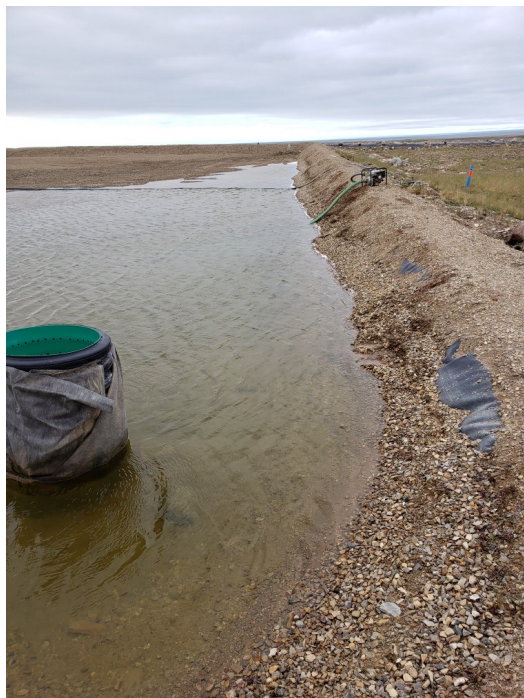
Photo 1 – Northwest FTA LTU Sump facing south prior to dewatering

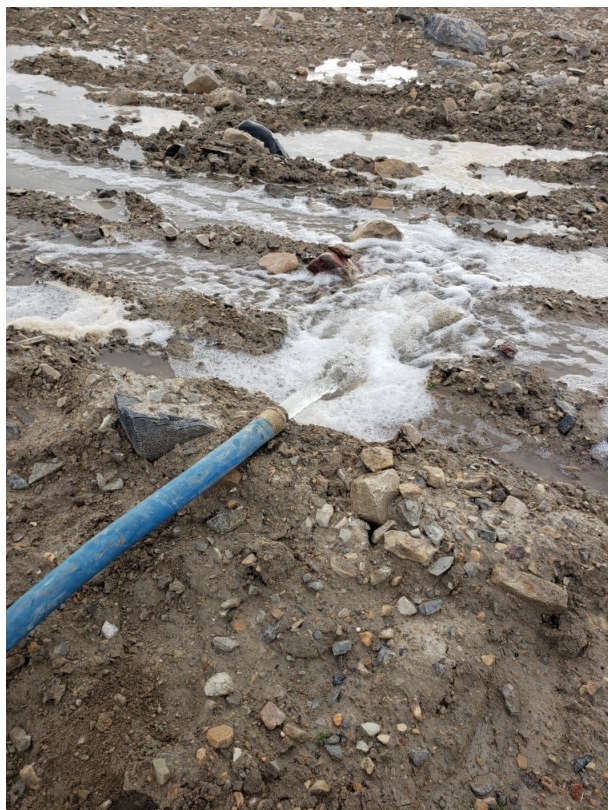
Photo 2 – Water discharging onto FTA LTU

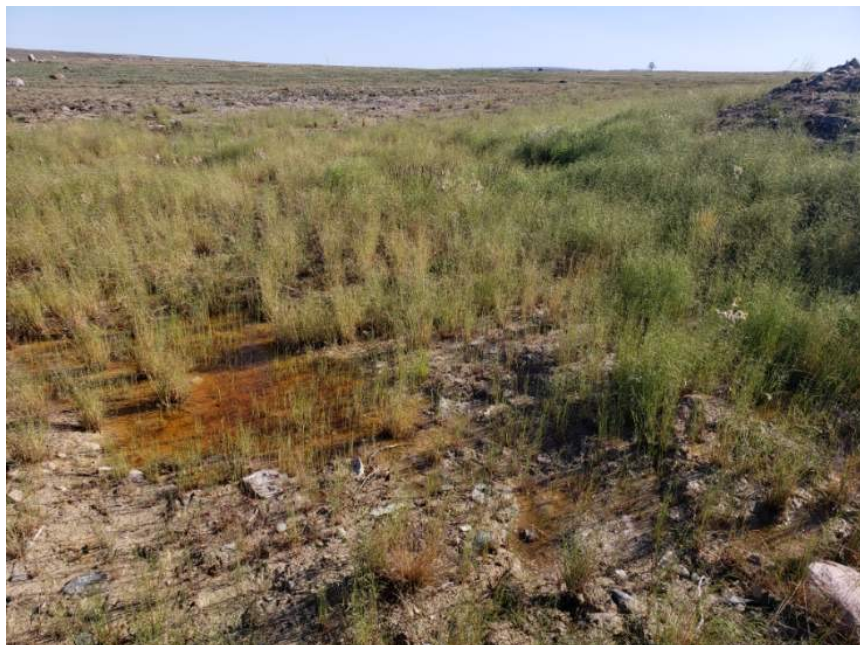
Notes Include visitors, Any equipment issues etc		Pump operated all day besides periods of refueling or adding hoses. Some surface water observed outside NW corner of LTU (similar to previous years observation)
Weather & ground cover conditions		14 degrees C, Sunny, 35 km/h wind

Photo 3 – Surface water observed adjacent to NW corner of FTA LTU

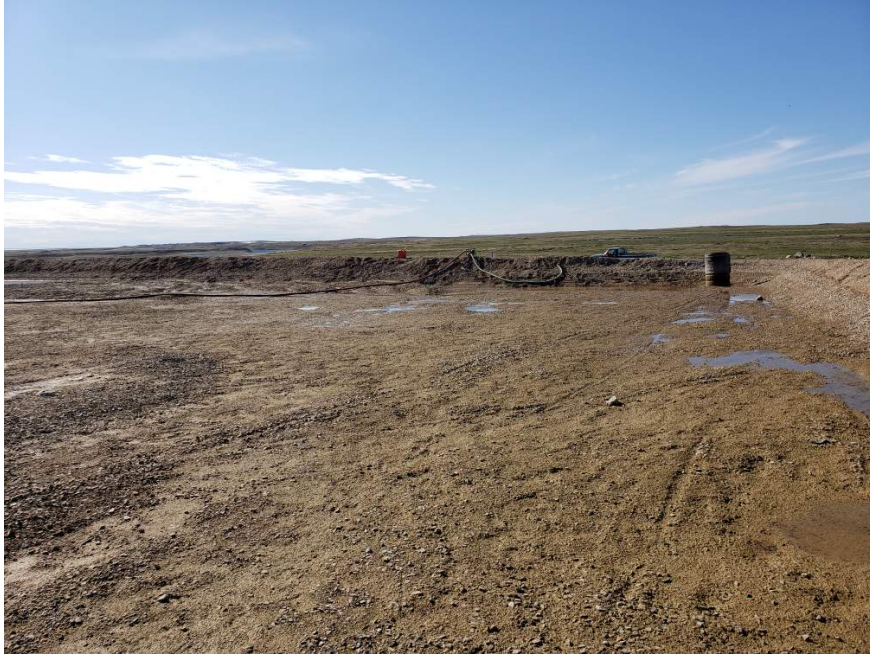
Photo 4 – Northwest FTA LTU sump upon completion of dewatering

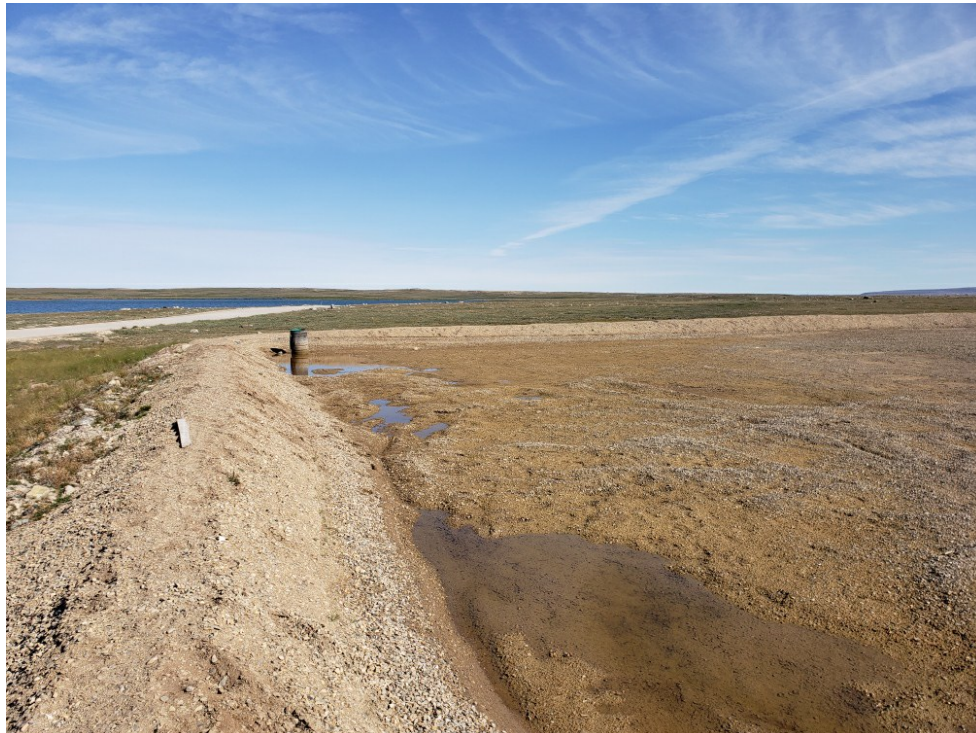
Photo 1 – Northwest FTA LTU Sump facing north at 12:00 noon, showing limited recharge

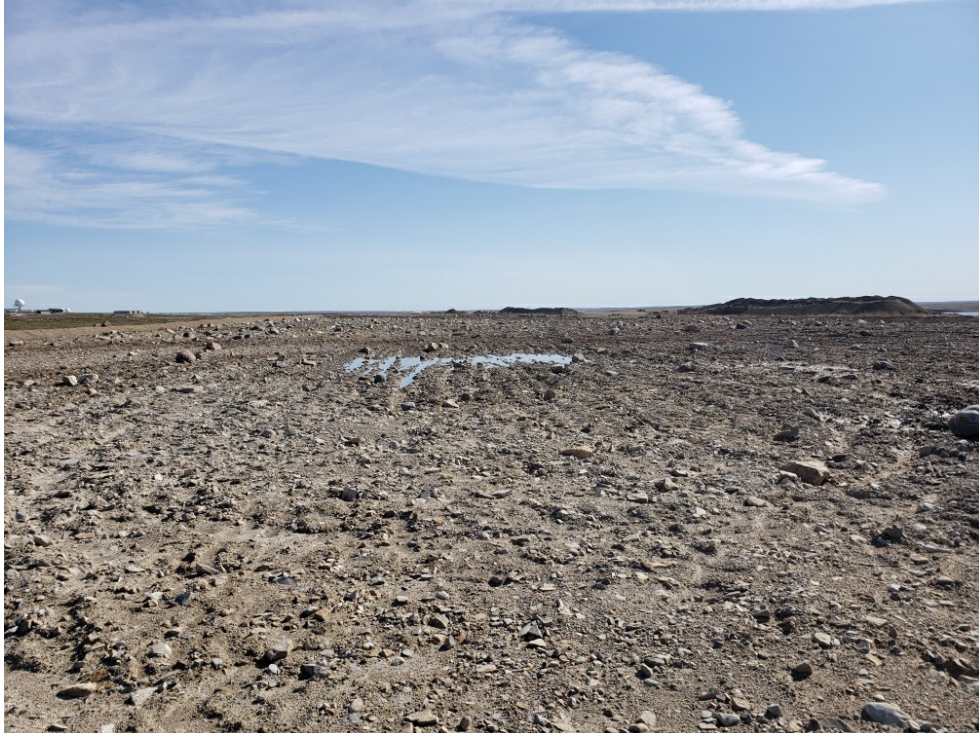
Photo 2 – FTA LTU facing northwest at 12:00 noon showing slight pooling of water and good absorption following dewatering the previous day

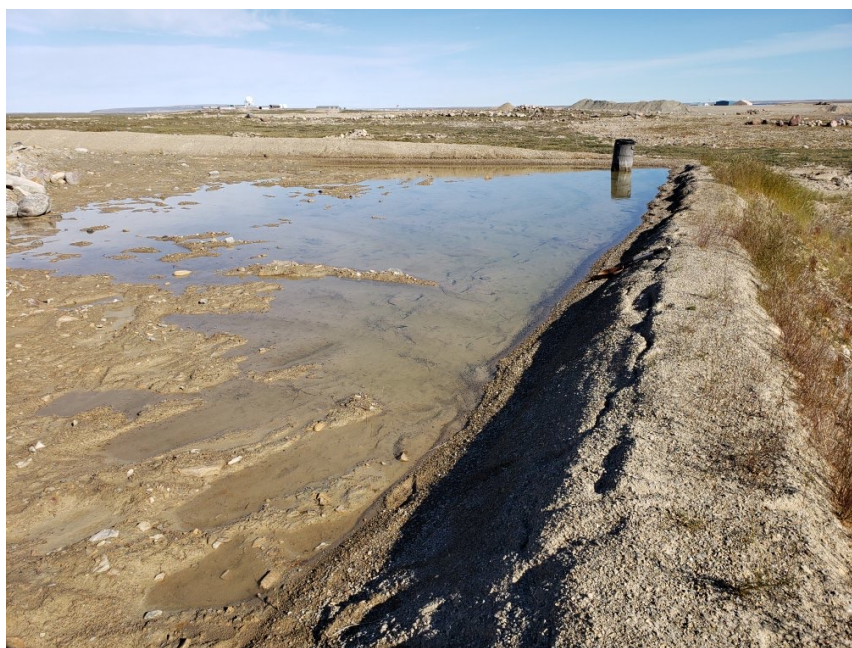
Photo 1 – Southeast FTA LTU Sump prior to dewatering (facing east)

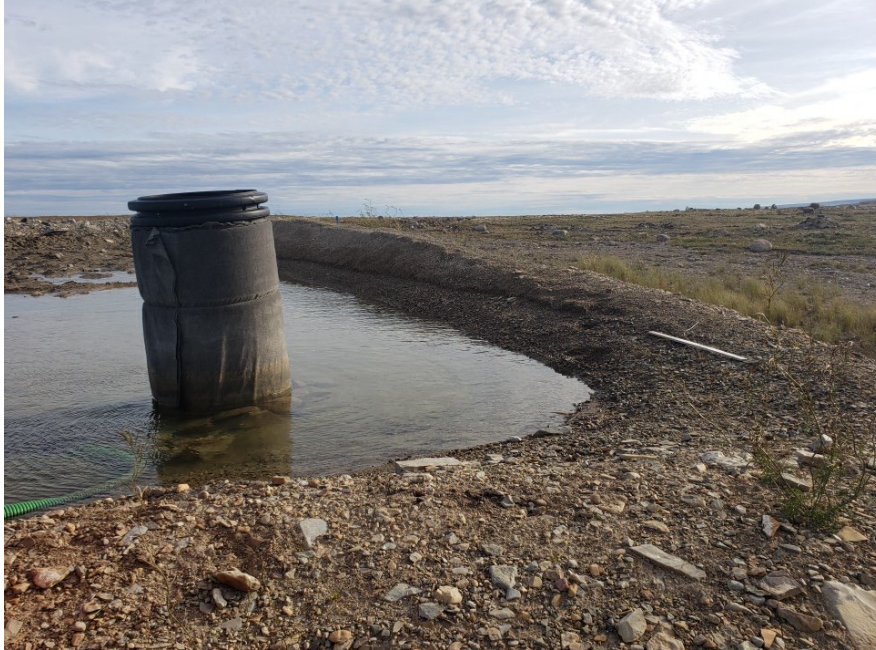
Notes Include visitors, Any equipment issues etc		Approximately 25 cm of sediment is estimated to be in the SE sump (consistent with previous year). Berm in the south east corner of the FTA SE Sump appears lower than adjacent berm. It appears that water potentially flowed over the berm at some time in the last year. No surface water observed outside the LTU adjacent to the berm in the southeast corner.
Weather & ground cover conditions		14 degrees C, Partly Cloudy

Photo 2 – SE FTA LTU sump showing decreasing berm height in corner of LTU (facing northeast)

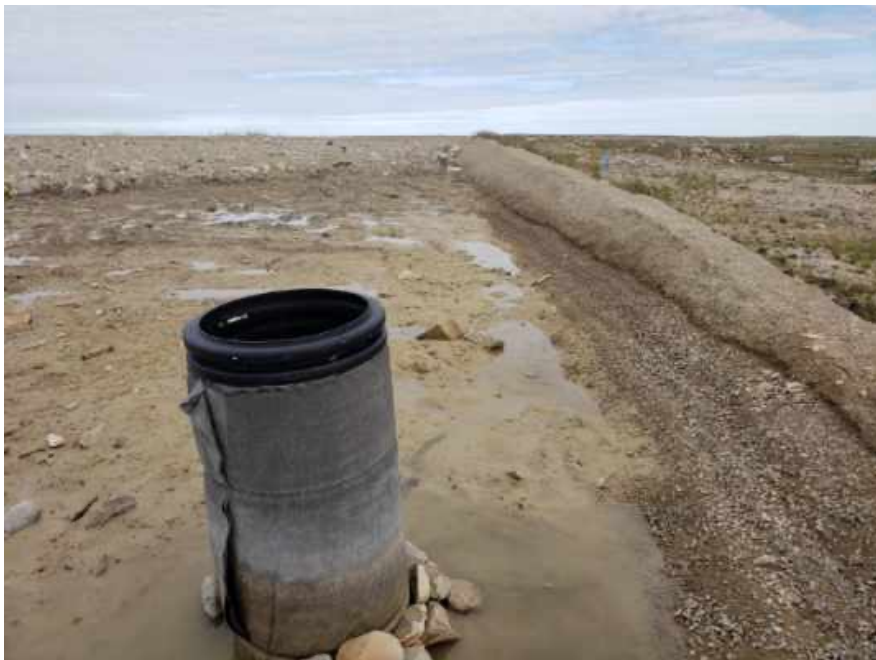
Photo 3 – SE FTA LTU sump upon completion of dewatering (facing north)

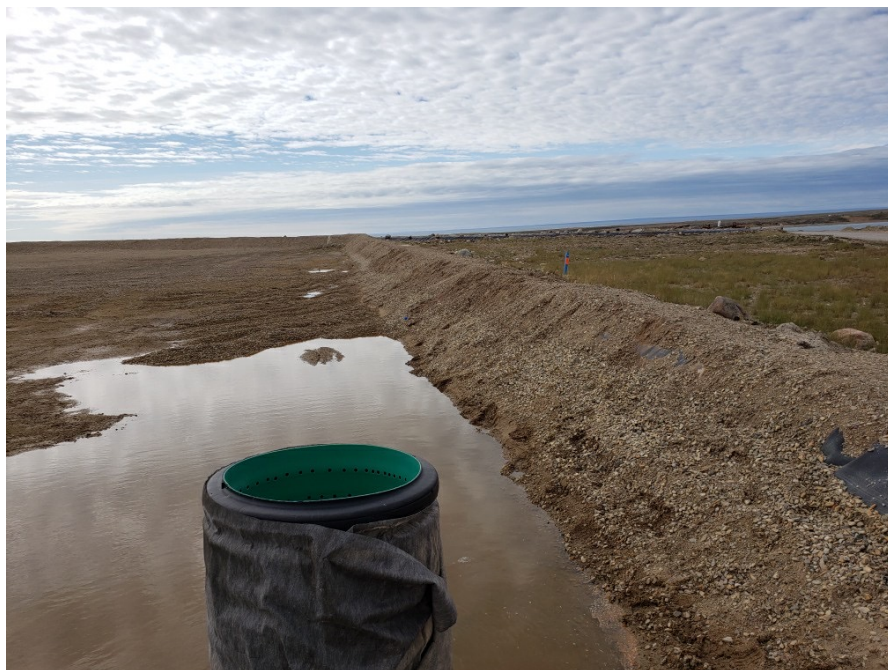
Photo 4: NW FTA LTU sump recharge two days after dewatering (facing south)

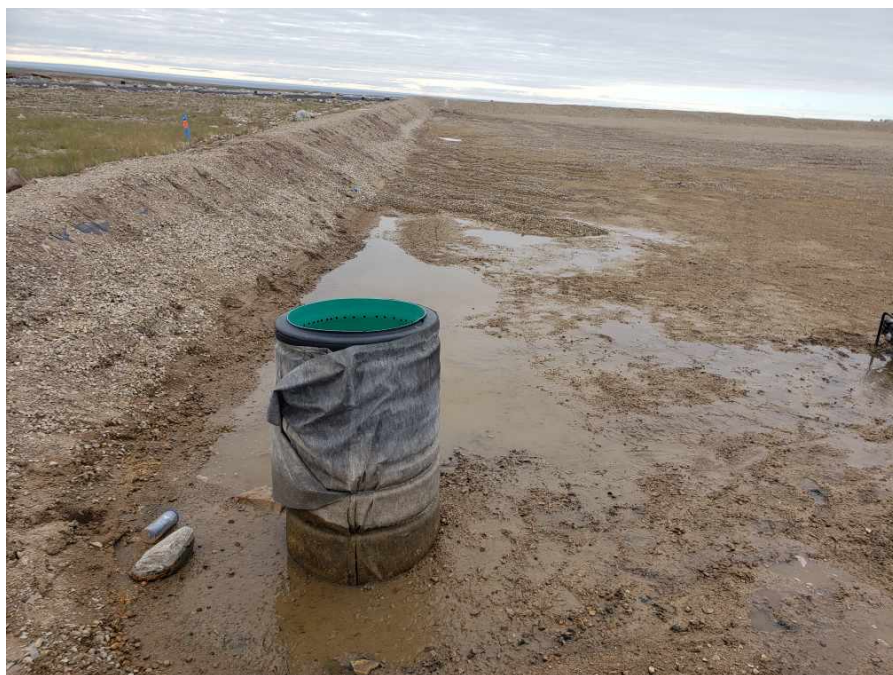
Photo 5: NW FTA LTU following second dewatering (facing north)

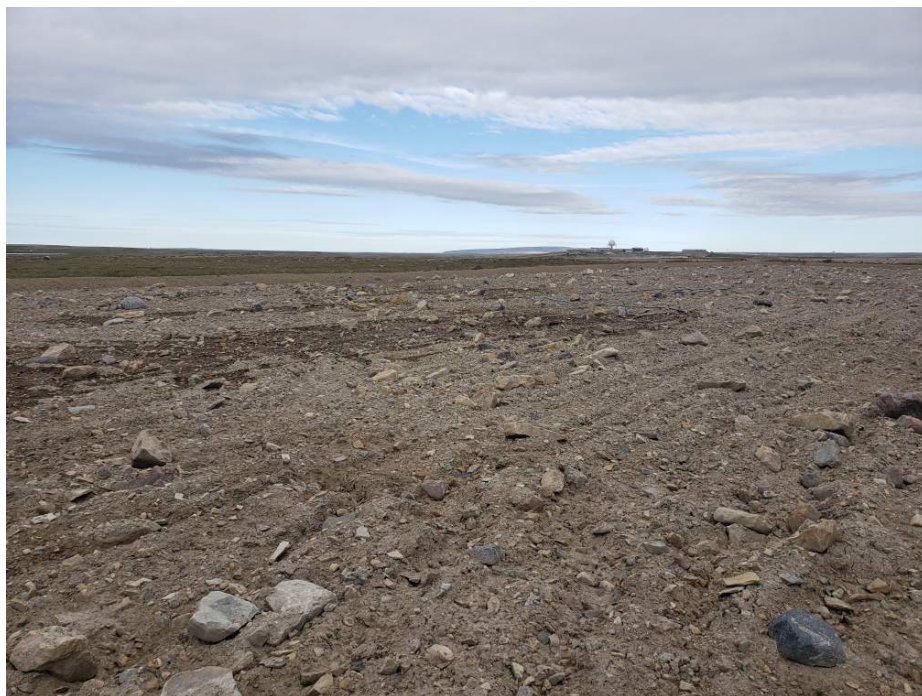
Photo 6: FTA LTU facing northeast showing sufficient water absorption and evaporation

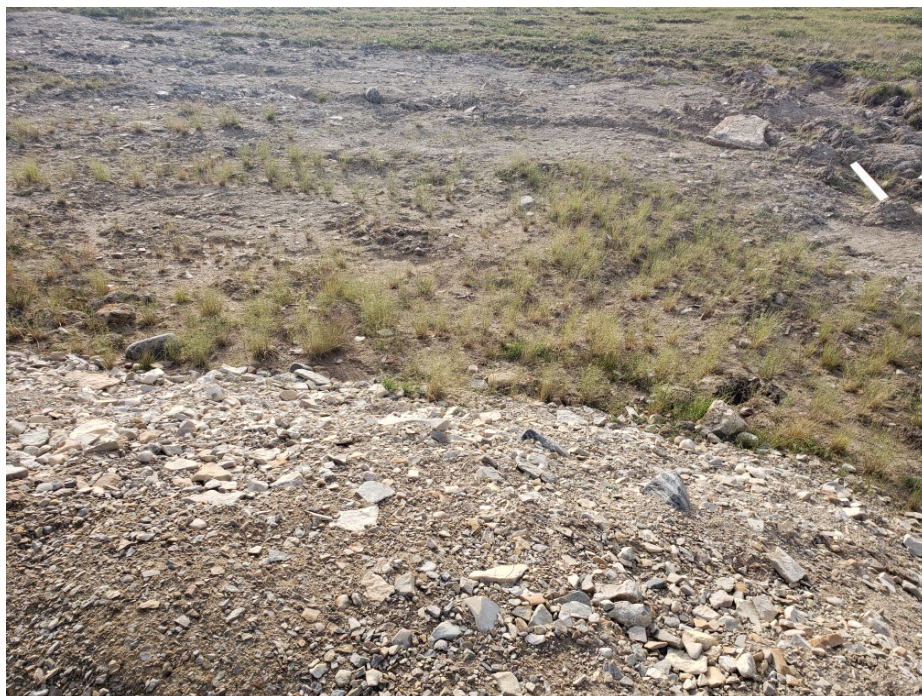
Photo 7: Area adjacent to southeast corner extent of FTA LTU facing east from top of berm, showing no observed surface water

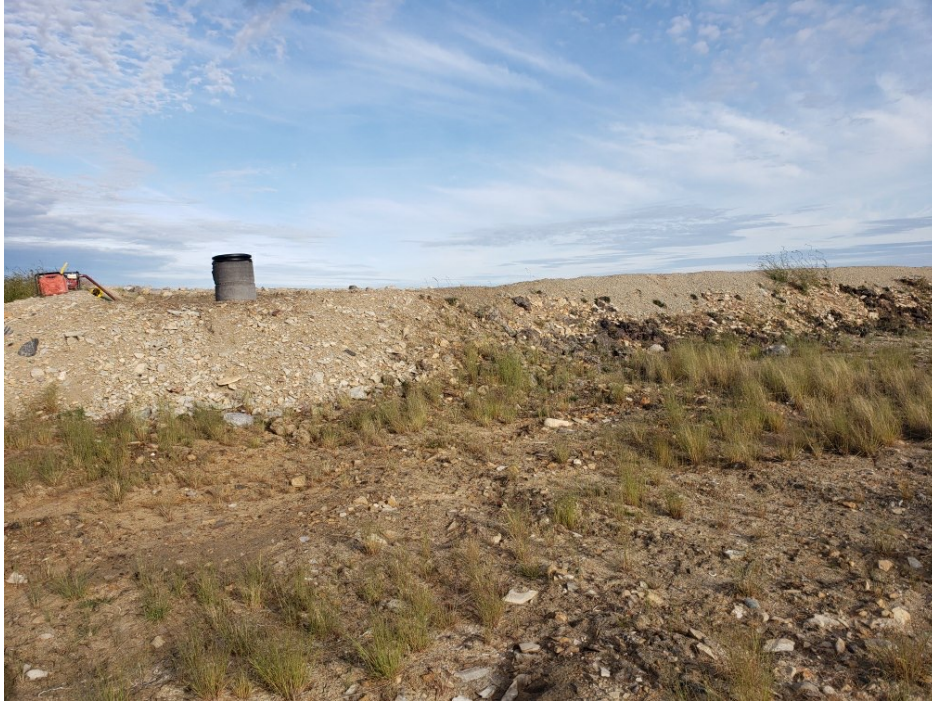
Photo 8: Southeast corner of FTA LTU facing west from area east of FTA LTU
