**THE COLLECTION OF LANDFILL  
MONITORING DATA AT THE FORMER  
CAM-2 DEW LINE SITE**

Gladman Point, Nunavut

**FINAL REPORT– 2012 SEASON**

**DEFENCE CONSTRUCTION CANADA**

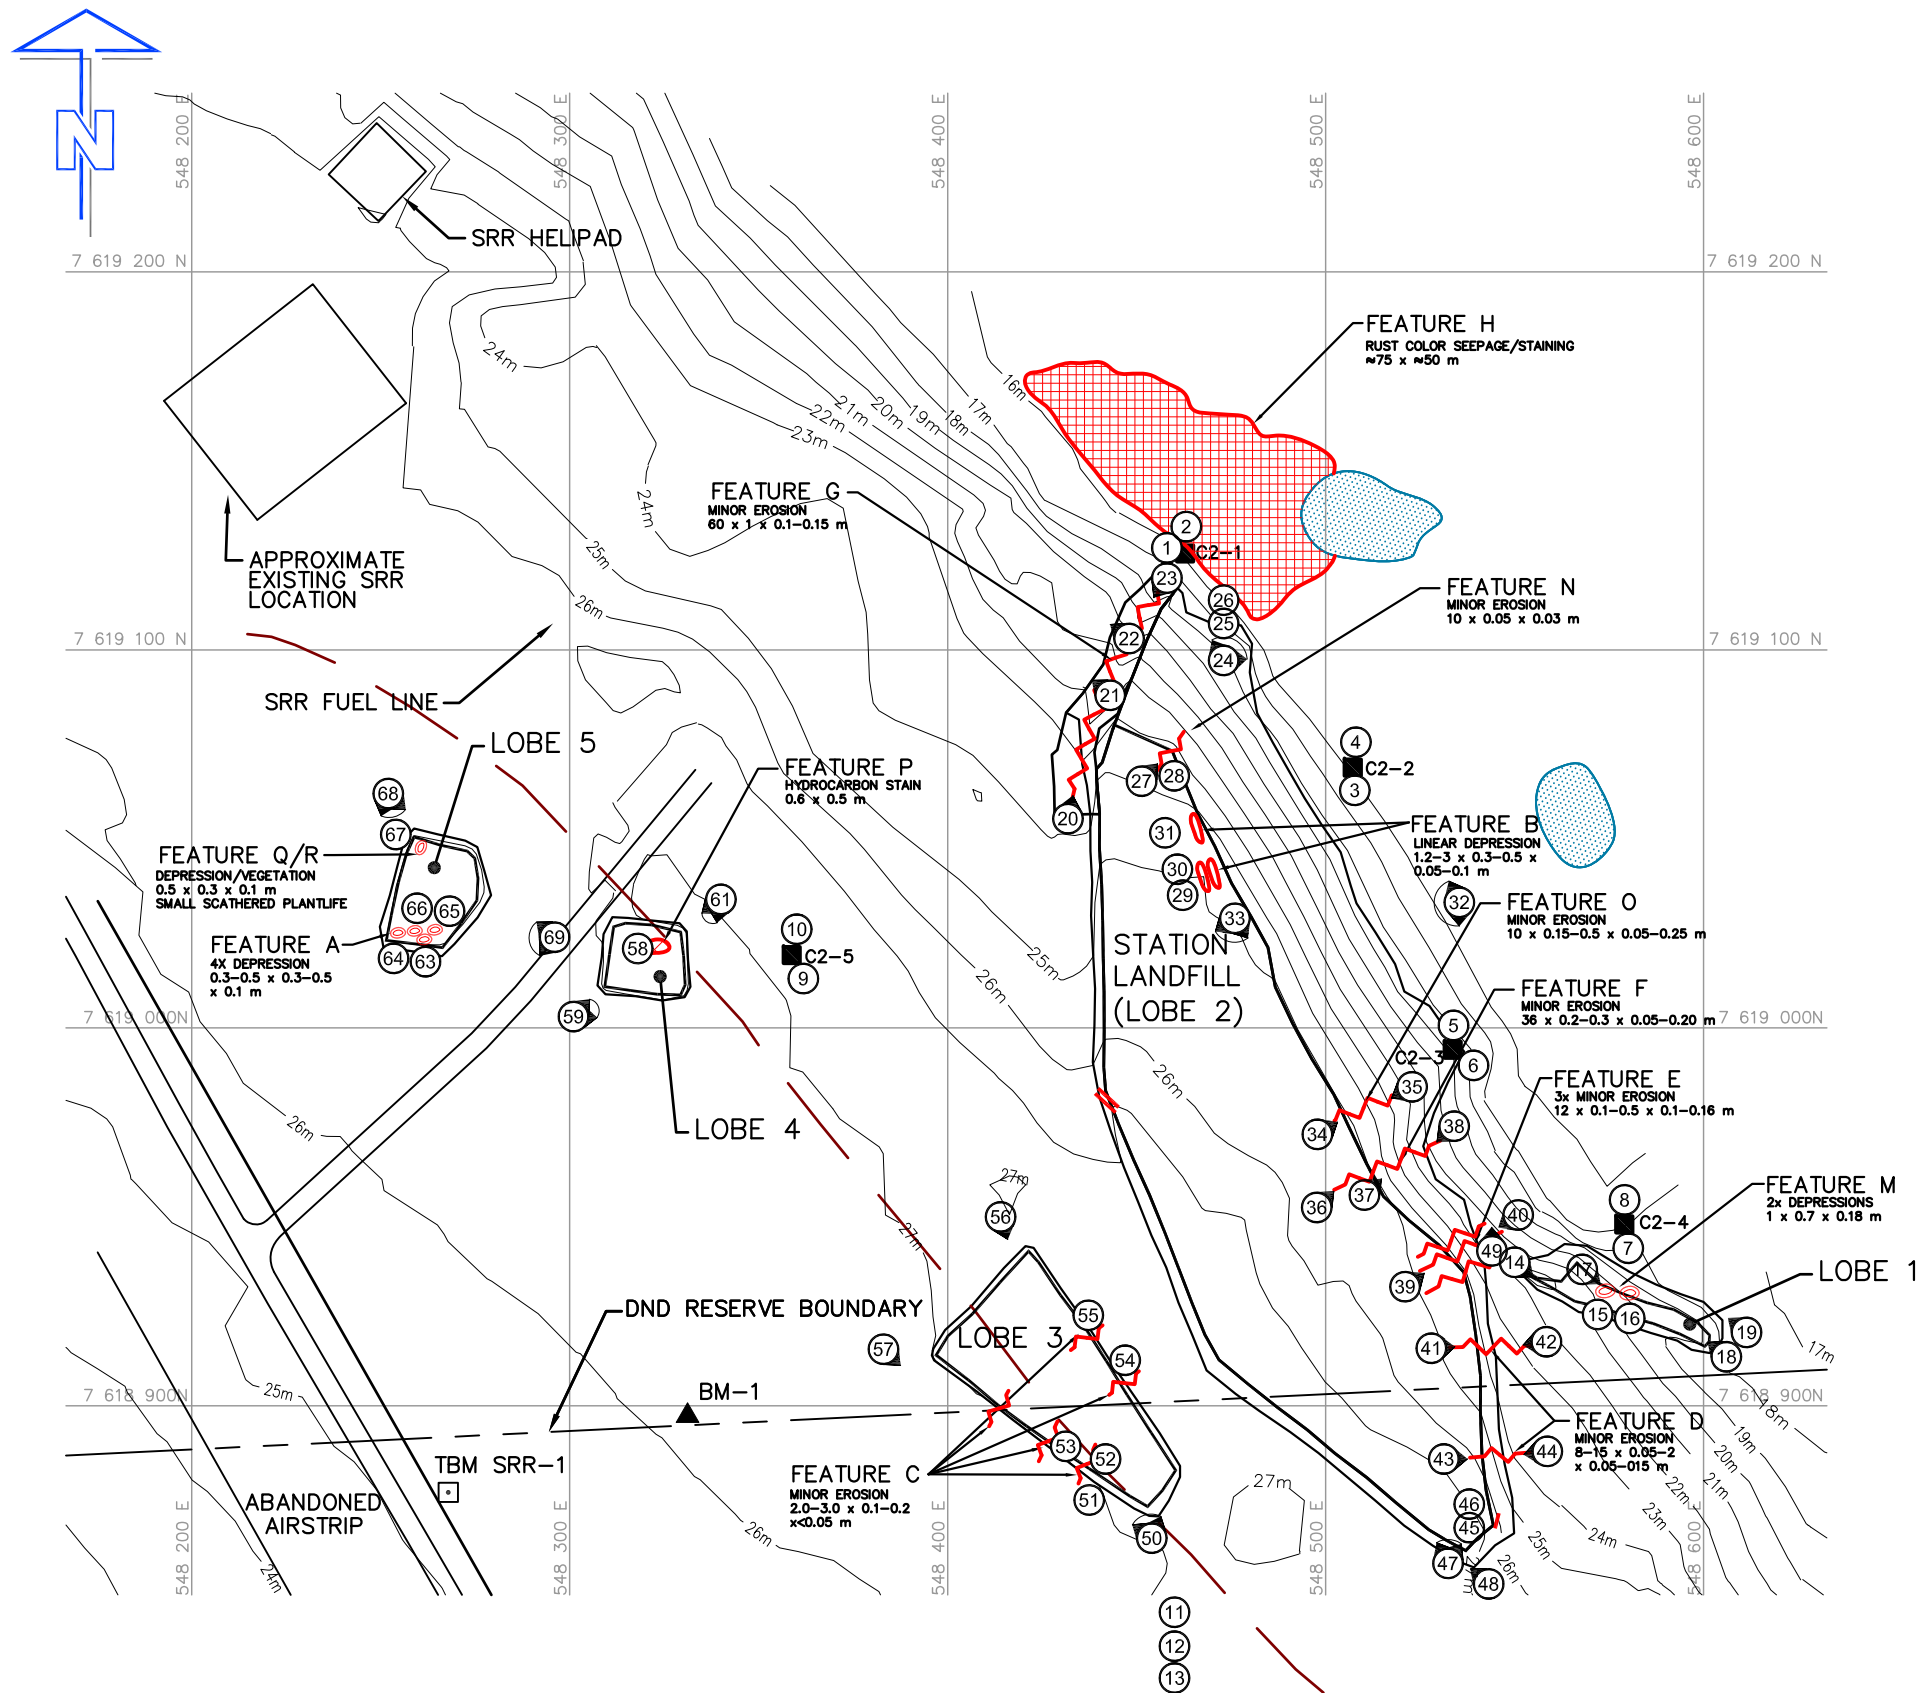
The Location Plan for the Station Landfill has been completed as per the TOR and is included in the following page as Figure CAM-2.2 Gladman Point – Station Landfill.

Four areas of minor settlement were noted at the Station Landfill at Lobes: 1 (Feature M), 2 (Feature B) and 5 (Features A and Q) during the 2012 monitoring program.

Further settlement has been observed in the vicinity of Feature B which was first identified during the 2010 monitoring program; two additional linear depressions were observed within 5 m of the original feature. Despite the increases in the settlement, the features are relatively minor and the Landfill Lobe continues to function as designed.

Indications of settlement have increased at Lobe 5 of the Station Landfill. An additional two depressions have been observed at Feature A, for total of four. Feature Q consists of a depression associated with large cobble and vegetation. Based on the size of the extent of the vegetation although small, Feature Q is believed to have existed for some time (potentially since construction, given its associated cobble). Lobe 5 continues to function as designed.

Erosion was observed at two of the five Lobes at the Station Landfill, Lobes 2 and 3. Observations of shallow erosion on the east and west side slopes of Lobe 3 remain consistent with the 2010 sampling program. The performance of Lobe 3 is considered acceptable.

One area of rust-coloured staining (Feature H) was observed on the northeast corner of Lobe 2, extending from the Landfill toe to a nearby pond situated approximately 25 m to the east, and from the pond north; encompassing a low lying area approximately 75 x 50 m. Similar staining was observed at other low lying areas not associated with the Landfill, and in keeping with the conclusions drawn in the 2010 monitoring report, appear to be a natural feature of the area. Bacterial sheen was observed on the surface of ponded water at the toe of the Landfill.

A hydrocarbon stain (Feature P) was observed approximately in the middle of Lobe 4. As it was not observed during previous monitoring programs, it is assumed the stain is a result of recent activities or was simply an oversight (although unlikely). A consultation with the Field Assistants and Bear Monitors revealed that the area is frequented by members of a nearby community for Ranger duties and hunting trips. ATVs and snowmobiles are used to access the site and are thus, a potential source of leaks and therefore stains.

During the 2010 monitoring program, several tension/desiccation cracks were noted on the surface and/side slope of Lobes 2 and 3. During the 2012 monitoring program, Features I, K and L were not observed, and Feature J was  $\frac{1}{4}$  the length previously observed. In the week leading up to the monitoring program, as well as during the site visit, the area experienced several precipitation events which may have eliminated any cracks caused by desiccation and/or filled in smaller cracks through erosion processes. Features J and L on Lobe 2 consisted of relatively short parallel cracks that extended approximately 45 degrees to the slope direction. What remains of Feature J has an acceptable severity rating.

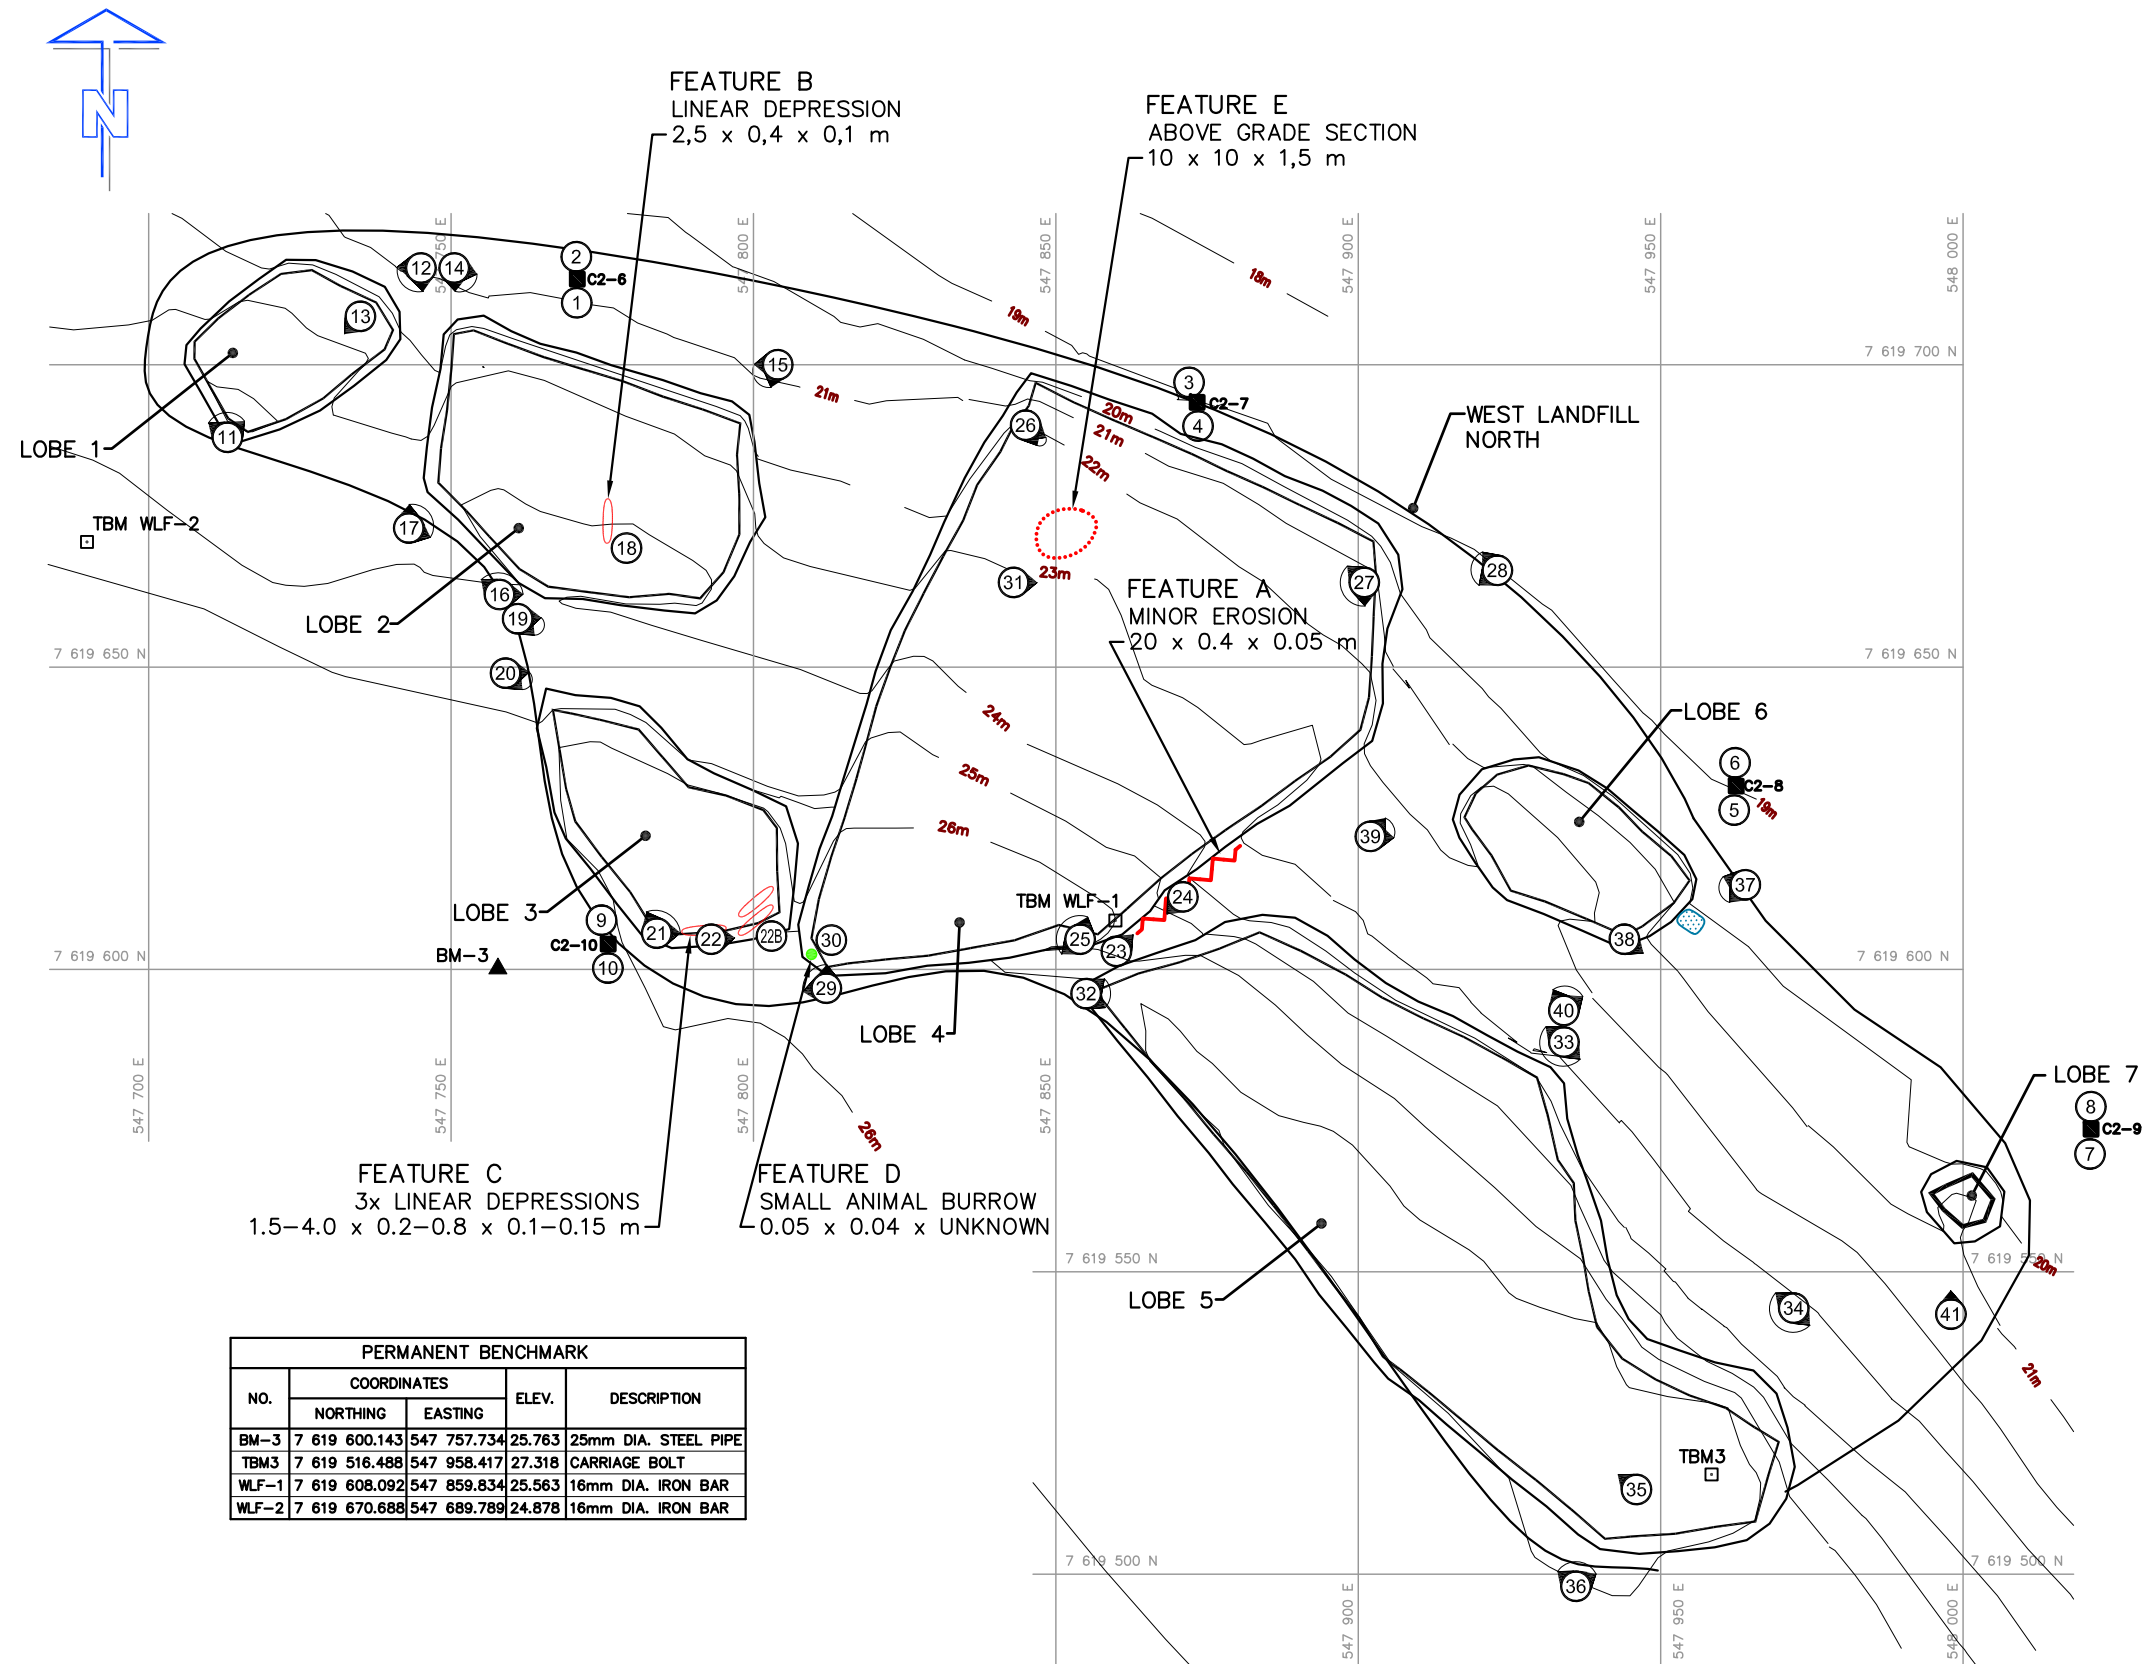
The Location Plan for the West Landfill – North has been completed as per the TOR and is included in the following page as Figure CAM-2.3 Gladman Point – West Landfill – North.

Settlement was noted at two locations during the 2012 monitoring program at Lobe 2 (Feature B) and Lobe 3 (Feature C). Feature B on the south/middle surface of Lobe 2 is a long shallow depression of little consequence to the stability of the Lobe. Feature C consists of three depressions, one on the south side slope, a linear depression running parallel to the toe and a

Minor surface erosion was noted along a runoff channel that extends between two closely spaced Lobes (Lobes 4 and 5) in the central area of the Landfill (Feature A). The erosion extends along the toe of Lobe 4 and is not in direct contact with the Landfill. 2012 observations of Feature A remain consistent with the 2010 findings.

Evidence of an animal was observed at the south corner (on the side slope) of Lobe 4, Feature D. Similar burrows were observed at different areas on the Site but the feature at Lobe 4 was the only burrow observed on a Landfill Lobe. The small size of the burrow suggests it was made by a small rodent of an unknown type, no animals were observed entering or leaving the burrow. Feature D has an acceptable severity rating.

Another feature of note (Feature E) was observed on the north eastern surface of Lobe 4, a raised area approximately 10 m in diameter and 1.5 m above the grade of the surrounding Landfill surface. The change in gradient is not indicated on the drawings and was not mentioned in the 2010 report.

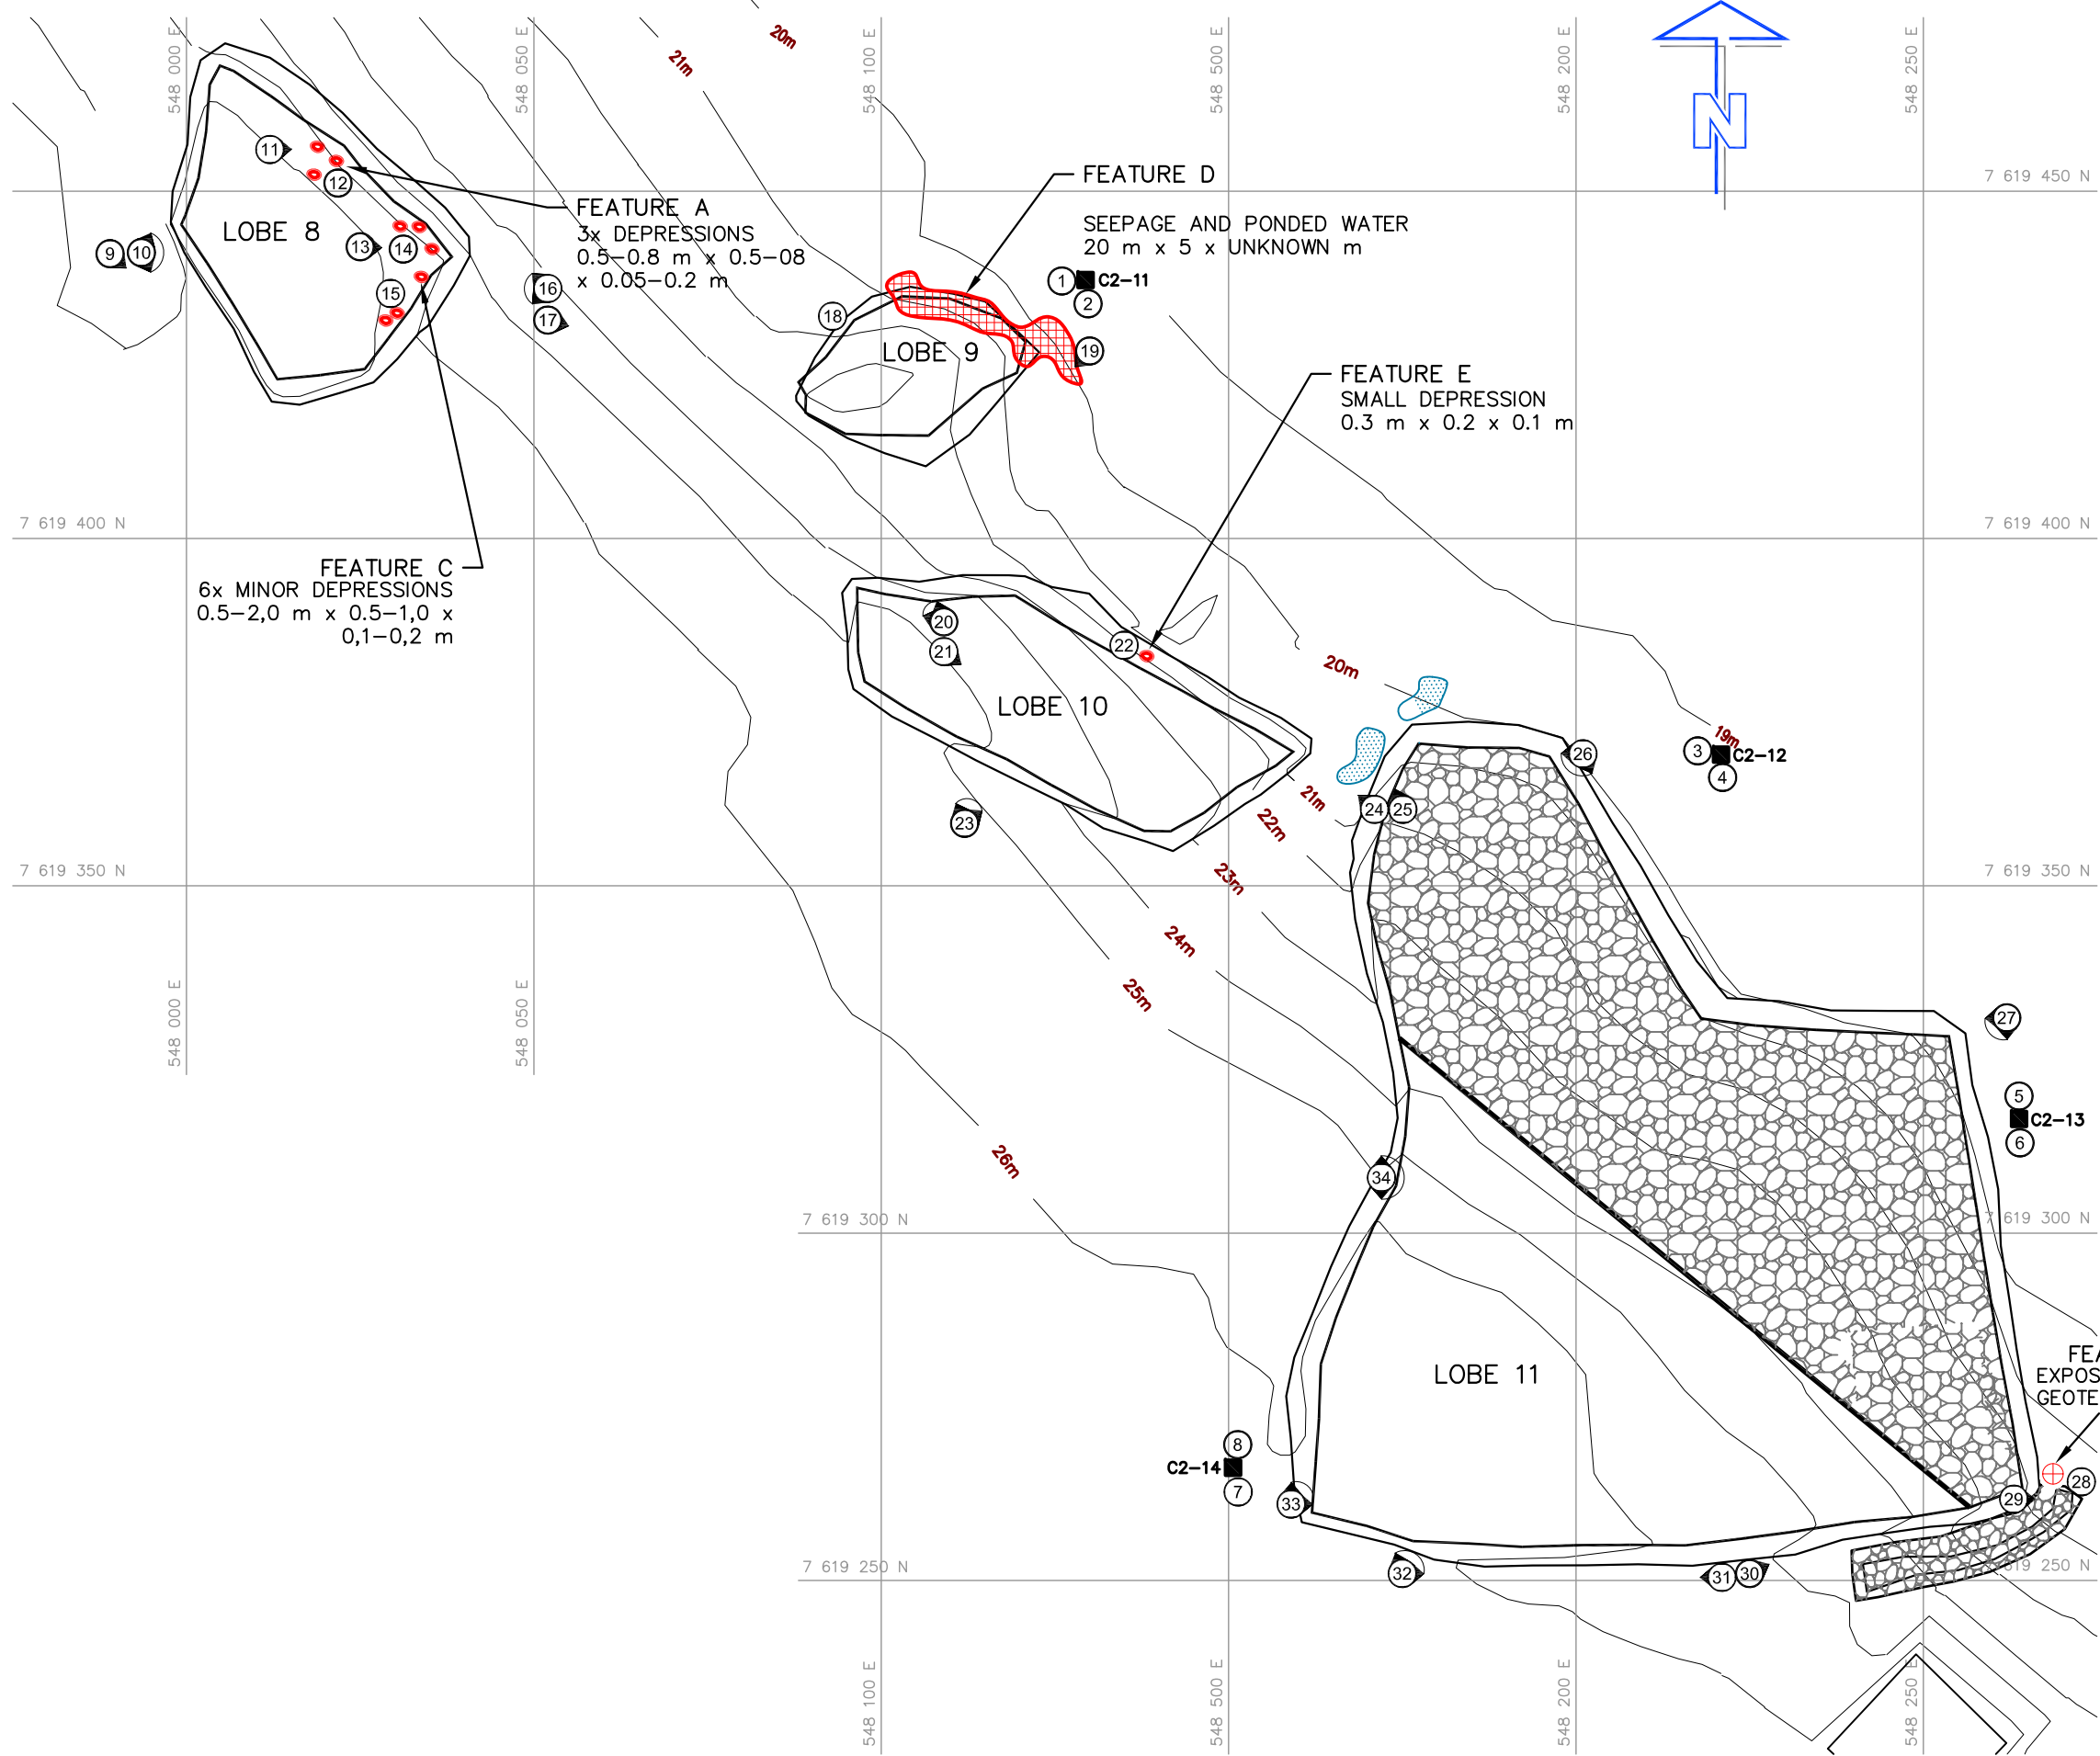
The Location Plan for the West Landfill – South has been completed as per the TOR and is included in the following page as Figure CAM-2.4 Gladman Point – West Landfill – South.

During the 2012 monitoring program, minor indications of settlement were noted at three locations at the West Landfill – South, including two areas at Lobe 8 (Feature A and C) and a third location at Lobe 10 (Feature E)

Feature A, first noted in the 2010 monitoring program, showed a series of three closely spaced depressions on the east surface of Lobe 8, which have experienced little to no significant change. Feature C includes six depressions east of Feature A on the surface of the Lobe, four of which are a tight cluster of potholes, while two slightly to the south appear to be the remnants of pick-up tire tracks. It appears as though settlement has increased since the 2010 monitoring program however, at least two of the depressions are a relic of the remediation contract.

Feature D, first noted during the 2012 monitoring program, consists of surface wetting across the north portion of the Landfill toe, extending 5 m onto the surface of the Lobe. Ponded water in direct contact with the toe is present in two locations, on the northwest and the northeast side of the landfill. The tundra on the northwest side has evidence of rutting from machinery traffic which is now collecting water.

Debris Exposed	Yes	FEATURE B See Figure CAM-2.4 (east end of drainage channel - Lobe 11)	0.3	0.4	Unknown	Isolated	Black geotextile fabric	28, 29	Acceptable	Similar material used in construction of drainage channel.
Presence/Condition of Monitoring Instruments	No	N/A	N/A	N/A	N/A	N/A	N/A	N/A	Not Observed	N/A
Other Features of Note	Yes	See Figure CAM-2.4 (ponding north of Lobe 11)	25	41186	41187	N/A	Ponding in downgradient area north of Lobe 11	25	Acceptable	Localized ponding between lobes.
Additional Photos	Yes	See Figure CAM-2.4 and Photographic Record	N/A	N/A	N/A	N/A	General Photographic Record	N/A	Not Observed	General photos for documentation, no features of note.
<b>Overall Landfill Performance:</b>		<b>Acceptable</b>

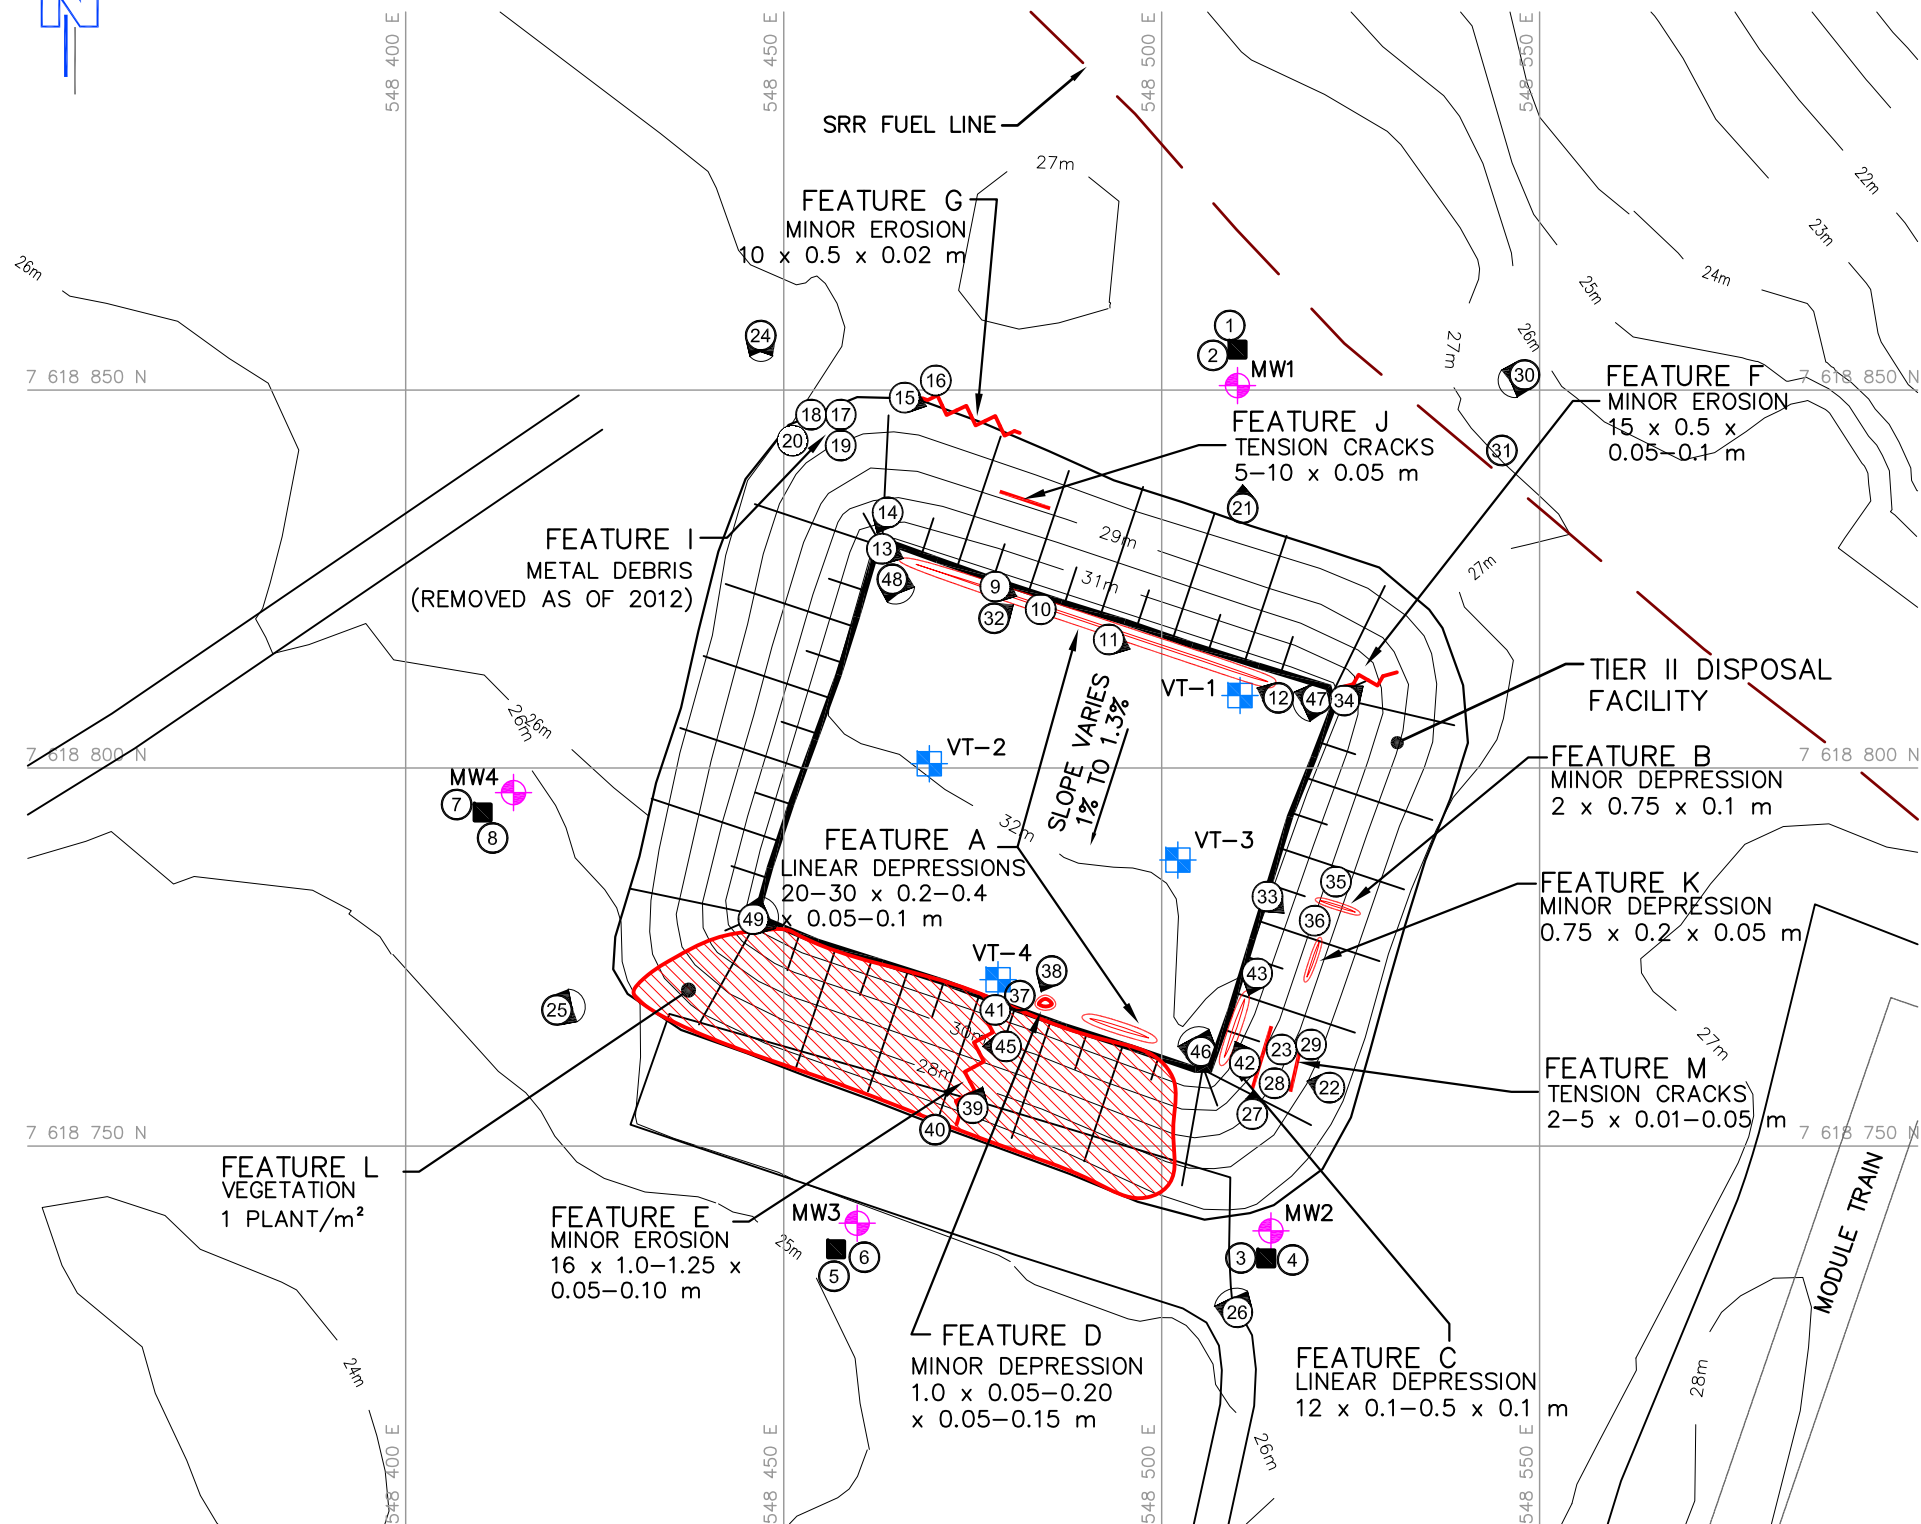
The Location Plan for the Tier II Disposal Facility has been completed as per the TOR and is included in the following page as Figure CAM-2.5 Gladman Point – Tier II Disposal Facility.

Indications of settlement were noted at five locations (Features A through D and K) on the surface and side slopes of the Tier II Disposal Facility, an increase of one area from the 2010 monitoring program.

Feature A consists of subtle narrow linear depressions extending along the north and south crests of the landfill, whereas Features B, C, D and K consist of more localized depressions. Observations of Feature A are consistent with the dimensions observed during the 2010 monitoring program however, the small tension crack associated with this feature is no longer visible. Feature B on the eastern slope of the Landfill has decreased in size from the 2010 monitoring program, potentially the result of deposition of material eroded from further up the slope. Feature C, a relatively small depression at the time of the 2010 monitoring program at 0.4 m in length, has increased to 12 m in length extending along the crest of the Landfill. Feature D remains constant in size and extent. Newly observed Feature K consists of a small linear depression close to the middle of the slope and runs parallel to the Landfill toe.

Evidence of minor surface erosion was noted at two locations on the surface of the Tier II Disposal Facility including Feature E located on the slope southwest of VT-4 and Feature F located on the northeast corner of the Landfill. Both features extend perpendicular to the slope, appear to be self-armouring, and have an acceptable severity rating. Features E and F exhibited little to no change since 2009 and have an acceptable severity rating.

One additional area (Feature G), of minor erosion, was noted along the northwest toe and is not in direct contact with the Tier II Disposal Facility. Overall, the Tier II Disposal Facility cover appears stable and relatively unchanged from the 2010 report.

Indications of vegetation were noted on the southern slope of the Tier II Disposal Facility. Plants have colonized the slope at an approximate density of 1 plant per 3 m<sup>2</sup>.

Evidence of debris was noted at one location on the northwest toe of the Tier II Disposal Facility (Feature I), consisting of a partially exposed piece of 50 mm diameter iron pipe. The iron pipe was subsequently removed and disposed of. Feature I will not be included in 2015 monitoring program.
