**THE COLLECTION OF LANDFILL  
MONITORING DATA AT THE FORMER  
CAM-2 DEW LINE SITE**

Gladman Point, Nunavut

**FINAL REPORT – 2009 SEASON**

**DEFENCE CONSTRUCTION CANADA**

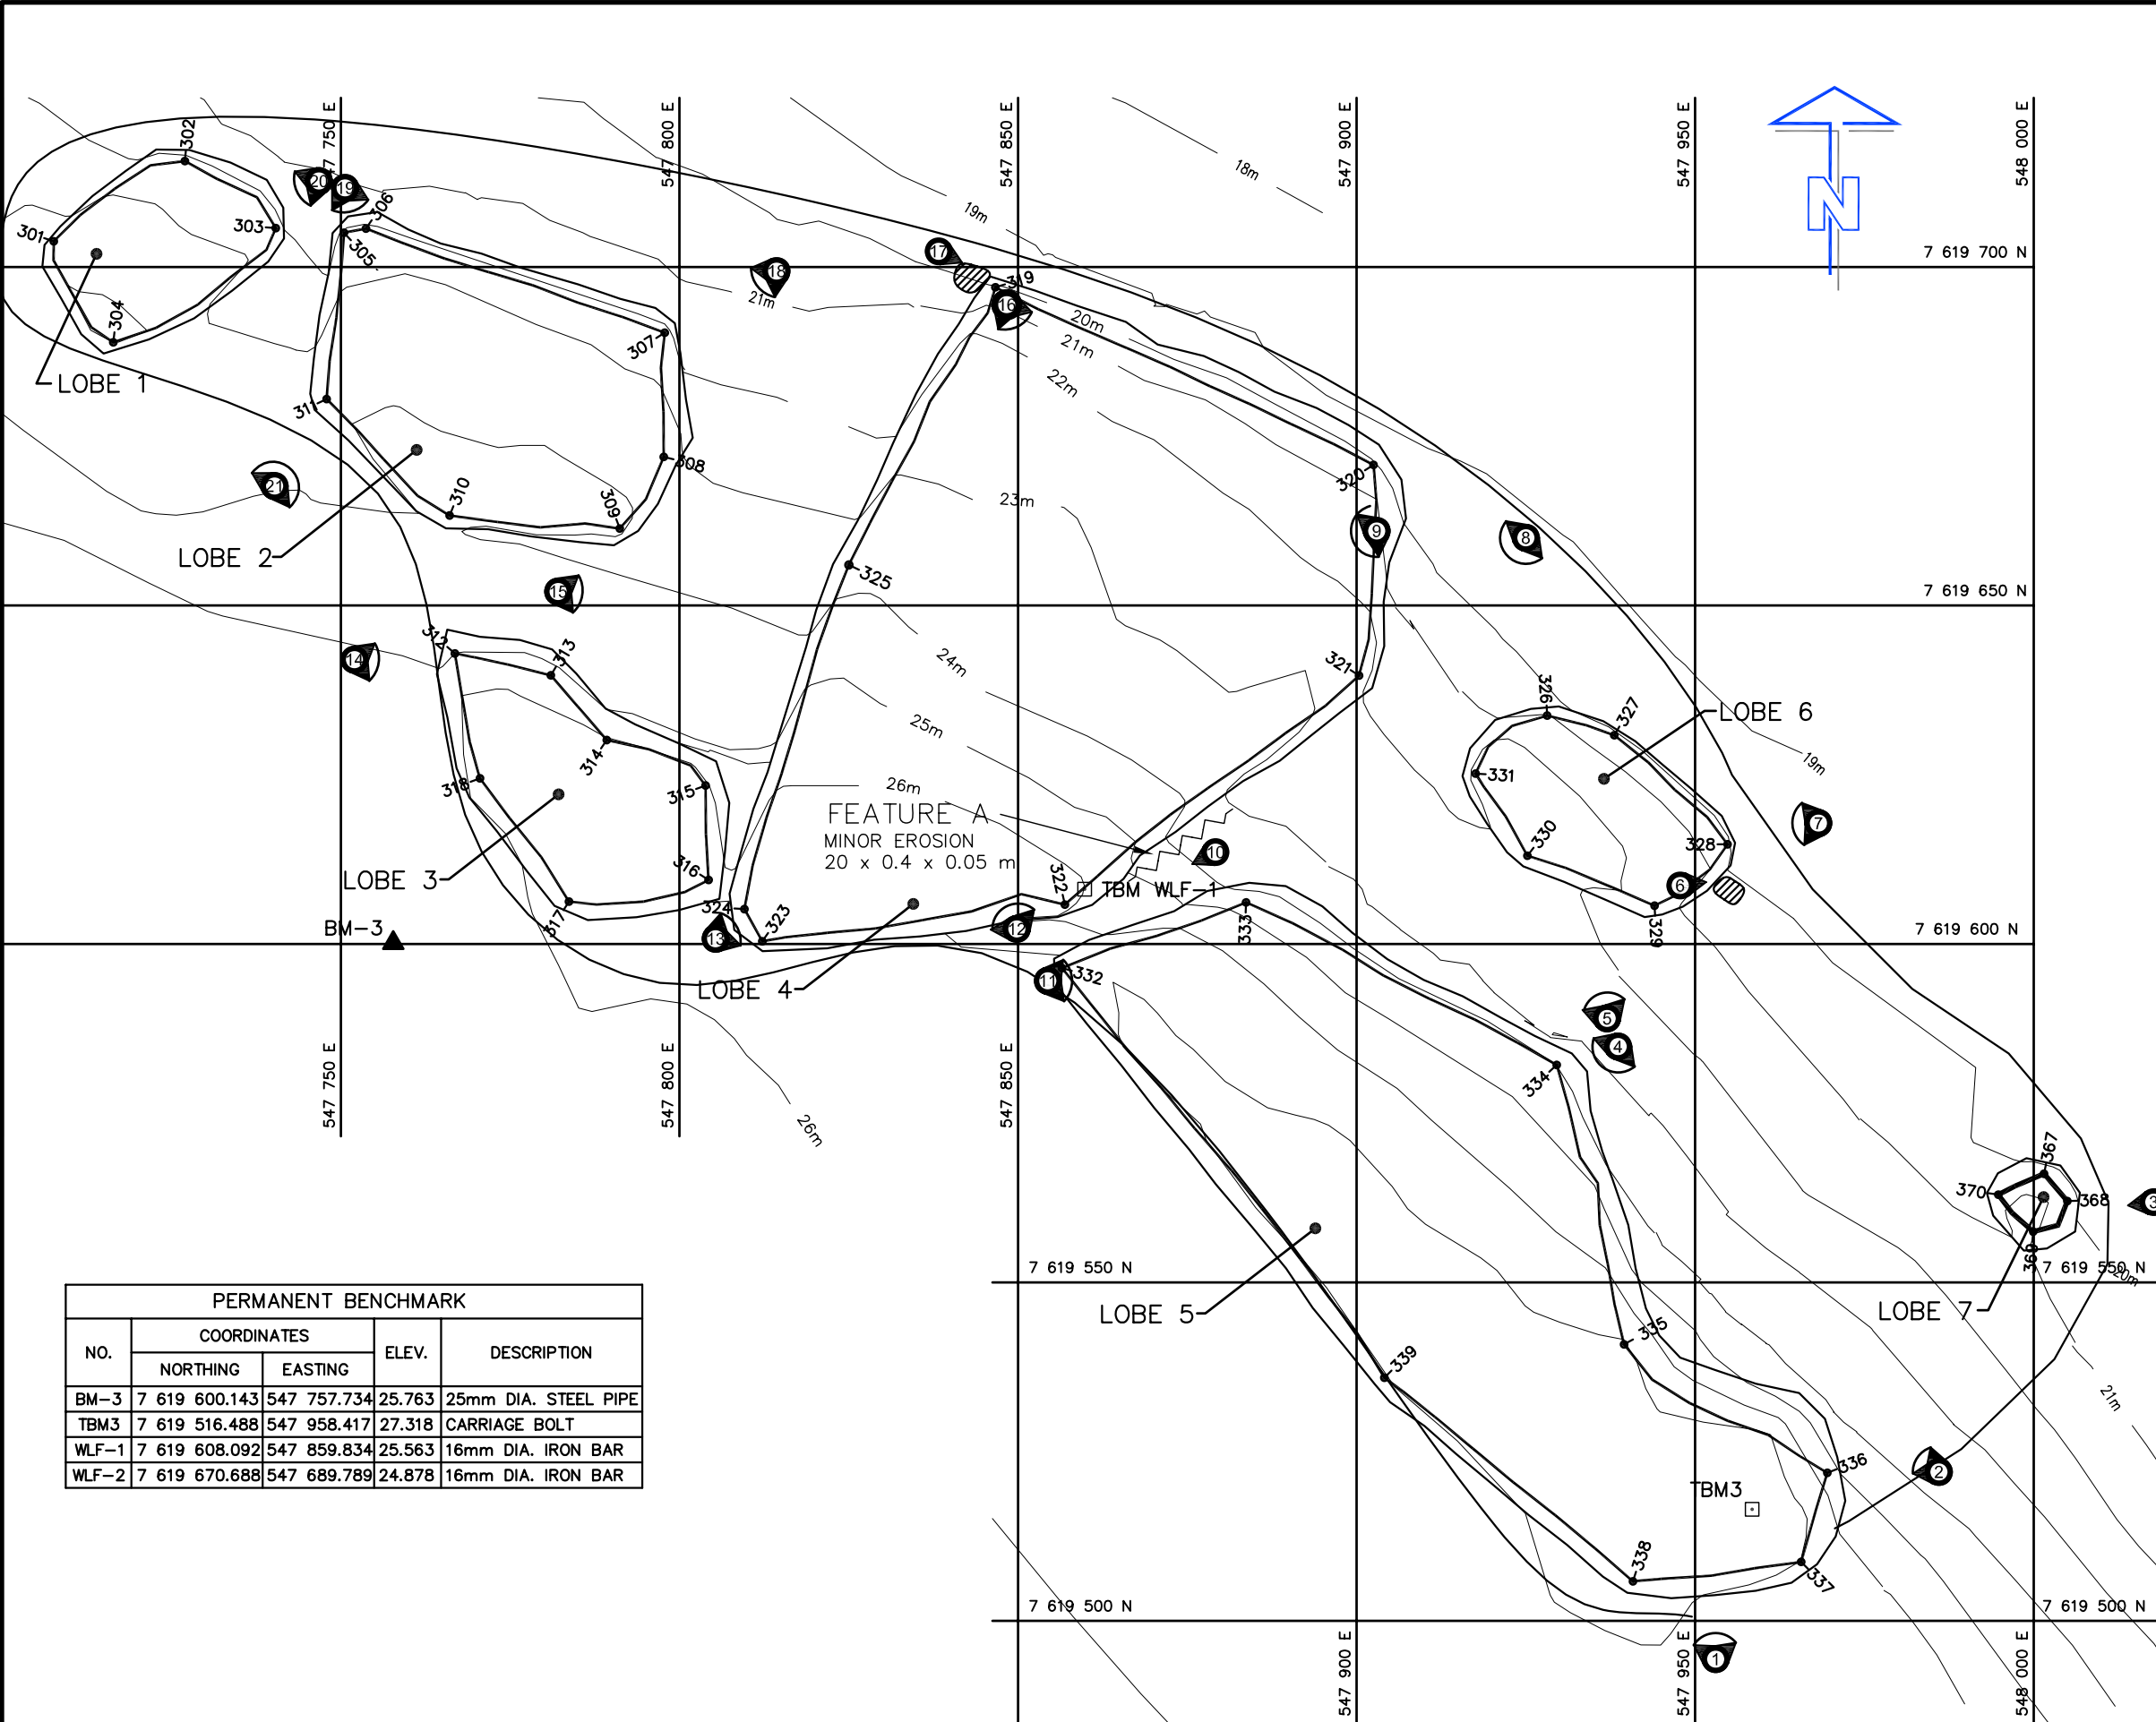
The Location Plan for the West Landfill – North has been completed as per the ToR and is presented in Figure CAM-2.3.

Minor surface erosion was noted along a runoff channel that extends between two closely spaced lobes in the central area of the landfill (Feature A). The erosion was noted to extend along the toe of the lobe 4 and is not in direct contact with the landfill.

A single area of ponding was noted at the toe of one of the downgradient lobes. The ponded water was contained to a pre-construction dug-out area.

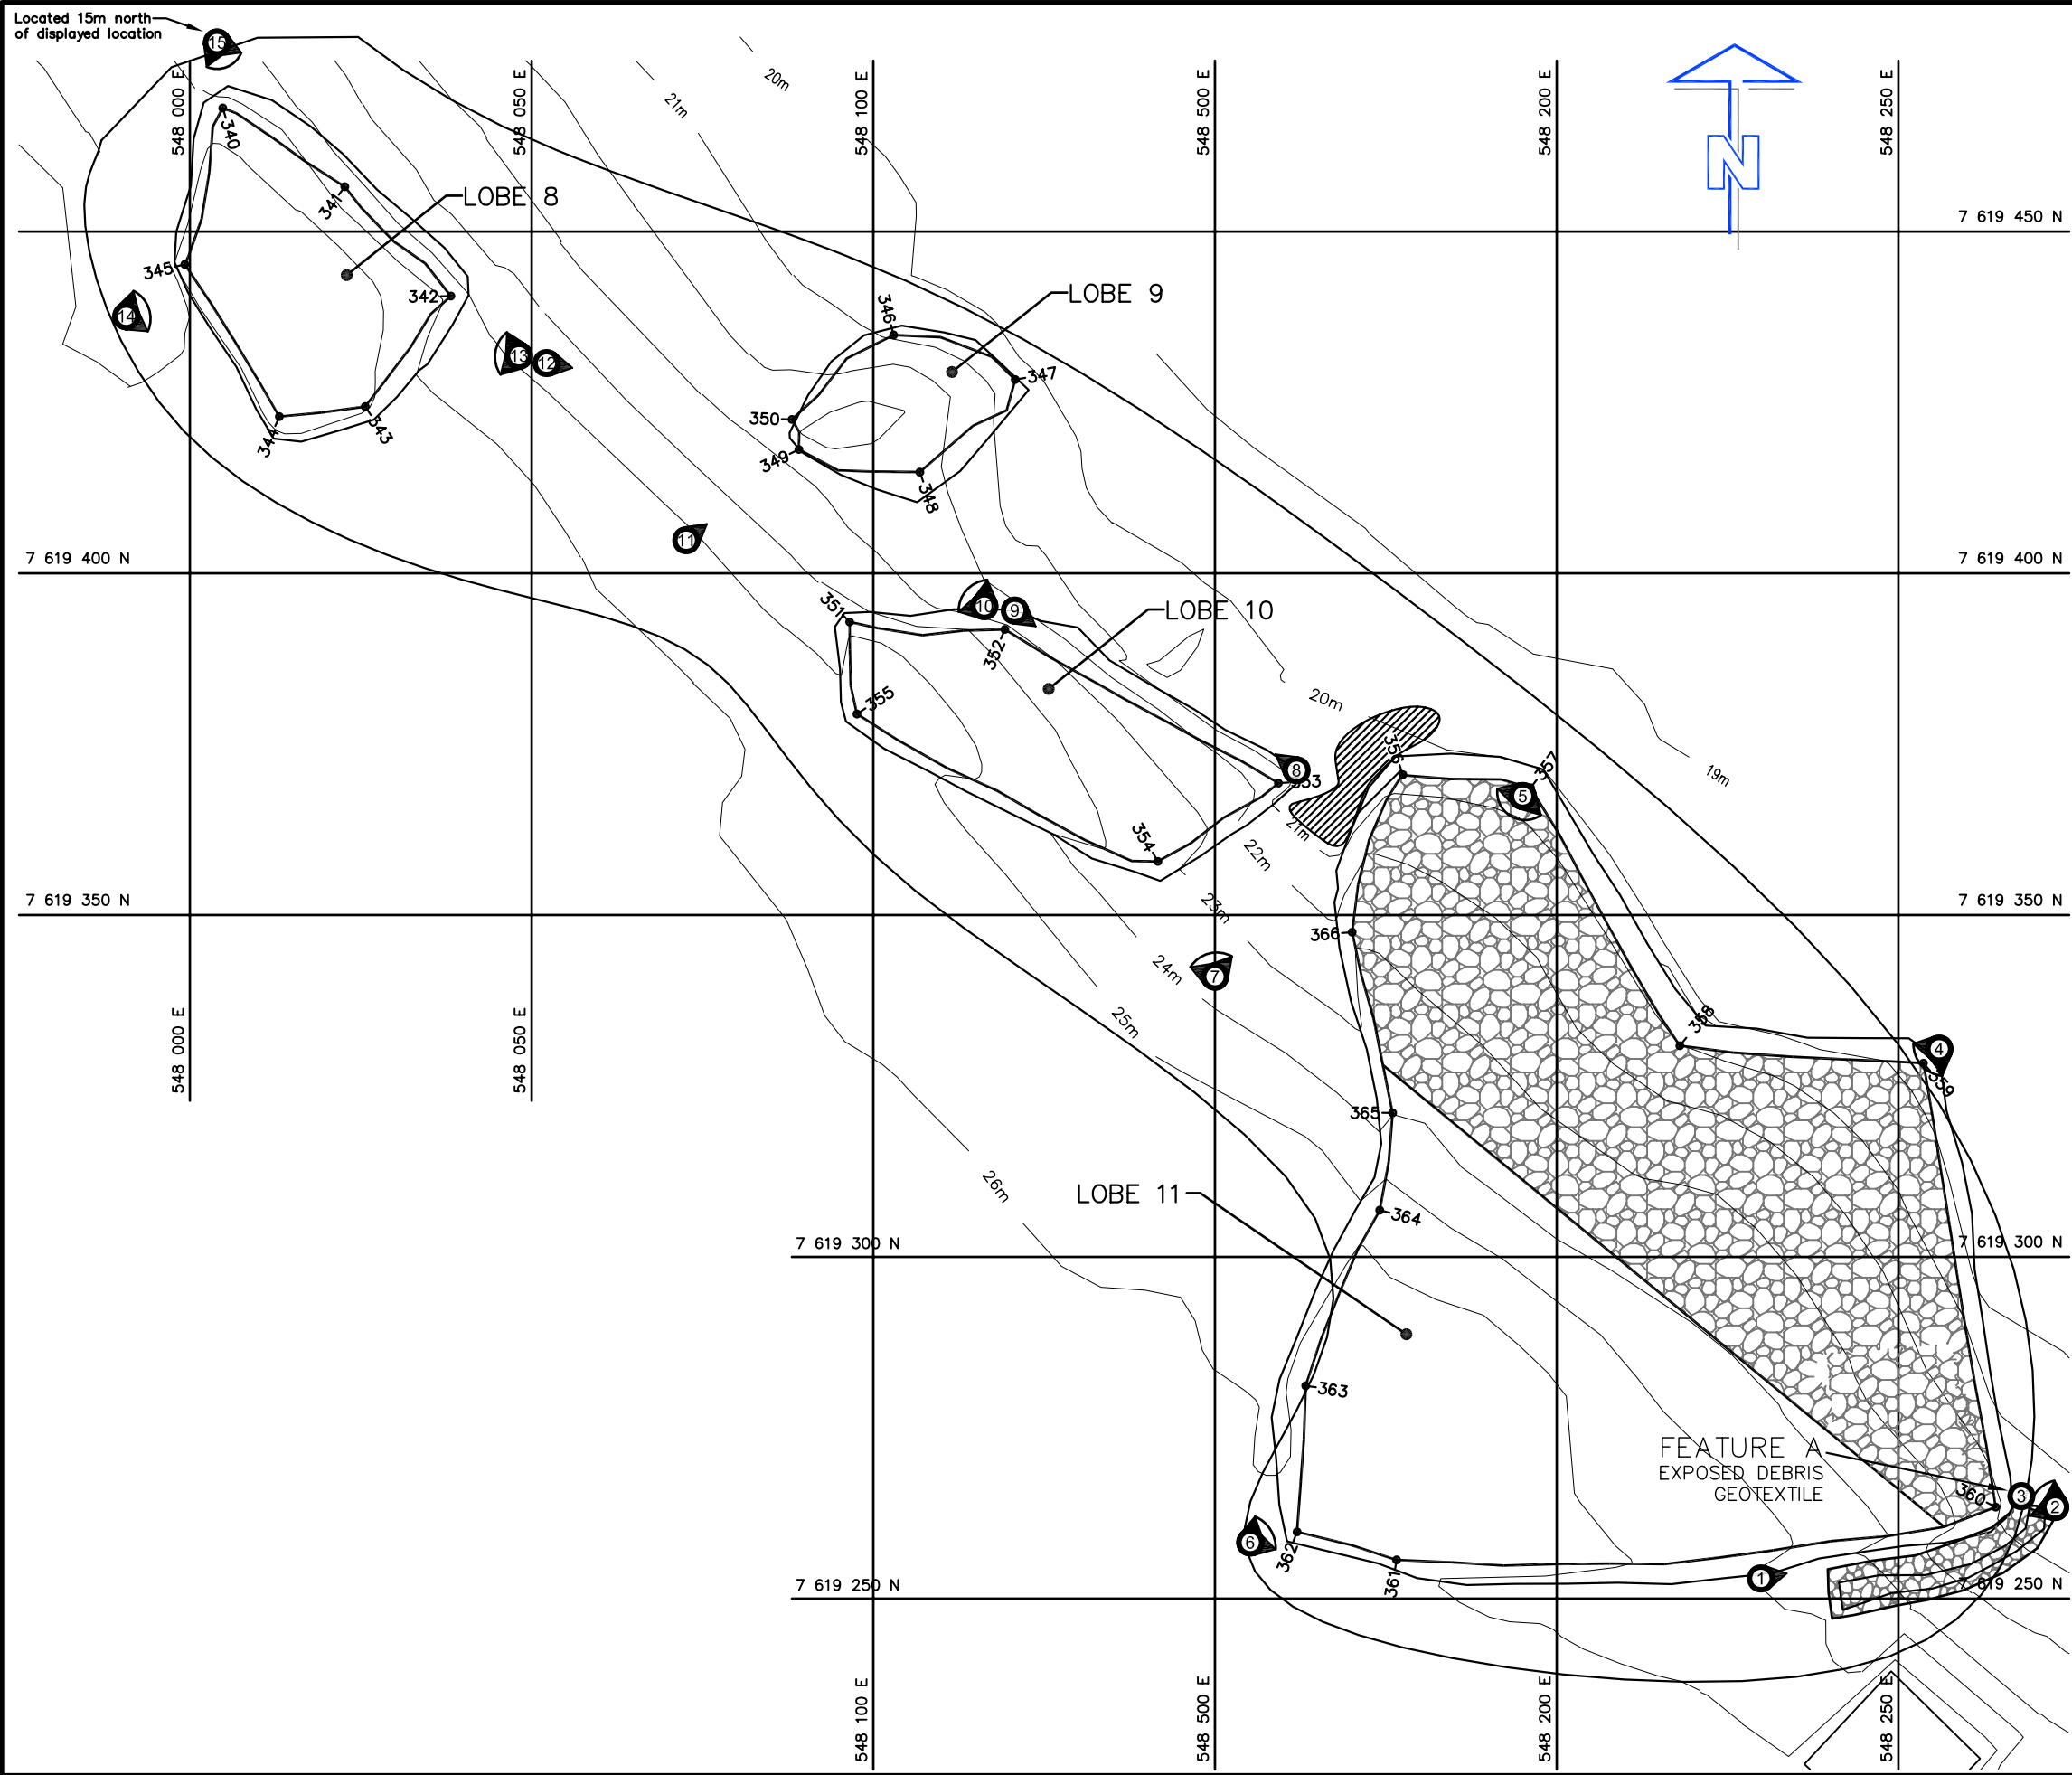
The Location Plan for the West Landfill – South has been completed as per the ToR and is presented in Figure CAM-2.4.

A single area of ponding was noted in a low lying area extending between the lobe 11 and adjacent lobe 10 to the north. There was no seepage point or staining associated with the ponded water.

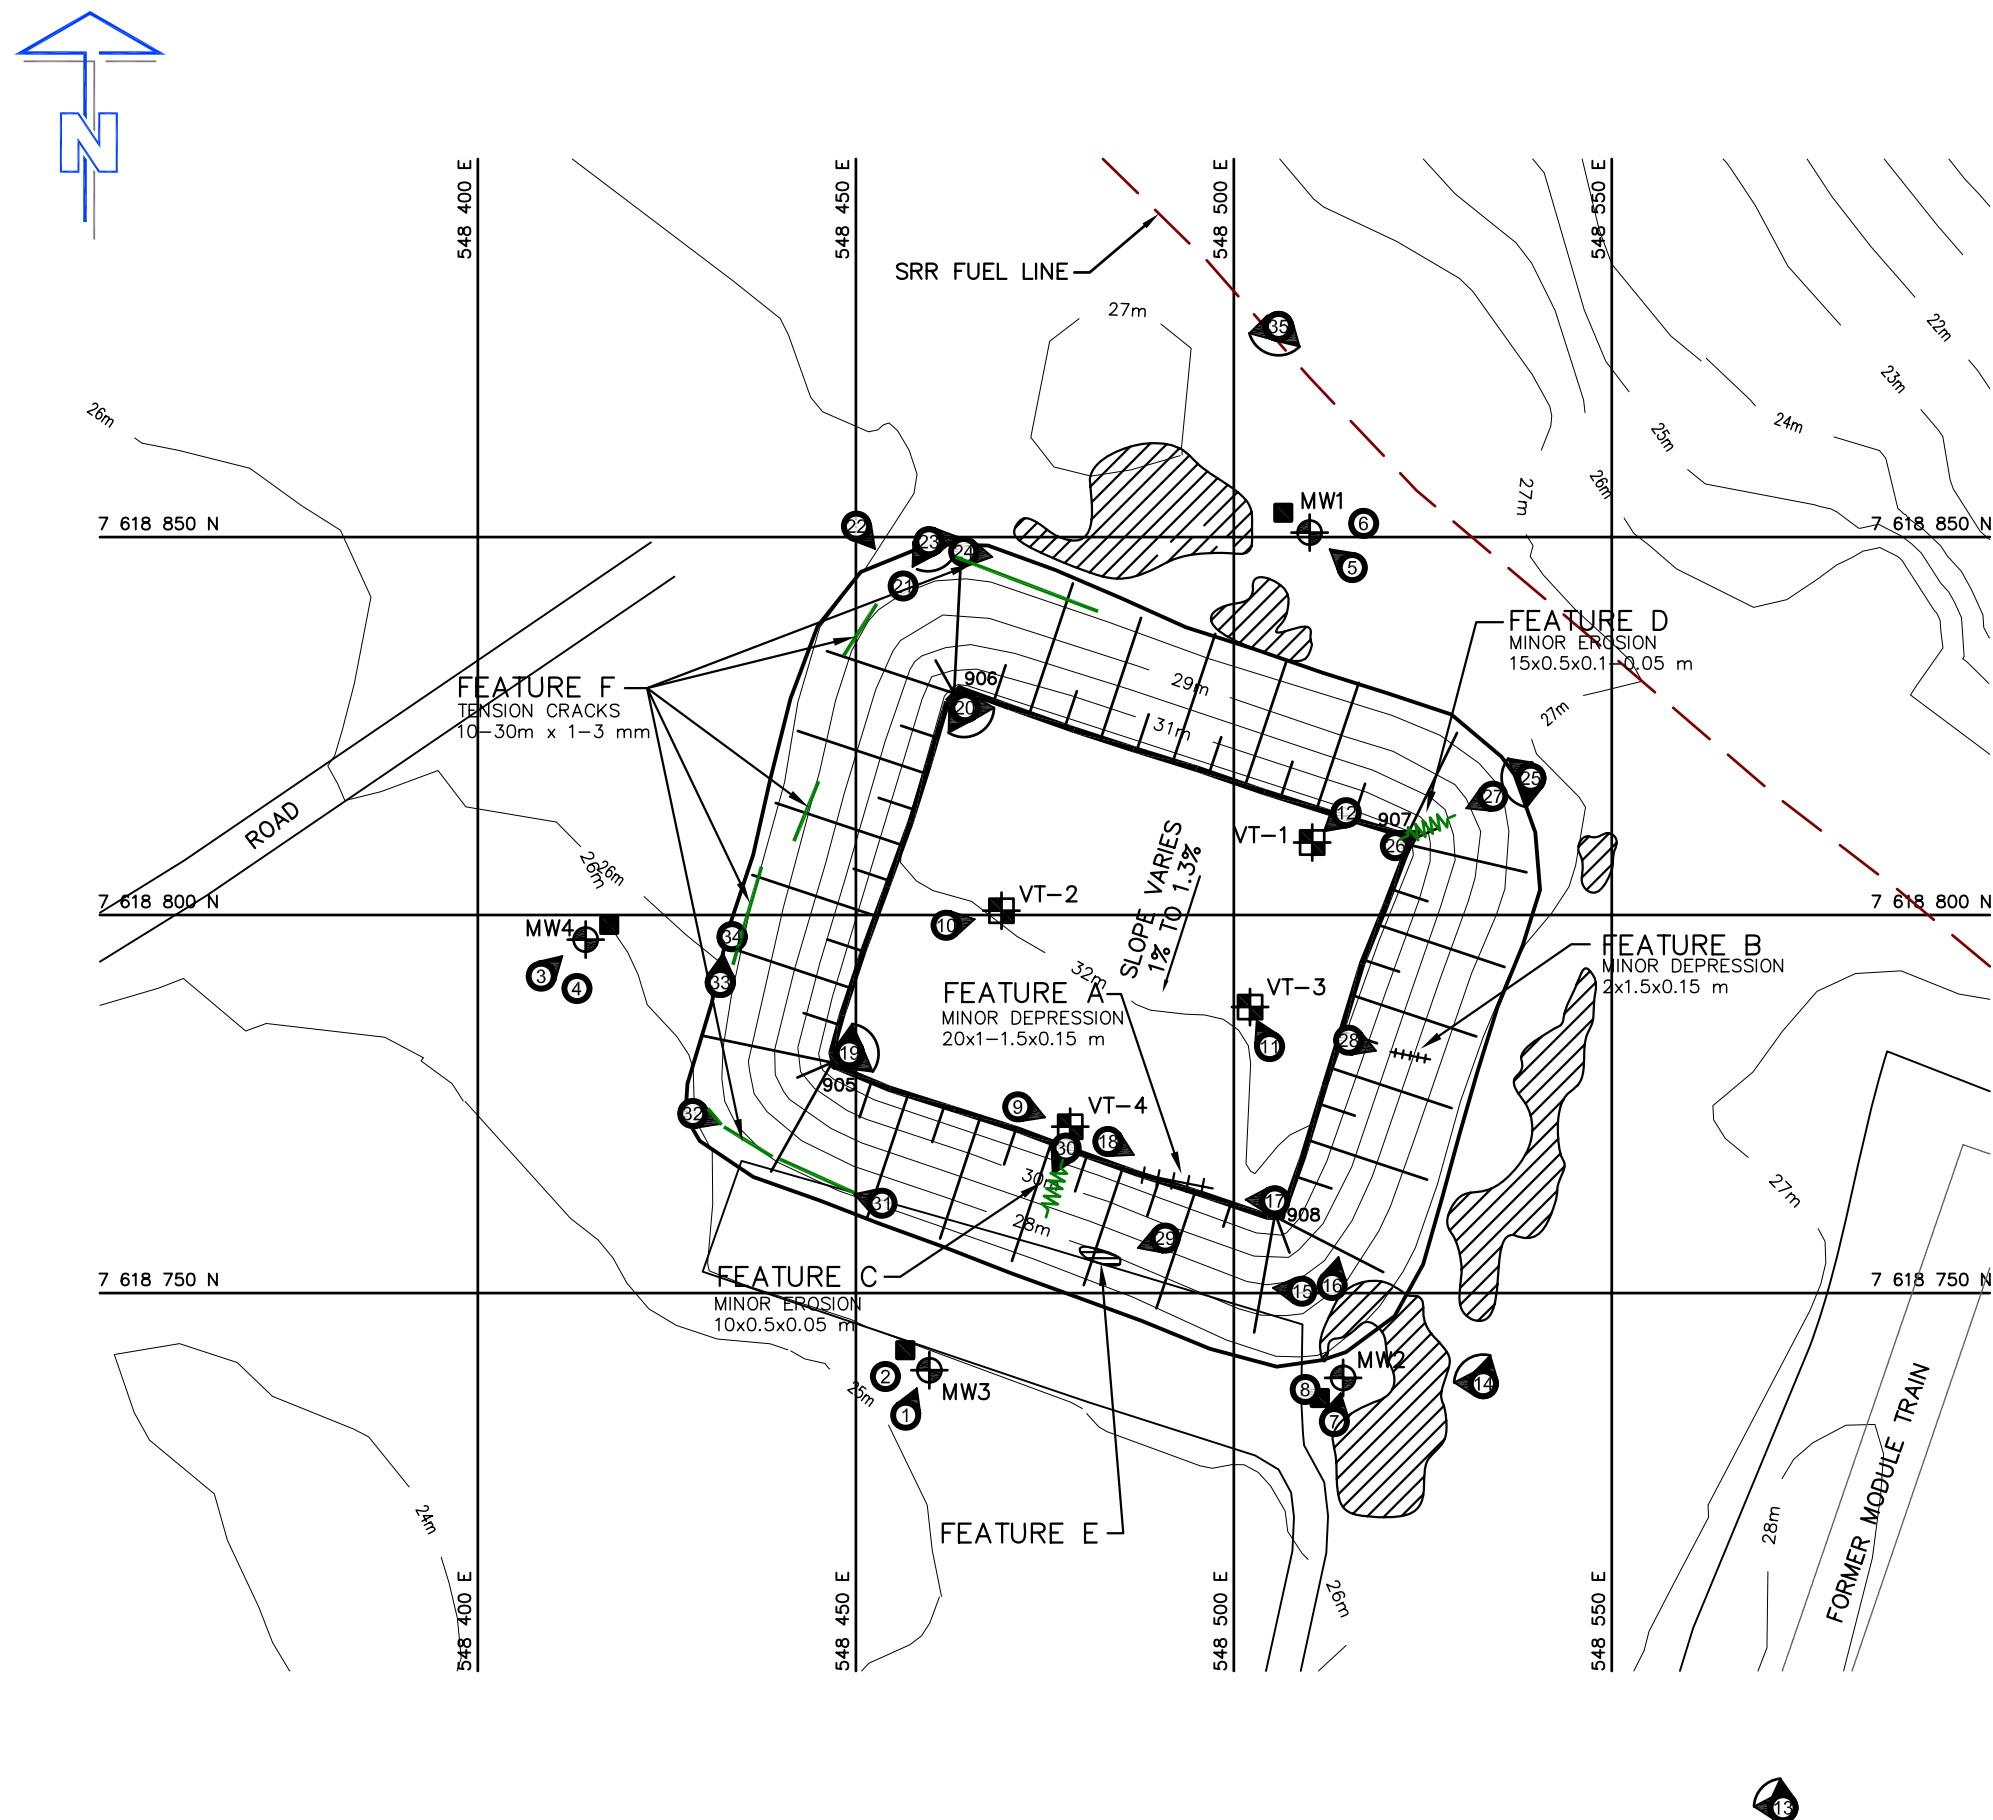
The Location Plan for the Tier II Disposal Facility has been completed as per the ToR and is presented in Figure CAM-2.5.

Indications of settlement were noted at two locations (Feature A and B) on the facility surface. Feature A consisted of linear depression extending parallel to the crest on the southeast area of the facility (southeast of VT-4), whereas Feature B consisted of a more localized depression on the east facing slope east of VT-3. Both features appear unchanged from the previous 2008 inspection and have an acceptable severity rating.

Evidence of minor surface erosion was noted at two locations on the surface of the landfill, including Feature C located on the slope southwest of VT-4 and Feature D located on the northeast corner of the landfill. Both features extend perpendicular to the slope, appear to be self-armouring and have an acceptable severity rating. Overall, the facility cover appears stable and unchanged from the 2008 inspection.

Evidence of seepage was noted at one location on the southwest slope of the facility consisting of a localized wetted area approximately 5 m above the toe (Feature E). The facility cover appears stable with no erosion noted.

Several thin tension/desiccation cracks were noted extending along the toe parallel to the slope on the southwest, west and northwest sides of the facility cover (Feature F). The frequency and magnitude of cracks appear to be less than that observed in 2008, possibly due to partial/complete infilling. No further indications of desiccation/movement were noted.

Several areas of ponded water were noted along the north and east sides of the facility, including an area in close proximity to MW-2. The ponding is the result of low relief and poor drainage through fine-grained soils that underlay the area.

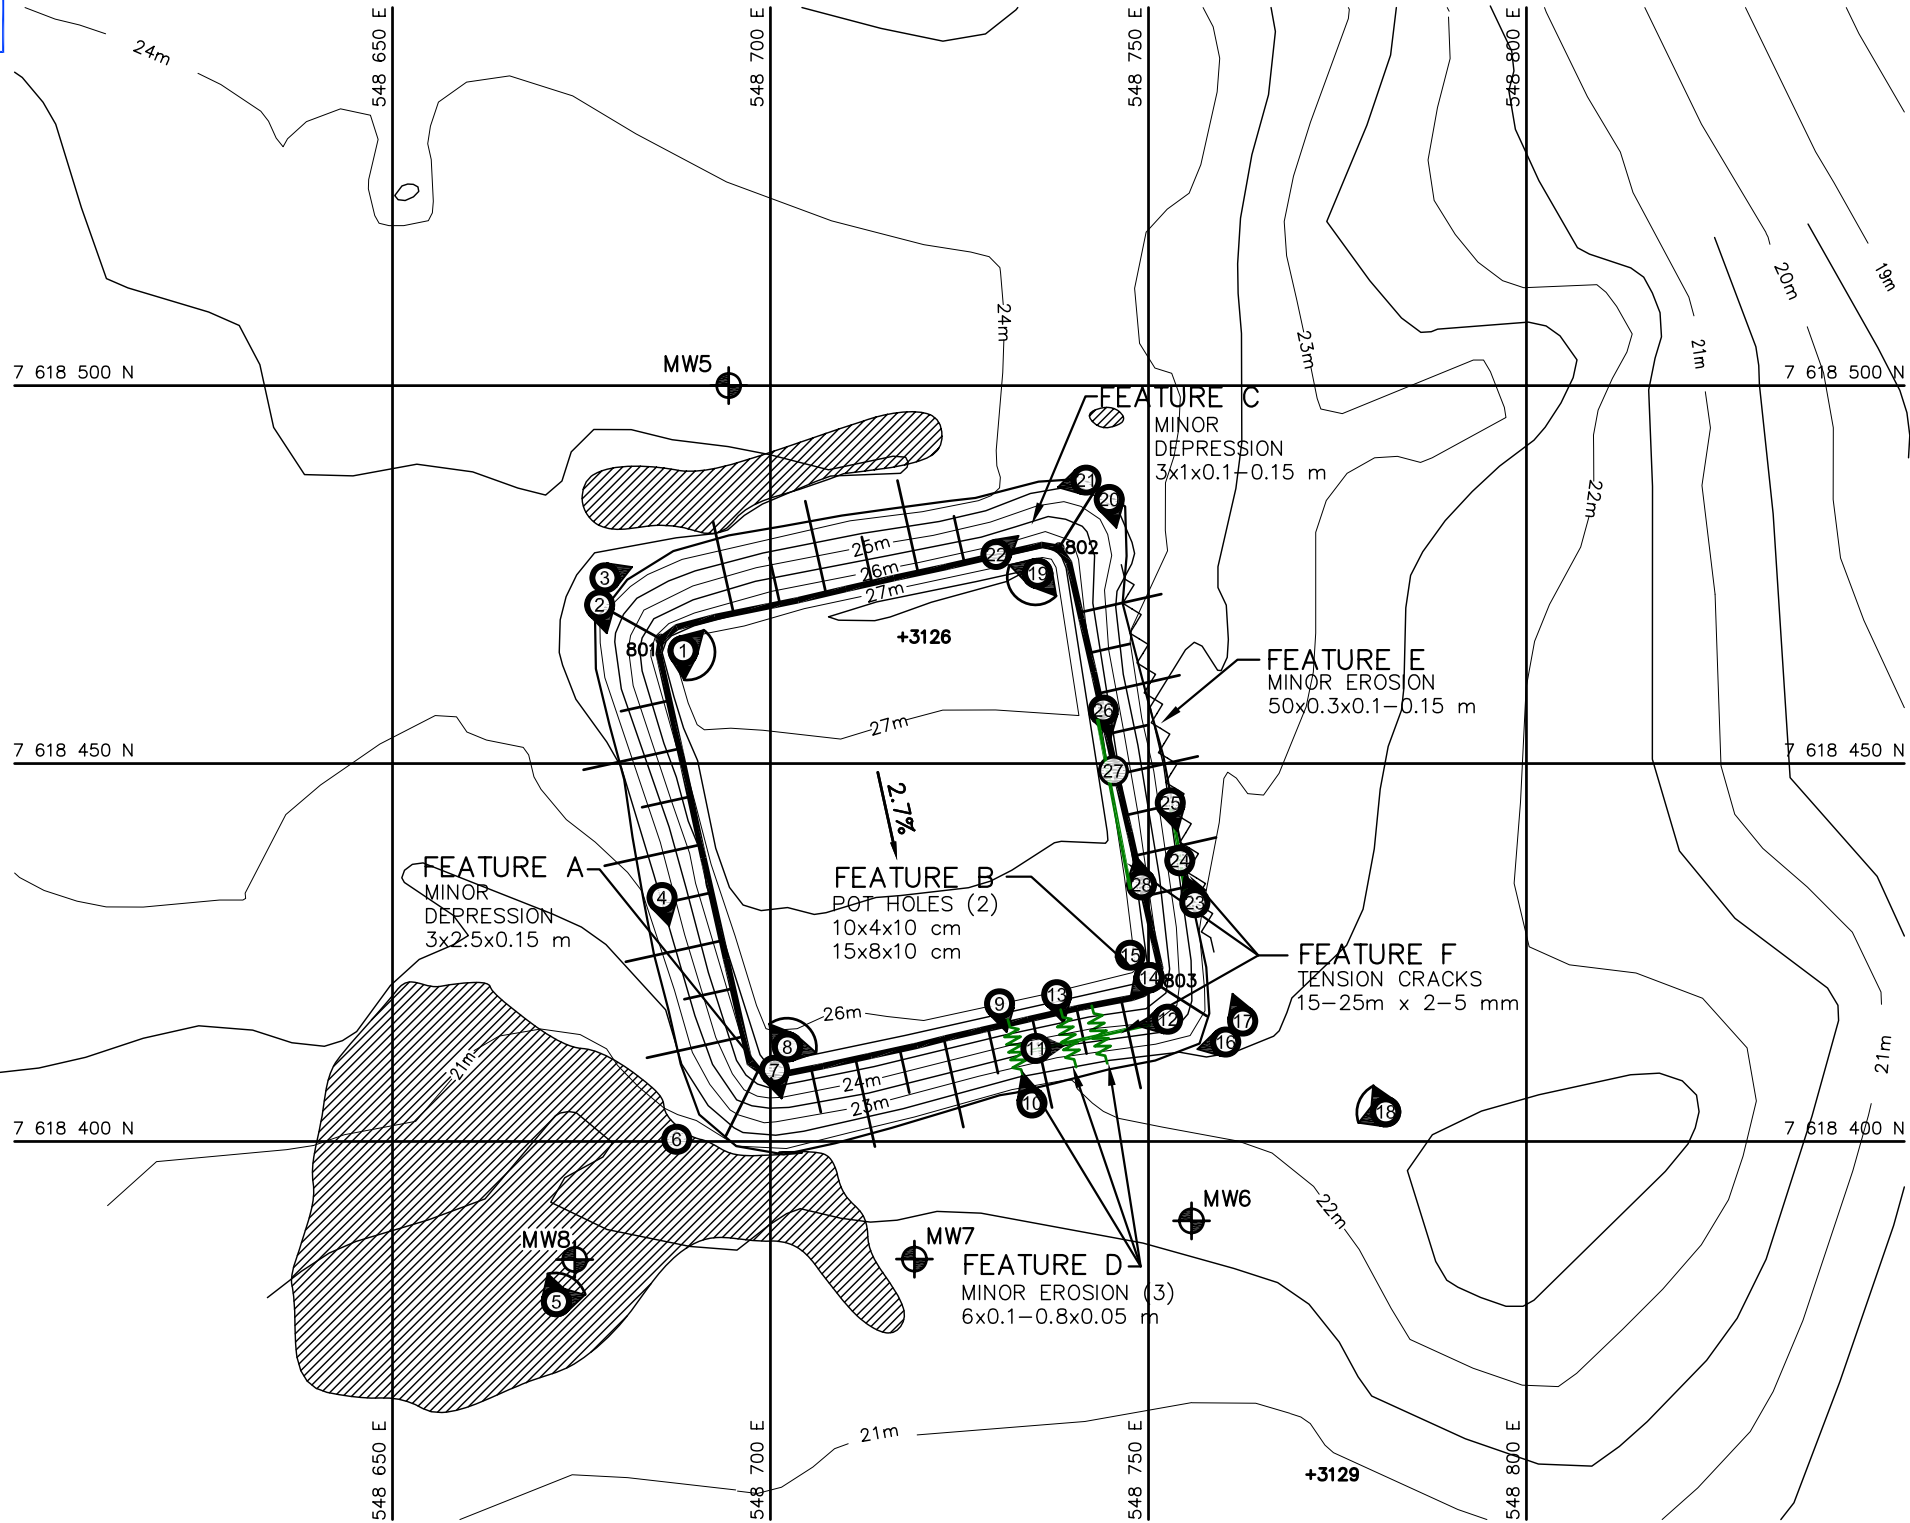
The Location Plan for the NHWLF has been completed as per the ToR and is presented in Figure CAM-2.6.

Indications of localized settlement were noted at three areas (Features A, B and C) on the landfill surface, including two linear depressions extending parallel to the crest on the southwest and northeast corners of the landfill (Features A & C) and two isolated pot holes in a common area on the southeast corner of the landfill surface. These features were not noted as part of the 2008 inspection. These features have an acceptable severity rating.

Evidence of erosion was noted in two areas at the landfill, including several minor surface erosion channels extending along the south slope of the landfill cover (Feature D) and a minor erosion channel extending along the east toe of the landfill (Feature E). The level of erosion appears consistent with the previous year's observations (photos) and planned measures to direct flow around the landfill. Both features appear to be self-armouring and have an acceptable severity rating. Overall, the facility cover appears stable and unchanged from the 2008 inspection.

Several tension/desiccation cracks were noted extending along and parallel to the south and east slopes and east crest of the landfill cover (Feature F). The frequency and magnitude of cracks appear to be less than that observed in 2008, possibly due to partial/complete infilling. No further indications of desiccation/movement were noted.

Areas of ponded water were noted along the north and southwest sides of the landfill. The ponded area to the southwest exhibited slight rust-coloured staining in the area immediate to the landfill toe. Areas of direct seepage were not observed at this location. The ponding is largely the result of low relief and poor drainage through the fine-grained soils that underlay the site.
