**THE COLLECTION OF LANDFILL  
MONITORING DATA AT THE FORMER  
CAM-2 DEW LINE SITE**

Gladman Point, Nunavut

**FINAL REPORT – 2010**

**DEFENCE CONSTRUCTION CANADA**

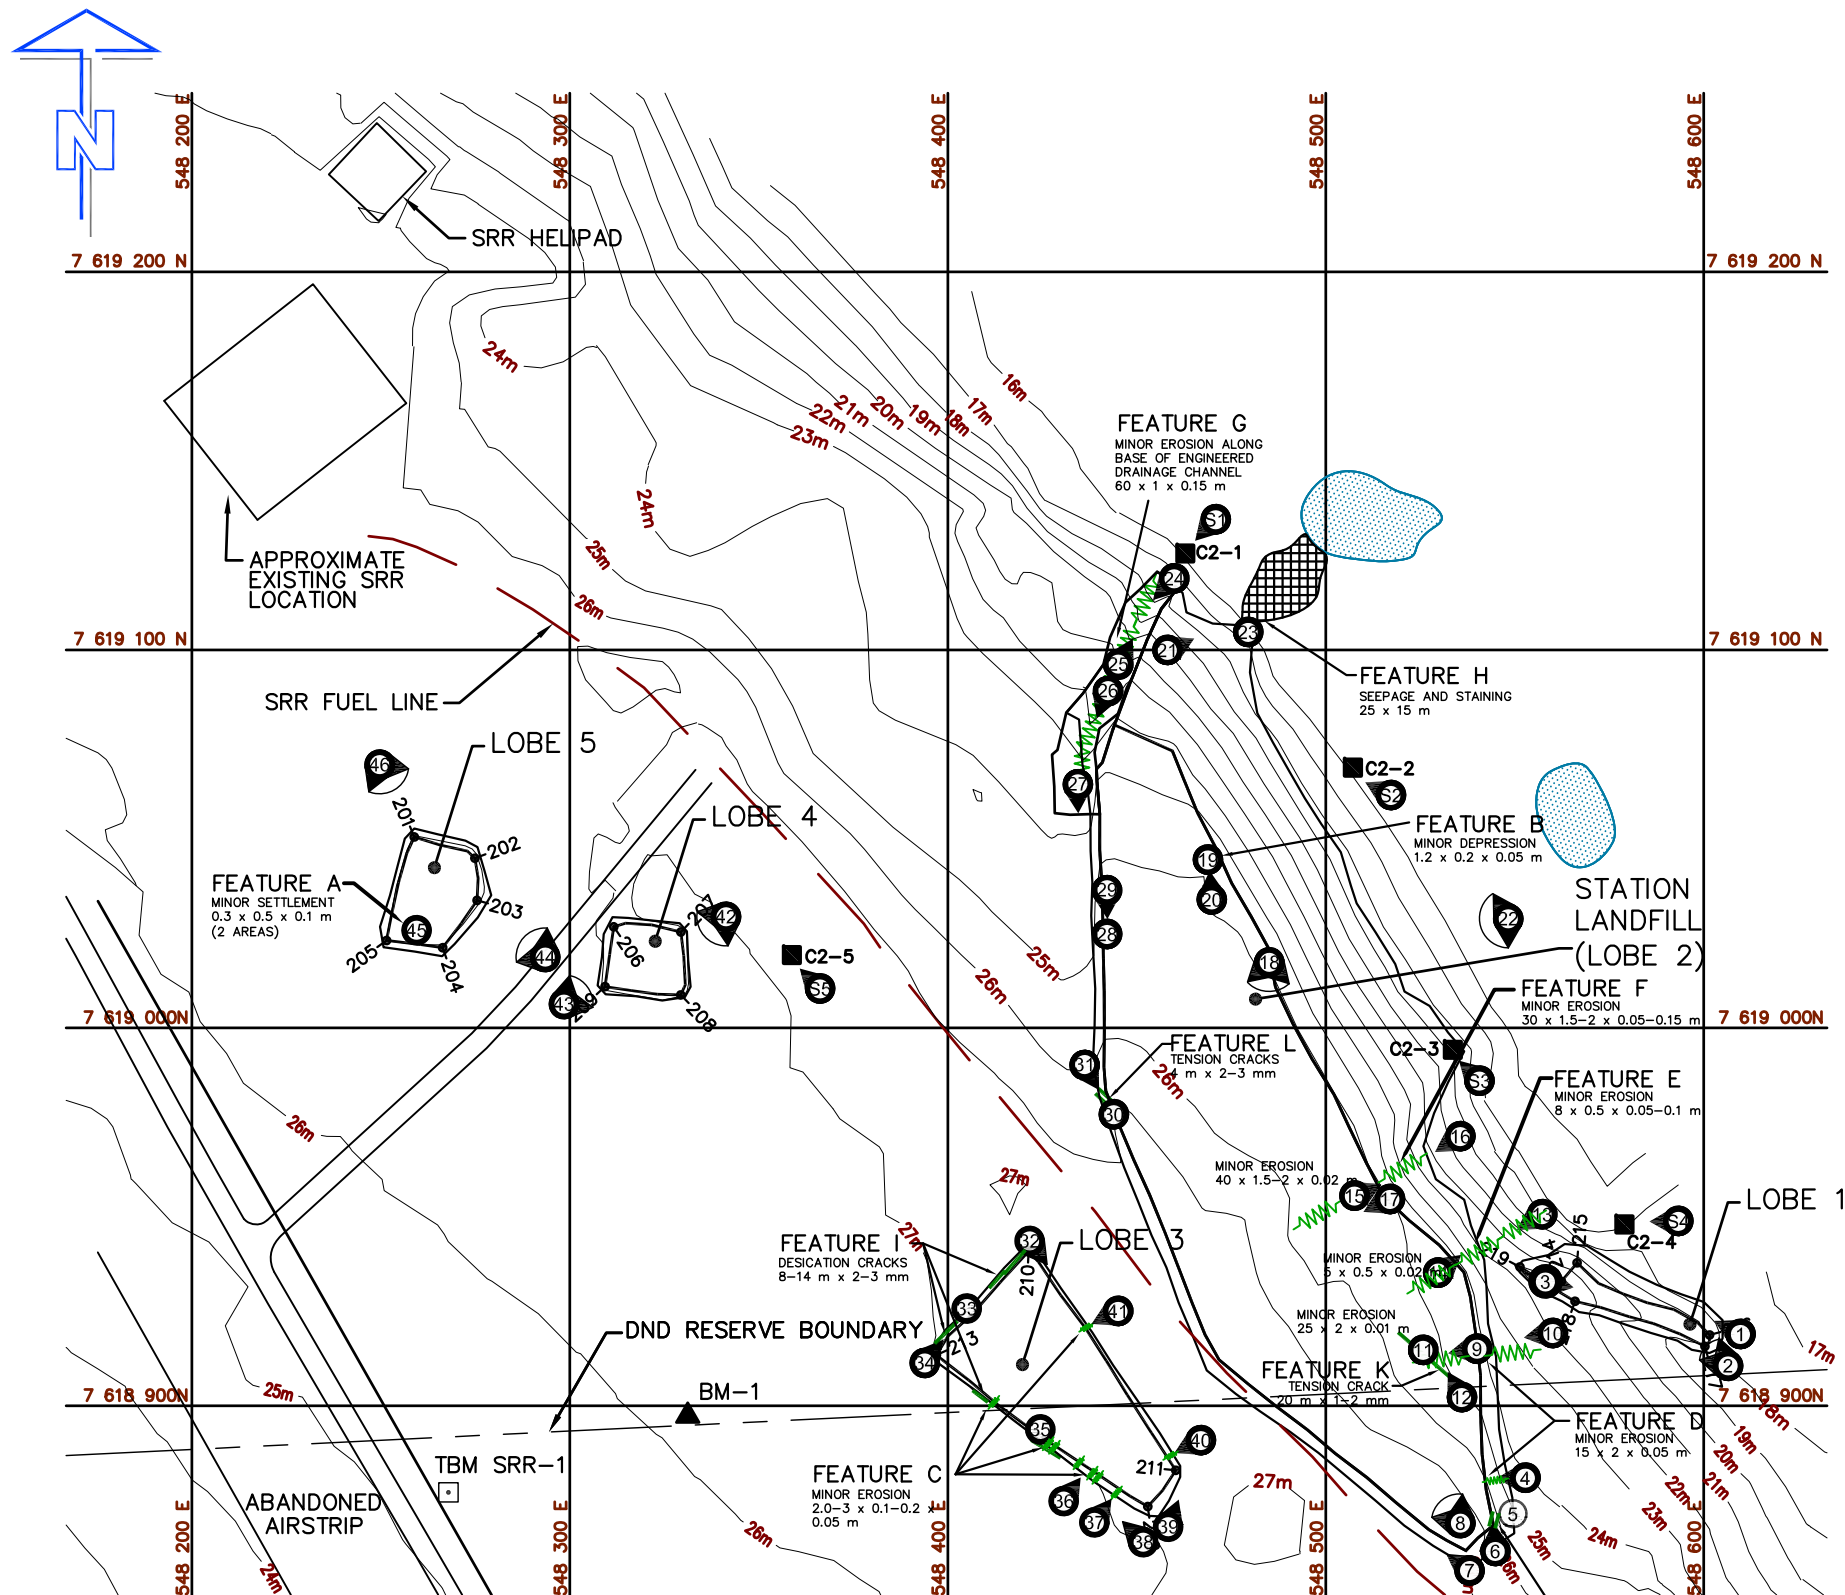
The Location Plan for the Station Landfill has been completed as per the ToR and is included in the following page as Figure CAM-2.2 Gladman Point – Station Landfill.

Indications of minor settlement were noted at two locations (Feature A and B) on the landfill surface of Lobes 5 and 2, respectively. Feature A consisted of two small depressions (potholes) situated on the southwest surface of Lobe 5, with no observable change since the 2009 inspection. Feature B consisted of a single linear depression orientated parallel to the crest on the west side of Lobe 2 and was not noted during the previous 2009 inspection. Both features have an acceptable severity rating.

Five general areas (Features C through G) of erosion were noted on the surface, side slopes and/or margins of the Station Landfill during the 2010 inspection. Several localized areas of shallow erosion were noted on the southwest facing slope of Lobe 3 (Feature C); and several larger areas of shallow erosion that extended across the top and side slopes on the southeast and east area of Lobe 2 (Features D, E and F).

One area of rust-coloured staining (Feature H) was observed on the northeast corner of Lobe 2, extending from the landfill toe to a nearby pond situated approximately 25 m to the east. Staining was consistent with observations made during the 2009 inspection, and appears to be a pre-existing feature at the landfill. There was no hydrocarbon sheen associated with the staining at the time of the inspection.

One area of seepage associated with the rust-coloured staining (Feature H) was noted on the northeast side of Lobe 2. Wet and saturated soil conditions were observed on the downgradient slope within 5 m of the toe. Based on the location of the seepage, it is assumed that this feature is contributing to the ponded water and rust-coloured staining observed at the toe of the landfill.

Several thin tension/desiccation cracks were noted on the surface and/or side slopes of Lobes 3 (Feature I) and Lobe 2 (Features J, K and L). Feature I generally consisted of single cracks that extended perpendicular to the slope direction on the northwest and southeast sides of the lobe. Some areas of multi-directional cracking were also noted on the southwest side of the lobe. Features J and L on Lobe 2 consisted of relatively short parallel cracks that extended approximately 45 degrees to the slope direction. Feature K consisted of a longer single crack that was orientated in a NW/SE direction across the surface on the east side of the lobe. Feature I appeared consistent with observations made during the 2009 inspection, whereas Features J, K and L were new observations. Based on observations made during the 2010 inspection, the landfill surface appears stable and all features have an acceptable severity rating.

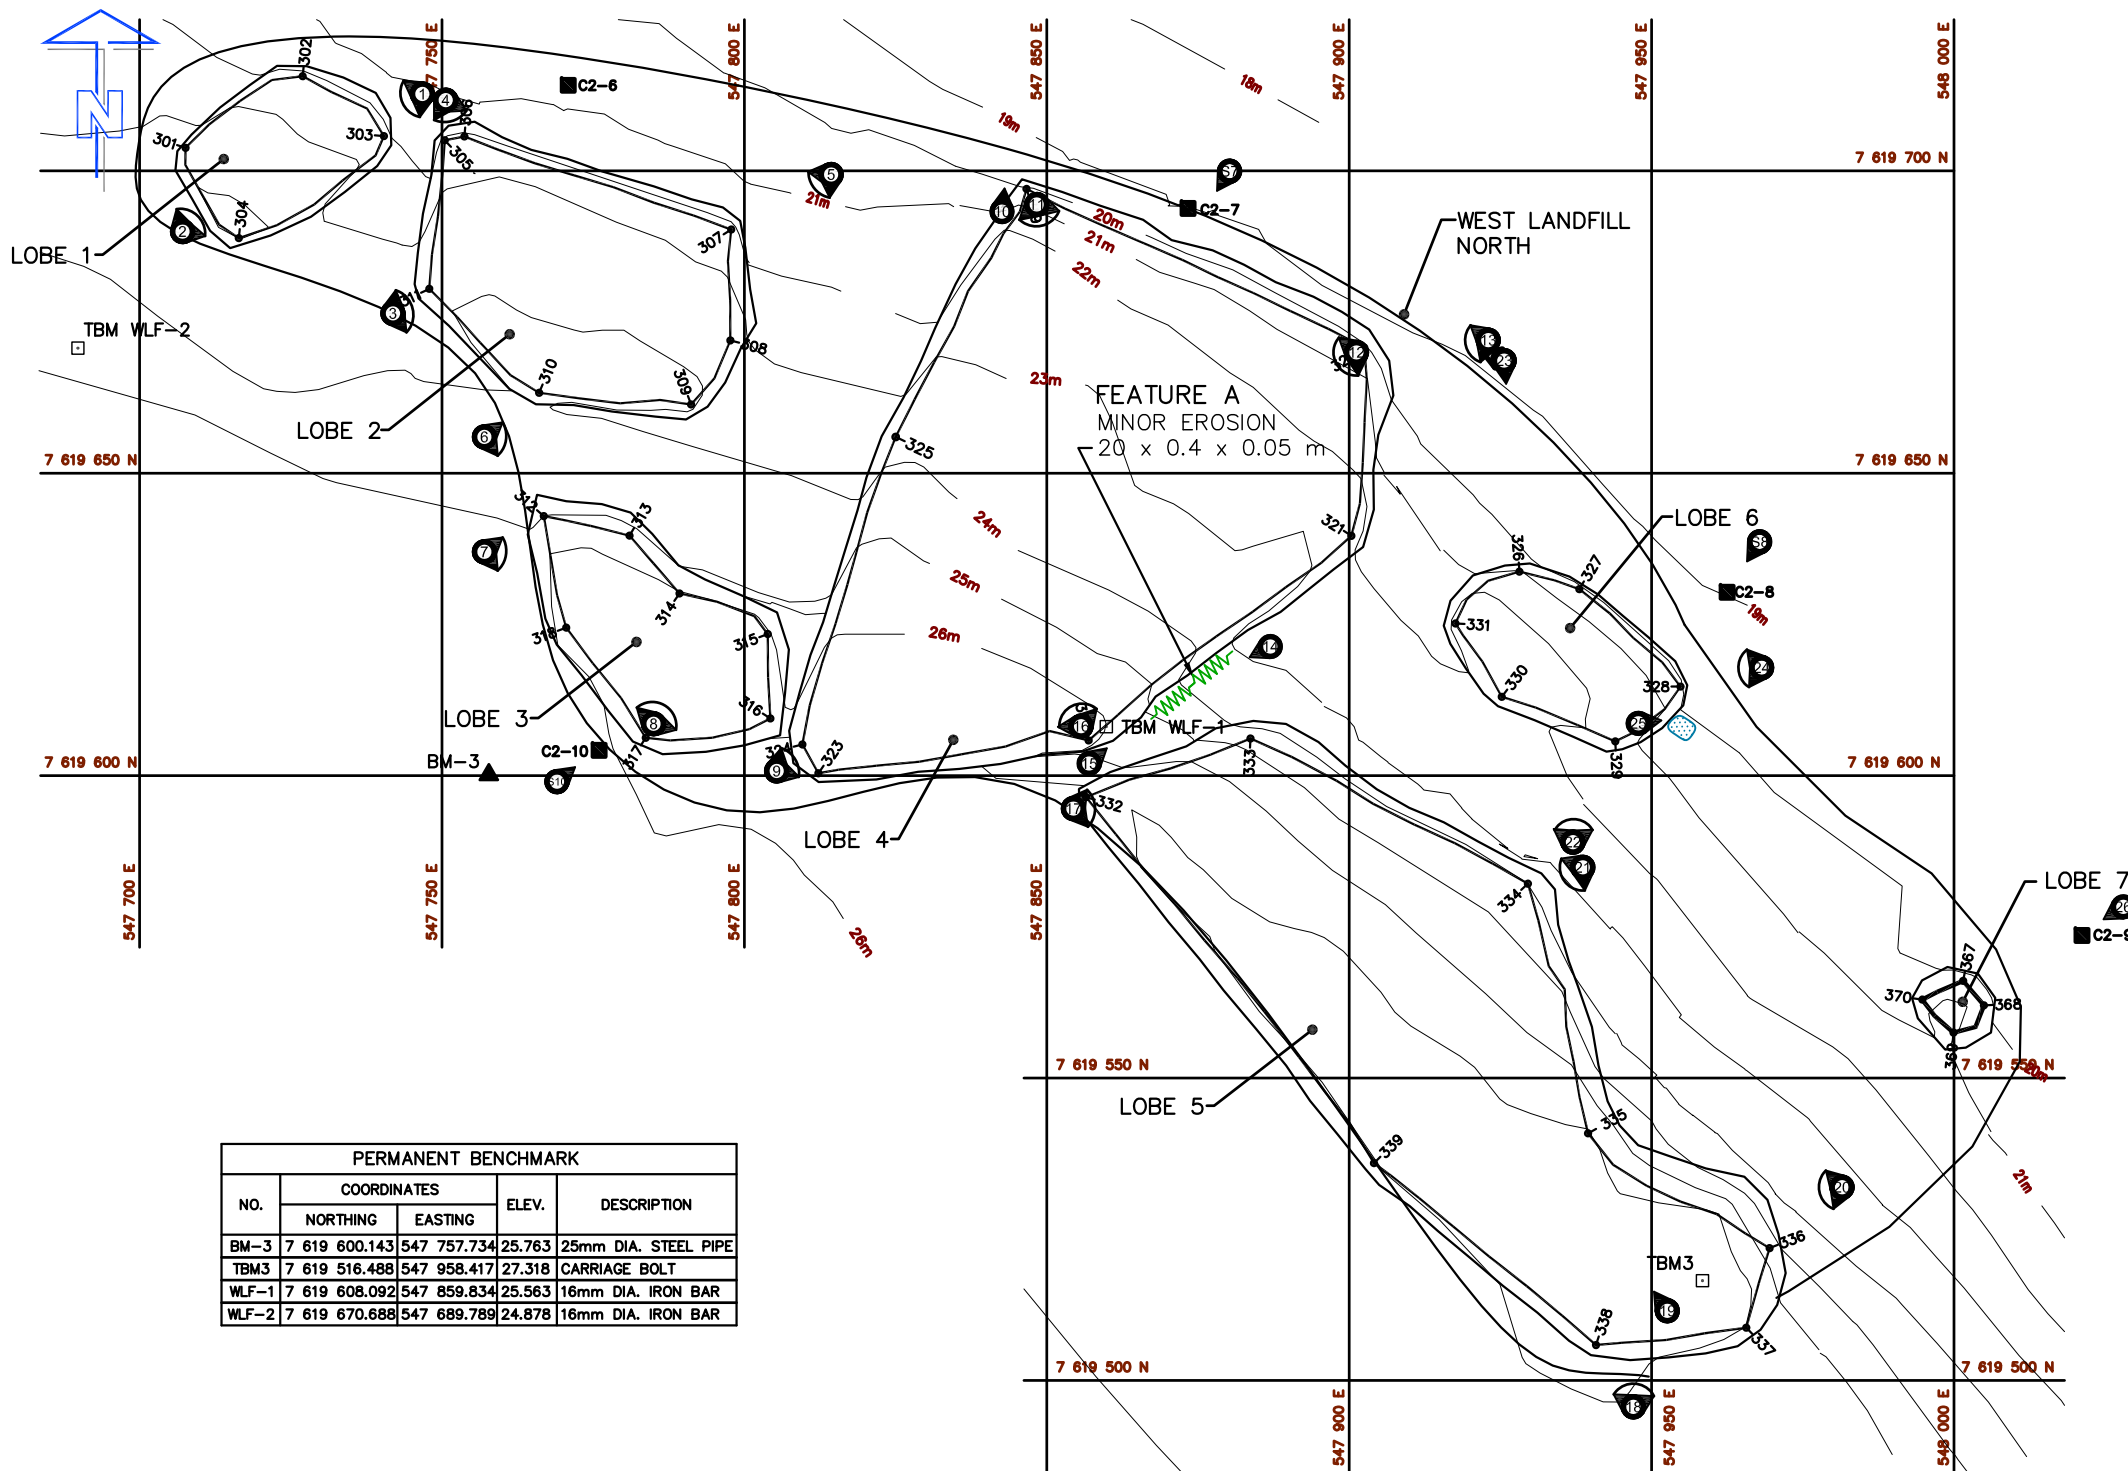
The Location Plan for the West Landfill – North has been completed as per the ToR and is included in the following page as Figure CAM-2.3 Gladman Point – West Landfill – North.

Minor surface erosion was noted along a runoff channel that extends between two closely spaced lobes (Lobes 4 and 5) in the central area of the landfill (Feature A). The erosion was noted to extend along the toe of Lobe 4 and is not in direct contact with the landfill.

A single area of ponding was noted at the toe of one of the downgradient lobes. The ponded water was contained to a small dug-out area located immediately adjacent to Lob 6.

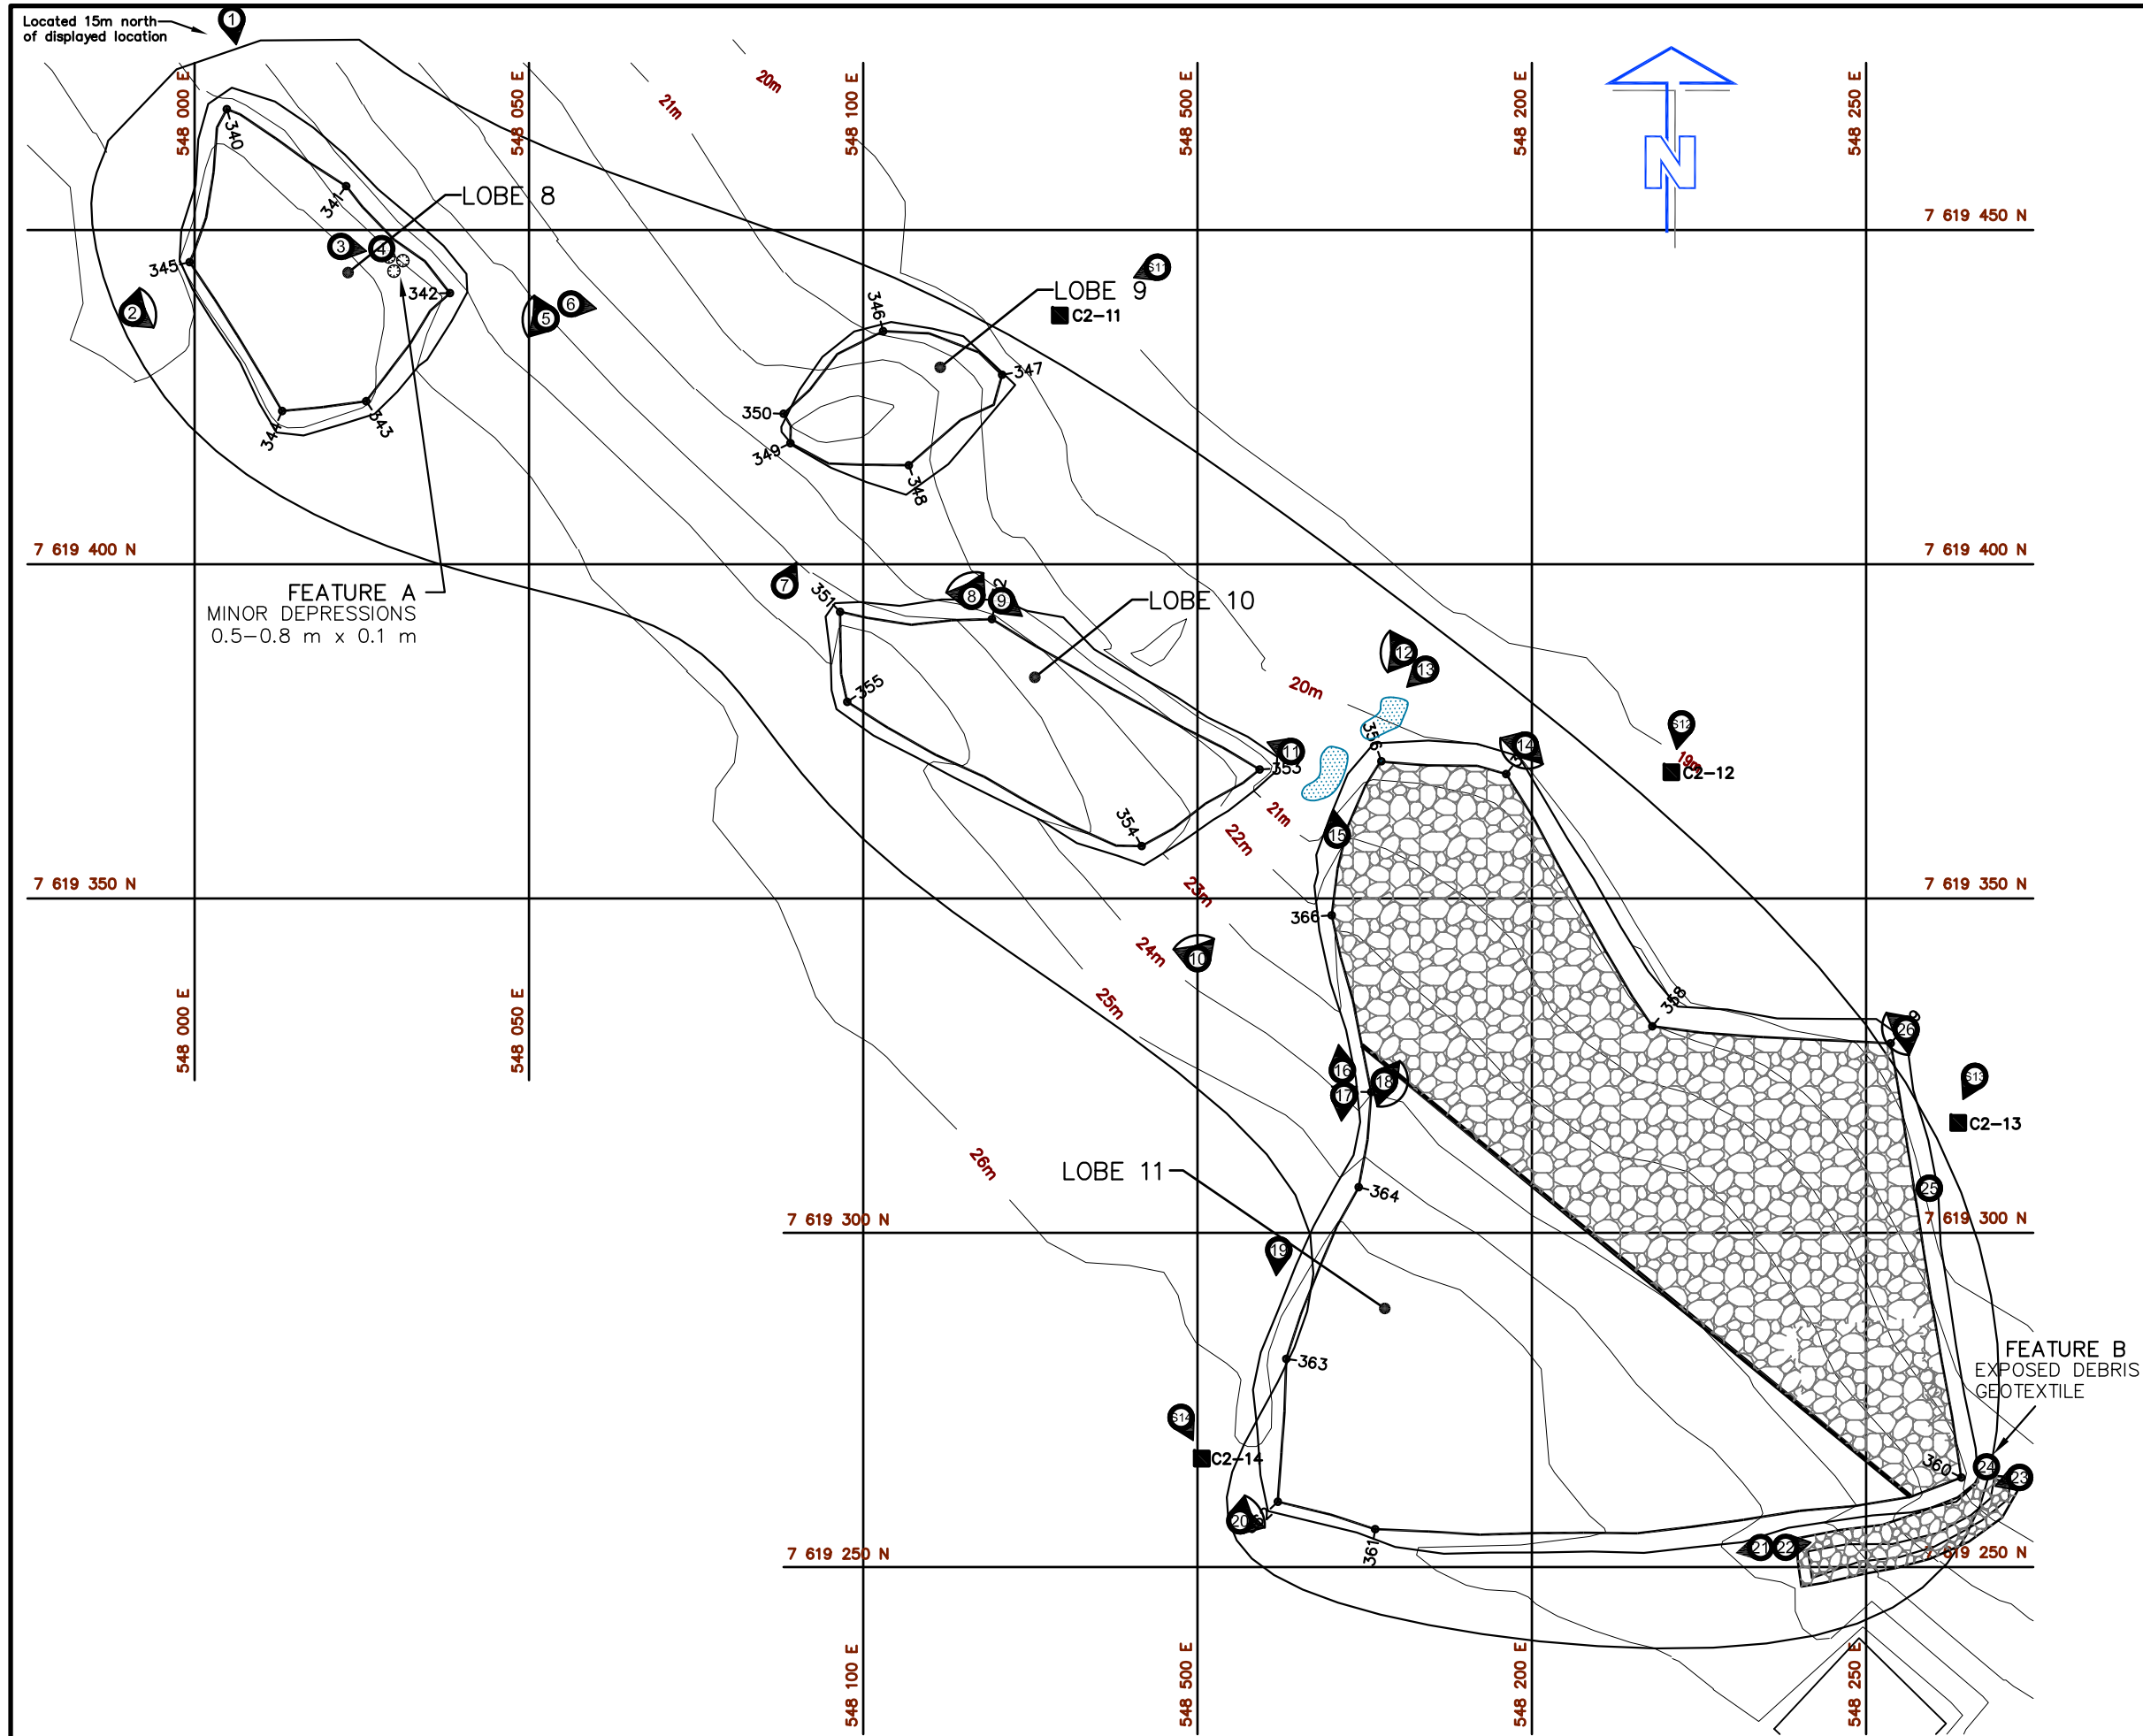
The Location Plan for the West Landfill – South has been completed as per the ToR and is included in the following page as Figure CAM-2.4 Gladman Point – West Landfill – South.

Indications of minor settlement were noted in one area (Feature A) on Lobe 8. Feature A consisted of three small closely spaced depressions (potholes) situated on the east surface of the lobe. Feature A was not noted during the previous 2009 inspection.

There was one notation of debris in the area immediately south of the landfill, including a piece partially exposed black geotextile material (Feature B). The length and depth of the debris is not known, however it is suspected the geotextile may be associated with the engineered drainage channel constructed immediately to the west. The piece of debris appeared to be isolated and outside the landfill regrade area. A single piece of metal debris was also noted on surface immediately east of Lobe 11.

A single area of ponding was noted in a low lying area extending between Lobe 11 and adjacent Lobe 10 to the north. There were no seepage points or staining associated with the ponded water.

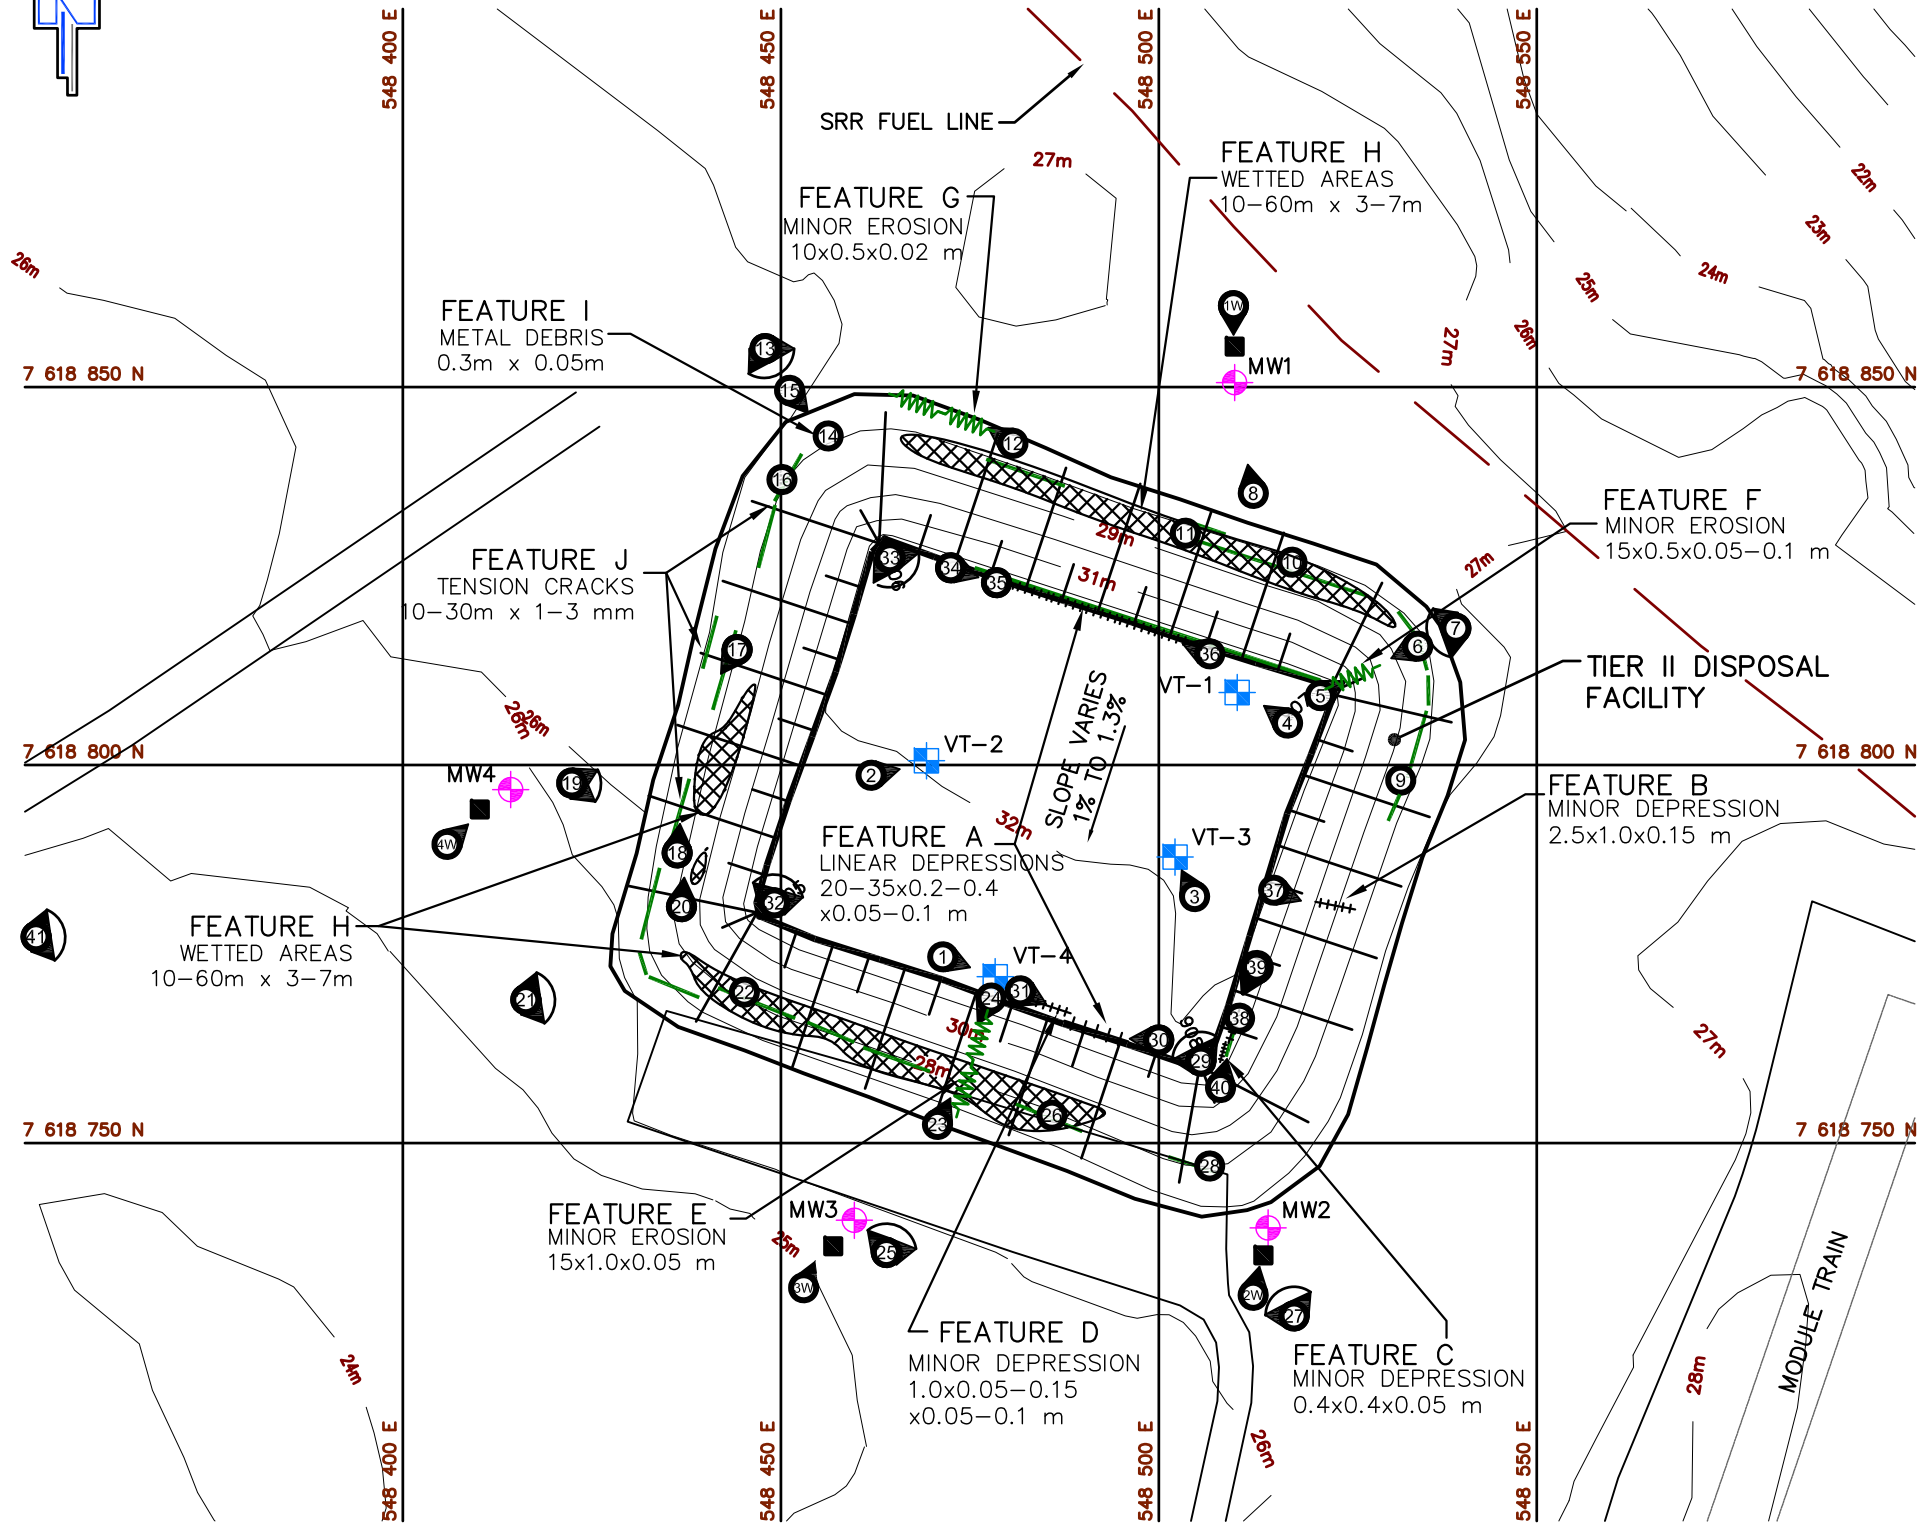
The Location Plan for the Tier II Disposal Facility has been completed as per the ToR and is included in the following page as Figure CAM-2.5 Gladman Point – Tier II Disposal Facility.

Indications of settlement were noted at four locations (Features A through D) on the facility surface. Feature A consists of subtle narrow linear depressions extending along the north central and southeast crests, whereas Features B, C and D consist of more localized depressions on the east facing slope, southeast corner and south central surface, respectively. The linear depression along the north crest (part of Feature A) and Features C and D were new observations during the 2010 inspection. All features have an acceptable severity rating.

Evidence of minor surface erosion was noted at two locations on the surface of the facility, including Feature E located on the slope southwest of VT-4 and Feature F located on the northeast corner of the landfill. Both features extend perpendicular to the slope, appear to be self-armouring and have an acceptable severity rating. One additional area (Feature G) of minor erosion was noted along the northwest toe and is not in direct contact with the facility. Overall, the facility cover appears stable and relatively unchanged from the 2009 inspection.

Evidence of seepage (Feature H) was noted along the southwest, south and north side slopes of the facility with extensive wetted areas generally extending within 5 m of the toe in each affected area. The facility cover appears stable with no erosion noted. However, numerous tension cracks were also generally associated with these areas.

Evidence of debris was noted at one location on the northwest toe of the facility (Feature I), consisting of a partially exposed piece of 50 mm diameter steel pipe. The debris appeared to be isolated however the overall length and depth are unknown. This feature was referenced under the Station Landfill in the 2009 inspection report.

Numerous thin continuous and discontinuous tension/desiccation cracks were noted along the north, northeast, west and south slope of the facility cover (Feature J). The frequency and magnitude of cracks appears to be greater than previously observed in 2009, with several areas of newly developed parallel cracks along the north and west sides of the facility. Crack locations were generally located within the lower 5 m of the slope, with many of the cracks extending in the 4-5 m range up from the toe.
