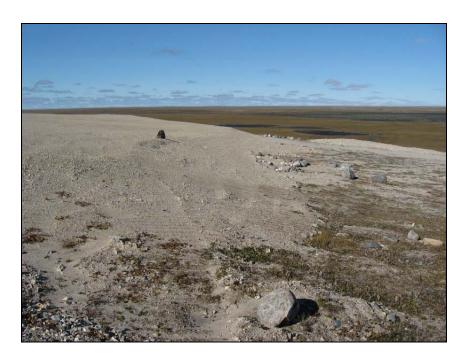
Photograph STA-1. Looking N from SE corner of main (larger eastern) landfill cell.

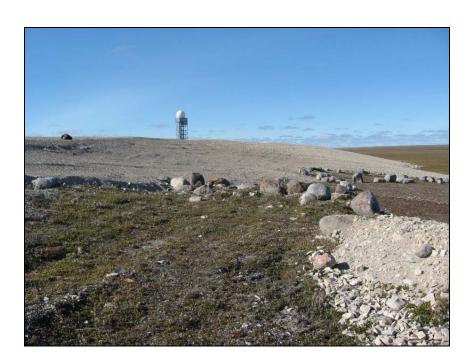
Photograph STA-2. Looking NNW along E toe of main landfill cell.

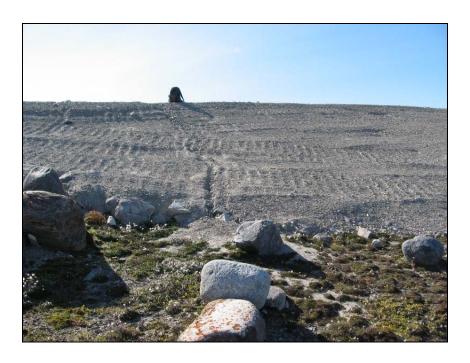
Photograph STA-3. Looking upslope to area of minor surficial erosion. Condition is essentially uncharged from last year. Granular cover is self-armouring. ♠

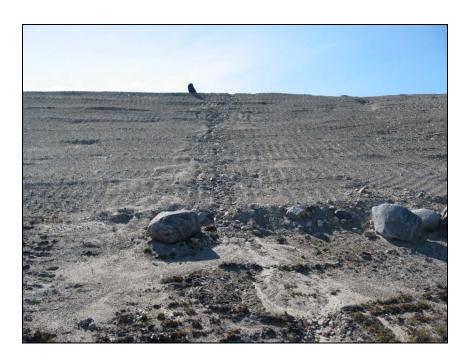
**Photograph STA-4.** Looking upslope to area of minor surficial erosion. Condition is essentially unchanged from last year. Granular cover is self-armouring. ♠

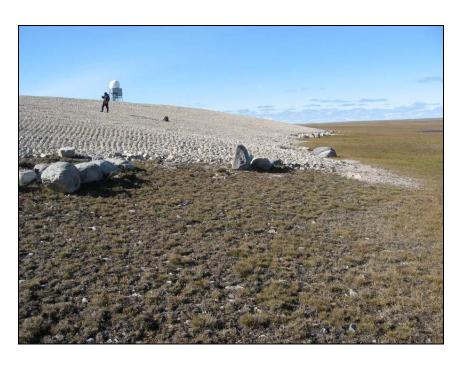
Photograph STA-5. Looking NNW along E slope of landfill looking to the NE corner of the main landfill cell. ↑

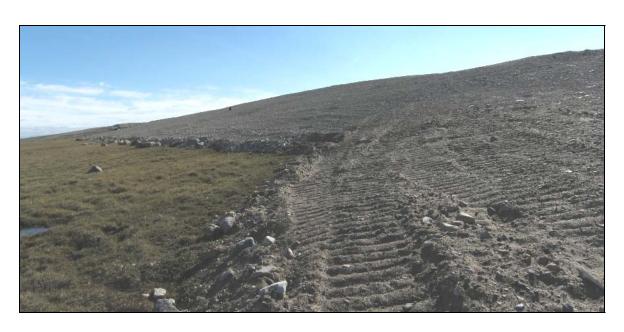
Photograph STA-6. Looking SSE along E slope. Slope appears stable.

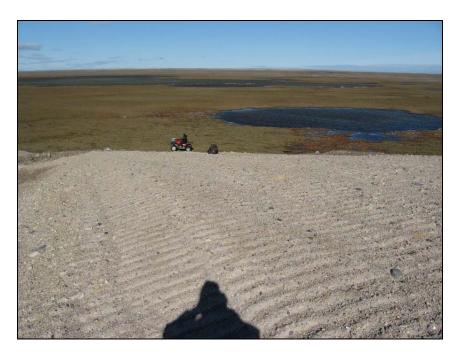
Photograph STA-7. Looking NE to NE toe of main landfill cell. Granular cover appears stable No features of note. ♠

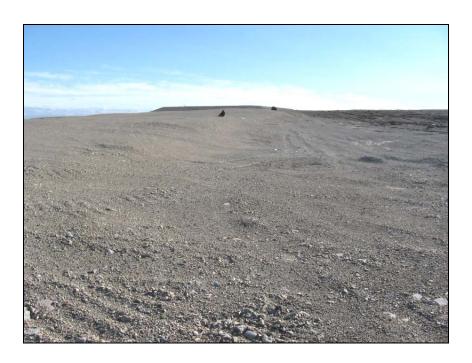
**Photograph STA-8.** Looking S from the NW corner of the main landfill cell along W side.

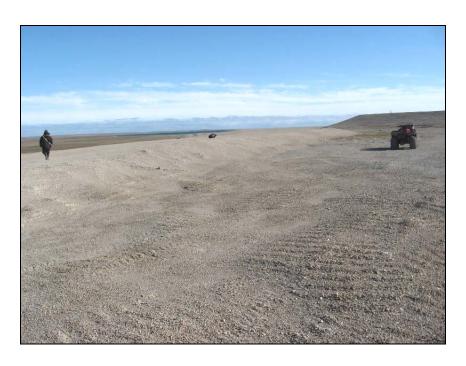
Photograph STA-9. Looking SSE along W side of the main cell of the Station landfill to the SW corner.

Minor relief. Granular cover appears stable. ↑

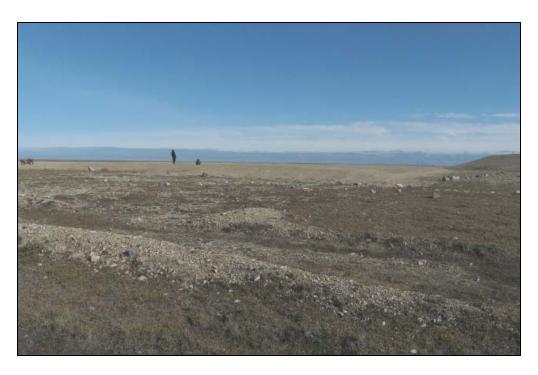
Photograph STA-10. Looking E to NW corner of the small SW cell of the Station Landfill. Granular cover appears stable. Honda parked adjacent to main cell on the extreme left of the photo. Tier II landfill (NE corner) visible in the background. ↑

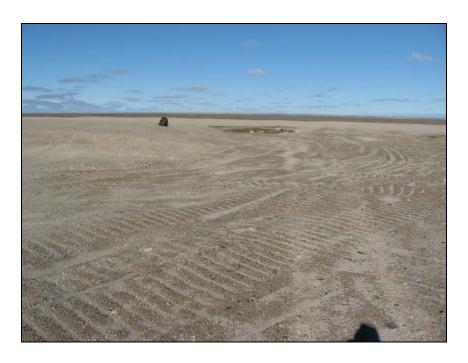
Photograph STA-11. Looking NE to the SW corner of small SW cell. Main Station Landfill cell is visible in the background. ♠

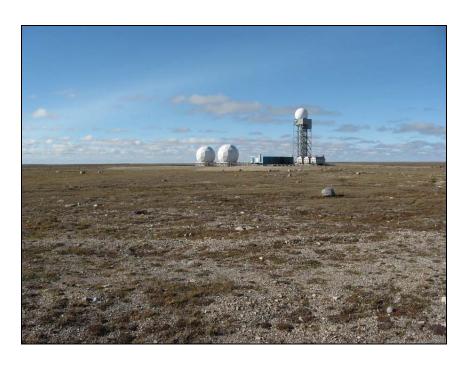
Photograph STA-12. Looking NW to the two small cells NW of the main Station Landfill cell. No features of note upon detailed inspection. ♠

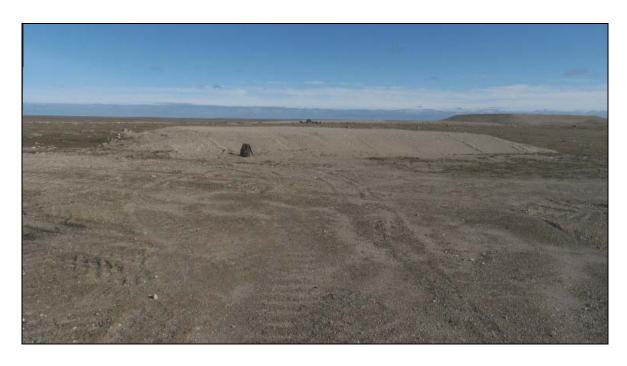
Photograph STA-13. Looking SE to the NW corner of the SE most of the two small landfill cells. Granular cover appears stable. No features of note. ↑

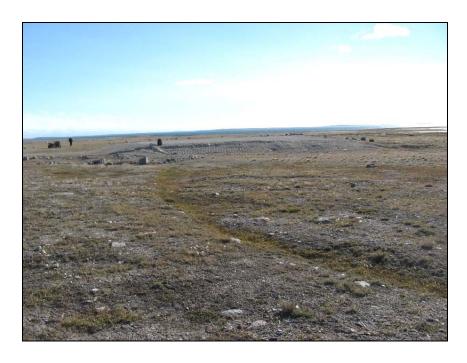
Photograph STA-14. Looking S to the NE corner of the NW most of the 2 small cells. Granular cover appears stable. No features of note. ♠

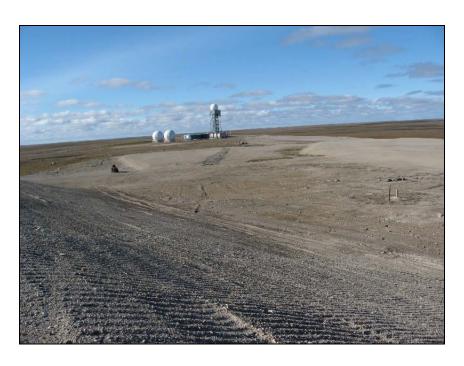
Photograph STA-15. Looking NNW from top of Tier II to the 3 cells to the west of the main Station Landfill cell. Standing on crest at NE corner of Tier II. ♠

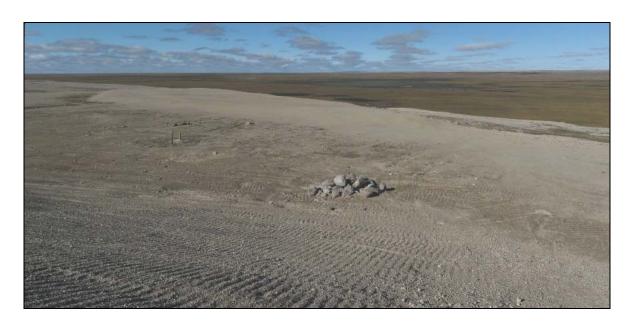
Photograph STA-16. Panoramic of the main Station Landfill cell looking N from the NE crest of the Tier II Landfill. ♠
