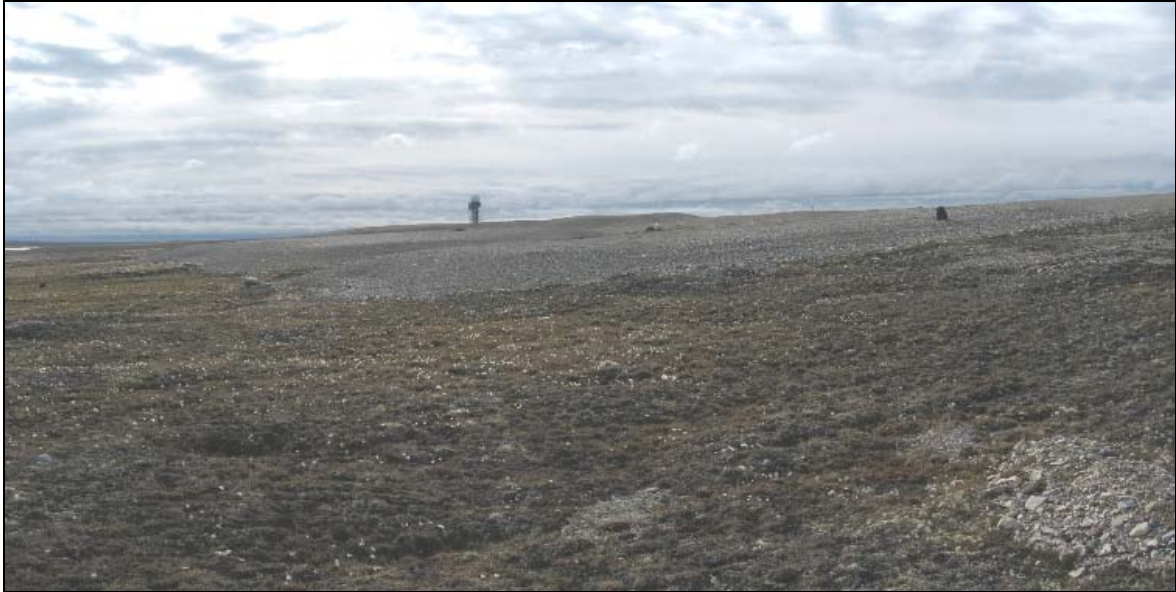
**Photograph WLFN-1.** Looking SW to NE corner of northern most landfill cell. Granular cover appears stable. No features of note. ↑

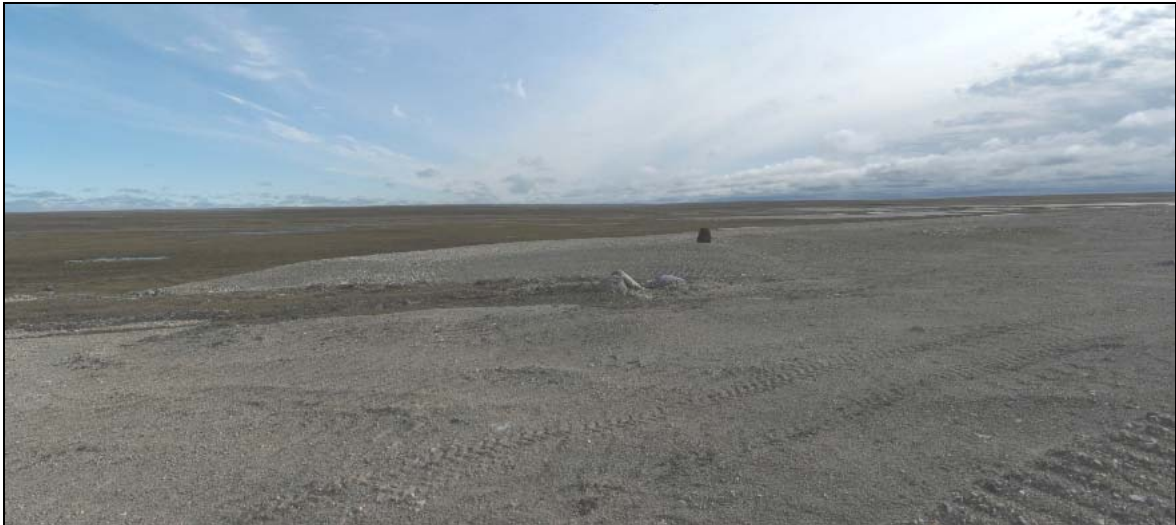
**Photograph WLFN-2.** Looking E to NW corner of 2nd lobe from N. Backpack is near the SW corner for scale. No features of note. ↑

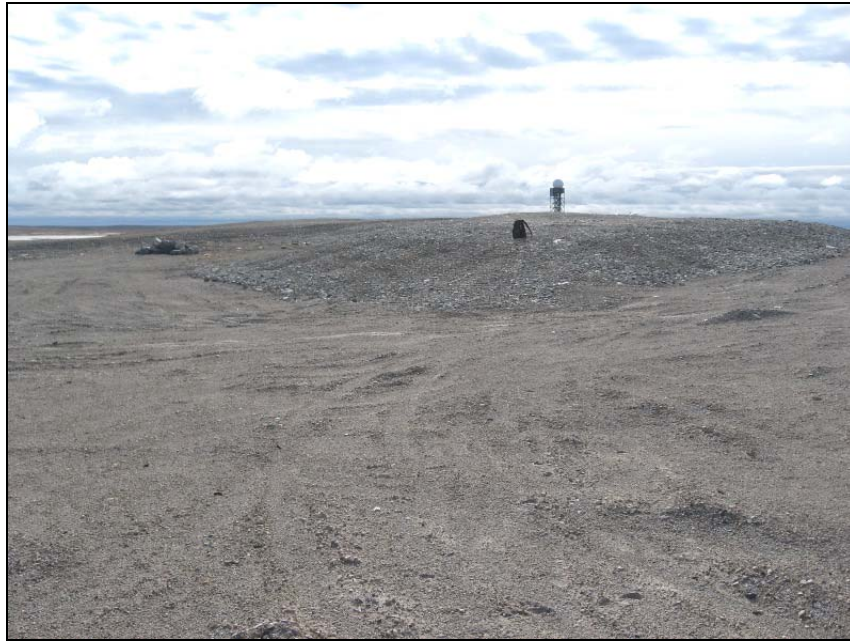
**Photograph WLFN-3.** Looking SE along the northern side of the 3rd cell from the N. Backpack is on the NW corner of the cell. Radar ball tower is visible in the background. ↑

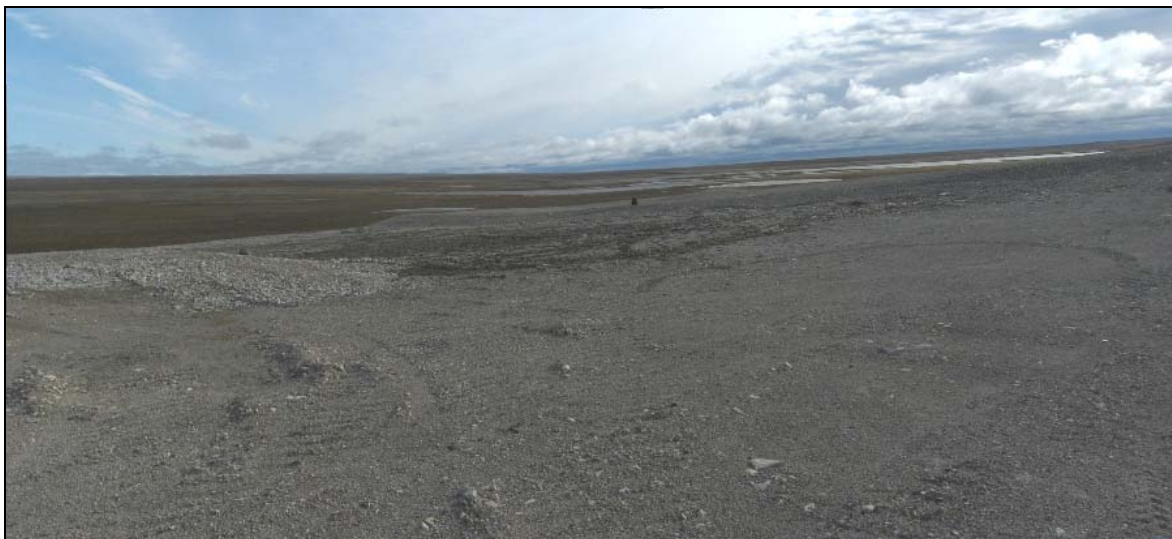
**Photograph WLFN-4.** Looking SE to the large central landfill cell from near north end of 3rd cell. The south side of the the 2nd cell from N is visible on left side of the photo. ↑

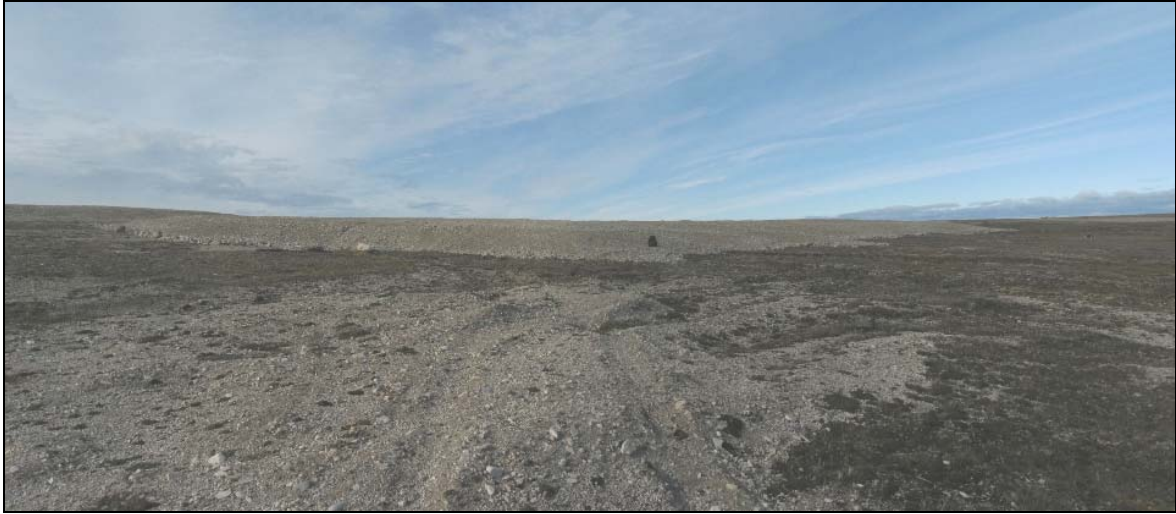
**Photograph WLFN-5.** Looking W to NE corner of the 2nd cell. Standing near the NW corner of the large central landfill cell. ↑

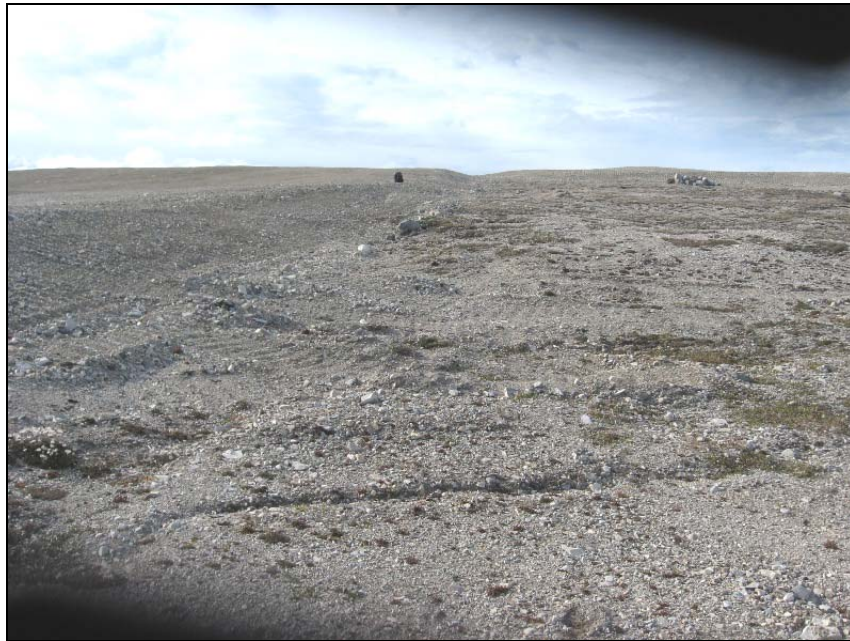
**Photograph WLFN-6.** Looking SSW along the W side of the large central landfill cell. Granular cover appears stable. 3rd cell is visible at the right side of the frame. ↑

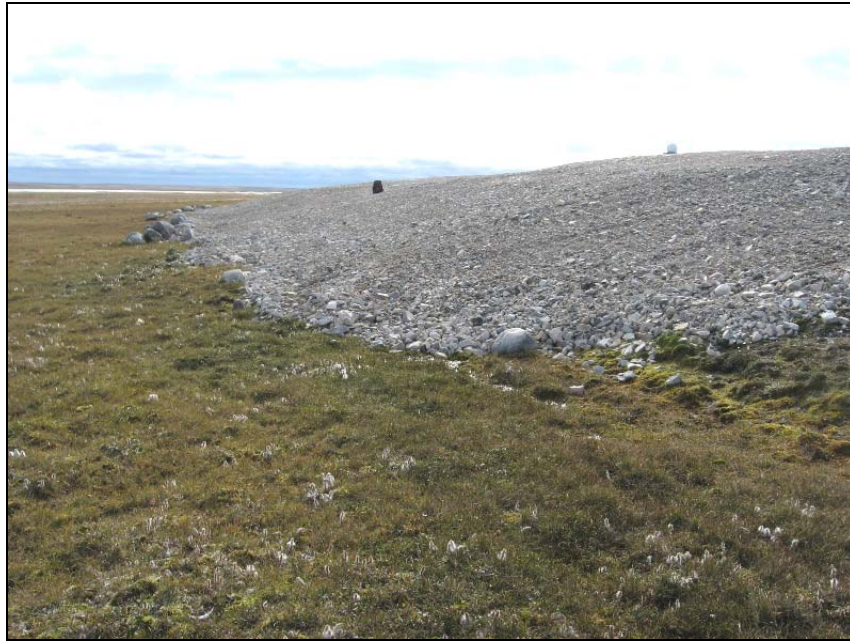
**Photograph WLFN-7.** Looking SE along N toe of the large central cell from NW corner. Granular cover and toe area appear stable. No problematic conditions observed. ↑

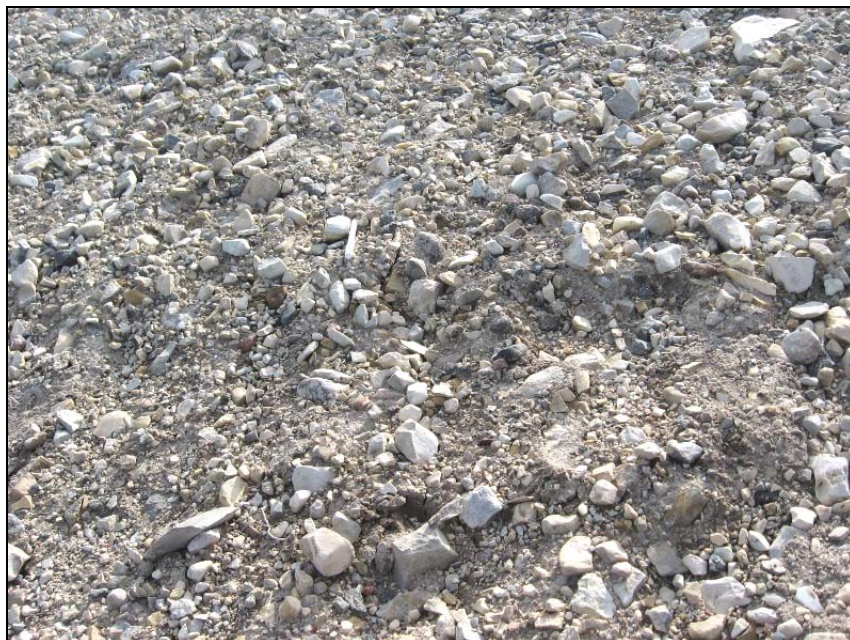
**Photograph WLFN-8.** Close-up of minor cracking along N corner of central cell. Crack observed to be about 4m long and 1 to 3mm wide. Several other similar type minor cracks observed for next 25m (discontinuous, partially in-filled). Trivial feature, not documented in detail. ↑

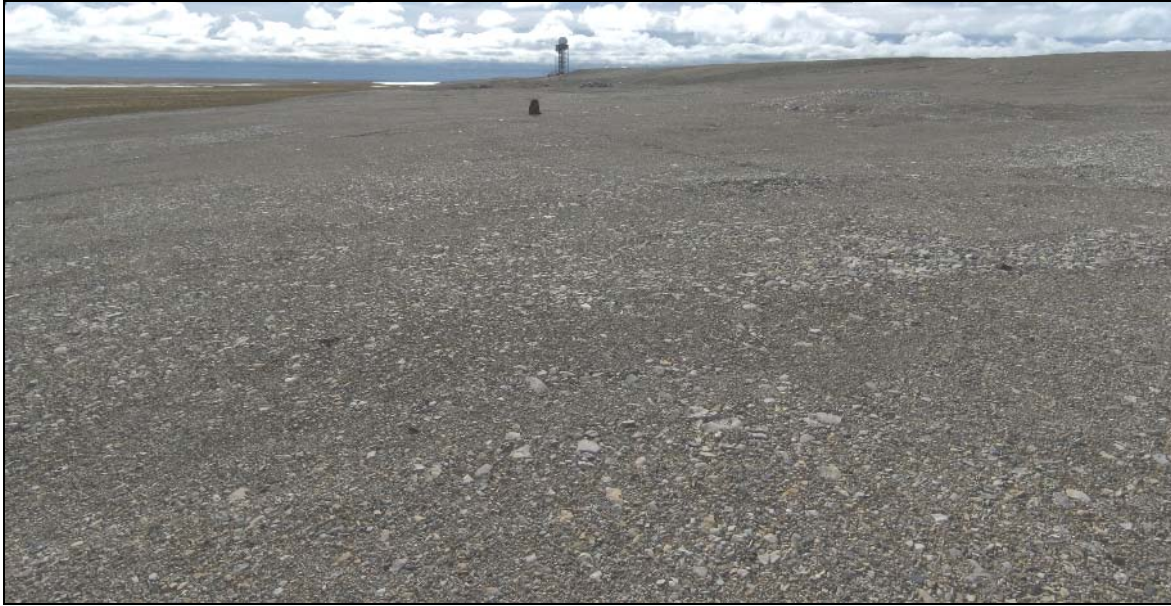
**Photograph WLFN-9.** Panoramic along top of the large central cell. Looking SE from N corner. No features of note. ↑

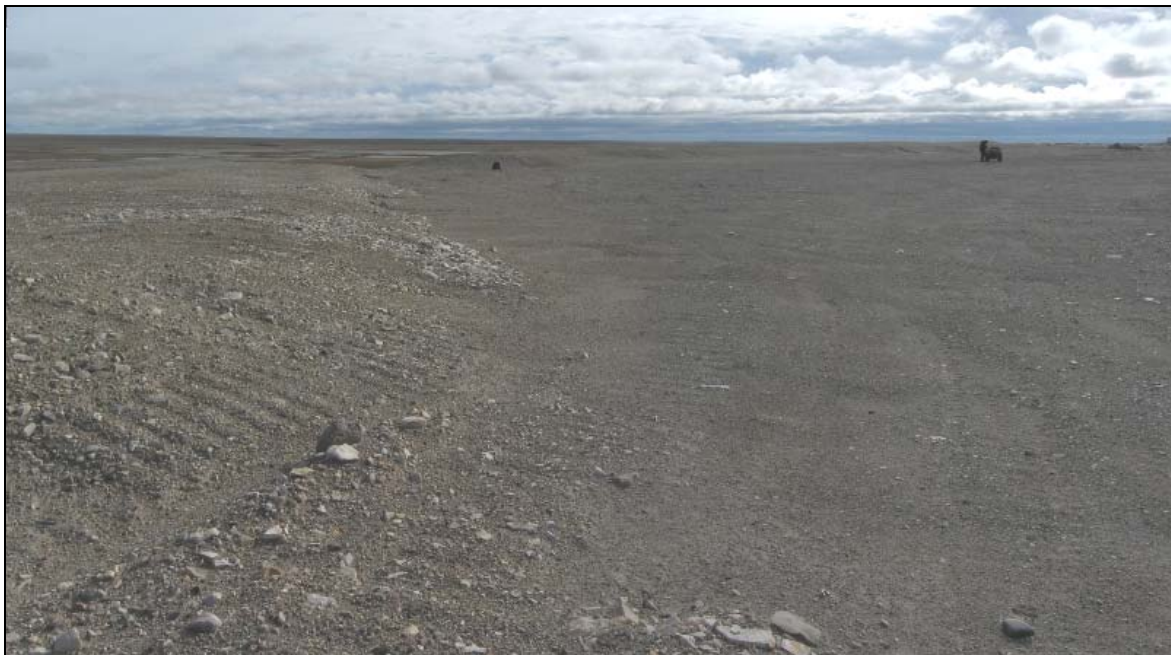
**Photograph WLFN-10.** Looking SE from SW corner of large central cell. Looking to NW corner of long SW cell. ATV in background. No features of note. ↑

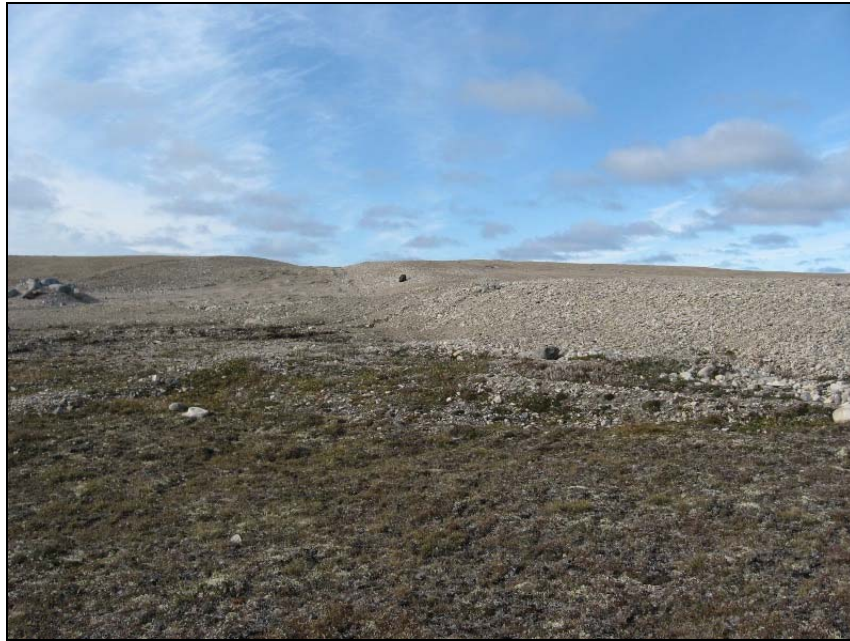
**Photograph WLFN-11.** Looking SW along S side of central cell from E corner. Long SW cell visible in left of frame.     ↑

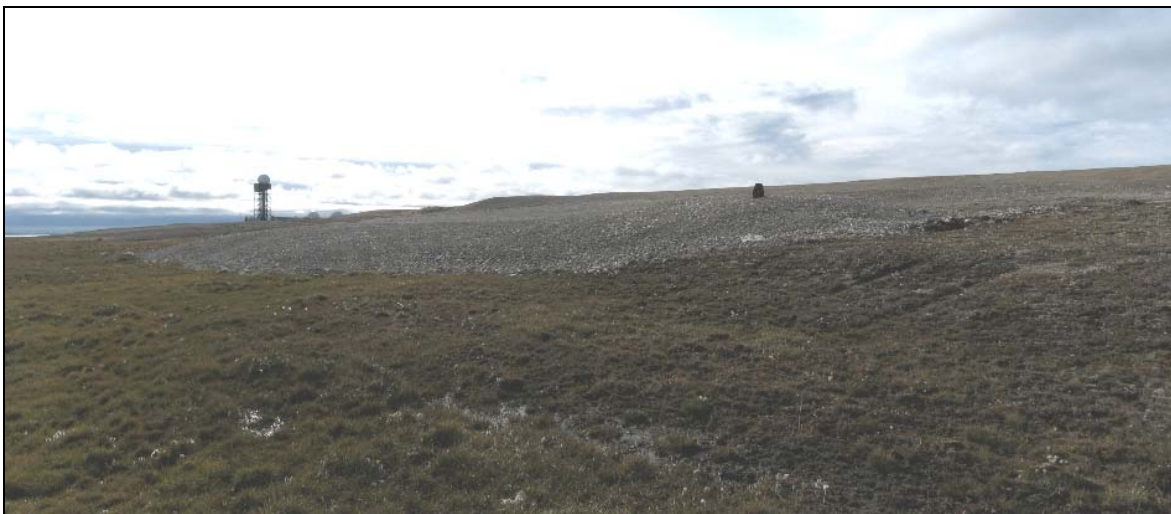
**Photograph WLFN-12.** Looking S to small eastern cell. Granular cover appears stable. Smallest SE cell visible in background.     ↑

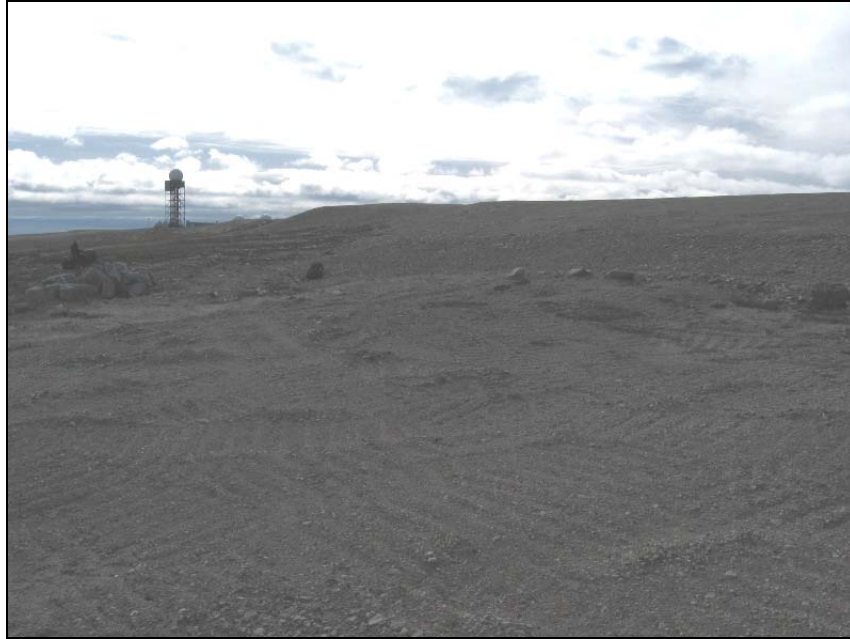
**Photograph WLFN-13.** Looking SSE along east side of long SW cell from near small E cell. ↑

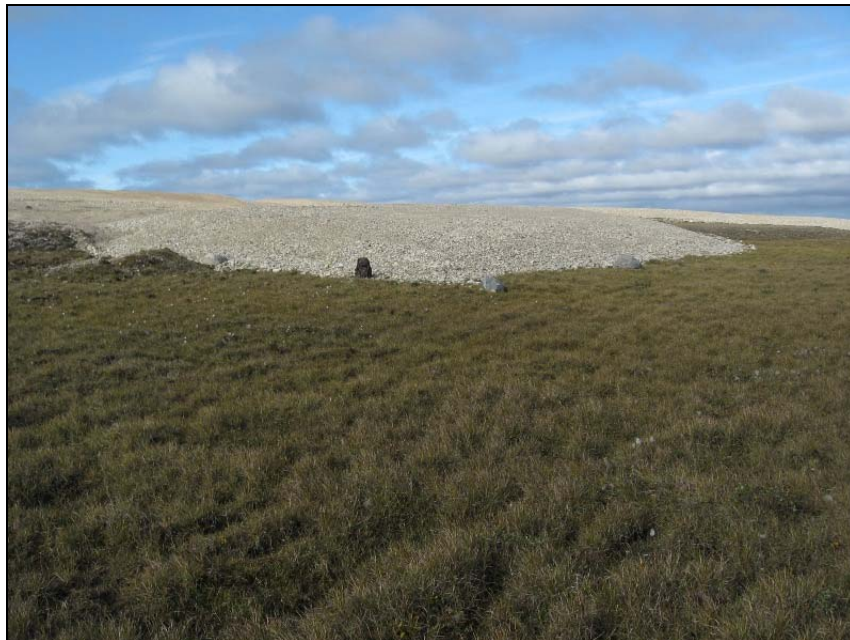
**Photograph WLFN-14.** Looking WNW to SE corner of small E cell. Granular cover appears stable. No features of note. ↑

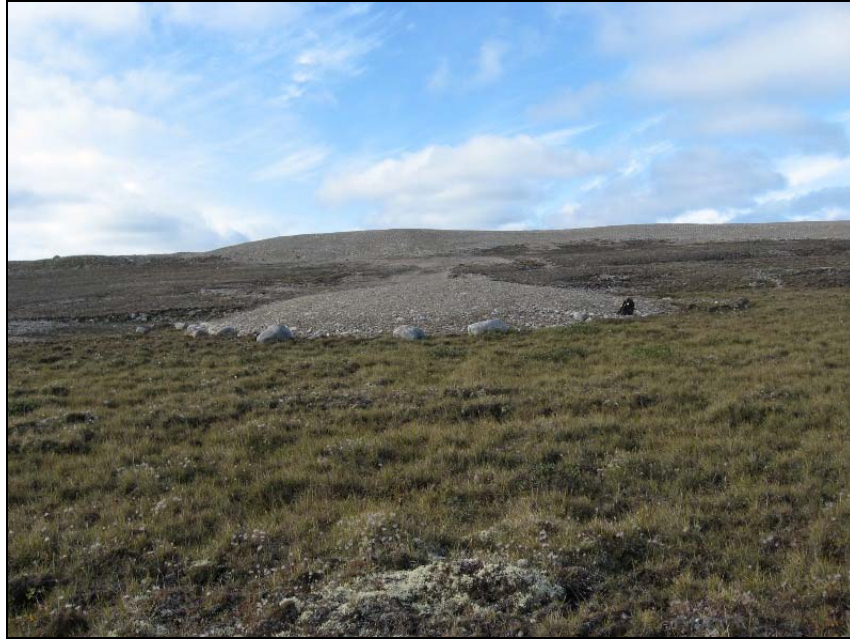
**Photograph WLFN-15.** Looking W to smallest SE cell. Granular cover appears stable. Long SW landfill cell visible in background. ↑

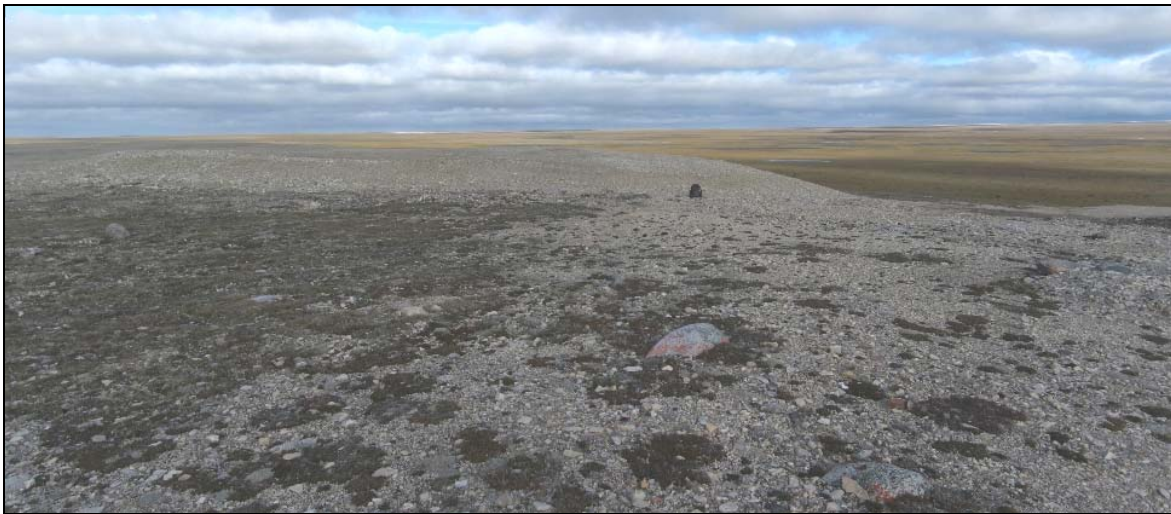
**Photograph WLFN-16.** Looking N to the S end of the long SW cell. Note elevations difference to SE cell. ↑

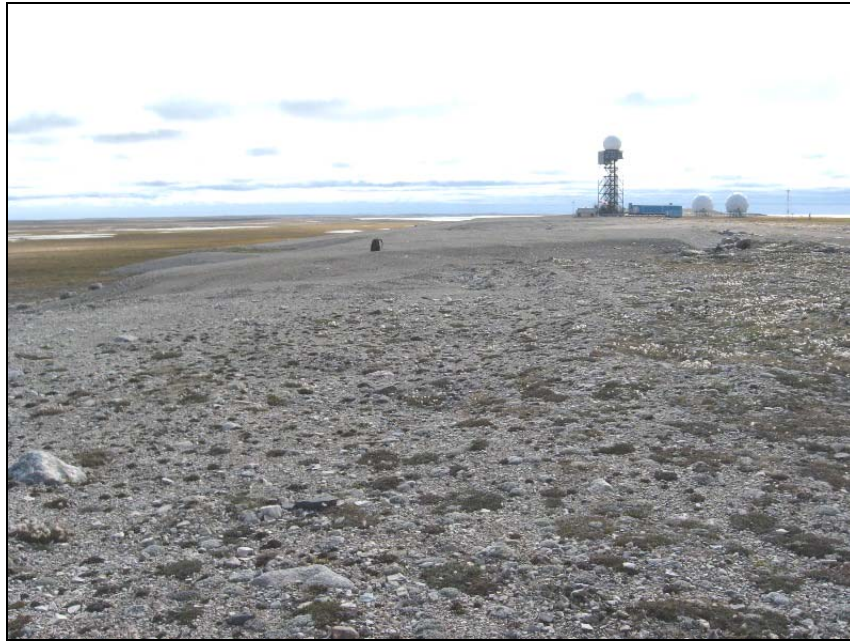
**Photograph WLFS-1.** Looking S to N end of N cell. ↑

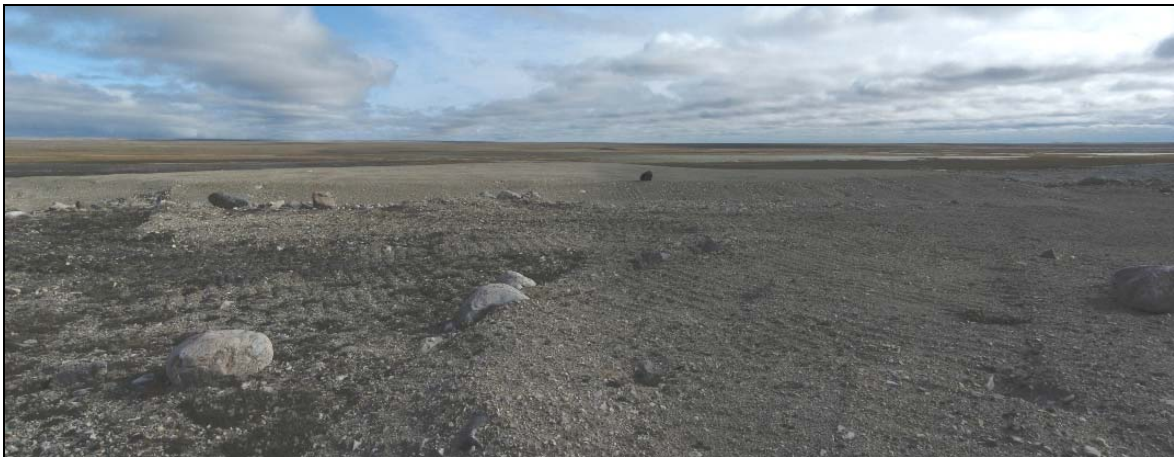
**Photograph WLFS-2.** Looking E to W side of N cell. ↑

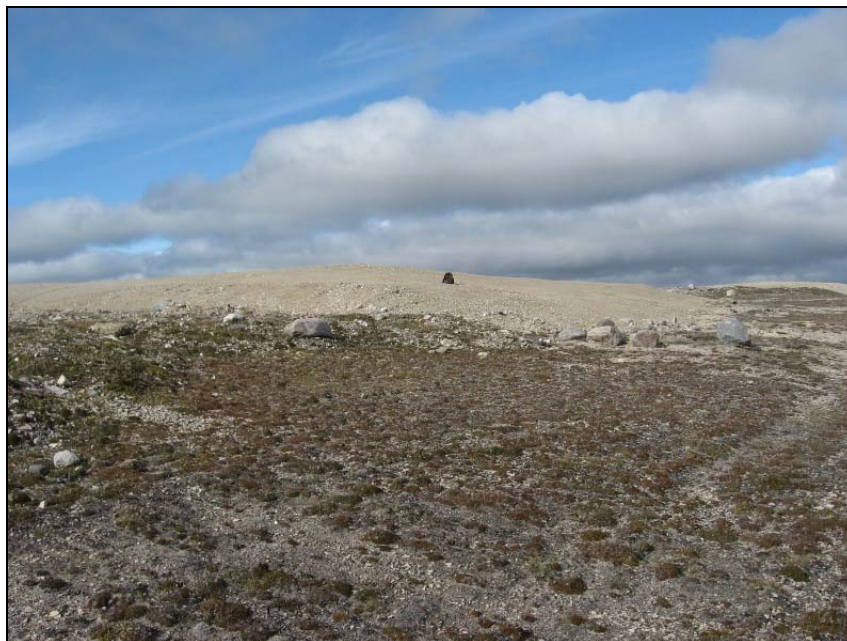
**Photograph WLFS-3.** Looking NW along E side of N cell.      ↑

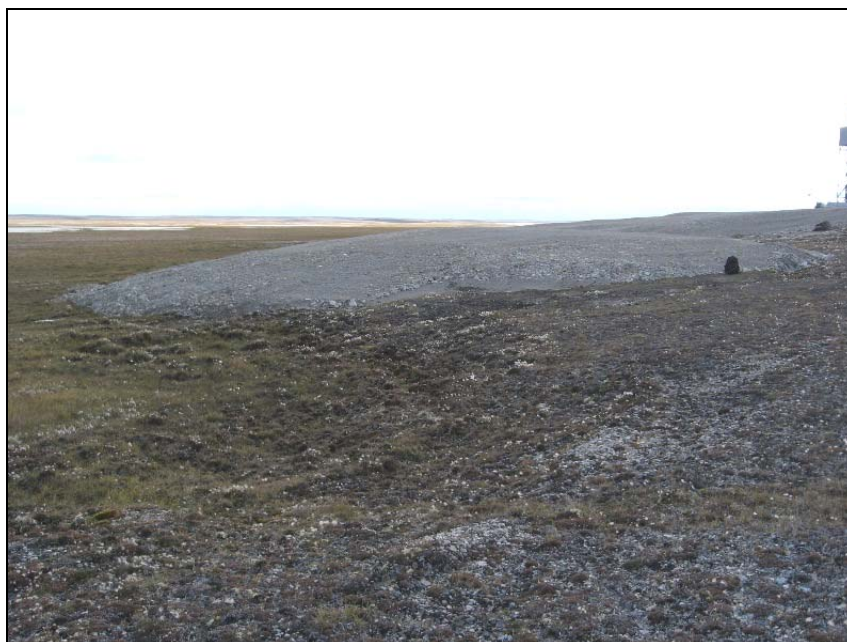
**Photograph WLFS-4.** Looking S to N side of 2nd cell on the E side. Granular cover appears stable.  
No features of note.      ↑

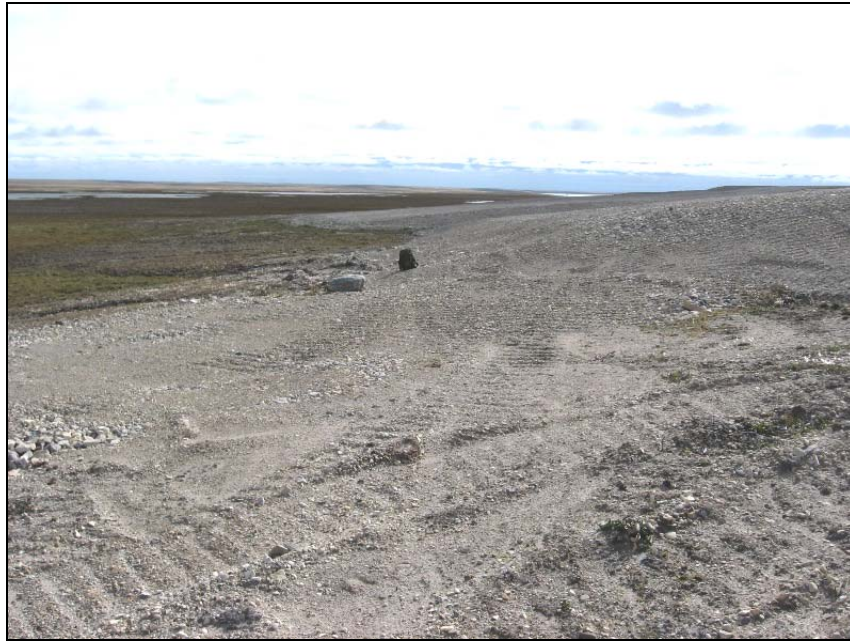
**Photograph WLFS-5.** Looking ESE along NE side of 3rd cell. No features of note. Granular cover appears stable. ↑

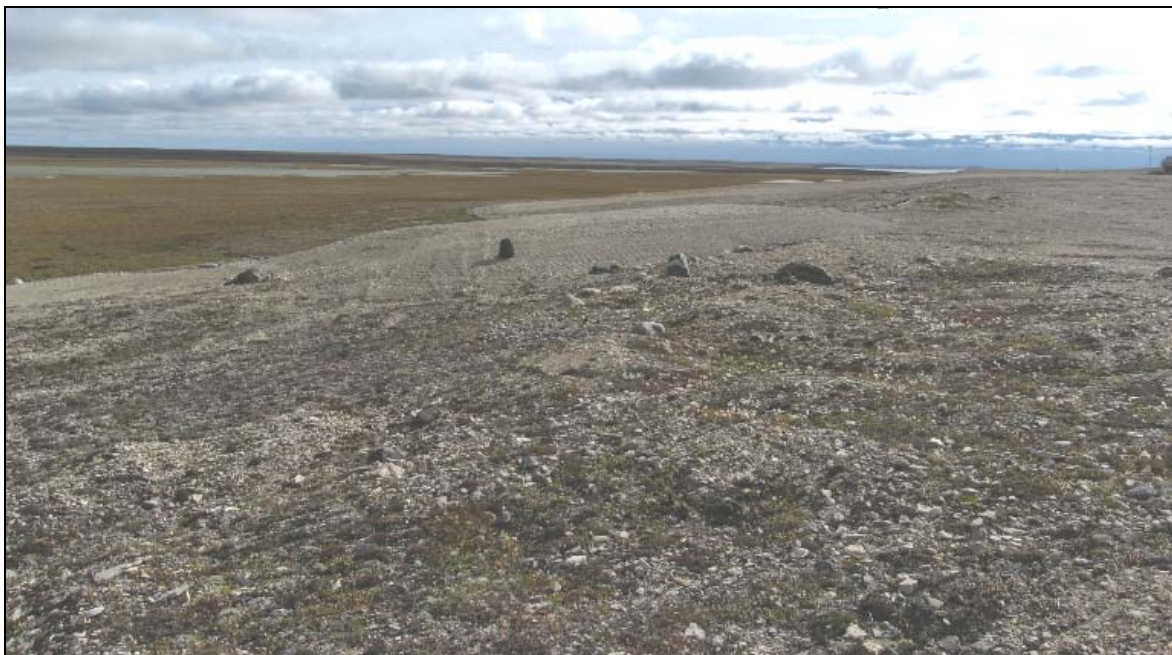
**Photograph WLFS-6.** Looking E to NW corner of 3rd cell. Largest (southern most) landfill cell visible in the background. ↑

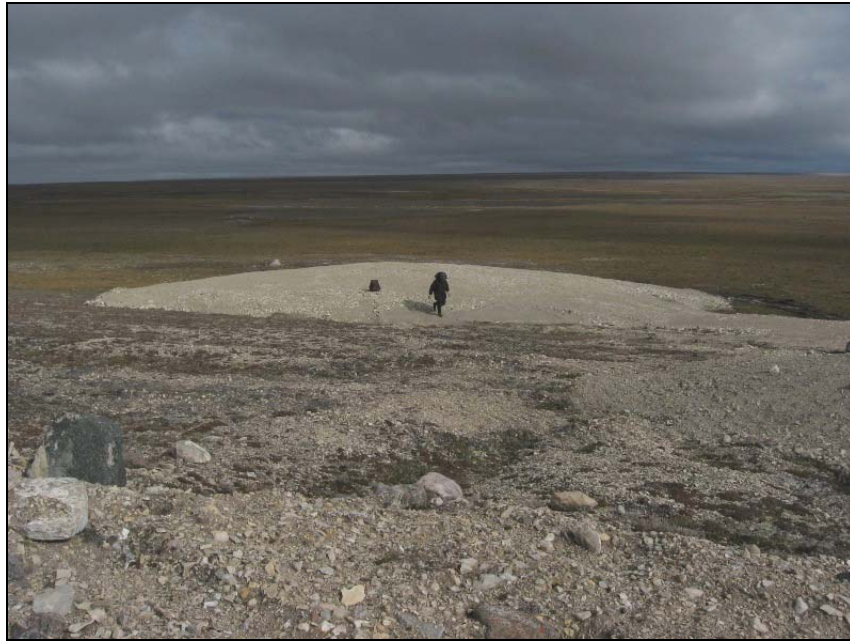
**Photograph WLFS-7.** Looking NE to 2nd cell from near NW corner of 3rd cell. ↑

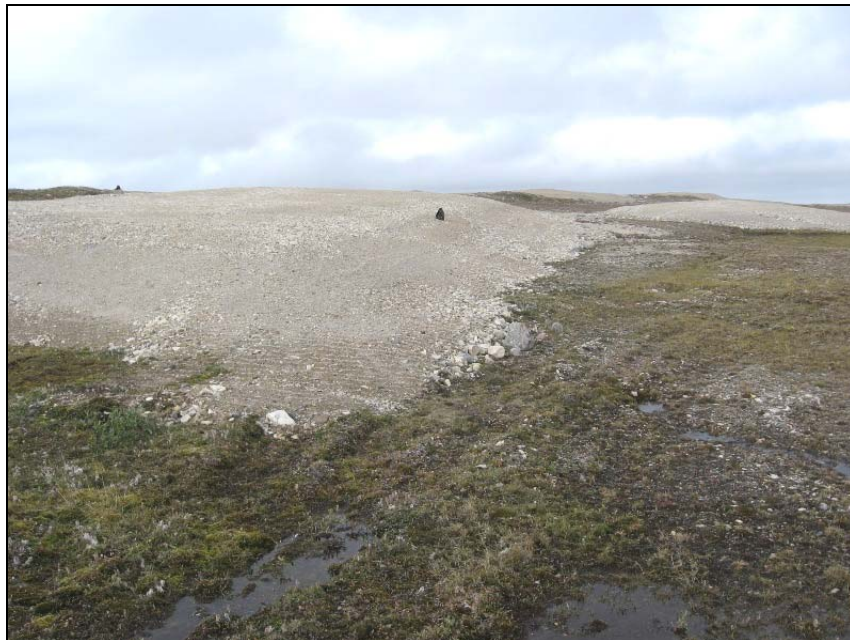
**Photograph WLFS-8.** Looking NW along east side of 3rd cell from NE corner of large S cell. Granular cover appears stable. ↑

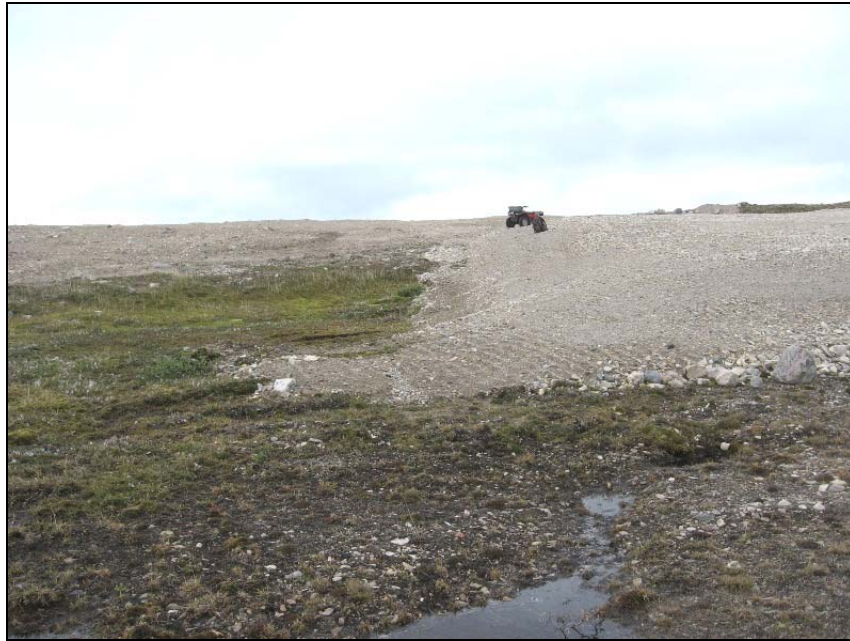
**Photograph WLFS-9.** Looking WSW along S side of 3rd cell. No features of note. ↑

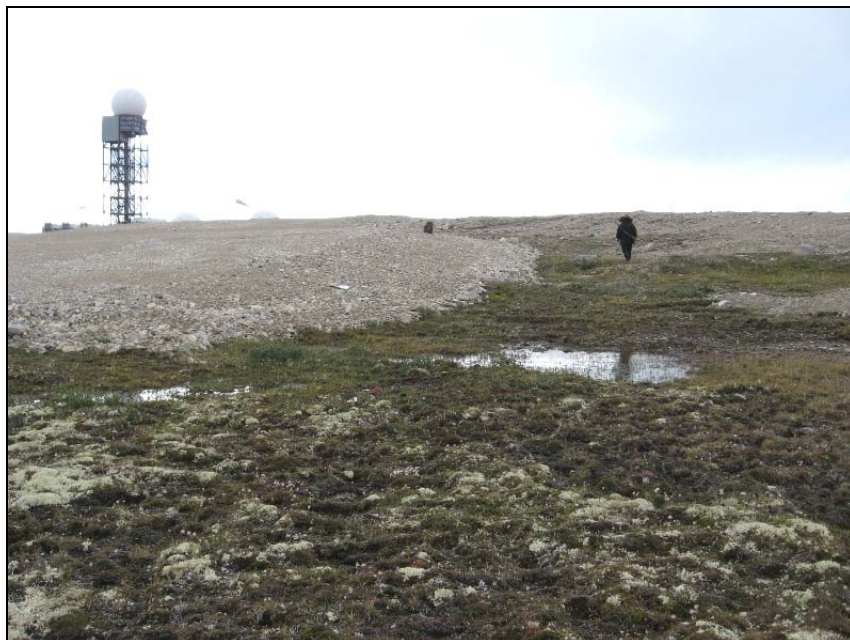
**Photograph WLFS-10.** Looking W along N side of 4th cell. Ponded water appears to be associated with recent precipitation events. No staining or clear indications of seepage. ↑

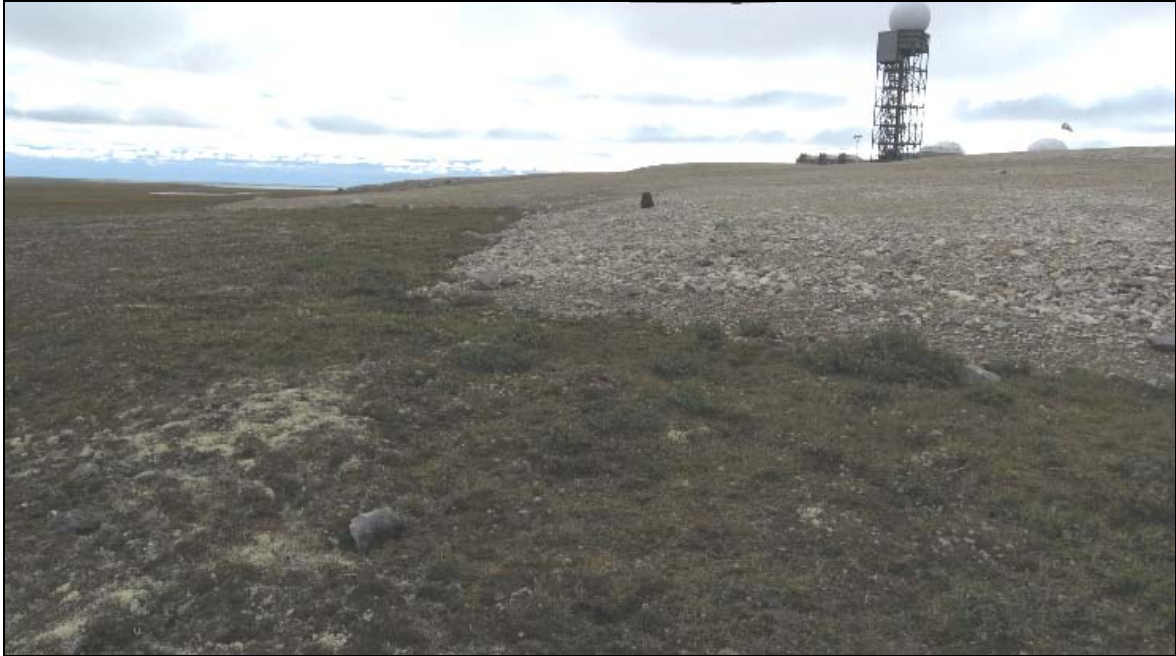
**Photograph WLFS-11.** Looking S along E side of largest, most southerly landfill cell. Viewed from NE corner. ↑

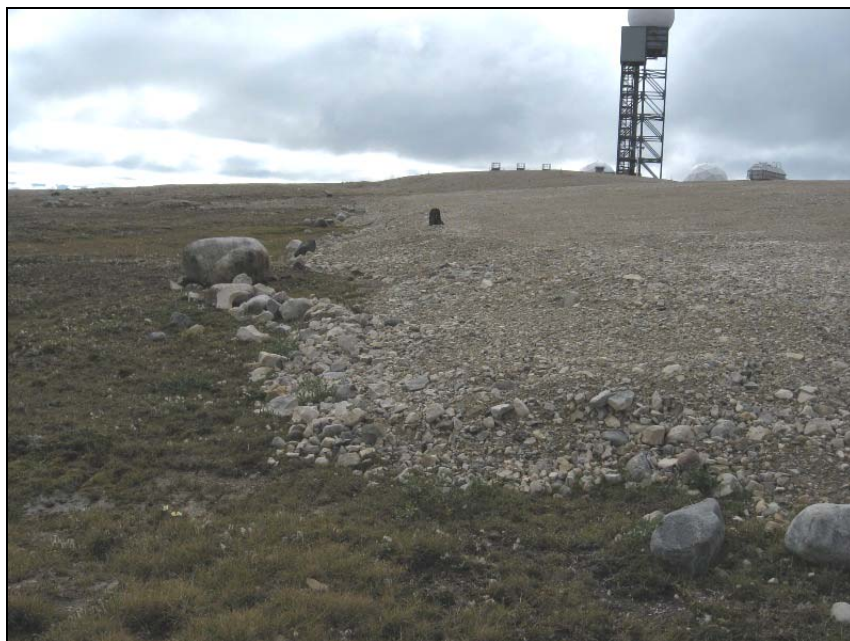
**Photograph WLFS-12.** Looking S along E side of large southern cell to the SE corner. Radar tower in background. ↑

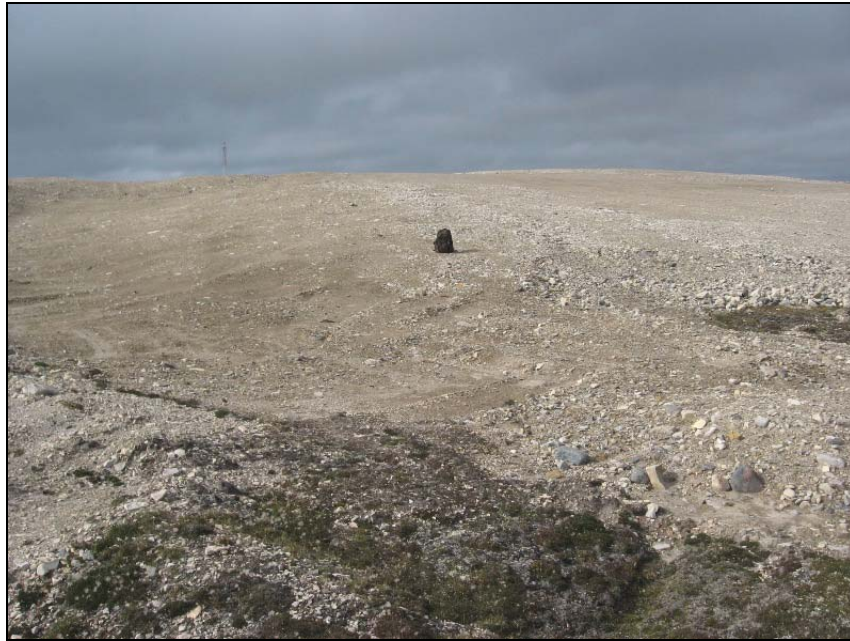
**Photograph WLFS-13.** Looking W to SE corner of large southern landfill cell. Drainage swale is visible, however it does not appear to be protected by erosion protection. ↑

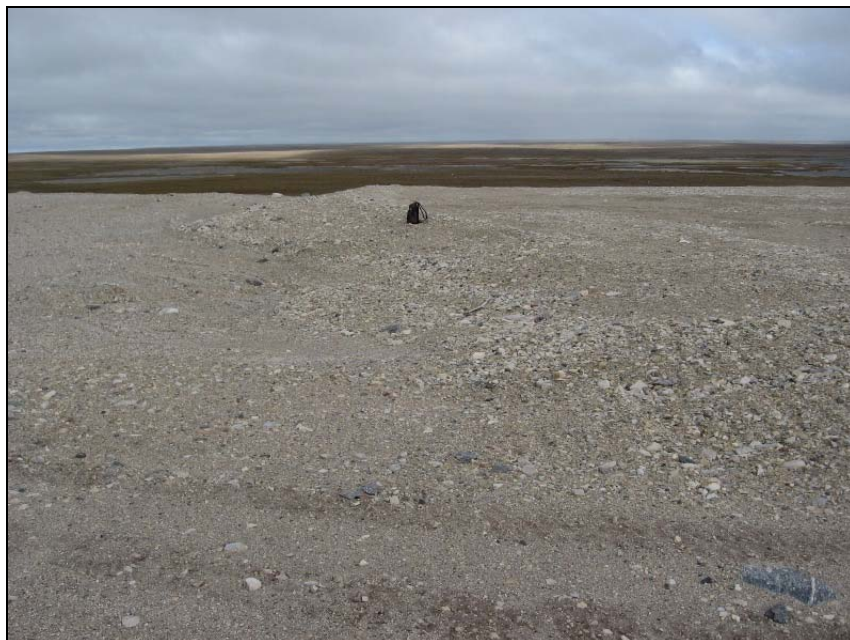
**Photograph WLFS-14.** Looking NNE from SW corner of the south cell. ↑
