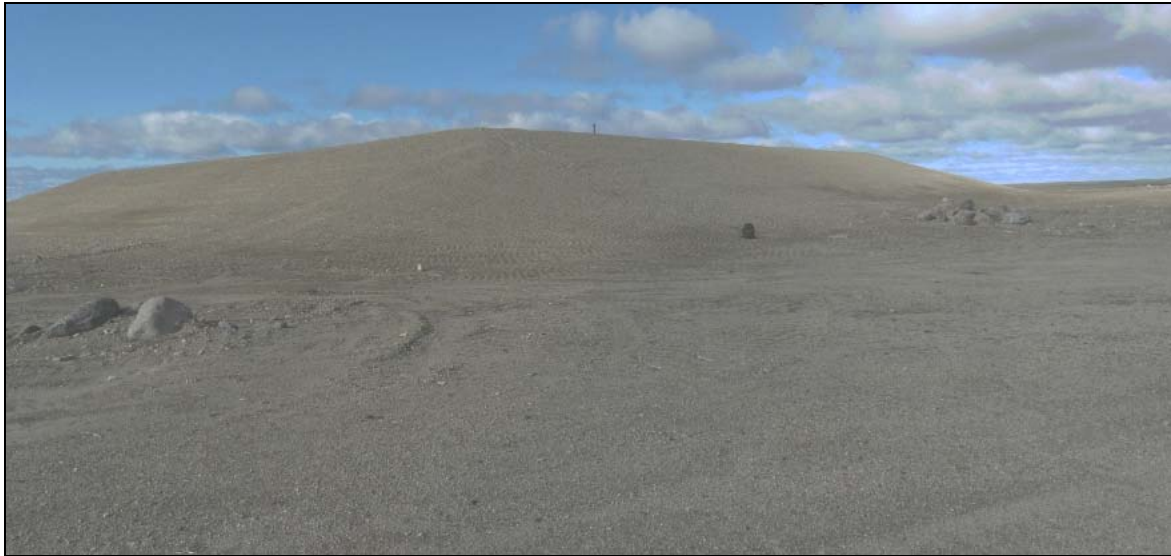
**Photograph T2-1.** Panoramic of N side of landfill looking SW from about 30m NE of NE corner. ↑

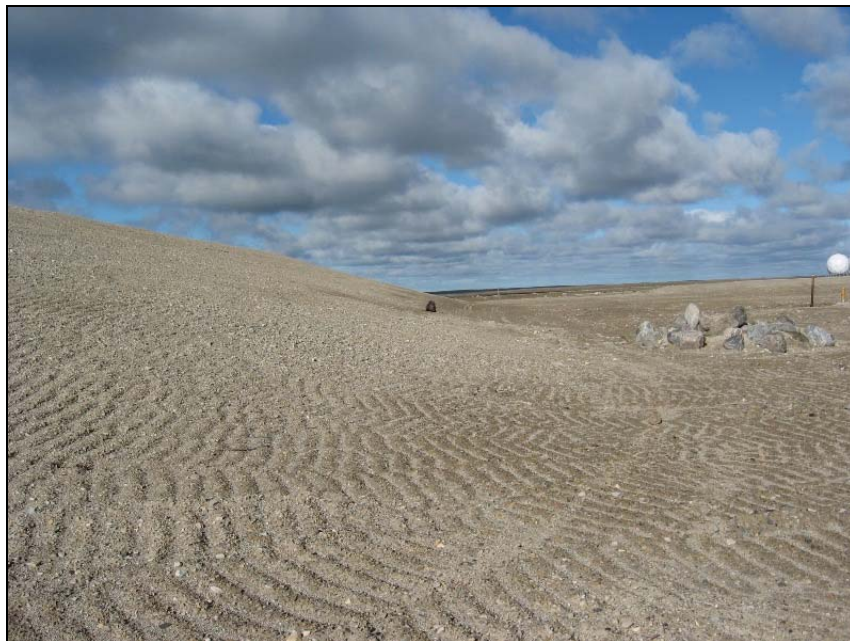
**Photograph T2-2.** Looking WNW along toe of slope from NE toe. ↑

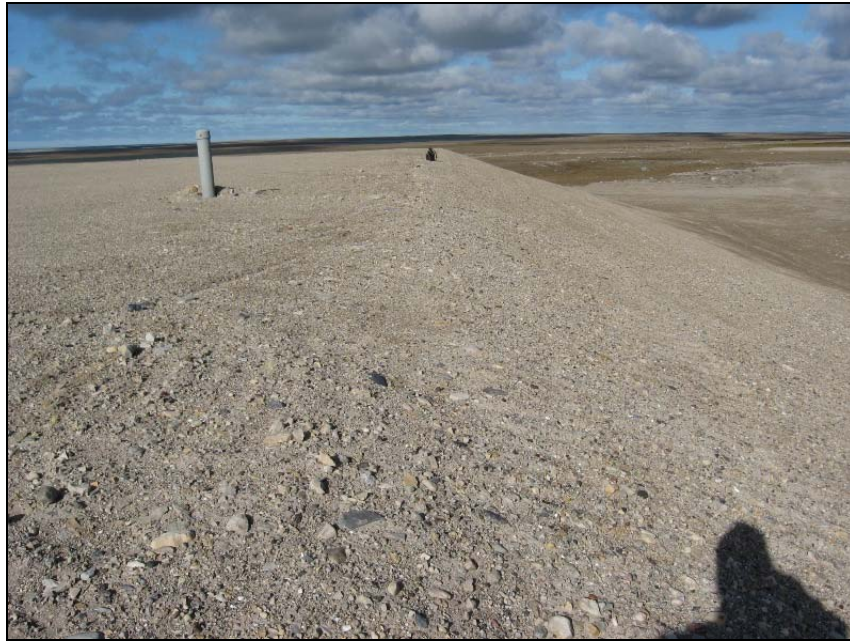
**Photograph T2-3.** Looking WNW along crest. Thermistor VT-1 is visible. ↑

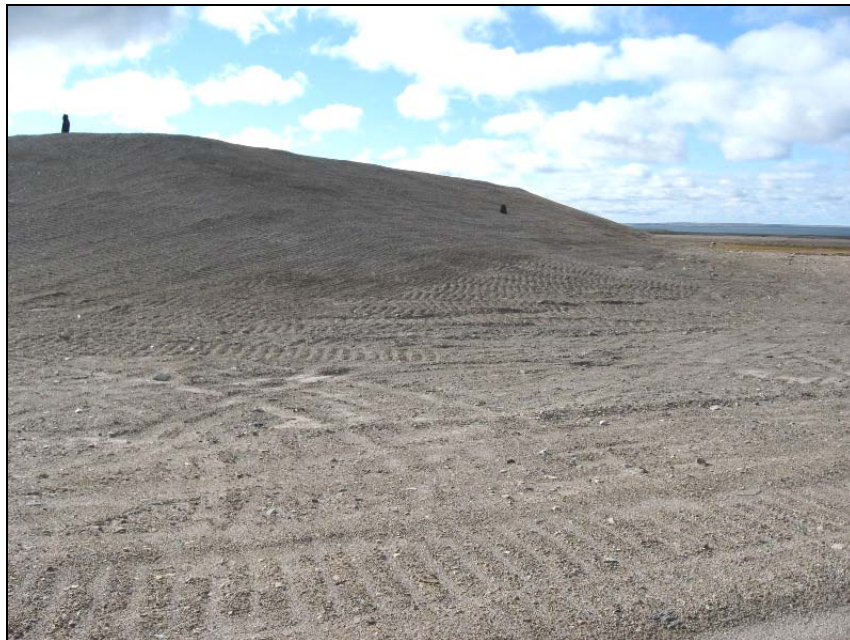
**Photograph T2-4.** Looking S along west slope of LF from about 30m NW of NW corner. ↑

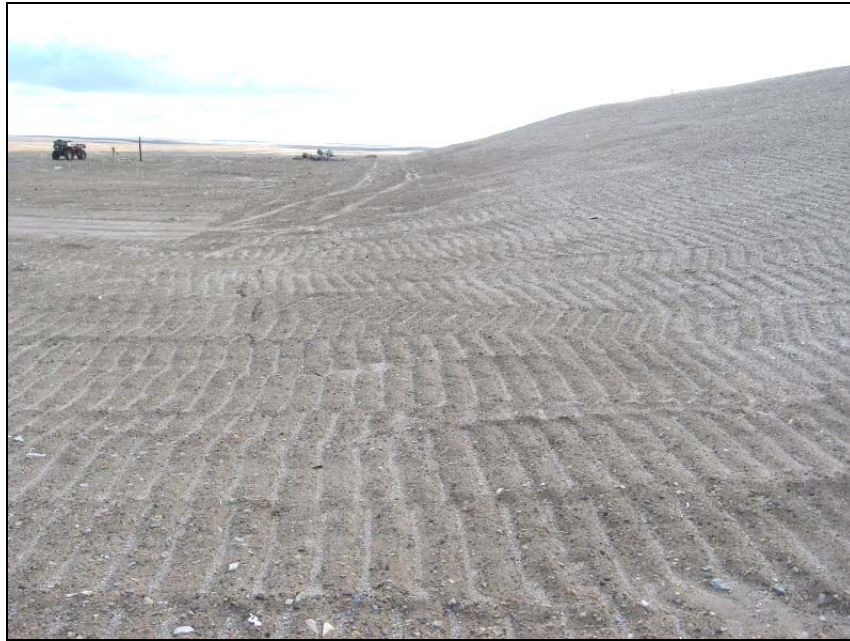
**Photograph T2-5.** Looking ESE along toe from NW corner of LF towards area where minor cracking was observed in 2007. The previously observed cracks (in foreground) are largely in-filled with sediments and show no indication of recent movement. ↑

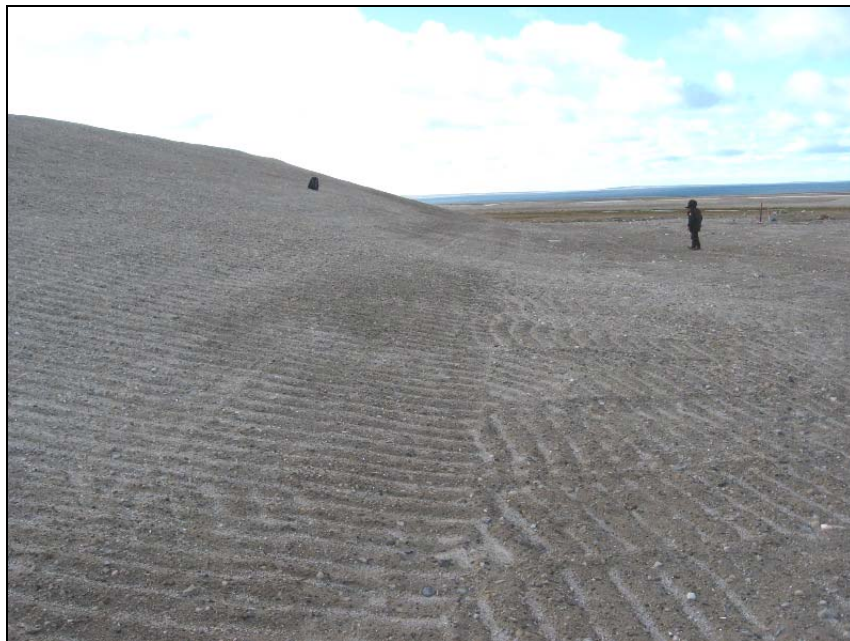
**Photograph T2-6.** Looking S along toe of W slope from NW corner. ↑

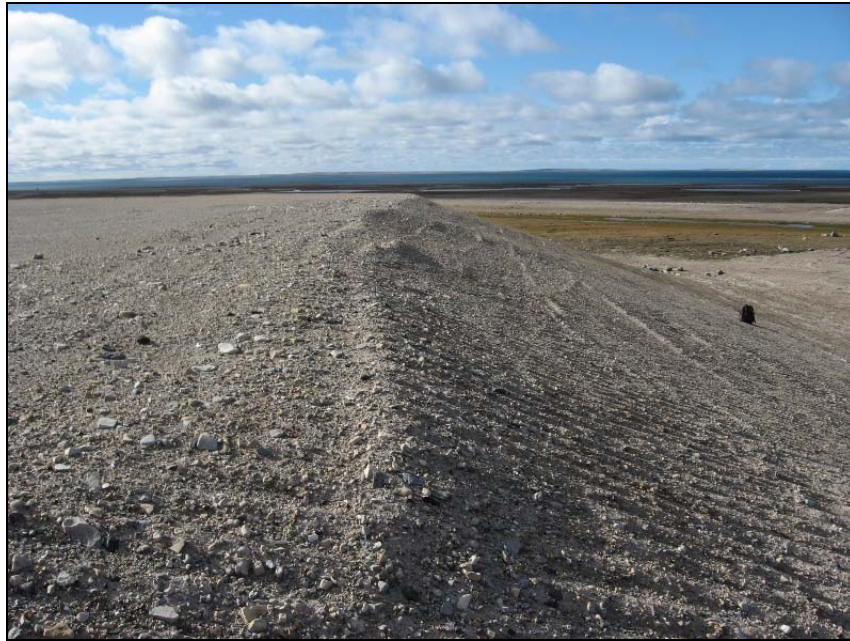
**Photograph T2-7.** Looking S along crest from NW corner. Minor cracks that were noted last year are barely visible and partially infilled. No sign of recent movement. ↑

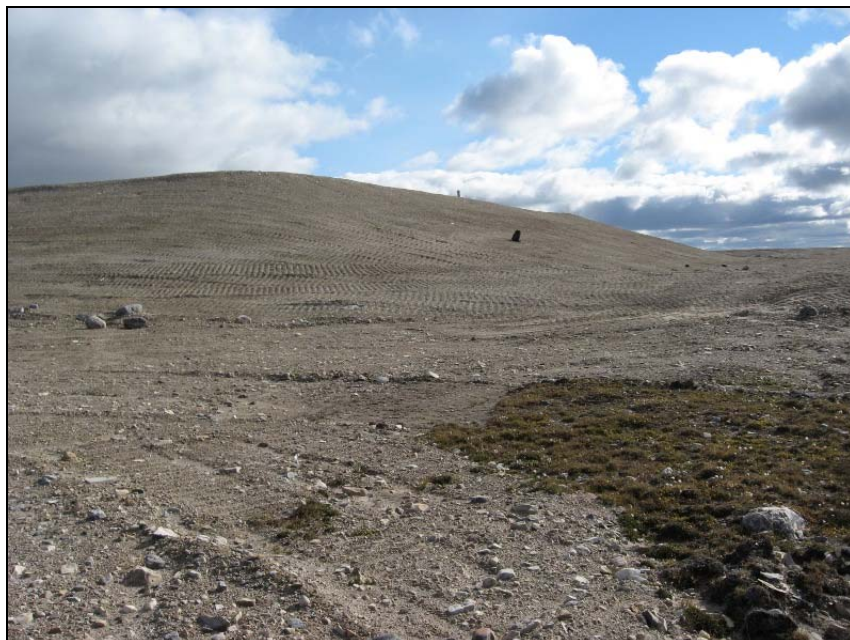
**Photograph T2-8.** Looking E to SW corner from about 30m SW of SW corner. ↑

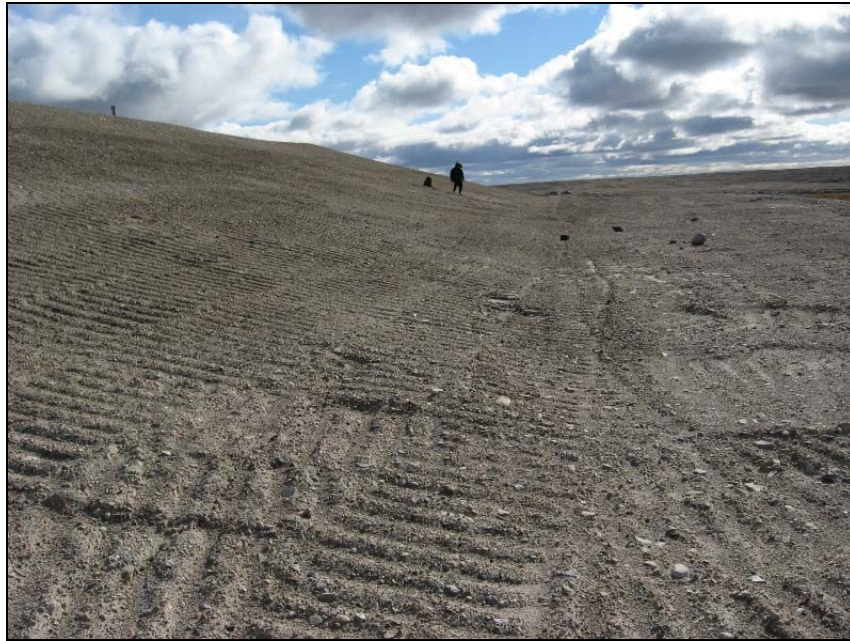
**Photograph T2-9.** Looking E along toe of S side from SE corner. 20m long tension crack (old) runs parallel to slope. ↑

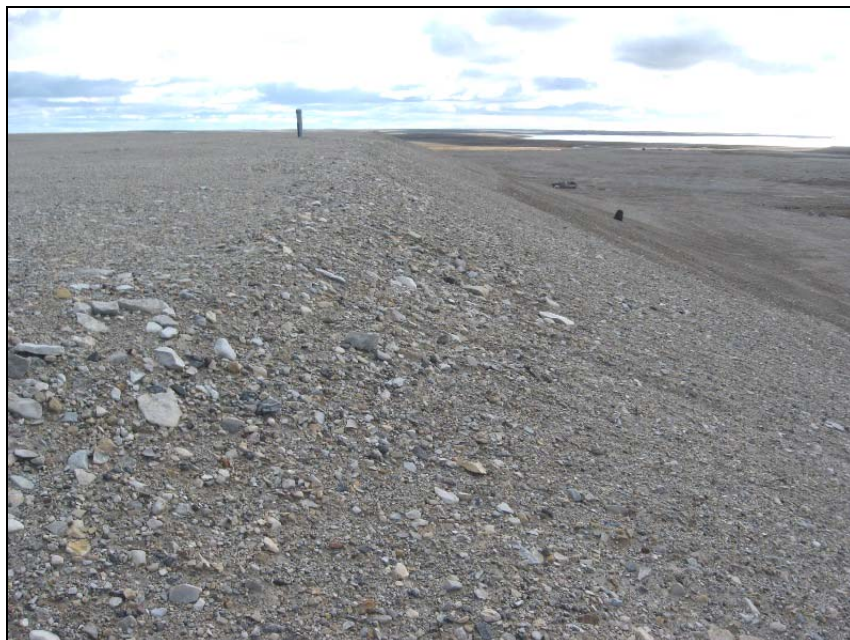
**Photograph T2-10.** Looking E along crest from SW corner. ↑

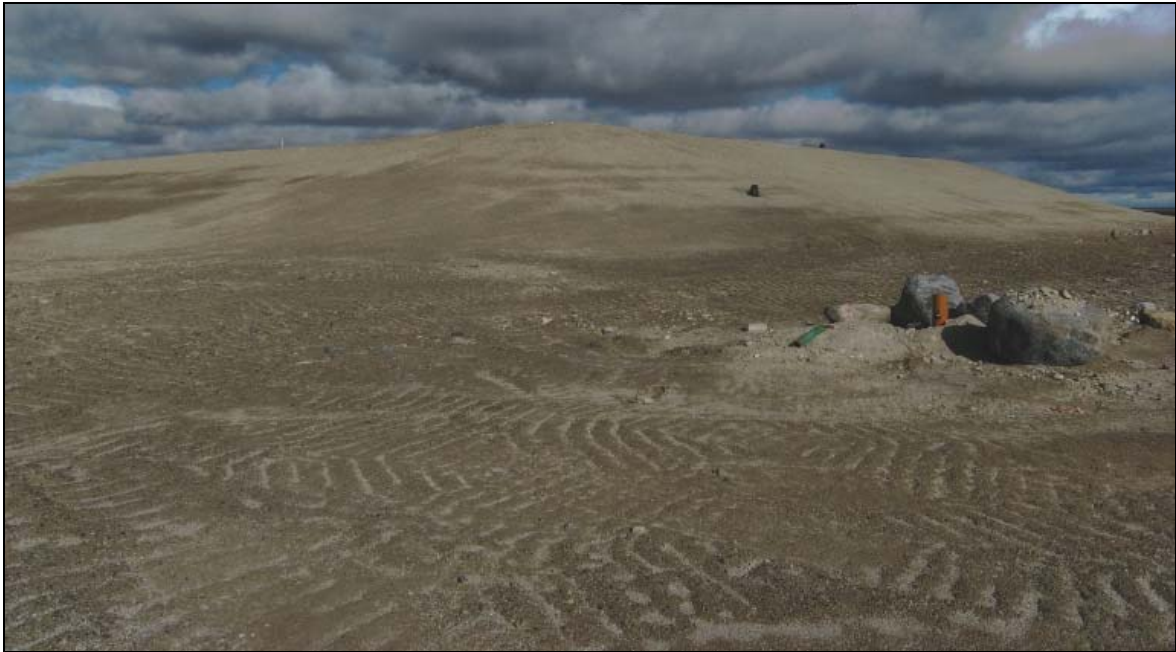
**Photograph T2-11.** Looking NW to SE corner of landfill. MW2 visible in foreground. ↑

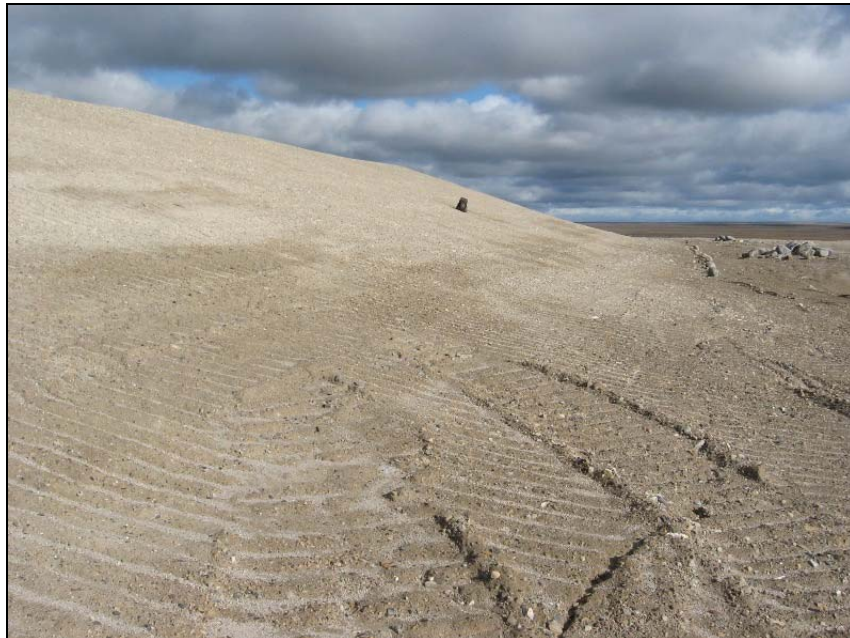
**Photograph T2-12.** Looking NNE along toe of E slope from SE corner. ↑

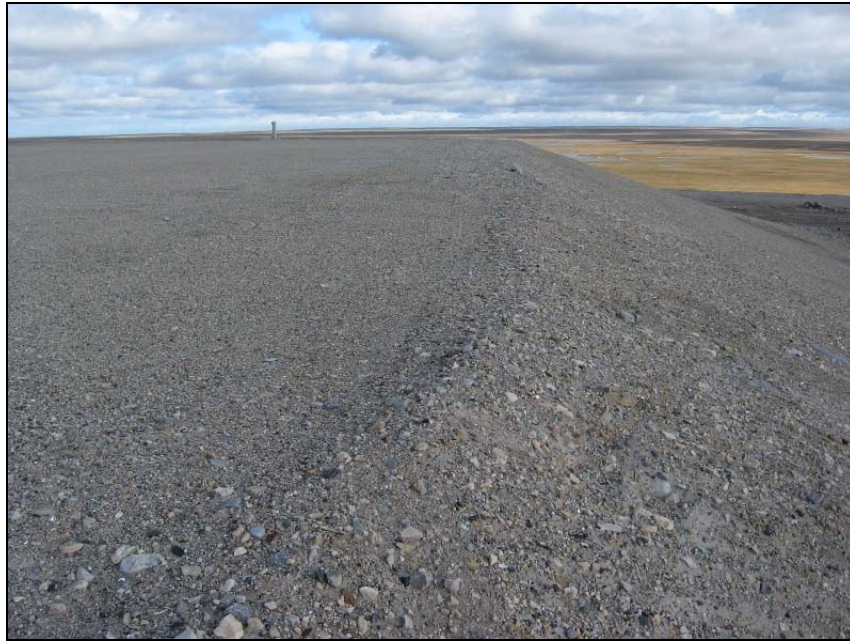
**Photograph T2-13.** Looking N along E crest from SE crest corner. ↑

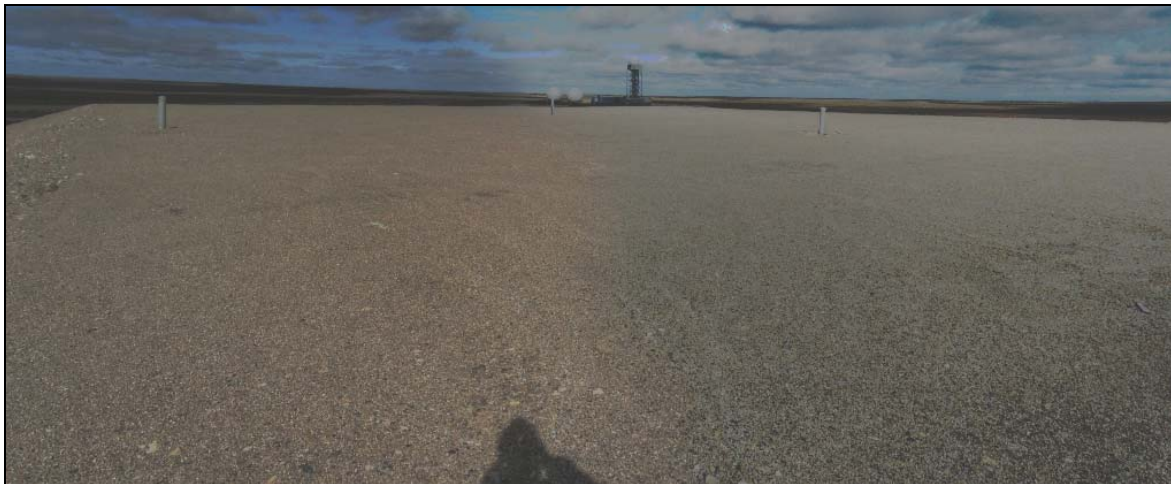
**Photograph T2-14.** Looking NW from near SE corner. Panoramic showing about 2/3 of top surface of the landfill. Granular cover appears stable. ↑

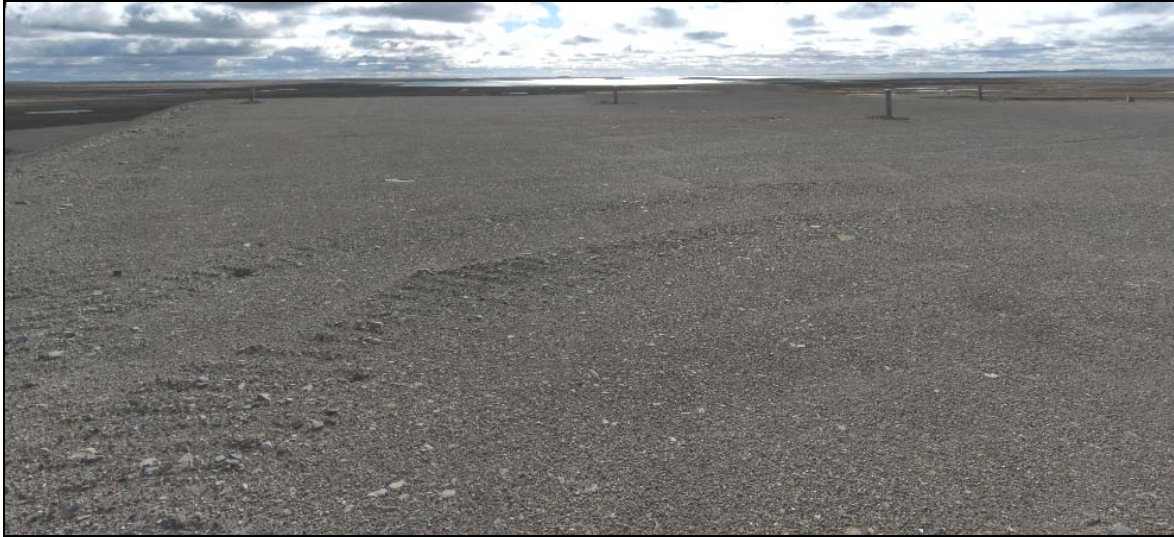
**Photograph T2-15.** Looking ESE from NW corner. Panoramic showing upper surface of landfill. Granular cover appears stable with no indications of problematic conditions. ↑

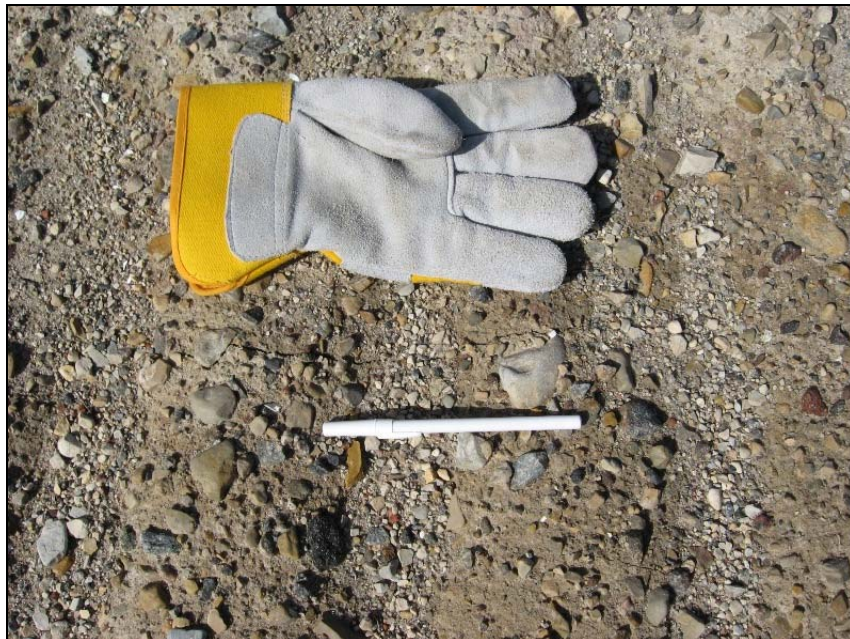
**Photograph T2-16.** Start of fine crack that runs from 20m S of NE corner to about 20m W of NE corner. 1 to 4mm wide, parallel to toe, 5 m upslope from toe, portions in-filled. Crack was observed in 2007 and appears to have stabilized. No indications of recent movement or degraded condition. ↑

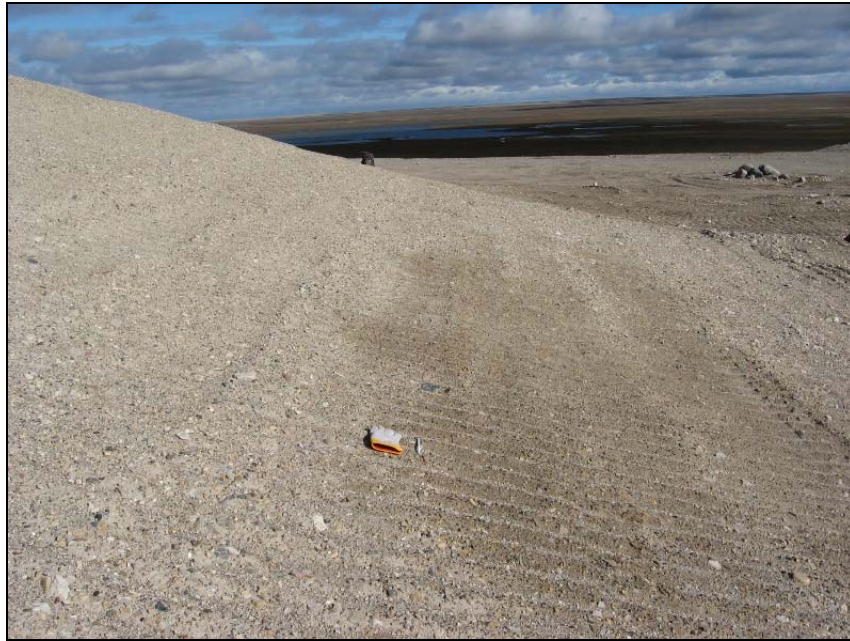
**Photograph T2-17.** Looking N to NE corner. Fine crack starts between glove and pen and progresses around corner to just downslope of backpack and continues at roughly same elevation for another 35m, splays up to 1 m offset. No indications of recent movement. ↑

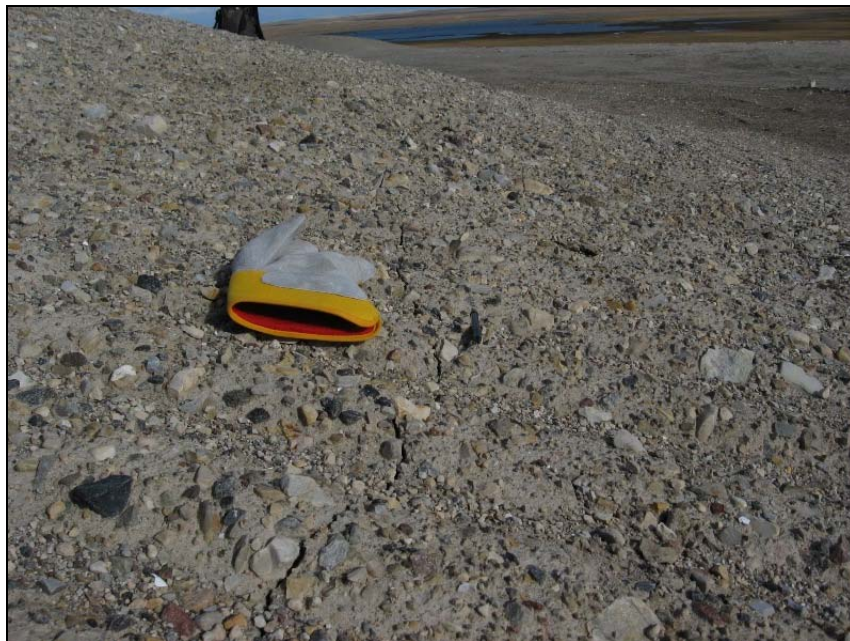
**Photograph T2-18.** Close-up of same crack as in T2-17. This photo is representative of much of the length of the crack. ↑

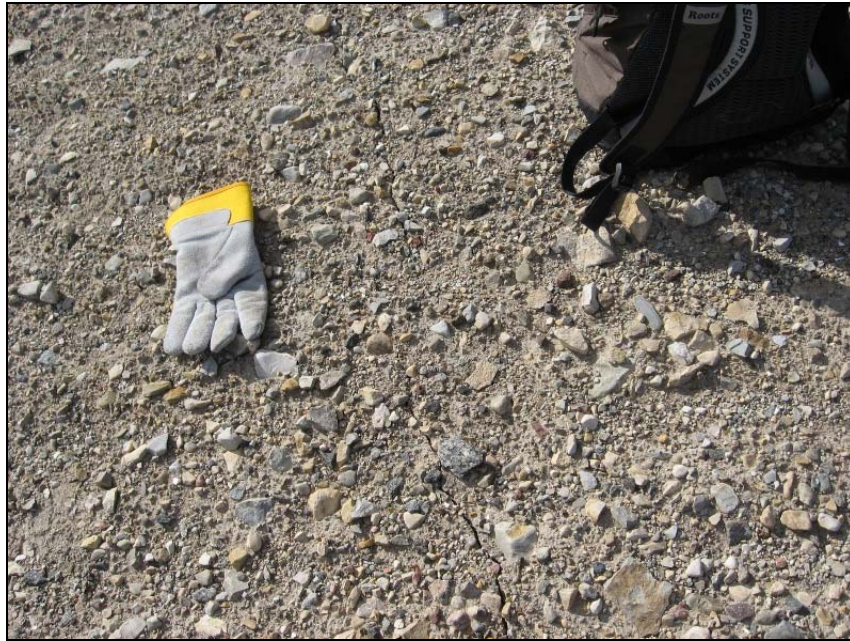
**Photograph T2-19.** Close-up of crack, backpack in same location as photo T2-17. ↑

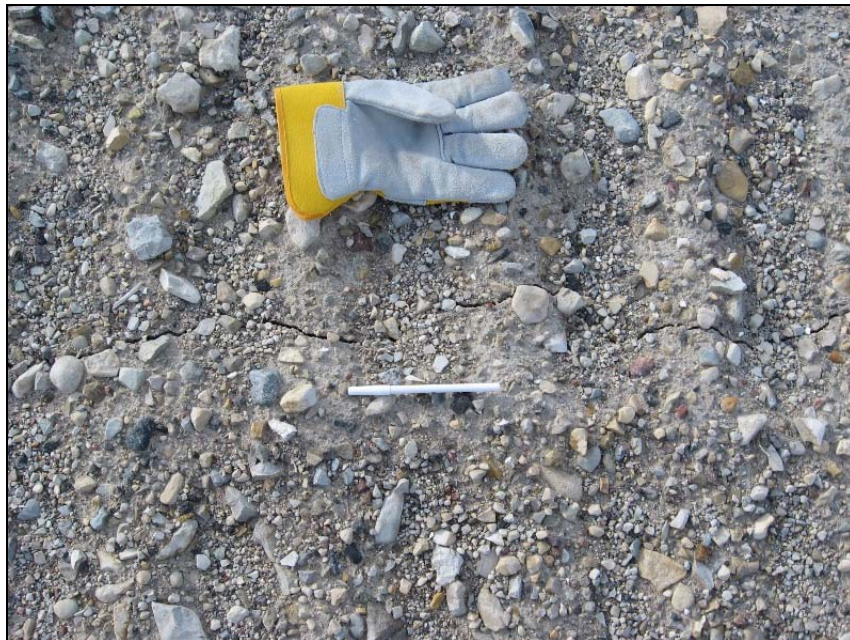
**Photograph T2-20.** Close-up of crack on N slope near NE toe. About 10m W of the NE corner of the landfill. Edges of the crack appear rounded (weathered) and portions of the crack are infilled with sediments. ↑

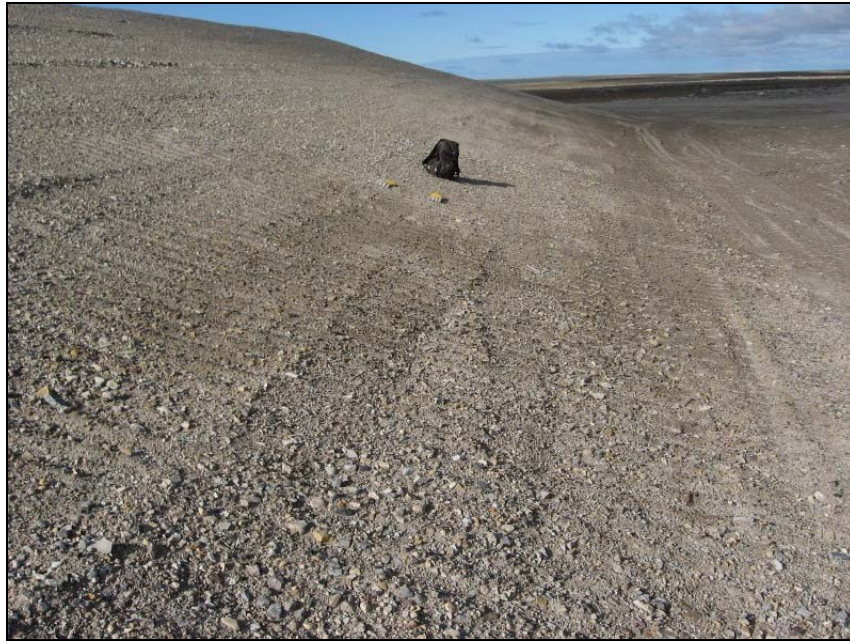
**Photograph T2-21.** Standing on crack looking west to the end of the crack (at backpack). The crack is largely in-filled with fine sediments and there is no sign of recent movement. ↑

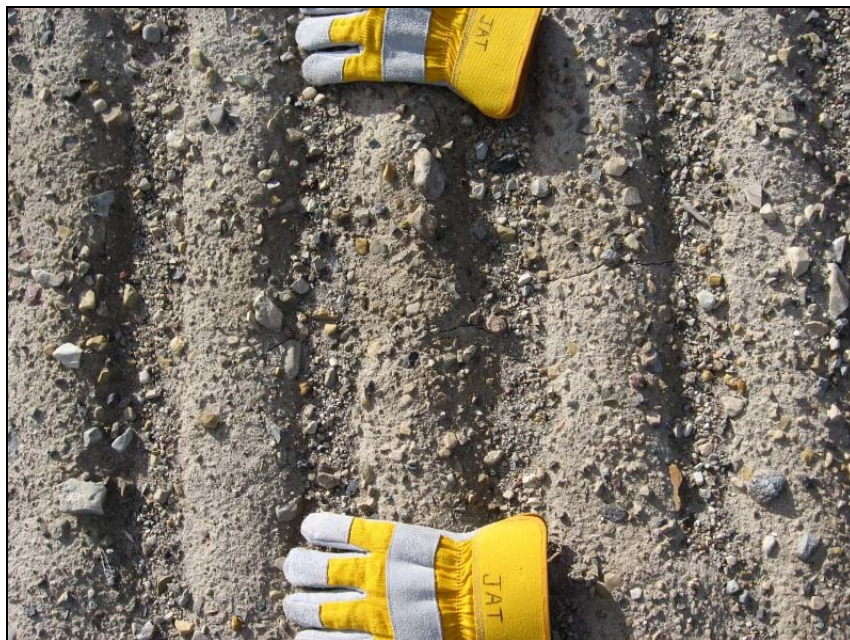
**Photograph T2-22.** Close-up of previous crack between gloves shown in photo T2-21. ↑

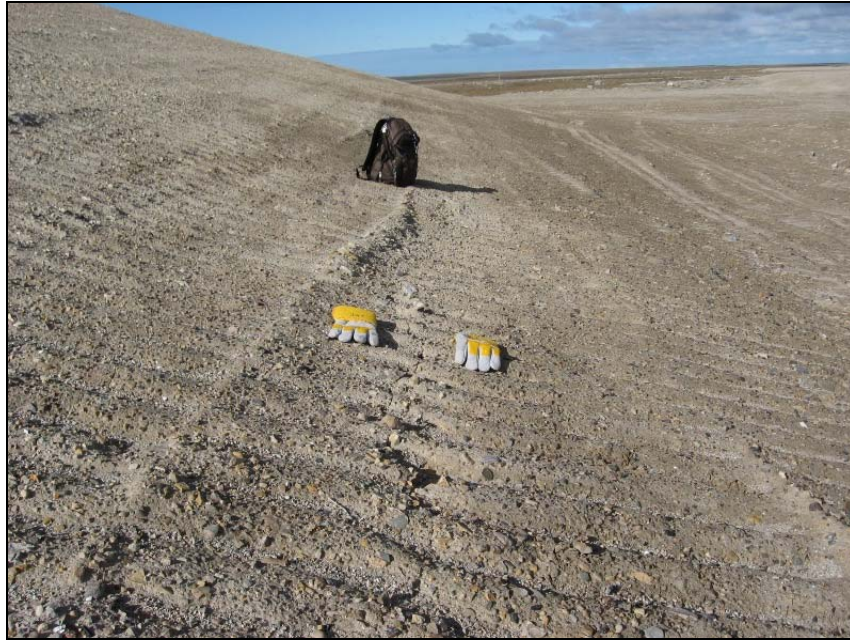
**Photograph T2-23.** Looking W along N slope to old crack. 1 to 7mm wide, largely eroded/in-filled. Backpack at end (starts 5m E, ends 12m W). ↑

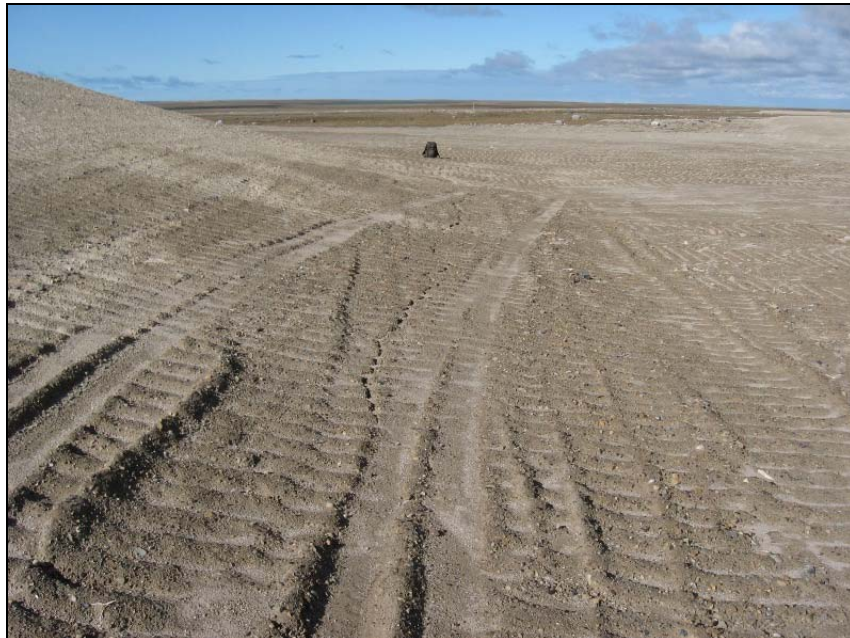
**Photograph T2-24.** Looking W to NW corner along toe and old eroded tension crack. Heavy rains and wind has essentially in-filled the other cracks that were observed last year. ↑

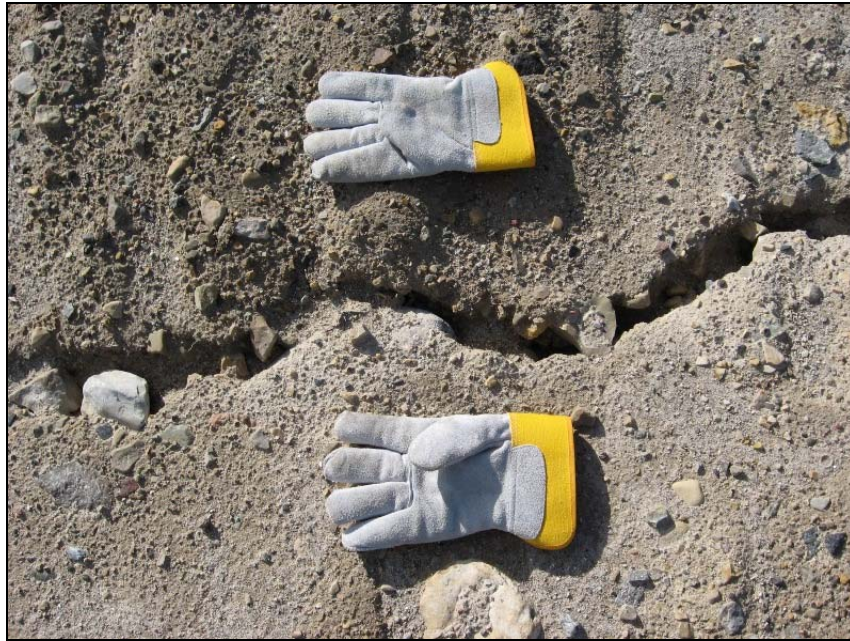
**Photograph T2-25.** Close-up of old crack noted in T2-24. No indications of recent movement. Slope appears stable. ↑

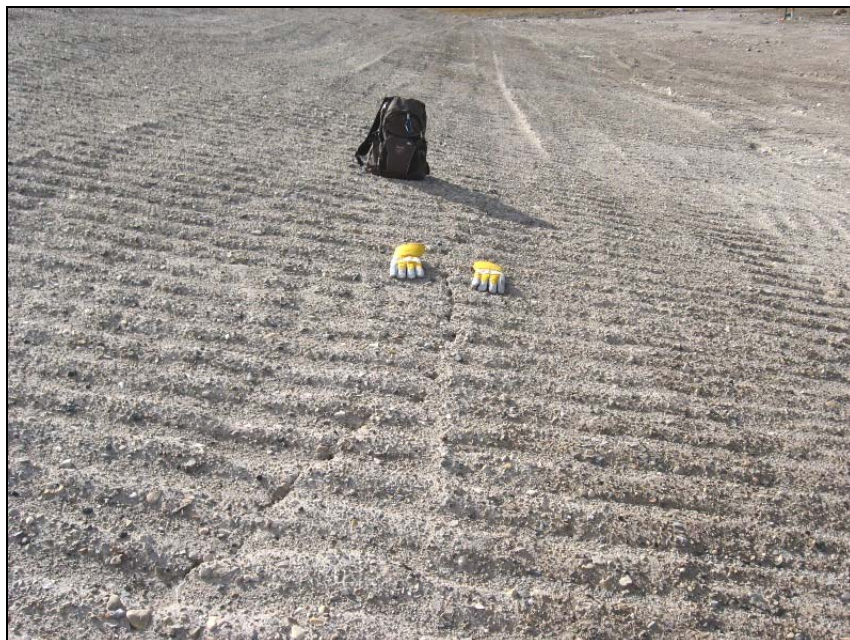
**Photograph T2-26.** Looking S from near NW corner along old crack. ↑

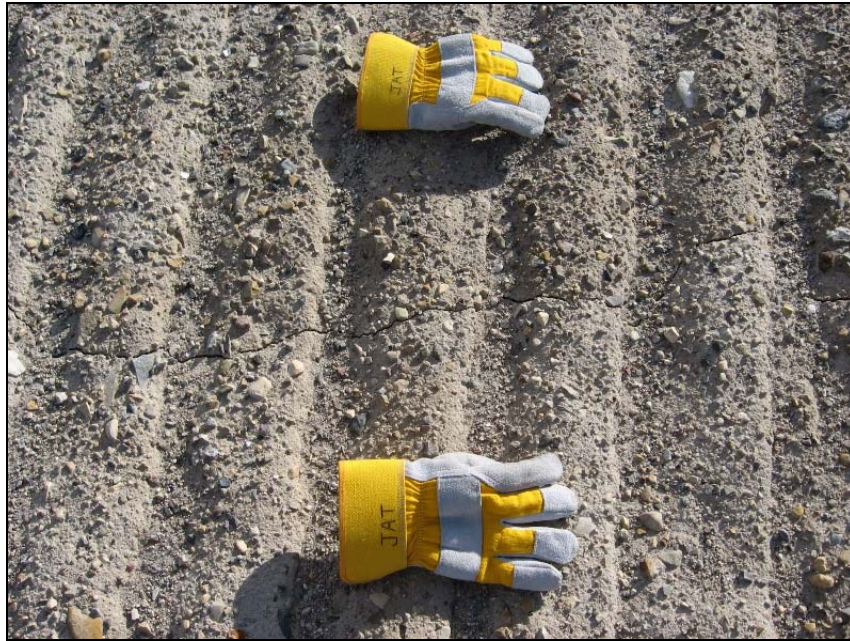
**Photograph T2-27.** Close-up of representative crack. This crack continues, splaying into two parallel cracks, 1m to 2m apart, and back again along entire toe of slope. Crack was observed in 2007 and shows no indication of recent movement. ↑

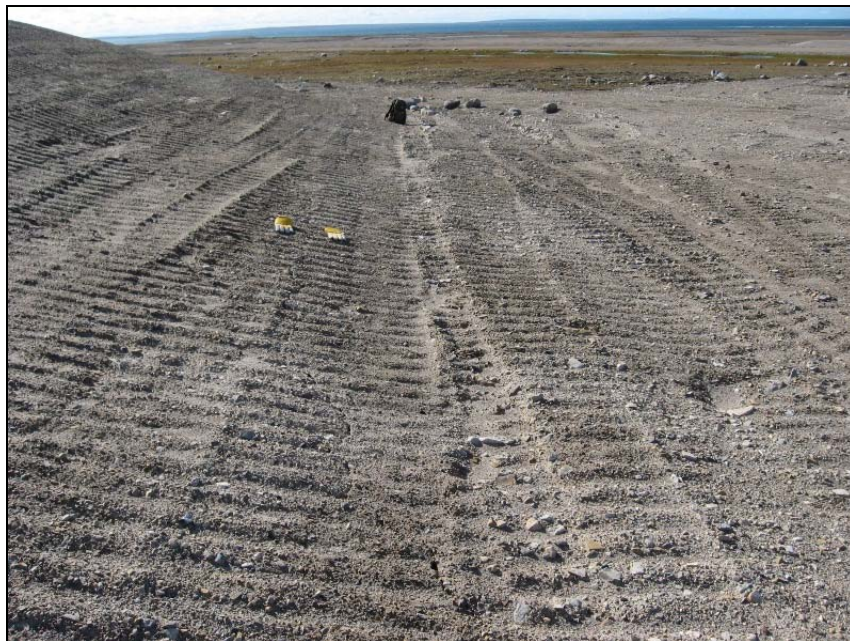
**Photograph T2-28.** Looking S along toe of W slope along old, partially in-filled crack. Crack passes between gloves and ends at backpack. ↑

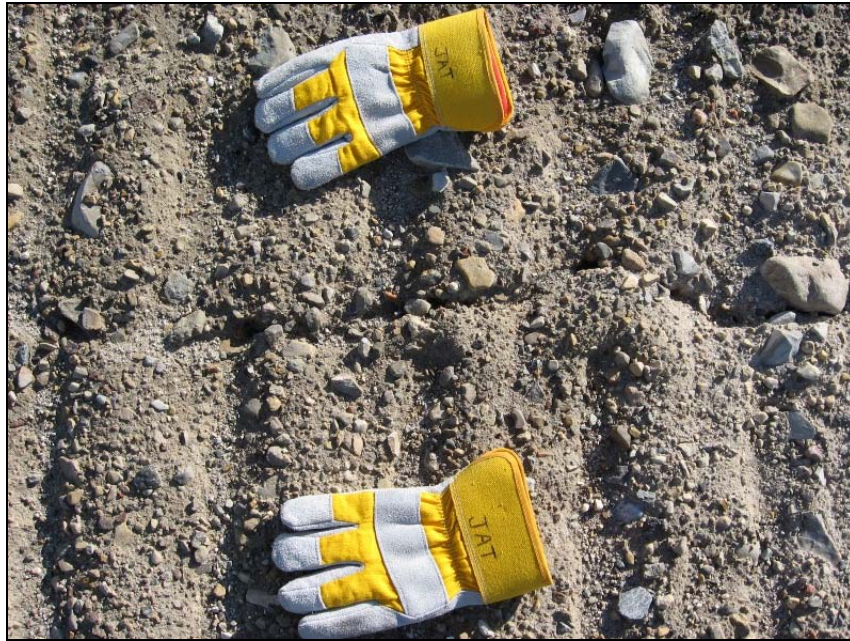
**Photograph T2-29.** Close-up of crack between gloves. Partially infilled, no sign of recent movement. ↑

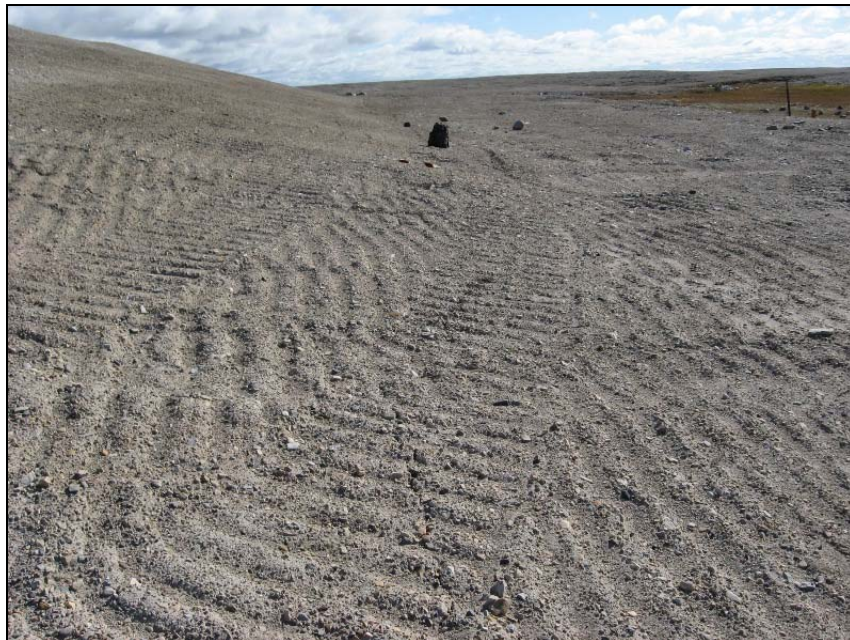
**Photograph T2-30.** Looking E along toe from SW corner. Old crack runs between gloves and ends at backpack. All other cracks in this area that were observed in 2007 were either completely in-filled or not observed. ↑
