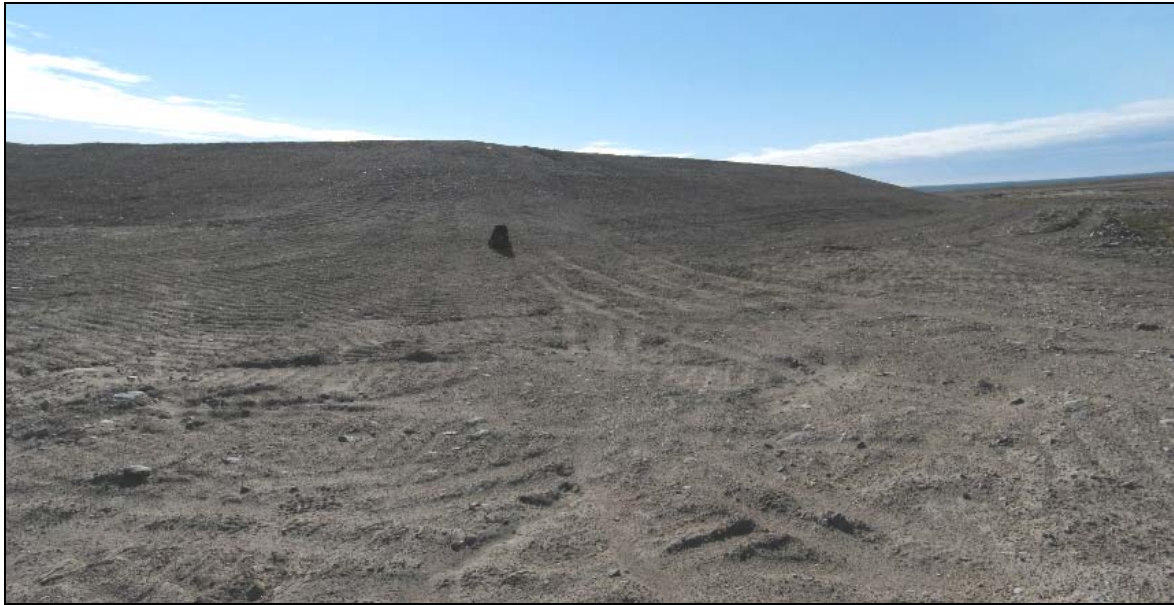
Photograph NH-1. Looking SW towards NE corner of Landfill. ↑

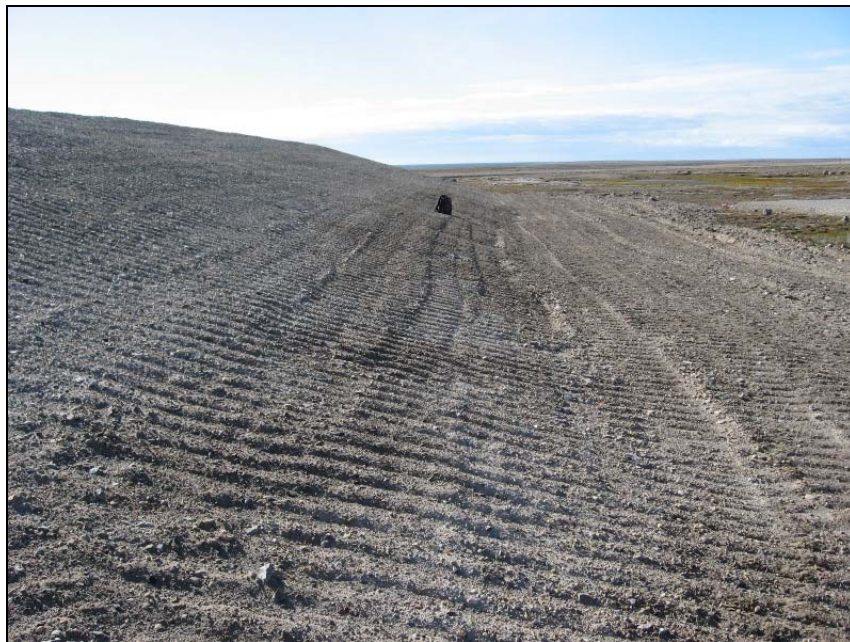
Photograph NH-2. Looking W along the toe of the N side of NE corner. ↑

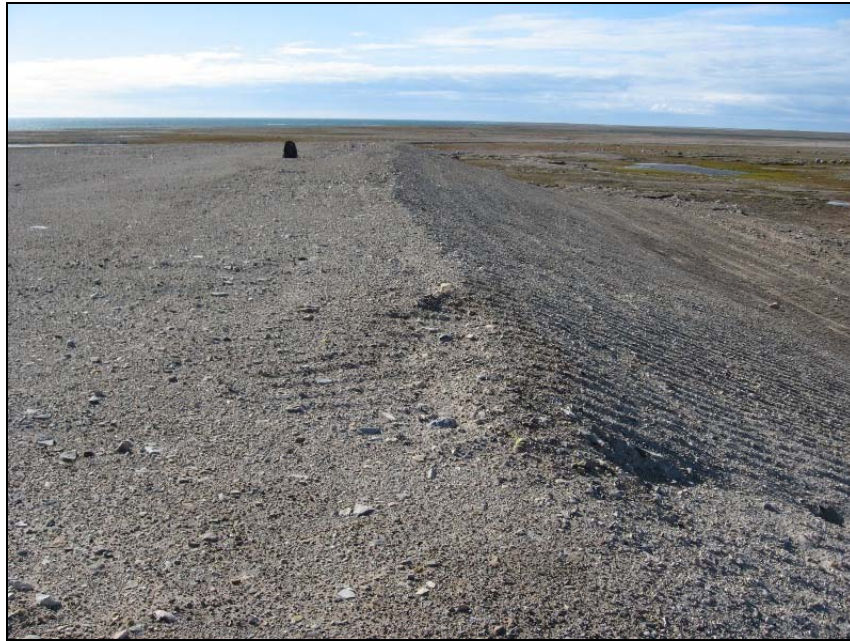
Photograph NH-3. Looking W along crest from NE corner. ↑

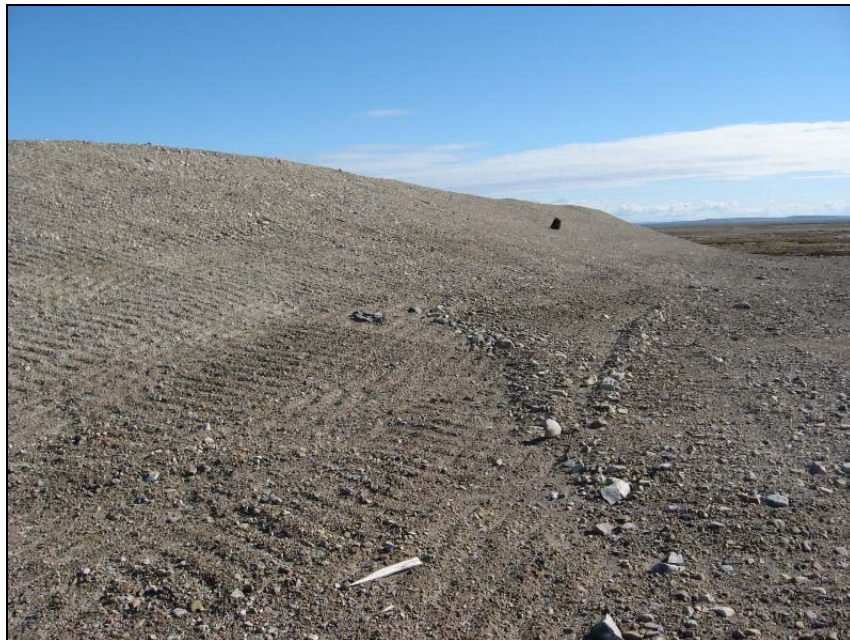
Photograph NH-4. Looking S along W side of LF from 10m NW of NW corner. ↑

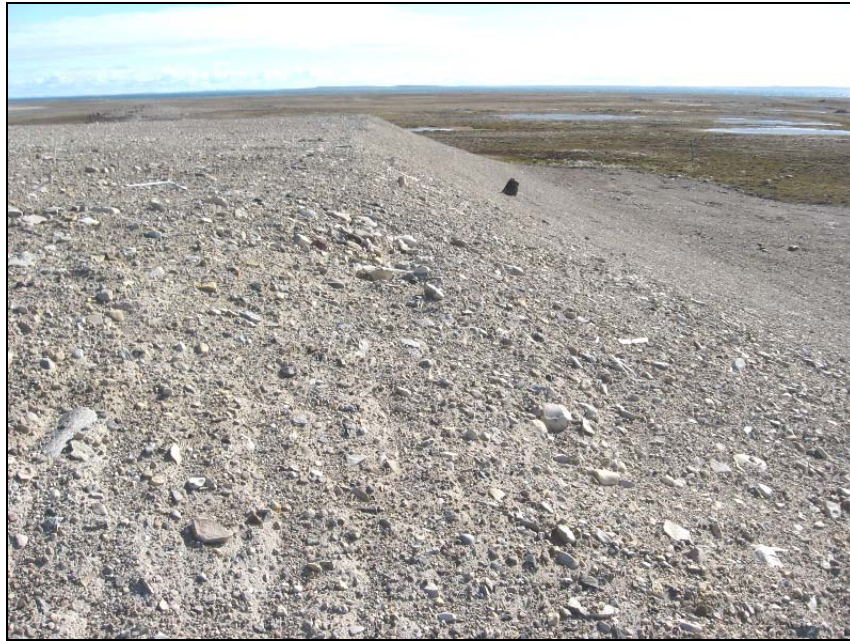
Photograph NH-5. Looking S along crest from NW corner. Fine cracks that were observed last year cannot be seen. ↑

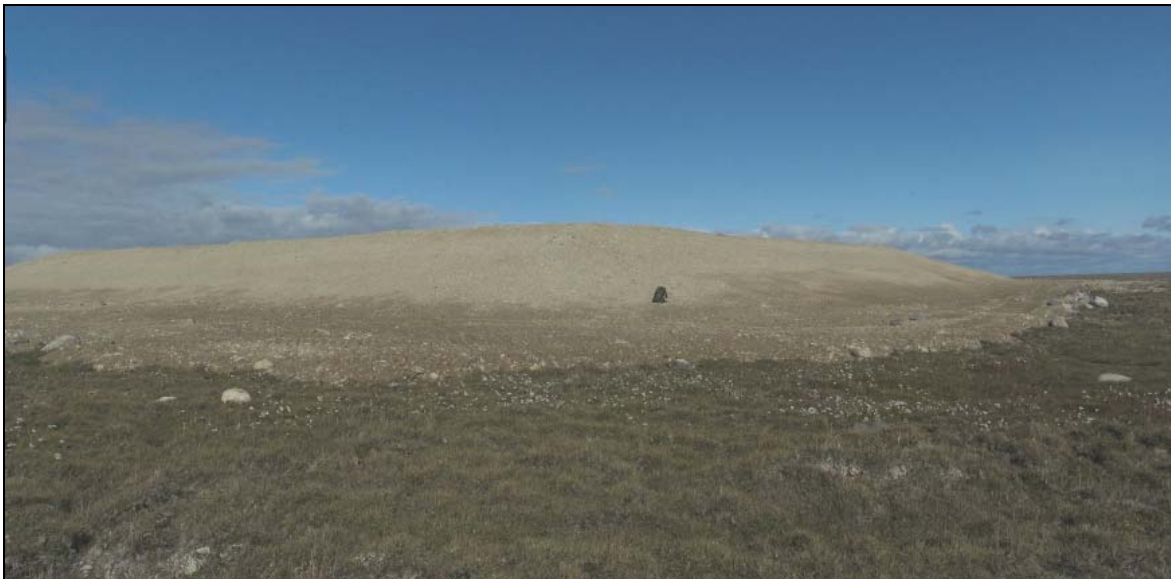
Photograph NH-6. Panoramic looking NE from adjacent to MW-8 looking to SW corner of LF. ↑

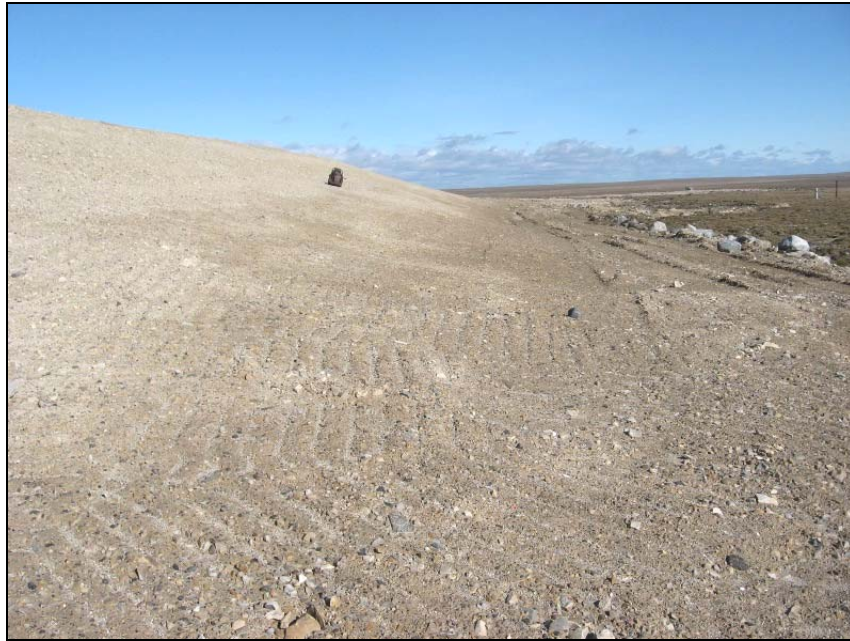
Photograph NH-7. Looking ENE along toe of S slope from SW corner of LF. Backpack located next to old in-filled crack. ↑

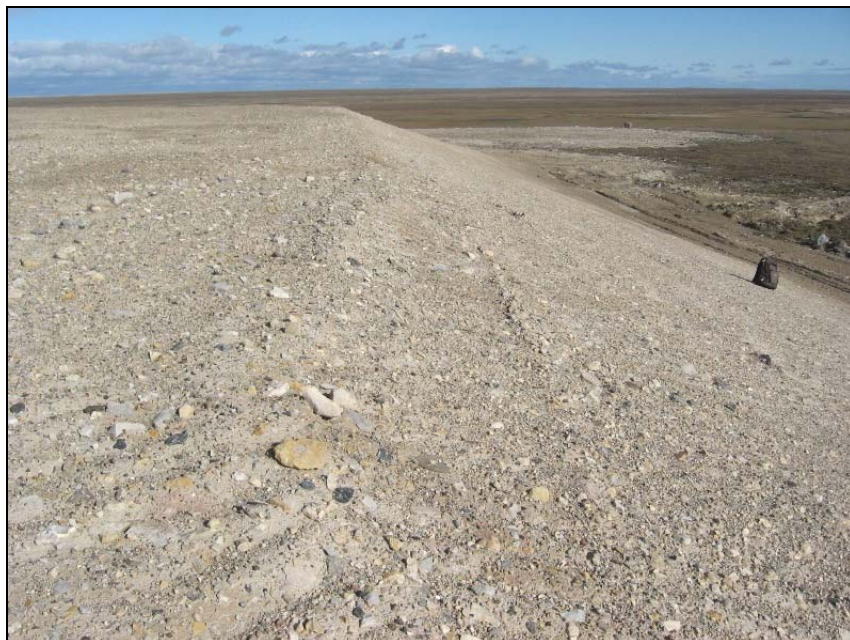
Photograph NH-8. Looking ENE along crest from SW top of LF. ↑

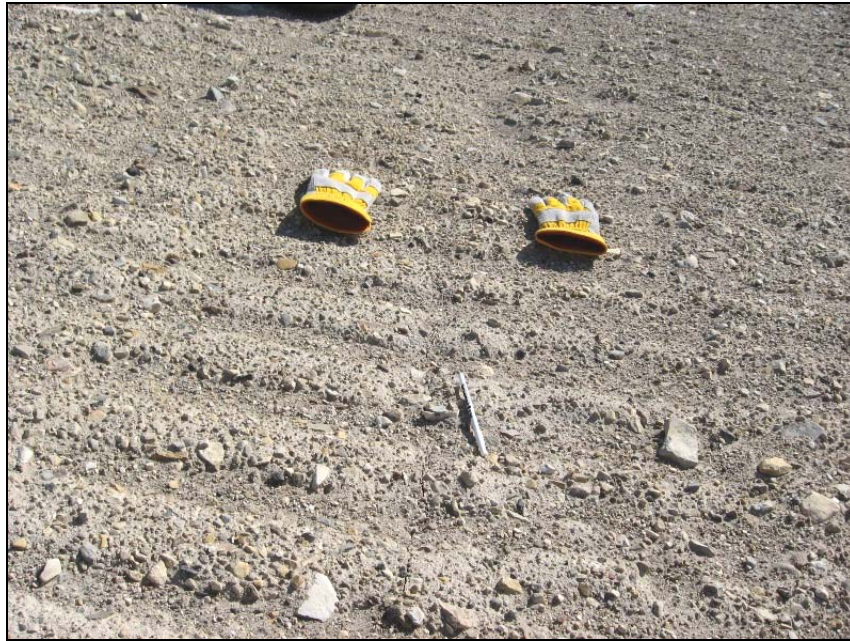
Photograph NH-9. Close-up of crack from last year, partially in-filled with no sign of recent movement (gloves and pen for scale). Splays and offset by up to 1m, always fine. ↑

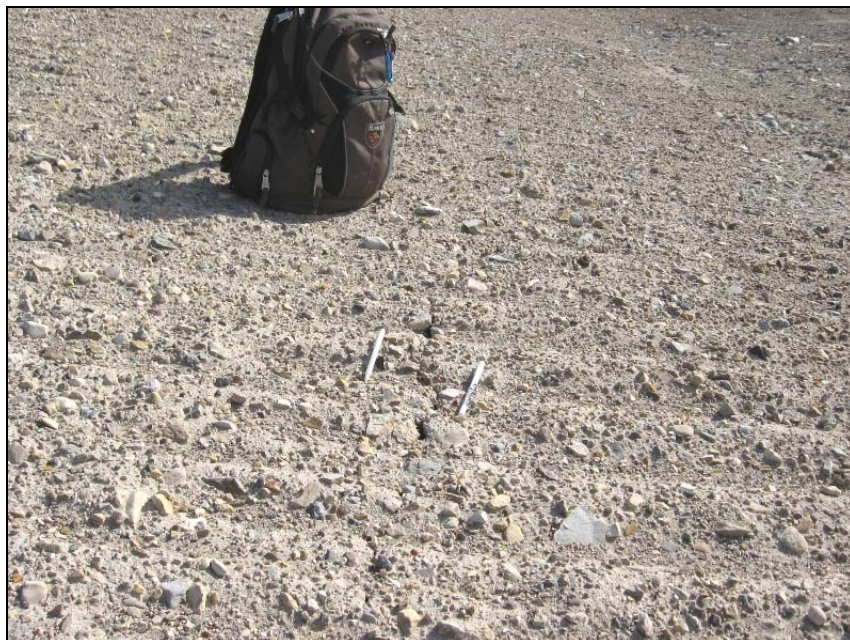
Photograph NH-10. Close-up, portion of lower crack along W toe that was observed last year. Most has been in-filled and cannot be seen. ↑

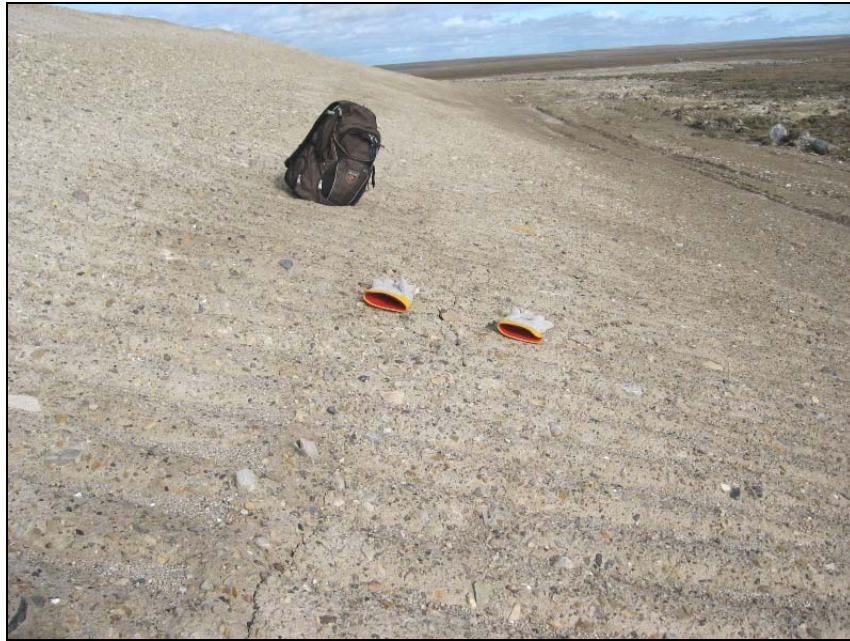
Photograph NH-11. Looking ENE along slope along old, partially in-filled crack (between gloves). ↑

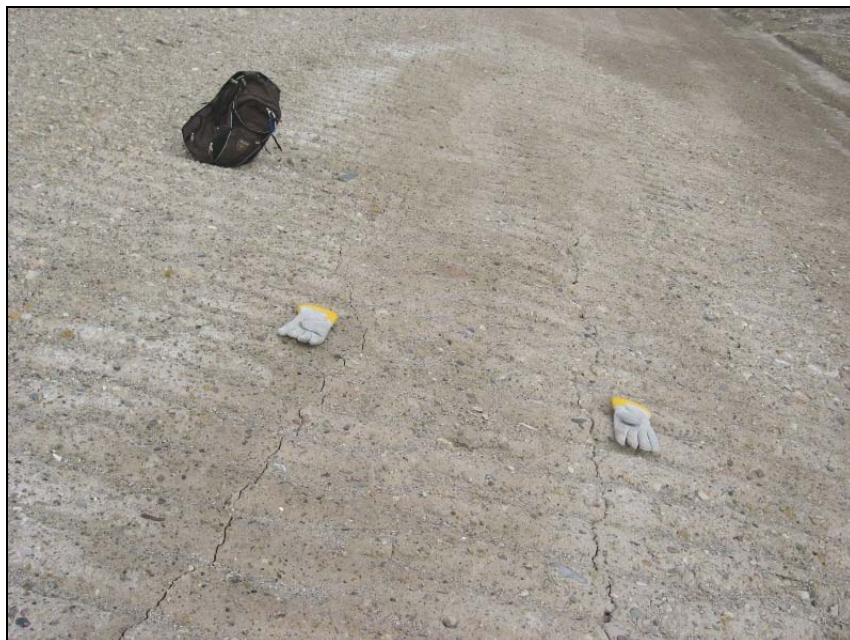
Photograph NH-12. Looking ENE at parallel cracks (old). ↑

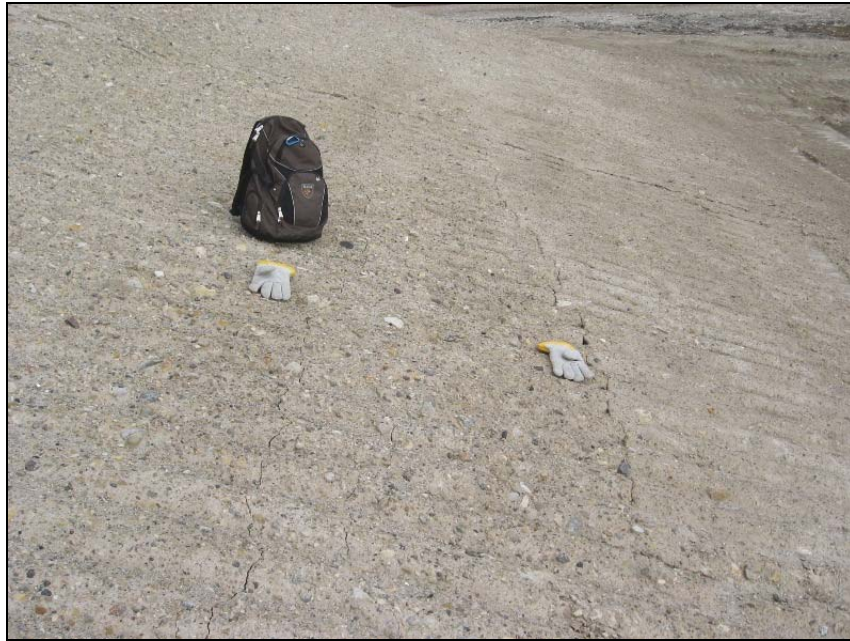
Photograph NH-13. Looking ENE at parallel cracks (old) approaching SE corner. Area of minor (self armoured) surficial erosion visible in background. Zone of erosion appears unchanged from the time of the 2007 inspection. ↑

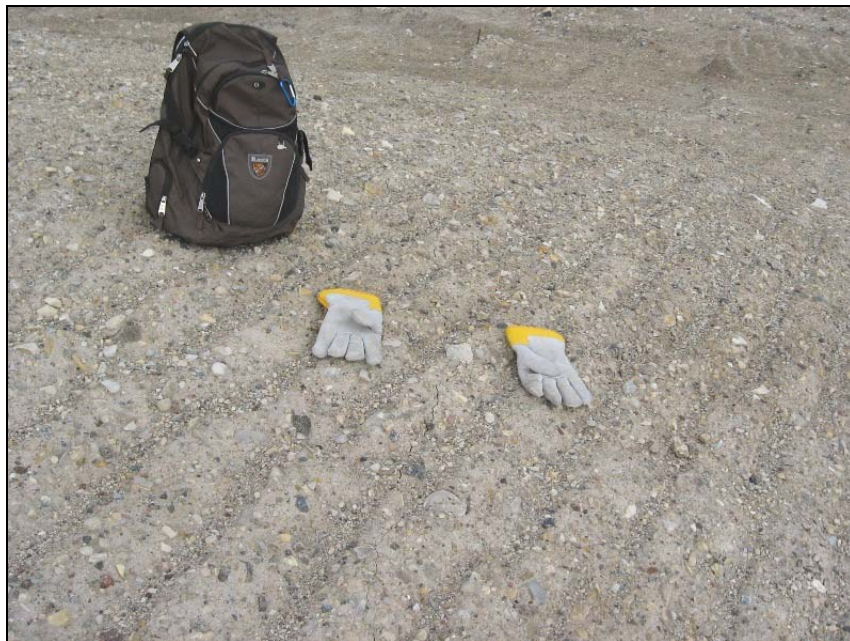
Photograph NH-14. Close-up, crack becomes narrow at SE corner. ↑

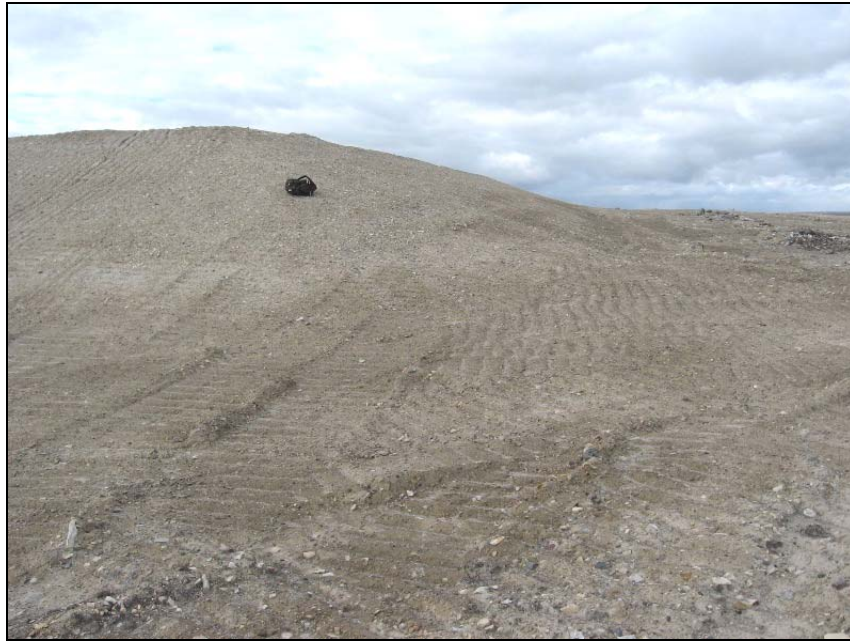
Photograph NH-15. Looking N along E toe from SE corner. ↑

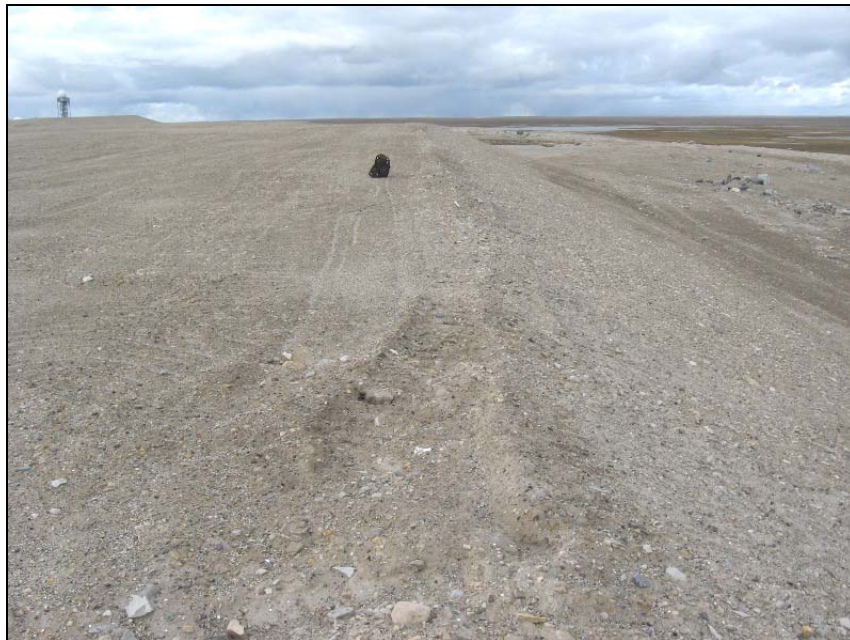
Photograph NH-16. Looking N along crest from SE corner. ↑

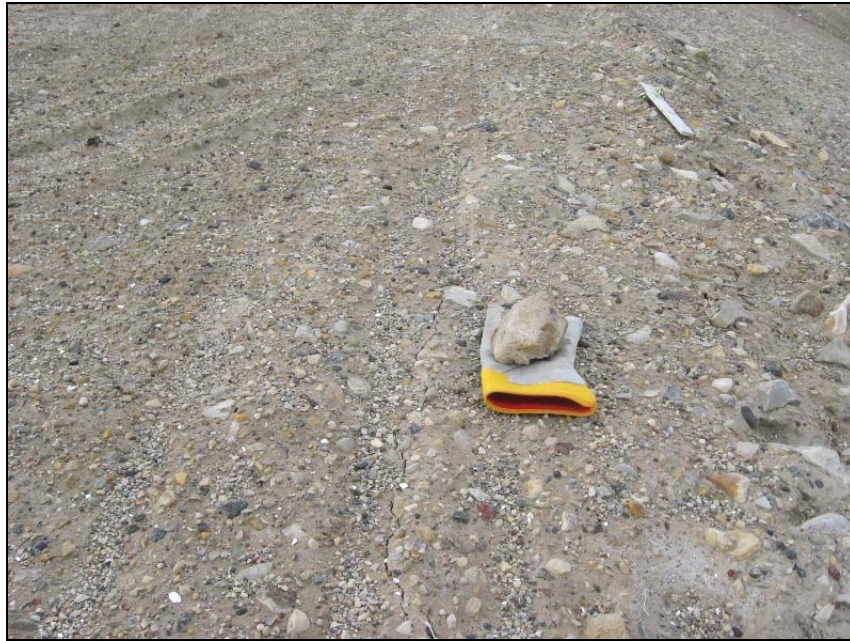
Photograph NH-17. Minor crack along crest (old) looking N. ↑

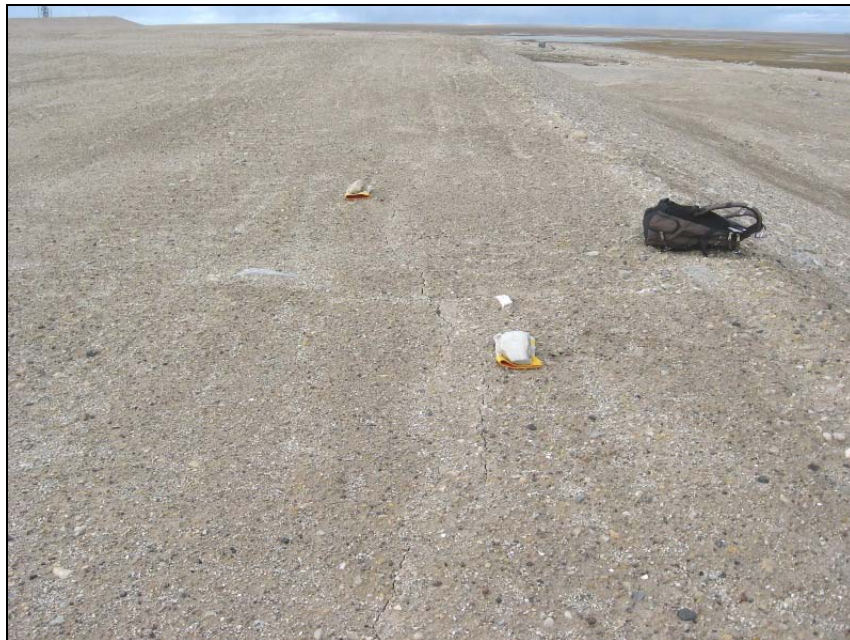
Photograph NH-18. Crack along E crest looking N. Similar to last year. Gloves on either side of crack. ↑

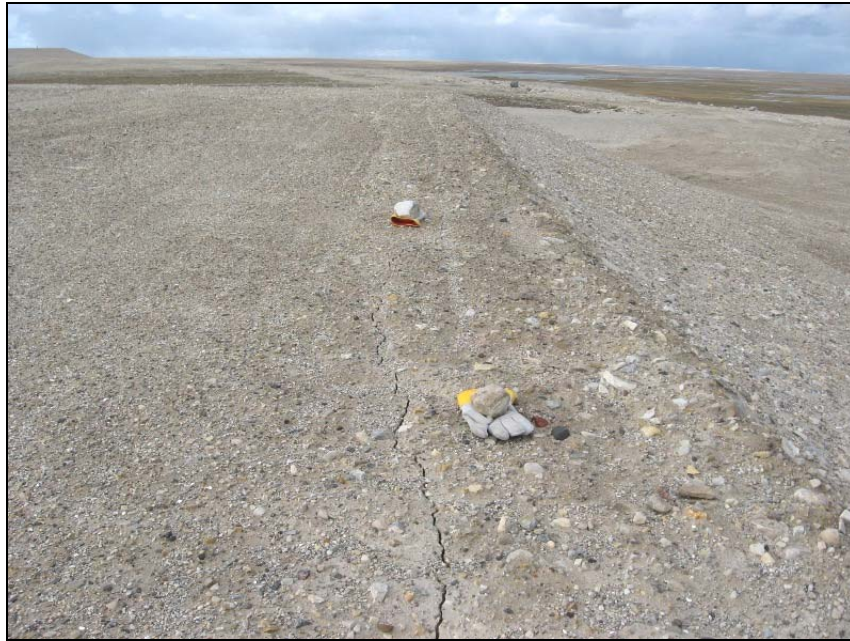
Photograph NH-19. Following crack on crest. Looking N approaching NE corner. ↑

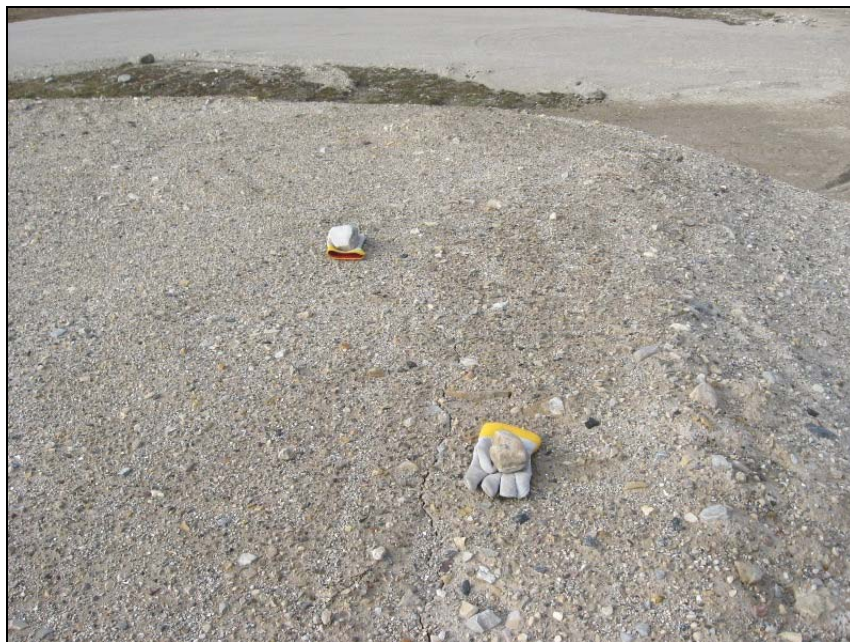
Photograph NH-20. Following crest crack to NE corner. Crack largely in-filled as it rounds corner. Faintly visible from about 30m W along N crest. ↑

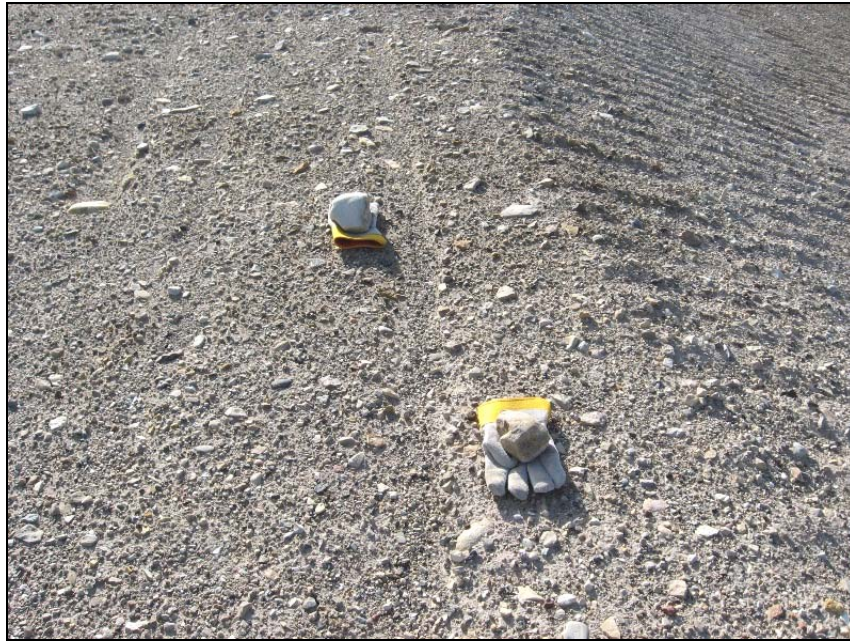
Photograph NH-21. Representative picture of crack as it rounds corner and turns W. Gloves for scale on either side of in-filled crack. ↑

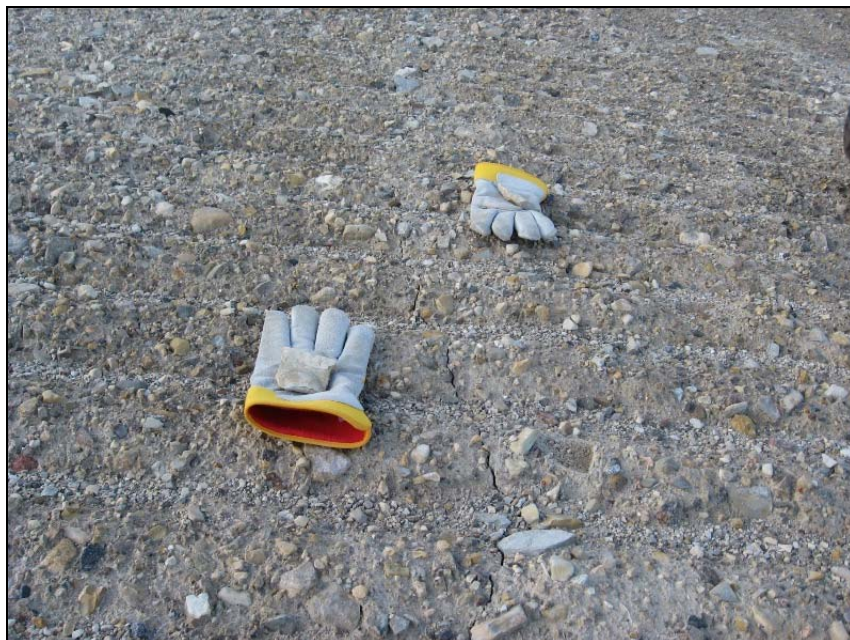
Photograph NH-22. Representative crack along E slope looking N. ↑

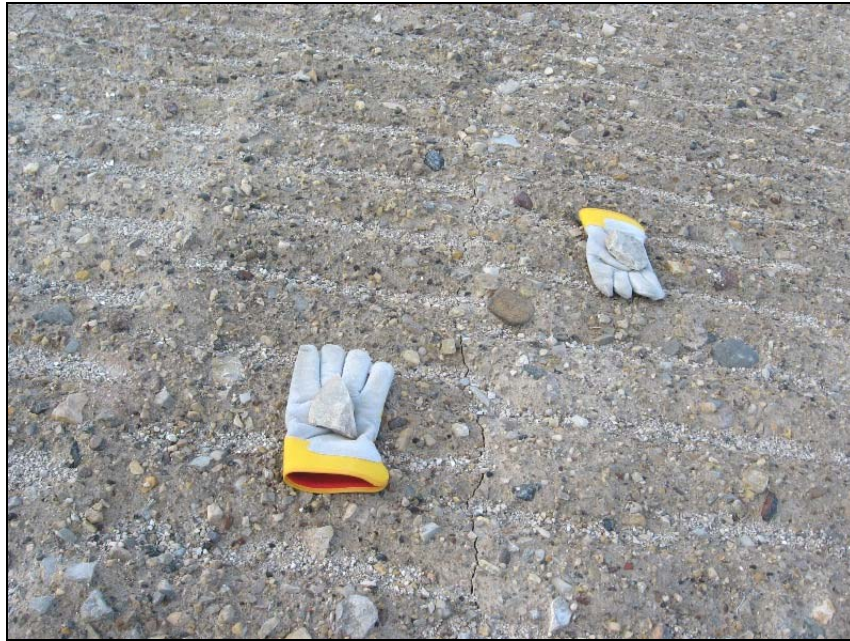
Photograph NH-23. Following crack on E slope looking N. ↑

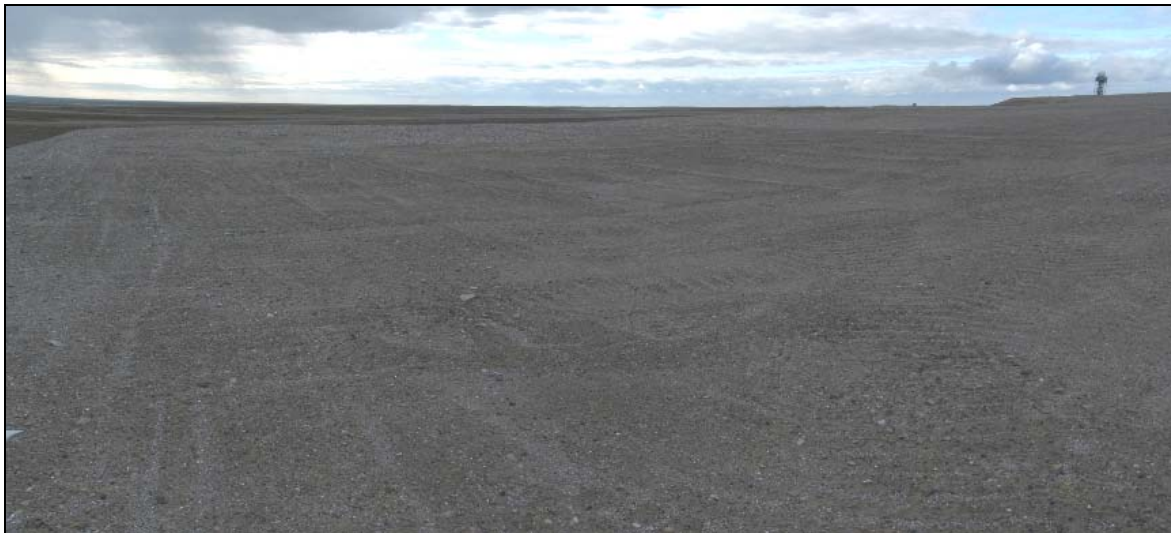
Photograph NH-24. Looking NW from SE corner scanning L to R. Note approaching snow! ↑
