# **The Collection of Landfill Monitoring Data at the CAM-2 Gladman Point – 2007 FINAL Report**

Prepared for  
**Defence Construction Canada**

Submitted by  
**Gartner Lee Limited**

**January, 2008**

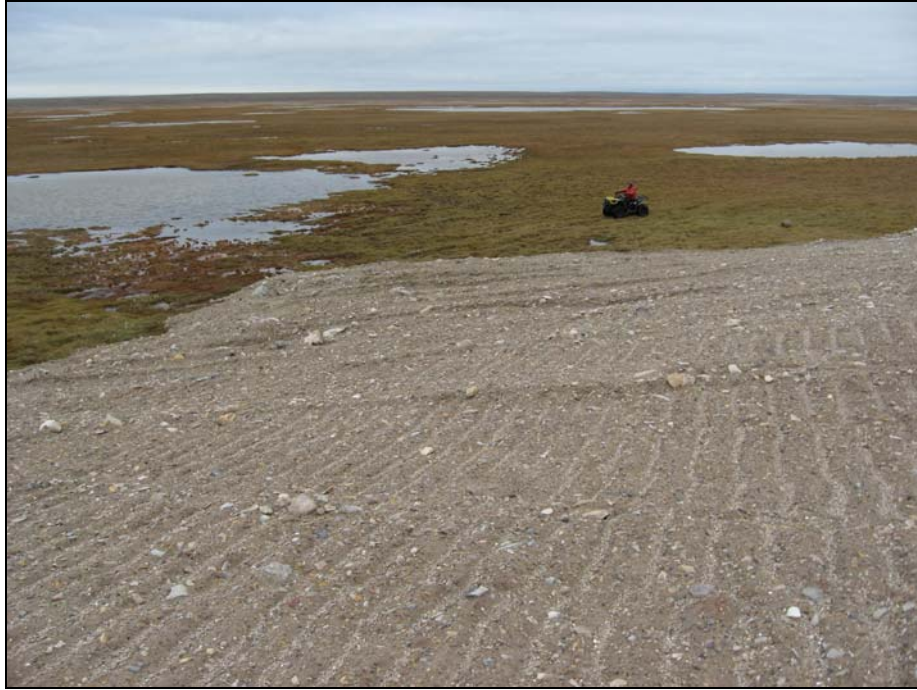
**Photograph 6. Station Landfill: Looking SSE along east side of Station LF from near NE corner. Coarse granular cover appears stable and has been contoured to a shallow slope.**

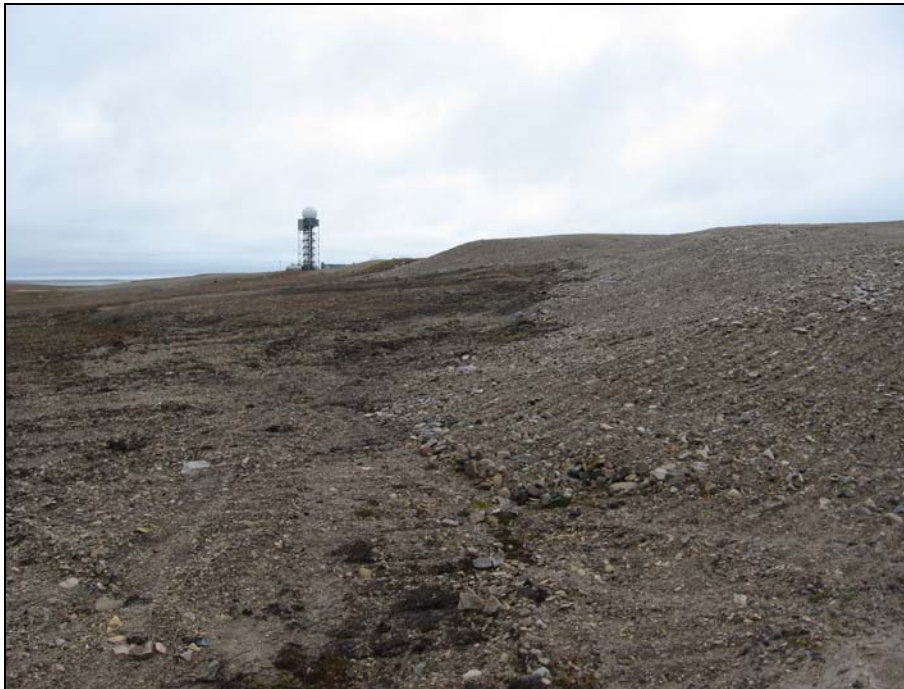
**Photograph 7. Panoramic looking SSW to SW towards the small central east lobe and large southern lobe. No features of note. ↑**

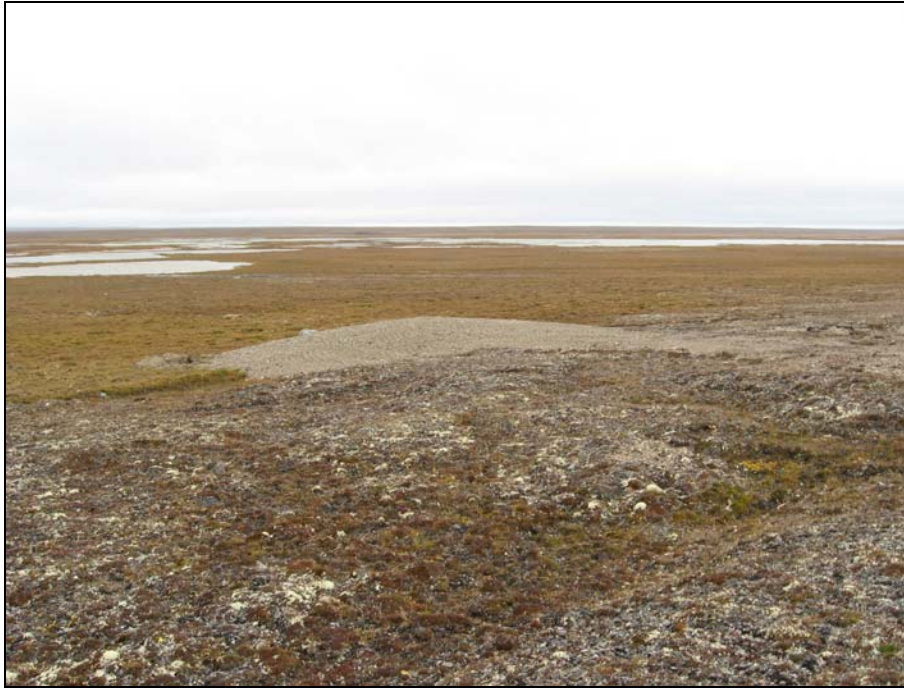
**Photograph 8. Looking south along eastern edge of large southern cell. No features of note. No problematic conditions observed. ↑**

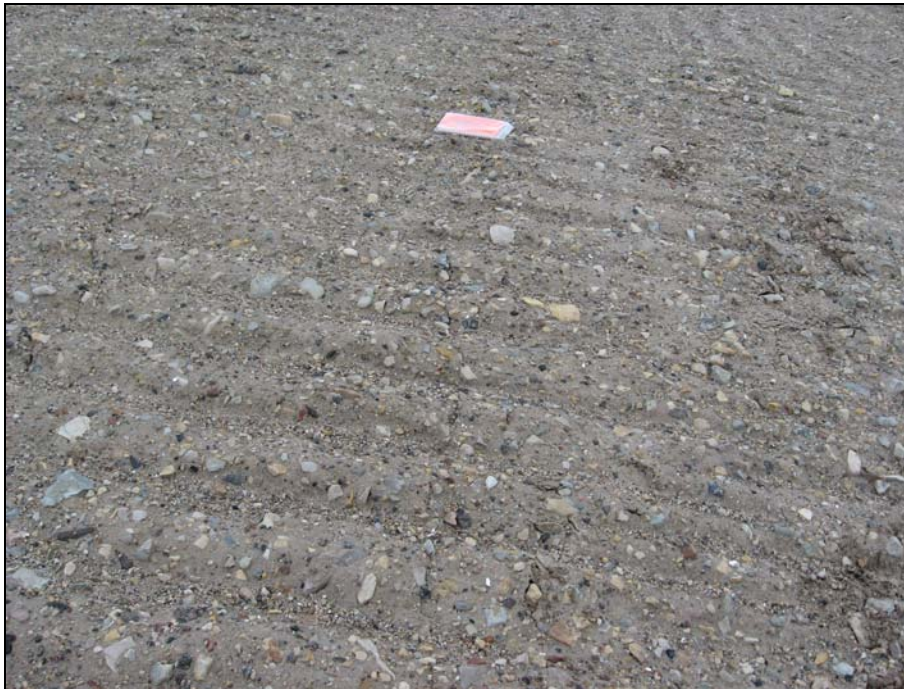
**Photograph 3. Looking west along north crest of the landfill from the NE corner. VT-1 in frame. ↑**

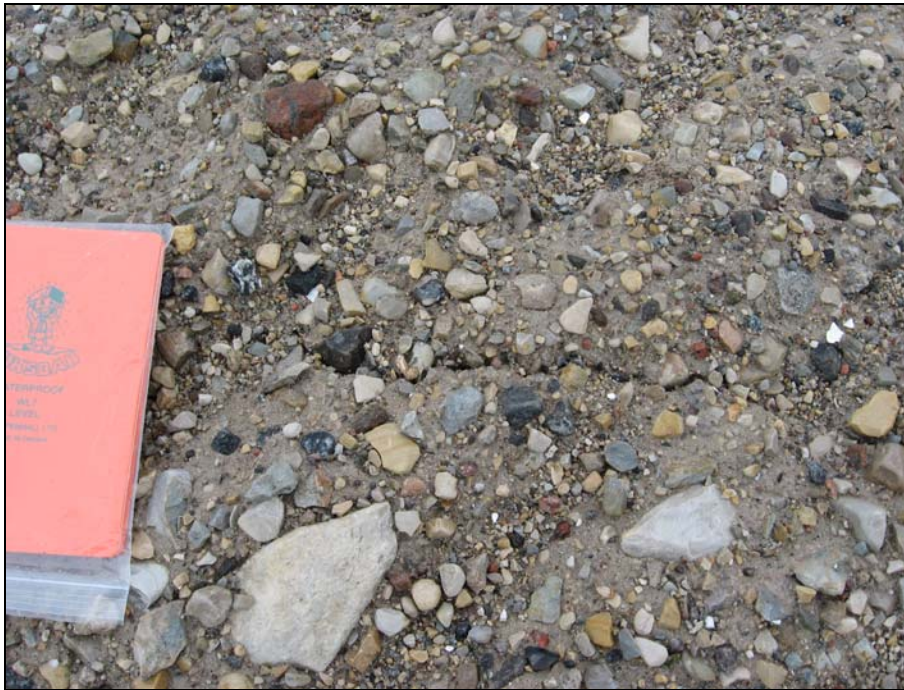
**Photograph 5.** Looking N following the lower fine tension crack noted above. The crack is obscured by fines that have washed in. ↑

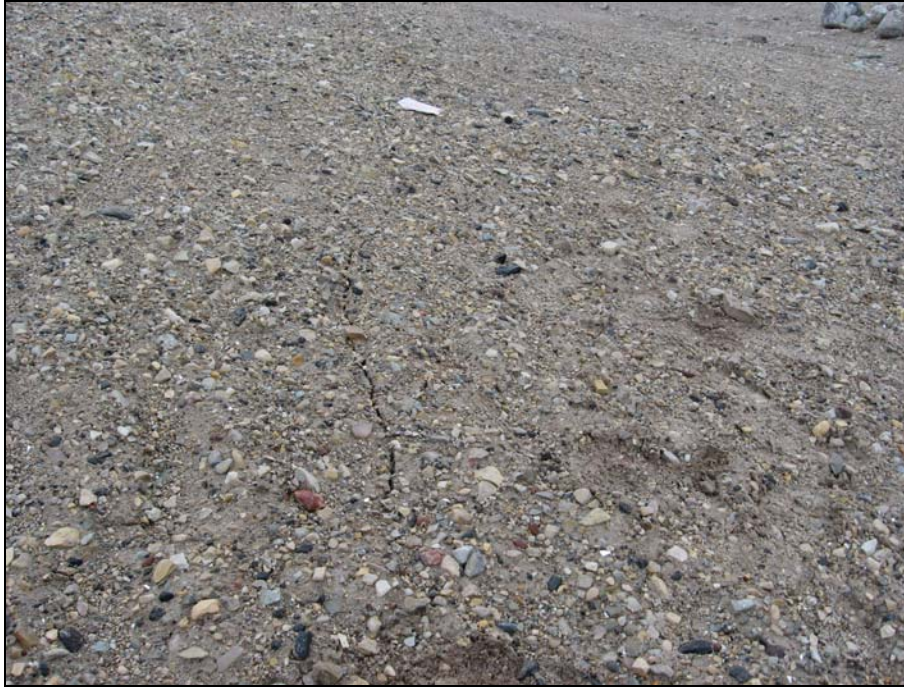
**Photograph 6.** Close-up of typical crack at NE corner 5m up-slope. Crack fades in and out as some fines have washed in, completely filling some portions of the thin crack. ↑

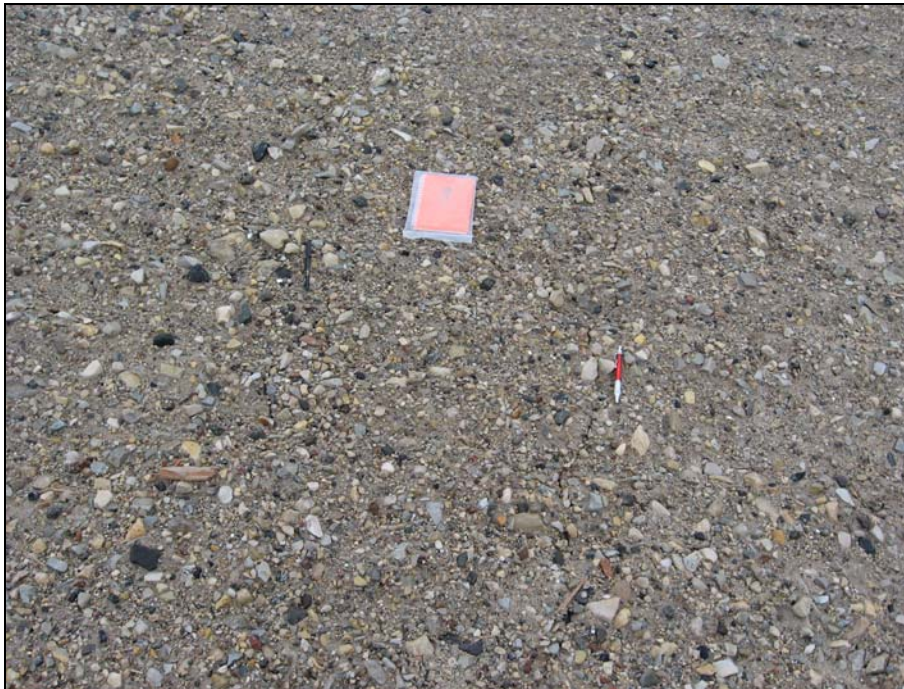
**Photograph 7. Tracking the lower (most consistent) tension crack that originated near Photo 4. Looking WNW along the northern toe of the landfill from near the NE corner. ↑**

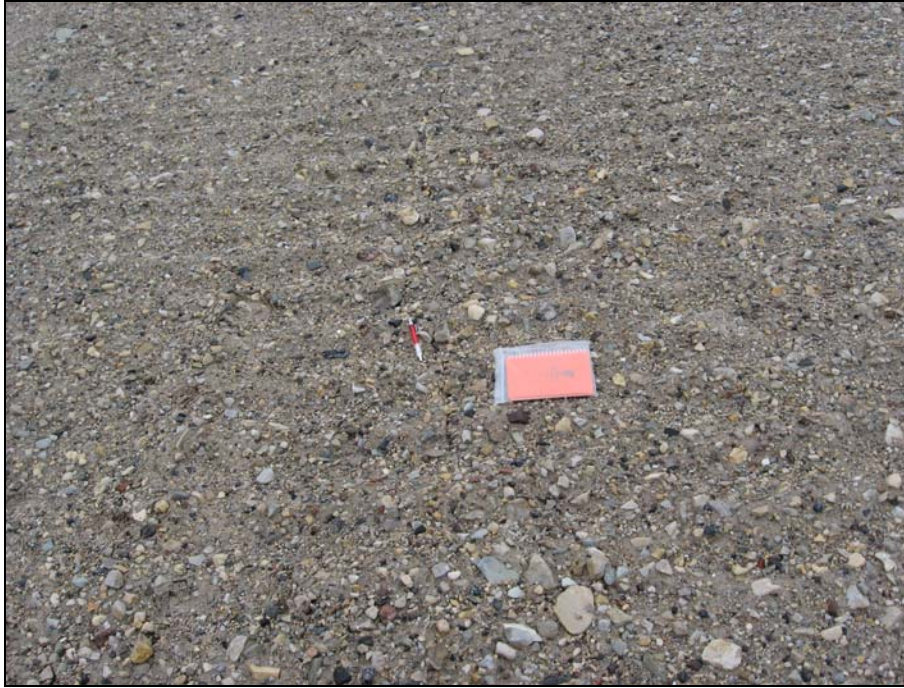
**Photograph 8. Close-up photo. Continuing to tracking the tension crack westward along the toe. The pens bracket two tension cracks. The upper crack ends and lower crack continues with a 0.6m offset. ↑**

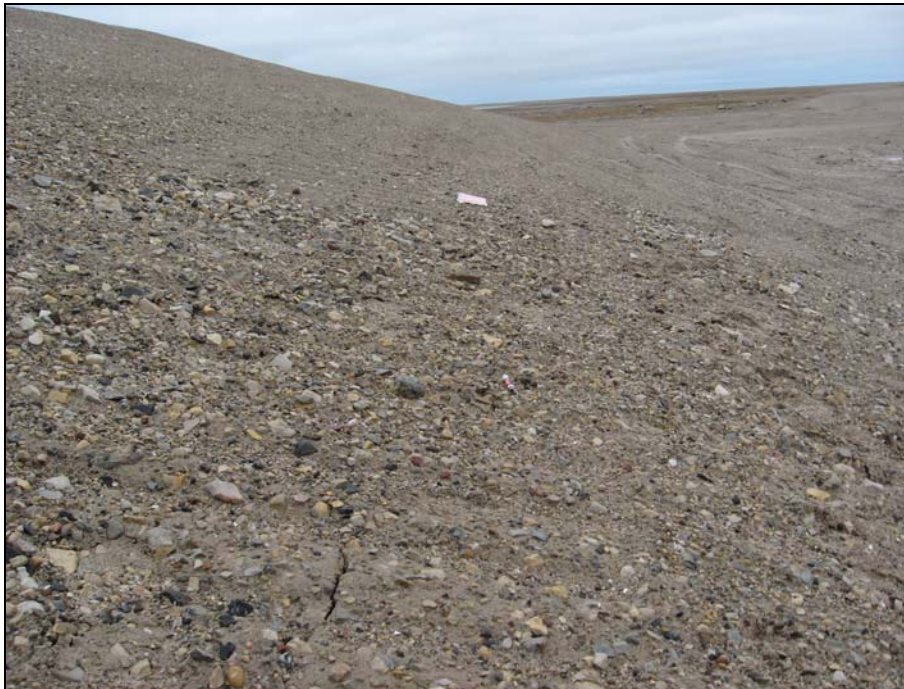
**Photograph 9. Looking east along the north toe of the landfill. Continuing to follow the lower tension crack. ↑**

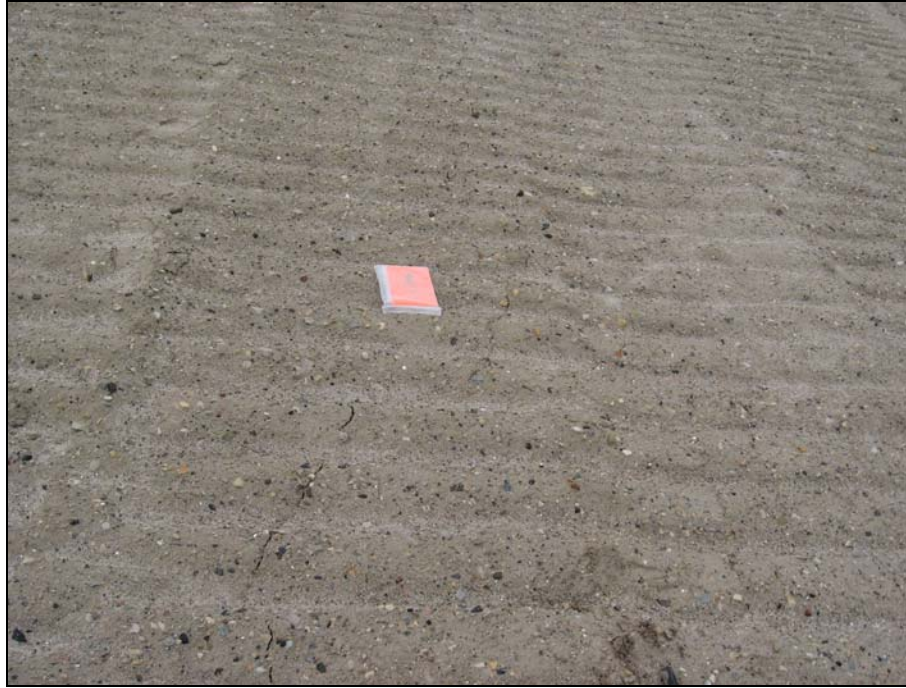
**Photograph 10. Continuing to track the lower (most consistent) tension crack along the north toe of the landfill. Looking west along toe of north slope. Field book for scale. ↑**

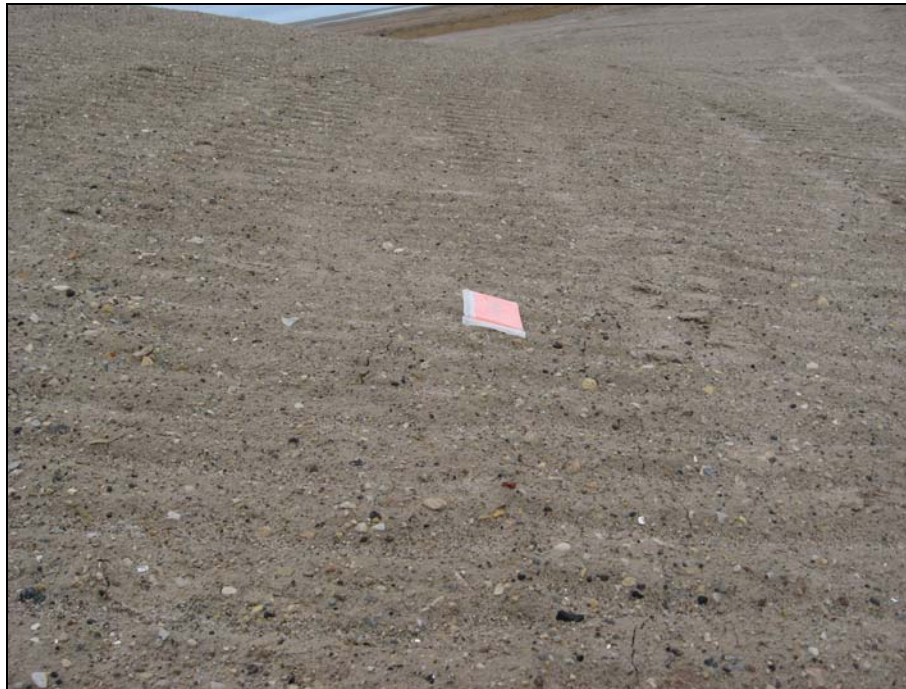
**Photograph 11.** Looking west following crack where it splays and shifts downslope to 3m from toe. Still no indication of additional tension cracks upslope. ↑

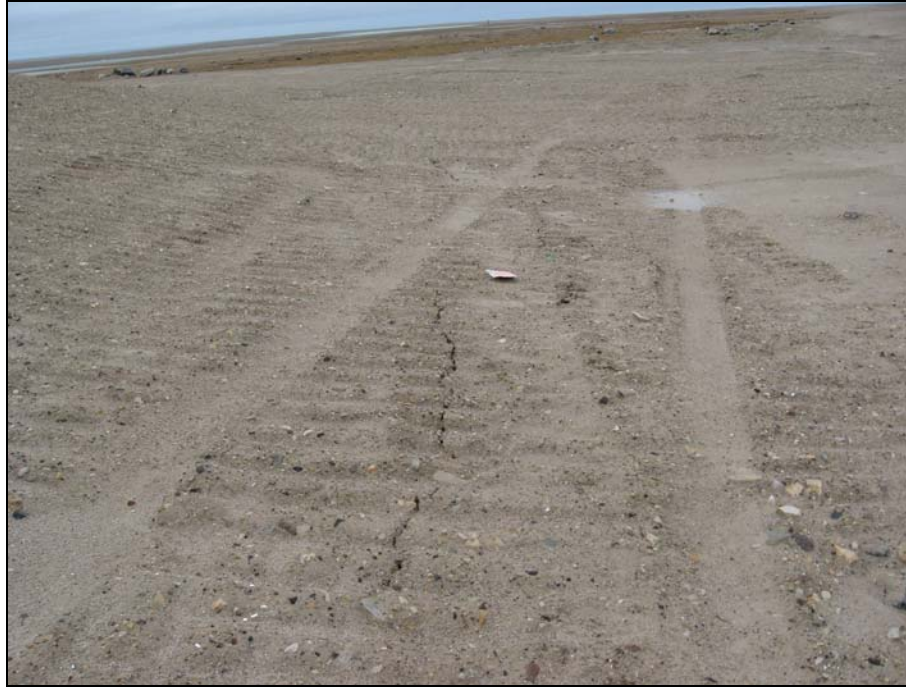
**Photograph 12.** Tension crack in parallel. Cracks remain fine, but geometry is becoming consistent with slow retrogression. Looking west to NW corner. Hints of tension cracks upslope but sediment infilling prevents clear diagnosis. ↑

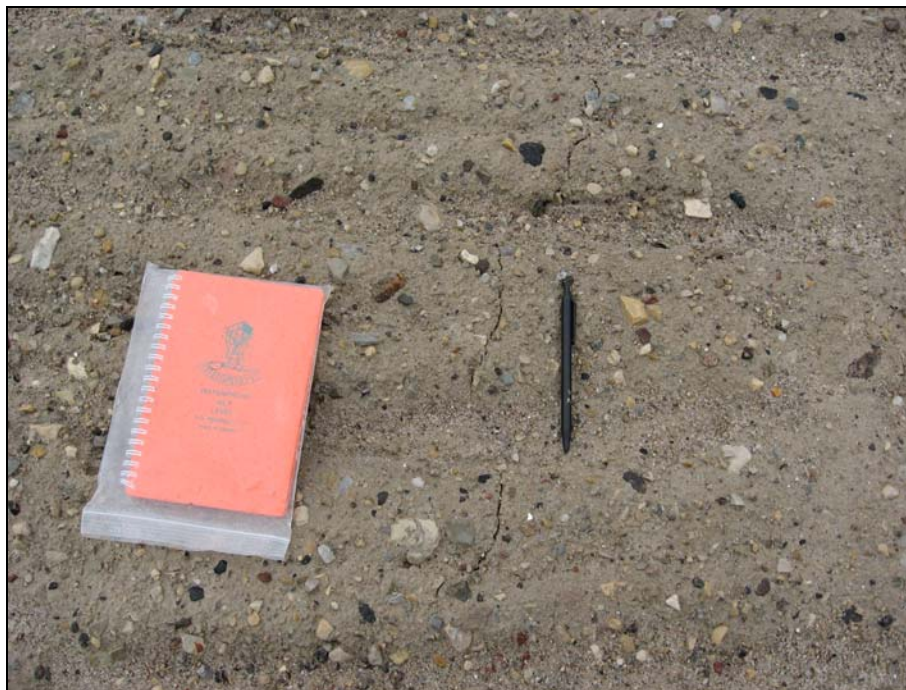
**Photograph 13.** Looking WNW along toe of slope to larger (up to 2cm wide) tension crack near the NW corner. Additional fine cracks continue 3m upslope. Large crack continues until it is obscured by sediment infilling. ↑

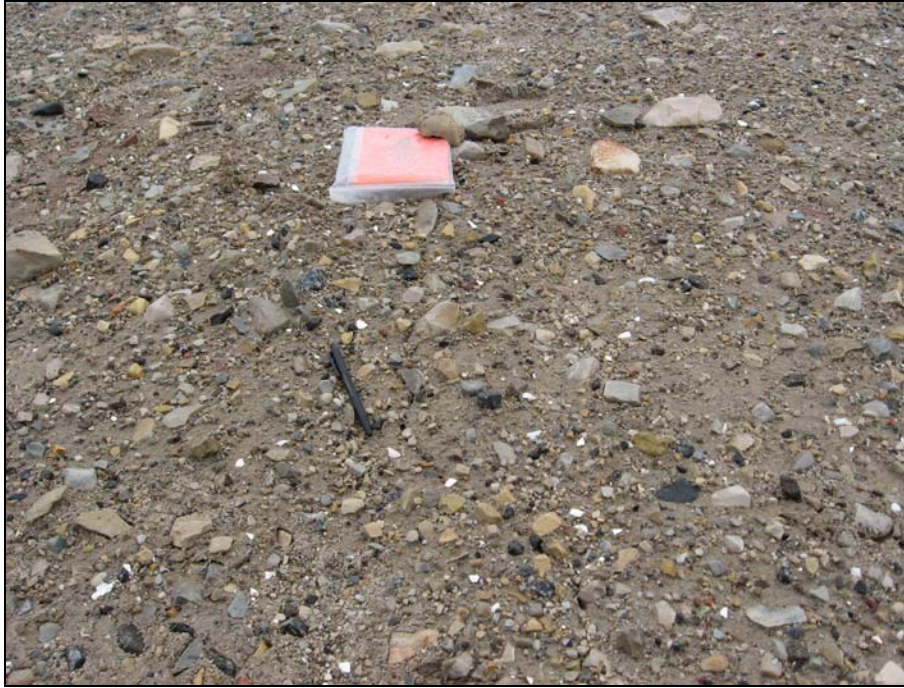
**Photograph 14.** Fine tension crack about 10 m upslope from the wider crack noted in Photo 13. The crack is parallel to the slope and suggests entire slope may be moving. ↑

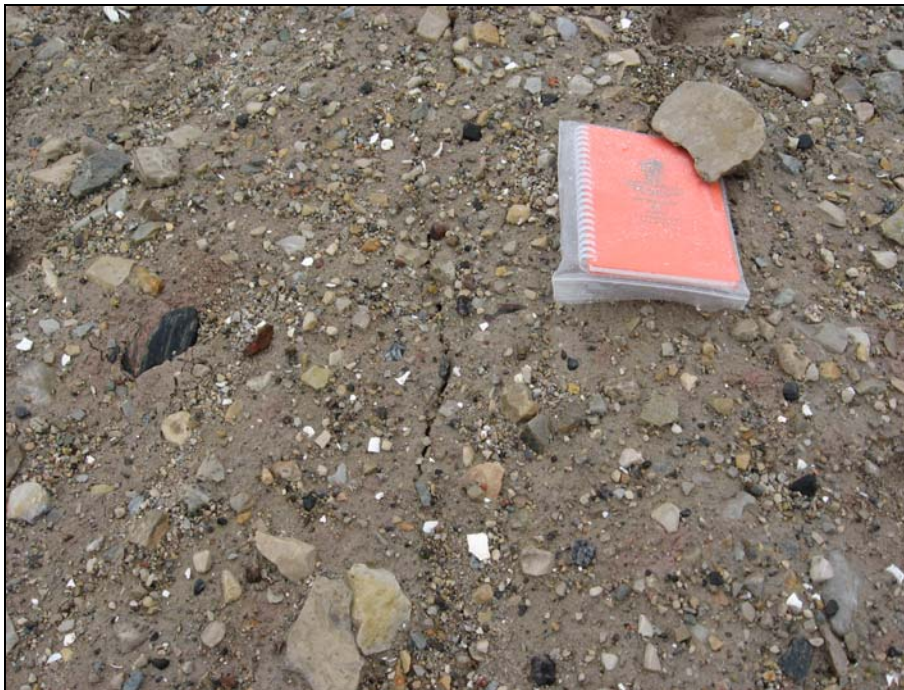
**Photograph 15. Close-up of tension crack at top of slope along the NW corner of the landfill. This tension crack is parallel to the cracks noted in Photos 13 and 14. Note sediment infilling. ↑**

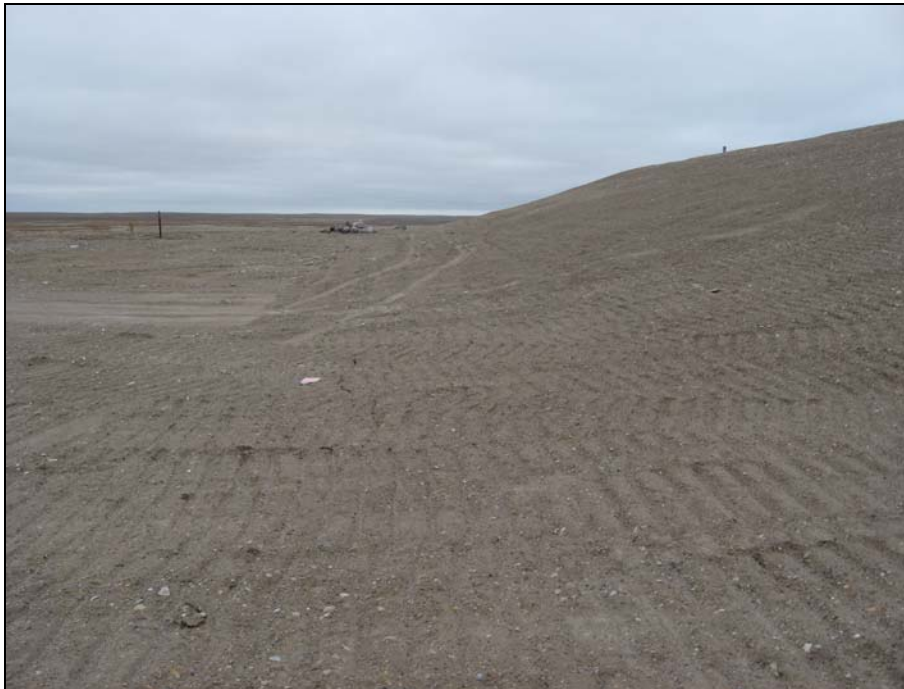
**Photograph 17. Looking SE to NW corner of landfill (Tier II) from about 30 m NW of the NW corner of the landfill. West side of the landfill is on the right side of the frame. ↑**

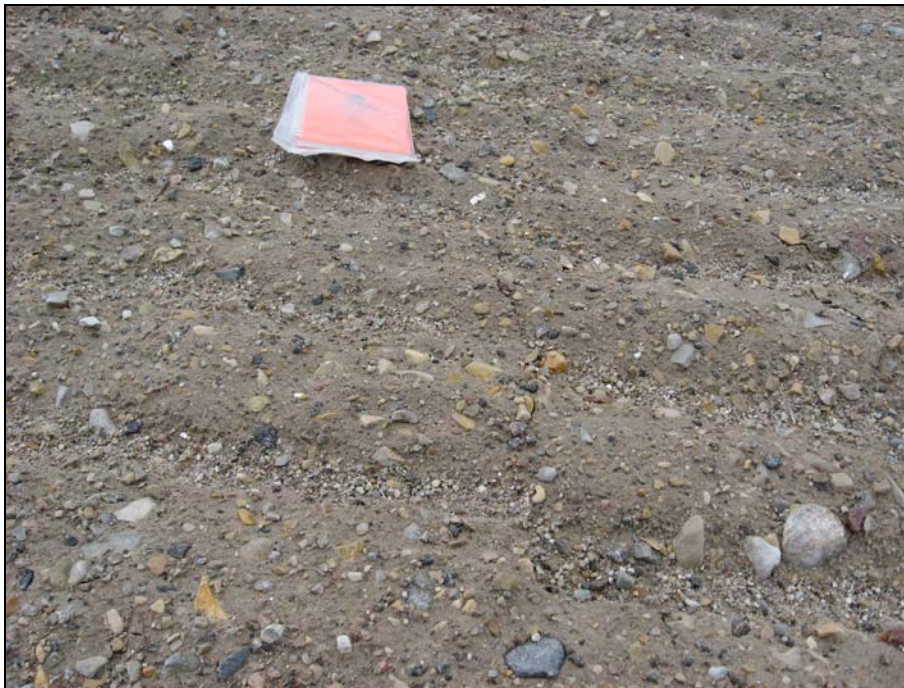
**Photograph 19.** Looking south along the toe of the west side of the landfill from NW corner. ↑

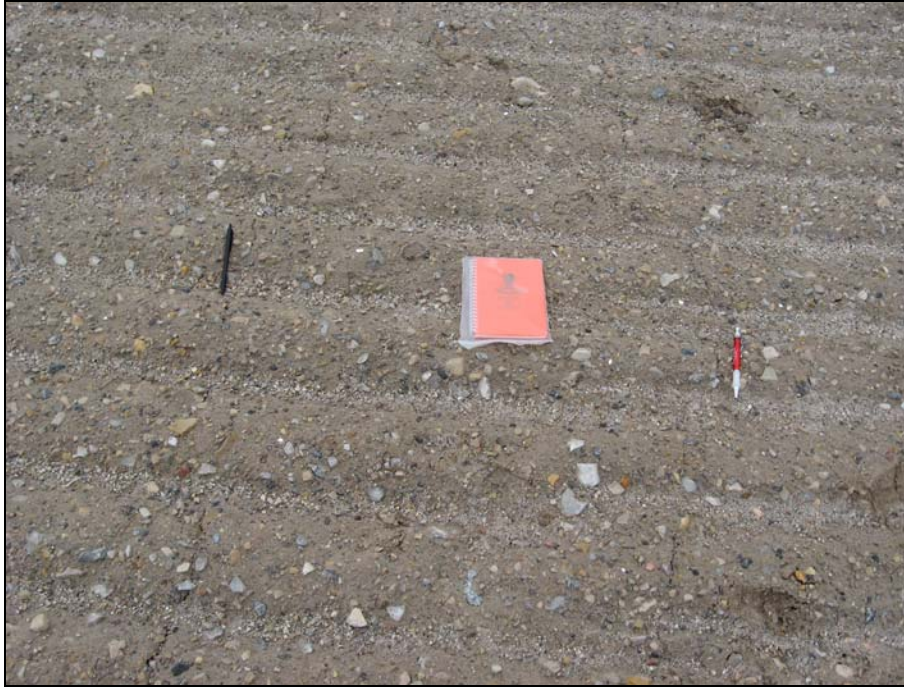
**Photograph 20.** Following a thin tension crack along west side of landfill from the NW corner. Crack runs parallel to slope about 4m upslope from downslope toe. Appears to continue from the north side of the landfill. ↑

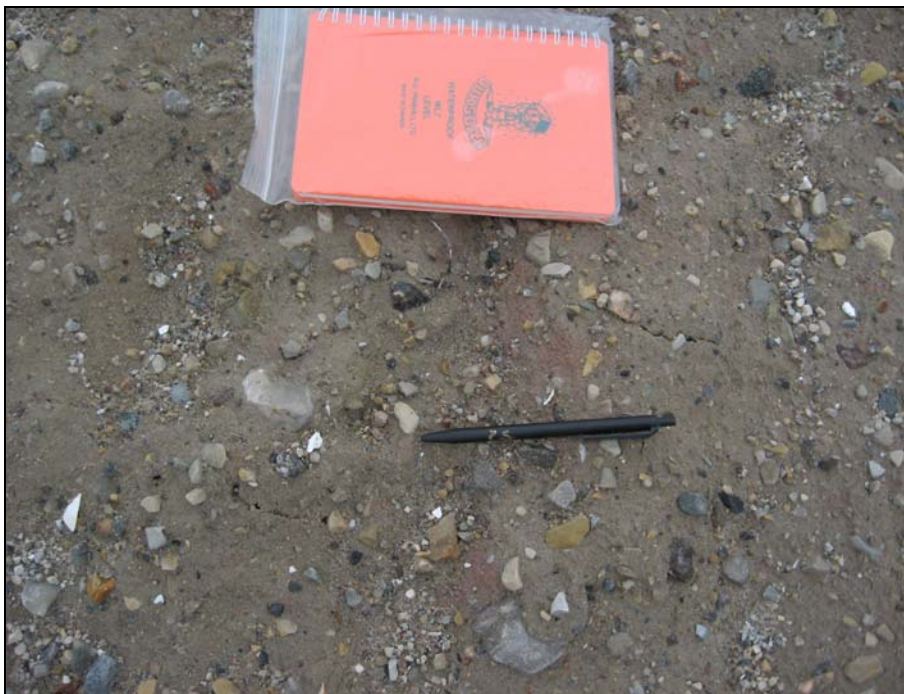
**Photograph 21. Following continuation of tension crack noted in Photo 20 (black pen) and noting the start of a second lower crack (red pen). Sediment infilling partially masks cracking. ↑**

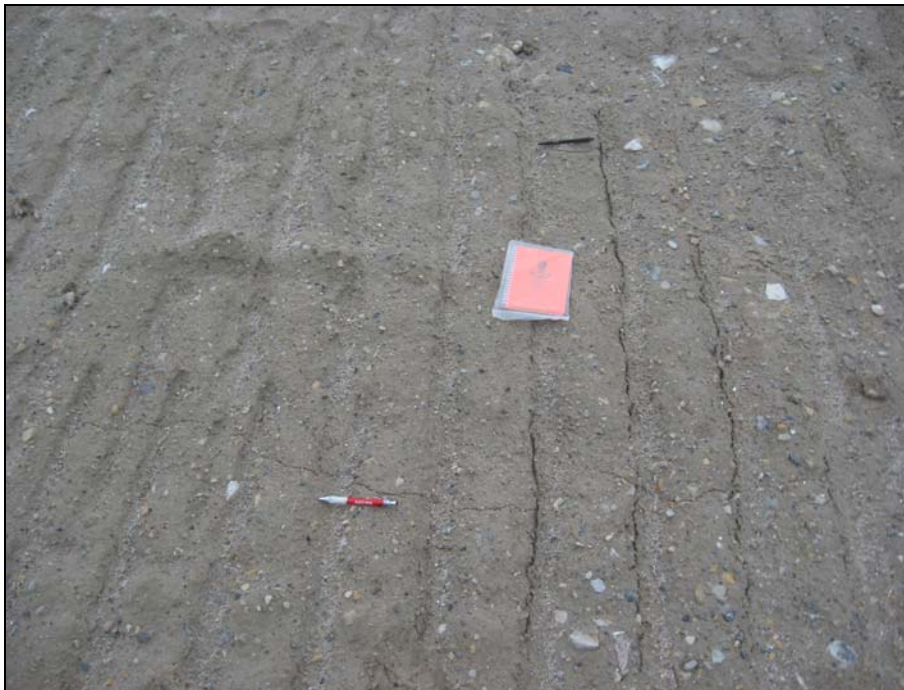
**Photograph 23. Looking south along Tier II crest from NW corner. ↑**

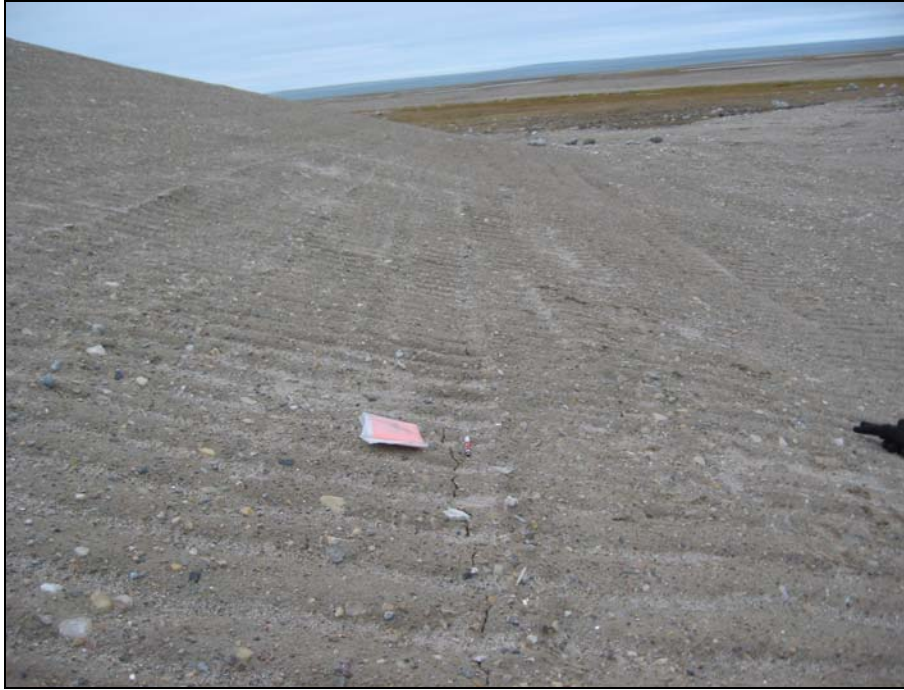
**Photograph 24. Area where two parallel cracks (5m and 6m upslope from toe) merge into one. Note additional cracks perpendicular to slope. The cracks that are perpendicular to slope appear to be related to erosion/weathering of fine cover material in dozer tracks.  
Looking upslope. ↑**

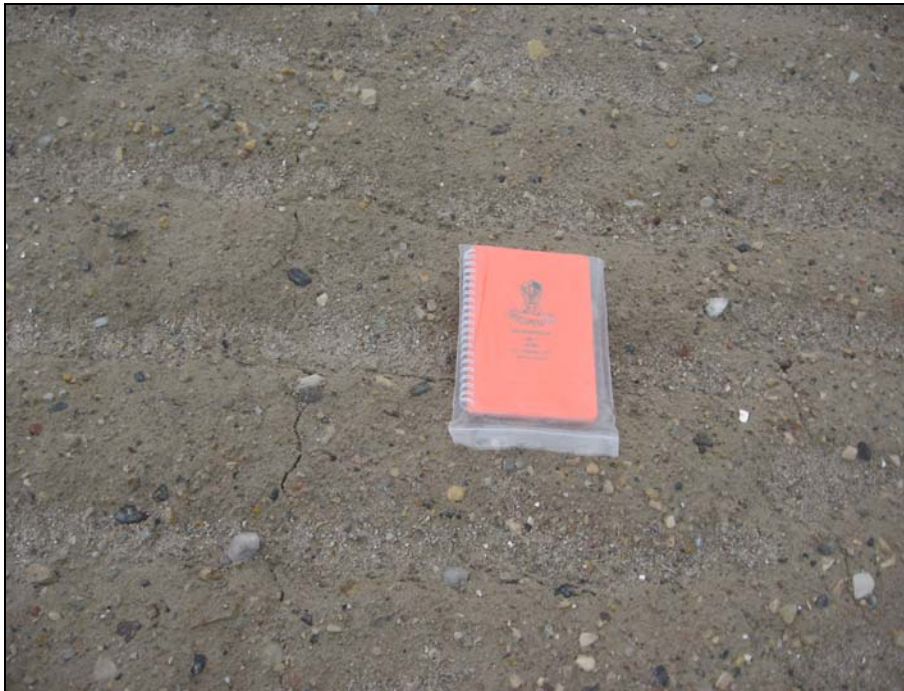
**Photograph 25. Typical tension crack looking south along west slope. Fine tension cracks (up to 3 sets) often appear adjacent to and parallel to the larger (e.g. 1 to 2 cm width) cracks . ↑**

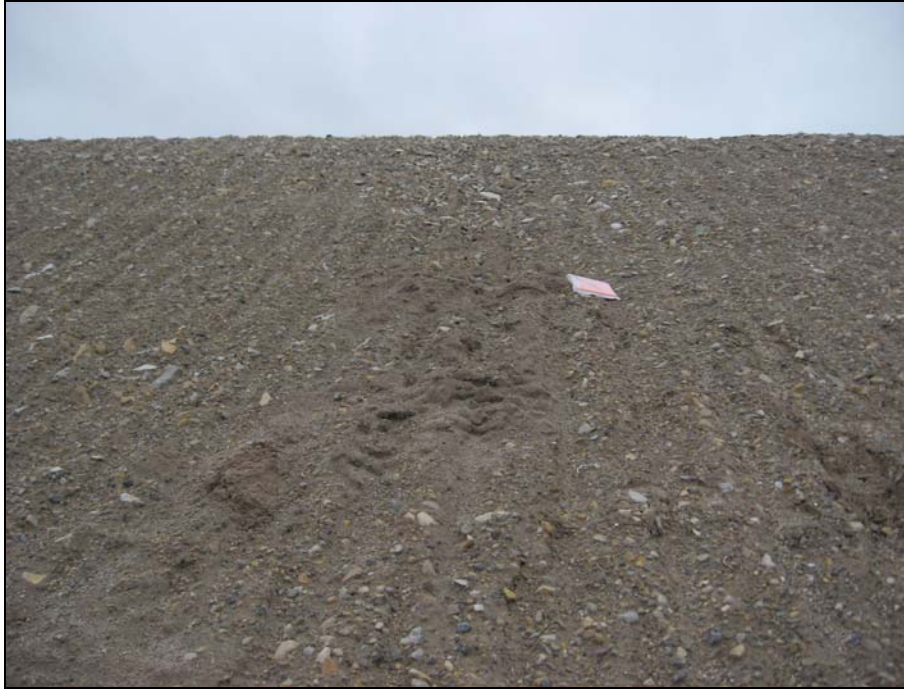
**Photograph 26. Following the tension crack along the toe of slope. Moving S, the cracking appears to shift upslope to approx. 7m from toe. Portions obscured by sediment infilling. ↑**

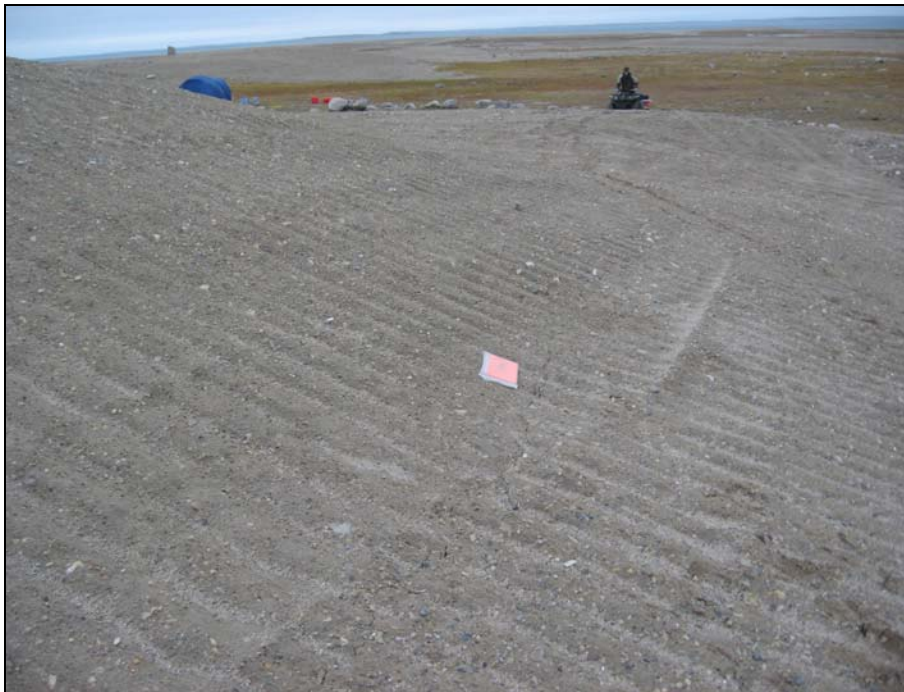
**Photograph 27. Minor surface erosion (3m long, 0.7m wide) near crest of west slope about 10m N of the SW corner. Granular cover appears to be self armouring. Excess sand shifted exposing gravel. ↑**

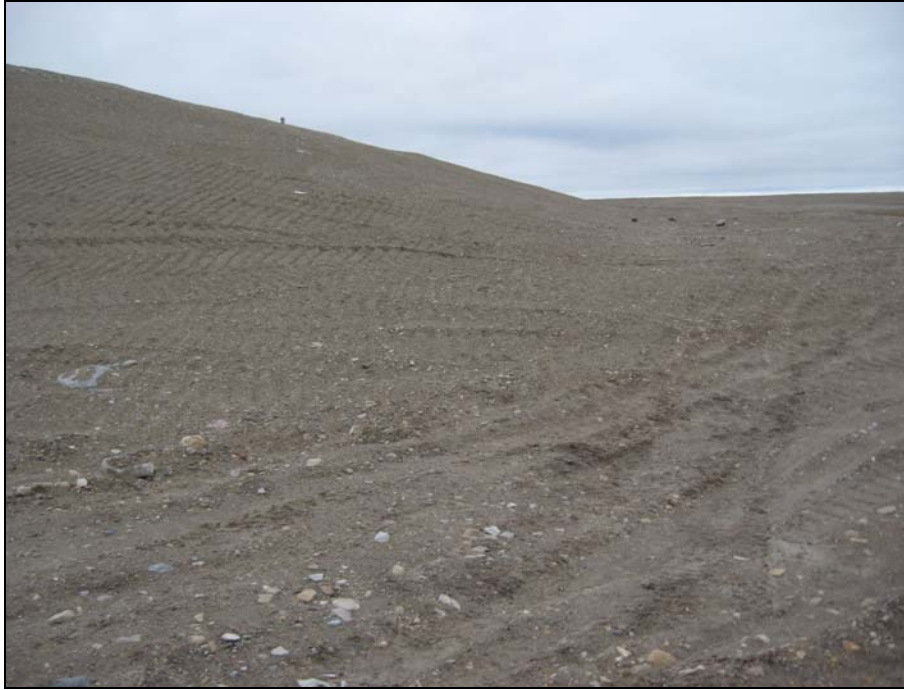
**Photograph 28. Looking S towards SW corner. Continuation of tension crack observed (adjacent to field book) but disappears around the corner. ↑**

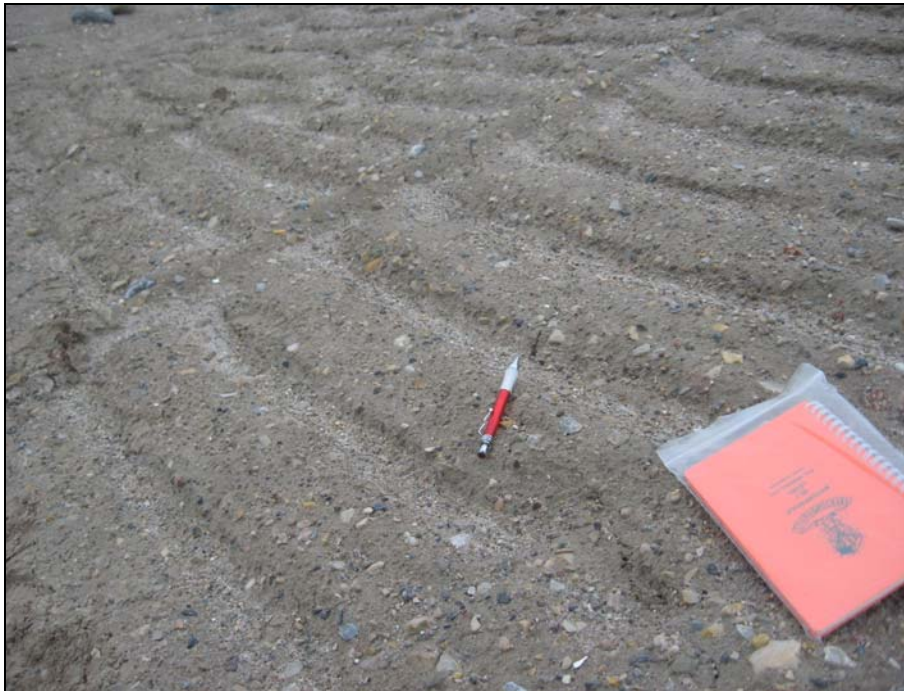
**Photograph 29. South slope Tier II landfill viewed looking east from 10 m west of the SW corner. Field book marks the end of tension crack observed in Photo 28. ↑**

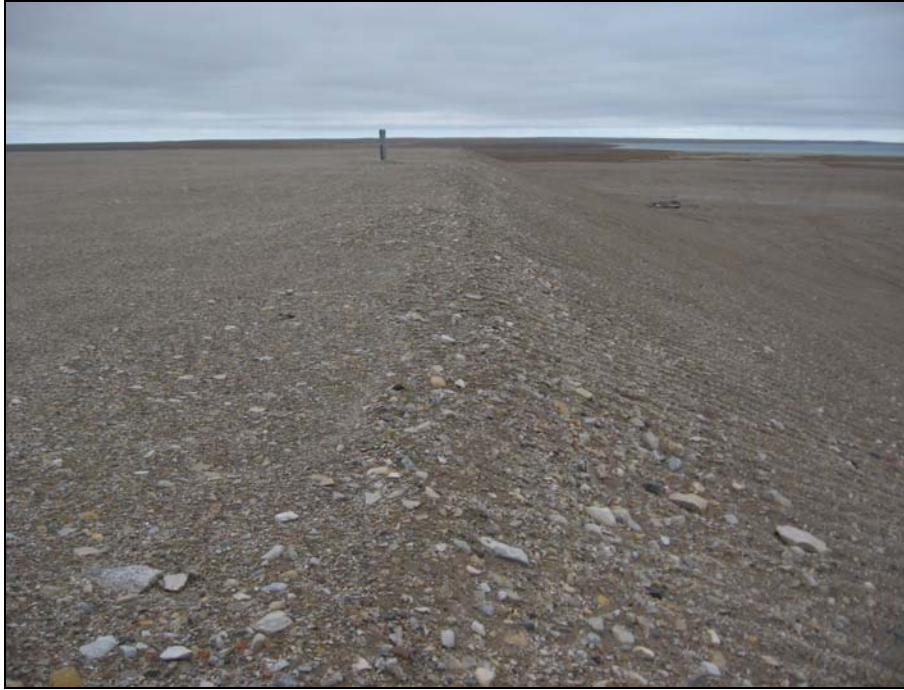
**Photograph 30. Tension crack observed in Photo 28 appear to end (likely due to stabilizing influence of downslope granular pad). ↑**

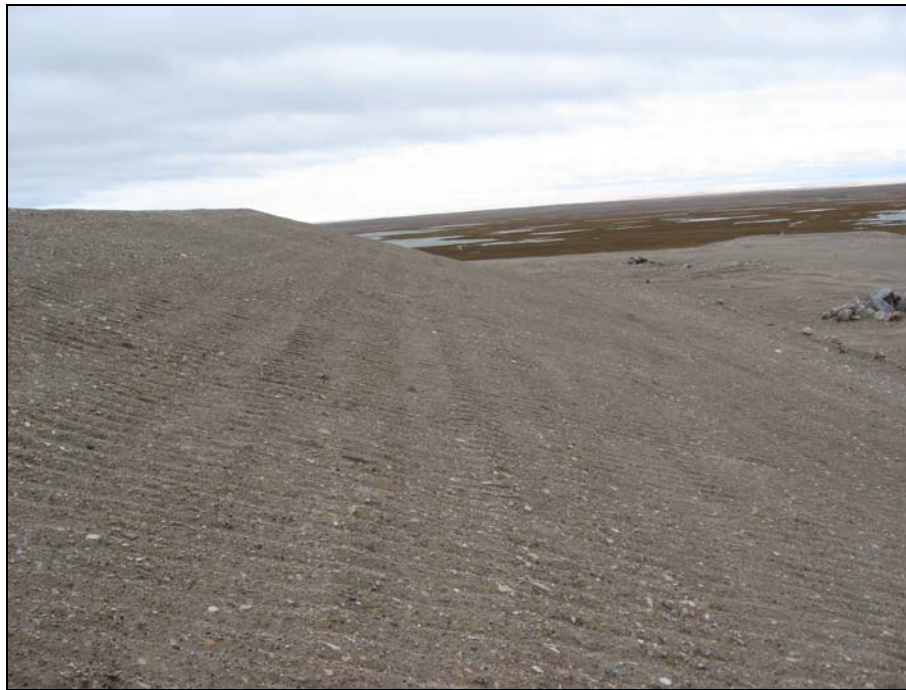
**Photograph 33. Panoramic of Tier II looking NW to SE corner from SE of MW2. ↑**

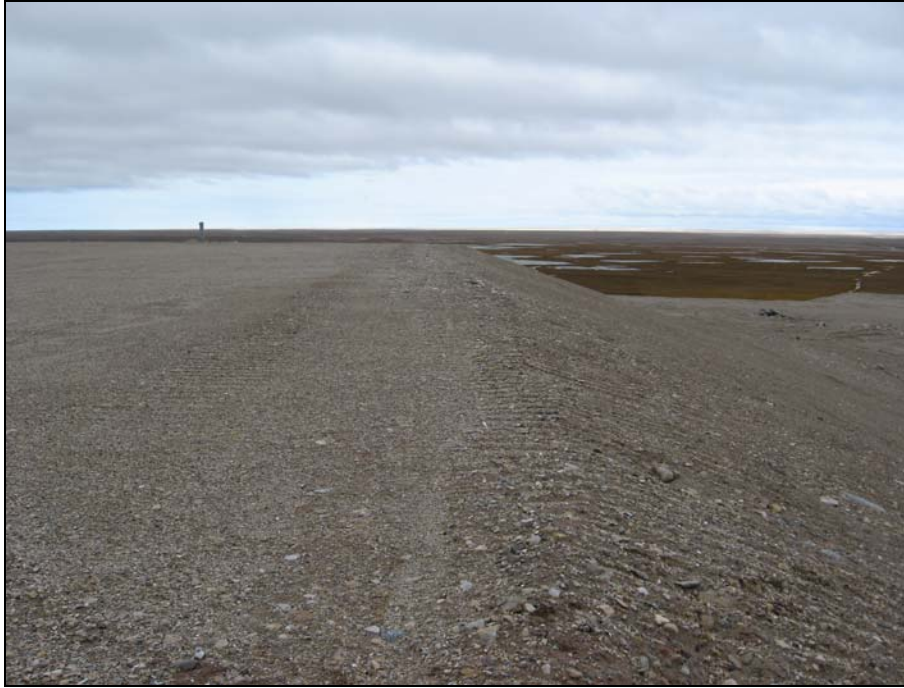
**Photograph 34. Looking N from mid-slope east side Tier II . Note minor depression in upslope foreground. There are no indications of recent movement or problematic conditions. ↑**

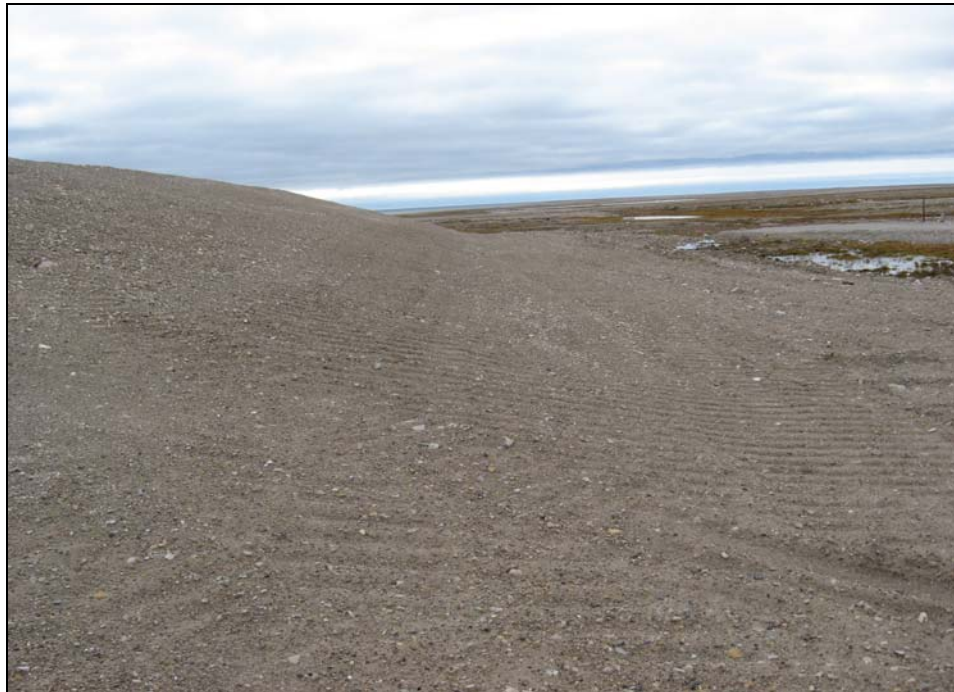
**Photograph 1. Looking SW towards NE corner of the landfill. ↑**

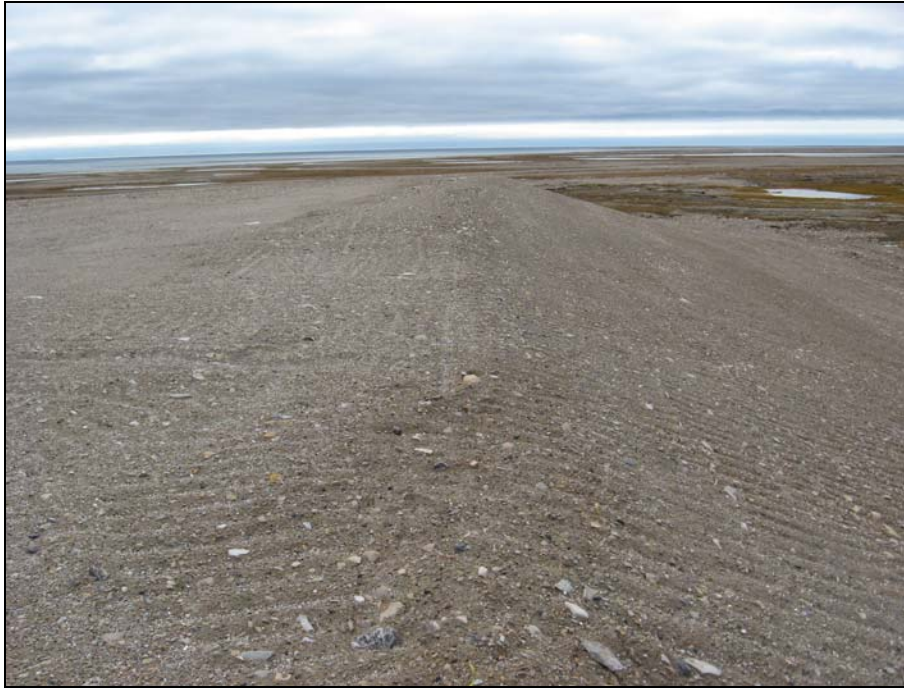
**Photograph 2. Looking west along the toe of the north side of the landfill from the NE corner Granular slope is graded uniformly and appears stable. ↑**

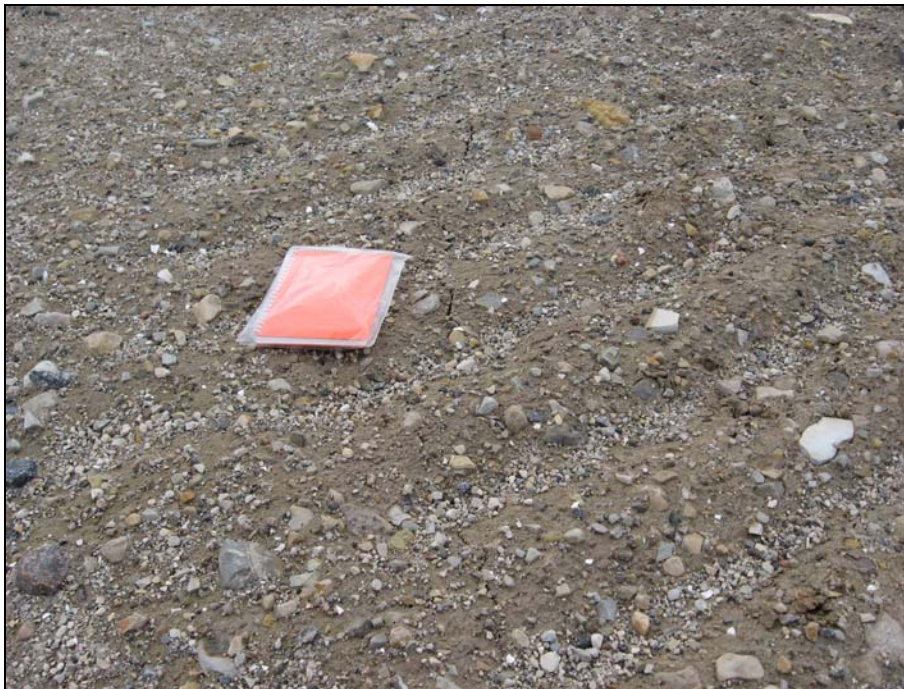
**Photograph 3. Looking west along crest from NE corner. Faint tension crack visible along the top of slope. ↑**

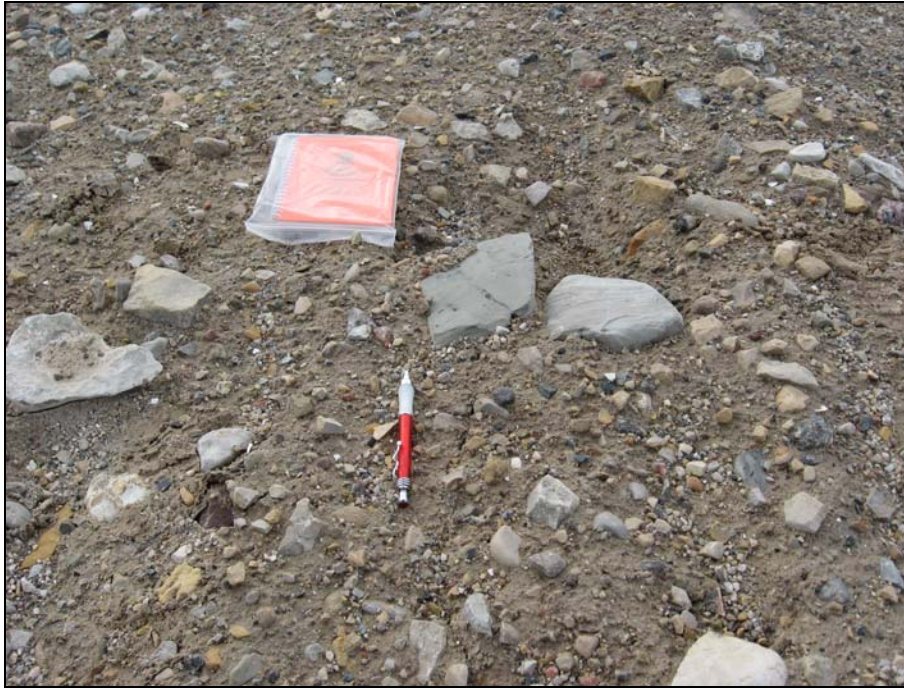
**Photograph 4. Closeup of crack identified in Photo 3 looking west from crest. Field book for scale. ↑**

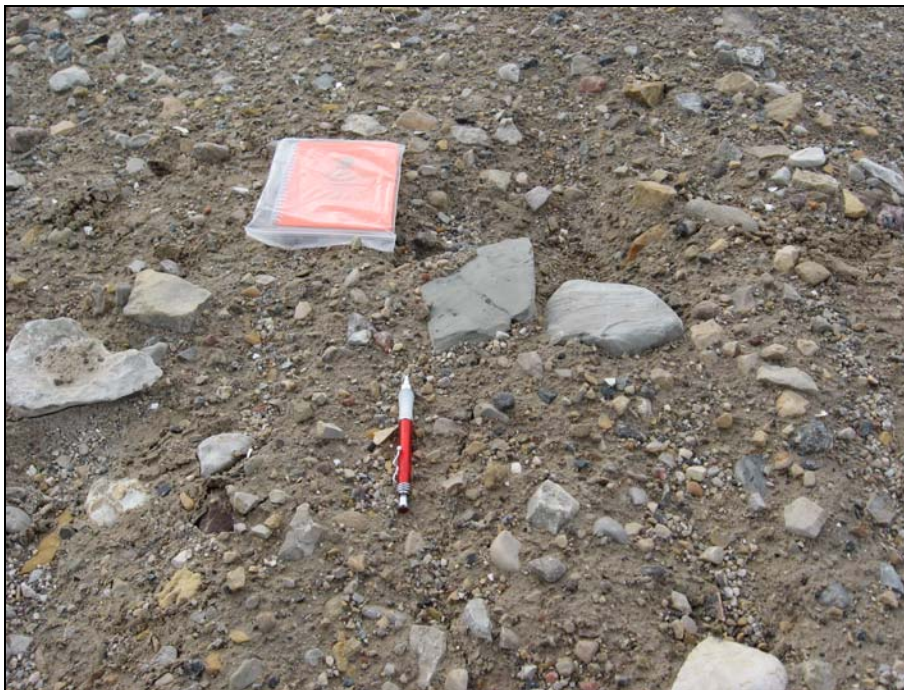
**Photograph 5. Tension crack extends from the NE corner and appears to gradually migrate from 1 m inside the crest to the lip of crest. Portions of the crack are infilled with sediment. Width of crack varies from barely discernable to up to 5mm wide. ↑**
