# **The Collection of Landfill Monitoring Data at the CAM-2 Gladman Point – 2007 FINAL Report**

Prepared for  
**Defence Construction Canada**

Submitted by  
**Gartner Lee Limited**

**January, 2008**

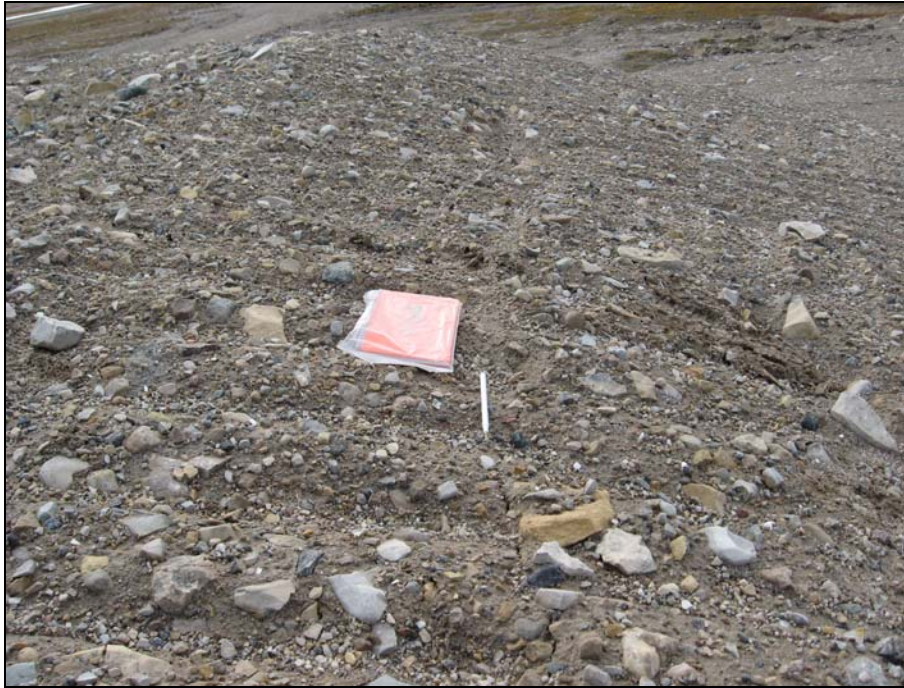
**Photograph 6. Tension crack resumes along the crest of the north slope. Crack was not readily apparent between Photos 5 and 6. ↑**

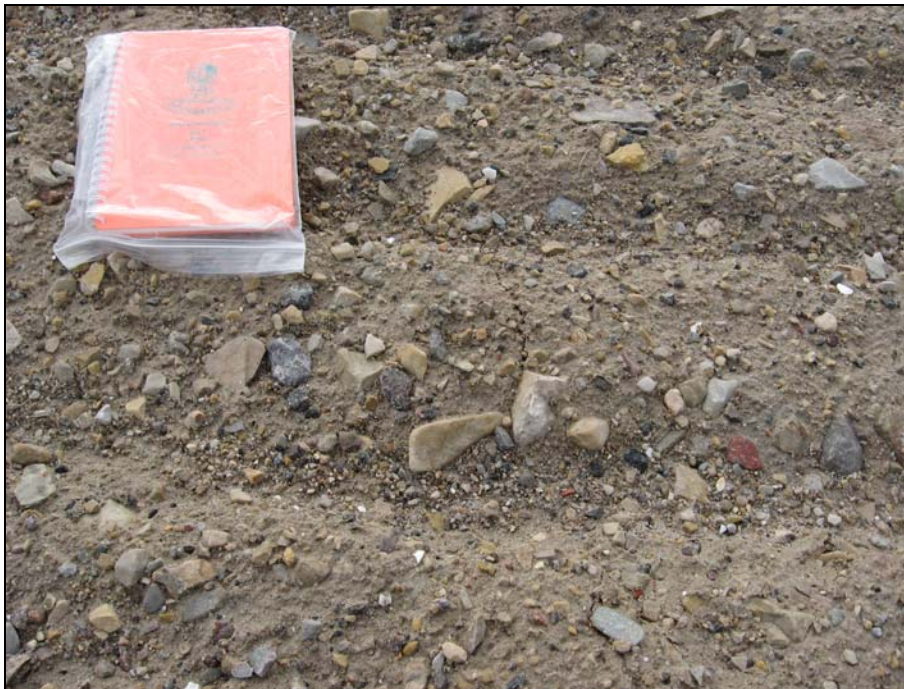
**Photograph 7. Tension crack ends about 7m from the NW corner about 1m from top of crest. Field book at end of crack. ↑**

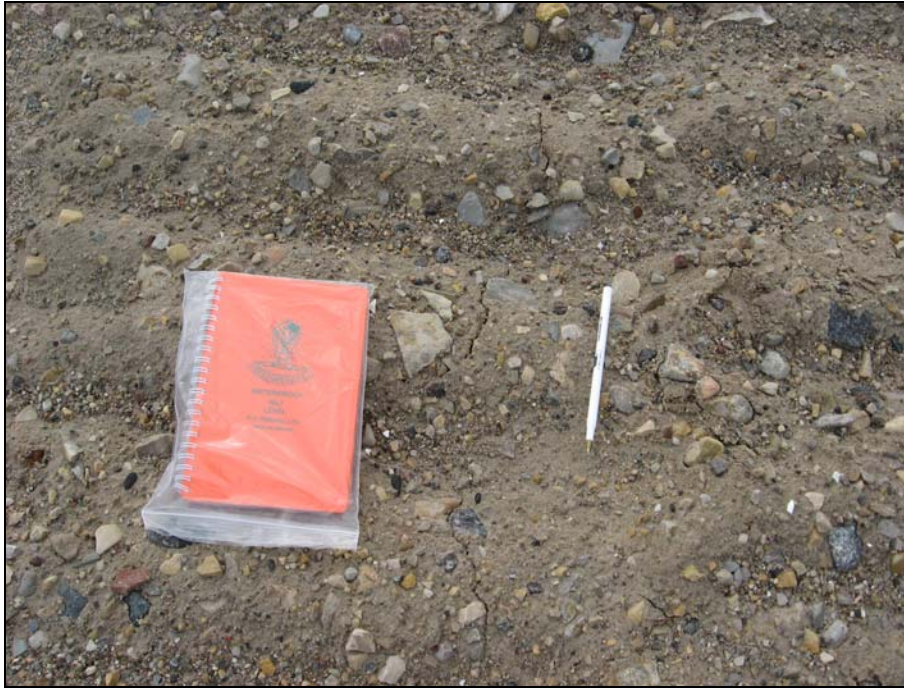
**Photograph 8. Tension crack observed midslope on north face about 5m upslope from toe. Field book for scale. ↑**

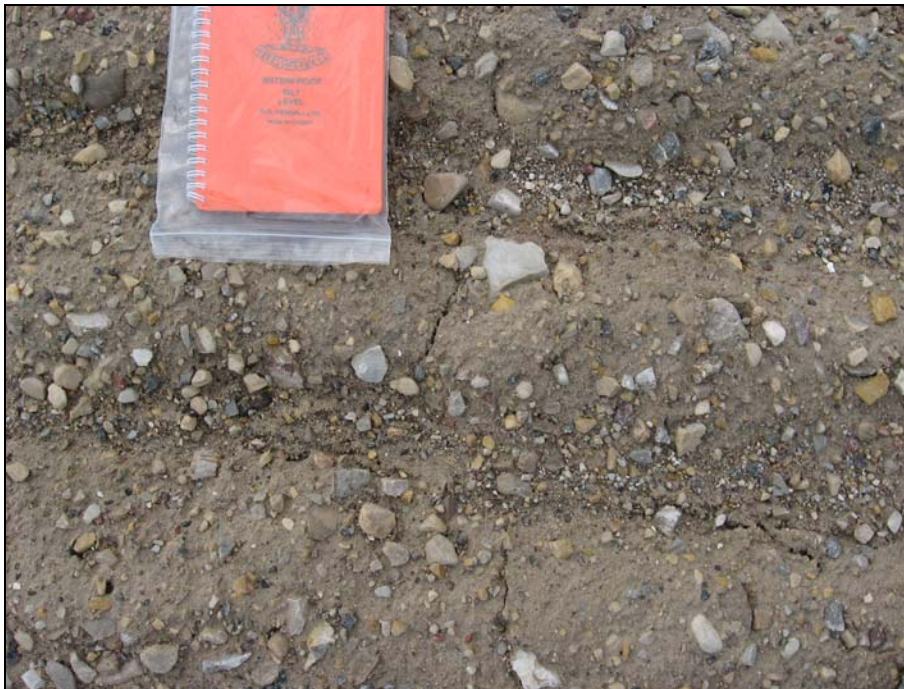
**Photograph 9. Following mid-slope tension crack on north face (continues from Photo 8) . Crack splays into minor parallel cracks about 0.5m to 1.0m apart and rejoins. ↑**

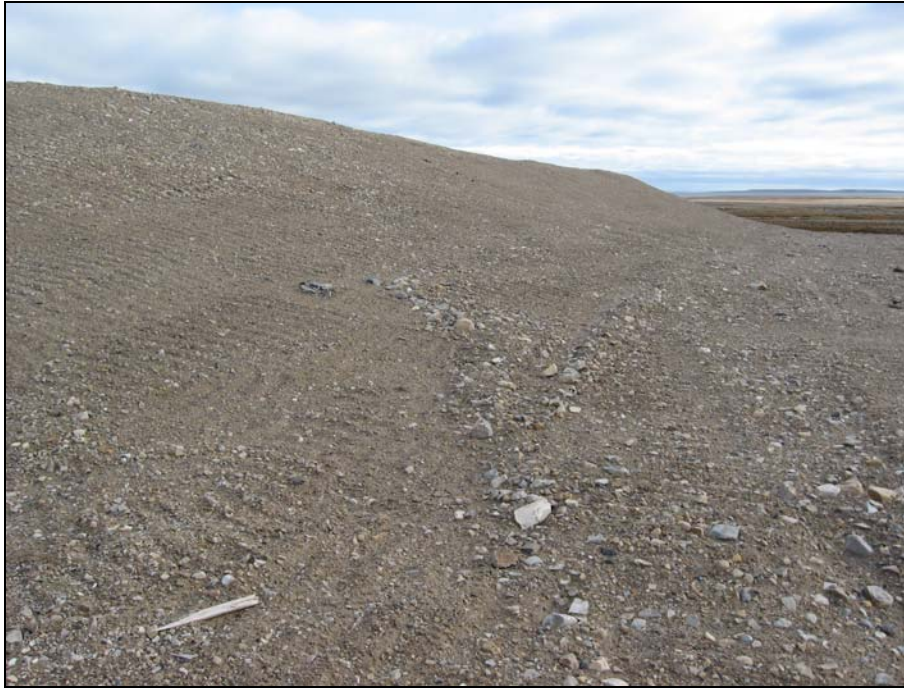
**Photograph 10. Tension crack appears to end, possibly infilled with sediments, about 4m up from toe of slope. ↑**

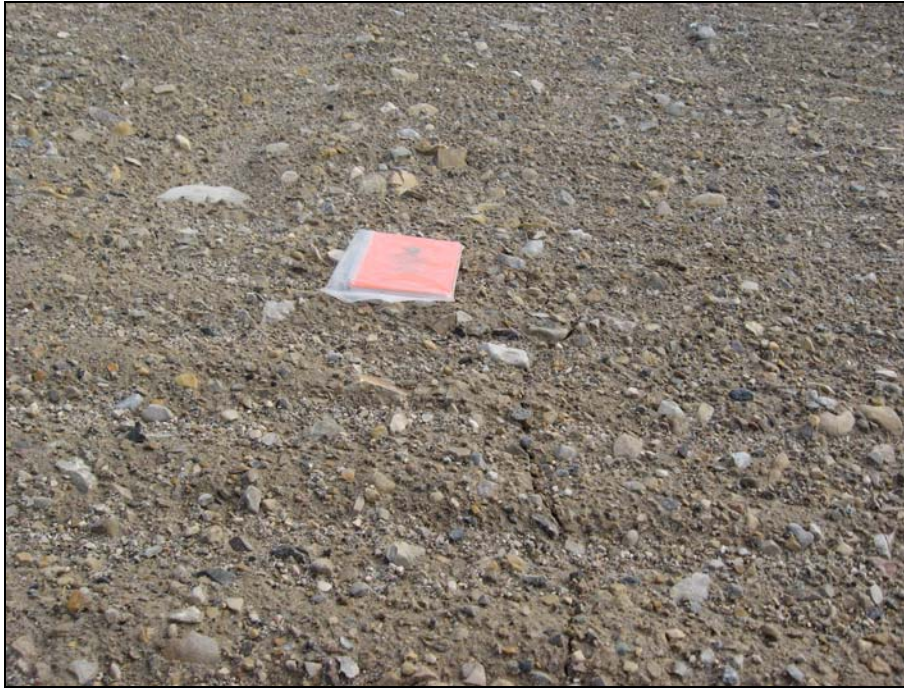
**Photograph 12. Closeup of tension crack along the toe of slope, looking south. ↑**

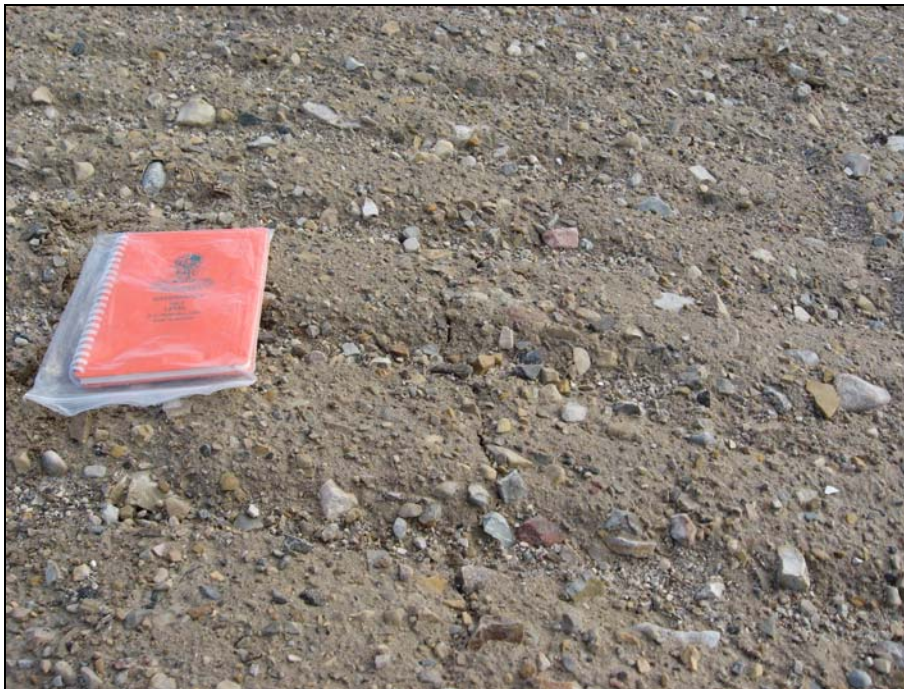
**Photograph 13. Tracking the continuous tension crack from Photo 12 along the toe of the west side of the landfill. ↑**

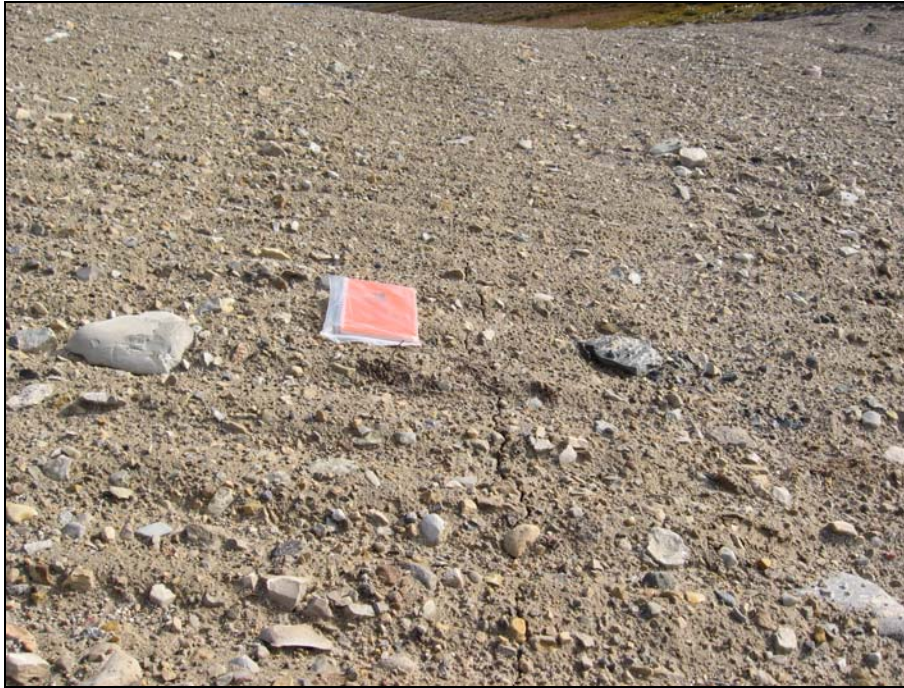
**Photograph 14. Tracking the lower tension crack south along the toe of the slope. The tension crack appears to run along the entire toe of slope. ↑**

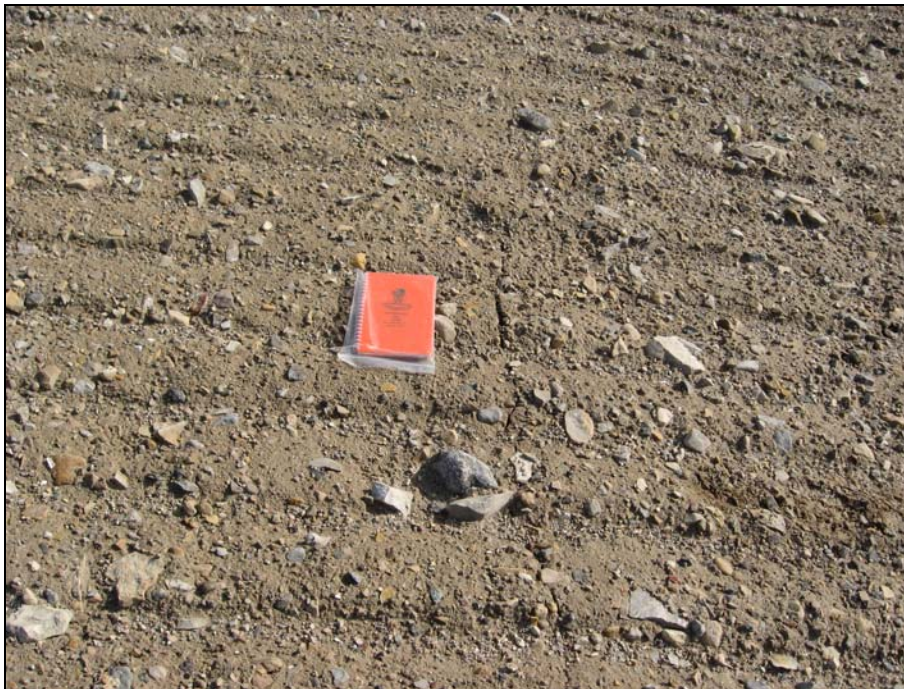
**Photograph 15. Following the lower tension crack, near southern limit on the west slope looking S. ↑**

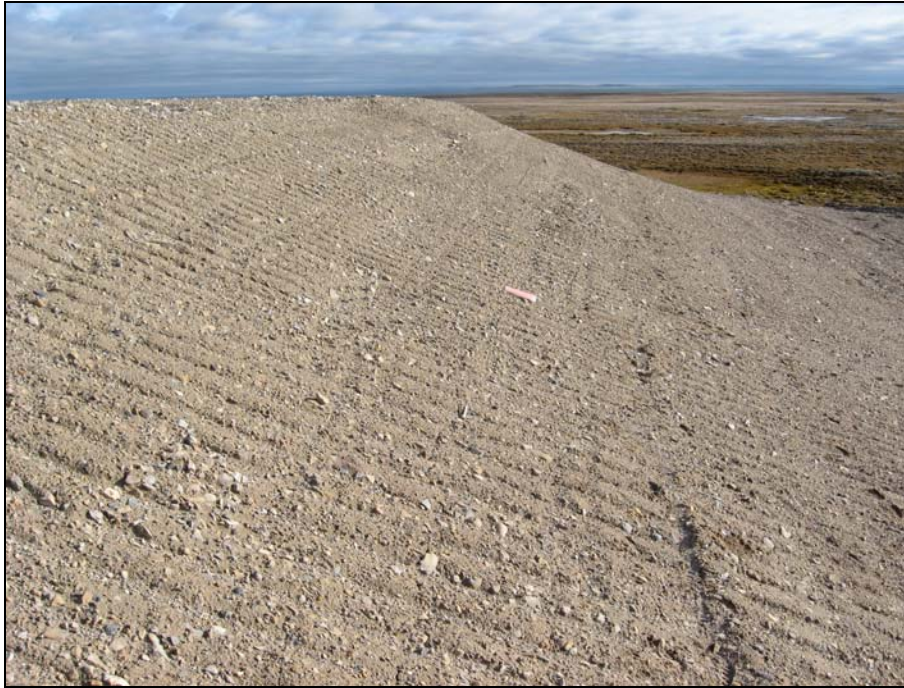
**Photograph 16. Tension crack along the upper slope west side looking south (5m from crest). Crack runs parallel to the crest. ↑**

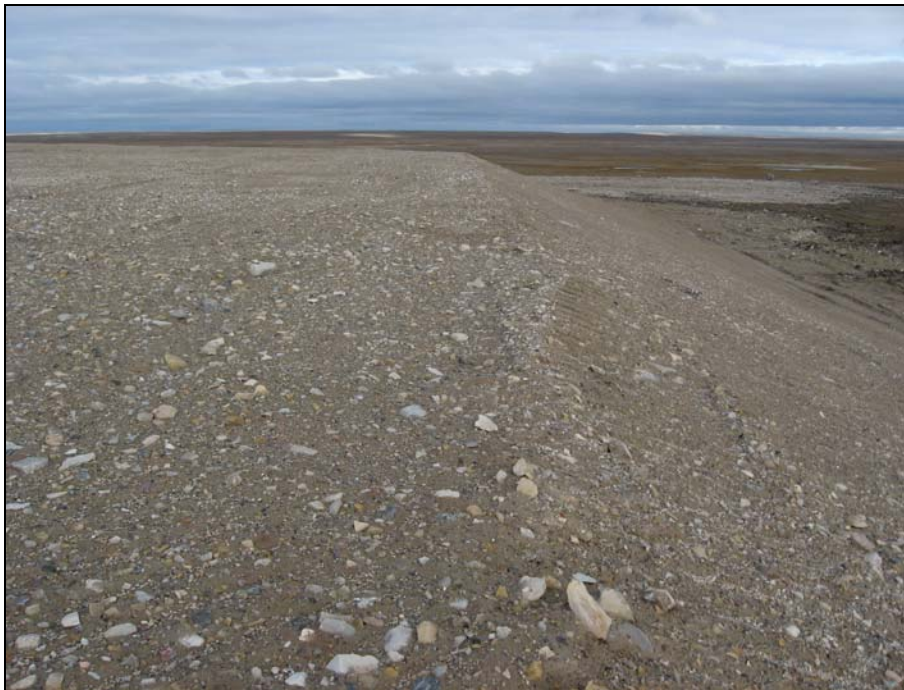
**Photograph 19. Looking S from crest at NW corner. No tension cracks observed along top of crest. ↑**

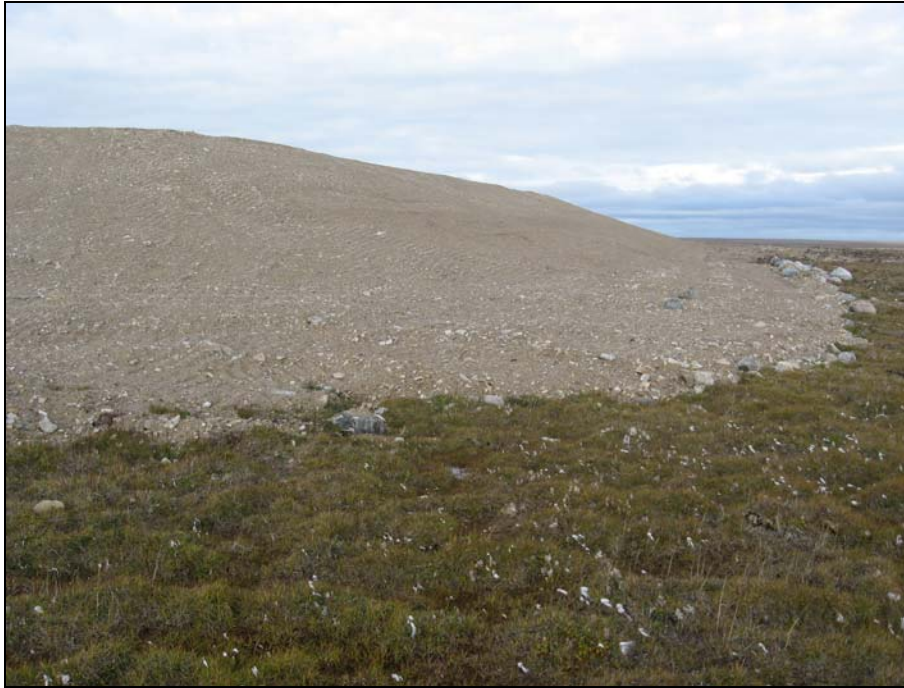
**Photograph 20. Looking east along the crest of the southern slope of the landfill from the SW corner. ↑**

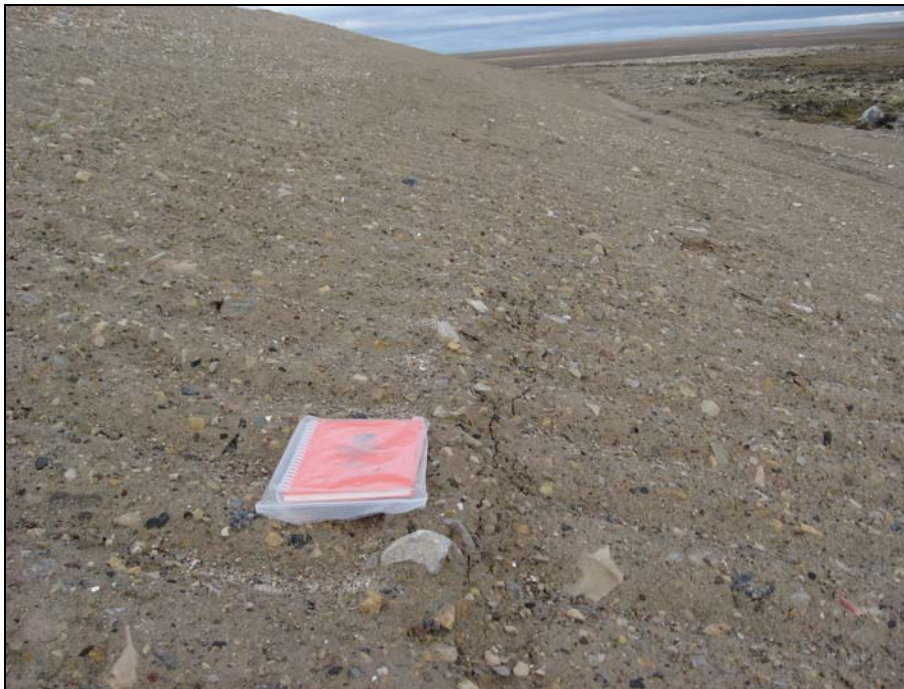
**Photograph 21. Looking east along the southern toe of the landfill from about 20 m west of the SW corner. ↑**

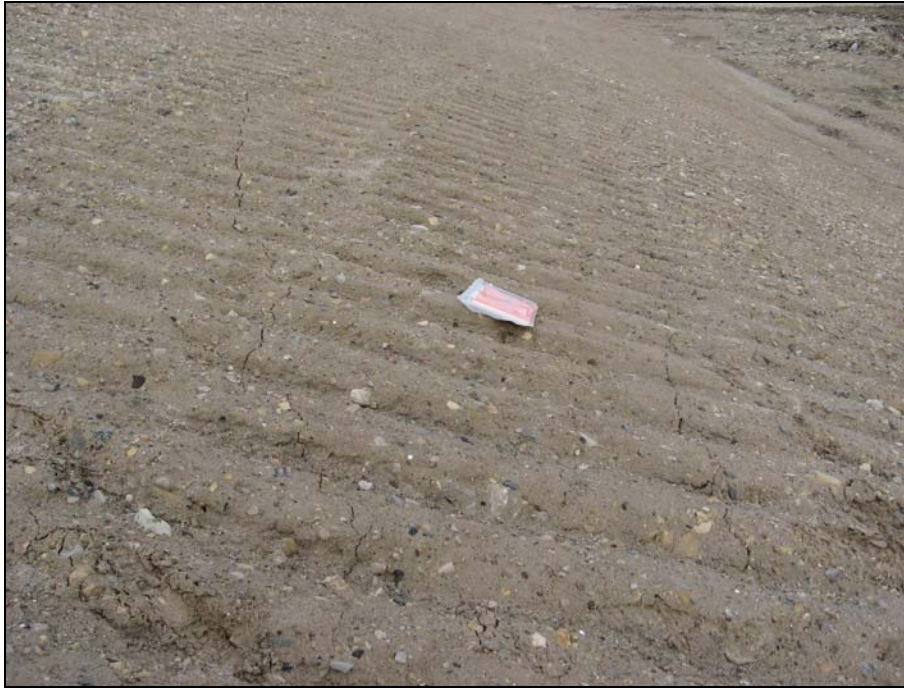
**Photograph 22. Tension crack observed mid-slope of the south side of the landfill. Looking E from about 10m east for the SW corner. ↑**

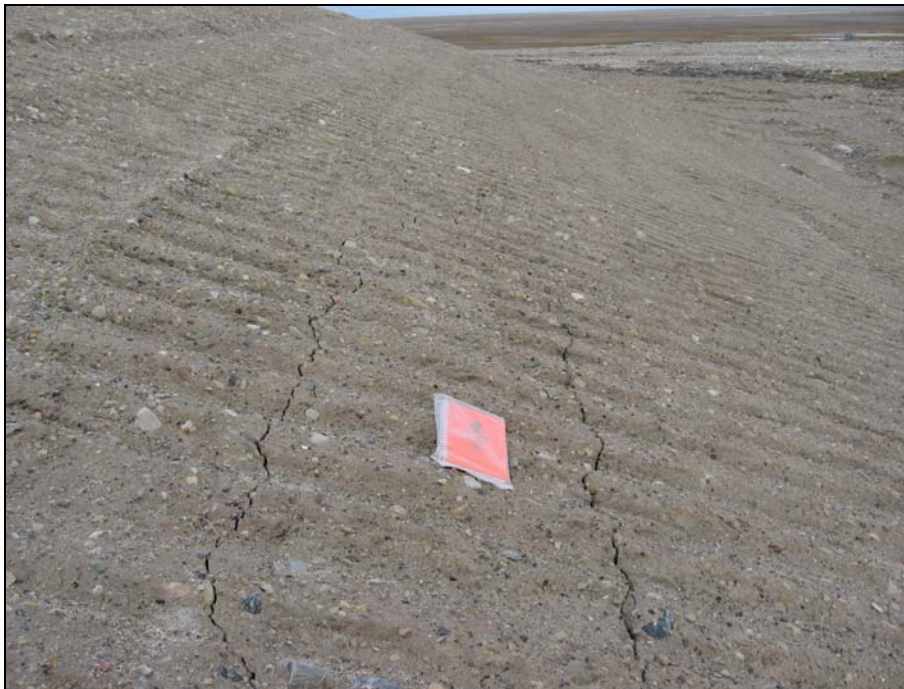
**Photograph 23. Tension crack mid-slope on the south slope splays into two cracks with 0.6m to 1.5m roughly parallel spacing. ↑**

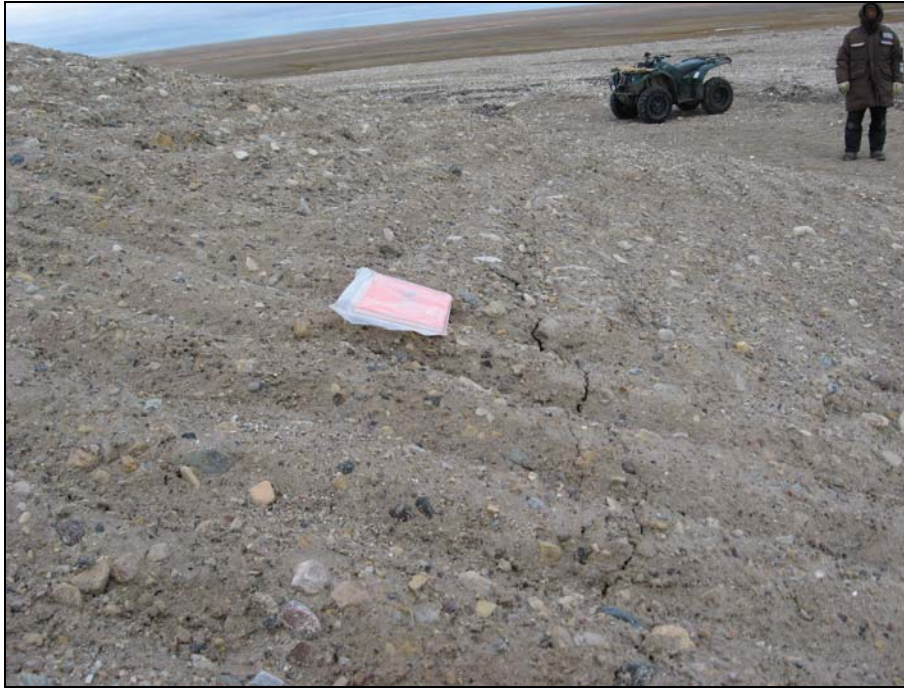
**Photograph 24. Following cracks east along the south slope looking east from midslope. The crack originated near the SW corner. ↑**

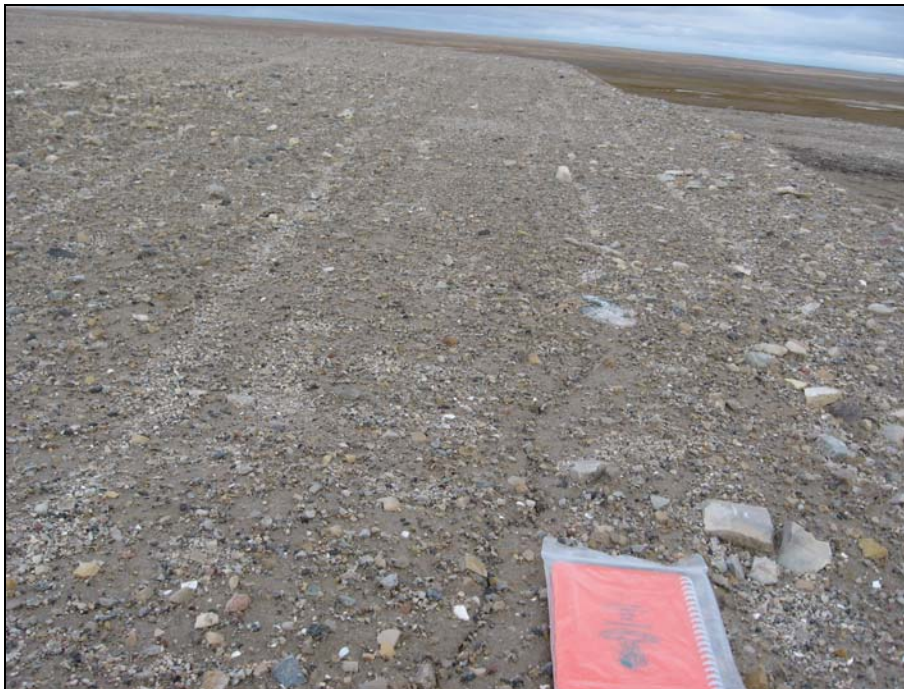
**Photograph 25. Tension crack approaching the SE corner. Midslope tension crack continues around SE corner from where it turns north shifting to 1/3 up the slope. ↑**

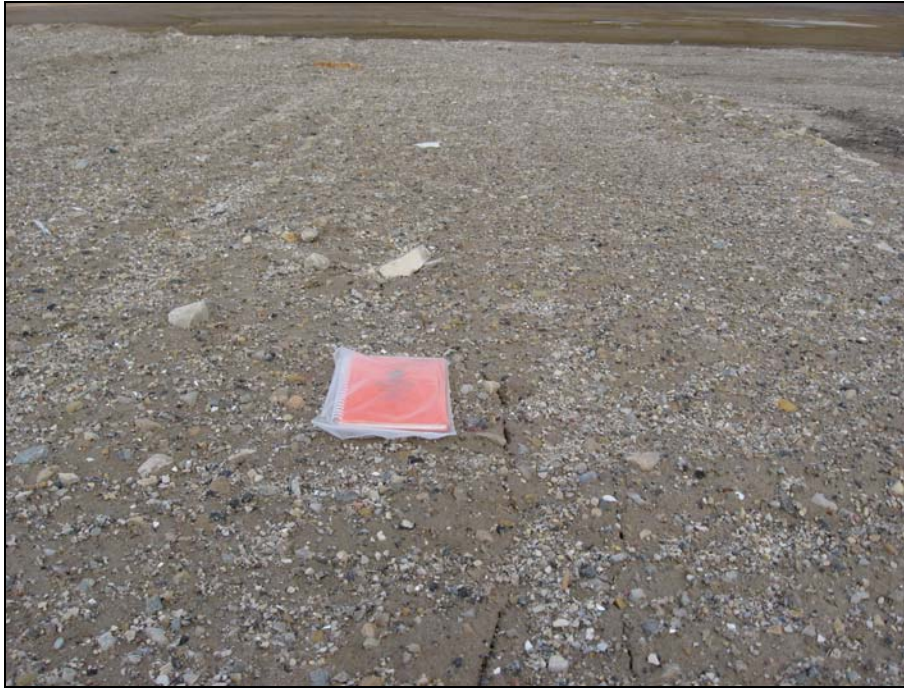
**Photograph 26. Tension crack along the crest of the south slope. Looking east to SE corner. The crack is largely infilled with sediments and migrates from 0.5m to 2m in. ↑**

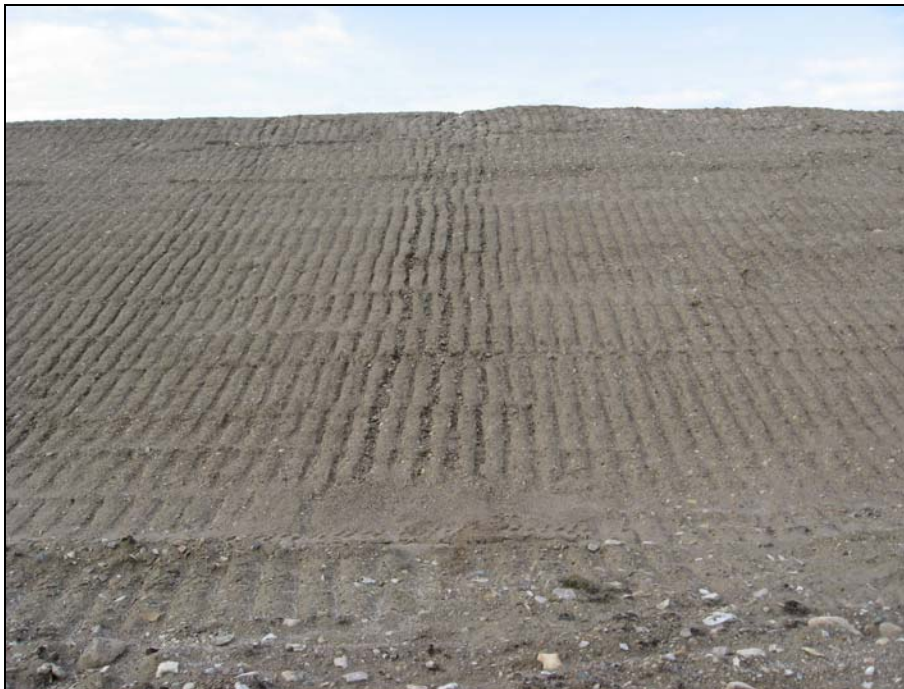
**Photograph 27. Following crack along crest from Photo 26 to the SE corner. Looking east to the SE corner. ↑**

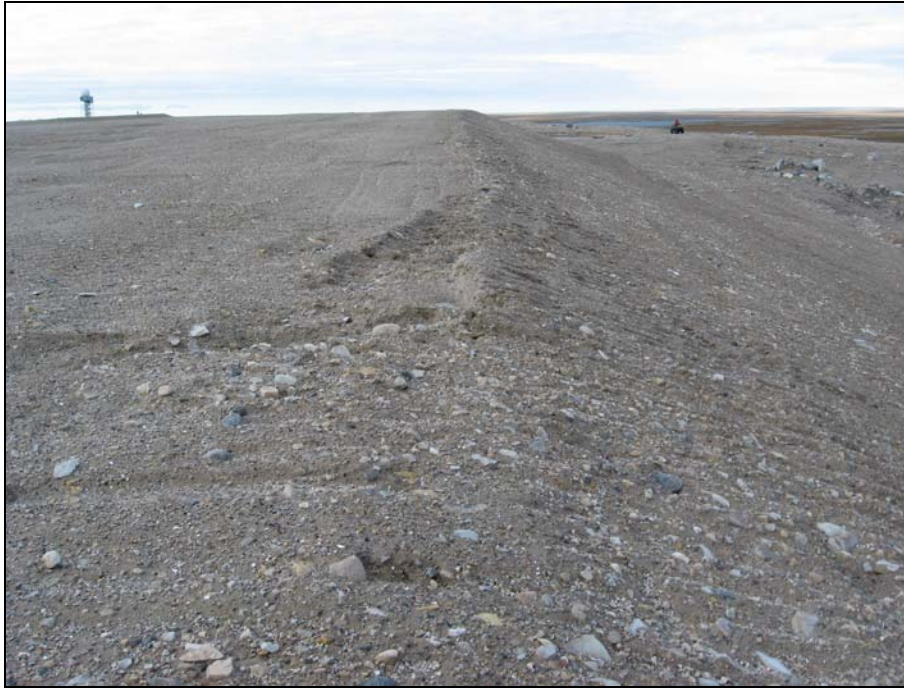
**Photograph 28. Minor surficial erosion, self armouring, along east side of south slope looking north from downslope of toe. ↑**

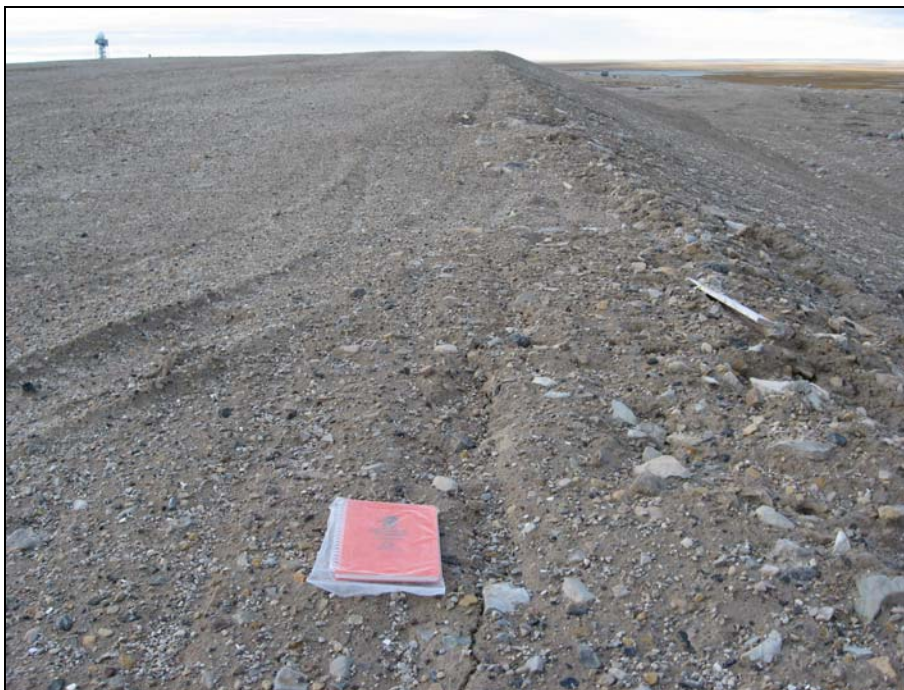
**Photograph 29. Looking N along east crest from SE corner. Tension crack along entire crest. ↑**

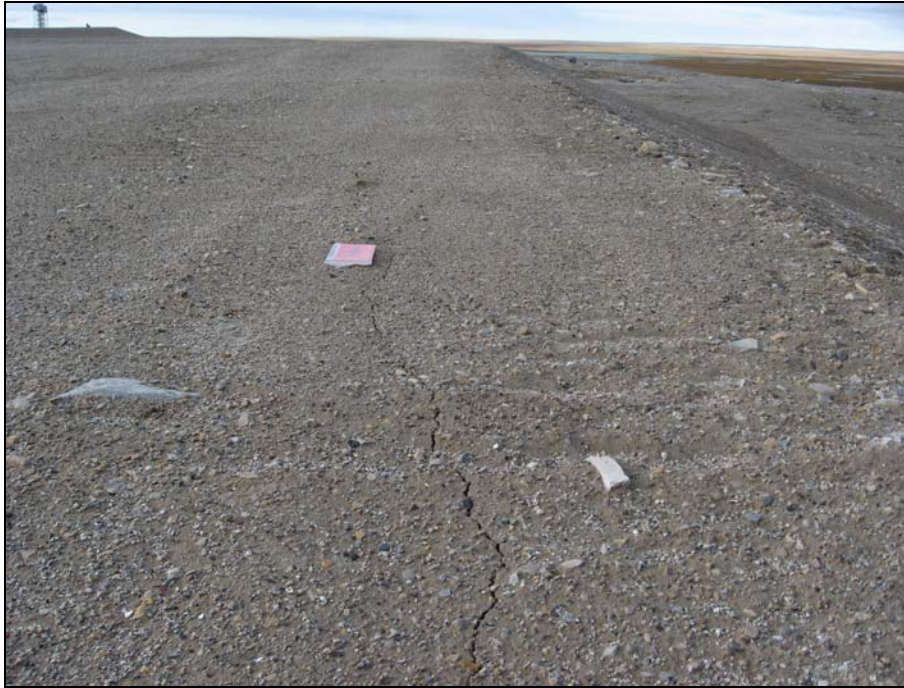
**Photograph 30. Following tension crack N along east crest from Photo 29. ↑**

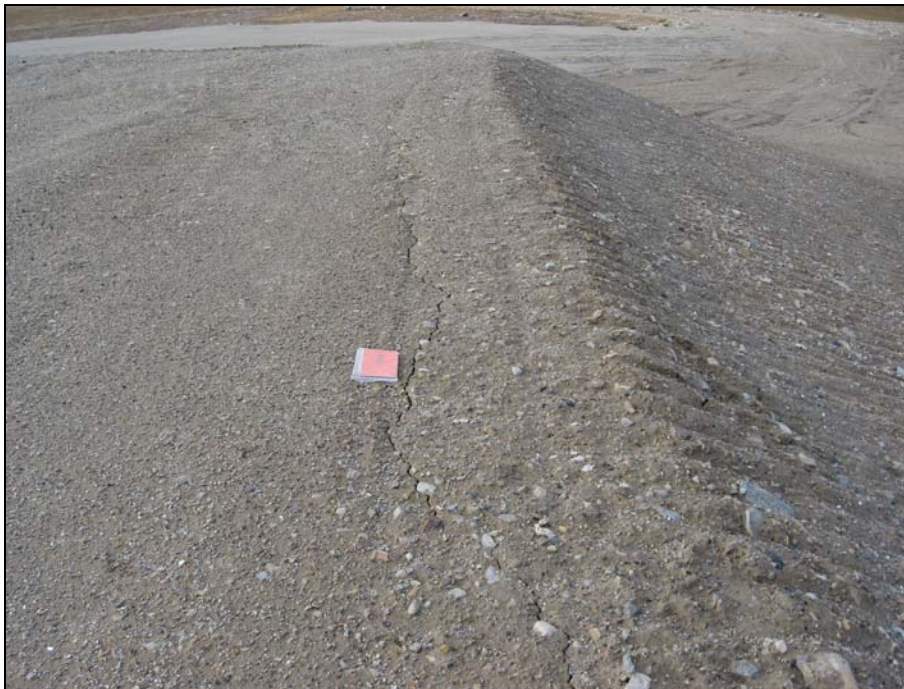
**Photograph 31. Following the tension crack north. Crack is essentially continuous from the SE corner and splays and migrates up to 6 m from the crest. ↑**

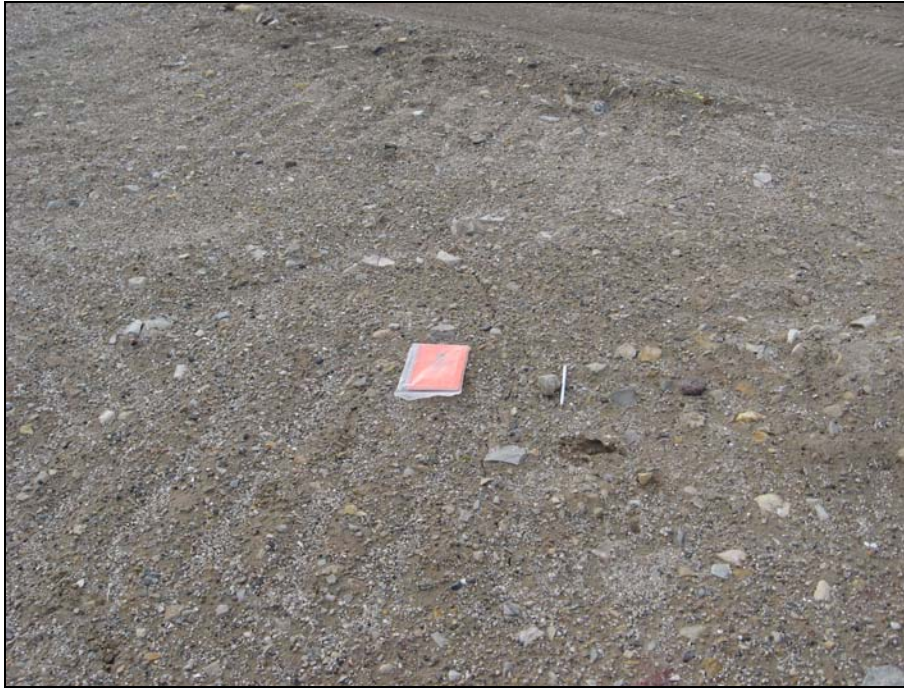
**Photograph 32. Single tension crack continues to NE corner along the east crest of the landfill. ↑**

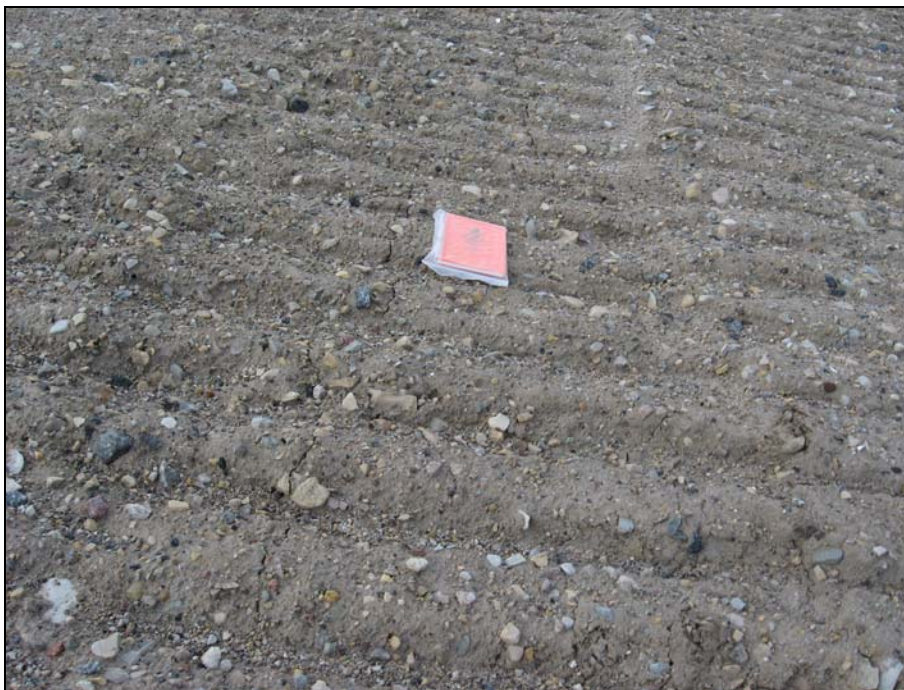
**Photograph 33. Tension crack from east side of the landfill curves and joins up with tension crack on the north slope. ↑**

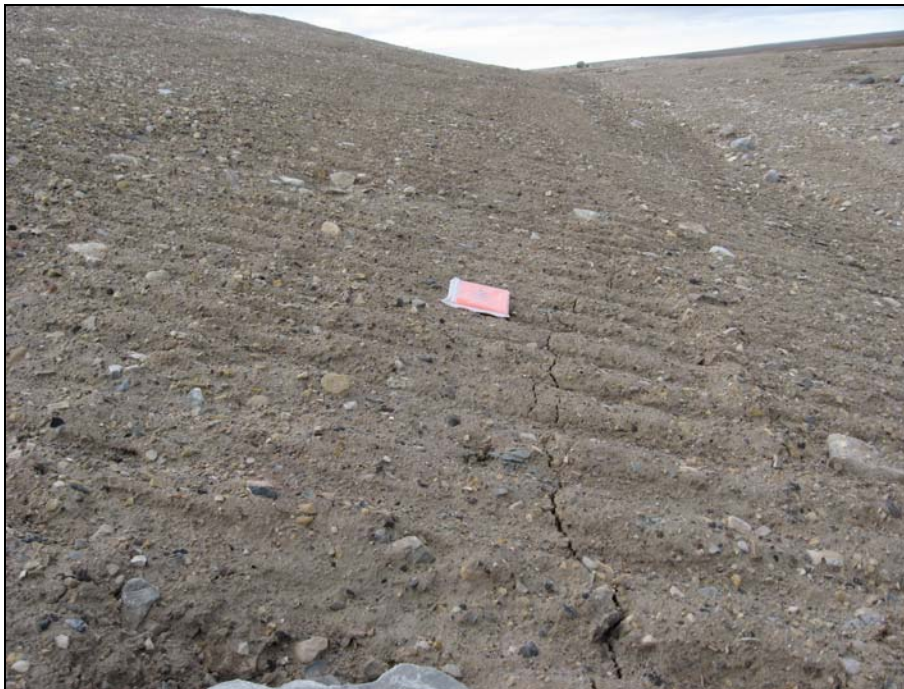
**Photograph 34. Tension crack in NE corner curves and continues. ↑**

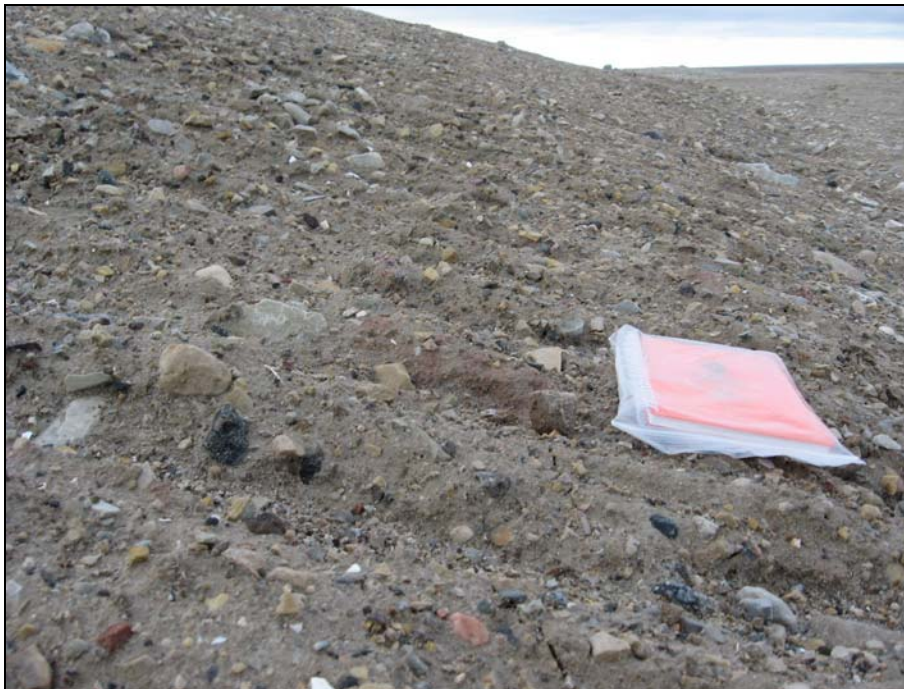
**Photograph 36. Following crack N along the east side of the landfill. Crack is essentially continuous from the SE corner. ↑**

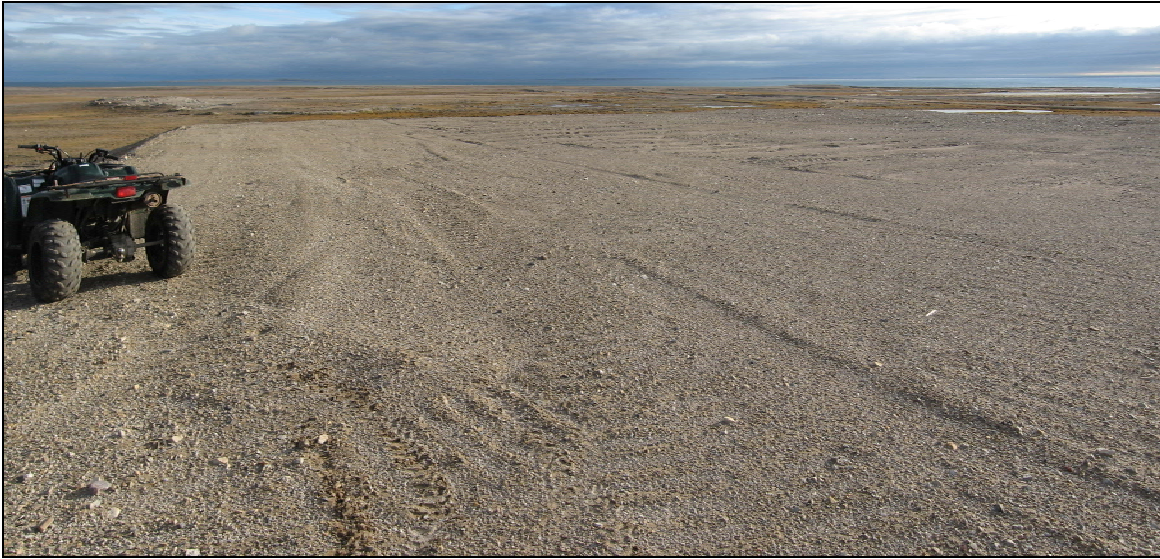
**Photograph 38. Tension crack ends mid-slope about 13m south of NE corner. ↑**
