**Defence Construction Canada**

## **The Collection of Landfill Monitoring Data at the CAM-2 Gladman Point Site**

November, 2008

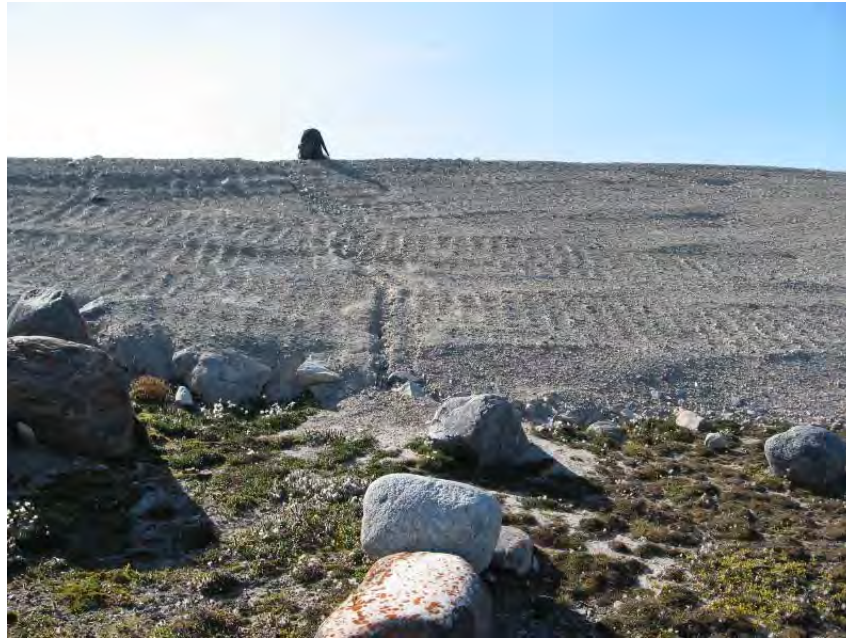
Minor surficial erosion, which appears to be associated with surface runoff, was noted at several locations along the eastern slope of the granular cover (refer to Photos 3 and 4). These areas of minor surficial erosion were first documented in 2006 (inspection by EBA) and re-evaluated in 2007 at the time of last years inspection. The granular cover in the areas of observed surficial erosion appears to be self armouring with limited potential for significant further degradation. None of the areas of observed surficial erosion appear to warrant remediation at this time.

**Photograph STA-3.** Looking upslope to area of minor surficial erosion. Condition is essentially unchanged from last year. Granular cover is self-armouring. ↑

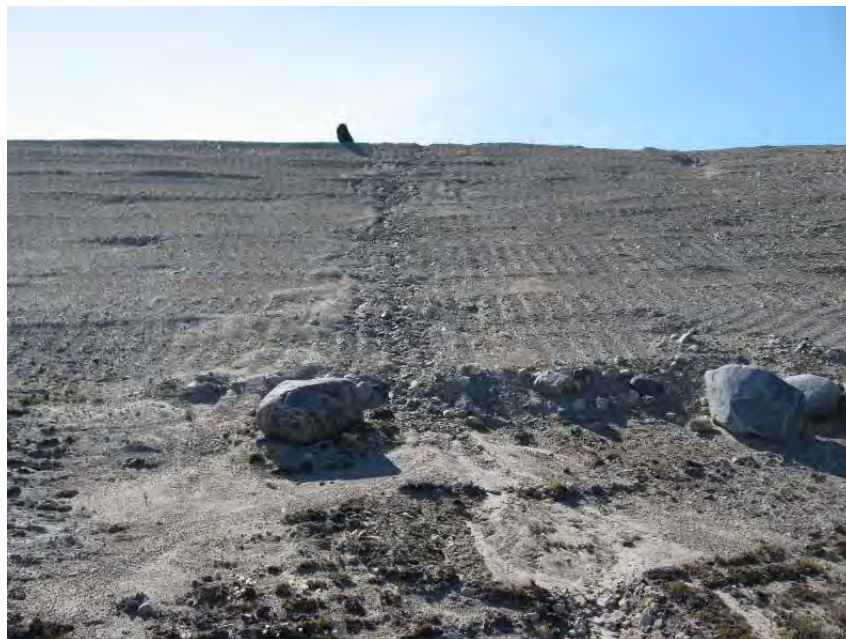
**Photograph STA-4.** Looking upslope to area of minor surficial erosion. Condition is essentially unchanged from last year. Granular cover is self-armouring. ↑

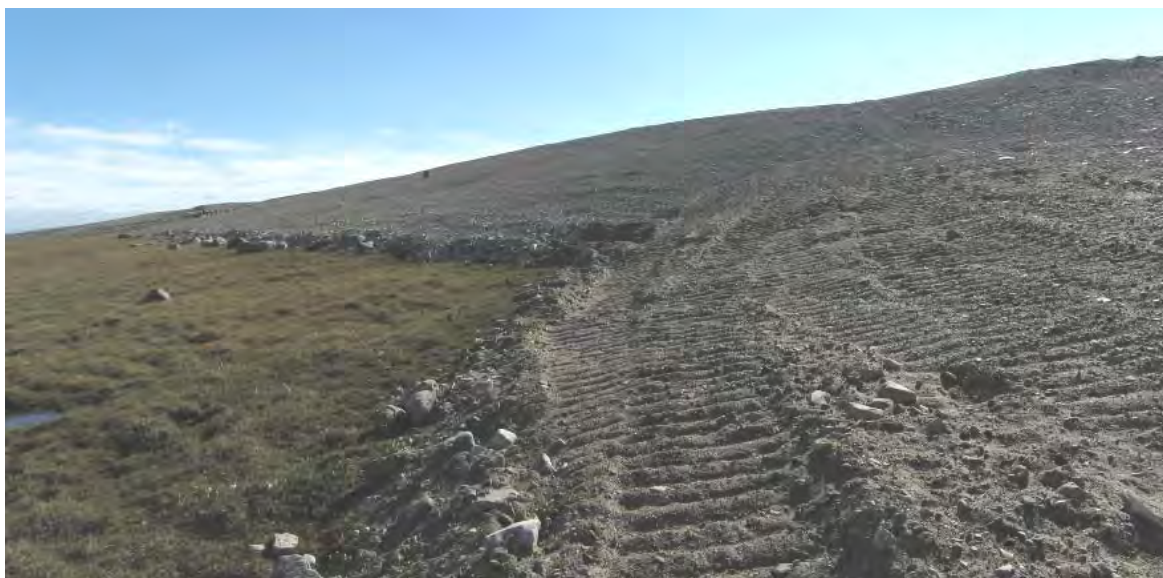
**Photograph STA-6.** Looking SSE along E slope. Slope appears stable. ↑

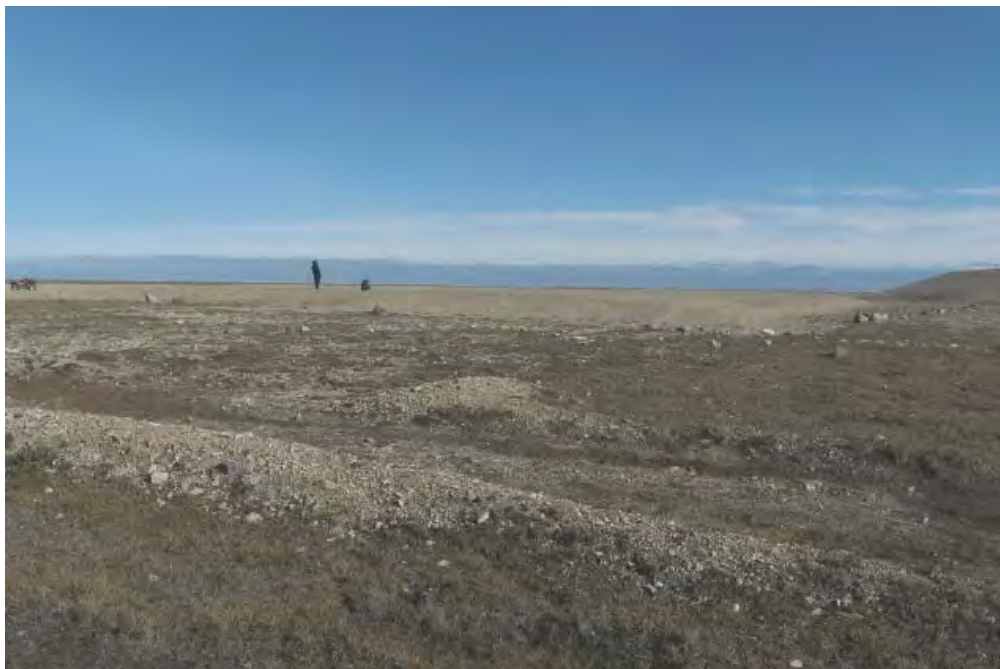
**Photograph STA-10.** Looking E to NW corner of the small SW cell of the Station Landfill. Granular cover appears stable. Honda parked adjacent to main cell on the extreme left of the photo. Tier II landfill (NE corner) visible in the background. ↑

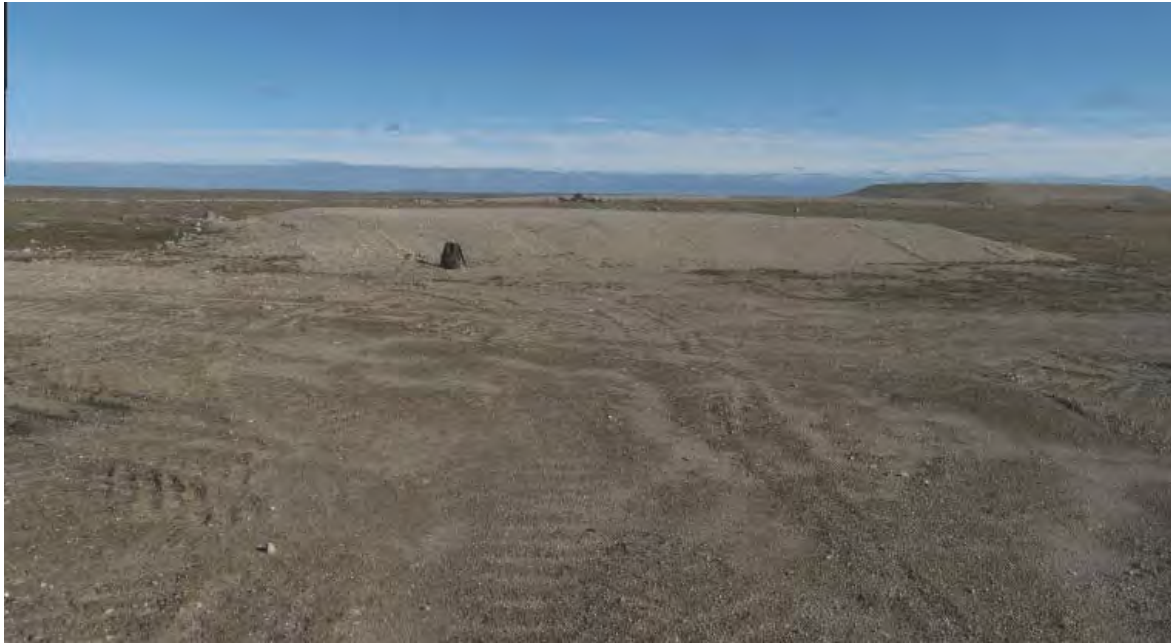
**Photograph STA-13.** Looking SE to the NW corner of the SE most of the two small landfill cells. Granular cover appears stable. No features of note. ↑

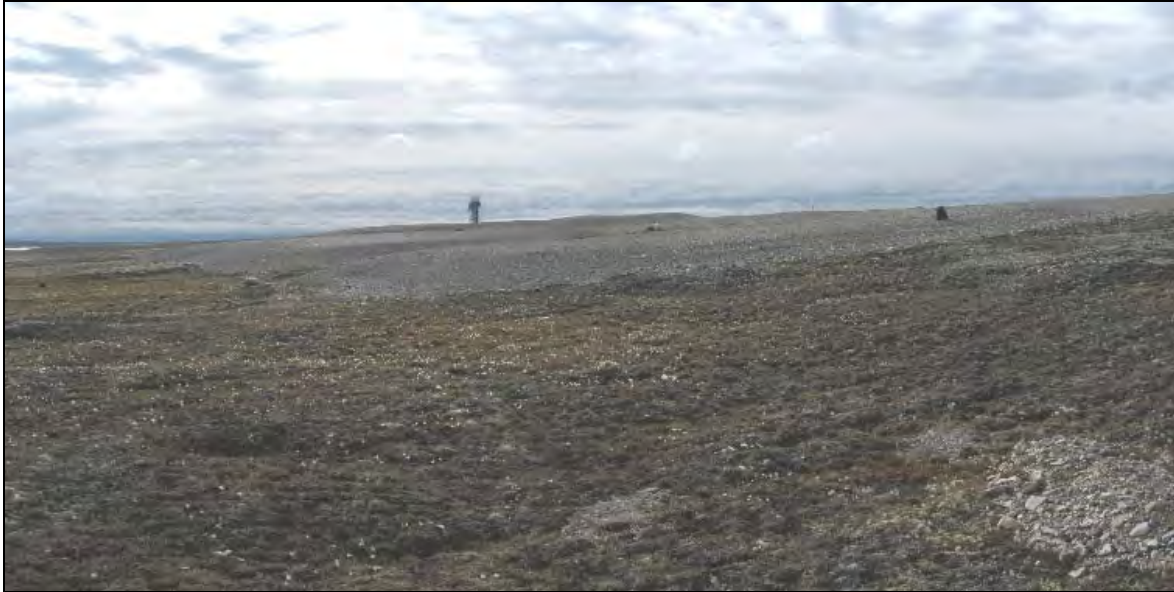
**Photograph WLFN-1.** Looking SW to NE corner of northern most landfill cell. Granular cover appears stable. No features of note. ↑

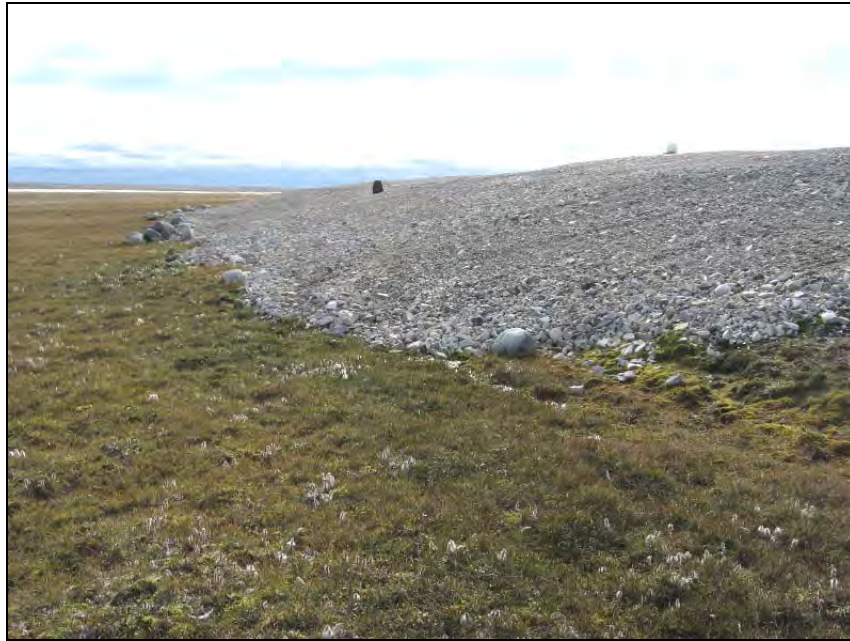
**Photograph WLFN-7.** Looking SE along N toe of the large central cell from NW corner. Granular cover and toe area appear stable. No problematic conditions observed. ↑

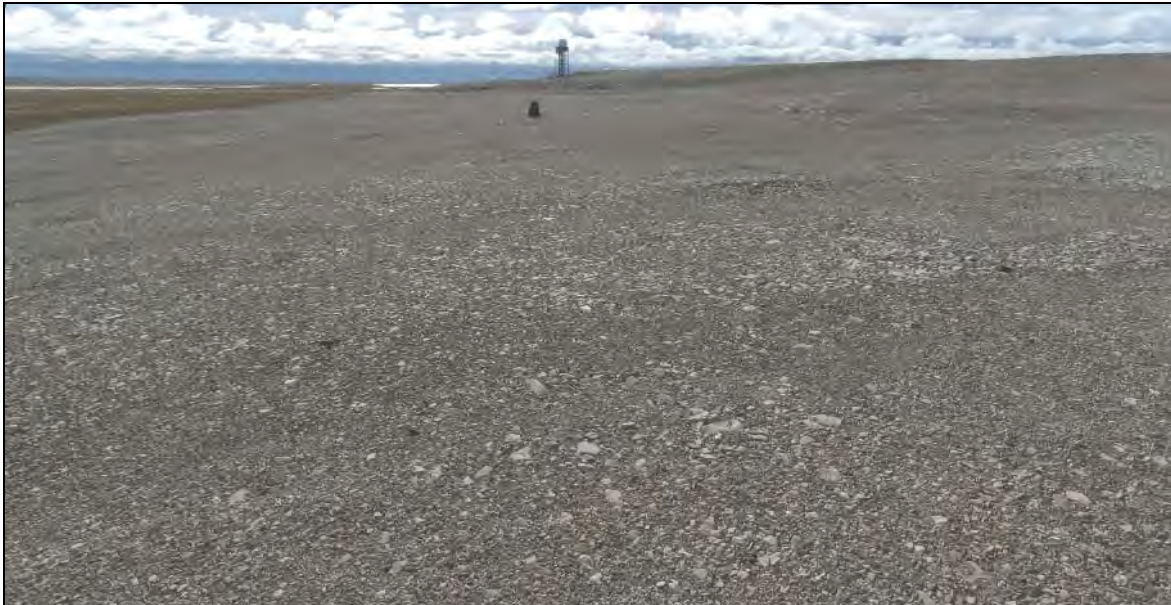
**Photograph WLFN-9.** Panoramic along top of the large central cell. Looking SE from N corner. No features of note. ↑

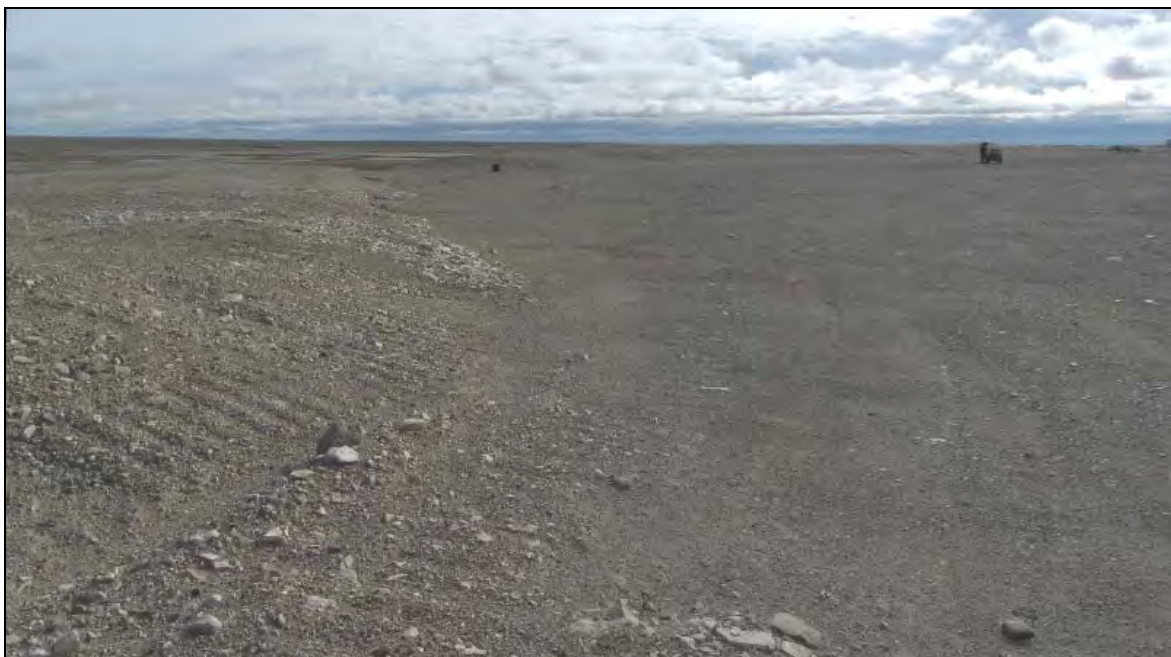
**Photograph WLFN-10.** Looking SE from SW corner of large central cell. Looking to NW corner of long SW cell. ATV in background. No features of note. ↑

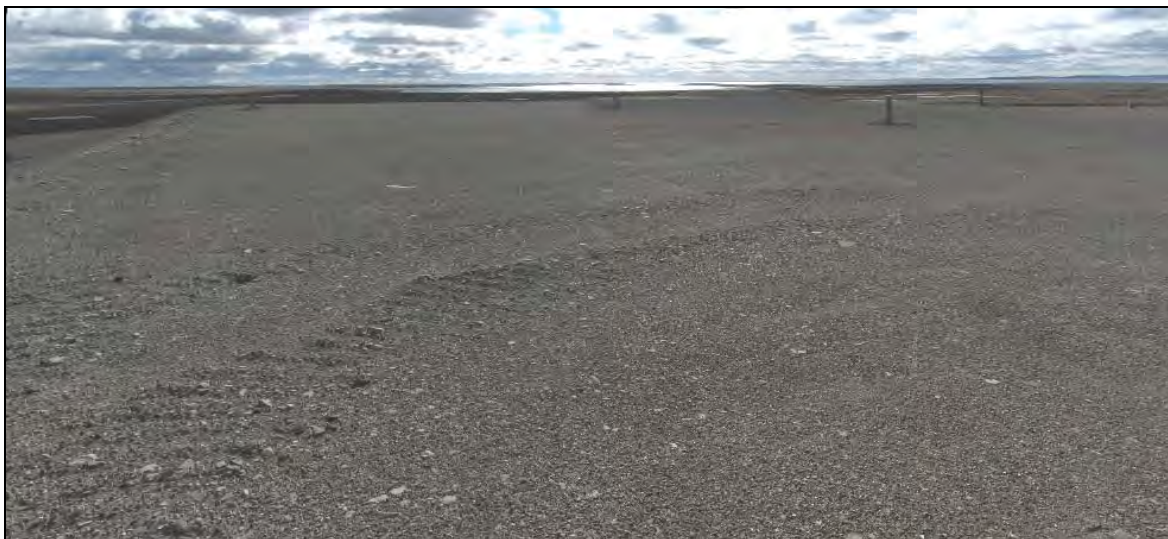
**Photograph T2-15.** Looking ESE from NW corner. Panoramic showing upper surface of landfill. Granular cover appears stable with no indications of problematic conditions. ↑

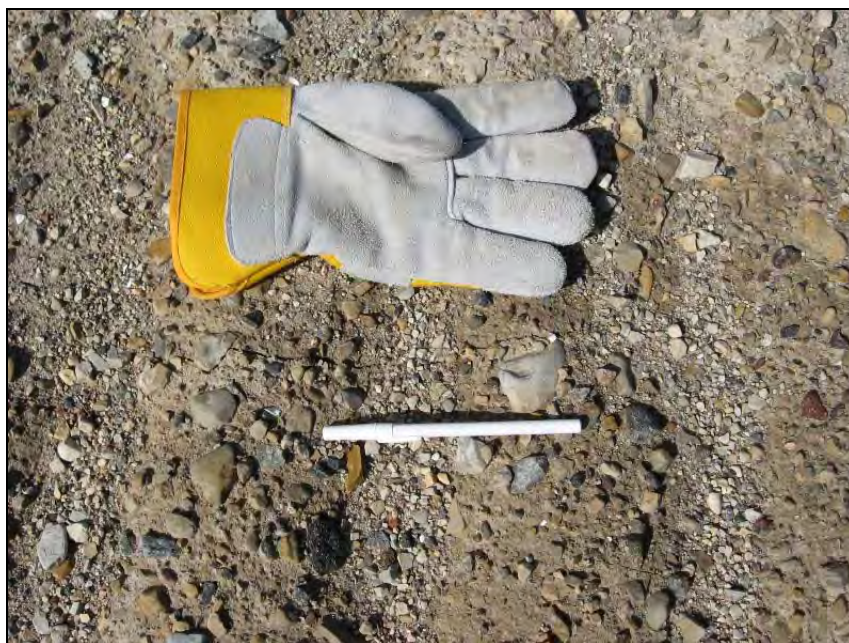
**Photograph T2-16.** Start of fine crack that runs from 20m S of NE corner to about 20m W of NE corner. 1 to 4mm wide, parallel to toe, 5 m upslope from toe, portions in-filled. Crack was observed in 2007 and appears to have stabilized. No indications of recent movement or degraded condition. ↑

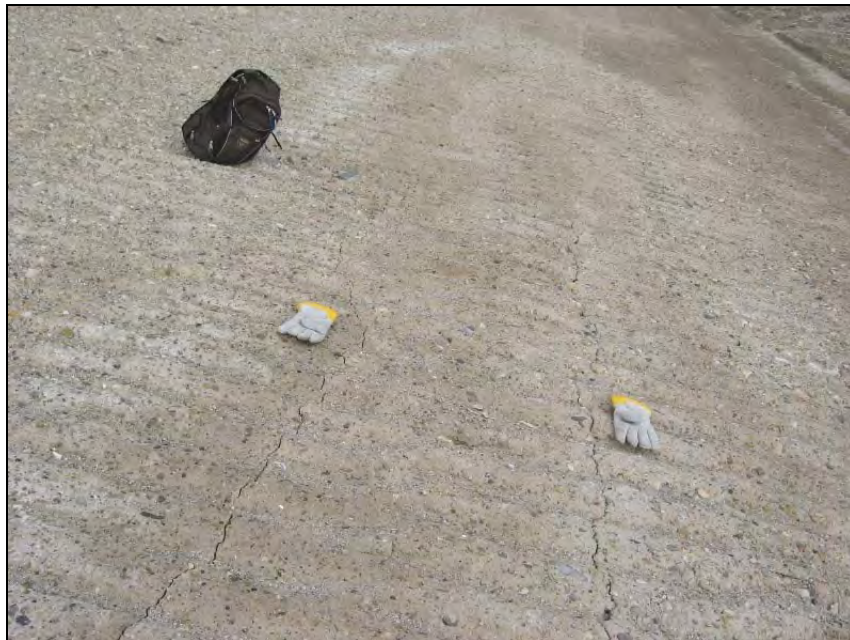
**Photograph NH-12.** Looking ENE at parallel cracks (old). ↑

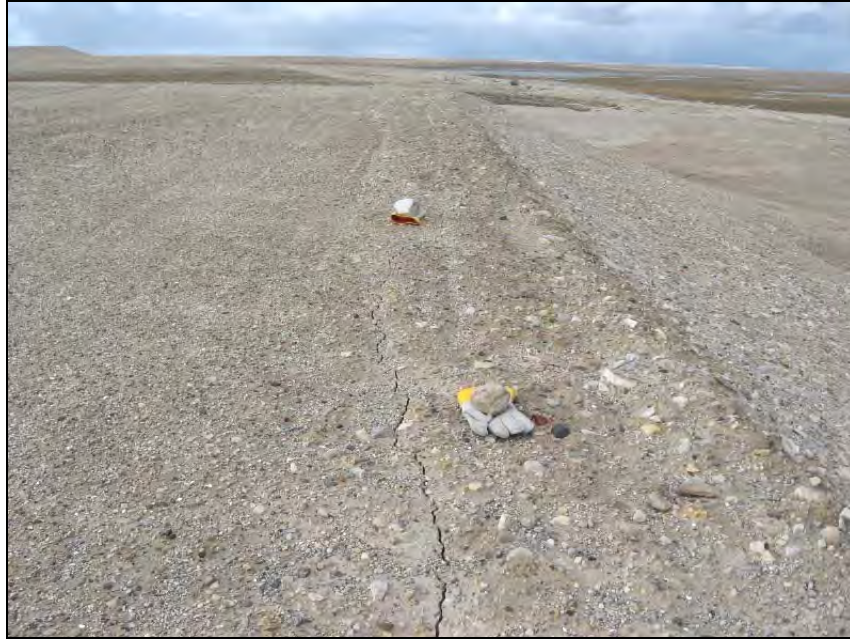
**Photograph NH-19.** Following crack on crest. Looking N approaching NE corner. ↑

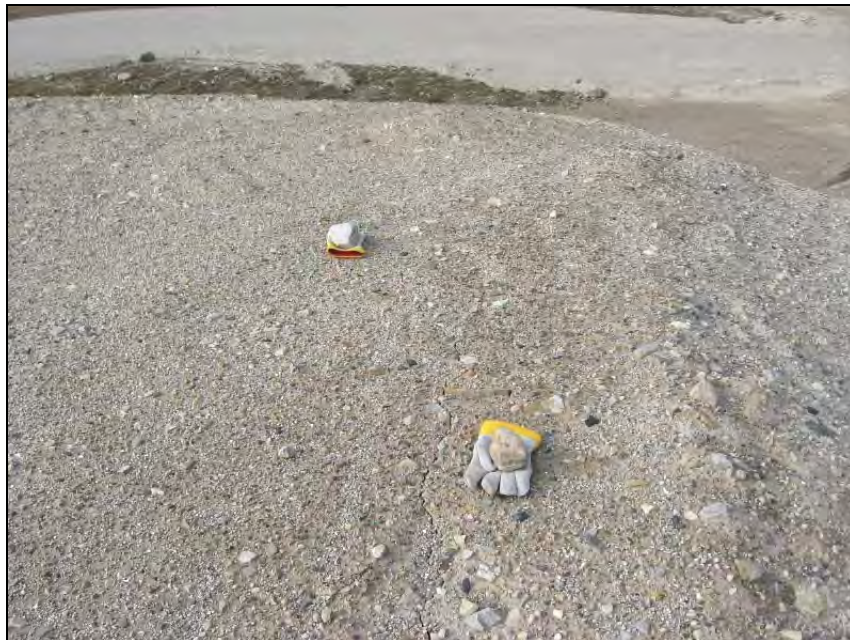
**Photograph NH-20.** Following crest crack to NE corner. Crack largely in-filled as it rounds corner. Faintly visible from about 30m W along N crest. ↑
