## **The Collection of Landfill Monitoring Data at the CAM-2 Gladman Point Site – 2008 Final Report**

**The Collection of Landfill Monitoring Data at the  
CAM-2 Gladman Point Site**

**AECOM Canada Ltd.**

January, 2009

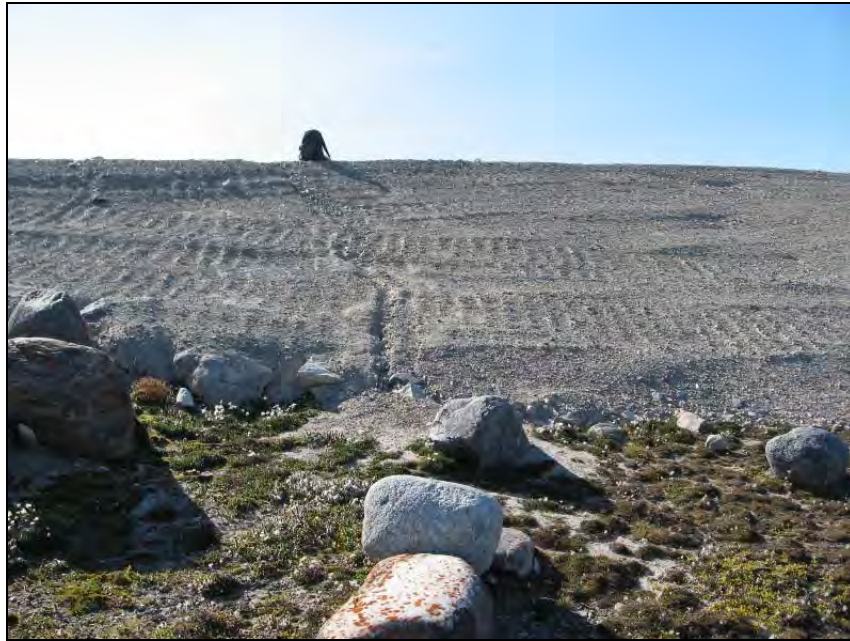
Minor surficial erosion, which appears to be associated with surface runoff, was noted at several locations along the eastern slope of the granular cover (refer to Photos 3 and 4). These areas of minor surficial erosion were first documented in 2006 (inspection by EBA) and re-evaluated in 2007 at the time of last years inspection. The granular cover in the areas of observed surficial erosion appears to be self armouring with limited potential for significant further degradation. None of the areas of observed surficial erosion appear to warrant remediation at this time.

**Photograph STA-3.** Looking upslope to area of minor surficial erosion. Condition is essentially unchanged from last year. Granular cover is self-armouring. ↑

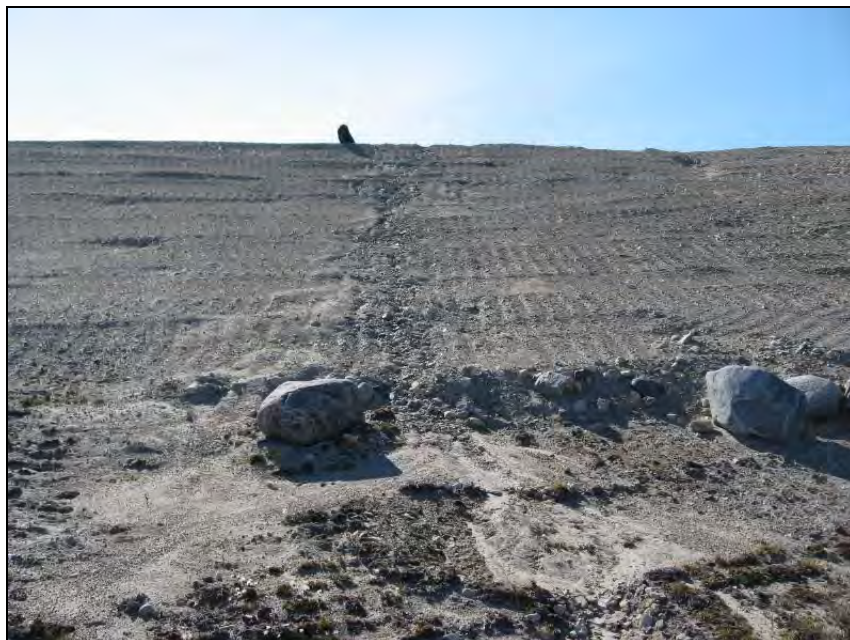
**Photograph STA-4.** Looking upslope to area of minor surficial erosion. Condition is essentially unchanged from last year. Granular cover is self-armouring. ↑

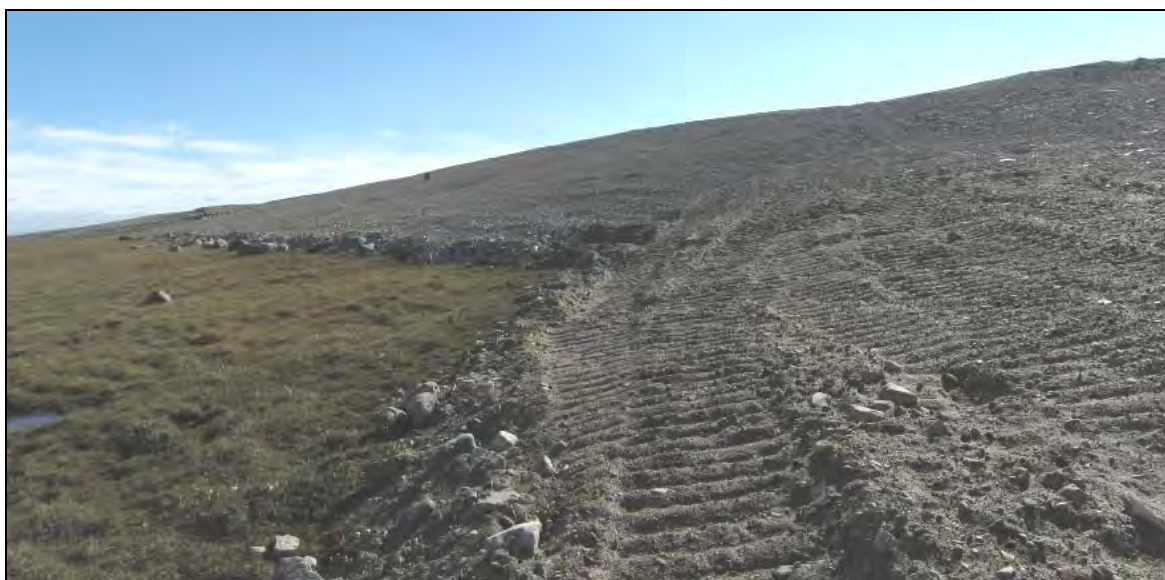
**Photograph STA-6.** Looking SSE along E slope. Slope appears stable. ↑

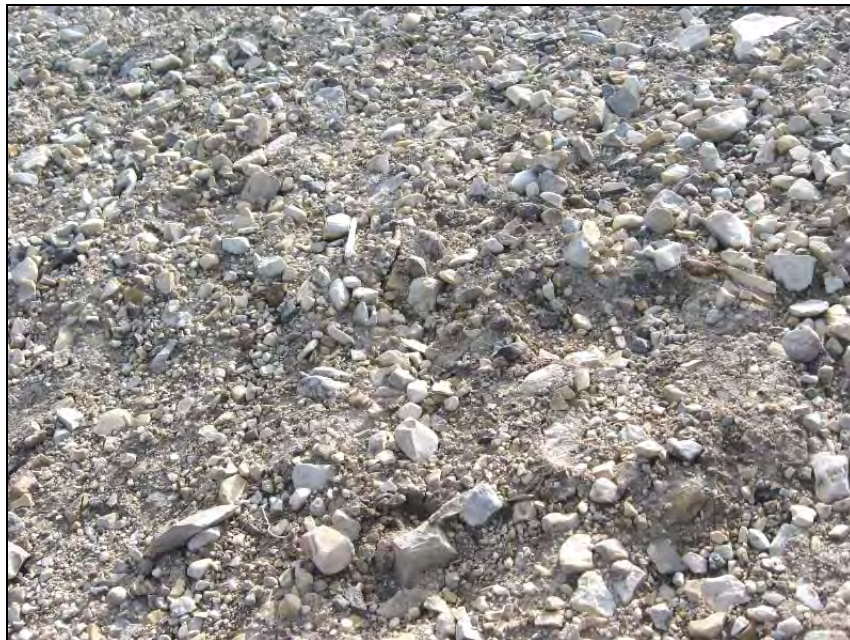
**Photograph WLFN-8.** Close-up of minor cracking along N corner of central cell. Crack observed to be about 4m long and 1 to 3mm wide. Several other similar type minor cracks observed for next 25m (discontinuous, partially in-filled). Trivial feature, not documented in detail. ↑

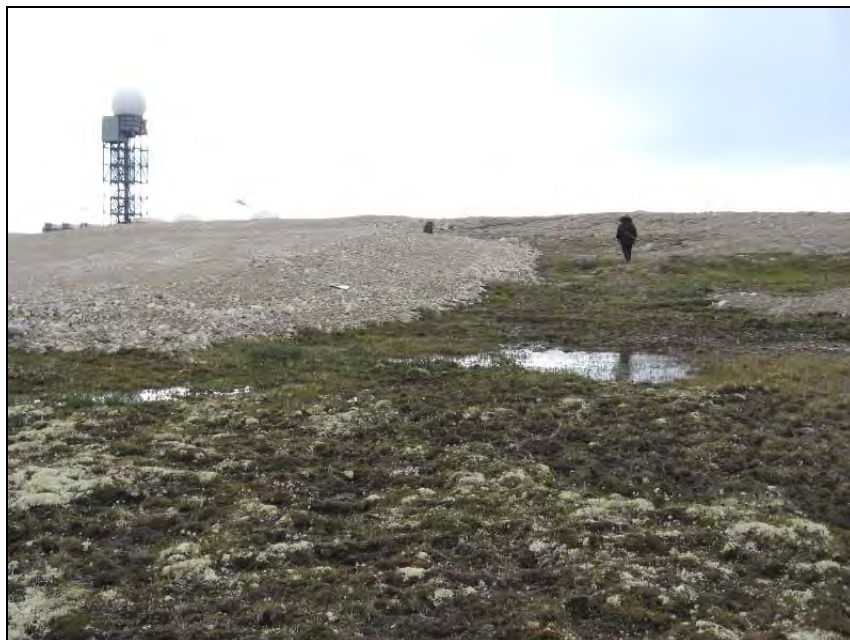
**Photograph WLFS-10.** Looking W along N side of 4th cell. Ponded water appears to be associated with recent precipitation events. No staining or clear indications of seepage. ↑

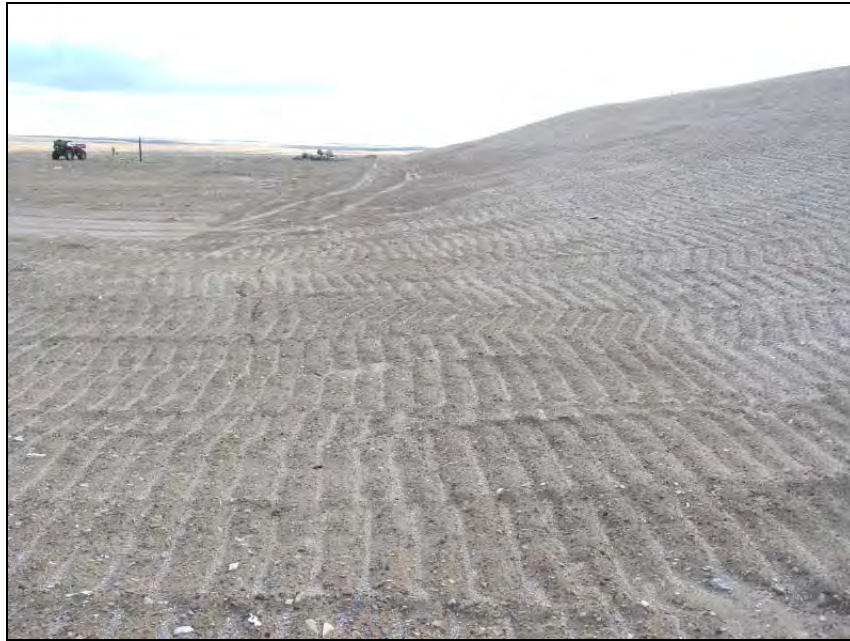
**Photograph T2-5.** Looking ESE along toe from NW corner of LF towards area where minor cracking was observed in 2007. The previously observed cracks (in foreground) are largely in-filled with sediments and show no indication of recent movement. ↑

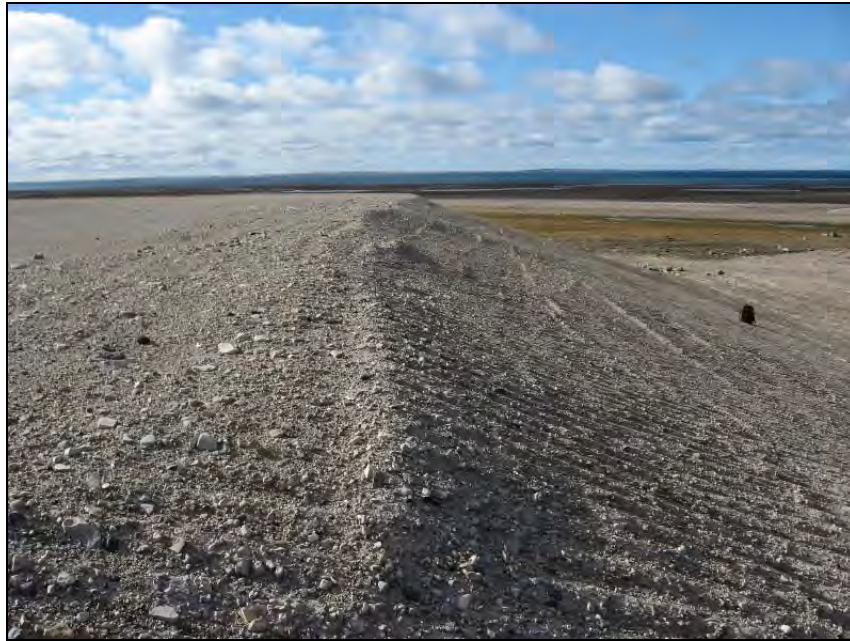
**Photograph T2-7.** Looking S along crest from NW corner. Minor cracks that were noted last year are barely visible and partially infilled. No sign of recent movement. ↑

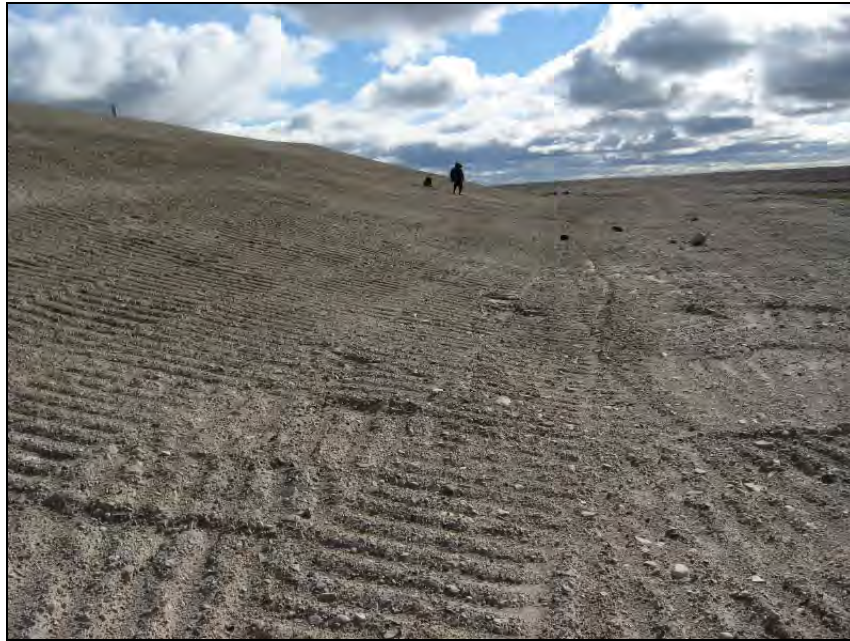
**Photograph T2-9.** Looking E along toe of S side from SE corner. 20m long tension crack (old) runs parallel to slope. ↑

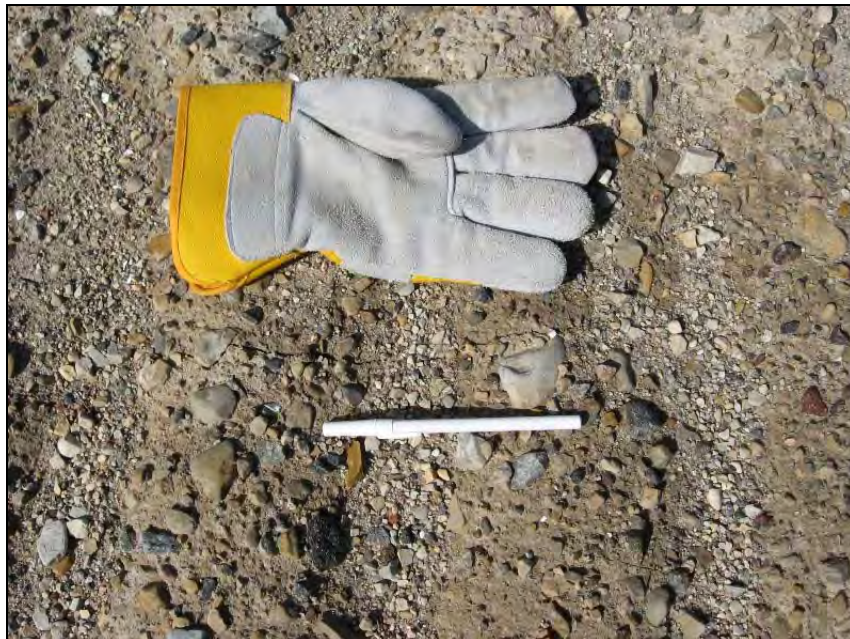
**Photograph T2-16.** Start of fine crack that runs from 20m S of NE corner to about 20m W of NE corner. 1 to 4mm wide, parallel to toe, 5 m upslope from toe, portions in-filled. Crack was observed in 2007 and appears to have stabilized. No indications of recent movement or degraded condition. ↑

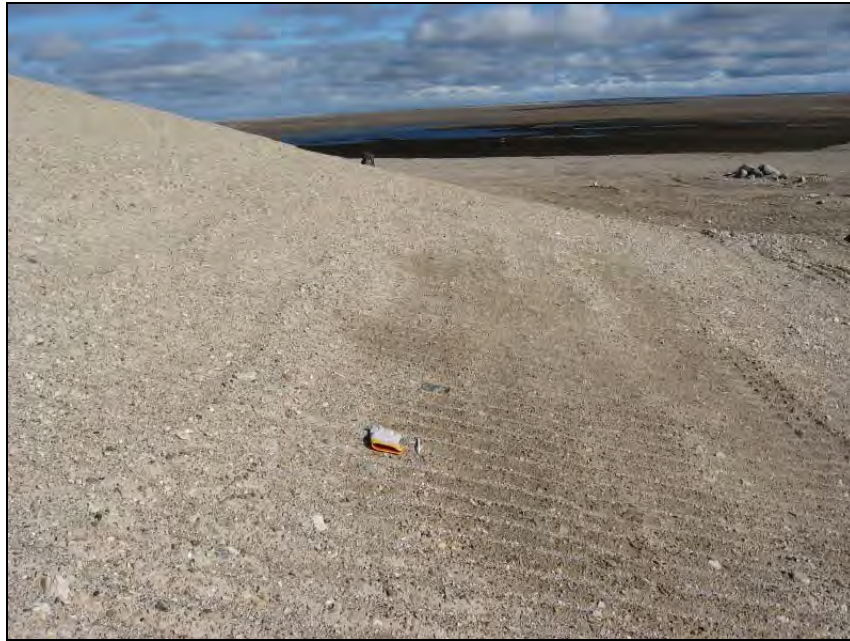
**Photograph T2-17.** Looking N to NE corner. Fine crack starts between glove and pen and progresses around corner to just downslope of backpack and continues at roughly same elevation for another 35m, splays up to 1 m offset. No indications of recent movement. ↑

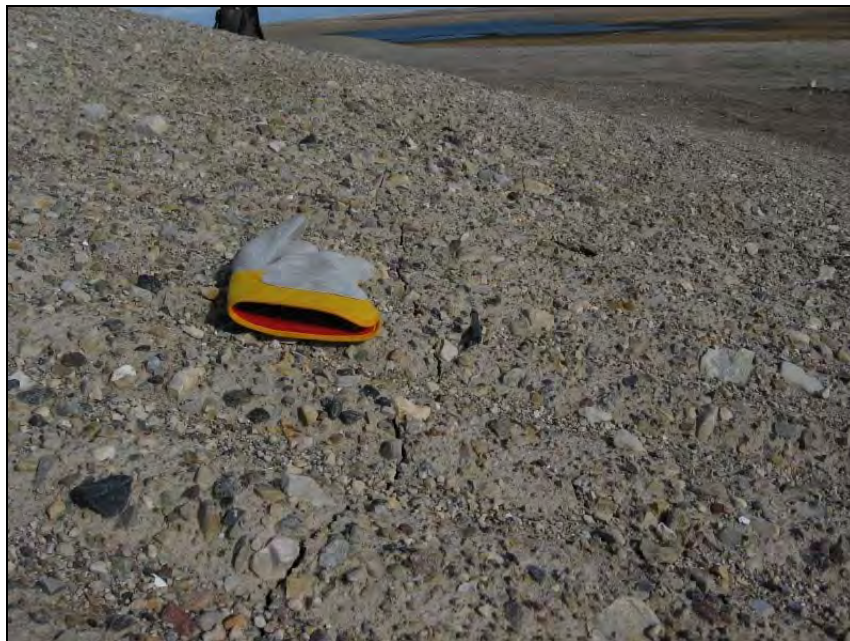
**Photograph T2-18.** Close-up of same crack as in T2-17. This photo is representative of much of the length of the crack. ↑

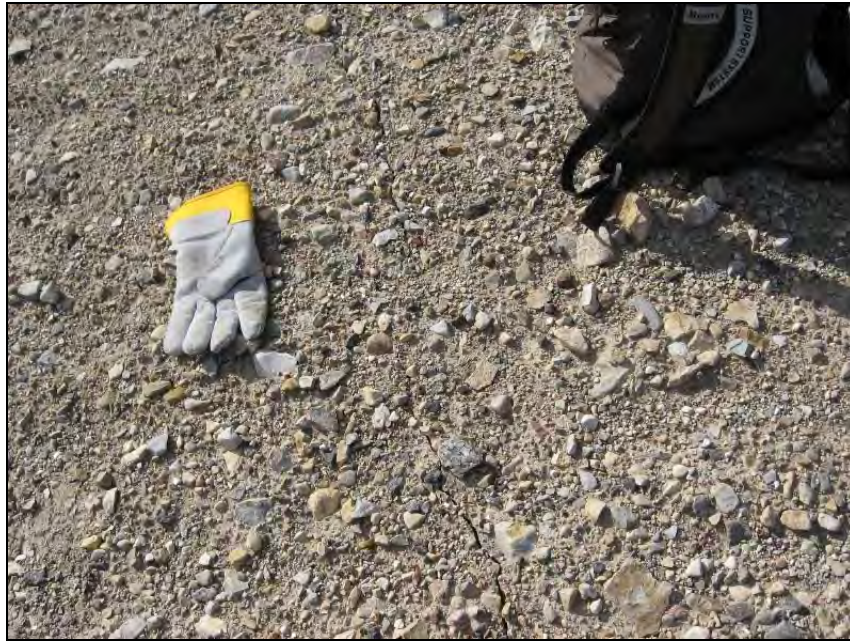
**Photograph T2-19.** Close-up of crack, backpack in same location as photo T2-17. ↑

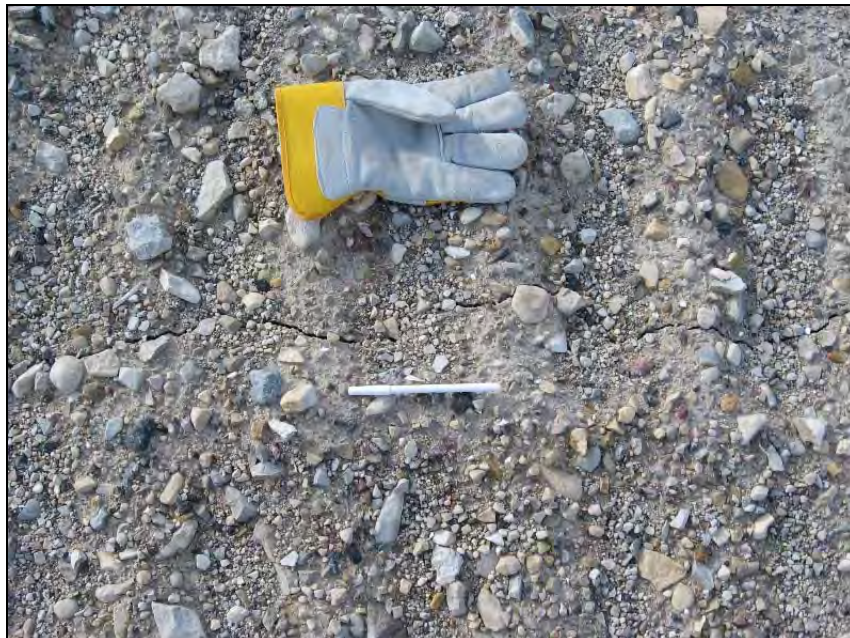
**Photograph T2-20.** Close-up of crack on N slope near NE toe. About 10m W of the NE corner of the landfill. Edges of the crack appear rounded (weathered) and portions of the crack are infilled with sediments. ↑

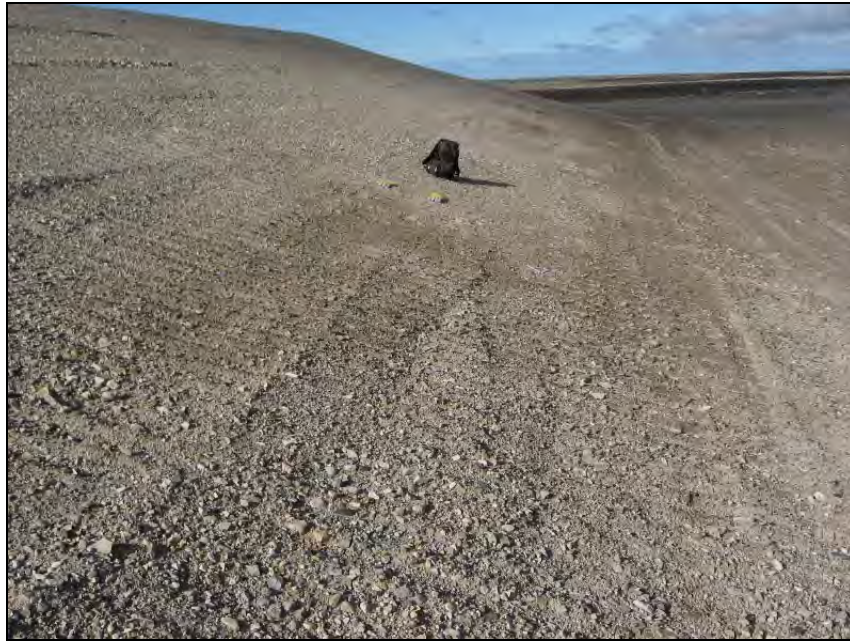
**Photograph T2-21.** Standing on crack looking west to the end of the crack (at backpack). The crack is largely in-filled with fine sediments and there is no sign of recent movement. ↑

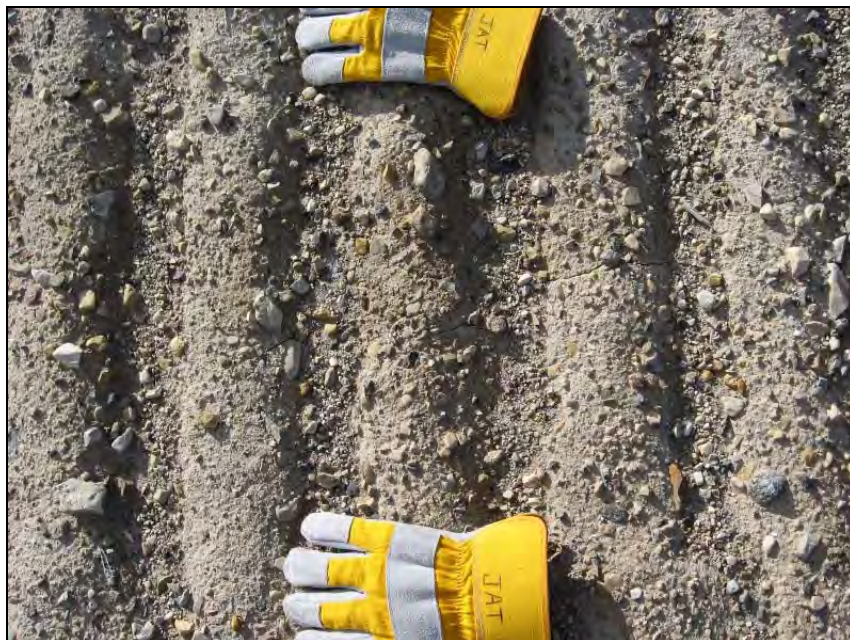
**Photograph T2-22.** Close-up of previous crack between gloves shown in photo T2-21. ↑

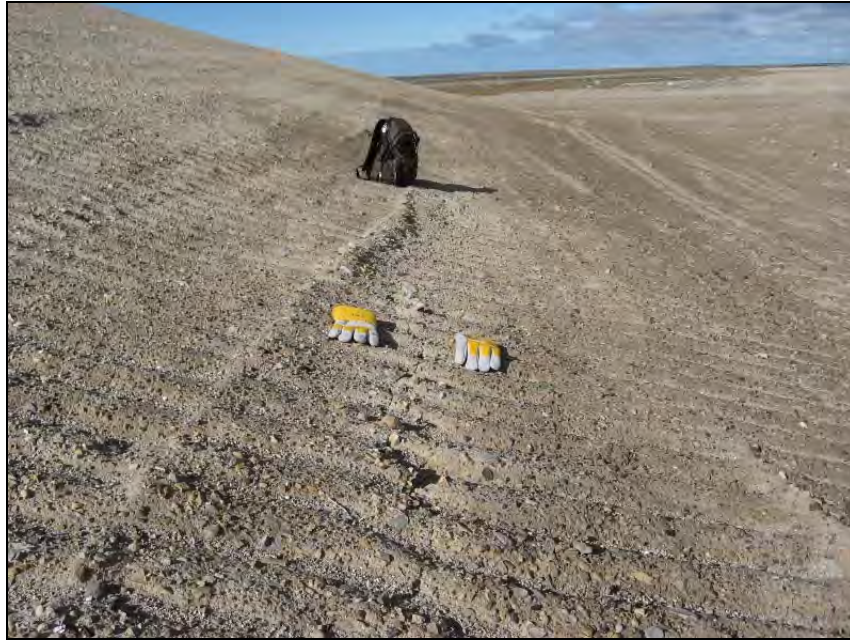
**Photograph T2-23.** Looking W along N slope to old crack. 1 to 7mm wide, largely eroded/in-filled. Backpack at end (starts 5m E, ends 12m W). ↑

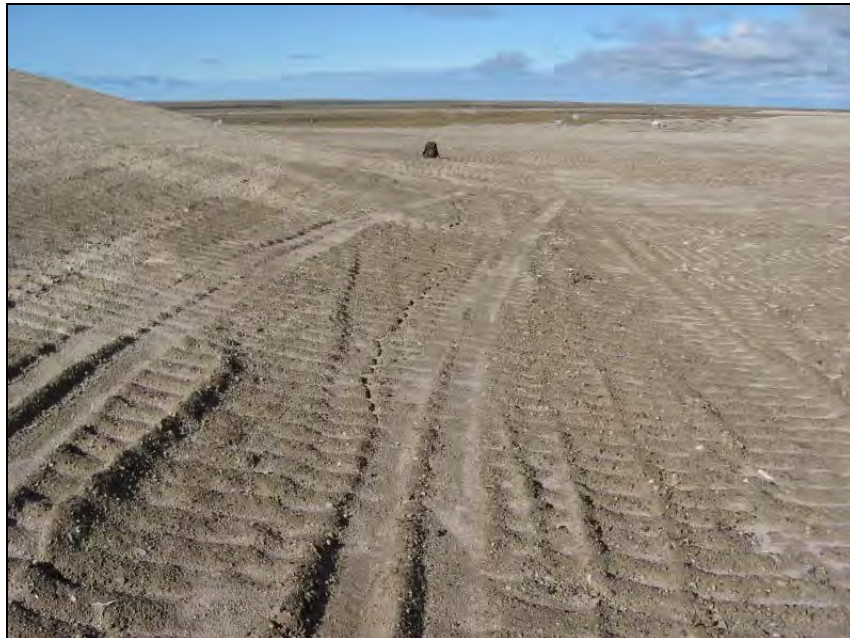
**Photograph T2-24.** Looking W to NW corner along toe and old eroded tension crack. Heavy rains and wind has essentially in-filled the other cracks that were observed last year. ↑

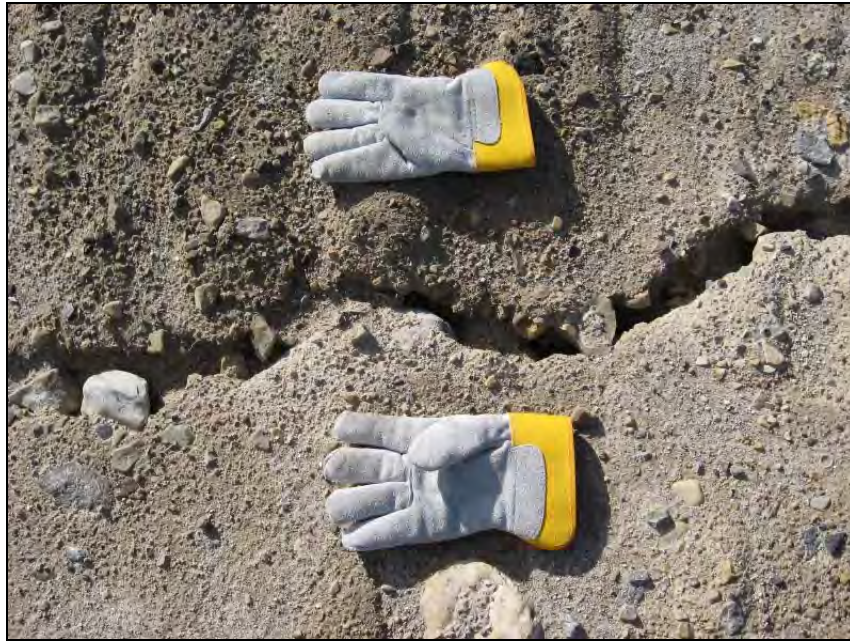
**Photograph T2-25.** Close-up of old crack noted in T2-24. No indications of recent movement. Slope appears stable. ↑

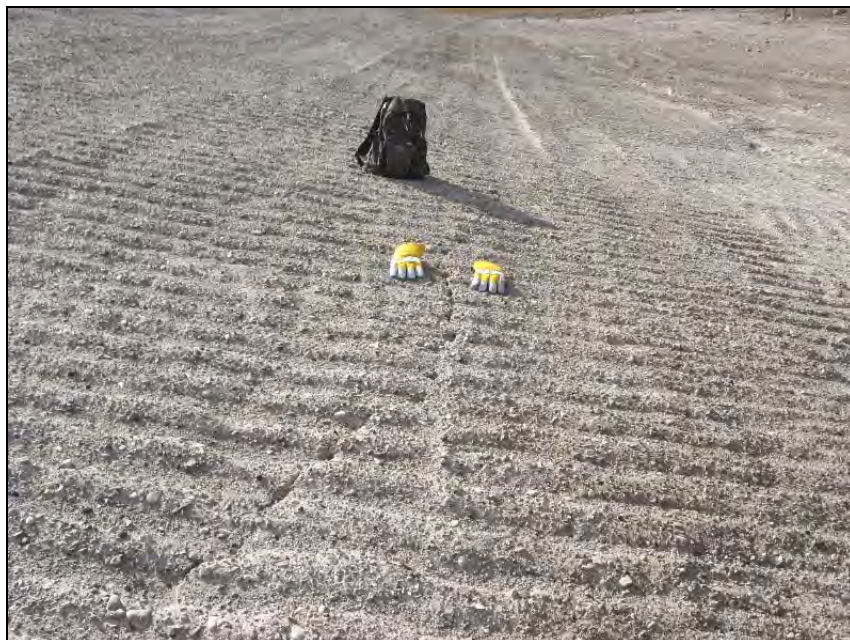
**Photograph T2-26.** Looking S from near NW corner along old crack. ↑

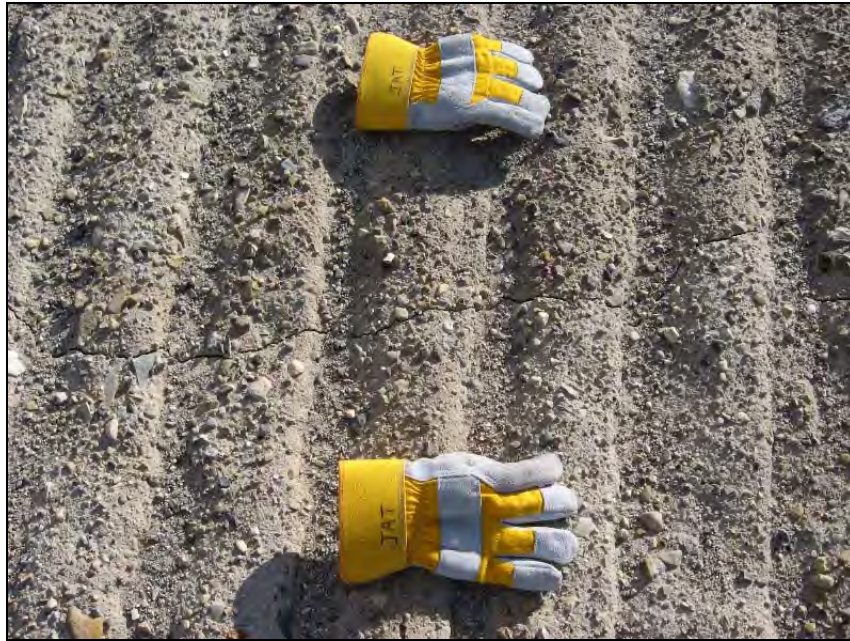
**Photograph T2-27.** Close-up of representative crack. This crack continues, splaying into two parallel cracks, 1m to 2m apart, and back again along entire toe of slope. Crack was observed in 2007 and shows no indication of recent movement. ↑

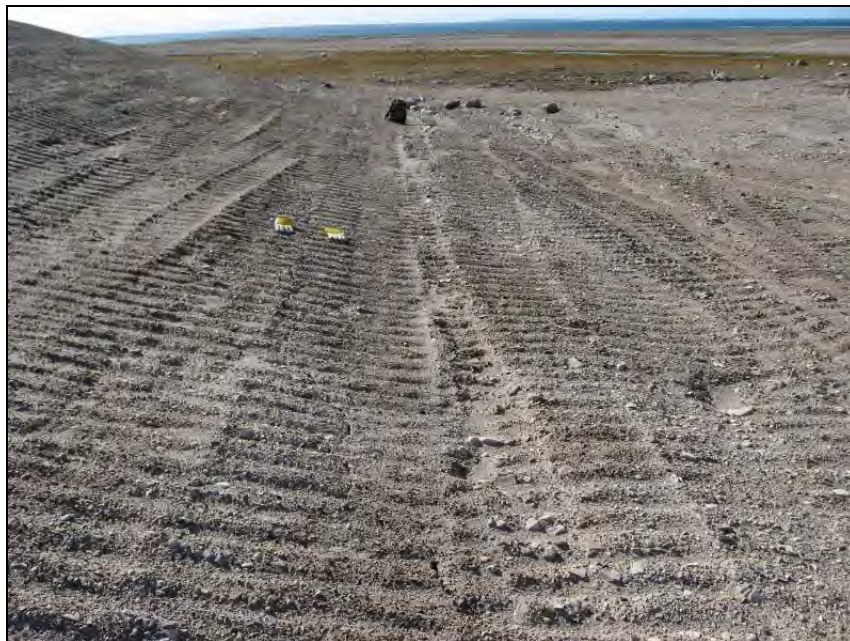
**Photograph T2-28.** Looking S along toe of W slope along old, partially in-filled crack. Crack passes between gloves and ends at backpack. ↑

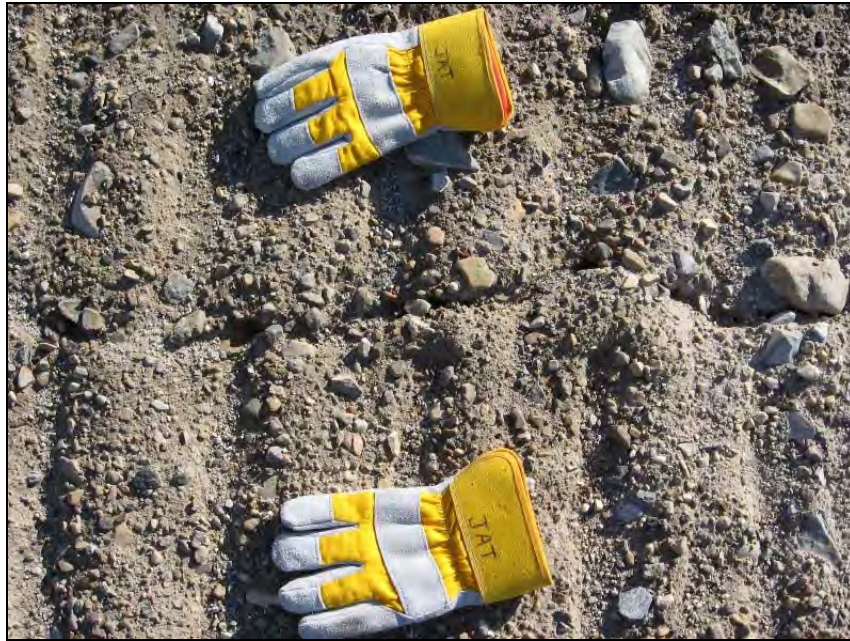
**Photograph T2-29.** Close-up of crack between gloves. Partially infilled, no sign of recent movement. ↑

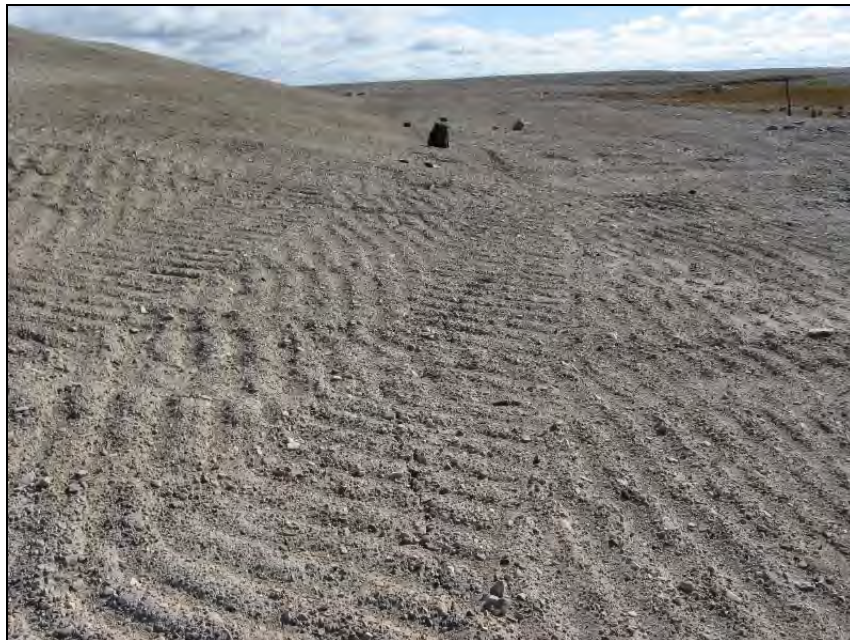
**Photograph T2-30.** Looking E along toe from SW corner. Old crack runs between gloves and ends at backpack. All other cracks in this area that were observed in 2007 were either completely in-filled or not observed. ↑

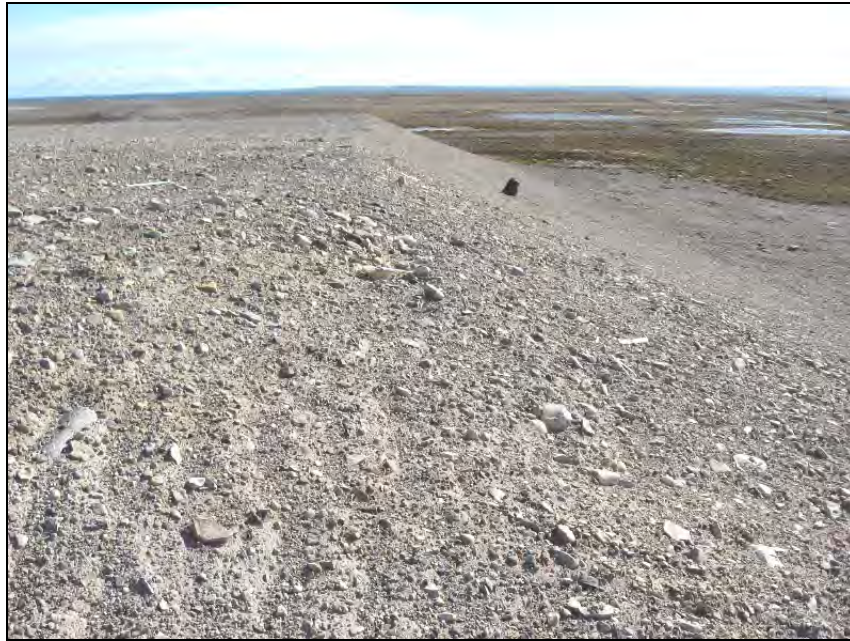
**Photograph NH-5.** Looking S along crest from NW corner. Fine cracks that were observed last year cannot be seen. ↑

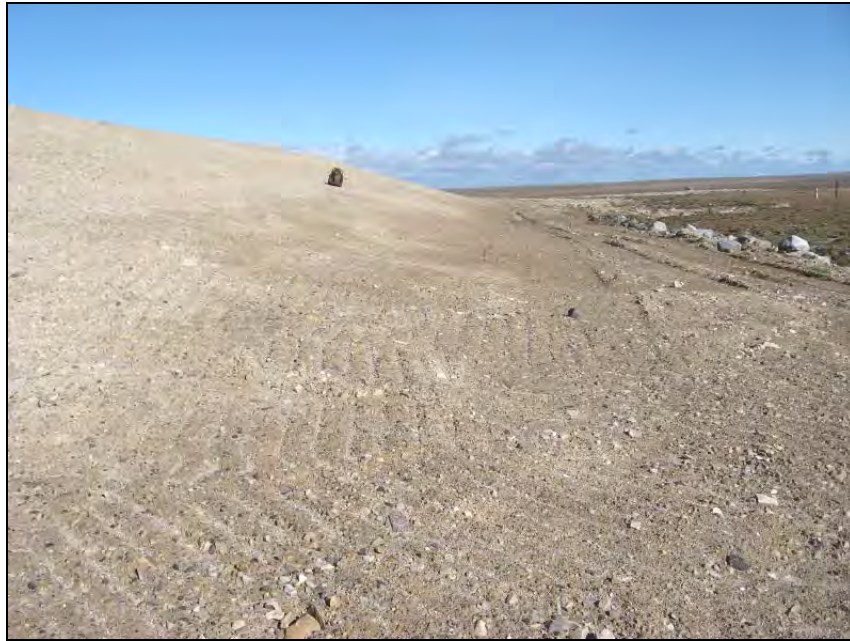
**Photograph NH-7.** Looking ENE along toe of S slope from SW corner of LF. Backpack located next to old in-filled crack. ↑

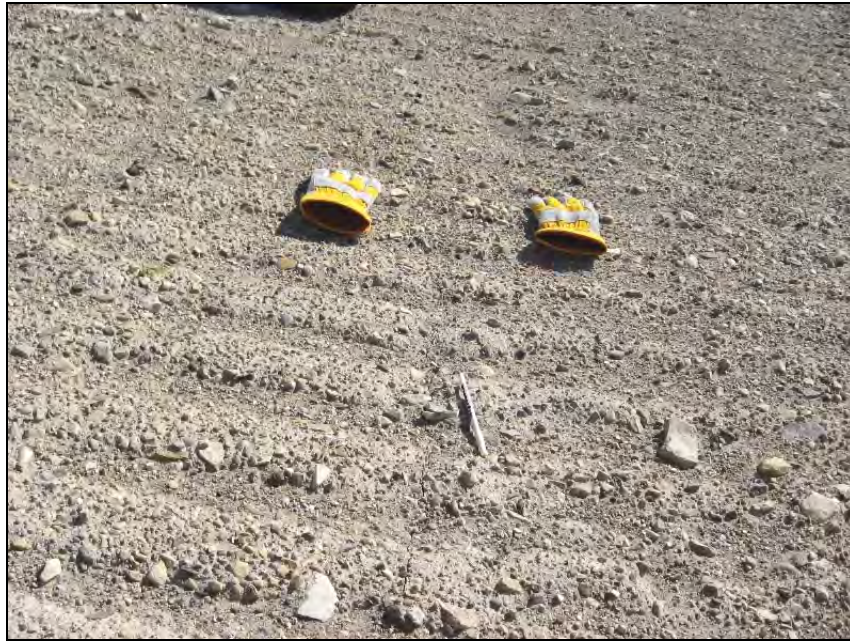
**Photograph NH-9.** Close-up of crack from last year, partially in-filled with no sign of recent movement (gloves and pen for scale). Splays and offset by up to 1m, always fine. ↑

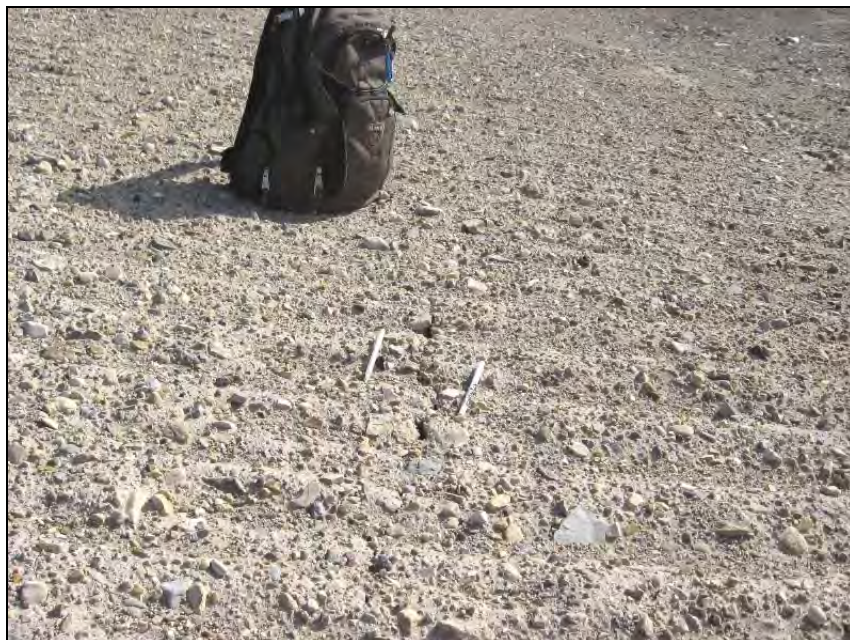
**Photograph NH-10.** Close-up, portion of lower crack along W toe that was observed last year. Most has been in-filled and cannot be seen. ↑

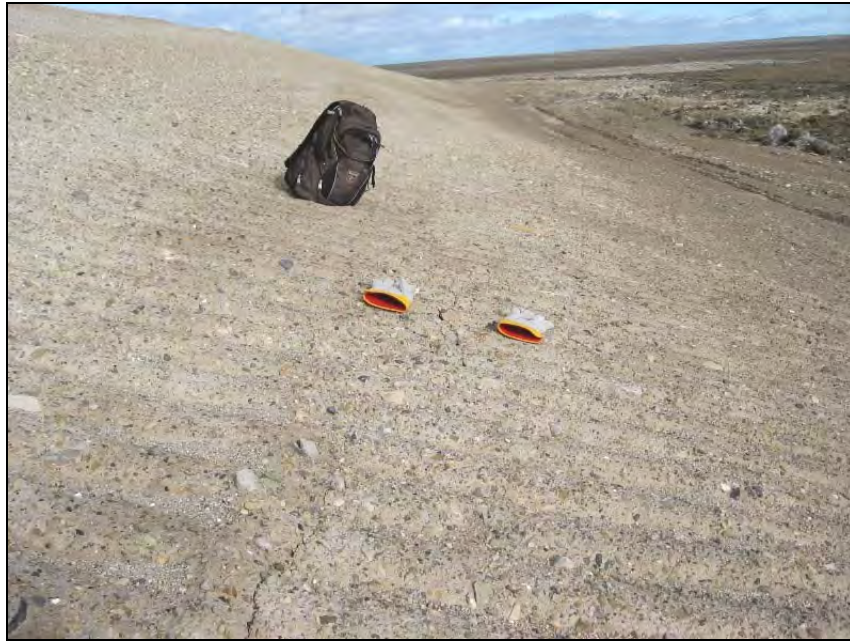
**Photograph NH-11.** Looking ENE along slope along old, partially in-filled crack (between gloves). ↑

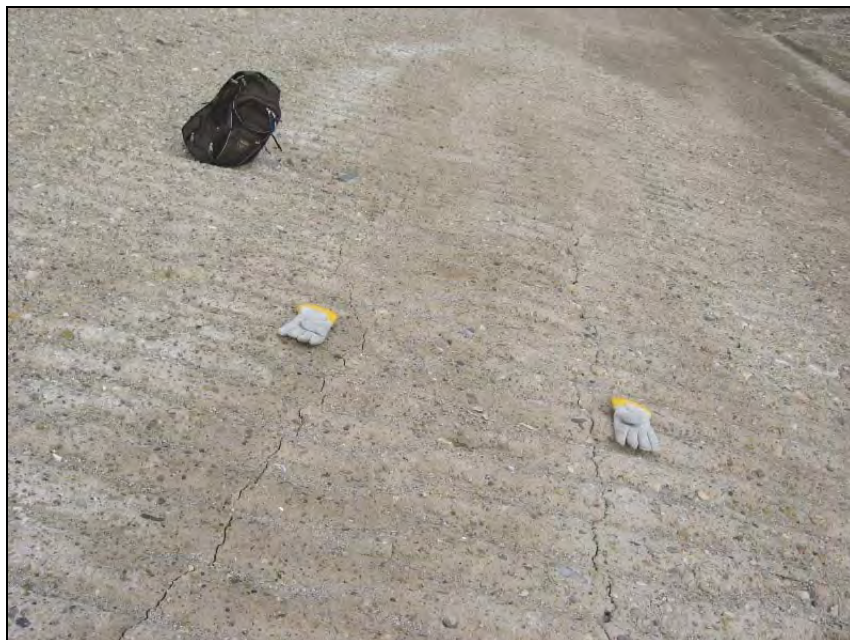
**Photograph NH-12.** Looking ENE at parallel cracks (old). ↑

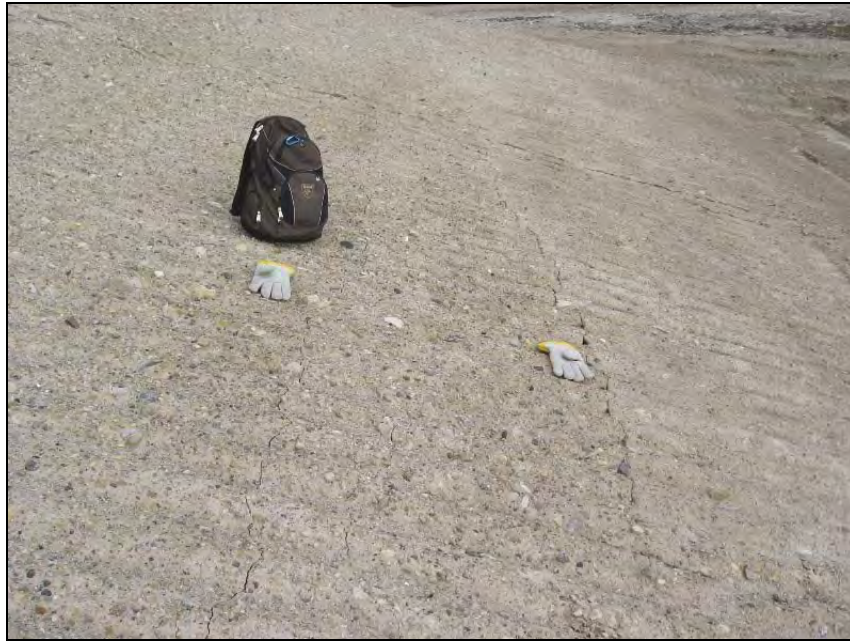
**Photograph NH-13.** Looking ENE at parallel cracks (old) approaching SE corner. Area of minor (self armoured) surficial erosion visible in background. Zone of erosion appears unchanged from the time of the 2007 inspection. ↑

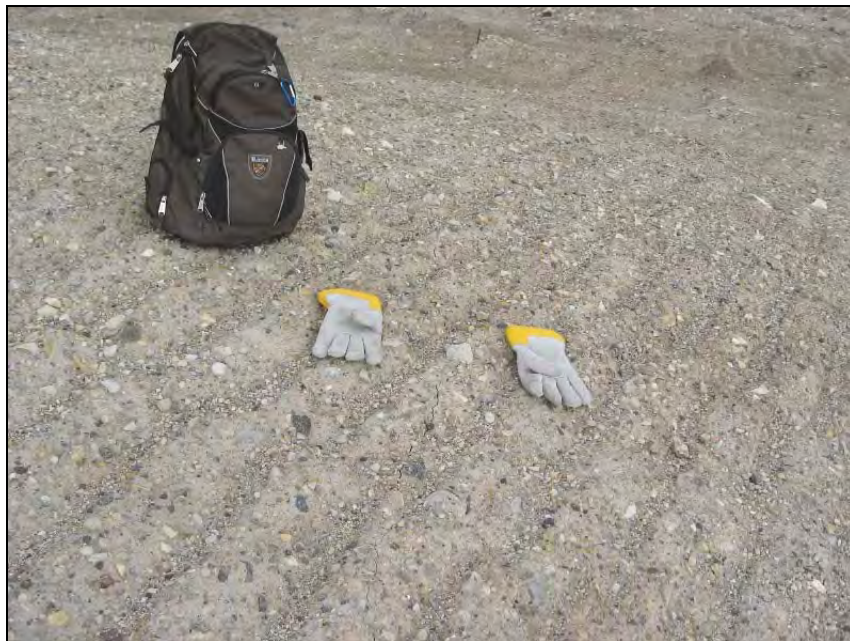
**Photograph NH-14.** Close-up, crack becomes narrow at SE corner. ↑

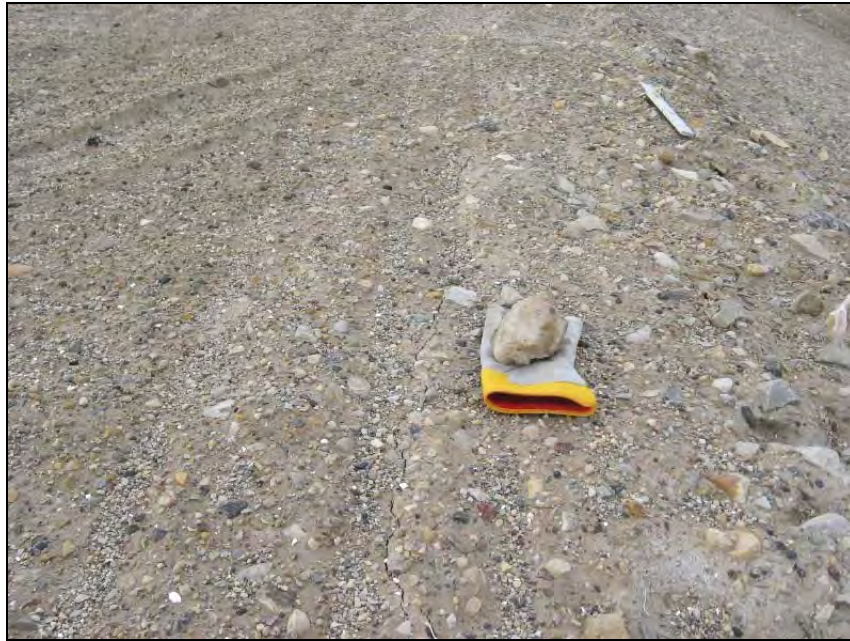
**Photograph NH-17.** Minor crack along crest (old) looking N. ↑

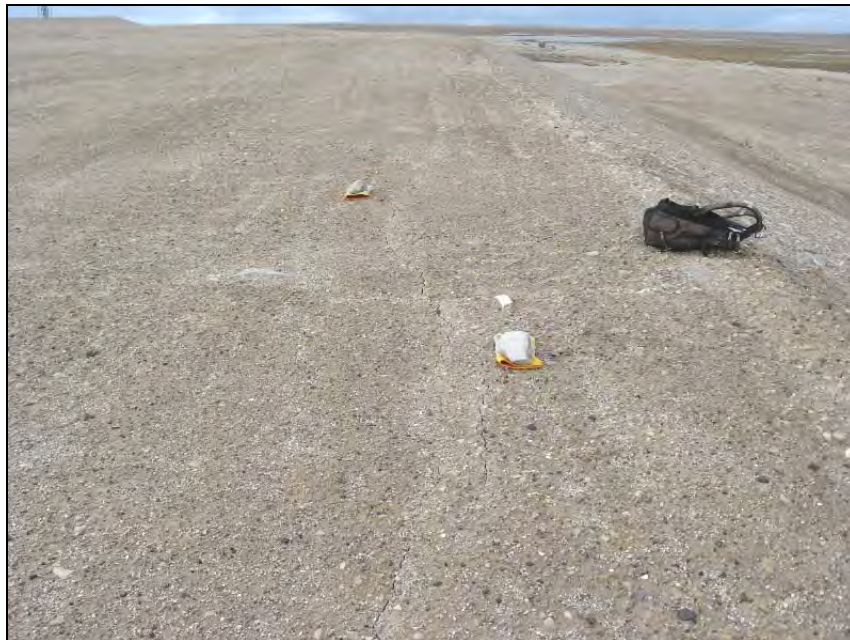
**Photograph NH-18.** Crack along E crest looking N. Similar to last year. Gloves on either side of crack. ↑

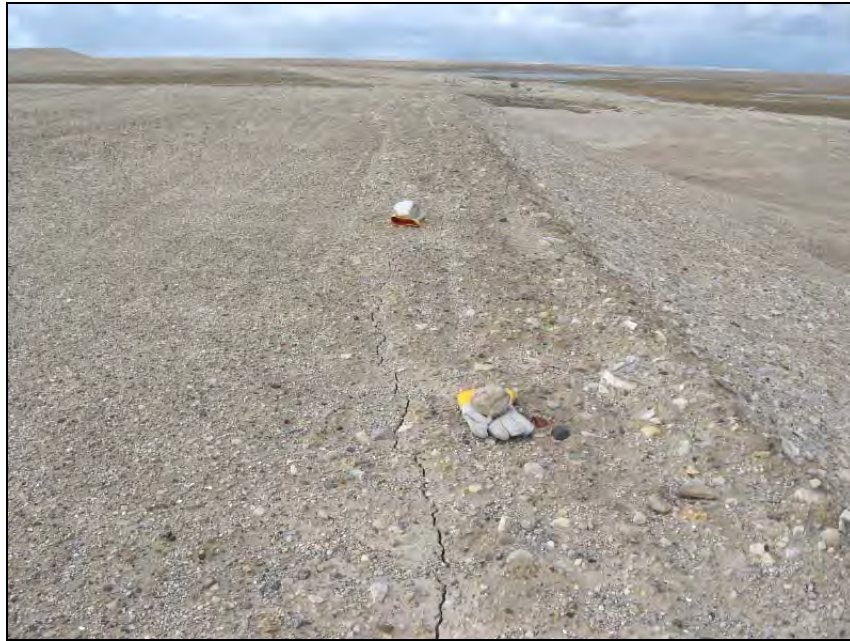
**Photograph NH-19.** Following crack on crest. Looking N approaching NE corner. ↑

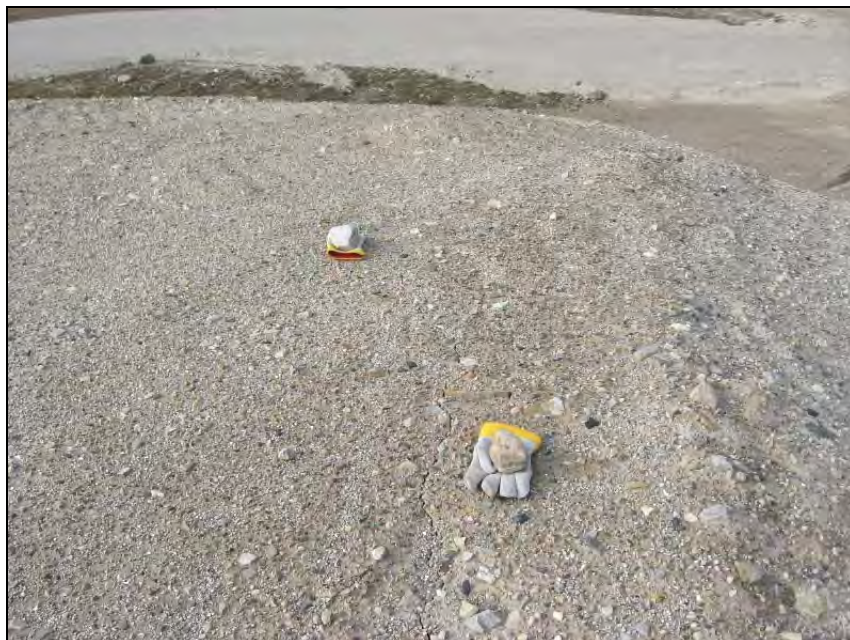
**Photograph NH-20.** Following crest crack to NE corner. Crack largely in-filled as it rounds corner. Faintly visible from about 30m W along N crest. ↑

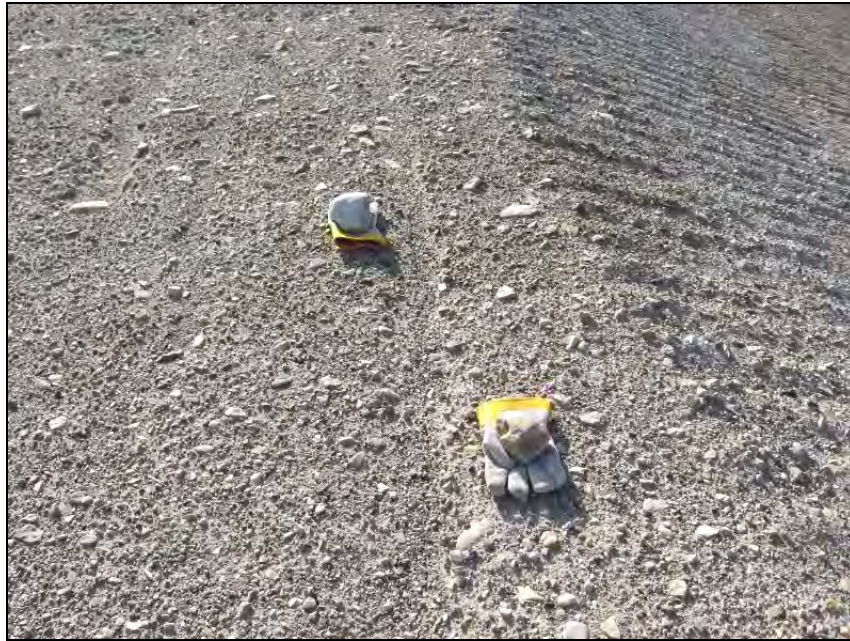
**Photograph NH-21.** Representative picture of crack as it rounds corner and turns W. Gloves for scale on either side of in-filled crack. ↑

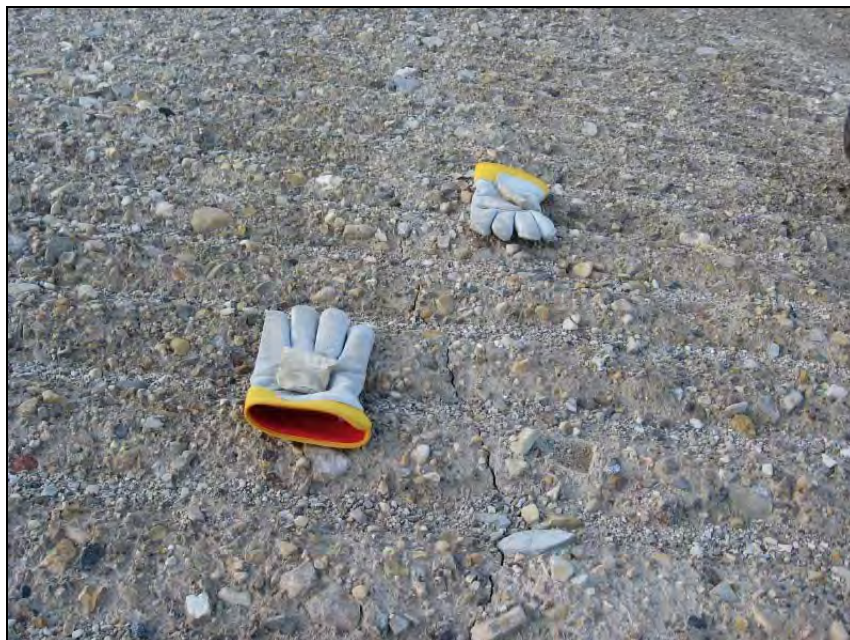
**Photograph NH-22.** Representative crack along E slope looking N. ↑

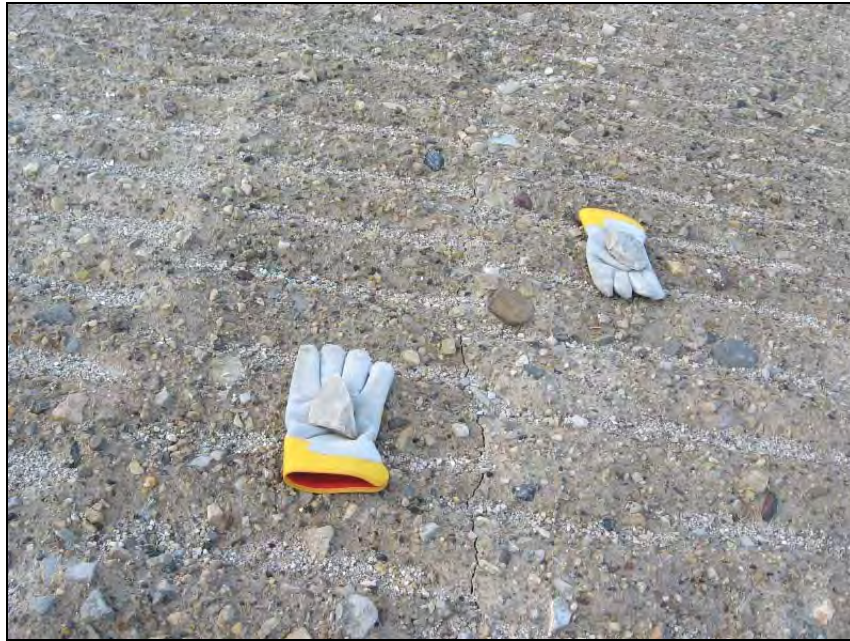
**Photograph NH-23.** Following crack on E slope looking N. ↑
