**THE COLLECTION OF LANDFILL
MONITORING DATA AT THE FORMER
FOX-M DEW LINE SITE**

Hall Beach, Nunavut

FINAL REPORT – 2009 SEASON

DEFENCE CONSTRUCTION CANADA

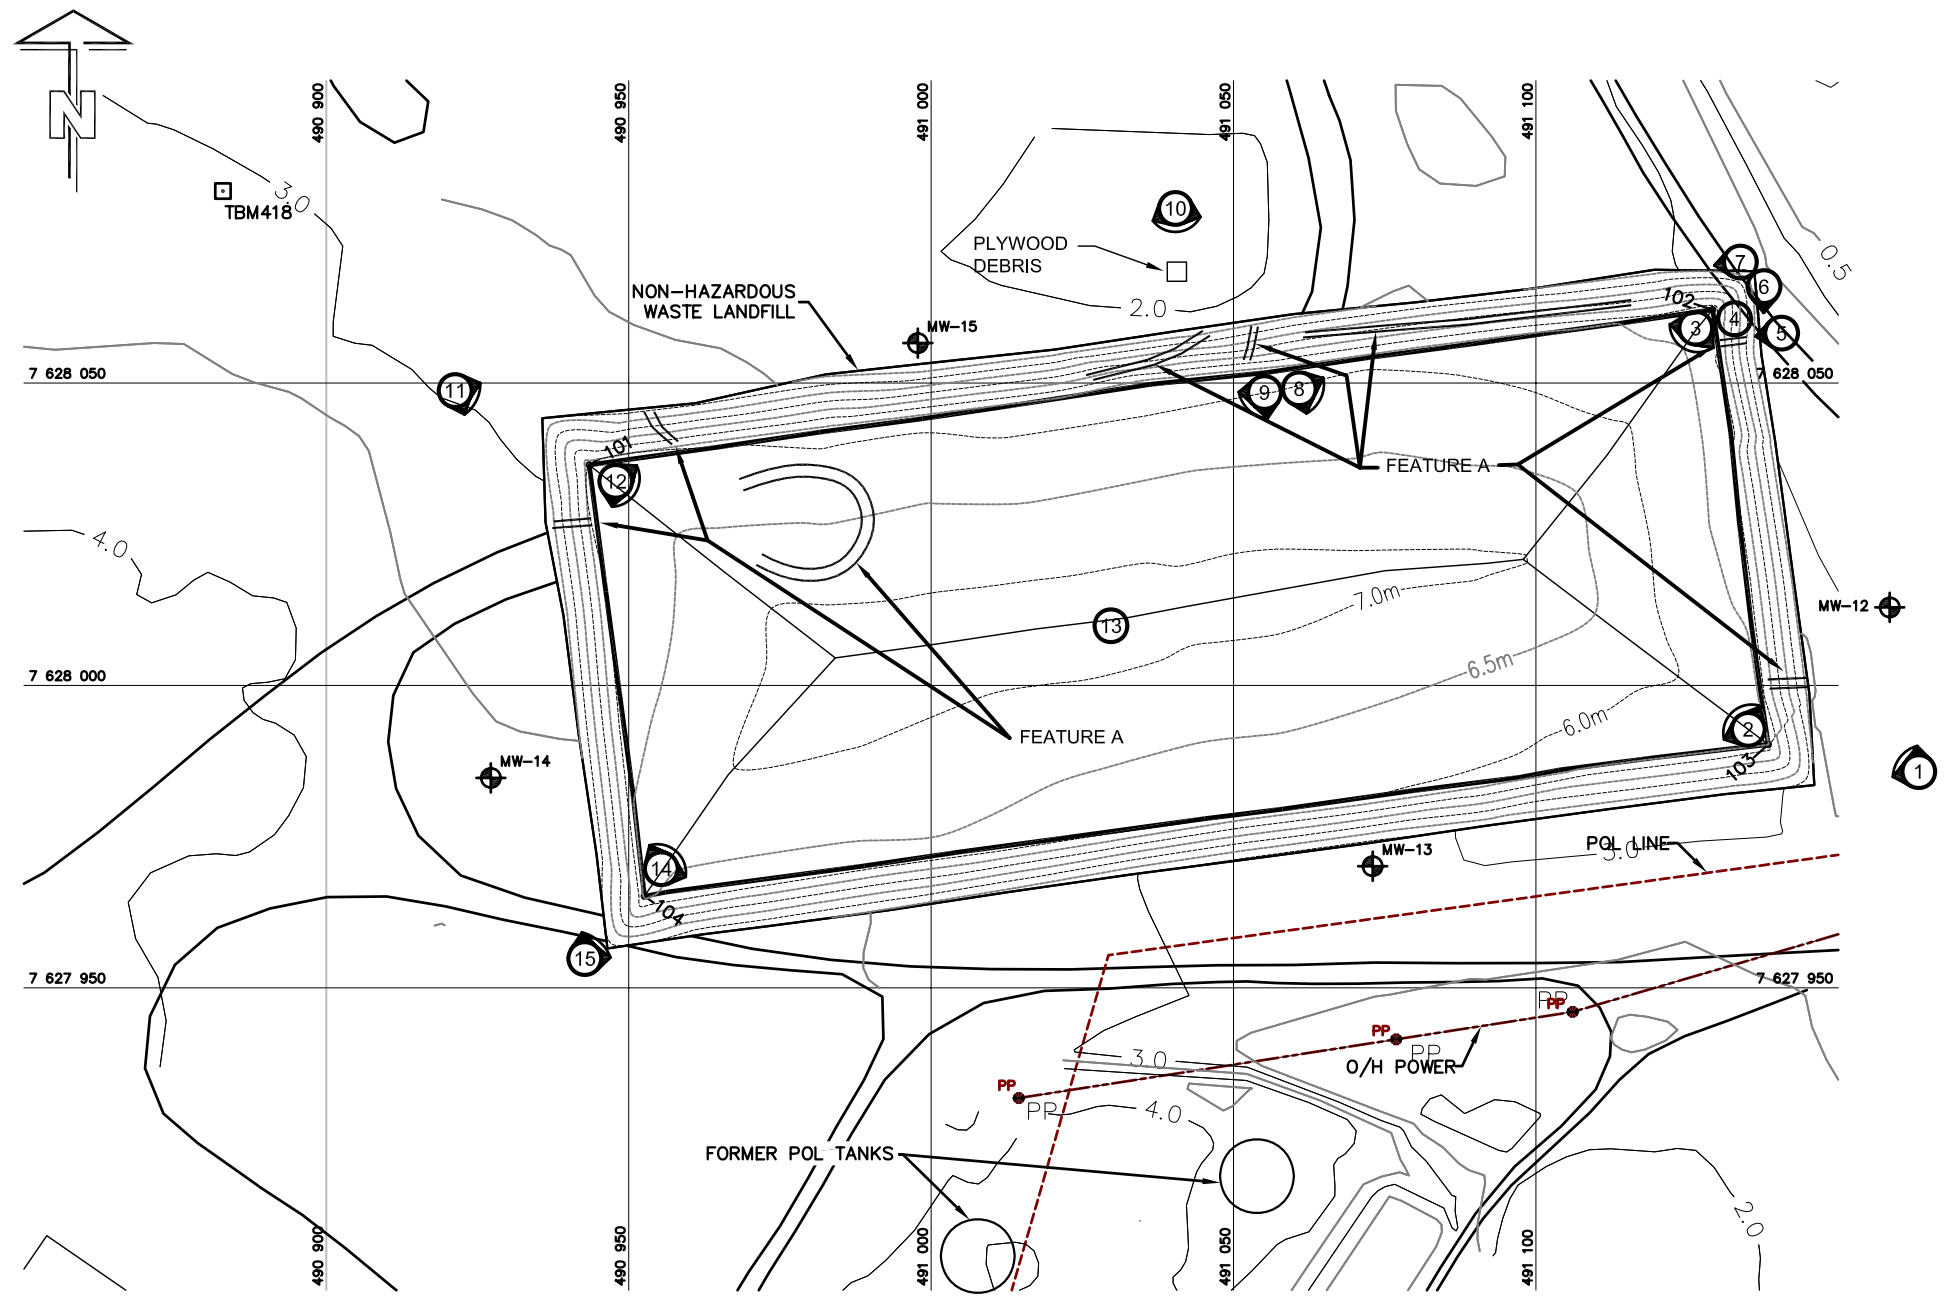
The Location Plan for the NHWLF has been completed as per the ToR and is included as Figure FOX-M.2.

Numerous vehicle tracks were observed on the surface and side slopes of the landfill cover, including several deeper ruts noted along the northwest, north and east side slopes and on the northwest corner of the landfill cover (Feature A). The vehicle tracks/ruts typically extended between 0.1 to 0.3 m in depth and covered approximately 2% of the landfill surface. Minor debris (plywood) was also noted in proximity to the landfill's north side.

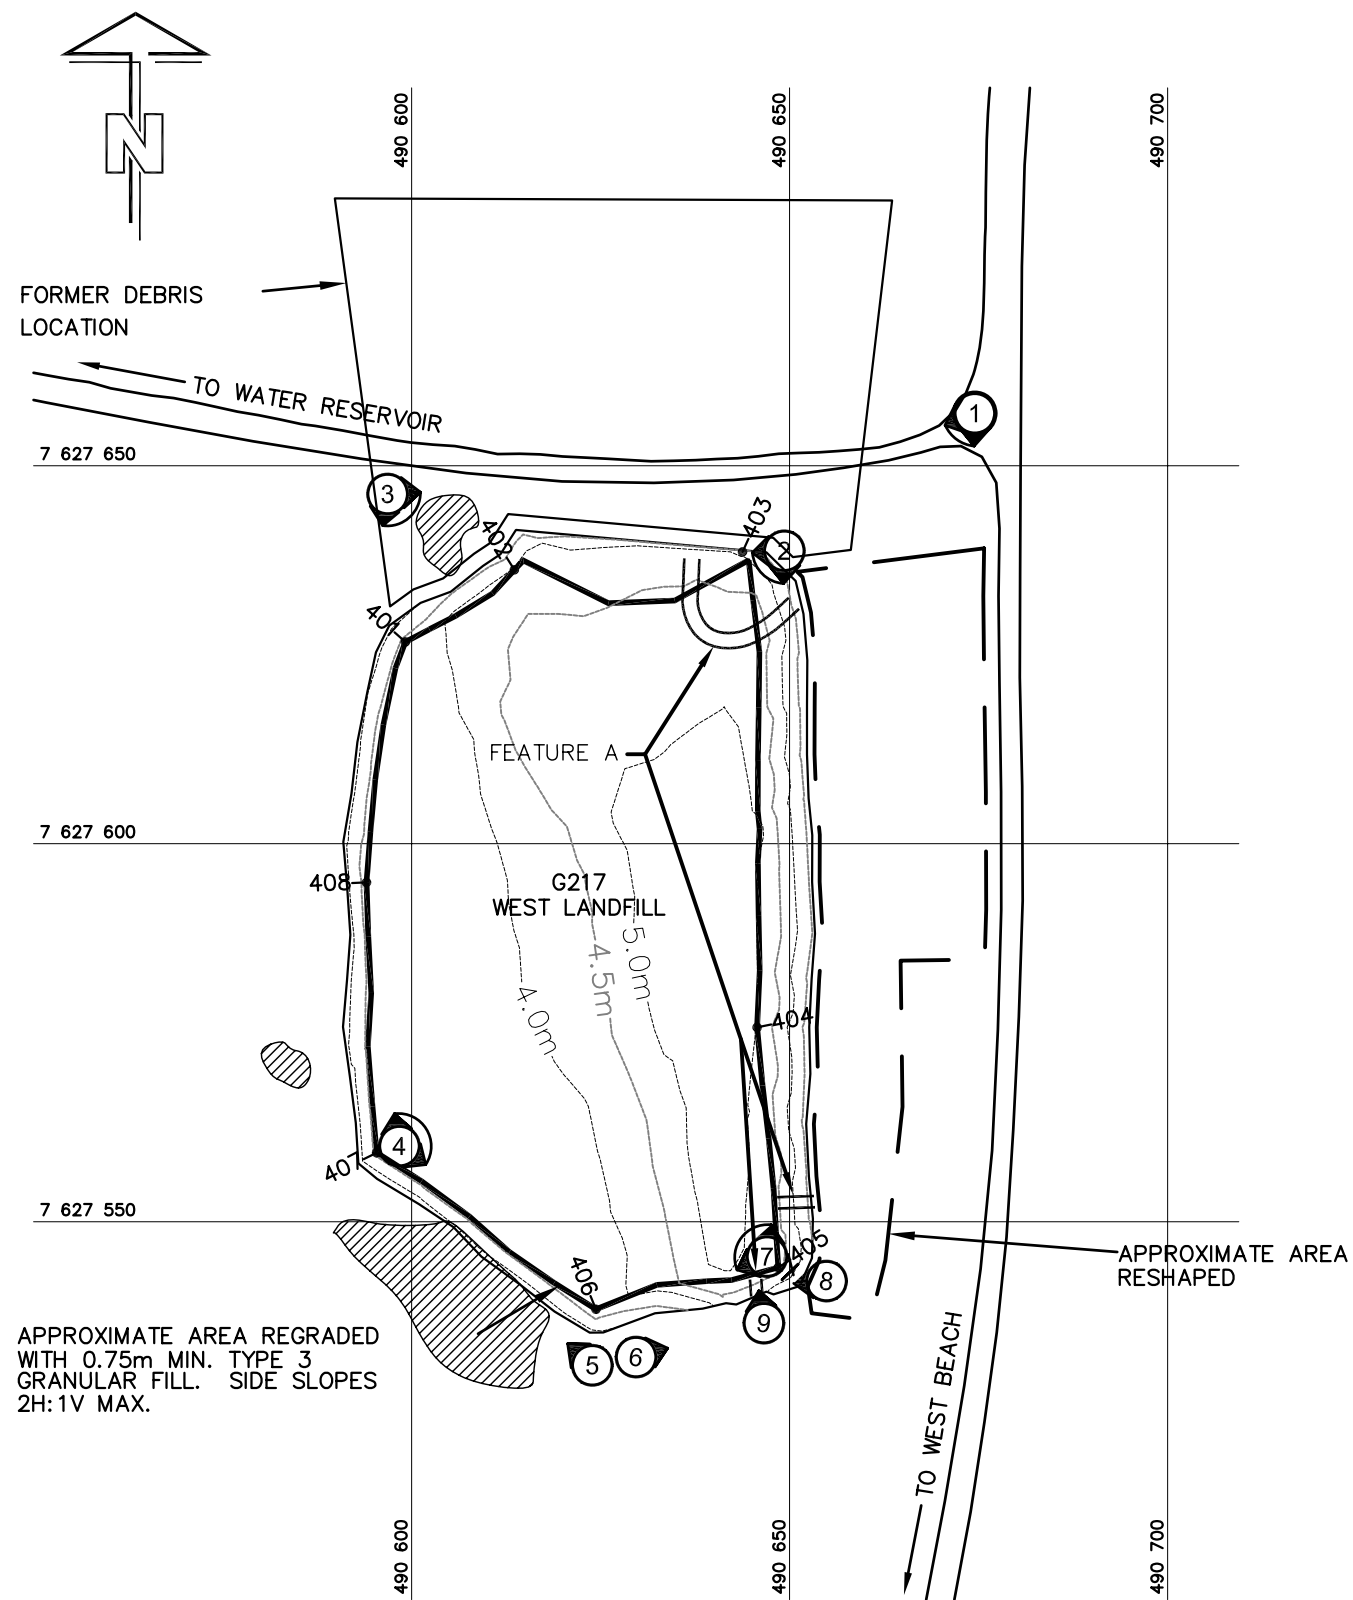
The Location Plan for the G217 – West Landfill has been completed as per the ToR and is presented as Figure FOX-M.3.

Several vehicle tracks/ruts were observed on the northeast and southeast corners of the landfill cover (Feature A). The vehicle tracks/ruts extended between 0.2 to 0.3 m in depth and covered approximately 2% of the landfill surface. Ponded water was also noted in proximity to the northeast and southwest sides of the landfill.

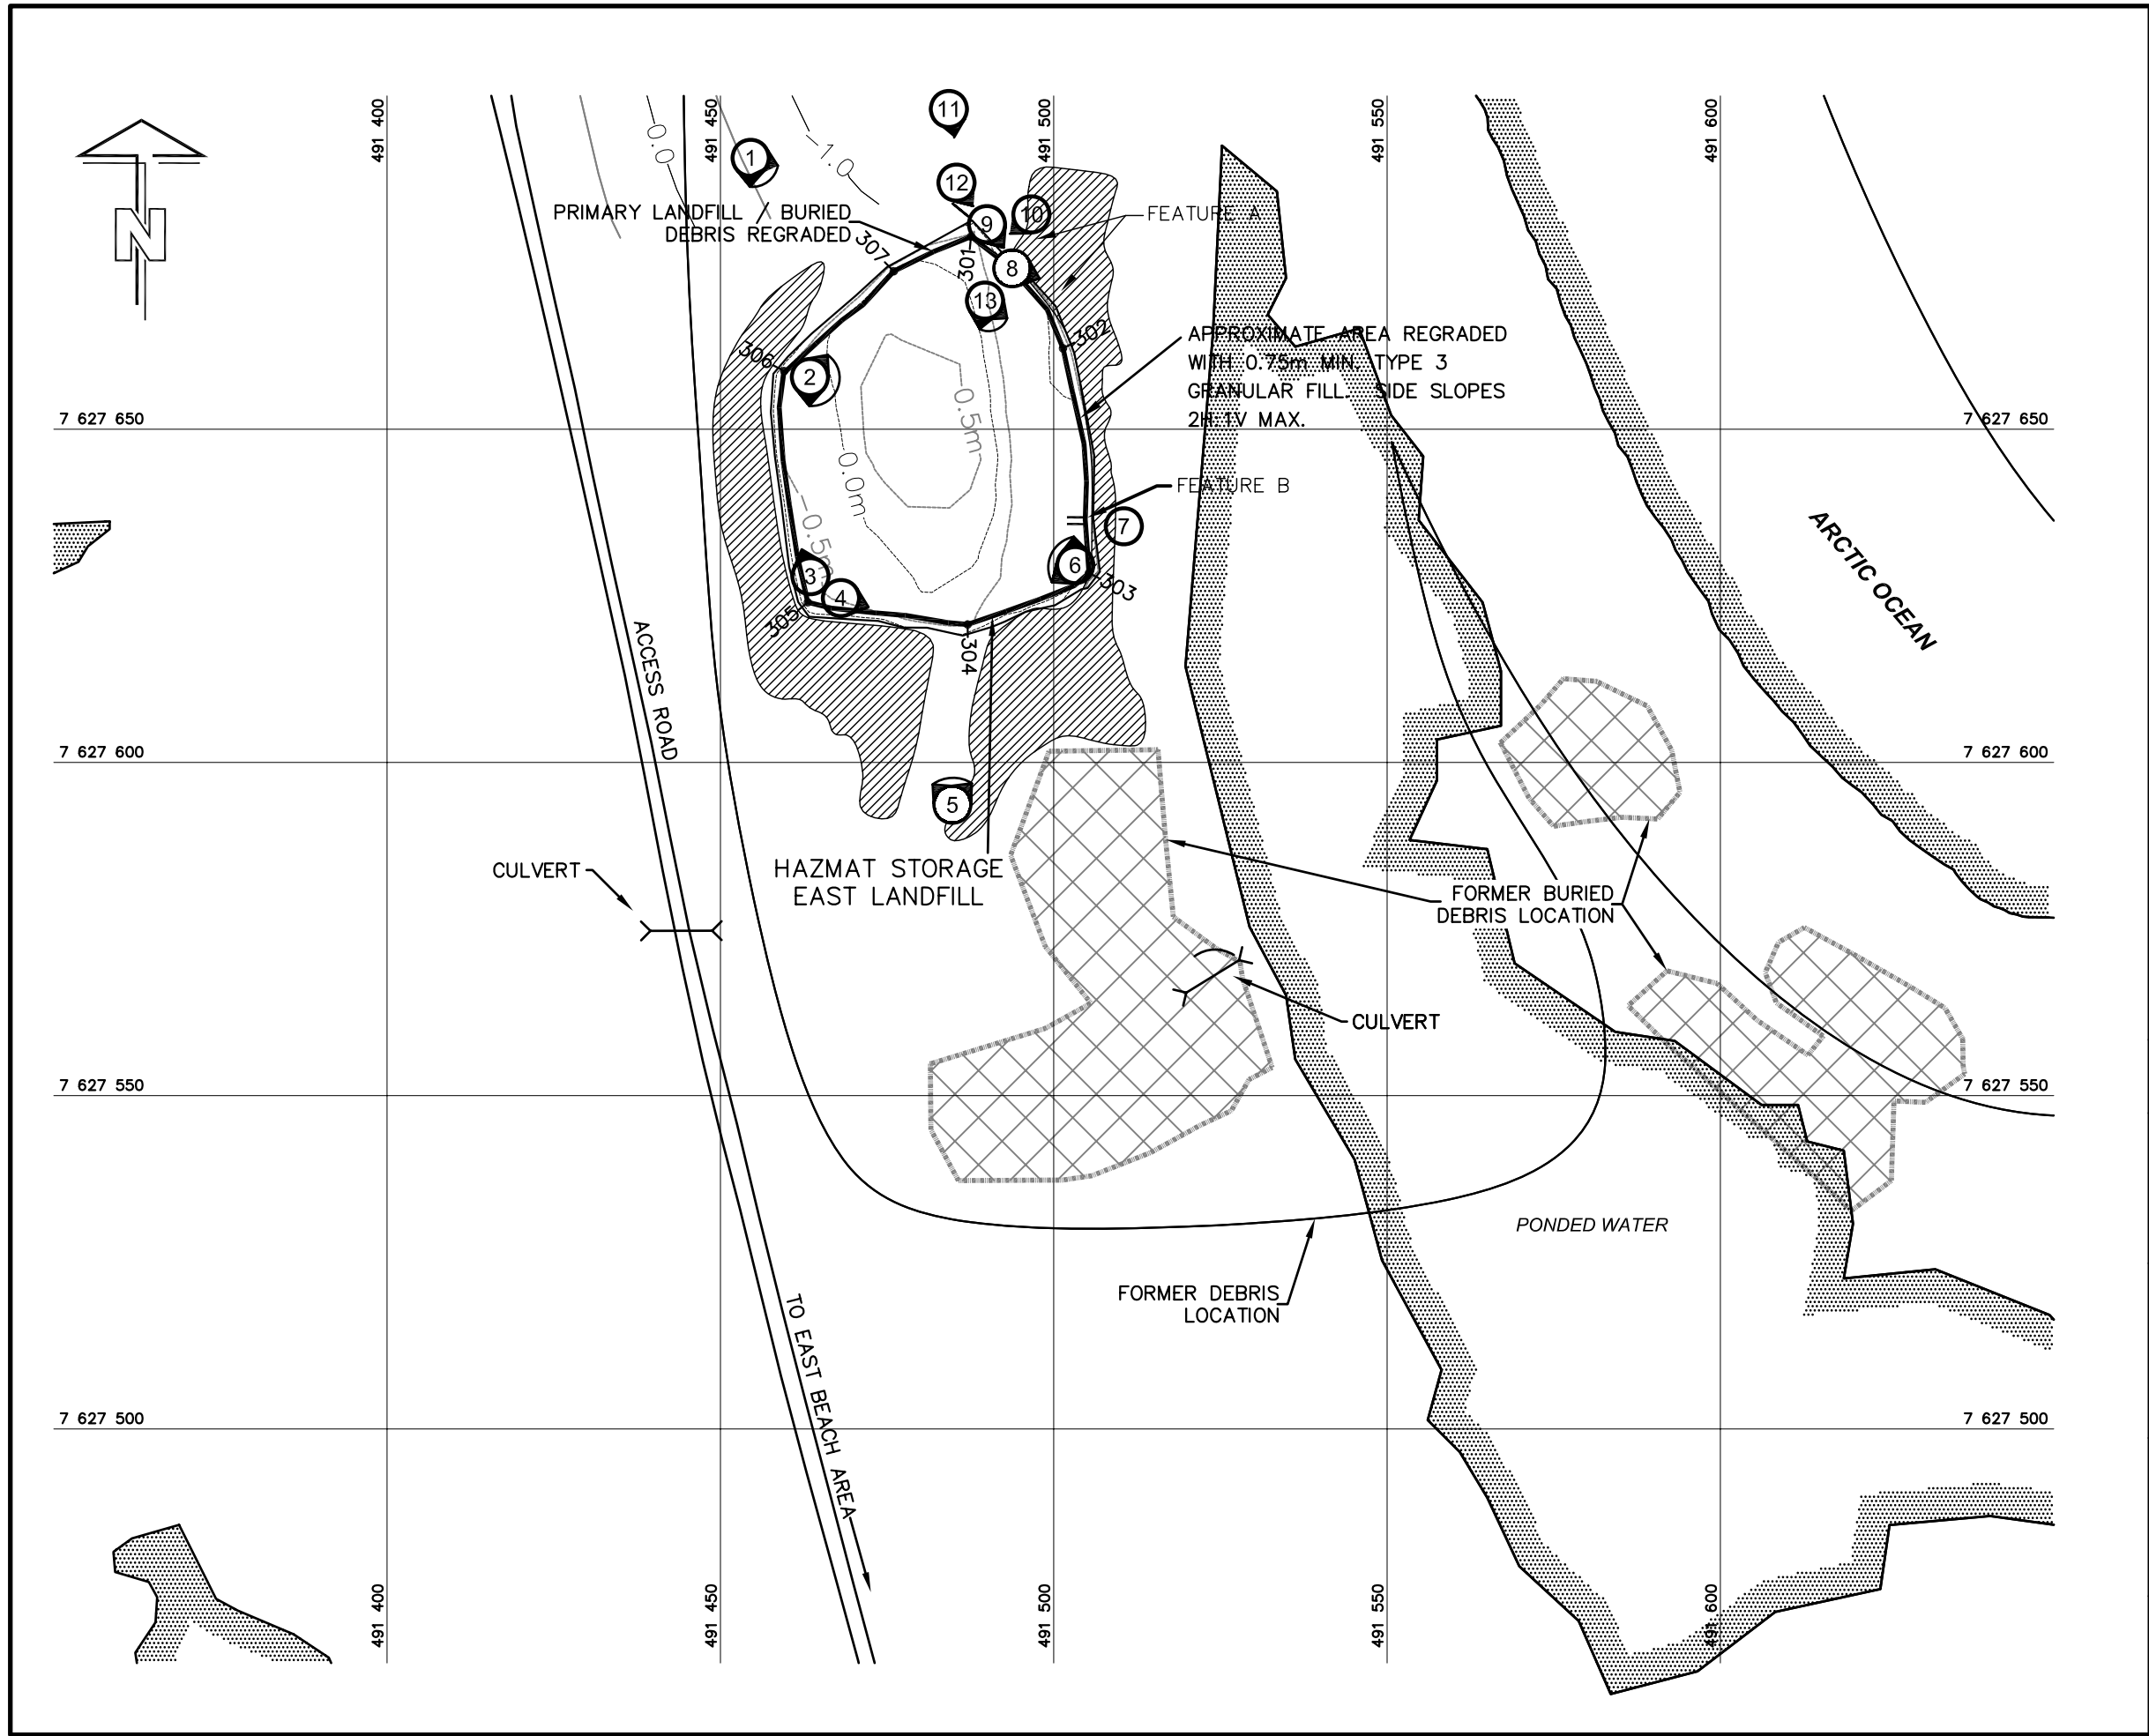
The Location Plan for the Hazmat Storage - East Landfill has been completed as per the ToR and is included in Figure FOX-M.5.

Evidence of debris was noted adjacent to the northeast corner of the landfill (Feature A). The debris consisted primarily of surface and partially buried metal debris, including corrugated sheet metal, rebar, wire and plywood.

One set of vehicle tracks/ruts were observed on the southeast side of the landfill (Feature B). The vehicle tracks/ruts extended 0.15 m in depth and covered less than 1% of the landfill surface.

The landfill is located within a low lying area bordered by the East Beach access road to the west and the beach ridge to the east. At the time of the inspection, ponded water surrounded approximately 80% of the landfill perimeter, including the northwest, west, south and east sides of the landfill. There was no evidence of erosion or staining associated with the ponded water.

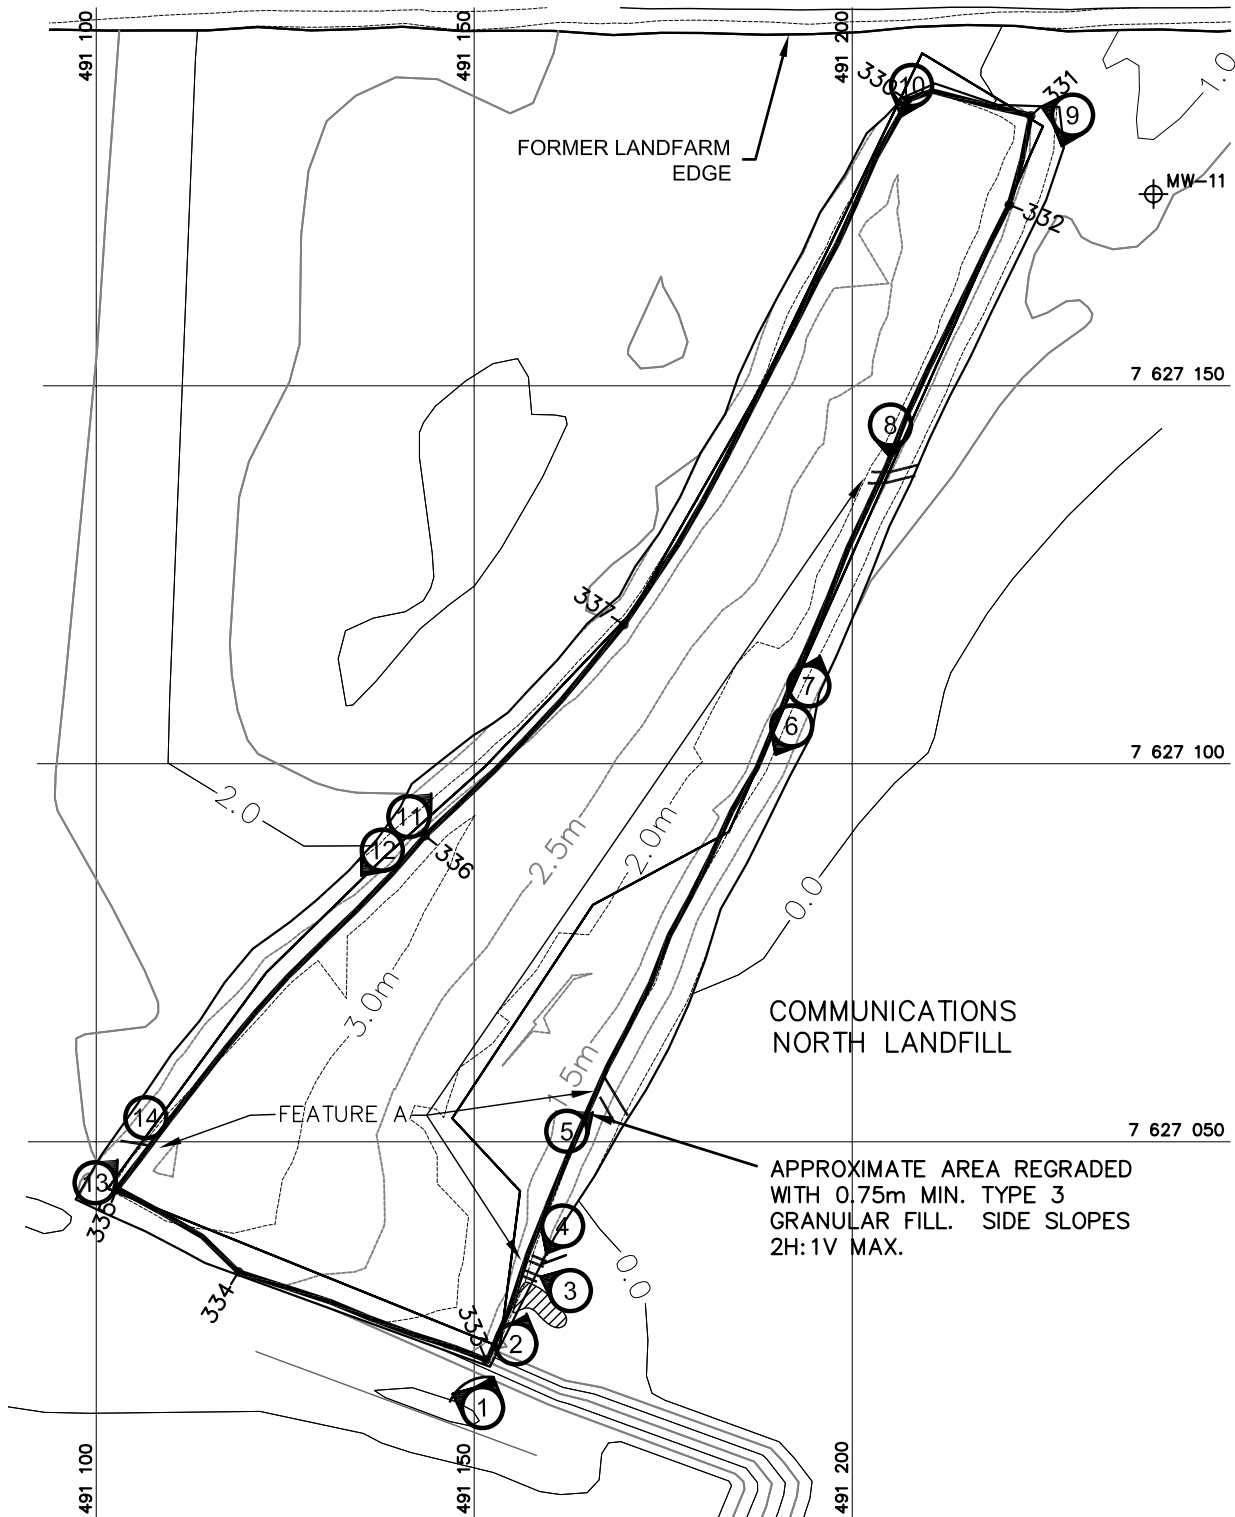
The Location Plan for the Communications North Landfill has been completed as per the ToR and is included in Figure FOX-M.6.

Several vehicle tracks/ruts were observed on the southeast, east and southwest sides of the landfill (Feature A). The vehicle tracks/ruts extended between 0.1-0.2 m in depth and covered approximately 1% of the landfill surface.

In addition, an isolated area of ponded water was also noted along the southeast toe of the landfill. Evidence of erosion or staining was not observed within the ponded area.

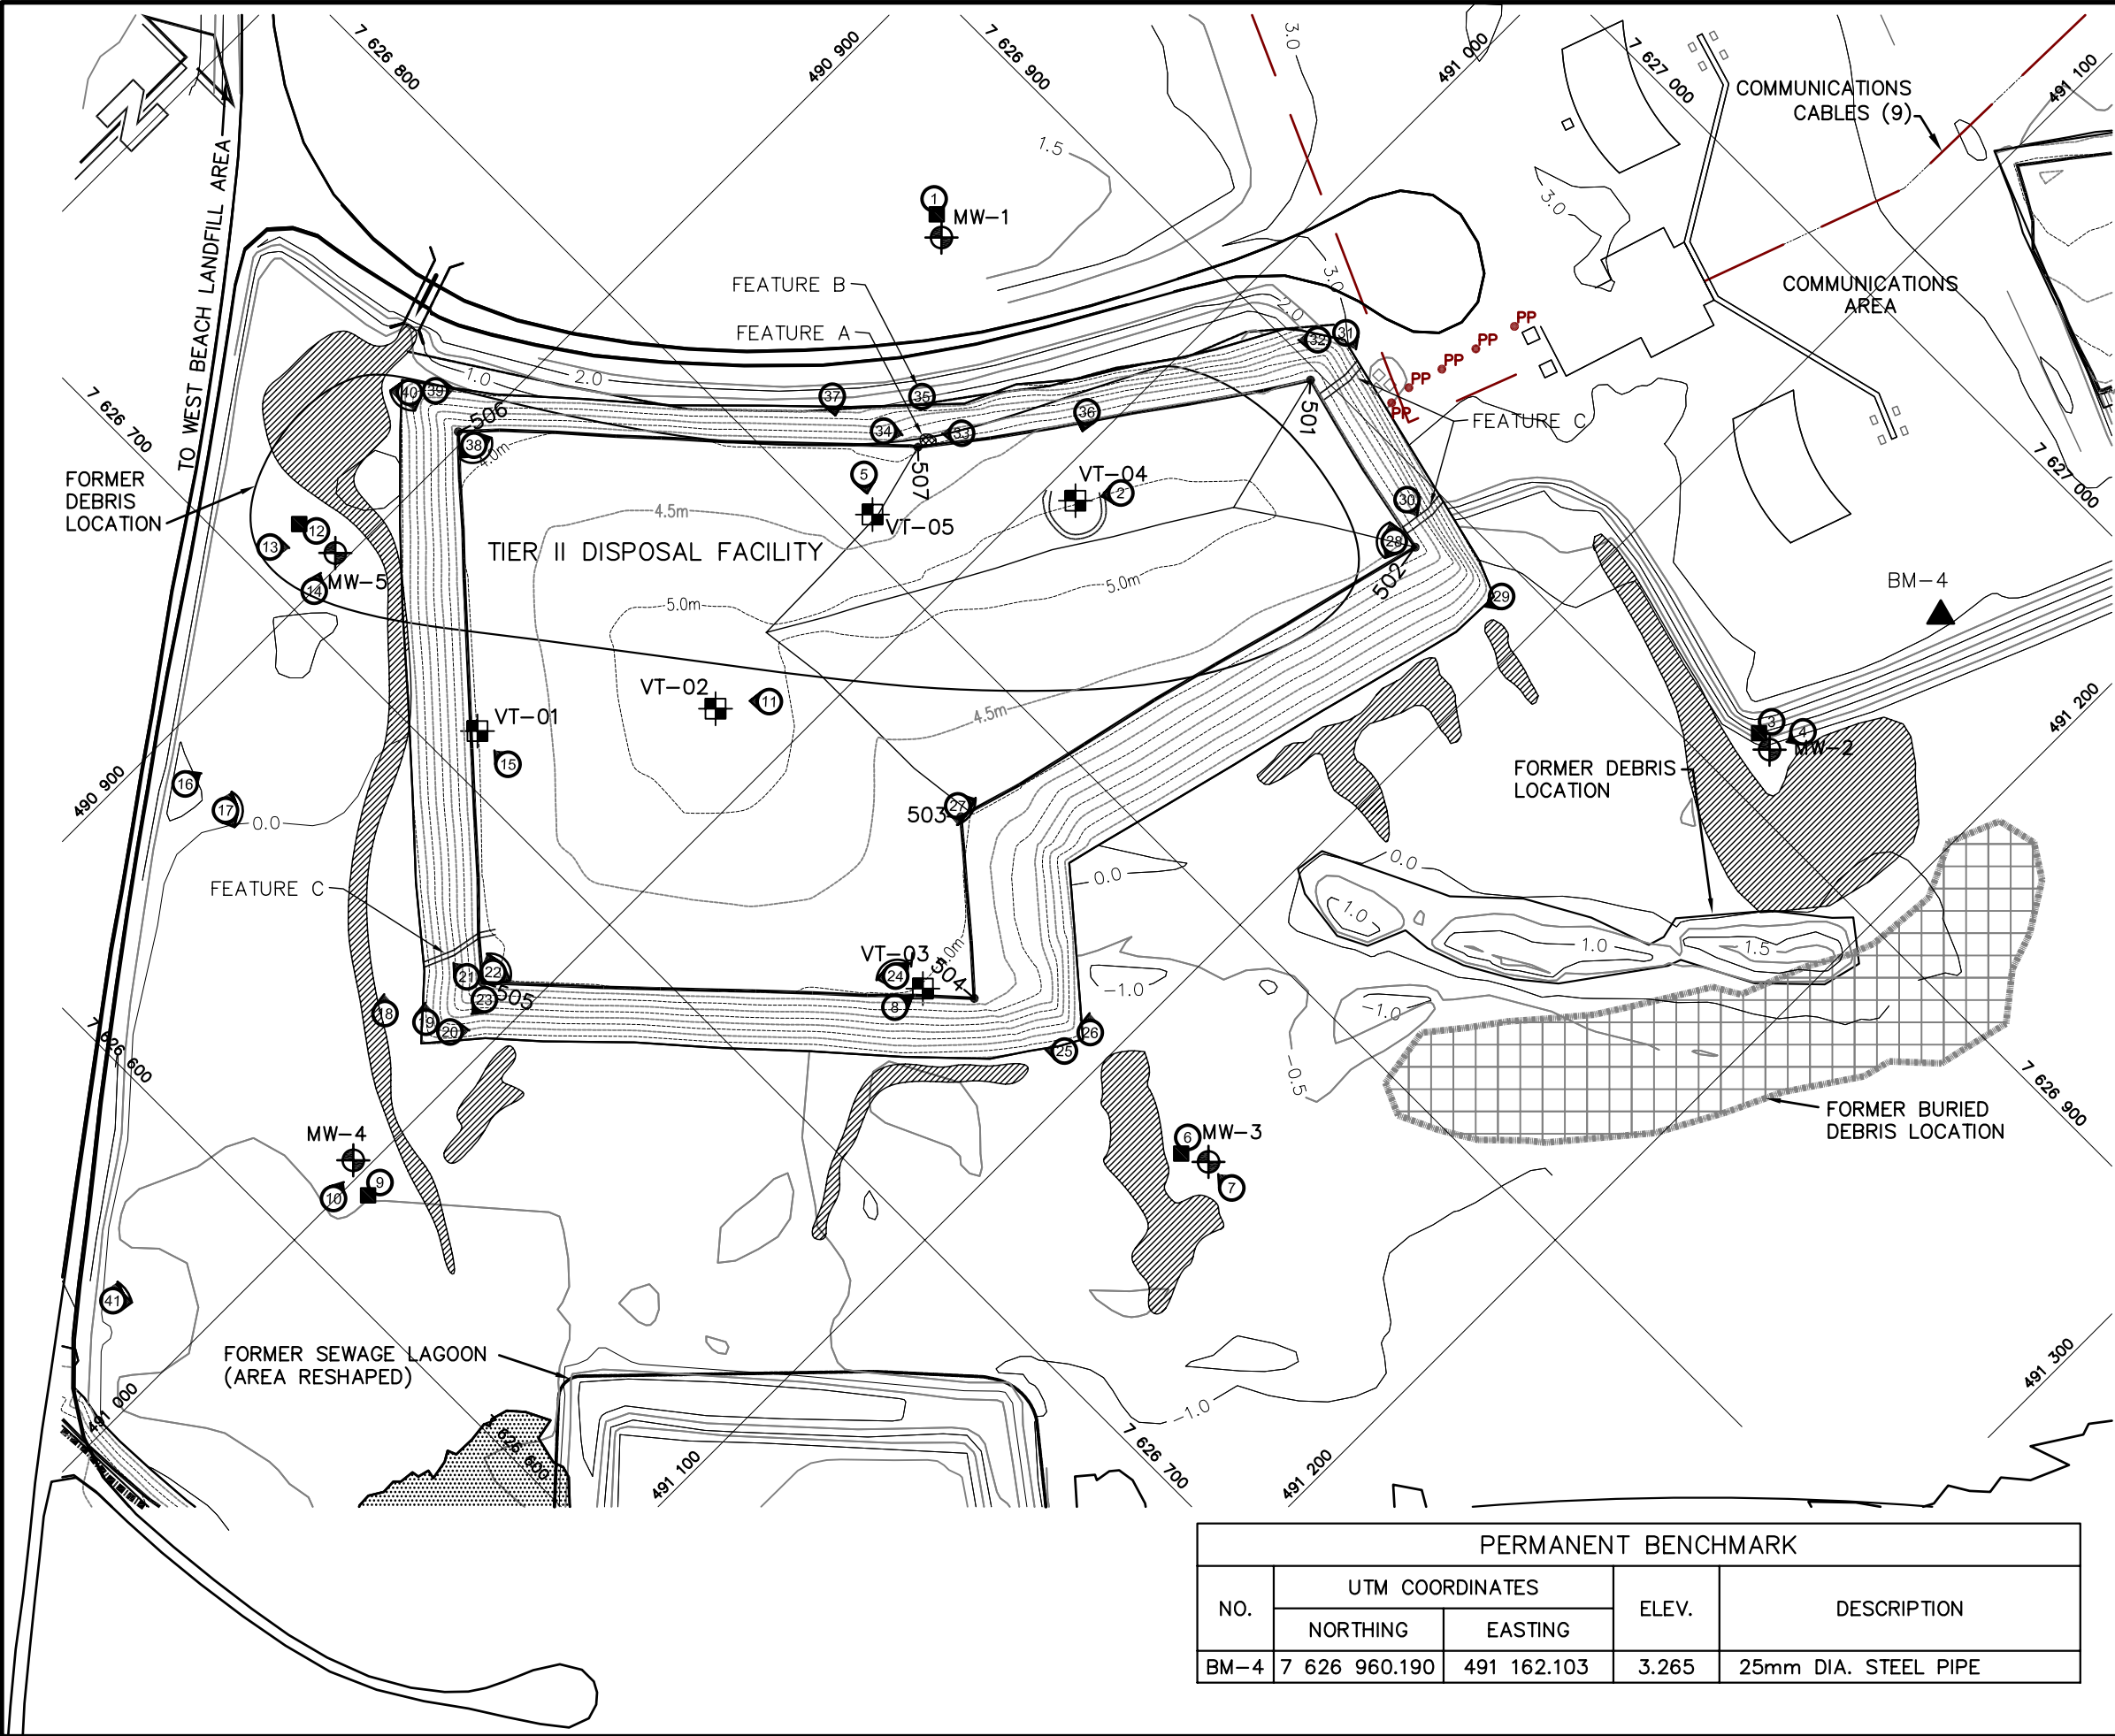
The Location Plan for the Tier II Disposal Facility has been completed as per the ToR and is included in Figure FOX-M.8.

Evidence of minor settlement was noted at one location on the northwest side of the facility (Feature A). Feature A consisted of a small isolated surface depression near the crest approximately mid-point along the northwest side of the facility.

One piece of exposed non-woven black geotextile was noted on the northwest side slope of the facility (Feature B). The geotextile material was used in construction of the facility liner system. In addition, one piece of miscellaneous surface metal debris (steel bar and attached metal bracket) was also noted in proximity to Feature B on the northwest side of the facility.

Numerous vehicle tracks/ruts were observed on the north and south sides and surface of the facility around VT-04 (Feature C). The vehicle tracks/ruts extended between 0.1 to 0.25 m in depth and covered less than 1% of the landfill surface.

Checklist Item	Present (Yes/No)	Location	Length	Width	Depth	Extent	Description	Photographic Record	Severity Rating	Additional Comments
Settlement	Yes	FEATURE A See Figure FOX-M.8 (mid-west side)	1.2 m	1 m	0.1 m	Isolated (<<1%)	Minor surface depression	Tier II - 33, 34	Acceptable	Minor depression near crest at mid-point along west side of landfill cover.
Erosion	No	N/A	N/A	N/A	N/A	None	N/A	N/A	N/A	N/A
Frost Action	No	N/A	N/A	N/A	N/A	None	N/A	N/A	N/A	N/A
Animal Burrows	No	N/A	N/A	N/A	N/A	None	N/A	N/A	N/A	N/A
Vegetation	No	N/A	N/A	N/A	N/A	None	N/A	N/A	N/A	N/A
Staining	No	N/A	N/A	N/A	N/A	None	N/A	N/A	N/A	N/A
Vegetation Stress	No	N/A	N/A	N/A	N/A	None	N/A	N/A	N/A	N/A
Seepage Points	No	N/A	N/A	N/A	N/A	None	N/A	N/A	N/A	N/A
Debris Exposed	Yes	FEATURE B See Figure FOX-M.8 (mid-west side)	0.25 m 0.8 m	0.05 m 0.03 m	Unknown Surface	Isolated (<<1%)	Exposed piece of black geotextile. Metal surface debris.	Tier II-35 Tier II-37	Acceptable	Geotextile material used in construction of containment liner system. Surface debris consists of steel bar and attached bracket.
