**THE COLLECTION OF LANDFILL
MONITORING DATA AT THE FORMER
FOX-M DEW LINE SITE**

Hall Beach, Nunavut

FINAL REPORT– 2012 SEASON

DEFENCE CONSTRUCTION CANADA

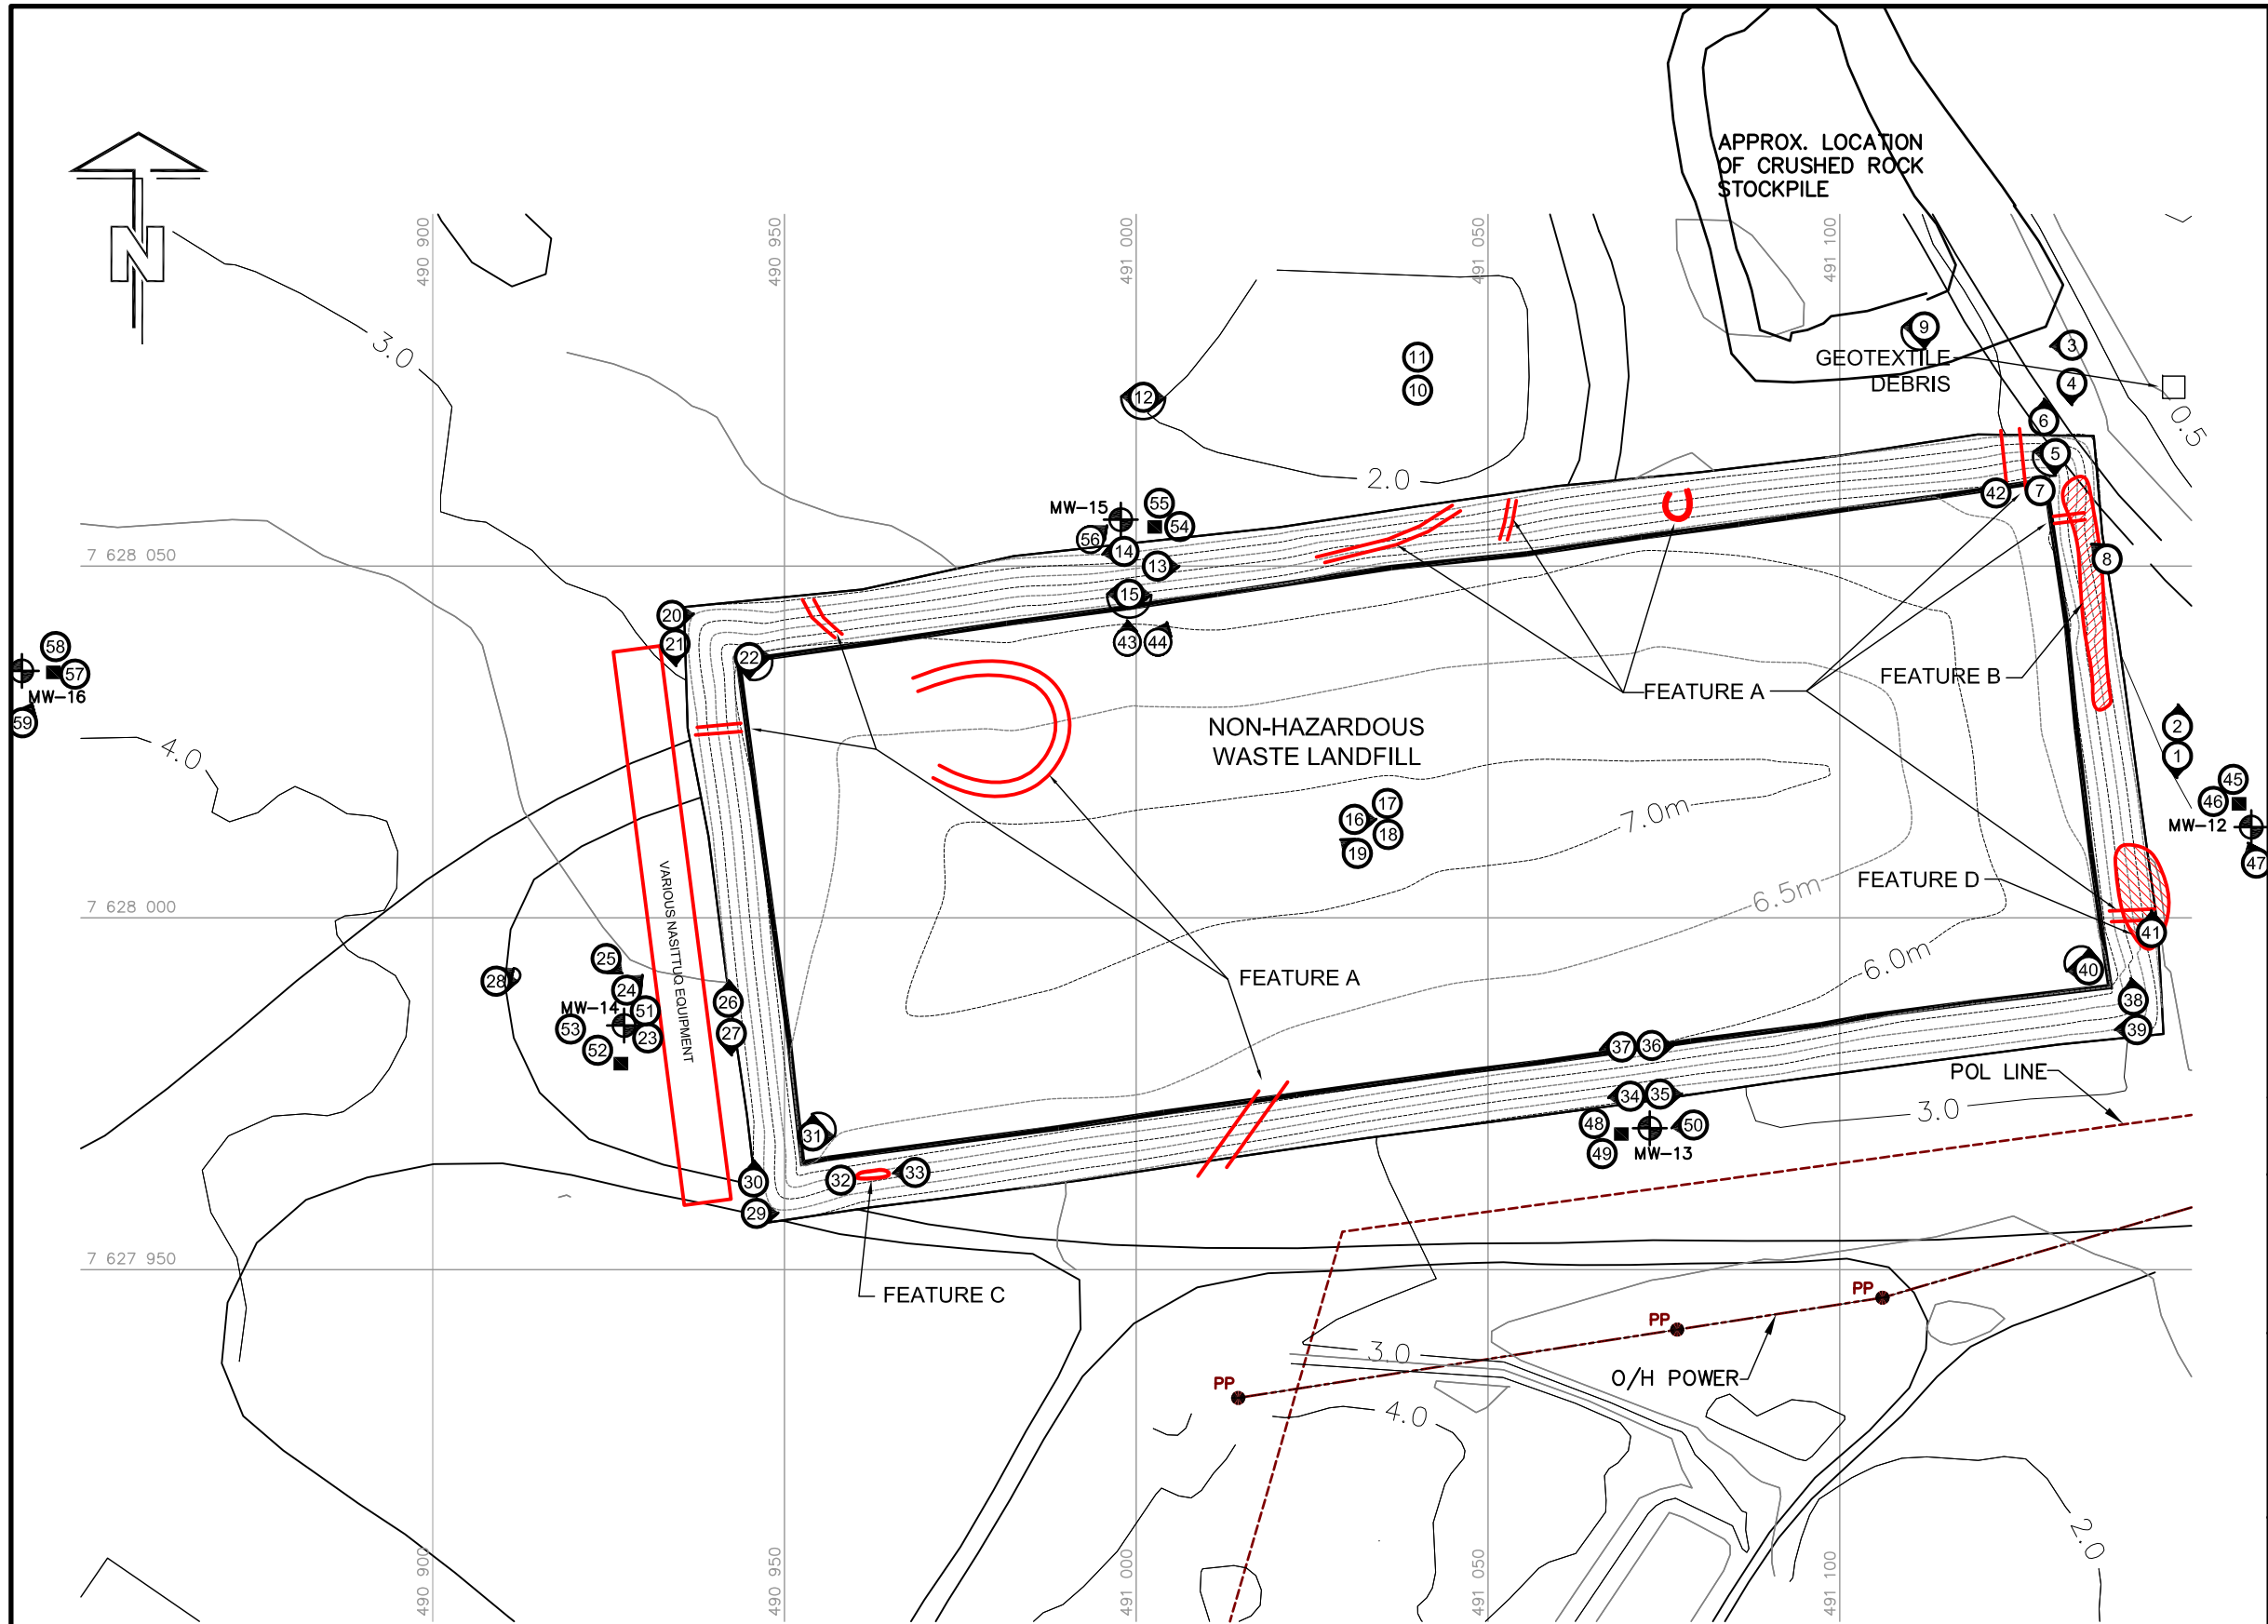
Evidence of settlement was noted at one location on the southern side slope of the landfill – Feature C. The newly observed feature is a minor linear depression with an acceptable severity rating.

A concentration of small arctic grasses (Feature D) was observed growing on the eastern side slope of the landfill in a 1.5 m x 12 m area; extending along the landfill toe. The vegetation has an acceptable severity rating.

An area of iron staining not previously observed was noted on the eastern side slope of the landfill, Feature B. The staining may be an indication of seepage; however at the time of the investigation the area was dry. Feature B has an acceptable severity rating.

All monitoring well installations appeared to be in good condition at the landfill, with the exception of MW-14. Although the protective casing was replaced, gravel still remains in the well. Based on measurements it would appear more gravel has been added since the 2010 investigation.

Numerous vehicle tracks were observed on the surface and side slopes of the landfill cover, including several deeper ruts noted along the northwest, north and east side slopes and on the northwest corner of the landfill cover (Feature A). The vehicle tracks/ruts typically extended between 0.05 to 0.3 m in depth. The rutting typically impacts the superficial layer of gravel on the landfill cap with little impact to the cap itself. The amount of ATV tracks has increased since 2010, however these areas are relatively shallow (0.05 m) with little impact to the stability of the facility. Feature A has an acceptable severity rating.

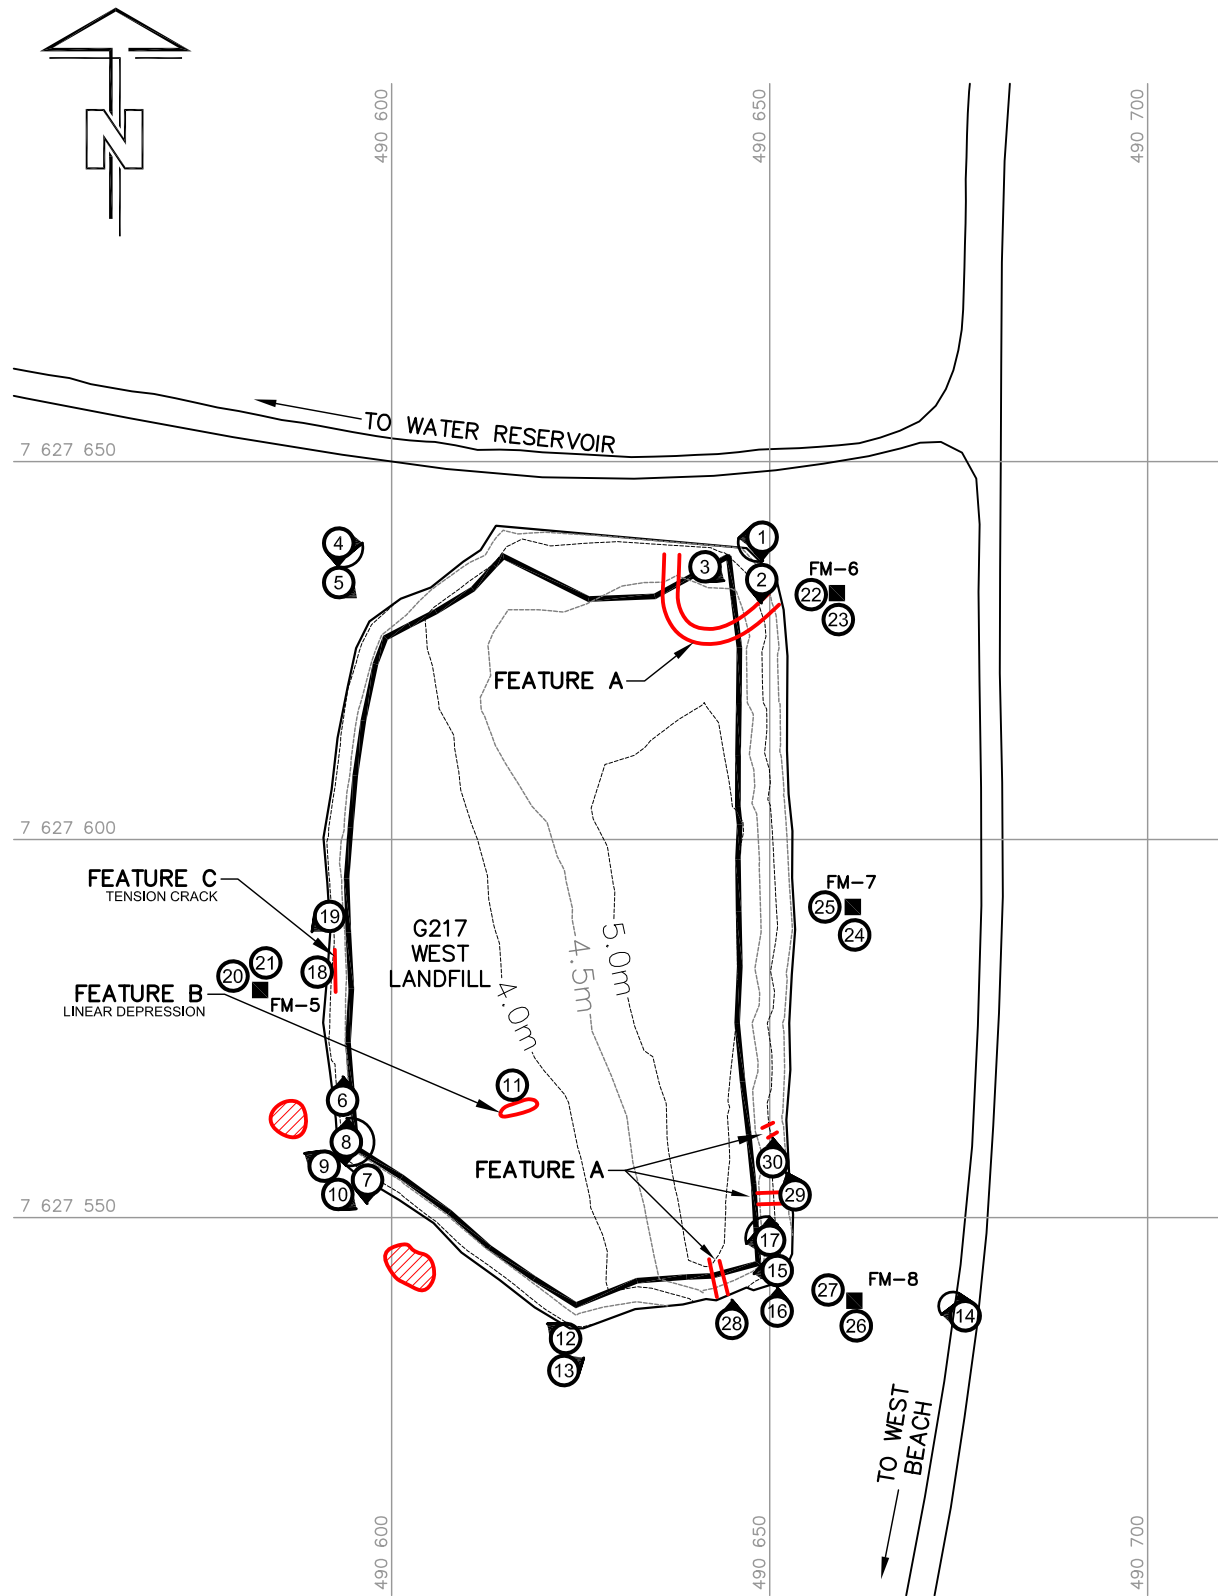
A new area of settlement was observed during the 2012 monitoring event, Feature B. The minor depression is located on the landfill surface and has an acceptable severity rating.

Several vehicle tracks/ruts were observed on the northeast and southeast corners of the landfill cover (Feature A). The vehicle tracks/ruts extended between 0.05 to 0.1 m in depth and covered approximately 2% of the landfill surface. Unlike the other landfills located at the FOX-M site, the G217 – West has seen little increase in rutting caused by ATV traffic.

Ponded water was also noted in proximity to the southwestern corner of the lobe, an area of ponded water observed during the 2010 season along the northern toe was not observed.

A small tension crack was observed on the western crest of the landfill (Feature C). This feature currently of little impact to the stability of the landfill and has an acceptable severity rating.

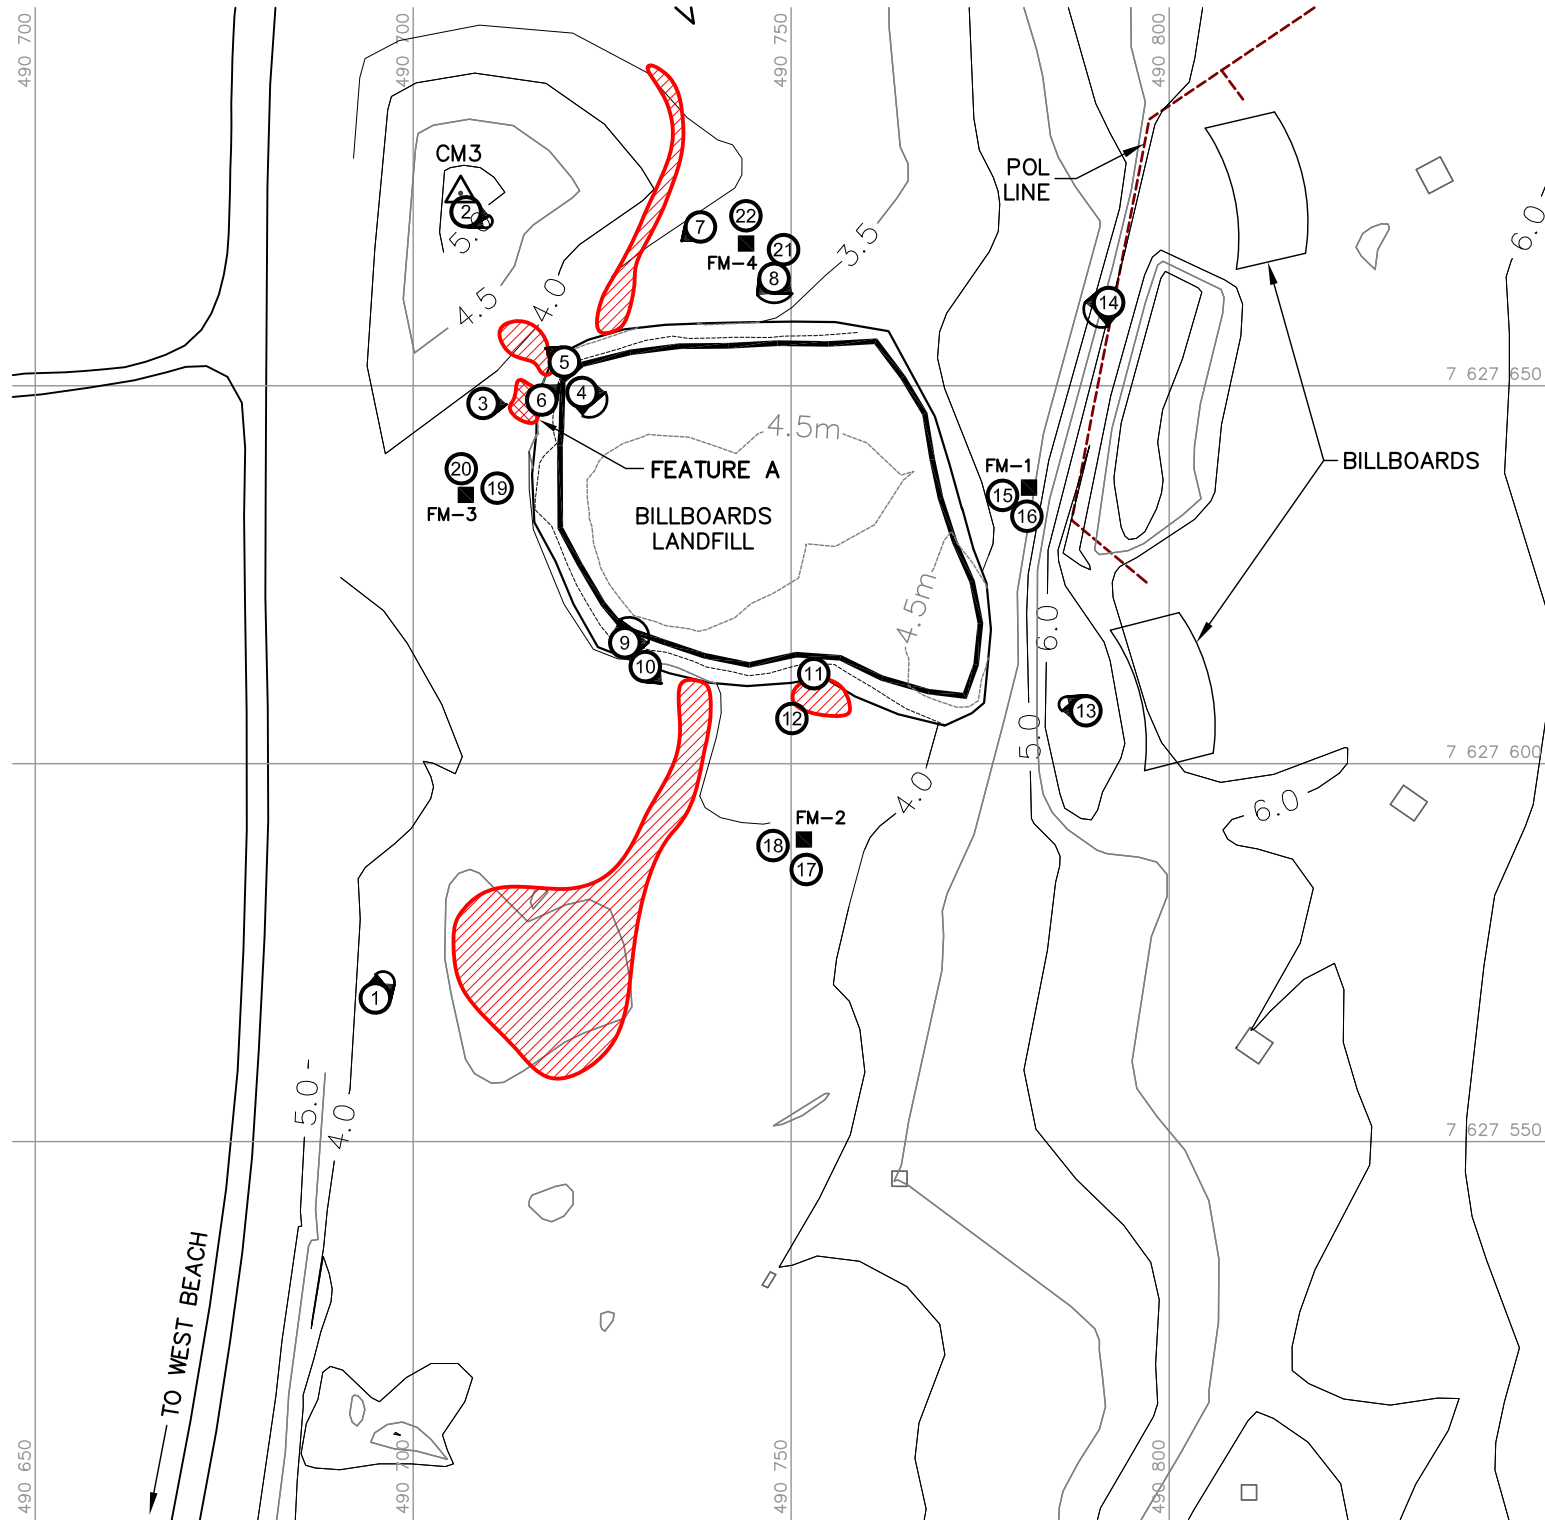
Feature A has increased since the 2010 investigation. Iron staining was observed at three locations (up from one in 2010) on gravel at the bottom of pools of water along the north and south toe of the landfill. The Billboards Landfill is located in a low lying area; the iron staining is believed to be a feature of the natural environment.

The landfill is located within a low lying area bordered by the station access road to the west and communication pads to the north and east. Ponded water was observed in proximity along the north and south sides of the landfill. At one location along southern toe of the landfill, the organic material associated with the ponded water caused some staining on the gravel cover of the landfill toe.
