HOPE LAKE
REMEDICATION PROJECT

REMEDIAL ACTION PLAN

**REMEDIAL ACTION PLAN
HOPE LAKE, NUNAVUT**

Y22101167.005

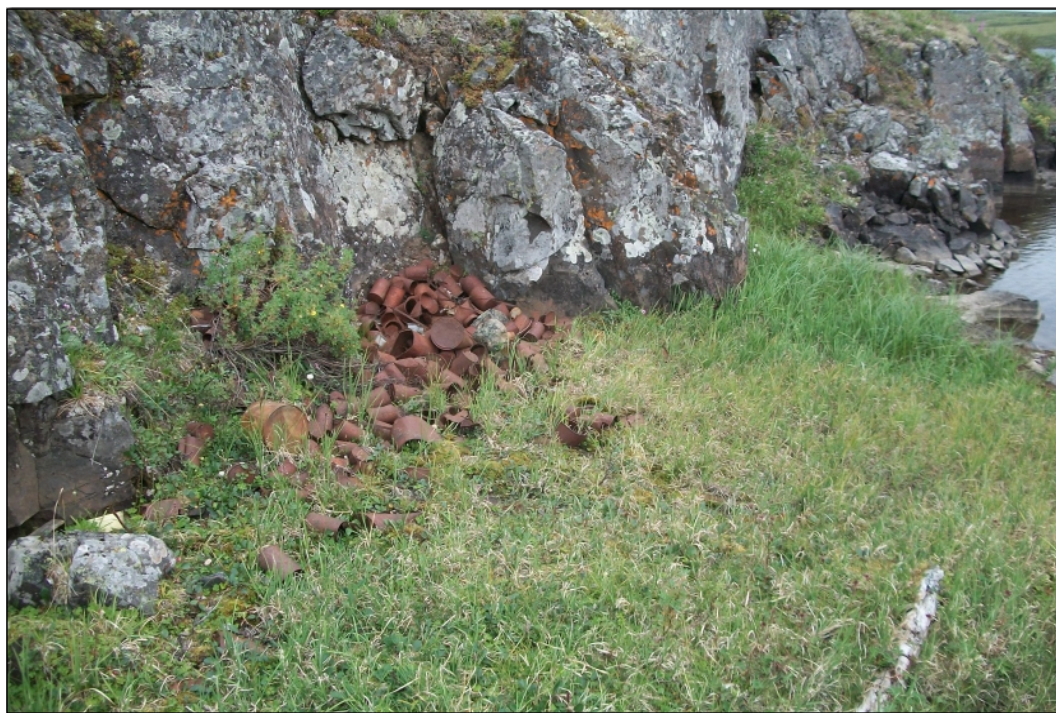
Photo 64

Willow Creek WKB01 South Cabin: APEC 17, rusted metal food cans

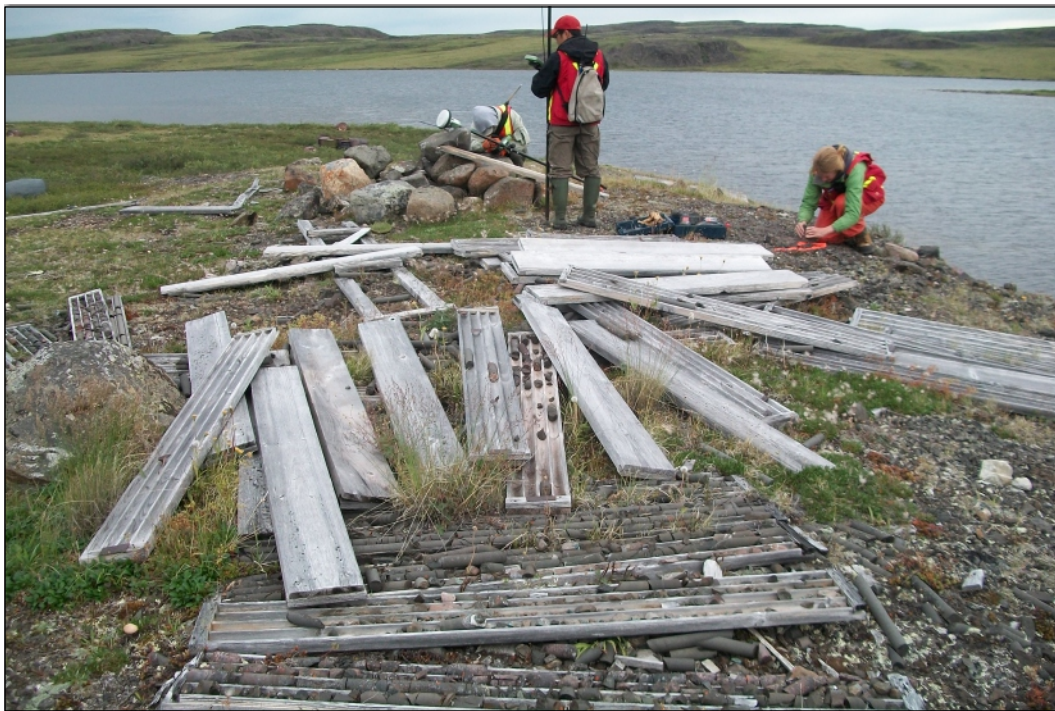
Photo 65

Willow Creek WKB01 South Cabin: APEC 18, drill core boxes with drill core

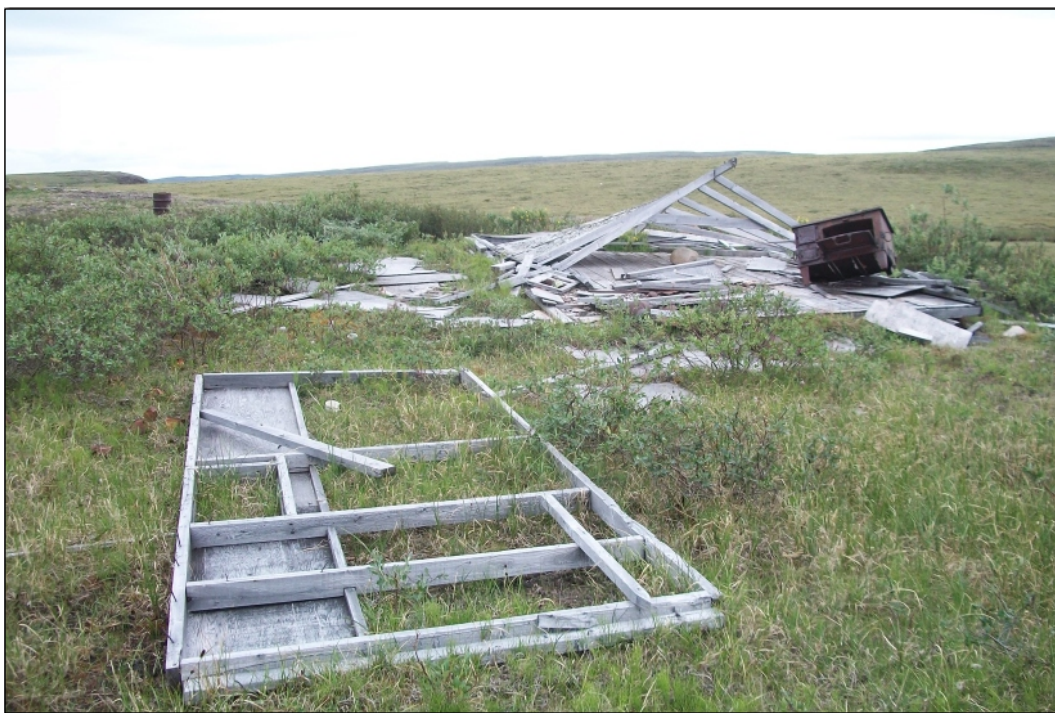
Photo 66

Willow Creek WKB01 South Cabin: APEC 19, wood platform with collapsed walls and roof, vents, cans, pots, a wood burning stove, and grey insulation

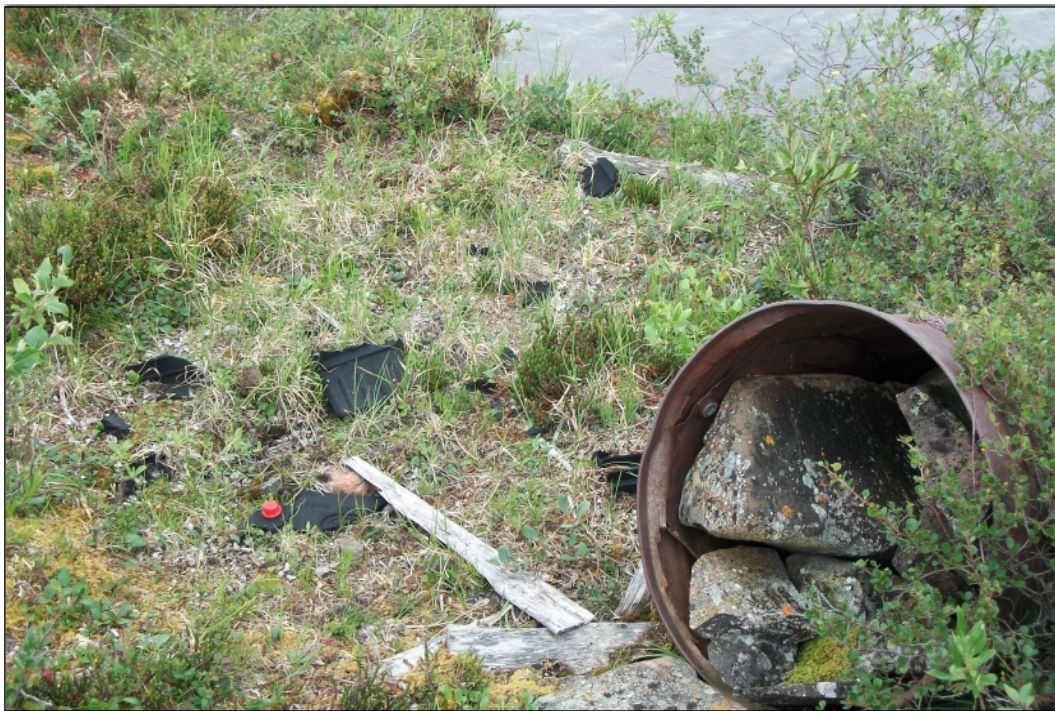
Photo 71

Willow Creek WKB01 South Cabin: APEC 21, drum and broken battery

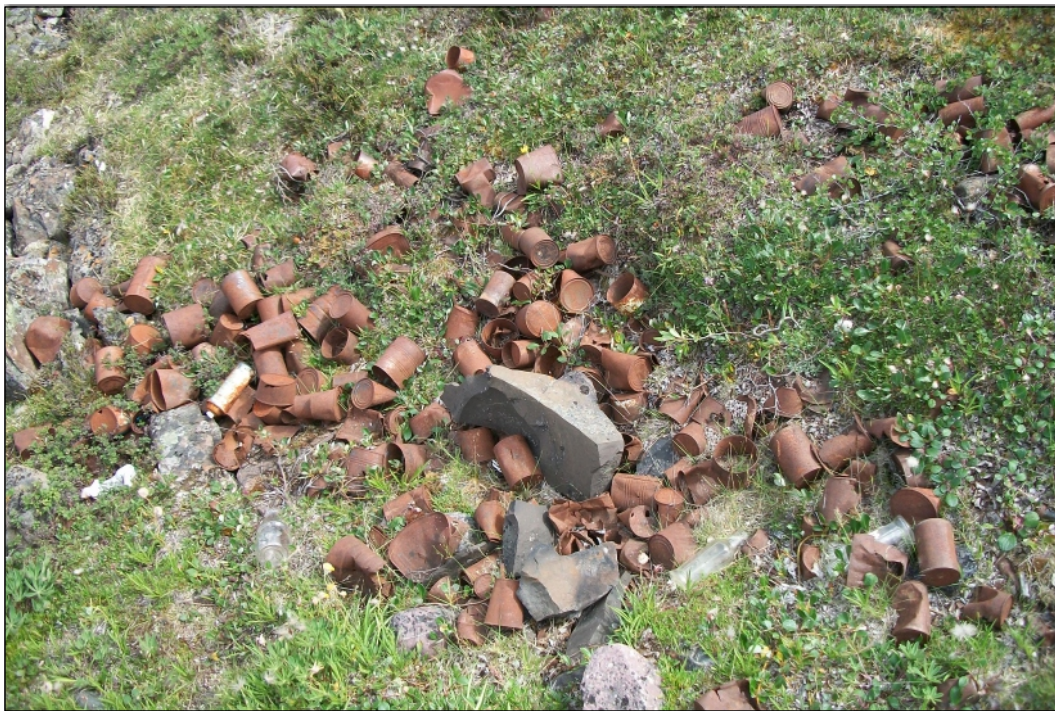
Photo 82

Willow Creek WKB02 Southwest Cabin: APEC 23, rusted cans

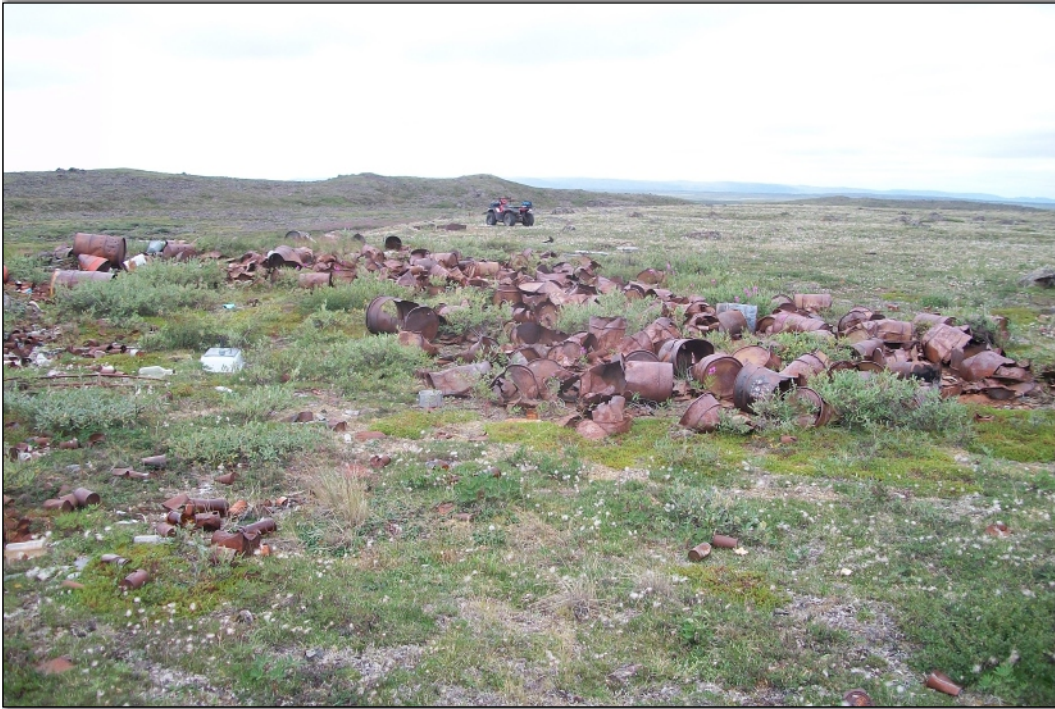
Photo 129

Hope Lake WK027: APEC 1A, heavily rusted drums and tin cans (looking north)

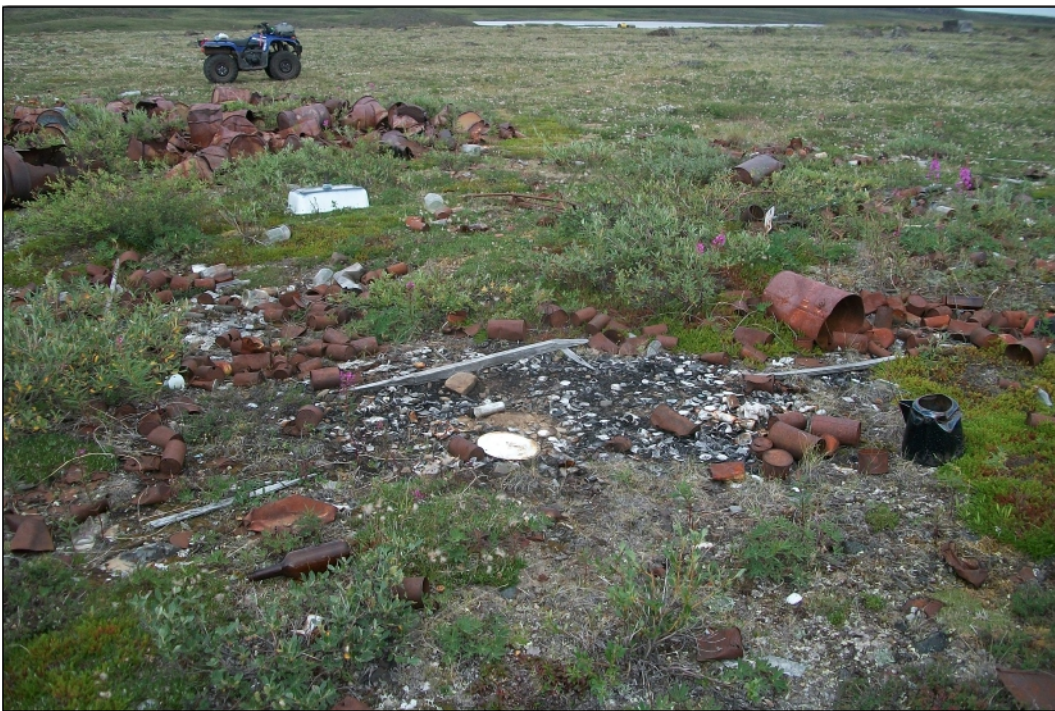
Photo 130

Hope Lake WK027: APEC 1A, burn pit with battery ends (looking north toward Hope Lake)

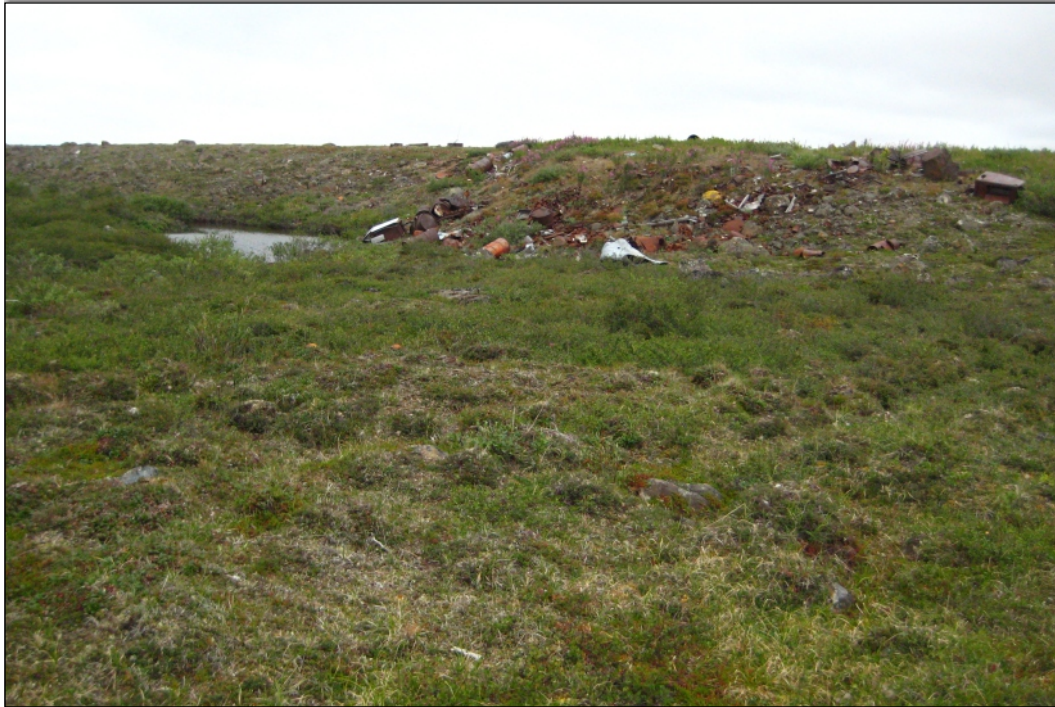
Photo 131

Hope Lake WK027: APEC 1A, heavily rusted drums scattered on south facing slope (looking west)

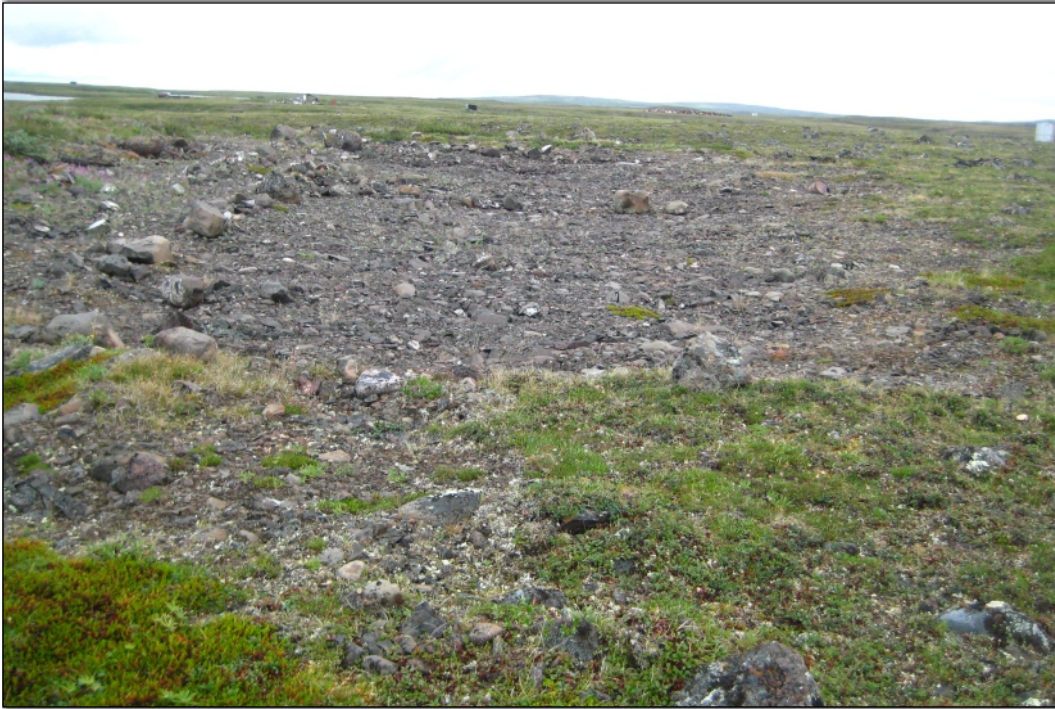
Photo 135

Hope Lake WK027: APEC 1B, area of former tent foundation (looking east)

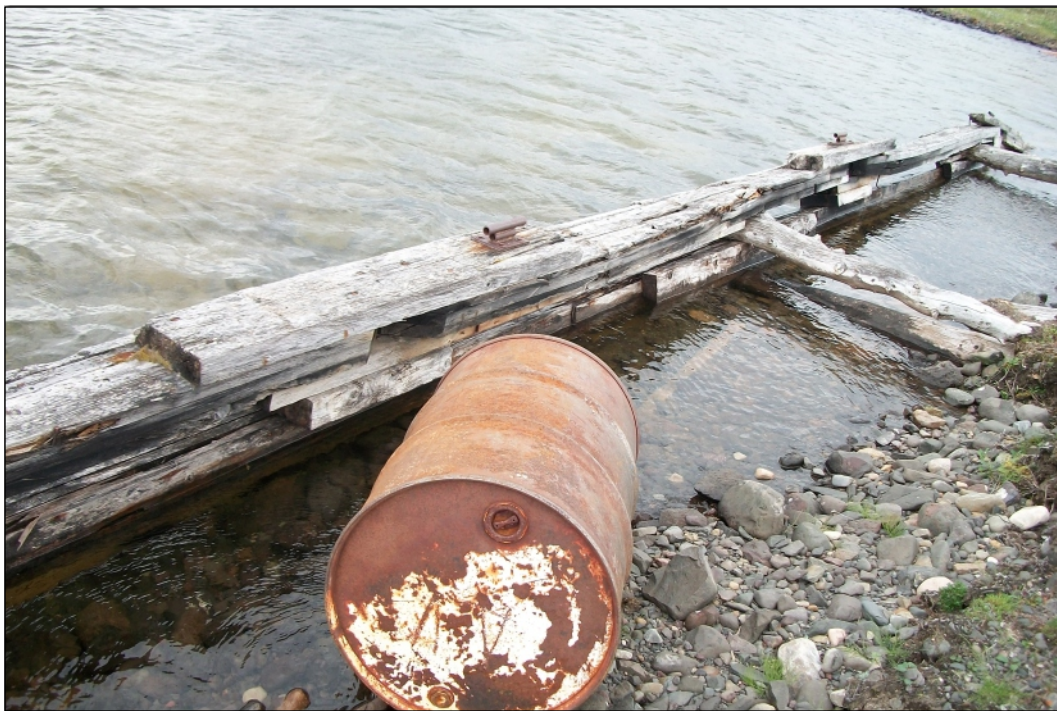
Photo 152
Hope Lake WK027: APEC 3A, dock and rusted drum

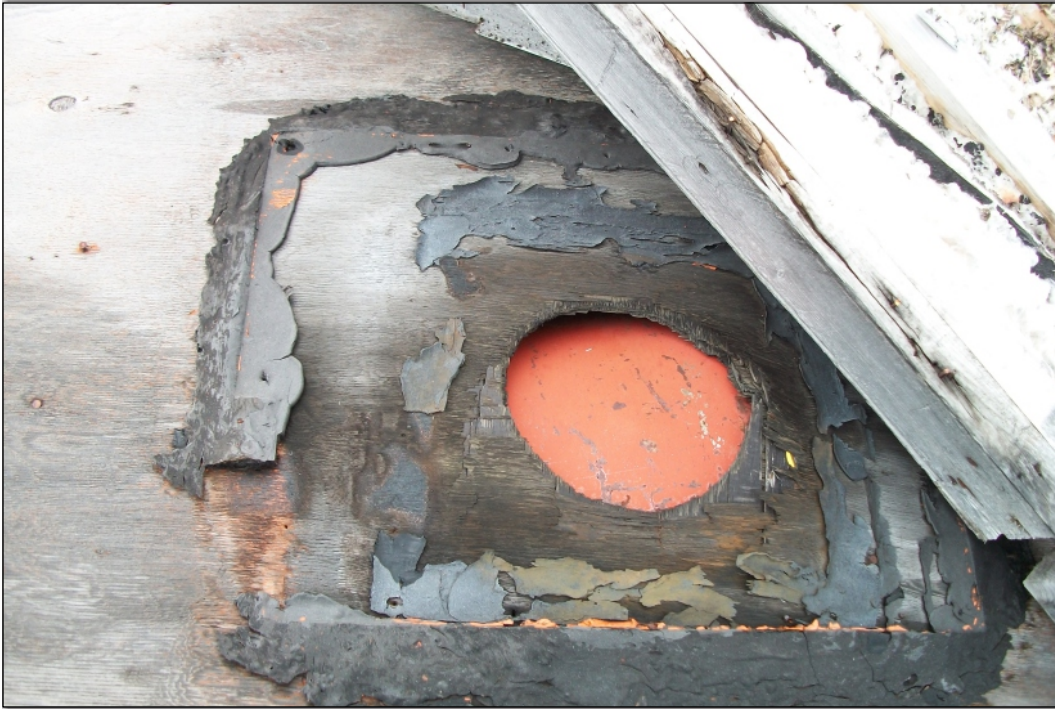
Photo 161

Hope Lake WK027: APEC 3C, mastic asbestos containing material observed in most APEC 3 structures

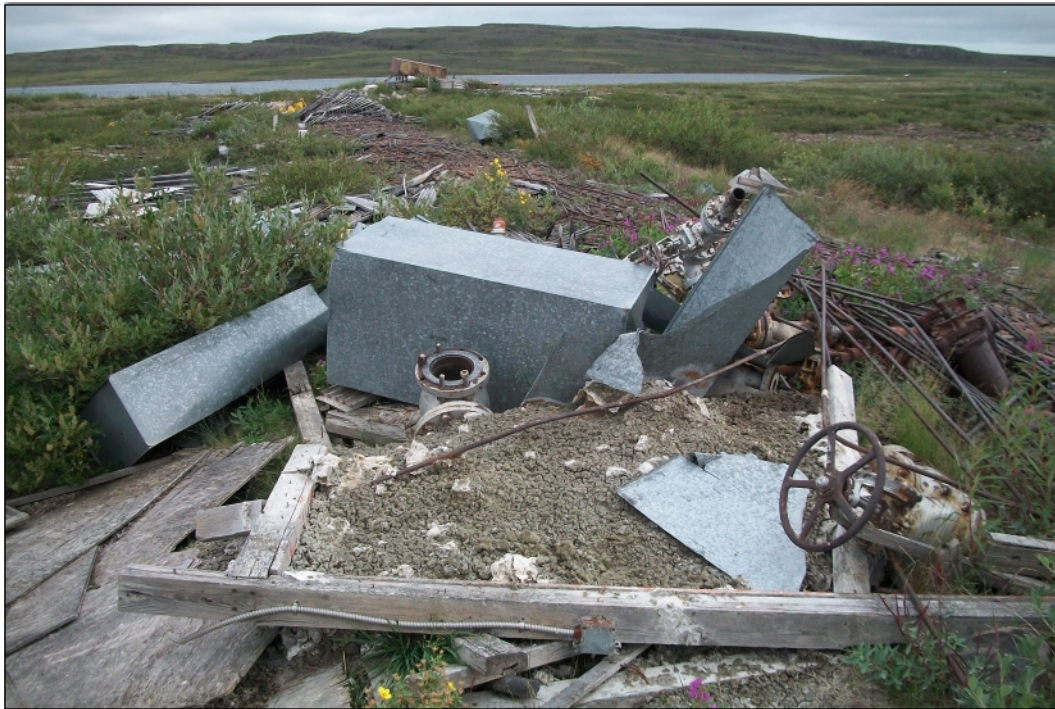
Photo 185

Hope Lake WK027: APEC 3P, non-hazardous materials, may have been a drilling compound

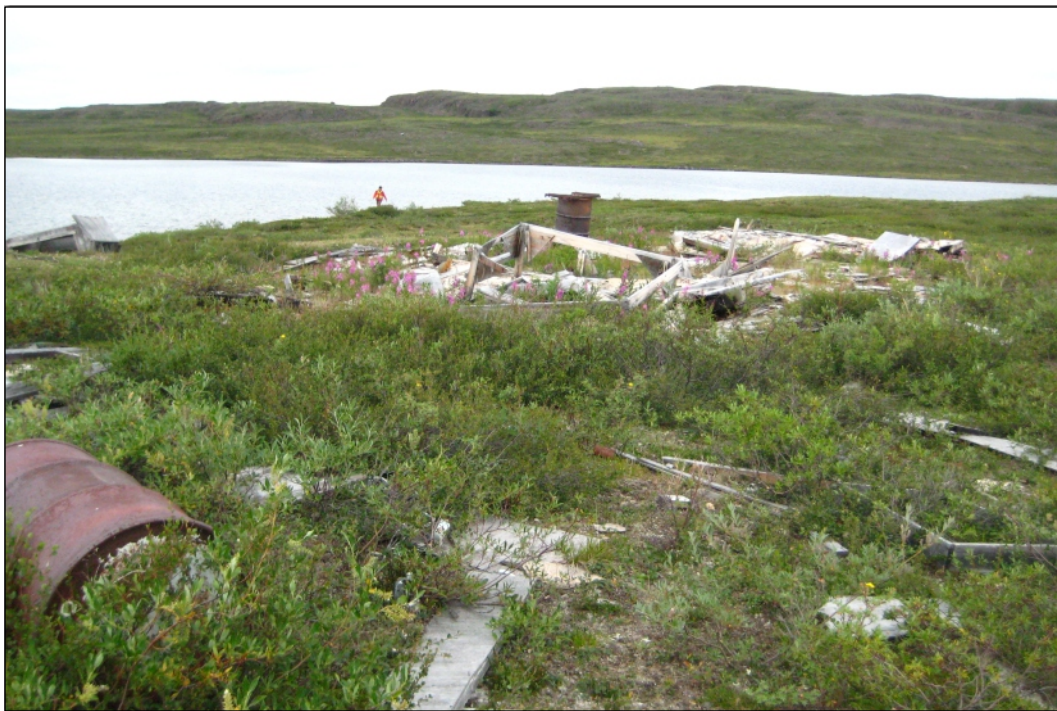
Photo 196
Hope Lake WK027: APEC 4A, drums and collapsed building in background

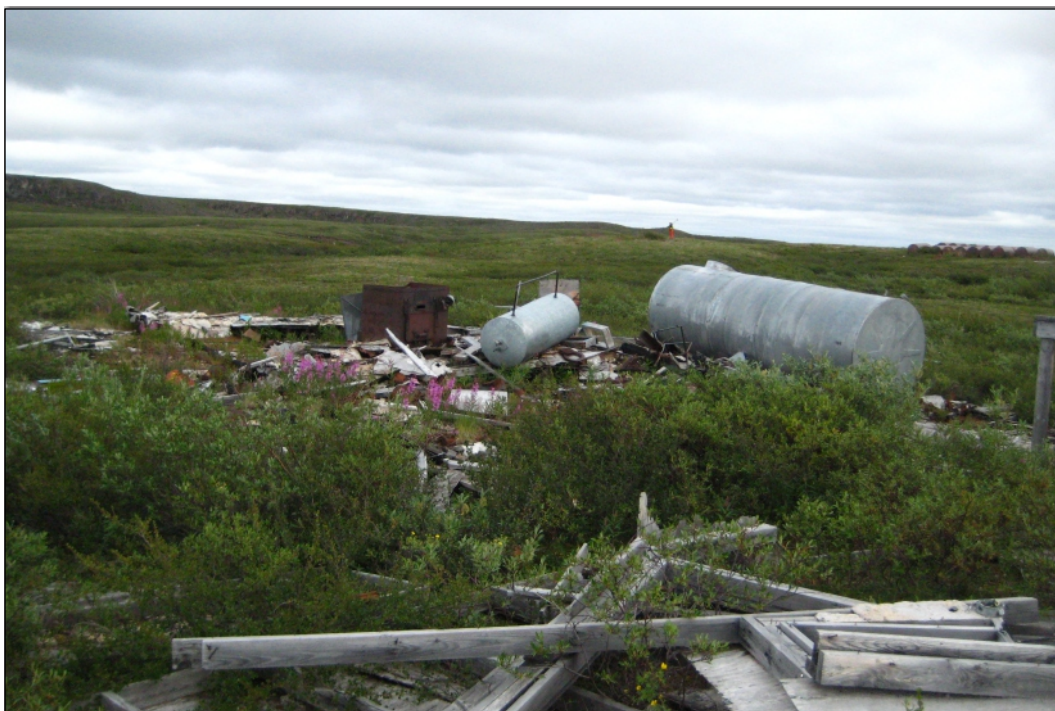
Photo 197

Hope Lake WK027: APEC 4A, tank, furnace, building foundation and miscellaneous debris

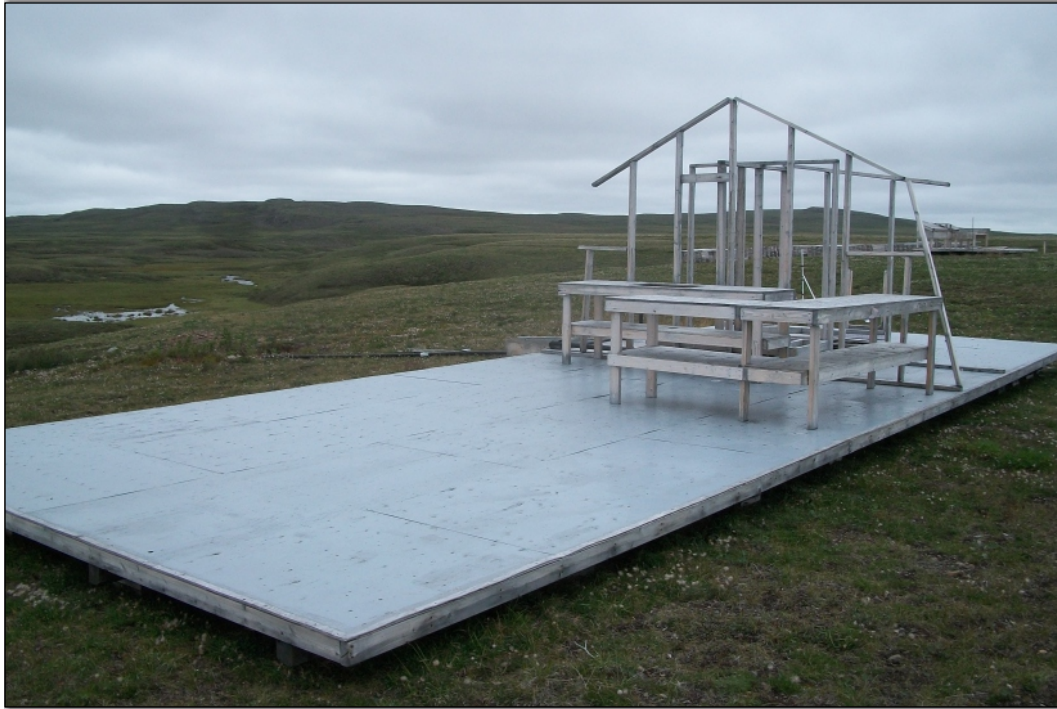
Photo 213

Hope Lake WK027: APEC 5, building platform in good condition; blue paint sampled doesn't contain lead over guidelines

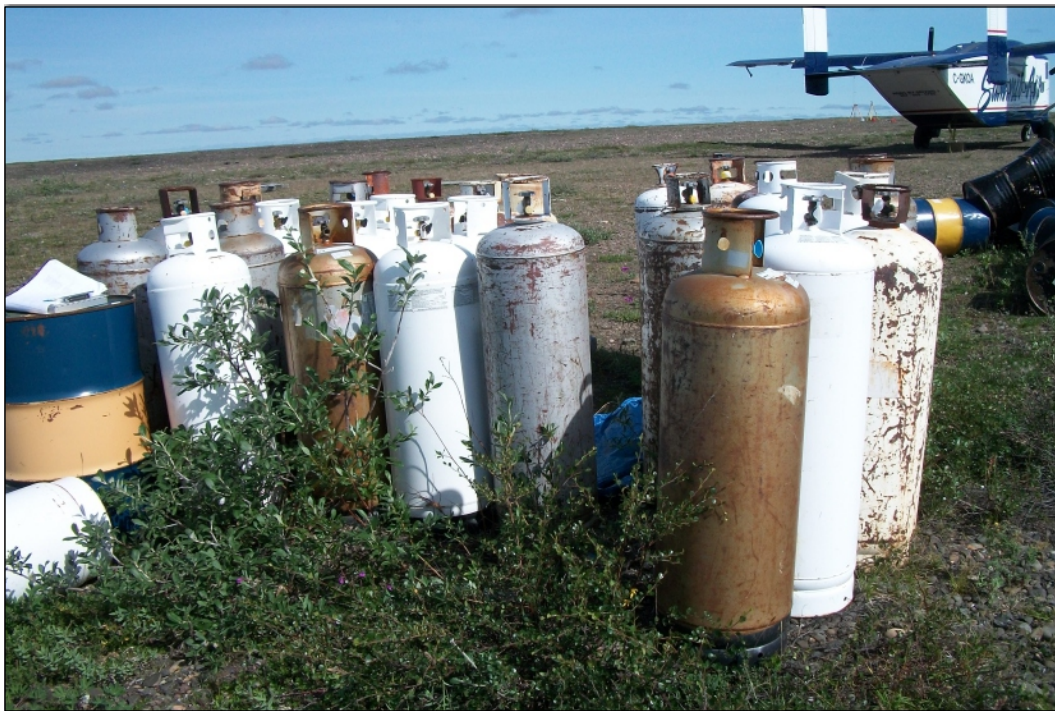
Photo 241
Hope Lake WK027: APEC 7E, hazardous propane cylinders

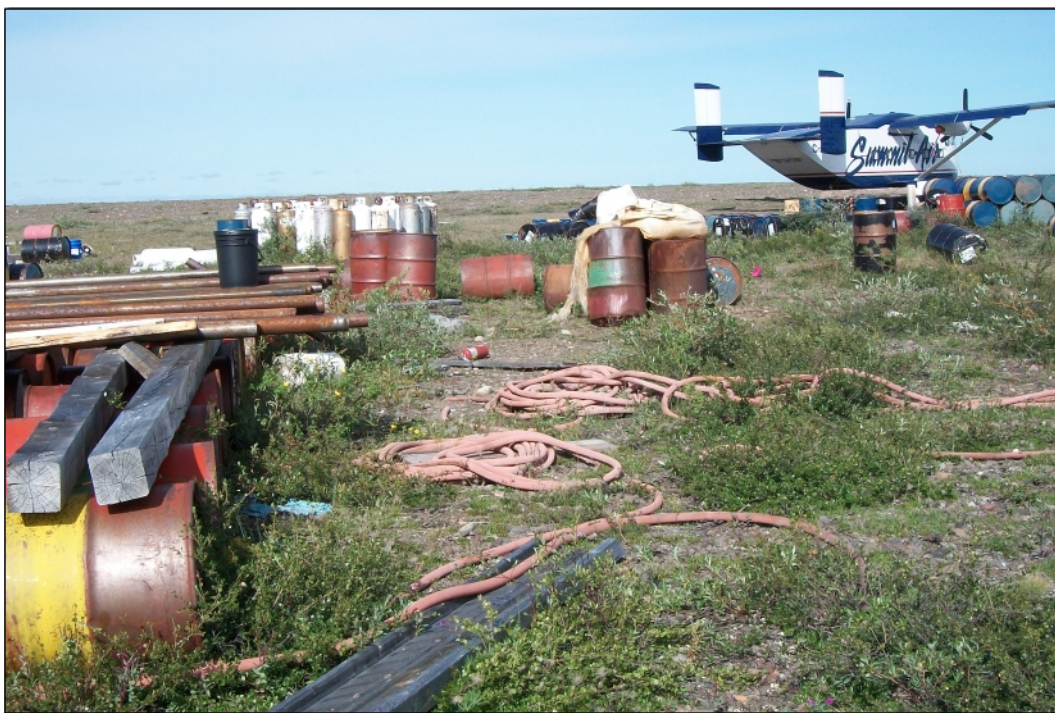
Photo 242
Hope Lake WK027: APEC 7E and G, drums, piping, hoses and wood debris
