HOPE LAKE
REMEDICATION PROJECT
REMEDIAL ACTION PLAN

**REMEDIAL ACTION PLAN
HOPE LAKE, NUNAVUT**

**SOLICITATION NUMBER: EW699-110498/001/NCS
PWGSC PROJECT NUMBER: R.040717.012
SUPPLY ARRANGEMENT NUMBER: EW699-100053/003/NCS**

March 2011

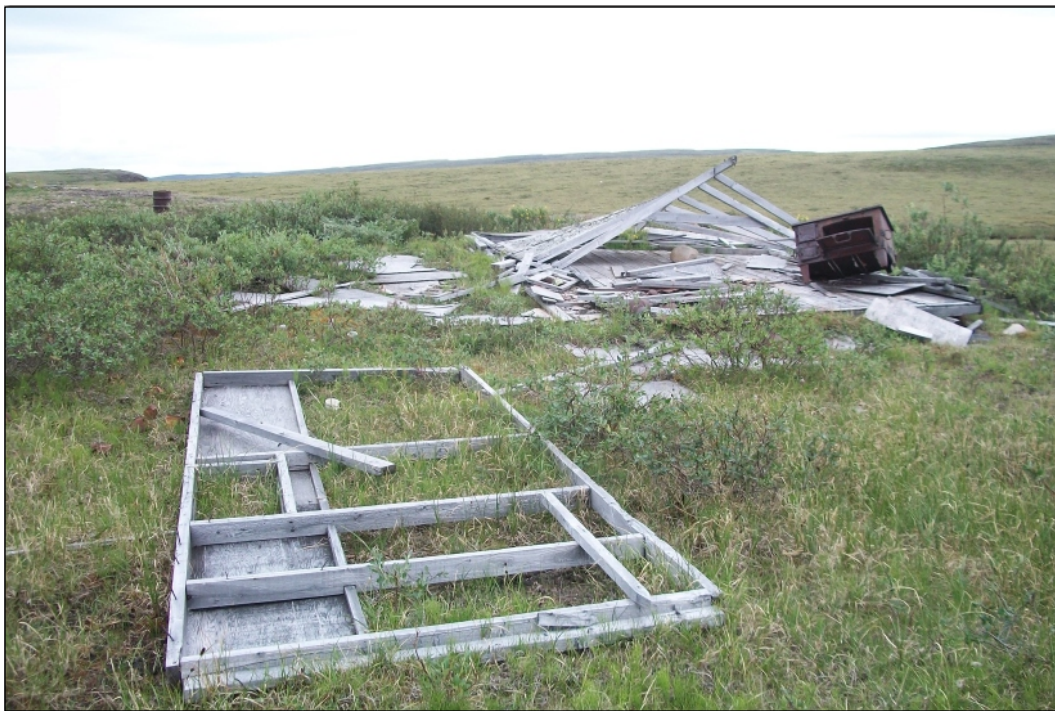
Photo 66

Willow Creek WKB01 South Cabin: APEC 19, wood platform with collapsed walls and roof, vents, cans, pots, a wood burning stove, and grey insulation

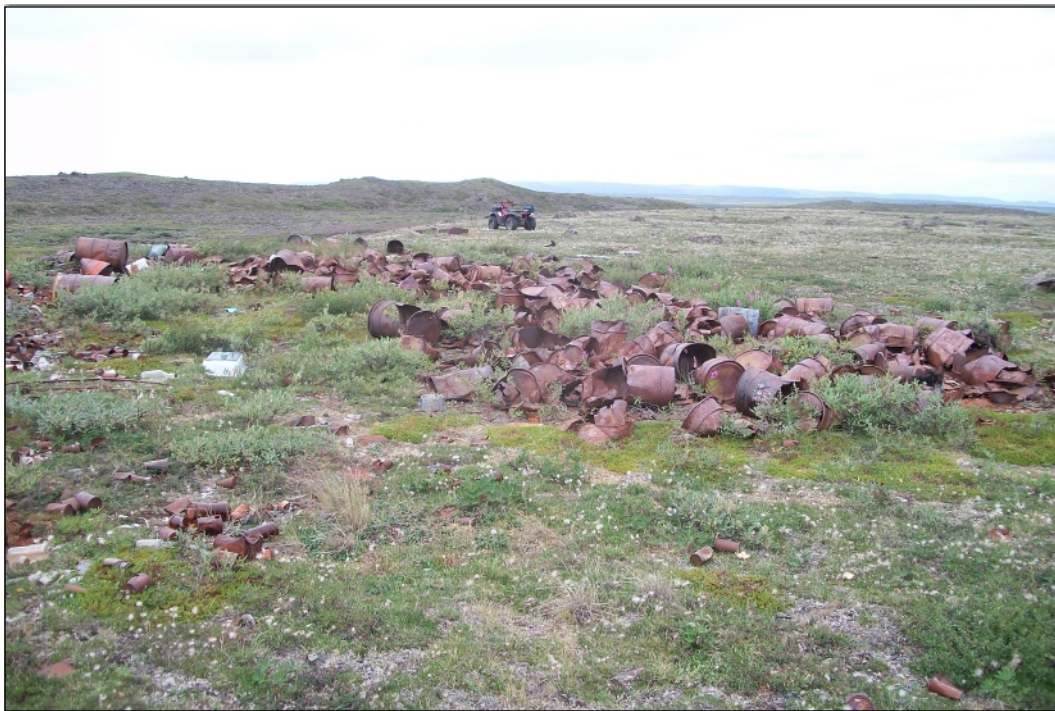
Photo 129

Hope Lake WK027: APEC 1A, heavily rusted drums and tin cans (looking north)

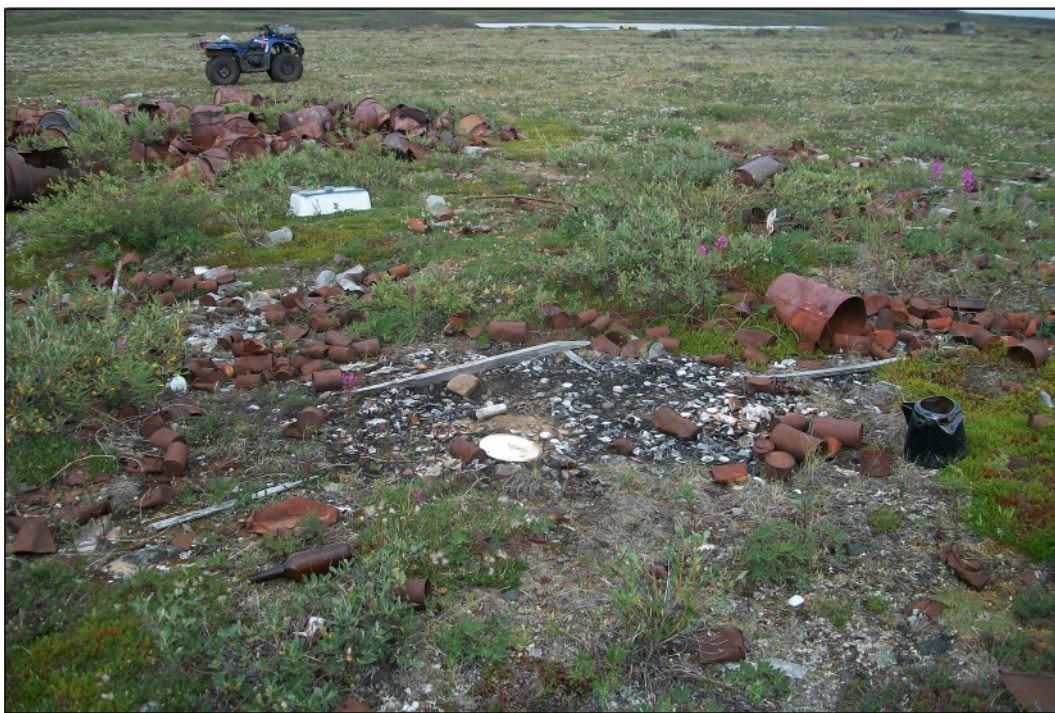
Photo 130

Hope Lake WK027: APEC 1A, burn pit with battery ends (looking north toward Hope Lake)

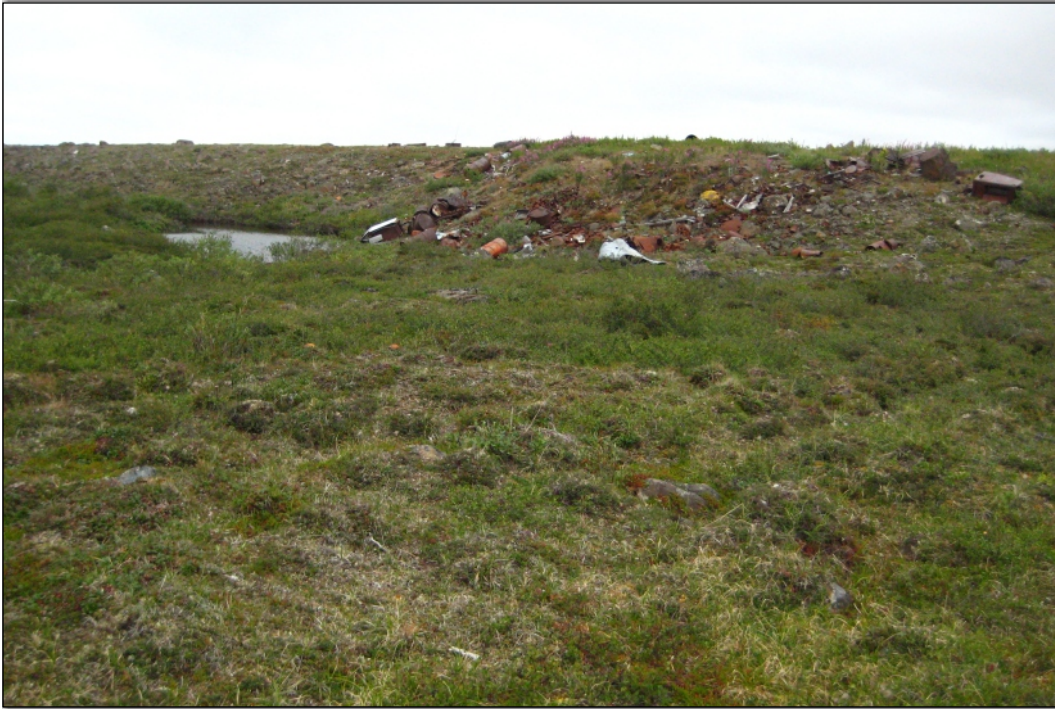
Photo 131

Hope Lake WK027: APEC 1A, heavily rusted drums scattered on south facing slope (looking west)

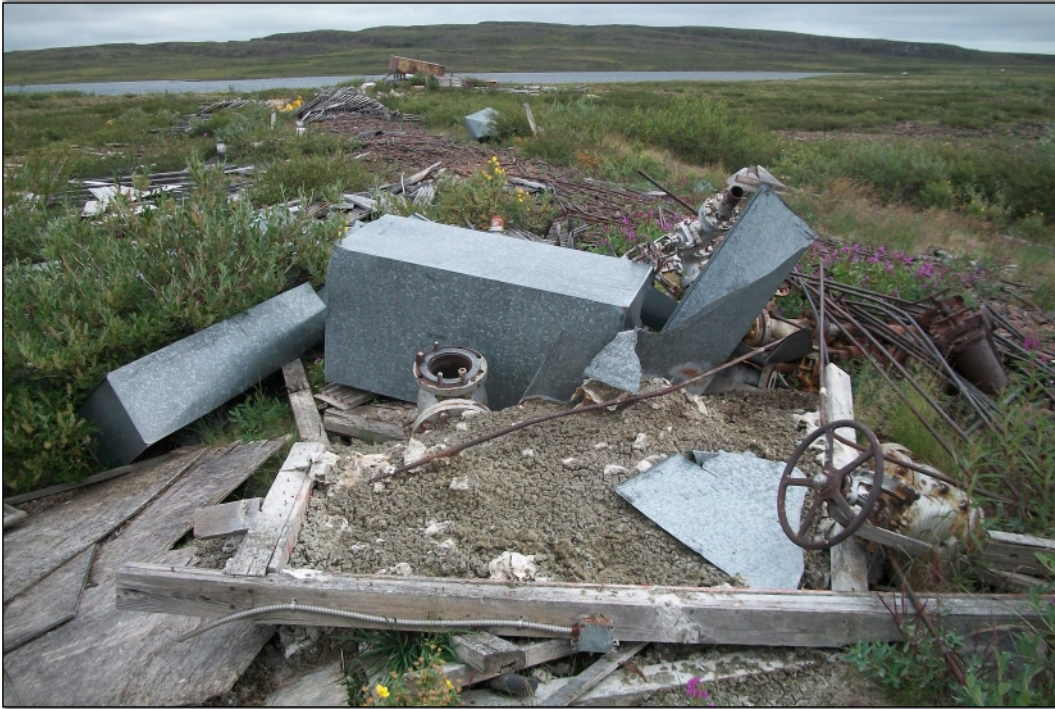
Photo 185

Hope Lake WK027: APEC 3P, non-hazardous materials, may have been a drilling compound

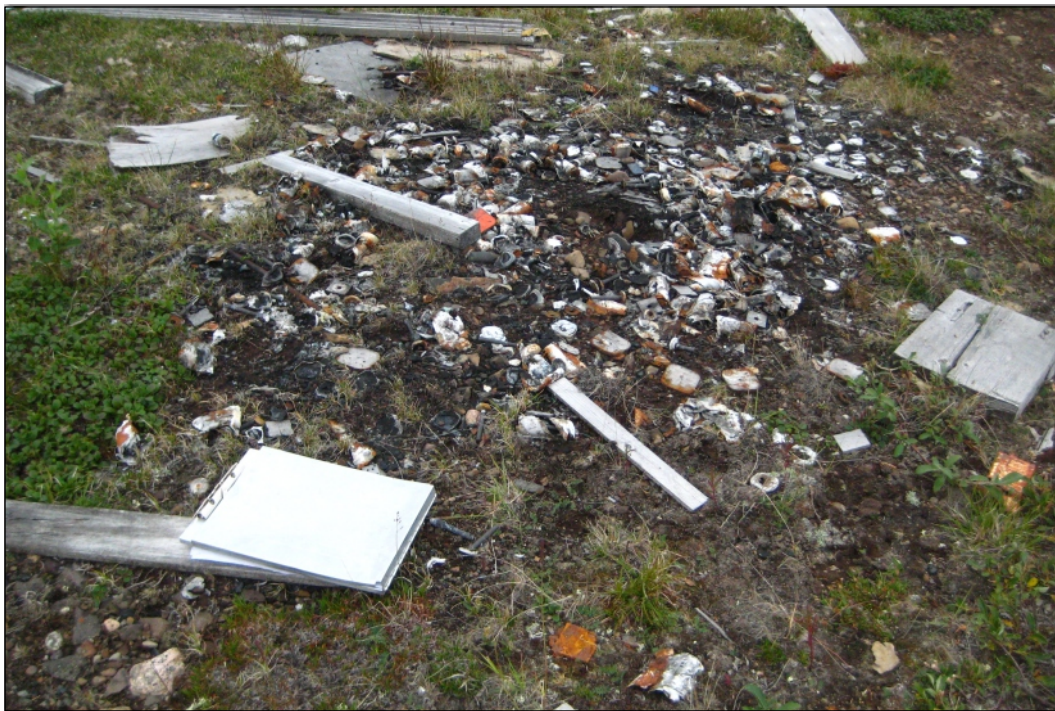
Photo 195

Hope Lake WK027: APEC 4A, burn pit and battery components

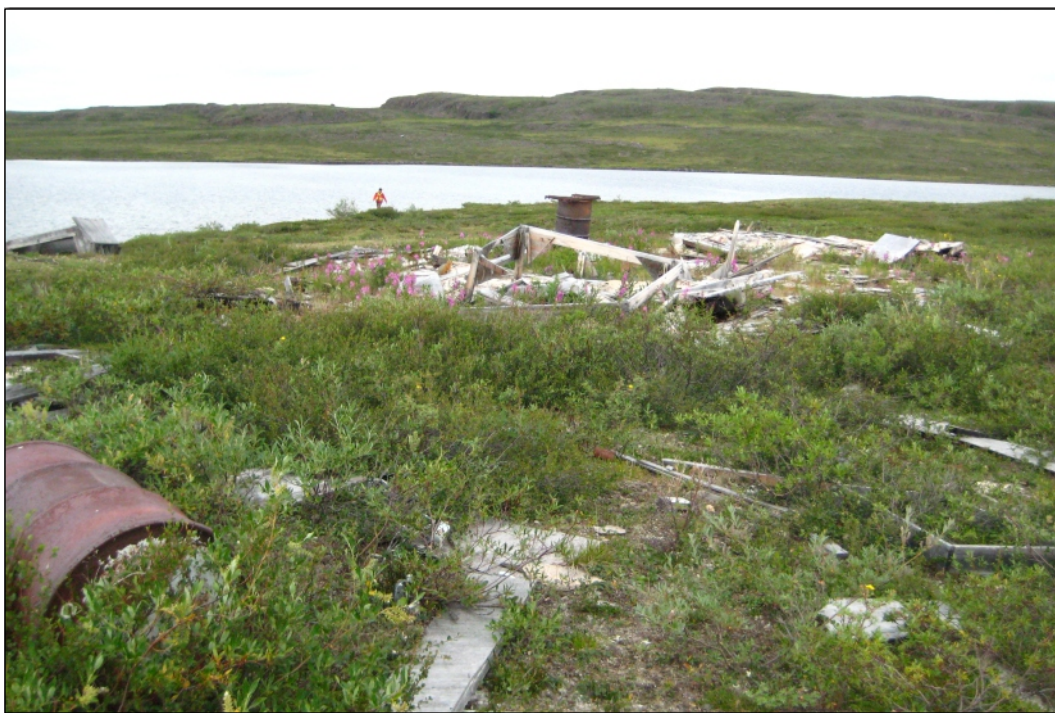
Photo 196

Hope Lake WK027: APEC 4A, drums and collapsed building in background

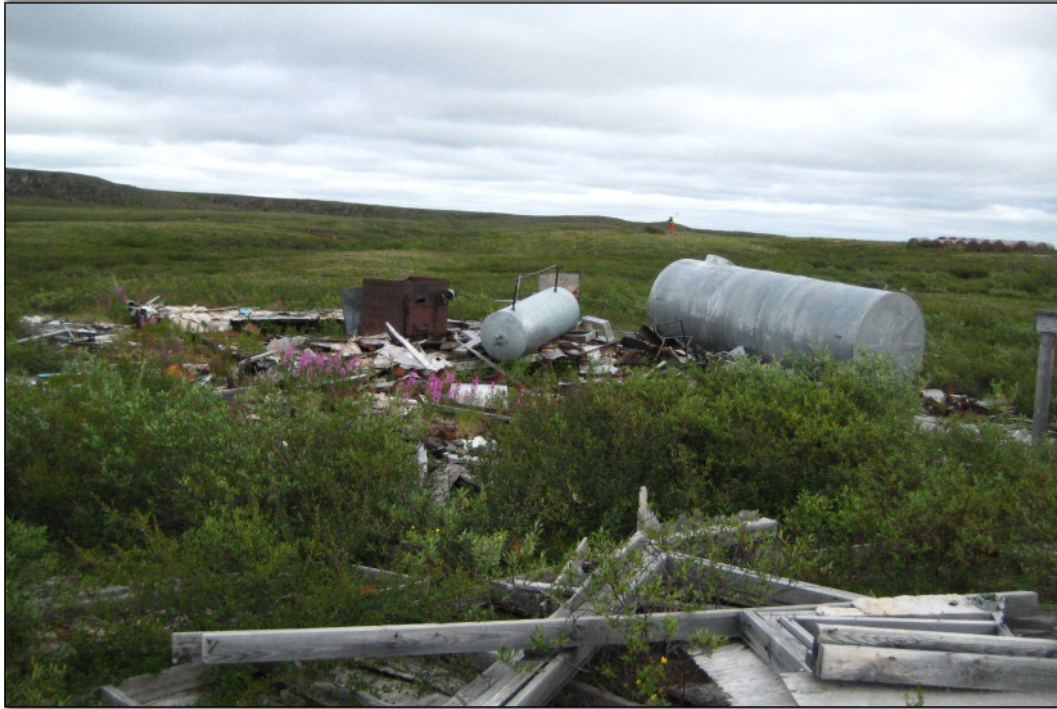
Photo 197

Hope Lake WK027: APEC 4A, tank, furnace, building foundation and miscellaneous debris
