2014-10-01

Ref. No.: RQ14-214-4

Re: Report on Drum Cache Activities

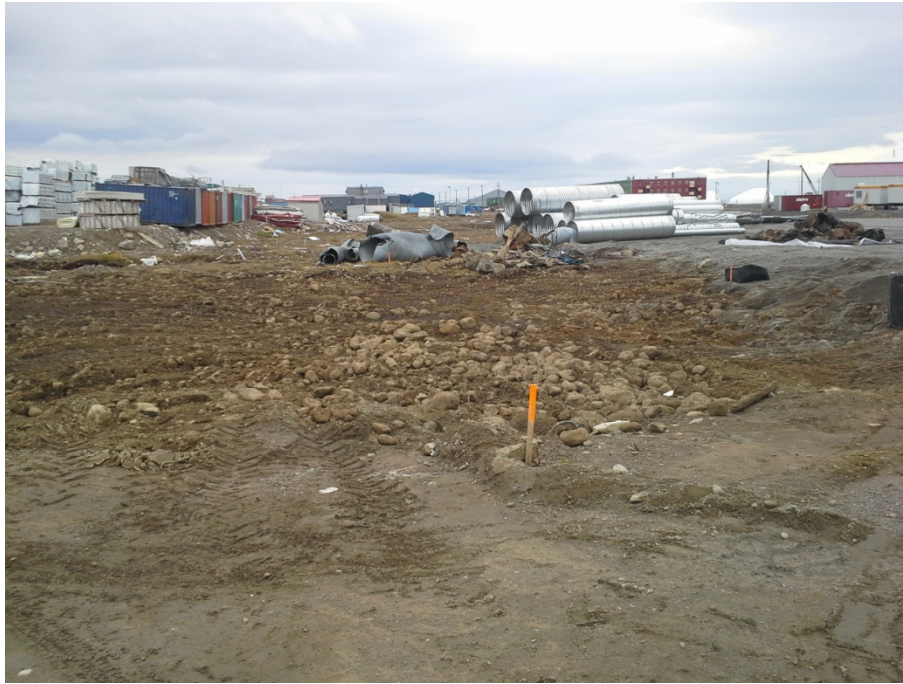
Figure 1: Drum Cache Area Following Excavation of Contaminated Soil

Finally, all of the tar and ethyl benzene contaminated soil was excavated from the area. The contaminated soil and pieces of tar were placed in small wranglers. In total, 224 wranglers were filled with contaminated soils. Each wrangler holds 0.76 m³ of contaminated soil for a total of 170 m³ of tar and ethyl benzene contaminated soil. The wranglers were stored at the work site but then moved to the Beach for the sealift as the area needed to be vacated for the airport Design Build Joint Venture for storage of their construction materials.

Once the pre-determined area for ethyl benzene contaminated soils had been excavated and all tar contaminated materials had been removed, a geotextile was placed at the bottom of the excavation as per the methodology presented Pre-Existing Contamination Remediation Work Plan. No test results were collected at the end as per the methodology presented in the PECAMP. Additionally, all test results immediately next to the area where tar associated ethyl benzene contamination was found did not show any signs of contamination further supporting that as long as all of the dried tar and soils immediately adjacent to it was removed, no contamination would remain. The area was then backfilled with clean fill and the site was closed.

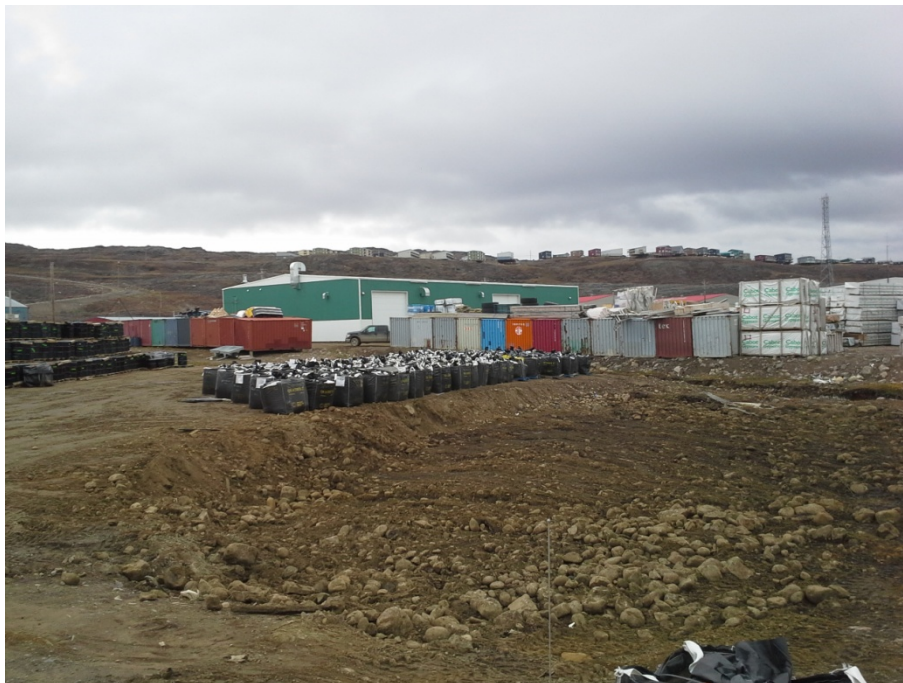
Figure 2: Drum Cache Area Following Excavation of Contaminated Soil

Please note that a pad was constructed for the storage of construction materials next to the drum cache area and the depth shown in the photo is much greater than the actual depth of excavation

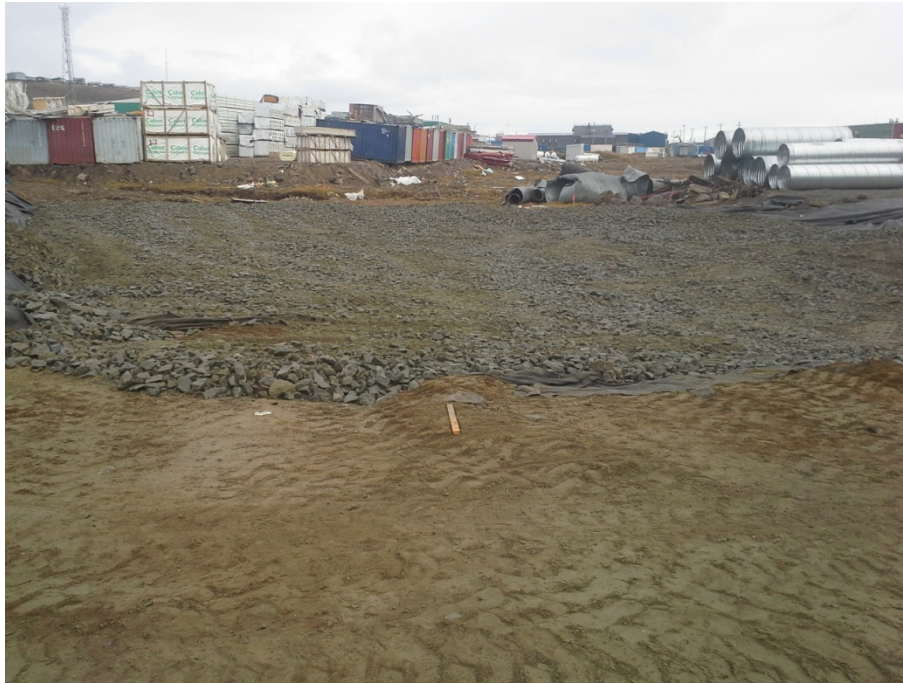
Figure 3: Drum Cache Area During Backfill

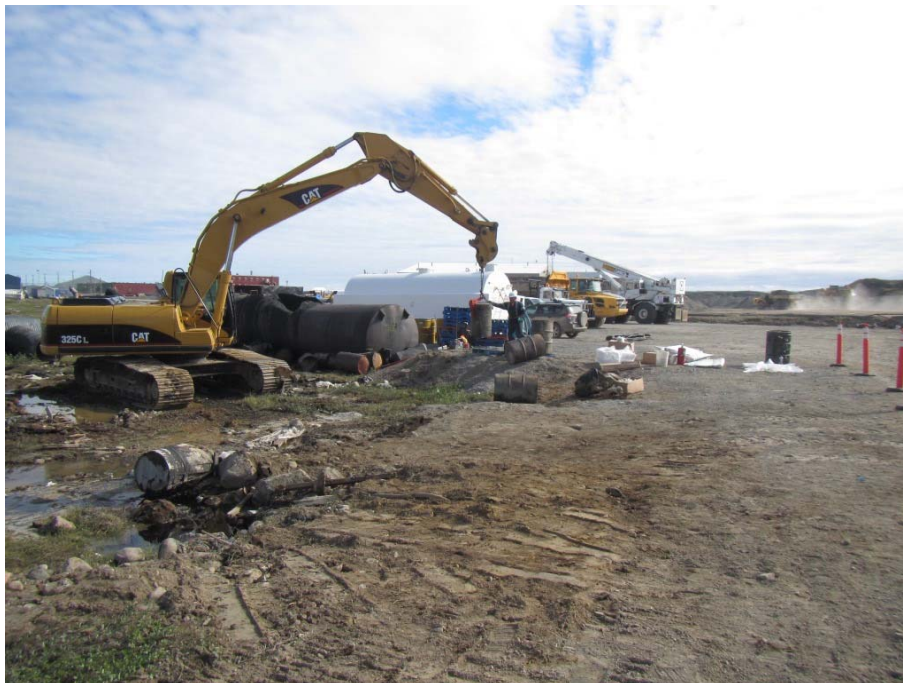
Figure 4: Removal of Drums

Work at the drum cache area was carried out over two periods, from July 7th to July 26th, 2014 and September 8th to September 23rd, 2014. Work started with the removal of all of the drums containing tar from the drum cache area. Drums that were damaged or leaking were placed into 7.2 m³ wranglers. All other drums were strapped on pallets and moved to QE's Hazardous Waste Transfer Centre (HWTC) located at 1571 Kakivak Crescent, Iqaluit. The wranglers were also transported to the HWTC for temporary storage until the sealift. At the HWTC, all of the drums on pallets were placed inside marine shipping containers. The marine shipping containers were lined with polyethylene sheeting and a granular absorbent was placed at the bottom of the container to absorb any possible spills. These containers were then transported to the Beach and are currently awaiting the sealift to Montreal for disposal.

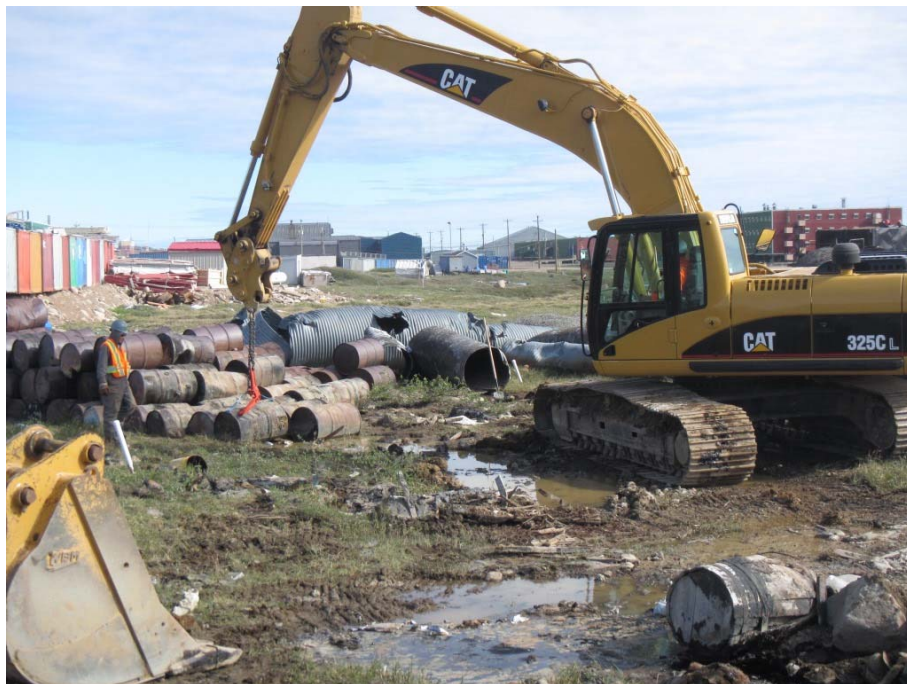
Figure 5: Removal of Drums

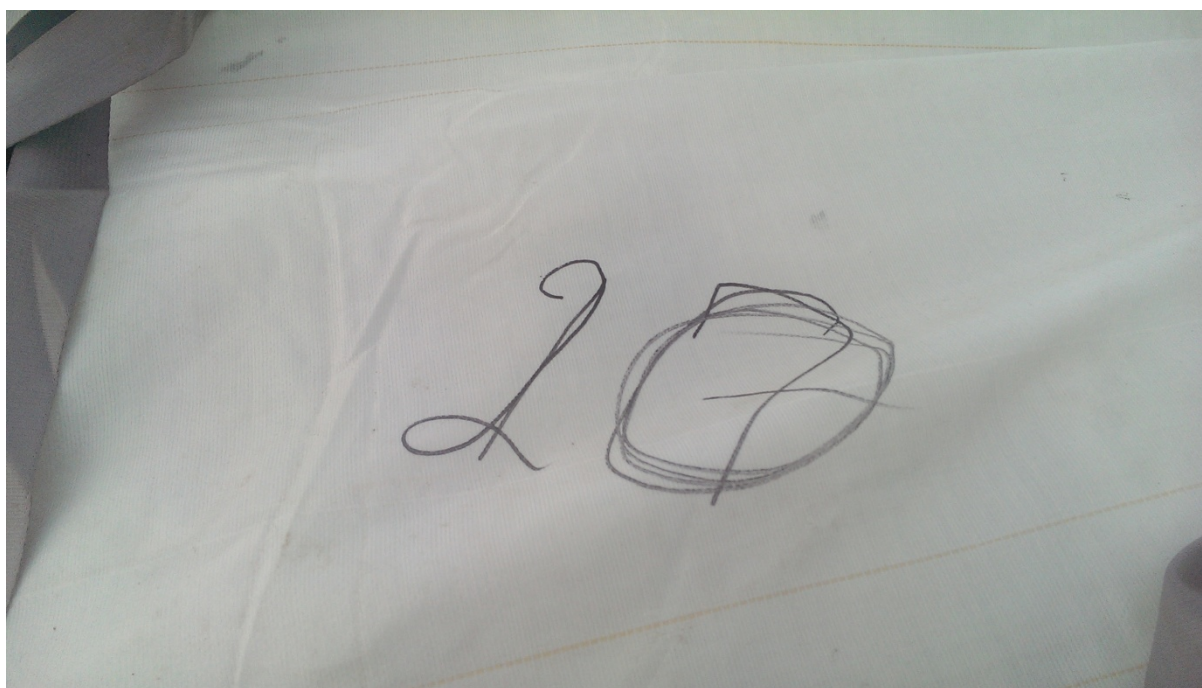
Figure 6: Lift Liners Filled with Drums

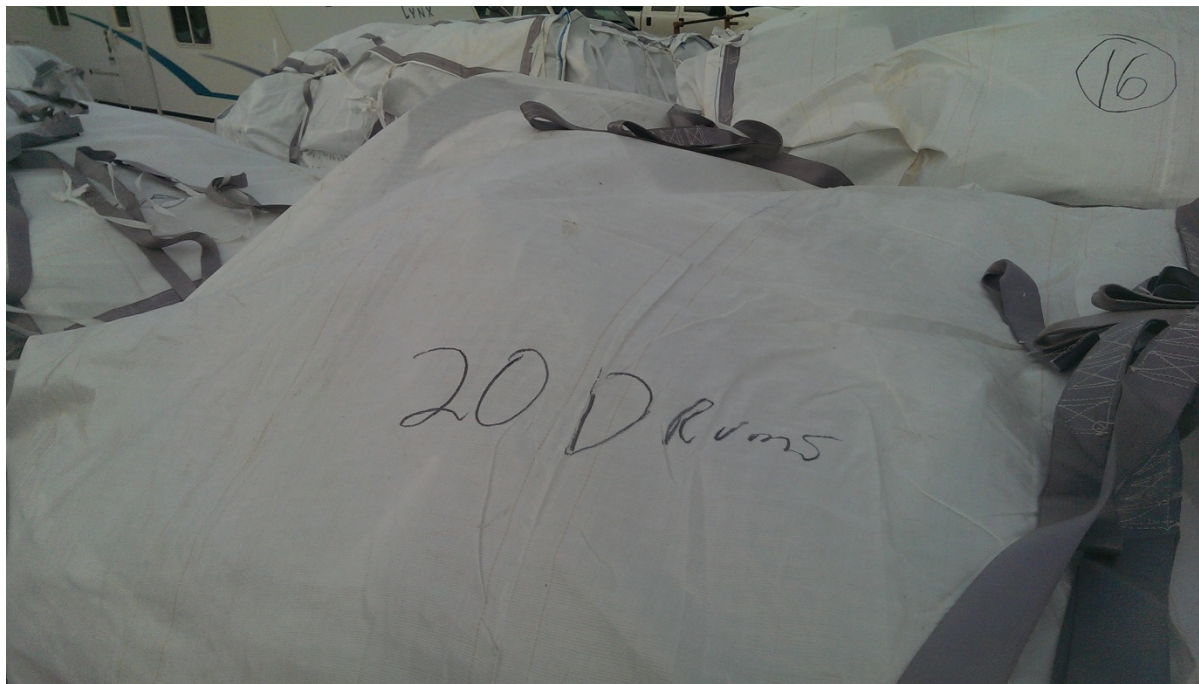
Figure 7: Lift Liners Filled with Drums

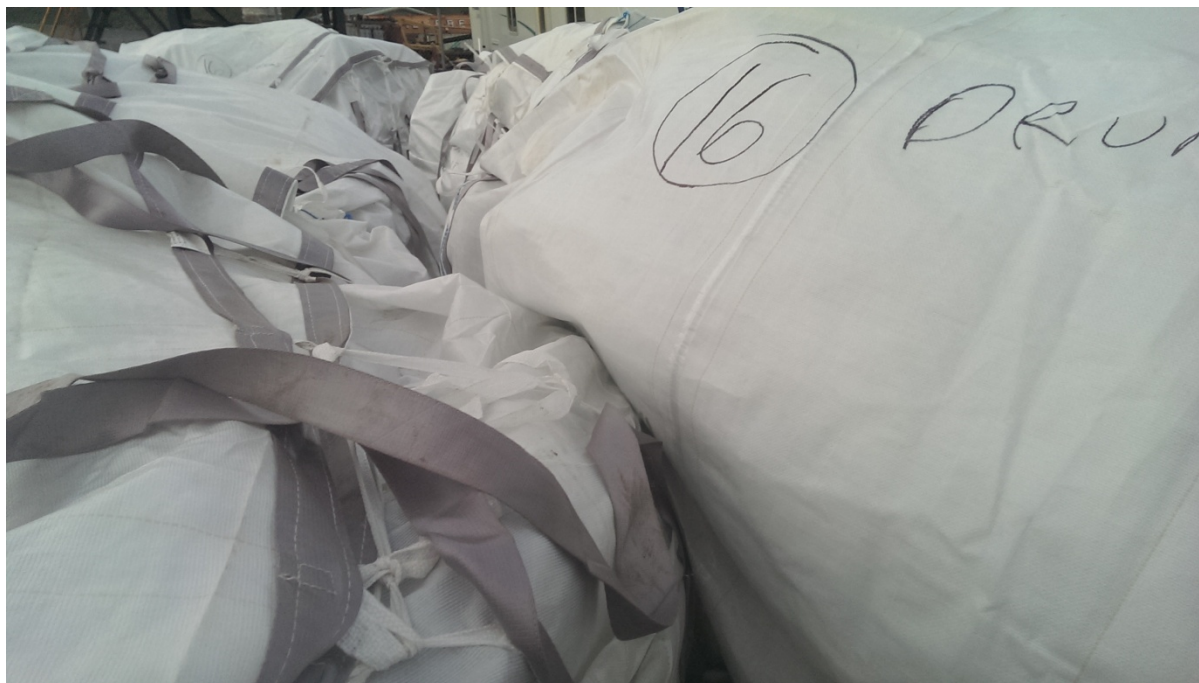
Figure 8: Lift Liners Filled with Drums

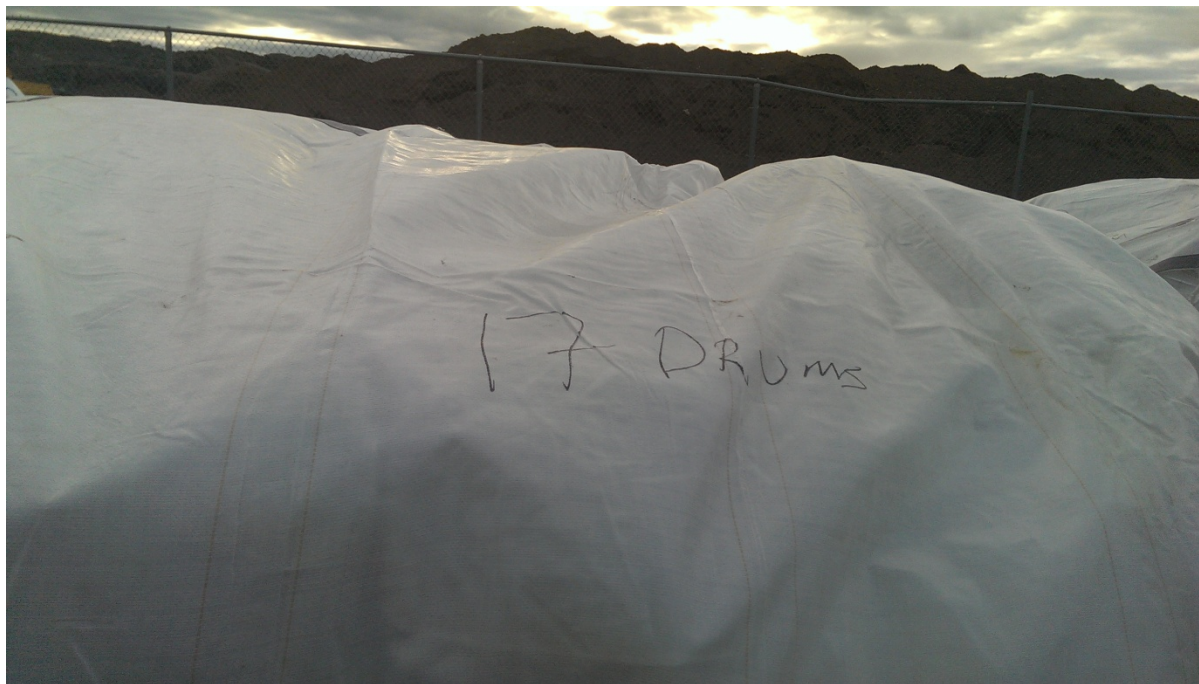
Figure 9: Lift Liners Filled with Drums

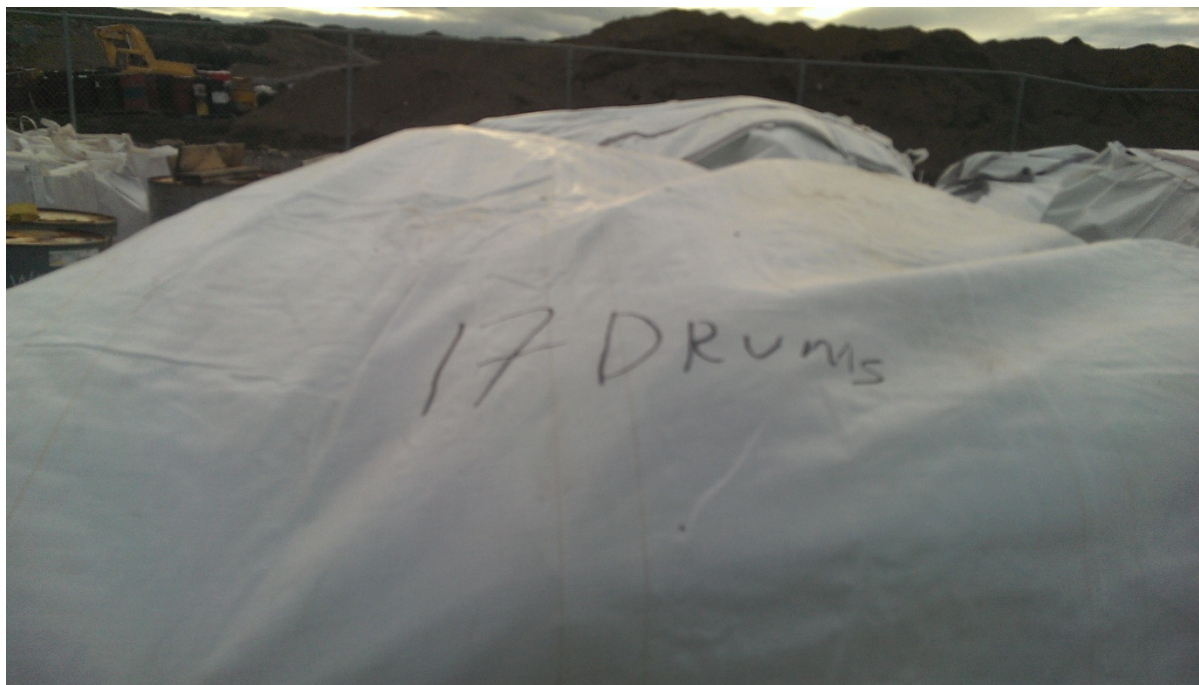
Figure 10: Lift Liners Filled with Drums

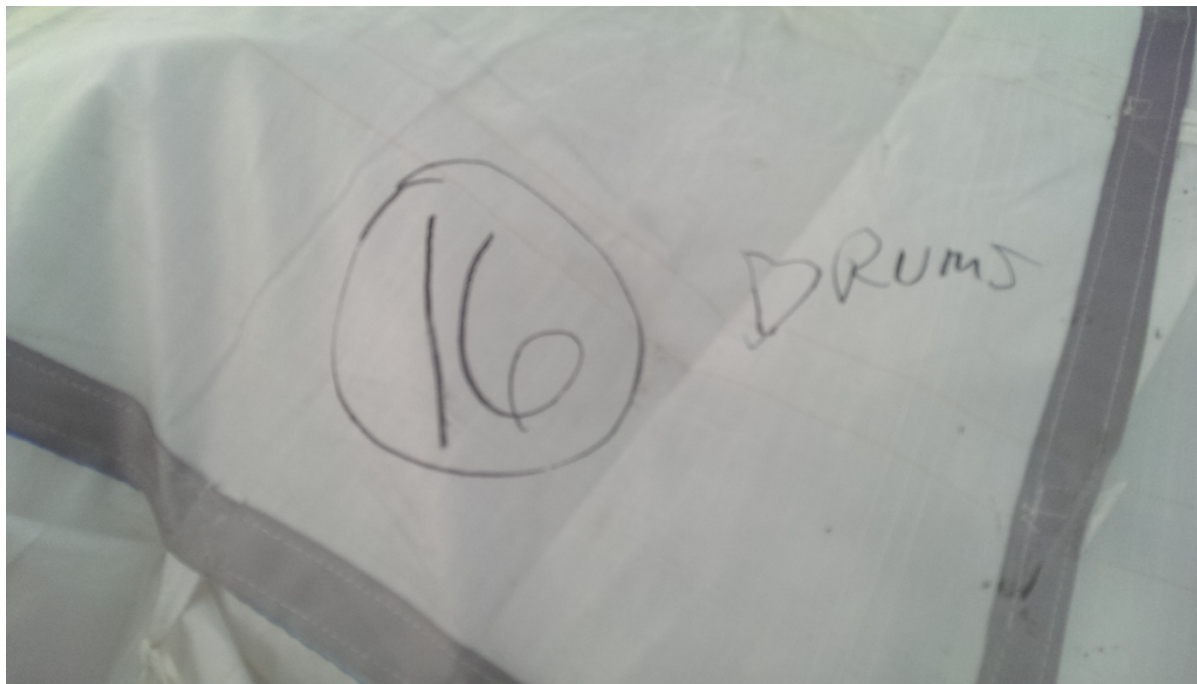
Figure 11: Lift Liners Filled with Drums

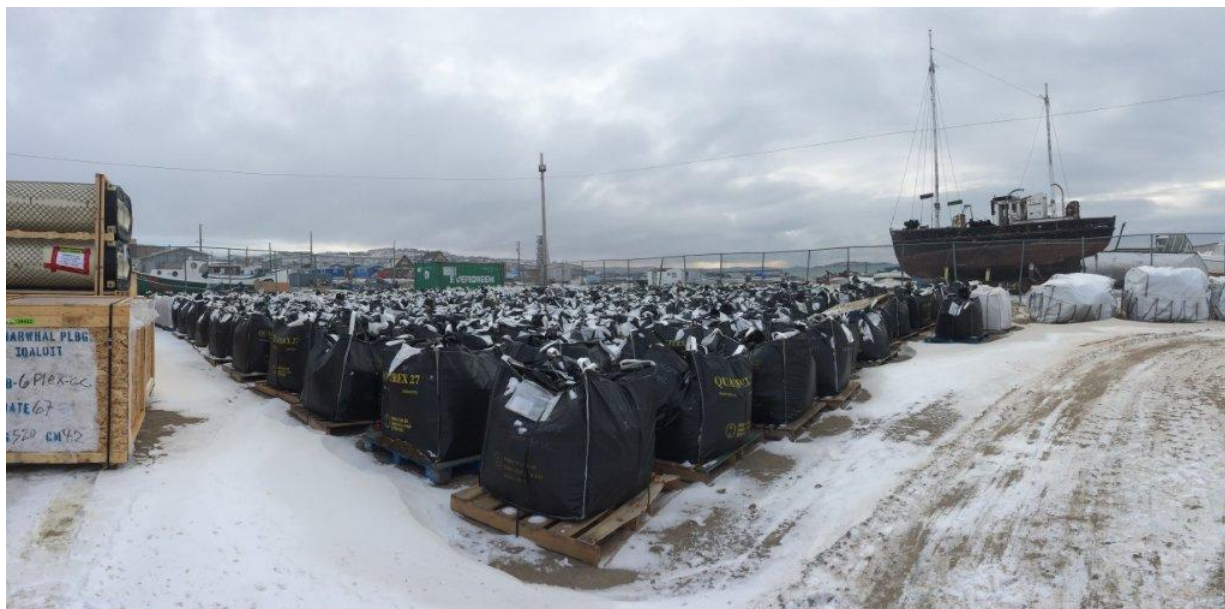
Figure 12: Quatrex Bags of Contaminated Soil and Tar Stored at the Beach and Lift Liners with Drums

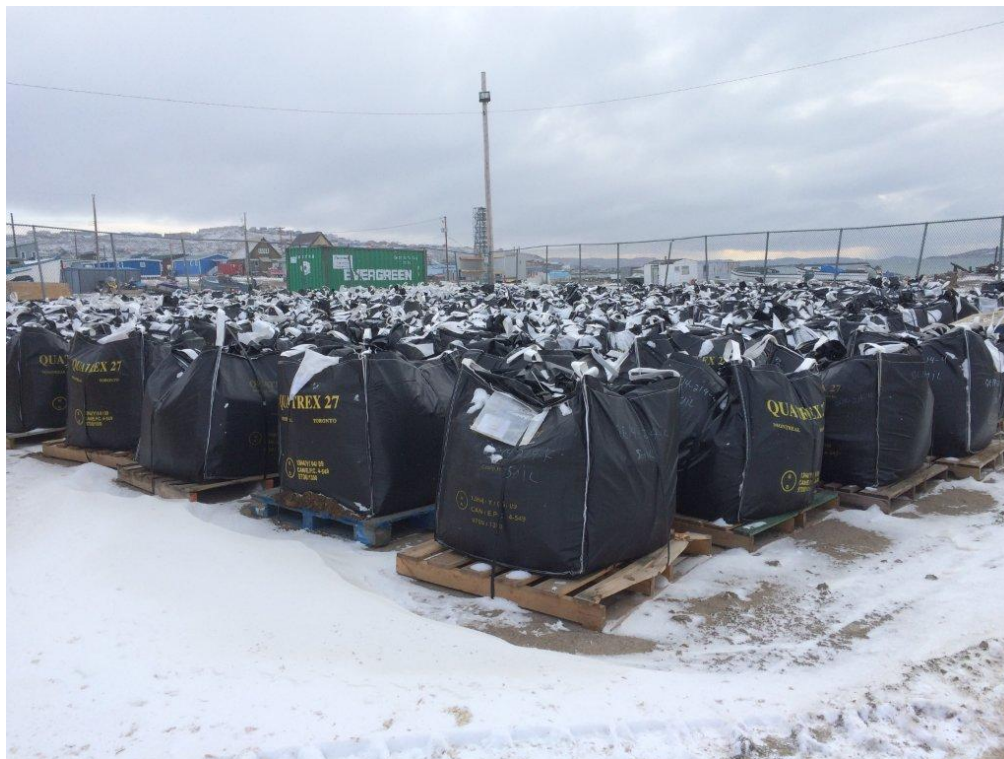
Figure 13: Quatrex Bags of Contaminated Soil Stored at the Beach

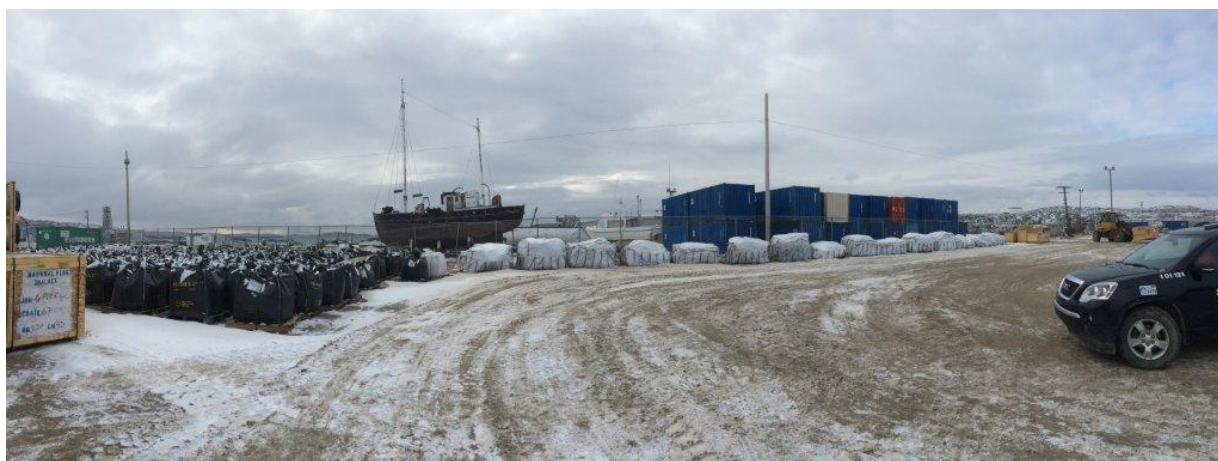
Figure 14: Quatrex Bags of Contaminated Soil and Tar Stored at the Beach and Lift Liners with Drums

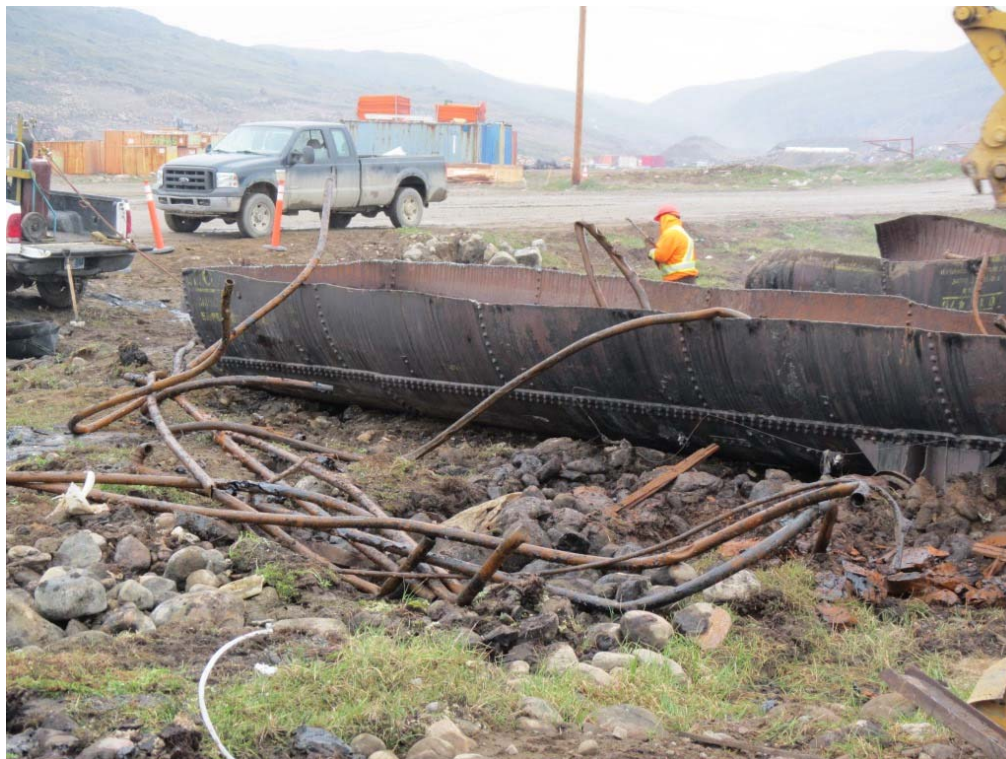
Figure 15: Tank Cut in Half

Once all of the drums were removed from the drum cache, the railroad tanker was relocated, away from the diesel fuel storage tank in the area, so it could be securely cut open using hot cutting tools. Once cut, the water was pumped from the tanker and stored at the HWTC. The

Once the interior of the tank was cleaned it was cut up and disposed of. Photos of the tank work are also attached at the end of the report.

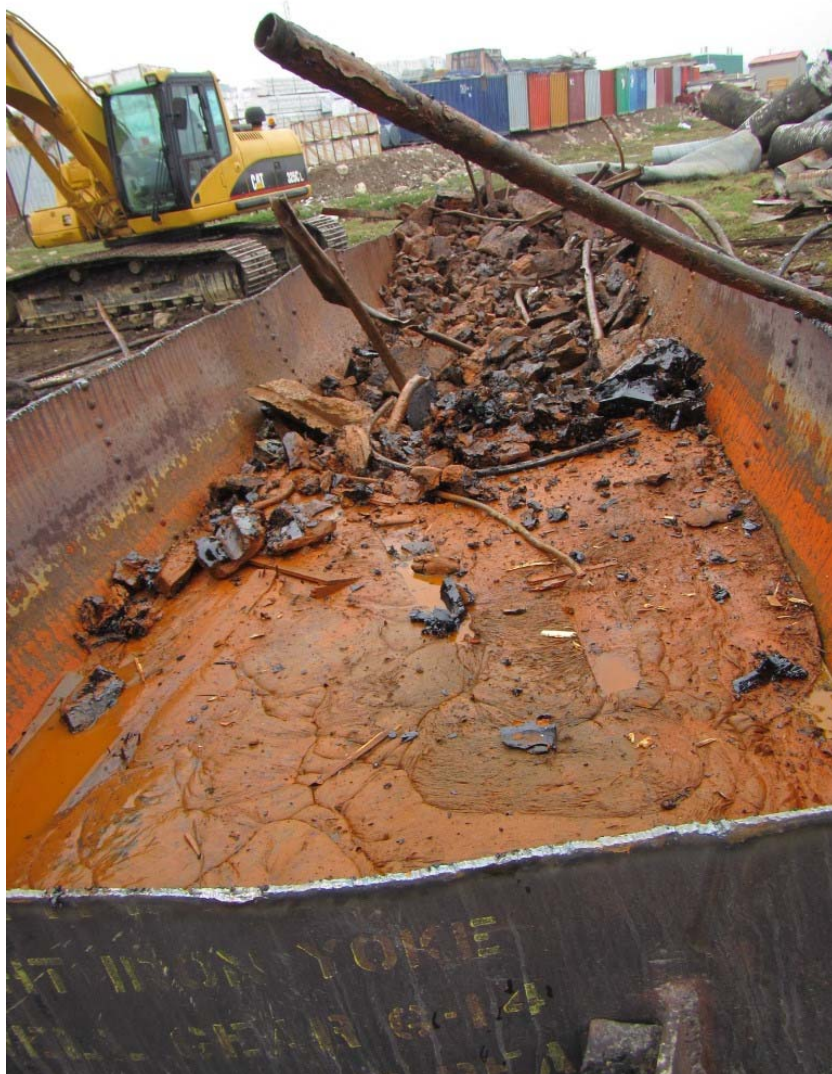
Figure 16: Hardened Tar Broken Up by Ripper

solid tar at the bottom of the tanker was broken up using a ripper on an excavator. The ripped material was packaged in smaller wrangler for disposal in the South at an authorised facility. There were also several steel pipes located at the bottom of the tank. All pipes were tar contaminated and was packaged for disposal in the South in a 7.2 m³ wrangler.

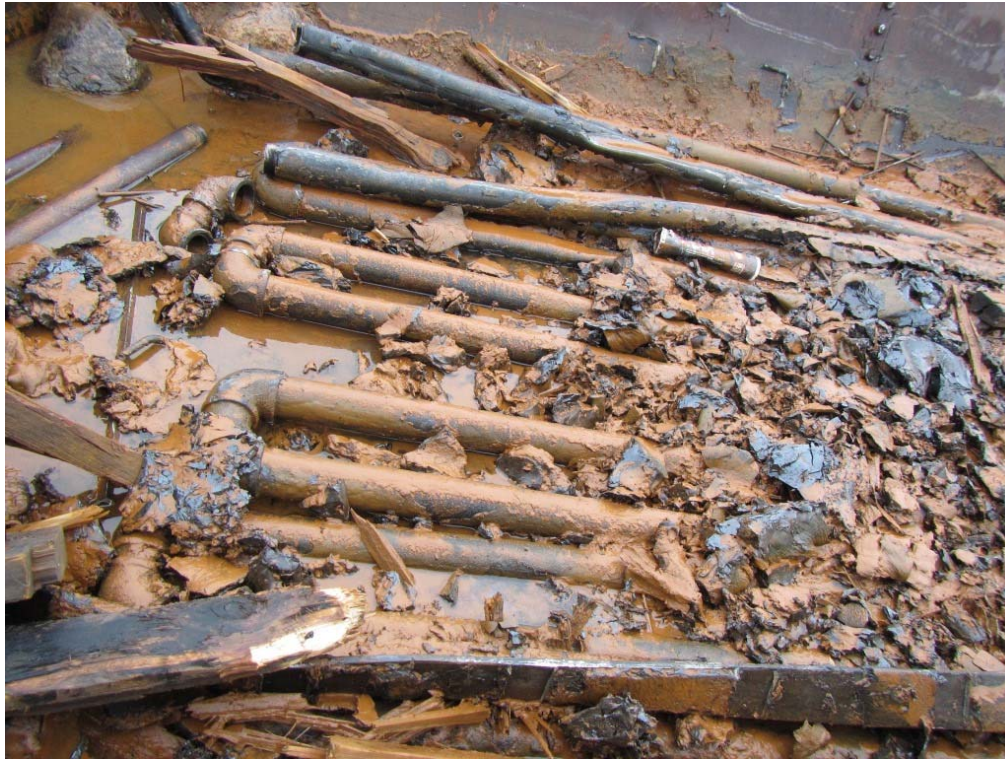
Figure 17: Pipes in Bottom of Tank

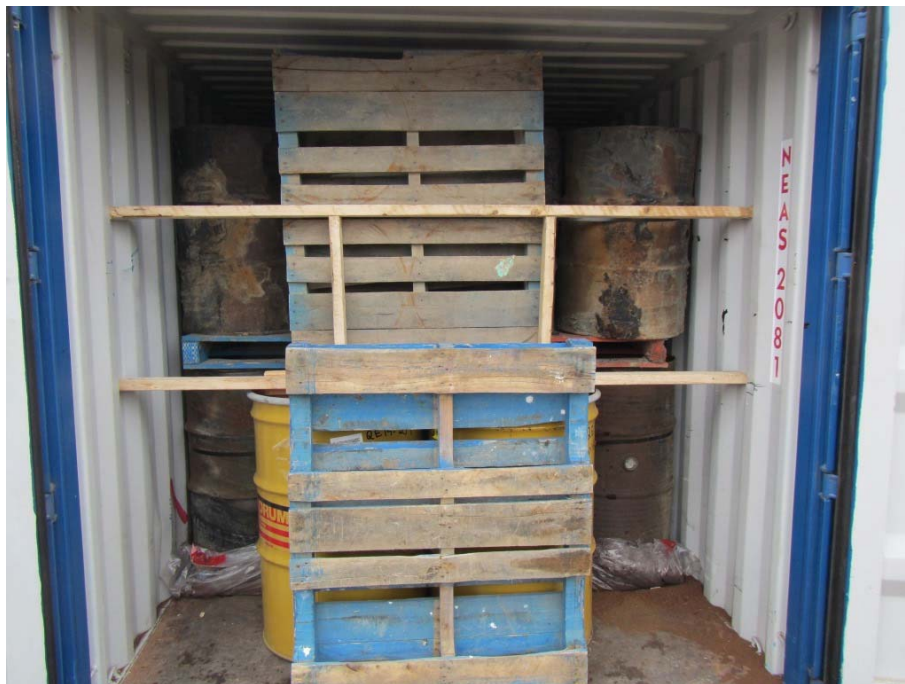
Figure 18: Marine Containers Ready For Shipment

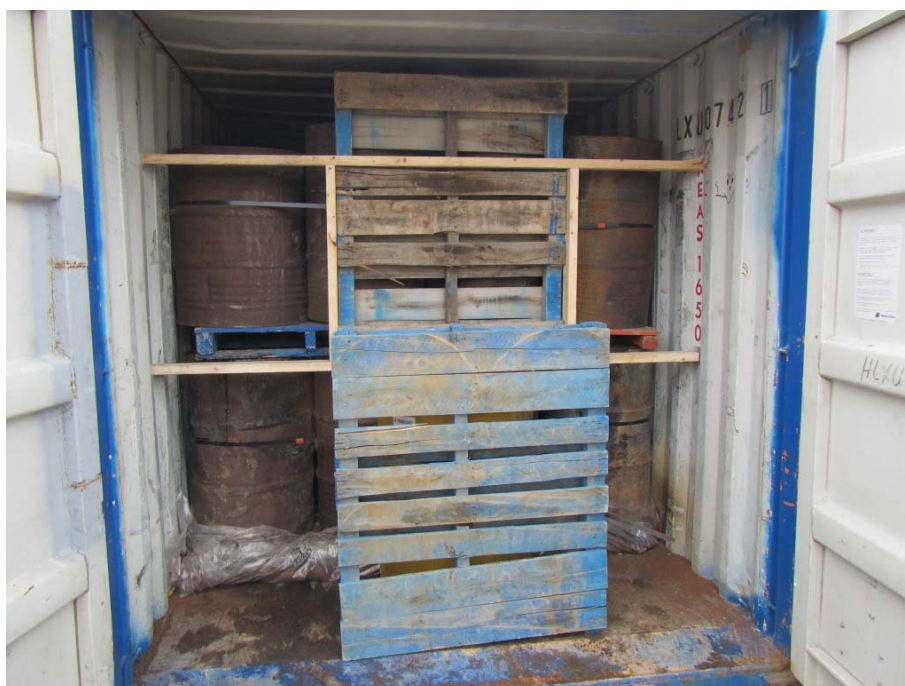
Figure 19: Marine Containers Ready for Shipment

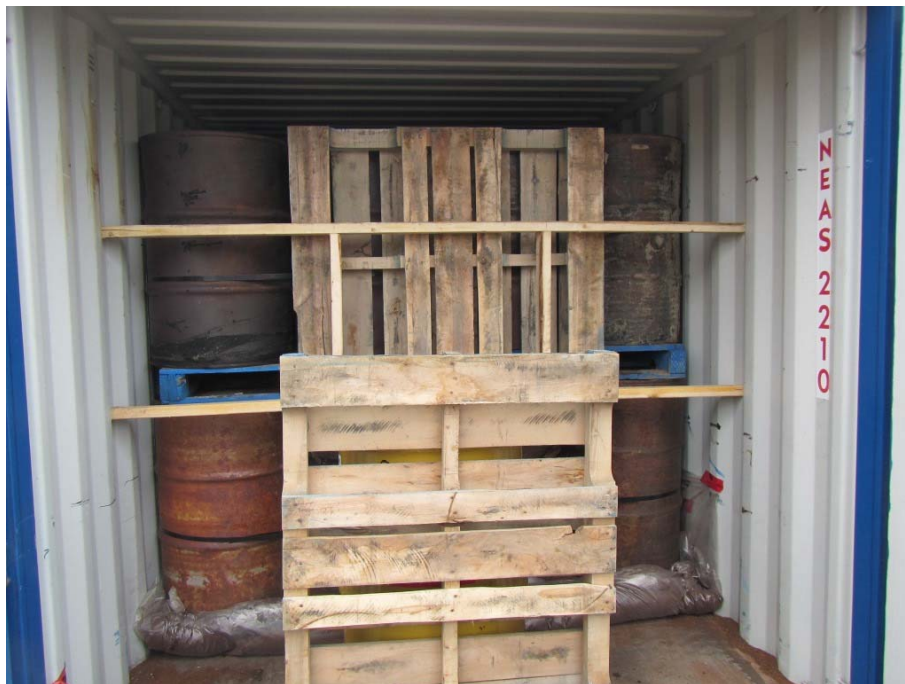
Figure 20: Marine Containers Ready for Shipment
