**Re: 2008 Annual Report for Water Use License 1BR-JEN0712: CAM-1, Jenny Lind Island  
DEW Line Site**

# **1BR-JEN0712: Executive Summary**

Project Name: CAM-1, Jenny Lind Island DEW Line Site Clean Up

## INDUSTRIAL WATER USE INSPECTION REPORT

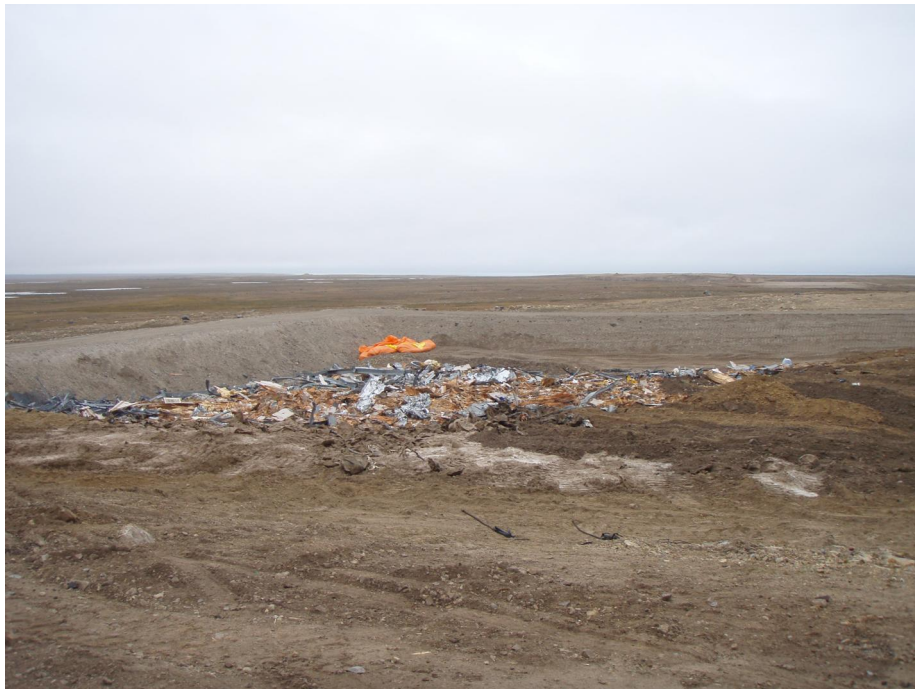
**Photograph 1:** Non-Hazardous Waste Landfill.

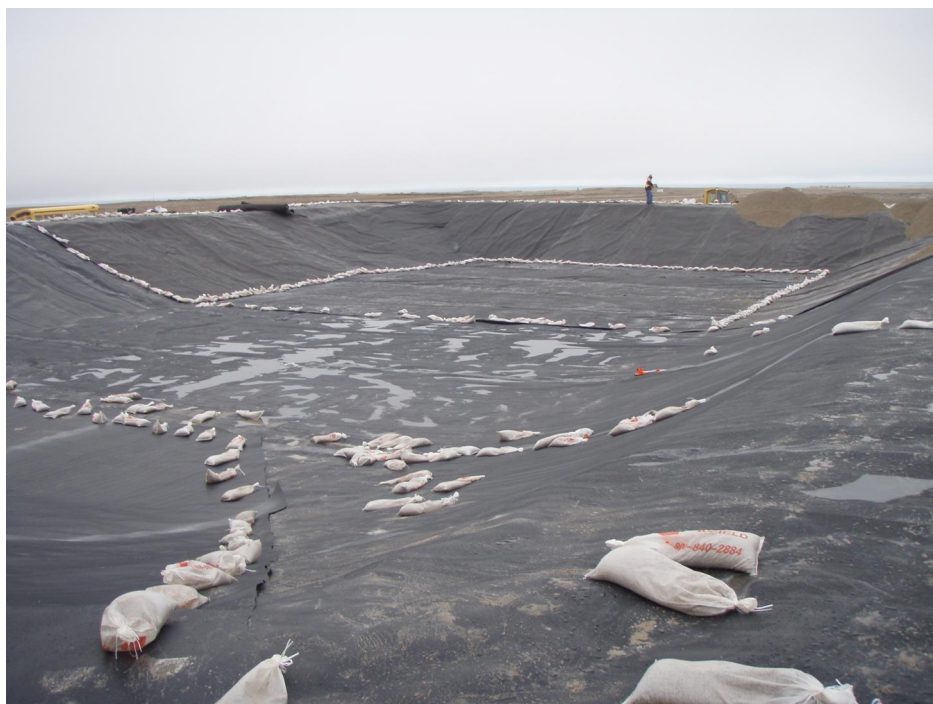
**Photograph 2:** Tier II Soil Disposal Facility

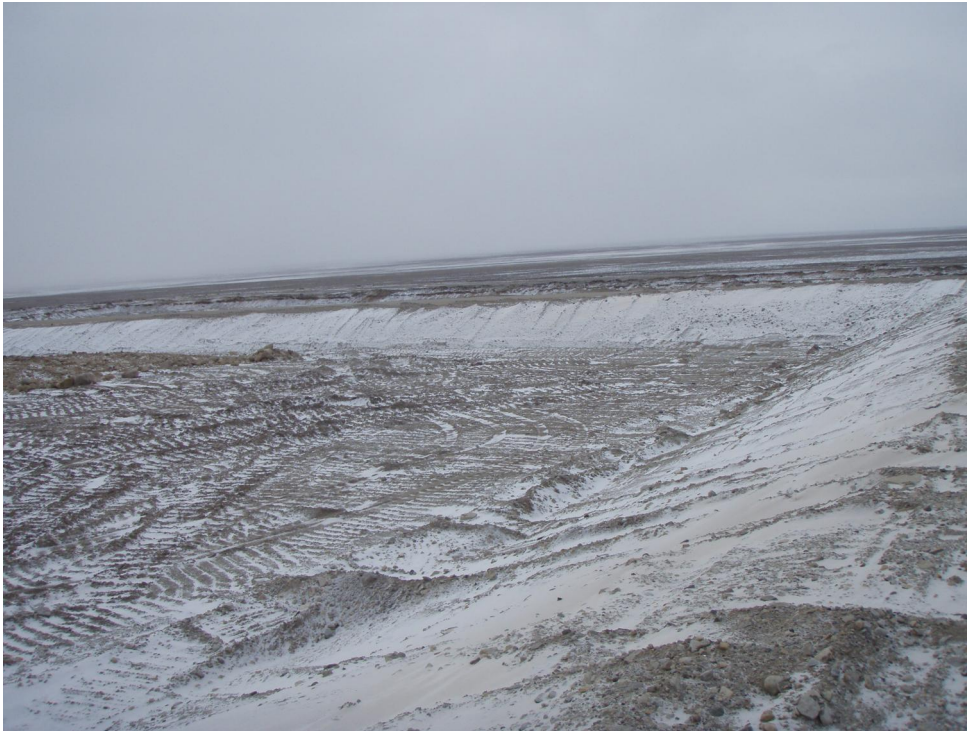
**Photograph 3:** Landfarm

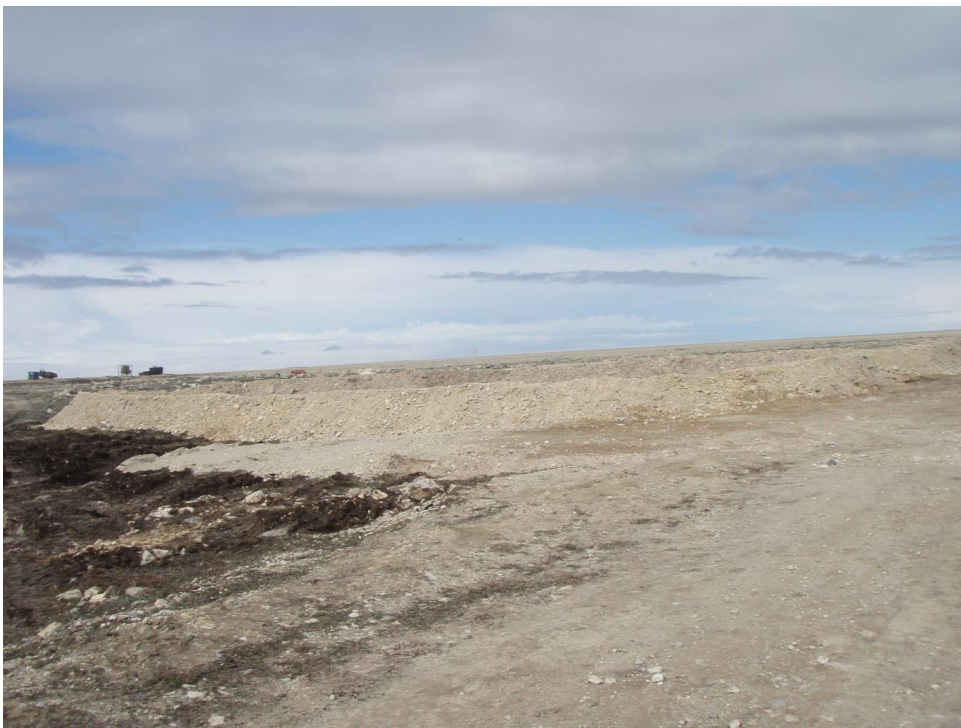
**Photograph 4:** Sewage Lagoon

Effluent Discharge Rate: daily Samples Collected: d downhill of lagoon/incinerator area near shore  
Comments: Sewage is pumped into a septic tank which is pumped out daily into sewage "lagoon" (2 cells) \* Lagoon has no liners (just a dirt/gravel bermed area) and seepage is apparent.  
Incinerator (open stack) for burnable wastes; ashes scooped into bin for burial at a non-hazardous landfill site

1. **Observation:** The Discharge Quality, Pond Treatment, and Seepages of the sewage lagoon were found to be unacceptable.

**Response:** The berms of the lagoon will be reshaped and compacted, and the base of the cells will be compacted to better retain the effluent.

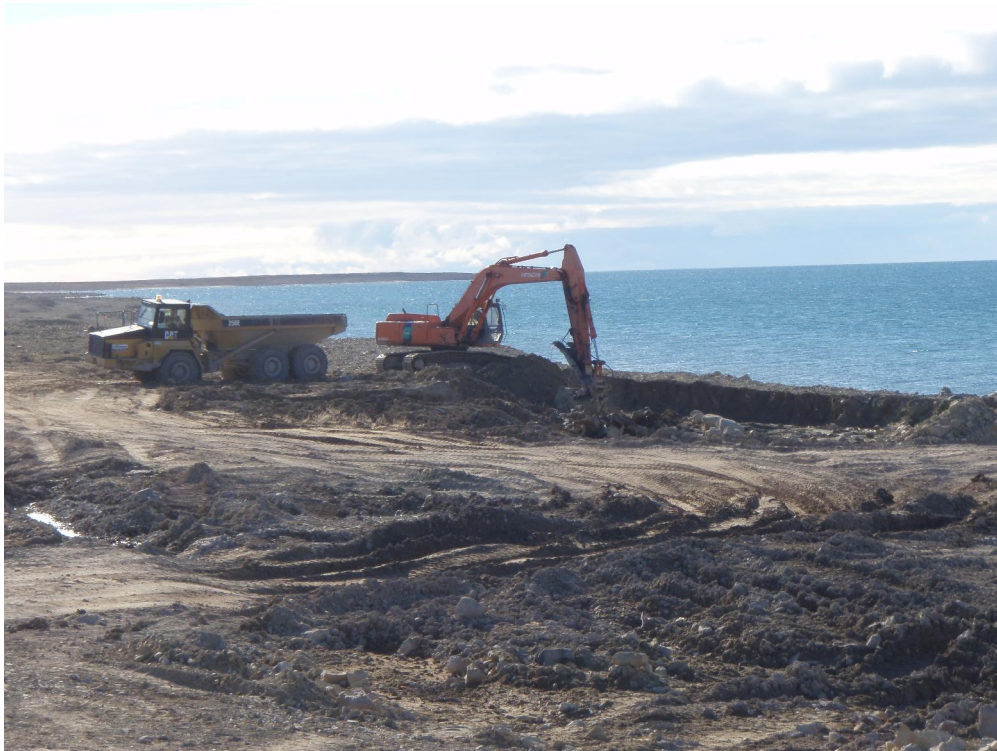
**Photograph 5:** East Landing Landfill Excavation.

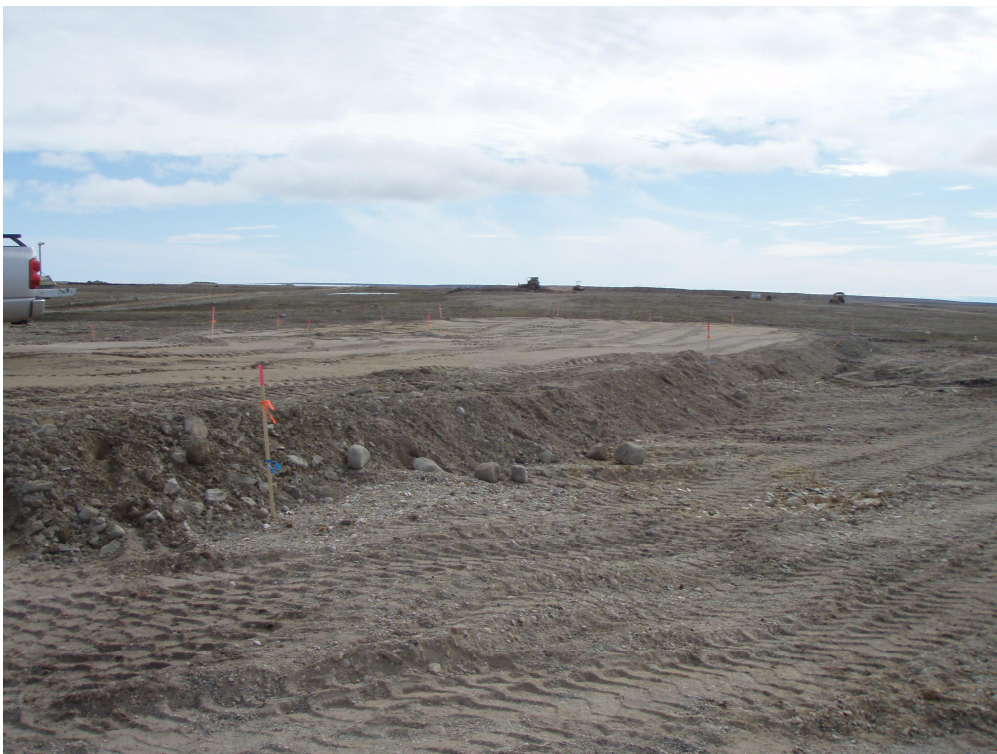
**Photograph 6:** Southeast Landfill Regrade.
