**THE COLLECTION OF LANDFILL
MONITORING DATA AT THE FORMER
CAM-1 DEW LINE SITE**

Jenny Lind Island, Nunavut

DRAFT REPORT– 2011 SEASON

DEFENCE CONSTRUCTION CANADA

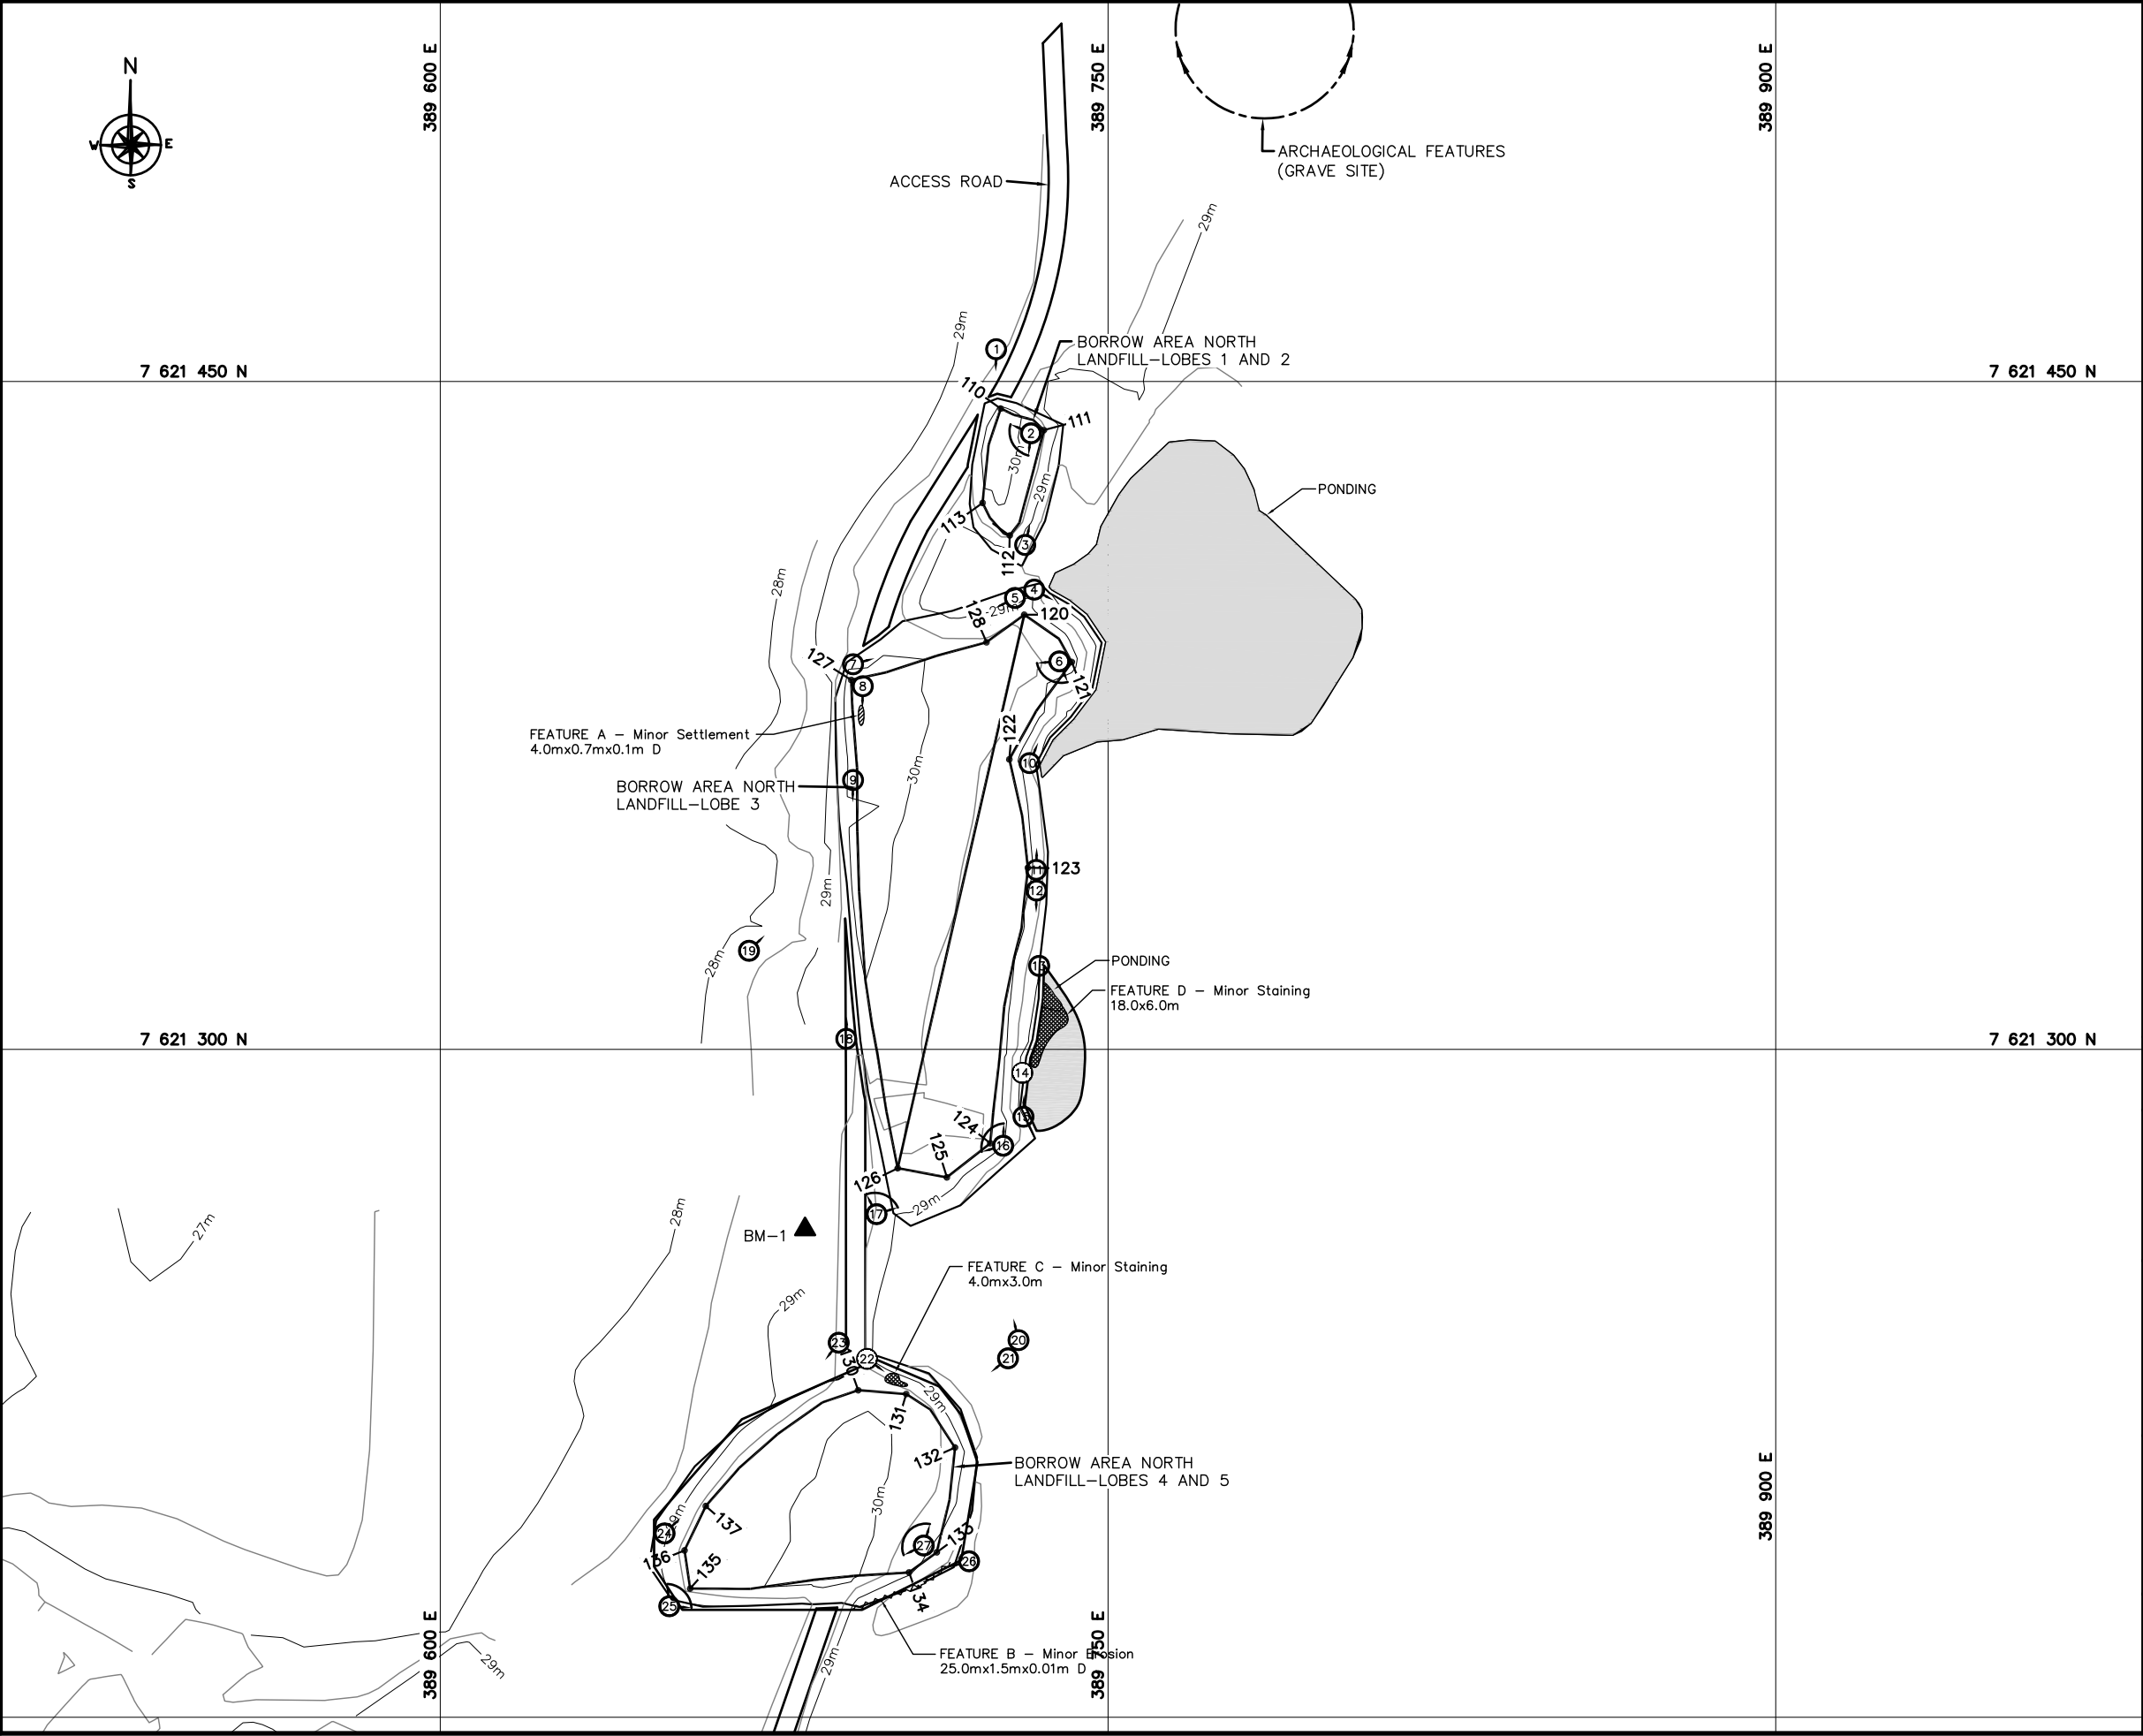
The Location Plan for the Borrow Area North Landfill has been completed as per the ToR and is presented in Figure CAM-1.2.

An indication of minor settlement was noted at one location, consisting of a linear depression on the northwest corner of Lobe 3 (Feature A). The 4 m by 0.7 m depression extended in a north-south direction and was 0.1m deep. This feature was not noted during the previous 2010 inspection.

One area of minor erosion was noted on the southeast side slope of the Lobes 4&5 regrade (Feature B). The erosion consisted of fines washing along approximately 25 linear meters of the toe of slope. Erosion appears to be the result of seasonal ponding along the southeast side of the lobe. This feature was dry at the time of the 2011 inspection and appears to be self-armouring with an acceptable severity rating. This feature was not noted during the previous 2010 inspection.

Two areas of discoloration (staining) were noted during the 2011 inspection, including one relatively small area on the north side slope of the Lobe 4&5 regrade (Feature C) and a larger area associated with a

Significant ponding was noted along the northeast side of Lobe 3 during the 2011 inspection. This area was consistent with findings from the 2002 site investigation and the 2010 landfill inspection and included observations of rust-colored staining in wetted areas along the toe of the lobe. There was no direct seepage from the landfill.

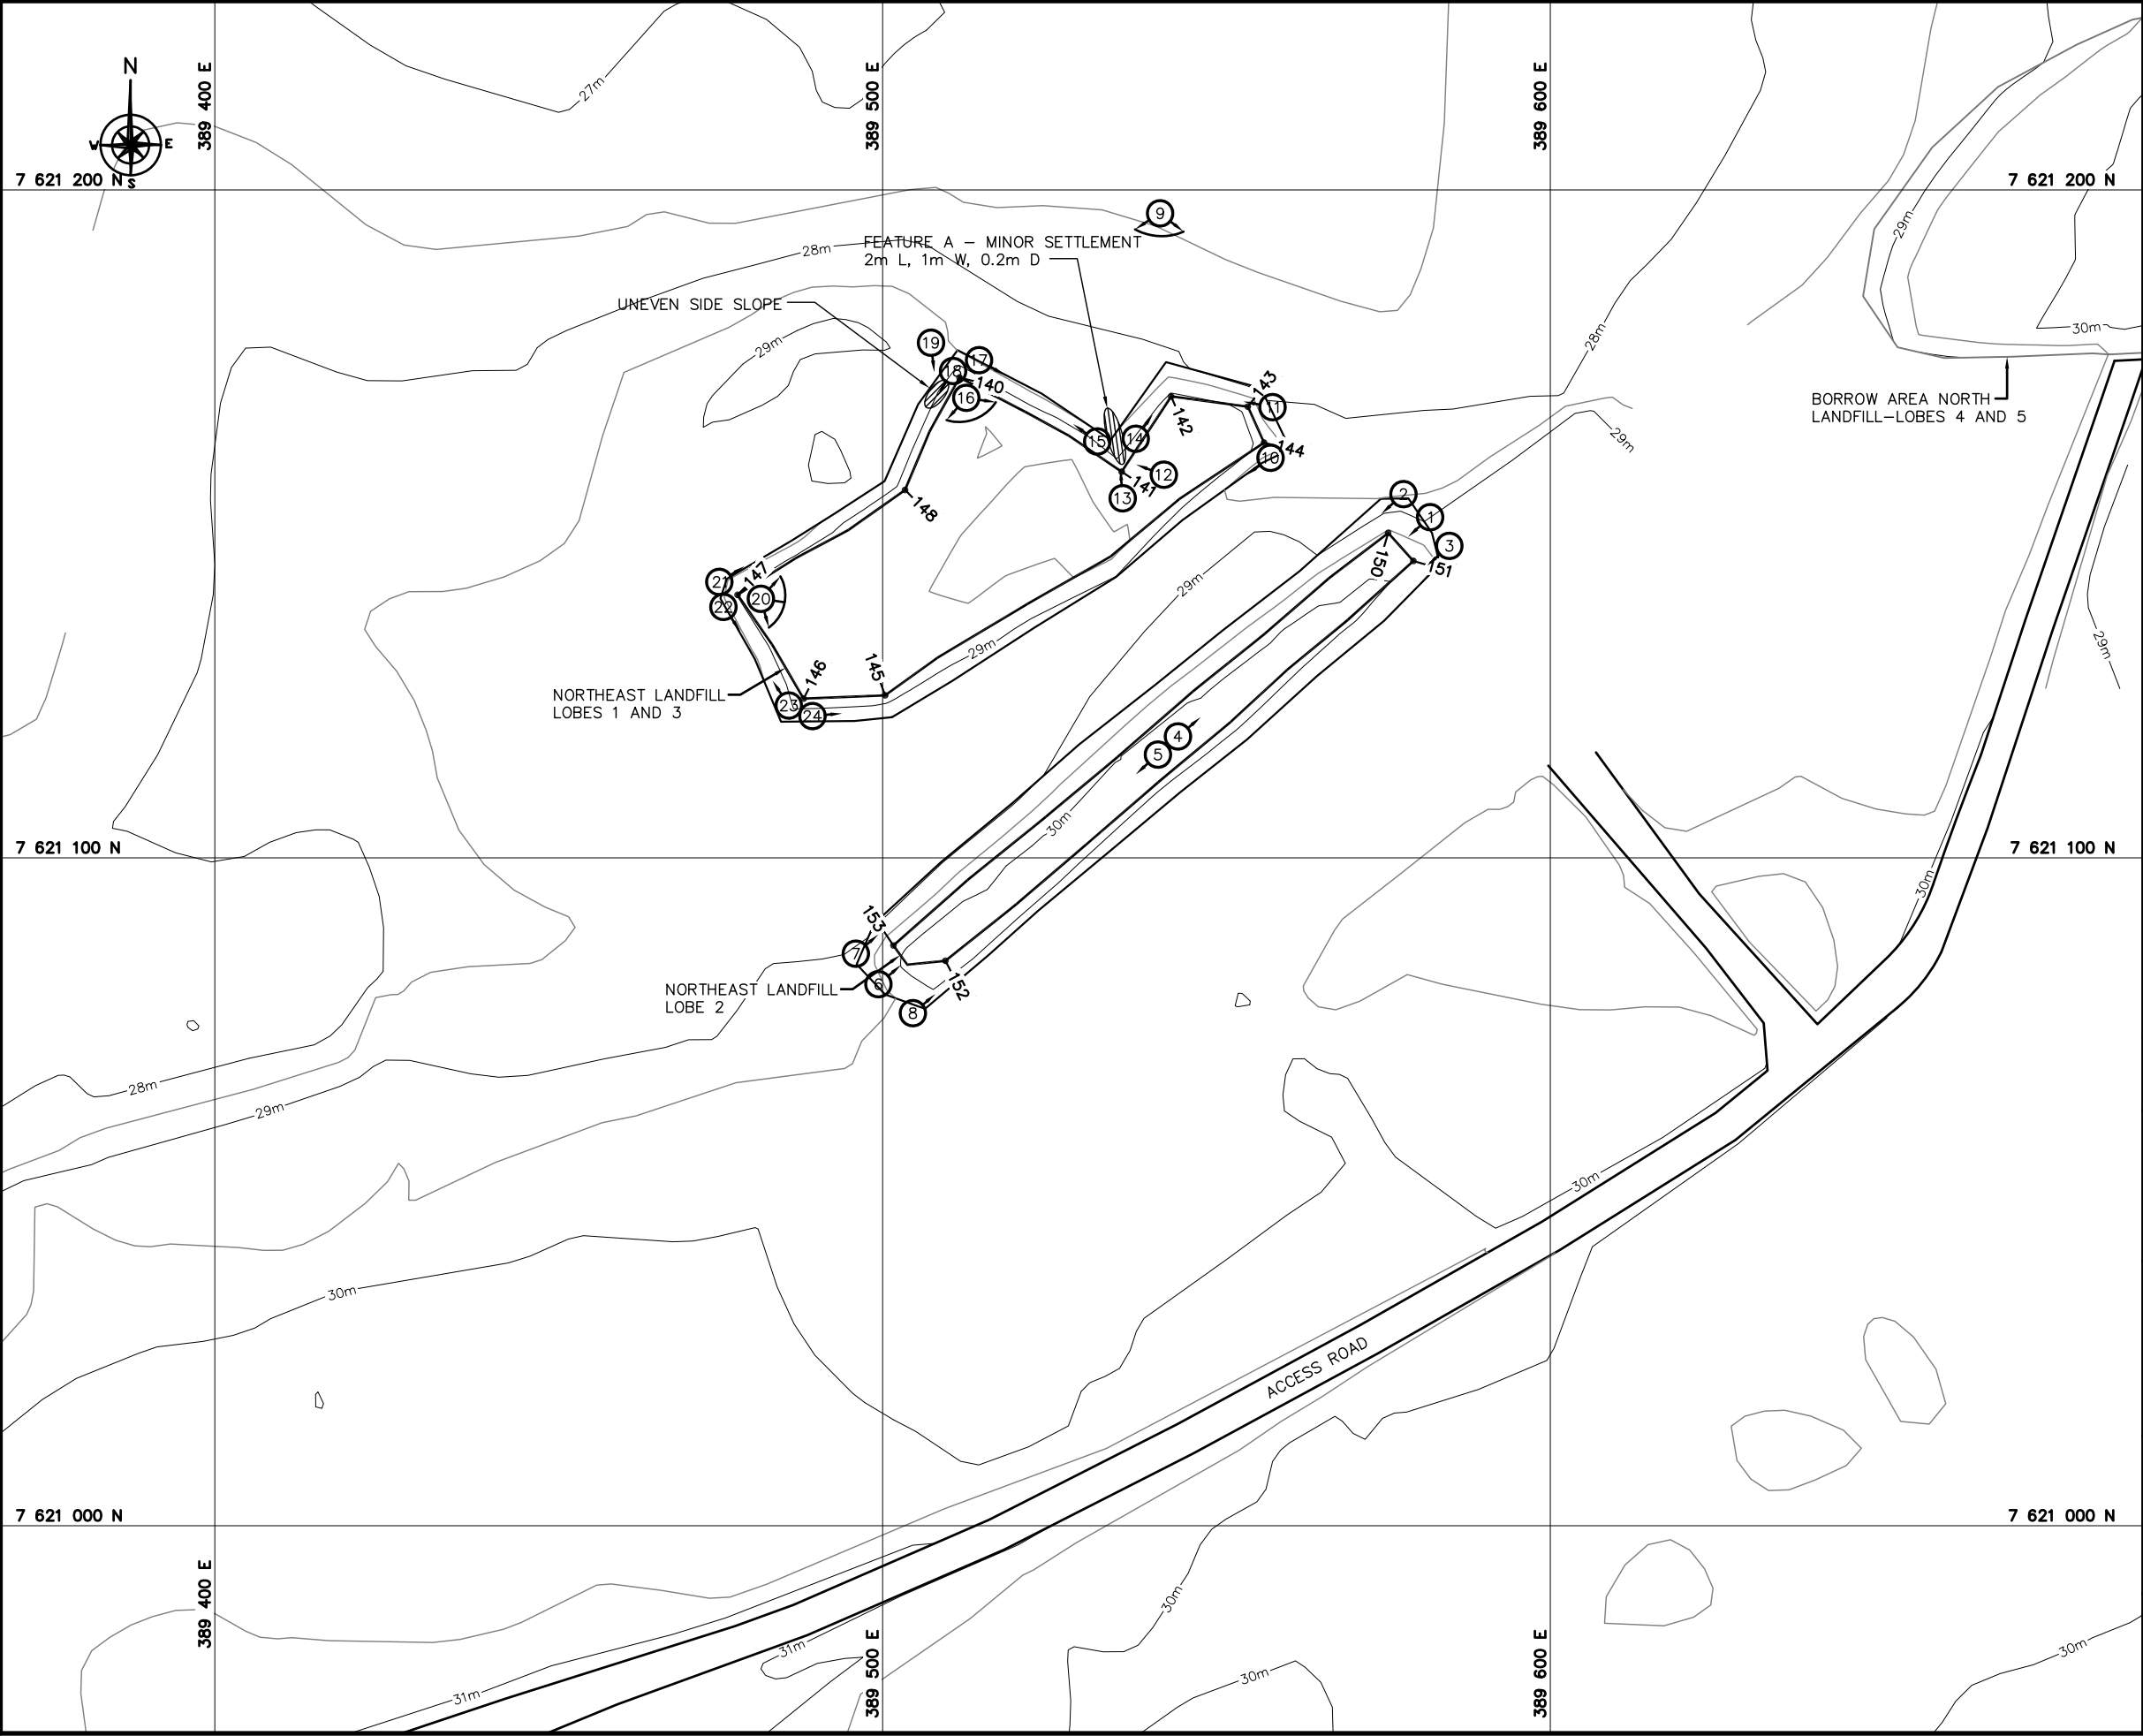
The Location Plan for the Northeast Landfill has been completed as per the ToR and is presented in Figure CAM-1.3.

An indication of minor settlement was noted at one location, consisting of a linear depression on the north inside corner of Lobes 1&3 regrade (Feature A). The 2 m by 1 m depression extended in a north-south direction and was 0.2 m deep. This feature was not noted during the 2010 inspection.

One 4 m by 4 m area of uneven side slope was noted on the northwest corner of the Lobes 1&3 regrade. A similar notation was made in the 2010 inspection report; however there was no photograph or dimension provided for year-to-year comparison. The uneven slope does not appear to be associated with settlement or erosion.

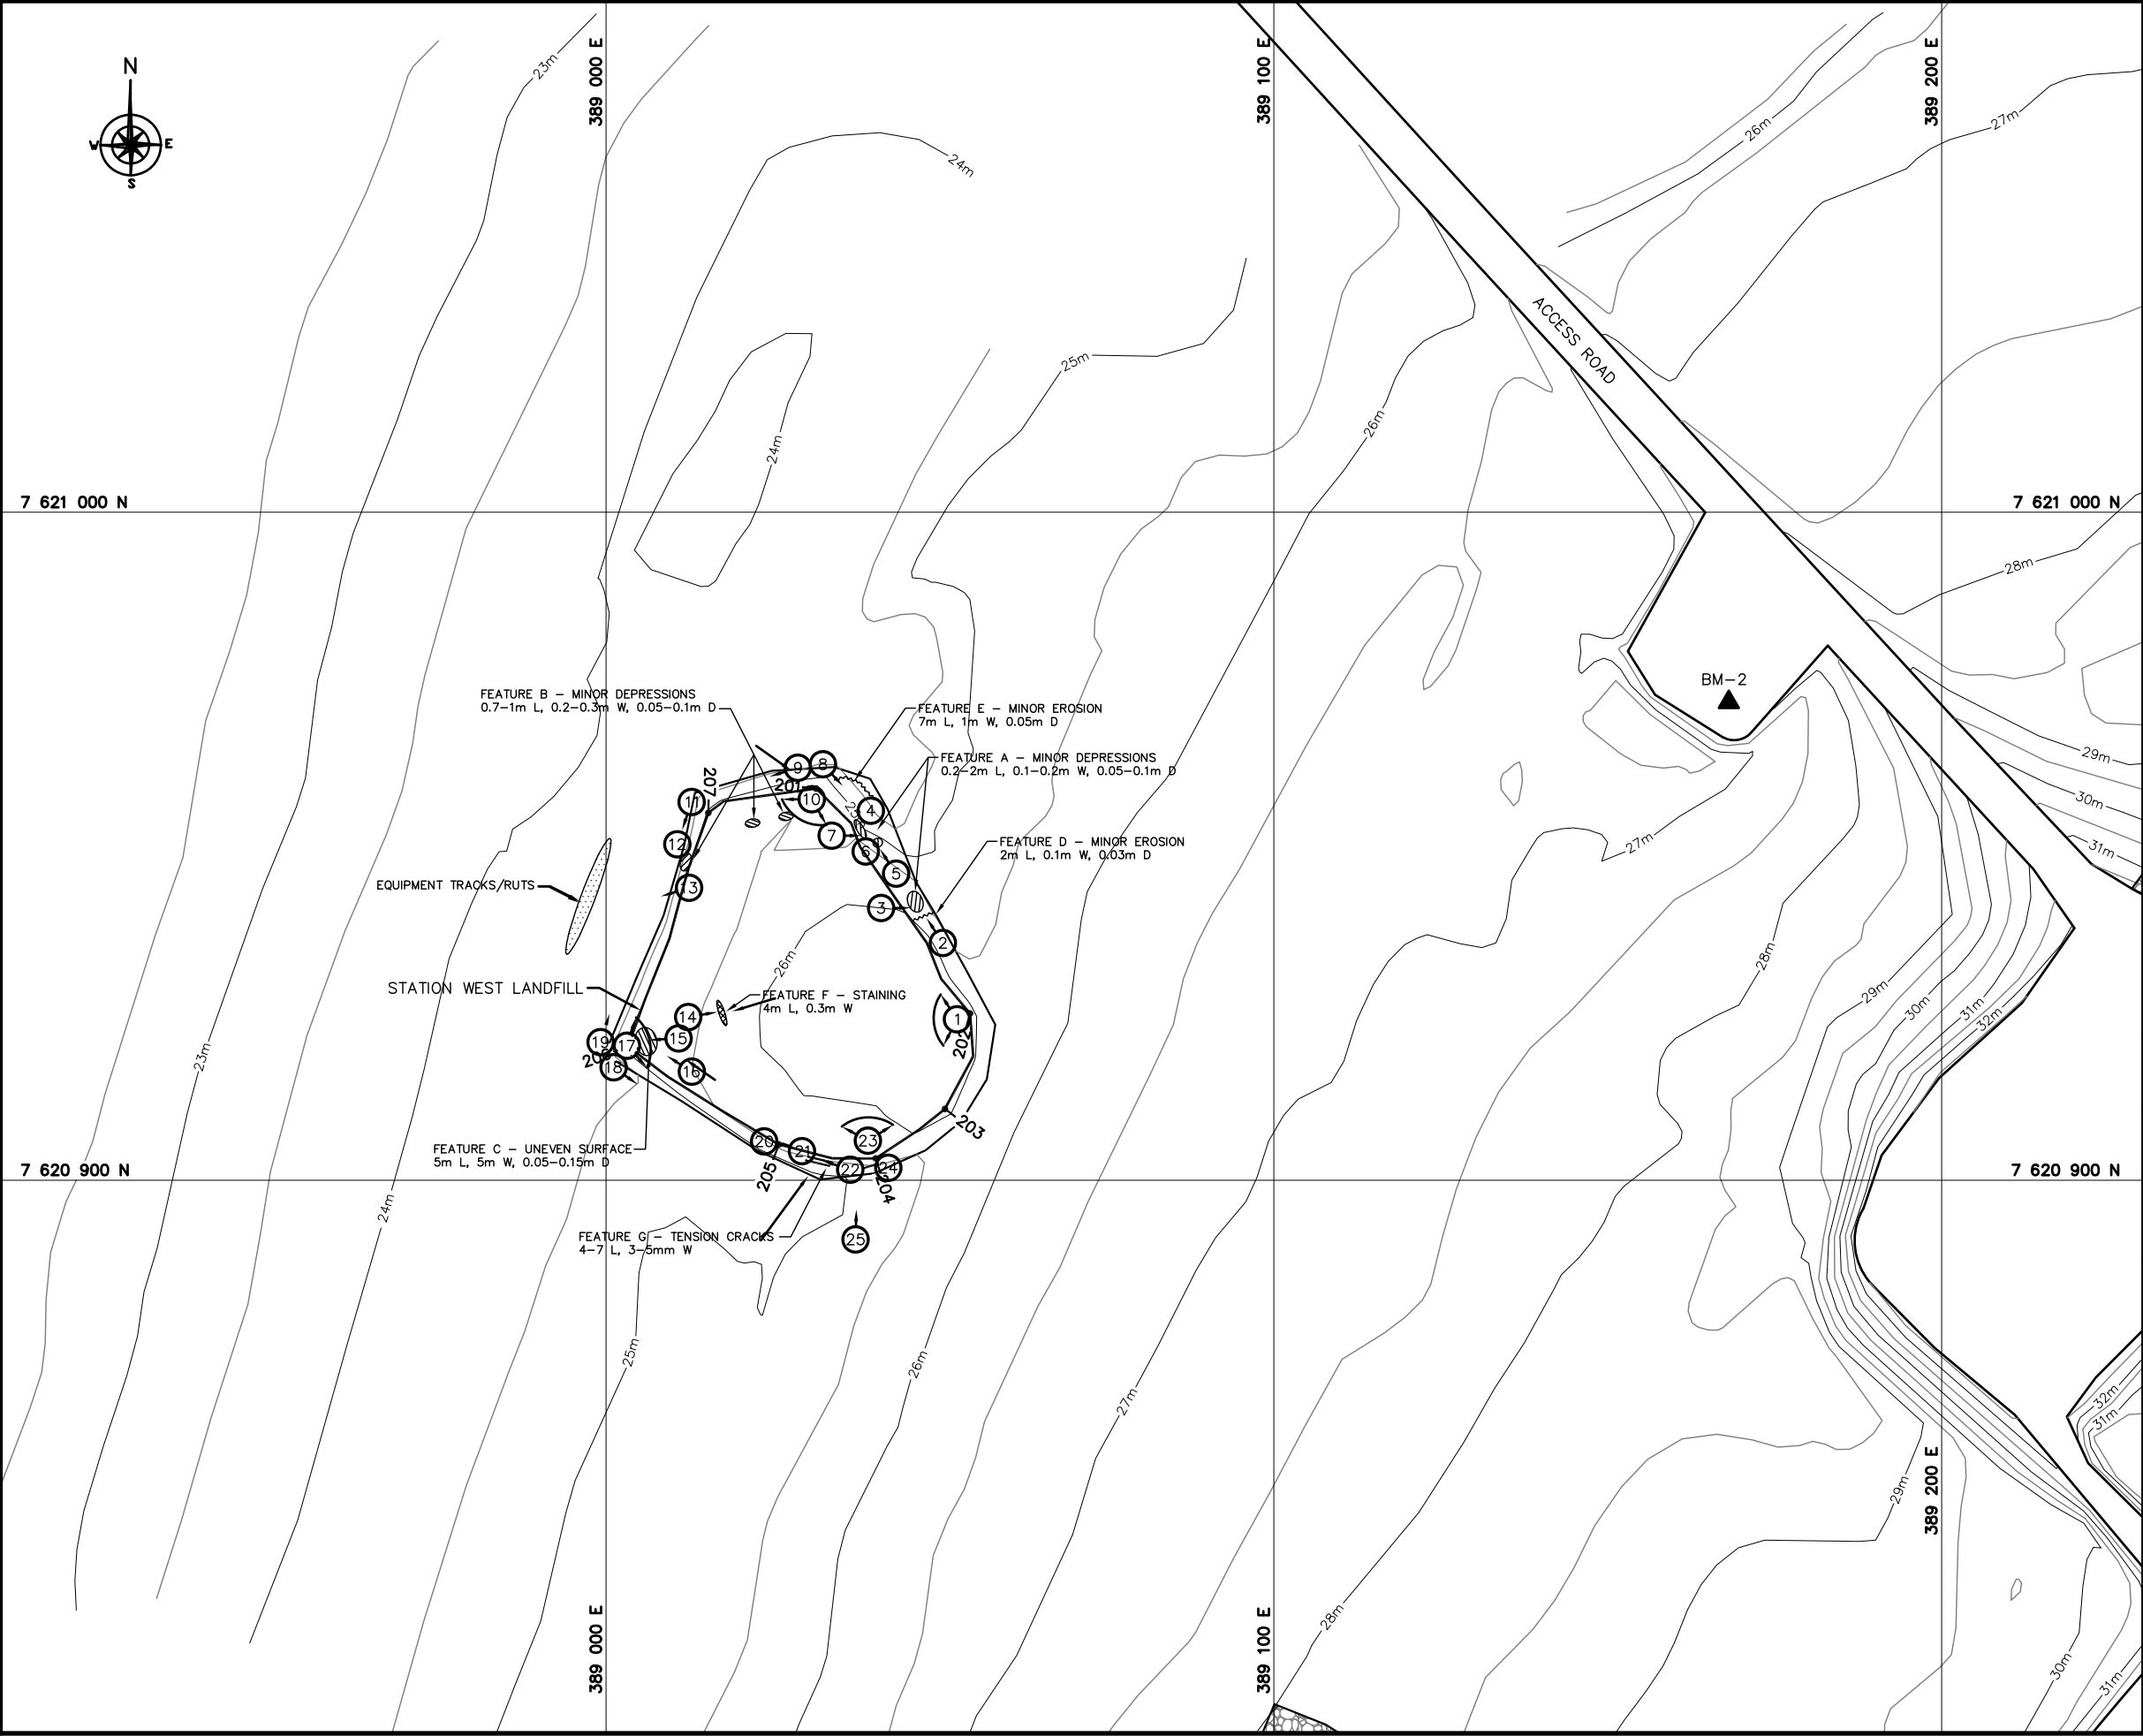
The Location Plan for the Station West Landfill has been completed as per the ToR and is presented in Figure CAM-1.4.

Indications of minor settlement were noted in three general areas (Features A, B and C) on the landfill surface, including: five relatively small sized (round and linear) depressions situated on the northeast side slope (Feature A); four small depressions on the north cover area (Feature B); and a moderate sized uneven area on the east corner of the landfill (Feature C). All three features have an acceptable severity rating. With the exception of Feature C, all areas of settlement were not noted during the 2010 inspection.

Two areas (Features D and E) of erosion were noted on the surface, side slopes and/or margins of the Station West Landfill during the 2011 inspection. Feature D consisted of a shallow linear runoff feature extending down the east side slope, whereas Feature E consisted of a larger area extending along the north margin of the landfill where seasonal ponding has resulted in minor erosion along the toe and side slope. Both areas appear stable and have an acceptable severity rating. Observations appear consistent with the 2010 inspection.

One localized area of staining was noted on the west cover area of the landfill (Feature F). The linear rust coloured stain appears consistent with findings from the 2010 inspection.

Two parallel and one single tension crack were noted on the southeast corner of the landfill (Feature G). The cracks ranged in length from 4 to 7 m long, were typically 3 to 5 mm wide and extended in a perpendicular direction to the slope. The location and frequency of cracks on the southeast corner appears consistent with findings from the previous 2010 inspection. Based on observations made during the 2011 inspection, the landfill surface appears stable and has an acceptable severity rating.

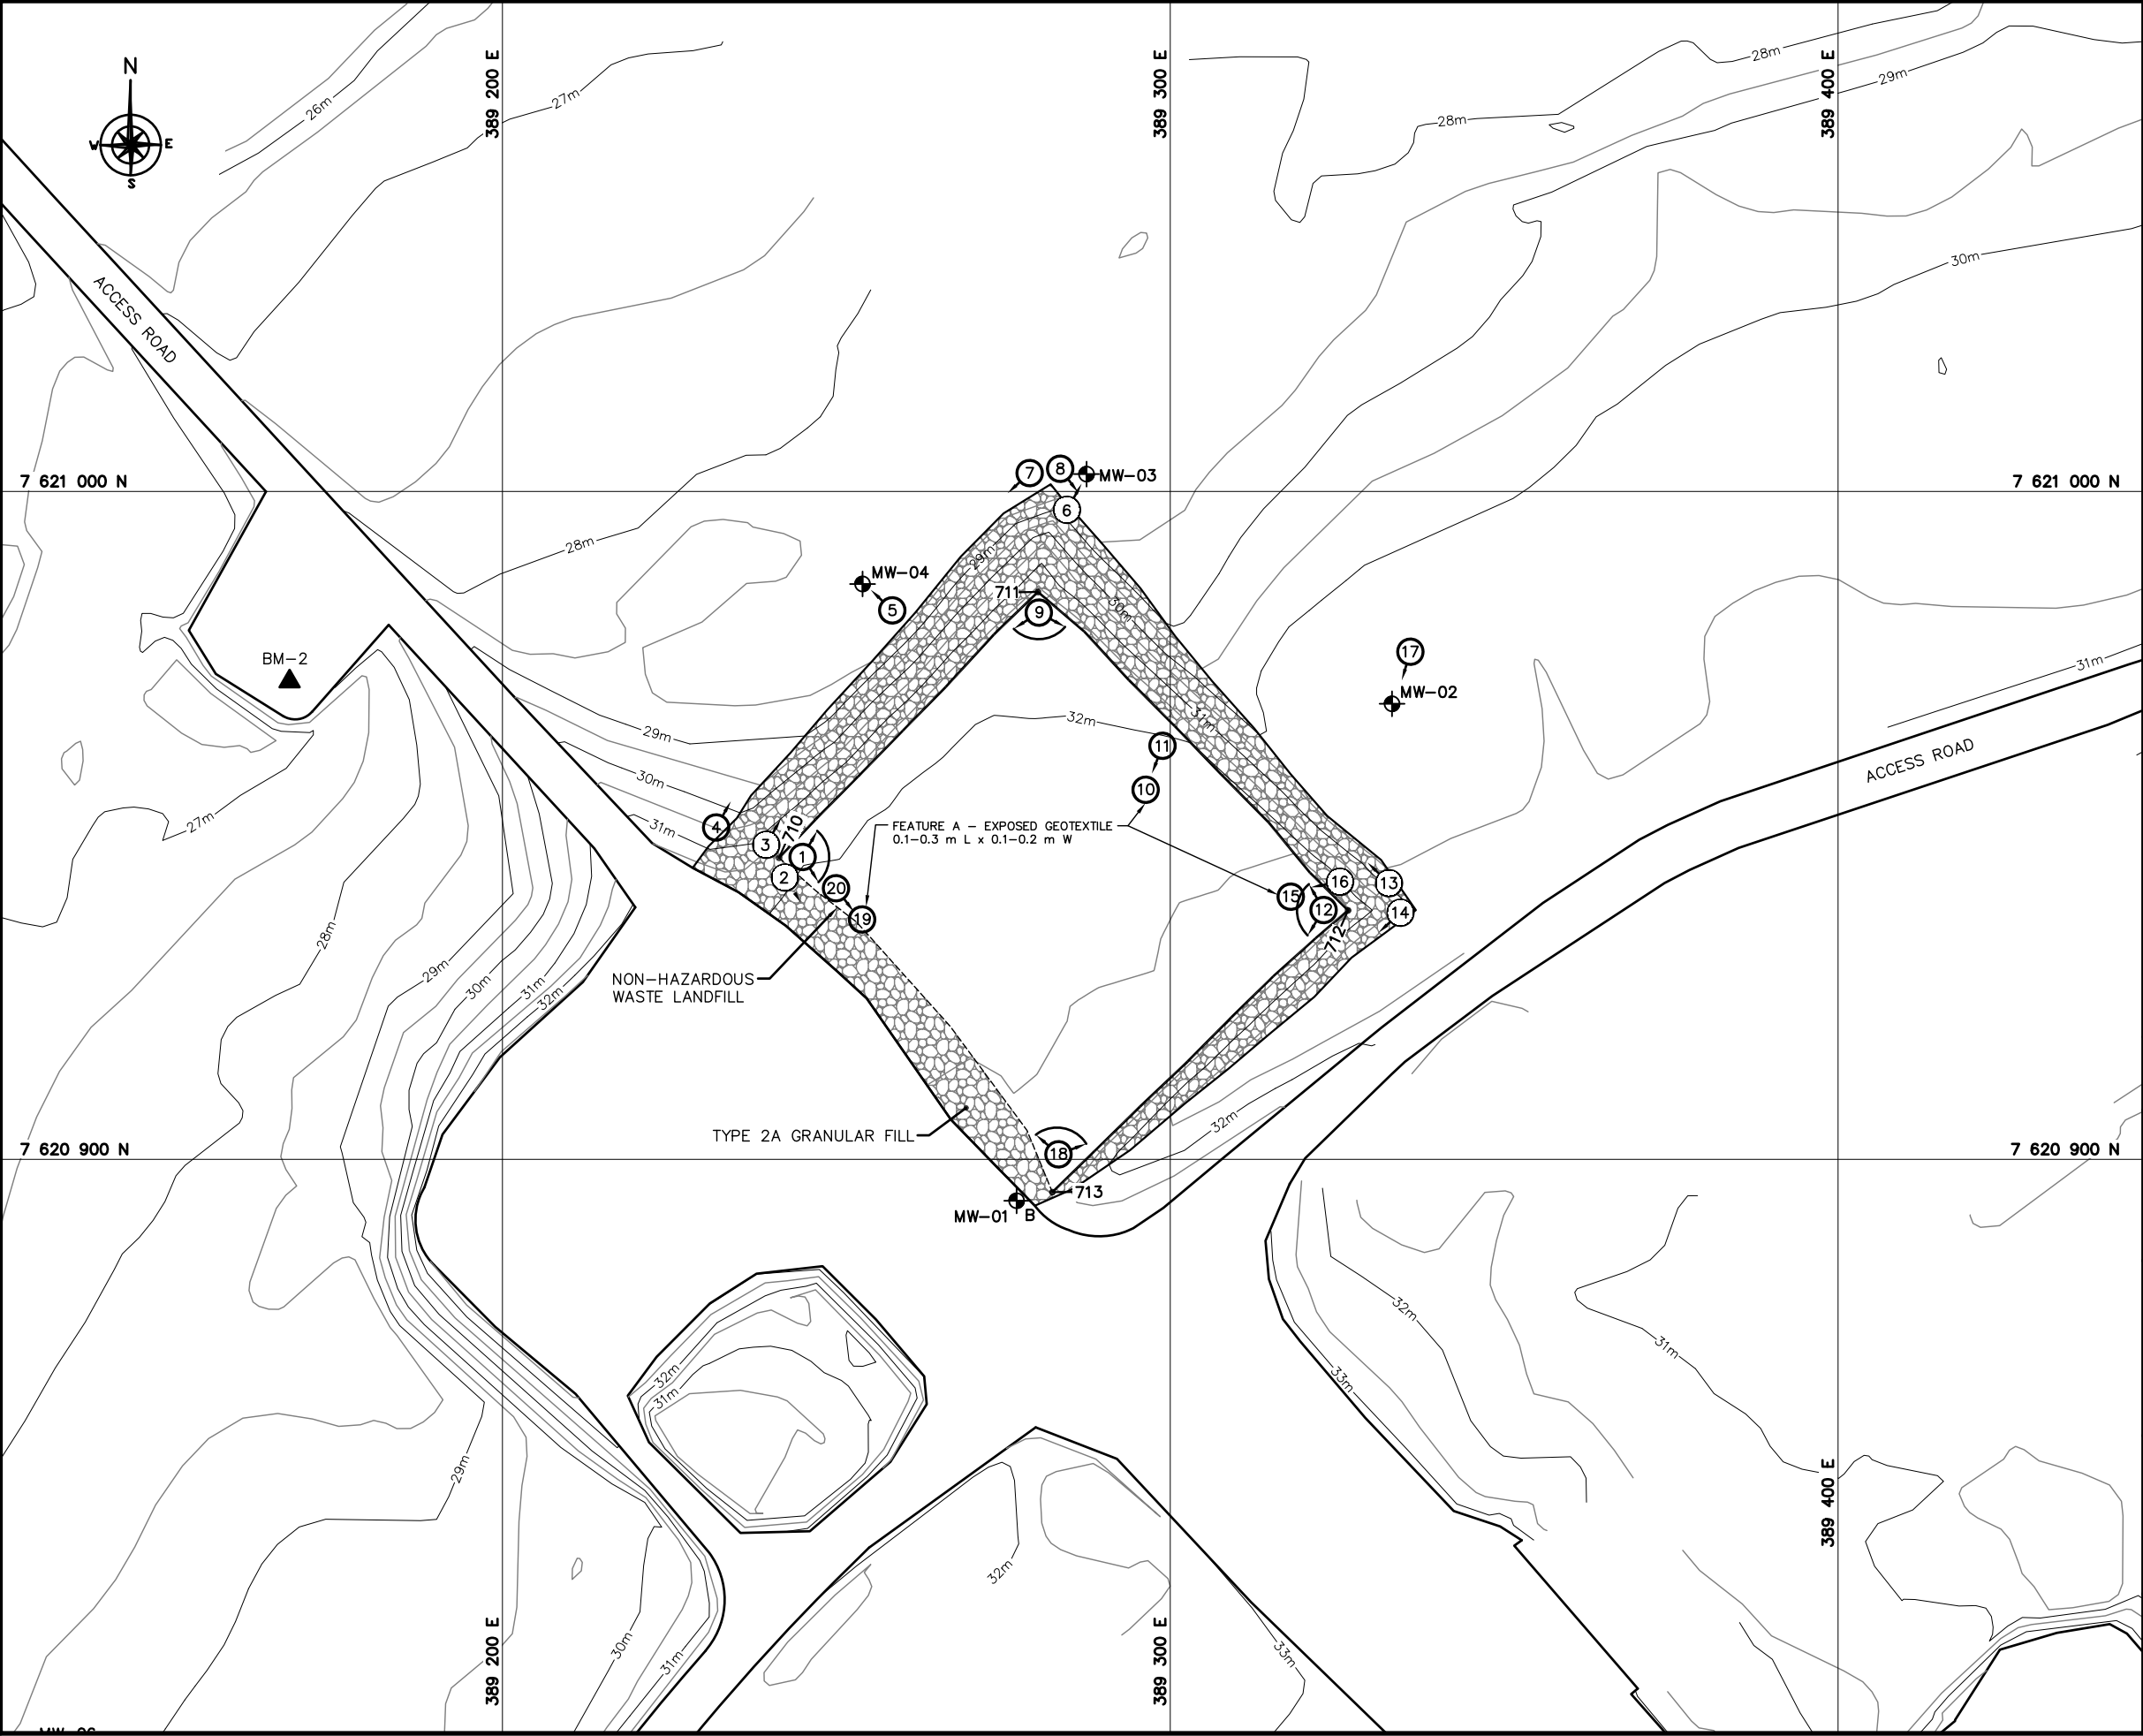
The Location Plan for the NHWLF has been completed as per the ToR and is presented in Figure CAM-1.5.

Three areas of partially exposed black geotextile material were noted on the northeast, east and west sides of the landfill surface (Feature A). This feature appears unchanged from the previous 2010 inspection. There was no other indication of debris at the landfill.

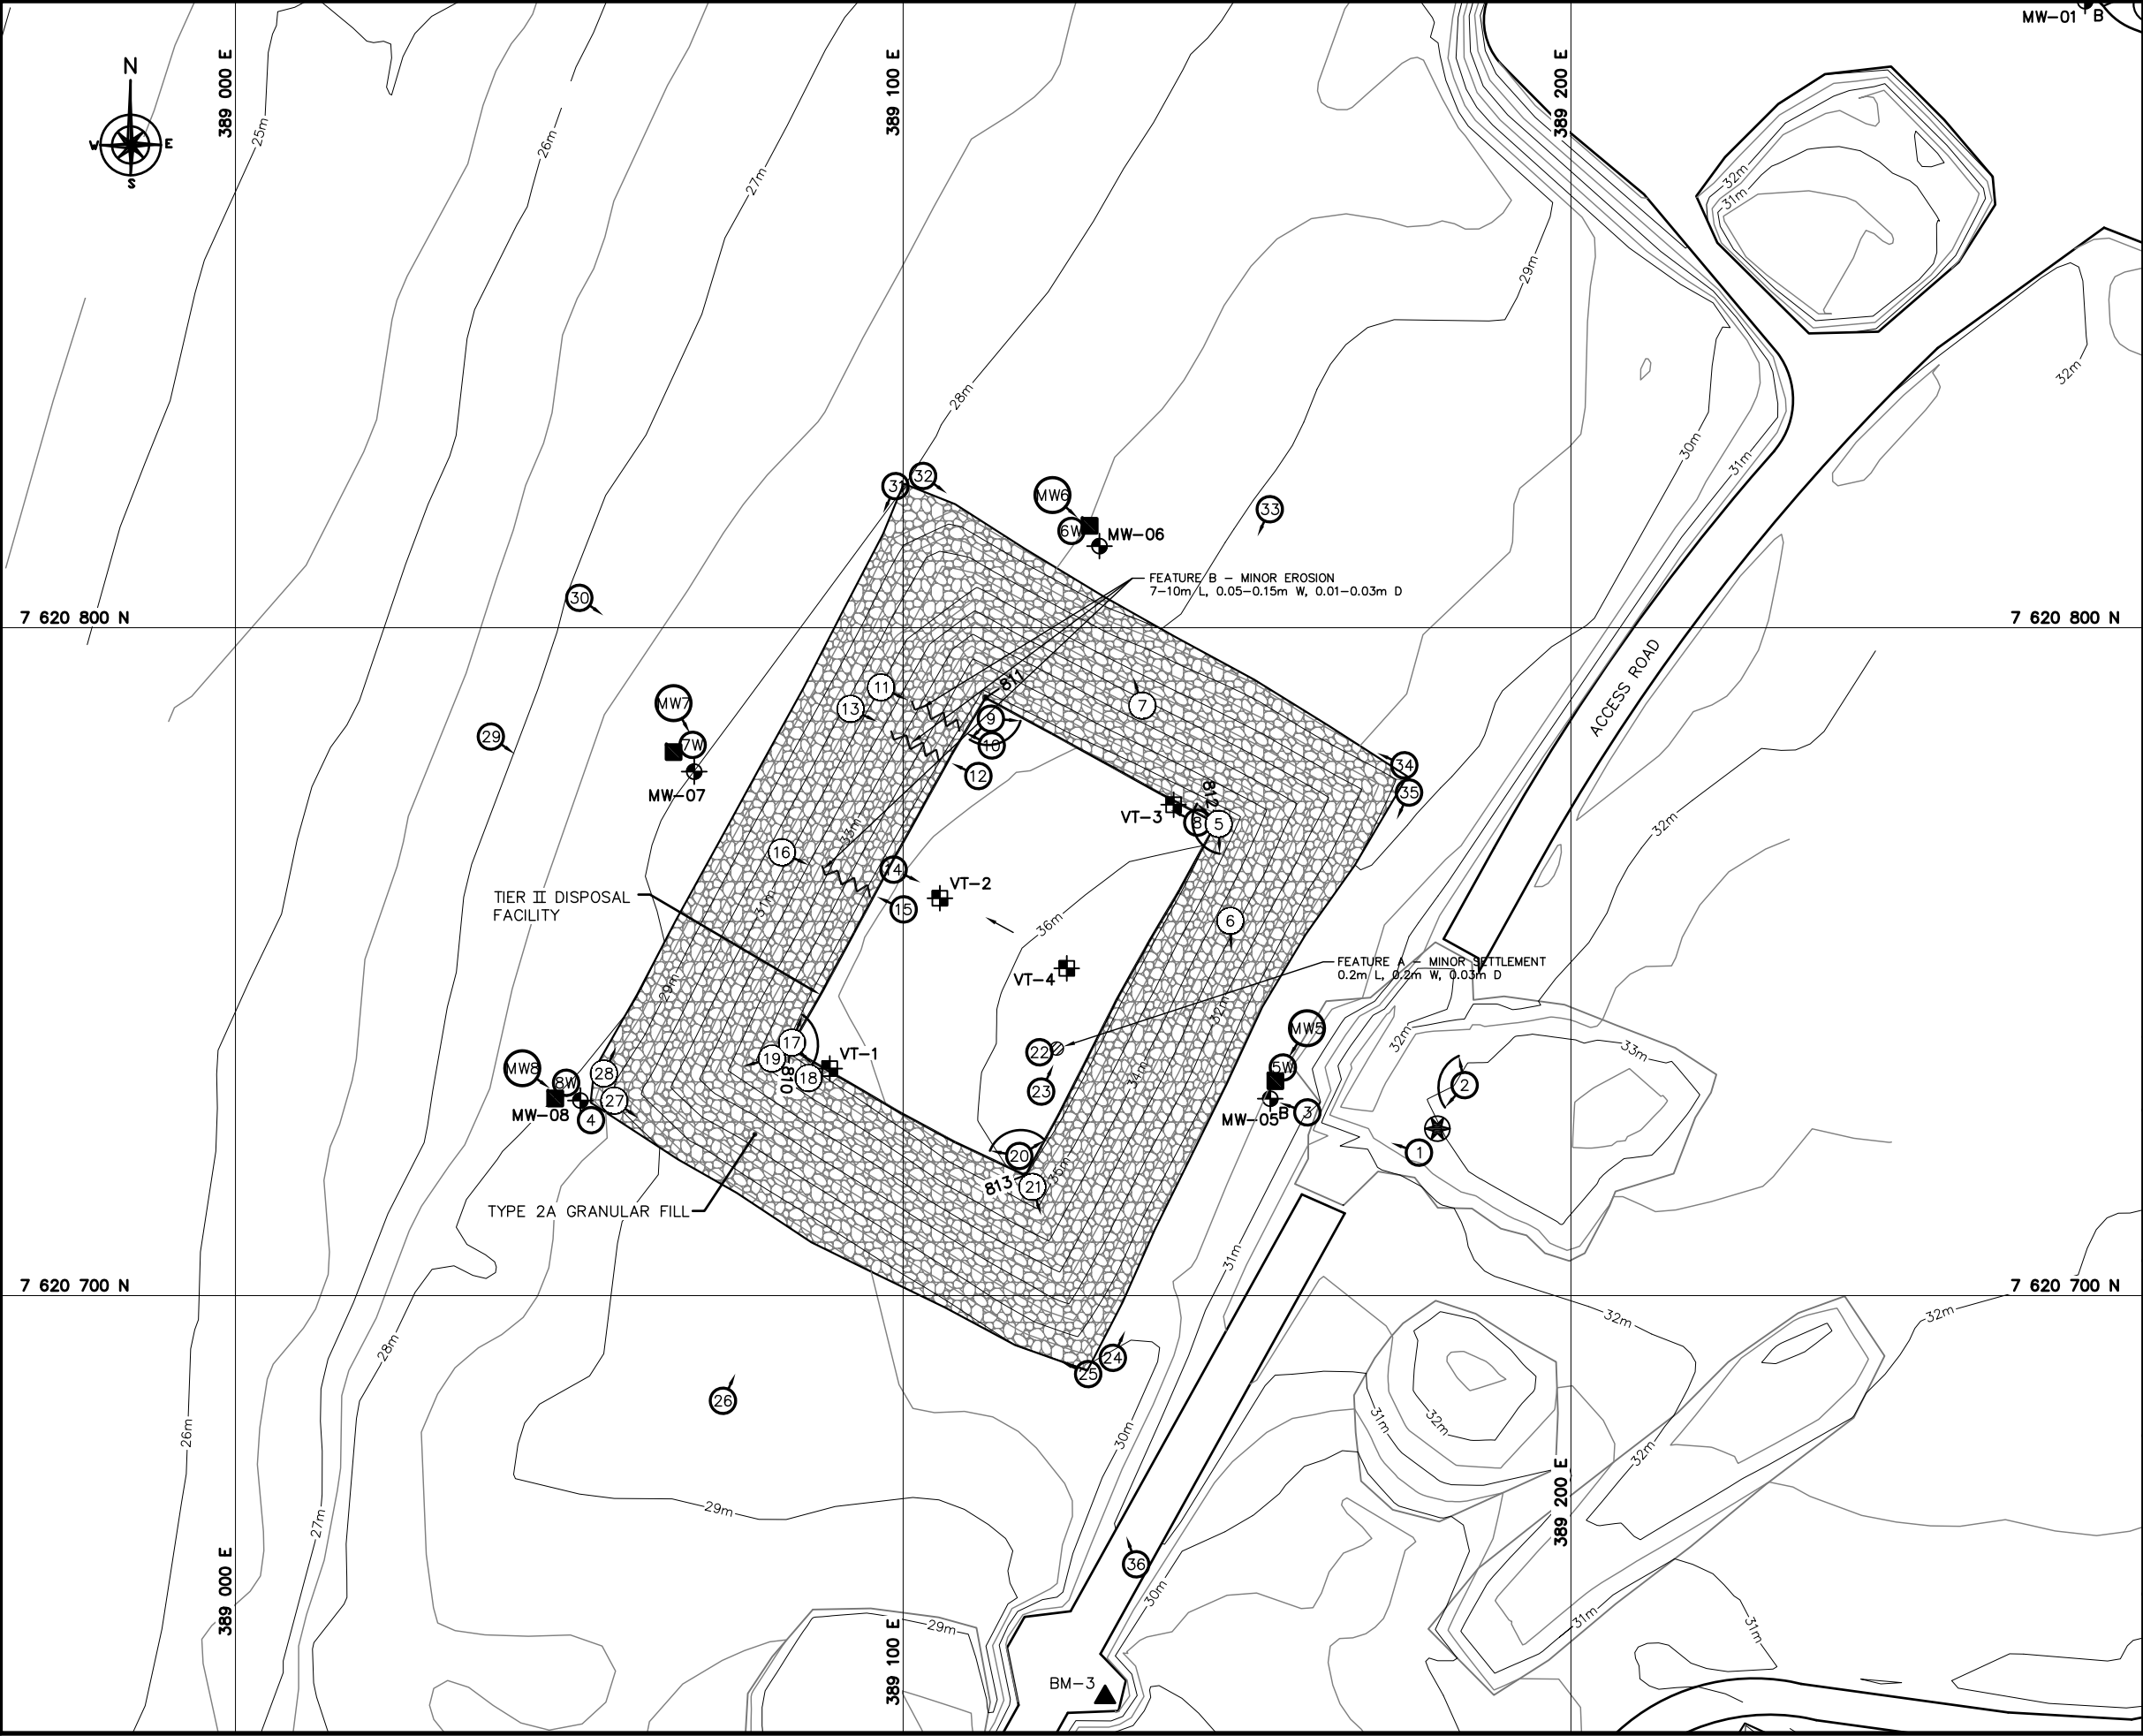
The Location Plan for the Tier II Soil Disposal Facility has been completed as per the ToR and is included in the following page as Figure CAM-1.6.

An indication of minor settlement was noted at a single location on the southeast area of the landfill cover (Feature A). It consists of an isolated “pothole” depression measuring 0.2 m in diameter. No settlement was noted at the facility during the 2010 inspection.

Evidence of minor surface erosion was noted at three locations on the northwest facing slope (Feature B) of the facility. The erosion at the three locations was shallow and extended perpendicular to the slope from crest to 7 to 10 m downslope. The areas affected appear to be self-armouring and have an acceptable severity rating. Overall, the facility cover appears stable.
