**THE COLLECTION OF LANDFILL  
MONITORING DATA AT THE FORMER  
CAM-1 DEW LINE SITE**

Jenny Lind Island, Nunavut

**DRAFT REPORT – 2012 SEASON  
Monitoring Event – 2**

**DEFENCE CONSTRUCTION CANADA**

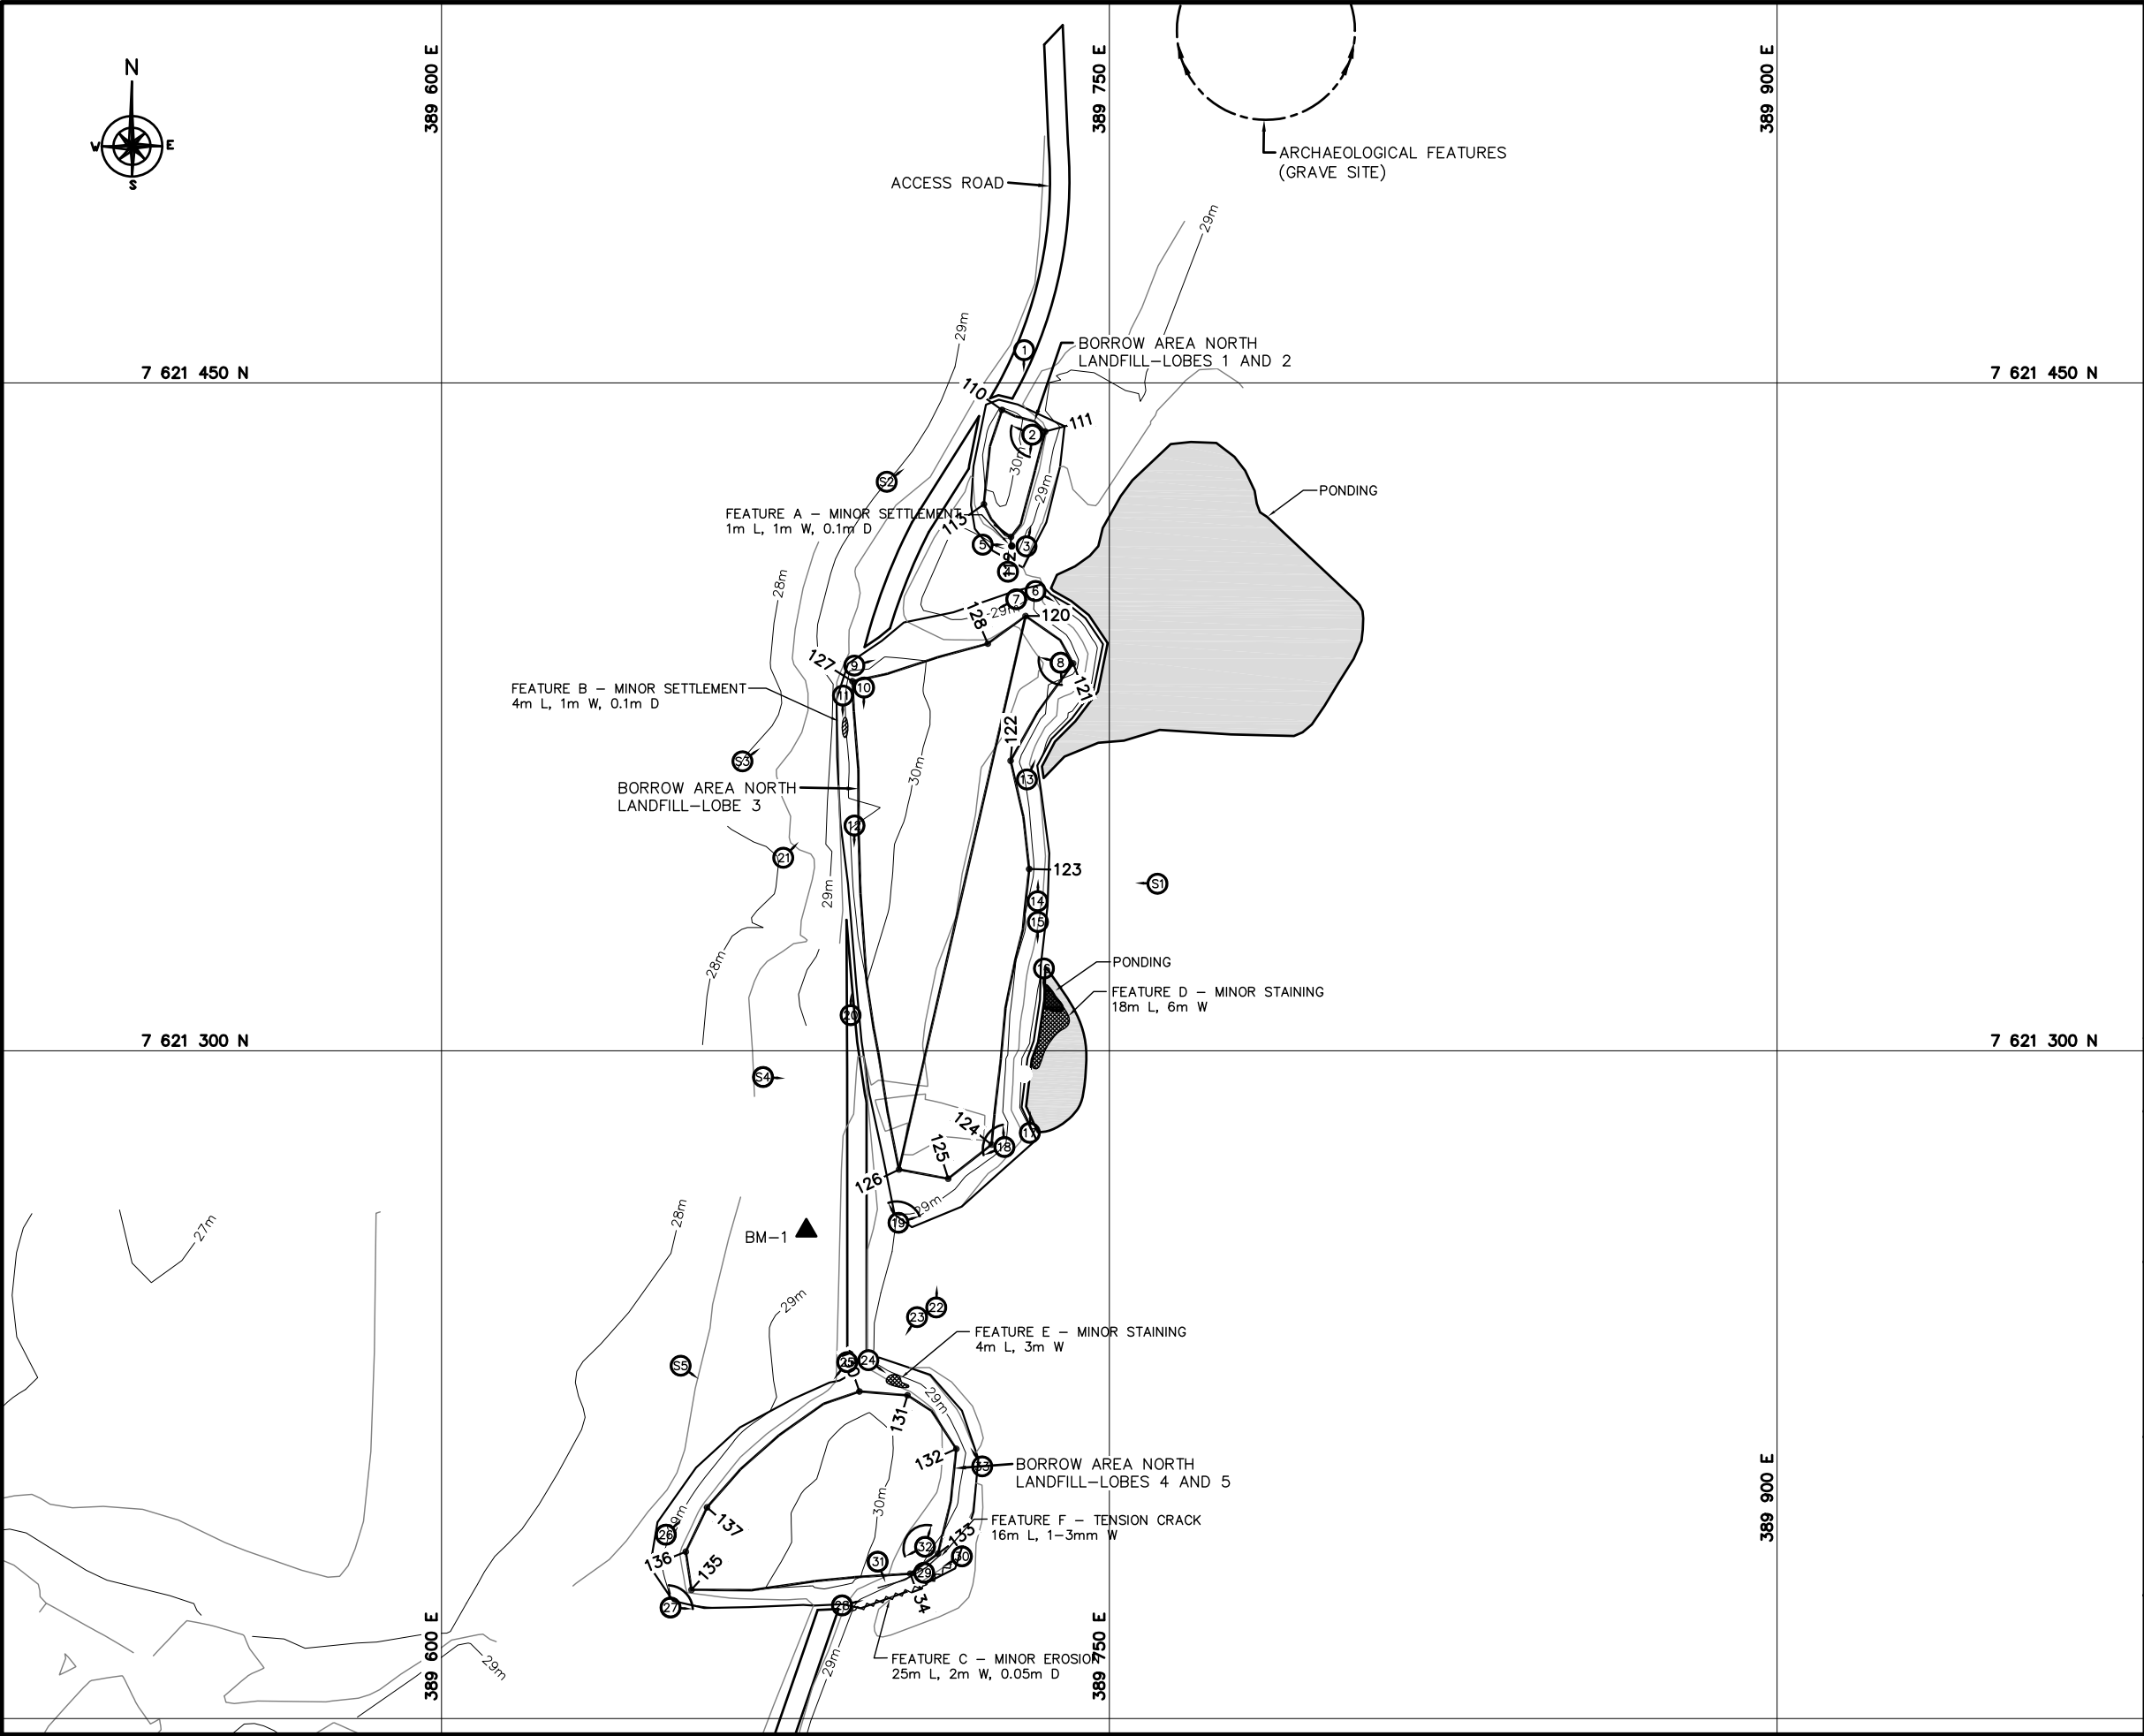
The Location Plan for the Borrow Area North Landfill has been completed as per the ToR and is presented in Figure CAM-1.2.

Indications of minor settlement were noted at two locations, consisting of a 1m by 1m localized depression on the southeast side slope of Lobes 1&2 (Feature A), and a linear depression on the northwest side slope of Lobe 3 (Feature B). Feature A was not noted during the previous inspection, whereas Feature B was marginally wider than previously noted in 2011.

One area of minor erosion was noted on the southeast side slope of the Lobes 4&5 regrade (Feature C). The erosion consisted of fines washing along approximately 25 linear meters of the toe of slope. Erosion appears to be the result of seasonal ponding along the southeast side of the lobe. This feature was dry at the time of the 2012 inspection and appears to be self-armouring with an acceptable severity rating. This feature was consistent with the previous 2011 inspection.

Two areas of discoloration (staining) were noted during the 2012 inspection, including one relatively small area on the north side slope of the Lobe 4&5 regrade (Feature D) and a larger area associated with a wetted area immediately east of Lobe 3 (Feature E). There were no odours noted with either area at the time of the 2012 inspection and observations at both areas were consistent with the previous 2011 inspection.

Significant ponding was noted along the northeast side of Lobe 3 during the 2012 inspection. This area was consistent with findings from the 2002 site investigation and 2010 and 2011 landfill inspections and included observations of rust-colored staining in wetted areas along the toe of the lobe. Direct seepage from the landfill was not observed.

One discontinuous tension crack was noted on the southeast corner of Lobes 4&5 (Feature F). The crack was noted to extend approximately 16 m in a northeast-southwest direction just below the crest and varied between 1-3 mm in width. The crack was not noted during the previous 2011 inspection.

Staining	Yes	FEATURE D See Figure CAM-1.2 (Lobe 3 - E side)	18 m	6 m	Unknown	N/A	Rust coloured staining east of Lobe 3	BANLF-15,16	Acceptable	Not in contact with landfill.
		FEATURE E See Figure CAM-1.2 (Lobes 4&5 - N side)	4 m	1 - 3 m	Unknown	Isolated (<1%)	Minor staining of cover material on side slope	BANLF-24	Acceptable	N/A
Vegetation Stress	No	N/A	N/A	N/A	N/A	N/A	N/A	N/A	Not Observable	N/A
Seepage Points	No	N/A	N/A	N/A	N/A	N/A	N/A	N/A	Not Observable	N/A
Debris Exposed	No	N/A	N/A	N/A	N/A	N/A	N/A	N/A	Not Observable	N/A
Presence/Condition of Monitoring Instruments	No	N/A	N/A	N/A	N/A	N/A	N/A	N/A	Not Observable	N/A
Other Features of Note:	Yes	See Figure CAM-1.2 (Lobe 3 - E and NE sides)	Varies	Varies	Unknown	N/A	Water ponding along toe	BANLF-6,13,14	Acceptable	Ponding consistent with observations prior to landfill regrading and 2011 inspection. Slopes appear stable.
		FEATURE F See Figure CAM-1.2 (Lobes 4&5- SE corner - <b>New Obs.</b> )	16 m	1 - 3 mm	Unknown	Isolated (<1%)	Single discontinuous tension crack	BANLF-29,30	Acceptable	Ponding consistent with observations prior to landfill regrading and 2011 inspection. Slopes appear stable.

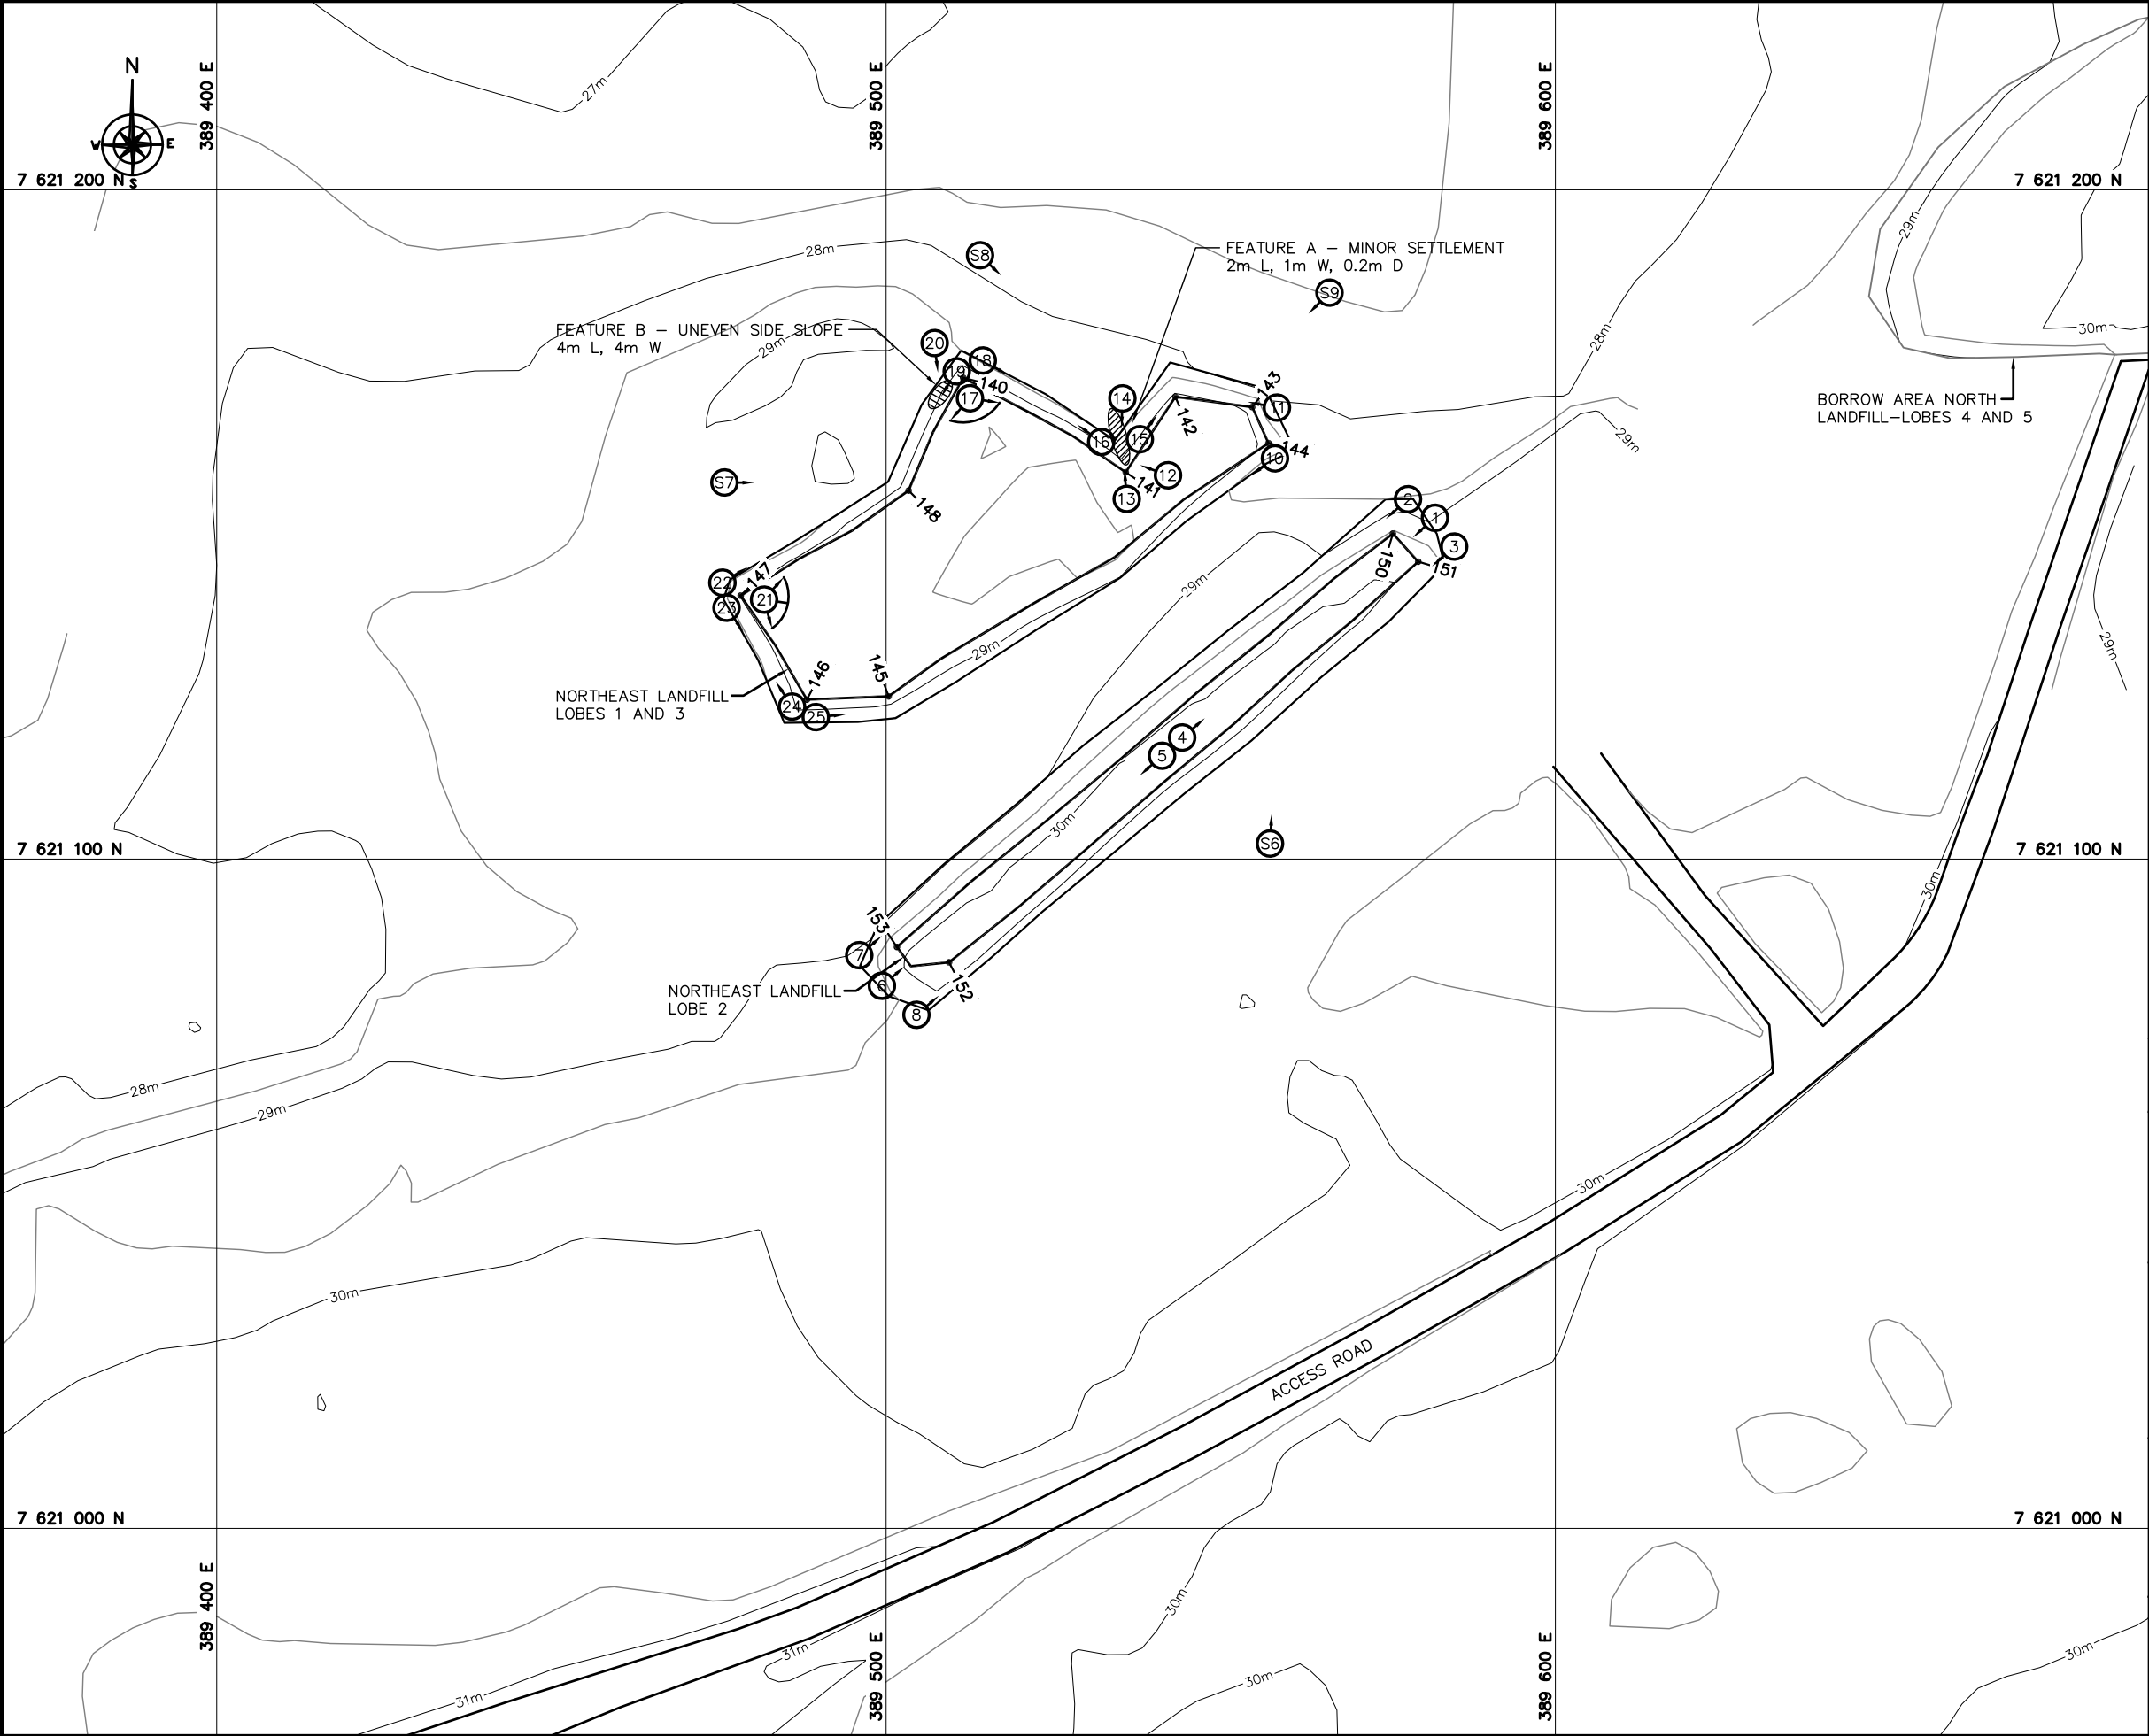
The Location Plan for the Northeast Landfill has been completed as per the ToR and is presented in Figure CAM-1.3.

An indication of minor settlement was noted at one location, consisting of a linear depression on the north inside corner of Lobes 1&3 regrade (Feature A). The 2 m by 1 m depression extended in a north-south direction and was 0.2 m deep. This feature was consistent with the previous 2011 inspection.

One 4 m by 4 m area of uneven side slope was noted on the northwest corner of the Lobes 1&3 regrade. A similar notation was made in the 2010/11 inspection reports. The uneven slope does not appear to be associated with settlement or erosion.

Checklist Item	Present (Yes/No)	Location	Length	Width	Depth	Extent	Description	Photographic Record	Severity Rating	Additional Comments
Settlement	Yes	FEATURE A See Figure CAM-1.3 (Lobes 1 & 3 - N side slope)	2 m	1 m	0.2 m	Isolated (<1%)	Minor settlement on inside corner slope	NELF-12, 13, 14	Acceptable	Cover and slopes appear stable.
Erosion	No	N/A	N/A	N/A	N/A	N/A	N/A	N/A	Not Observable	N/A
Frost Action	No	N/A	N/A	N/A	N/A	N/A	N/A	N/A	Not Observable	N/A
Animal Burrows	No	N/A	N/A	N/A	N/A	N/A	N/A	N/A	Not Observable	N/A
Vegetation	No	N/A	N/A	N/A	N/A	N/A	N/A	N/A	Not Observable	N/A
Staining	No	N/A	N/A	N/A	N/A	N/A	N/A	N/A	Not Observable	N/A
Vegetation Stress	No	N/A	N/A	N/A	N/A	N/A	N/A	N/A	Not Observable	N/A
Seepage Points	No	N/A	N/A	N/A	N/A	N/A	N/A	N/A	Not Observable	N/A
Debris Exposed	No	N/A	N/A	N/A	N/A	N/A	N/A	N/A	Not Observable	N/A
Presence/Condition of Monitoring Instruments	No	N/A	N/A	N/A	N/A	N/A	N/A	N/A	Not Observable	N/A

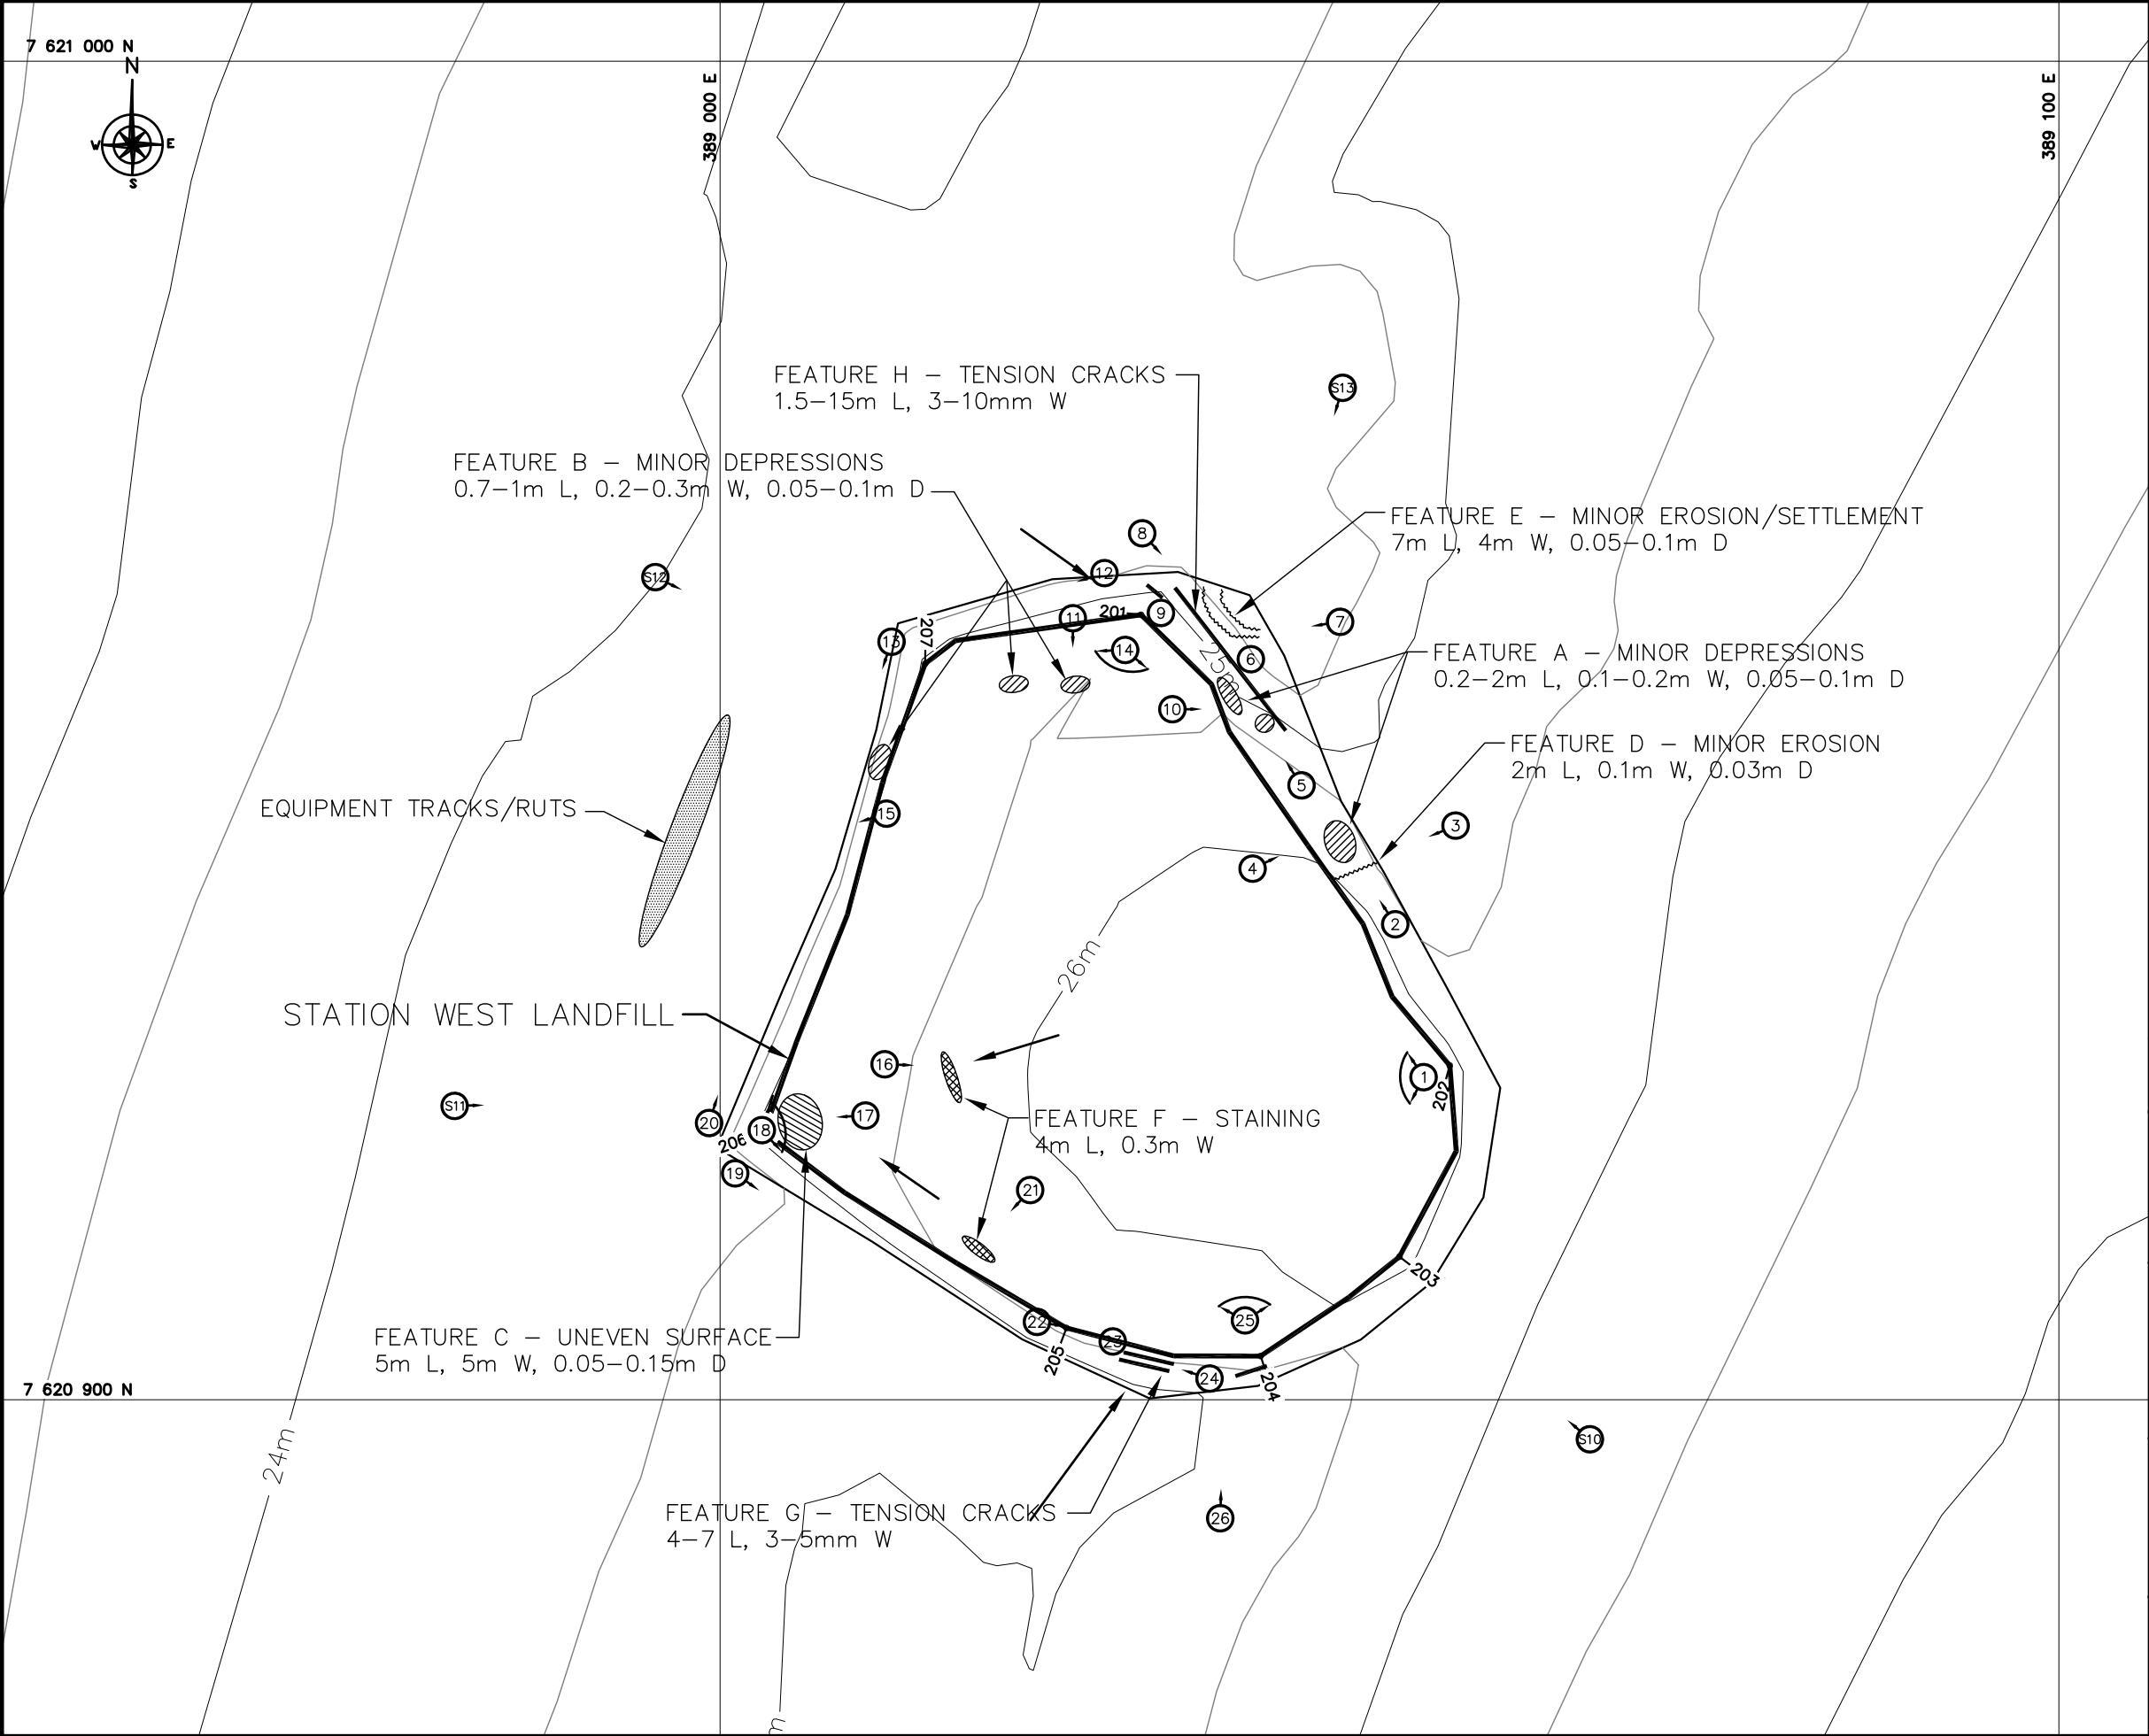
The Location Plan for the Station West Landfill has been completed as per the ToR and is presented in Figure CAM-1.4.

Indications of minor settlement were noted in three general areas (Features A, B and C) on the landfill surface, including: five relatively small sized (round and linear) depressions situated on the northeast side slope (Feature A); three small depressions on the north cover and northwest side slope areas (Feature B); and a moderate sized uneven area on the east corner of the landfill (Feature C). All three features have an acceptable severity rating. All areas of settlement were noted to be relatively consistent with the previous 2011 inspection.

Two areas (Features D and E) of erosion were noted on the surface, side slopes and/or margins of the Station West Landfill during the 2012 inspection. Feature D consisted of a shallow linear runoff feature extending down the east side slope, whereas Feature E consisted of a larger area extending along the north margin of the landfill where seasonal ponding has resulted in minor erosion along the toe and side slope. Both areas appear stable and have an acceptable severity rating. Observations appear consistent with the previous 2011 inspection.

Two localized areas of rust-colored staining were noted on the southwest cover area of the landfill (Feature F). The stains range in size from 2-4 m long and 0.2-0.3 m wide. The southern smaller stained area was not noted during the previous 2011 inspection.

Two parallel and one single tension crack were noted on the southeast corner of the landfill (Feature G). The cracks ranged in length from 4 to 7 m long, were typically 3 to 5 mm wide and extended in a perpendicular direction to the slope. The location and frequency of cracks on the southeast corner appears consistent with findings from the previous 2010/11 inspections. Two additional tension cracks (Feature H) were also noted on the northeast side slope of the landfill during the 2012 inspection. The cracks ranged in length from 1.5 to 15 m long and 3 to 10 mm in width. Based on observations made during the 2012 inspection, the landfill surface appears stable and has an acceptable severity rating.

Frost Action	No	N/A	N/A	N/A	N/A	N/A	N/A	N/A	Not Observable	N/A
Animal Burrows	No	N/A	N/A	N/A	N/A	N/A	N/A	N/A	Not Observable	N/A
Vegetation	No	N/A	N/A	N/A	N/A	N/A	N/A	N/A	Not Observable	N/A
Staining	Yes	FEATURE F See Figure CAM-1.4 (SW cover - 2 areas - 1 New Obs)	2 - 4 m	0.2 - 0.3 m	Unknown	Isolated (<1%)	Linear rust coloured stains	WLF-16, 21	Acceptable	N/A
Vegetation Stress	No	N/A	N/A	N/A	N/A	N/A	N/A	N/A	Not Observable	N/A
Seepage Points	No	N/A	N/A	N/A	N/A	N/A	N/A	N/A	Not Observable	N/A
Debris Exposed	No	N/A	N/A	N/A	N/A	N/A	N/A	N/A	Not Observable	N/A
Presence/Condition of Monitoring Instruments	No	N/A	N/A	N/A	N/A	N/A	N/A	N/A	Not Observable	N/A
Other Features of Note:	Yes	FEATURE G See Figure CAM-1.4 (Tension Cracks - SE corner)	4 - 7 m	3 - 5 mm	Unknown	Isolated (<1%)	Parallel and single tension cracks on side slope	WLF-20, 23, 24	Acceptable	N/A
		FEATURE H See Figure CAM-1.4 (Tension Cracks - NE side slope - New Obs.)	1.5 - 15 m	3 - 10 mm	Unknown	Isolated (<1%)	Continuous single tension cracks on side slope	WLF-5, 6	Acceptable	N/A
