**THE COLLECTION OF LANDFILL MONITORING
DATA AT THE FORMER
CAM-1 DEW LINE SITE**

Jenny Lind Island, Nunavut

FINAL REPORT– 2013 SEASON

DEFENCE CONSTRUCTION CANADA

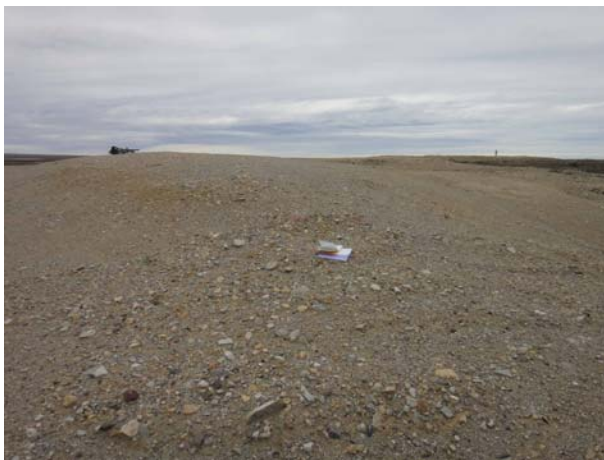
Indications of minor settlement were noted at two locations, consisting of a 1m by 1 m localized depression on the south side slope of Lobes 1 & 2 (Feature A), and a linear 4 m by 1 m depression on the northwest side slope of Lobe 3 (Feature B). Both features were noted to be consistent with the previous 2012 inspection.

BANLF-4: (left) View looking north at minor depression on south corner of Lobes 1&2 (Feature A).

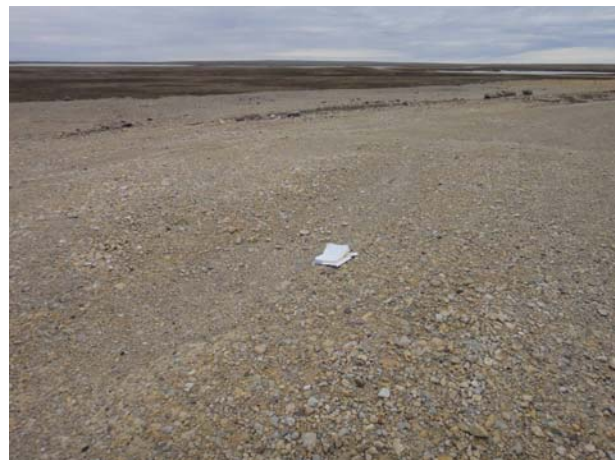
BANLF-9: (right) View looking north-northwest at linear depression on northwest crest of Lobe 3 (Feature B)

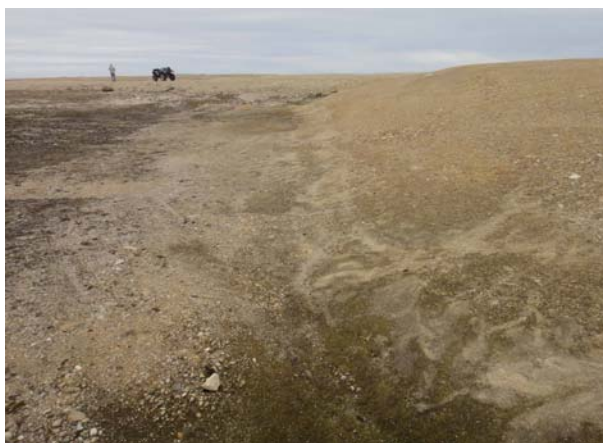
One area of minor erosion was noted on the southeast side slope and along the toe of Lobes 4 & 5 regrade (Feature C). The erosion consisted of fines washing along approximately 4 m of the side slope and along 25 linear meters of the adjoining toe of slope. Erosion along the toe appears to be the result of seasonal ponding bordering the southeast side of the lobe and was consistent with the previous 2011 and 2012 inspections, whereas the minor erosion on the side slope appears recent to the 2013 inspection. The area southeast of the lobe was dry at the time of the 2013 inspection. The erosion along the side slope and toe areas appears to be self-armouring with an acceptable severity rating.

BANLF-29: View looking southwest at minor erosion (Feature C on southeast side slope and toe of Lobes 4&5.

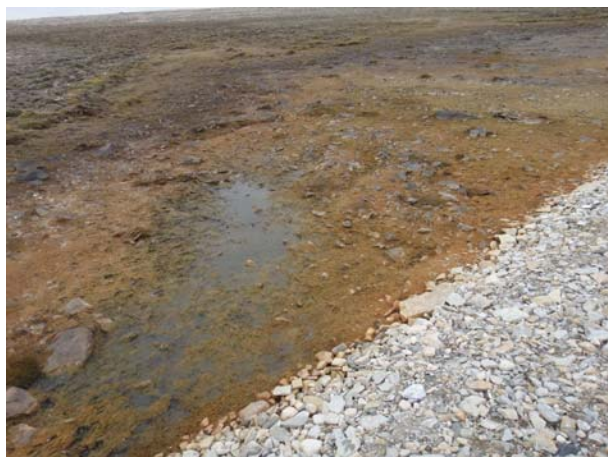
Two areas of discoloration (staining) were noted during the 2013 inspection, including one relatively small area on the north side slope of the Lobe 4 & 5 regrade (Feature E) and a larger area associated with a wetted area immediately east of Lobe 3 (Feature D). There were no odours noted with either area at the time of the 2013 inspection and observations at both areas were consistent with the previous 2011 and 2012 inspections.

BANLF-17: (left) View looking south at rust coloured staining southeast of Lobe 3 (Feature D).

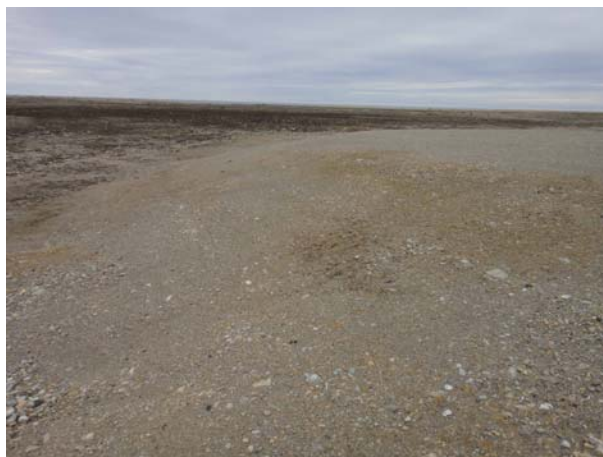
BANLF-22: (right) View looking southeast at minor staining on north side slope of Lobes 4&5 (Feature E).

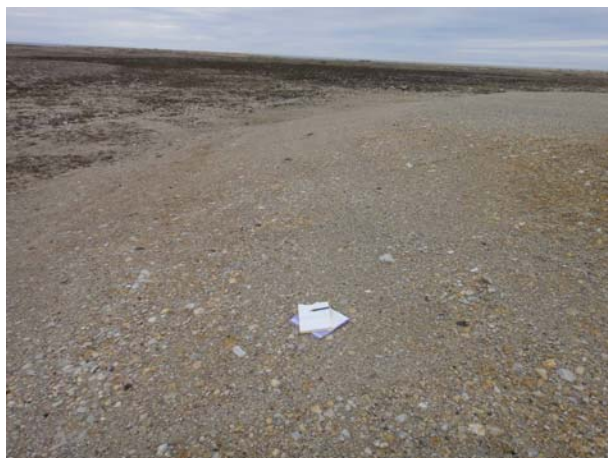
One partially infilled continuous tension crack was noted on the northeast corner of Lobes 4 & 5 (Feature F). The crack was noted to extend approximately 10 m in a northeast-southwest direction approximately 1 m below the crest and varied between 2-3 mm in width. The crack was not noted during the previous 2012 inspection.

BANLF-25: (left) View east-southeast at crack extending across northeast corner of Lobes 4&5 (Feature F)

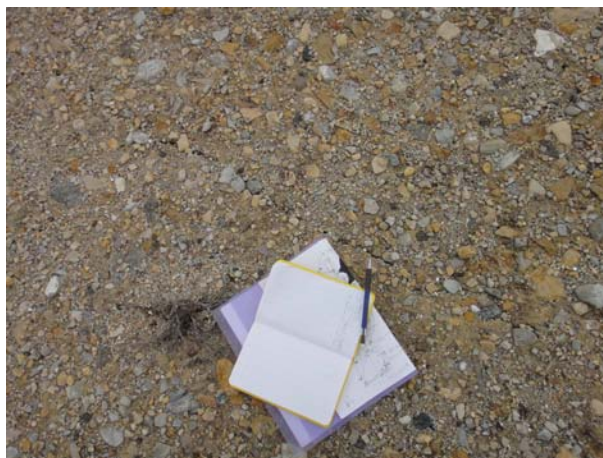
BANLF-26: (right) View of tension crack on northeast corner of Lobes 4&5 (Feature F)

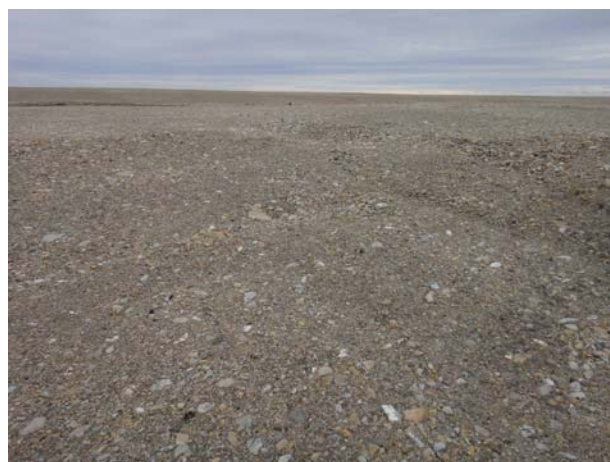
An indication of minor settlement was noted at one location, consisting of a linear depression on the north inside corner of Lobes 1 & 3 regrade (Feature A). The feature consisted of 2 separate depressions, measuring 0.8-2m long, 1-2m wide and between 0.1-0.2m deep. This feature appears relatively consistent with the previous 2011 and 2012 inspections.

NELF-14: (left) View looking south at minor settlement on inside side slope of Lobes 1&3 (Feature A).

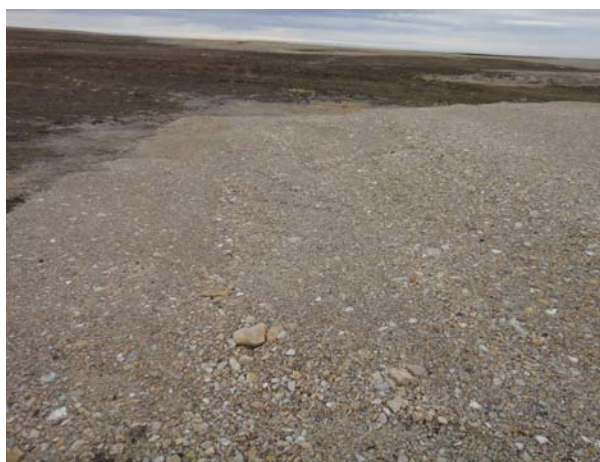
One area of minor erosion was noted on the north side slope of Lobes 1 & 3 regrade (Feature C). The erosion extended 3.5 m along the side slope in a north-south direction and was 0.15 m wide and 0.05 m deep. The erosion along the side slope appears to be self-armouring with an acceptable severity rating. The erosion was not noted during the previous 2012 inspection.

NELF-15: (right) View looking northeast at minor erosion along west side slope of Lobes 1&3 (Feature C).

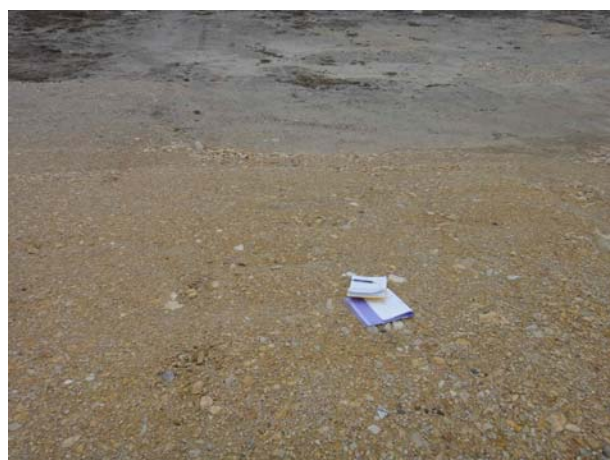
Indications of minor settlement were noted in three general areas (Features A, B and C) on the landfill surface, including: five relatively small sized (round and linear) depressions situated on the east side slope (Feature A); three small depressions on the north cover and northwest side slope areas (Feature B); and a moderate sized uneven area on the southwest corner of the landfill (Feature C). All three features have an acceptable severity rating. All areas of settlement were noted to be relatively consistent with the previous 2011 and 2012 inspections.

SWLF-6: (left) View looking northeast at minor depressions on side slope (Feature A).

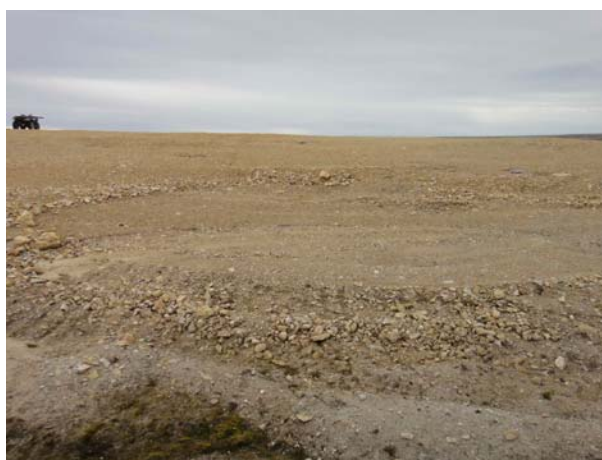
SWLF-11 (right) View looking west at erosion from seasonal ponding on northeast side (Features A and E).

Two areas (Features D and E) of minor erosion were noted on the surface, side slopes and/or margins of the Station West Landfill during the 2013 inspection. Feature D consisted of a shallow linear runoff feature extending down the east side slope, whereas Feature E consisted of a larger area extending along the north margin of the landfill where seasonal ponding has resulted in minor erosion along the toe and side slope. Both areas appear stable and have an acceptable severity rating. Observations appear consistent with the previous 2011 and 2012 inspections.

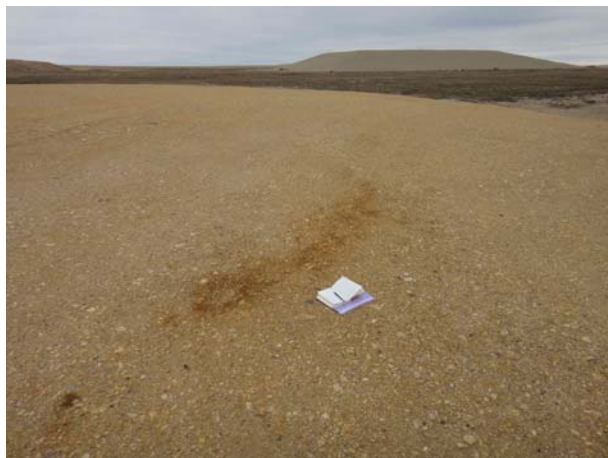
Four localized areas of rust-colored staining were noted on the south cover area of the landfill (Feature F). The stains range in size from 2-4 m long and 0.2-0.3 m wide. The pair of parallel stains on the south central cover area was not noted during the previous 2012 inspection, whereas the two stained areas located on the southwest cover area appear consistent from the previous inspection.

SWLF 23: (left) View looking east at linear stain on surface (Feature F).

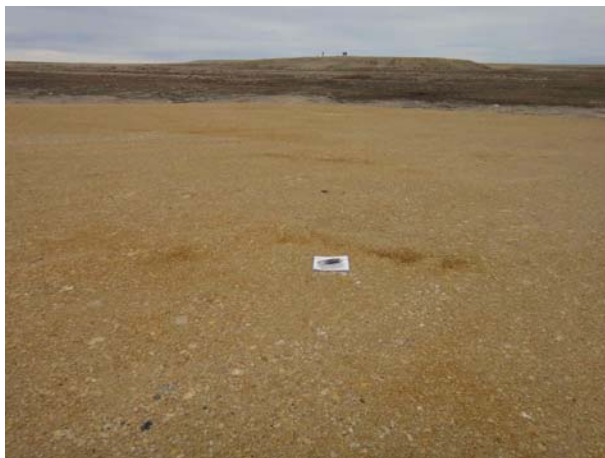
SWLF 32: (right) View looking southeast at two areas of staining on south cover (Feature F).

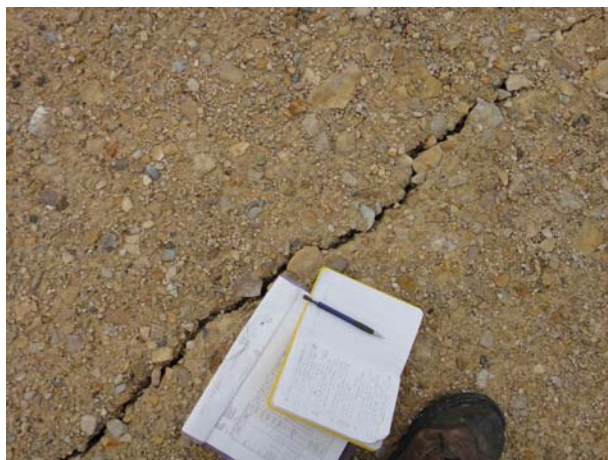
Parallel and single tension cracks were noted on the southeast corner of the landfill (Feature G). The cracks were somewhat discontinuous along the side slope and ranged in length from 4 to 15 m long, and were typically 2 to 10 mm wide. The magnitude and frequency of cracks on the southeast corner appears to have increased from findings noted during the previous 2012 inspection. Other features include continuous single and parallel parabolic orientated tension cracks on the northeast side slope (Feature

SWLF-28: (left) Tension crack on south side slope (Feature G)

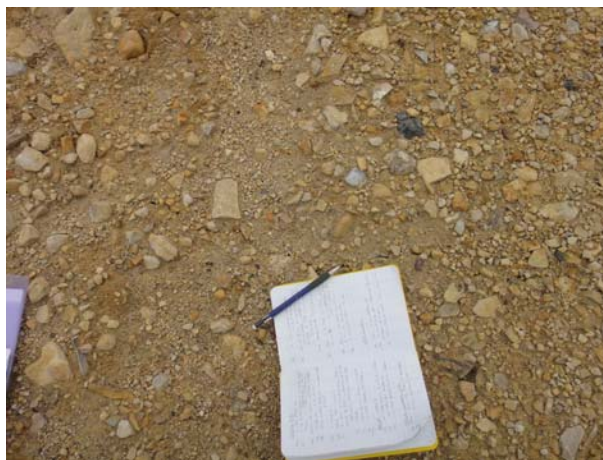
SWLF-5: (right) Single crack extending 1 m up from northeast toe (Feature I)

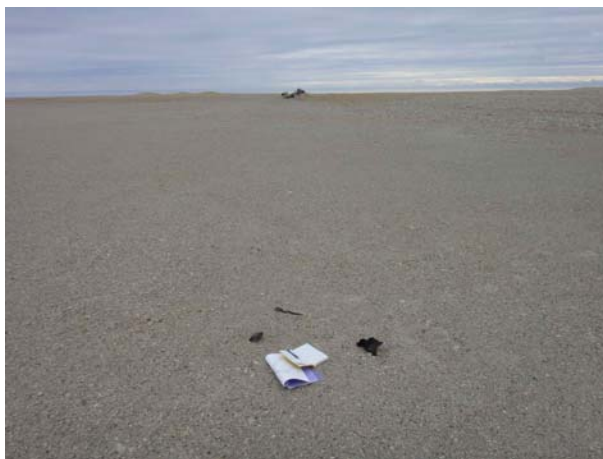
Four areas of partially exposed black geotextile material were noted on the northeast, east and west sides of the landfill surface (Feature B). This feature appears unchanged from the previous 2010/11 inspections with the exception of one new partially exposed piece of geotextile that was noted on the west cover area. There was no other indication of debris at the landfill.

NHWLF-9: View looking north at exposed geotextile material on west cover area (Feature B)

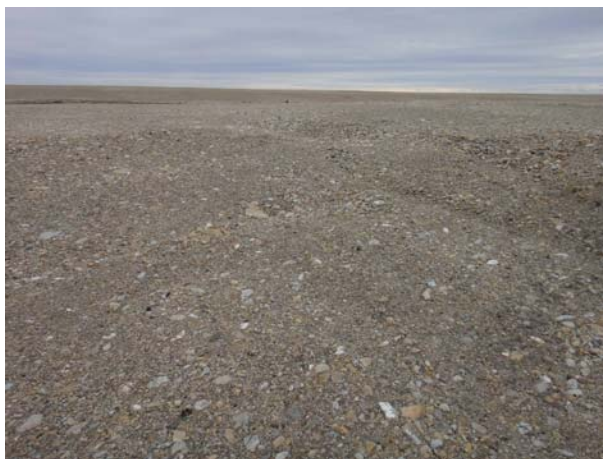
An indication of minor settlement was noted at a single location near the northwest crest of the landfill cover (Feature A), consisting of an isolated linear depression measuring 1.2 m long, 0.25 m wide and 0.1 m in depth. Indications of settlement in this area were not noted during the previous 2012 inspection.

Tier II-24: View looking northeast at minor depression below west crest (Feature A).

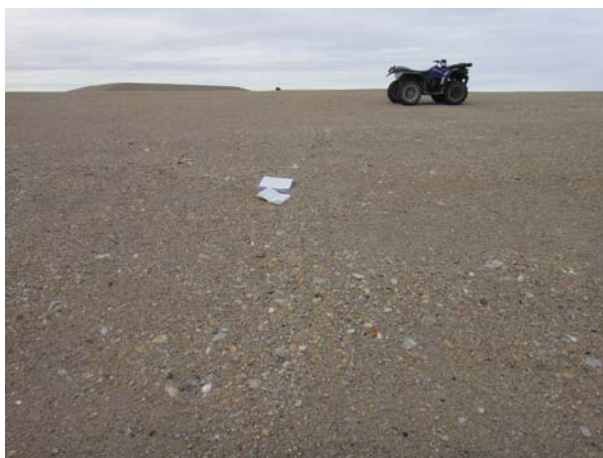
Evidence of minor erosion was noted on the southeast cover and side slope of Lobe 1 (Feature C). The erosion consisted of a narrow (5-7 cm wide) and shallow channel where fines had washed from the granular cover. The erosion extended approximately 15 m south-southeast from the north central area of the lobe to the southeast side slope and toe. This feature appears consistent with the previous 2012 inspection findings.

SELF-12: View looking northwest at minor erosion on cover of Lobe 1 (Feature C)

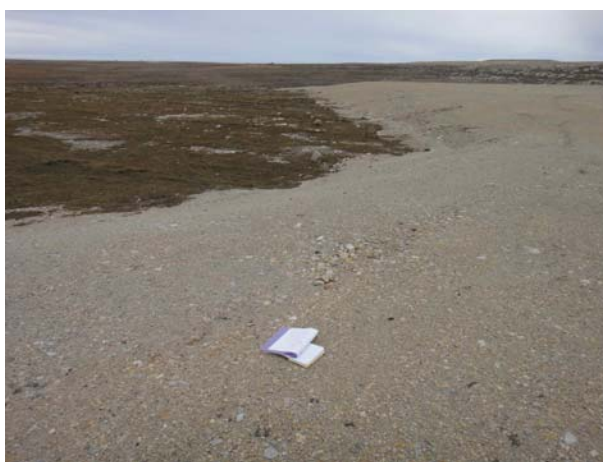
Indications of minor settlement were noted at five isolated locations on the northwest, southwest and south cover areas and on the northwest and east side slopes (Feature C). The linear shaped depressions ranged in size from 0.4 to 3 m in length, 0.15 to 0.7 m in width and 5 to 25 cm in depth. These features were noted during the previous 2012 inspection with the exception of one new linear depression located on the southwest cover, measuring 0.75 m long, 0.25 m wide and 5 cm deep.

MLF-34: View looking southwest at minor depression on south cover (Feature C).

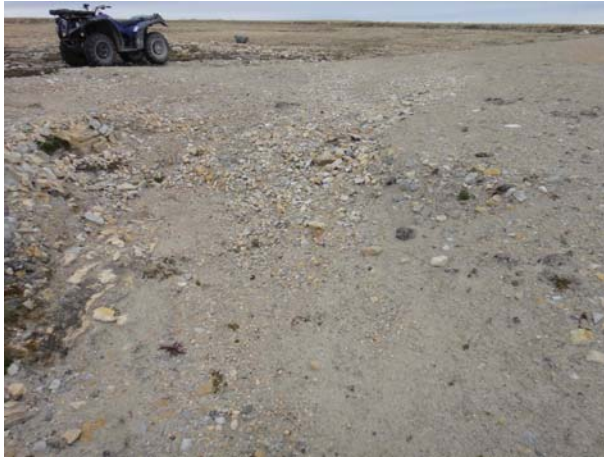
Indications of minor erosion were noted in three general areas (Features D, E and F) on the northwest, southwest and northeast margins of the landfill, ranging from 1.5 to 30 m in length. At each area, the erosion generally consisted of fines washing along the side slope and toe of slope and appear to be the result in part of localized seasonal ponding along the margins of the landfill. These features were dry at the time of the 2013 inspection and appear to be self-armouring with an acceptable severity rating. All three features appear to be relatively consistent with findings from the 2012 inspection, with the exception of an increase in magnitude of Feature D on the northwest corner of the landfill.

MLF-7: (left) View north at minor erosion on northwest corner (Feature D).

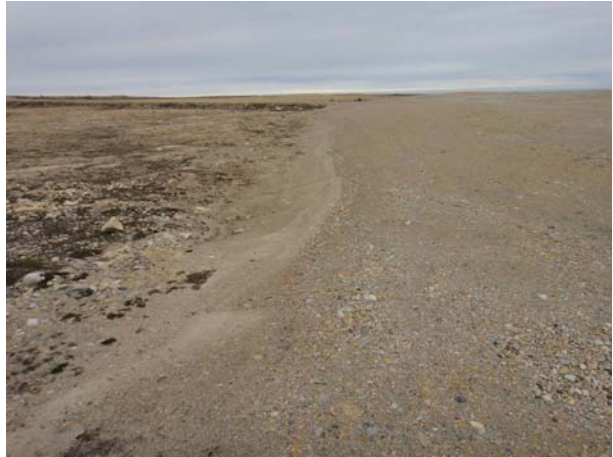
MLF-5: (right) View looking northeast at minor erosion along northwest side slope (Feature D).

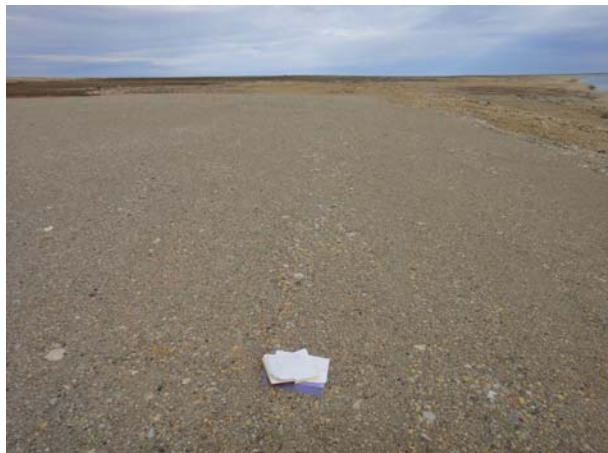
One partially infilled continuous tension crack was noted on the southeast cover area of the landfill (Feature B). The crack was noted to extend approximately 28 m in an east-west direction just north of the crest and varied between 10-30 mm in width. The magnitude (length and width) of the crack has noticeably increased from the previous 2012 inspection.

ELLF-17: (left) View looking east-southeast at partially infilled tension crack on southeast cover (Feature B)

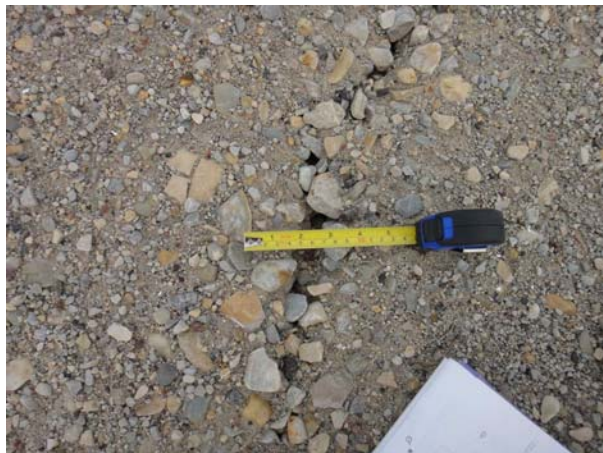
ELLF-19: (right) View of partially infilled tension crack on southeast cover (Feature B)
