**THE COLLECTION OF LANDFILL  
MONITORING DATA AT THE FORMER  
CAM-1 DEW LINE SITE**

Jenny Lind Island, Nunavut

**FINAL REPORT– 2014**

**DEFENCE CONSTRUCTION CANADA**

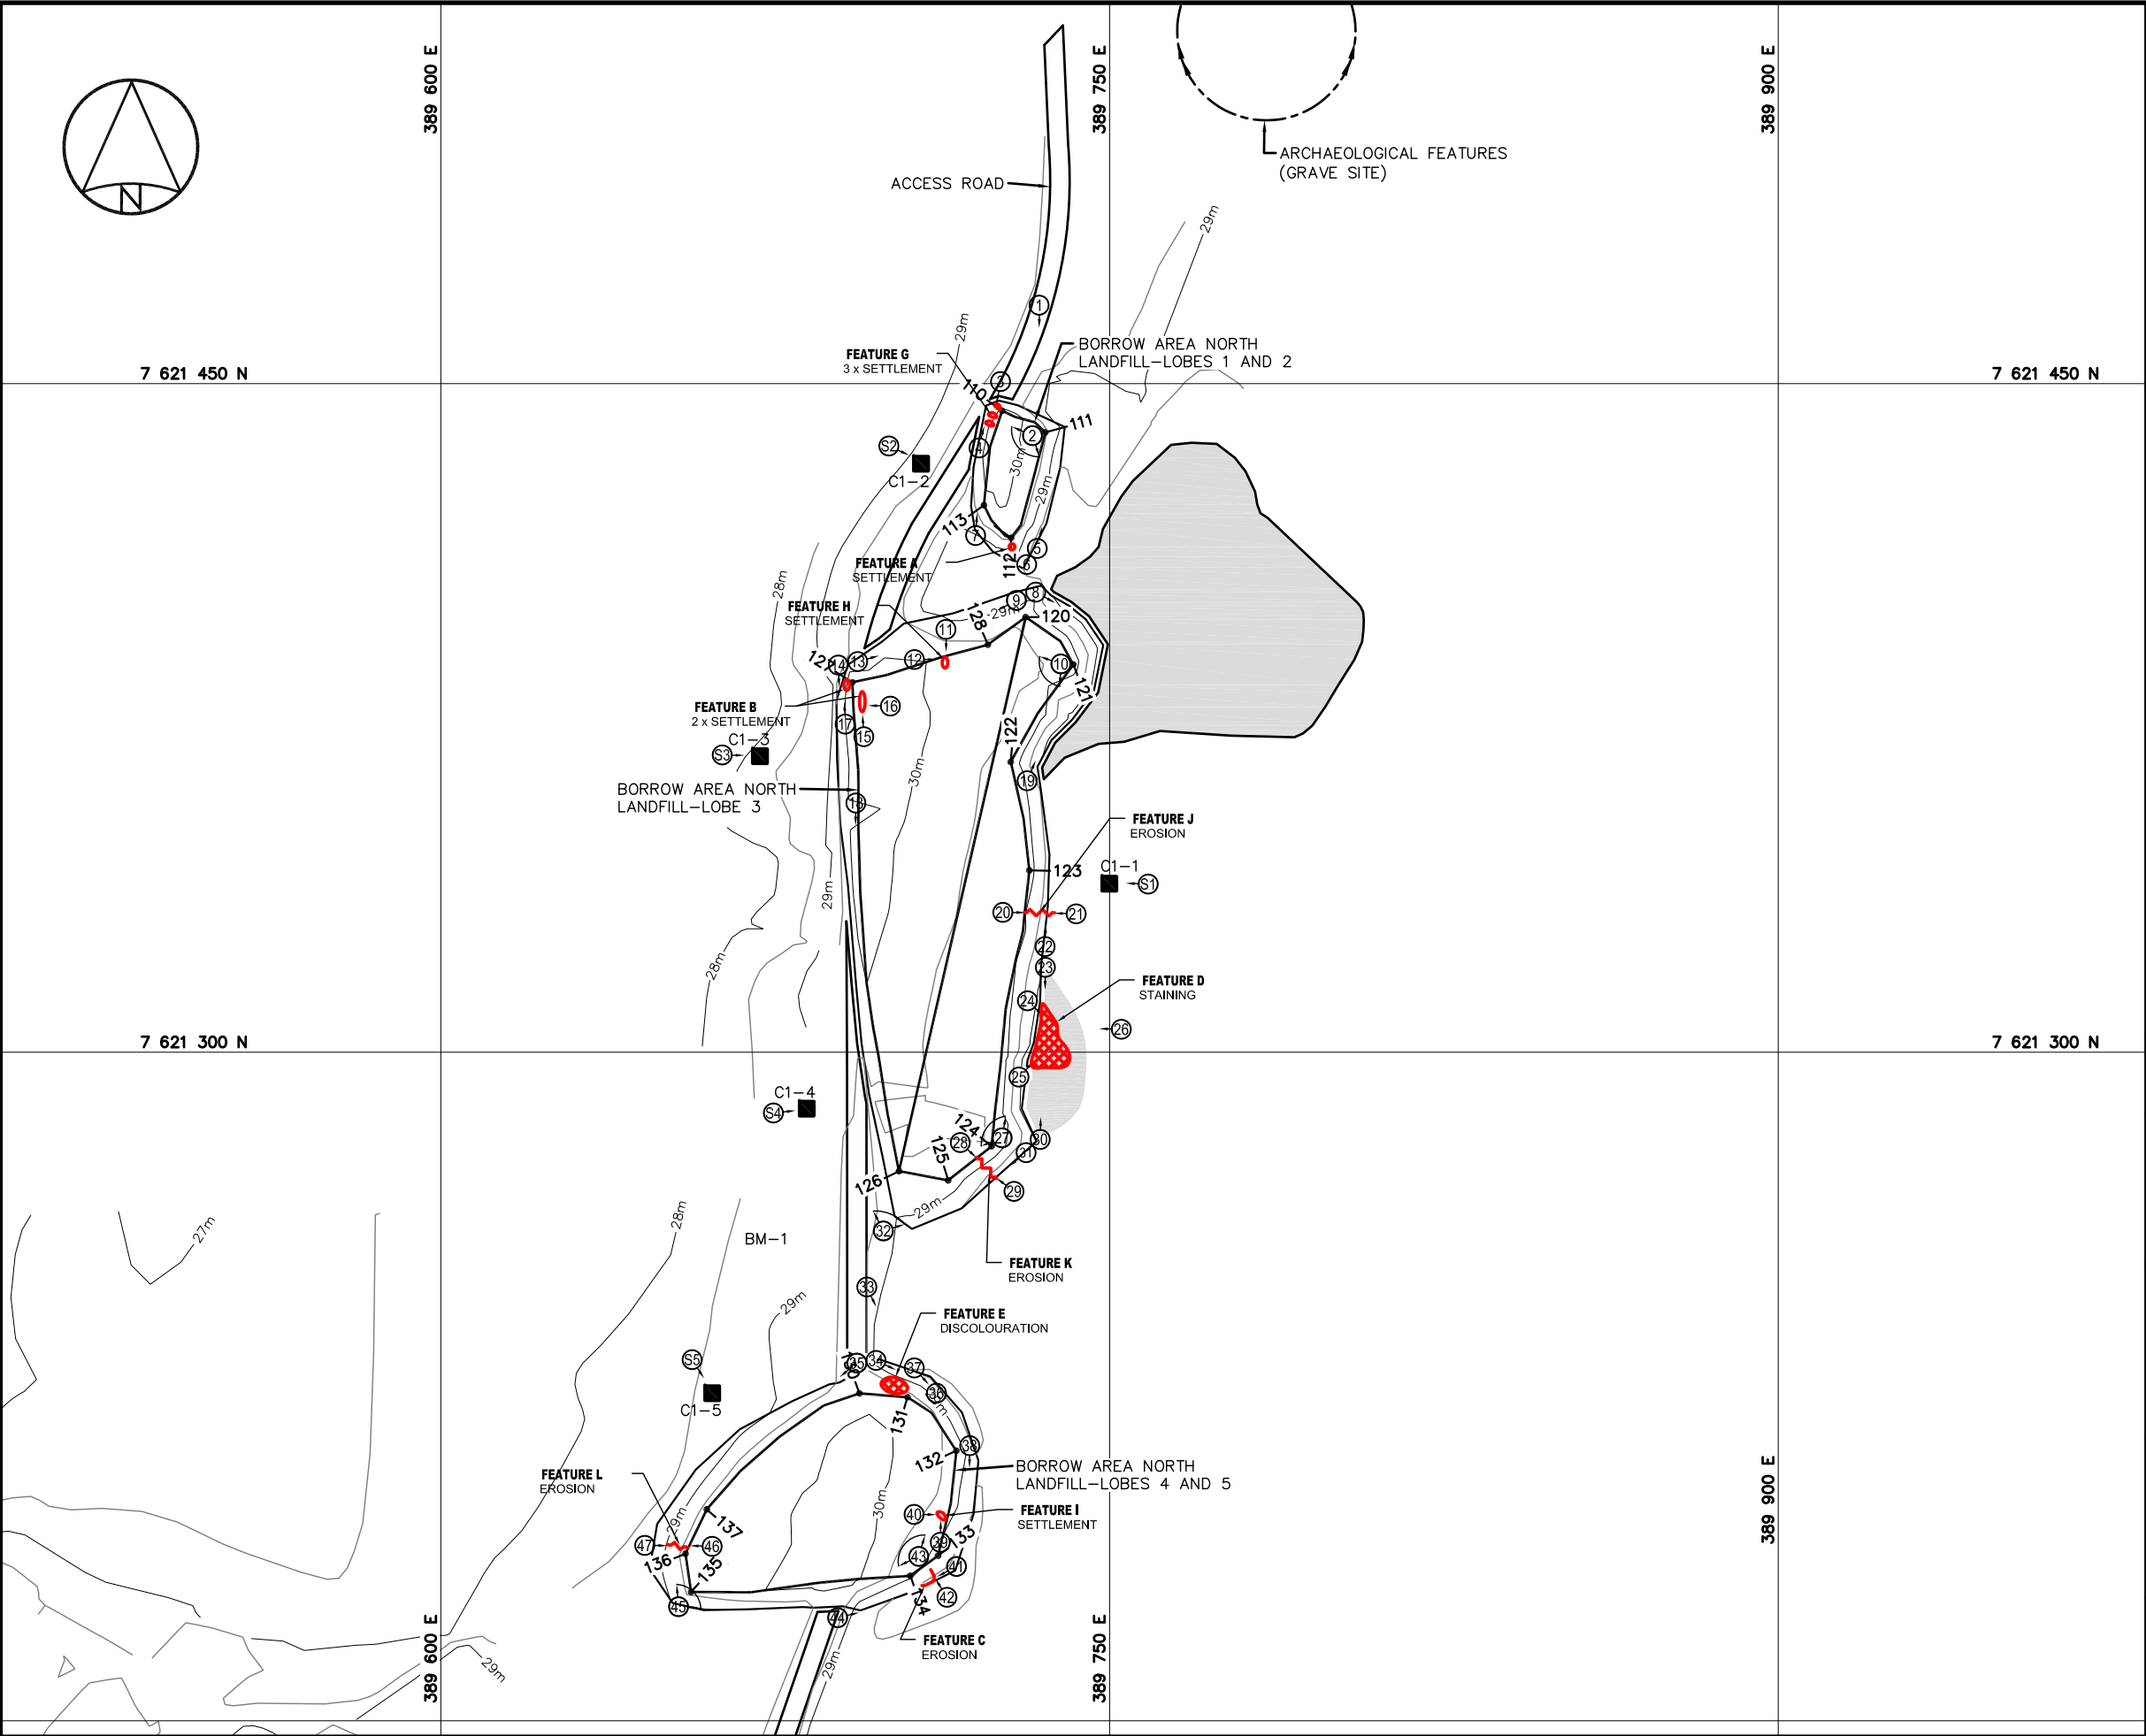
The Location Plan for the Borrow Area North Landfill has been completed as per the ToR and is presented in Figure CAM-1.2.

As of 2014, no stability features with “significant” or “unacceptable” severity ratings were identified during the Preliminary Stability Assessment of the Borrow Area North Landfill. There are several observations of minor settlement and erosion on the landfill cover and side slope, including four newly observed areas of settlement and three areas of erosion. Two existing areas of minor staining previously noted on the east side of Lobe 3 and north side of Lobes 4 & 5 remain relatively unchanged from previous assessment periods. There is localized ponding along the east and northeast sides of Lobe 3, which has also remained consistent since the baseline assessment. No exposed debris was observed. A tension crack previously noted on the northeast corner of Lobes 4 & 5 was not observed during the 2014 assessment.

Checklist Item	Present (Yes/No)	Location	Length	Width	Depth	Extent	Description	Photographic Record	Severity Rating	Additional Comments
Settlement	Yes	FEATURE A See Figure CAM-1.2 (Lobes 1 & 2 - S side slope)	1 m	1 m	0.1 m	Isolated	Localized depression on side slope	BANLF-6	Acceptable	No substantial change in feature since first noted in Year 3 (2012). Cover and slopes appear stable.
		FEATURE B See Figure CAM-1.2 (Lobe 3 - NW side slope) - <b>New Obs.</b>	0.4 - 4 m	0.2 - 1 m	0.1 m	Isolated	Minor linear depressions - 2 locations	BANLF-15-17	Acceptable	No substantial change in feature since first noted in Year 2 (2011) as Feature A. Changed to Feature B in 2012 - 2014. Cover and slopes appear stable.
		FEATURE G See Figure CAM-1.2 (Lobes 1 & 2 - NW side slope) - <b>New Obs.</b>	0.6 - 1 m	0.4 - 0.6 m	0.1 m	Occassional (<1%)	Minor depressions - 3 locations	BANLF-3, 4	Acceptable	New feature in Year 5. Cover and slopes appear stable.

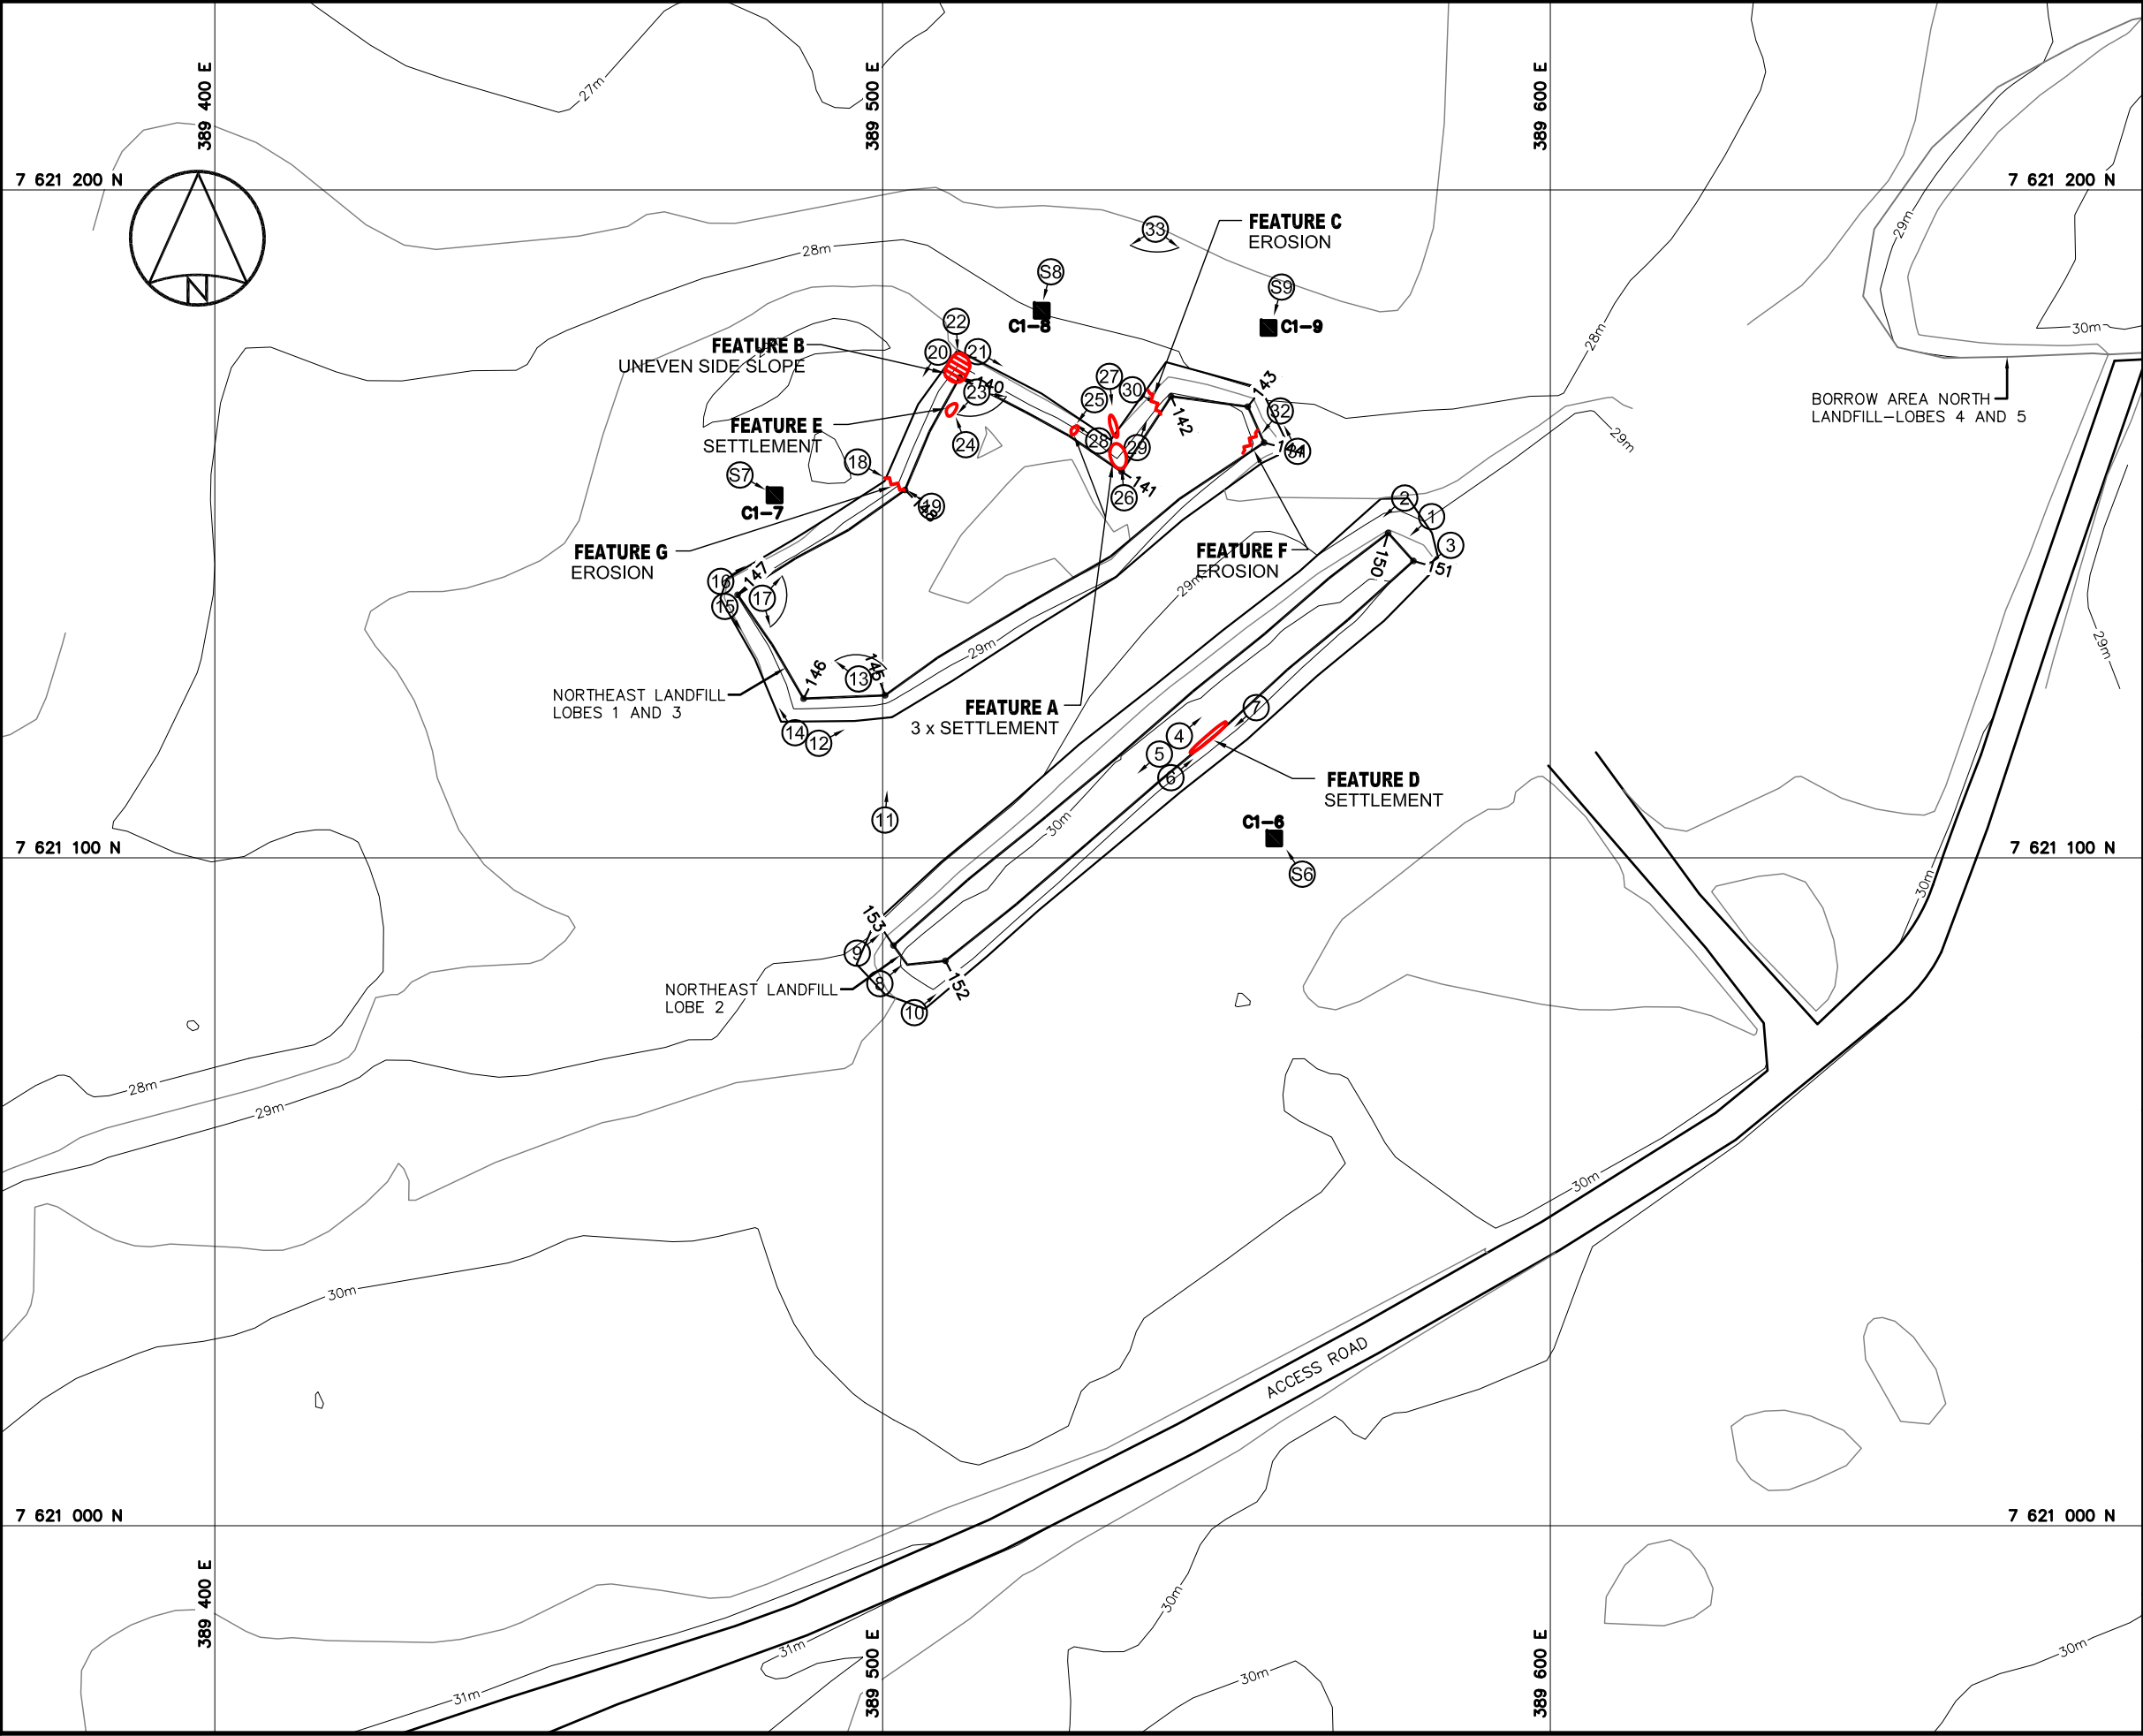
The Location Plan for the Northeast Landfill has been completed as per the ToR and is presented in Figure CAM-1.3.

As of 2014, no stability features with “significant” or “unacceptable” severity ratings were identified during the Preliminary Stability Assessment of the Northeast Landfill. In addition to one existing settlement feature, three new areas of localized minor settlement were observed on the east cover of Lobe 2 and north side slope / northwest cover of Lobes 1 & 3. Similarly, one existing (north side slope) and two new areas of minor erosion were noted on the northeast corner and west side slope of Lobes 1 & 3. Existing features were consistent with observations made during the previous assessment period. One uneven area on the northwest corner of Lobes 1 & 3 was also consistent with previous observations. No exposed debris was observed.

Checklist Item	Present (Yes/No)	Location	Length	Width	Depth	Extent	Description	Photographic Record	Severity Rating	Additional Comments
Settlement	Yes	FEATURE A See Figure CAM-1.3 (Lobes 1 & 3 - N side slope) - <b>1 New Obs.</b>	0.03 - 5 m	0.02 - 2 m	0.1 - 0.3 m	Occassional	3 depressions, including 2 on the inside corner slope (existing) and north side slope (new)	NELF-25-27	Acceptable	Linear and pothole type. Some secondary erosion on inside corner. Slopes appear stable.Feature first noted in 2011 with marginal increases in magnitude and/or depth in 2013 and 2014.
		FEATURE D See Figure CAM-1.3 (Lobe 2 - E cover) - <b>New Obs.</b>	11 m	0.1 m	0.02 - 0.04 m	Isolated	Linear depression	NELF-6, 7	Acceptable	New observation in Year 5. Cover appears stable.
		FEATURE E See Figure CAM-1.3 (Lobes 1 & 3 - NW cover) - <b>New Obs.</b>	0.4 m	0.3 m	0.1 m	Isolated	Pothole depression	NELF-24	Acceptable	New observation in Year 5. Cover appears stable.

Erosion	Yes	FEATURE C See Figure CAM-1.3 (N side slope)	3.5 m	0.15 m	0.05 m	Isolated (<1%)	Minor erosion	NELF-30	Acceptable	Washing of fines. Self armouring. No notable changes in feature since first observed in Year 4 (2013).
		FEATURE F See Figure CAM-1.3 (Lobes 1 & 3 - NE corner) - <b>New Obs.</b>	3 m	0.1 m	0.1 m	Isolated	Minor erosion	NELF-32	Acceptable	New observation in Year 5. Cover appears stable.
		FEATURE G See Figure CAM-1.3 (Lobes 1 & 3 - W side slope) - <b>New Obs.</b>	4 m	0.5 - 1.5 m	0.1 m	Isolated	Minor erosion	NELF-18, 19	Acceptable	New observation in Year 5. Fines washing. Slope appears stable.
Frost Action	No	N/A	N/A	N/A	N/A	N/A	N/A	N/A	Not Observable	N/A
Animal Burrows	No	N/A	N/A	N/A	N/A	N/A	N/A	N/A	Not Observable	N/A
Vegetation	No	N/A	N/A	N/A	N/A	N/A	N/A	N/A	Not Observable	N/A
Staining	No	N/A	N/A	N/A	N/A	N/A	N/A	N/A	Not Observable	N/A
Vegetation Stress	No	N/A	N/A	N/A	N/A	N/A	N/A	N/A	Not Observable	N/A

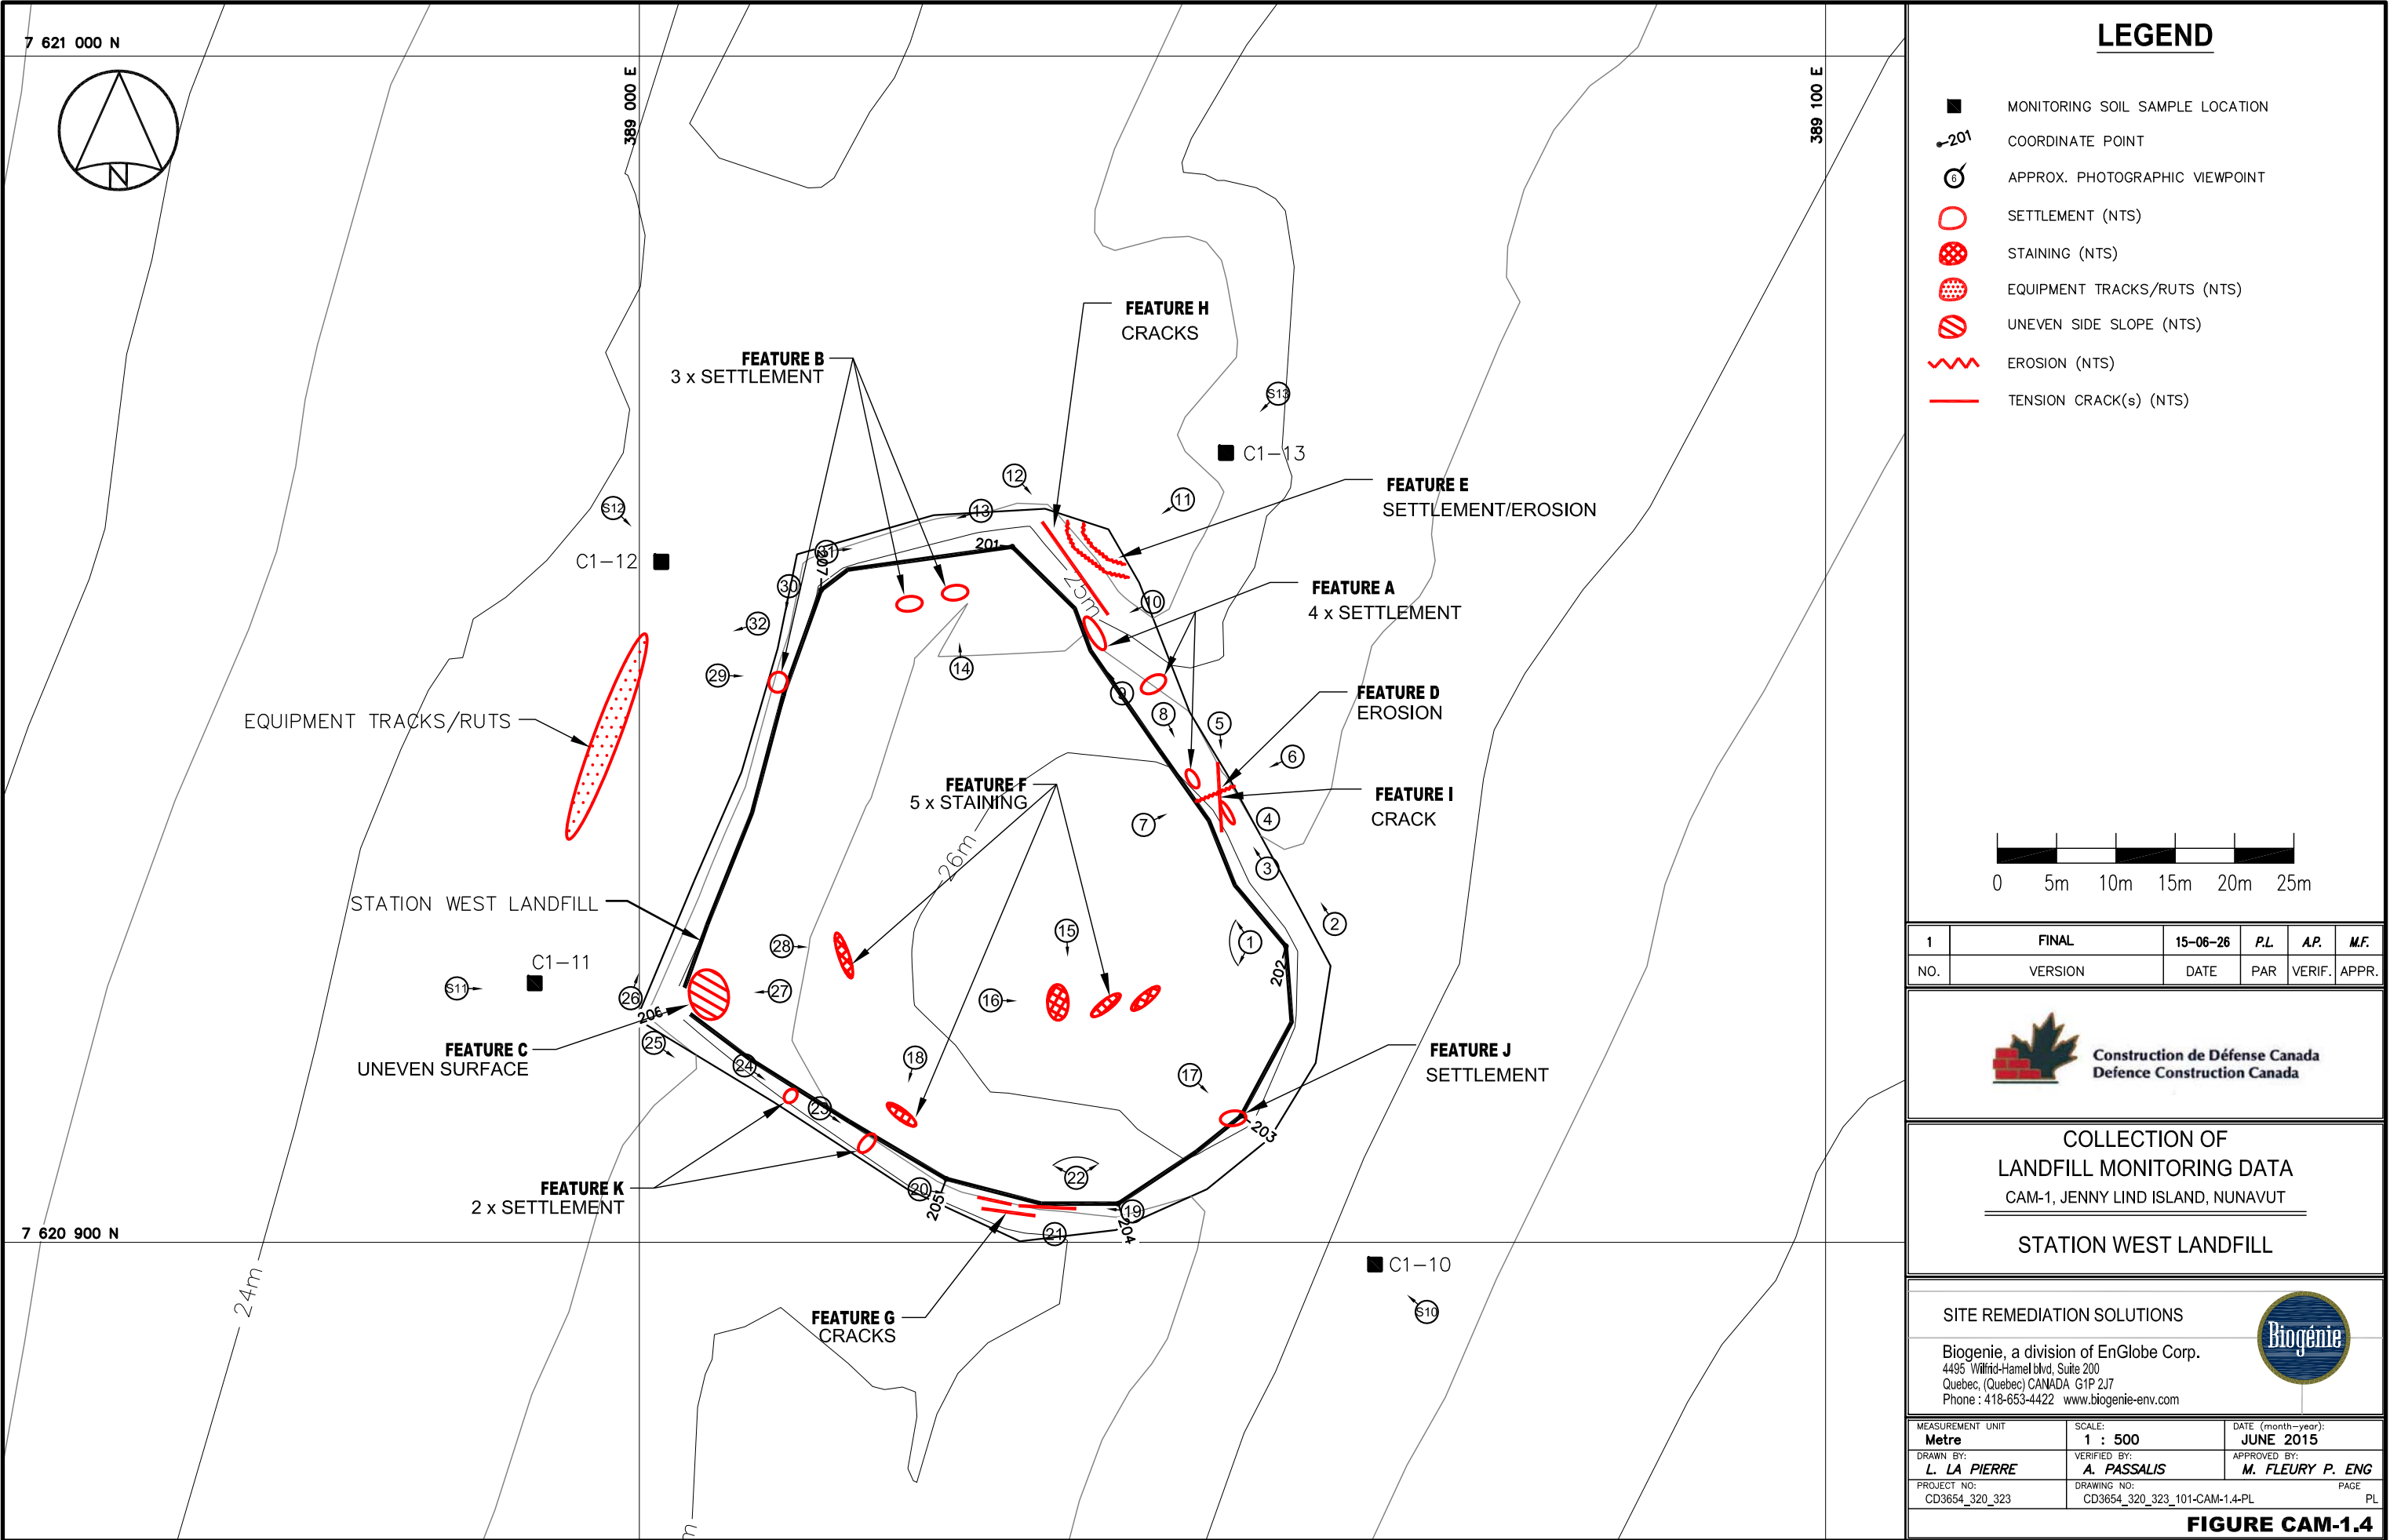
The Location Plan for the Station West Landfill has been completed as per the ToR and is presented in Figure CAM-1.4.

As of 2014, no stability features with “significant” or “unacceptable” severity ratings were identified during the Preliminary Stability Assessment of the Station West Landfill. There are several observations of minor settlement on the landfill cover and side slope, including three existing feature areas on the east and northwest side slopes, southwest corner of cover and north cover, and two new feature areas on the southeast and southwest side slopes. The existing settlement areas appear unchanged from the previous inspection. Evidence of minor erosion was observed at two existing locations on the north corner and east side slope. Similarly, these features appear unchanged from the previous assessment period. Five localized areas of discolouration granular cover soils were noted on the south cover of the landfill. With the exception of one newly observed area, this feature appears relatively unchanged from the previous assessment. Two areas containing tension cracks were noted on the south corner (single and parallel) and east side slope (single). The magnitude of cracks on the south corner appears to have decreased, whereas the crack on the east side slope appears to have increased from the previous inspection period. A third area on the northeast side slope was previously noted to contain single and parallel cracks, however were not observed during the 2014. No exposed debris was observed.

Checklist Item	Present (Yes/No)	Location	Length	Width	Depth	Extent	Description	Photographic Record	Severity Rating	Additional Comments
Settlement	Yes	FEATURE A See Figure CAM-1.4 (E side slope)	0.2 - 2 m	0.1 - 0.2 m	0.05 - 0.1 m	Occasional	Minor depressions - 4 locations	WLF-3, 4, 8-10	Acceptable	No substantial change in feature since first noted in Year 2 (2011). Side slope appears stable.
		FEATURE B See Figure CAM-1.4 (NW side slope & N cover)	0.7 - 1.5 m	0.1 - 0.3 m	0.05 - 0.1 m	Occasional	Minor depressions - 3 locations	WLF-14, 29	Acceptable	No substantial change in feature since first noted in Year 2 (2011). Cover and side slopes appears stable.
		FEATURE C See Figure CAM-1.4 (SW corner of cover)	5 m	5 m	0.05 - 0.15 m	Isolated (<2%)	Uneven surface	WLF-27	Acceptable	No notable changes in feature since noted in Year 1 (2010). Cover appears stable.
		FEATURE J See Figure CAM-1.4 (SE side slope) - <b>New Obs.</b>	0.4 m	0.2 m	0.05 m	Isolated	Minor pothole-type depression	WLF-17	Acceptable	New observation in Year 5. Cover appears stable.

FEATURE K See Figure CAM-1.4 (SW side slope) - <b>New Obs.</b>	0.2 - 0.3 m	0.2 m	0.05 - 0.1 m	Occasional	Minor pothole-type depressions - 2 locations	WLF-23, 24, 32	Acceptable	New observation in Year 5. Side slope appears stable.
Erosion	Yes	FEATURE D See Figure CAM-1.4 (E side slope)	5 m	0.1 m	0.05 m	Isolated	Minor erosion	WLF-6, 7	Acceptable	Feature first noted in Year 2 (2011). Marginal increase in size between Years 4 and 5 (2013-2014). Washing of fines in cover material.
		FEATURE E See Figure CAM-1.4 (N corner)	6 m	4 m	0.05 - 0.1 m	Isolated (<2%)	Minor erosion	WLF-11, 12	Acceptable	Feature first noted in Year 2 (2011). Marginal increase in size between YearS 2 and 3 (2011-2012). Washing of fines on slope from seasonal ponding.
Frost Action	No	N/A	N/A	N/A	N/A	N/A	N/A	N/A	Not Observable	N/A
Animal Burrows	No	N/A	N/A	N/A	N/A	N/A	N/A	N/A	Not Observable	N/A
Vegetation	No	N/A	N/A	N/A	N/A	N/A	N/A	N/A	Not Observable	N/A

Staining	Yes	FEATURE F See Figure CAM-1.4 (S cover - 5 areas) - <b>1 New Obs</b>	2 - 4 m	0.2 - 0.4 m	Unknown	Isolated (<3%)	Discoloured granular areas on cover - 5 locations	WLF-15, 16, 18, 28	Acceptable	Feature first noted in Year 1 (2010). Additional localized staining noted in Year 3, 4 and 5.
Vegetation Stress	No	N/A	N/A	N/A	N/A	N/A	N/A	N/A	Not Observable	N/A
Seepage Points	No	N/A	N/A	N/A	N/A	N/A	N/A	N/A	Not Observable	N/A
Debris Exposed	No	N/A	N/A	N/A	N/A	N/A	N/A	N/A	Not Observable	N/A
Presence/Condition of Monitoring Instruments	No	N/A	N/A	N/A	N/A	N/A	N/A	N/A	Not Observable	N/A
Other Features of Note:	Yes	FEATURE G See Figure CAM-1.4 (Tension Cracks - S corner)	10 m	2-4 mm	Unknown	Isolated (<1%)	Parallel and single tension cracks on side slope	WLF-19-21	Acceptable	Feature first noted in Year 1 (2010). Notable increase in size in Year 4. Discontinuous crack extending around southeast corner of landfill.

FEATURE H See Figure CAM-1.4 (Tension Cracks - NE side slope)	Unknown	Unknown	Unknown	N/A	Continuous single and parallel tension cracks on side slope	WLF-11, 12	Acceptable	Feature first noted in Year 3 (2012) and decreased in size in Year 4. Feature assumed to be completely infilled in Year 5. Not visible.
		FEATURE I See Figure CAM-1.4 (Tension Crack - E side slope)	6 m	up to 10 mm	Unknown	Isolated	Single tension crack on side slope	WLF-5	Acceptable	Feature first observed in Year 4 (2013) with a notable increase in size in Year 5. Located on side slope 1 m above toe.
Additional Photos	Yes	See Figure CAM-1.4 and Photographic Record	N/A	N/A	N/A	N/A	General Photographic Record	N/A	Not Observable	General photos for documentation, no additional features of note.
Overall Landfill Performance:	Acceptable

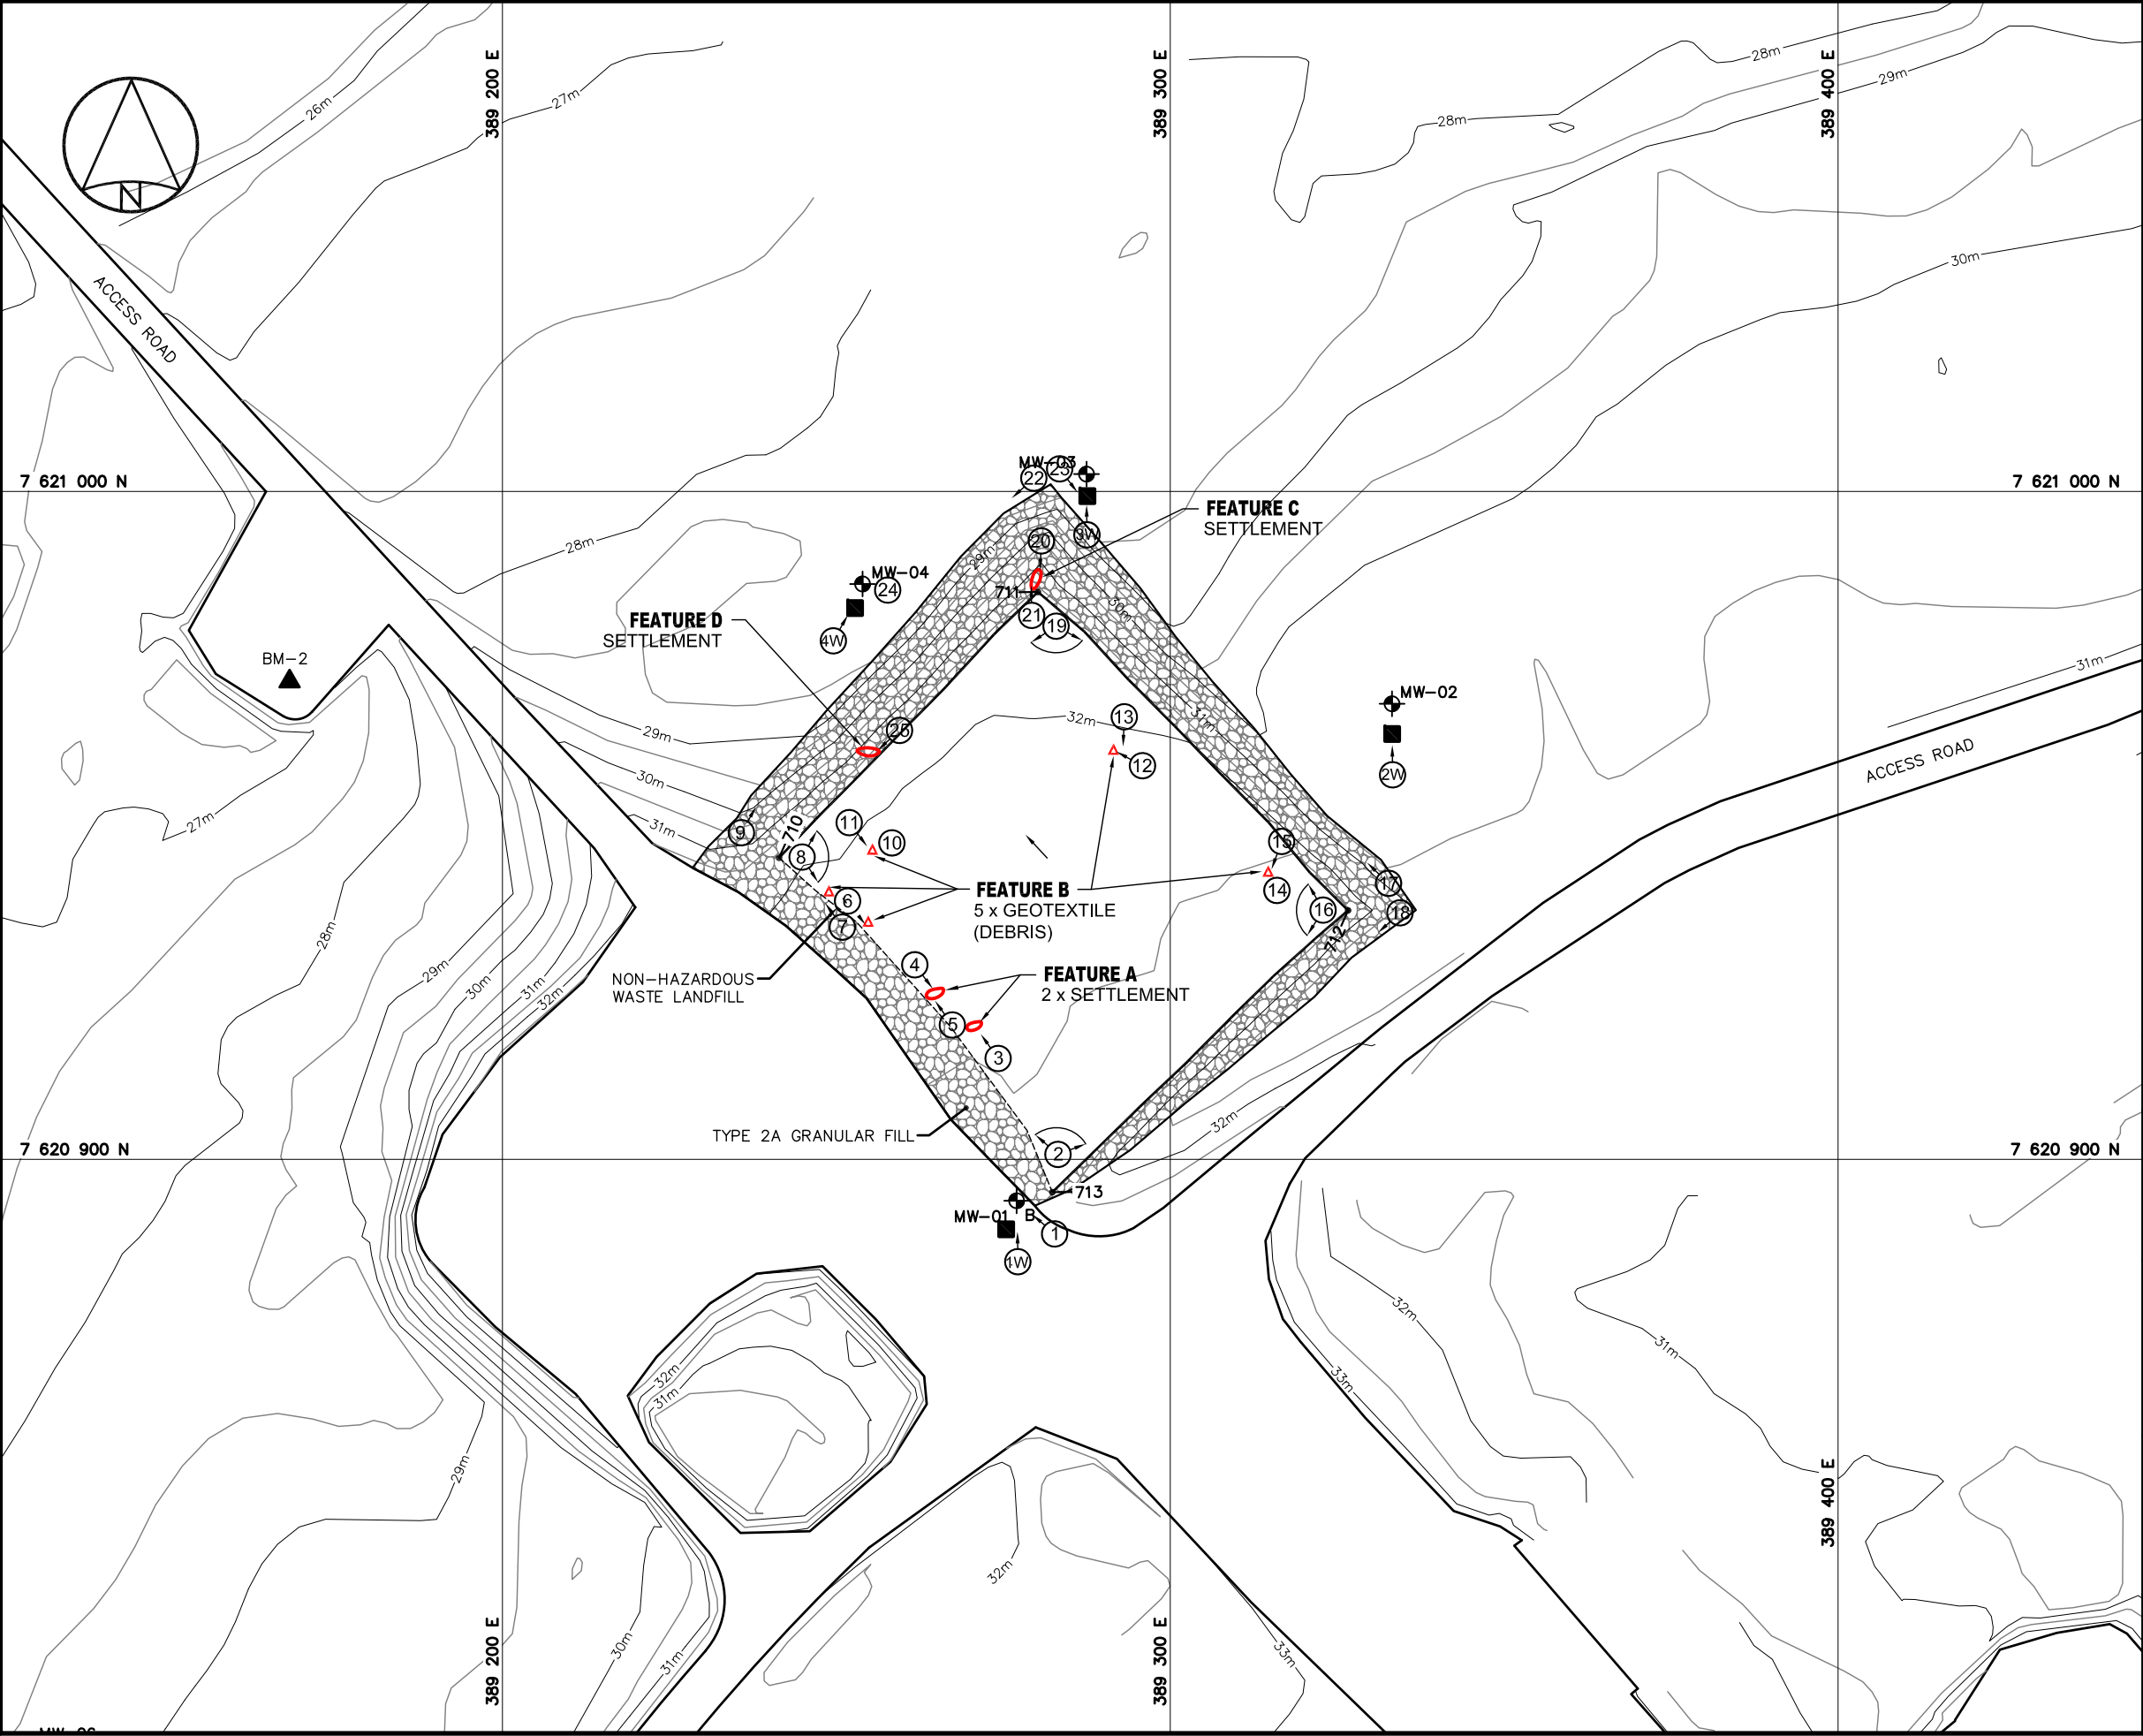
The Location Plan for the NHWLF has been completed as per the ToR and is presented in Figure CAM-1.5.

As of 2014, no stability features with “significant” or “unacceptable” severity ratings were identified during the Preliminary Stability Assessment of the NHWLF. Three areas of minor settlement (linear depressions) were noted on the cover and side slopes of the landfill, including one existing and one new depression on the southwest cover, one new depression on the north corner slope and one depression on the northwest side slope. Five areas of partially exposed geotextile material were noted on the northeast, east and west sides of the landfill surface, including one newly observed location on the west cover area.

Checklist Item	Present (Yes/No)	Location	Length	Width	Depth	Extent	Description	Photographic Record	Severity Rating	Additional Comments
Settlement	Yes	FEATURE A See Figure CAM-1.5 (SW cover) - 1 New Obs	0.4 - 0.6 m	0.15 - 0.2 m	0.05 m	Isolated	Linear depressions - 2 locations	NHWLF-3-5	Acceptable	Feature first noted in Year 3 (2012). Cover appears stable. Existing depression consistent with previous observations.
		FEATURE C See Figure CAM-1.5 (N corner slope) - New Obs.	1 m	0.4 m	0.05 m	Isolate	Linear depression	NHWLF-20, 21	Acceptable	New observation in Year 5. Some secondary erosion. Slope appears stable.
		FEATURE D See Figure CAM-1.5 (NW side slope) - New Obs.	1 m	0.2 m	0.1 m	Isolated	Linear depression	NHWLF-25	Acceptable	New observation in Year 5. Cover appears stable.
Erosion	No	N/A	N/A	N/A	N/A	N/A	N/A	N/A	Not Observable	N/A
Frost Action	No	N/A	N/A	N/A	N/A	N/A	N/A	N/A	Not Observable	N/A
Animal Burrows	No	N/A	N/A	N/A	N/A	N/A	N/A	N/A	Not Observable	N/A
