LONG-TERM LANDFILL MONITORING AT THE CAM-1 FORMER DEW LINE SITE

Jenny Lind Island, Nunavut

April 17, 2020

LONG-TERM LANDFILL MONITORING – CAM-1 FORMER DEW LINE SITE

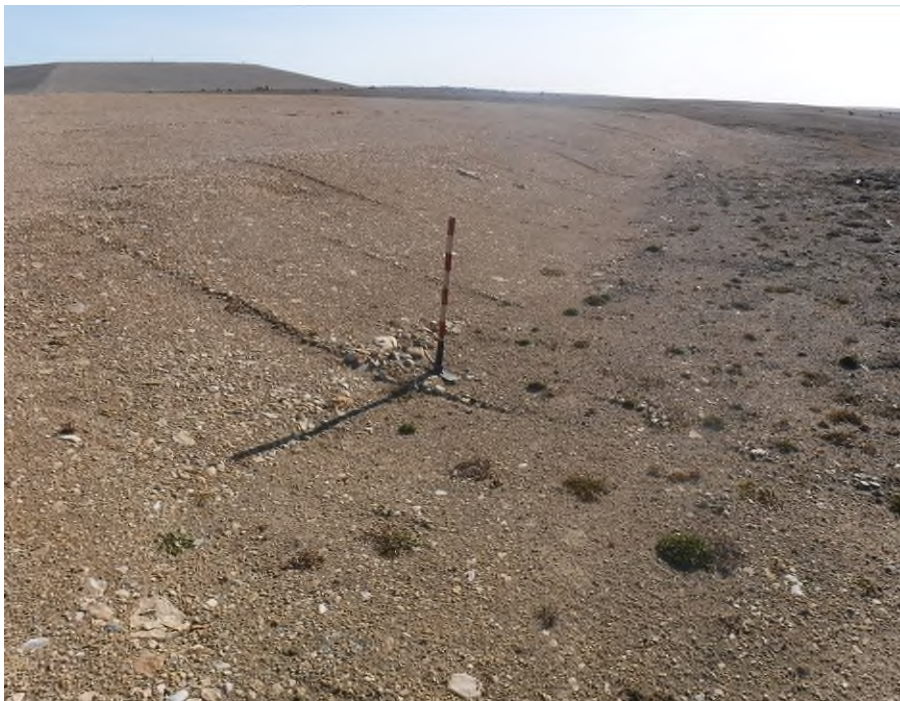
Photo: CAM-1 STNW-30 (Station West Landfill)

Description:
Staining of cover material at southwest corner of landfill (caused by increase soil quantity and reduced granular materials) -looking E.
