**CAM-E KEITH BAY LONG TERM MONITORING EVENT
2020 LONG TERM MONITORING REPORT**

**Crown-Indigenous Relations and Northern Affairs Canada
Contaminants and Remediation Division**

Project Number: 200537
February 18, 2021

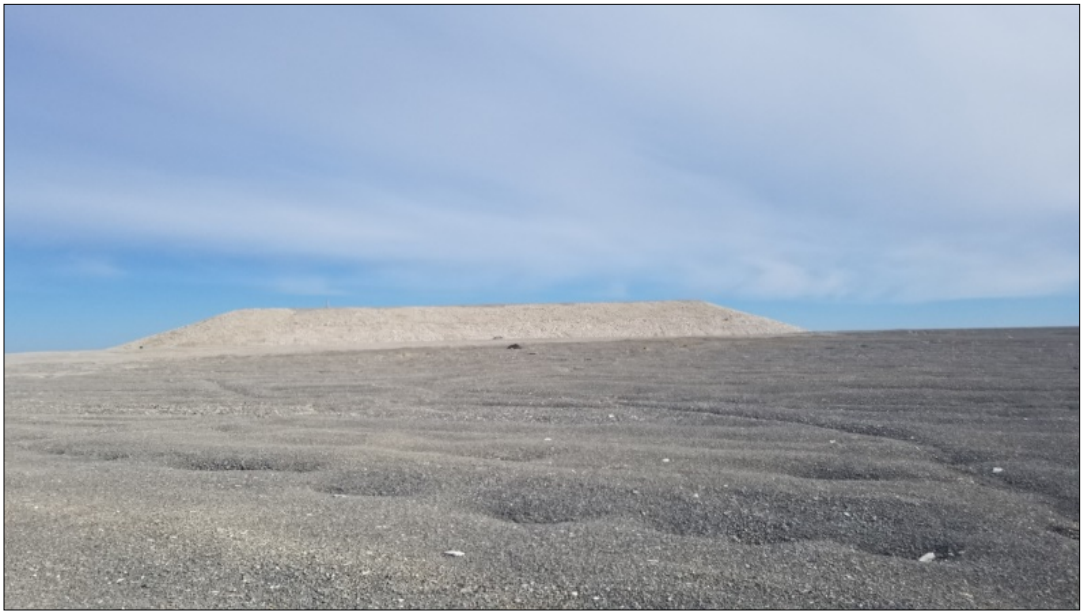
Erosion and settlement were noted in the uncompacted areas around the landfills (Photo 1). At the Tier II landfill, a frost crack leads up to the toe of the south berm but does not appear to affect the landfill (Photo 2). Another crack was found approximately 10 m from the northwest corner of the landfill (Photo 3). Two narrow depressions that appear to be small cracks or potholes were also observed nearby, Photo 4 shows the depression found to the west and Photo 5 shows the depression found by the southwest corner. At the NHWL, there is a frost crack that leads up to the toe of the south berm but does not appear to affect the landfill (Photo 6). To the west of the landfill, there are two more cracks shown in Photo 7 and 8. A washboard was noted south of the NHWL (Photo 9)

Photo 1: Erosion around the landfill.

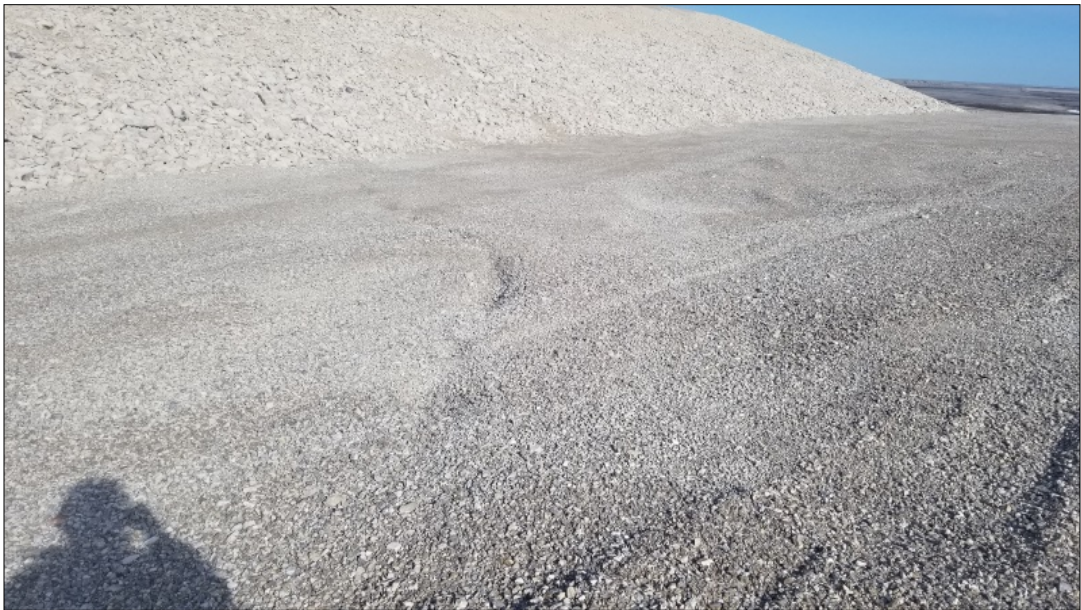
Photo 2: Crack adjacent to Tier II Landfill.

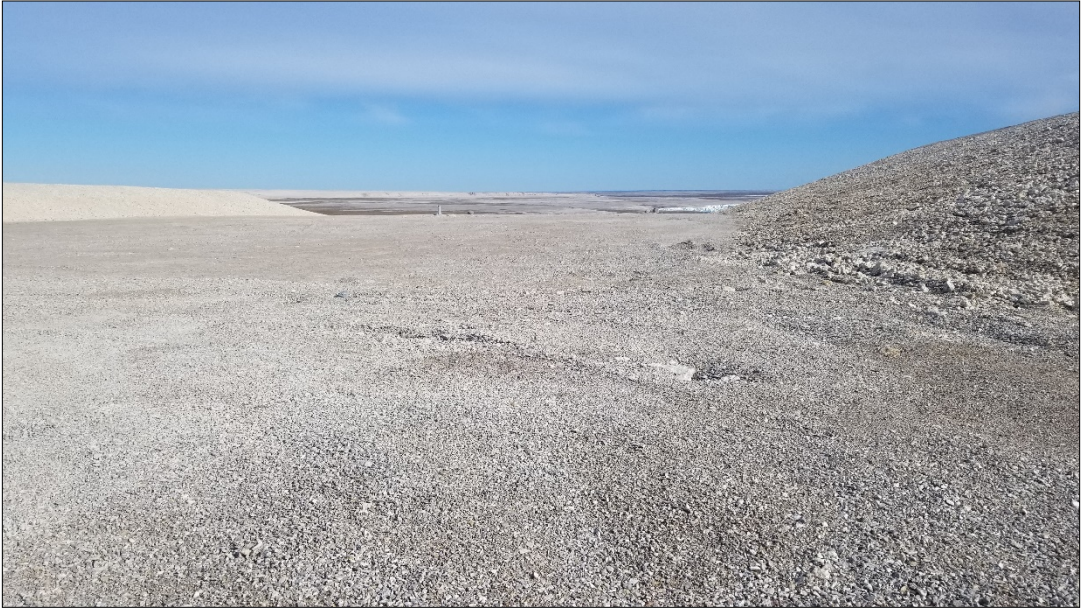
Photo 3: Crack Northwest of Tier II Landfill

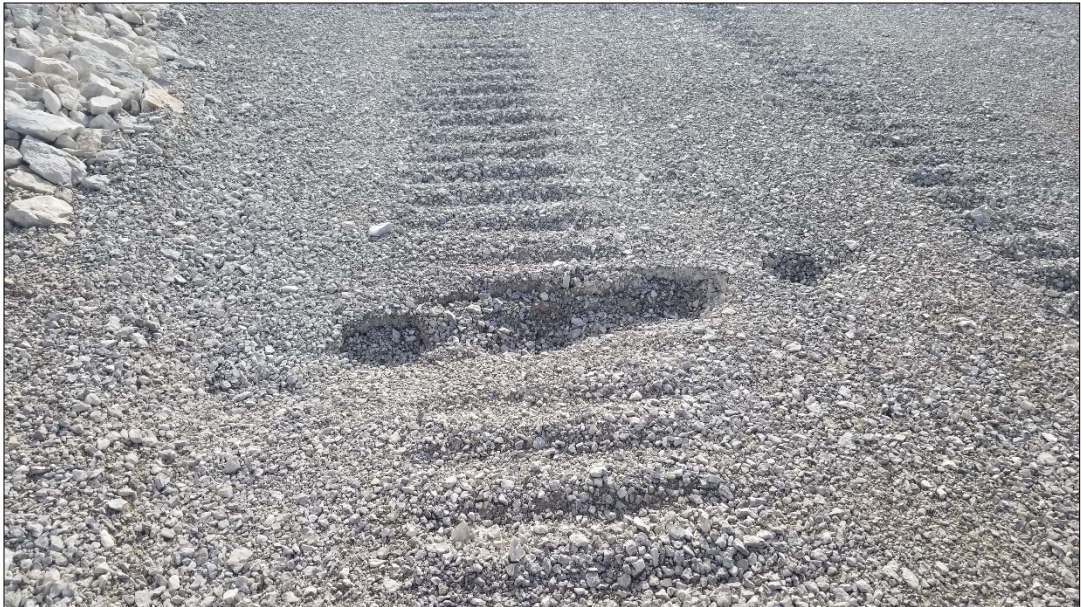
Photo 4: Small Depression West of Tier II Landfill

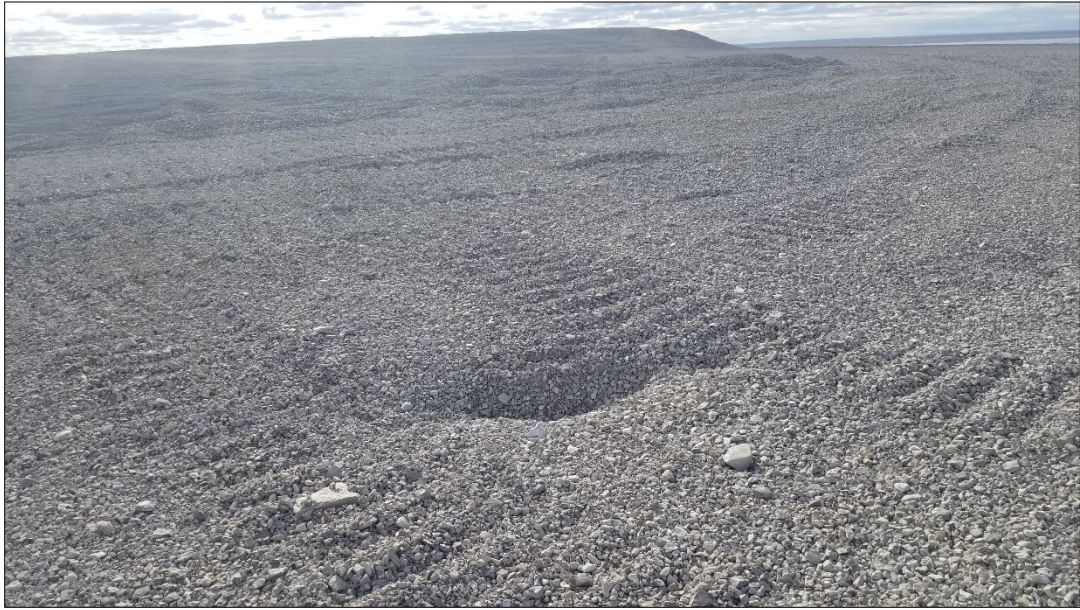
H	Settlement	SW of the Tier II Landfill	<1%	Narrow depression that appears to be a pothole or crack. small 0.25m wide by 1 m long depression to the south west of the Tier II Landfill. Does not appear to have any effect on the integrity of the landfill.	61, 64
I	Animal Burrow	E Berm of Tier II Landfill	<1%	Attempted burrow 0.85 m in diameter.	72, 73

Photo 5: Small Depression Southwest of Tier II Landfill

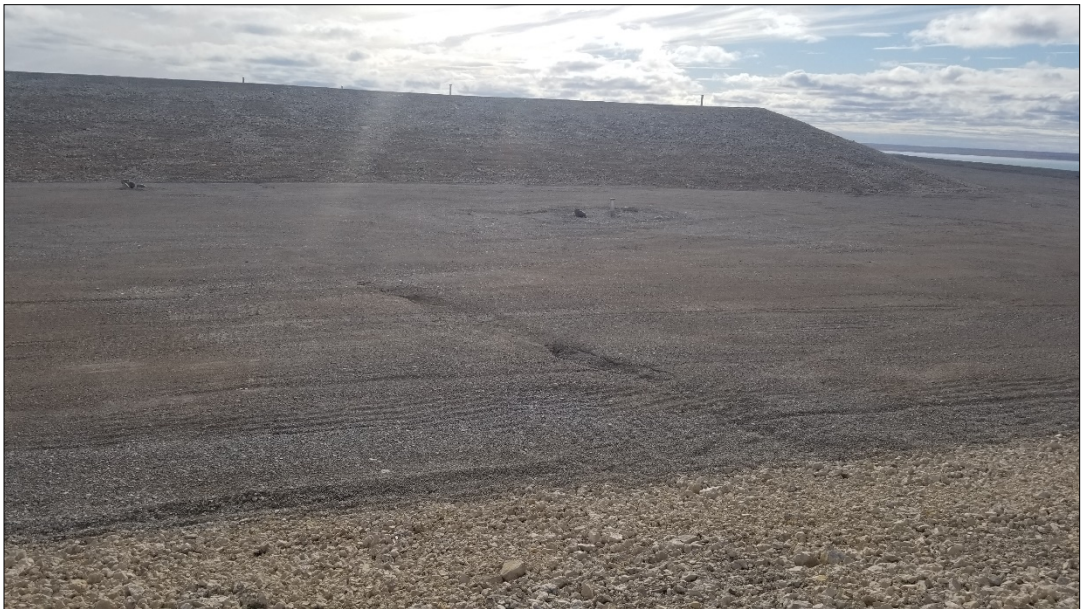
Photo 6: Crack adjacent to Non-Hazardous Waste Landfill.

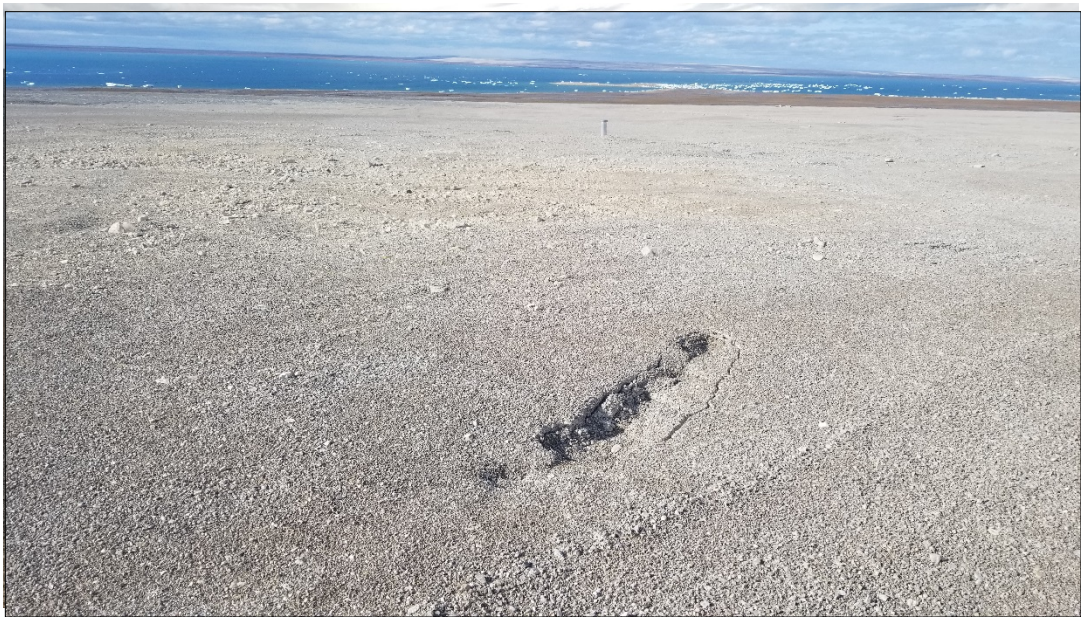
Photo 7: Small Crack West of Non-Hazardous Waste Landfill

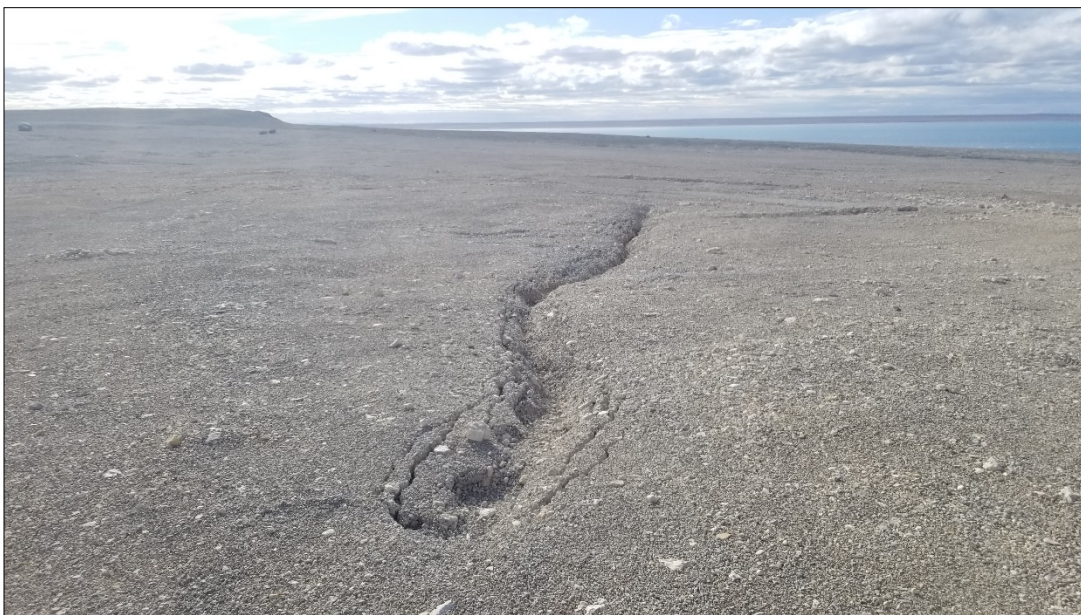
Photo 8: Large Crack West of Non-Hazardous Waste Landfill

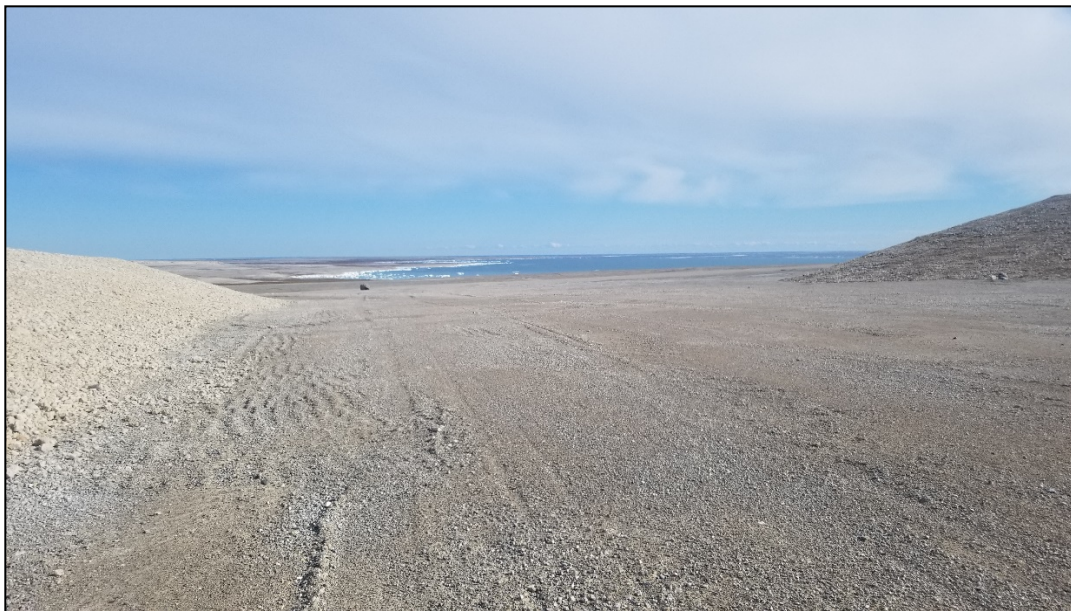
Photo 9: Washboard South of Non-Hazardous Waste Landfill.

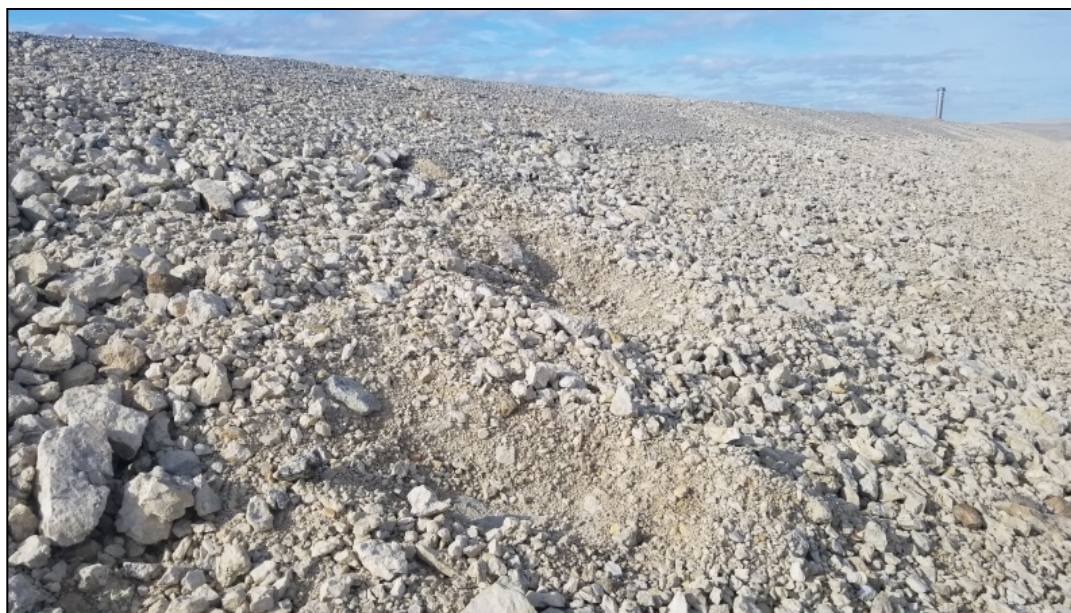
An attempted animal burrow was located on the east berm of the Tier II landfill. The disturbance was shallow and does not appear to impact the landfill (Photo 10). Natural re-vegetation has not yet begun at the site. Seepage and staining were not present and the site was clear of any debris.

Photo 10: Attempted Animal Burrow.

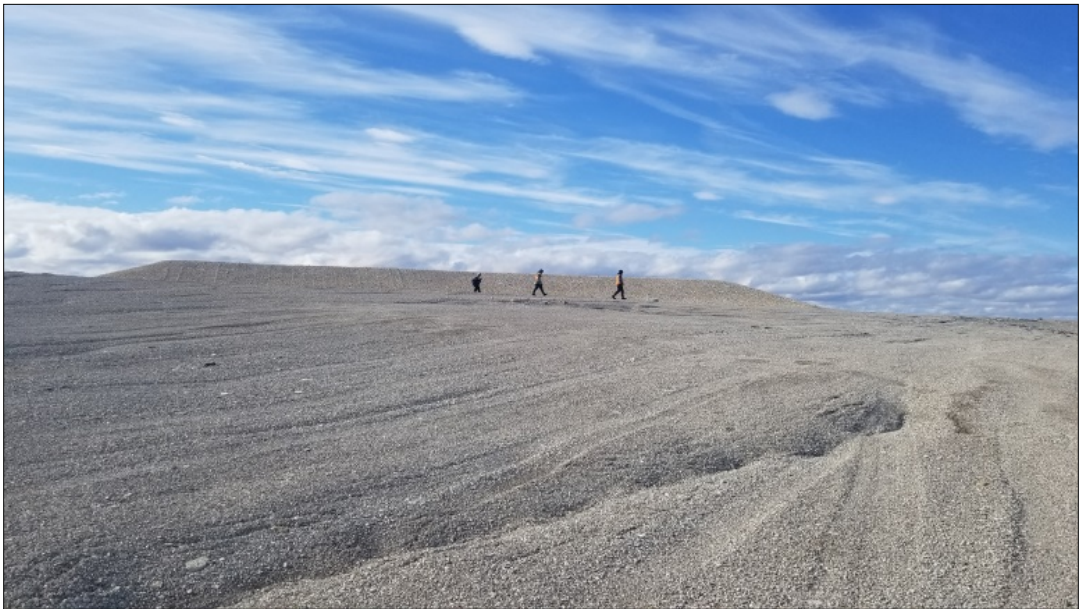
There was no evidence of revegetation observed on the landfill (Photo 14).

Photo 14: Limited vegetation observed on site.

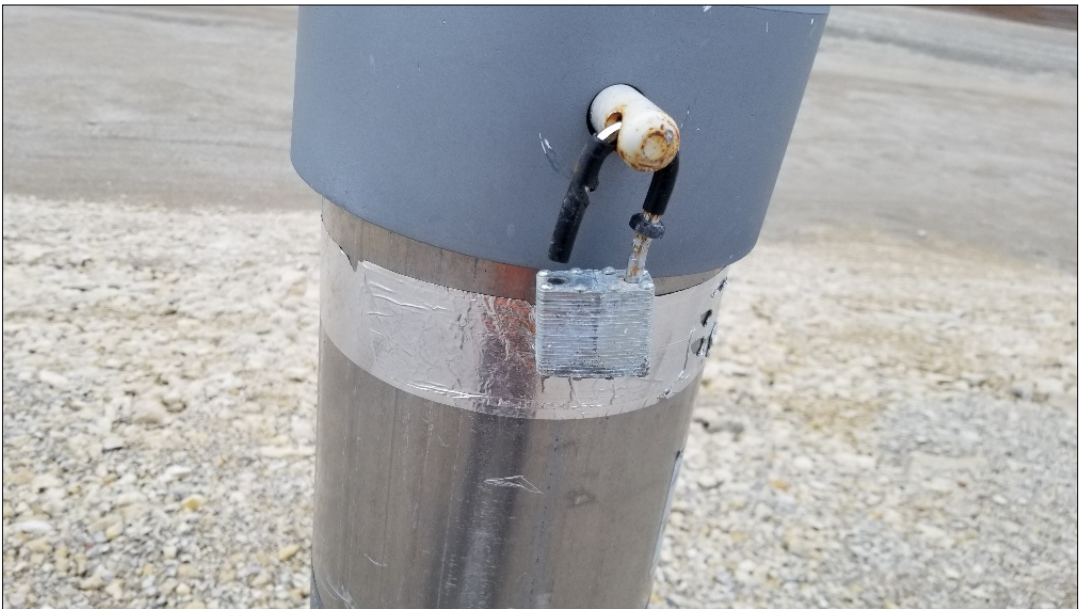
BluMetric was successful at downloading the raw data from the thermistors after which they were reset. It was noted that the key to open the thermistors was not the correct one and the locks were cut to access the thermistors. The security pins were put back in place after the data was downloaded to prevent thermistor exposure to rain, snow, and sunlight and to allow future access (see Photos 15 through 17). Replacement locks should be brought to site during the next monitoring event to secure the thermistors.

Photo 16: Cut thermistor lock.

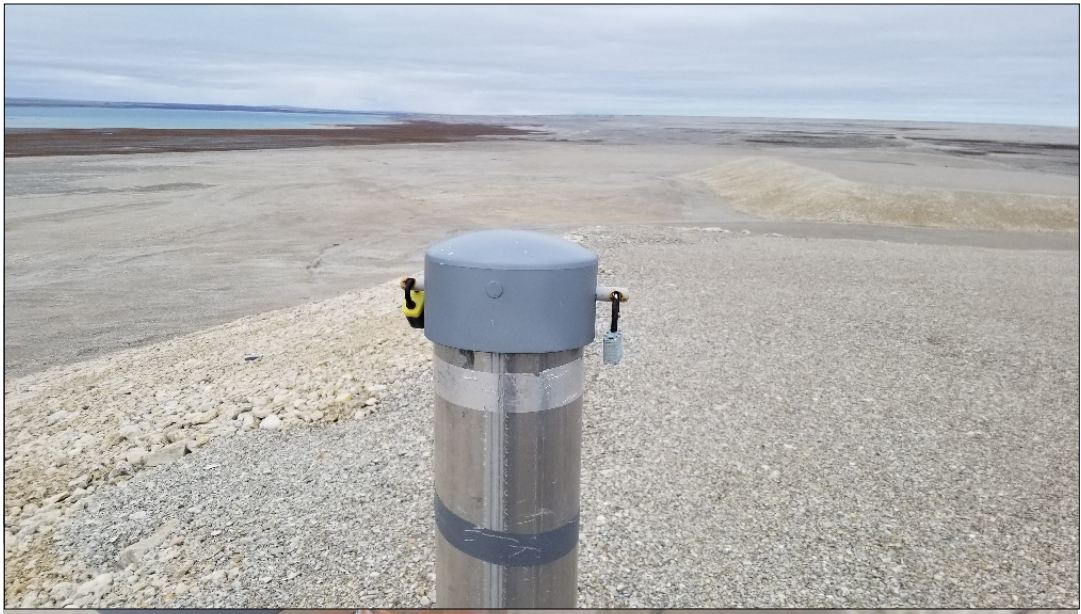
Photo 17: Condition of thermistor at end of site visit.
