**RE: CAM-E (Keith Bay) Remediation Project: 2018 Annual Report  
for Water Licence No: 1BR-KEI1722**

NWB Annual Report

License No: 1BR-KEI1722

Project Name: CAM-E (Keith Bay) Site Remediation

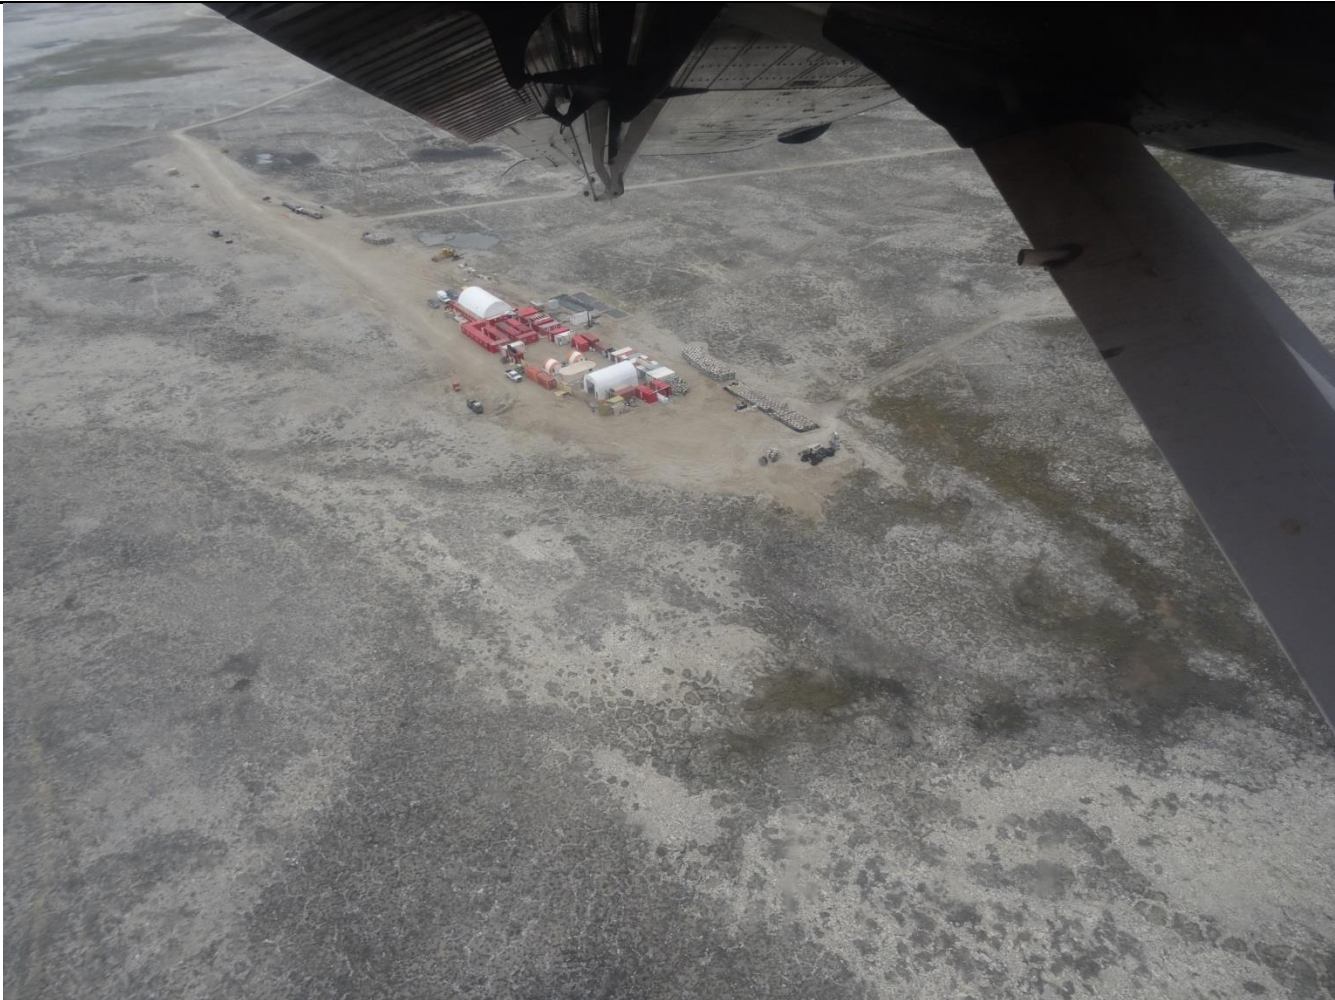
Photo 1

Description: Aerial View of the CAM-E Keith Bay Remediation Camp

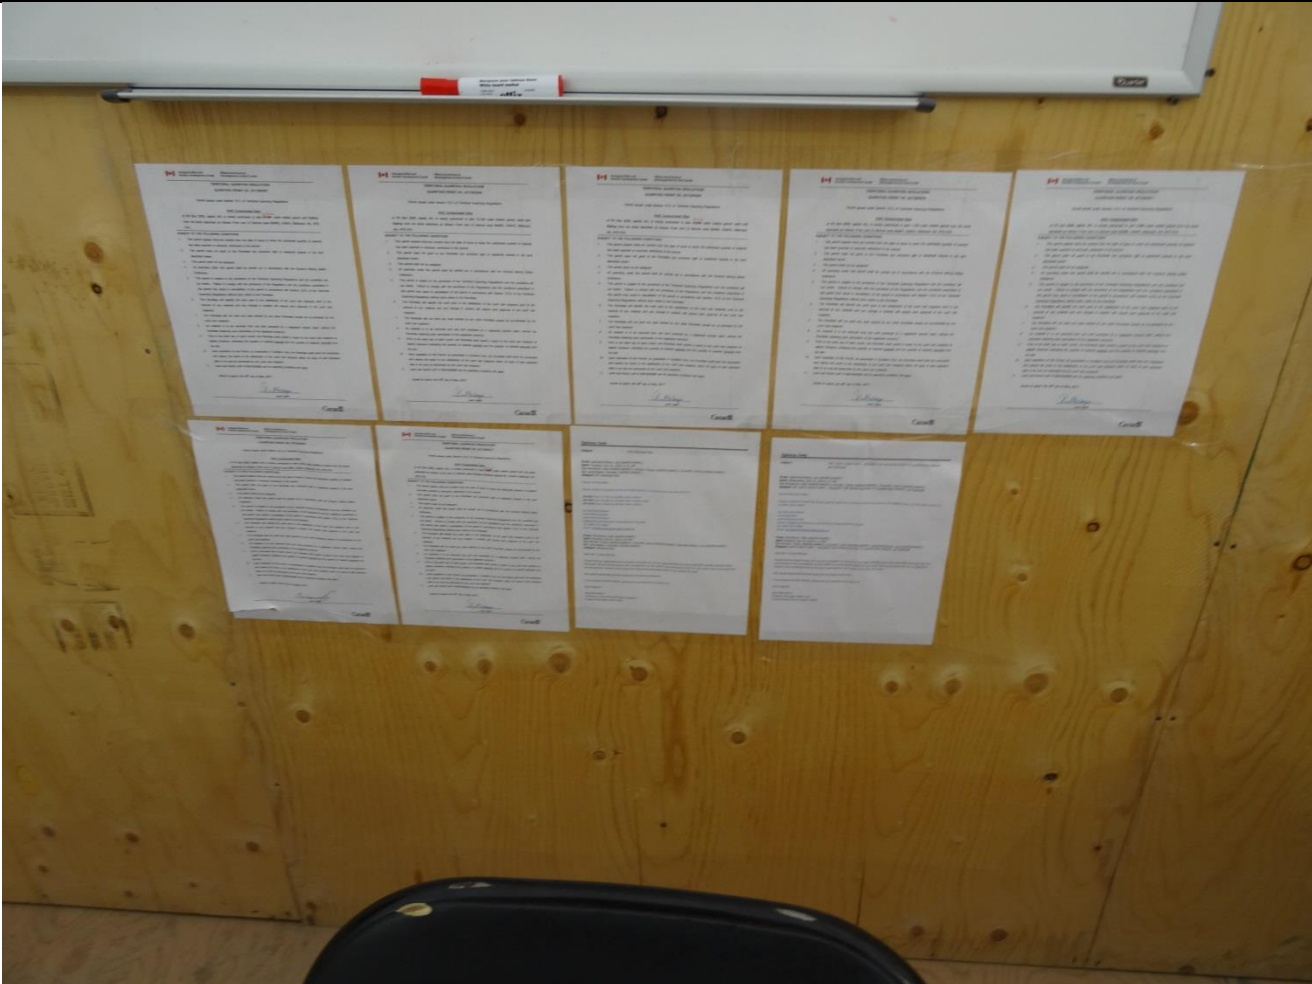
Photo 2

Description: All Permits & Authorizations Posted on Wall in Dinning Hall

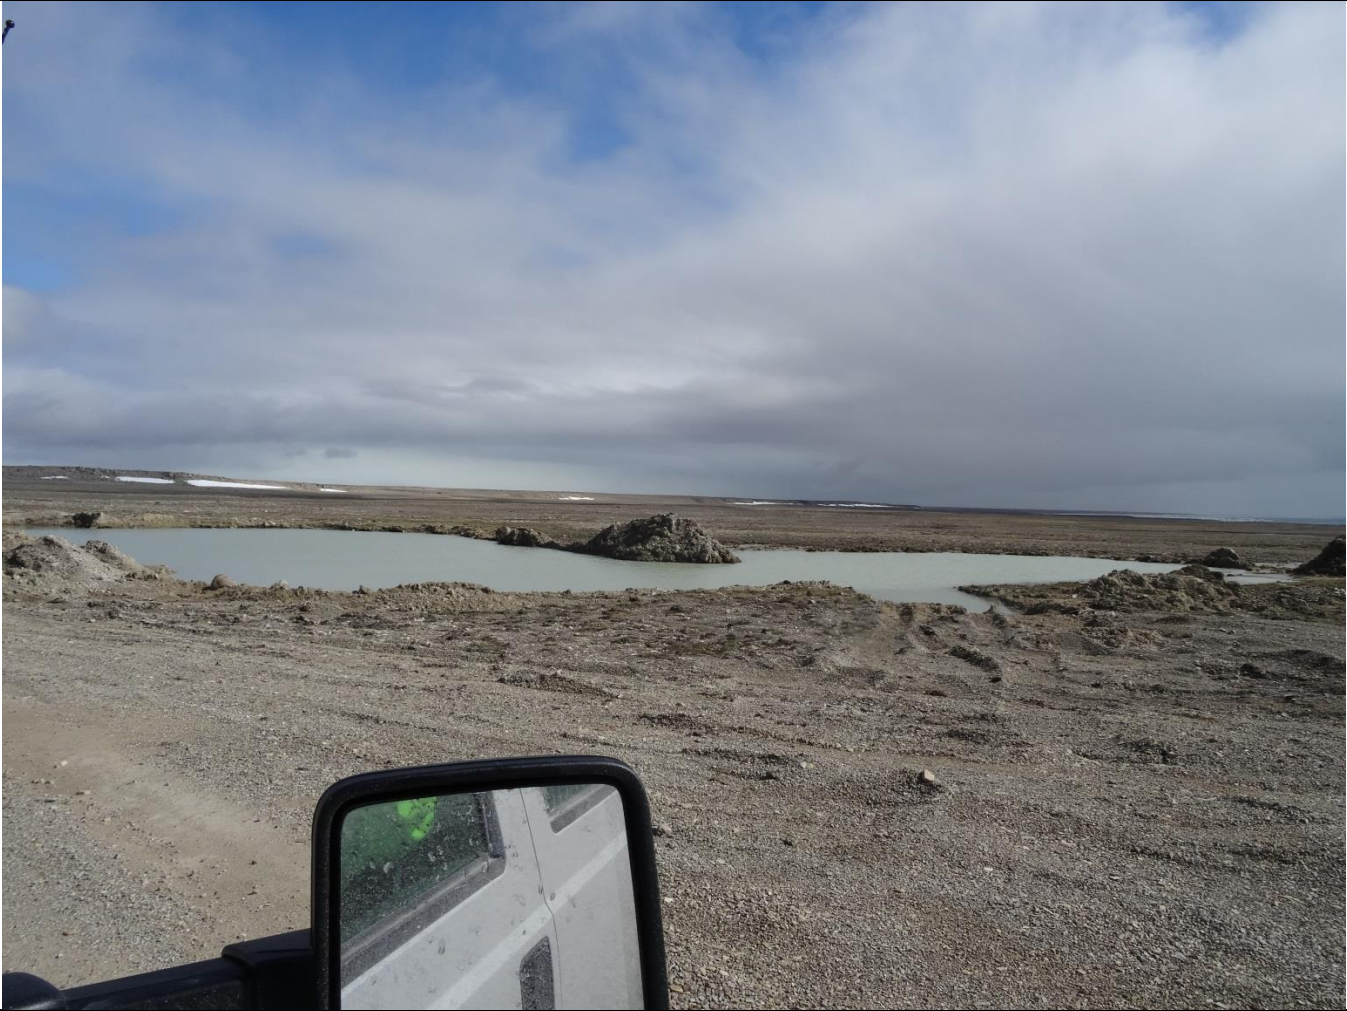
Photo 7

Description: Borrow Area B

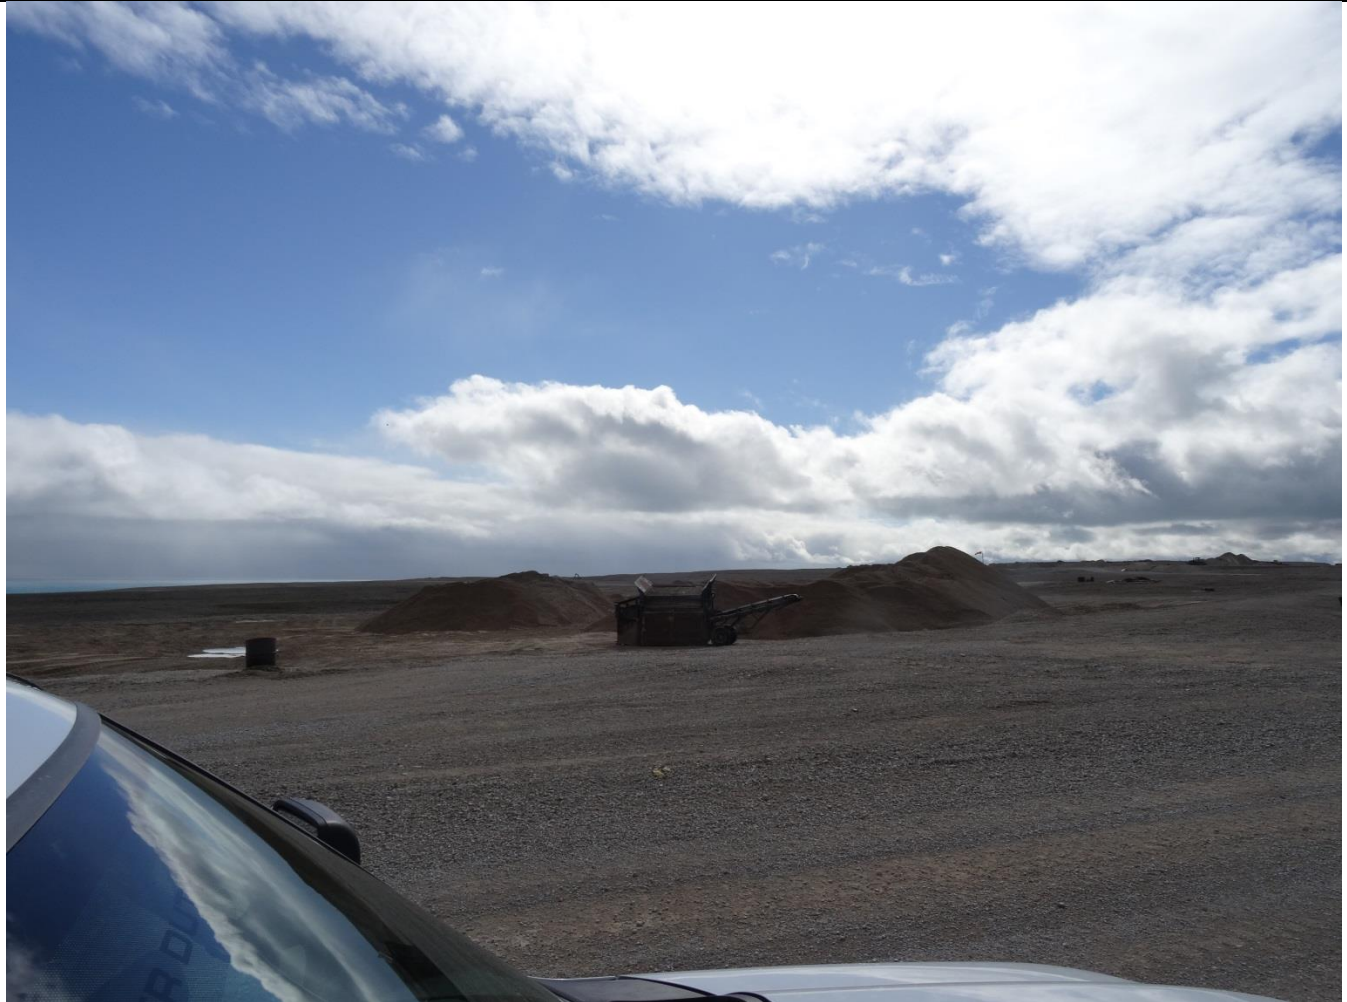
Photo 8

Description: Borrow Area #2

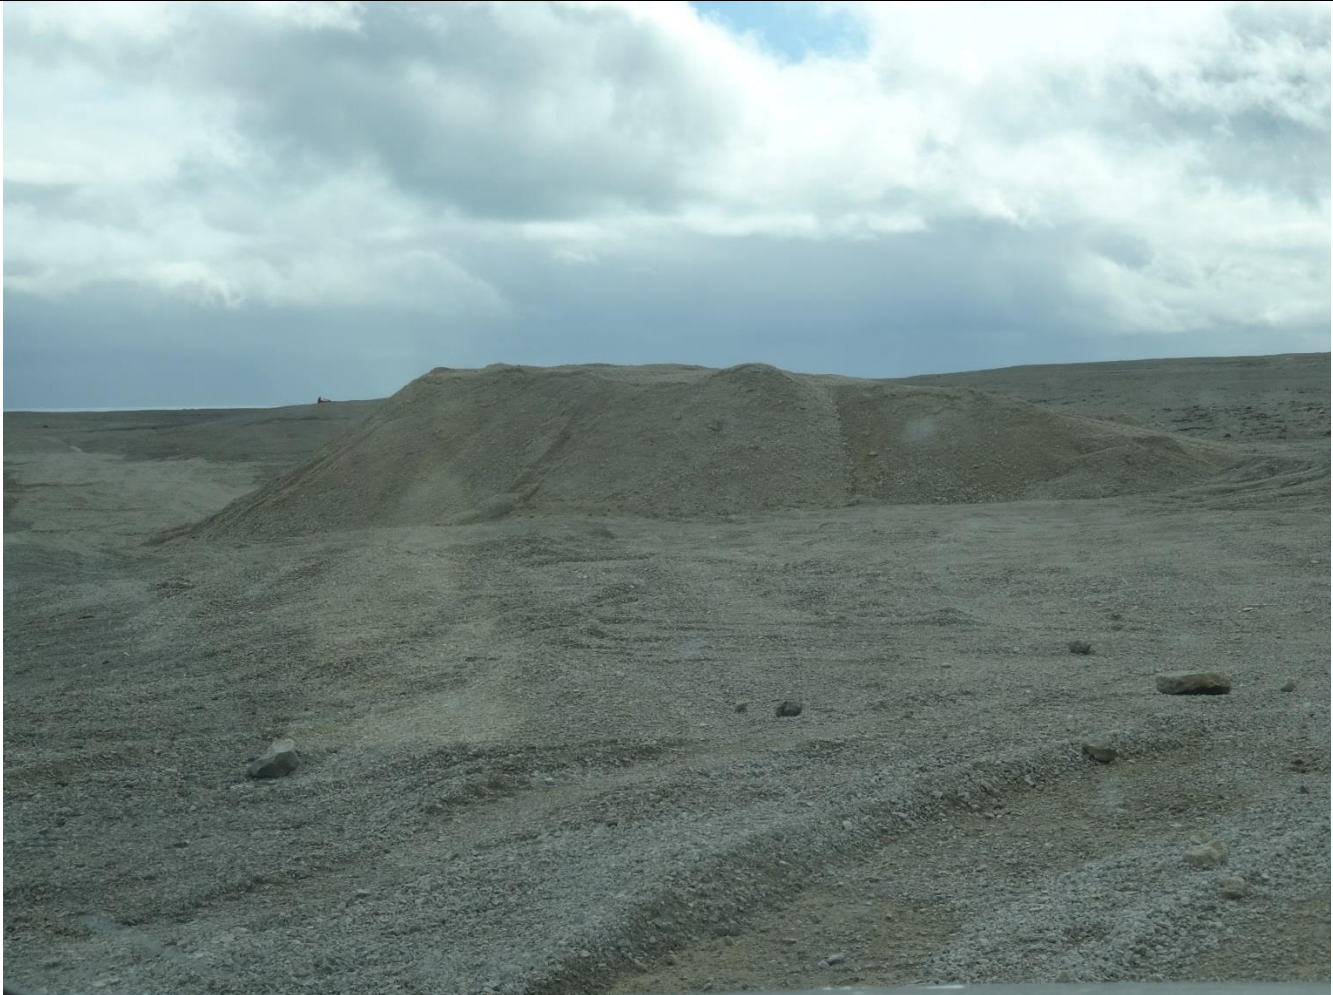
Photo 9

Description: Treated Type B Material from Land Farm

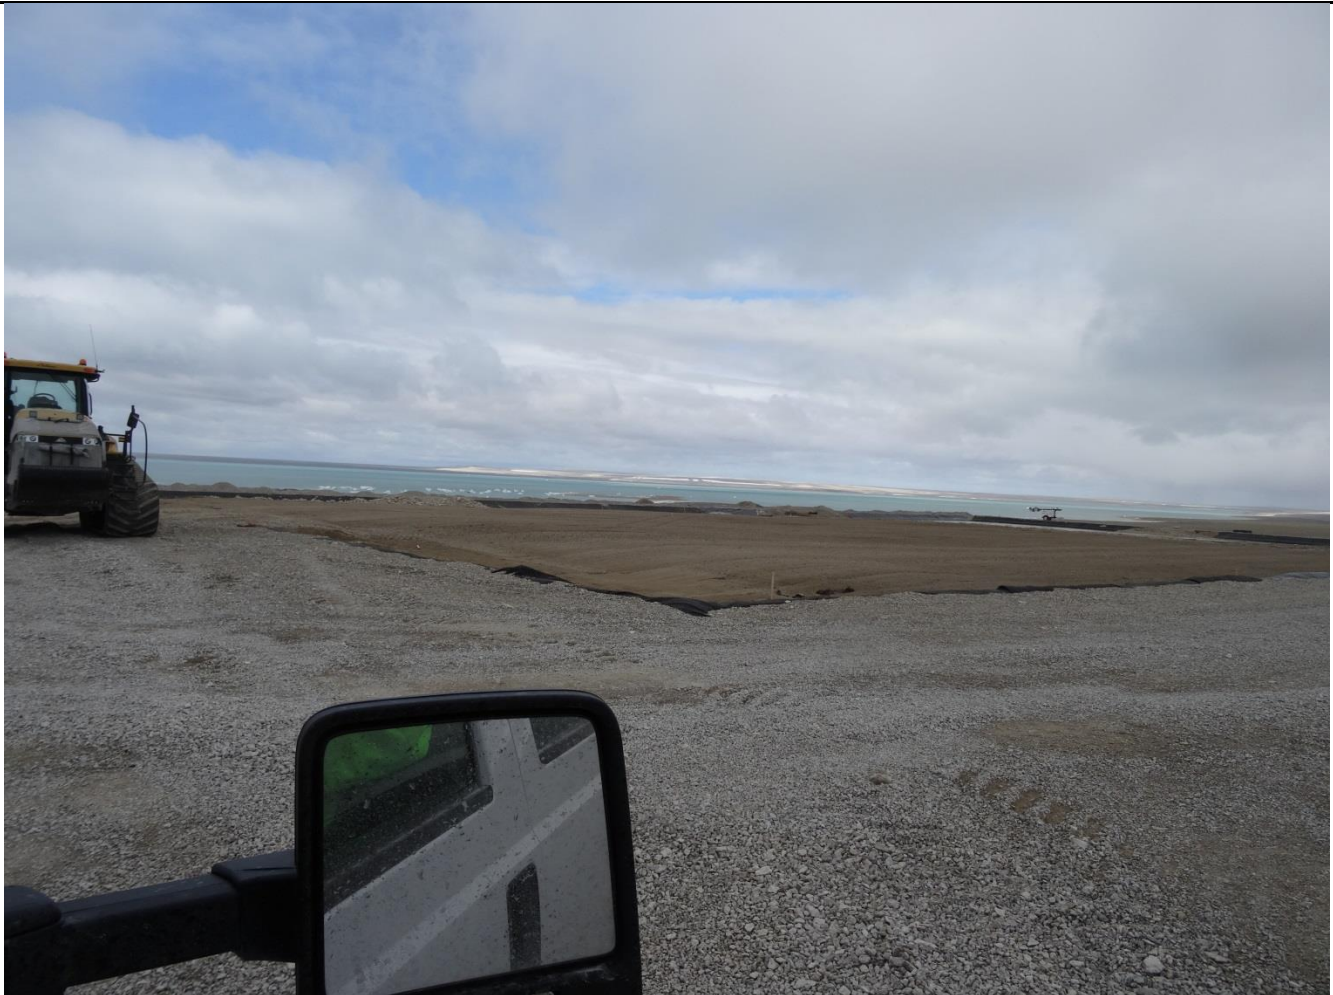
Photo 10

Description: Active Land Farm

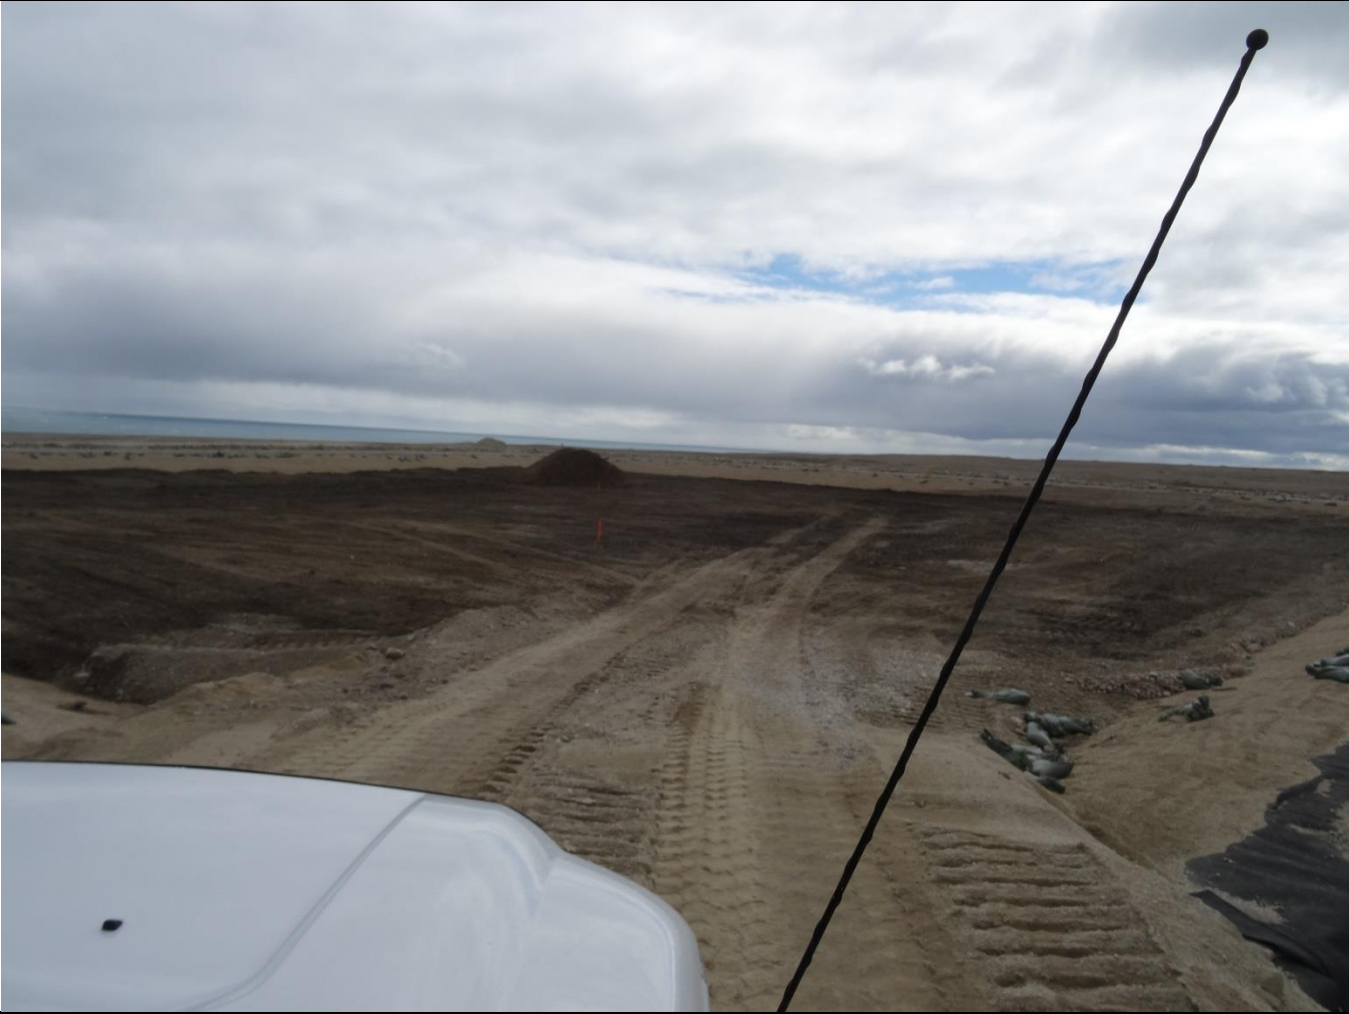
Photo 11

Description: Tier II Facility

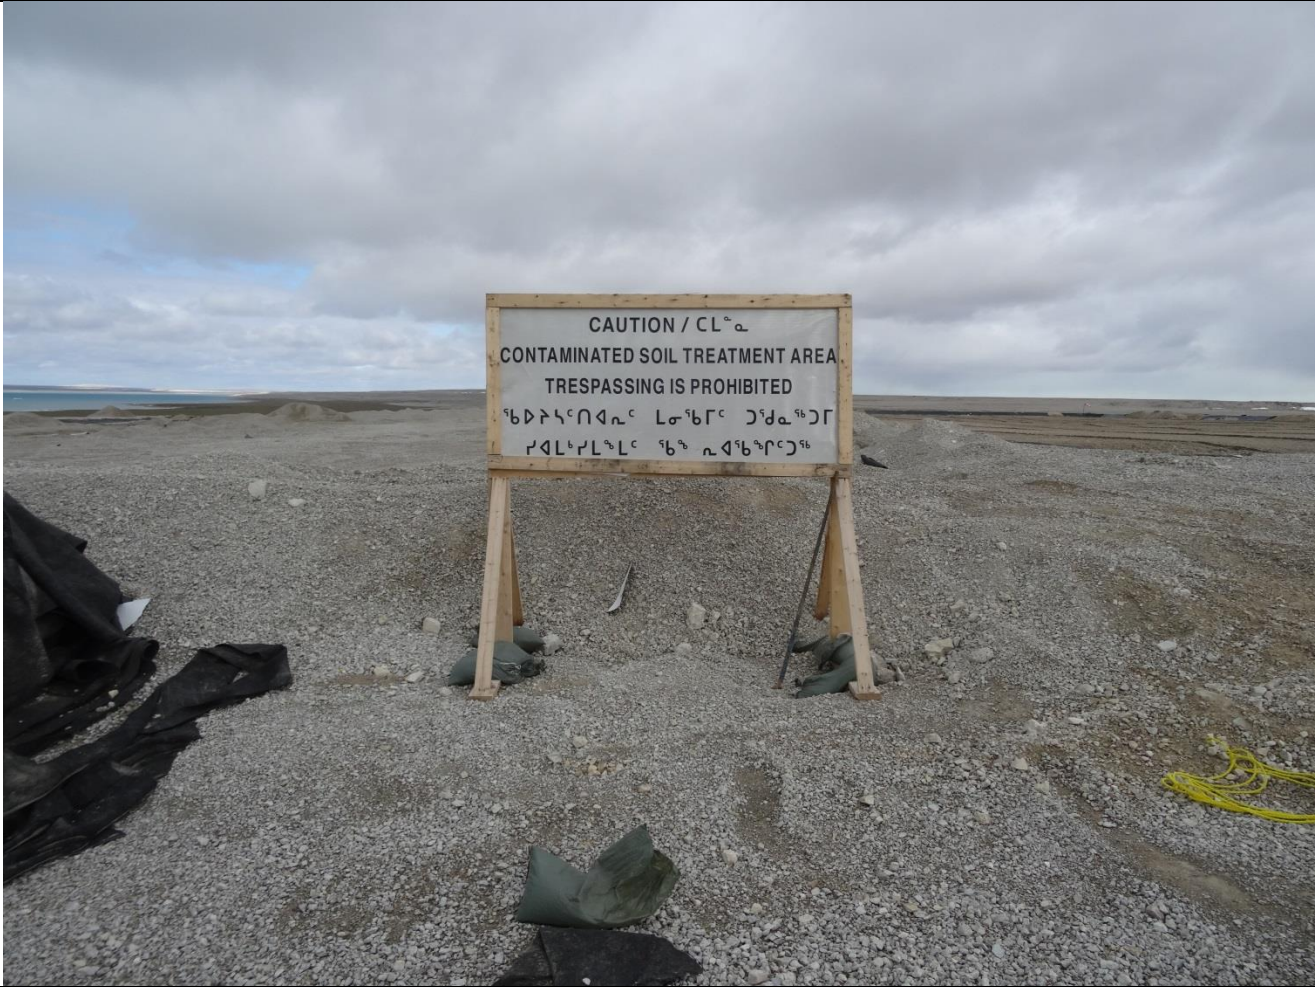
Photo 12

Description: Tier II Facility Signage

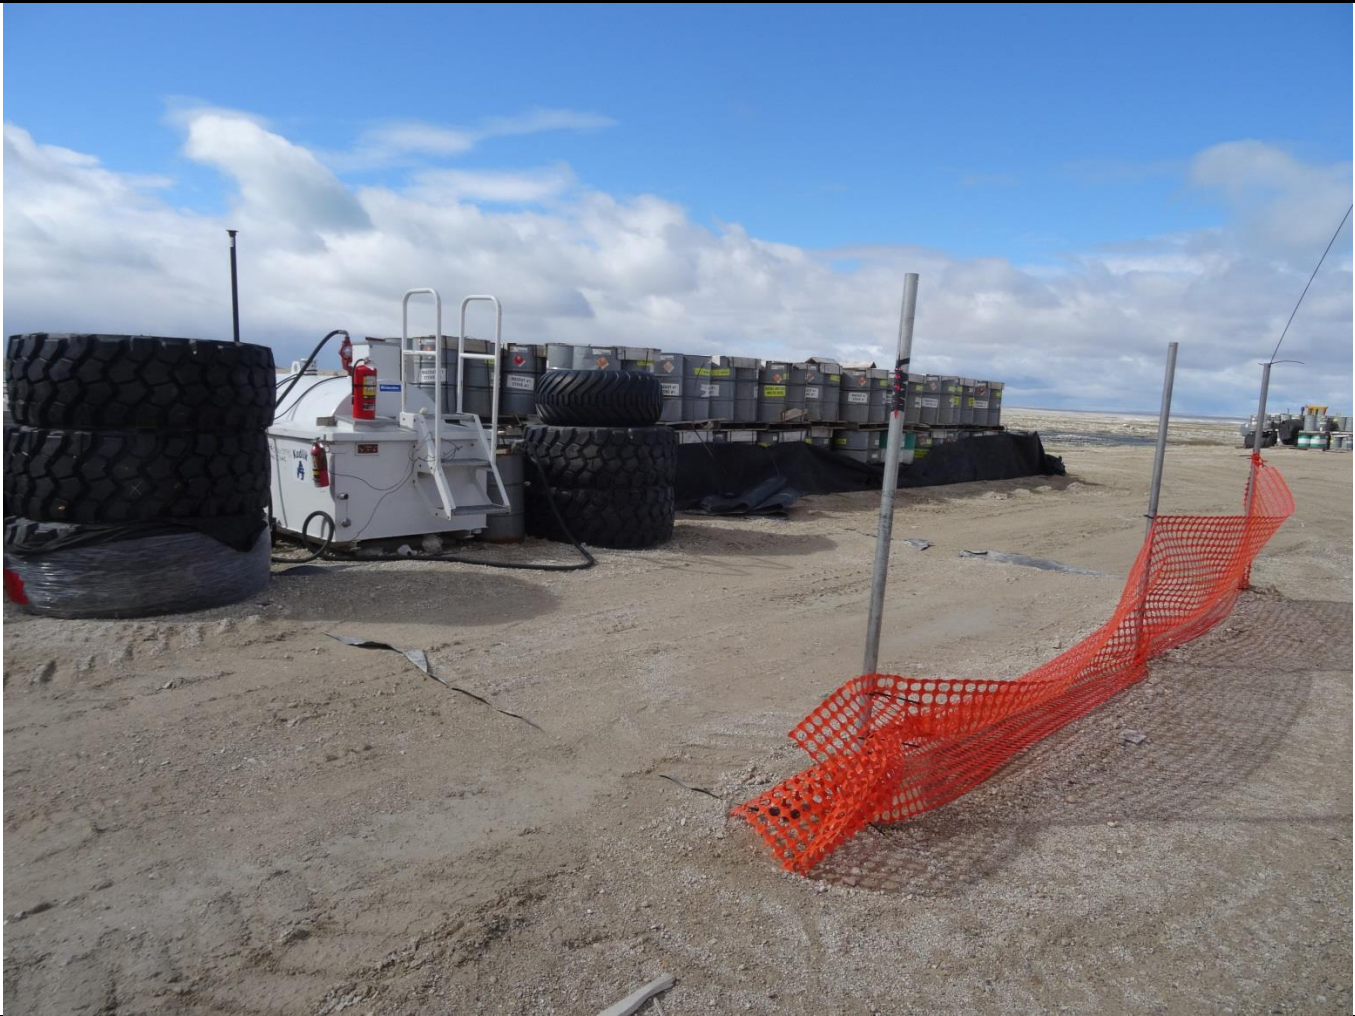
Photo 13

Description: Diesel Truck-Fill Station

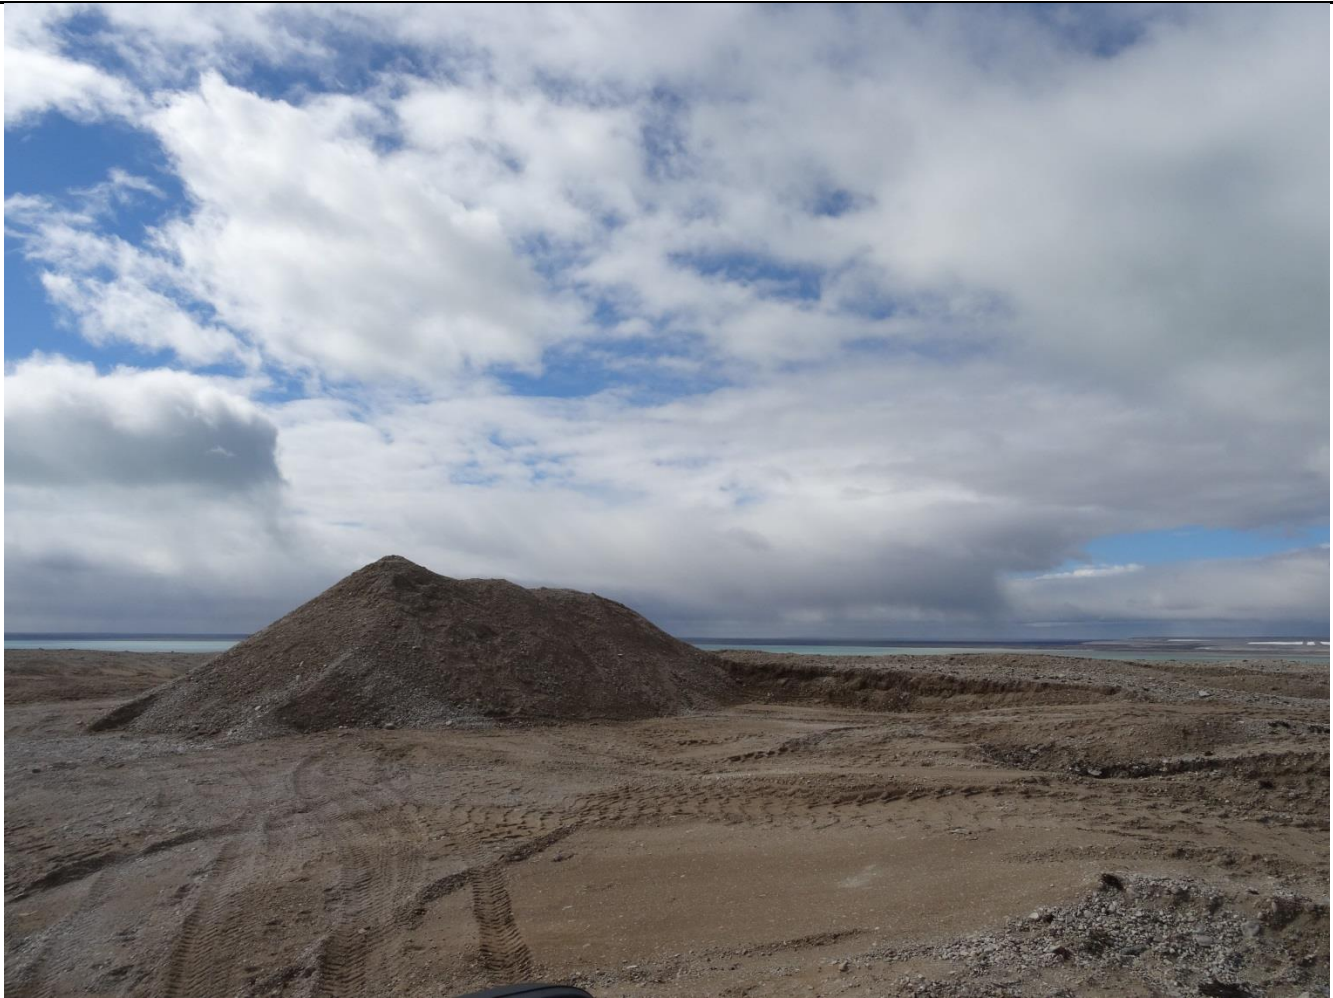
Photo 14

Description: Borrow Area #8
