## **CAM-E KEITH BAY LONG TERM MONITORING EVENT 2020 LONG TERM MONITORING REPORT**

Crown-Indigenous Relations  
and Northern Affairs Canada

Project Number: 200537  
March 12, 2021

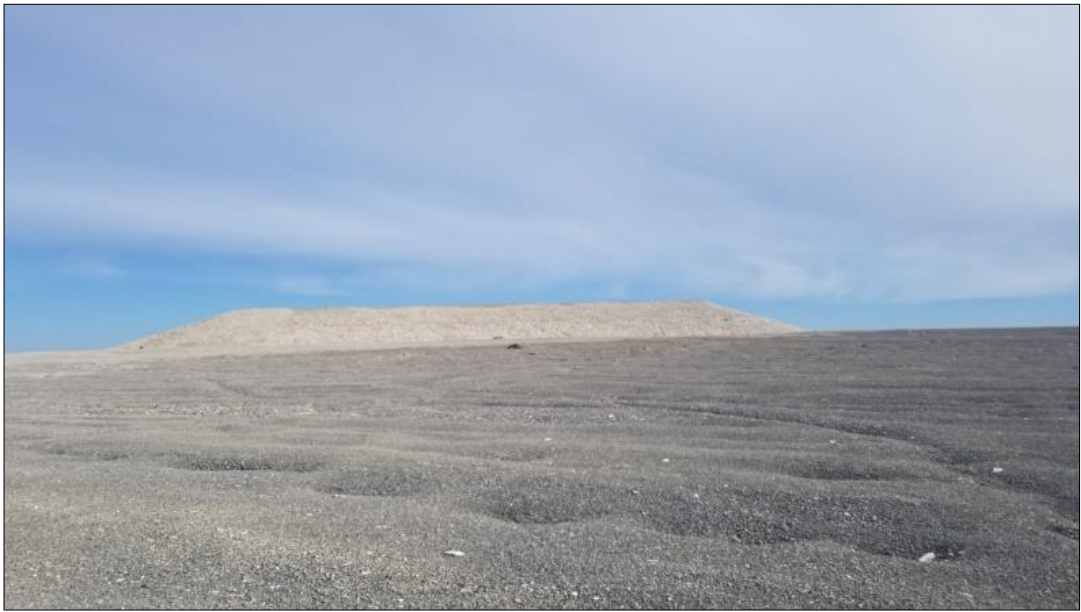
Erosion and settlement were noted in the uncompacted areas around the landfills (Photo 1). At the Tier II landfill, a frost crack leads up to the toe of the south berm but does not appear to affect the landfill (Photo 2). Another crack was found approximately 10 m from the northwest corner of the landfill (Photo 3). Two narrow depressions that appear to be small cracks or potholes were also observed nearby, Photo 4 shows the depression found to the west and Photo 5 shows the depression found by the southwest corner. At the NHWL, there is a frost crack that leads up to the toe of the south berm but does not appear to affect the landfill (Photo 6). To the west of the landfill, there are two more cracks shown in Photo 7 and 8. A washboard was noted south of the NHWL (Photo 9)

Photo 1: Erosion around the Tier II Landfill.

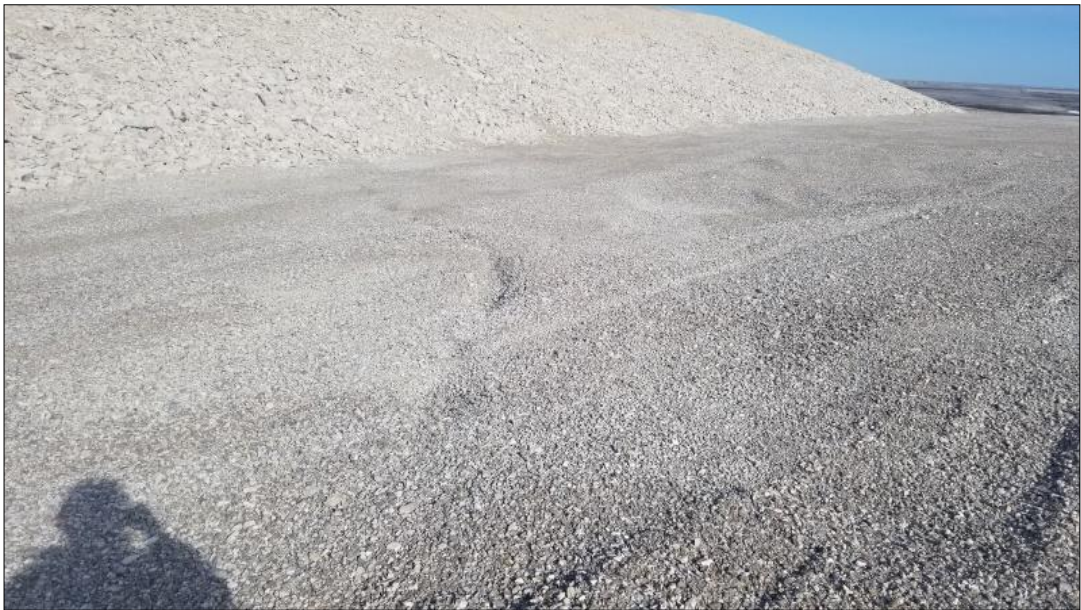
Photo 2: Crack adjacent to Tier II Landfill.

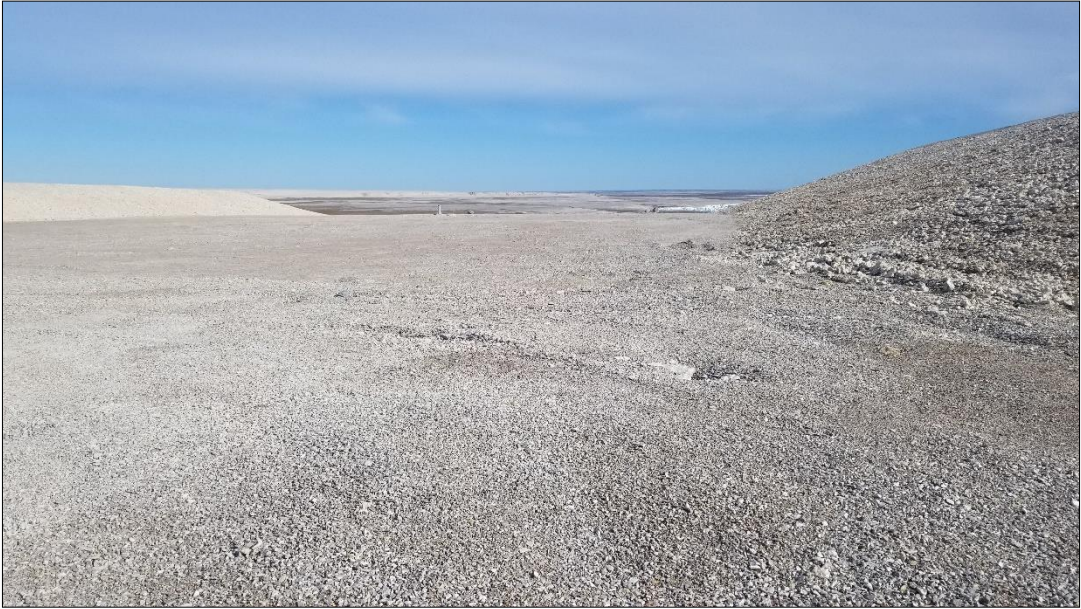
| Feature Letter | Feature Type | Location | Extent | Description/Change Comments | Photos |
|---|---|---|---|---|---|
| <b>C</b> | Settlement | By NW corner of Tier II landfill | <1% | Horizontal crack, 0.27 m wide and approximately 3 m long running NE. | 11 |

Photo 3: Crack Northwest of Tier II Landfill.

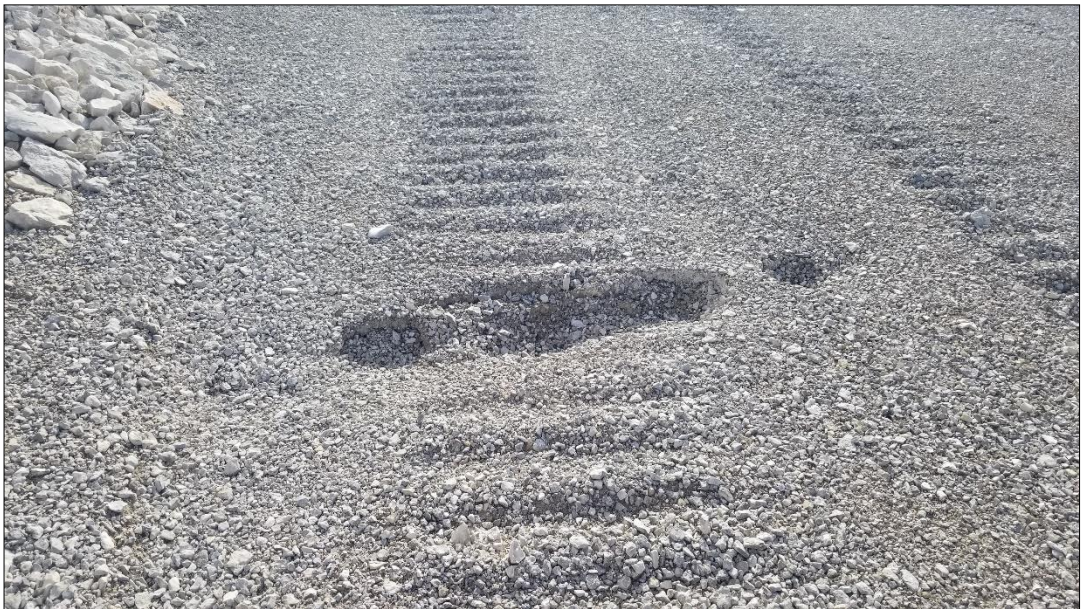
| Feature Letter | Feature Type | Location | Extent | Description/Change Comments | Photos |
|---|---|---|---|---|---|
| <b>G</b> | Settlement | W of the Tier II Landfill | <1% | Narrow depression that appears to be a pothole or crack, small 0.27 m wide by 1 m long depression to the west of the Tier II Landfill. Does not appear to have any effect on the integrity of the landfill. | 58, 59, 60 |

Photo 4: Small Depression West of Tier II Landfill.

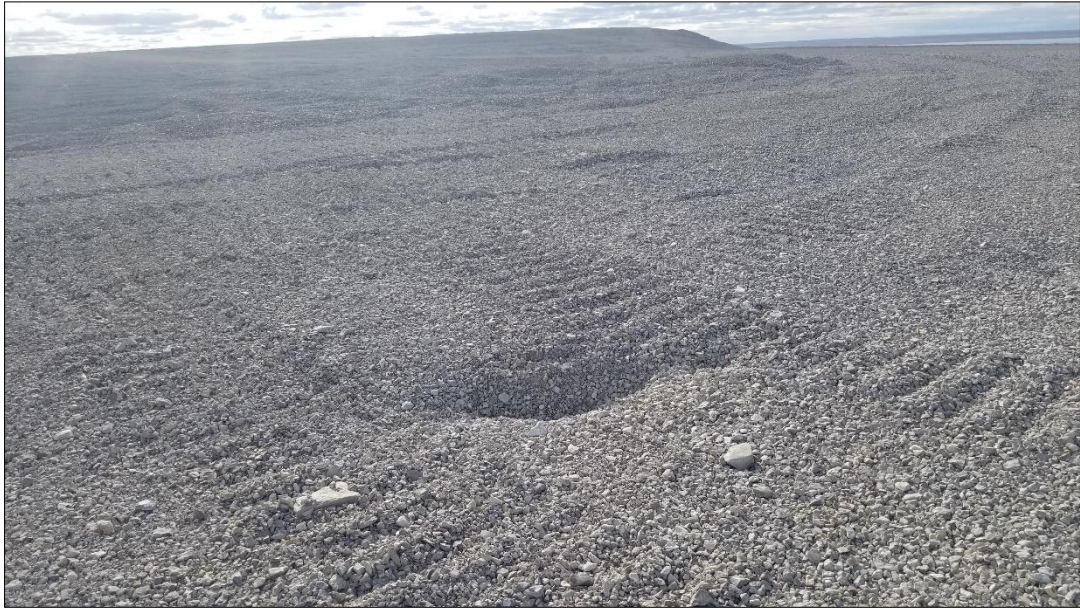
| Feature Letter | Feature Type | Location | Extent | Description/Change Comments | Photos |
|---|---|---|---|---|---|
| <b>H</b> | Settlement | SW of the Tier II Landfill | <1% | Narrow depression that appears to be a pothole or crack. small 0.25m wide by 1 m long depression to the south west of the Tier II Landfill. Does not appear to have any effect on the integrity of the landfill. | 61, 64 |

Photo 5: Small Depression Southwest of Tier II Landfill.

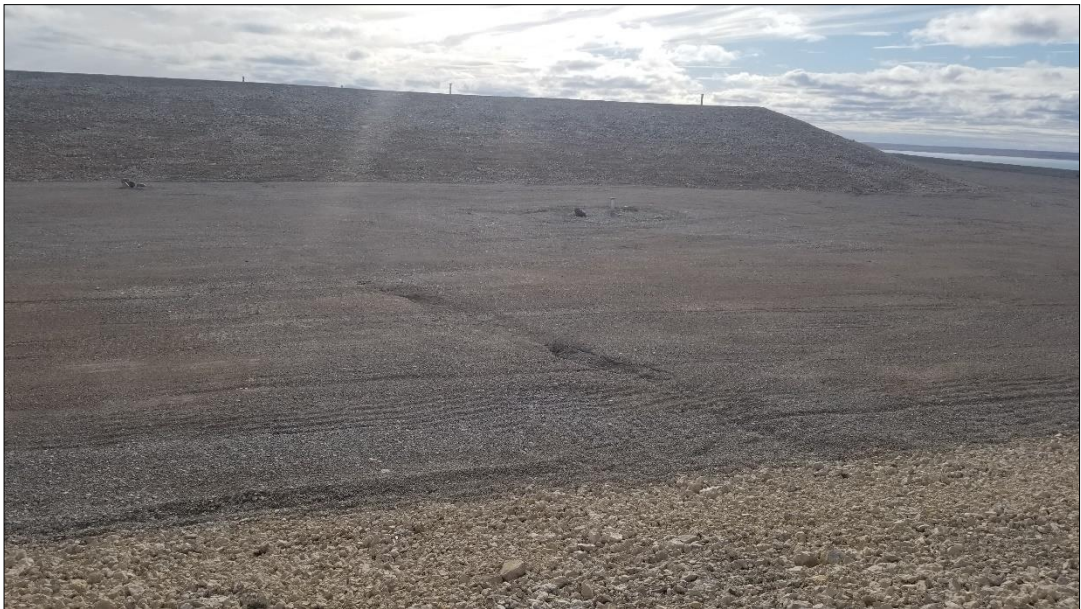
Photo 6: Crack adjacent to Non-Hazardous Waste Landfill.

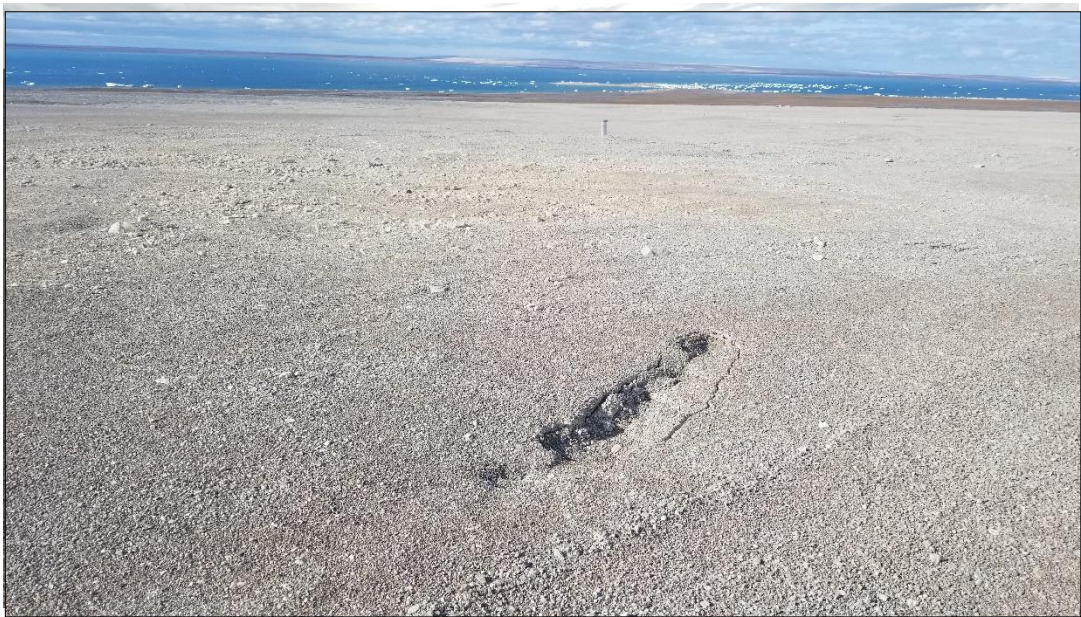
| Feature Letter | Feature Type | Location | Extent | Description/Change Comments | Photos |
|---|---|---|---|---|---|
| <b>F</b> | Settlement | W of NHWL | <1% | Two horizontal cracks. Smaller crack 0.4 m wide by approximately 2m long, and larger crack 0.44 m wide at the west end, 0.84 m wide at the east end and approximately 5 m long, both to the west of the NHWL. | 47, 48, 49, 50 |

Photo 7: Small Crack West of Non-Hazardous Waste Landfill.

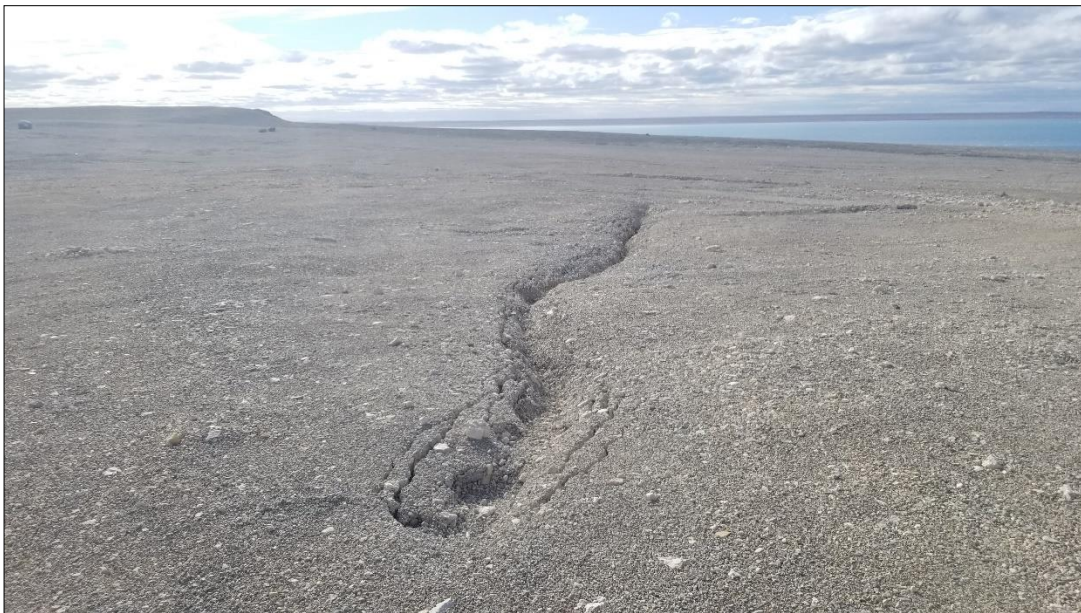
Photo 8: Large Crack West of Non-Hazardous Waste Landfill.

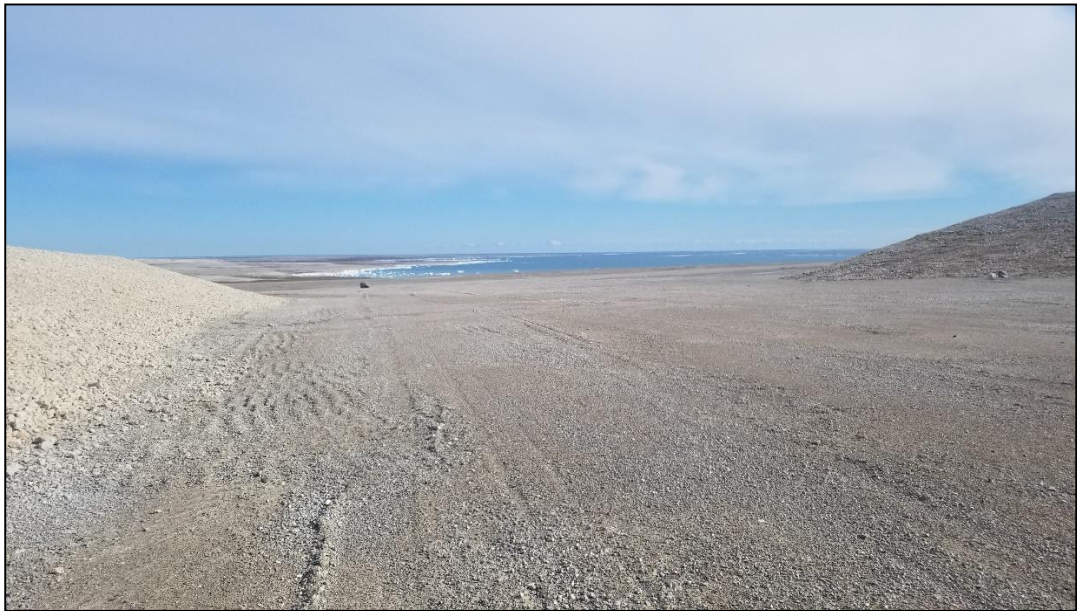
Photo 9: Washboard South of Non-Hazardous Waste Landfill.

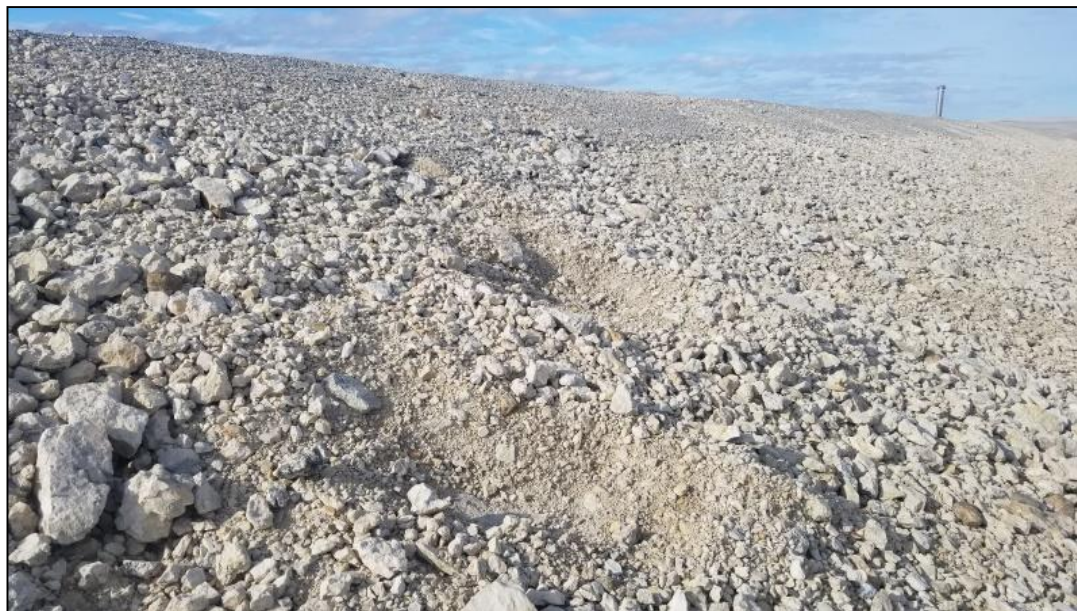
An attempted animal burrow was located on the east berm of the Tier II landfill. The disturbance was shallow and does not appear to impact the landfill (Photo 10). Natural re-vegetation has not yet begun at the site. Seepage and staining were not present and the site was clear of any debris.

Photo 10: Attempted Animal Burrow.

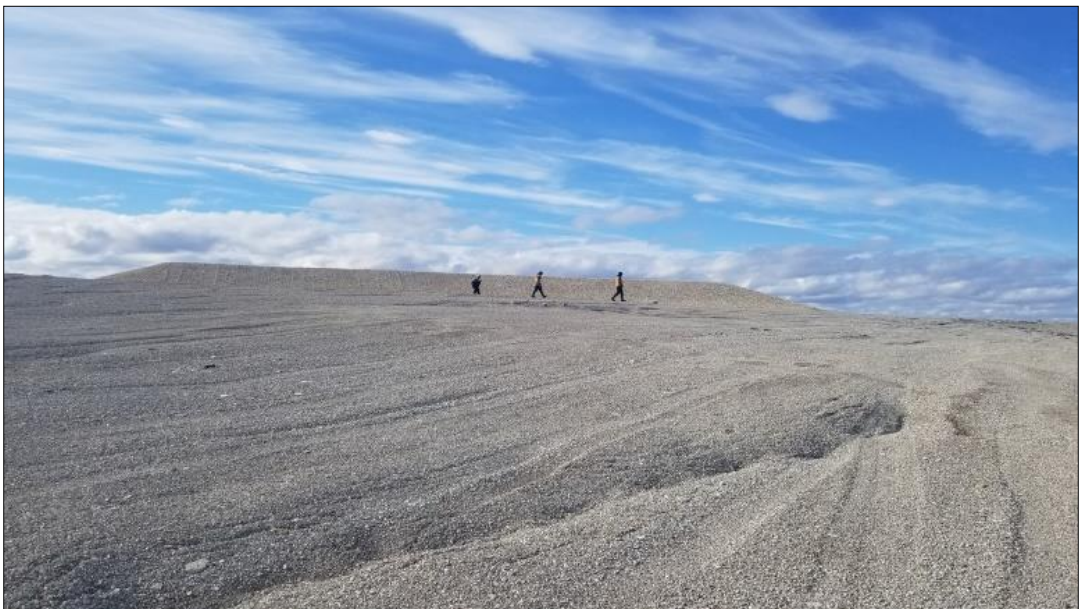
There was no evidence of revegetation observed on the landfill (Photo 14).

Photo 14: Limited vegetation observed on site.

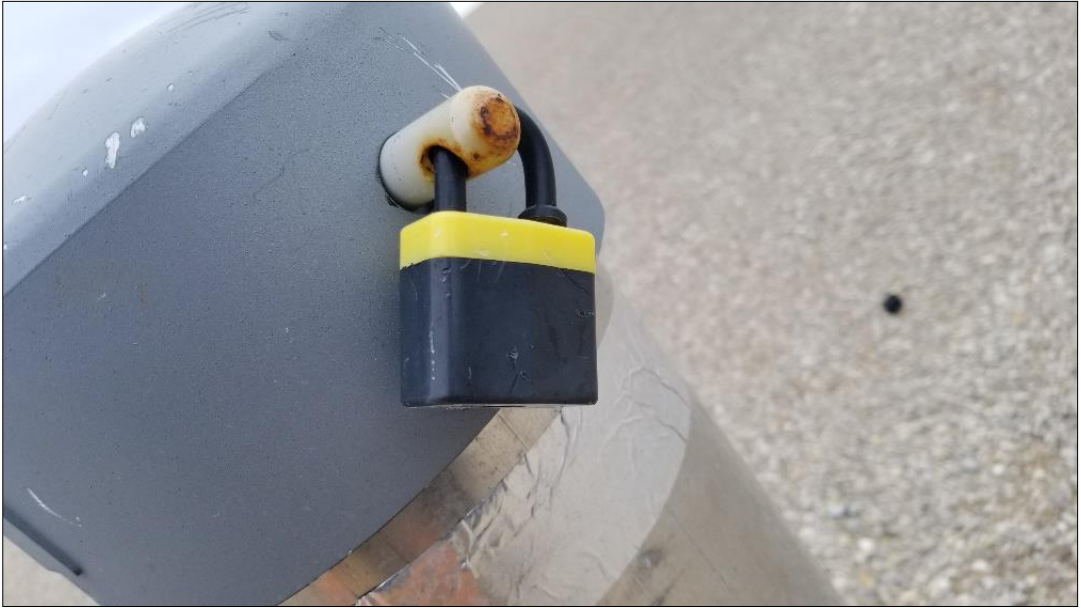
Photo 15: Thermistor lock.

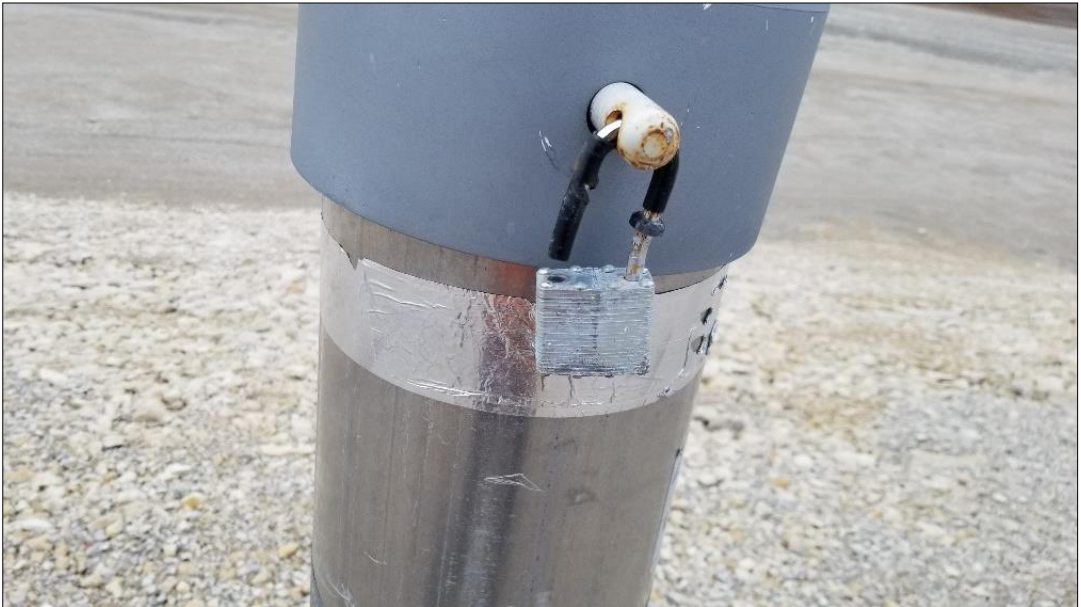
BluMetric was successful at downloading the raw data from the thermistors after which they were reset. It was noted that the key to open the thermistors was not the correct one and the locks were cut to access the thermistors. The security pins were put back in place after the data was downloaded to prevent thermistor exposure to rain, snow, and sunlight and to allow future access (see Photos 15 through 17). Replacement locks should be brought to site during the next monitoring event to secure the thermistors.

Photo 16: Cut thermistor lock.

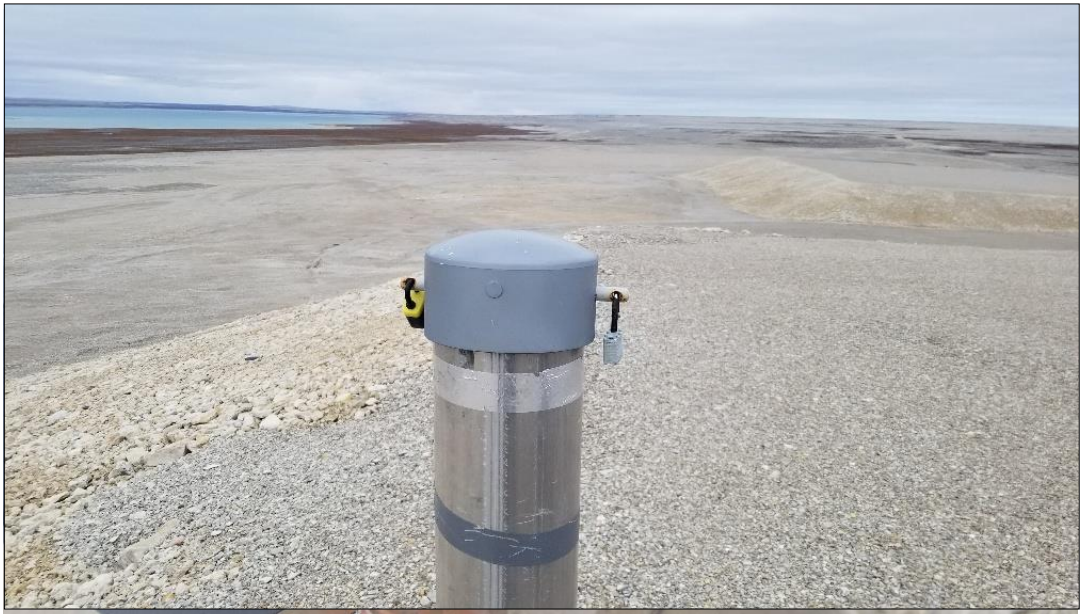
Photo 17: Condition of thermistor at end of site visit.
