# CAM-E Keith Bay Long Term Monitoring

Year 3 Report

Crown-Indigenous Relations and Northern Affairs Canada

Project number: 60686962

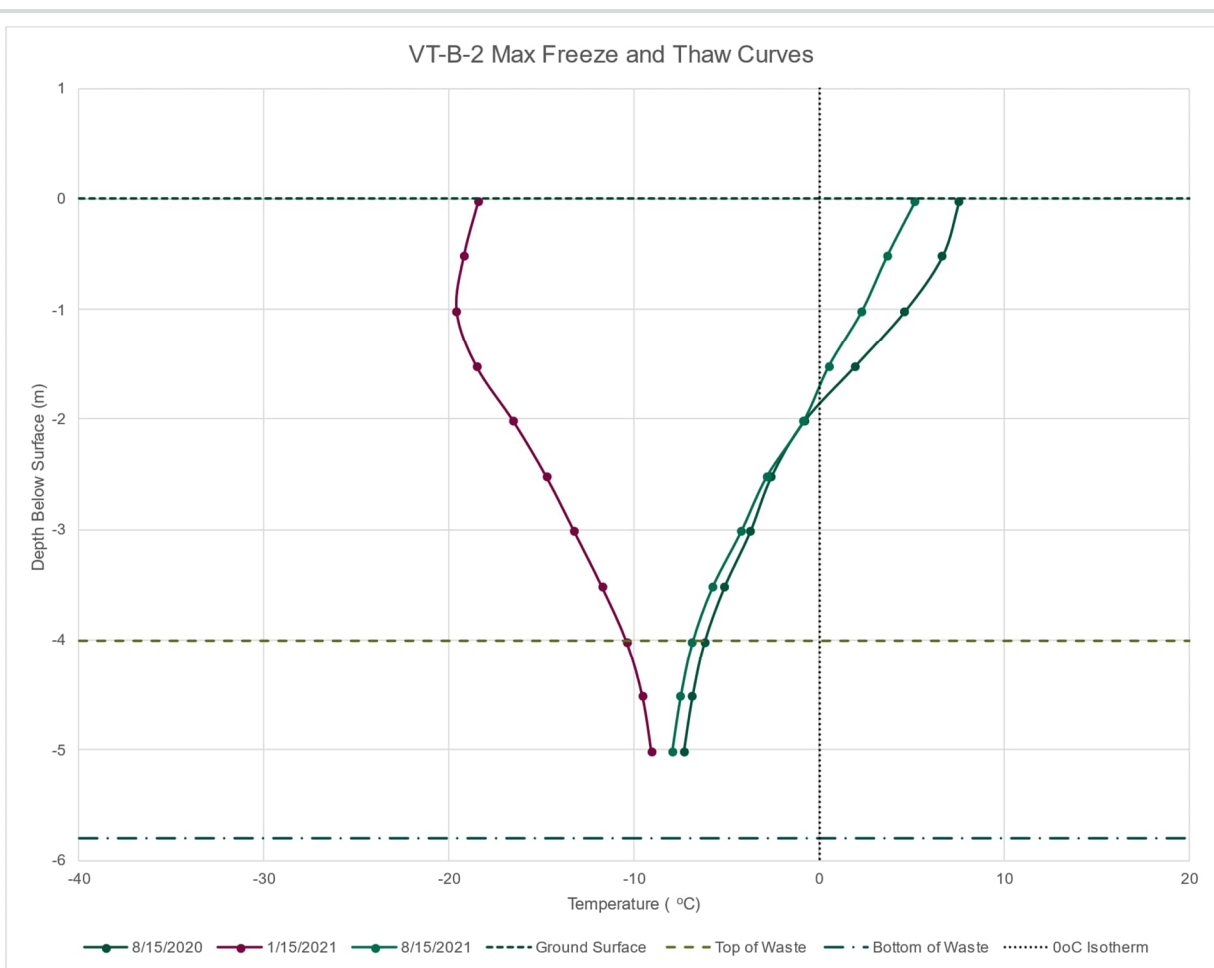
**Figure 4. VT-B-2 Max Freeze and Thaw Curves**

*Note: 2022 data unavailable due to severance on November 6, 2021. Data Logger has been removed from site.*

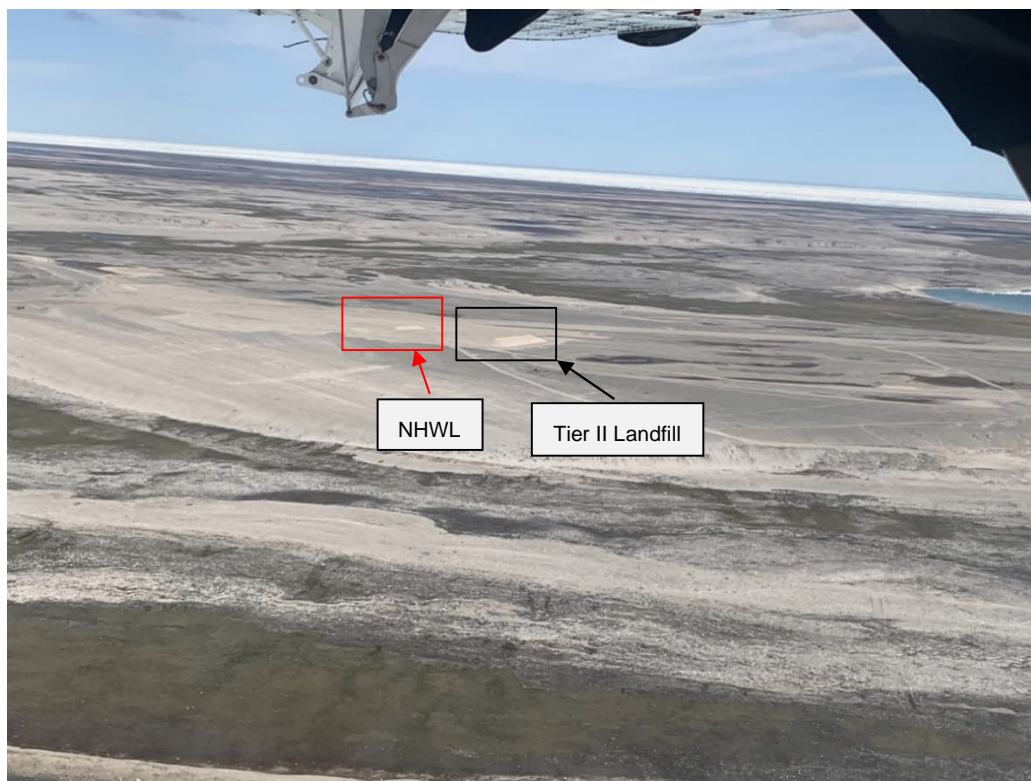
Photo No.	Date
<b>1</b>	8/7/2022
Direction Photo Taken	
East	
Area	
Site Condition	
Description	
<p>Aerial view of main station overlooking NHWL and Tier II Landfill. Various frost wedge cracks were visible on the east side from aerial view. Cracks are natural permafrost terrain features. Landfills visible in photo (boxed).</p>

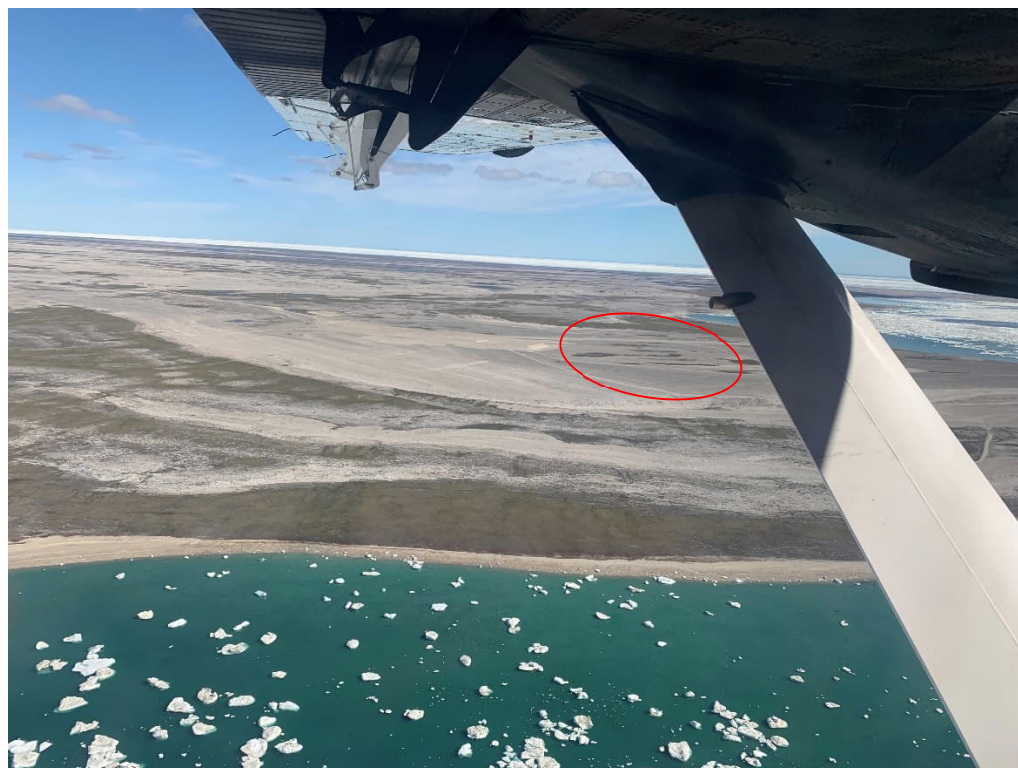
Photo No.	Date
<b>2</b>	8/7/2022
Direction Photo Taken	
East	
Area	
Site Condition	
Description	
<p>Frost wedge cracking visible on the south side from aerial view (circled).</p>

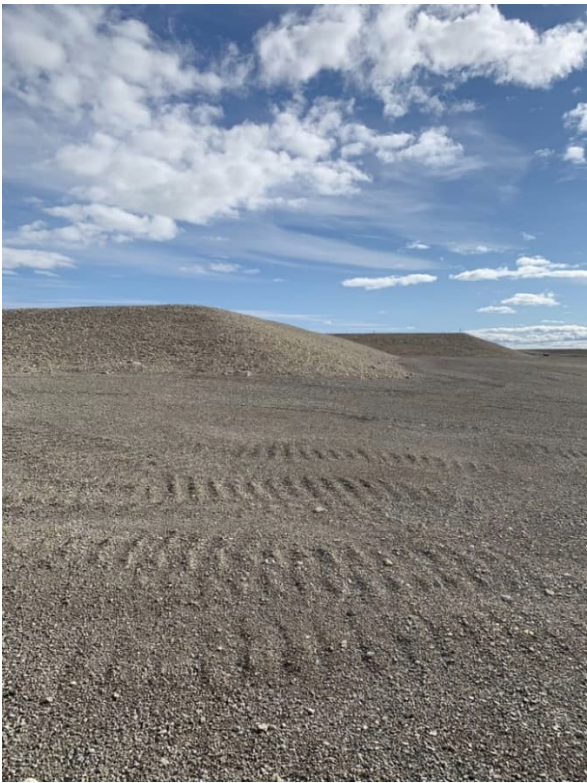
<b>Photo No.</b> <b>9</b>	<b>Date</b> 8/7/2022

<b>Direction Photo Taken</b> Southeast		
<b>Area</b> NHWL		
<b>Description</b> Northwest corner of NHWL in good condition. Tier II Landfill in distance.

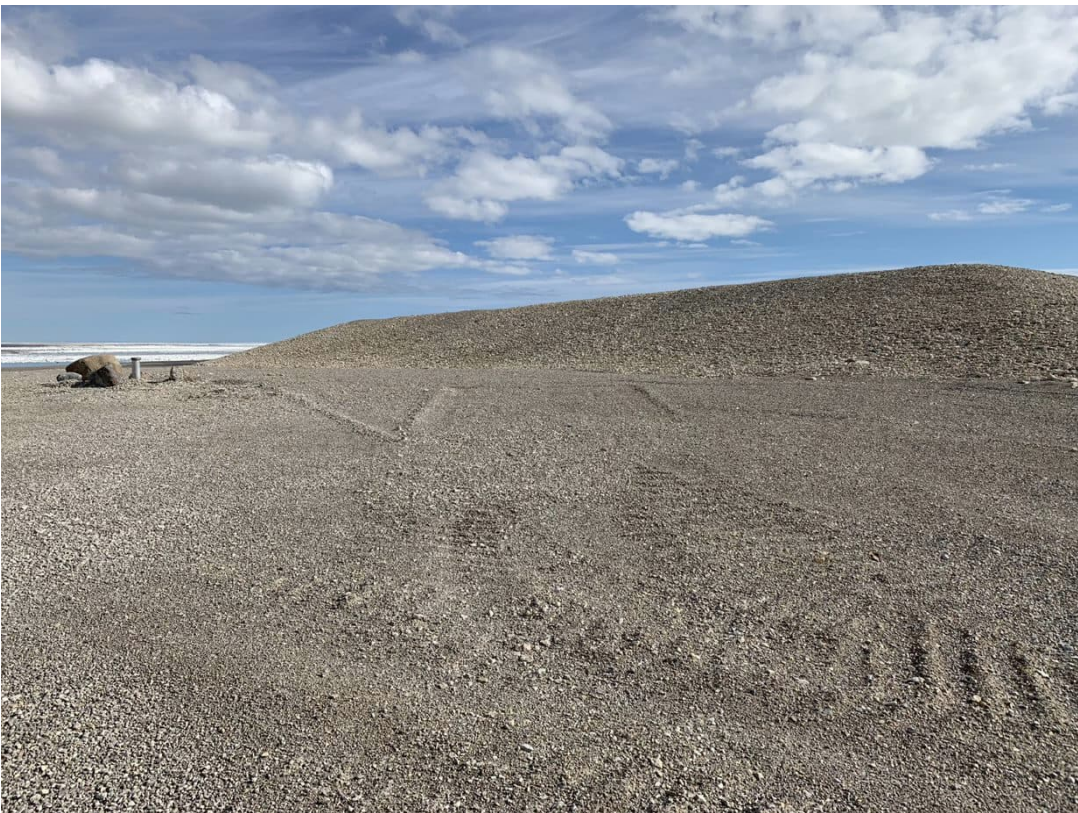
<b>Photo No.</b> <b>10</b>	<b>Date</b> 8/7/2022

<b>Direction Photo Taken</b> South-southwest		
<b>Area</b> NHWL		
<b>Description</b> MW17-06. North slope of NHWL in good condition.

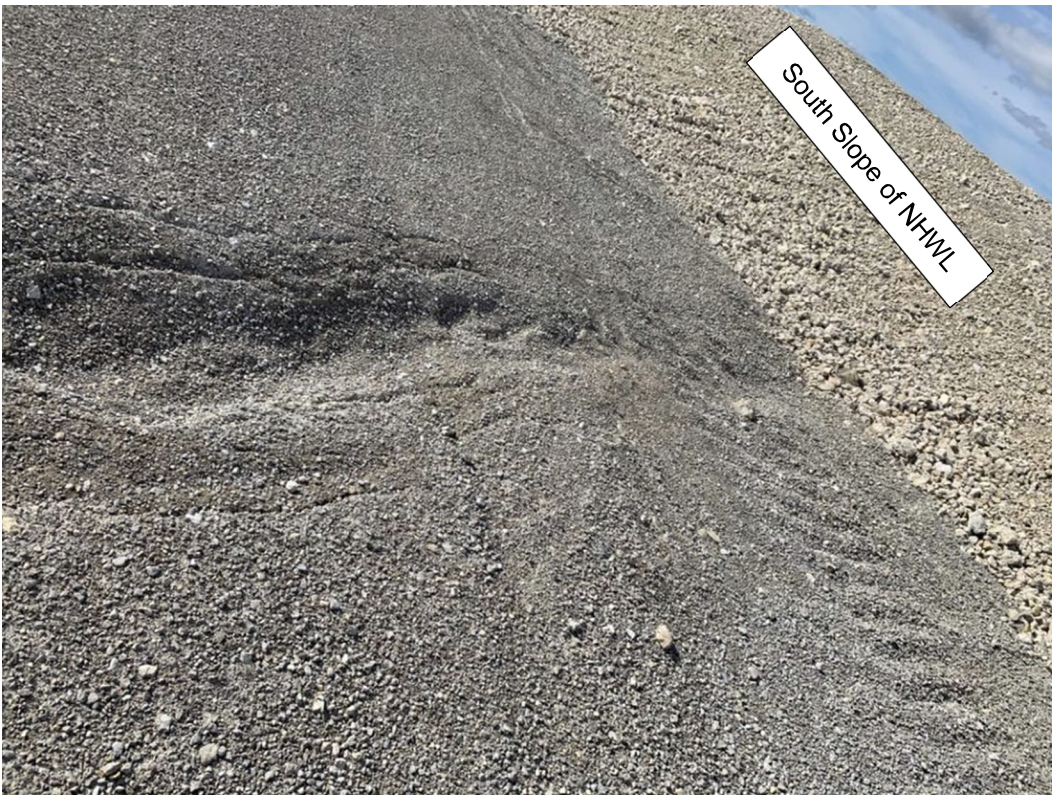
Photo No. <b>17</b>	Date 8/7/2022

Some differential settlement was noted on the west side of the NHWL extending 30-40 m out from the slope (see Photograph 13 in **Appendix B**). Differential settlement was also noted midway on the south slope extending approximately 10 m out from the slope with smaller settlement on the southeast corner (Photographs 17 and 18 in **Appendix B**). This settlement was noted in the previous Year 1 investigation in 2020 (BluMetric, 2021) and appears to have continued to develop. Currently, the features do not compromise the performance of the NHWL. The north and east slopes were found to be in good condition with no notable defects. Of note is that the mainly linear shape of the settlement and its position moving away from the landfill toe suggests that it may be due to pre-existing frost wedge cracks that were covered during construction. If this is the case, the settlement should not be expected to continue to worsen.

Direction Photo Taken North		
Area NHWL		
Description Differential settlement midway on south side of NHWL, extending approximately 10 m.

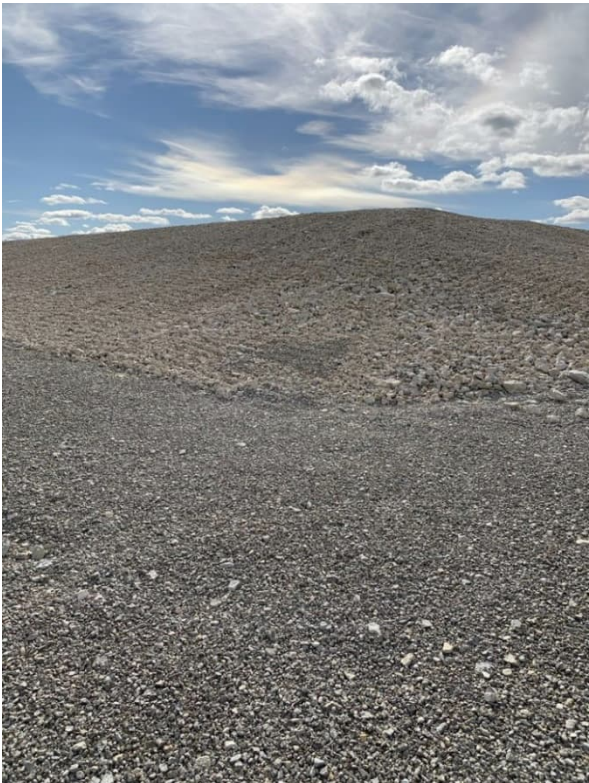
Photo No. <b>20</b>	Date 8/7/2022

Direction Photo Taken Southwest		
Area NHWL		
Description Northeast corner of NHWL in good condition.

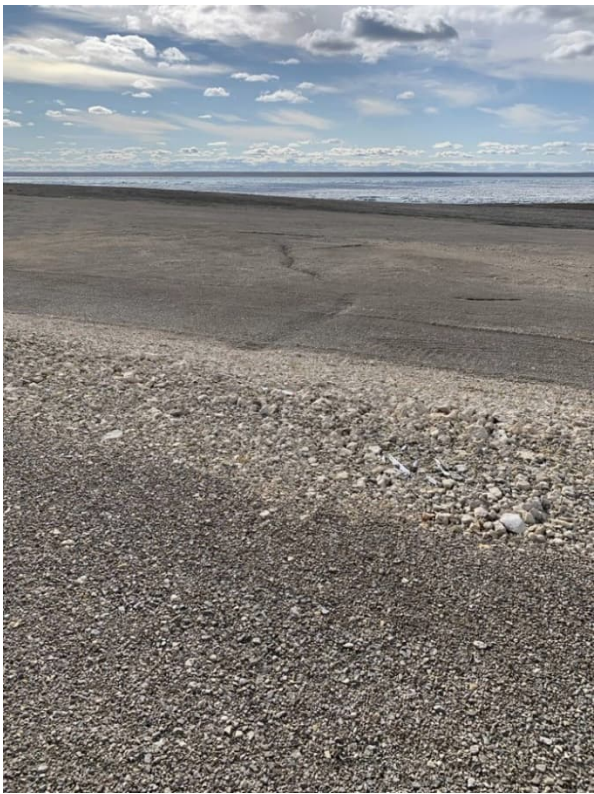
Photo No. <b>23</b>	Date 8/7/2022

Direction Photo Taken East		
Area NHWL		
Description Frost wedge cracking off west side of NHWL viewed from top of cell. This may be source of observed linear settlement features moving away from the landfill toe.

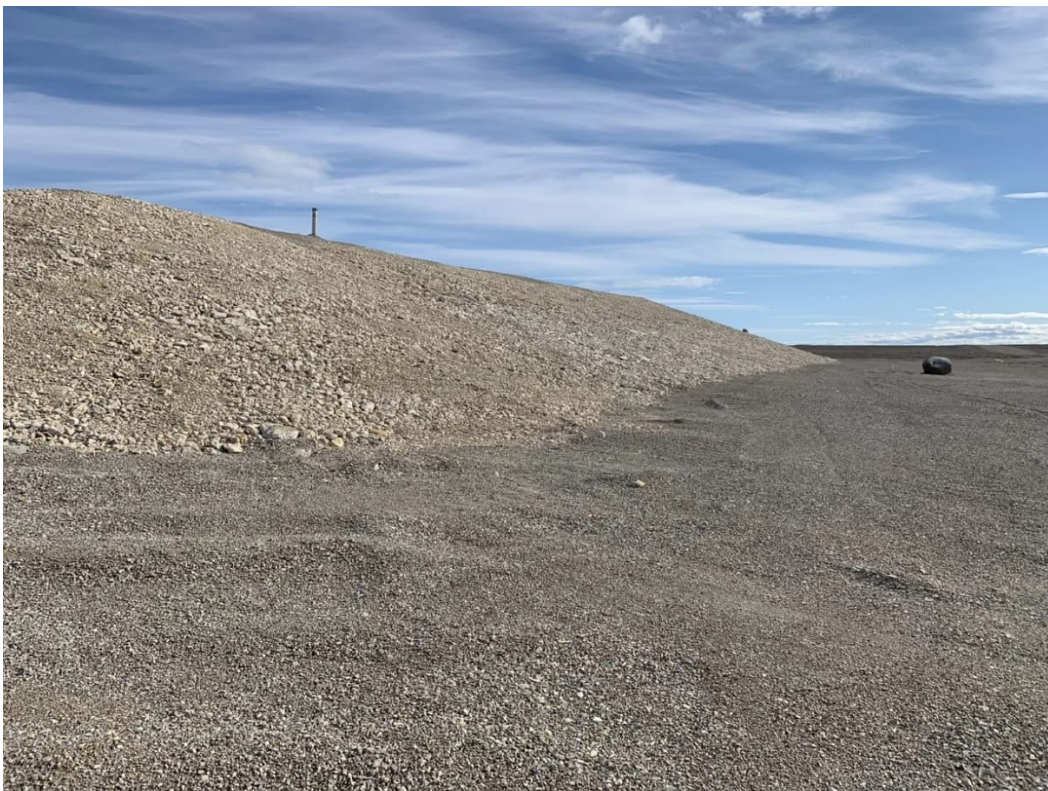
<b>Photo No.</b> <b>26</b>	<b>Date</b> 8/7/2022

<b>Direction Photo Taken</b> North		
<b>Area</b> Tier II Landfill		
<b>Description</b> West slope of Tier II Landfill in good condition.

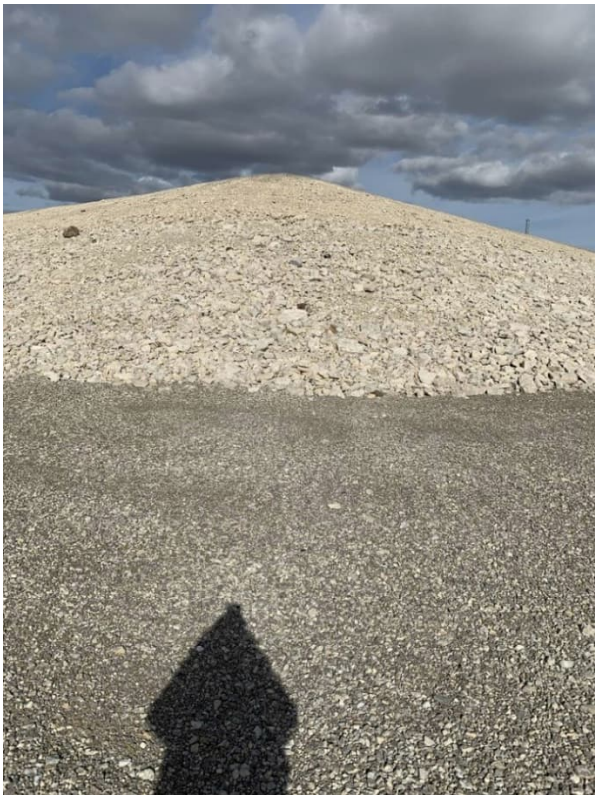
Photo No. <b>28</b>	Date 8/7/2022

Direction Photo Taken Northeast		
Area Tier II Landfill		
Description Southwest corner of Tier II Landfill in good condition.

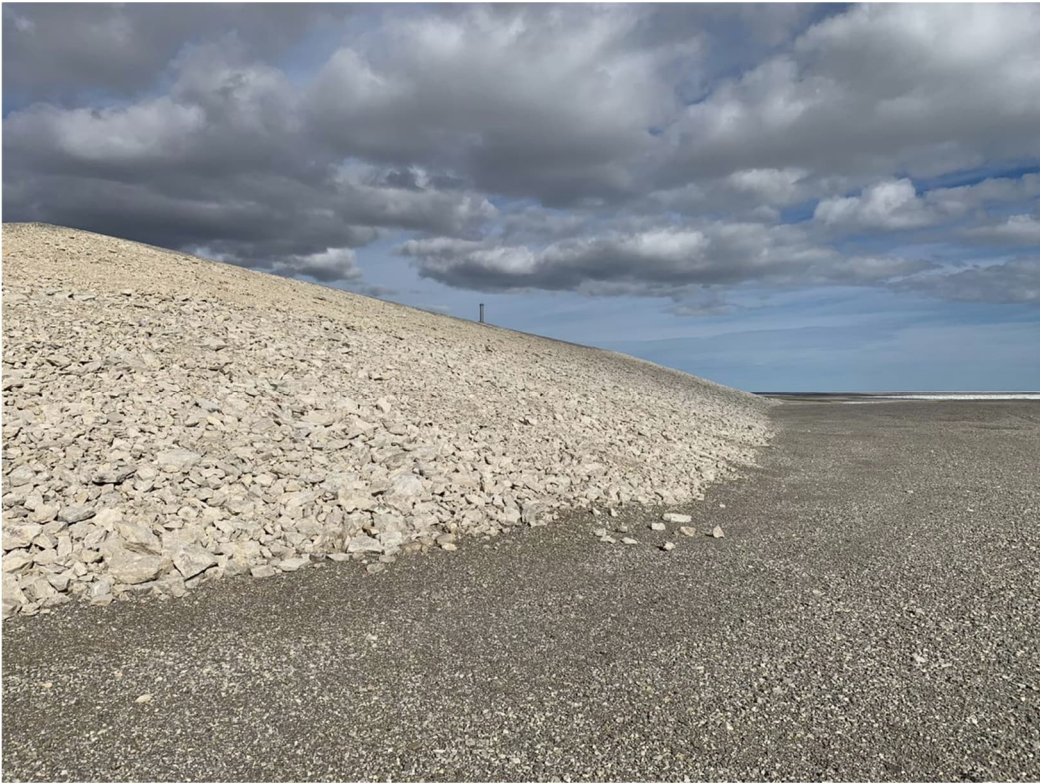
Photo No. <b>29</b>	Date 8/7/2022

Direction Photo Taken West		
Area Tier II Landfill		
Description South slope of Tier II Landfill in good condition.

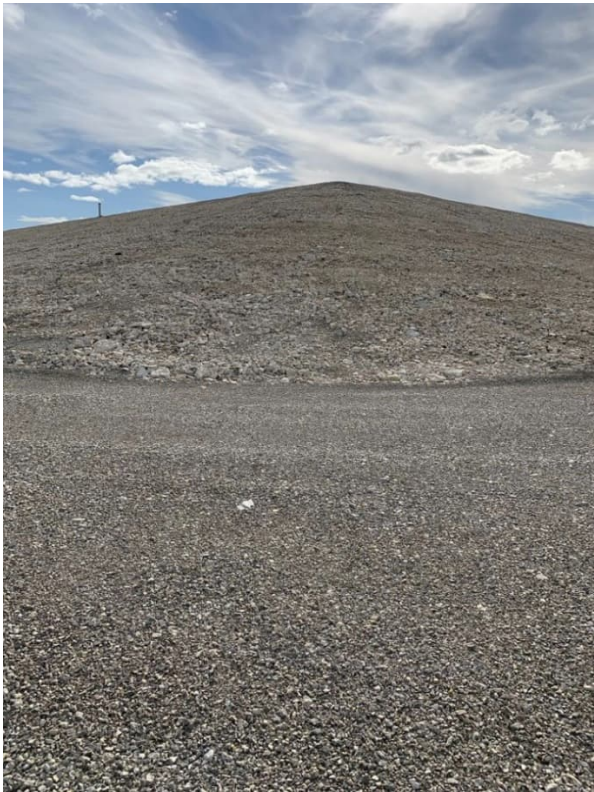
<b>Photo No.</b> <b>33</b>	<b>Date</b> 8/7/2022

<b>Direction Photo Taken</b> Southwest		
<b>Area</b> Tier II Landfill		
<b>Description</b> Northeast corner of Tier II Landfill in good condition.

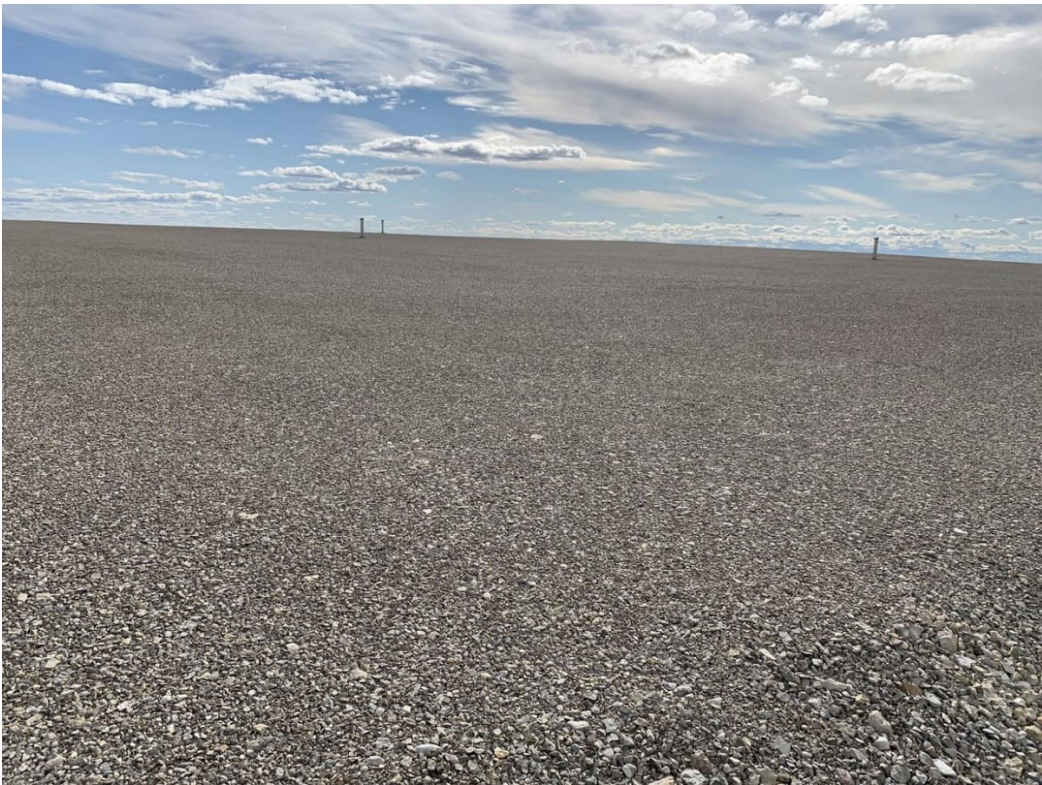
<b>Photo No.</b> <b>34</b>	<b>Date</b> 8/7/2022

<b>Direction Photo Taken</b> South		
<b>Area</b> Tier II Landfill		
<b>Description</b> Top of Tier II Landfill in good condition.

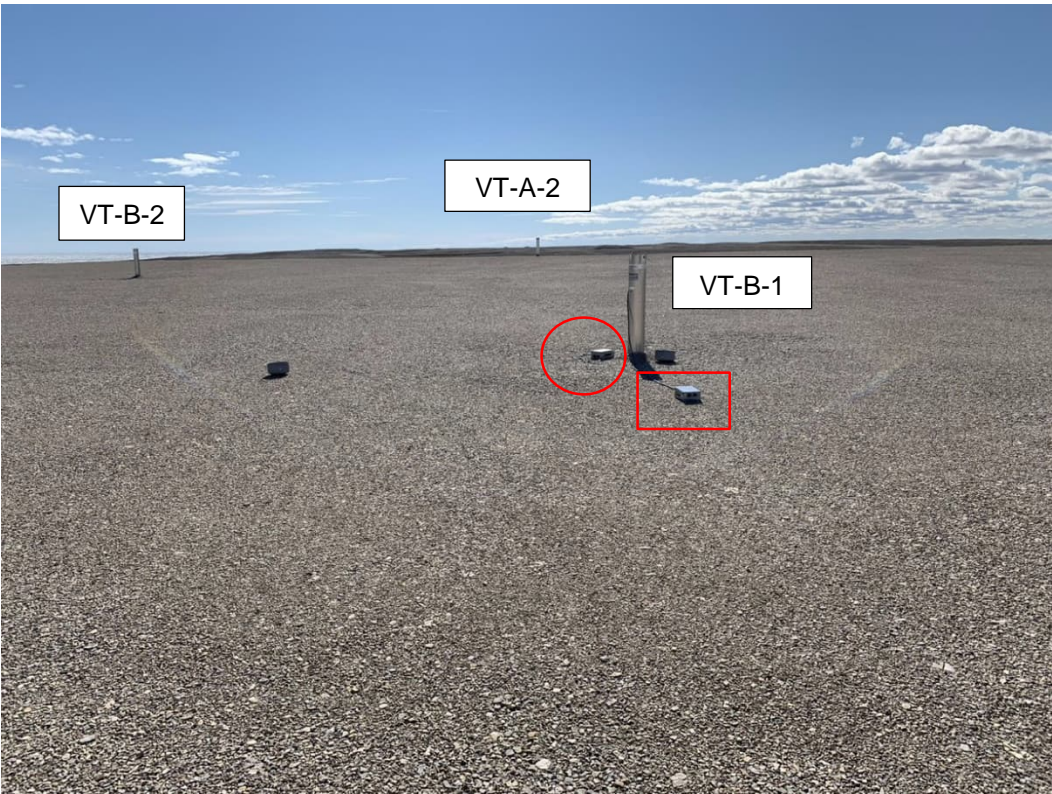
Photo No. <b>35</b>	Date 8/7/2022

Direction Photo Taken Southeast		
Area Tier II Landfill		
Description Top of Tier II Landfill in good condition. Severed Data Logger from VT-B-2 (circled), pulled cable from VT-B-1 (boxed).

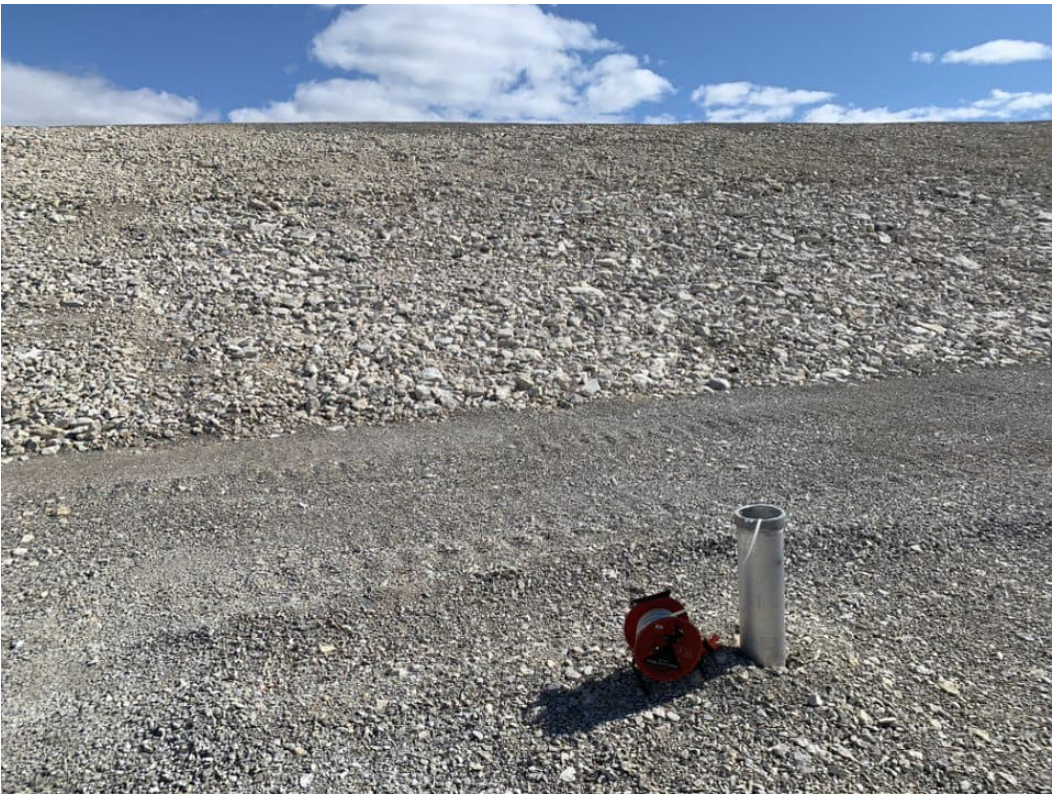
Photo No. <b>39</b>	Date 8/7/2022

Direction Photo Taken N/A		
Area Groundwater Wells		
Description MW17-01. Frozen, unable to sample. Bailer frozen inside well. Depth to ice recorded. Well in good condition. West slope of Tier II Landfill in background.

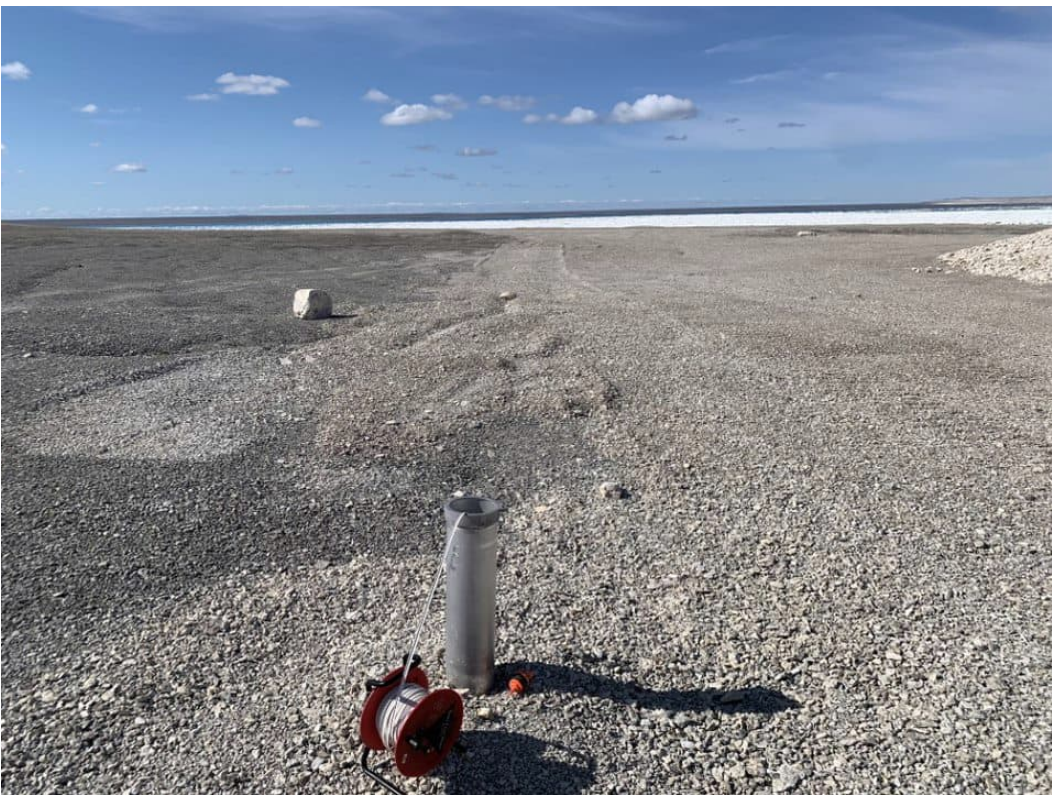
Photo No. <b>40</b>	Date 8/7/2022

Direction Photo Taken West		
Area Groundwater Wells		
Description MW17-02. Frozen, unable to sample. Depth to ice recorded. Well in good condition. Southwest toe of Tier II Landfill on far right side. Frost wedge cracking visible on natural ground to the left.

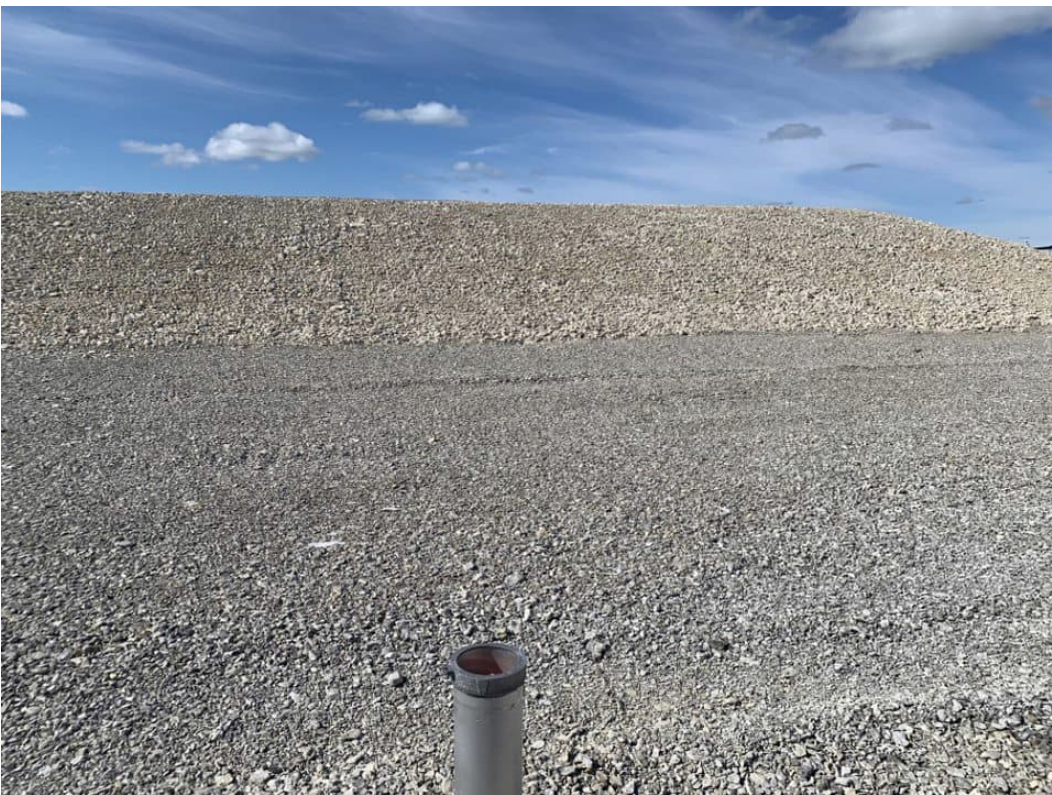
Photo No. <b>42</b>	Date 8/7/2022

Direction Photo Taken West		
Area Groundwater Wells		
Description MW17-07. Frozen, unable to sample. Depth to ice recorded. Well in good condition. East slope of NHWL in background.

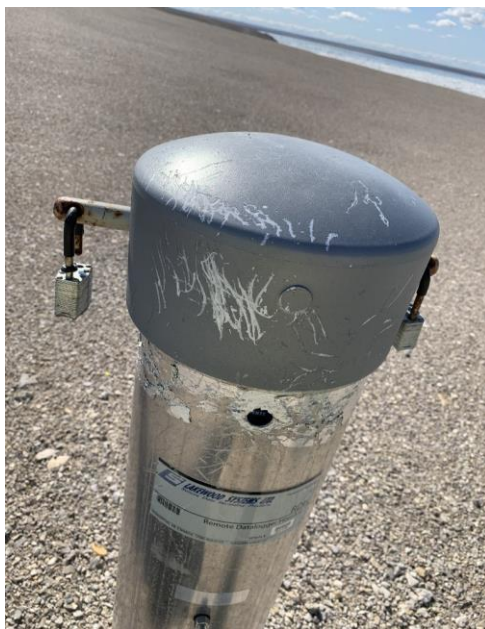
**Photograph 1: Evidence of Polar Bear Claw Marks on Thermistor Casings**

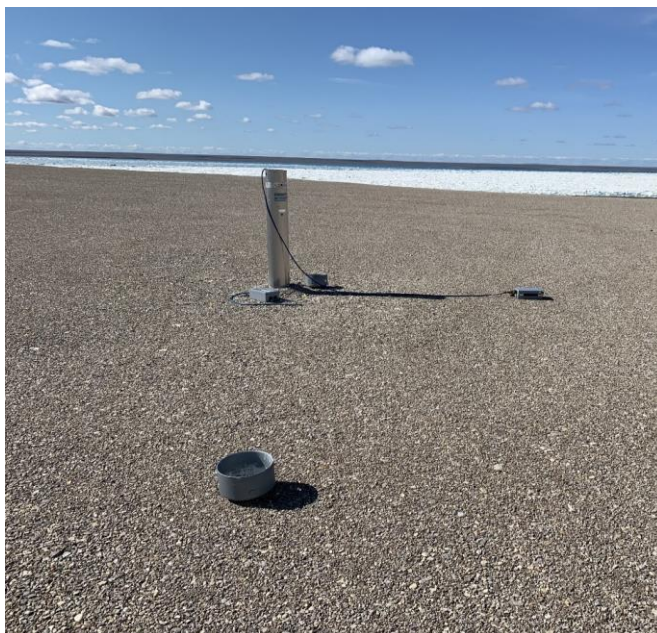
**Photograph 2: VT-B-1 Pulled from Casing with VT-B-2 Severed Nearby**

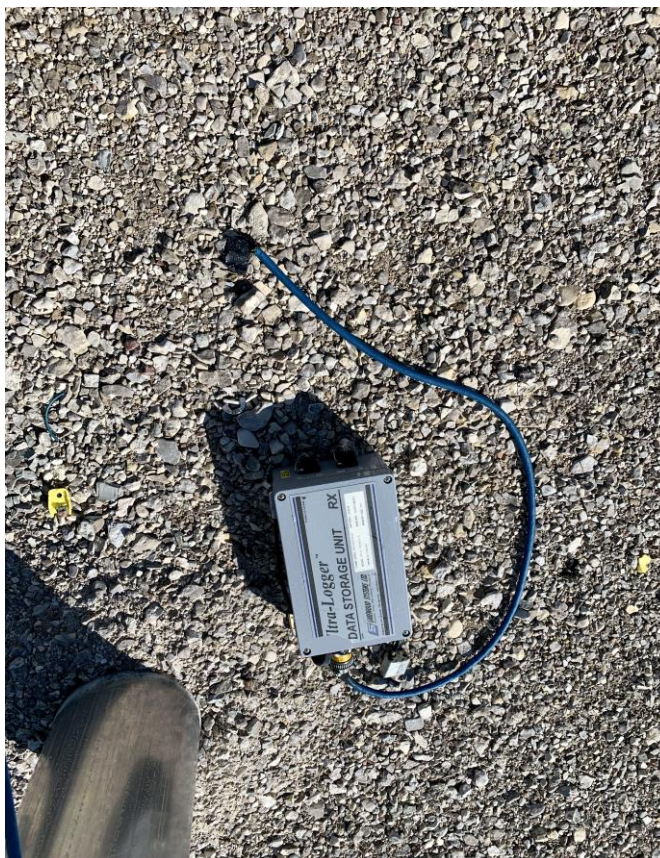
Photograph 3: Severed Data Logger (VT-B-2)

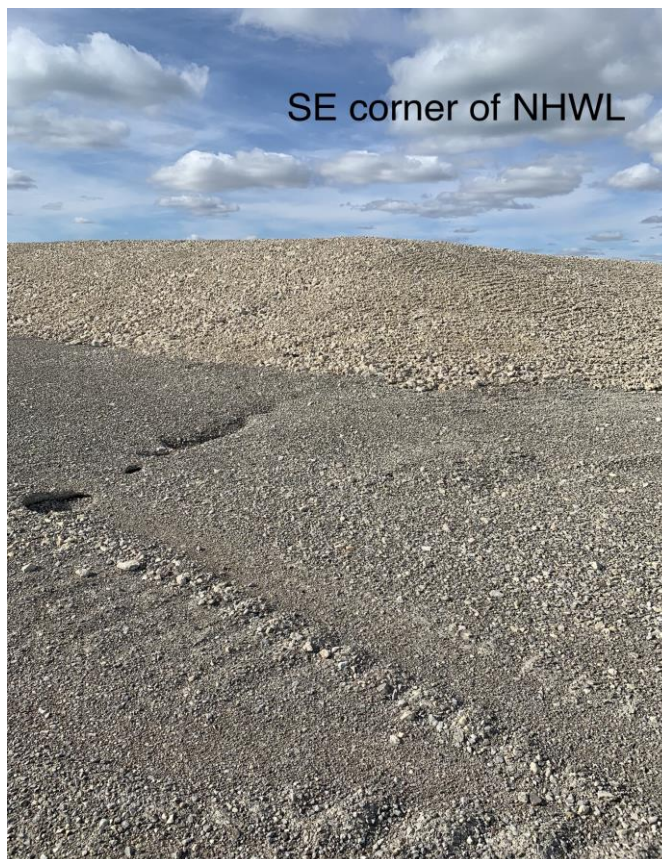
Photograph 4: Frost Settlement off Southeast Corner of NHWL

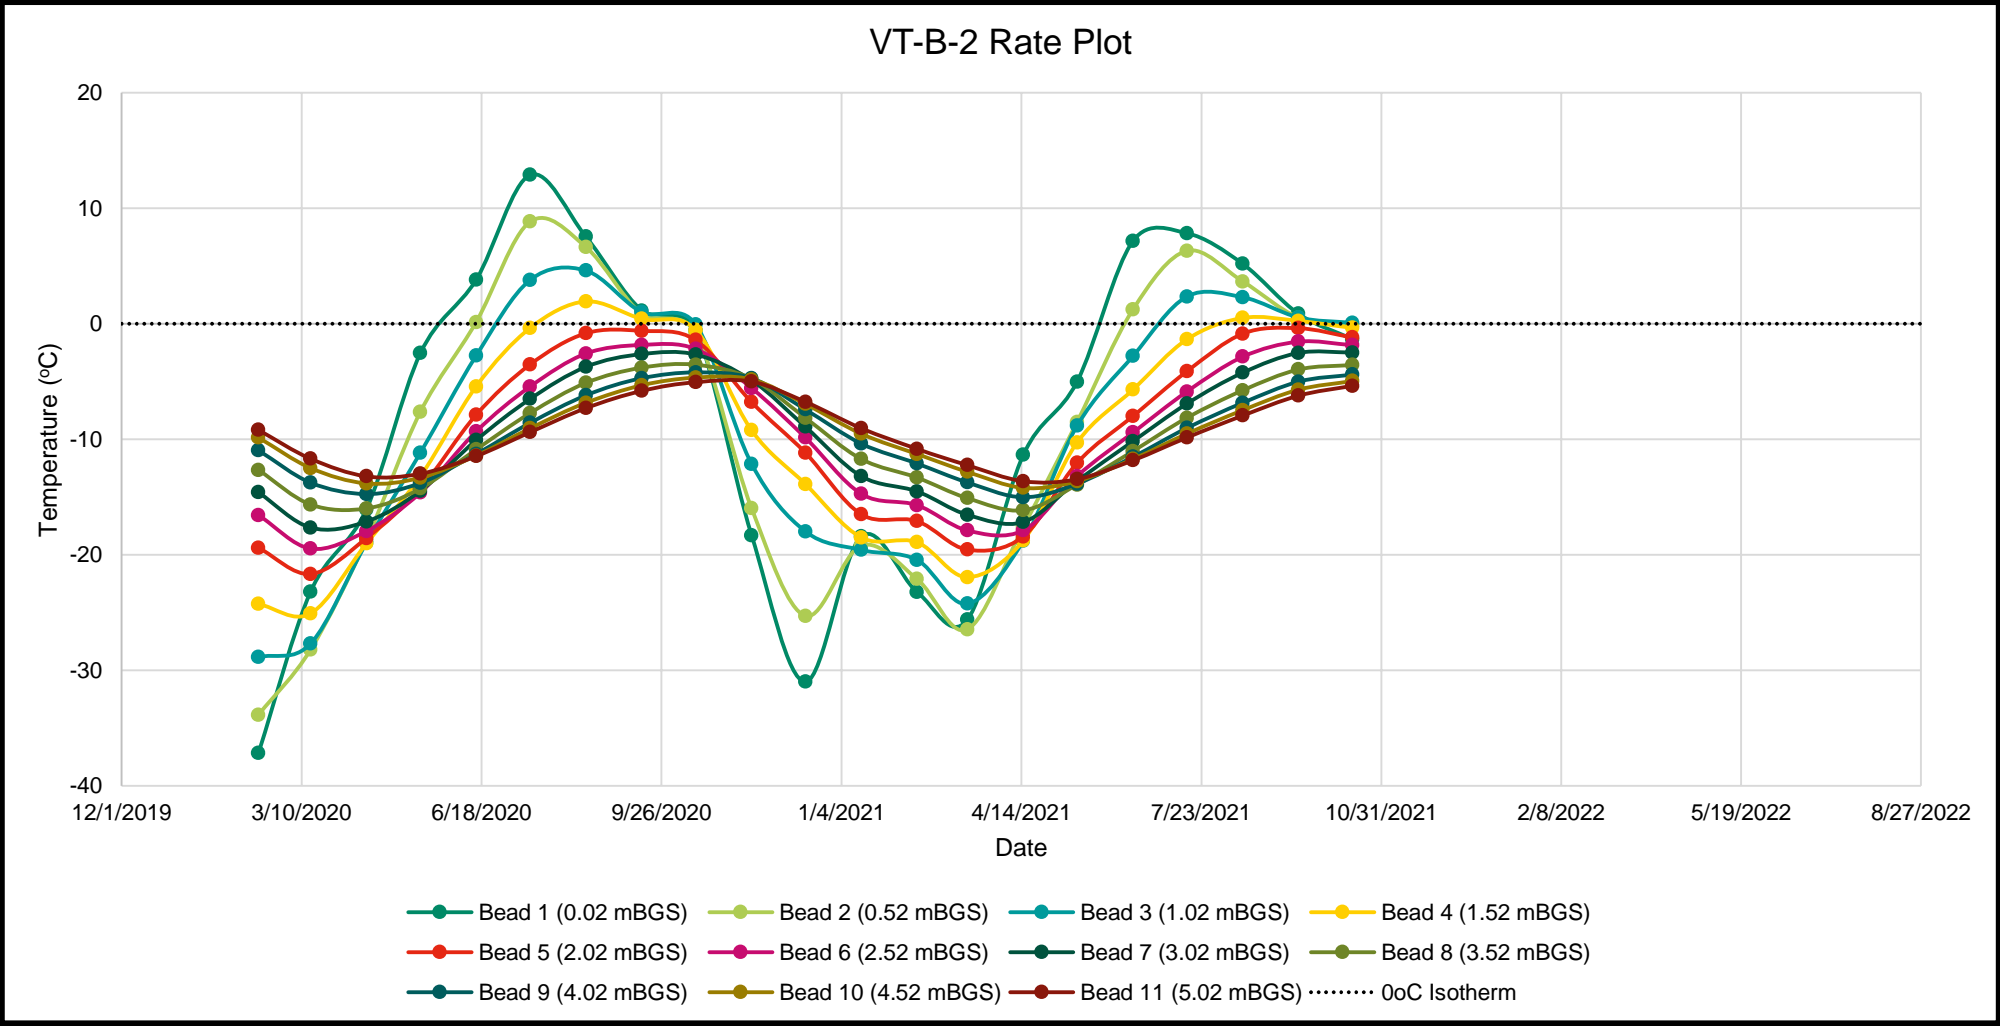
FIGURE E-4

**Notes:**  
mBGS = Metres Below Ground Surface  
Data Logger severed on November 6, 2021
