*Former U.S. Coast Guard Loran  
Station, Cape Christian, Nunavut  
Environmental Site Delineation  
and Material Inventory*

## Environmental Site Delineation and Material Inventory

February 2002

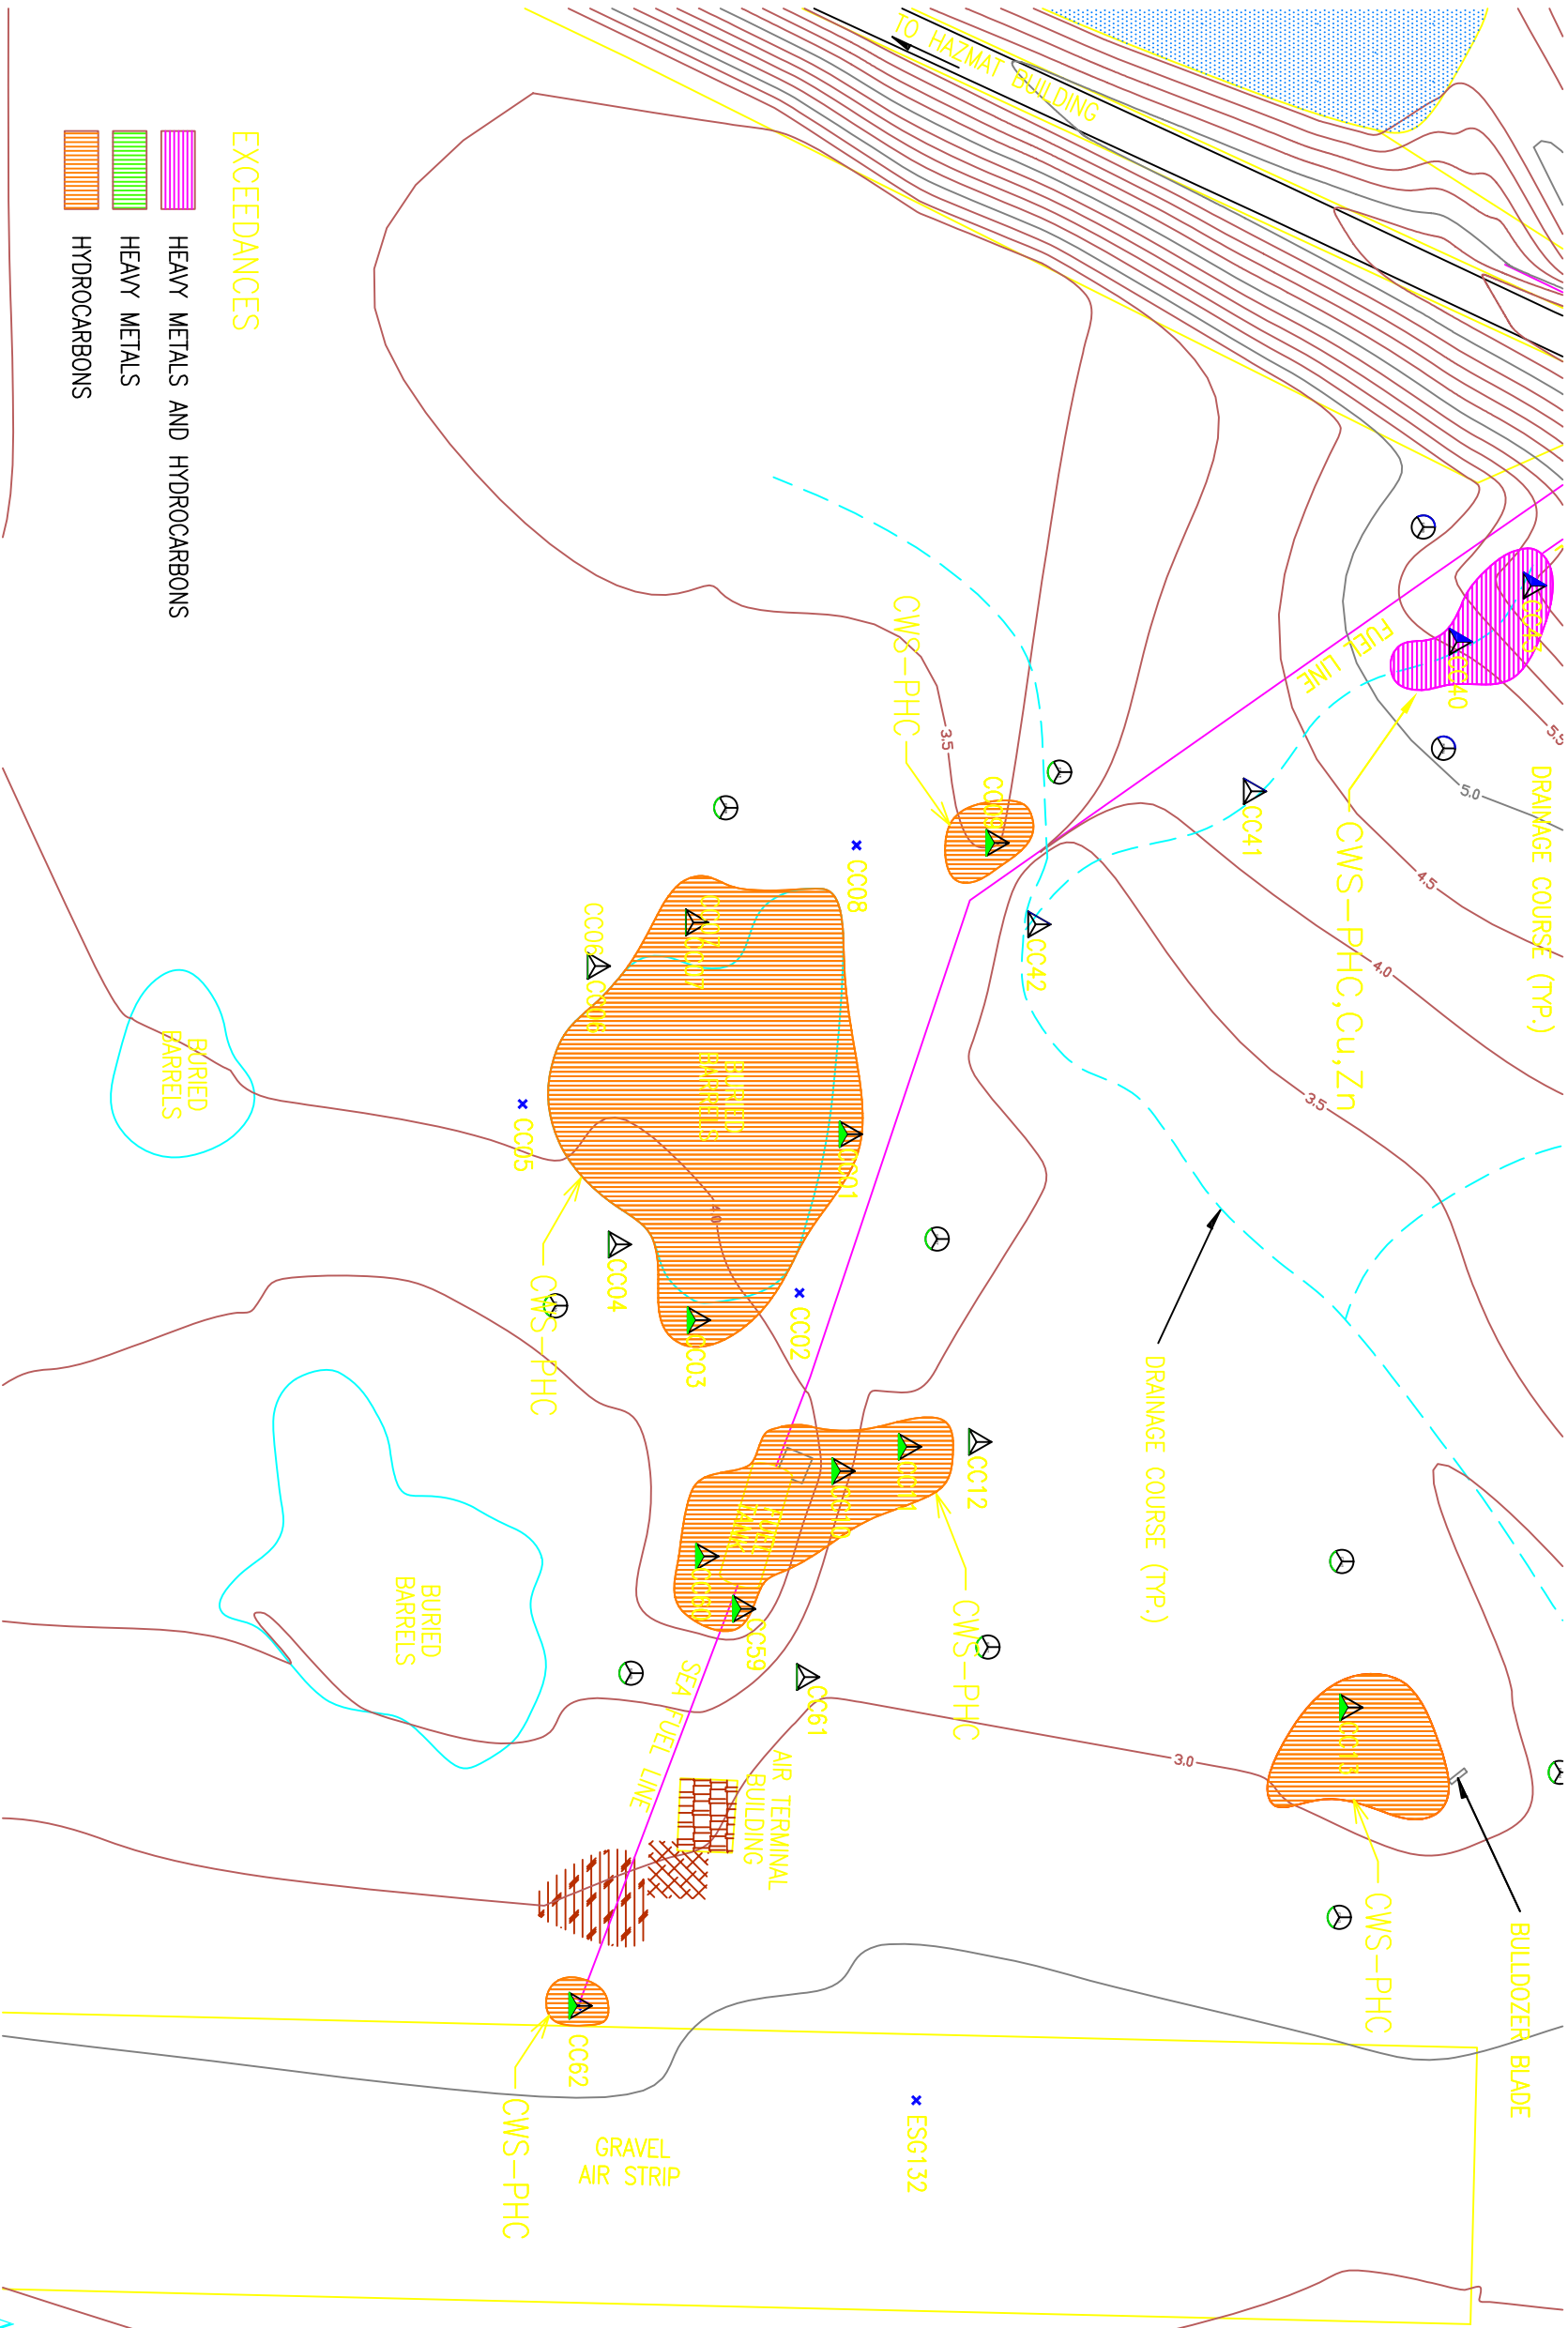
FIGURE 2.4

It should be noted that due to the size of the buried barrel areas identified at the beach area, (Figure 2.4) that confirmatory samples for the entire area were not retrieved. The main area near the AST and former terminal building had the greatest indication of petroleum staining. This area was extensively sampled for hydrocarbon contamination at various depths and some of the samples were submitted for analyses and others field-tested with the Petroflag sampling kits. The drums at the surface were partially accessible and randomly inspected to check if they contained petroleum products. None of the randomly selected drums contained product and the drums that were visible through the surface sands had a hollow sound (empty barrel) when walked on. With the exception of sample CC-01 sampled from 0.3-0.6 m below grade, most of the samples were saturated with melt water below 0.3 m and were subsequently not submitted for analyses. The areas on the site plan are representative of the sampled and delineated areas.
