RE: Cape Christian Remediation Project: 2010 Annual Report for Water Licence No: 1BR-LOR0813 and the Completion/Close out Report

Cape Christian Long Range Navigation (LORAN) Station NWB Licence No. 1BR-LOR0813

APPENDIX 4 SOME BEFORE AND AFTER REMEDIATION PHOTOS

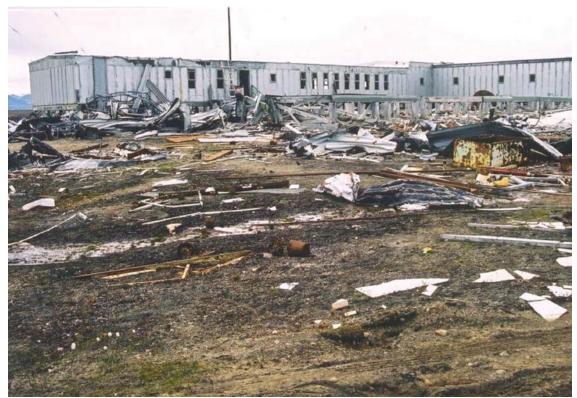
Cape Christian Main Station (Before Remediation)

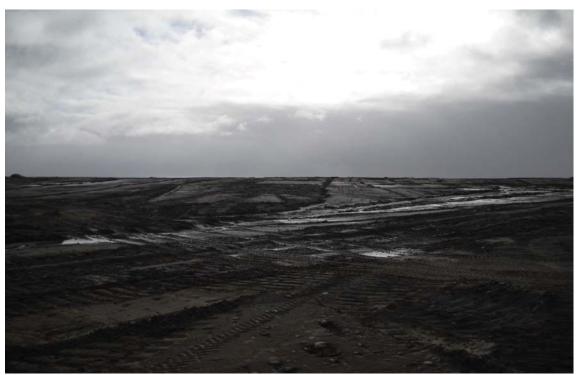
Cape Christian Main Station (After Remediation)

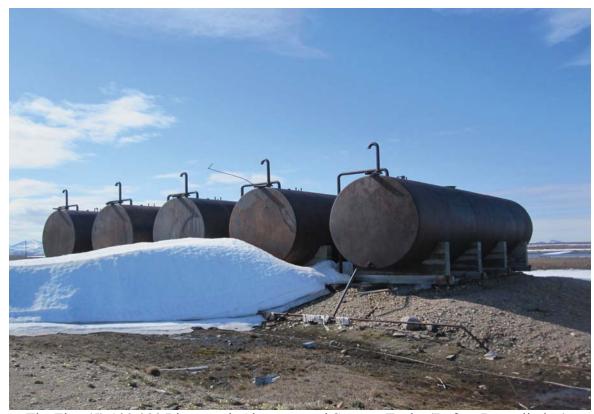
The Five (5) 100,000 Litres each Aboveground Storage Tanks (Before Remediation)

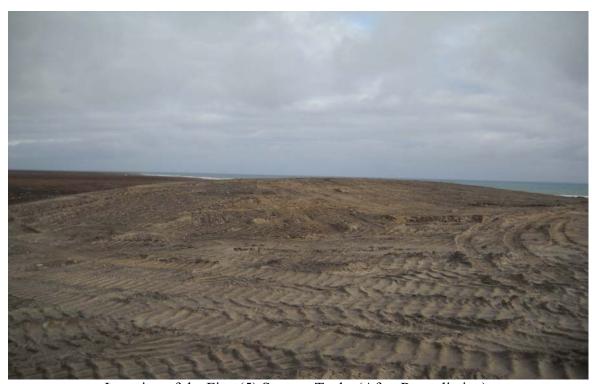
Location of the Five (5) Storage Tnaks (After Remediation)

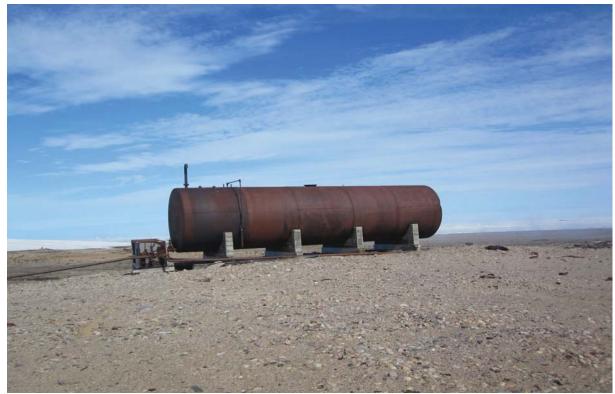
Beach Tank (100,000 Litres) (Before Remediation)

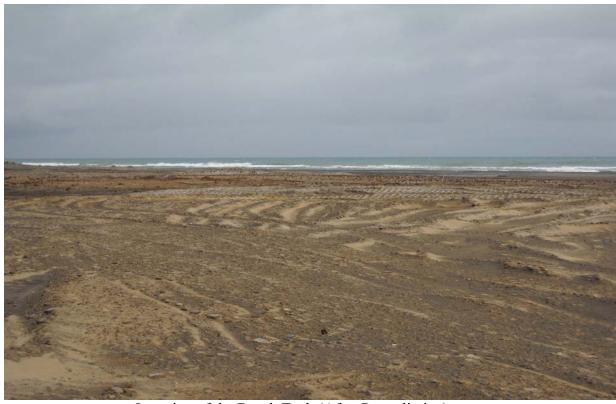
Location of the Beach Tank (After Remediation)

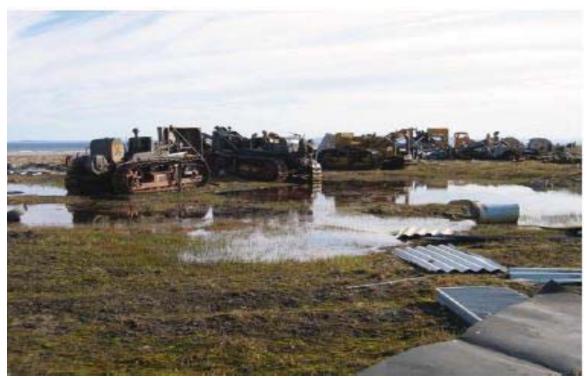
Equipment Yard (Before Remediation)

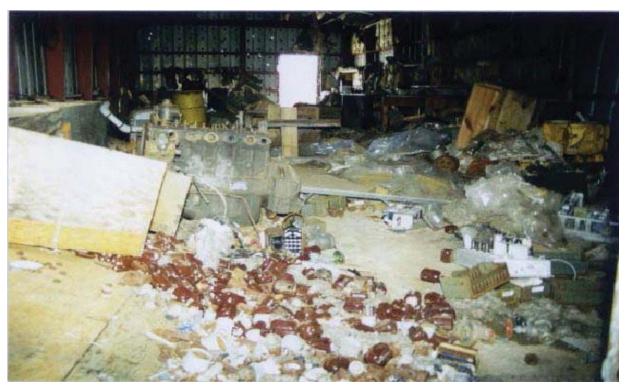
The interior of the Hazmat Building (Before Remediation)

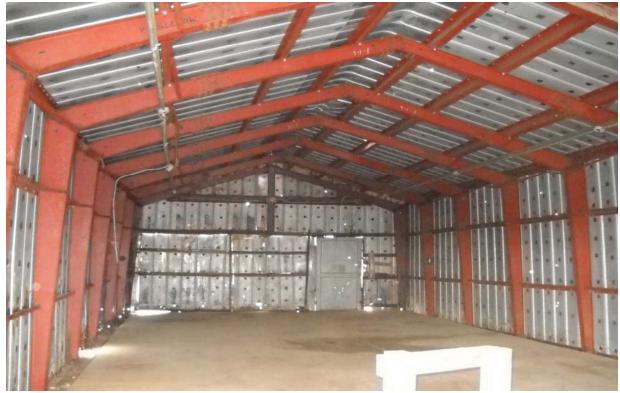
The interior of the Hazmat Building (now renamed Storm Shelter) (After Remediation)

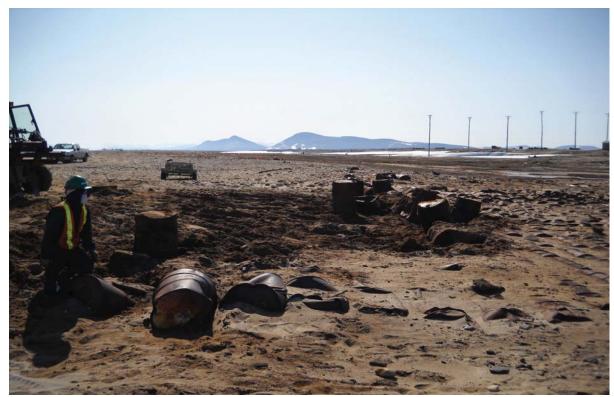
Worked Area # 1 (at the start of Remediation)

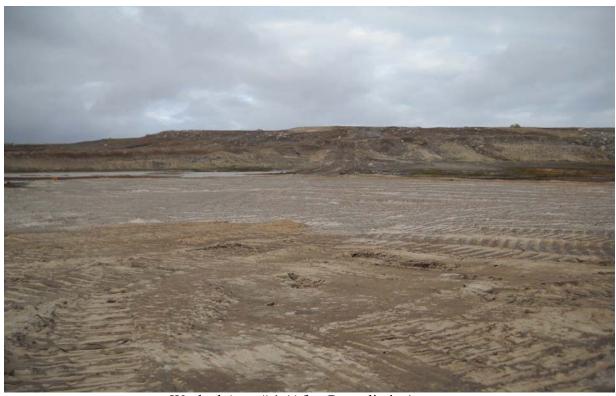
Worked Area # 1 (After Remediation)

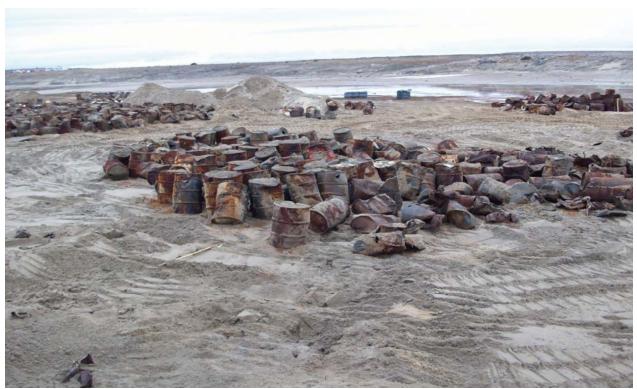
Worked Area # 6 (During remediation)

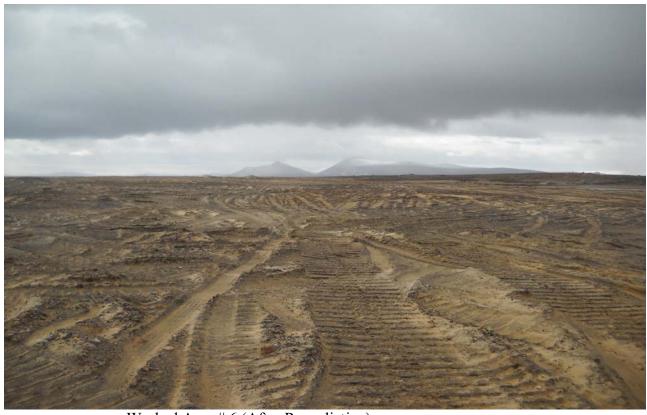
Worked Area # 6 (After Remediation)

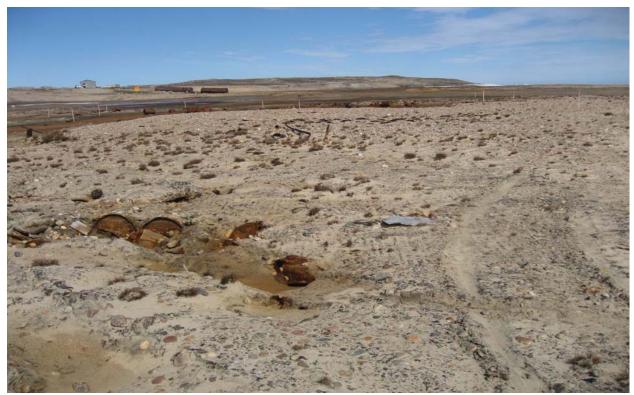
Worked Area # 8 (Before Remediation)

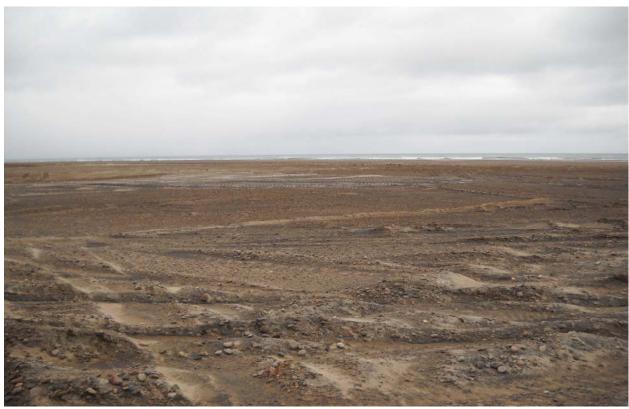
Worked Area # 8 (After Remediation)
