TRANSPORT CANADA

ENVIRONMENTAL SITE ASSESSMENT
IQALUIT AIRPORT
APRON 1

SITE PLAN

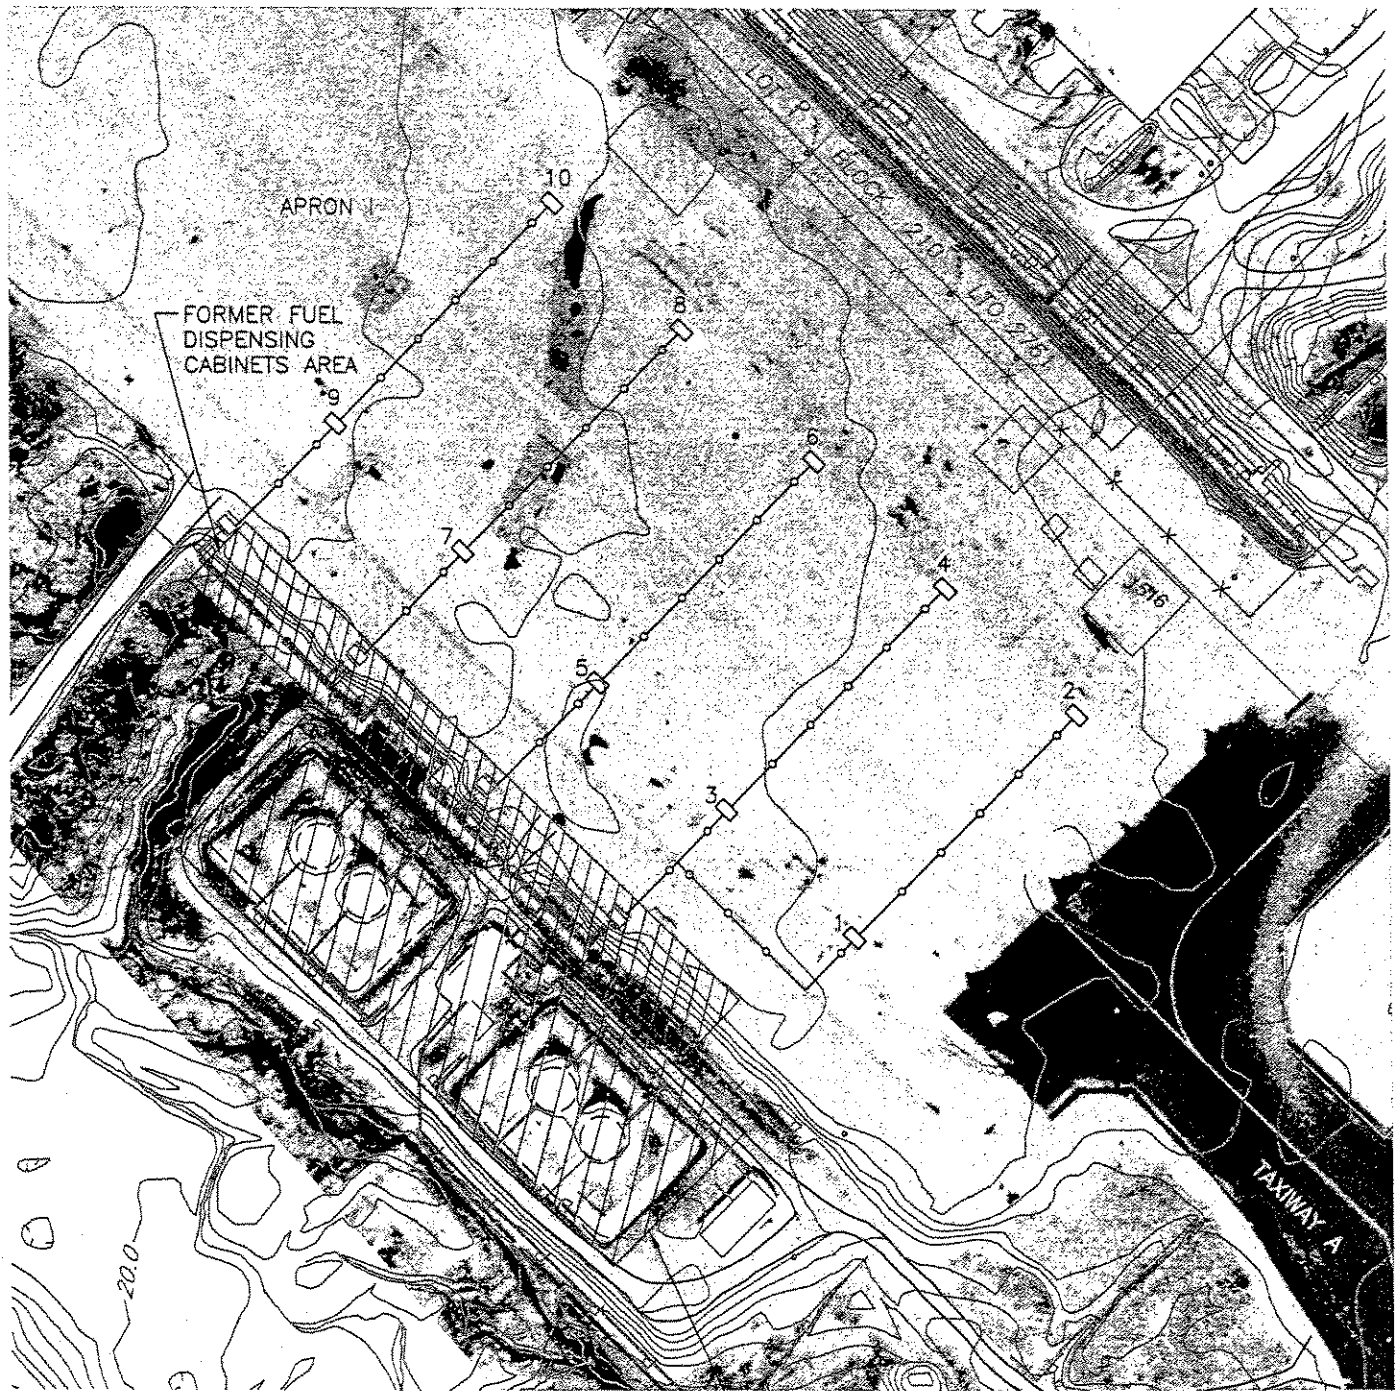
2

Monitoring wells were installed during this program next to hydrant boxes 1, 4, 6, 7, 8 and 9, as indicated on Figure 2. Only monitoring wells next to hydrant boxes 4 and 6 could be sampled for groundwater. Table G summarizes available monitoring well information.

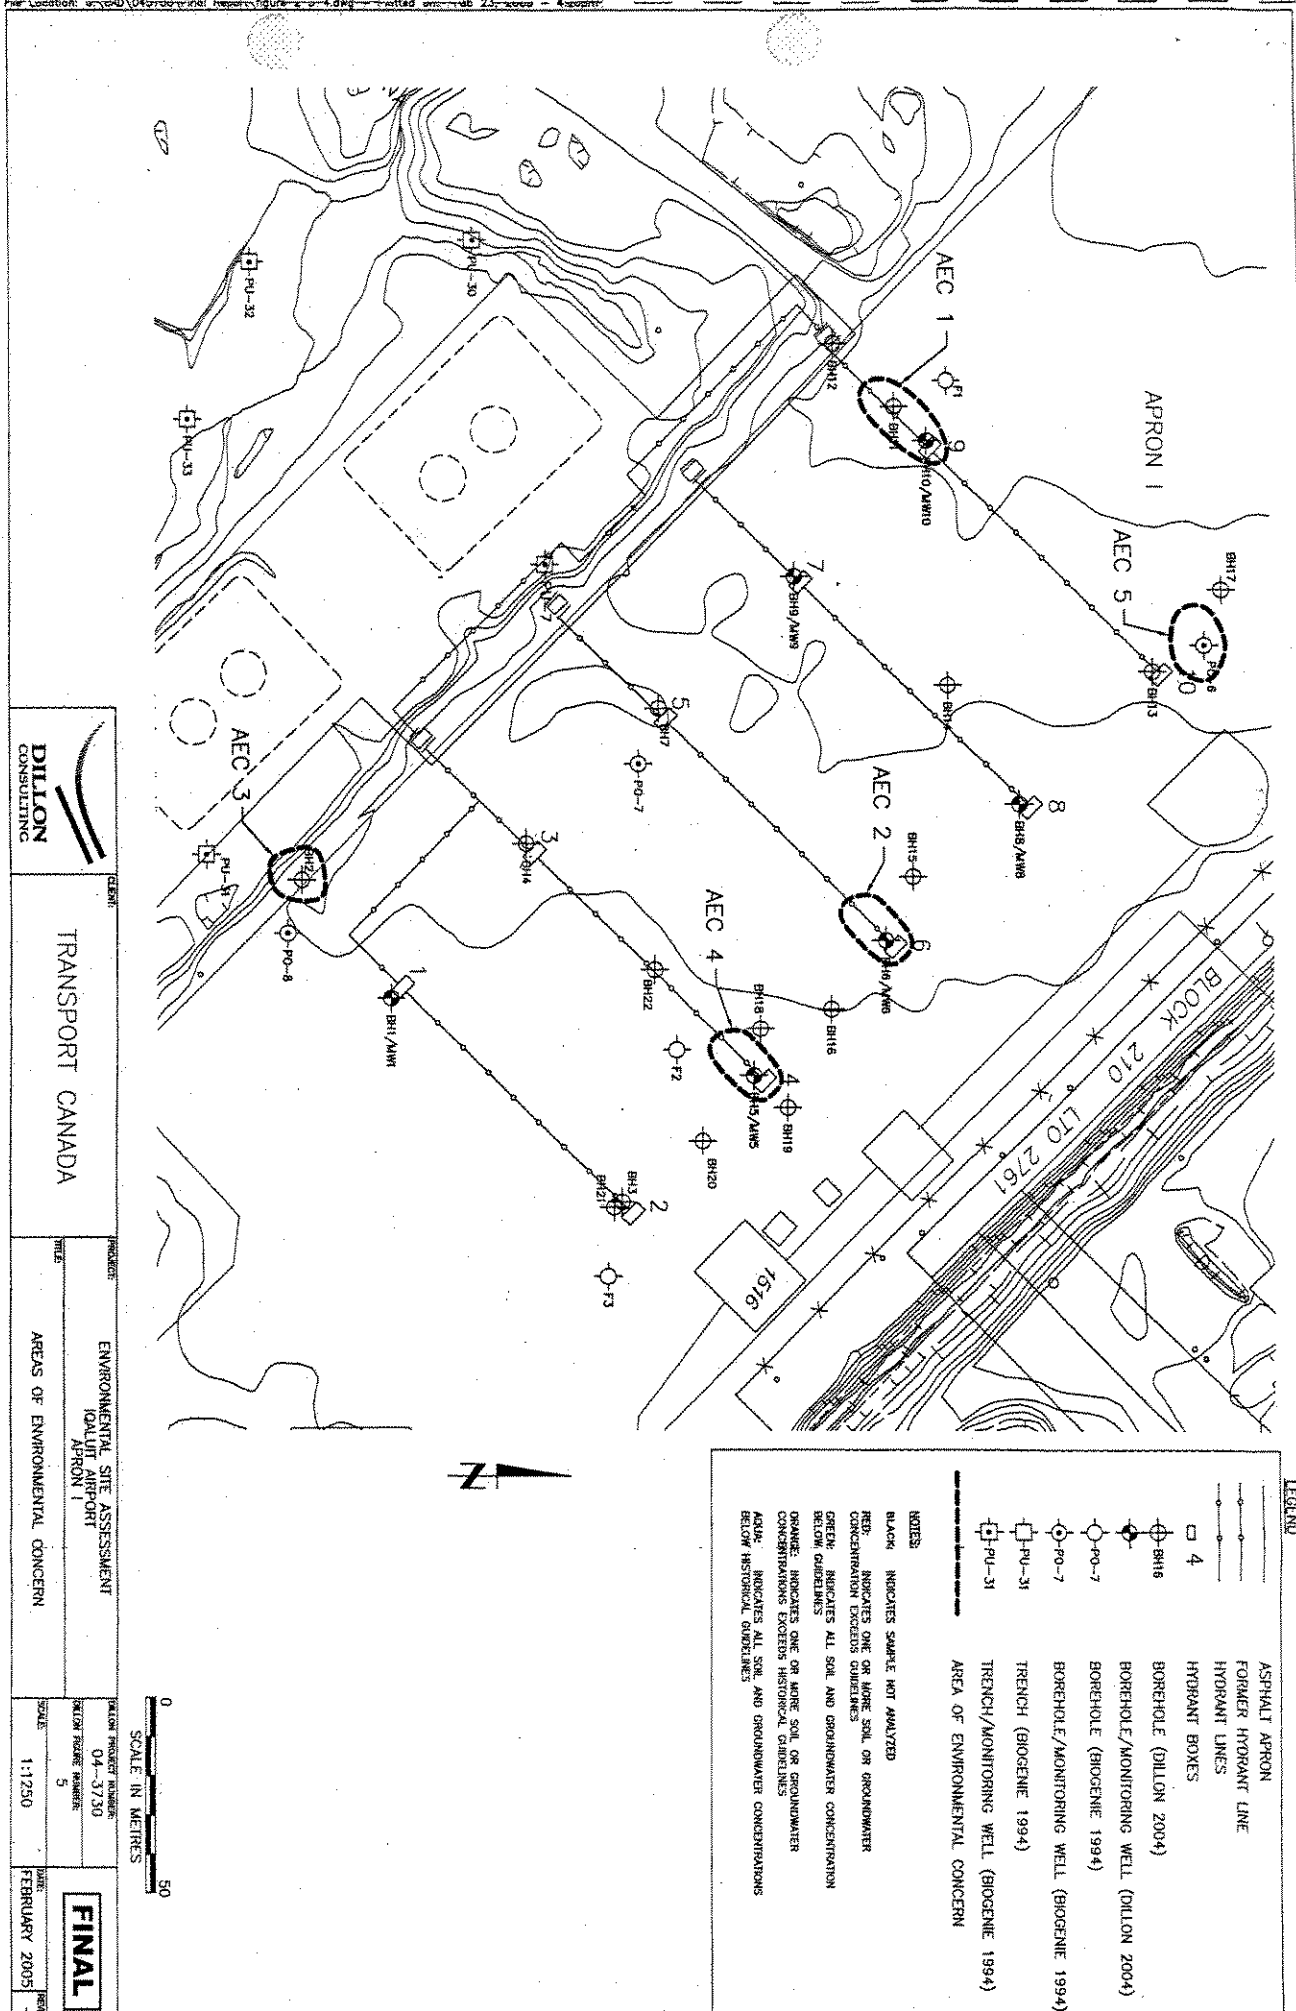
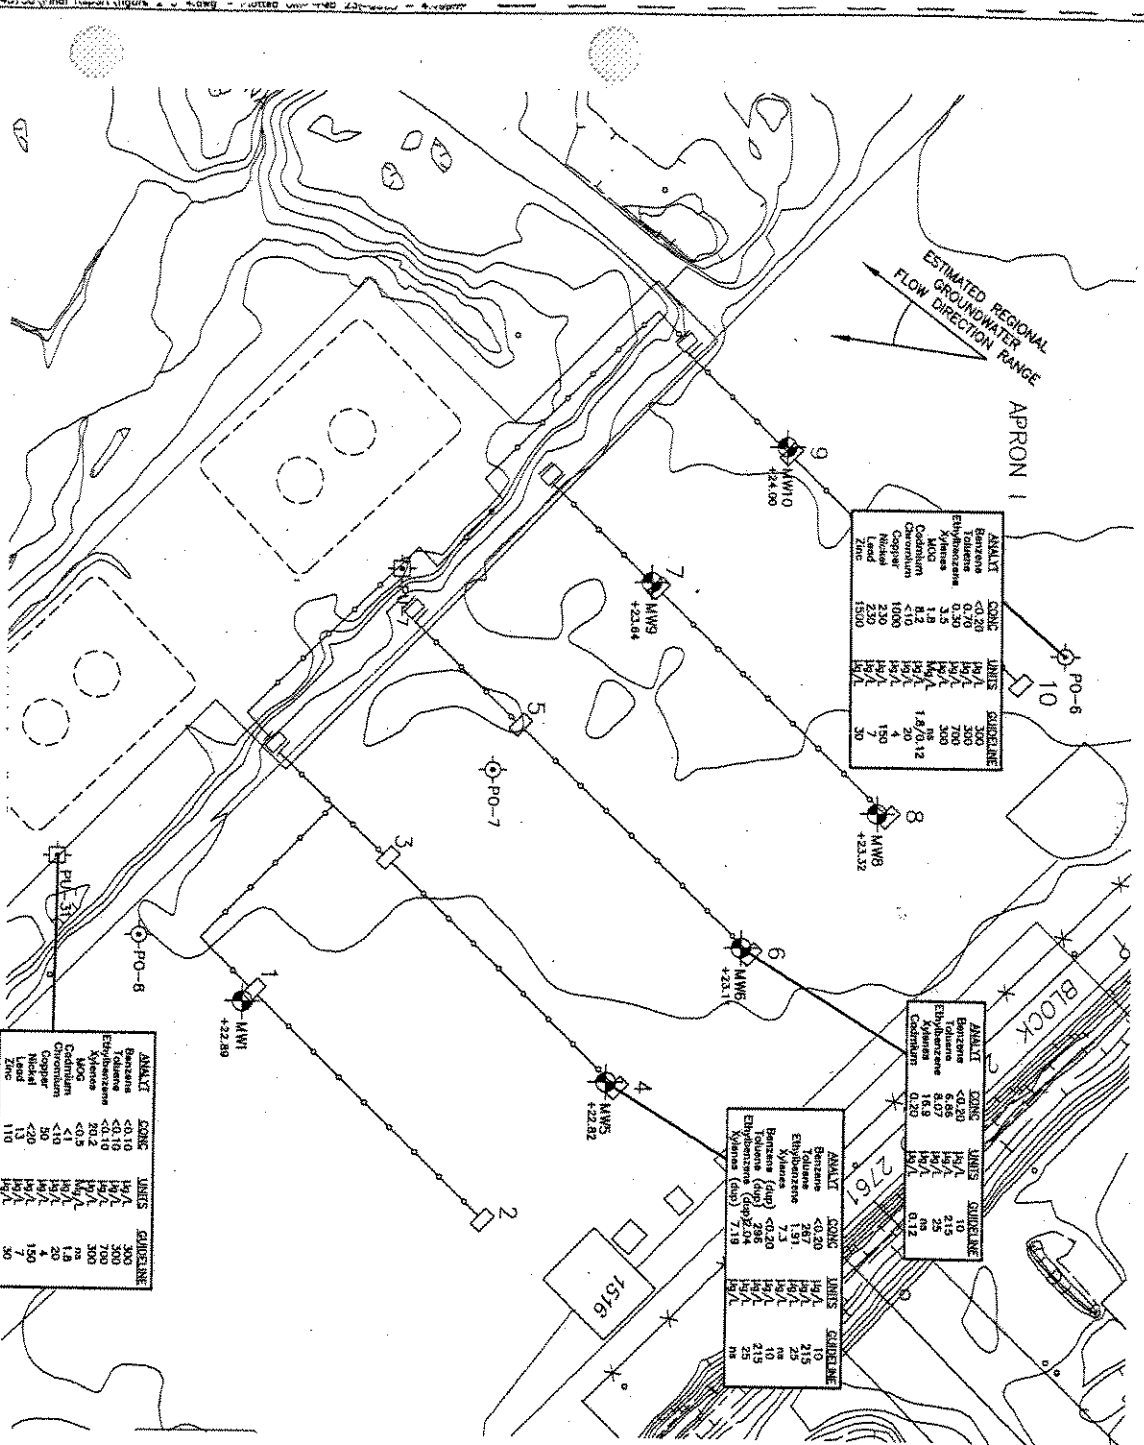
1994/2004 GROUNDWATER ASSESSMENT PROGRAMS

The results of the analysis of two groundwater samples collected from Apron I, are summarized in Table 3, and are presented on Figure 4.

Toluene concentrations from sample MW-5 and the duplicate sample (dup 1), exceeded applicable guidelines with concentrations of 267 µg/L and 296 µg/L. The cadmium concentration from MW-6 was 0.2 µg/L, which exceeded the CEQG Marine Aquatic Life guideline of 0.12 µg/L. Given the regular airplane de-icing activities which may have occurred on Apron I, sample MW-5 was analyzed for glycol. The concentration of glycol in this well fell below the analytical detection limit. All other analysed parameters were below applicable guidelines. In addition, results from PHC fractions in samples MW-5 and MW-6, indicate that concentration were present at elevated levels; however, there are no applicable guidelines for comparison.

Hydrant	Well	Sample	Parameter	Concentration	Units	Guideline
Hydrant 4	MW-5	mw5	Toluene	267	µg/L	215
Hydrant 4	MW-5	dup1	Toluene	296	µg/L	215
Hydrant 6	MW-6	mw6	Cadmium	0.2	µg/L	0.12
