**Transport Canada  
LTU Annual Report 2008  
Iqaluit Airport, Nunavut  
Water License No. 1BR-LTU0608**

**March 2009**

**Re: Fertilizing Two LTUs**  
**Iqaluit Airport, Iqaluit, Nunavut Territory**  
**File No.: E1001-077-08**

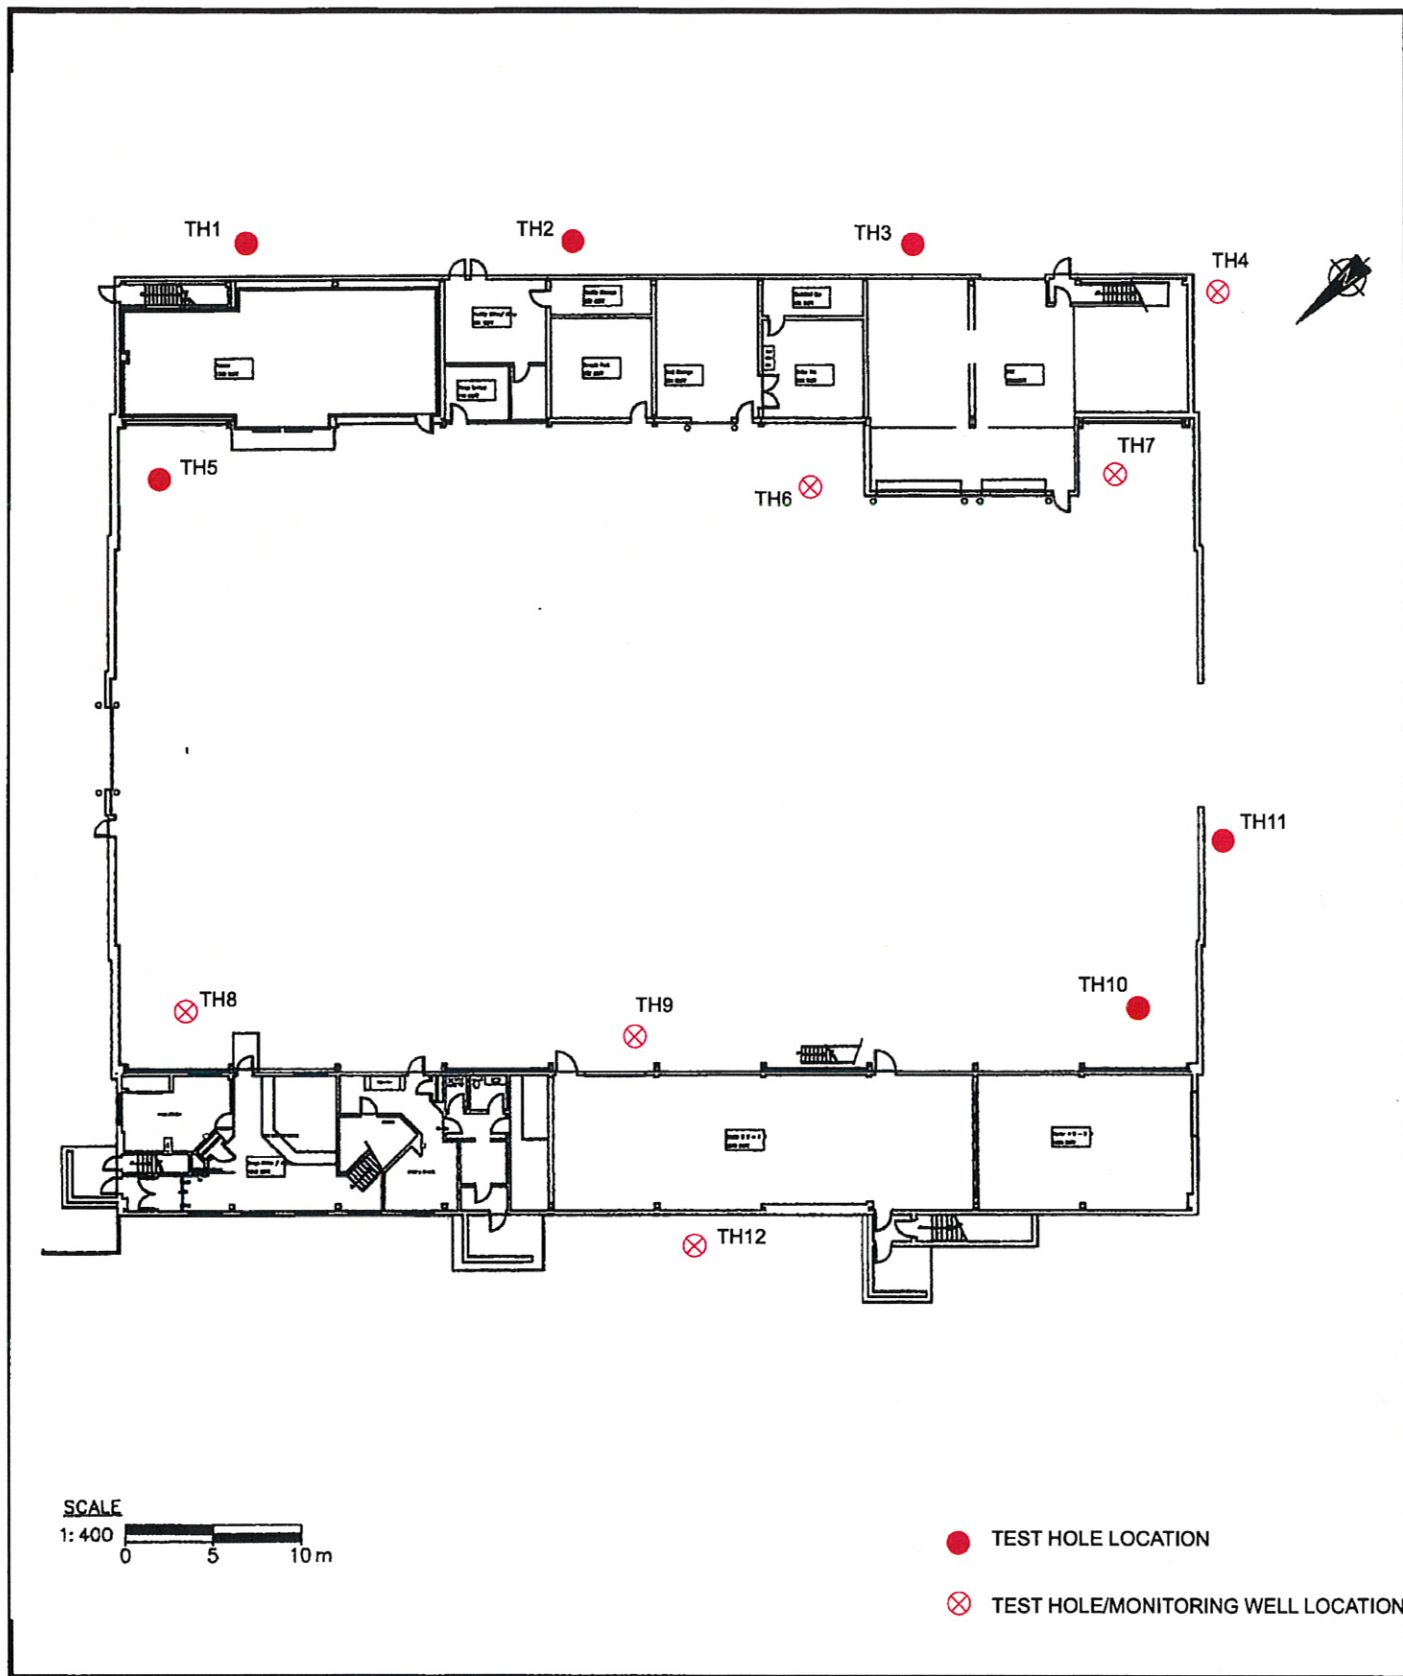
**FIGURE 2:**  
**TEST HOLE AND MONITORING WELL LOCATIONS**  
 First Air Office Building and Cargo Hangar - Iqaluit, Nunavut

As you are aware it is First Air's intention to undergo a major renovation to our Iqaluit Cargo Building this summer including the installation of a new heated concrete floor. Installation of the new floor will require the removal of the existing asphalt floor and about a one half meter excavation to provide space for the new insulation, support structure, and the actual floor. This will result in about 1,200 cu meters of removed granular material that has to be disposed of. Investigation shows that varying amounts of hydrocarbon contamination impact this material.
