7.0 FACILITY DECOMMISSIONING AND CLEAN-UP OPTIONS

CAM-5, MacKar Inlet was an auxiliary station within the original DEW Station System. It will be decommissioned and totally abandoned. The DEW site will be restored under the DND/DIAND MOU, as discussed in Volume 2, Section 1.0.

CAM-5 MACKAR INLET

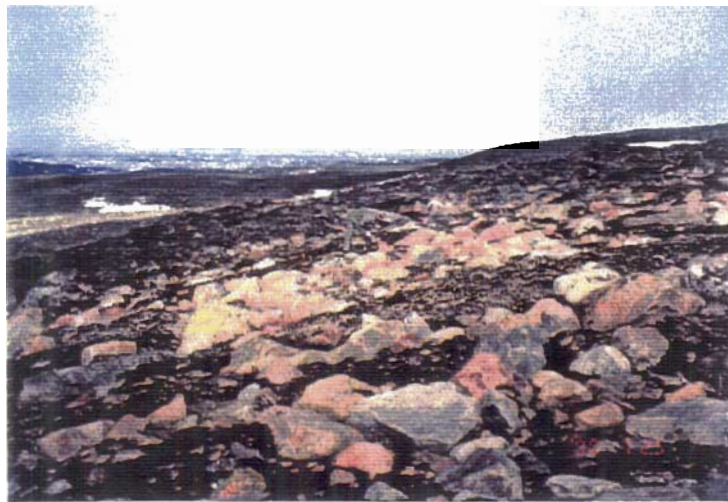
PLATE 2

- Volatile compounds detected in the pond 1.1 km north of the Main Module Train.
- PCB contamination above Level B was found in two soil samples.

SEWAGE OUTFALL-UPPER BASE
VIEW TOWARDS EAST

- As part of the clean-up procedure, the levels and extent of contamination should be confirmed by field sampling and analysis prior to soil remediation.
- After the extent of contamination has been determined, the appropriate soil remediation technique can be identified.
- PCB contaminated soils may be remediated by solvent extraction or placement in a secure landfill.
- The area should be restored by regrading and covering with clean fill.

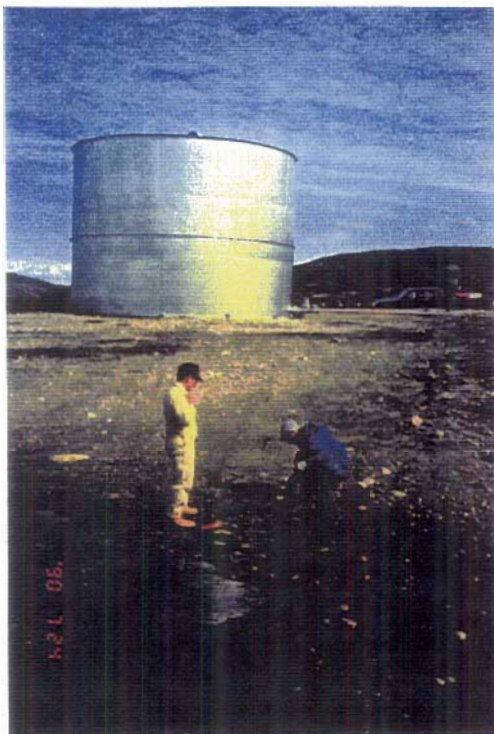
PLATE 3

AIRSTRIP POL TANK
STORAGE FACILITY
VIEW TOWARDS EAST

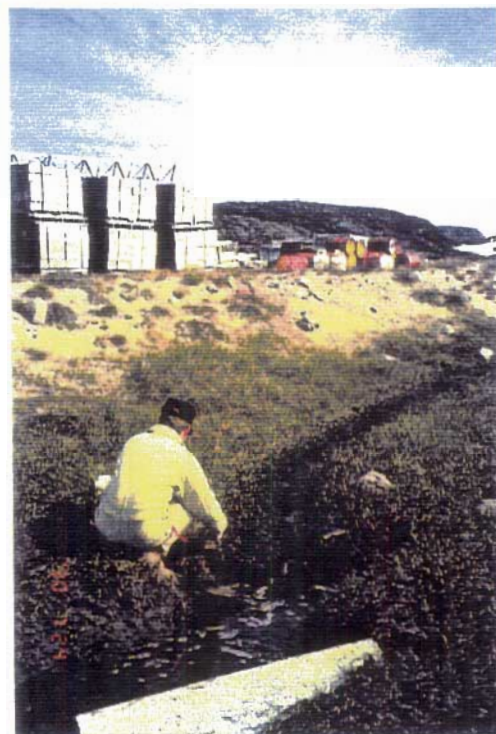
PLATE 4

STAGING/STORAGE AREA
NEAR AIRSTRIP

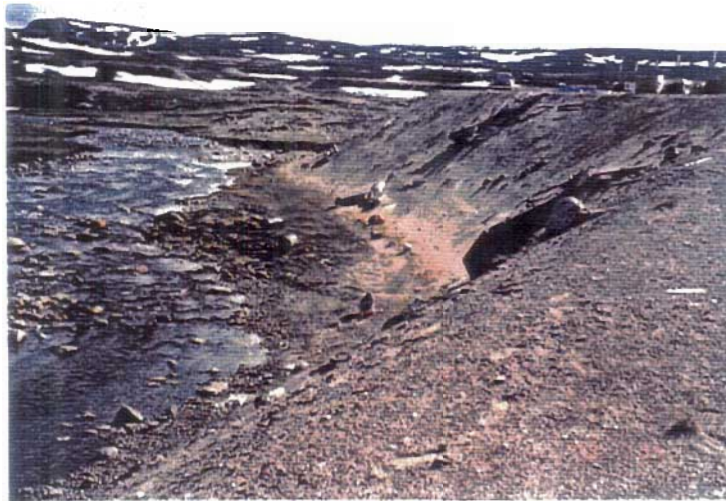
PLATE 5

LANDFILL AT LOWER BASE
VIEW TO SOUTHWEST

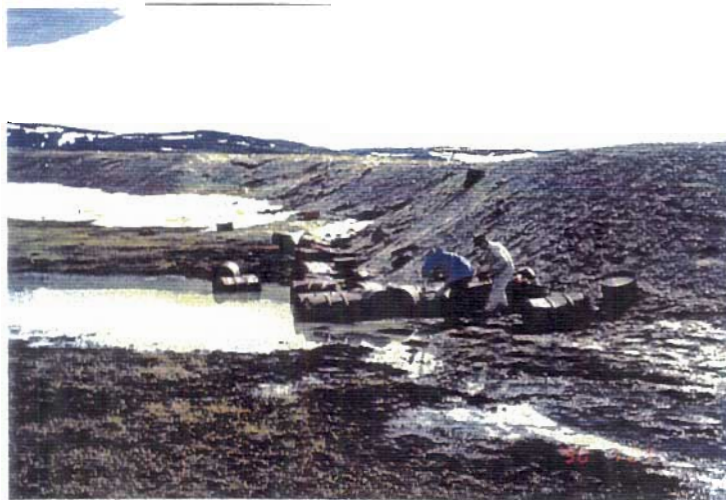
PLATE 6

LANDFILL AT LOWER BASE
EASTERN EDGE OF LANDFILL

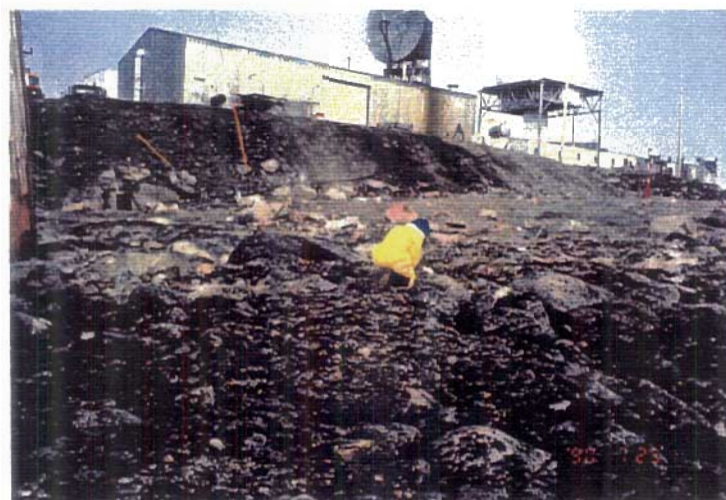
PLATE 7

- Several small stain areas were observed.
- A hydrocarbon film was noted on a small stream downslope from the Main Module Train.
- TPH and PCBs were detected in excess of Level A.

SOIL STAINING ON GARAGE EMBANKMENT
VIEW TO NORTH

- As part of the clean-up procedure, the levels and extent of soil contamination should be confirmed by field sampling and analysis prior to soil remediation.
- Hydrocarbon contaminated soil may be remediated using incineration or placement in a secure landfill.
- PCB contaminated soil should be remediated by solvent extraction or placement in a secure landfill.
- Due to the presence of PCBs in the soil, higher temperatures must be used for incineration of the hydrocarbon contaminated soils than if the soils were contaminated by hydrocarbons only.
