Re: 2008 Annual Report for Water Use License 1BR-MAC0712: CAM-5, Mackar Inlet DEW Line Site

1BR-MAC0712: Executive Summary

Project Name: CAM-5, Mackar Inlet DEW Line Site

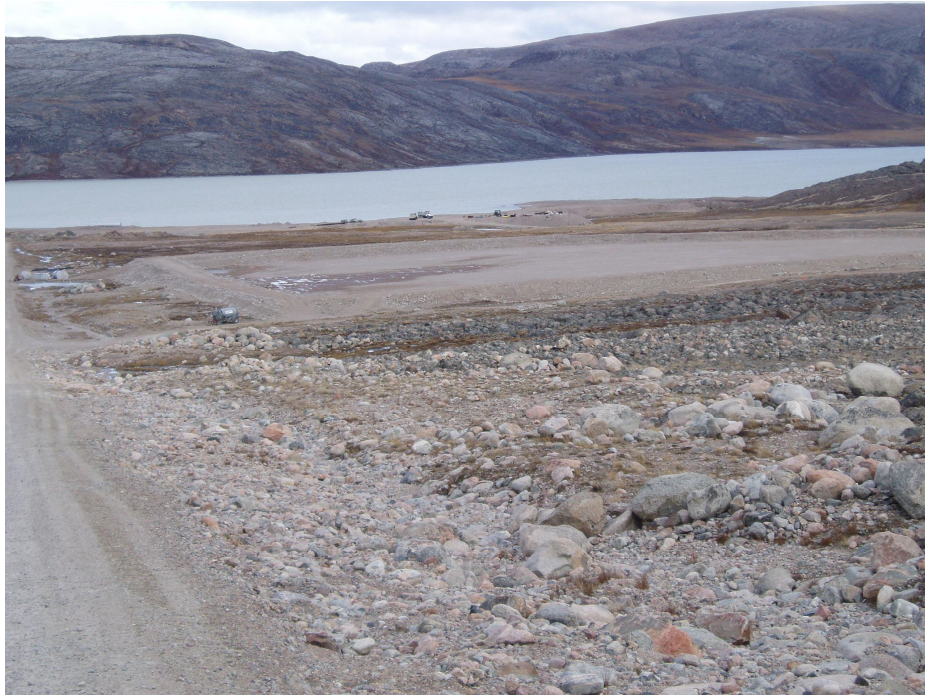
Landfarm: Construction of the landfarm was completed in 2008 and is ready to accept hydrocarbon-impacted soils for treatment in 2009.

Photograph 1: Landfarm.

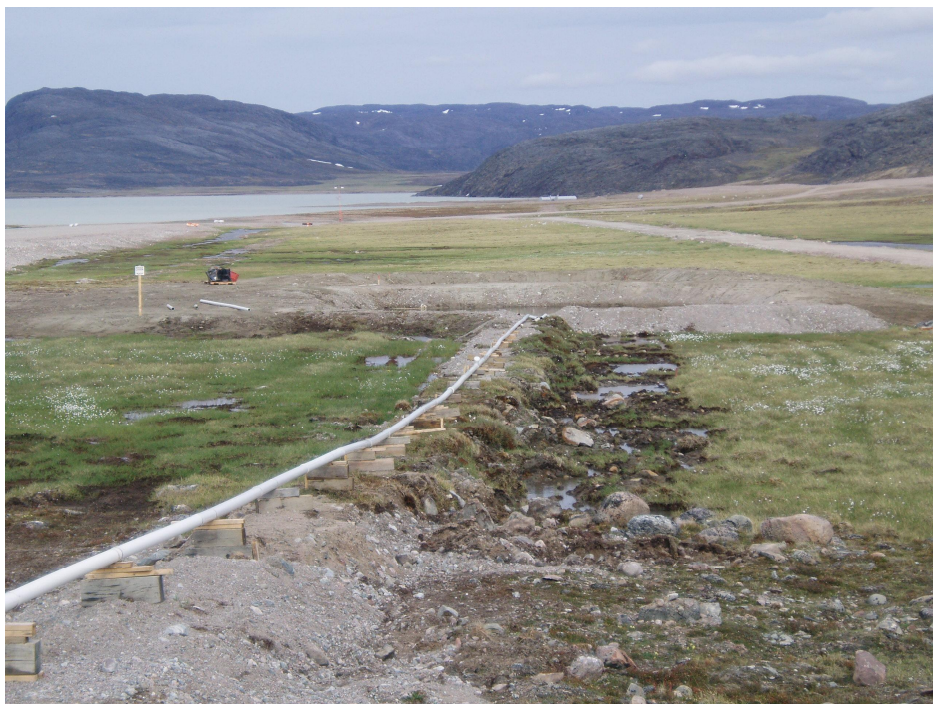
Photograph 2: Sewage Lagoon

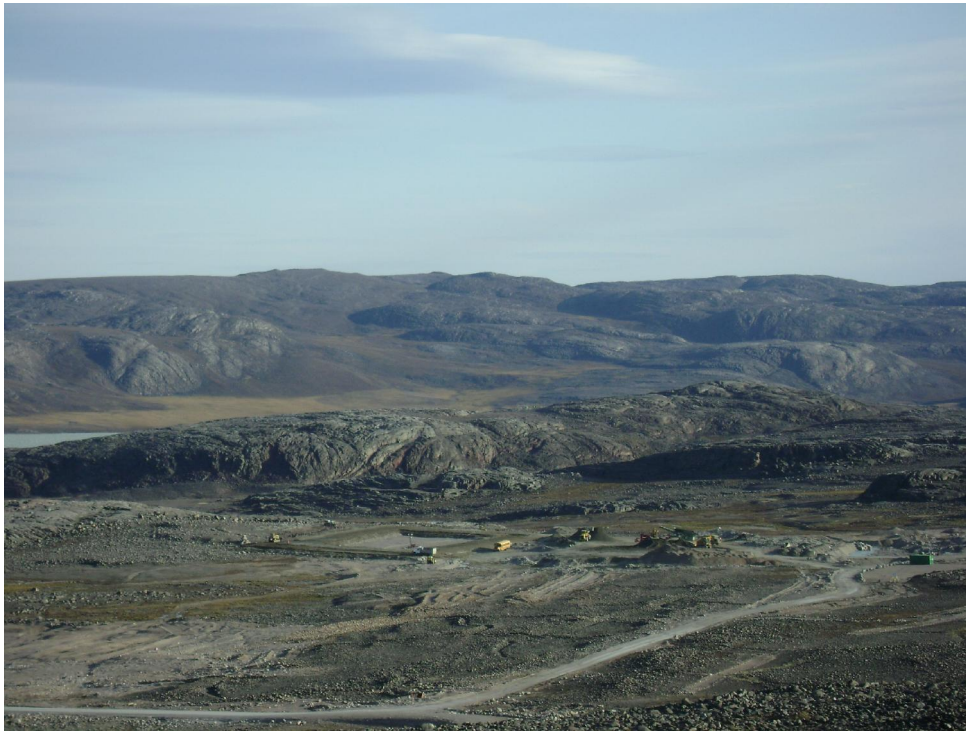
Tier II Soil Disposal Facility: Construction of the Tier II Soil Disposal Facility is mostly complete with some minor reshaping of the berms required before it can accept Tier II impacted soils. This task will be completed in 2009, along with the placement of Tier II impacted soils.

Photograph 3: Tier II Landfill

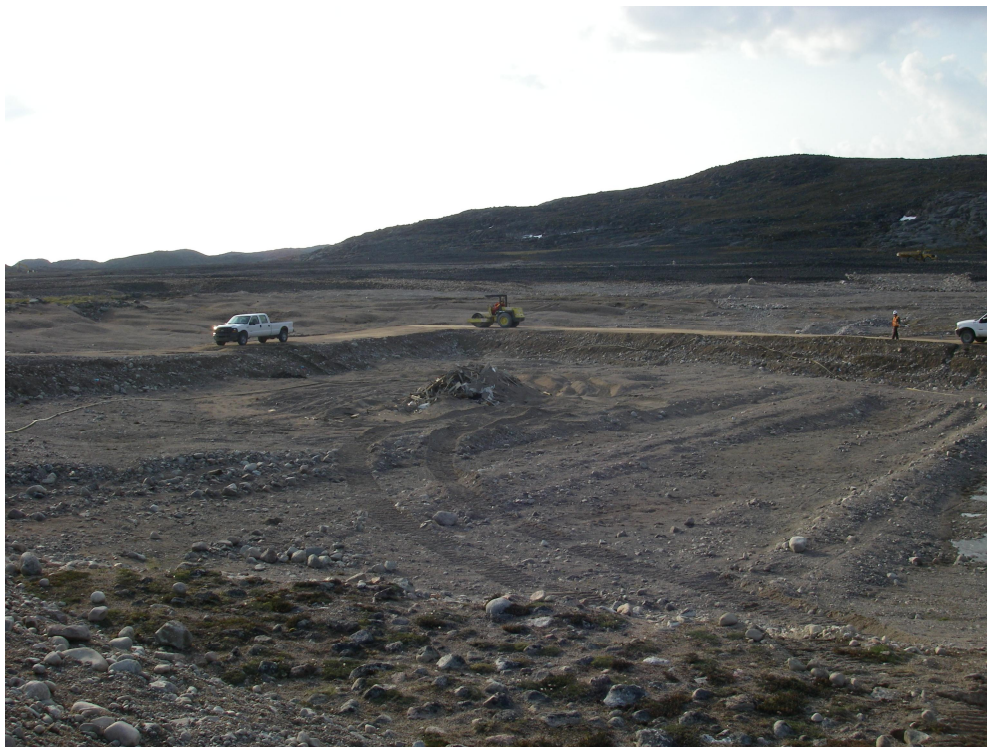
Non-Hazardous Waste Landfill: Construction of the Non-Hazardous Waste Landfill was completed in 2008 to the point where the facility could accept inert debris. Approximately 200 m³ of debris was placed in 2008. An intermediate fill layer was placed on the facility at the end of the 2008 season in September to winterize the facility.

Photograph 4: Non-Hazardous Waste Landfill
