**THE COLLECTION OF LANDFILL  
MONITORING DATA AT THE FORMER  
CAM-5 DEW LINE SITE**

Mackar Inlet, Nunavut

**FINAL REPORT – 2012**

**DEFENCE CONSTRUCTION CANADA**

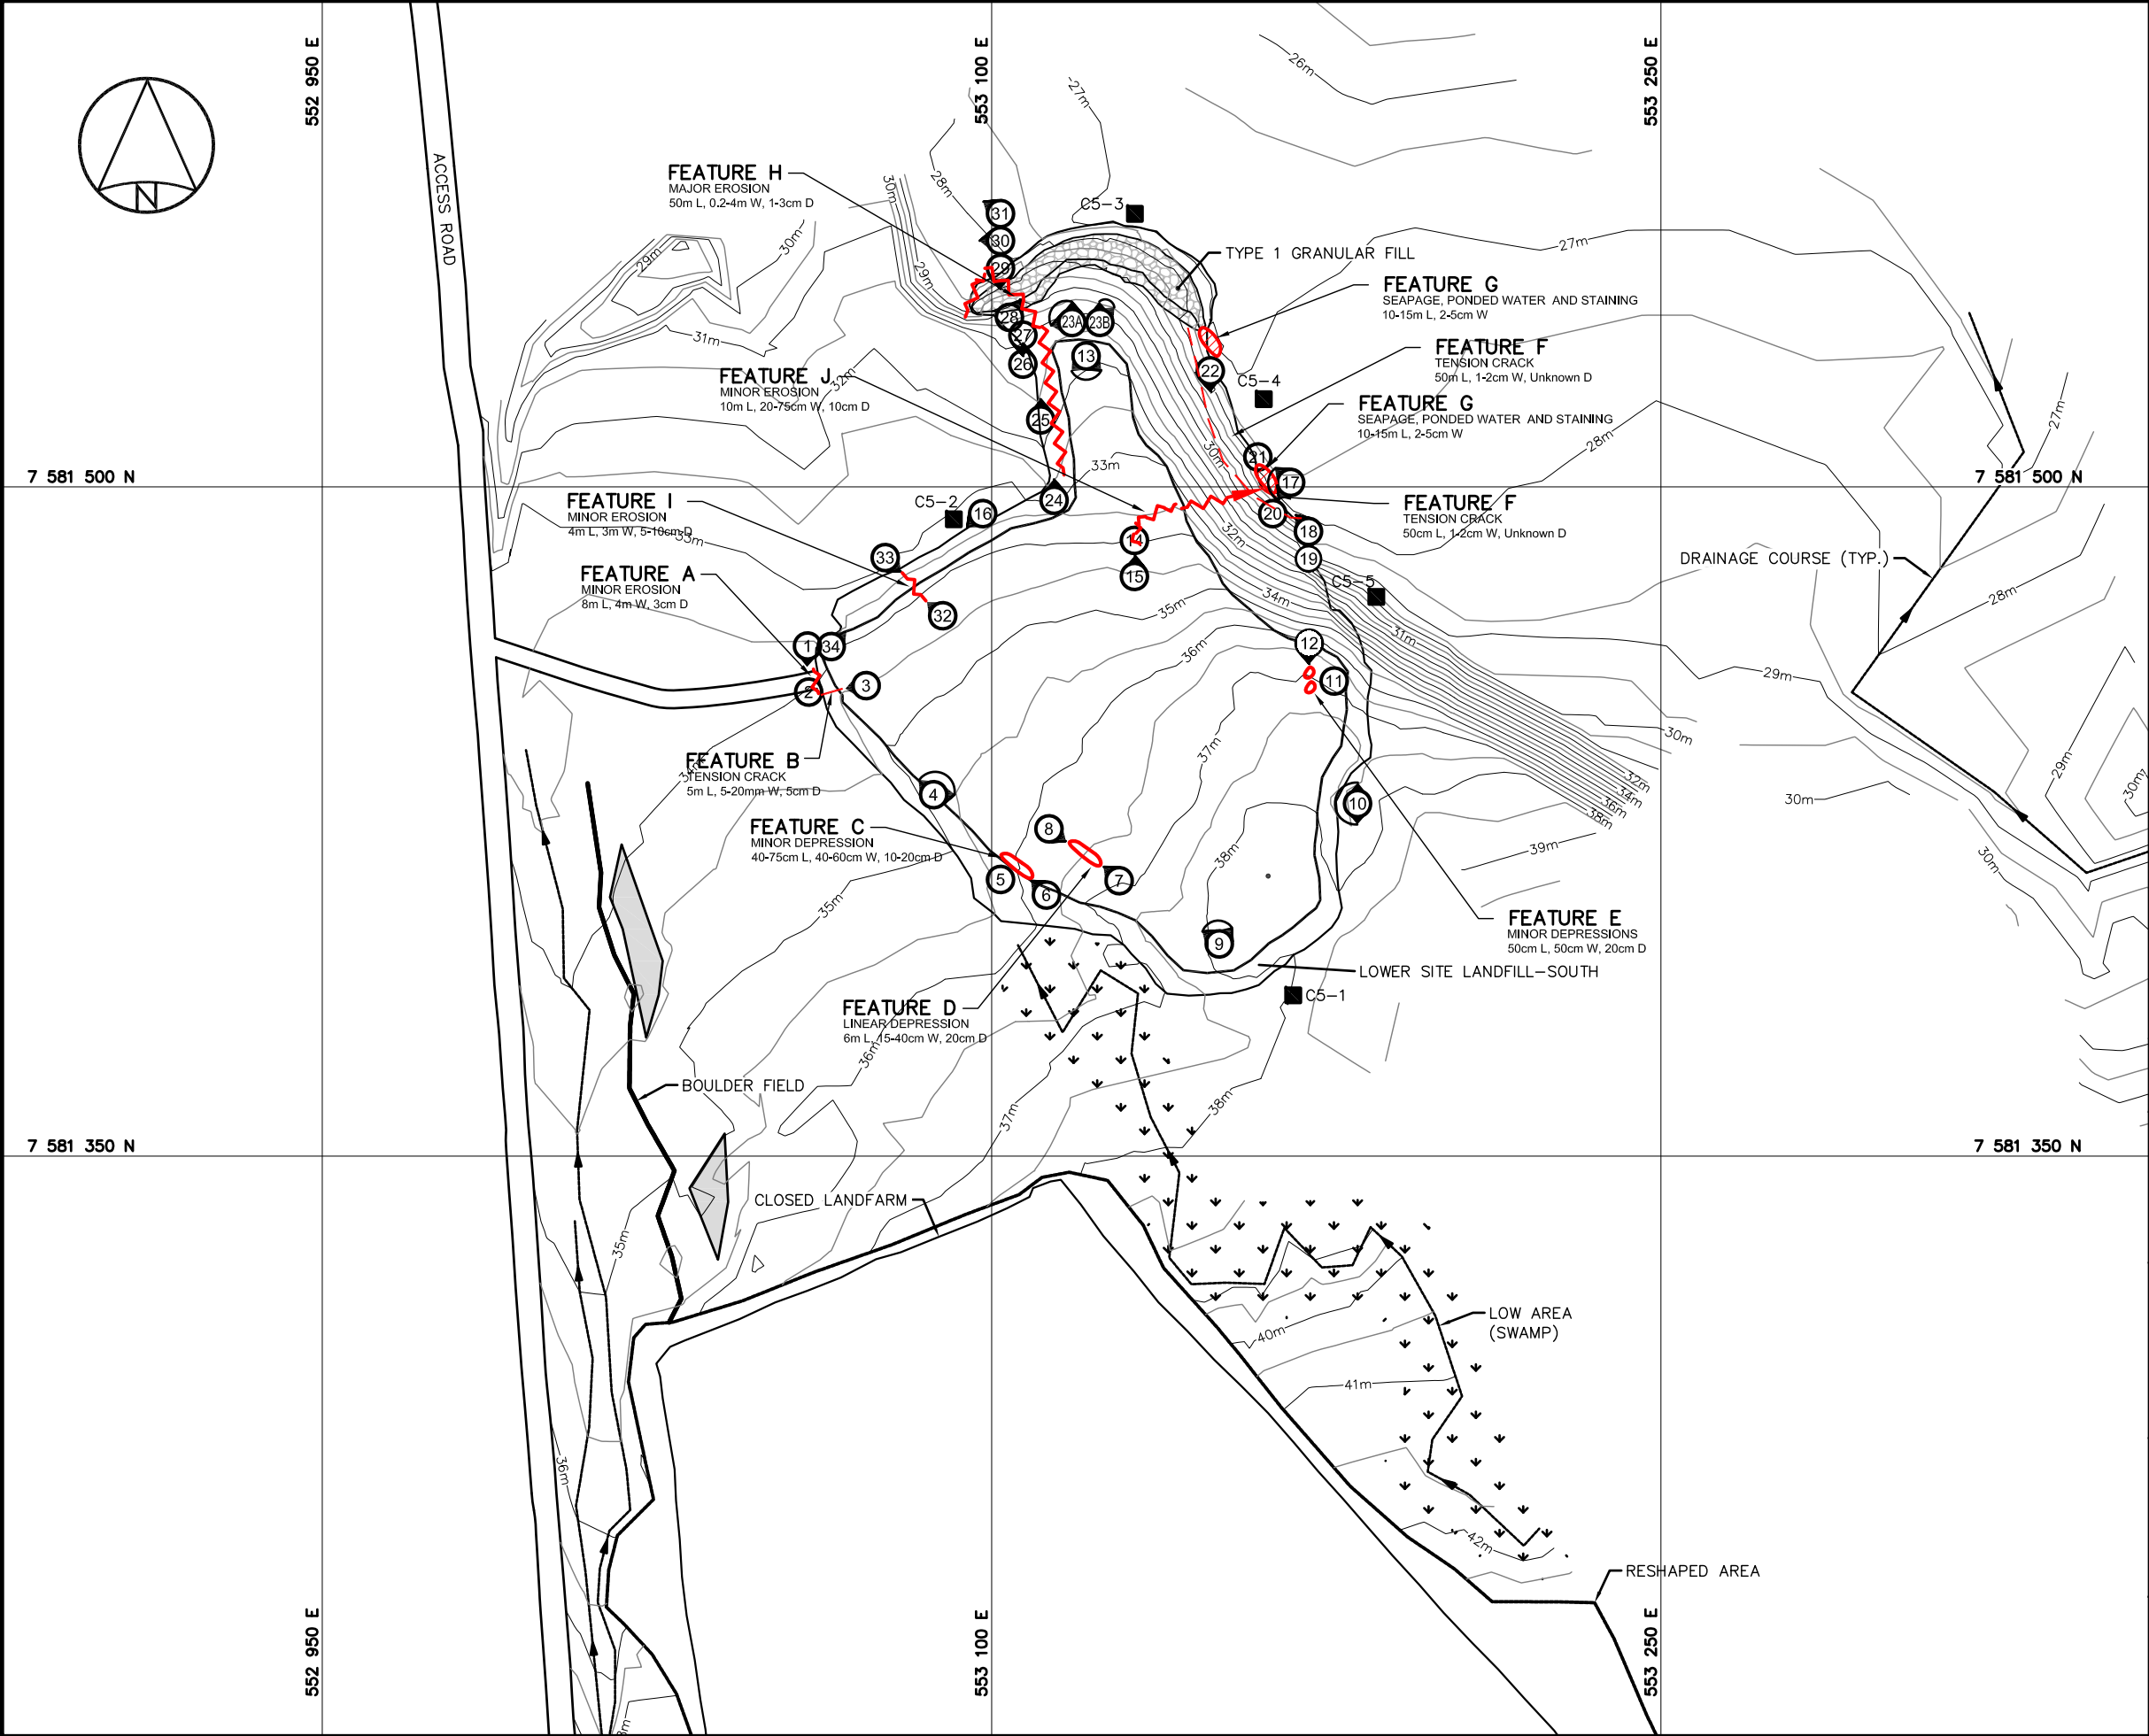
The Location Plan for the Lower Site Landfill - South has been completed as per the TOR and is included in the following page as Figure CAM-5.2 Lower Site Landfill – South.

Areas of settlement were noted at three locations on the landfill surface, Features C, D and E. All three features are new observations not indicated on the baseline investigation drawings. Feature C consists of two small depressions (potholes) on the western surface of the south section of the landfill. Feature D consists of a single linear depression orientated parallel to the crest on the west side of the south section and approximately 10m from the crest. Feature E consists of two small depressions (potholes) on the eastern surface of the south section. The features have an acceptable severity rating.

Feature H located in the north landfill section (previously noted in the baseline investigation), consists of a large erosion channel which runs the length of the western toe and deposits material on the armoured north toe. The feature appears to have increased in size since the baseline study conducted in 2011 (based on the provided photographs). The feature appears to be self-armouring however, there is evidence that the erosion is extending east into the landfill. At this time, no debris is exposed and the landfill is still functioning as intended. The severity rating of Feature H is considered marginal.

Feature K, on the eastern side slope of the landfill (both north and south sections), features two distinct areas of seepage (consisting of surface wetting) with associated bacterial sheen and ponding water. The northern area extends south for 8m from the Type 1 riprap on the north toe of the landfill, while the southern area is central and 15m in length. Each section extends west 2–8m from the landfill toe. There are several areas of pooled water at the toe of the landfill where rutting caused by variations in compaction have filled with water, iron bacteria sheen was present adjacent to one of these pools. It should be noted the landfill is bordered on the east and north sides by muskeg and thus, pooled water is present at the toes.

A thin tension crack (Feature B) not noted in the baseline observations, was observed on the side slope of the landfill running parallel to the southern side of the access road.

Previously observed tensile cracking (Feature F) appear to have increased in size relative to pictures provided by the baseline study. Discontinuous tensile cracking extends

The previously mentioned seepage occurs within 1–3 m of the cracking. Currently, the severity rating of Feature F is considered acceptable with a low probability of failure.

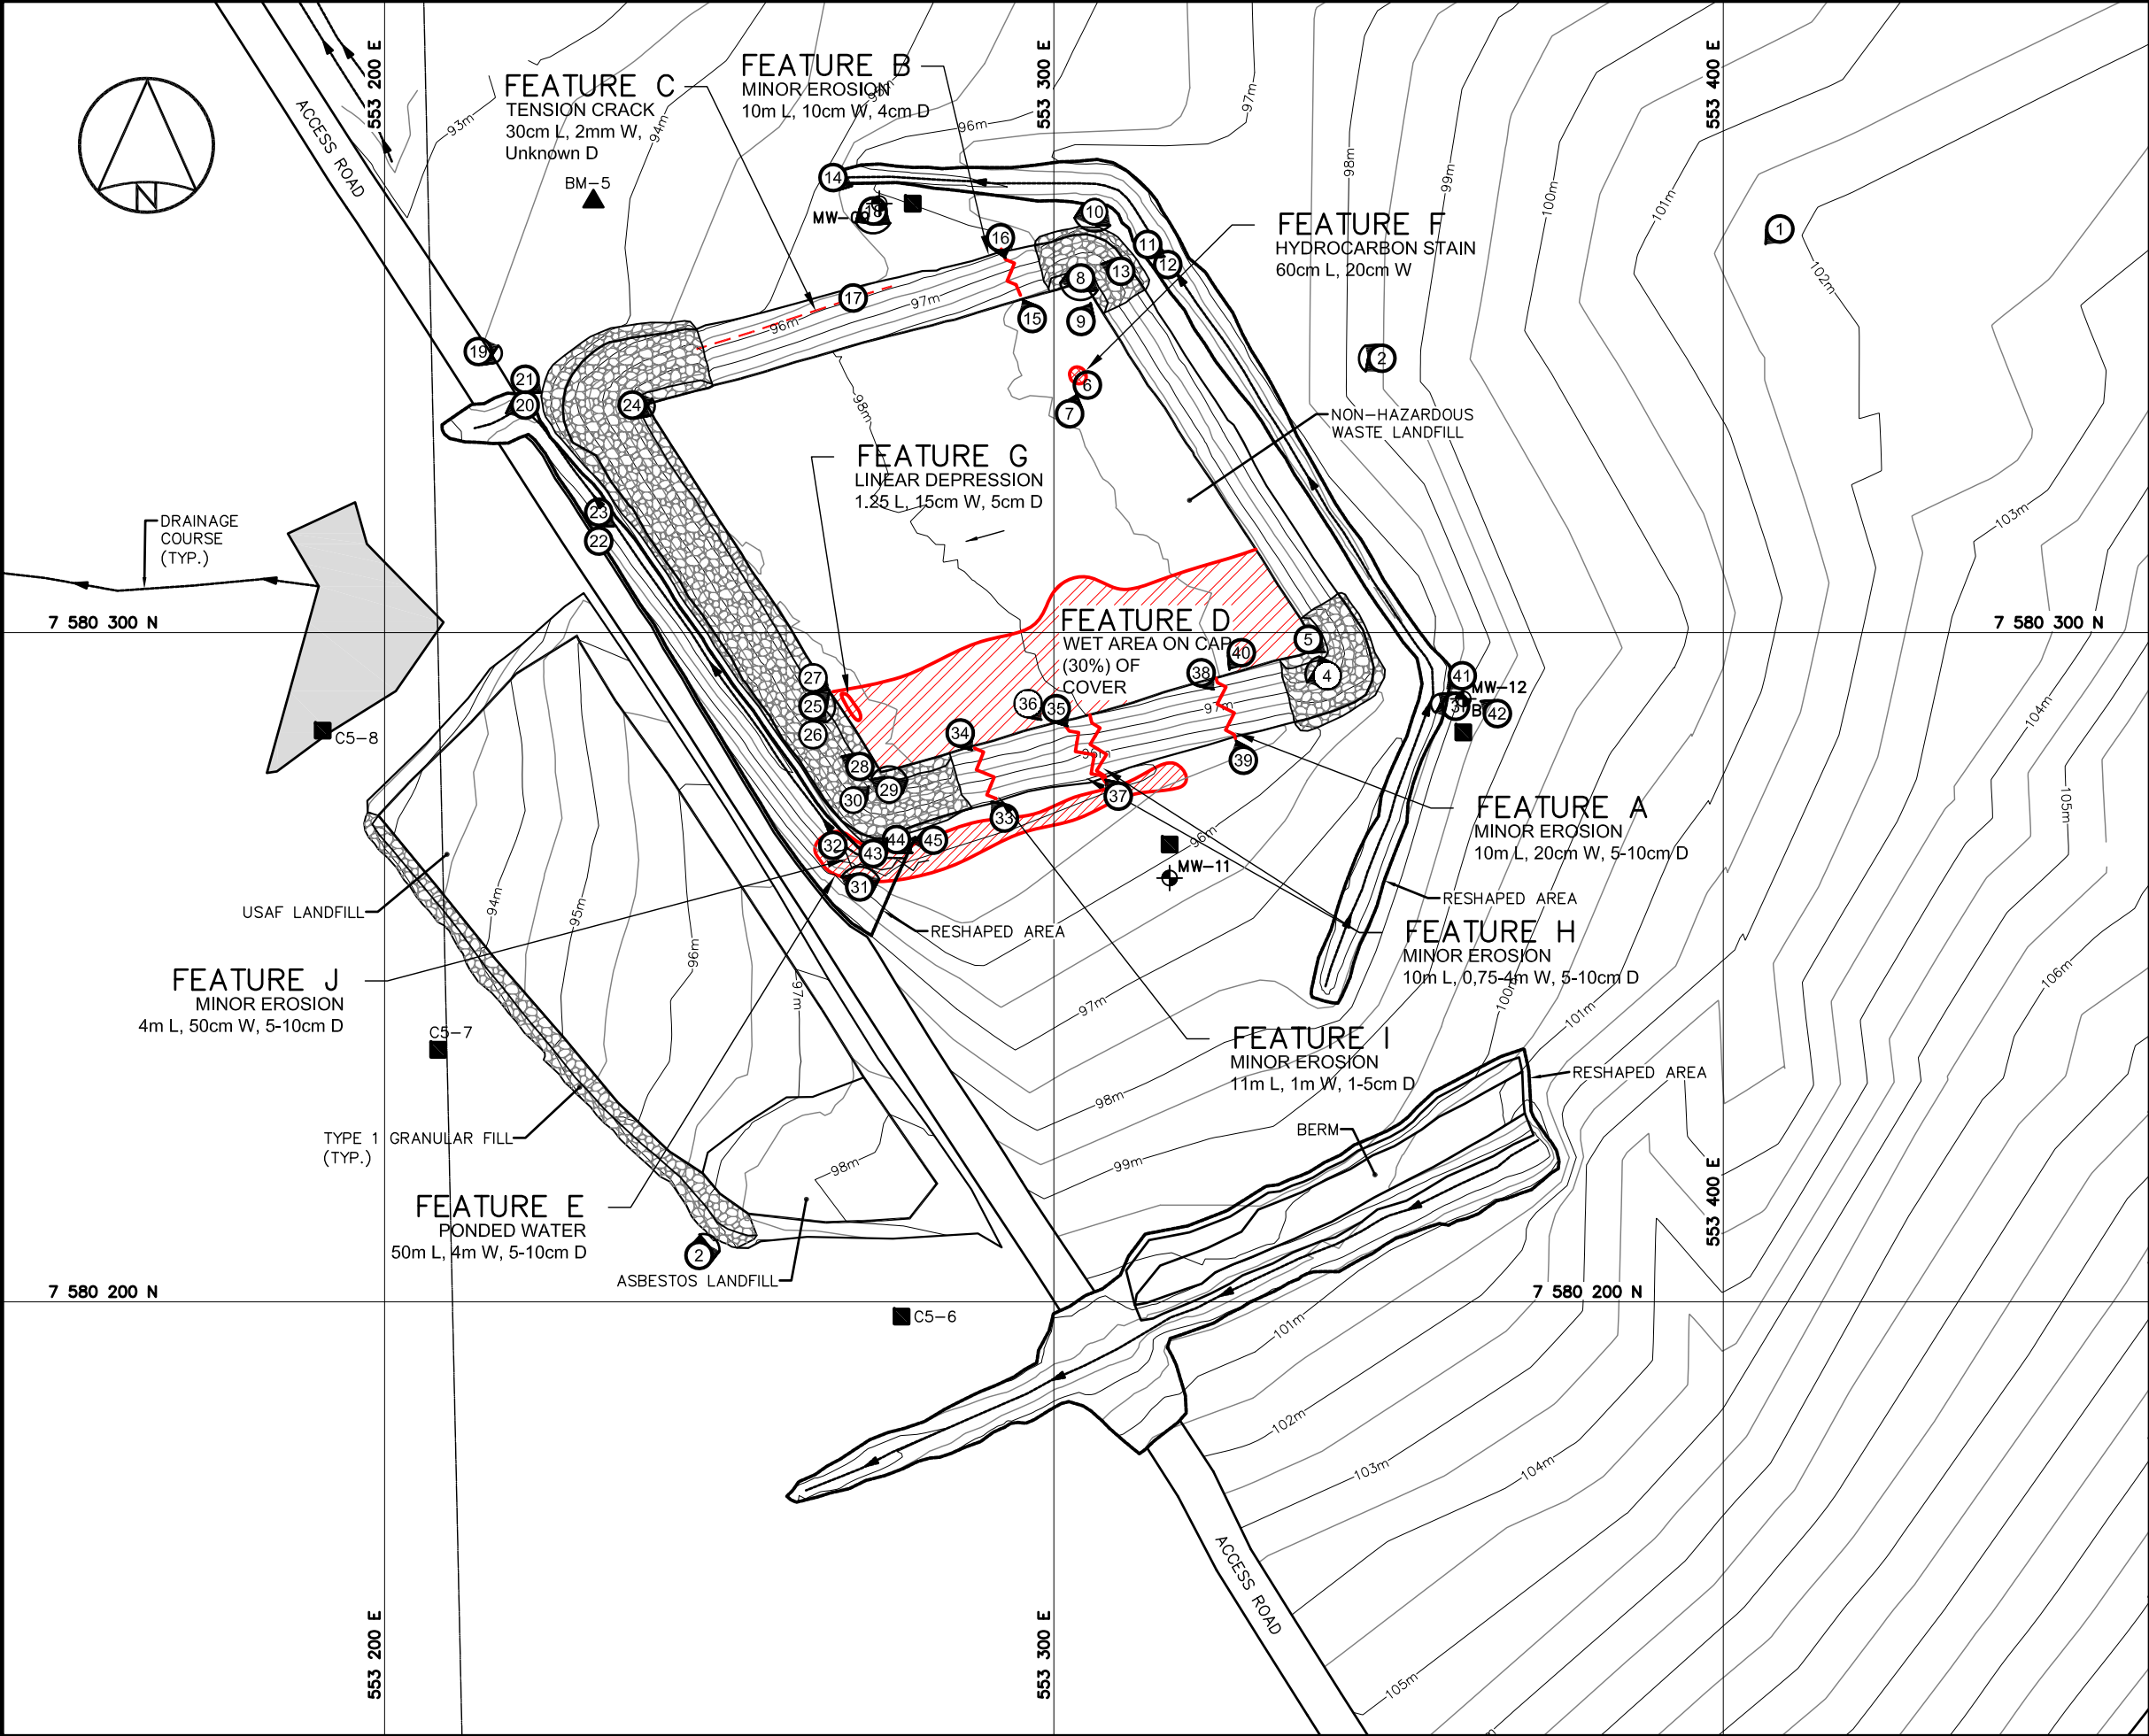
The Location Plan for the NHWL has been completed as per the TOR and is included in the following page as Figure CAM-5.3 Mackar Inlet – Non-Hazardous Waste Landfill.

A small hydrocarbon stain (Feature F) was observed on the surface of the NHWL. A new observation, it is suspected the stain may be the result of recent exploration activities at the CAM-5 site, as no other source of oil remains at the CAM-5 site. It is possible the staining is a result hunter activities during the winter months or simply went unnoticed during the baseline activities.

A small area of linear settlement Feature G (new observation) was observed adjacent and running parallel to the west crest of the landfill. Based on its size, shape, orientation and location (at the edge of the compacted surface), the depression is likely the result of a compactor remaining in this location for too long when changing directions. The severity rating of Feature G is acceptable.

Five areas of erosion were observed at the NHWL during the 2012 monitoring program, two of which were noted during the baseline investigation. Feature A (previously noted) on the South landfill slope, appears to have increased slightly in width and depth based on the AECOM photographic record (picture 183), with a reduction of fine material present in the erosion channel. Feature A appears to be self-armouring and has an acceptable severity rating.

Feature B (previously noted) on the north slope of the NHWL, remains stable in size and is self-armouring. Feature B has an acceptable severity rating.

A discontinuous tension crack (Feature C) previously noted was observed running  $\frac{3}{4}$  of the length of the north side slope of the NHWL fluctuating between 1–2m from the landfill toe. The tension crack (never larger than 2mm in width) has an acceptable severity rating.

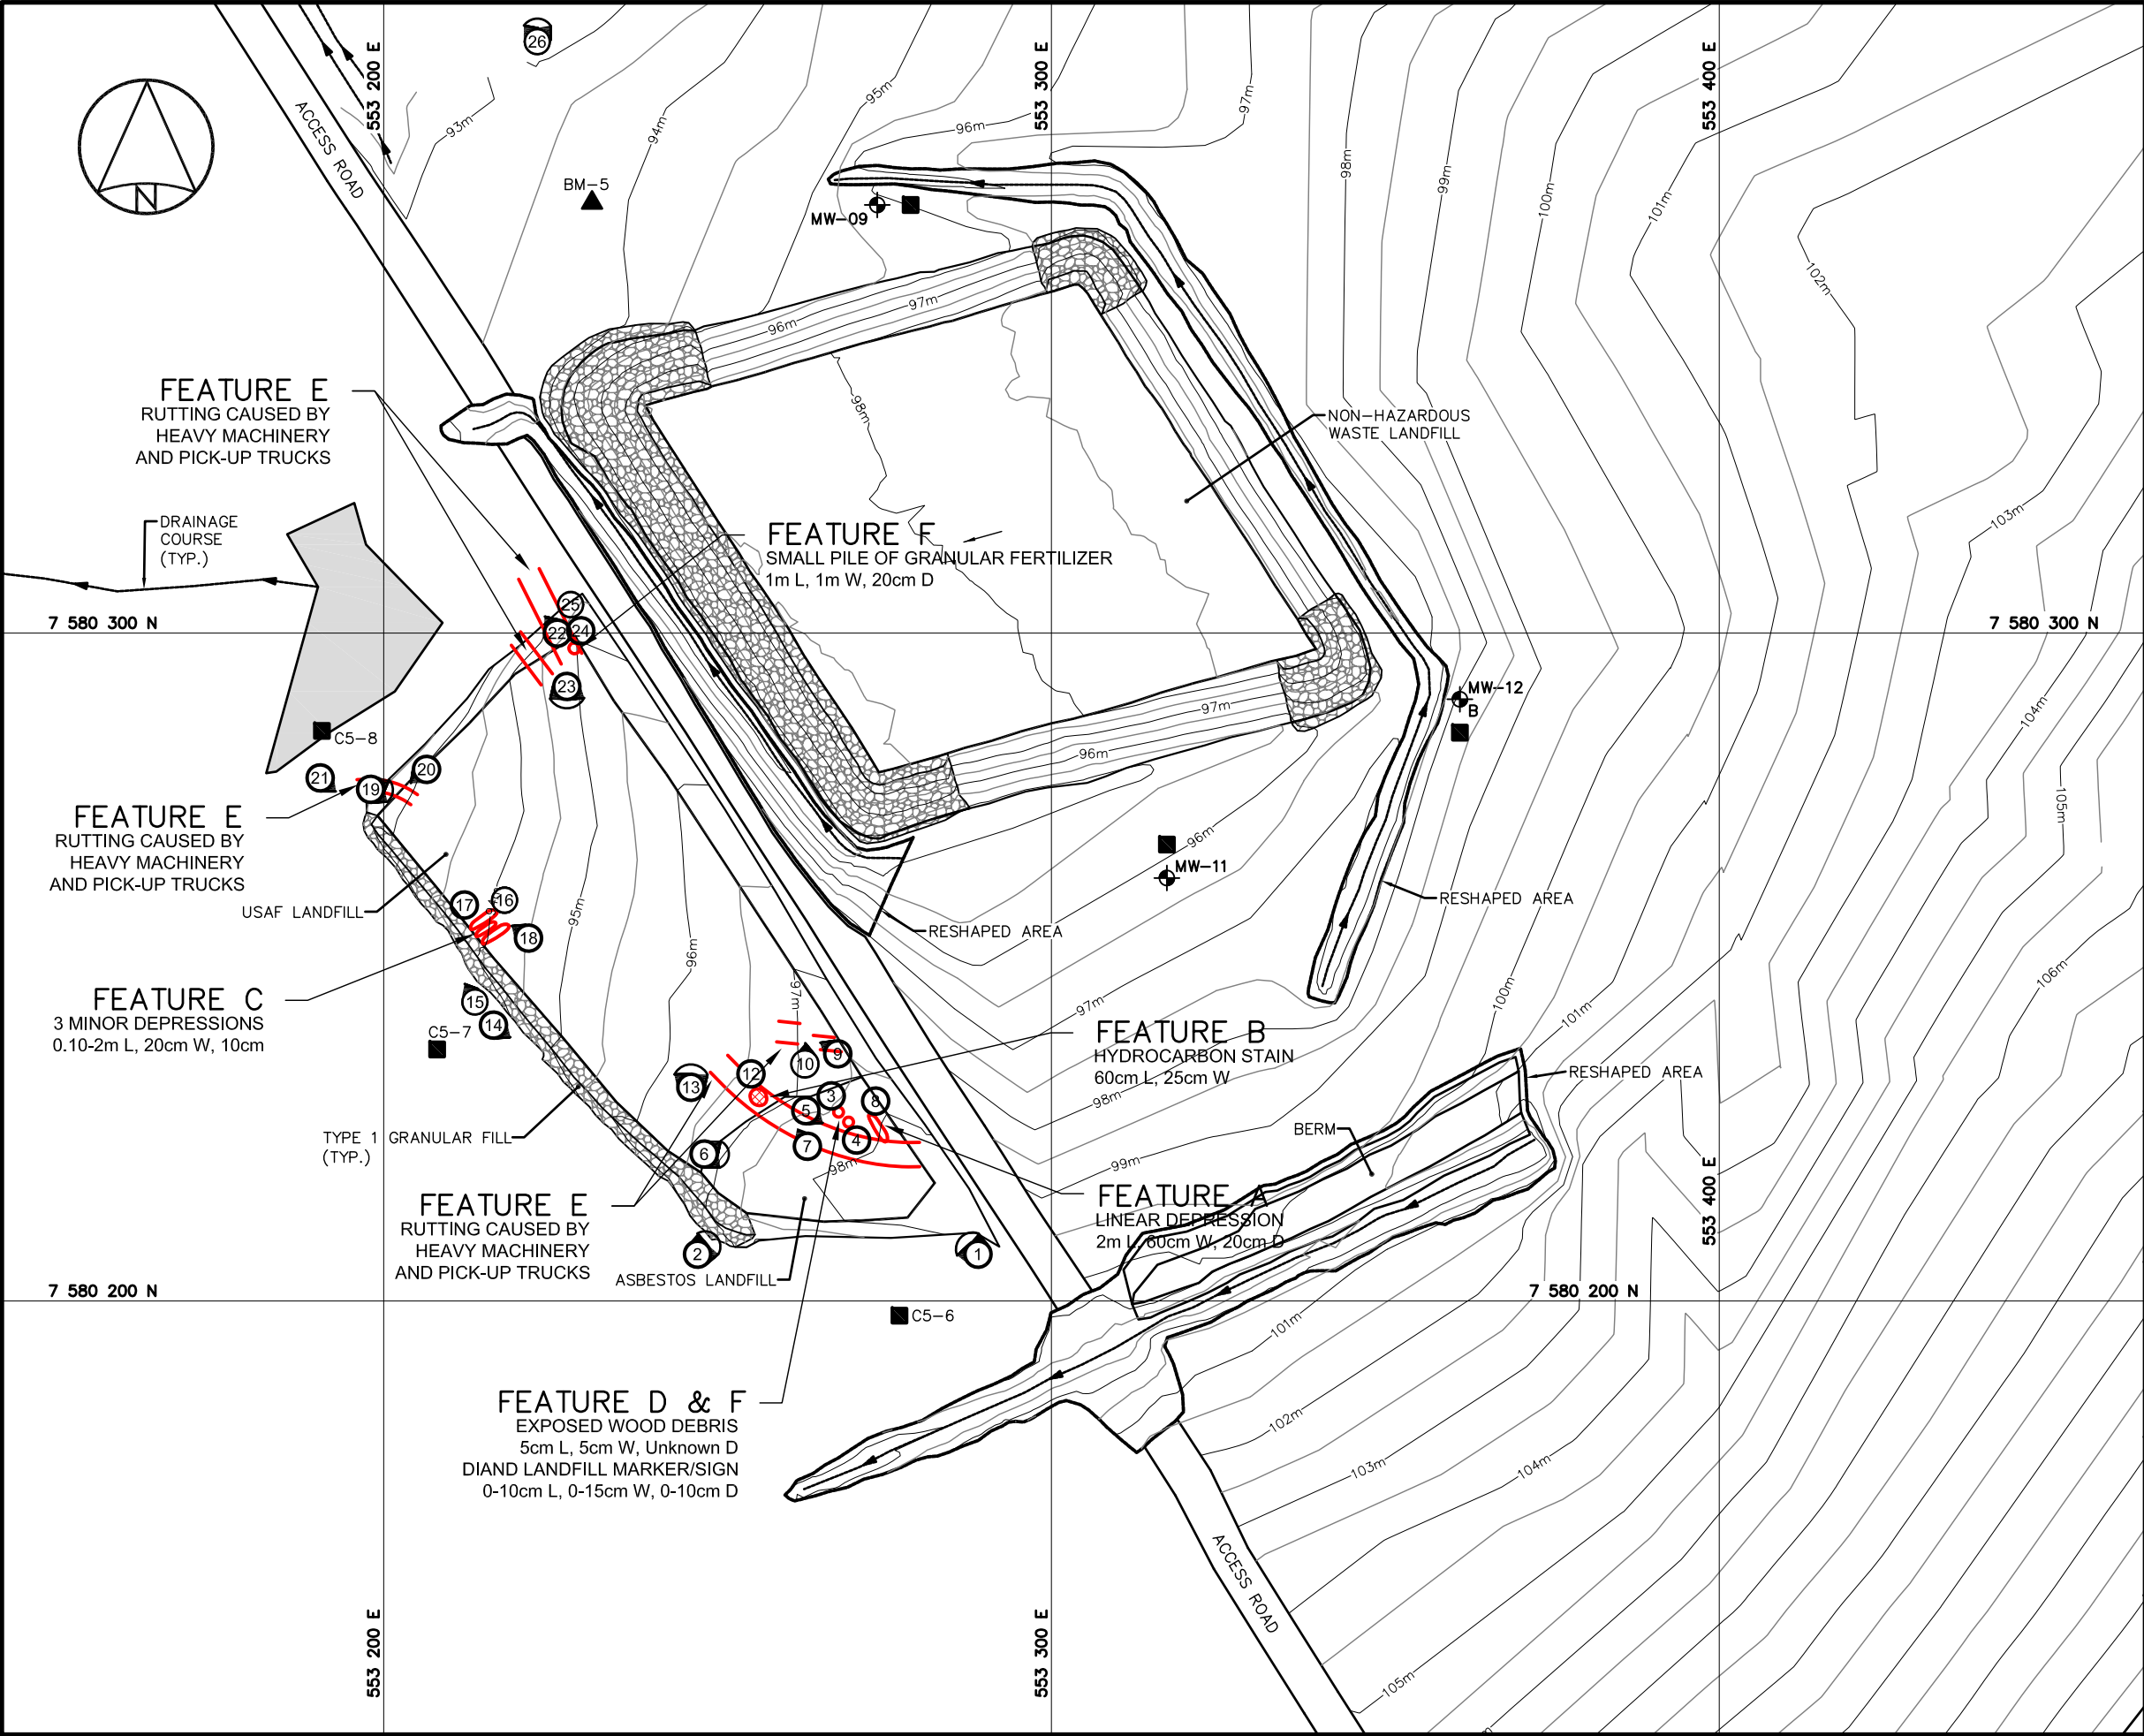
The Location Plan for the USAF & Asbestos Landfill has been completed as per the TOR and is included in the following page as Figure CAM-5.4 Mackar Inlet – USAF & Asbestos Landfill.

Two areas of minor settlement were noted, one on the surface of the Asbestos section of the landfill, the other on the USAF lobe. Feature A, north of the access road consists of small linear depressions with an acceptable severity rating. Feature C consists of three small closely spaced depressions (potholes) situated on the west surface of the USAF lobe and has an acceptable severity rating. These areas of settlement were not noted during the baseline investigation.

An area of hydrocarbon staining (Feature B) was noted on the surface of the USAF section of the landfill. The feature has an acceptable severity rating and as mentioned previously, could be removed during future monitoring events.

Indications of vehicle traffic are prevalent on the landfill surface including vehicle tracks and depressions (Feature E). The size of the tracks and depressions are consistent with a pick-up and heavy equipment. Vehicle rutting/tracks is more prevalent at the access from the road (at the east side of the Asbestos lobe) and the north toe of the landfill where rutting is also present on the surrounding tundra. As none of the depressions and tracks caused by vehicle traffic is of a significant depth, Feature E has an acceptable severity rating.

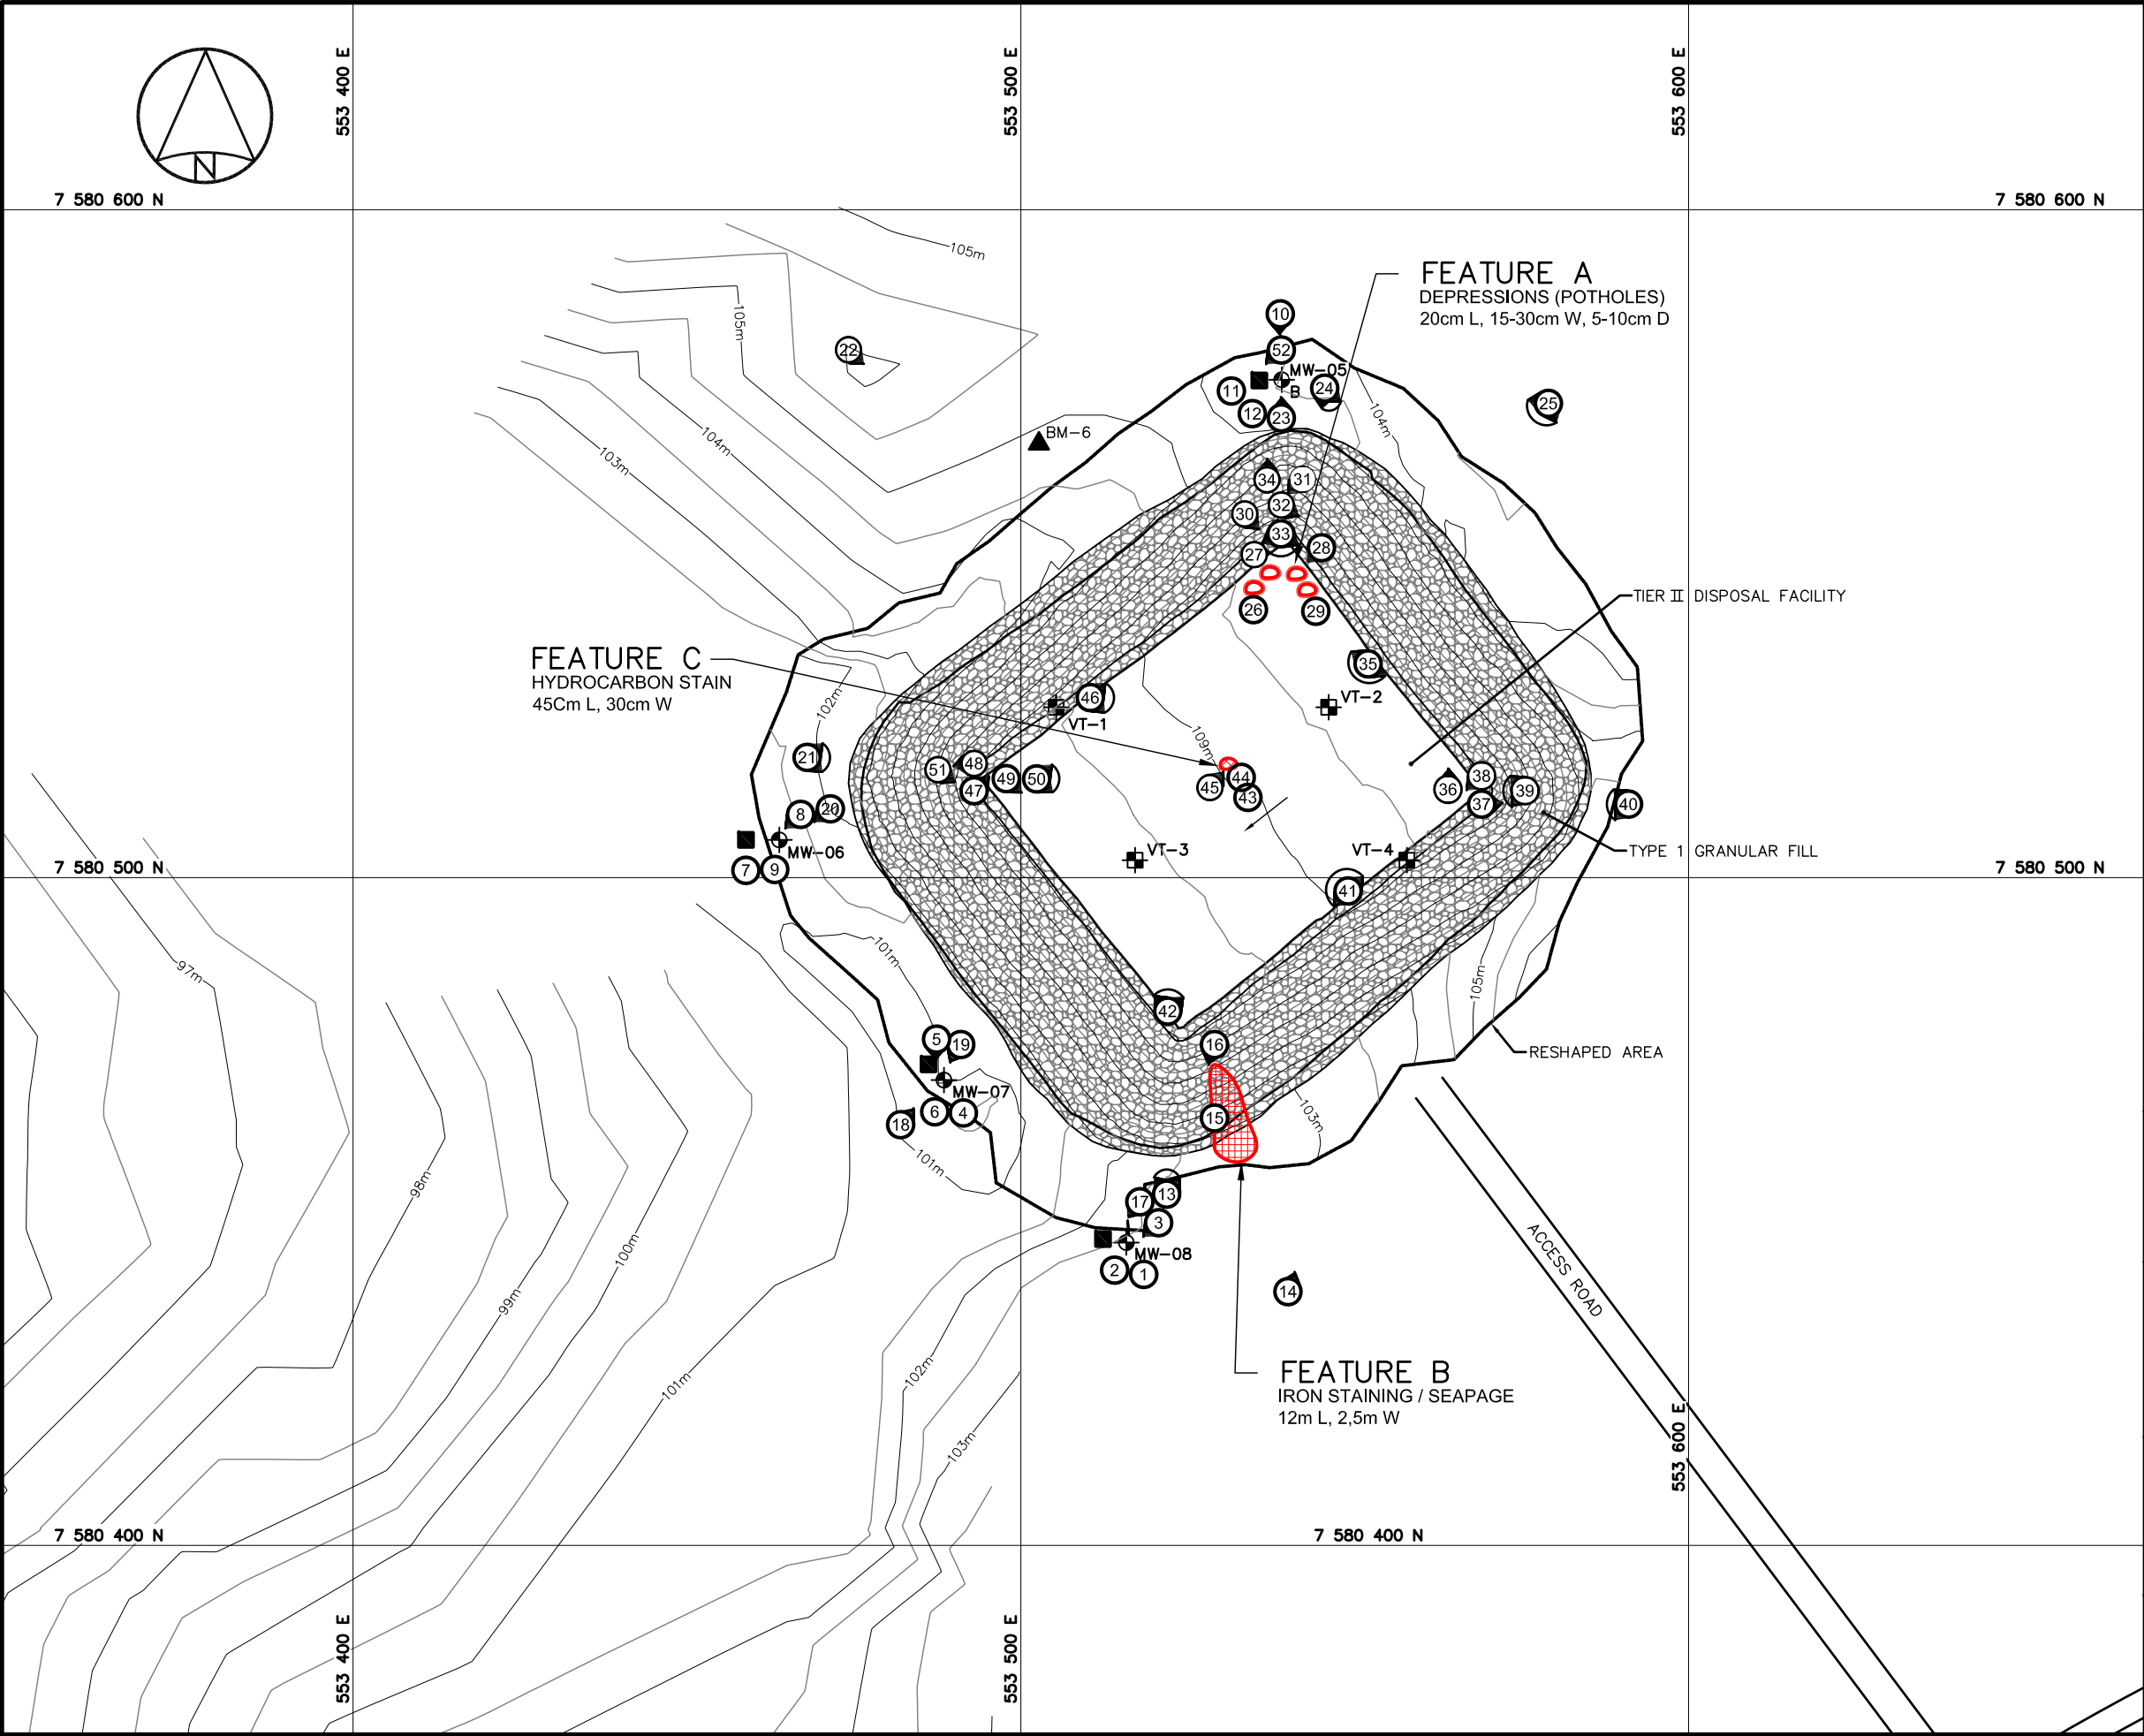
The Location Plan for the Tier II Disposal Facility has been completed as per the TOR and is included in the following page as Figure CAM-5.5 Mackar Inlet – Tier II Disposal Facility.

Indications of localized settlement were observed at two locations in close proximity and thus, labelled as the singular Feature A. Feature A consisted of four small circular depressions or “pot holes”, two of which were observed previously along the north crest of the facility while an additional two depressions were observed during the 2012 investigation along the east crest. Each depression is associated with a large cobblestone, which may have impacted material placement or compaction during construction. Feature A has an acceptable severity rating.
