**THE COLLECTION OF LANDFILL  
MONITORING DATA AT THE  
FORMER CAM-5 DEW LINE SITE**

Mackar Inlet, Nunavut

**FINAL REPORT – 2014**

**DEFENCE CONSTRUCTION CANADA**

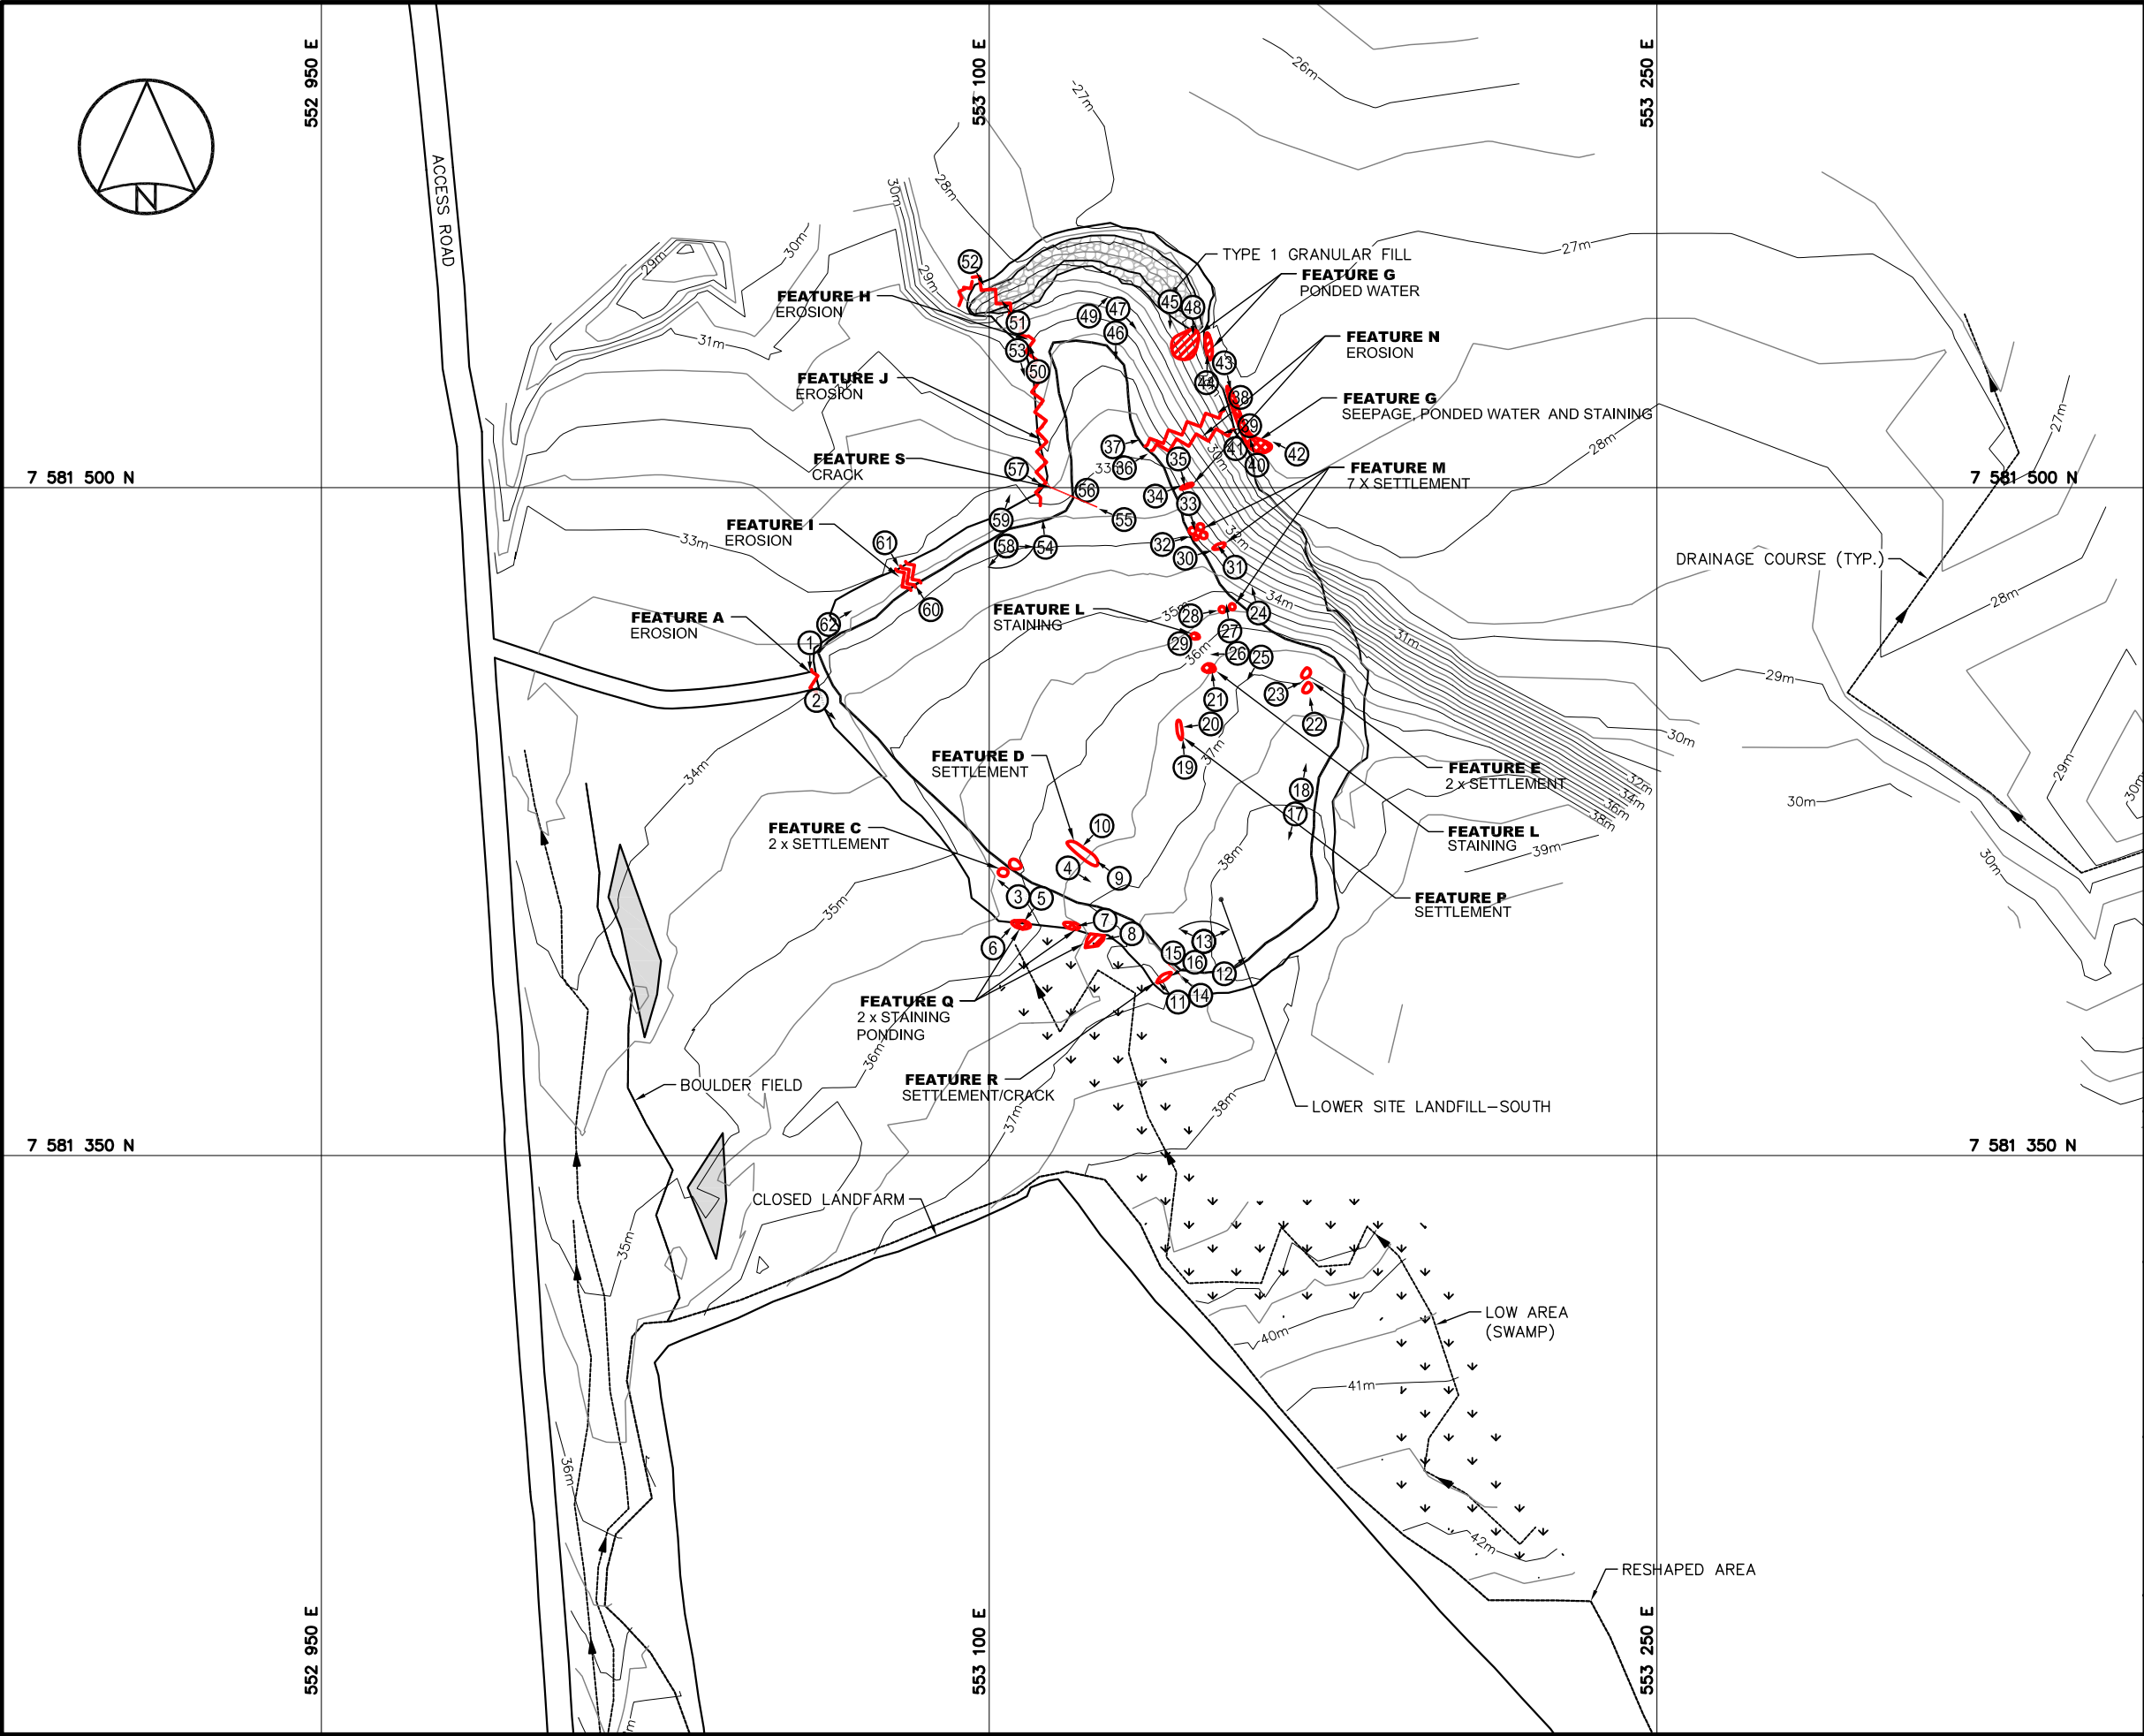
Vegetation Stress	No	N/A	N/A	N/A	N/A	N/A	N/A	N/A	N/A	N/A
Seepage Points	Yes	FEATURE G See Figure CAM-5.2 (NE side slope and toe)	8 - 15	1 - 4	N/A	Occasional	Seepage along toe and slope	LSLF- 40-43, 45, 47, 48	Acceptable	Seepage and ponded water along east side slope and toe. Large wetted area on east side slope. Consistent with previous observation.
Debris exposed	No	N/A	N/A	N/A	N/A	N/A	N/A	N/A	N/A	N/A
Presence/Condition of Monitoring Instruments	No	N/A	N/A	N/A	N/A	N/A	N/A	N/A	N/A	N/A
Other Feature of Note	Yes	FEATURE K See Figure CAM-5.2 (S cover)	N/A	N/A	N/A	N/A	Ponded water on south cover	N/A	N/A	Not observed during 2014 inspection.
		FEATURE O See Figure CAM-5.2 (NW toe)	N/A	N/A	N/A	N/A	Ponded water northwest of landfill	N/A	N/A	Not observed during 2014 inspection.
		FEATURE R See Figure CAM-5.2 (SW side slope) - New Obs.	3	0.001-0.003	Unknown	Isolated	Tension crack	LSLF-14-16	N/A	Tension crack extending across southwest side slope. Localized settlement in area.

FEATURE S See Figure CAM-5.2 (NW side slope) - New Obs.	16	0.02-0.1	Unknown	Isolated	Partially infilled tension crack	LSLF-55-57	Acceptable	Tension crack extending across cover at inside corner on northwest side of landfill.
Additional Photographs	Yes	See Figure CAM-5.2 and Photographic Record	N/A	N/A	N/A	N/A	General photographic record	N/A	N/A	No features of note, general photos of the landfill for record keeping purposes.
Overall Landfill Performance	Acceptable

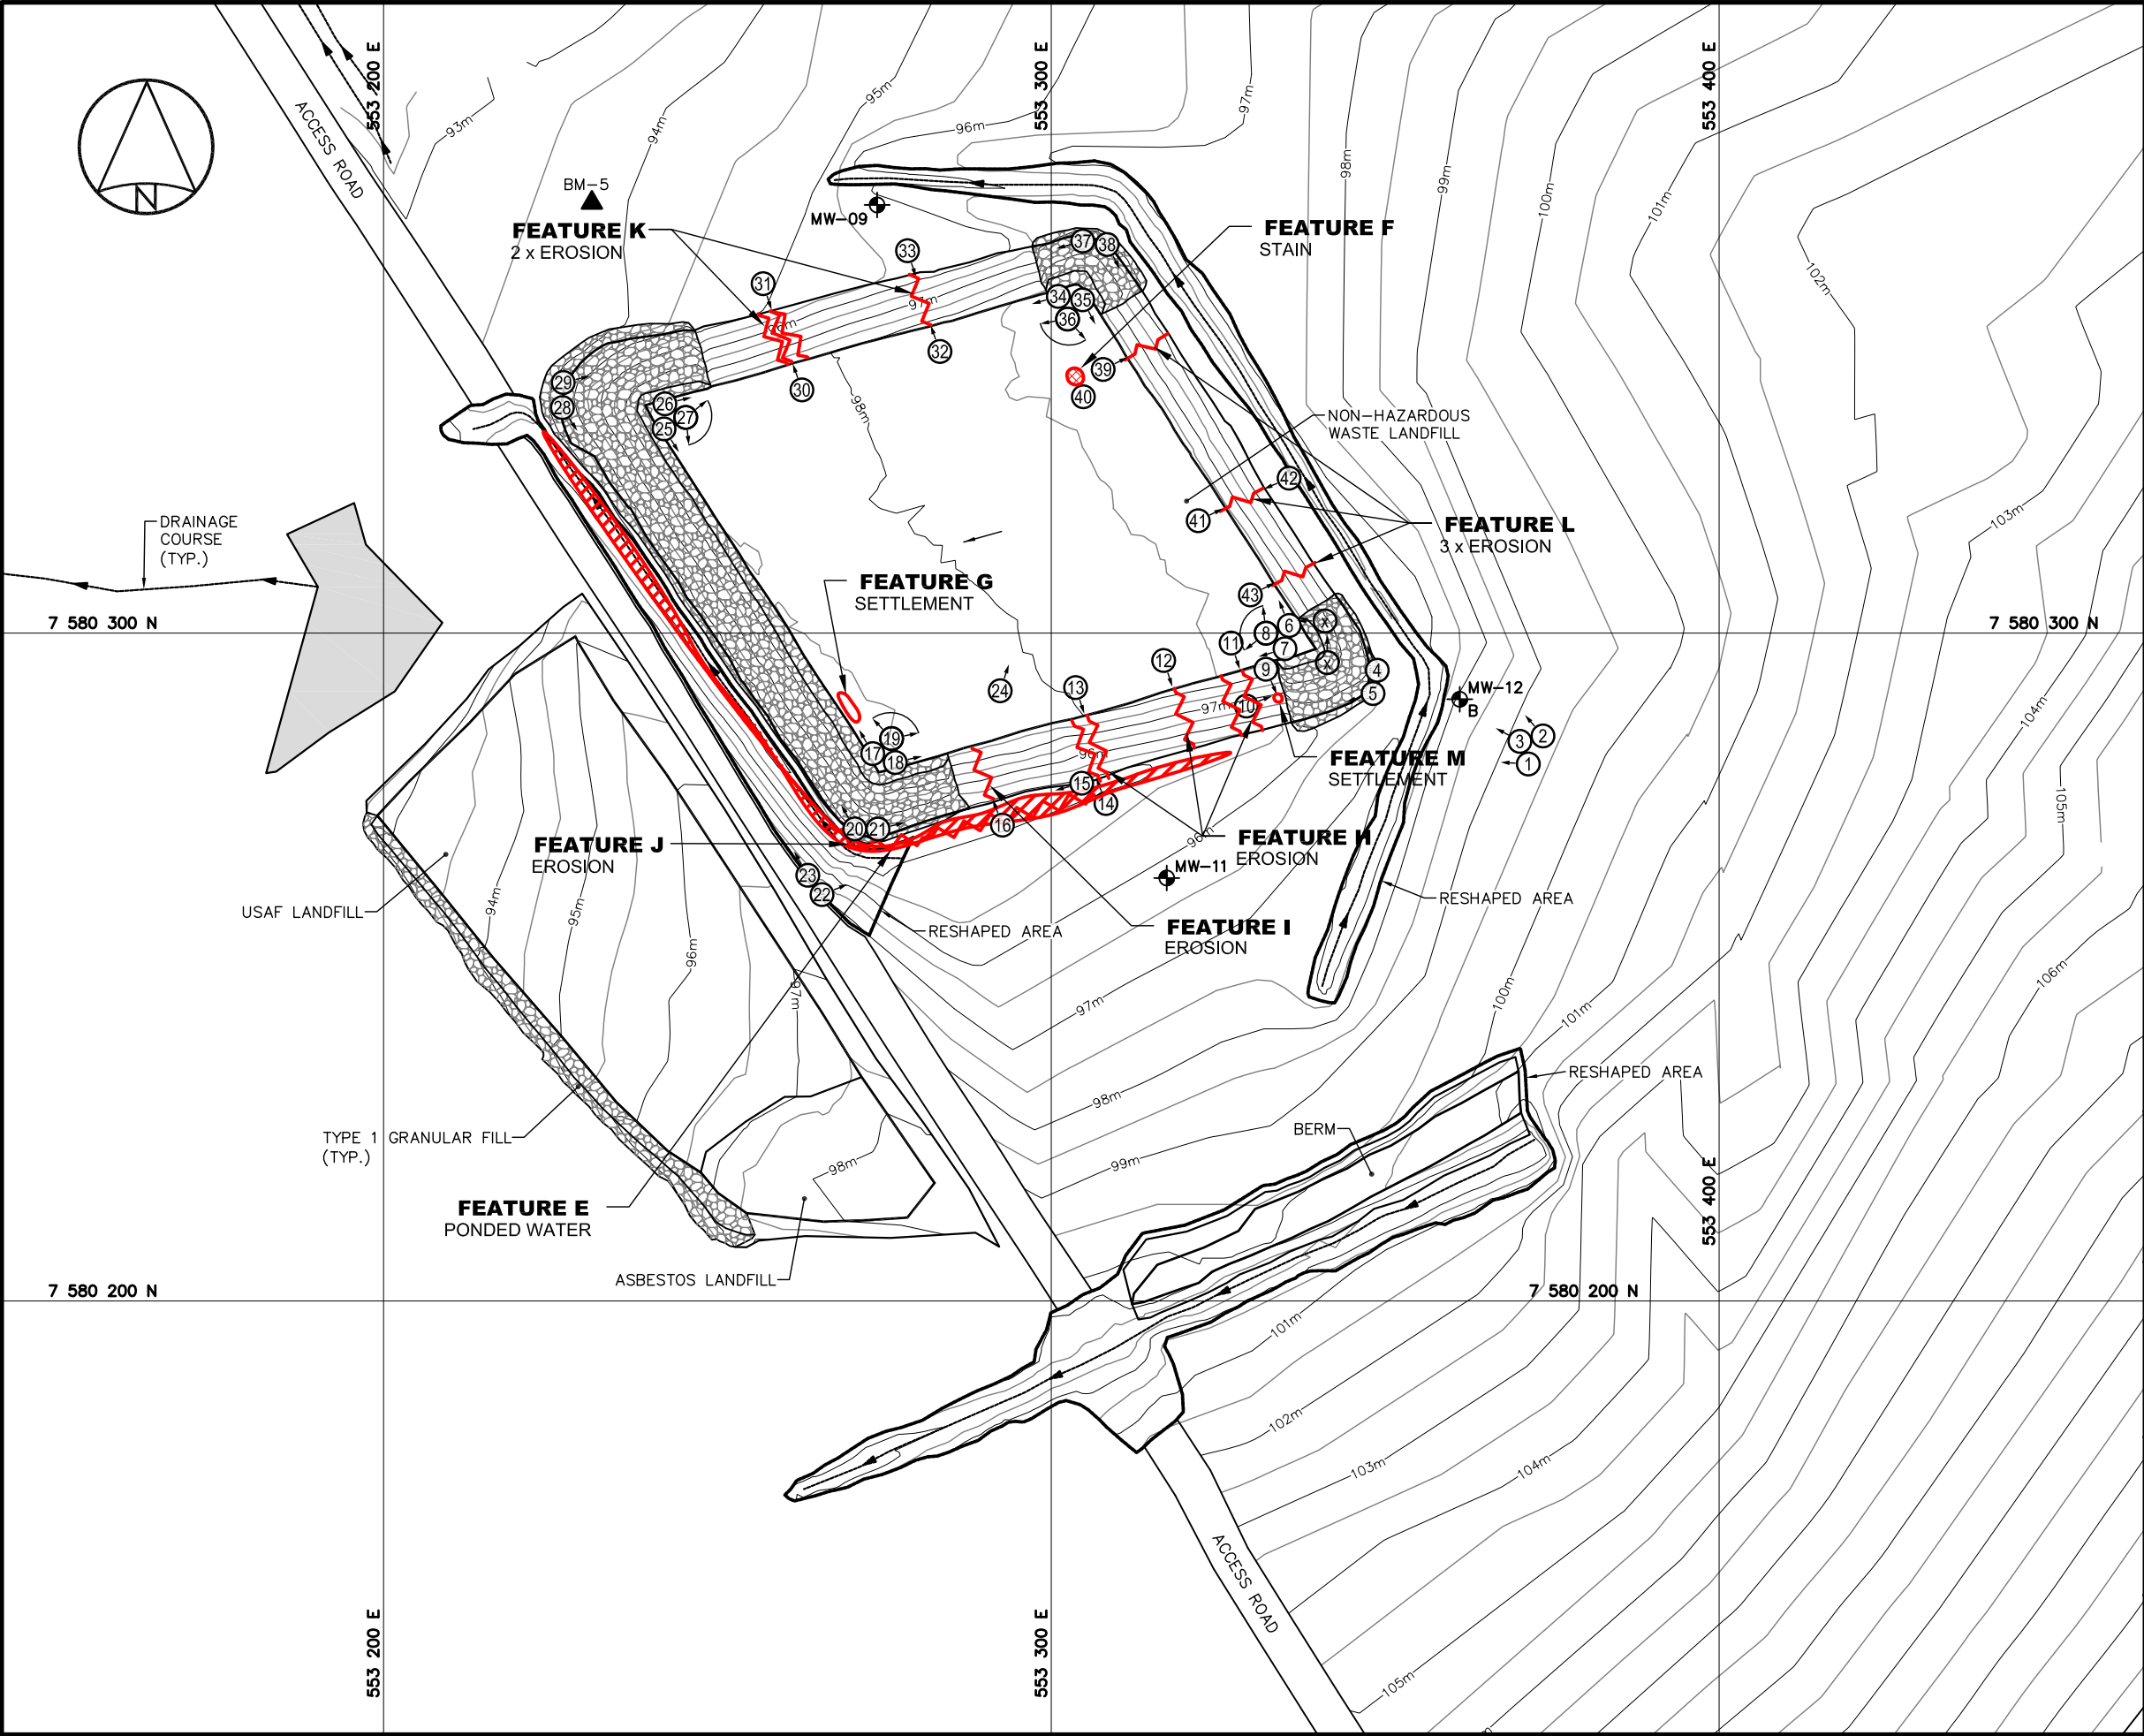
The Location Plan for the NHWLF has been completed as per the TOR and is included in the following page as Figure CAM-5.3 Mackar Inlet – Non-Hazardous Waste Landfill.

As of the 2014 monitoring event, no feature with “significant” or “unacceptable” severity ratings was identified in the Preliminary Stability Assessment of the NHWLF. One isolated area of settlement and staining, and numerous minor erosional features were observed on the landfill surface or side slopes, all of which have an acceptable severity rating. During the 2014 investigation, additional erosional features were identified on the north, south and east side slopes.

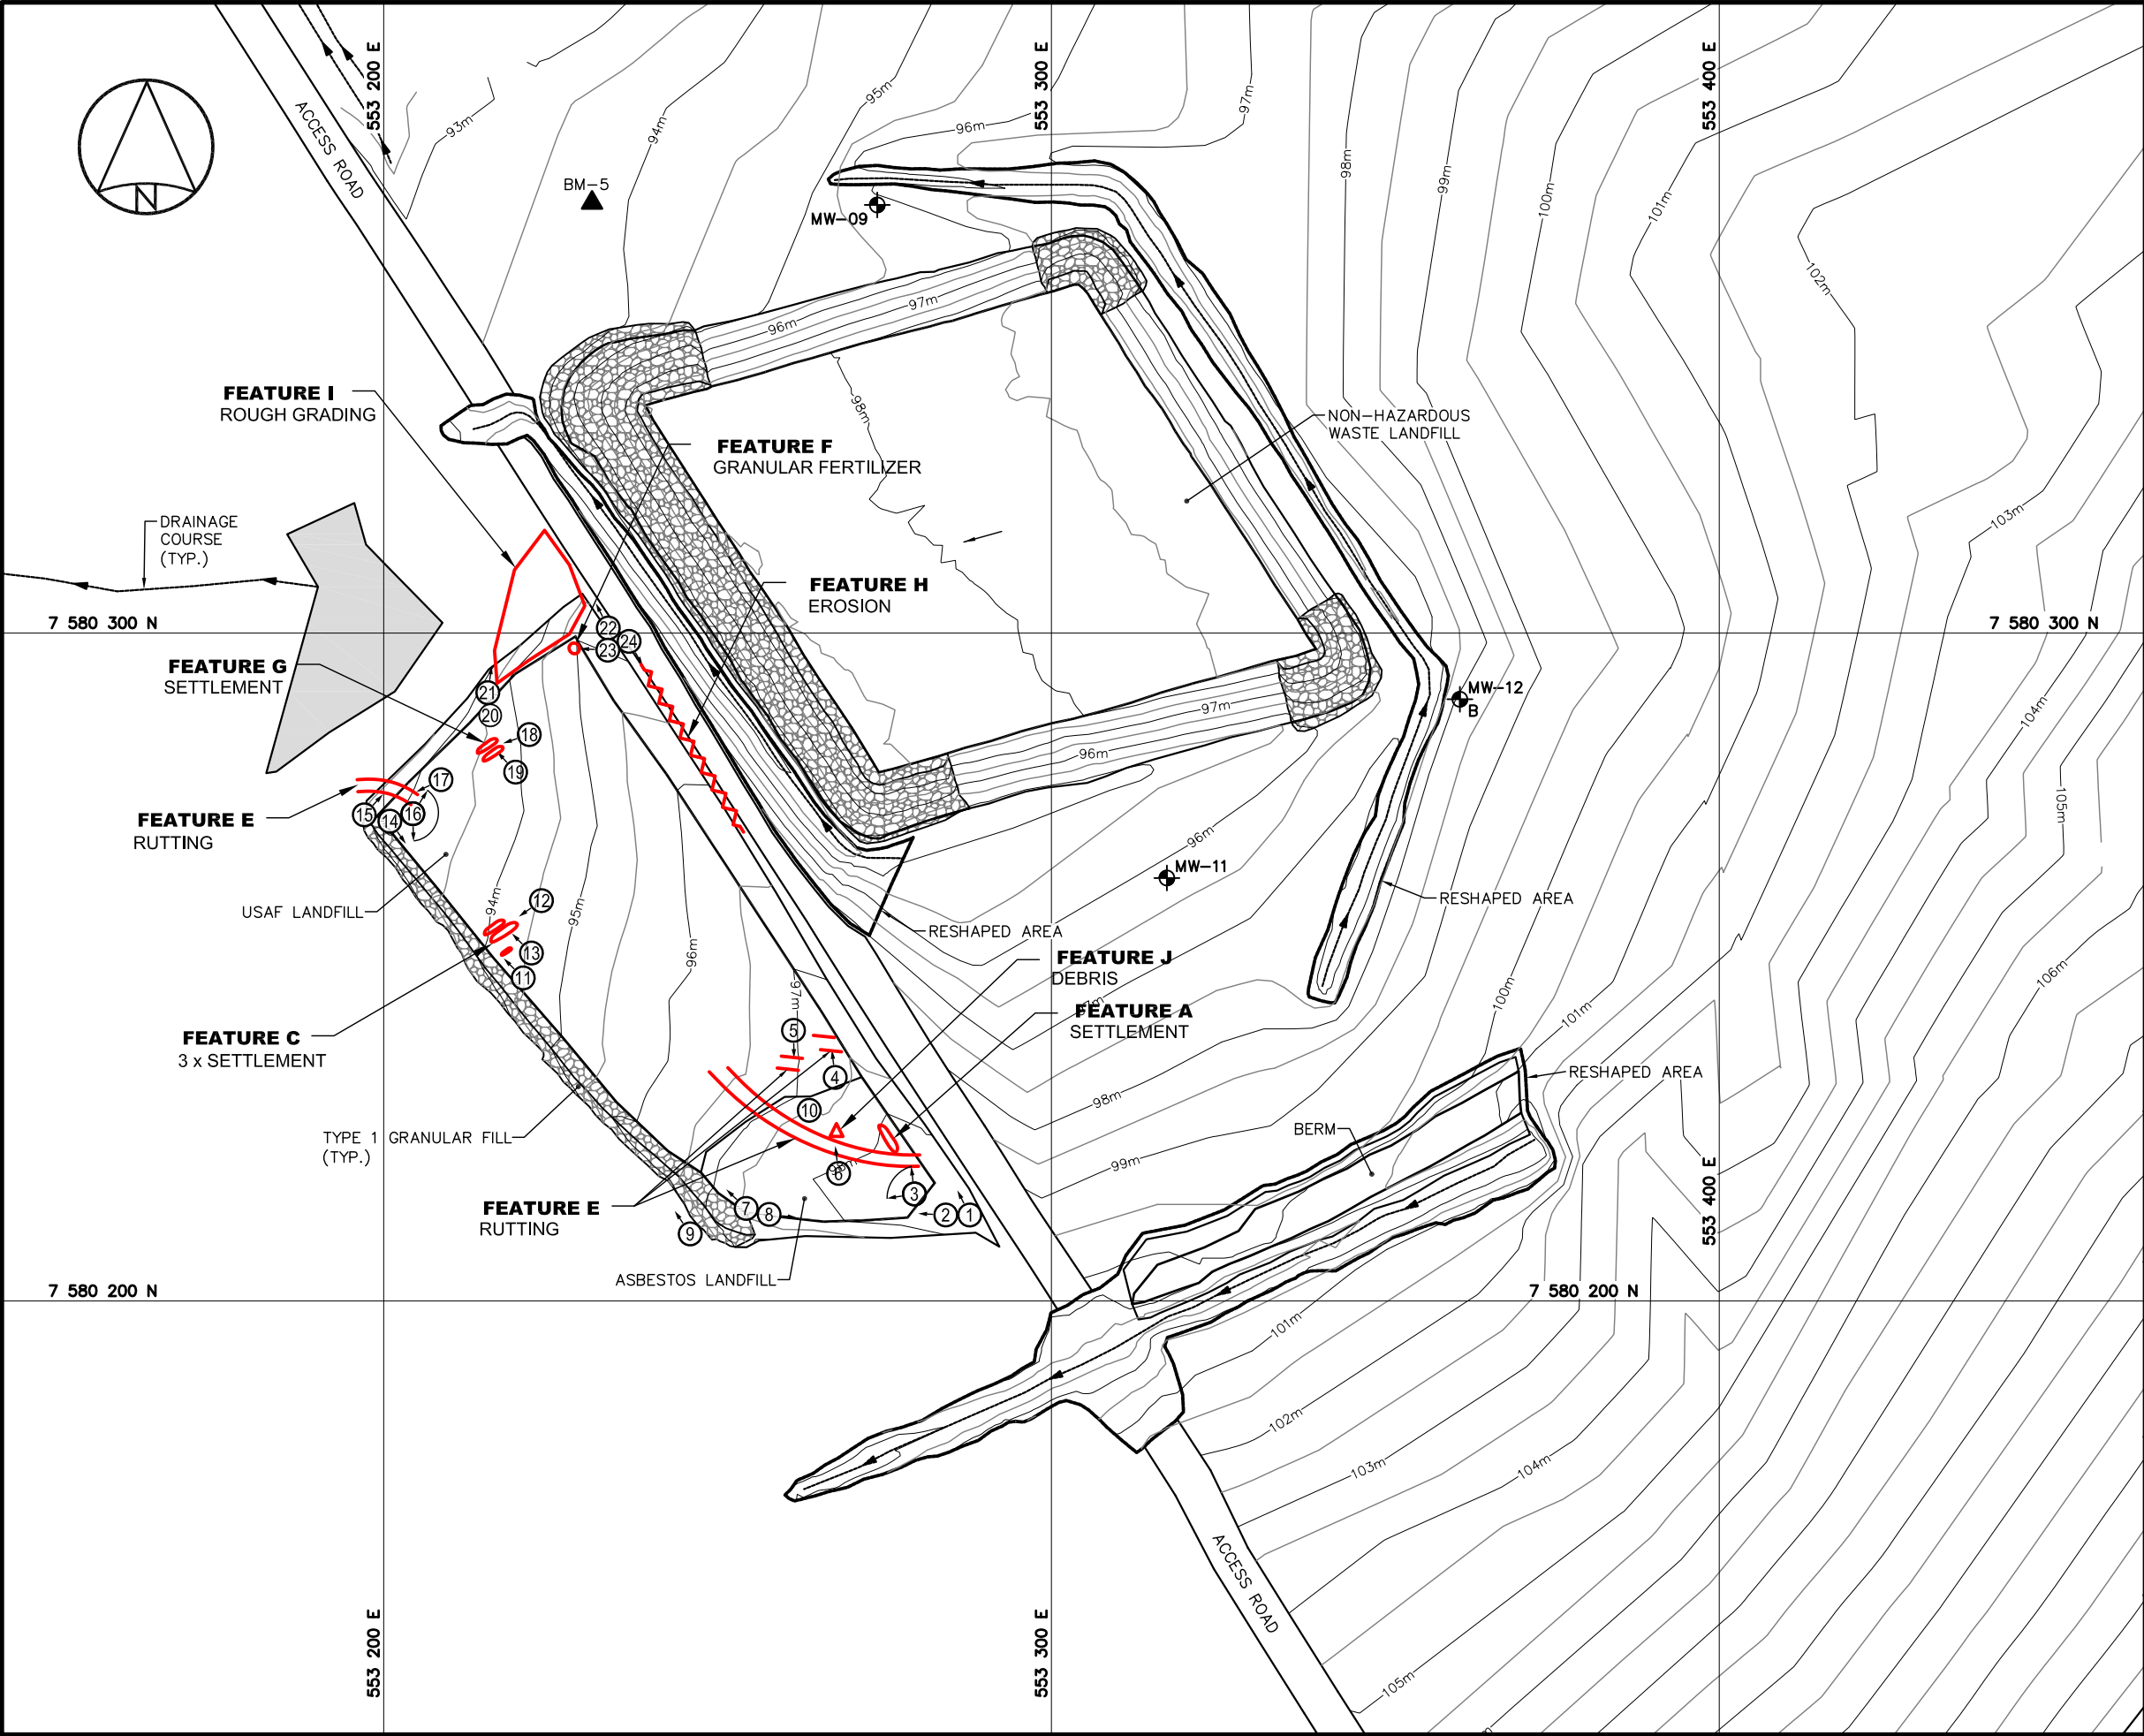
The Location Plan for the USAF & Asbestos Landfills has been completed as per the TOR and is included in the following page as Figure CAM-5.4 Mackar Inlet – USAF & Asbestos Landfills.

As of the 2014 monitoring event, no feature with “significant” or “unacceptable” severity ratings was identified in the Preliminary Stability Assessment of the USAF & Asbestos Landfill. Little to no change was observed since the 2013 investigation, as the features identified at the landfill appear to be primarily construction artifacts (rutting caused by various vehicles). New single settlement and erosional features were identified in 2014.

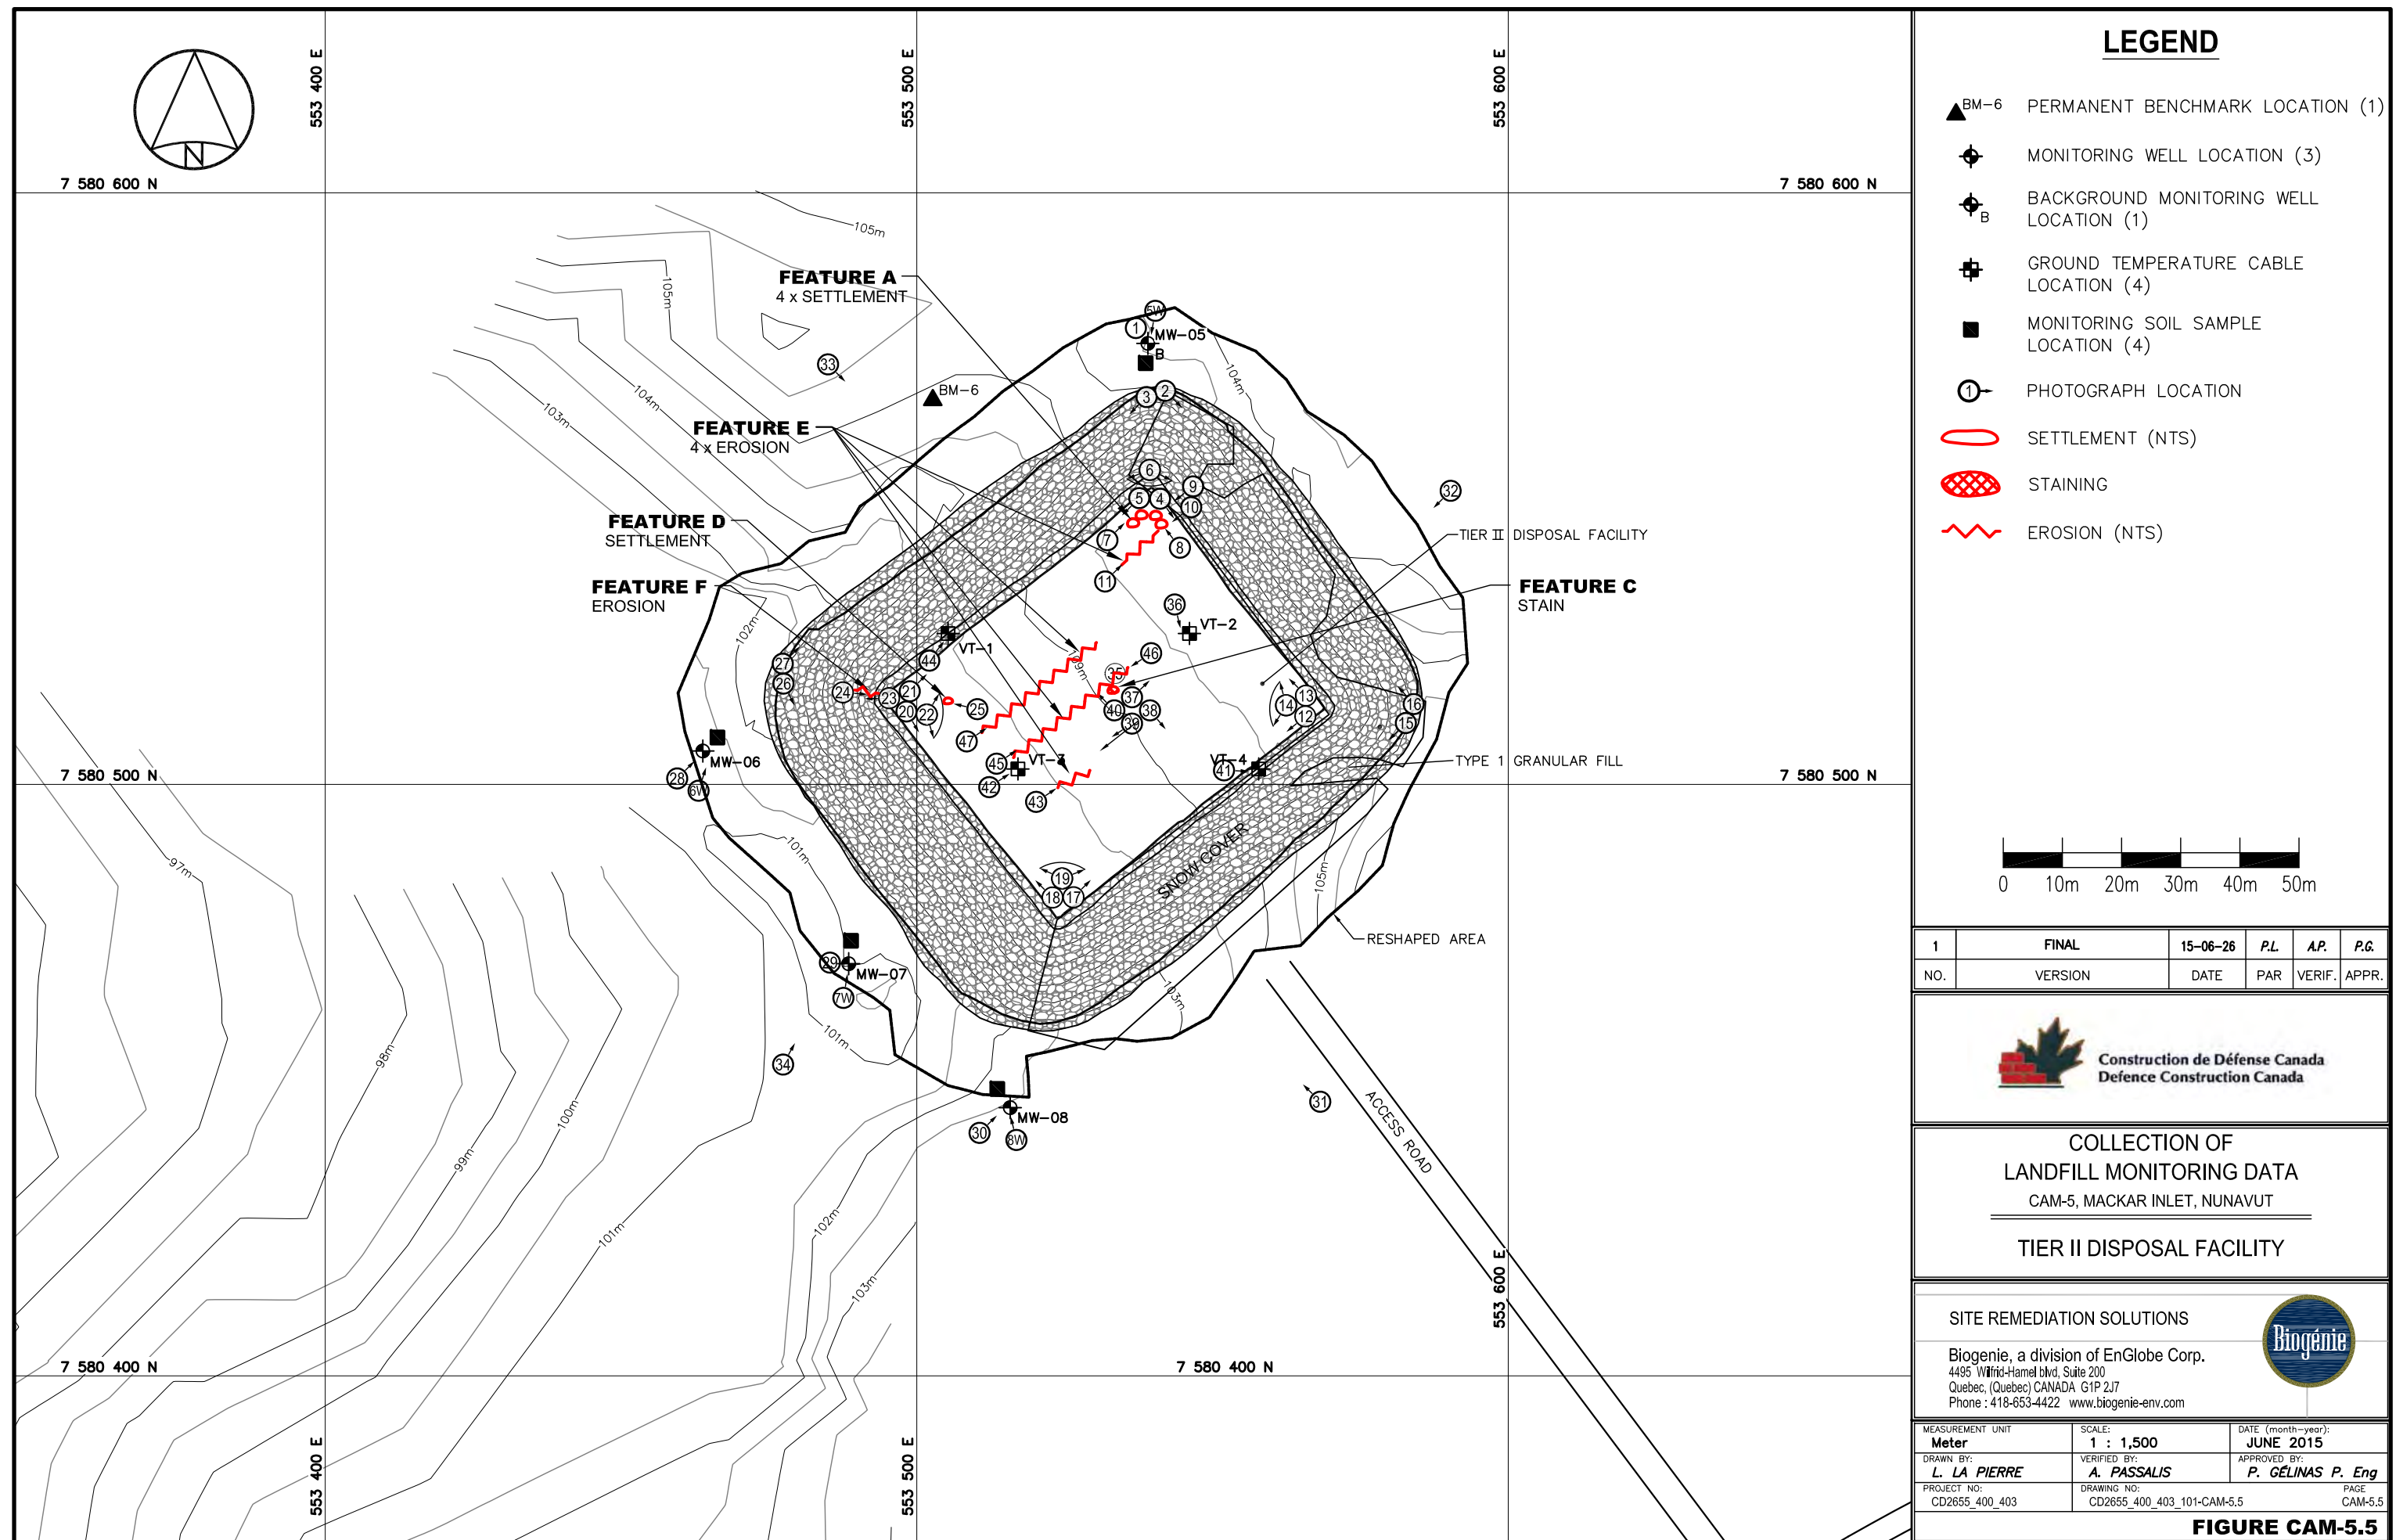
The Location Plan for the Tier II Disposal Facility has been completed as per the TOR and is included in the following page as Figure CAM-5.5 Mackar Inlet – Tier II Disposal Facility.

Frost Action	No	N/A	N/A	N/A	N/A	N/A	N/A	N/A	N/A	N/A
Animal Burrows		N/A	N/A	N/A	N/A	N/A	N/A	N/A	N/A	N/A
Vegetation		N/A	N/A	N/A	N/A	N/A	N/A	N/A	N/A	N/A
Staining	Yes	FEATURE C See Figure CAM-5.5 (C cover)	0.4	0.35	N/A	Isolated	Hydrocarbon stain	Tier II-35	Acceptable	Hydrocarbon stain located at the approximate center of the facility. Consistent with previous observation.
Vegetation Stress	No	N/A	N/A	N/A	N/A	N/A	N/A	N/A	N/A	N/A
Seepage Points	No	N/A	N/A	N/A	N/A	N/A	N/A	N/A	N/A	N/A
Debris Exposed	No	N/A	N/A	N/A	N/A	N/A	N/A	N/A	N/A	N/A
Presence/Condition of Monitoring Instruments	Yes	N/A	N/A	N/A	N/A	N/A	Thermistors (VT-1 through VT-4) and Groundwater Wells (MW-5 though MW-8)	Tier II-44, 36, 42, 41 Tier II-1, 28, 29, 30	N/A	Monitoring wells and thermistor casings are in good condition.
Other Features of Note	No	N/A	N/A	N/A	N/A	N/A	N/A	N/A	N/A	N/A
Additional Photographs	Yes	See Figure CAM-5.5 and Photographic Record	N/A	N/A	N/A	N/A	General Photographic record	General Photographic record	N/A	N/A
