QIKIQ15 BAFFIN REGION DEW LINE SITE MONITORING

2017 CAM-5 Monitoring Report

Report Number: 1530908-3000-R3-V4

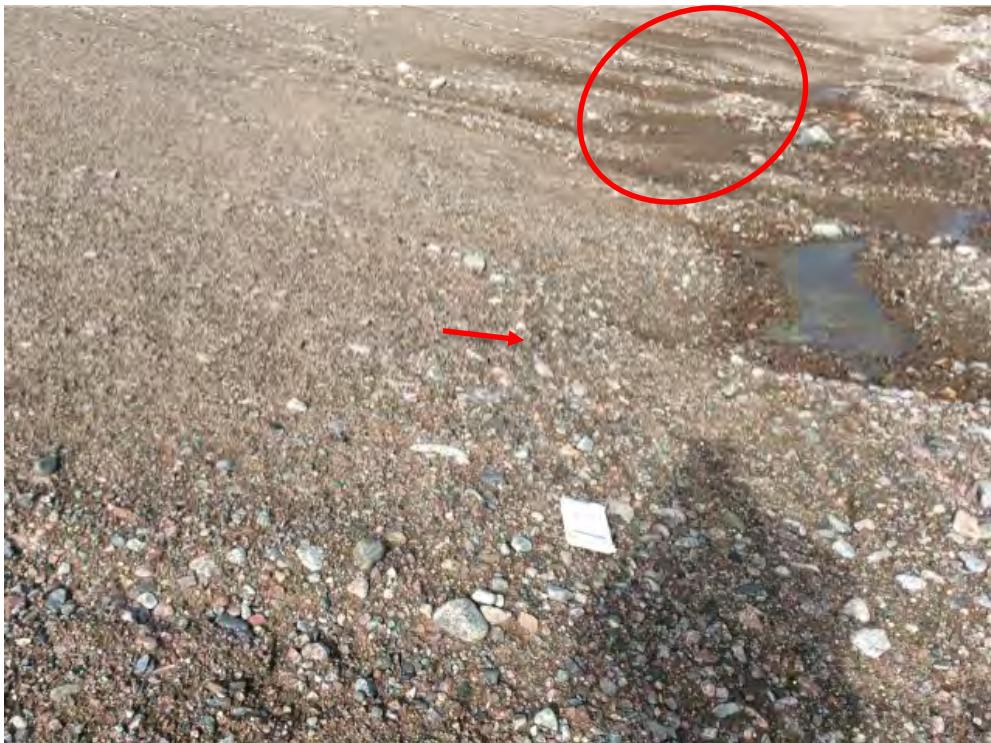
Photo 27: Lower Site Landfill South- Cover surface east corner, Feature E-Two small minor settlement areas, facing northwest (Acceptable) (CAM5_Photo70.jpg)

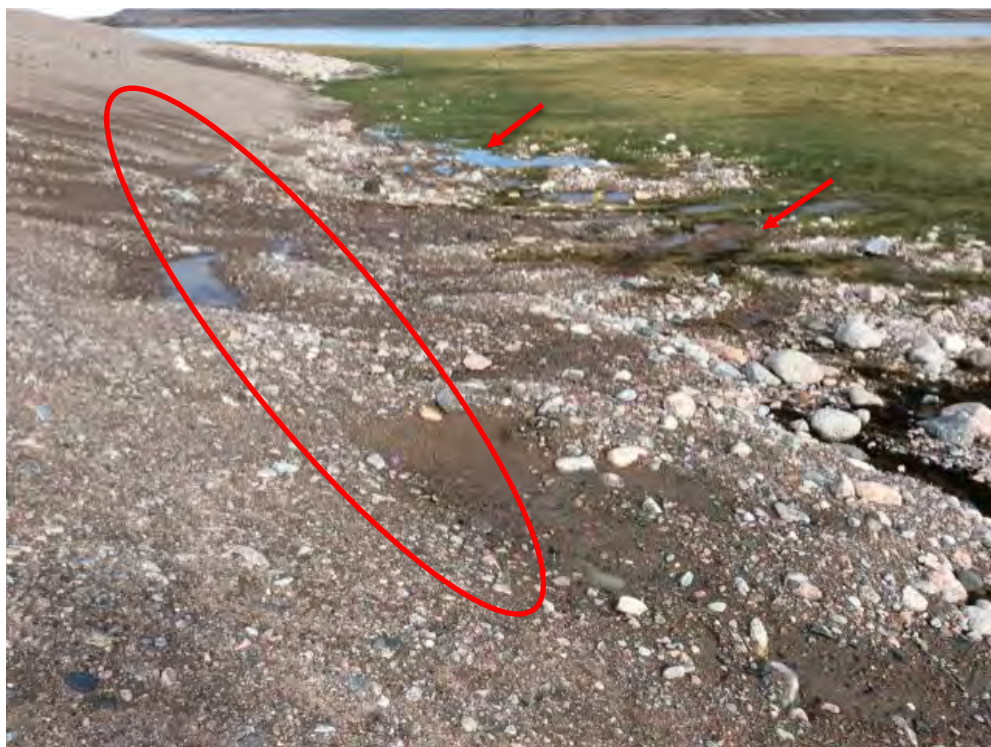
Photo 29: Lower Site Landfill South- East toe, Feature G-Intermittent ponded water (arrows) along toe with less iron staining, Feature W2-Wet area on slope (ellipse), facing northwest (Acceptable) (CAM5_Photo80.jpg)

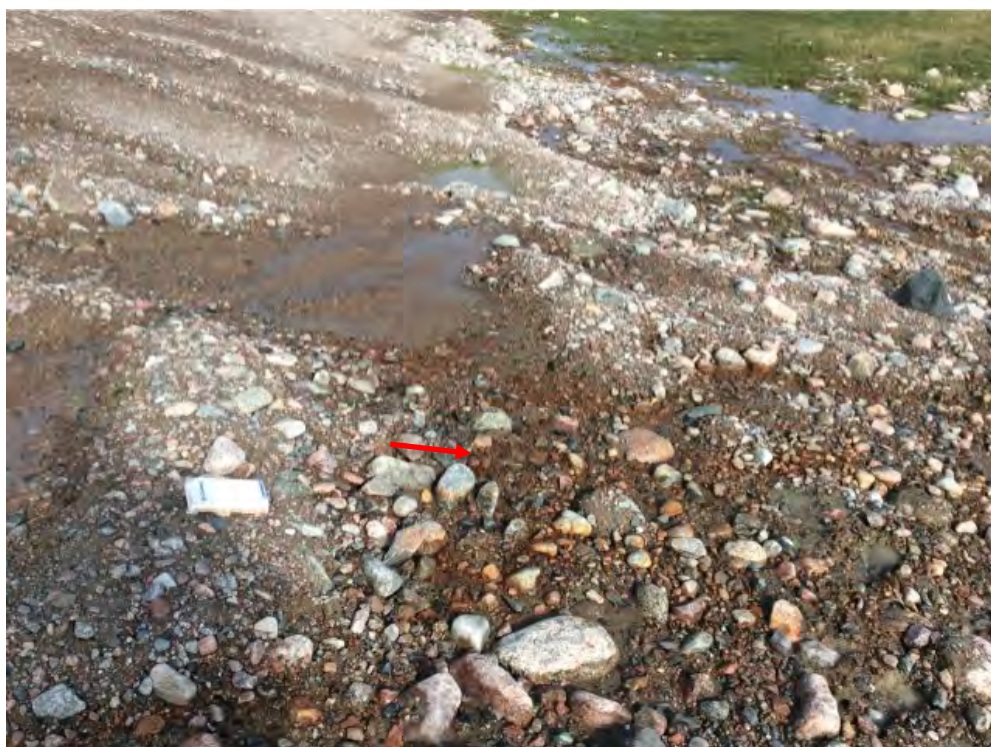
Photo 30: Lower Site Landfill South- East toe, Feature G-Previously reported as seepage with iron staining, intermittent ponded water with less staining in 2017, facing northwest (Acceptable) (CAM5_Photo83.jpg)

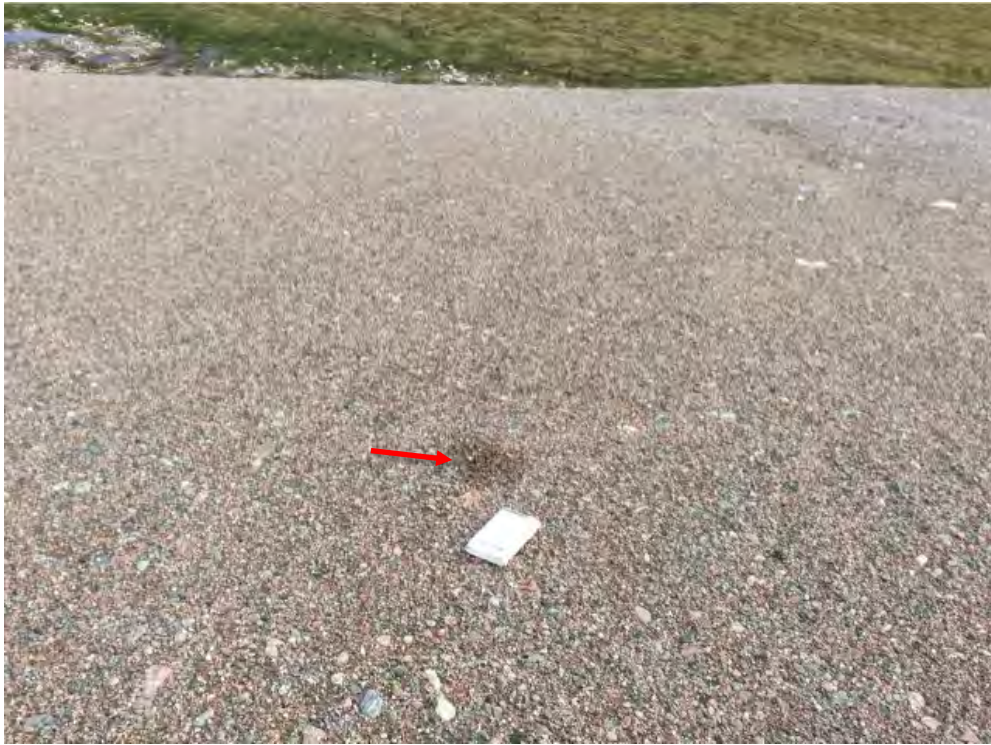
Photo 35: Lower Site Landfill South- Cover surface, Feature L-Small hydrocarbon stain, facing northeast (Acceptable) (CAM5_Photo72.jpg)

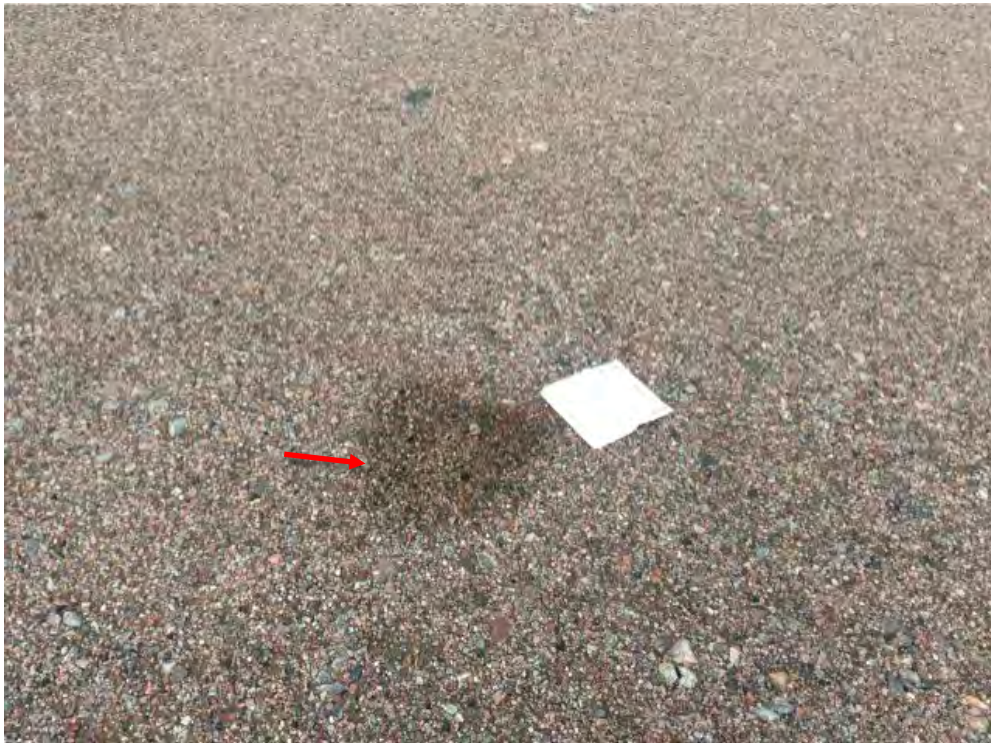
Photo 36: Lower Site Landfill South- Cover surface, Feature L-Small hydrocarbon stain (Acceptable) (CAM5_Photo71.jpg)

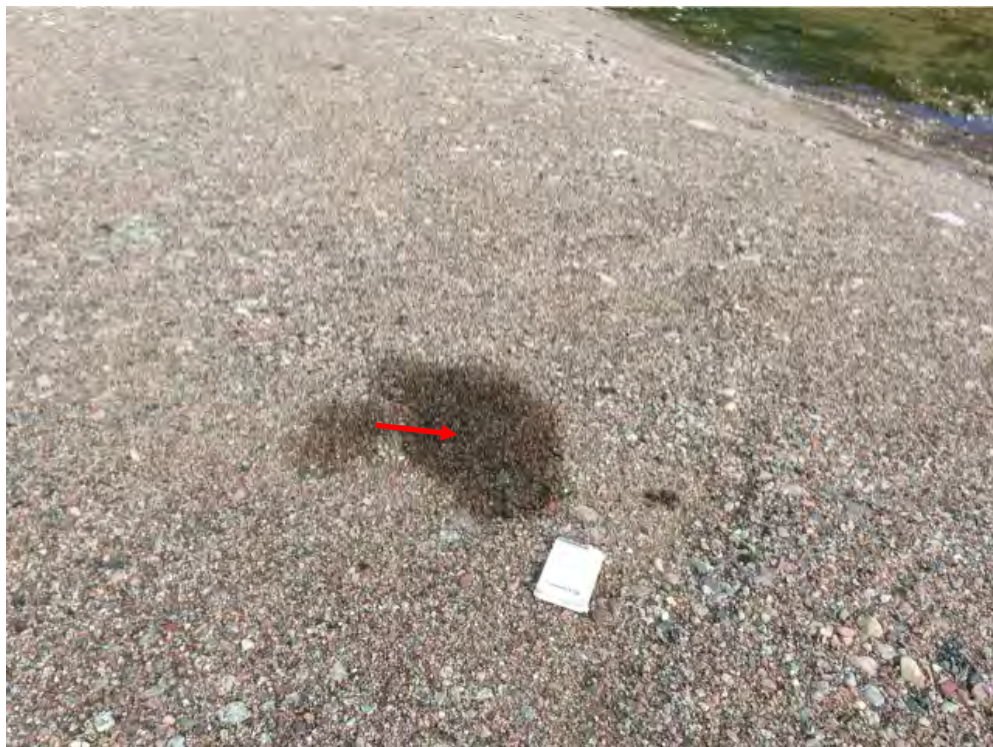
Photo 51: Lower Site Landfill South- East crest, Feature T-Small hydrocarbon stain, facing northeast (Acceptable) (CAM5_Photo74.jpg)

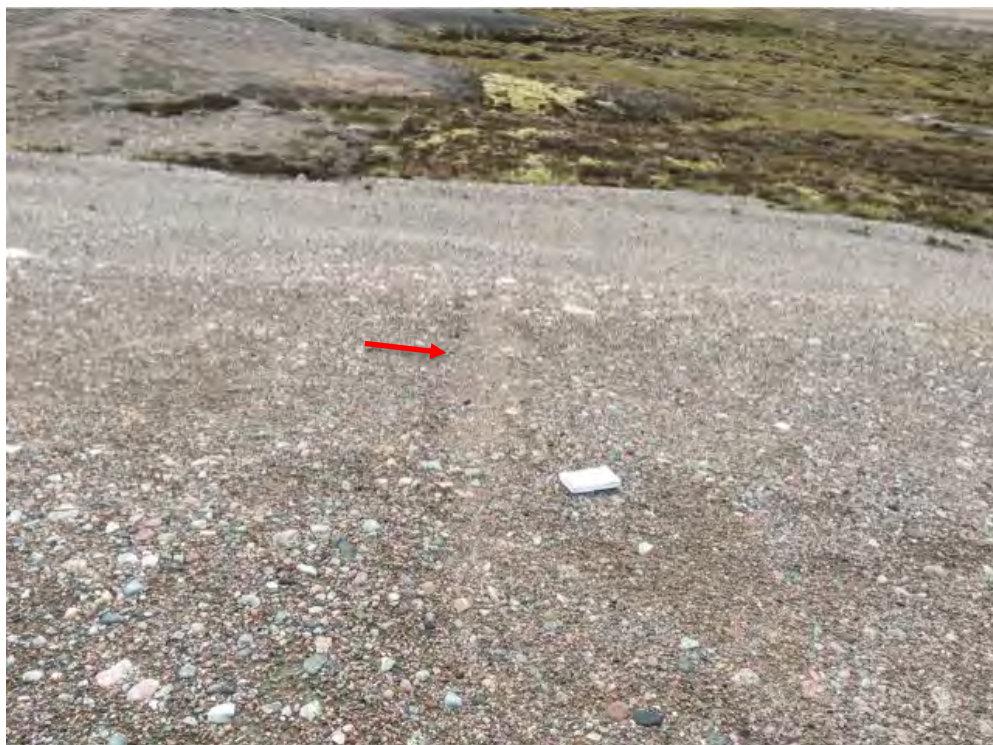
Photo 52: Lower Site Landfill South- South slope, Feature V1-Minor erosion channels, facing southeast (Acceptable) (CAM5_Photo65.jpg)

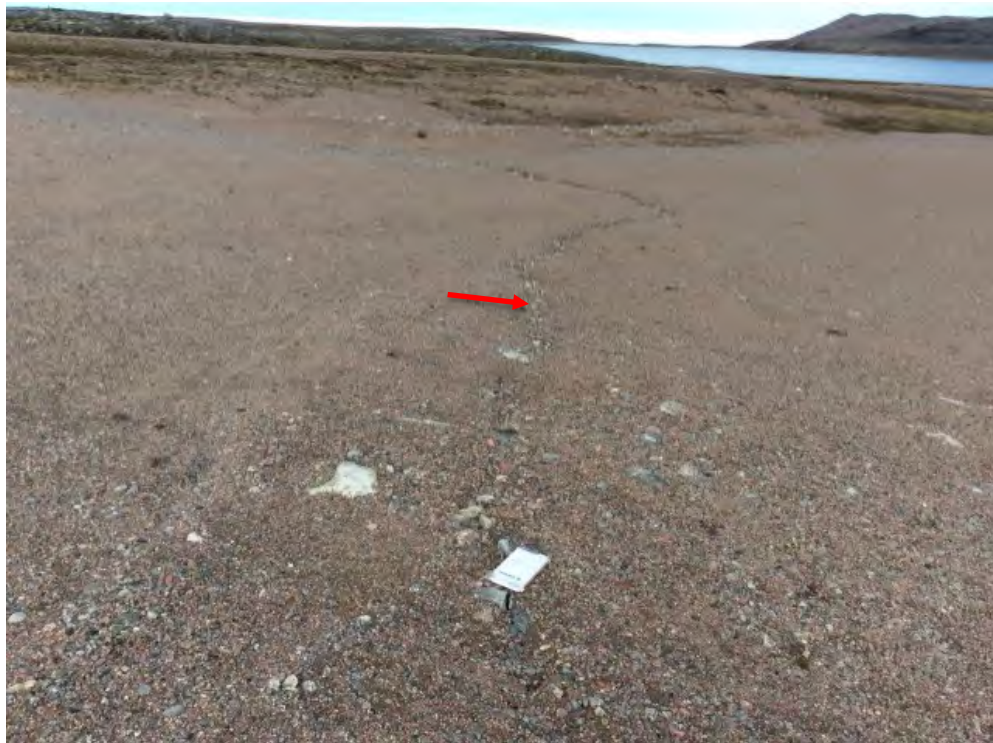
Photo 55: Lower Site Landfill South- Northwest crest and slope, Feature S-Crack and erosion channel, facing northwest (Acceptable) (CAM5_Photo75.jpg)

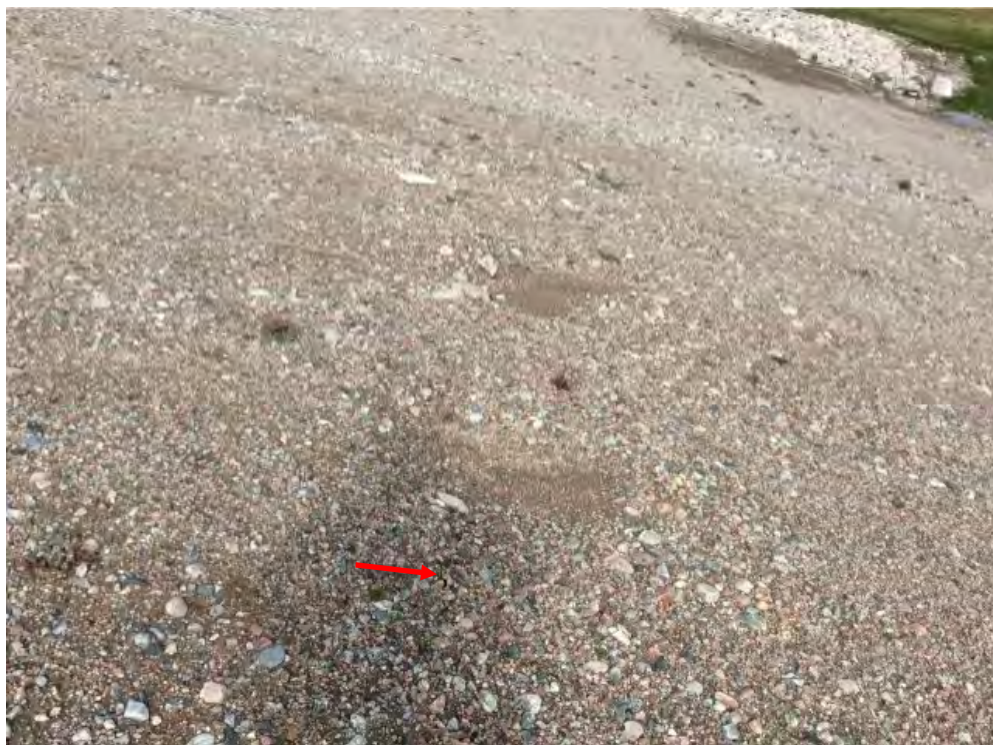
Photo 56: Lower Site Landfill South- East slope near crest, Feature Y-Crack on slope near crest, facing northwest (Acceptable) (CAM5_Photo86.jpg)

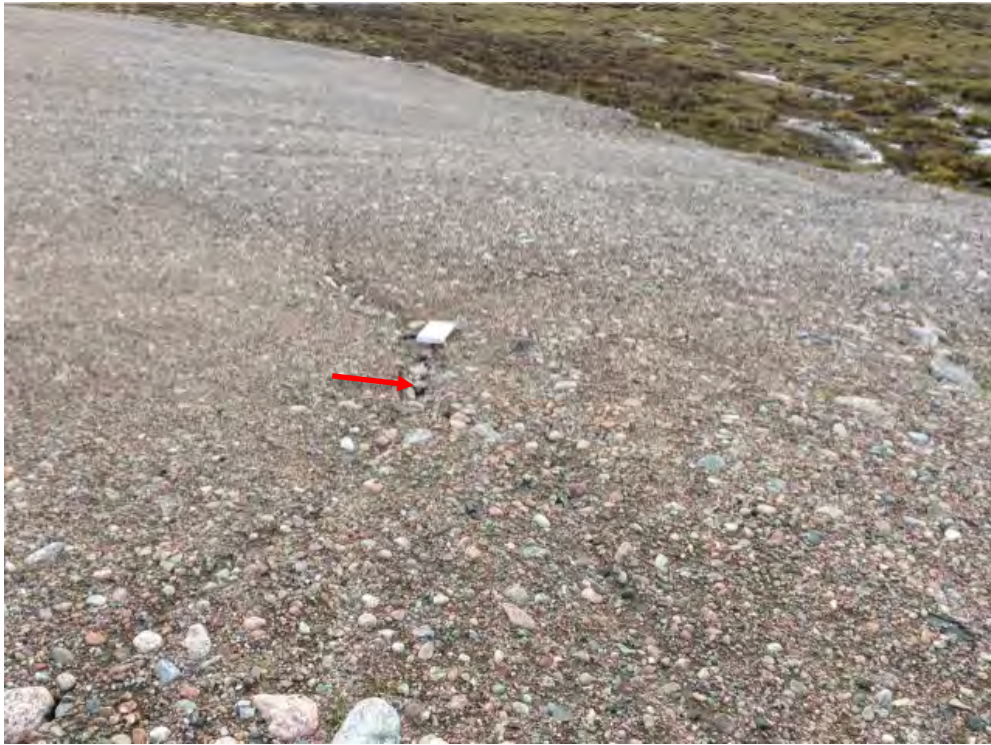
Photo 57: Lower Site Landfill South- West slope, Feature V3- Minor self-armouring erosion with new infilled cracking, facing southeast (Acceptable) (CAM5_Photo63.jpg)

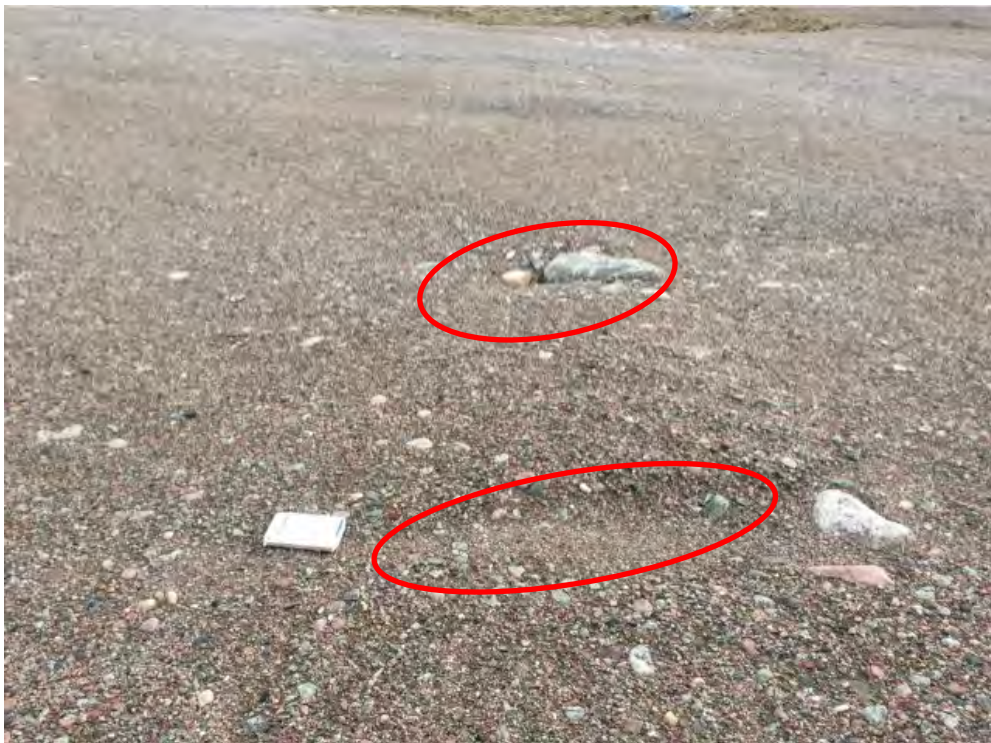
Photo 58: Lower Site Landfill South- Cover surface, Feature Z- Two small settlement areas, facing east (Acceptable) (CAM5_Photo68.jpg)

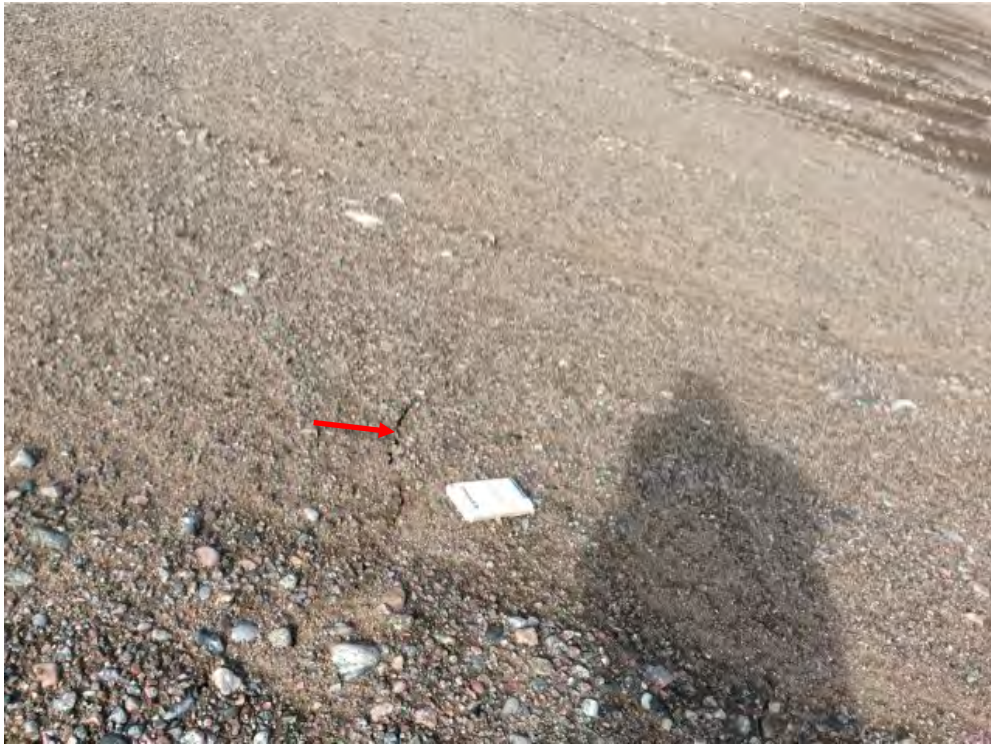
Photo 61: Lower Site Landfill South- East slope, Feature F2 -New small minor tension crack, facing northwest (Acceptable) (CAM5_Photo82.jpg)

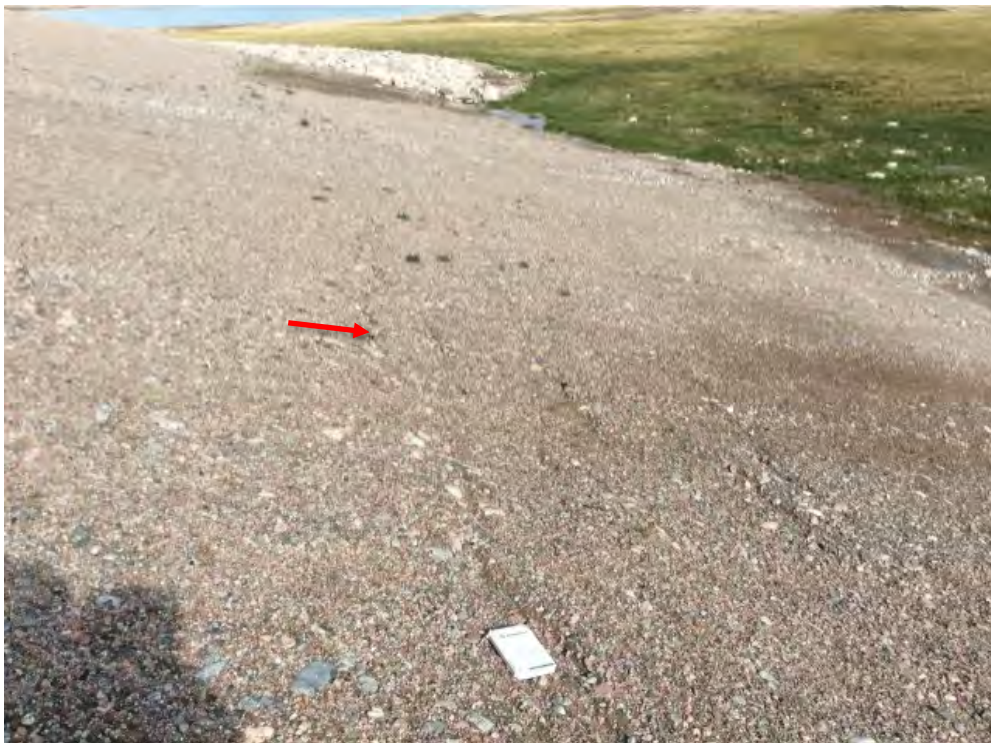
Photo 62: Lower Site Landfill South- East slope, Feature F1 – Previously observed crack above toe, facing northwest (CAM5_Photo84.jpg)

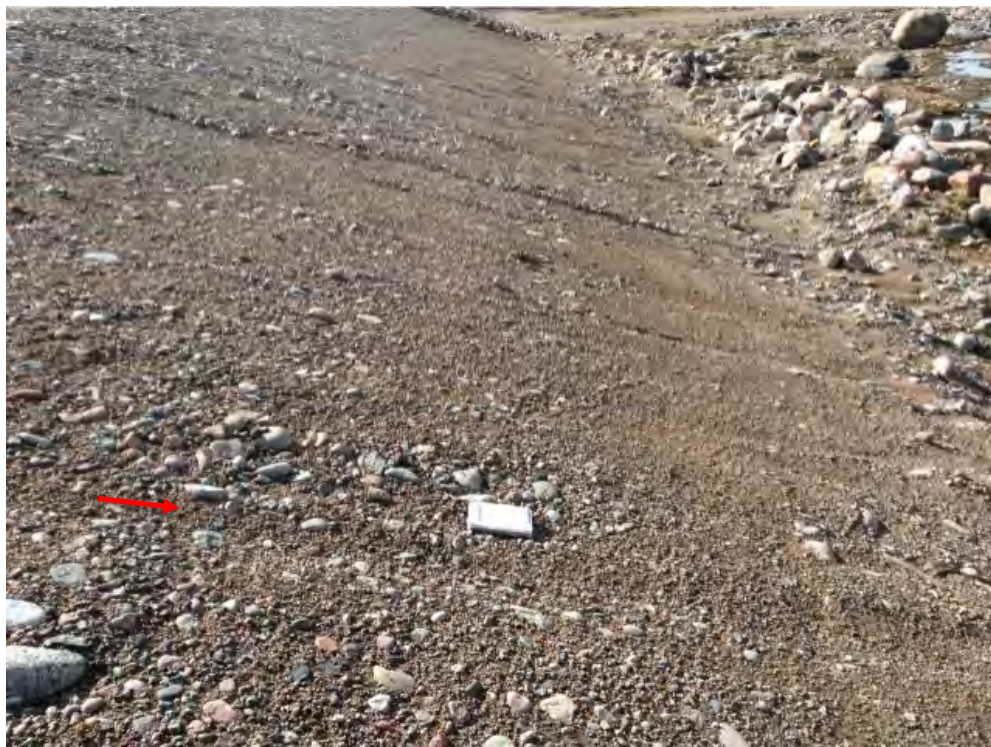
Photo 91: Non-Hazardous Waste Landfill- North slope, Feature B-Self-armouring erosion, facing southwest (Acceptable) (CAM5_Photo24.jpg)

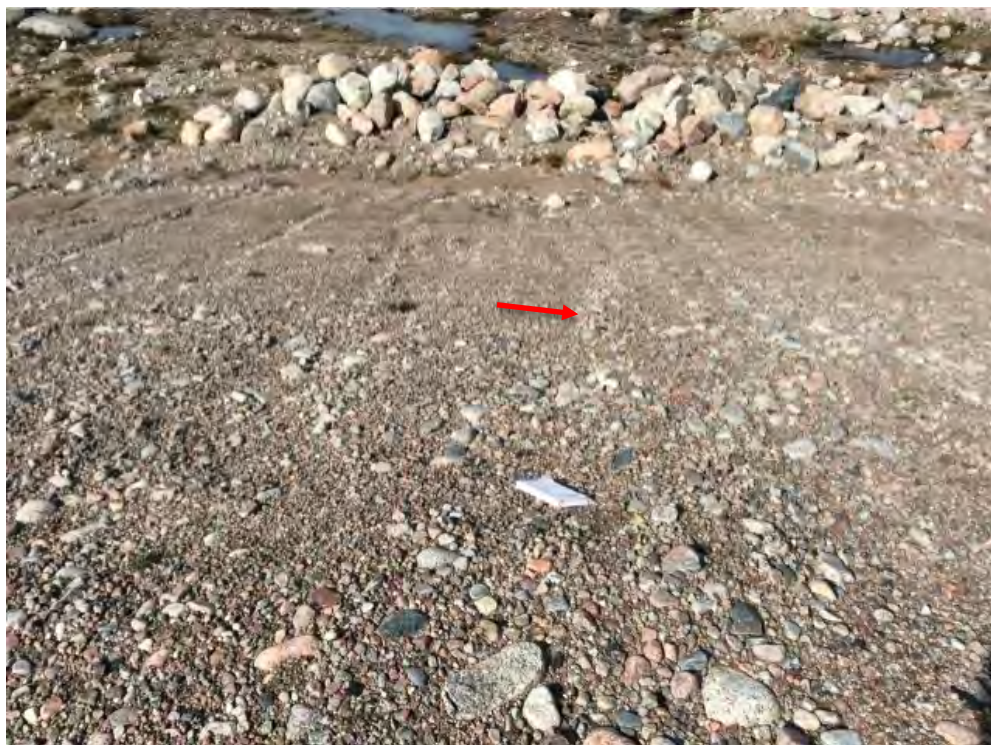
Photo 92: Non-Hazardous Waste Landfill- North slope, Feature B-Self-armouring erosion, facing northwest (Acceptable) (CAM5_Photo25.jpg)

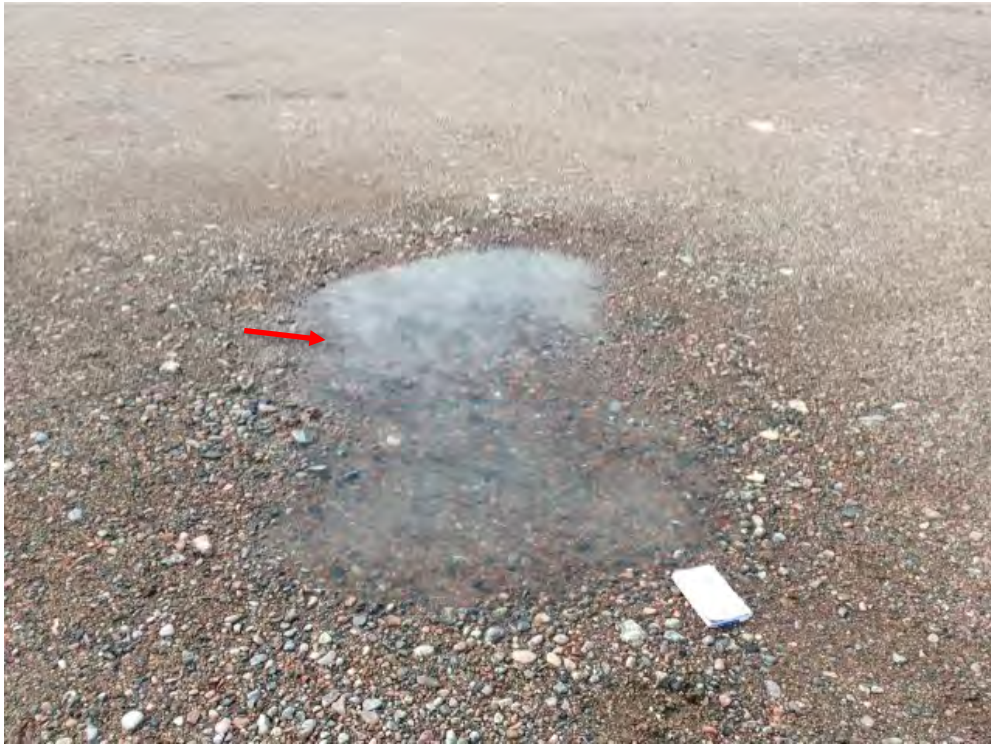
Photo 93: Non-Hazardous Waste Landfill- South crest surface, Feature D-Minor settlement with ponded water, facing east (Acceptable) (CAM5_Photo33.jpg)

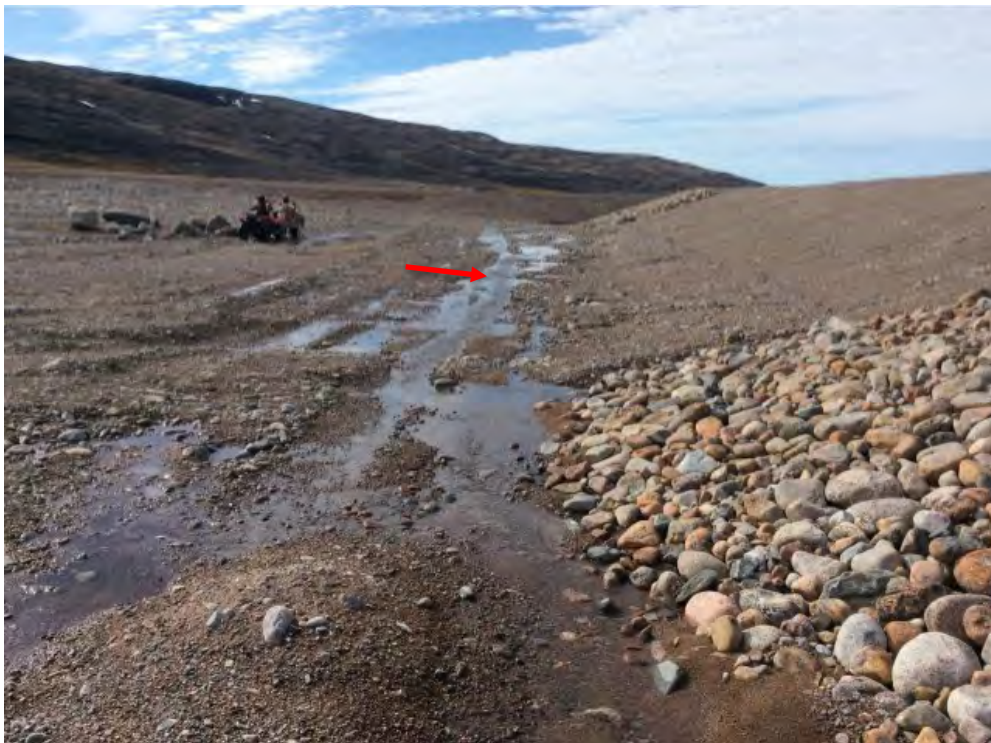
Photo 94: Non-Hazardous Waste Landfill- South toe, Feature E-Running water along toe, facing southwest (Acceptable) (CAM5_Photo12.jpg)

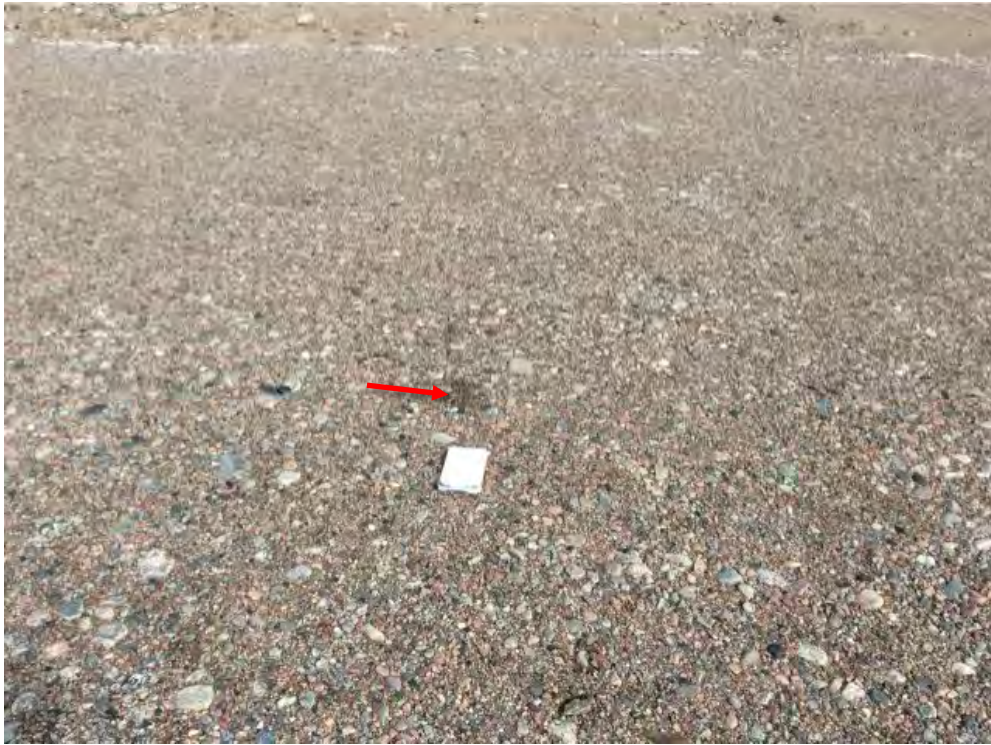
Photo 95: Non-Hazardous Waste Landfill- northeast corner crest, Feature F-Small hydrocarbon stain, facing north (Acceptable) (CAM5_Photo31.jpg)

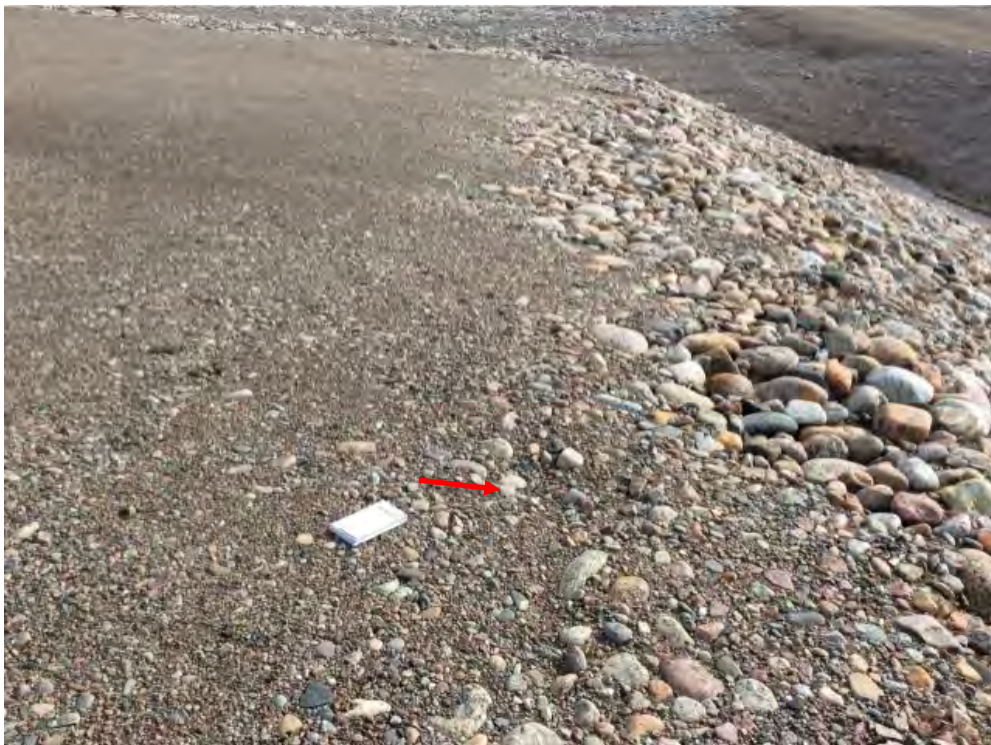
Photo 96: Non-Hazardous Waste Landfill- Southwest corner along crest, Feature G-Minor linear settlement near crest, facing southeast (Acceptable) (CAM5_Photo28.jpg)

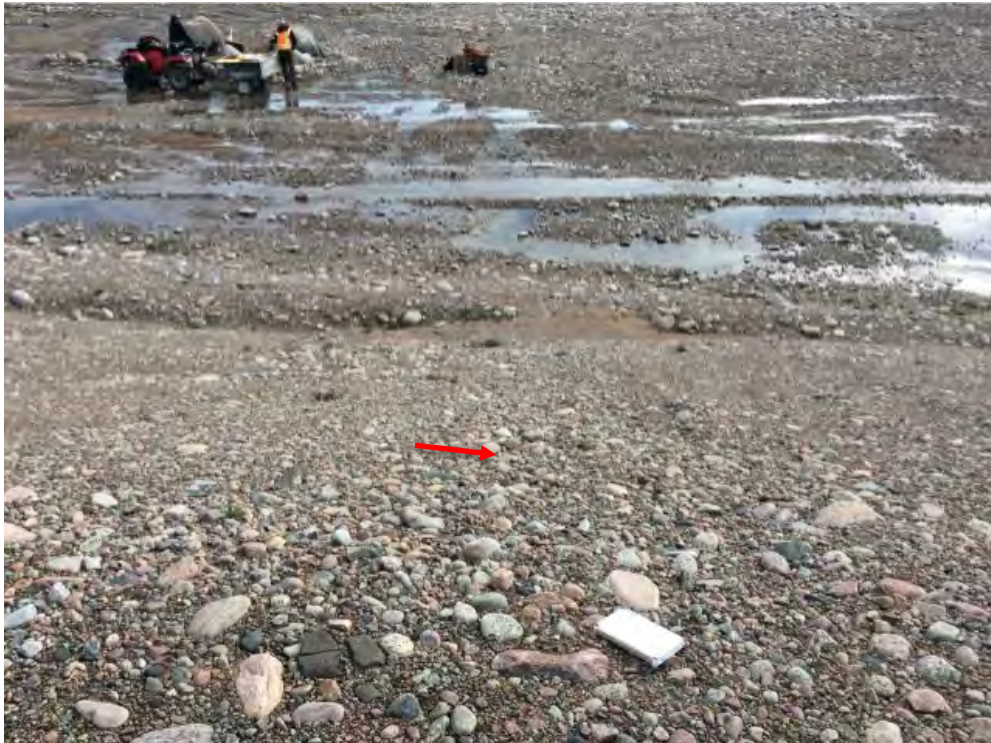
Photo 97: Non-Hazardous Waste Landfill- South slope, Feature H-Self-armouring erosion, facing southeast (Acceptable) (CAM5_Photo32.jpg)

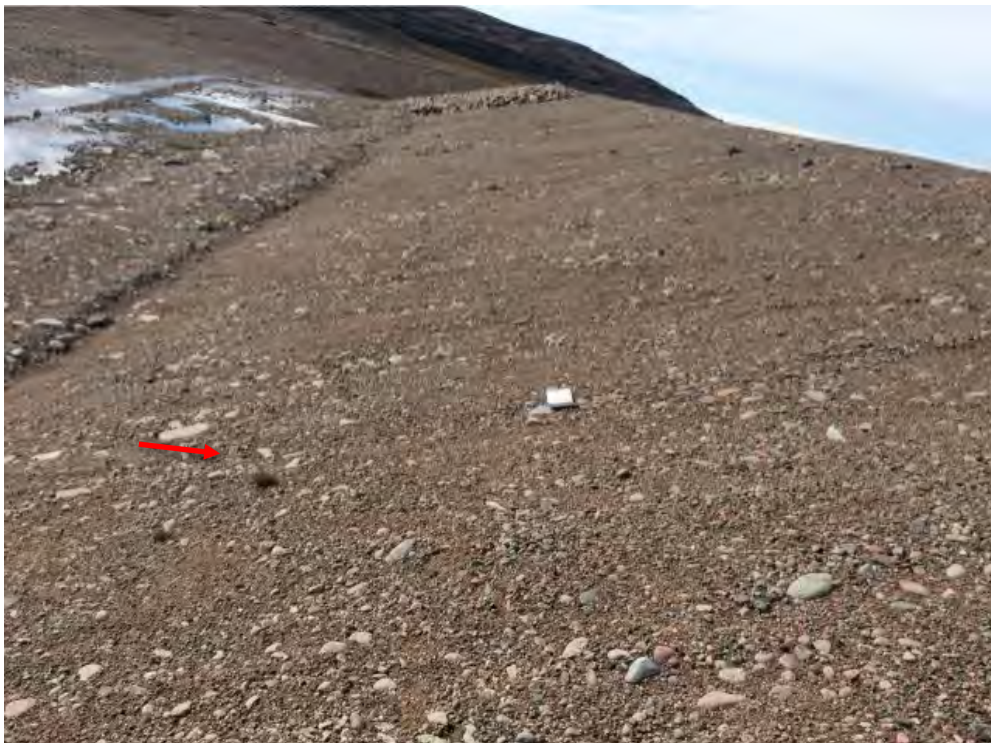
Photo 98: Non-Hazardous Waste Landfill- South slope, Feature A-Self-armouring erosion, facing southwest (Acceptable) (CAM5_Photo15.jpg)

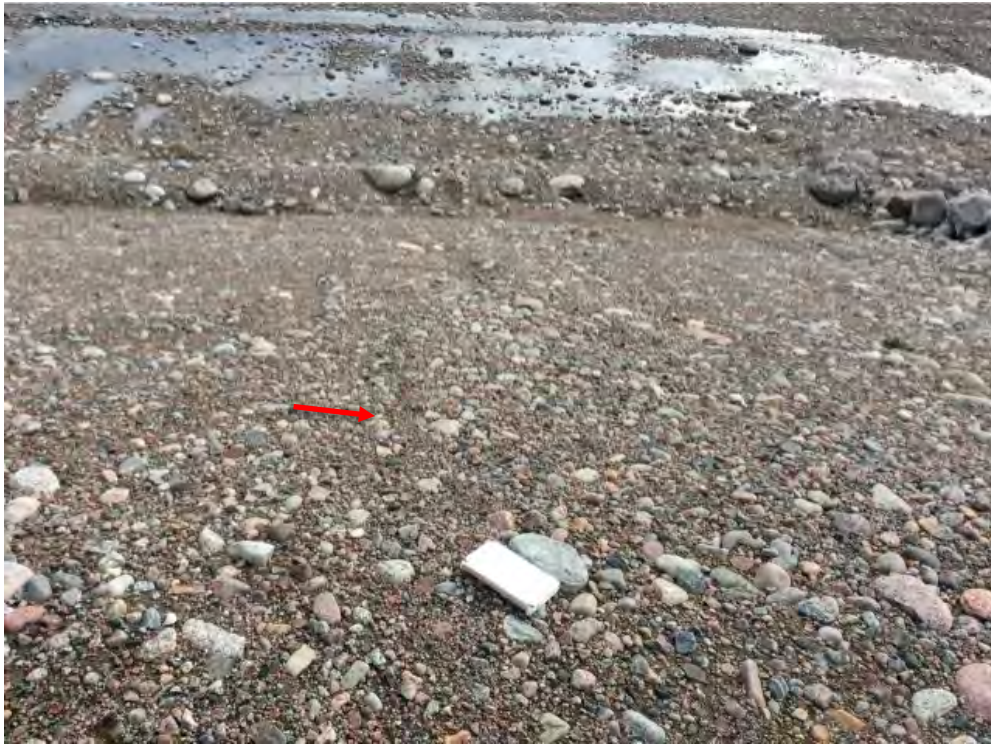
Photo 99: Non-Hazardous Waste Landfill- South slope, Feature I-Self-armouring erosion, facing southeast (Acceptable) (CAM5_Photo34.jpg)

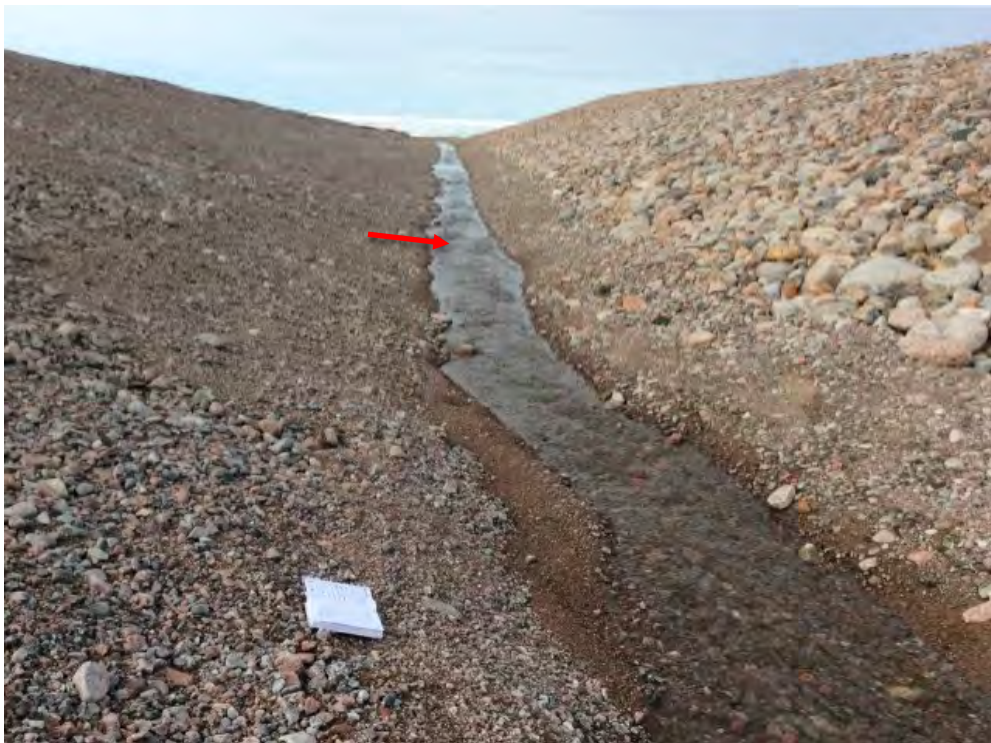
Photo 100: Non-Hazardous Waste Landfill- West toe, Feature J- Ephemeral stream along toe, facing northwest (Acceptable) (CAM5_Photo36.jpg)

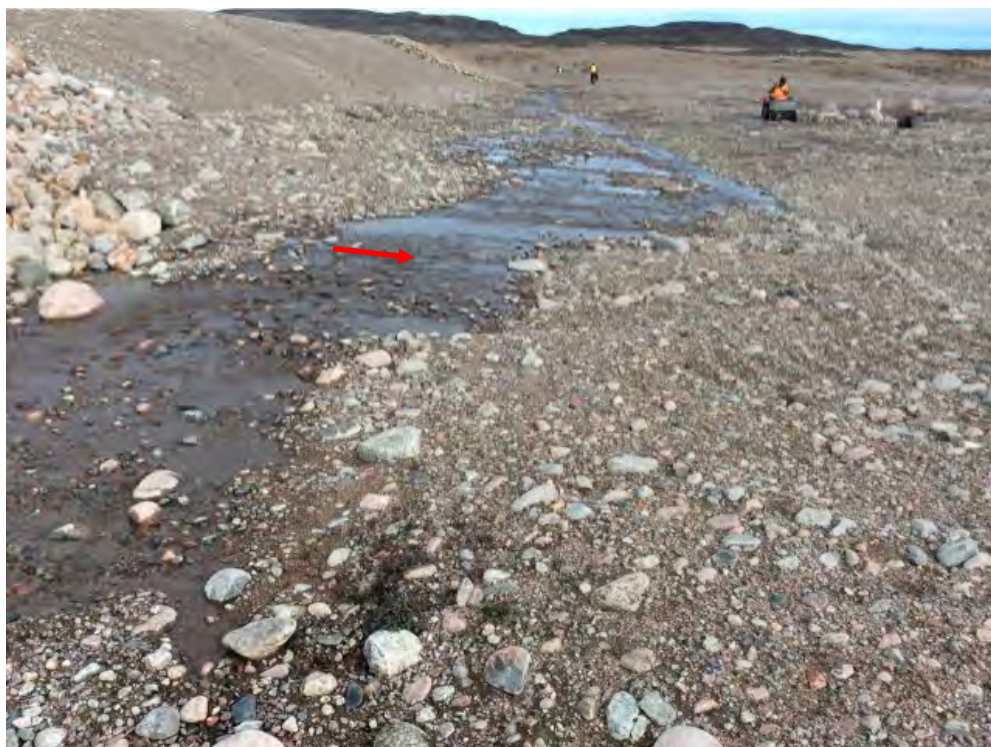
Photo 101: Non-Hazardous Waste Landfill- South toe, Feature E-Ponded/Running water along toe, facing east (Acceptable) (CAM5_Photo35.jpg)

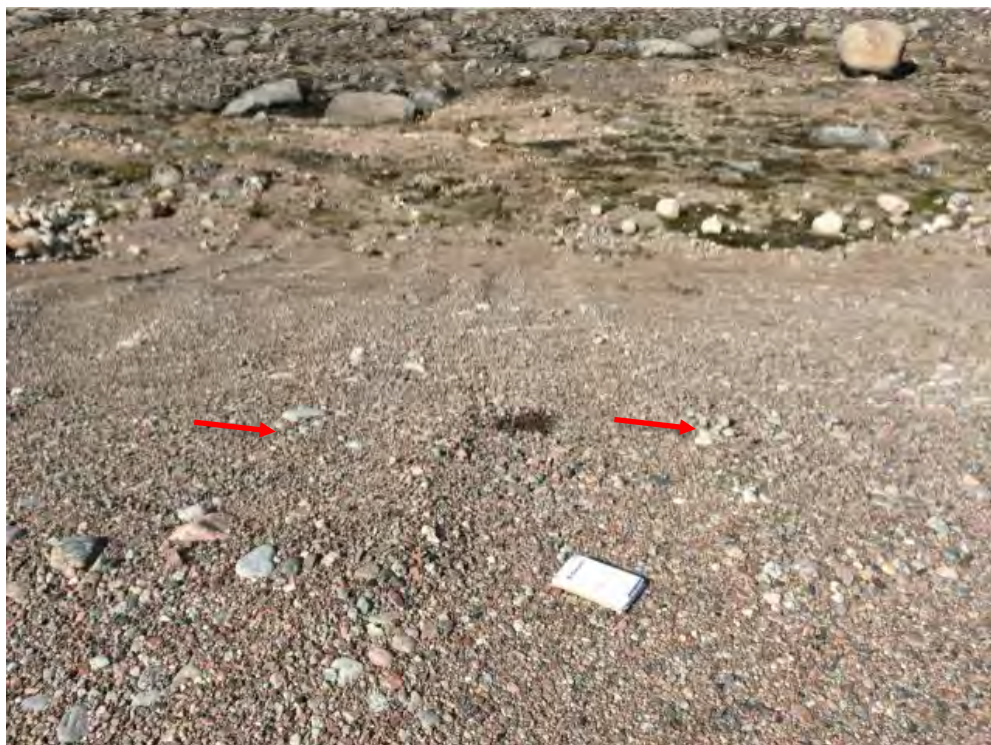
Photo 102: Non-Hazardous Waste Landfill- North slope, Feature K-Self-armouring erosion, facing northwest (Acceptable) (CAM5_Photo27.jpg)

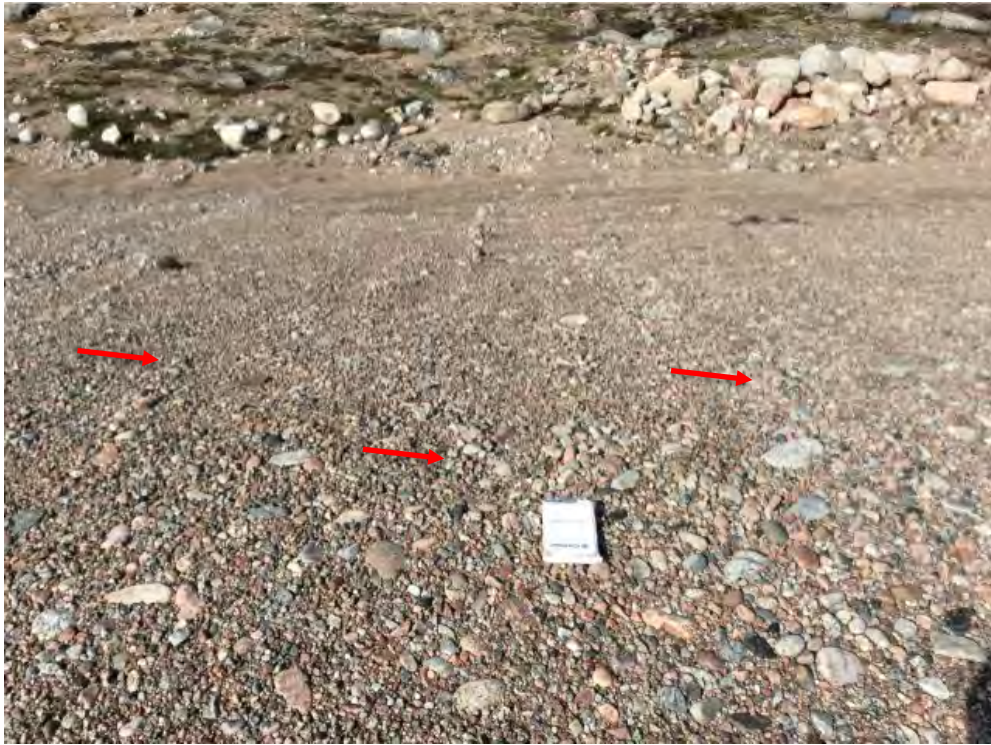
Photo 103: Non-Hazardous Waste Landfill- North slope, Feature K-Self-armouring erosion, facing northwest (Acceptable) (CAM5_Photo26.jpg)

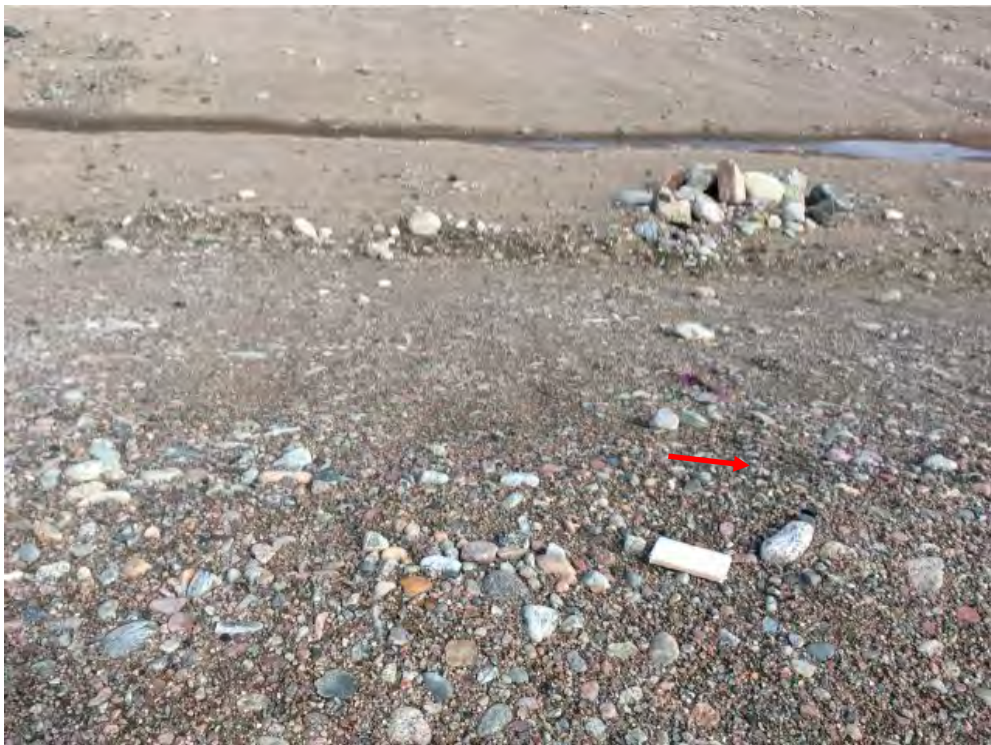
Photo 104: Non-Hazardous Waste Landfill- East slope, Feature L-Self-armouring erosion, facing northeast (Acceptable) (CAM5_Photo20.jpg)

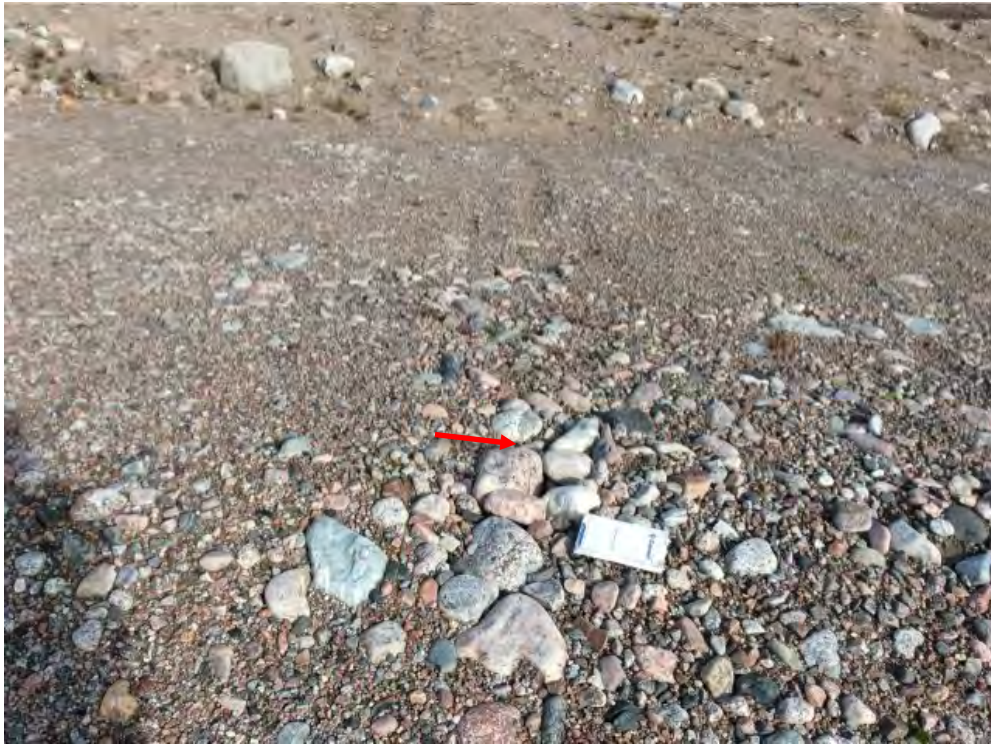
Photo 105: Non-Hazardous Waste Landfill- East slope, Feature L-Self-armouring erosion, facing northeast (Acceptable) (CAM5_Photo22.jpg)

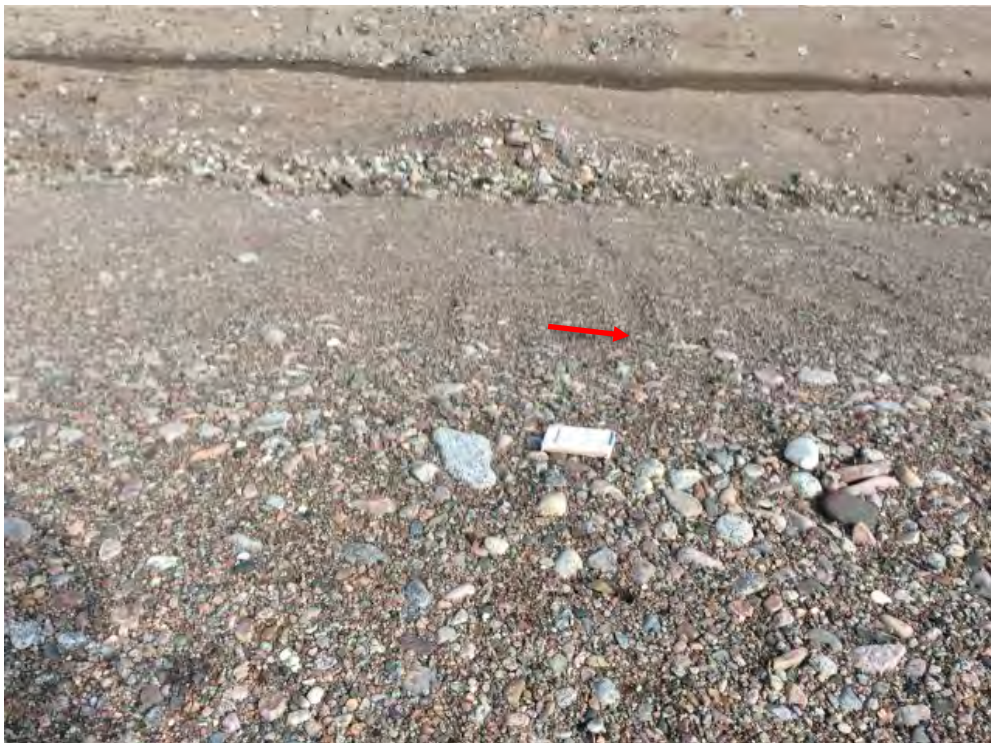
Photo 106: Non-Hazardous Waste Landfill- East slope, Feature L-Self-armouring erosion, facing northeast (Acceptable) (CAM5_Photo21.jpg)
